**Flood Control Project Maintenance  
Levee Inspections**

**Fall 2019 Levee Maintenance Deficiency Summary Report**

**Reclamation District No. 0827 Elkhorn**

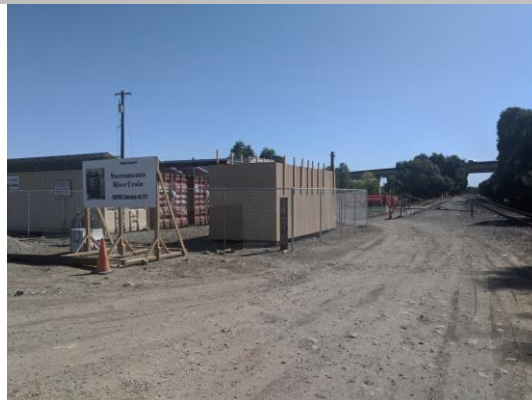
Photo 1 of 1 : FA\_2019\_RD0827\_187\_20\_20191021\_00019.jpg

LM Start	<b>0.00</b>	Rating **	M	Issue No.	<b>25</b>
LM End	<b>0.00</b>	Issue Type +	En	Location *	
Category	Supplemental			GPS Latitude/Longitude	
				Start	End
Item	DRAFT DWR UCIP Field Study			38.661210 °	38.661210 °
				-121.613030 °	-121.613030 °
DWR ID	21163				
Comment Code					
Inspector Comment					
DS_ID:21163 FS_ID:39703 EP_NO: N/A Repair Type: Non-Urgent Crossing Status: Not Found UCIP Comments: No pipe was found only what appears to be an abandoned pump house on landward side. Need to contact owner to determine status of crossing. FIELD_STRUCT_DESC: 30-inch steel pipe through the levee, 9.1 feet below the crown. Pump in pump house on landward side not waterward side as mentioned in desk study. (USACE-1955). This entry matches the Drainage or Irrigation Structure referenced in O&M manual (RM 69.50). FS Date: 3/18/2014

View of the structures on the waterside shoulder. Fall 2019.

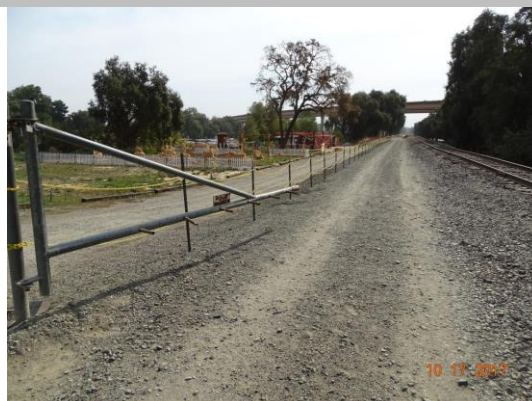
Photo 1 of 1 : FA\_2019\_RD0827\_187\_16\_20190829\_00012.jpg

View of fence on crown. Fall 2017.

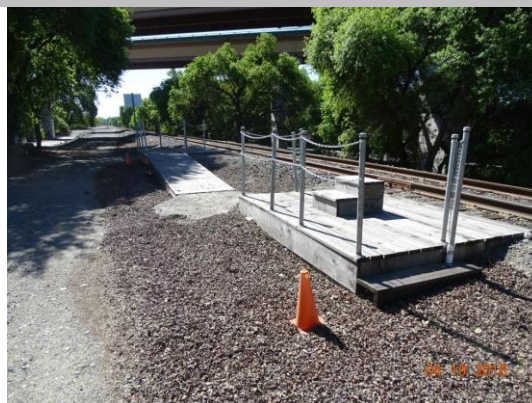
Photo 1 of 2 : FA\_2019\_RD0827\_187\_10\_20190829\_00005.jpg

View of the existing stairs and new ramp. Spring 2018.

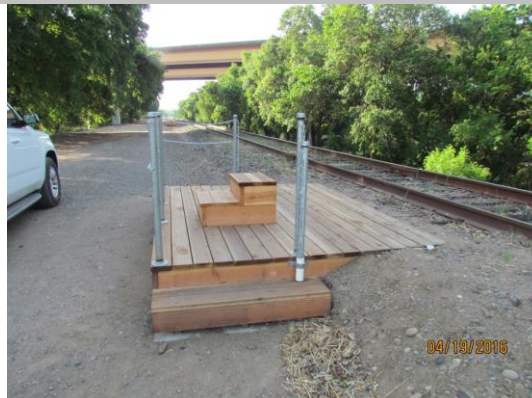
Photo 2 of 2 : FA\_2019\_RD0827\_187\_10\_20190829\_00006.jpg

View of the stairs on the crown of the levee looking downstream. Spring 2016.

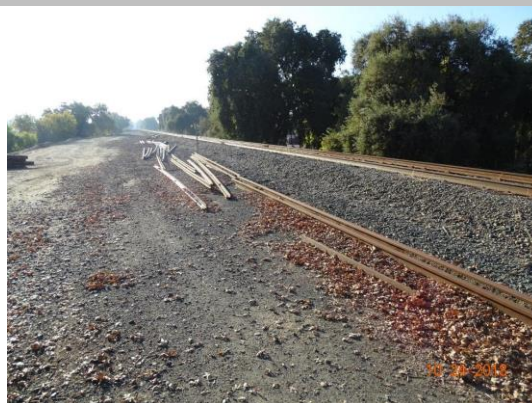
Photo 1 of 2 : FA\_2019\_RD0827\_187\_12\_20190829\_00007.jpg

LM Start	0.24	Rating **	M	Issue No.	12
LM End	0.58	Issue Type +	En	Location *	CR
Category	Earthen Levee			GPS Latitude/Longitude	
				Start	End
Item	Encroachments			38.672749 °	38.669200 °
				-121.627333 °	-121.622851 °
DWR ID	DWR_RD0827_01_s_2016_12				
Comment Code					
MA : Material					
Inspector Comment					
RR rails and ties on the levee crown.

View of railroad ties on the crown. Fall 2018.

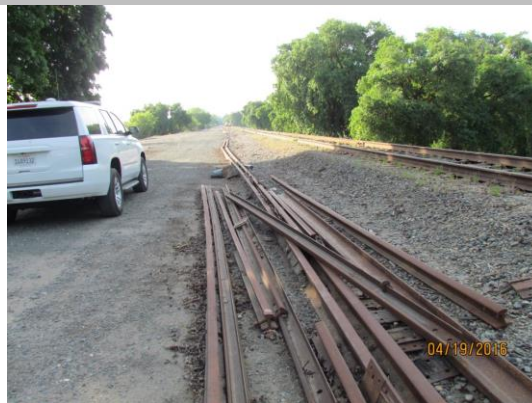
Photo 2 of 2 : FA\_2019\_RD0827\_187\_12\_20190829\_00008.jpg

View of the rails on the crown of the levee looking downstream. Spring 2016.

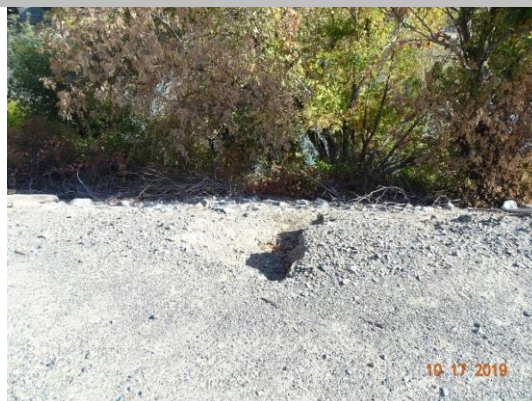
Photo 1 of 1 : FA\_2019\_RD0827\_187\_21\_20191021\_00020.jpg

LM Start	0.34	Rating **	M	Issue No.	21
LM End	0.34	Issue Type +	Ma	Location *	WS
Category	Earthen Levee			GPS Latitude/Longitude	
				Start	End
Item	Erosion / Bank Caving			38.671773 °	38.671773 °
				-121.626077 °	-121.626077 °
DWR ID	DWR_RD0827_01_f_2019_21				
Comment Code					
E2 : Schedule repair of erosion site prior to the next inspection.					
Inspector Comment					
Runoff erosion on the waterside slope near hinge point.

View of the erosion on the waterside slope. Fall 2019.

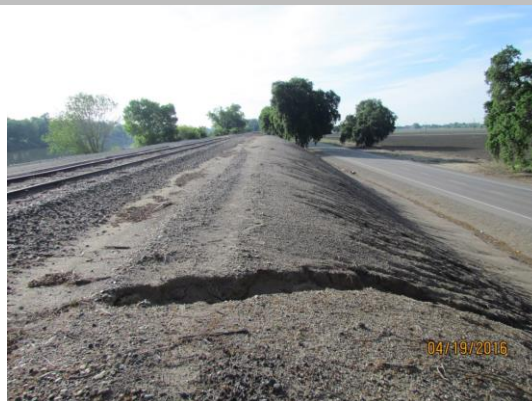
Photo 1 of 2 : FA\_2019\_RD0827\_187\_13\_20190829\_00009.jpg

LM Start	0.51	Rating **	M	Issue No.	13
LM End	0.51	Issue Type +	Ma	Location *	LS
Category	Earthen Levee			GPS Latitude/Longitude	
				Start	End
Item	Erosion / Bank Caving			38.669929 °	38.669929 °
				-121.623776 °	-121.623776 °
DWR ID	DWR_RD0827_01_s_2016_13				
Comment Code					
E2 : Schedule repair of erosion site prior to the next inspection.					
Inspector Comment					
Rills caused by rain.

View of the erosion on the landward side of the levee looking downstream. Spring 2016.

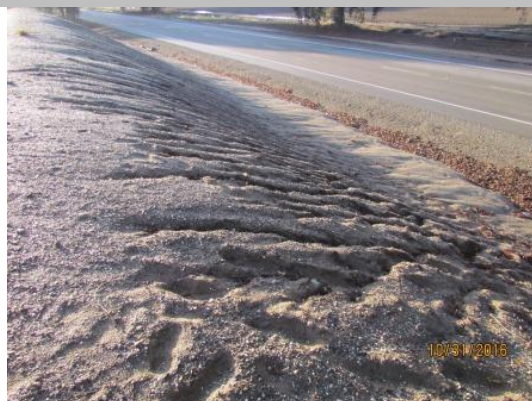
Photo 2 of 2 : FA\_2019\_RD0827\_187\_13\_20190829\_00010.jpg

LM Start	0.51	Rating **	M	Issue No.	13 (cont)	
LM End	0.51	Issue Type +	Ma	Location *	LS	
Category	Earthen Levee			GPS Latitude/Longitude		
				Start		End
Item	Erosion / Bank Caving			38.669929 °		38.669929 °
				-121.623776 °		-121.623776 °
DWR ID	DWR_RD0827_01_s_2016_13					
Comment Code						
E2 : Schedule repair of erosion site prior to the next inspection.						
Inspector Comment						
Rills caused by rain.

View of runoff erosion site. LS slope. Fall 2016.

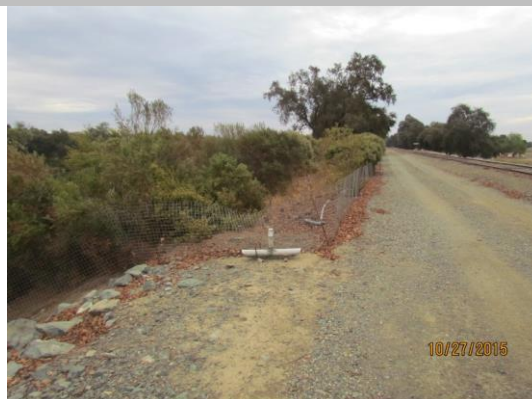
Photo 2 of 2 : FA\_2019\_RD0827\_187\_22\_20190829\_00015.jpg

View of the revegetation site on the waterward side of the levee looking downstream. Fall 2015.

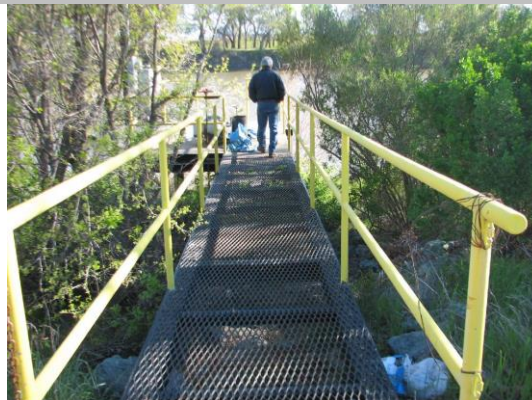
Photo 1 of 3 : UCIP\_FA\_2019\_38983\_59737.jpg

Comment Code						
Inspector Comment						
DS_ID:21147 FS_ID:38983 EP_NO: N/A Repair Type: Non-Urgent Crossing Status: Found UCIP Comments: Need to contact owner to obtain additional information for this crossing. This crossing does not match original description listed in desk study. Need to coordinate with owner to obtain permit number authorizing modification. FIELD_STRUCT_DESC: 14-inch (not 16-inch as listed in desk study) pipe through the levee, 10.3 feet below the crown. 10-inch bypass pipe on waterside (WS). Siphon breaker on landside (LS) (not WS) shoulder. Pump on platform (not mounted on 48-inch concrete pipe as described in desk study) on WS bank. Metal (not wooden) walkway to the pump. 3/4-inch conduit through levee at unknown depth. [Additional Reference(s): DWR Levee Logs, 2005] FS Date: 3/18/2014

Platform for pump located on waterward side.

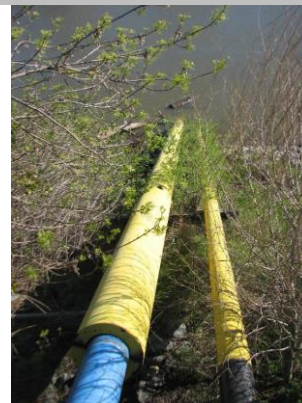
Photo 2 of 3 : UCIP\_FA\_2019\_38983\_59736.jpg

Pipe visible on waterward side.

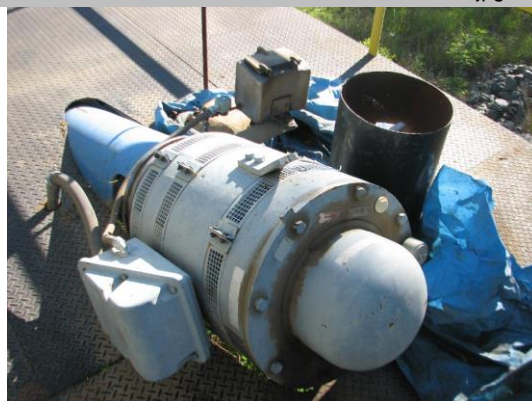
Photo 3 of 3 : UCIP\_FA\_2019\_38983\_59735.jpg

Comment Code						
Inspector Comment						
DS_ID:21147 FS_ID:38983 EP_NO: N/A Repair Type: Non-Urgent Crossing Status: Found UCIP Comments: Need to contact owner to obtain additional information for this crossing. This crossing does not match original description listed in desk study. Need to coordinate with owner to obtain permit number authorizing modification. FIELD_STRUCT_DESC: 14-inch (not 16-inch as listed in desk study) pipe through the levee, 10.3 feet below the crown. 10-inch bypass pipe on waterside (WS). Siphon breaker on landside (LS) (not WS) shoulder. Pump on platform (not mounted on 48-inch concrete pipe as described in desk study) on WS bank. Metal (not wooden) walkway to the pump. 3/4-inch conduit through levee at unknown depth. [Additional Reference(s): DWR Levee Logs, 2005] FS Date: 3/18/2014

Slant pump located on waterward side.

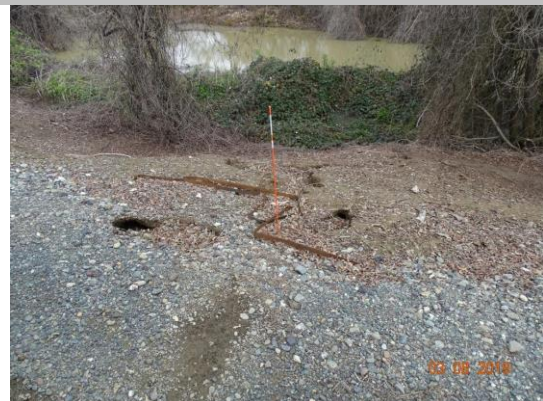
Photo 1 of 1 : FA\_2019\_RD0827\_187\_17\_20190829\_00013.jpg

LM Start	1.09	Rating **	M	Issue No.	17
LM End	1.09	Issue Type +	Ma	Location *	WS
Category	Earthen Levee			GPS Latitude/Longitude	
				Start	End
Item	Erosion / Bank Caving			38.663946 °	38.663946 °
				-121.616453 °	-121.616453 °
DWR ID	DWR_RD0827_01_s_2019_17				
Comment Code					
E2 : Schedule repair of erosion site prior to the next inspection.					
Inspector Comment					
Runoff site through rodent holes.

View of erosion on the waterside slope. Spring 2019.

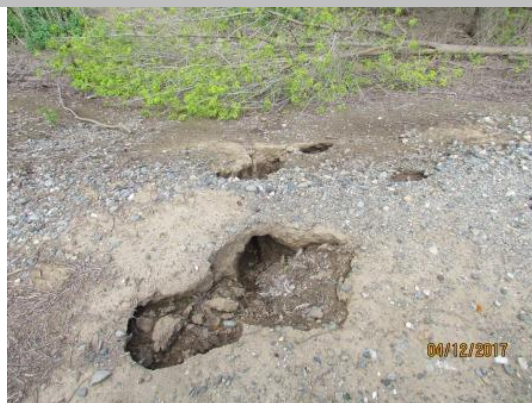
Photo 1 of 3 : FA\_2019\_RD0827\_187\_3\_20190829\_00001.jpg

LM Start	1.12	Rating **	M	Issue No.	3
LM End	1.12	Issue Type +	Ma	Location *	WS
Category	Earthen Levee			GPS Latitude/Longitude	
				Start	End
Item	Erosion / Bank Caving			38.663542 °	38.663542 °
				-121.616056 °	-121.616056 °
DWR ID	DWR_RD0827_01_f_2016_3				
Comment Code					
E2 : Schedule repair of erosion site prior to the next inspection.					
Inspector Comment					
Erosion on the crown and waterside slope from runoff.

View of erosion on waterside levee slope. Spring 2017.

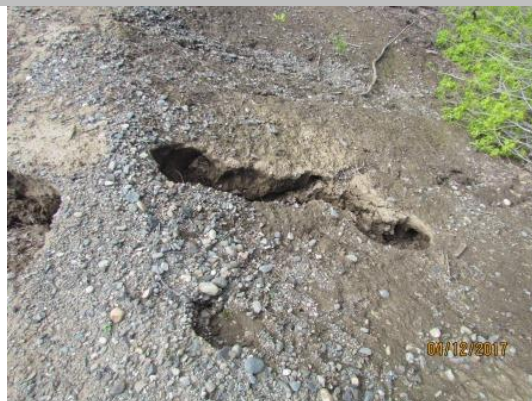
Photo 2 of 3 : FA\_2019\_RD0827\_187\_3\_20190829\_00002.jpg

Another view of erosion on levee slope. A hole on the waterside slope has widened due to runoff. Spring 2017.

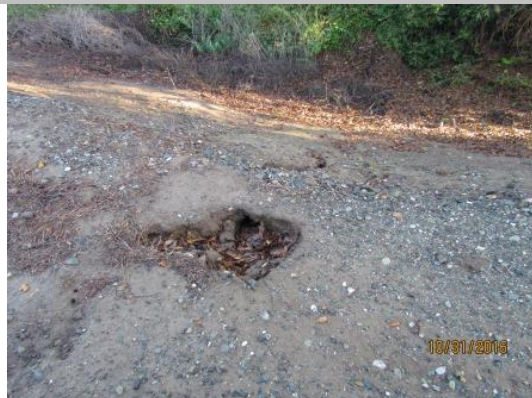
Photo 3 of 3 : FA\_2019\_RD0827\_187\_3\_20190829\_00003.jpg

LM Start	1.12	Rating **	M	Issue No.	3 (cont)	
LM End	1.12	Issue Type +	Ma	Location *	WS	
Category	Earthen Levee			GPS Latitude/Longitude		
				Start		End
Item	Erosion / Bank Caving			38.663542 °		38.663542 °
				-121.616056 °		-121.616056 °
DWR ID	DWR_RD0827_01_f_2016_3					
Comment Code						
E2 : Schedule repair of erosion site prior to the next inspection.						
Inspector Comment						
Erosion on the crown and waterside slope from runoff.

View of erosion on crown continuing to WS slope. Fall 2016.

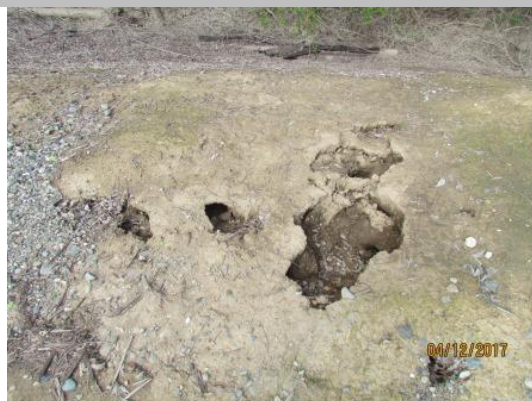
Photo 1 of 1 : FA\_2019\_RD0827\_187\_14\_20190829\_00011.jpg

LM Start	1.14	Rating **	A/W	Issue No.	14
LM End	1.14	Issue Type +	Ma	Location *	WS
Category	Earthen Levee			GPS Latitude/Longitude	
				Start	End
Item	Erosion / Bank Caving			38.663377 °	38.663377 °
				-121.615895 °	-121.615895 °
DWR ID	DWR_RD0827_01_s_2017_14				
Comment Code					
E2 : Schedule repair of erosion site prior to the next inspection.					
Inspector Comment					
Minor erosion on waterside slope. Recommend monitoring

View of erosion on waterside levee slope. Spring 2017.

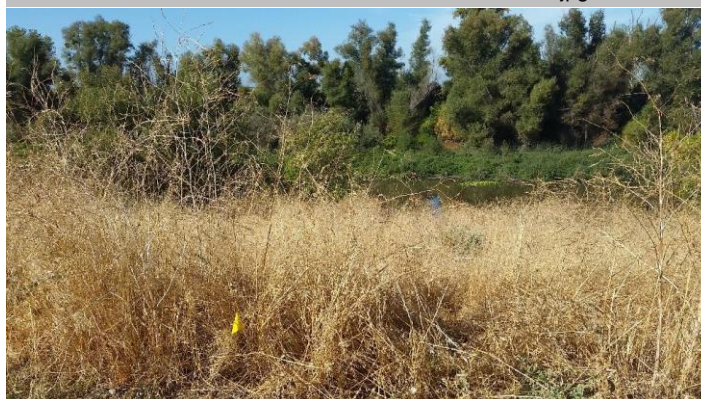
Photo 1 of 3 : UCIP\_FA\_2019\_50065\_75673.jpg

DS_ID:24844
FS_ID:50065
EP_NO: 17403
Repair Type: Non-Urgent
Crossing Status: Indicator Found

View of WS--Tule Canal.

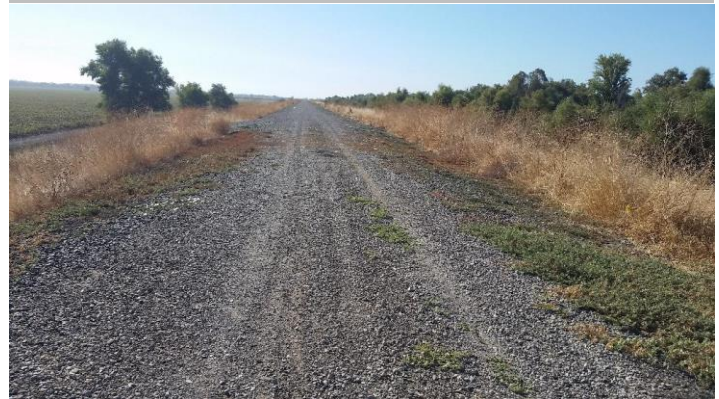
Photo 2 of 3 : UCIP\_FA\_2019\_50065\_75672.jpg

View of levee crown at crossing--yellow flag markers visible on both WS and LS shoulder.

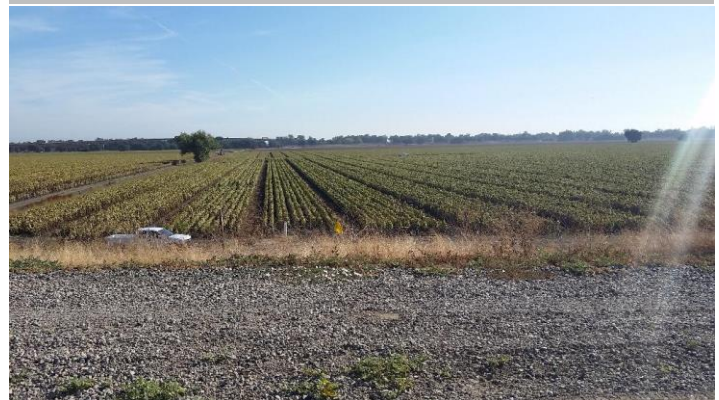
Photo 3 of 3 : UCIP\_FA\_2019\_50065\_75671.jpg

View of LS.

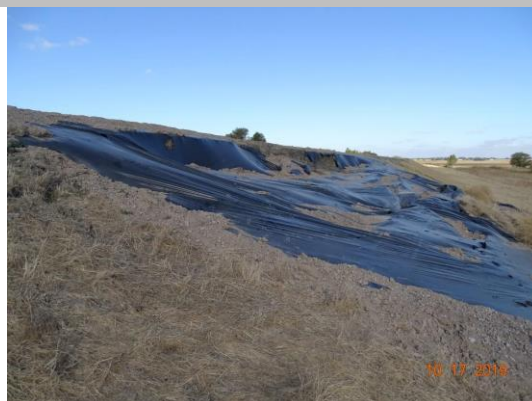
Photo 1 of 3 : FA\_2019\_RD0827\_188\_8\_20191021\_00026.jpg

LM Start	1.94	Rating **	U	Issue No.	8
LM End	1.96	Issue Type +	Ma	Location *	LS
Category	Earthen Levee			GPS Latitude/Longitude	
				Start	End
Item	Slope Stability			38.652232°	38.651939°
				-121.627264°	-121.627088°
DWR ID	DWR_RD0827_02_s_2019_8				
Comment Code					
S1 : Repair slope instability.					
Inspector Comment					
100' sloughing section on the landside slope. Exposed scarp is approximately 4' at the worst section. LMA placed visqueen over the issue.

View of sloughing on the landside slope. Fall 2019.

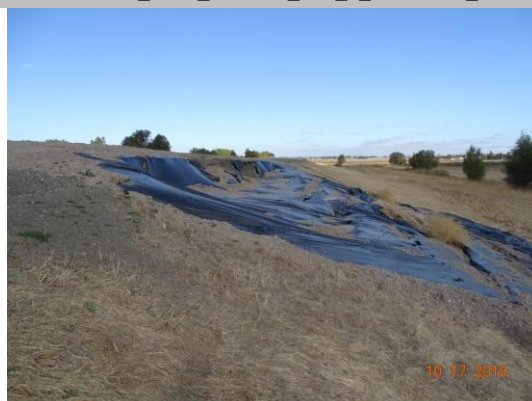
Photo 2 of 3 : FA\_2019\_RD0827\_188\_8\_20191021\_00025.jpg

Additional view of sloughing on the landside slope. Fall 2019.

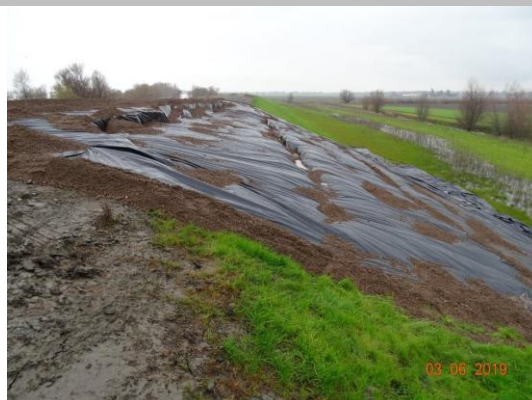
Photo 3 of 3 : FA\_2019\_RD0827\_188\_8\_20190829\_00002.jpg

View of sloughing on the landside slope. Spring 2019.

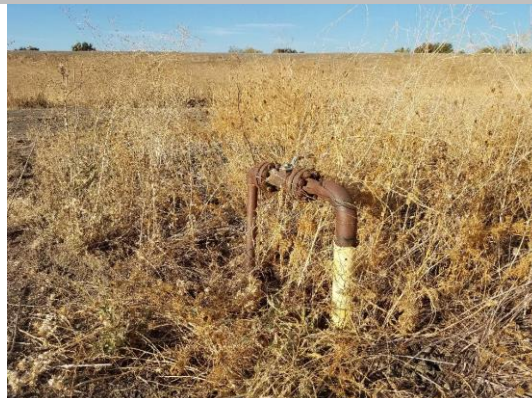
Photo 1 of 3 : UCIP\_FA\_2019\_53087\_78352.jpg

Comment Code					
Inspector Comment					
DS_ID:21159 FS_ID:53087 EP_NO: 15904 Repair Type: Non-Urgent Crossing Status: Indicator Found UCIP Comments: 10/25/2018 Markers on levee not found. Pipe not in use. Valve located on pipe bend near ditch on LS is shut down. Crossing has been downgraded to "Non-Urgent" due to reclassification of gas lines. (O.Yakimov - DWR UCIP) 8/31/2016 Meet with Greg Lucas, Assistant Production Coordinator from California Resources Corporation and Steve Steim from Noble Methan, Inc. to discuss the status of a different line upstream. Mr. Steve Steim was aware of the 3-inch line by Two Bay Petroleum as known as a PG&E old pipe at this location. According to Steve Stein the appurtenances previously located on the landside have been removed and the 3-inch line abandoned. Need to contact owner to confirm status of crossing. If crossing is no longer in use the owner will need to coordinate with CVFPB to comply with Title 23. (DWR UCIP - omagana)8/04/2016 No markers found on either WS or LS. Need to coordinate with owner to determine status of crossing. (DWR UCIP - omagana)3/10/2015 Sign missing on WS and LS. Need to confirm status of crossing with permittee. Appears abandoned. (DWR UCIP - wwylie) 03/18/2014 crossing not found. (DWR UCIP - omagana) FIELD_STRUCT_DESC: 3-inch steel gas pipeline through the levee, 20 feet below the crown. Sign on waterside (WS) (not found 2015). Yellow pipe visible east of ditch approximately 150 feet off landside (LS) toe. Contact Number 415-459-3445 for Two Bay Petroleum also referred as Pacific Energetics, Inc. (3-inch line authorized under Permit No. 15904, 1992 - Two Bay Petroleum) FS Date: 10/25/2018 10:29:07 AM

Gas pipe with shut-down valve closed.

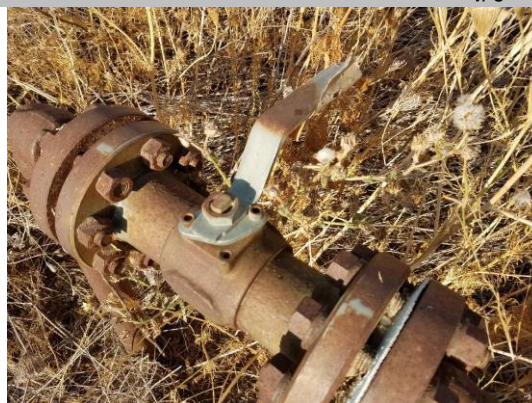
Photo 2 of 3 : UCIP\_FA\_2019\_53087\_78353.jpg

UCIP Comments: 10/25/2018 Markers on levee not found. Pipe not in use. Valve located on pipe bend near ditch on LS is shut down. Crossing has been downgraded to "Non-Urgent" due to reclassification of gas lines. (O.Yakimov - DWR UCIP) 8/31/2016 Meet with Greg Lucas, Assistant Production Coordinator from California Resources Corporation and Steve Steim from Noble Methan, Inc. to discuss the status of a different line upstream. Mr. Steve Steim was aware of the 3-inch line by Two Bay Petroleum as known as a PG&E old pipe at this location. According to Steve Stein the appurtenances previously located on the landside have been removed and the 3-inch line abandoned. Need to contact owner to confirm status of crossing. If crossing is no longer in use the owner will need to coordinate with CVFPB to comply with Title 23. (DWR UCIP - omagana)8/04/2016 No markers found on either WS or LS. Need to coordinate with owner to determine status of crossing. (DWR UCIP - omagana)3/10/2015 Sign missing on WS and LS. Need to confirm status of crossing with permittee. Appears abandoned. (DWR UCIP - wwylie)

FIELD\_STRUCT\_DESC: 3-inch steel gas pipeline through the levee, 20 feet below the crown. Sign on waterside (WS) (not found 2015). Yellow pipe visible east of ditch approximately 150 feet off landside (LS) toe. Contact Number 415-459-3445 for Two Bay Petroleum also referred as Pacific Energetics, Inc. (3-inch line authorized under Permit No. 15904, 1992 - Two Bay Petroleum)

Closer view of gas pipe with shut-down valve closed.

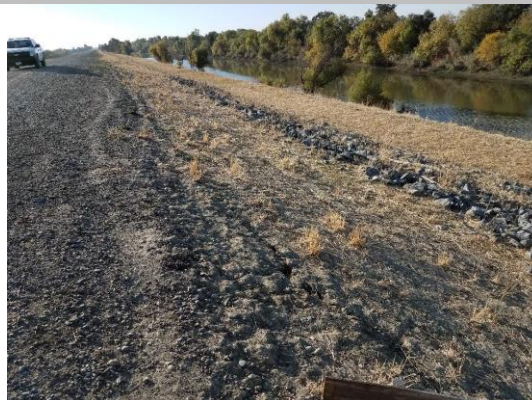
Photo 3 of 3 : UCIP\_FA\_2019\_53087\_78354.jpg

DS\_ID:21159  
FS\_ID:53087  
EP\_NO: 15904  
Repair Type: Non-Urgent  
Crossing Status: Indicator Found  
UCIP Comments: 10/25/2018 Markers on levee not found. Pipe not in use. Valve located on pipe bend near ditch on LS is shut down. Crossing has been downgraded to "Non-Urgent" due to reclassification of gas lines. (O.Yakimov - DWR UCIP) 8/31/2016 Meet with Greg Lucas, Assistant Production Coordinator from California Resources Corporation and Steve Steim from Noble Methan, Inc. to discuss the status of a different line upstream. Mr. Steve Steim was aware of the 3-inch line by Two Bay Petroleum as known as a PG&E old pipe at this location. According to Steve Stein the appurtenances previously located on the landside have been removed and the 3-inch line abandoned. Need to contact owner to confirm status of crossing. If crossing is no longer in use the owner will need to coordinate with CVFPB to comply with Title 23. (DWR UCIP - omagana)8/04/2016 No markers found on either WS or LS. Need to coordinate with owner to determine status of crossing. (DWR UCIP - omagana)3/10/2015 Sign missing on WS and LS. Need to confirm status of crossing with permittee. Appears abandoned. (DWR UCIP - wwylie)

View of WS slope at crossing.

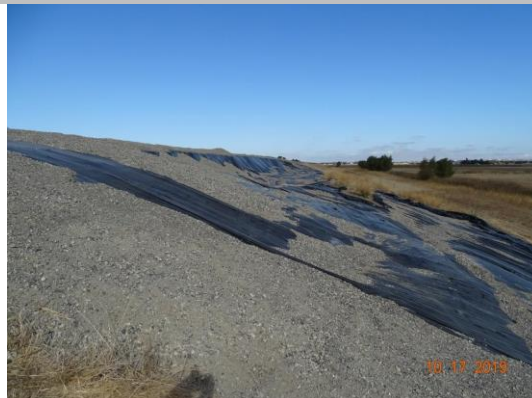
Photo 1 of 2 : FA\_2019\_RD0827\_188\_7\_20191021\_00024.jpg

LM Start	2.09	Rating **	U	Issue No.	7
LM End	2.14	Issue Type +	Ma	Location *	LS
Category	Earthen Levee			GPS Latitude/Longitude	
				Start	End
Item	Slope Stability			38.650245 °	38.649602 °
				-121.626036 °	-121.625646 °
DWR ID	DWR_RD0827_02_s_2019_7				
Comment Code					
S1 : Repair slope instability.					
Inspector Comment					
Sloughing from 2019 storm damage. LMA placed visqueen over the issue.

View of the sloughing on the landside slope. Fall 2019.

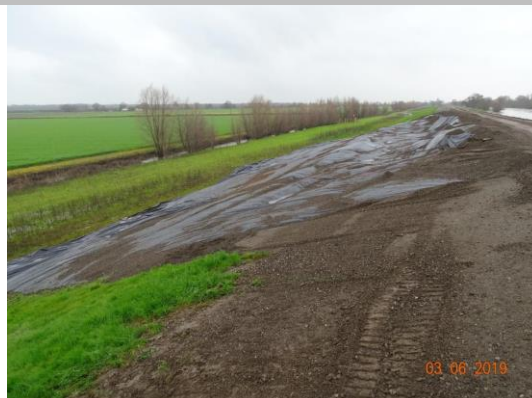
Photo 2 of 2 : FA\_2019\_RD0827\_188\_7\_20190829\_00001.jpg

View of sloughing on the landside slope. Spring 2019.

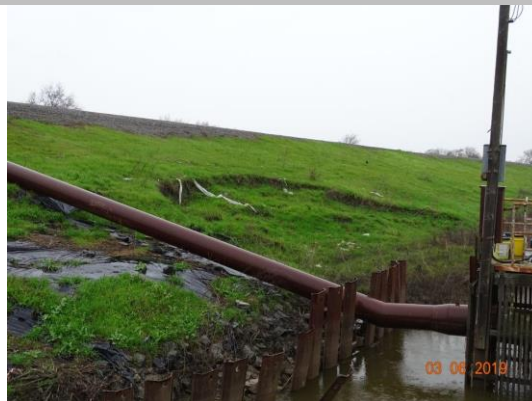
Photo 1 of 4 : FA\_2019\_RD0827\_188\_13\_20190829\_00006.jpg

LM Start	2.72	Rating **	M	Issue No.	13
LM End	2.73	Issue Type +	Ma	Location *	LS
Category	Supplemental			GPS Latitude/Longitude	
				Start	End
Item	2017 Storm Damage			38.642139°	38.642028°
				-121.620750°	-121.620667°
DWR ID	RD 827-01				
Comment Code					
Inspector Comment					
Levee Evaluation Comments					
Description:					
Site ID No:199					
Site Designation:RD 827-01					
Repair Type: Erosion					
Rating:Area of Concern					
Field Date:6/6/2017					
Notes: landside. Sloughing on the landside slope near pump.					
Movement has stabilized and the LMA will be constructing a setback levee within the next 3 years. Recommend monitoring.

View of sloughing on the landside slope. Spring 2019.

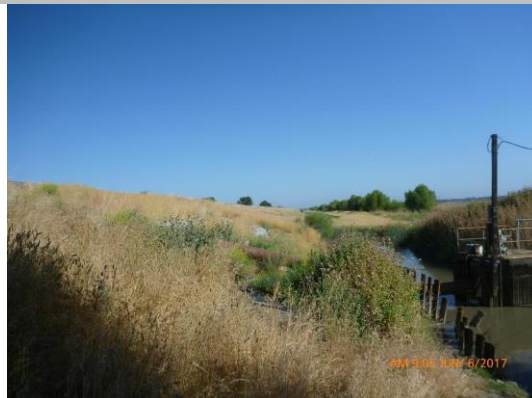
Photo 2 of 4 : LEVAL\_FA\_2019\_199\_1231.jpg

LM Start	2.72	Rating **	M	Issue No.	13 (cont)
LM End	2.73	Issue Type +	Ma	Location *	LS
Category	Supplemental			GPS Latitude/Longitude	
				Start	End
Item	2017 Storm Damage			38.642139°	38.642028°
				-121.620750°	-121.620667°
DWR ID	RD 827-01				
Comment Code					
Inspector Comment					
Levee Evaluation Comments					
Description:					
Site ID No:199					
Site Designation:RD 827-01					
Repair Type: Erosion					
Rating:Area of Concern					
Field Date:6/6/2017					
Notes: landside. Sloughing on the landside slope near pump.					
Movement has stabilized and the LMA will be constructing a setback levee within the next 3 years. Recommend monitoring.

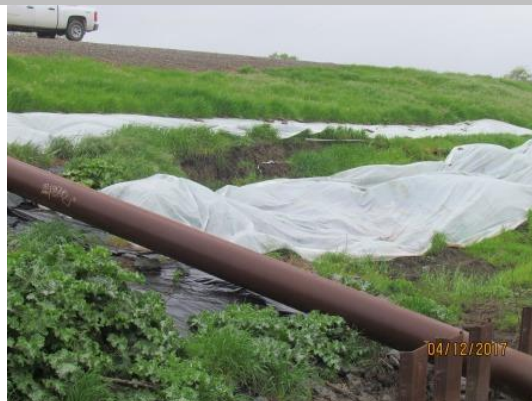
Photo 1 of 2 : FA\_2019\_RD0827\_188\_14\_20190829\_00010.jpg

LM Start	2.72	Rating **	A/W	Issue No.	14
LM End	2.72	Issue Type +	Ma	Location *	LS
Category	Earthen Levee			GPS Latitude/Longitude	
				Start	End
Item	Slope Stability			38.642018 °	38.642018 °
				-121.620944 °	-121.620944 °
DWR ID	DWR_RD0827_02_s_2017_14				
Comment Code					
S1 : Repair slope instability.					
Inspector Comment					
Sloughing on the landside slope near pump. Movement has stabilized.

View of sloughing and visqueen on landside levee slope. Spring 2017.

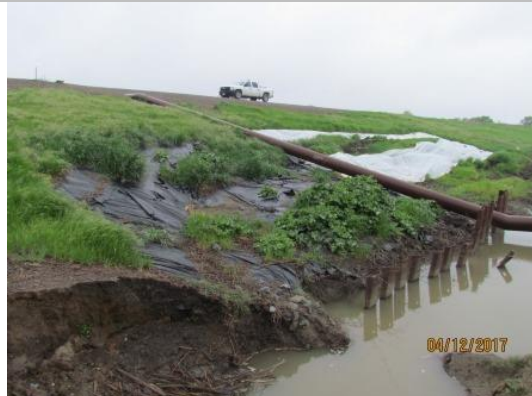
Photo 2 of 2 : FA\_2019\_RD0827\_188\_14\_20190829\_00011.jpg

Additional view of sloughing on landside levee slope. Spring 2017.

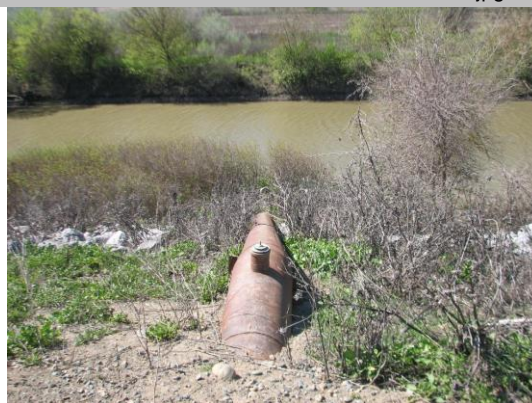
Photo 1 of 3 : UCIP\_FA\_2019\_38984\_59769.jpg

LM Start	2.73	Rating **	M	Issue No.	17	
LM End	2.73	Issue Type +	En	Location *		
Category	Supplemental			GPS Latitude/Longitude		
				Start	End	
Item	DRAFT DWR UCIP Field Study			38.641922 °	38.641922 °	
				-121.620884 °	-121.620884 °	
DWR ID	21151

View of pipe visible on waterward side.

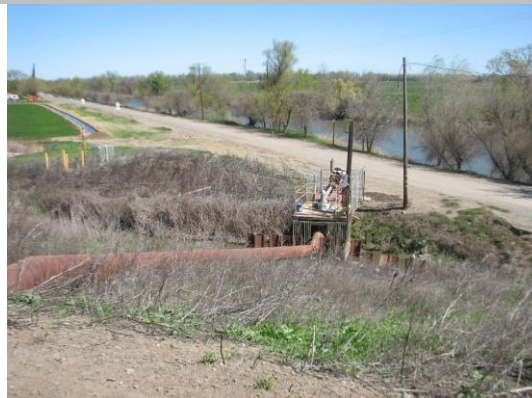
Photo 2 of 3 : UCIP\_FA\_2019\_38984\_59768.jpg

View of landward side.

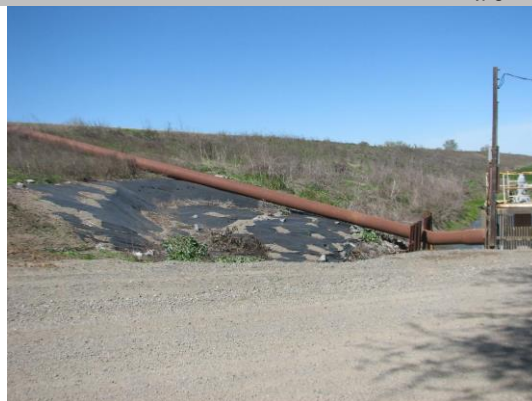
Photo 3 of 3 : UCIP\_FA\_2019\_38984\_59767.jpg

Pipe exposed on landward side.

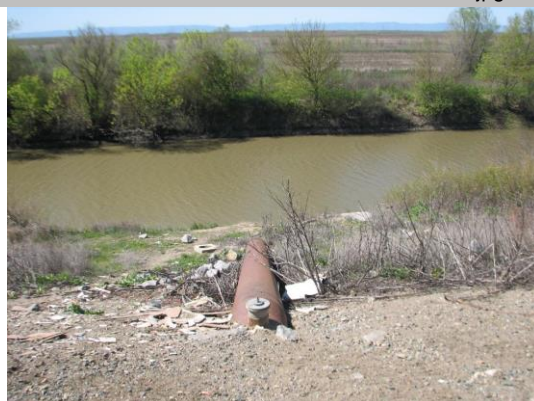
Pipe exposed on waterward side.

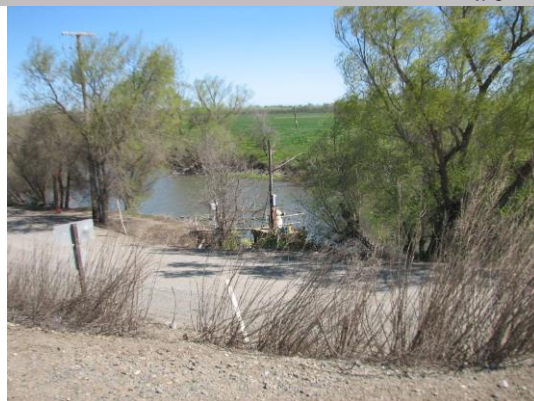
Pump station located on landward side.

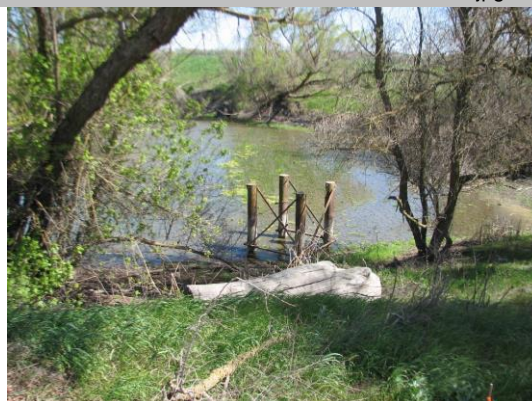
Photo 3 of 3 : UCIP\_FA\_2019\_33032\_59776.jpg

Remininse piles located on landward side.
