Flood Control Project Maintenance Levee Inspections

Fall 2020 Levee Maintenance Deficiency Summary Report

Sacramento River Basin

Reclamation District No. 0827 Elkhorn

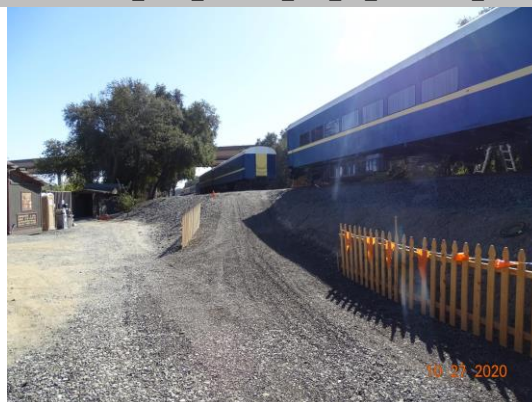
Photo 1 of 1 : FA_2020_RD0827_187_30_20201028_00023.jpg

LM Start	0.00	Rating **	U	Issue No.	30
LM End	0.16	Issue Type +	En	Location *	CR
Category	Earthen Levee			GPS Latitude/Longitude	
				Start	End
Item	Encroachments			38.675168 °	38.673575 °
				-121.630530 °	-121.628398 °
DWR ID	DWR_RD0827_01_s_2020_30				
Comment Code					
EQ : Equipment					
Inspector Comment					
Sierra Railroad has placed track and rail cars on the crown that prevent vehicle access. They have constructed a new ramp and berm to access the portion of levee that does not have track on the crown.

View of ramp to adjacent waterside berm. Fall 2020.

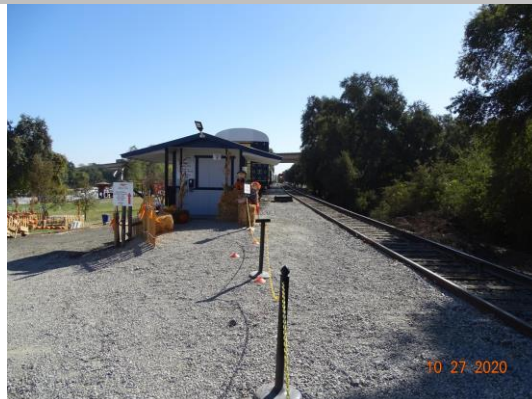
Photo 1 of 1 : FA_2020_RD0827_187_20_20201028_00024.jpg

LM Start	0.03	Rating **	U	Issue No.	20
LM End	0.03	Issue Type +	En	Location *	WS
Category	Earthen Levee			GPS Latitude/Longitude	
				Start	End
Item	Encroachments			38.674912 °	38.674912 °
				-121.630133 °	-121.630133 °
DWR ID	DWR_RD0827_01_f_2019_20				
Comment Code					
BU : Building					
Inspector Comment					
Sacramento River Train has constructed their office and a ticket booth on the waterside shoulder and crown.

View of ticket booth on crown. Fall 2020.

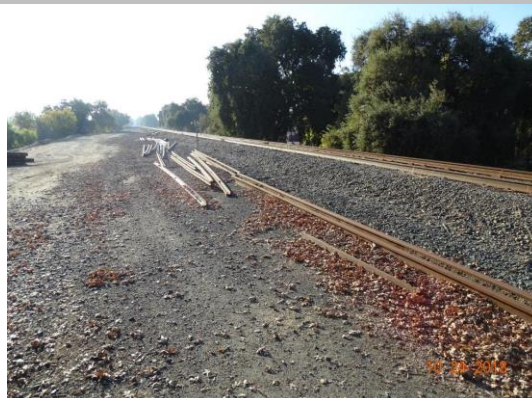
Photo 1 of 1 : FA_2020_RD0827_187_12_20200813_00004.jpg

LM Start	0.23	Rating **	M	Issue No.	12
LM End	0.27	Issue Type +	En	Location *	CR
Category	Earthen Levee			GPS Latitude/Longitude	
				Start	End
Item	Encroachments			38.672803 °	38.672400 °
				-121.627416 °	-121.626890 °
DWR ID	DWR_RD0827_01_s_2016_12				
Comment Code					
MA : Material					
Inspector Comment					
RR rails and ties on the levee crown.

View of railroad ties on the crown. Fall 2018.

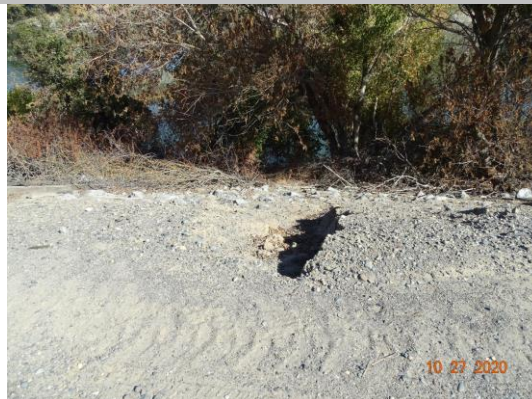
Photo 1 of 1 : FA_2020_RD0827_187_21_20201028_00025.jpg

LM Start	0.34	Rating **	M	Issue No.	21
LM End	0.34	Issue Type +	Ma	Location *	WS
Category	Earthen Levee			GPS Latitude/Longitude	
				Start	End
Item	Erosion / Bank Caving			38.671773 °	38.671773 °
				-121.626077 °	-121.626077 °
DWR ID	DWR_RD0827_01_f _ 2019_21				
Comment Code					
E2 : Schedule repair of erosion site prior to the next inspection.					
Inspector Comment					
Erosion on the waterside shoulder.

View of erosion on the waterside slope. Fall 2020.

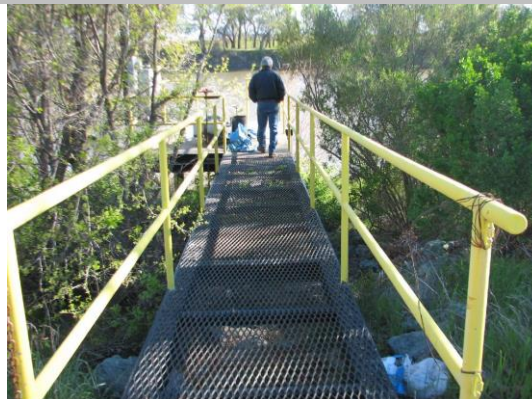
Photo 1 of 3 : UCIP_FA_2020_38983_59737.jpg

Comment Code						
Inspector Comment						
DS_ID:21147 FS_ID:38983 EP_NO: N/A Repair Type: Non-Urgent EVAL Issue: Crossing Status: Found UCIP Comments: Need to contact owner to obtain additional information for this crossing. This crossing does not match original description listed in desk study. Need to coordinate with owner to obtain permit number authorizing modification. FIELD_STRUCT_DESC: 14-inch (not 16-inch as listed in desk study) pipe through the levee, 10.3 feet below the crown. 10-inch bypass pipe on waterside (WS). Siphon breaker on landside (LS) (not WS) shoulder. Pump on platform (not mounted on 48-inch concrete pipe as described in desk study) on WS bank. Metal (not wooden) walkway to the pump. 3/4-inch conduit through levee at unknown depth. [Additional Reference(s): DWR Levee Logs, 2005] FS Date: 3/18/2014

Platform for pump located on waterward side.

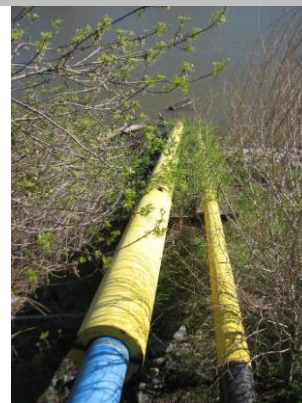
Photo 2 of 3 : UCIP_FA_2020_38983_59736.jpg

Pipe visible on waterward side.

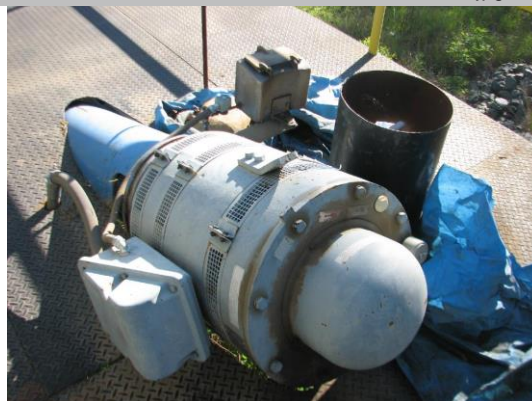
Photo 3 of 3 : UCIP_FA_2020_38983_59735.jpg

Slant pump located on waterward side.

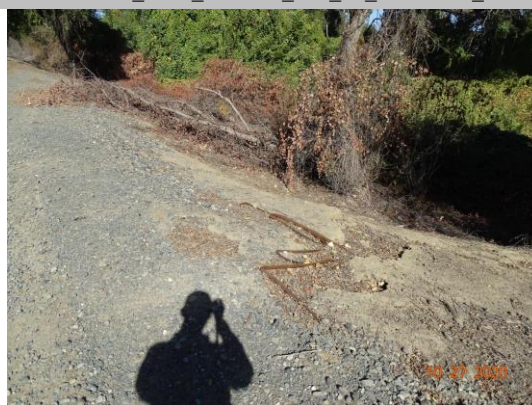
Photo 1 of 1 : FA_2020_RD0827_187_17_20201028_00021.jpg

LM Start	1.09	Rating **	A/W	Issue No.	17
LM End	1.09	Issue Type +	Ma	Location *	WS
Category	Earthen Levee			GPS Latitude/Longitude	
				Start	End
Item	Erosion / Bank Caving			38.663946 °	38.663946 °
				-121.616453 °	-121.616453 °
DWR ID	DWR_RD0827_01_s_2019_17				
Comment Code					
E2 : Schedule repair of erosion site prior to the next inspection.					
Inspector Comment					
Previous runoff site that has filled in with material. Recommend monitoring.

View of erosion on the waterside slope. Fall 2020.

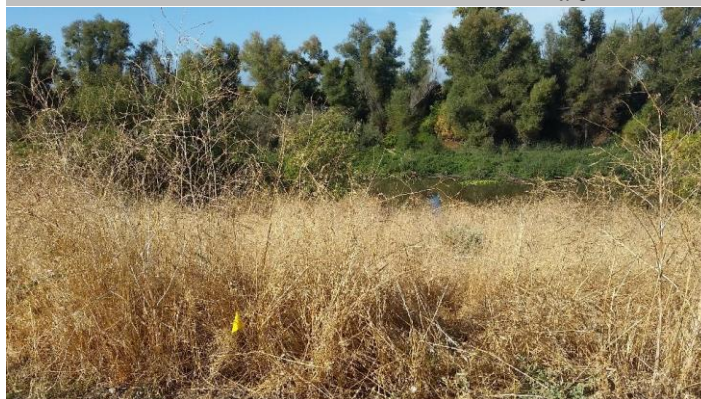
Photo 1 of 3 : UCIP_FA_2020_50065_75673.jpg

DS_ID:24844
FS_ID:50065
EP_NO: 17403
Repair Type: Non-Urgent
EVAL Issue:
Crossing Status: Indicator Found
UCIP Comments: 9/27/2016 Need to coordinate with Greg Lucas (gregory.lucas@crc.com) with California Resources Corporation to determine if line will be brought online. Crossing was downgraded from Urgent to Non-Urgent--new owner has not brought the pipe online. New owner will need to update permit name and if line becomes active markers will be required per Title 23. (DWR UCIP - omagana)9/02/2016 Meet with Jimmy Preston from California Resources Corporation at site. Alignment of crossing was confirmed (new location is approximately 290 feet upstream from previous point)--report has been updated. Pending action -- Name Change (DWR UCIP - omagana)9/01/2016 Email was sent to Greg Lucas from California Resources Corporation with an updated UCIP detailed report and Central Valley Flood Protection Board (CVFPB) name change form. New owner will need to update permit information with the CVFPB to be compliant with Title 23 requirements. (DWR UCIP - omagana)8/31/2016 New owner--California Resources Corporation. Gas line is currently not in use. Meet with Greg Lucas, Assistant Production Coordinator from California Resources Corporation and Steve Stein from Noble Methan, Inc. to clarify current status of crossing and determine crossing alignment. Gas well is part of the gas line appurtenances. Gas line alignment is still pending--California Resources Corporation will send out someone to confirm alignment. Crossing is missing markers, if line becomes active markers will be needed on both the WS and LS to comply with Title 23--encouraged owner to contact CVFPB. (DWR UCIP - omagana)8/30/2016 Coordinating with AA Production Services, Inc. to determine location of where crossing goes through levee. It appears that the gas well located on LS is not part of this crossing. (DWR UCIP - omagana)8/04/2016 Meet with Bill Mattos, representative of RD 827, and he took me to the gas well visible from levee crown. Mr. Mattos was unable to confirm if gas well and pipeline that goes through the levee were connected. 3/18/2014 No markers visible on either banks. Need to contact owner to determine status of crossing. Need date of last inspection and confirmation that crossing is still in operable condition. (DWR UCIP - omagana)

FIELD_STRUCT_DESC: [Hanks 34-2] 2.375-inch steel natural gas pipe through the levee, 30 feet below the crown and under (bored) Tule Canal. Gas well is located on the landside (LS) approximately 994 feet from levee crown. California Resources Corporation acquired AA Production Services, Inc. The new owner of the 2.375-inch gas pipe is California Resources Corporation. (2.375-inch line authorized under

View of WS--Tule Canal.

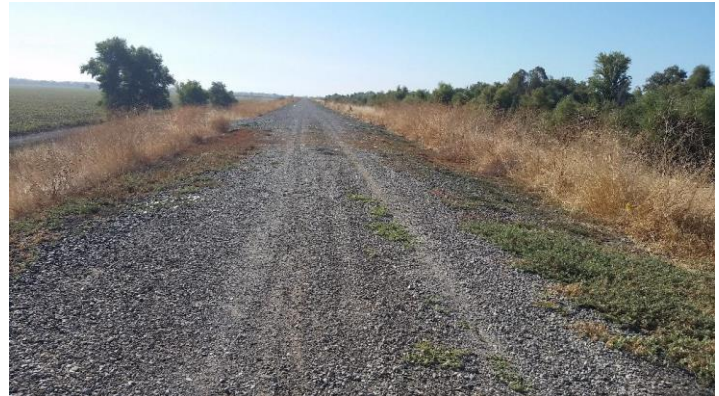
Photo 2 of 3 : UCIP_FA_2020_50065_75672.jpg

View of levee crown at crossing--yellow flag markers visible on both WS and LS shoulder.

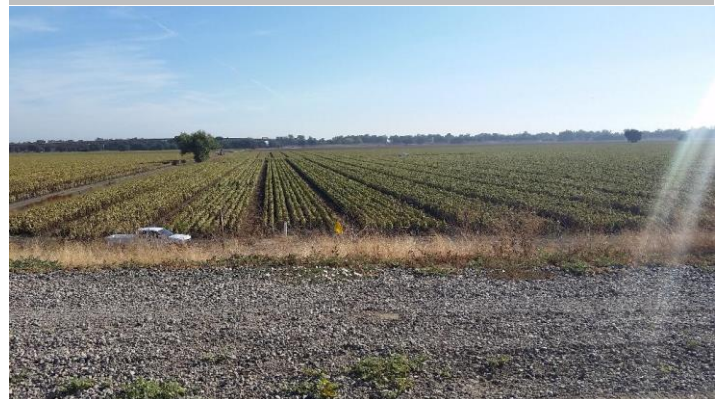
Photo 3 of 3 : UCIP_FA_2020_50065_75671.jpg

View of LS.

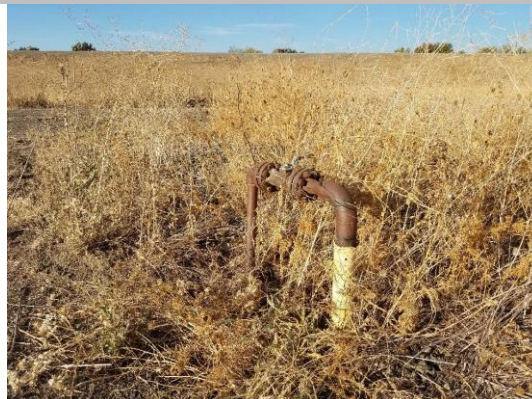
Photo 1 of 3 : UCIP_FA_2020_53087_78352.jpg

Comment Code						
Inspector Comment						
DS_ID:21159 FS_ID:53087 EP_NO: 15904 Repair Type: Non-Urgent EVAL Issue: Crossing Status: Indicator Found UCIP Comments: 10/25/2018 Markers on levee not found. Pipe not in use. Valve located on pipe bend near ditch on LS is shut down. Crossing has been downgraded to "Non-Urgent" due to reclassification of gas lines. (O.Yakimov - DWR UCIP) 8/31/2016 Meet with Greg Lucas, Assistant Production Coordinator from California Resources Corporation and Steve Steim from Noble Methan, Inc. to discuss the status of a different line upstream. Mr. Steve Steim was aware of the 3-inch line by Two Bay Petroleum as known as a PG&E old pipe at this location. According to Steve Stein the appurtenances previously located on the landside have been removed and the 3-inch line abandoned. Need to contact owner to confirm status of crossing. If crossing is no longer in use the owner will need to coordinate with CVFPB to comply with Title 23. (DWR UCIP - omagana)8/04/2016 No markers found on either WS or LS. Need to coordinate with owner to determine status of crossing. (DWR UCIP - omagana)3/10/2015 Sign missing on WS and LS. Need to confirm status of crossing with permittee. Appears abandoned. (DWR UCIP - wwylie) 03/18/2014 crossing not found. (DWR UCIP - omagana) FIELD_STRUCT_DESC: 3-inch steel gas pipeline through the levee, 20 feet below the crown. Sign on waterside (WS) (not found 2015). Yellow pipe visible east of ditch approximately 150 feet off landside (LS) toe. Contact Number 415-459-3445 for Two Bay Petroleum also referred as Pacific Energetics, Inc. (3-inch line authorized under Permit No. 15904, 1992 - Two Bay Petroleum) FS Date: 10/25/2018 10:29:07 AM

Gas pipe with shut-down valve closed.

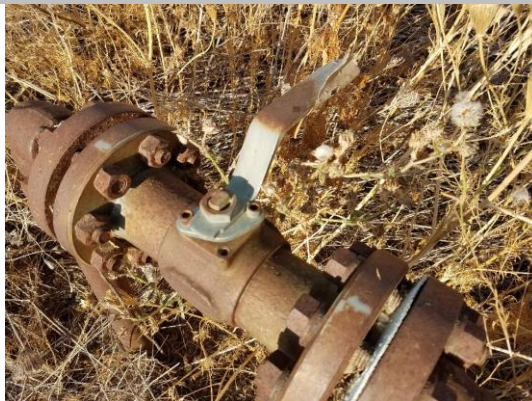
Photo 2 of 3 : UCIP_FA_2020_53087_78353.jpg

Closer view of gas pipe with shut-down valve closed.

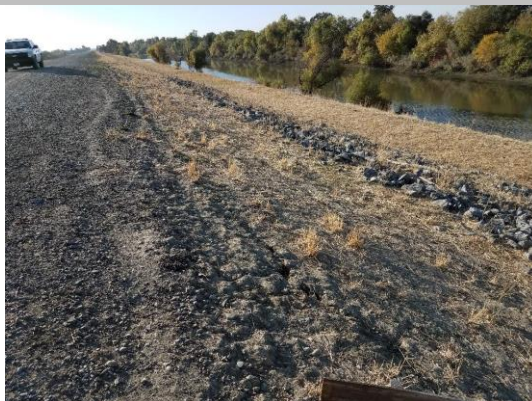
Photo 3 of 3 : UCIP_FA_2020_53087_78354.jpg

View of WS slope at crossing.

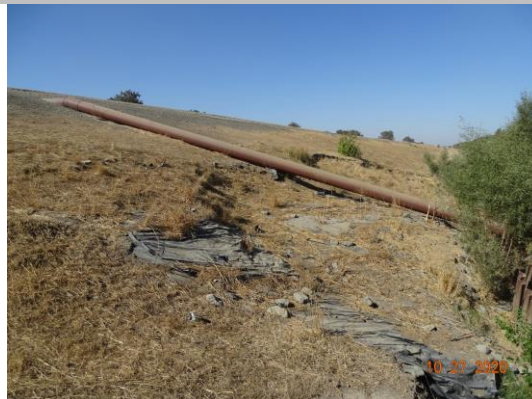
Photo 1 of 1 : FA_2020_RD0827_188_13_20201028_00020.jpg

LM Start	2.72	Rating **	A/W	Issue No.	13
LM End	2.73	Issue Type +	Ma	Location *	LS
Category	Earthen Levee			GPS Latitude/Longitude	
				Start	End
Item	Slope Stability			38.642139 °	38.642028 °
				-121.620750 °	-121.620667 °
DWR ID	RD 827-01				
Comment Code					
S1 : Repair slope instability.					
Inspector Comment					
Sloughing on the landside slope near pump. Movement has stabilized and the LMA will be constructing a setback levee within the next few years. The current levee will be degraded. Recommend monitoring.					
Site ID No:199					
Site Designation:RD 827-01

View of sloughing on the landside slope. Fall 2020.

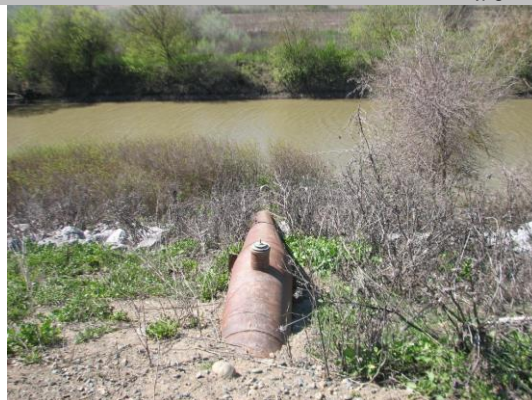
Photo 1 of 3 : UCIP_FA_2020_38984_59769.jpg

Comment Code					
Inspector Comment					
DS_ID:21151 FS_ID:38984 EP_NO: 3277 Repair Type: Non-Urgent EVAL Issue: Crossing Status: Found UCIP Comments: Crossing appears to have been removed and replaced under maintenance back in 2008. No permit has been found--need to contact owner to obtain additional information about replacement. Landward slope sloughing--does not appear to be associated with crossing. Landward slope is being monitored by LMA. FIELD_STRUCT_DESC: 18-inch (not 20-inch as noted in desk study) steel drainage pipe through the levee, 4 feet below the crown. Cutoff wall around pipe at center of levee. Siphon breaker on apex of pipe at waterside (WS) shoulder. Pump on pipe structure in drainage ditch at landside (LS) toe. Rock revetment on WS slope. (20-inch drainage pipe authorized under Permit No. 3277, 1960-Reclamation District No. 827; no permit found authorizing the 18-inch pipe) [Additional Reference(s): DWR Levee Logs, 2005] FS Date: 3/18/2014

View of pipe visible on waterward side.

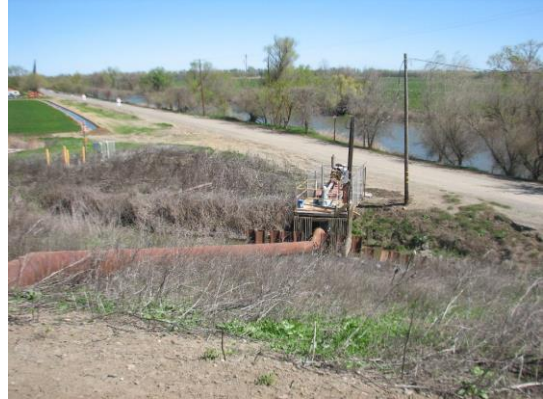
Photo 2 of 3 : UCIP_FA_2020_38984_59768.jpg

View of landward side.

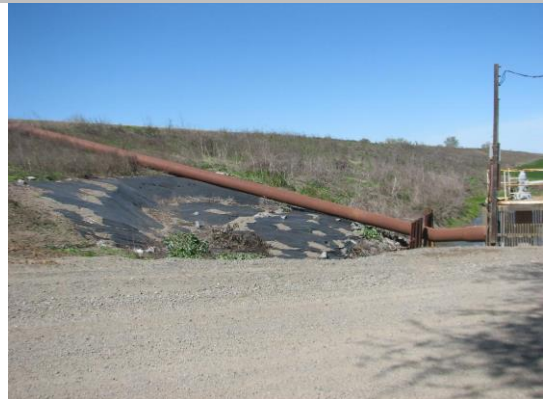
Photo 3 of 3 : UCIP_FA_2020_38984_59767.jpg

Pipe exposed on landward side.

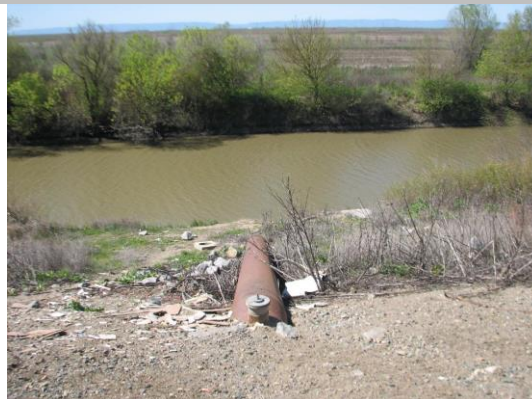
Photo 1 of 3 : UCIP_FA_2020_33032_59778.jpg

DS_ID:21169
FS_ID:33032
EP_NO: 5611
Repair Type: Non-Urgent
EVAL Issue:
Crossing Status: Found
UCIP Comments: Crossing appears to have been removed and replaced under maintenance back in 2008. No permit has been found--need to contact owner to obtain additional information about replacement.
FIELD_STRUCT_DESC: [RD No. 827 Pumping Plant] 22-inch (not 24-inch as mentioned in desk study) steel drainage pipe through the levee, 8 feet below the crown. Corrugated metal cutoff wall around pipe at center of levee. Siphon breaker on waterside (WS) slope. Flap gate on WS end. Pipe is exposed along WS slope. (portion of pipe was removed and replaced, from landside to waterside shoulder, under Permit No. 5611 (1968)). [Additional Reference(s): DWR Levee Logs, 2005. USACE Sacramento O&M Manual Unit No. 122 Part No. 1, August 1955, (Station 3+75)]
FS Date: 3/18/2014

Pipe exposed on waterward side.

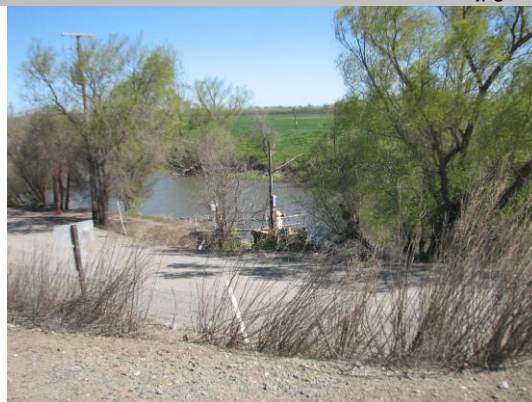
Photo 2 of 3 : UCIP_FA_2020_33032_59777.jpg

Pump station located on landward side.

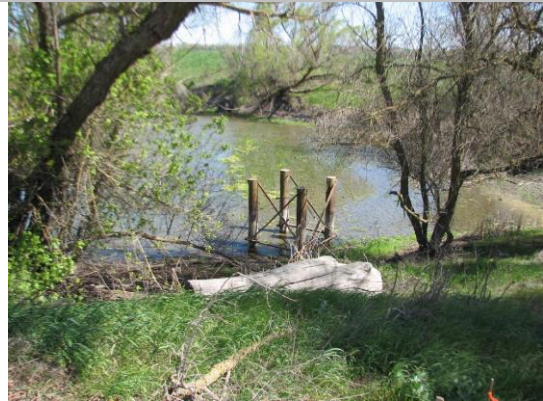
Photo 3 of 3 : UCIP_FA_2020_33032_59776.jpg

Reminse piles located on landward side.
