Flood Control Project Maintenance Levee Inspections

Fall 2021 Levee Maintenance Deficiency Summary Report

Reclamation District No. 0827 Elkhorn

Levee Inspection Report By Mile - Fall 2021

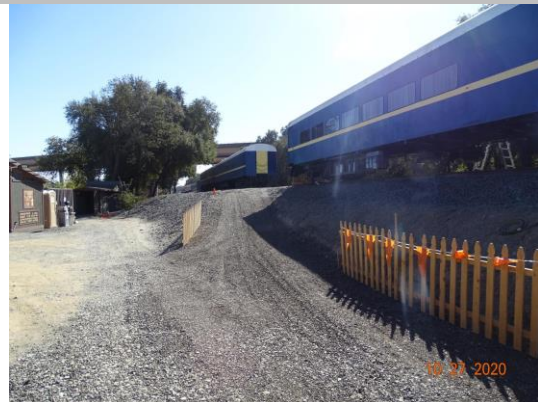
Photo 1 of 1 : FA_2021_RD0827_187_30_20210907_00006.jpg

LM Start	0.00	Rating **	U	Issue No.	30
LM End	0.16	Issue Type +	En	Location *	CR
Category	Earthen Levee			GPS Latitude/Longitude	
				Start	End
Item	Encroachments			38.675168 °	38.673575 °
				-121.630530 °	-121.628398 °
DWR ID	DWR_RD0827_01_s_2020_30				
Comment Code					
EQ : Equipment					
Inspector Comment					
Sierra Railroad has placed track and rail cars on the crown that prevent vehicle access. They have constructed a new ramp and berm to access the portion of levee that does not have track on the crown.

View of ramp to adjacent waterside berm. Fall 2020.

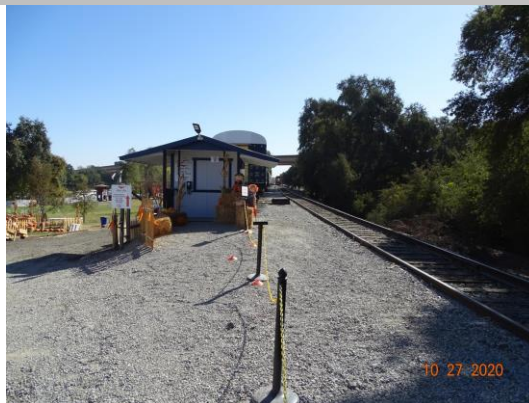
Photo 1 of 1 : FA_2021_RD0827_187_20_20210907_00003.jpg

LM Start	0.03	Rating **	U	Issue No.	20
LM End	0.03	Issue Type +	En	Location *	WS
Category	Earthen Levee			GPS Latitude/Longitude	
				Start	End
Item	Encroachments			38.674912 °	38.674912 °
				-121.630133 °	-121.630133 °
DWR ID	DWR_RD0827_01_f_2019_20				
Comment Code					
BU : Building					
Inspector Comment					
Sacramento River Train has constructed their office and a ticket booth on the waterside shoulder and crown.

View of ticket booth on crown. Fall 2020.

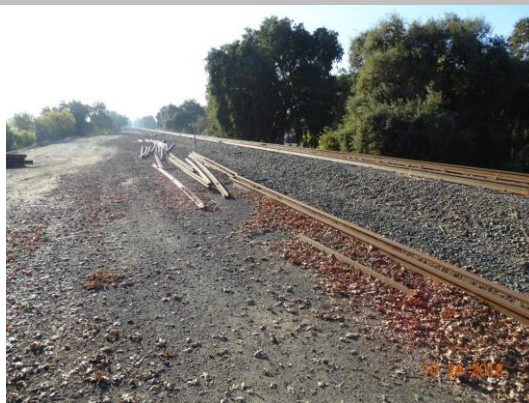
Photo 1 of 1 : FA_2021_RD0827_187_12_20210907_00001.jpg

LM Start	0.23	Rating **	M	Issue No.	12
LM End	0.27	Issue Type +	En	Location *	CR
Category	Earthen Levee			GPS Latitude/Longitude	
				Start	End
Item	Encroachments			38.672803 °	38.672400 °
				-121.627416 °	-121.626890 °
DWR ID	DWR_RD0827_01_s_2016_12				
Comment Code					
MA : Material					
Inspector Comment					
RR rails and ties on the levee crown.

View of railroad ties on the crown. Fall 2018.

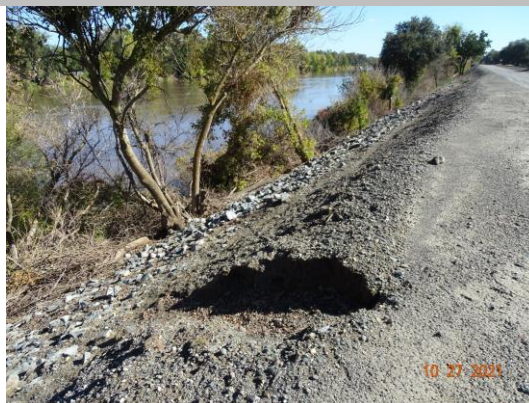
Photo 1 of 1 : FA_2021_RD0827_187_21_20211102_00010.jpg

LM Start	0.34	Rating **	M	Issue No.	21
LM End	0.34	Issue Type +	Ma	Location *	WS
Category	Earthen Levee			GPS Latitude/Longitude	
				Start	End
Item	Erosion / Bank Caving			38.671773 °	38.671773 °
				-121.626077 °	-121.626077 °
DWR ID	DWR_RD0827_01_f_2019_21				
Comment Code					
E2 : Schedule repair of erosion site prior to the next inspection.					
Inspector Comment					
Erosion on the waterside shoulder.

View of erosion on the waterside slope. Fall 2021.

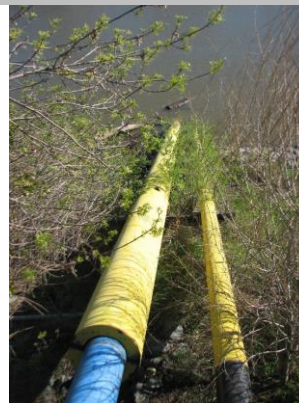
Photo 2 of 3 : UCIP_FA_2021_38983_59736.jpg

LM Start	0.73	Rating **	M	Issue No.	32 (cont)
LM End	0.73	Issue Type +	En	Location *	
Category	Supplemental			GPS Latitude/Longitude	
				Start	End
Item	DWR UCIP Field Study			38.667731 °	38.667731 °
				-121.620992 °	-121.620992 °
DWR ID	21147

Pipe visible on waterward side.

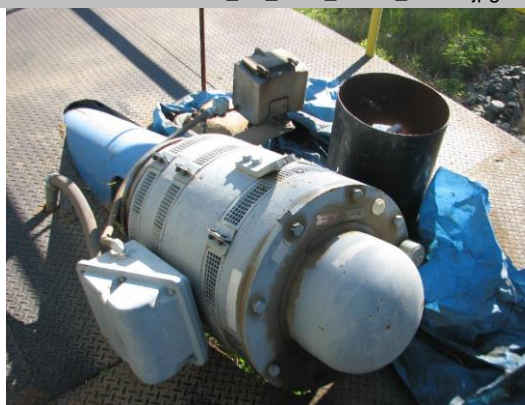
Photo 3 of 3 : UCIP_FA_2021_38983_59735.jpg

Slant pump located on waterward side.

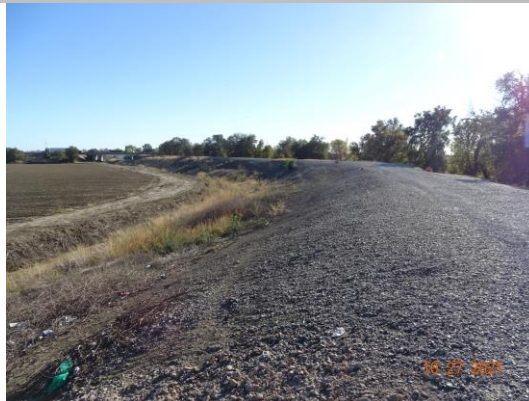
Photo 1 of 1 : FA_2021_RD0827_188_7_20211102_00015.jpg

LM Start	0.02	Rating **	A	Issue No.	7
LM End	0.02	Issue Type +	Ma	Location *	LS
Category	Earthen Levee			GPS Latitude/Longitude	
				Start	End
Item	Vegetation			38.676569 °	38.676569 °
				-121.642692 °	-121.642692 °
DWR ID	DWR_RD0827_02_f_2021_7				
Comment Code					
V1 : Control annual grass and weeds on the levee slopes and easements.					
Inspector Comment					
The LMA maintains the vegetation at a high level.

View of maintained landside slope. Fall 2021.

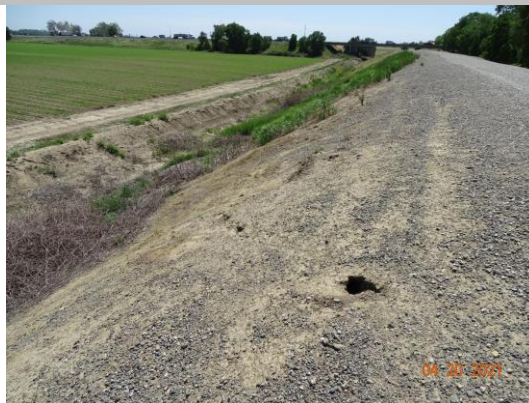
Photo 1 of 1 : FA_2021_RD0827_188_5_20210907_00001.jpg

LM Start	0.10	Rating **	M	Issue No.	5
LM End	0.10	Issue Type +	Ma	Location *	LS
Category	Earthen Levee			GPS Latitude/Longitude	
				Start	End
Item	Animal Control			38.675397 °	38.675397 °
				-121.643025 °	-121.643025 °
DWR ID	DWR_RD0827_02_s_2021_5				
Comment Code					
A1 : Exterminate rodents and backfill and compact or grout burrows.					
Inspector Comment					
Active rodent holes on the landside slope.

View of rodent holes on the landside slope. Spring 2021.

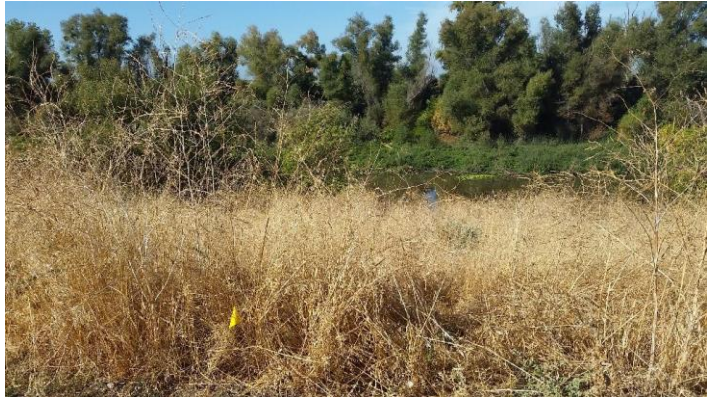
Photo 1 of 3 : UCIP_FA_2021_50065_75673.jpg

DS_ID:24844
FS_ID:50065
EP_NO: 17403
Repair Type: Non-Urgent
EVAL Issue:
Crossing Status: Indicator Found
UCIP Comments: 9/27/2016 Need to coordinate with Greg Lucas (gregory.lucas@crc.com) with California Resources Corporation to determine if line will be brought online. Crossing was downgraded from Urgent to Non-Urgent--new owner has not brought the pipe online. New owner will need to update permit name and if line becomes active markers will be required per Title 23. (DWR UCIP - omagana)9/02/2016 Meet with Jimmy Preston from California Resources Corporation at site. Alignment of crossing was confirmed (new location is approximately 290 feet upstream from previous point)--report has been updated. Pending action -- Name Change (DWR UCIP - omagana)9/01/2016 Email was sent to Greg Lucas from California Resources Corporation with an updated UCIP detailed report and Central Valley Flood Protection Board (CVFPB) name change form. New owner will need to update permit information with the CVFPB to be compliant with Title 23 requirements. (DWR UCIP - omagana)8/31/2016 New owner--California Resources Corporation. Gas line is currently not in use.Meet with Greg Lucas, Assistant Production Coordinator from California Resources Corporation and Steve Stein from Noble Methan, Inc. to clarify current status of crossing and determine crossing alignment. Gas well is part of the gas line appurtenances. Gas line alignment is still pending--California Resources Corporation will send out someone to confirm alignment. Crossing is missing markers, if line becomes active markers will be needed on both the WS and LS to comply with Title 23--encouraged owner to contact CVFPB. (DWR UCIP - omagana)8/30/2016 Coordinating with AA Production Services, Inc. to determine location of where crossing goes through levee. It appears that the gas well located on LS is not part of this crossing. (DWR UCIP - omagana)8/04/2016 Meet with Bill Mattos, representative of RD 827, and he took me to the gas well visible from levee crown. Mr. Mattos was unable to confirm if gas well and pipeline that goes through the levee were connected.3/18/2014 No markers visible on either banks. Need to contact owner to determine status of crossing. Need date of last inspection and confirmation that crossing is still in operable condition. (DWR UCIP - omagana)

FIELD_STRUCT_DESC: [Hanks 34-2] 2.375-inch steel natural gas pipe through the levee, 30 feet below the crown and under (bored) Tule Canal. Gas well is located on the landside (LS) approximately 994 feet from levee crown. California Resources Corporation acquired AA Production Services, Inc. The new owner of the 2.375-inch gas pipe is California Resources Corporation. (2.375-inch line authorized under

View of WS--Tule Canal.

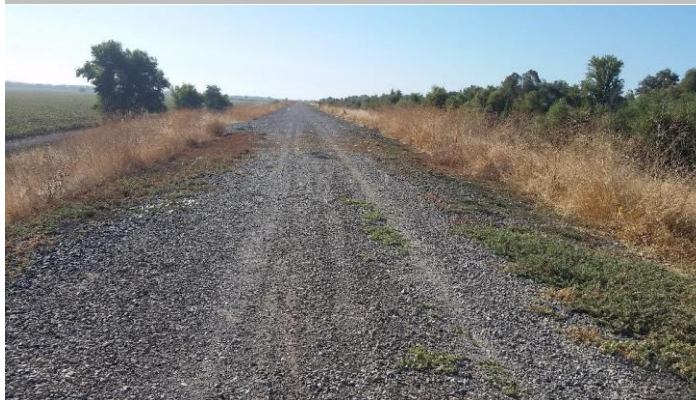
Photo 2 of 3 : UCIP_FA_2021_50065_75672.jpg

View of levee crown at crossing--yellow flag markers visible on both WS and LS shoulder.

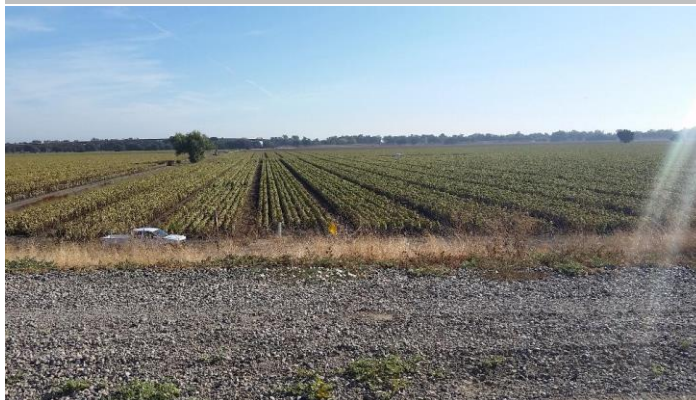
Photo 3 of 3 : UCIP_FA_2021_50065_75671.jpg

View of LS.

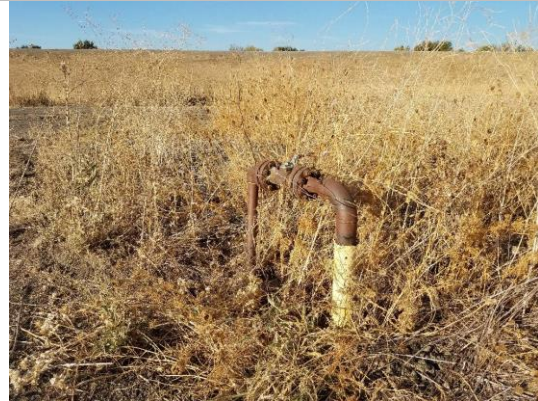
Photo 1 of 3 : UCIP_FA_2021_53087_78352.jpg

Comment Code					
Inspector Comment					
DS_ID:21159 FS_ID:53087 EP_NO: 15904 Repair Type: Non-Urgent EVAL Issue: Crossing Status: Indicator Found UCIP Comments: 10/25/2018 Markers on levee not found. Pipe not in use. Valve located on pipe bend near ditch on LS is shut down. Crossing has been downgraded to "Non-Urgent" due to reclassification of gas lines. (O.Yakimov - DWR UCIP) 8/31/2016 Meet with Greg Lucas, Assistant Production Coordinator from California Resources Corporation and Steve Steim from Noble Methan, Inc. to discuss the status of a different line upstream. Mr. Steve Steim was aware of the 3-inch line by Two Bay Petroleum as known as a PG&E old pipe at this location. According to Steve Stein the appurtenances previously located on the landside have been removed and the 3-inch line abandoned. Need to contact owner to confirm status of crossing. If crossing is no longer in use the owner will need to coordinate with CVFPB to comply with Title 23. (DWR UCIP - omagana)8/04/2016 No markers found on either WS or LS. Need to coordinate with owner to determine status of crossing. (DWR UCIP - omagana)3/10/2015 Sign missing on WS and LS. Need to confirm status of crossing with permittee. Appears abandoned. (DWR UCIP - wwylie) 03/18/2014 crossing not found. (DWR UCIP - omagana) FIELD_STRUCT_DESC: 3-inch steel gas pipeline through the levee, 20 feet below the crown. Sign on waterside (WS) (not found 2015). Yellow pipe visible east of ditch approximately 150 feet off landside (LS) toe. Contact Number 415-459-3445 for Two Bay Petroleum also referred as Pacific Energetics, Inc. (3-inch line authorized under Permit No. 15904, 1992 - Two Bay Petroleum) FS Date: 10/25/2018 10:29:07 AM

Gas pipe with shut-down valve closed.

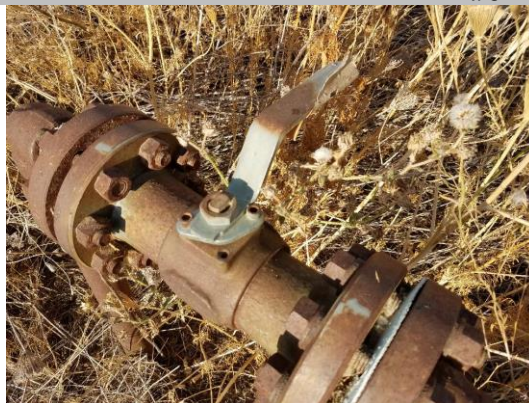
Photo 2 of 3 : UCIP_FA_2021_53087_78353.jpg

Closer view of gas pipe with shut-down valve closed.

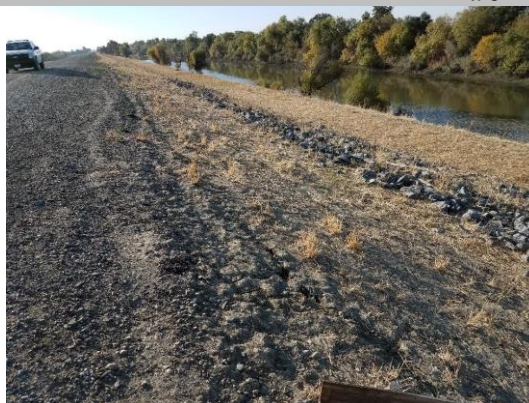
Photo 3 of 3 : UCIP_FA_2021_53087_78354.jpg

View of WS slope at crossing.

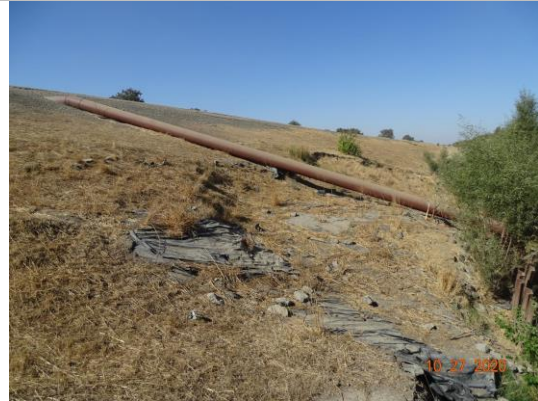
Photo 1 of 1 : FA_2021_RD0827_188_13_20210907_00002.jpg

LM Start	2.72	Rating **	A/W	Issue No.	13
LM End	2.73	Issue Type +	Ma	Location *	LS
Category	Earthen Levee			GPS Latitude/Longitude	
				Start	End
Item	Slope Stability			38.642139 °	38.642028 °
				-121.620750 °	-121.620667 °
DWR ID	RD 827-01				
Comment Code					
S1 : Repair slope instability.					
Inspector Comment					
Sloughing on the landside slope near pump. Movement has stabilized and the LMA will be constructing a setback levee within the next few years. The current levee will be degraded. Recommend monitoring.					
Site ID No:199					
Site Designation:RD 827-01

View of sloughing on the landside slope. Fall 2020.

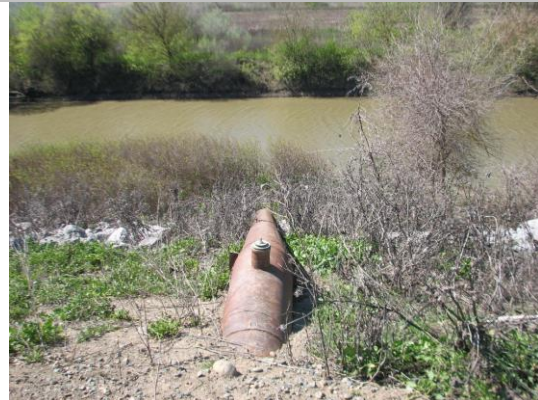
Photo 1 of 3 : UCIP_FA_2021_38984_59769.jpg

Comment Code						
Inspector Comment						
DS_ID:21151 FS_ID:38984 EP_NO: 3277 Repair Type: Non-Urgent EVAL Issue: Crossing Status: Found UCIP Comments: Crossing appears to have been removed and replaced under maintenance back in 2008. No permit has been found--need to contact owner to obtain additional information about replacement. Landward slope sloughing--does not appear to be associated with crossing. Landward slope is being monitored by LMA. FIELD_STRUCT_DESC: 18-inch (not 20-inch as noted in desk study) steel drainage pipe through the levee, 4 feet below the crown. Cutoff wall around pipe at center of levee. Siphon breaker on apex of pipe at waterside (WS) shoulder. Pump on pipe structure in drainage ditch at landside (LS) toe. Rock revetment on WS slope. (20-inch drainage pipe authorized under Permit No. 3277, 1960-Reclamation District No. 827; no permit found authorizing the 18-inch pipe) [Additional Reference(s): DWR Levee Logs, 2005] FS Date: 3/18/2014

View of pipe visible on waterward side.

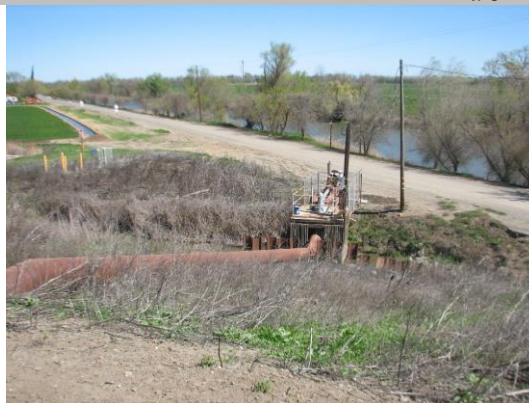
Photo 2 of 3 : UCIP_FA_2021_38984_59768.jpg

View of landward side.

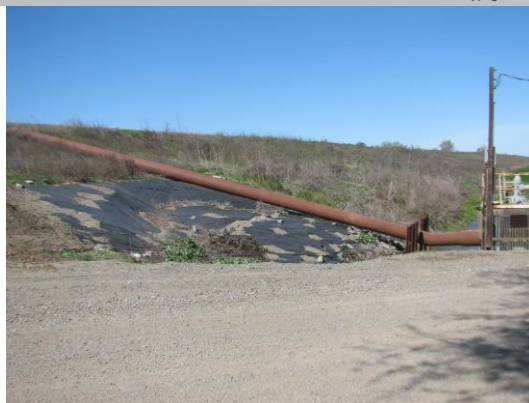
Photo 3 of 3 : UCIP_FA_2021_38984_59767.jpg

Pipe exposed on landward side.

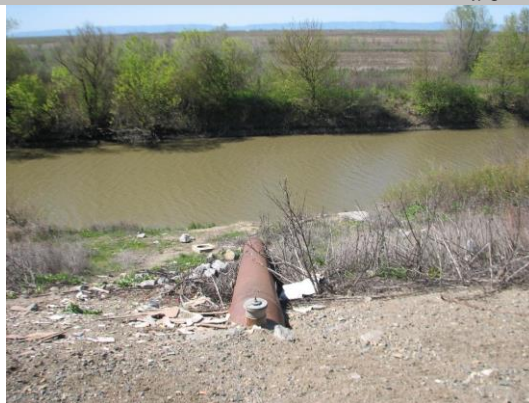
Photo 1 of 3 : UCIP_FA_2021_33032_59778.jpg

DS_ID:21169
FS_ID:33032
EP_NO: 5611
Repair Type: Non-Urgent
EVAL Issue:
Crossing Status: Found
UCIP Comments: Crossing appears to have been removed and replaced under maintenance back in 2008. No permit has been found--need to contact owner to obtain additional information about replacement.
FIELD_STRUCT_DESC: [RD No. 827 Pumping Plant] 22-inch (not 24-inch as mentioned in desk study) steel drainage pipe through the levee, 8 feet below the crown. Corrugated metal cutoff wall around pipe at center of levee. Siphon breaker on waterside (WS) slope. Flap gate on WS end. Pipe is exposed along WS slope. (portion of pipe was removed and replaced, from landside to waterside shoulder, under Permit No. 5611 (1968)). [Additional Reference(s): DWR Levee Logs, 2005. USACE Sacramento O&M Manual Unit No. 122 Part No. 1, August 1955, (Station 3+75)]
FS Date: 3/18/2014

Pipe exposed on waterward side.

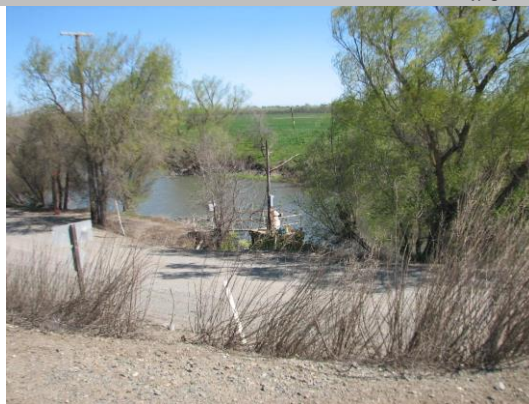
Photo 2 of 3 : UCIP_FA_2021_33032_59777.jpg

Pump station located on landward side.

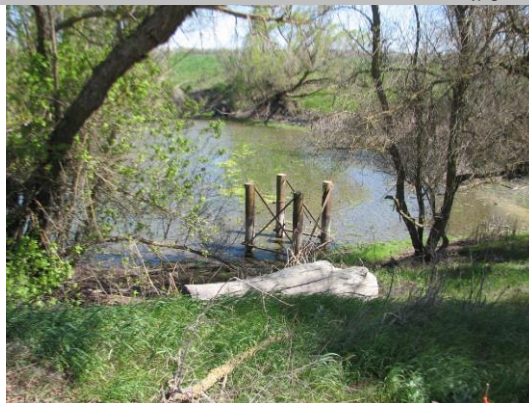
Photo 3 of 3 : UCIP_FA_2021_33032_59776.jpg

Reminise piles located on landward side.
