**Flood Control Project Maintenance
Levee Inspections
Fall 2022 Levee Maintenance Deficiency Summary Report**

Sacramento River Basin

Reclamation District No. 0827 Elkhorn

Levee Inspection Report By Mile - Fall 2022

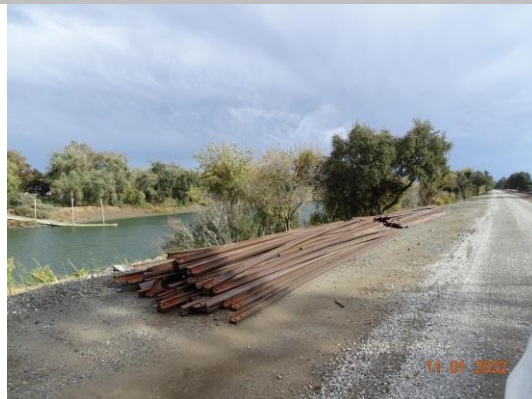
Photo 1 of 1 : FA_2022_RD0827_187_11_20221102_00009.jpg

LM Start	0.30	Rating **	M	Issue No.	11
LM End	0.30	Issue Type +	En	Location *	WS
Category	Earthen Levee			GPS Latitude/Longitude	
				Start	End
Item	Encroachments			38.672157 °	38.672157 °
				-121.626596 °	-121.626596 °
DWR ID	DWR_RD0827_01_f_2022_11				
Comment Code					
MA : Material					
Inspector Comment					
Railroad ties on the waterside shoulder.

View of railroad ties on the waterside shoulder. Fall 2022.

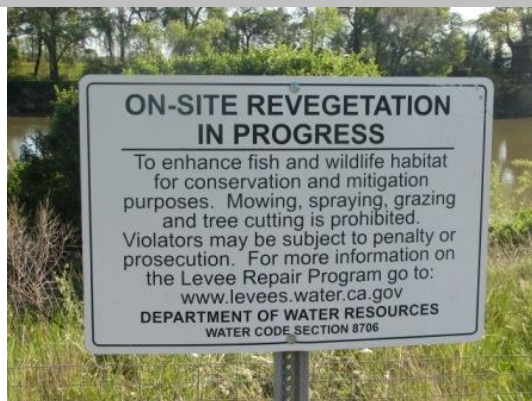
Photo 1 of 1 : FA_2022_RD0827_187_22_20220921_00005.jpg

LM Start	0.61	Rating **	A/W	Issue No.	22
LM End	0.92	Issue Type +	Ob	Location *	WS
Category	Earthen Levee			GPS Latitude/Longitude	
				Start	End
Item	Vegetation			38.668873 °	38.665750 °
				-121.622513 °	-121.618523 °
DWR ID	DWR_RD0827_01_s_2012_22				
Comment Code					
V5 : Environmental Requirements.					
Inspector Comment

Revegetation site spring 2012.

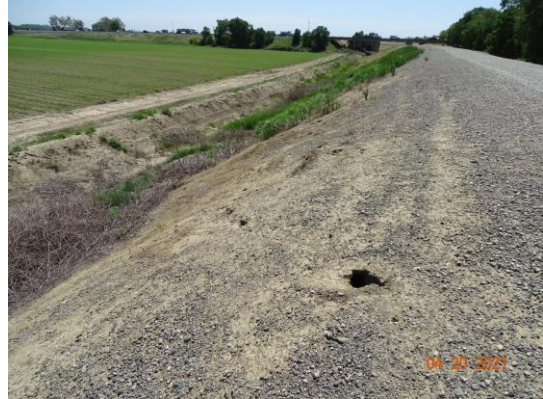
Photo 1 of 1 : FA_2022_RD0827_188_5_20220921_00001.jpg

LM Start	0.10	Rating **	M	Issue No.	5
LM End	0.10	Issue Type +	Ma	Location *	LS
Category	Earthen Levee			GPS Latitude/Longitude	
				Start	End
Item	Animal Control			38.675397 °	38.675397 °
				-121.643025 °	-121.643025 °
DWR ID	DWR_RD0827_02_s _ 2021_5				
Comment Code					
A1 : Exterminate rodents and backfill and compact or grout burrows.					
Inspector Comment					
Active rodent holes on the landside slope.

View of rodent holes on the landside slope. Spring 2021.

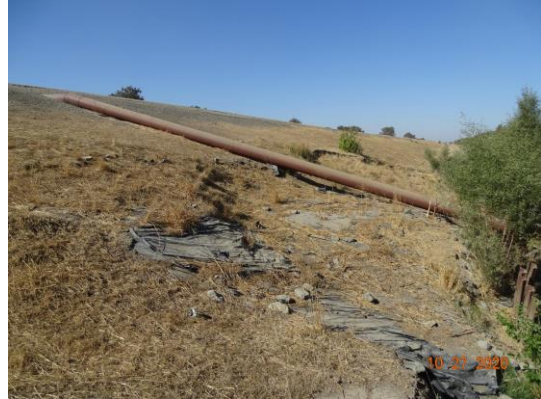
Photo 1 of 1 : FA_2022_RD0827_188_13_20220921_00002.jpg

LM Start	2.72	Rating **	A/W	Issue No.	13
LM End	2.73	Issue Type +	Ma	Location *	LS
Category	Earthen Levee			GPS Latitude/Longitude	
				Start	End
Item	Slope Stability			38.642139 °	38.642028 °
				-121.620750 °	-121.620667 °
DWR ID	RD 827-01				
Comment Code					
S1 : Repair slope instability.					
Inspector Comment					
Sloughing on the landside slope near pump. Movement has stabilized and the LMA will be constructing a setback levee within the next few years. The current levee will be degraded. Recommend monitoring.					
Site ID No:199					
Site Designation:RD 827-01

View of sloughing on the landside slope. Fall 2020.

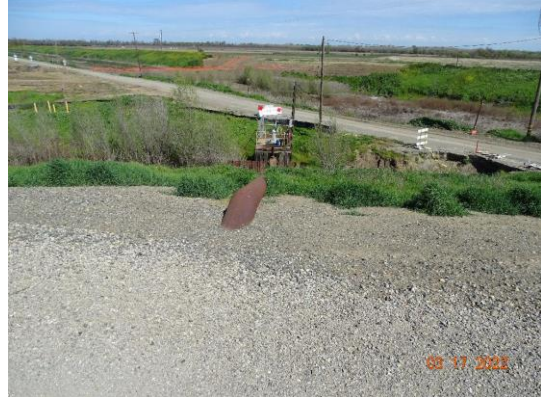
Photo 1 of 3 : UCIP_FA_2022_74199_110777.jpg

Comment Code						
Inspector Comment						
DS_ID:21151 FS_ID:74199 EP_NO: 3277 Repair Type: Non-Urgent EVAL Issue: 10, Unauthorized Modification or Non-Compliant Permit Crossing Status: Found UCIP Comments: 03/17/2022 Record remains Non-Urgent. Previous comments suggest that the crossing has been removed and replaced under maintenance in 2008. Unable to find a permit for modification. Irrigation ditch on landside causing erosion of landside ramp. (O.Yakimov - DWR UCIP) 03/18/2014 Crossing appears to have been removed and replaced under maintenance back in 2008. No permit has been found--need to contact owner to obtain additional information about replacement. Landward slope sloughing--does not appear to be associated with crossing. Landward slope is being monitored by LMA. (O.Magana - DWR UCIP) FIELD_STRUCT_DESC: 18-inch (not 20-inch as noted in desk study) steel drainage pipe through the levee, 4 feet below the crown. Cutoff wall around pipe at center of levee. Siphon breaker on apex of pipe at waterside (WS) shoulder. Pump on pipe structure in drainage ditch at landside (LS) toe. Rock revetment on WS slope. (20-inch drainage pipe authorized under Permit No. 3277, 1960-Reclamation District No. 827; no permit found authorizing the 18-inch pipe) [Additional Reference(s): DWR Levee Logs, 2005] FS Date: 3/17/2022 11:22:36 AM

Land-Side: View of levee slope looking from crown. Pump on piled platform at levee toe

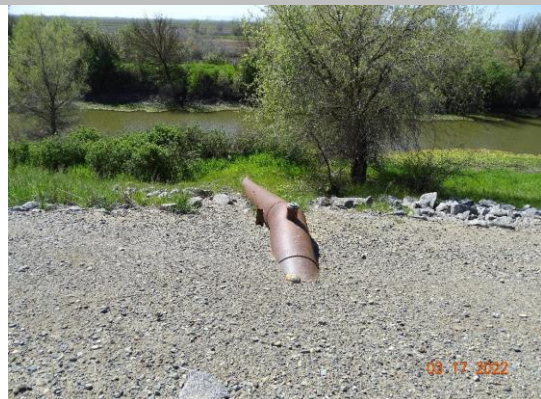
Photo 2 of 3 : UCIP_FA_2022_74199_110776.jpg

Water-Side: View of levee slope looking from crown. Siphon breaker on pipe at levee shoulder

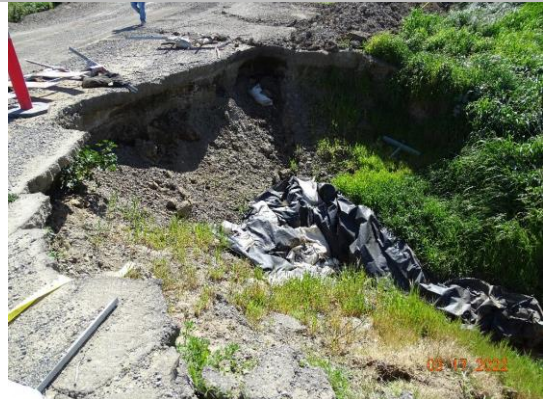
Photo 3 of 3 : UCIP_FA_2022_74199_110779.jpg

Land-Side: Landside ramp erosion caused by irrigation ditch

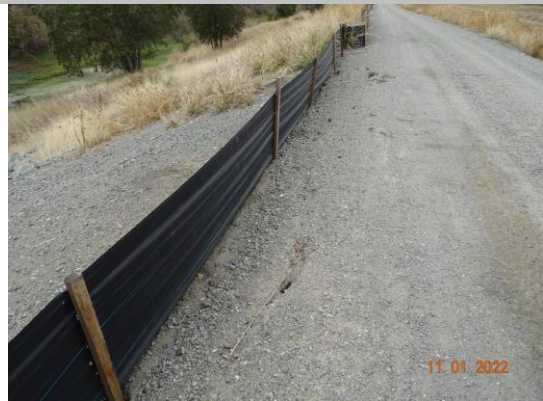
Photo 1 of 1 : FA_2022_RD0827_188_7_20221102_00003.jpg

LM Start	2.73	Rating **	A/W	Issue No.	7
LM End	2.73	Issue Type +	Ma	Location *	WS
Category	Earthen Levee			GPS Latitude/Longitude	
				Start	End
Item	Cracking			38.641894 °	38.641894 °
				-121.620868 °	-121.620868 °
DWR ID	DWR_RD0827_02_f_2022_7				
Comment Code					
CR1 : Monitor and have inspected by geotechnical engineer.					
Inspector Comment					
Cracking on the waterside shoulder. Recommend monitoring.

View of crack on the waterside shoulder. Fall 2022.

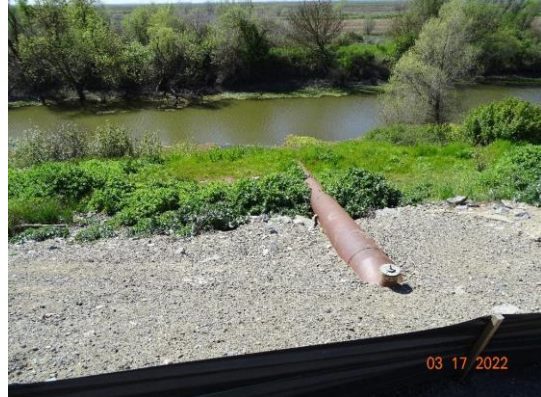
Photo 1 of 3 : UCIP_FA_2022_74200_110786.jpg

DS_ID:21169
FS_ID:74200
EP_NO: 5611
Repair Type: Non-Urgent
EVAL Issue: 10, Unauthorized Modification or Non-Compliant Permit
Crossing Status: Found
UCIP Comments: 03/17/2022 Record remains Non-Urgent. Piles of old pumping platform observed in irrigation canal on landside. New piled pumping platform and pump installed in the canal. Pipe makes a turn from pump to landside levee slope. Unable to find a permit for modification. No permit has been identified authorizing installation of pipe. (O.Yakimov - DWR UCIP)
03/18/2014 Crossing appears to have been removed and replaced under maintenance back in 2008. No permit has been found--need to contact owner to obtain additional information about replacement. (O.Magana - DWR UCIP)
FIELD_STRUCT_DESC: [RD No. 827 Pumping Plant] 22-inch (not 24-inch as mentioned in desk study) steel drainage pipe through the levee, 8 feet below the crown. Corrugated metal cutoff wall around pipe at center of levee. Siphon breaker on waterside (WS) slope. Flap gate on WS end. Pipe is exposed along WS slope. (portion of pipe was removed and replaced, from landside to waterside shoulder, under Permit No. 5611 (1968)). [Additional Reference(s): DWR Levee Logs, 2005. USACE Sacramento O&M Manual Unit No. 122 Part No. 1, August 1955, (Station 3+75)]

Water-Side: View of levee slope looking from crown. Siphon breaker on pipe at levee shoulder

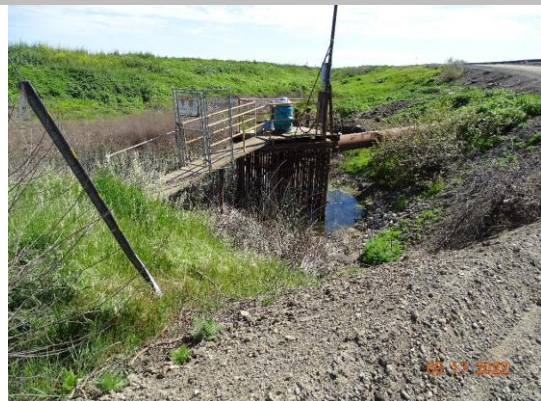
Photo 2 of 3 : UCIP_FA_2022_74200_110784.jpg

Land-Side: New pump on piled platform in irrigation canal

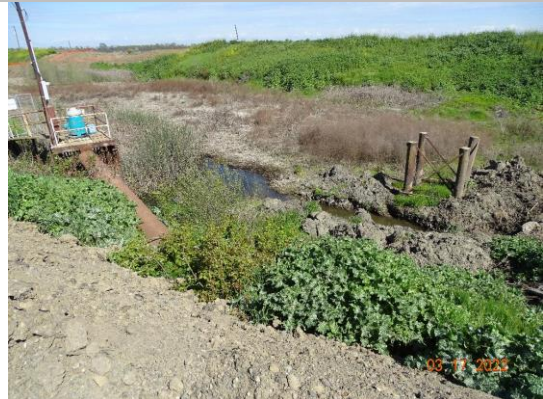
Photo 3 of 3 : UCIP_FA_2022_74200_110785.jpg

Land-Side: View of levee slope looking from crown. Remnants of pumping platform in irrigation canal
