**Flood Control Project Maintenance  
Levee Inspections  
Fall 2023 Levee Maintenance Deficiency Summary Report**

**Sacramento River Basin**

**Reclamation District No. 0827 Elkhorn**

**Levee Inspection Report By Mile - Fall 2023**

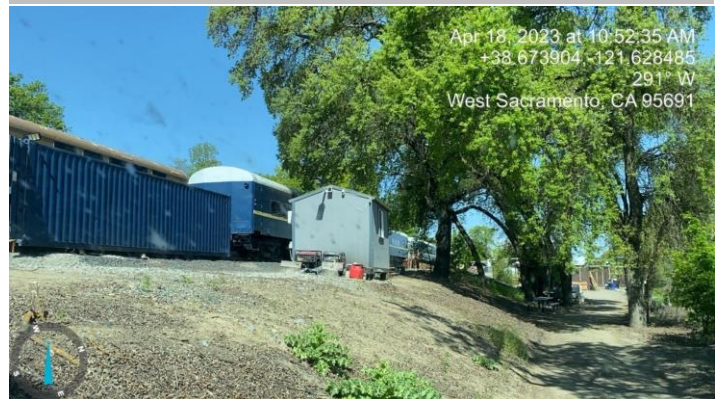
Photo 1 of 1 : FA\_2023\_RD0827\_187\_30\_20230927\_00009.jpg

LM Start	0.00	Rating **	U	Issue No.	30
LM End	0.16	Issue Type +	En	Location *	CR
Category	Earthen Levee			GPS Latitude/Longitude	
				Start	End
Item	Encroachments			38.675168°	38.673575°
				-121.630530°	-121.628398°
DWR ID	DWR_RD0827_01_s_2020_30				
Comment Code					
EQ : Equipment					
Inspector Comment					
Sierra Railroad has placed track and rail cars on the crown that prevent vehicle access. They have constructed a new ramp and berm to access the portion of levee that does not have track on the crown. Shed and shipping container are blocking access.

View of shed, shipping container and rail car on the levee crown (Spring 2023).

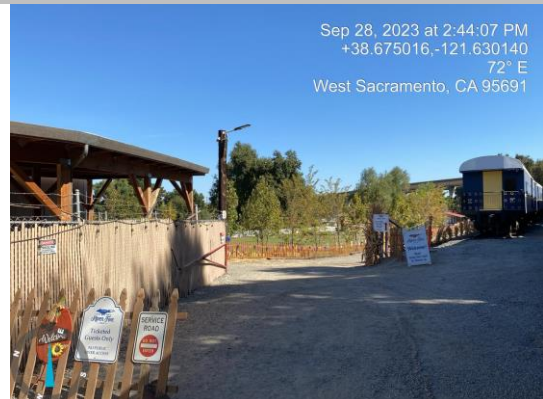
Photo 1 of 1 : FA\_2023\_RD0827\_187\_20\_20231002\_00012.jpg

LM Start	0.03	Rating **	U	Issue No.	20
LM End	0.03	Issue Type +	En	Location *	WS
Category	Earthen Levee			GPS Latitude/Longitude	
				Start	End
Item	Encroachments			38.674912°	38.674912°
				-121.630133°	-121.630133°
DWR ID	DWR_RD0827_01_f_2019_20				
Comment Code					
BU : Building					
Inspector Comment					
Sacramento River Train has constructed their office and a ticket booth on the waterside shoulder and crown.

View of office on levee crown (Fall 2023).

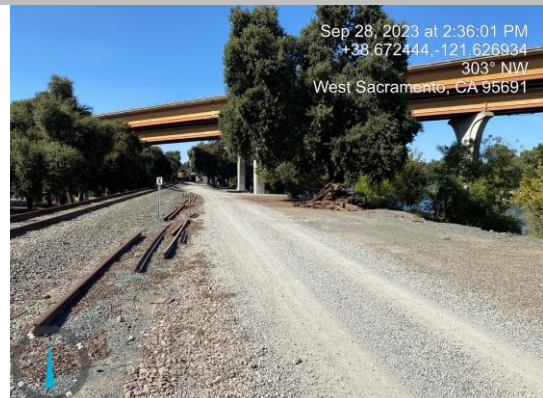
Photo 1 of 1 : FA\_2023\_RD0827\_187\_12\_20231002\_00013.jpg

LM Start	0.24	Rating **	M	Issue No.	12
LM End	0.28	Issue Type +	En	Location *	CR
Category	Earthen Levee			GPS Latitude/Longitude	
				Start	End
Item	Encroachments			38.672763°	38.672357°
				-121.627371°	-121.626858°
DWR ID	DWR_RD0827_01_s_2016_12				
Comment Code					
MA : Material					
Inspector Comment					
Railroad rails and ties on the levee crown.

View of railroad ties and rails on levee crown (Fall 2023).

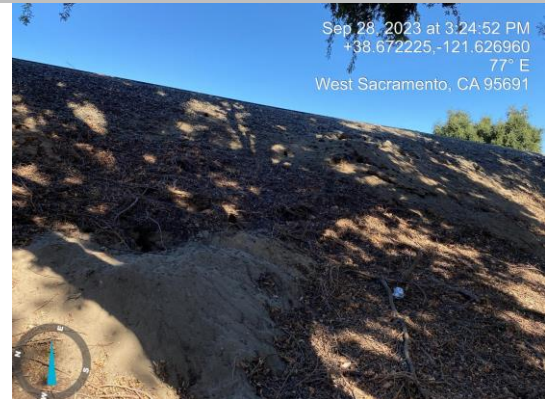
Photo 1 of 1 : FA\_2023\_RD0827\_187\_6\_20231002\_00010.jpg

LM Start	0.28	Rating **	U	Issue No.	6
LM End	0.28	Issue Type +	Ma	Location *	LS
Category	Earthen Levee			GPS Latitude/Longitude	
				Start	End
Item	Animal Control			38.672174°	38.672174°
				-121.626995°	-121.626995°
DWR ID	DWR_RD0827_01_f _ 2023_6				
Comment Code					
A3 : No rodents visible, but rodent burrows visible; need to backfill and compact or grout burrows.					
Inspector Comment					
Large rodent holes are located on the landside slope.

View of rodent holes on landside slope (Fall 2023).

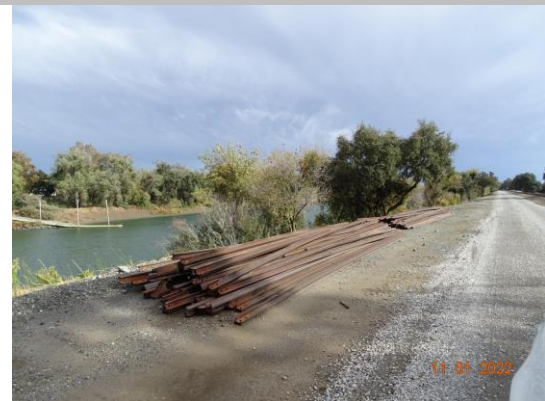
Photo 1 of 1 : FA\_2023\_RD0827\_187\_11\_20230927\_00005.jpg

LM Start	0.30	Rating **	M	Issue No.	11
LM End	0.30	Issue Type +	En	Location *	WS
Category	Earthen Levee			GPS Latitude/Longitude	
				Start	End
Item	Encroachments			38.672157°	38.672157°
				-121.626596°	-121.626596°
DWR ID	DWR_RD0827_01_f_2022_11				
Comment Code					
MA : Material					
Inspector Comment					
Railroad rails on the waterside shoulder.

View of railroad ties on the waterside shoulder. Fall 2022.

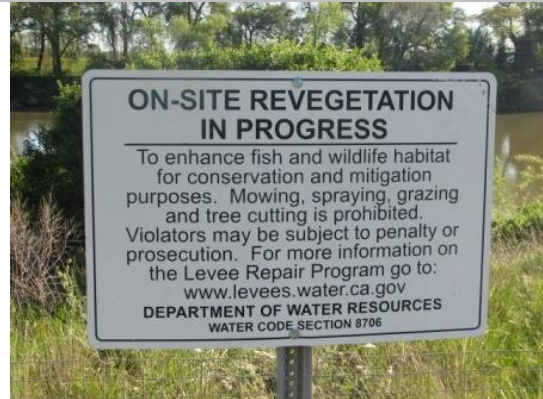
Photo 1 of 1 : FA\_2023\_RD0827\_187\_22\_20230927\_00008.jpg

LM Start	0.61	Rating **	A/W	Issue No.	22
LM End	0.92	Issue Type +	Ob	Location *	WS
Category	Earthen Levee			GPS Latitude/Longitude	
				Start	End
Item	Vegetation			38.668873 °	38.665750 °
				-121.622513 °	-121.618523 °
DWR ID	DWR_RD0827_01_s_2012_22				
Comment Code					
V5 : Environmental Requirements.					
Inspector Comment

Revegetation site, Spring 2012.

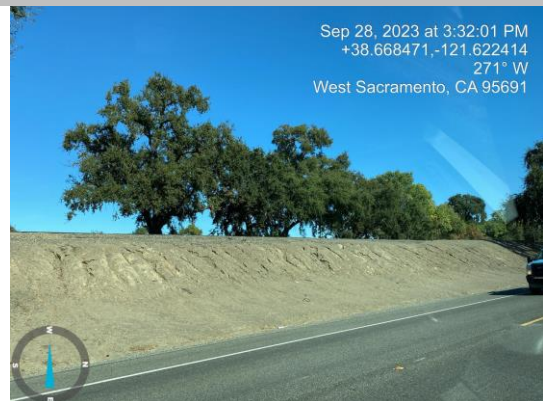
Photo 1 of 1 : FA\_2023\_RD0827\_187\_10\_20231002\_00011.jpg

LM Start	0.64	Rating **	M	Issue No.	10
LM End	0.67	Issue Type +	Ma	Location *	LS
Category	Earthen Levee			GPS Latitude/Longitude	
				Start	End
Item	Erosion / Rills			38.668424 °	38.668090 °
				-121.622451 °	-121.622038 °
DWR ID	DWR_RD0827_01_f _ 2023_10				
Comment Code					
E5 : Schedule repair of rills prior to the next inspection.					
Inspector Comment

View of erosion on landside slope (Fall 2023).

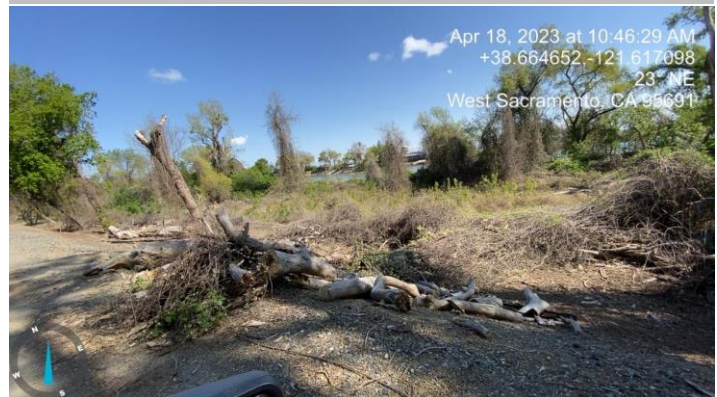
Photo 1 of 1 : FA\_2023\_RD0827\_187\_4\_20230927\_00004.jpg

LM Start	1.03	Rating **	U	Issue No.	4
LM End	1.03	Issue Type +	Ma	Location *	WS
Category	Earthen Levee			GPS Latitude/Longitude	
				Start	End
Item	Trim / Thin Trees			38.664645°	38.664645°
				-121.617048°	-121.617048°
DWR ID	DWR_RD0827_01_s_2023_4				
Comment Code					
T2 : Tree or limb.					
Inspector Comment

View of fallen trees and branches on the levee slope (Spring 2023).

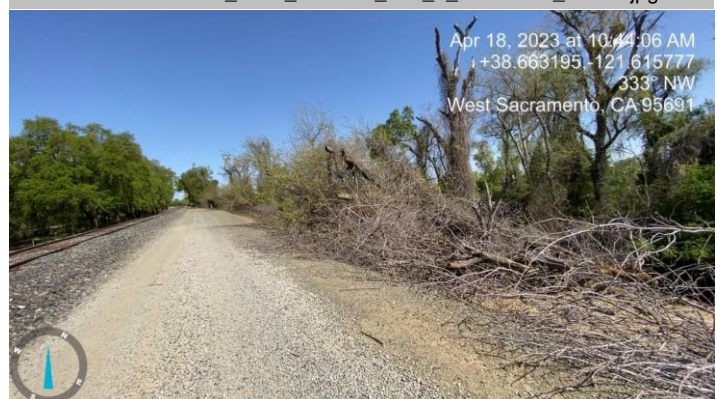
Photo 1 of 1 : FA\_2023\_RD0827\_187\_3\_20230927\_00003.jpg

LM Start	1.15	Rating **	U	Issue No.	3
LM End	1.15	Issue Type +	Ma	Location *	WS
Category	Earthen Levee			GPS Latitude/Longitude	
				Start	End
Item	Trim / Thin Trees			38.663195°	38.663195°
				-121.615777°	-121.615777°
DWR ID	DWR_RD0827_01_s_2023_3				
Comment Code					
T2 : Tree or limb.					
Inspector Comment

View of fallen trees and branches on the levee slope (Spring 2023).

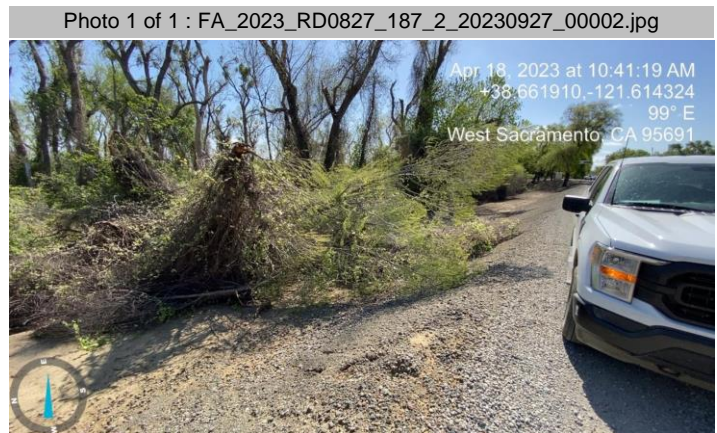
LM Start	1.27	Rating **	U	Issue No.	2
LM End	1.27	Issue Type +	Ma	Location *	WS
Category	Earthen Levee			GPS Latitude/Longitude	
				Start	End
Item	Trim / Thin Trees			38.661910°	38.661910°
				-121.614324°	-121.614324°
DWR ID	DWR_RD0827_01_s_2023_2				
Comment Code					
T2 : Tree or limb.					
Inspector Comment

View of fallen trees and branches on the levee slope (Spring 2023).

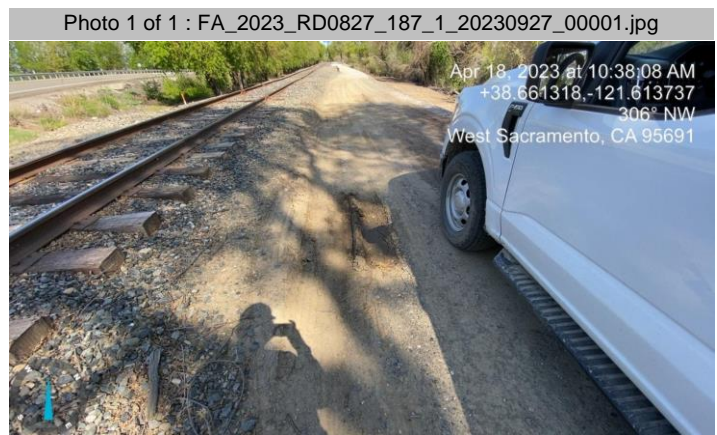
LM Start	1.32	Rating **	M	Issue No.	1
LM End	1.32	Issue Type +	Ma	Location *	CR
Category	Earthen Levee			GPS Latitude/Longitude	
				Start	End
Item	Crown Surface / Depressions / Rutting			38.661318°	38.661318°
				-121.613737°	-121.613737°
DWR ID	DWR_RD0827_01_s_2023_1				
Comment Code					
C2 : Repair depressions or ruts in the crown or slope.					
Inspector Comment					
Vehicle ruts on the levee crown.

View of vehicle ruts on levee crown (Spring 2023).

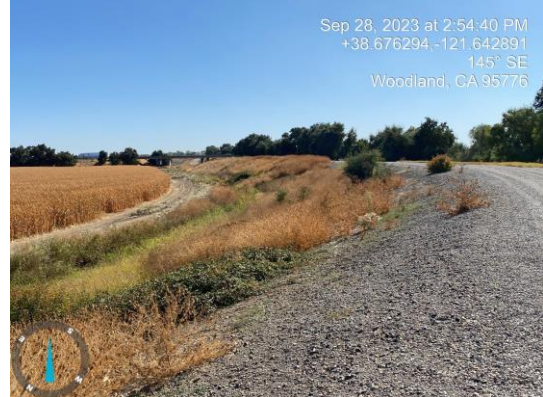
Photo 1 of 1 : FA\_2023\_RD0827\_188\_4\_20231006\_00012.jpg

LM Start	0.03	Rating **	U	Issue No.	4
LM End	0.23	Issue Type +	Ma	Location *	LS
Category	Earthen Levee			GPS Latitude/Longitude	
				Start	End
Item	Vegetation			38.676352°	38.673628°
				-121.642863°	-121.642589°
DWR ID	DWR_RD0827_02_f_2023_4				
Comment Code					
V1 : Control annual grass and weeds on the levee slopes and easements.					
Inspector Comment					
Remove vegetation off the landside slope.

View of vegetation on landside slope (Fall 2023).

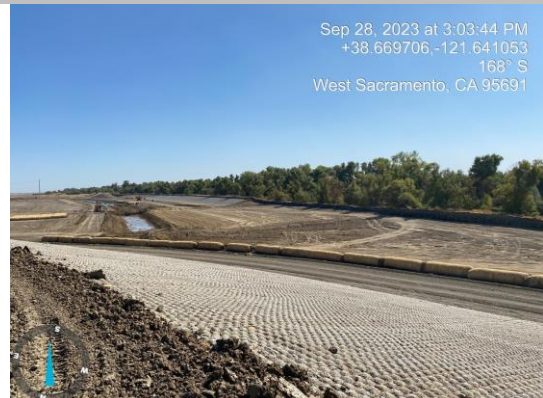
Photo 1 of 1 : FA\_2023\_RD0827\_188\_8\_20231006\_00011.jpg

LM Start	0.38	Rating **	A/W	Issue No.	8
LM End	2.78	Issue Type +	En	Location *	CR
Category	Earthen Levee			GPS Latitude/Longitude	
				Start	End
Item	Encroachments			38.671453°	38.641252°
				-121.642055°	-121.620500°
DWR ID	DWR_RD0827_02_f_2023_8				
Comment Code					
LC : Authorized Levee Construction					
Inspector Comment					
Levee is being degraded and not accessible. The maintenance issues found during past levee inspections will be rated A/W until the levee becomes accessible again.

View from the new levee being constructed and looking at the existing levee being degraded (Fall 2023).

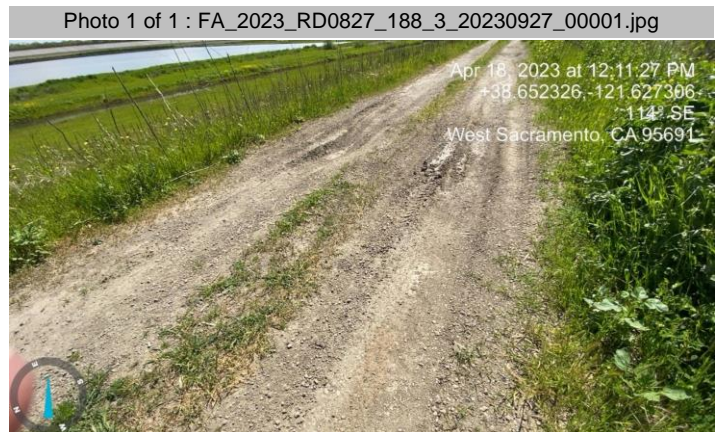
LM Start	1.93	Rating **	A/W	Issue No.	3
LM End	1.93	Issue Type +	Ma	Location *	CR
Category	Earthen Levee			GPS Latitude/Longitude	
				Start	End
Item	Crown Surface / Depressions / Rutting			38.652326°	38.652326°
				-121.627306°	-121.627306°
DWR ID	DWR_RD0827_02_s_2023_3				
Comment Code					
C2 : Repair depressions or ruts in the crown or slope.					
Inspector Comment

View of vehicle rutting on the levee crown (Spring 2023).

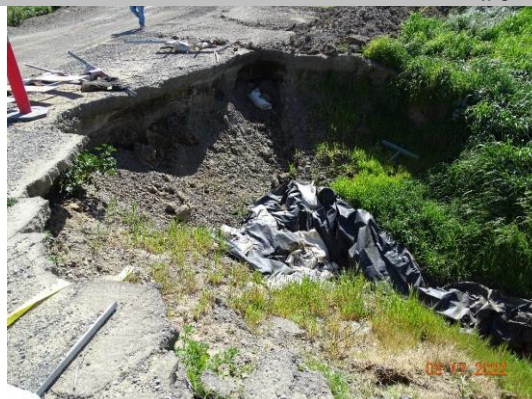
Photo 3 of 3 : UCIP\_FA\_2023\_74199\_110779.jpg

Comment Code						
Inspector Comment						
DS_ID:21151 FS_ID:74199 EP_NO: 3277 Repair Type: Non-Urgent EVAL Issue: 10, Unauthorized Modification or Non-Compliant Permit Crossing Status: Found UCIP Comments: 03/17/2022 Record remains Non-Urgent. Previous comments suggest that the crossing has been removed and replaced under maintenance in 2008. Unable to find a permit for modification. Irrigation ditch on landside causing erosion of landside ramp. (O.Yakimov - DWR UCIP) 03/18/2014 Crossing appears to have been removed and replaced under maintenance back in 2008. No permit has been found--need to contact owner to obtain additional information about replacement. Landward slope sloughing--does not appear to be associated with crossing. Landward slope is being monitored by LMA. (O.Magana - DWR UCIP) FIELD_STRUCT_DESC: 18-inch (not 20-inch as noted in desk study) steel drainage pipe through the levee, 4 feet below the crown. Cutoff wall around pipe at center of levee. Siphon breaker on apex of pipe at waterside (WS) shoulder. Pump on pipe structure in drainage ditch at landside (LS) toe. Rock revetment on WS slope. (20-inch drainage pipe authorized under Permit No. 3277, 1960-Reclamation District No. 827; no permit found authorizing the 18-inch pipe) [Additional Reference(s): DWR Levee Logs, 2005] FS Date: 3/17/2022 11:22:36 AM

Land-Side: Landside ramp erosion caused by irrigation ditch

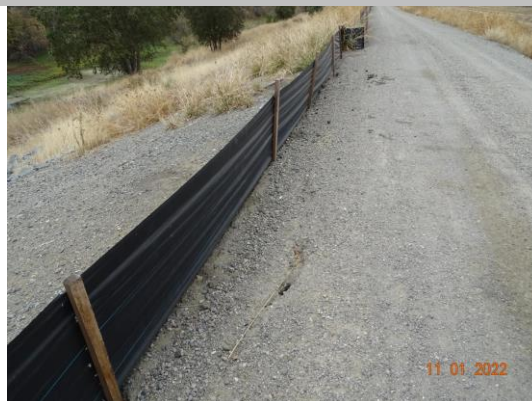
Photo 1 of 1 : FA\_2023\_RD0827\_188\_7\_20230927\_00003.jpg

LM Start	2.73	Rating **	A/W	Issue No.	7
LM End	2.73	Issue Type +	Ma	Location *	WS
Category	Earthen Levee			GPS Latitude/Longitude	
				Start	End
Item	Cracking			38.641894°	38.641894°
				-121.620868°	-121.620868°
DWR ID	DWR_RD0827_02_f_2022_7				
Comment Code					
CR1 : Monitor and have inspected by geotechnical engineer.					
Inspector Comment					
Cracking on the waterside shoulder. Recommend monitoring.

View of crack on the waterside shoulder. Fall 2022.

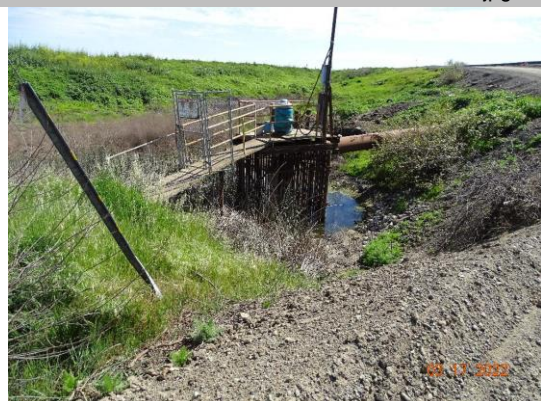
Photo 2 of 3 : UCIP\_FA\_2023\_74200\_110784.jpg

Comment Code						
Inspector Comment						
DS_ID:21169 FS_ID:74200 EP_NO: 5611 Repair Type: Non-Urgent EVAL Issue: 10, Unauthorized Modification or Non-Compliant Permit Crossing Status: Found UCIP Comments: 03/17/2022 Record remains Non-Urgent. Piles of old pumping platform observed in irrigation canal on landside. New piled pumping platform and pump installed in the canal. Pipe makes a turn from pump to landside levee slope. Unable to find a permit for modification. No permit has been identified authorizing installation of pipe. (O.Yakimov - DWR UCIP) 03/18/2014 Crossing appears to have been removed and replaced under maintenance back in 2008. No permit has been found--need to contact owner to obtain additional information about replacement. (O.Magana - DWR UCIP) FIELD_STRUCT_DESC: [RD No. 827 Pumping Plant] 22-inch (not 24-inch as mentioned in desk study) steel drainage pipe through the levee, 8 feet below the crown. Corrugated metal cutoff wall around pipe at center of levee. Siphon breaker on waterside (WS) slope. Flap gate on WS end. Pipe is exposed along WS slope. (portion of pipe was removed and replaced, from landside to waterside shoulder, under Permit No. 5611 (1968)). [Additional Reference(s): DWR Levee Logs, 2005. USACE Sacramento O&M Manual Unit No. 122 Part No. 1, August 1955, (Station 3+75)] FS Date: 3/17/2022 11:29:39 AM

Land-Side: New pump on piled platform in irrigation canal

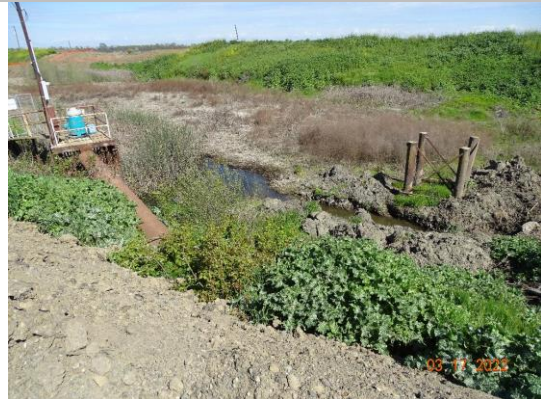
Photo 3 of 3 : UCIP\_FA\_2023\_74200\_110785.jpg

Land-Side: View of levee slope looking from crown. Remnants of pumping platform in irrigation canal
