**Flood Control Project Maintenance
Levee Inspections**
LMA District Cover Sheet
Spring 2010 Levee Inspection Results

Reclamation District No. 0827 Elkhorn

Levee Inspection Report By Mile - Spring 2010

Waterway	Bank	Unit Miles	Inspection Start/End	Inspector
Unit No. 01 Sacramento River	Right	1.35	05/03/2010 05/03/2010	John Williamson

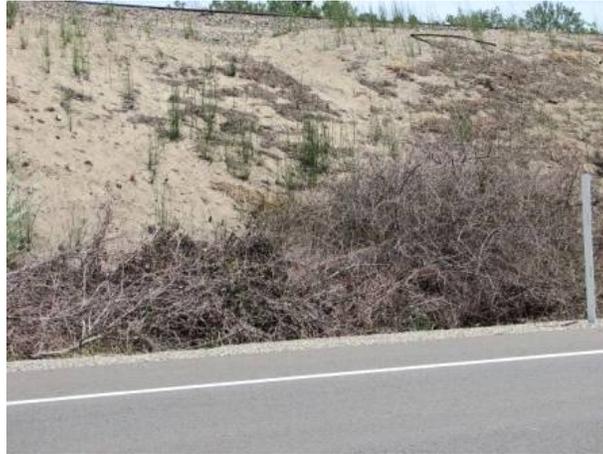
Levee Mile Report Line	5
Start Levee Mile	0.60
End Levee Mile	0.60
Location	Land Side
Category	Earthen Levee
Item	Encroachments
prunings at toe of levee	
johngw_s_20100608_246.jpg

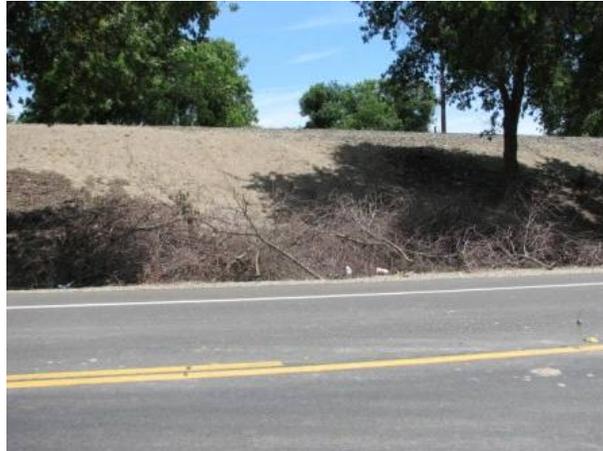
Levee Mile Report Line	8
Start Levee Mile	0.73
End Levee Mile	0.73
Location	Land Side
Category	Earthen Levee
Item	Encroachments
pruning pile at toe	
johngw_s_20100608_247.jpg

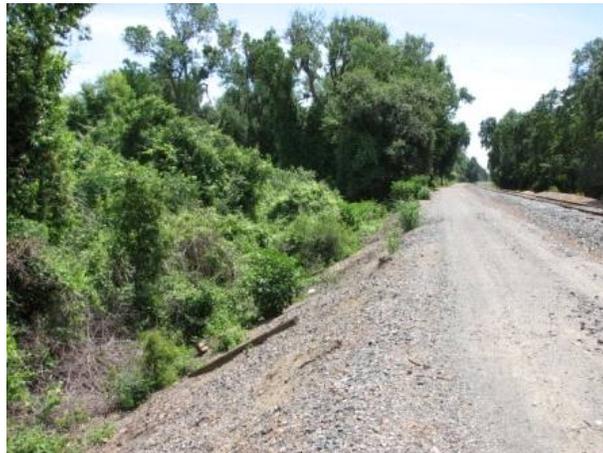
Levee Mile Report Line	12
Start Levee Mile	0.97
End Levee Mile	1.03
Location	Water Side
Category	Earthen Levee
Item	Vegetation
vegetation	
johngw_s_20100608_248.jpg

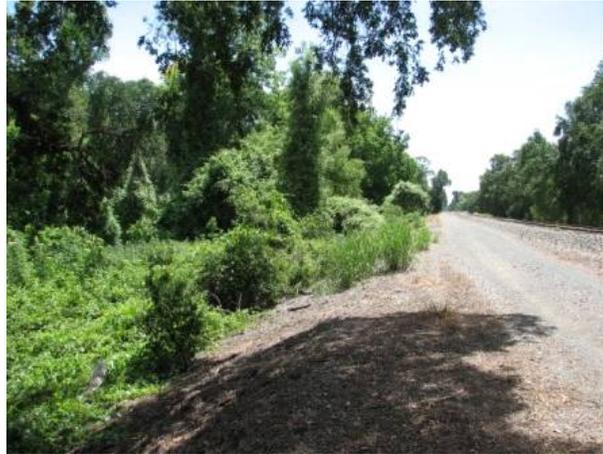
Levee Mile Report Line	13
Start Levee Mile	1.07
End Levee Mile	1.19
Location	Water Side
Category	Earthen Levee
Item	Vegetation
vegetation	
johngw_s_20100608_249.jpg

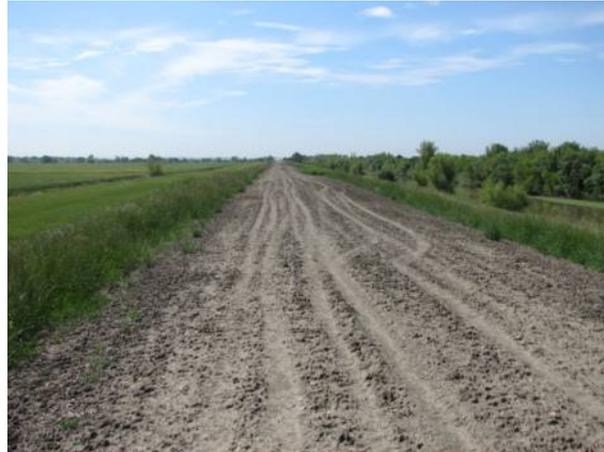
Levee Mile Report Line	6
Start Levee Mile	0.80
End Levee Mile	2.41
Location	
Category	Earthen Levee
Item	Crown Surface / Depressions / Rutting
crown needs grading and AB added	
johngw_s_20100518_177.jpg

LMIR No	Levee Mile		Category	Item	Location *	Rating **	Action/Comment	GPS Latitude/Longitude		Issue No. Photo
	Start	End						Start	End	
1	0.01	2.74	Earthen Levee	Vegetation	WS	M	Control annual grass and weeds on the levee slopes and easements.	38.676437 ° -121.642745 °	38.642300 ° -121.621080 °	3
2	0.01	2.74	Earthen Levee	Vegetation	LS	M	Control annual grass and weeds on the levee slopes and easements.	38.676437 ° -121.642744 °	38.642300 ° -121.621080 °	2
3	0.11	0.11	Earthen Levee	Trim / Thin Trees	WS	N	Tree stumps.	38.675236 ° -121.642985 °	38.675236 ° -121.642985 °	4
4	0.26	0.26	Earthen Levee	Encroachments	LS	M	Prunings	38.673640 ° -121.642370 °	38.673640 ° -121.642370 °	5
5	0.27	0.51	Earthen Levee	Encroachments	LS	PO	Agricultural Ditch	38.673035 ° -121.642390 °	38.669597 ° -121.641600 °	1
6	0.80	2.41	Earthen Levee	Crown Surface / Depressions / Rutting	LS	M	Add appropriate gravel or road base. Grade and compact.	38.665917 ° -121.639188 °	38.646564 ° -121.623705 °	6 Y
