**Flood Control Project Maintenance  
Levee Inspections**

**Fall 2014 Levee Maintenance Deficiency Summary Report**

**Reclamation District No. 0900 West Sacramento**

Waterway	Bank	Unit Miles
Unit No. 01 Sacramento River	Right	7.70

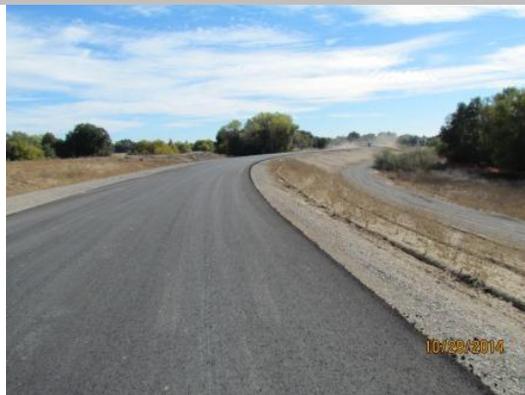
Photo 1 of 1 : FA\_2014\_RD0900\_230\_1\_20141029\_00024.jpg

View of the new setback levee looking downstream during fall 2014 inspection.

LM Start	<b>2.13</b>	Rating **	M	Issue No.	<b>30</b>
LM End	<b>2.13</b>	Issue Type +	Ob	Location *	WS
Category	Supplemental			GPS Latitude/Longitude	
				Start	End
Item	USACE Erosion Survey			38.557717 °	38.558194 °
				-121.516647 °	-121.516859 °
DWR ID	DWR_RD0900_01_f_2014_30				
Action/Comments					
Inspector Comments: 1997 - Old timber pile dikes remnant approximately 30 ft out into the channel. Oversized levee section. 1999 - Some additional erosion at water line. 2008 - Plans for setback levee repair (along with 57.2) currently in the design phase. 2011 - Setback levee under construction. 2013: Setback levee is constructed, should be finalized in 2014. [2013 Site ID: SAC_57-0_R] DWR Comment: This site is adjacent to high ground and a setback levee.

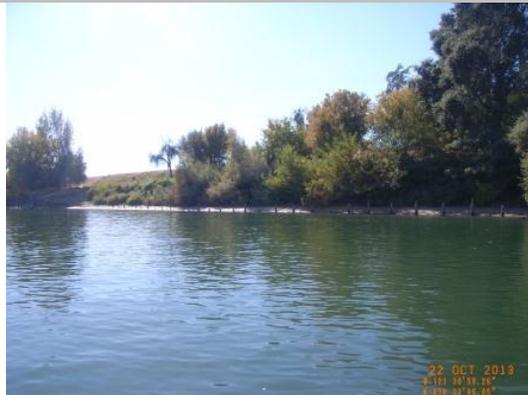
Photo 1 of 1 : FA\_2014\_RD0900\_230\_26\_20141021\_00012.jpg

LM Start	<b>2.59</b>	Rating **	M	Issue No.	<b>26</b>
LM End	<b>2.61</b>	Issue Type +	Ma	Location *	WS
Category	Supplemental		GPS Latitude/Longitude		
			Start	End	
Item	USACE Erosion Survey		38.551319 °	38.550090 °	
			-121.514423 °	-121.513983 °	
DWR ID	DWR_RD0900_01_f_2014_26				
Action/Comments					
Inspector Comments: 1997 - Low berm is contributing to erosion. Old timber pile dikes above water parallel to bank. The upstream mitigation low berm causes a flow separation at the site. 1999 - Some new localized erosion with less than one foot of bank retreat. 2000 - Some new erosion at the upstream end. Fat toe deposits at toe. 2003 - Some new erosion upstream, but have a wide berm. 2011 - Minor new erosion at toe. 2013: No observed changes. [2013 Site ID: SAC_56-5_R]

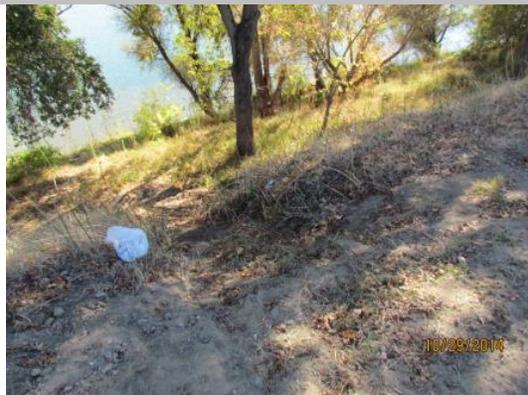
Photo 1 of 2 : FA\_2014\_RD0900\_230\_4\_20141029\_00025.jpg

Updated picture of the slope instability on the waterside of the levee during fall 2014 inspection

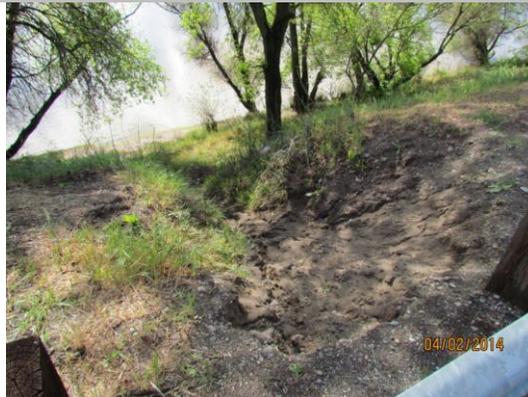
Photo 2 of 2 : FA\_2014\_RD0900\_230\_4\_20141021\_00003.jpg

LM Start	<b>3.42</b>	Rating **	M	Issue No.	<b>4 (cont)</b>
LM End	<b>3.42</b>	Issue Type +	Ma	Location *	WS

A slope instability was found on the waterside of the levee looking downstream.

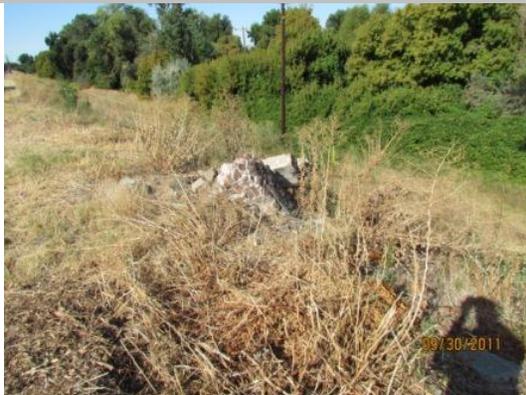
Photo 1 of 1 : FA\_2014\_RD0900\_230\_327\_20141021\_00018.jpg

Concrete debris were found on the landside of the levee looking upstream.

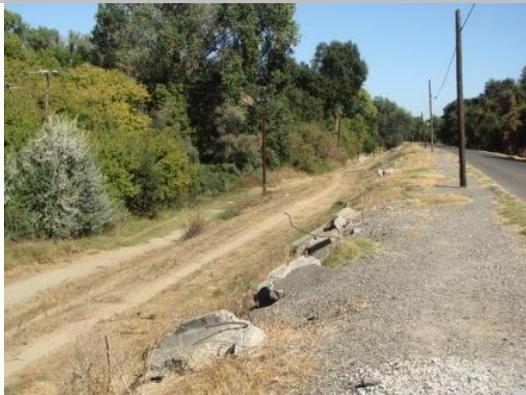
Photo 1 of 1 : FA\_2014\_RD0900\_230\_54\_20141021\_00014.jpg

LM Start	<b>4.11</b>	Rating **	M	Issue No.	<b>54</b>
LM End	<b>4.11</b>	Issue Type +	Ma	Location *	LS
Category	Earthen Levee		GPS Latitude/Longitude		
			Start	End	
Item	Encroachments		38.534364 °	38.534364 °	
			-121.526051 °	-121.526051 °	
DWR ID	DWR_RD0900_01_s_2012_54				
Action/Comments					
Debris Inspector Comments: Concrete debris with metal posing a safety risk.

View of concrete debris with metal looking upstream.

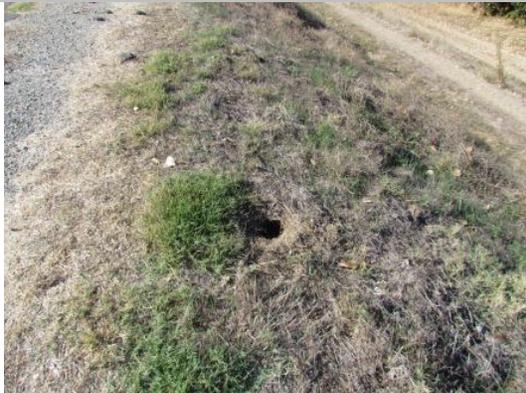
Photo 1 of 1 : FA\_2014\_RD0900\_230\_14\_20141021\_00008.jpg

LM Start	<b>4.12</b>	Rating **	M	Issue No.	<b>14</b>
LM End	<b>4.12</b>	Issue Type +	Ma	Location *	LS
Category	Earthen Levee		GPS Latitude/Longitude		
			Start	End	
Item	Animal Control		38.534345 °	38.534345 °	
			-121.525966 °	-121.525966 °	
DWR ID	DWR_RD0900_01_f_2013_14				
Action/Comments					
No rodents visible, but rodent burrows visible; need to backfill and compact or grout burrows.

An animal hole was found on the landside shoulder of the levee looking downstream.

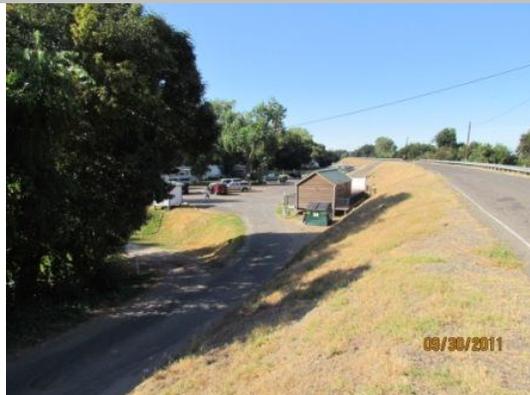
Photo 1 of 1 : FA\_2014\_RD0900\_230\_20\_20141021\_00010.jpg

View of Sherwood harbor's unpermitted properties on the waterside of the levee. The picture was taken from the crown looking upstream.

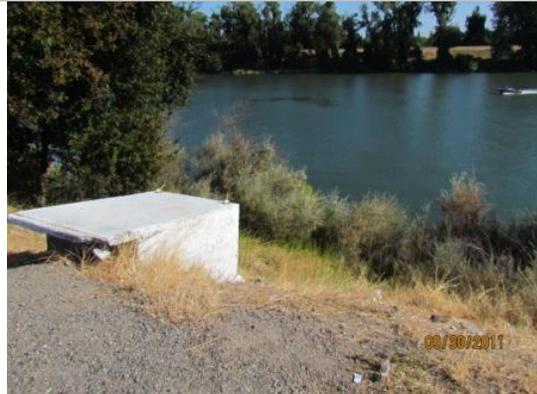
Photo 1 of 1 : FA\_2014\_RD0900\_230\_330\_20141021\_00019.jpg

Concrete anchor was found on the waterside slope of the levee looking upstream.

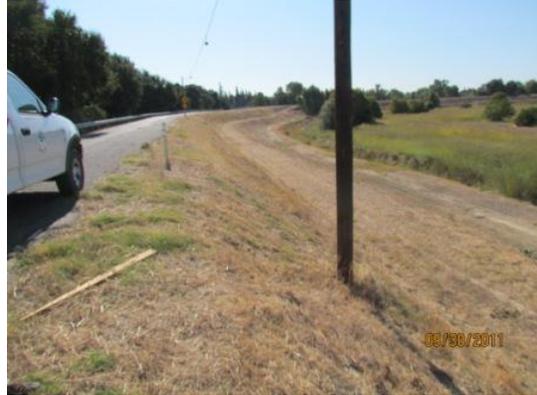
Photo 1 of 1 : FA\_2014\_RD0900\_230\_332\_20141021\_00020.jpg

View of the pole on the landside of the levee looking upstream.

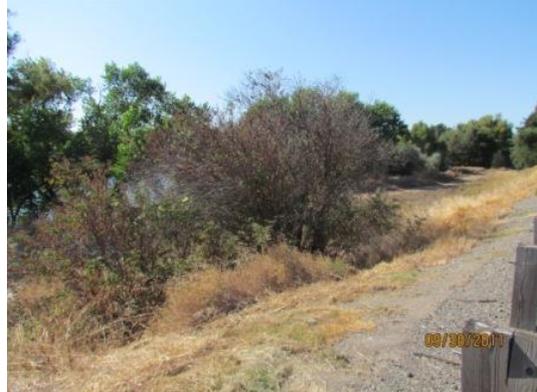
Photo 1 of 1 : FA\_2014\_RD0900\_230\_335\_20141021\_00021.jpg

View of elderberry bush on the waterside of the levee looking upstream.

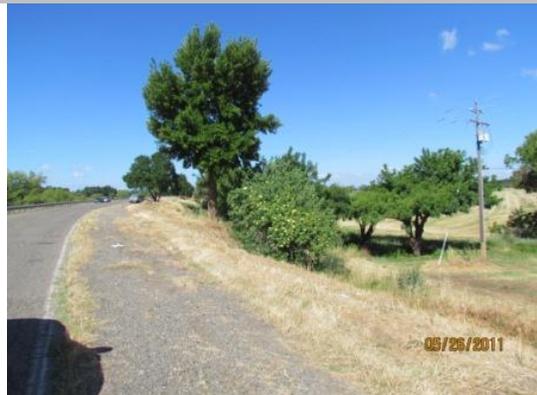
Photo 1 of 1 : FA\_2014\_RD0900\_230\_958\_20141021\_00023.jpg

LM Start	<b>5.53</b>	Rating **	A/W	Issue No.	<b>958</b>
LM End	<b>5.53</b>	Issue Type +	Ma	Location *	LS
Category	Earthen Levee		GPS Latitude/Longitude		
			Start	End	
Item	Vegetation		38.518988 °	38.518988 °	
			-121.527738 °	-121.527738 °	
DWR ID	DWR_RD0900_01_s_2012_958				
Action/Comments					
Elderberries are blocking visibility and flood fight capability.

Elderberry on the landside of the levee. The picture was taken from the crown looking downstream.

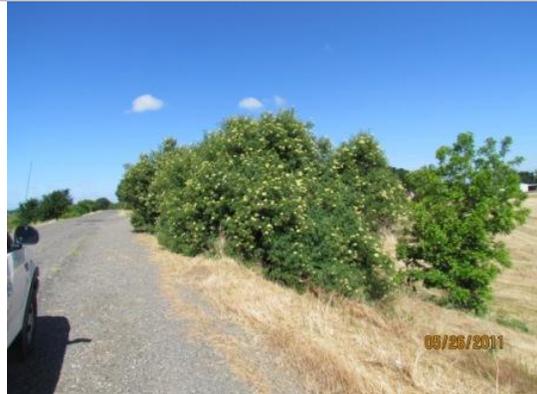
Photo 1 of 1 : FA\_2014\_RD0900\_230\_25\_20141021\_00011.jpg

Elderberry located on the landside of the levee obstructing the view. The picture was taken from the crown looking downstream.

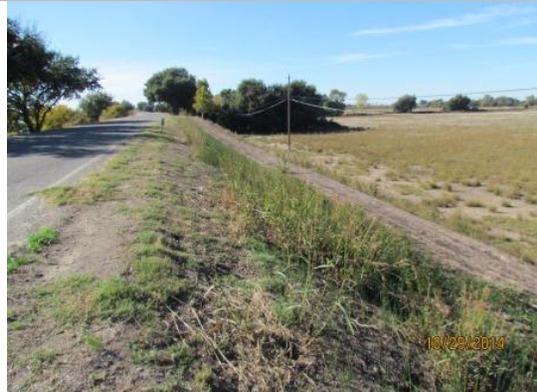
Photo 1 of 1 : FA\_2014\_RD0900\_230\_70\_20141029\_00027.jpg

LM Start	<b>6.15</b>	Rating **	M	Issue No.	<b>70</b>
LM End	<b>6.83</b>	Issue Type +	Ma	Location *	LS
Category	Earthen Levee		GPS Latitude/Longitude		
			Start	End	
Item	Vegetation		38.517877 °	38.515364 °	
			-121.538981 °	-121.551063 °	
DWR ID	DWR_RD0900_01_f_2014_70				
Action/Comments					
Control annual grass and weeds on the levee slopes and easements.

View of the vegetation on the landside of the levee looking downstream.

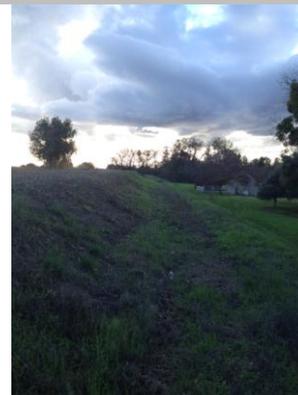
Photo 1 of 1 : FA\_2014\_RD0900\_230\_73\_20141204\_00029.jpg

View of the landside slope of the levee looking downstream.

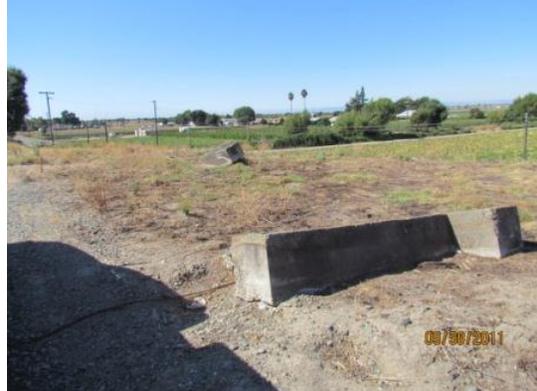
Photo 1 of 1 : FA\_2014\_RD0900\_230\_343\_20141021\_00022.jpg

Concrete debris from old rail road track was found on the landside of the levee looking upstream.

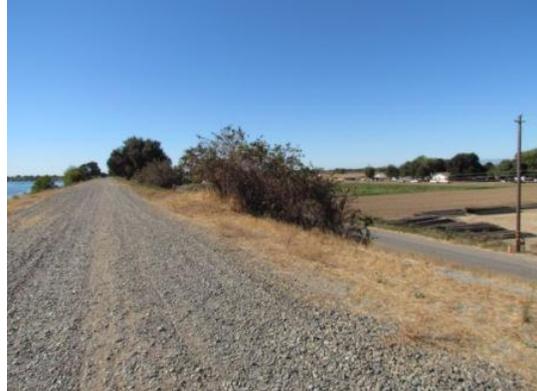
Photo 1 of 1 : FA\_2014\_RD0900\_230\_8\_20141021\_00005.jpg

An elderberry bush was found on the landside of the levee looking downstream.

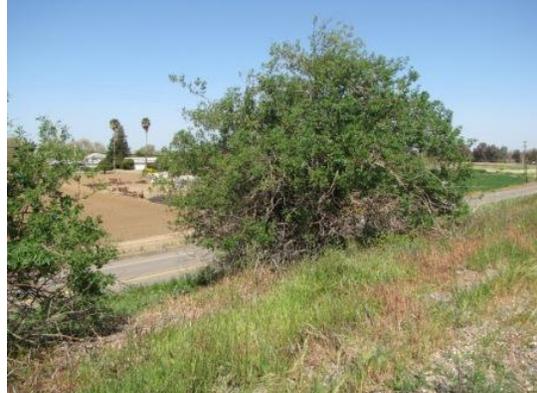
Photo 1 of 1 : FA\_2014\_RD0900\_230\_7\_20141021\_00004.jpg

LM Start	<b>7.27</b>	Rating **	A/W	Issue No.	<b>7</b>
LM End	<b>7.27</b>	Issue Type +	Ma	Location *	LS
Category	Earthen Levee		GPS Latitude/Longitude		
			Start	End	
Item	Vegetation		38.510613 °	38.510613 °	
			-121.555969 °	-121.555969 °	
DWR ID	DWR_RD0900_01_s_2012_7				
Action/Comments					
Elderberries are blocking visibility and flood fight capability.

View of elderberries blocking visibility on the landward slope looking upstream.

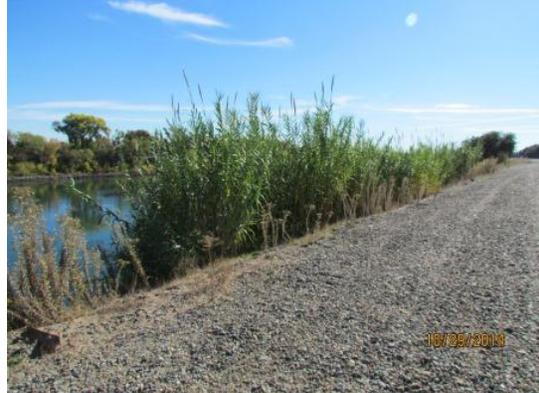
Photo 1 of 3 : FA\_2014\_RD0900\_230\_59\_20141029\_00026.jpg

View of arundo on the waterside of the levee during the fall 2014 inspection.

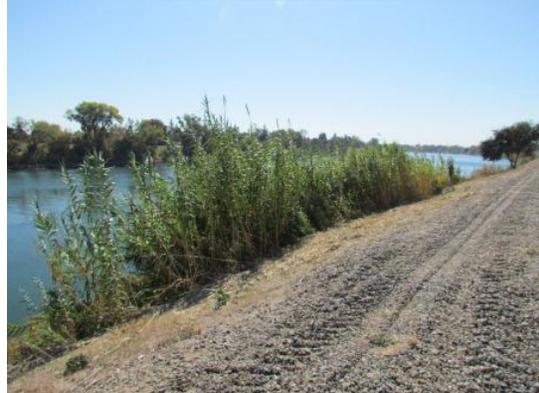
Photo 2 of 3 : FA\_2014\_RD0900\_230\_59\_20141021\_00017.jpg

LM Start	<b>7.49</b>	Rating **	M	Issue No.	<b>59 (cont)</b>
LM End	<b>7.49</b>	Issue Type +	Ma	Location *	WS

View of arundo on the waterside of the levee looking downstream during the fall 2013 inspection.

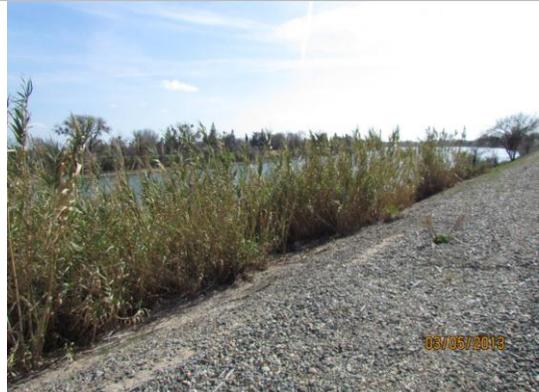
Photo 3 of 3 : FA\_2014\_RD0900\_230\_59\_20141021\_00016.jpg

LM Start	<b>7.49</b>	Rating **	M	Issue No.	<b>59 (cont)</b>
LM End	<b>7.49</b>	Issue Type +	Ma	Location *	WS

Arundo was found on the waterside slope of the levee looking downstream during spring 2013 inspection.

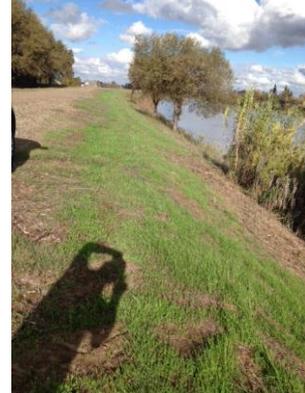
Photo 1 of 1 : FA\_2014\_RD0900\_230\_10\_20141204\_00028.jpg

View of the waterside slope of the levee looking upstream.

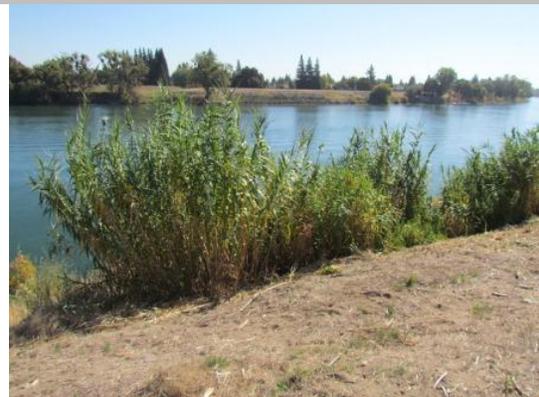
Photo 1 of 1 : FA\_2014\_RD0900\_230\_15\_20141021\_00009.jpg

LM Start	<b>7.80</b>	Rating **	M	Issue No.	<b>15</b>
LM End	<b>7.80</b>	Issue Type +	Ma	Location *	WS
Category	Earthen Levee		GPS Latitude/Longitude		
			Start	End	
Item	Vegetation		38.503490 °	38.503490 °	
			-121.559770 °	-121.559770 °	
DWR ID	DWR_RD0900_01_f_2013_15				
Action/Comments					
Remove the wild growth other than native grasses from the levee slopes. Inspector Comments: Arrundo on the waterside

View of arundo on the waterside of the levee looking downstream.

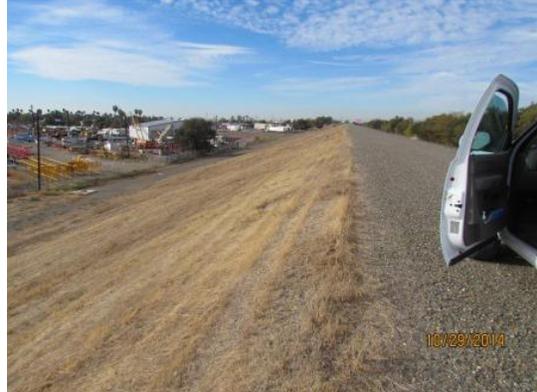
Photo 1 of 1 : FA\_2014\_RD0900\_231\_48\_20141029\_00008.jpg

View of the landside slope of the levee looking downstream.

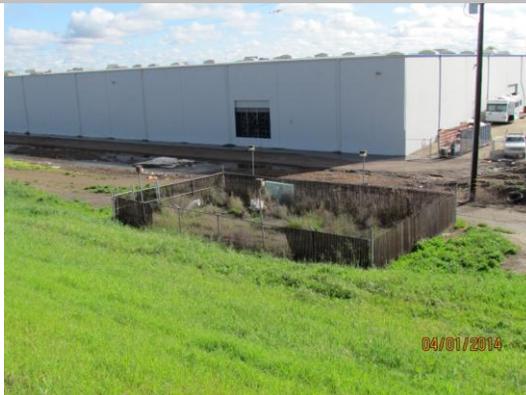
Photo 1 of 1 : FA\_2014\_RD0900\_231\_5\_20141021\_00002.jpg

View of the water well on the landside toe of the levee looking upstream.

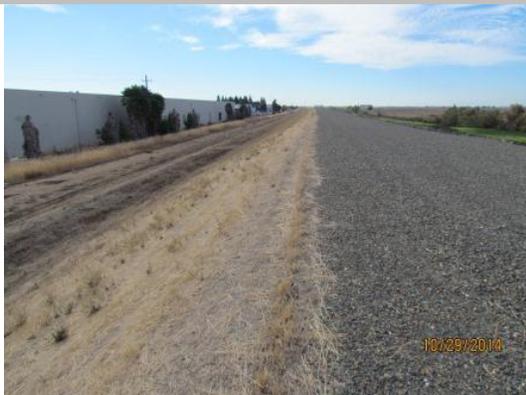
Photo 1 of 1 : FA\_2014\_RD0900\_231\_49\_20141029\_00009.jpg

LM Start	<b>1.43</b>	Rating **	A	Issue No.	<b>49</b>
LM End	<b>1.43</b>	Issue Type +	Ma	Location *	LS
Category	Earthen Levee		GPS Latitude/Longitude		
			Start	End	
Item	Vegetation		38.567407 °	38.567407 °	
			-121.582182 °	-121.582182 °	
DWR ID	DWR_RD0900_02_f_2014_49				
Action/Comments					
Control annual grass and weeds on the levee slopes and easements.

View of the vegetation on the landside of the levee looking downstream during fall 2014 inspection.

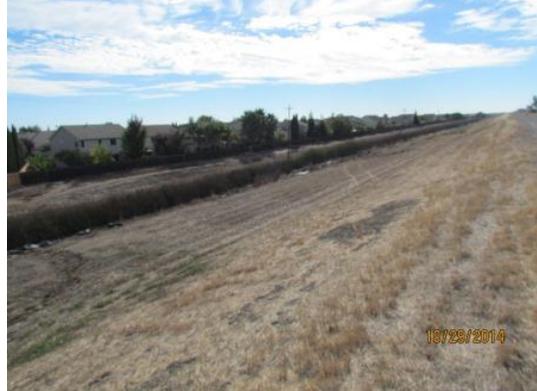
Photo 1 of 1 : FA\_2014\_RD0900\_231\_17\_20141029\_00010.jpg

View of the ditch on the landside toe of the levee looking downstream.

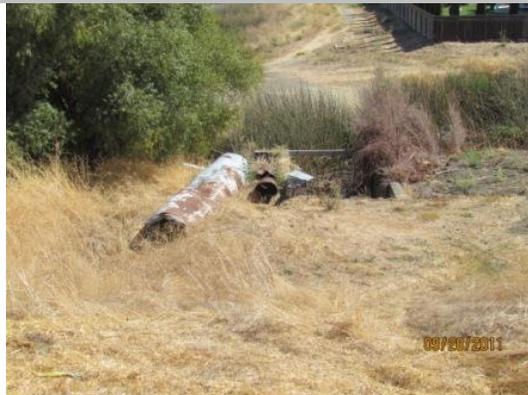
Photo 1 of 1 : FA\_2014\_RD0900\_231\_15\_20141021\_00005.jpg

Abandon pipes and debris was found on the landside of the levee looking upstream.

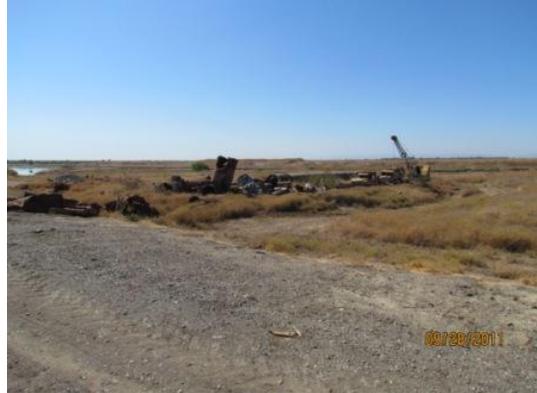
Photo 1 of 1 : FA\_2014\_RD0900\_231\_391\_20141021\_00006.jpg

Metal equipments and debris are purposely placed next to the gate by the LMA for barricade. The picture was taken from the crown looking upstream.

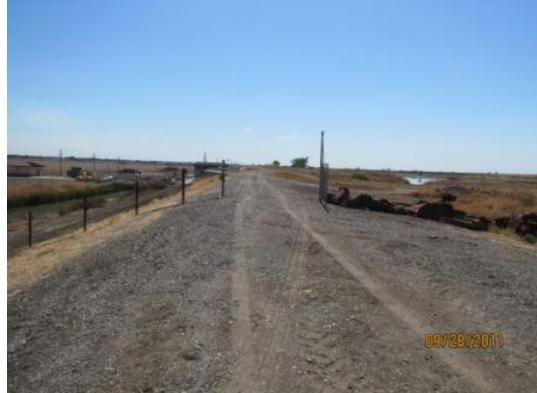
Photo 1 of 1 : FA\_2014\_RD0900\_231\_392\_20141021\_00007.jpg

LM Start	<b>4.85</b>	Rating **	M	Issue No.	<b>392</b>
LM End	<b>4.85</b>	Issue Type +	En	Location *	CR
Category	Earthen Levee		GPS Latitude/Longitude		
			Start	End	
Item	Encroachments		38.518072 °	38.518072 °	
			-121.582129 °	-121.582129 °	
DWR ID	DWR_RD0900_02_s_2012_392				
Action/Comments					
Fence Inspector Comments: A gate was put in by the LMA to keep the vehicles out.

A gate is installed by the LMA on the crown of the levee looking upstream.
