**Flood Control Project Maintenance
Levee Inspections**

Fall 2015 Levee Maintenance Deficiency Summary Report

Sacramento River Basin

Reclamation District No. 0900 West Sacramento

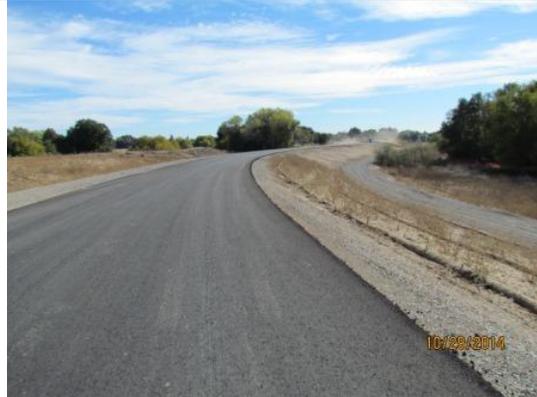
Photo 1 of 1 : FA_2015_RD0900_230_1_20150911_00001.jpg

LM Start	1.91	Rating **	C	Issue No.	5
LM End	1.99	Issue Type +	Ma	Location *	WS
Category	Supplemental			GPS Latitude/Longitude	
				Start	End
Item	2015 USACE Erosion Survey, DRAFT			38.560512 °	38.558998 °
				-121.518376 °	-121.517191 °
DWR ID					
Action/Comments					
Inspector Comments: 2007 - Steep levee slope with cobble revetment rolling off the bank and a silty clay toe. 2008 - Plans for setback levee repair currently in the design phase. 2011 - Setback levee under construction. 2013 - Setback levee is constructed, should be finalized in 2014. 2015: Setback levee complete, site is repaired. [2015 Site ID: SAC_57-2_R]

View of the new setback levee looking downstream during fall 2014 inspection.

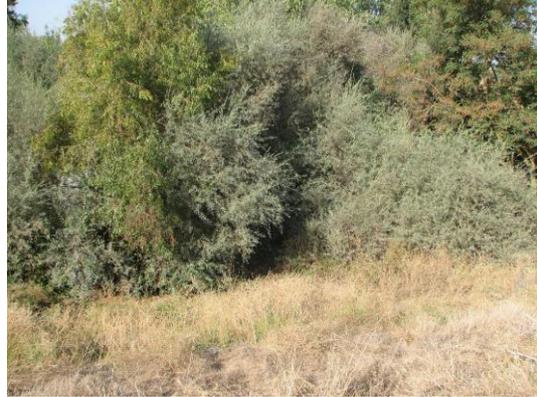
Photo 1 of 3 : UCIP_FA_2015_4725.jpg

Inspector Comments: FS_ID:37665
 DS_ID:17772
 EP_NO: N/A
 FS_HLM: 2.158
 Repair Type: Non-Urgent
 Crossing Status: Found
 UCIP Comments: Dense vegetation limits the inspector's visibility to identify signs of pipe failure (leaks) along the slope. Recommend removing vegetation along pipe alignment to conduct proper inspection of structure and appurtenances.
 FIELD_STRUCT_DESC: 42-inch pipeline through the levee 21.5 feet below the crown. Slide gate in concrete riser on the waterward slope. Flap gate on the waterward end.
 FS Date: 10/06/2009

Dense vegetation along landward side.

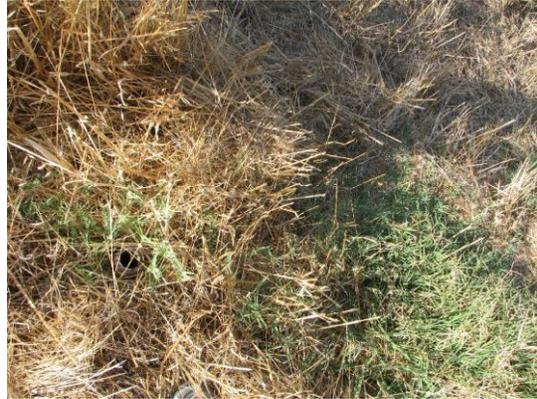
Photo 2 of 3 : UCIP_FA_2015_4726.jpg

Air vent visible through dense vegetation.

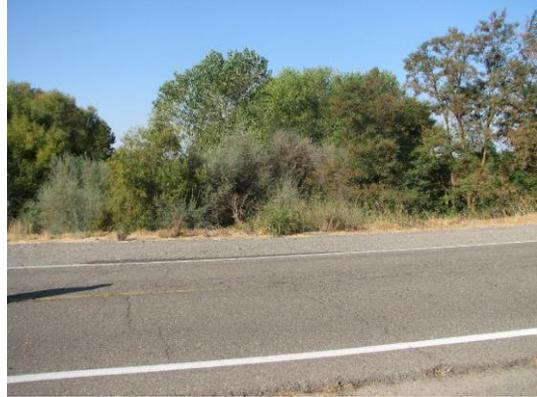
Photo 3 of 3 : UCIP_FA_2015_4727.jpg

LM Start	2.15	Rating **	M	Issue No.	971 (cont)
LM End	2.15	Issue Type +	En	Location *	WS
Category	Supplemental			GPS Latitude/Longitude	
				Start	End
Item	DWR UCIP Field Study			38.556994 °	38.556994 °
				-121.516843 °	-121.516843 °
DWR ID					
Action/Comments					
Inspector Comments: FS_ID:37665 DS_ID:17772 EP_NO: N/A FS_HLM: 2.158 Repair Type: Non-Urgent Crossing Status: Found

View of levee crown at crossing.

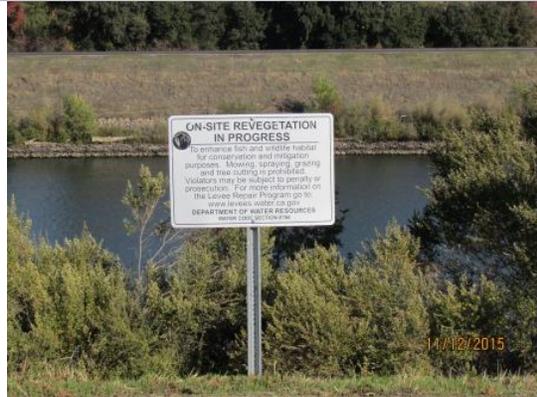
Photo 1 of 1 : FA_2015_RD0900_230_17_20151113_00022.jpg

LM Start	2.26	Rating **	A/W	Issue No.	17
LM End	3.72	Issue Type +	Ma	Location *	WS
Category	Earthen Levee			GPS Latitude/Longitude	
				Start	End
Item	Vegetation			38.555304 °	38.536946 °
				-121.516127 °	-121.519774 °
DWR ID	DWR_RD0900_01_s_2012_17				
Action/Comments					
Environmental Requirements.

View of the DWR environmental mitigation site.

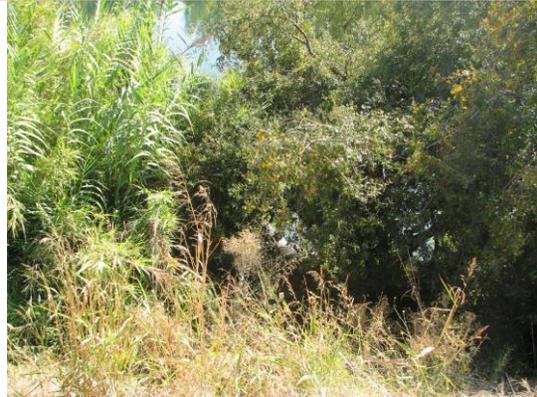
Photo 1 of 3 : UCIP_FA_2015_4752.jpg

Pipe visible on waterward side visible through dense vegetation.

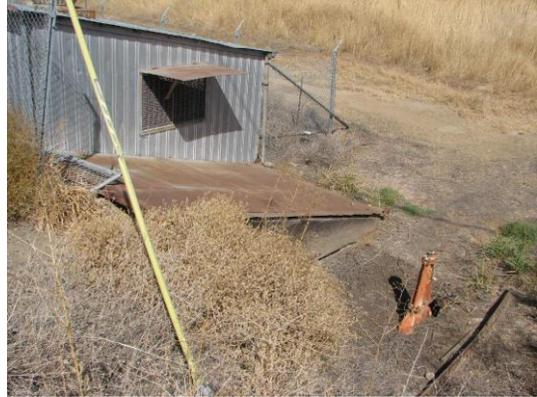
Photo 2 of 3 : UCIP_FA_2015_4753.jpg

Pump house located on landward side.

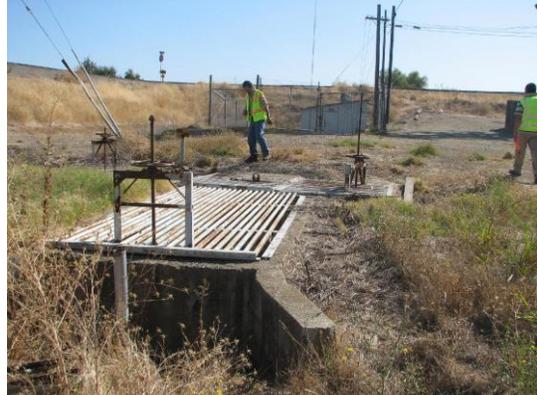
Photo 3 of 3 : UCIP_FA_2015_4754.jpg

View of concrete structure located on landward side.

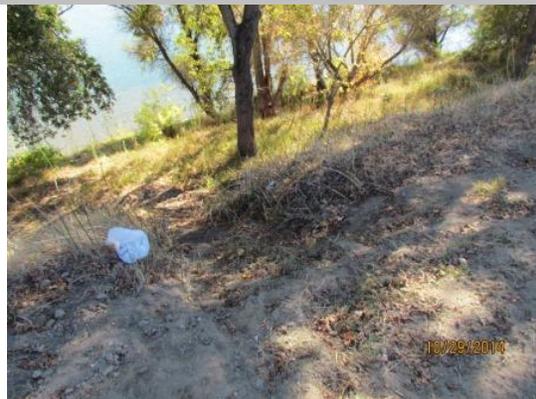
Photo 1 of 2 : FA_2015_RD0900_230_4_20150911_00002.jpg

Updated picture of the slope instability on the waterside of the levee during fall 2014 inspection

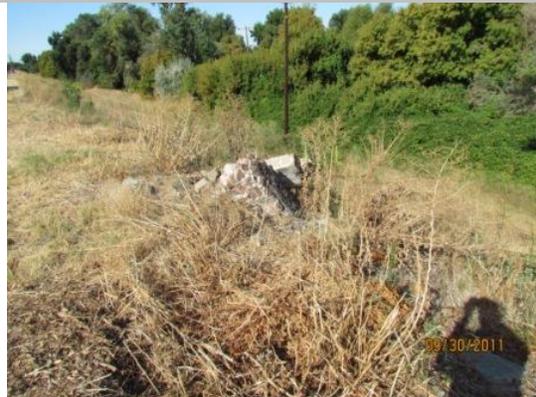
Photo 1 of 1 : FA_2015_RD0900_230_327_20150911_00016.jpg

Concrete debris were found on the landside of the levee looking upstream.

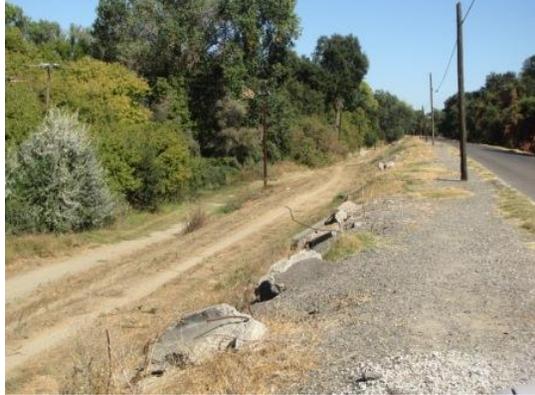
Photo 1 of 1 : FA_2015_RD0900_230_54_20150911_00012.jpg

View of concrete debris with metal looking upstream.

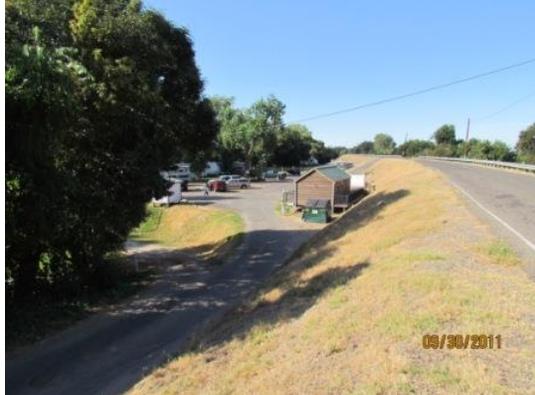
Photo 1 of 1 : FA_2015_RD0900_230_20_20150911_00008.jpg

LM Start	4.26	Rating **	U	Issue No.	20
LM End	4.26	Issue Type +	En	Location *	WS
Category	Earthen Levee		GPS Latitude/Longitude		
			Start	End	
Item	Encroachments		38.533274 °	38.533274 °	
			-121.528628 °	-121.528628 °	
DWR ID	DWR_RD0900_01_s_2012_20				
Action/Comments					
Building Inspector Comments: Miscellaneous unpermitted encroachments at the Sherwood Harbor. An encroachment permit application is being reviewed by RD900.

View of Sherwood harbor's unpermitted properties on the waterside of the levee. The picture was taken from the crown looking upstream.

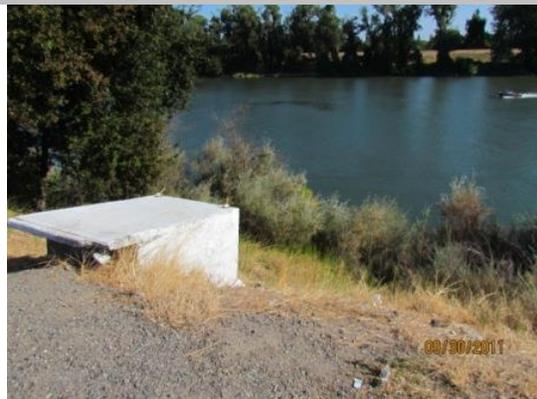
Photo 1 of 1 : FA_2015_RD0900_230_330_20150911_00017.jpg

Concrete anchor was found on the waterside slope of the levee looking upstream.

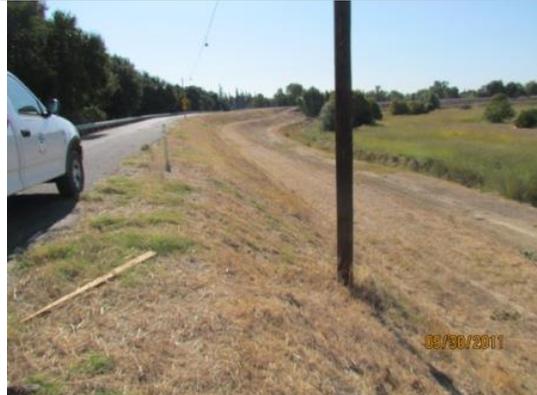
Photo 1 of 1 : FA_2015_RD0900_230_332_20150911_00018.jpg

View of the pole on the landside of the levee looking upstream.

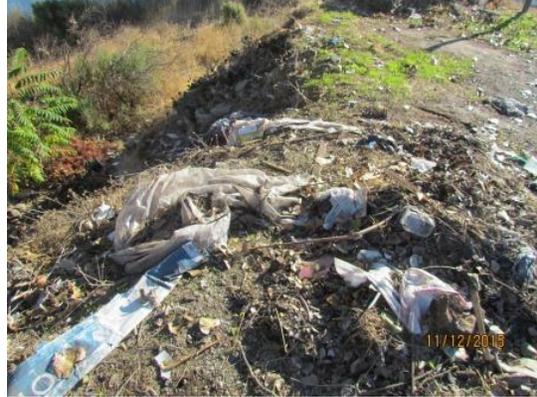
Photo 1 of 1 : FA_2015_RD0900_230_18_20151113_00023.jpg

View of the debris on the waterside slope of the levee looking downstream.

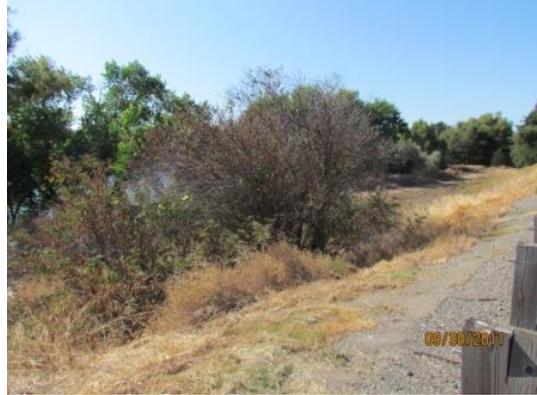
Photo 1 of 1 : FA_2015_RD0900_230_335_20150911_00019.jpg

View of elderberry bush on the waterside of the levee looking upstream.

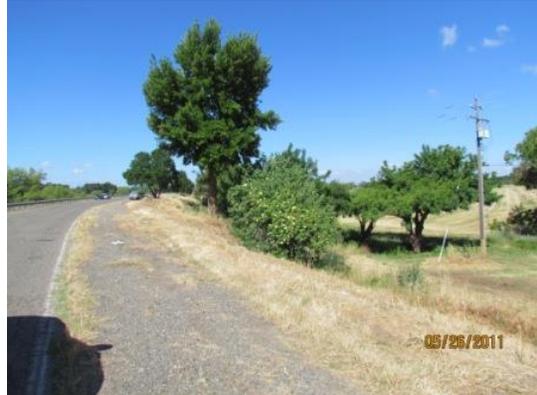
Photo 1 of 1 : FA_2015_RD0900_230_958_20150911_00021.jpg

Elderberry on the landside of the levee. The picture was taken from the crown looking downstream.

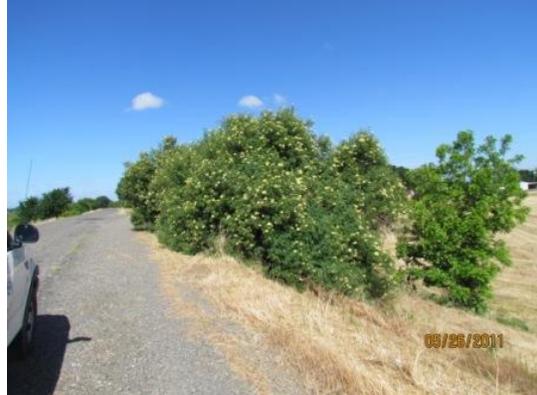
Photo 1 of 1 : FA_2015_RD0900_230_25_20150911_00009.jpg

Elderberry located on the landside of the levee obstructing the view. The picture was taken from the crown looking downstream.

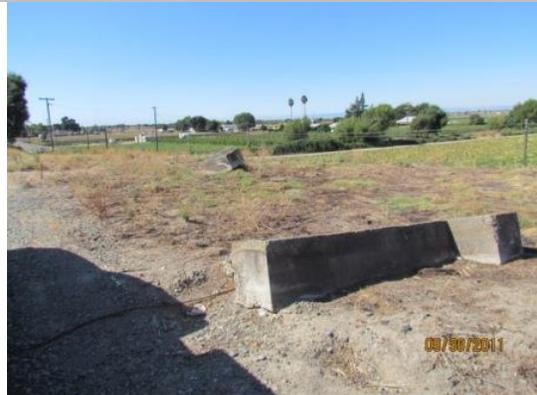
Photo 1 of 1 : FA_2015_RD0900_230_343_20150911_00020.jpg

Concrete debris from old rail road track was found on the landside of the levee looking upstream.

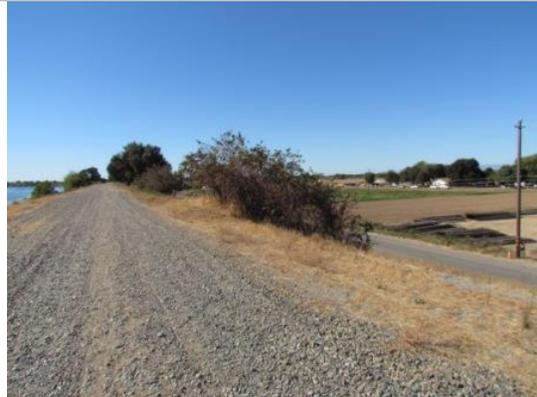
Photo 1 of 1 : FA_2015_RD0900_230_8_20150911_00005.jpg

An elderberry bush was found on the landside of the levee looking downstream.

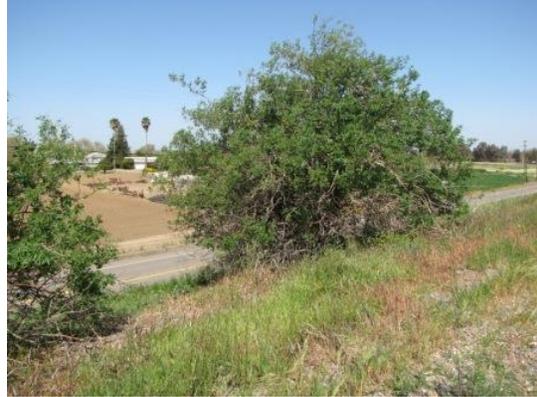
Photo 1 of 1 : FA_2015_RD0900_230_7_20150911_00004.jpg

View of elderberries on the landward slope looking upstream.

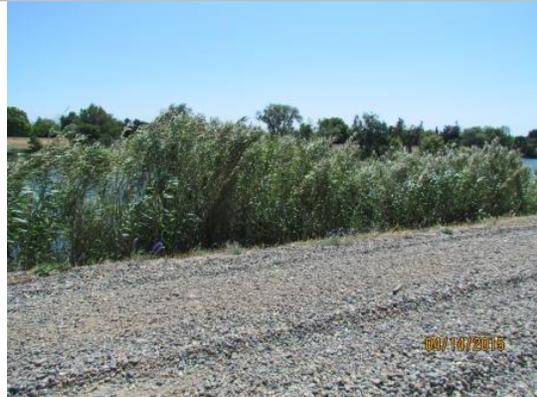
Photo 1 of 2 : FA_2015_RD0900_230_59_20150911_00013.jpg

Updated picture of the arundo on the waterside of the levee during spring 2015 inspection.

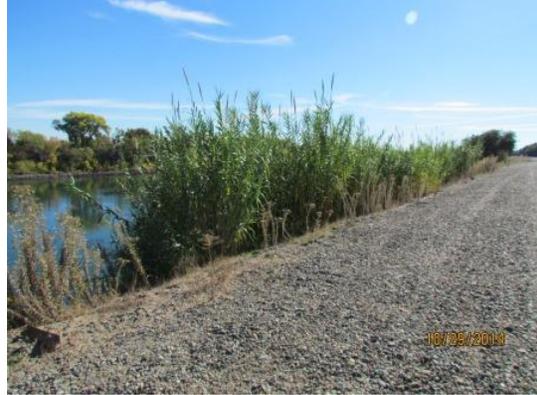
Photo 2 of 2 : FA_2015_RD0900_230_59_20150911_00014.jpg

View of arundo on the waterside of the levee during the fall 2014 inspection.

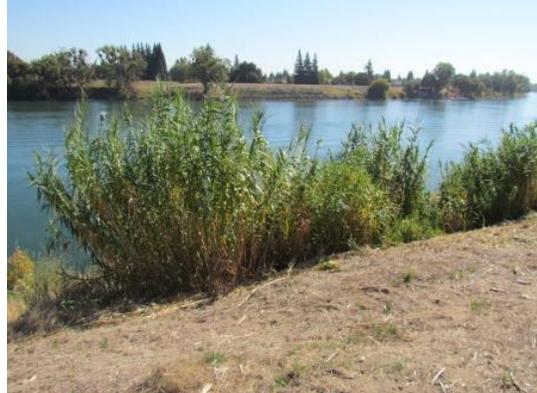
Photo 1 of 1 : FA_2015_RD0900_230_15_20150911_00007.jpg

View of arundo on the waterside of the levee looking downstream.

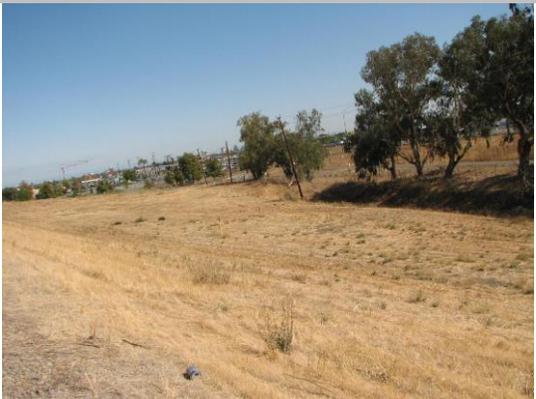
Photo 1 of 3 : UCIP_FA_2015_5920.jpg

Additional marker visible on landward side--unable to confirm if line is tied to other marker near levee shoulder.

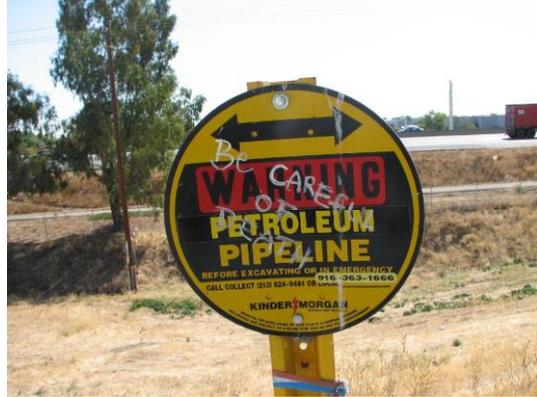
Photo 2 of 3 : UCIP_FA_2015_5921.jpg

Marker of petroleum pipeline unable to confirm permit--there are 3 gas line in desk study records for gas line but none for Kinder Morgan.

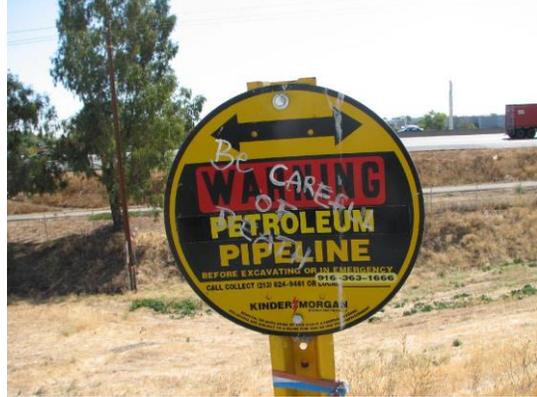
Photo 3 of 3 : UCIP_FA_2015_6402.jpg

Marker of petroleum pipeline unable to confirm permit--there are 3 gas line in desk study records for gas line but none for Kinder Morgan.

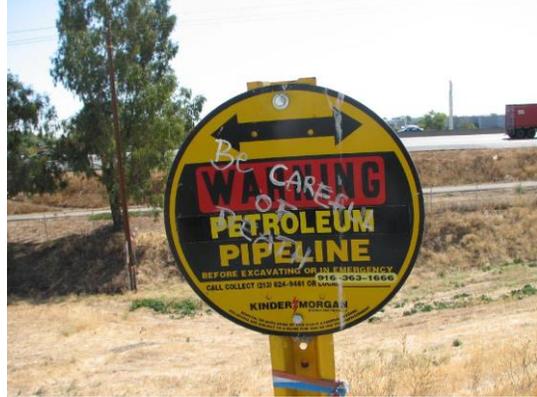
Photo 2 of 3 : UCIP_FA_2015_5924.jpg

Marker of petroleum pipeline unable to confirm permit--there are 3 gas line in desk study records for gas line but none for Kinder Morgan.

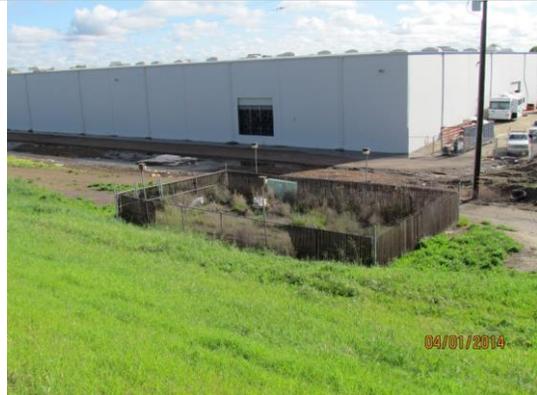
Photo 1 of 1 : FA_2015_RD0900_231_5_20150911_00001.jpg

View of the water well on the landside toe of the levee looking upstream.

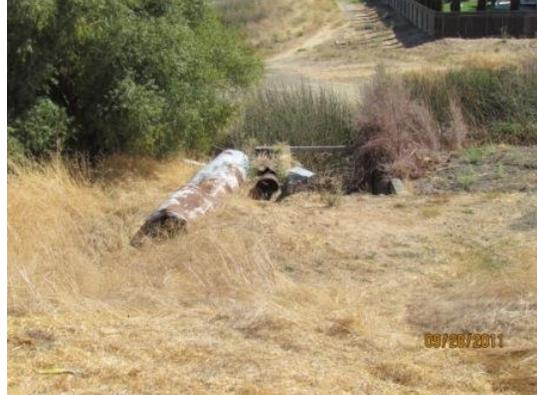
Photo 1 of 1 : FA_2015_RD0900_231_15_20150911_00004.jpg

Abandon pipes and debris was found on the landside of the levee looking upstream.

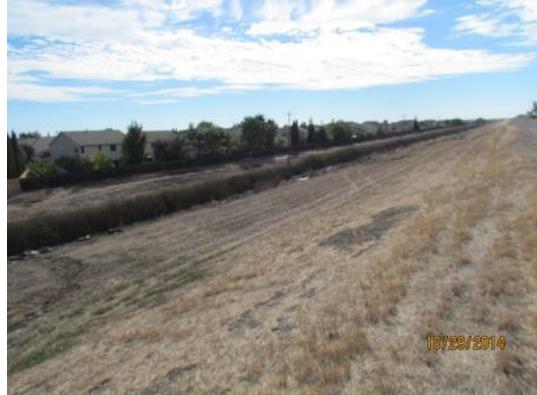
Photo 1 of 1 : FA_2015_RD0900_231_17_20150911_00005.jpg

View of the ditch on the landside toe of the levee looking downstream.
