**Flood Control Project Maintenance
Levee Inspections
LMA District Cover Sheet
Spring 2015 Levee Inspection Results**

Reclamation District No. 0900 West Sacramento

Spring 2015 Levee Inspection Results

Waterway		Bank	Unit Miles
Unit No. 01 Sacramento River		Right	7.82

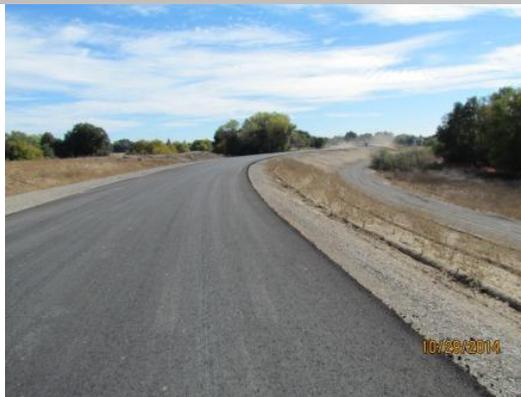
Photo 1 of 1 : SP_2015_RD0900_230_1_20150313_00001.jpg

View of the new setback levee looking downstream during fall 2014 inspection.

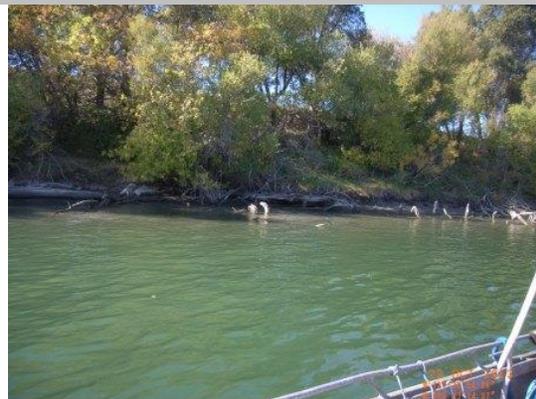
Photo 1 of 1 : SP_2015_RD0900_230_28_20150313_00012.jpg

LM Start	2.34	Rating **	M	Issue No.	28
LM End	2.47	Issue Type +	Ob	Location *	WS
Category	Supplemental		GPS Latitude/Longitude		
			Start	End	
Item	USACE Erosion Survey		38.554277 °	38.552504 °	
			-121.515263 °	-121.514752 °	
DWR ID	DWR_RD0900_01_f_2014_28				
Action/Comments					
Inspector Comments: 2007 - Have good berm width with minor toe erosion. Close to the levee toe protection, but levee slope is steep. 2011 - New large erosion pocket. 2012 - Minor new erosion at the toe. 2013: No observed changes. [2013 Site ID: SAC_56-7_R] DWR Comment: This site is adjacent to high ground and a setback levee.

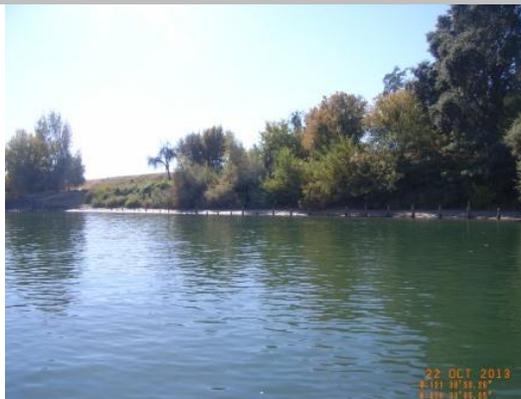
Photo 1 of 1 : SP_2015_RD0900_230_26_20150313_00011.jpg

LM Start	2.55	Rating **	M	Issue No.	26
LM End	2.64	Issue Type +	Ma	Location *	WS
Category	Supplemental			GPS Latitude/Longitude	
				Start	End
Item	USACE Erosion Survey			38.551319 °	38.550090 °
				-121.514423 °	-121.513983 °
DWR ID	DWR_RD0900_01_f_2014_26				
Action/Comments					
Inspector Comments: 1997 - Low berm is contributing to erosion. Old timber pile dikes above water parallel to bank. The upstream mitigation low berm causes a flow separation at the site. 1999 - Some new localized erosion with less than one foot of bank retreat. 2000 - Some new erosion at the upstream end. Fat toe deposits at toe. 2003 - Some new erosion upstream, but have a wide berm. 2011 - Minor new erosion at toe. 2013: No observed changes. [2013 Site ID: SAC_56-5_R]

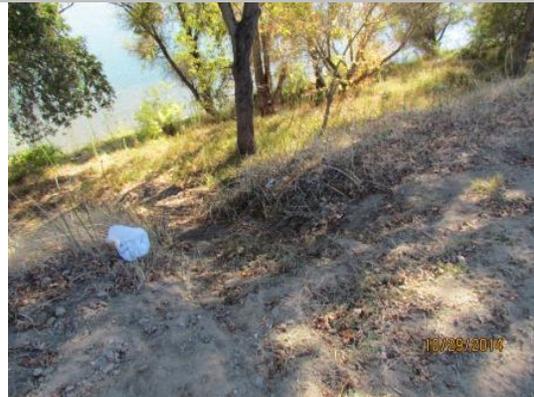
Photo 1 of 2 : SP_2015_RD0900_230_4_20150313_00002.jpg

LM Start	3.41	Rating **	M	Issue No.	4
LM End	3.41	Issue Type +	Ma	Location *	WS
Category	Earthen Levee			GPS Latitude/Longitude	
				Start	End
Item	Slope Stability			38.539770 °	38.539770 °
				-121.515276 °	-121.515276 °
DWR ID	DWR_RD0900_01_s_2014_4				
Action/Comments					
Repair the levee slope damaged by foot traffic and prevent access where possible.

Updated picture of the slope instability on the waterside of the levee during fall 2014 inspection

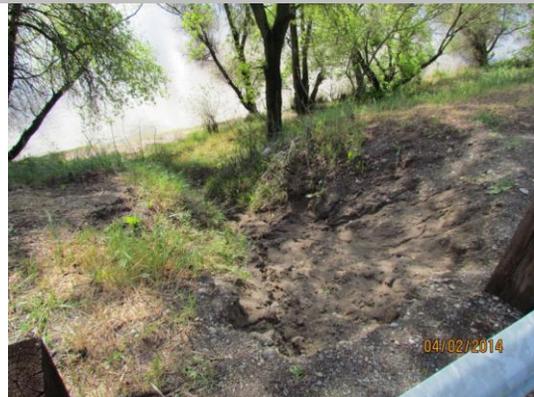
Photo 2 of 2 : SP_2015_RD0900_230_4_20150313_00003.jpg

A slope instability was found on the waterside slope of the levee looking downstream.

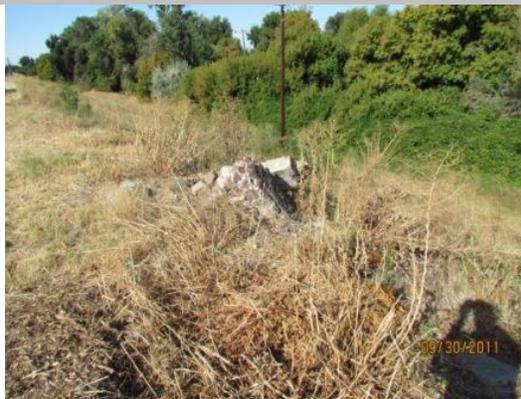
Photo 1 of 1 : SP_2015_RD0900_230_327_20150313_00018.jpg

Concrete debris were found on the landside of the levee looking upstream.

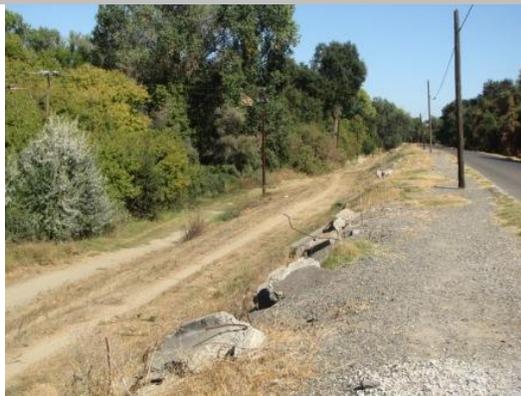
Photo 1 of 1 : SP_2015_RD0900_230_54_20150313_00013.jpg

View of concrete debris with metal looking upstream.

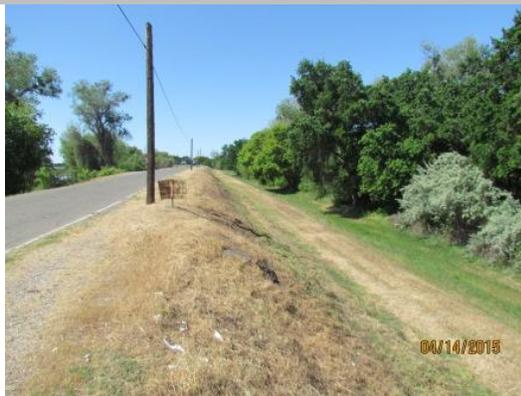
Photo 1 of 1 : SP_2015_RD0900_230_65_20150414_00024.jpg

LM Start	4.11	Rating **	A	Issue No.	65
LM End	4.11	Issue Type +	Ma	Location *	LS
Category	Earthen Levee			GPS Latitude/Longitude	
				Start	End
Item	Vegetation			38.534312 °	38.534312 °
				-121.526114 °	-121.526114 °
DWR ID	DWR_RD0900_01_s_2015_65				
Action/Comments					
Control annual grass and weeds on the levee slopes and easements.

Vegetation on the landside of the levee looking downstream.

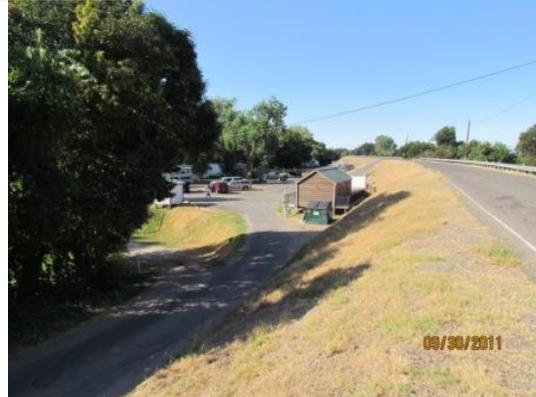
Photo 1 of 1 : SP_2015_RD0900_230_20_20150313_00009.jpg

View of Sherwood harbor's unpermitted properties on the waterside of the levee. The picture was taken from the crown looking upstream.

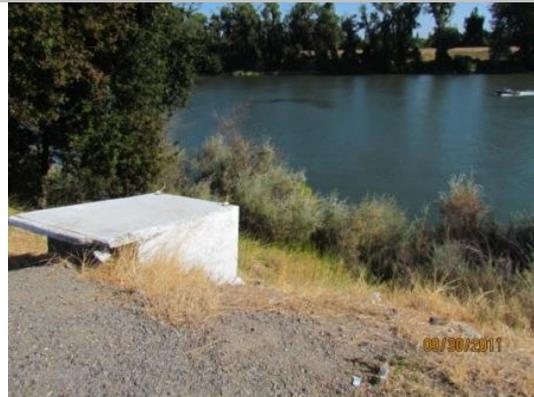
Photo 1 of 1 : SP_2015_RD0900_230_330_20150313_00019.jpg

Concrete anchor was found on the waterside slope of the levee looking upstream.

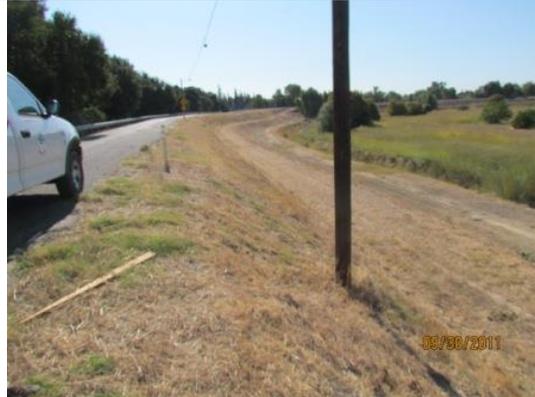
Photo 1 of 1 : SP_2015_RD0900_230_332_20150313_00020.jpg

View of the pole on the landside of the levee looking upstream.

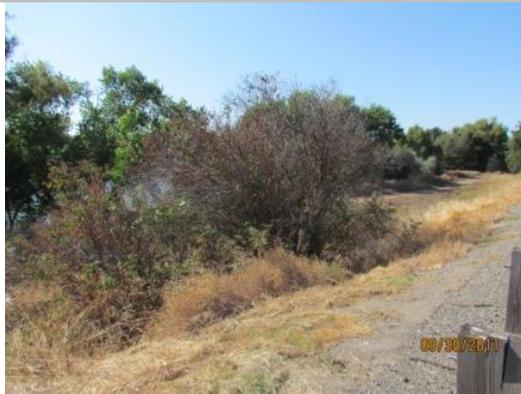
Photo 1 of 1 : SP_2015_RD0900_230_335_20150313_00021.jpg

View of elderberry bush on the waterside of the levee looking upstream.

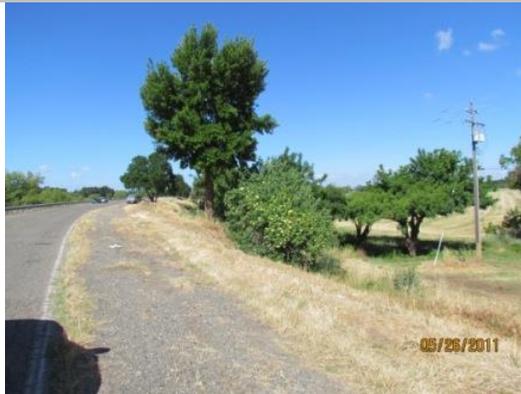
Photo 1 of 1 : SP_2015_RD0900_230_958_20150313_00023.jpg

LM Start	5.51	Rating **	A/W	Issue No.	958
LM End	5.51	Issue Type +	Ma	Location *	LS
Category	Earthen Levee			GPS Latitude/Longitude	
				Start	End
Item	Vegetation			38.518988 °	38.518988 °
				-121.527738 °	-121.527738 °
DWR ID	DWR_RD0900_01_s_2012_958				
Action/Comments					
Elderberries are blocking visibility and flood fight capability.

Elderberry on the landside of the levee. The picture was taken from the crown looking downstream.

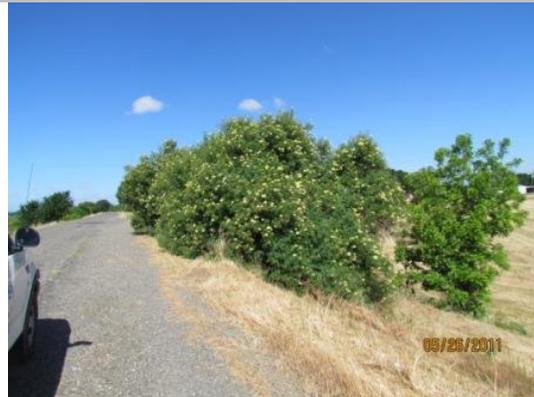
Photo 1 of 1 : SP_2015_RD0900_230_25_20150313_00010.jpg

Elderberry located on the landside of the levee obstructing the view. The picture was taken from the crown looking downstream.

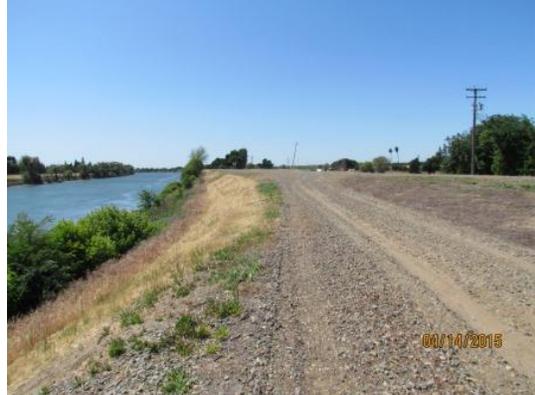
Photo 1 of 1 : SP_2015_RD0900_230_66_20150414_00025.jpg

Vegetation on the waterside of the levee looking downstream.

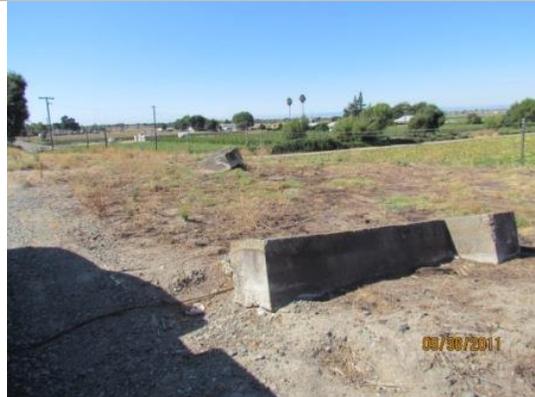
Photo 1 of 1 : SP_2015_RD0900_230_343_20150313_00022.jpg

LM Start	7.10	Rating **	A/W	Issue No.	343
LM End	7.10	Issue Type +	Ma	Location *	LS
Category	Earthen Levee			GPS Latitude/Longitude	
				Start	End
Item	Encroachments			38.512642 °	38.512642 °
				-121.554881 °	-121.554881 °
DWR ID	DWR_RD0900_01_s_2012_343				
Action/Comments					
Debris Inspector Comments: Concrete debris from old railroad track.

Concrete debris from old rail road track was found on the landside of the levee looking upstream.

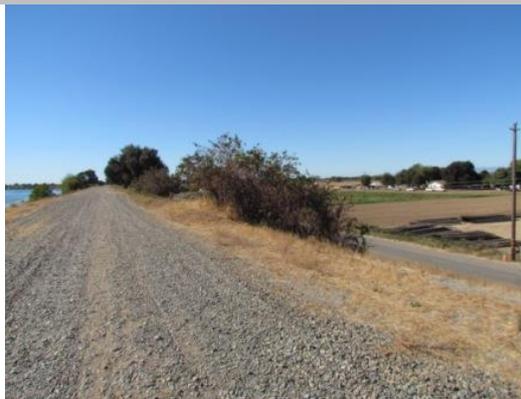
Photo 1 of 1 : SP_2015_RD0900_230_8_20150313_00005.jpg

An elderberry bush was found on the landside of the levee looking downstream.

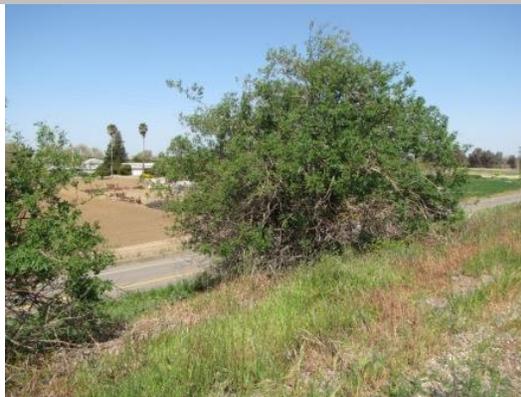
Photo 1 of 1 : SP_2015_RD0900_230_7_20150313_00004.jpg

View of elderberries blocking visibility on the landward slope looking upstream.

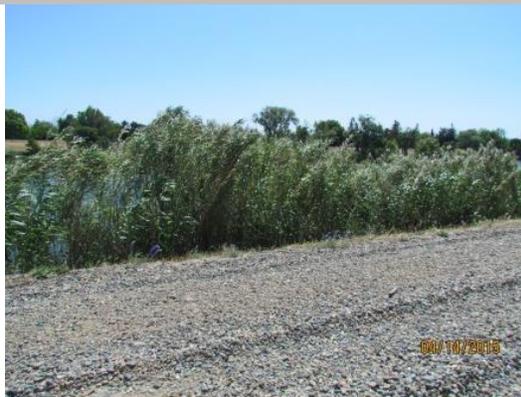
Photo 1 of 3 : SP_2015_RD0900_230_59_20150414_00026.jpg

Updated picture of the arrundo on the waterside of the levee during spring 2015 inspection.

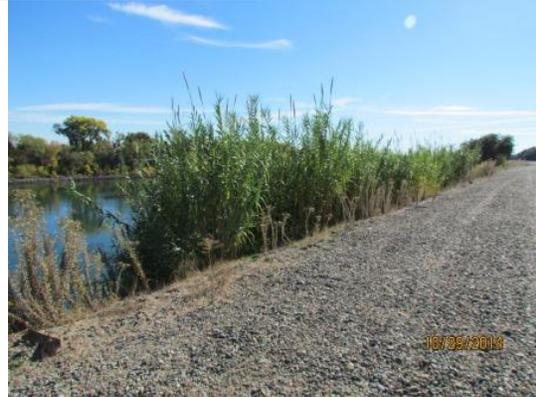
Photo 2 of 3 : SP_2015_RD0900_230_59_20150313_00014.jpg

View of arundo on the waterside of the levee during the fall 2014 inspection.

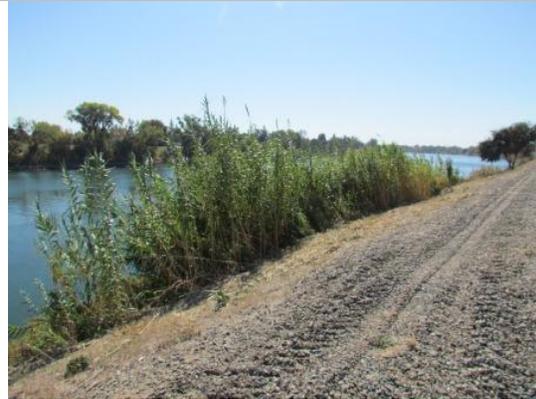
Photo 3 of 3 : SP_2015_RD0900_230_59_20150313_00015.jpg

View of arundo on the waterside of the levee looking downstream during the fall 2013 inspection.

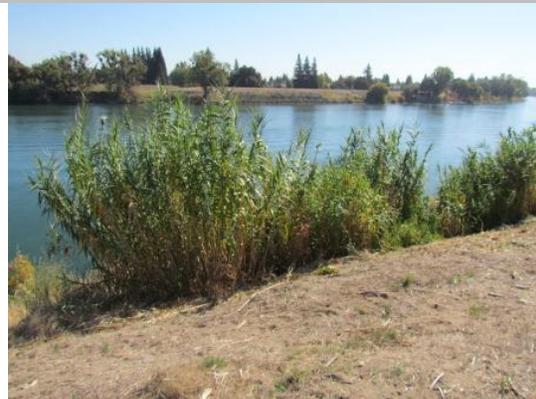
Photo 1 of 1 : SP_2015_RD0900_230_15_20150313_00008.jpg

LM Start	7.78	Rating **	M	Issue No.	15
LM End	7.78	Issue Type +	Ma	Location *	WS
Category	Earthen Levee			GPS Latitude/Longitude	
				Start	End
Item	Vegetation			38.503490 °	38.503490 °
				-121.559770 °	-121.559770 °
DWR ID	DWR_RD0900_01_f_2013_15				
Action/Comments					
Remove the wild growth other than native grasses from the levee slopes. Inspector Comments: Arrundo on the waterside

View of arundo on the waterside of the levee looking downstream.

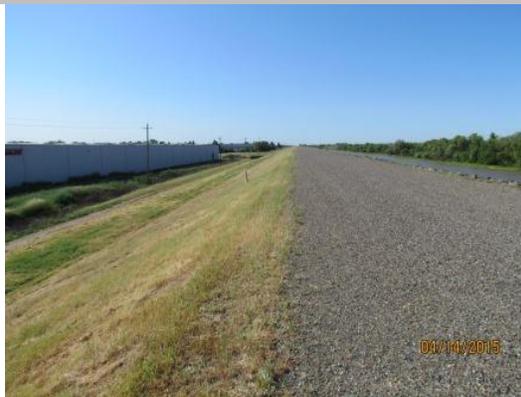
Photo 1 of 1 : SP_2015_RD0900_231_46_20150414_00008.jpg

Vegetation on the landside of the levee looking downstream.

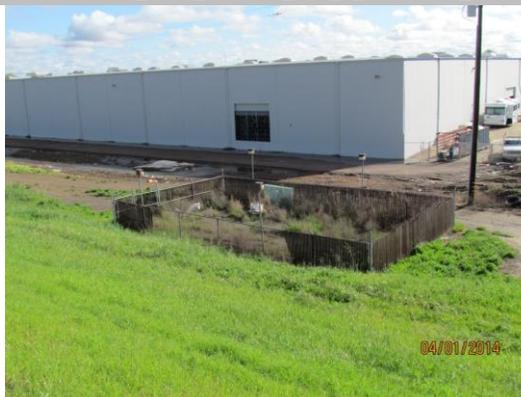
Photo 1 of 1 : SP_2015_RD0900_231_5_20150313_00001.jpg

LM Start	1.31	Rating **	M	Issue No.	5
LM End	1.31	Issue Type +	En	Location *	LS
Category	Earthen Levee		GPS Latitude/Longitude		
			Start	End	
Item	Encroachments		38.569258 °	38.569258 °	
			-121.582232 °	-121.582232 °	
DWR ID	DWR_RD0900_02_s_2012_5				
Action/Comments					
Building Inspector Comments: Abandoned city water well at the landward toe.

View of the water well on the landside toe of the levee looking upstream.

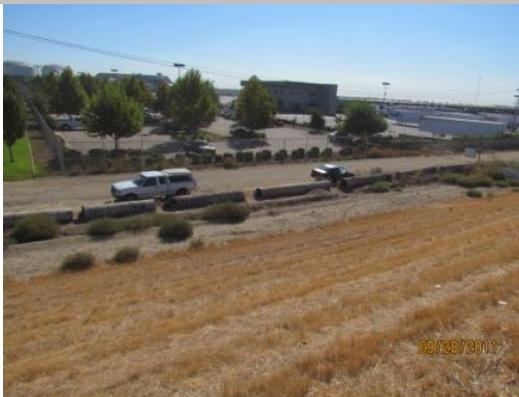
Photo 1 of 1 : SP_2015_RD0900_231_13_20150313_00002.jpg

Pipes were placed at the toe of the landside of the levee to prevent people from driving on the slope. The picture was taken from the crown looking upstream.

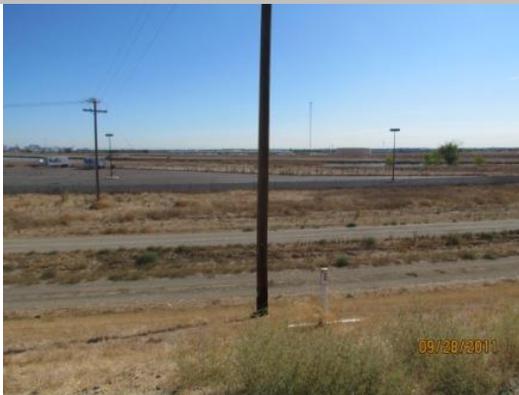
Photo 1 of 1 : SP_2015_RD0900_231_14_20150313_00003.jpg

LM Start	2.45	Rating **	M	Issue No.	14
LM End	2.45	Issue Type +	En	Location *	LS
Category	Earthen Levee		GPS Latitude/Longitude		
			Start	End	
Item	Encroachments		38.552639 °	38.552639 °	
			-121.582203 °	-121.582203 °	
DWR ID	DWR_RD0900_02_s_2012_14				
Action/Comments					
Pole Inspector Comments: Wood pole with electrical lines providing power to a pump in the bypass.

Wood pole for electrical lines was located on the landside of the levee. The picture was taken from the crown looking upstream.

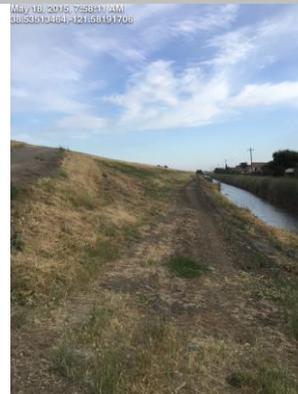
Photo 1 of 1 : SP_2015_RD0900_231_47_20150518_00009.jpg

LM Start	3.08	Rating **	A	Issue No.	47
LM End	4.74	Issue Type +	Ma	Location *	LS
Category	Earthen Levee		GPS Latitude/Longitude		
			Start	End	
Item	Vegetation		38.543580 °	38.519496 °	
			-121.582217 °	-121.582128 °	
DWR ID	DWR_RD0900_02_s_2015_47				
Action/Comments					
Control annual grass and weeds on the levee slopes and easements.

View of landside slope of the levee looking upstream.

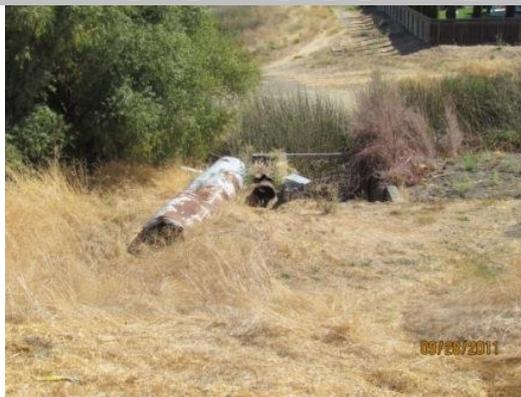
Photo 1 of 1 : SP_2015_RD0900_231_15_20150313_00004.jpg

Abandon pipes and debris was found on the landside of the levee looking upstream.

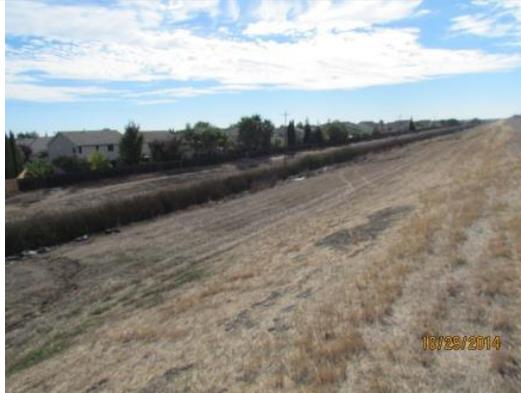
Photo 1 of 1 : SP_2015_RD0900_231_17_20150313_00005.jpg

View of the ditch on the landside toe of the levee looking downstream.

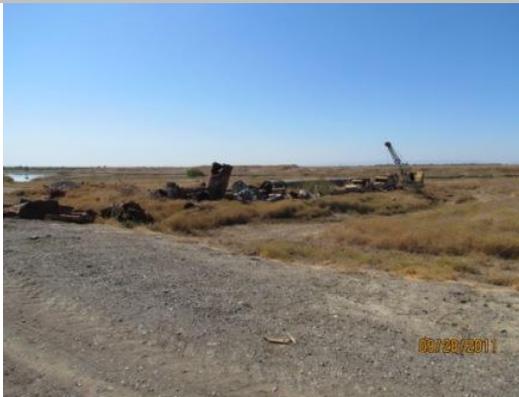
Photo 1 of 1 : SP_2015_RD0900_231_391_20150313_00006.jpg

Metal equipment and debris are purposely placed next to the gate by the LMA for barricade. The picture was taken from the crown looking upstream.

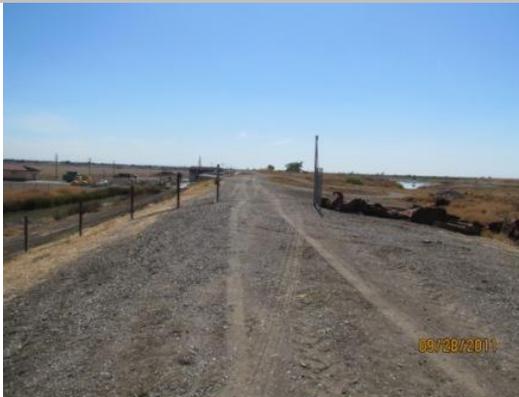
Photo 1 of 1 : SP_2015_RD0900_231_392_20150313_00007.jpg

A gate is installed by the LMA on the crown of the levee looking upstream.
