**Flood Control Project Maintenance
Levee Inspections**

Maintenance Issue Types Only, Levee Inspection Report By Mile - Fall 2015

Reclamation District No. 0900 West Sacramento

Waterway	Bank	Unit Miles	Inspection Start/End	Inspector
Unit No. 01 Sacramento River	Right	7.70	11/12/2015 11/12/2015	Pavel Kazi

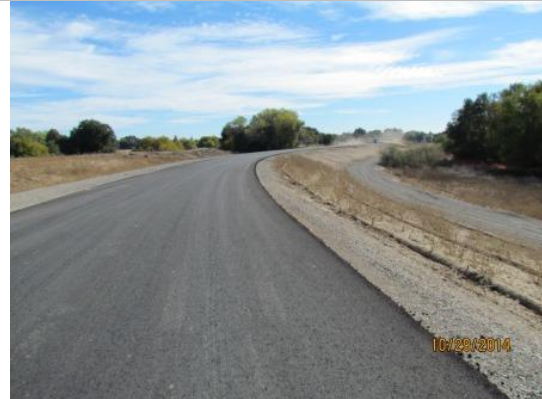
Photo 1 of 1 : FA_2015_RD0900_230_1_20150911_00001.jpg

LM Start	2.00	Rating **	A/W	Issue No.	1
LM End	2.25	Issue Type +	Ma	Location *	CR
Category	Earthen Levee			GPS Latitude/Longitude	
				Start	End
Item	Vegetation			38.559202 °	38.555462 °
				-121.517707 °	-121.516297 °
DWR ID	DWR_RD0900_01_s_2012_1

View of the new setback levee looking downstream during fall 2014 inspection.

Action/Comments					
Remove the wild growth other than native grasses from the levee slopes. Inspector Comments: USACE has started to construct a setback levee in this area and has taken control of this portion of the levee.

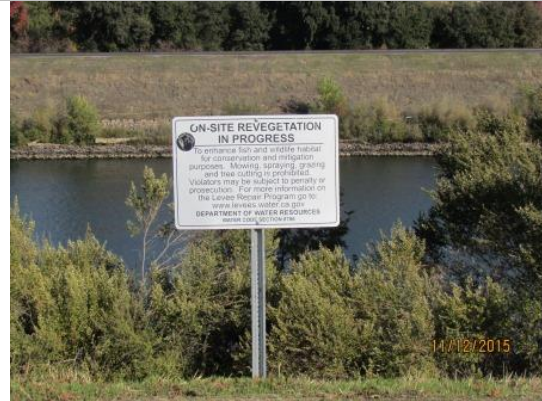
Photo 1 of 1 : FA_2015_RD0900_230_17_20151113_00022.jpg

LM Start	2.26	Rating **	A/W	Issue No.	17
LM End	3.72	Issue Type +	Ma	Location *	WS
Category	Earthen Levee			GPS Latitude/Longitude	
				Start	End
Item	Vegetation			38.555304 °	38.536946 °
				-121.516127 °	-121.519774 °
DWR ID	DWR_RD0900_01_s_2012_17				
Action/Comments					
Environmental Requirements.

View of the DWR environmental mitigation site.

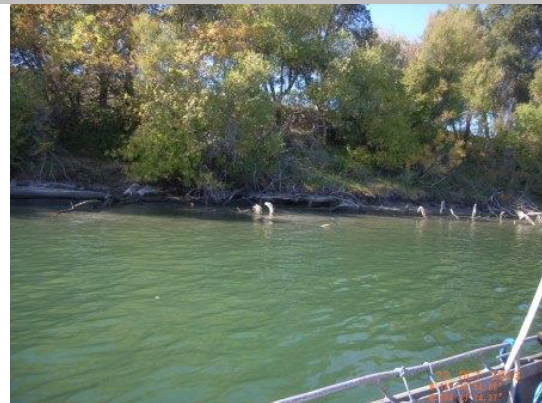
Photo 1 of 1 : USACE2013A_SAC_56-7_R_2.jpg

LM Start	2.35	Rating **	M	Issue No.	10
LM End	2.47	Issue Type +	Ma	Location *	WS
Category	Supplemental			GPS Latitude/Longitude	
				Start	End
Item	2015 USACE Erosion Survey, DRAFT			38.554277 °	38.552504 °
				-121.515263 °	-121.514752 °
DWR ID					
Action/Comments					
Inspector Comments: 2007 - Have good berm width with minor toe erosion. Close to the levee toe protection, but levee slope is steep. 2011 - New large erosion pocket. 2012 - Minor new erosion at the toe. 2015: No observed changes. [2015 Site ID: SAC_56-7_R]

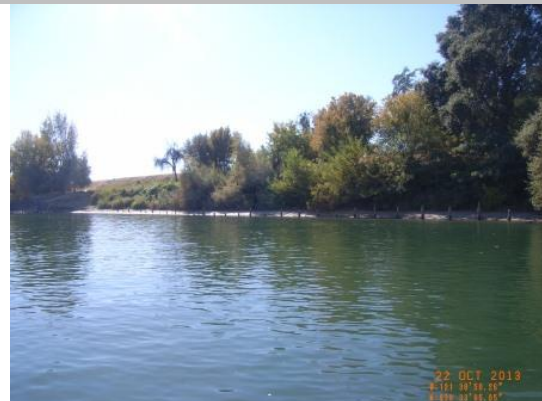
Photo 1 of 1 : USACE2013A_SAC_56-5_R_1.jpg

LM Start	2.55	Rating **	M	Issue No.	9
LM End	2.64	Issue Type +	Ma	Location *	WS
Category	Supplemental			GPS Latitude/Longitude	
				Start	End
Item	2015 USACE Erosion Survey, DRAFT			38.551319 °	38.550090 °
				-121.514423 °	-121.513983 °
DWR ID					
Action/Comments					
Inspector Comments: 1997 - Low berm is contributing to erosion. Old timber pile dikes above water parallel to bank. The upstream mitigation low berm causes a flow separation at the site. 1999 - Some new localized erosion with less than one foot of bank retreat. 2000 - Some new erosion at the upstream end. Fat toe deposits at toe. 2003 - Some new erosion upstream, but have a wide berm. 2011 - Minor new erosion at toe. 2015: No observed changes. [2015 Site ID: SAC_56-5_R]

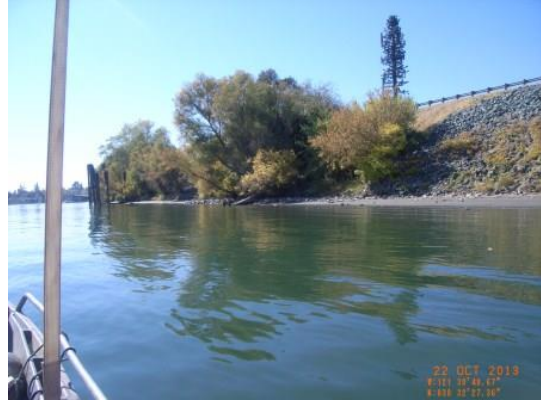
Photo 1 of 1 : USACE2013A_SAC_55-7_R_4.jpg

LM Start	3.27	Rating **	M	Issue No.	2
LM End	3.48	Issue Type +	Ma	Location *	WS
Category	Supplemental			GPS Latitude/Longitude	
				Start	End
Item	2015 USACE Erosion Survey, DRAFT			38.541246 °	38.538689 °
				-121.513561 °	-121.515916 °
DWR ID					
Action/Comments					
Inspector Comments: 2008 - Erosion into levee toe. Over steepened levee slope, worst at the upstream end. 2009 - Near vertical banks from rotational slumping, hidden by vegetation. 2010 - Boat sinking more, may be causing eddy scour around it. Difficult to see the vertical slumps due to dense vegetation. 2011 - Minor new erosion at the toe. The paddleboat that was sitting at this site for years has been removed. 2012 - Site extended upstream due to additional erosion. 2015: No observed changes. [2015 Site ID: SAC_55-7_R]

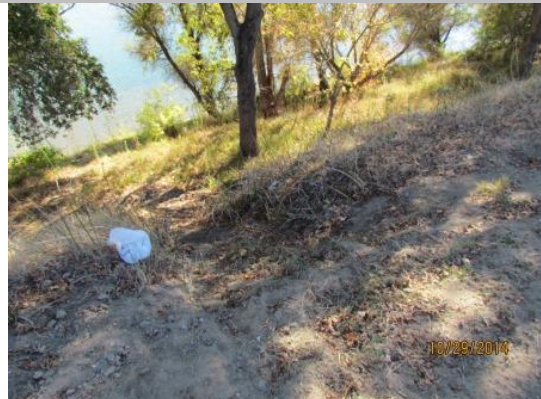
Photo 1 of 2 : FA_2015_RD0900_230_4_20150911_00002.jpg

Updated picture of the slope instability on the waterside of the levee during fall 2014 inspection

LM Start	3.41	Rating **	M	Issue No.	4
LM End	3.41	Issue Type +	Ma	Location *	WS
Category	Earthen Levee			GPS Latitude/Longitude	
				Start	End
Item	Slope Stability			38.539770 °	38.539770 °
				-121.515276 °	-121.515276 °
DWR ID	DWR_RD0900_01_s_2014_4				
Action/Comments					
Repair the levee slope damaged by foot traffic and prevent access where possible.

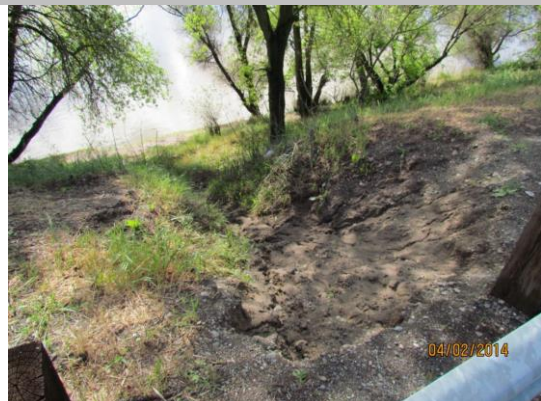
Photo 2 of 2 : FA_2015_RD0900_230_4_20150911_00003.jpg

A slope instability was found on the waterside slope of the levee looking downstream.

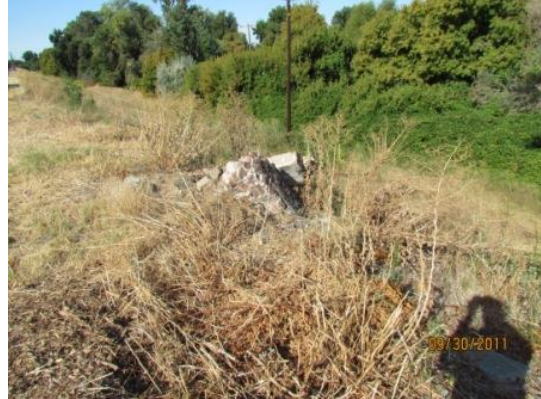
Photo 1 of 1 : FA_2015_RD0900_230_327_20150911_00016.jpg

LM Start	4.04	Rating **	M	Issue No.	327
LM End	4.04	Issue Type +	Ma	Location *	LS
Category	Earthen Levee			GPS Latitude/Longitude	
				Start	End
Item	Encroachments			38.534759 °	38.534759 °
				-121.524902 °	-121.524902 °
DWR ID	DWR_RD0900_01_s _ 2012_327				
Action/Comments					
Debris

Concrete debris were found on the landside of the levee looking upstream.

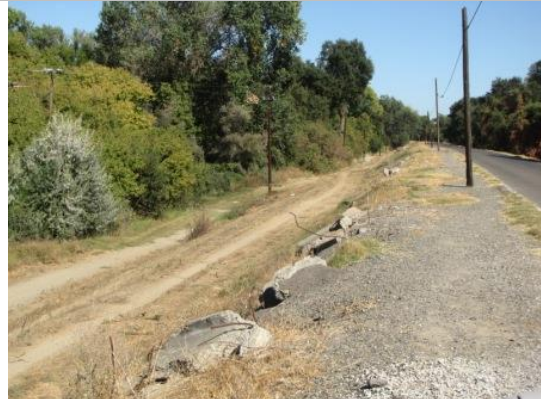
Photo 1 of 1 : FA_2015_RD0900_230_54_20150911_00012.jpg

LM Start	4.10	Rating **	M	Issue No.	54
LM End	4.10	Issue Type +	Ma	Location *	LS
Category	Earthen Levee			GPS Latitude/Longitude	
				Start	End
Item	Encroachments			38.534364 °	38.534364 °
				-121.526051 °	-121.526051 °
DWR ID	DWR_RD0900_01_s _ 2012_54				
Action/Comments					
Debris					
Inspector Comments: Concrete debris with metal posing a safety risk.

View of concrete debris with metal looking upstream.

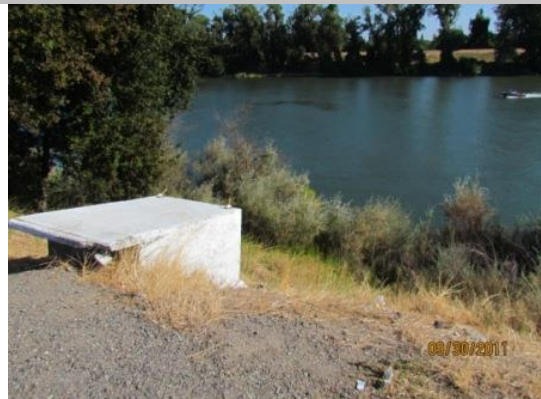
Photo 1 of 1 : FA_2015_RD0900_230_330_20150911_00017.jpg

LM Start	4.95	Rating **	M	Issue No.	330
LM End	4.95	Issue Type +	Ma	Location *	WS
Category	Earthen Levee			GPS Latitude/Longitude	
				Start	End
Item	Encroachments			38.524898 °	38.524898 °
				-121.529674 °	-121.529674 °
DWR ID	DWR_RD0900_01_s _ 2012_330				
Action/Comments					
Debris

Concrete anchor was found on the waterside slope of the levee looking upstream.

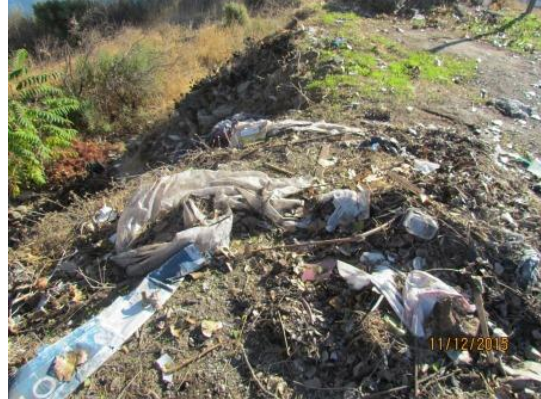
Photo 1 of 1 : FA_2015_RD0900_230_18_20151113_00023.jpg

LM Start	5.37	Rating **	M	Issue No.	18
LM End	5.37	Issue Type +	Ma	Location *	WS
Category	Earthen Levee			GPS Latitude/Longitude	
				Start	End
Item	Encroachments			38.520255 °	38.520255 °
				-121.525666 °	-121.525666 °
DWR ID	DWR_RD0900_01_f_2015_18				
Action/Comments					
Debris

View of the debris on the waterside slope of the levee looking downstream.

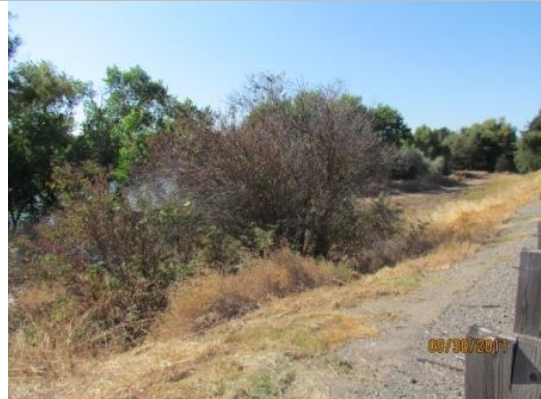
Photo 1 of 1 : FA_2015_RD0900_230_335_20150911_00019.jpg

LM Start	5.39	Rating **	M	Issue No.	335
LM End	5.39	Issue Type +	Ma	Location *	WS
Category	Earthen Levee			GPS Latitude/Longitude	
				Start	End
Item	Vegetation			38.520022 °	38.520022 °
				-121.525899 °	-121.525899 °
DWR ID	DWR_RD0900_01_s_2012_335				
Action/Comments					
Elderberries are blocking visibility and flood fight capability. Inspector Comments: Elderberries are partially blocking the visibility.

View of elderberry bush on the waterside of the levee looking upstream.

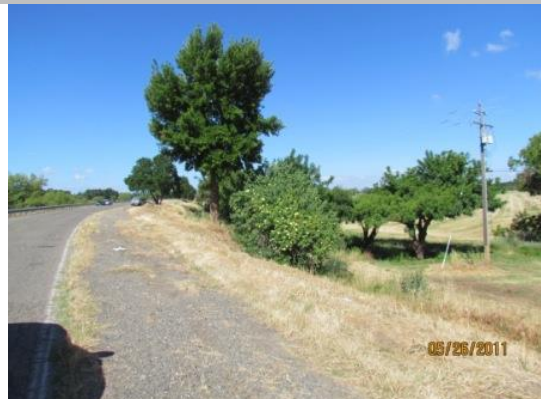
Photo 1 of 1 : FA_2015_RD0900_230_958_20150911_00021.jpg

LM Start	5.51	Rating **	M	Issue No.	958
LM End	5.51	Issue Type +	Ma	Location *	LS
Category	Earthen Levee			GPS Latitude/Longitude	
				Start	End
Item	Vegetation			38.518988 °	38.518988 °
				-121.527738 °	-121.527738 °
DWR ID	DWR_RD0900_01_s_2012_958				
Action/Comments					
Elderberries are blocking visibility and flood fight capability. Inspector Comments: Elderberries are partially blocking the visibility.

Elderberry on the landside of the levee. The picture was taken from the crown looking downstream.

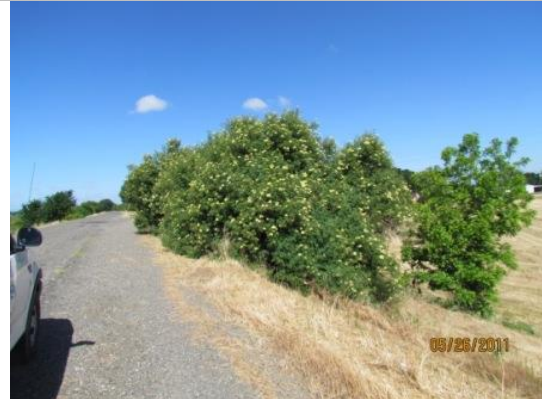
Photo 1 of 1 : FA_2015_RD0900_230_25_20150911_00009.jpg

LM Start	5.95	Rating **	M	Issue No.	25
LM End	5.96	Issue Type +	Ma	Location *	LS
Category	Earthen Levee			GPS Latitude/Longitude	
				Start	End
Item	Vegetation			38.517952 °	38.517948 °
				-121.535672 °	-121.535857 °
DWR ID	DWR_RD0900_01_s _ 2012_25				
Action/Comments					
Elderberries are blocking visibility and flood fight capability. Inspector Comments: Elderberries are partially blocking the visibility.

Elderberry located on the landside of the levee obstructing the view. The picture was taken from the crown looking downstream.

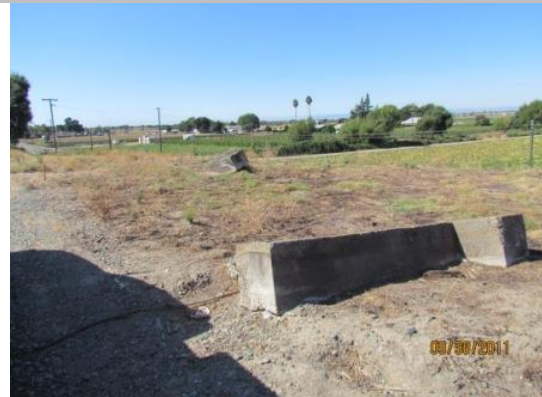
Photo 1 of 1 : FA_2015_RD0900_230_343_20150911_00020.jpg

LM Start	7.10	Rating **	M	Issue No.	343
LM End	7.10	Issue Type +	Ma	Location *	LS
Category	Earthen Levee			GPS Latitude/Longitude	
				Start	End
Item	Encroachments			38.512642 °	38.512642 °
				-121.554881 °	-121.554881 °
DWR ID	DWR_RD0900_01_s _ 2012_343				
Action/Comments					
Debris					
Inspector Comments: Concrete debris from old railroad track.

Concrete debris from old rail road track was found on the landside of the levee looking upstream.

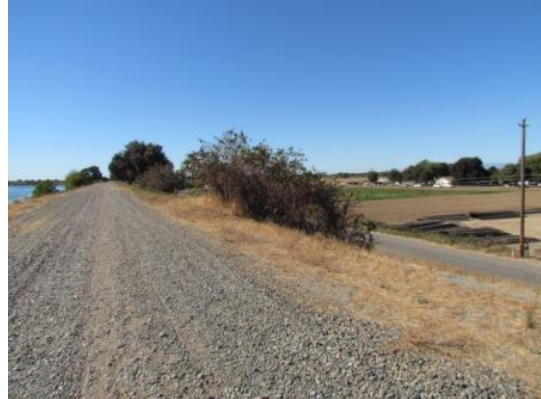
Photo 1 of 1 : FA_2015_RD0900_230_8_20150911_00005.jpg

LM Start	7.21	Rating **	M	Issue No.	8
LM End	7.21	Issue Type +	Ma	Location *	LS
Category	Earthen Levee			GPS Latitude/Longitude	
				Start	End
Item	Vegetation			38.511104 °	38.511104 °
				-121.555664 °	-121.555664 °
DWR ID	DWR_RD0900_01_s_2012_8				
Action/Comments					
Elderberries are blocking visibility and flood fight capability. Inspector Comments: Elderberries are partially blocking the visibility.

An elderberry bush was found on the landside of the levee looking downstream.

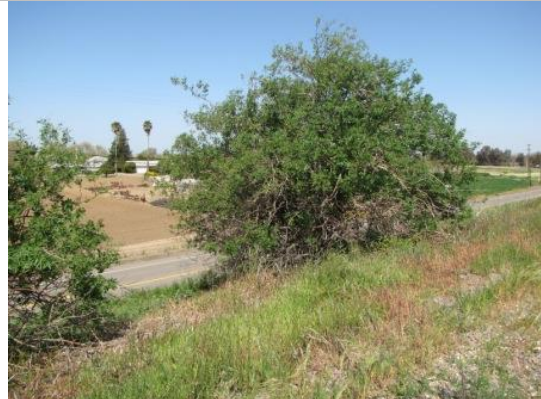
Photo 1 of 1 : FA_2015_RD0900_230_7_20150911_00004.jpg

LM Start	7.25	Rating **	M	Issue No.	7
LM End	7.25	Issue Type +	Ma	Location *	LS
Category	Earthen Levee			GPS Latitude/Longitude	
				Start	End
Item	Vegetation			38.510613 °	38.510613 °
				-121.555969 °	-121.555969 °
DWR ID	DWR_RD0900_01_s_2012_7				
Action/Comments					
Elderberries are blocking visibility and flood fight capability. Inspector Comments: Elderberries are partially blocking the visibility.

View of elderberries on the landward slope looking upstream.

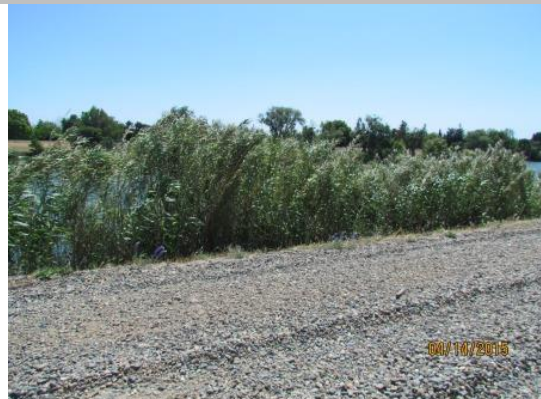
Photo 1 of 2 : FA_2015_RD0900_230_59_20150911_00013.jpg

LM Start	7.47	Rating **	M	Issue No.	59
LM End	7.47	Issue Type +	Ma	Location *	WS
Category	Earthen Levee			GPS Latitude/Longitude	
				Start	End
Item	Vegetation			38.507648 °	38.507648 °
				-121.557571 °	-121.557571 °
DWR ID	DWR_RD0900_01_f_2012_59				
Action/Comments					
Remove the wild growth other than native grasses from the levee slopes.					
Inspector Comments: Arrundo growth on the waterside slope of the levee.

Updated picture of the arundo on the waterside of the levee during spring 2015 inspection.

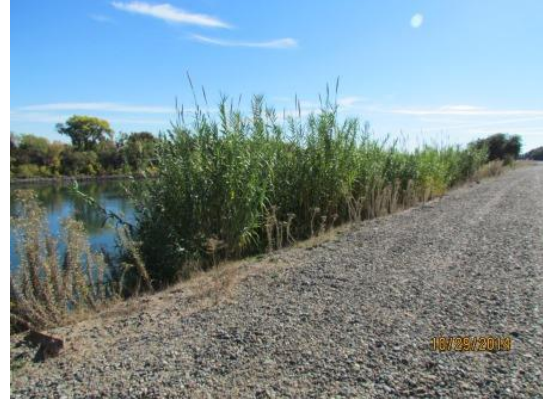
Photo 2 of 2 : FA_2015_RD0900_230_59_20150911_00014.jpg

LM Start	7.47	Rating **	M	Issue No.	59 (cont)
LM End	7.47	Issue Type +	Ma	Location *	WS
Category	Earthen Levee			GPS Latitude/Longitude	
				Start	End
Item	Vegetation			38.507648 °	38.507648 °
				-121.557571 °	-121.557571 °
DWR ID	DWR_RD0900_01_f_2012_59				
Action/Comments					
Remove the wild growth other than native grasses from the levee slopes. Inspector Comments: Arrundo growth on the waterside slope of the levee.

View of arundo on the waterside of the levee during the fall 2014 inspection.

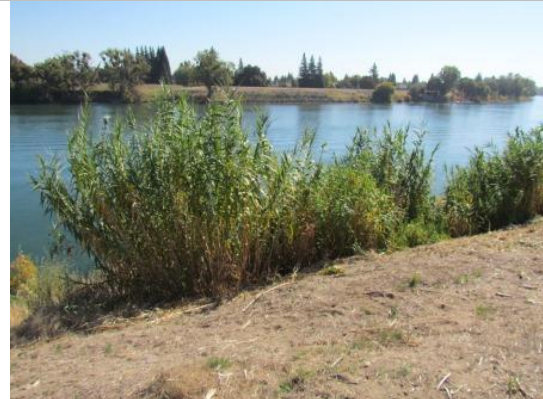
Photo 1 of 1 : FA_2015_RD0900_230_15_20150911_00007.jpg

LM Start	7.78	Rating **	M	Issue No.	15
LM End	7.78	Issue Type +	Ma	Location *	WS
Category	Earthen Levee			GPS Latitude/Longitude	
				Start	End
Item	Vegetation			38.503490 °	38.503490 °
				-121.559770 °	-121.559770 °
DWR ID	DWR_RD0900_01_f_2013_15				
Action/Comments					
Remove the wild growth other than native grasses from the levee slopes.					
Inspector Comments: Arrundo on the waterside

View of arundo on the waterside of the levee looking downstream.

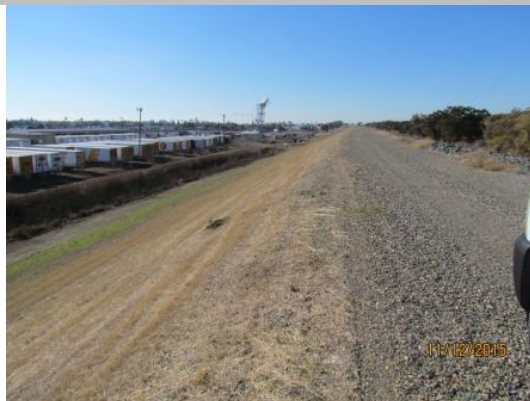
Photo 1 of 1 : FA_2015_RD0900_231_46_20151113_00008.jpg

LM Start	0.10	Rating **	A	Issue No.	46
LM End	0.10	Issue Type +	Ma	Location *	LS
Category	Earthen Levee			GPS Latitude/Longitude	
				Start	End
Item	Vegetation			38.580929 °	38.580929 °
				-121.568259 °	-121.568259 °
DWR ID	DWR_RD0900_02_f _ 2015_46				
Action/Comments					
Control annual grass and weeds on the levee slopes and easements. Inspector Comments: Acceptable vegetation.

View of the acceptable vegetation on the landside slope of the levee.
