**Flood Control Project Maintenance
Levee Inspections**

Maintenance Issue Types Only, Levee Inspection Report By Mile - Fall 2017

Reclamation District No. 0900 West Sacramento

Waterway	Bank	Unit Miles	Inspection Start/End	Inspector
Unit No. 01 Sacramento River	Right	7.70	09/21/2017 09/21/2017	Pavel Kazi

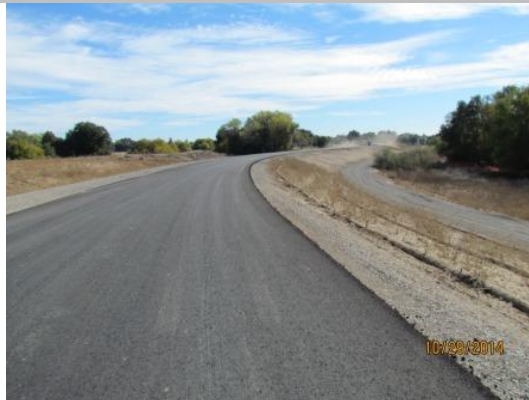
Photo 1 of 1 : FA_2017_RD0900_230_1_20170921_00001.jpg

LM Start	2.00	Rating **	A/W	Issue No.	1
LM End	2.25	Issue Type +	Ma	Location *	CR
Category	Earthen Levee			GPS Latitude/Longitude	
				Start	End
Item	Vegetation			38.559202 °	38.555462 °
				-121.517707 °	-121.516297 °
DWR ID	DWR_RD0900_01_s_2017_1				
Comment Code					
V2 : Remove the wild growth other than native grasses from the levee slopes.					
Inspector Comment					
USACE has completed constructing a setback levee in this area and they will be turning over this portion of the levee to the LMA in future.

View of the new setback levee looking downstream during fall 2014 inspection.

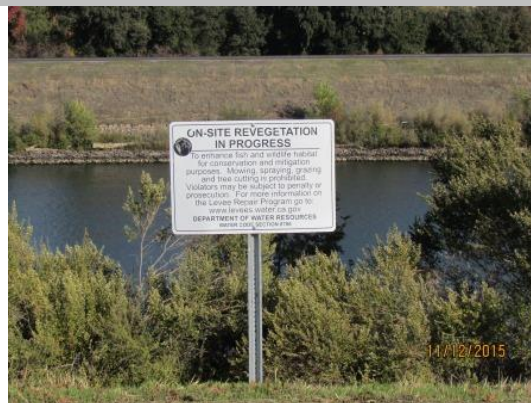
Photo 1 of 1 : FA_2017_RD0900_230_17_20170921_00009.jpg

LM Start	2.26	Rating **	A/W	Issue No.	17
LM End	3.72	Issue Type +	Ma	Location *	WS
Category	Earthen Levee			GPS Latitude/Longitude	
				Start	End
Item	Vegetation			38.555304 °	38.536946 °
				-121.516127 °	-121.519774 °
DWR ID	DWR_RD0900_01_s_2012_17				
Comment Code					
V8 : Environmental Requirements.					
Inspector Comment

View of the DWR environmental mitigation site.

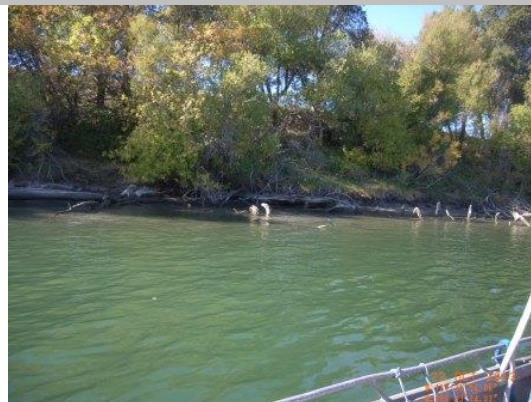
Photo 1 of 1 : FA_2017_RD0900_230_10_20170921_00006.jpg

LM Start	2.35	Rating **	M	Issue No.	10
LM End	2.47	Issue Type +	Ma	Location *	WS
Category	Supplemental			GPS Latitude/Longitude	
				Start	End
Item	2015 USACE Erosion Survey, DRAFT			38.554277 °	38.552504 °
				-121.515263 °	-121.514752 °
DWR ID	DWR_RD0900_01_s_2016_10				
Comment Code					
Inspector Comment					
2007 - Have good berm width with minor toe erosion. Close to the levee toe protection, but levee slope is steep. 2011 - New large erosion pocket. 2012 - Minor new erosion at the toe. 2015: No observed changes. [2015 Site ID: SAC_56-7_R]

USACE 2013 Photo #1

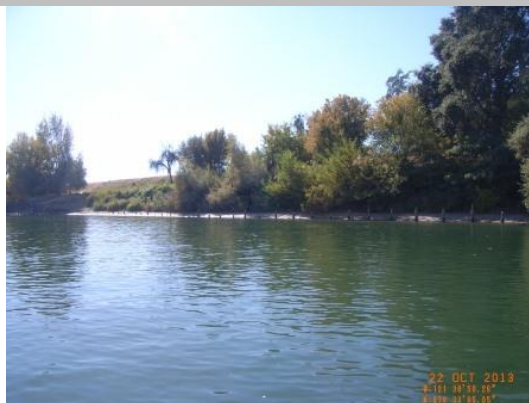
Photo 1 of 1 : FA_2017_RD0900_230_9_20170921_00005.jpg

LM Start	2.55	Rating **	M	Issue No.	9
LM End	2.64	Issue Type +	Ma	Location *	WS
Category	Supplemental			GPS Latitude/Longitude	
				Start	End
Item	2015 USACE Erosion Survey, DRAFT			38.551319 °	38.550090 °
				-121.514423 °	-121.513983 °
DWR ID	DWR_RD0900_01_s_2016_9				
Comment Code					
Inspector Comment					
1997 - Low berm is contributing to erosion. Old timber pile dikes above water parallel to bank. The upstream mitigation low berm causes a flow separation at the site. 1999 - Some new localized erosion with less than one foot of bank retreat. 2000 - Some new erosion at the upstream end. Fat toe deposits at toe. 2003 - Some new erosion upstream, but have a wide berm. 2011 - Minor new erosion at toe. 2015: No observed changes. [2015 Site ID: SAC 56-5 R]

USACE 2013 Photo #1

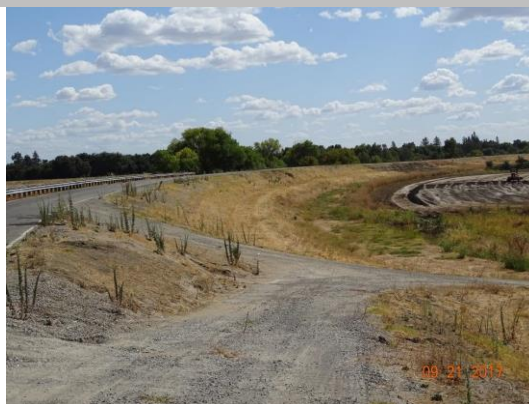
Photo 1 of 1 : FA_2017_RD0900_230_58_20170925_00029.jpg

LM Start	2.84	Rating **	A	Issue No.	58
LM End	2.84	Issue Type +	Ma	Location *	LS
Category	Earthen Levee			GPS Latitude/Longitude	
				Start	End
Item	Vegetation			38.547270 °	38.547270 °
				-121.513143 °	-121.513143 °
DWR ID	DWR_RD0900_01_f_2017_58				
Comment Code					
V1 : Control annual grass and weeds on the levee slopes and easements.					
Inspector Comment					
Acceptable vegetation.

View of the acceptable vegetation on the landside slope of the levee.
Fall 2017

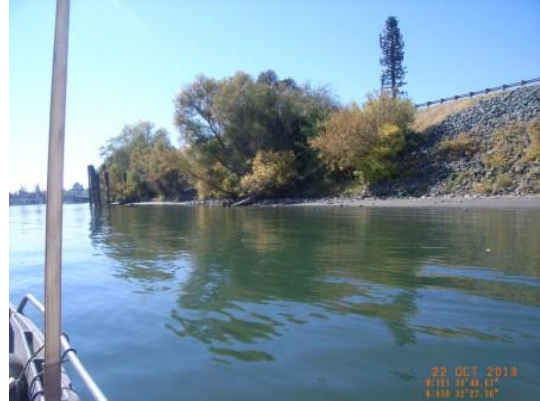
Photo 1 of 1 : FA_2017_RD0900_230_2_20170921_00002.jpg

LM Start	3.27	Rating **	M	Issue No.	2
LM End	3.48	Issue Type +	Ma	Location *	WS
Category	Supplemental			GPS Latitude/Longitude	
				Start	End
Item	2015 USACE Erosion Survey, DRAFT			38.541246 °	38.538689 °
				-121.513561 °	-121.515916 °
DWR ID	DWR_RD0900_01_s_2016_2				
Comment Code					
Inspector Comment					
2008 - Erosion into levee toe. Over steepened levee slope, worst at the upstream end. 2009 - Near vertical banks from rotational slumping, hidden by vegetation. 2010 - Boat sinking more, may be causing eddy scour around it. Difficult to see the vertical slumps due to dense vegetation. 2011 - Minor new erosion at the toe. The paddleboat that was sitting at this site for years has been removed. 2012 - Site extended upstream due to additional erosion. 2015: No observed changes. [2015 Site ID: SAC_55-7_R]

USACE 2013 Photo #1

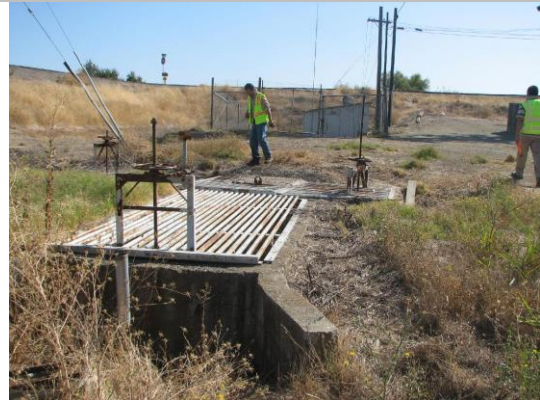
Photo 1 of 3 : UCIP_FA_2017_37668_68391.jpg

Comment Code					
Inspector Comment					
FS_ID:37668					
DS_ID:17769					
EP_NO: N/A					
Repair Type: Non-Urgent					
Crossing Status: Found					
UCIP Comments: Dense vegetation limits the inspector's visibility to identify signs of pipe failure (leaks) along the slope. Recommend removing vegetation along pipe alignment to conduct proper inspection of structure and appurtenances.					
FIELD_STRUCT_DESC: 24-inch pipe through the levee, 22.0 feet below the crown. Pump house at the landward toe. Screw gate in landside of the levee. As-built drawing available/found. As-built drawing# 6-13-1100 page 3, January 1933 and USGS River Mile 55.65 &M Manual Sac 116, Revision Year 2011					
FS Date: 10/6/2009

View of concrete structure located on landward side.

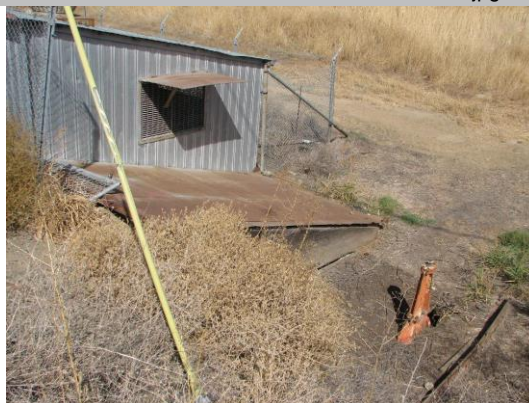
Photo 2 of 3 : UCIP_FA_2017_37668_68390.jpg

Pump house located on landward side.

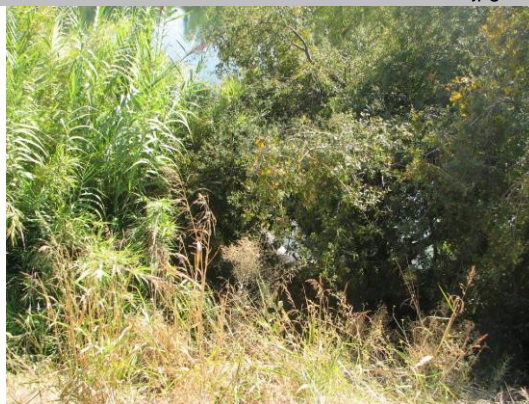
Photo 3 of 3 : UCIP_FA_2017_37668_68389.jpg

FS_ID:37668
DS_ID:17769
EP_NO: N/A
Repair Type: Non-Urgent
Crossing Status: Found
UCIP Comments: Dense vegetation limits the inspector's visibility to identify signs of pipe failure (leaks) along the slope. Recommend removing vegetation along pipe alignment to conduct proper inspection of structure and appurtenances.
FIELD_STRUCT_DESC: 24-inch pipe through the levee, 22.0 feet below the crown. Pump house at the landward toe. Screw gate in landside of the levee. As-built drawing available/found. As-built drawing# 6-13-1100 page 3, January 1933 and USGS River Mile 55.65 &M Manual Sac 116, Revision Year 2011
FS Date: 10/6/2009

Pipe visible on waterward side visible through dense vegetation.

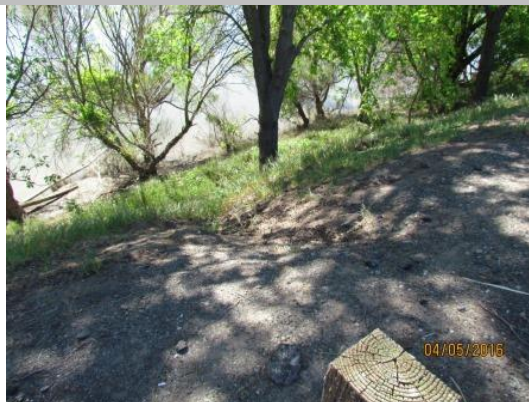
Photo 1 of 2 : FA_2017_RD0900_230_4_20170921_00003.jpg

LM Start	3.41	Rating **	M	Issue No.	4
LM End	3.41	Issue Type +	Ma	Location *	WS
Category	Earthen Levee			GPS Latitude/Longitude	
				Start	End
Item	Slope Stability			38.539770 °	38.539770 °
				-121.515276 °	-121.515276 °
DWR ID	DWR_RD0900_01_s_2014_4				
Comment Code					
S2 : Repair the levee slope damaged by foot traffic and prevent access where possible.					
Inspector Comment

Updated picture of the slope instability on the waterside of the levee looking downstream during spring 2016 inspection.

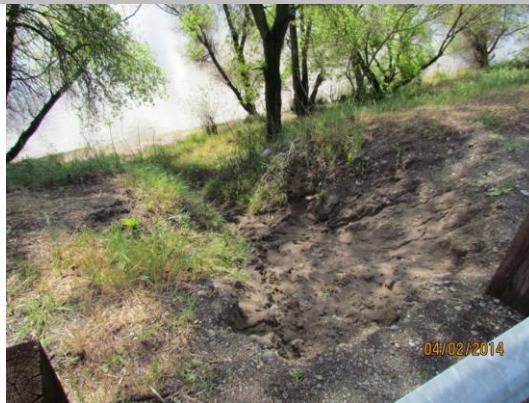
Photo 2 of 2 : FA_2017_RD0900_230_4_20170921_00004.jpg

LM Start	3.41	Rating **	M	Issue No.	4 (cont)	
LM End	3.41	Issue Type +	Ma	Location *	WS	
Category	Earthen Levee			GPS Latitude/Longitude		
				Start		End
Item	Slope Stability			38.539770 °		38.539770 °
				-121.515276 °		-121.515276 °
DWR ID	DWR_RD0900_01_s_2014_4					
Comment Code						
S2 : Repair the levee slope damaged by foot traffic and prevent access where possible.						
Inspector Comment

A slope instability was found on the waterside slope of the levee looking downstream.

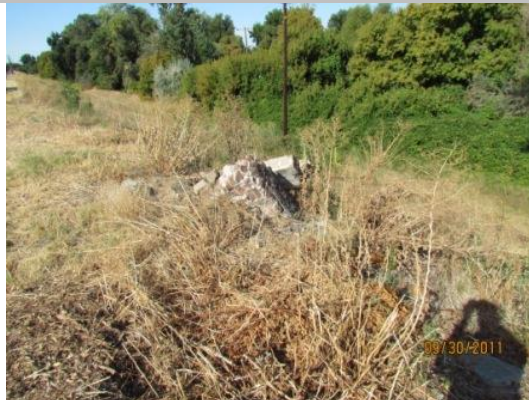
Photo 1 of 1 : FA_2017_RD0900_230_327_20170921_00016.jpg

LM Start	4.04	Rating **	M	Issue No.	327
LM End	4.04	Issue Type +	Ma	Location *	LS
Category	Earthen Levee			GPS Latitude/Longitude	
				Start	End
Item	Encroachments			38.534759 °	38.534759 °
				-121.524902 °	-121.524902 °
DWR ID	DWR_RD0900_01_s_2012_327				
Comment Code					
DE : Debris					
Inspector Comment

Concrete debris were found on the landside of the levee looking upstream.

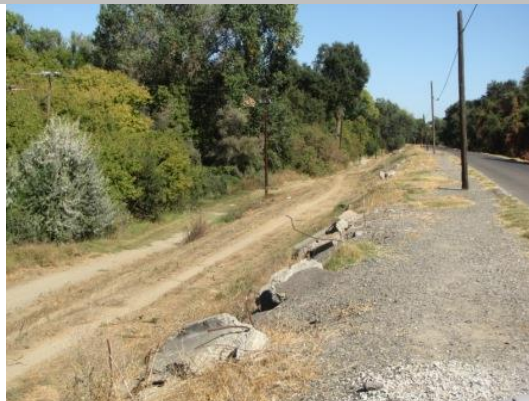
Photo 1 of 1 : FA_2017_RD0900_230_54_20170921_00012.jpg

LM Start	4.10	Rating **	M	Issue No.	54
LM End	4.10	Issue Type +	Ma	Location *	LS
Category	Earthen Levee			GPS Latitude/Longitude	
				Start	End
Item	Encroachments			38.534364 °	38.534364 °
				-121.526051 °	-121.526051 °
DWR ID	DWR_RD0900_01_s_2012_54				
Comment Code					
DE : Debris					
Inspector Comment					
Concrete debris with metal posing a safety risk.

View of concrete debris with metal looking upstream.

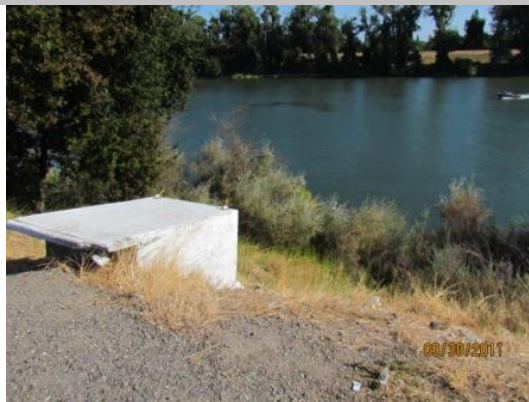
Photo 1 of 1 : FA_2017_RD0900_230_330_20170921_00017.jpg

LM Start	4.95	Rating **	M	Issue No.	330
LM End	4.95	Issue Type +	Ma	Location *	WS
Category	Earthen Levee			GPS Latitude/Longitude	
				Start	End
Item	Encroachments			38.524898 °	38.524898 °
				-121.529674 °	-121.529674 °
DWR ID	DWR_RD0900_01_s_2012_330				
Comment Code					
DE : Debris					
Inspector Comment

Concrete anchor was found on the waterside slope of the levee looking upstream.

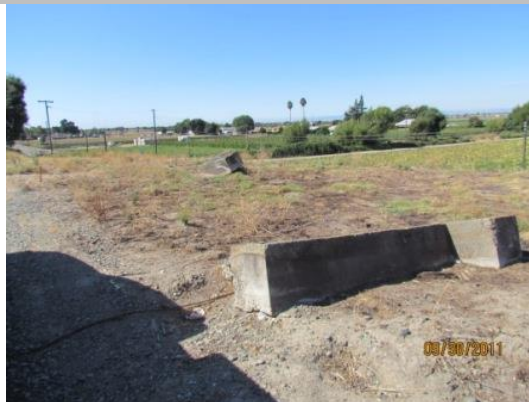
Photo 1 of 1 : FA_2017_RD0900_230_343_20170921_00019.jpg

LM Start	7.10	Rating **	M	Issue No.	343
LM End	7.10	Issue Type +	Ma	Location *	LS
Category	Earthen Levee			GPS Latitude/Longitude	
				Start	End
Item	Encroachments			38.512642 °	38.512642 °
				-121.554881 °	-121.554881 °
DWR ID	DWR_RD0900_01_s_2012_343				
Comment Code					
DE : Debris					
Inspector Comment					
Concrete debris from old railroad track.

Concrete debris from old rail road track was found on the landside of the levee looking upstream.

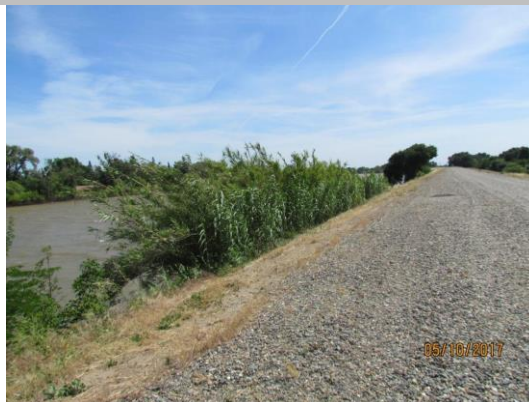
Photo 1 of 1 : FA_2017_RD0900_230_59_20170921_00013.jpg

LM Start	7.47	Rating **	M	Issue No.	59
LM End	7.47	Issue Type +	Ma	Location *	WS
Category	Earthen Levee			GPS Latitude/Longitude	
				Start	End
Item	Vegetation			38.507648 °	38.507648 °
				-121.557571 °	-121.557571 °
DWR ID	DWR_RD0900_01_f_2012_59				
Comment Code					
V2 : Remove the wild growth other than native grasses from the levee slopes.					
Inspector Comment					
Arrundo growth on the waterside slope of the levee.

View of the arundo on the waterside of the levee during spring 2017 inspection.

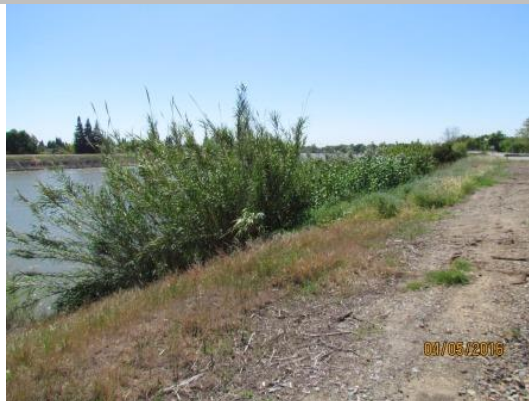
Photo 1 of 2 : FA_2017_RD0900_230_15_20170921_00007.jpg

LM Start	7.78	Rating **	M	Issue No.	15
LM End	7.78	Issue Type +	Ma	Location *	WS
Category	Earthen Levee			GPS Latitude/Longitude	
				Start	End
Item	Vegetation			38.503490 °	38.503490 °
				-121.559770 °	-121.559770 °
DWR ID	DWR_RD0900_01_f_2013_15				
Comment Code					
V2 : Remove the wild growth other than native grasses from the levee slopes.					
Inspector Comment					
Arrundo on the waterside

Updated picture of the arrundo on the waterside of the levee during spring 2016 inspection.

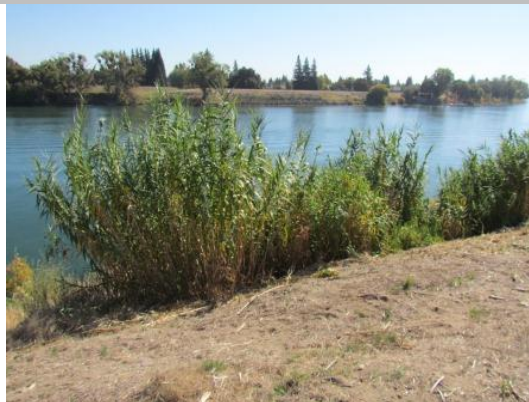
Photo 2 of 2 : FA_2017_RD0900_230_15_20170921_00008.jpg

View of arrundo on the waterside of the levee looking downstream.

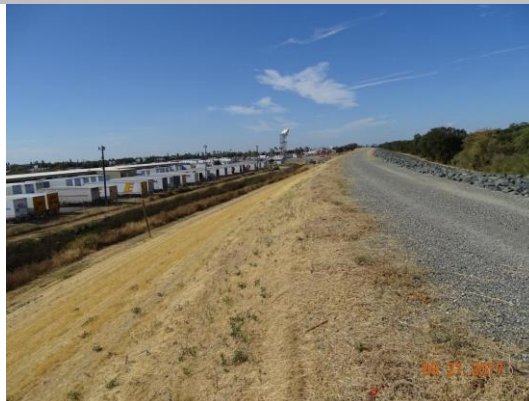
Photo 1 of 1 : FA_2017_RD0900_231_46_20170925_00051.jpg

View of the landside of the levee looking downstream. Fall 2017

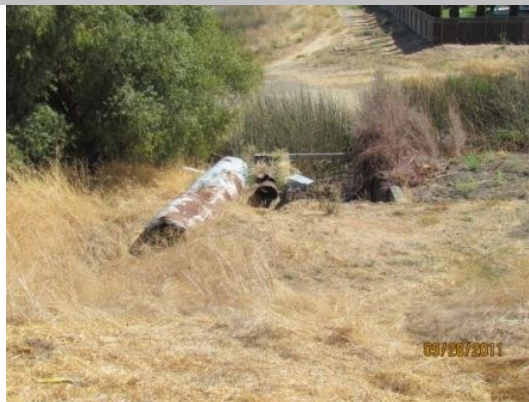
Photo 1 of 1 : FA_2017_RD0900_231_15_20170921_00002.jpg

LM Start	3.26	Rating **	M	Issue No.	15
LM End	3.26	Issue Type +	Ma	Location *	LS
Category	Earthen Levee			GPS Latitude/Longitude	
				Start	End
Item	Encroachments			38.540943 °	38.540943 °
				-121.582280 °	-121.582280 °
DWR ID	DWR_RD0900_02_s_2012_15				
Comment Code					
PI : Pipe					
Inspector Comment					
Recently removed waterward pump. Some pipe, equipment and debris remain.

Abandon pipes and debris was found on the landside of the levee looking upstream.

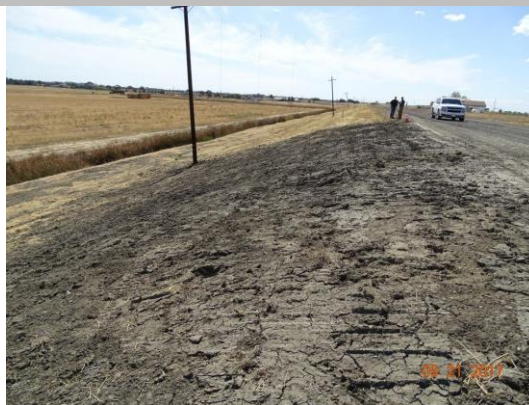
Photo 5 of 7 : FA_2017_RD0900_231_40_20170925_00055.jpg

Notes: LS, thorny vegetation is present at levee toe/canal. Light grass present along LS slope. Primary use of canal is for drainage, ranges in width 15-25; on average 20ft. RD rep. mentioned permitting has begun to replace drainage canal with 32in pipe for storm drainage to community. 8,600 LF of the LS levee has sloughing of the LS toe access road into drainage canal. There is no imminent threat of losing levee in next storm event. DWR inspector: LMA repaired two landside erosion sites (levee mile 5.26 and 4.63) during fall 2017 inspection.

View of the repaired slope instability site on the landside slope of the levee looking downstream on levee mile 5.26 (38.511915, -121.582167).
Fall 2017

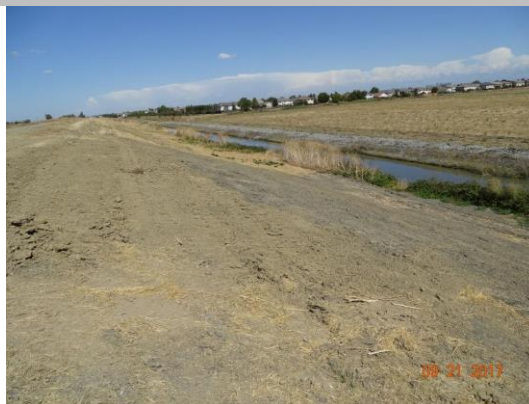
Photo 6 of 7 : FA_2017_RD0900_231_40_20170925_00058.jpg

View of a repaired slope instability site on the landside of the levee looking upstream on levee mile 4.63 (38.52111, -121.582148). Fall 2017

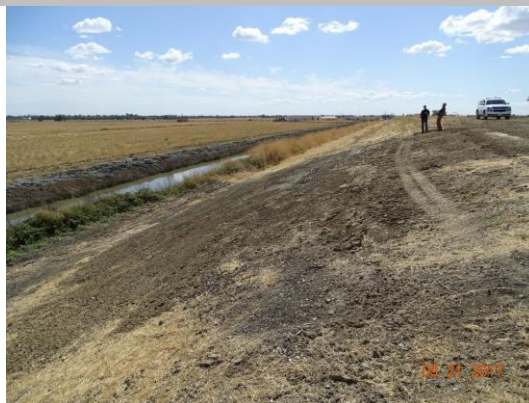
Photo 7 of 7 : FA_2017_RD0900_231_40_20170925_00059.jpg

Comment Code						
Inspector Comment						
Levee Evaluation Comments						
Description:						
Site ID No:198						
Site Designation:RD 900-01						
Repair Type: Erosion						
Rating:Serious						
Field Date:6/6/2017						
Notes: LS, thorny vegetation is present at levee toe/canal. Light grass present along LS slope. Primary use of canal is for drainage, ranges in width 15-25; on average 20ft. RD rep. mentioned permitting has begun to replace drainage canal with 32in pipe for storm drainage to community. 8,600 LF of the LS levee has sloughing of the LS toe access road into drainage canal. There is no imminent threat of losing levee in next storm event. DWR inspector: LMA repaired two landside erosion sites (levee mile 5.26 and 4.63) during fall 2017 inspection.

View of a repaired slope instability site on the landside of the levee looking downstream on levee mile 4.63 (38.52111, -121.582148). Fall 2017

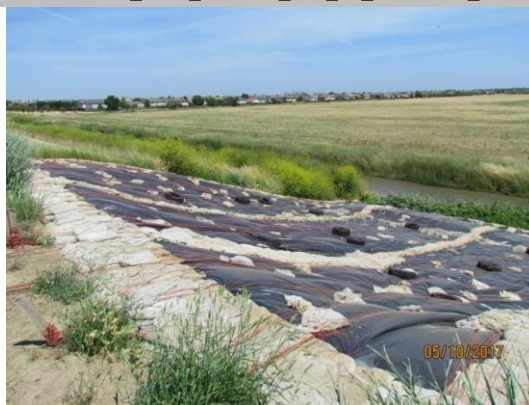
Photo 1 of 3 : FA_2017_RD0900_231_43_20170921_00007.jpg

LM Start	4.63	Rating **	A	Issue No.	43	
LM End	4.63	Issue Type +	Ma	Location *	LS	
Category	Earthen Levee			GPS Latitude/Longitude		
				Start		End
Item	Slope Stability			38.521110 °		38.521110 °
				-121.582148 °		-121.582148 °
DWR ID	DWR_RD0900_02_s_2017_43					
Comment Code						
S1 : Repair slope instability.						
Inspector Comment						
LMA fixed the erosion site.

View of a slope instability covered by raincoat on the landside slope of the levee looking upstream. Spring 2017

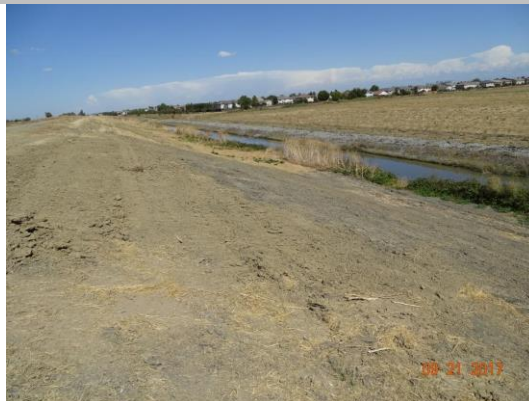
Photo 2 of 3 : FA_2017_RD0900_231_43_20170925_00056.jpg

LM Start	4.63	Rating **	A	Issue No.	43 (cont)	
LM End	4.63	Issue Type +	Ma	Location *	LS	
Category	Earthen Levee			GPS Latitude/Longitude		
				Start		End
Item	Slope Stability			38.521110 °		38.521110 °
				-121.582148 °		-121.582148 °
DWR ID	DWR_RD0900_02_s_2017_43					
Comment Code						
S1 : Repair slope instability.						
Inspector Comment						
LMA fixed the erosion site.

View of a repaired slope instability site on the landside of the levee looking upstream. Fall 2017

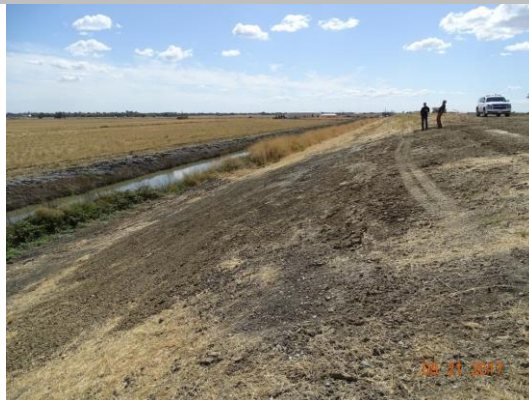
Photo 3 of 3 : FA_2017_RD0900_231_43_20170925_00057.jpg

View of a repaired slope instability site on the landside of the levee looking downstream. Fall 2017

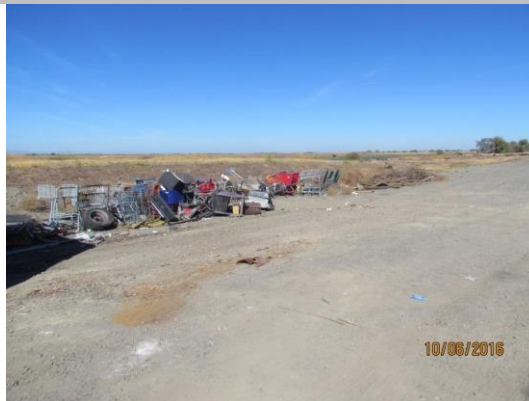
Photo 1 of 1 : FA_2017_RD0900_231_45_20170921_00008.jpg

View of debris on the landside shoulder of the levee looking upstream.

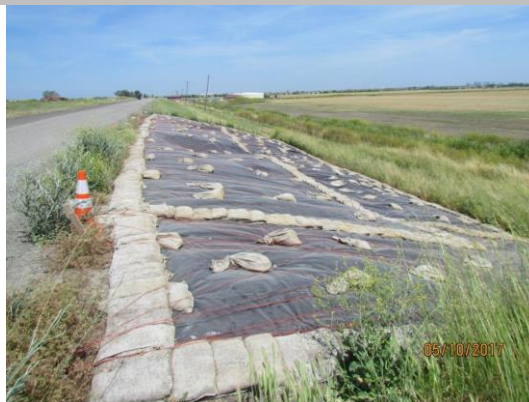
Photo 1 of 4 : FA_2017_RD0900_231_41_20170921_00003.jpg

LM Start	5.26	Rating **	A	Issue No.	41
LM End	5.26	Issue Type +	Ma	Location *	WS
Category	Earthen Levee			GPS Latitude/Longitude	
				Start	End
Item	Slope Stability			38.511915 °	38.511915 °
				-121.582167 °	-121.582167 °
DWR ID	DWR_RD0900_02_s_2017_41				
Comment Code					
S1 : Repair slope instability.					
Inspector Comment					
LMA fixed the damaged slope instability on the landside of the levee.

View of a slope instability covered by a raincoat on the landside of the levee looking upstream. Spring 2017

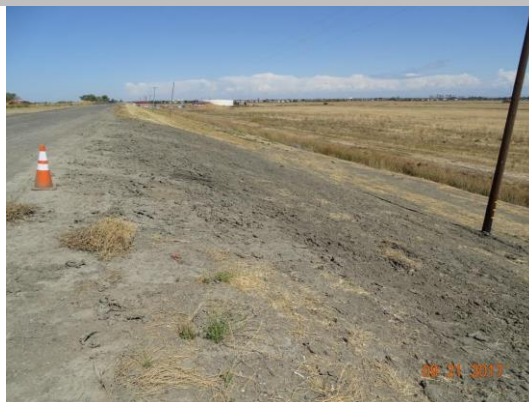
Photo 3 of 4 : FA_2017_RD0900_231_41_20170925_00052.jpg

View of the repaired slope instability site on the landside slope of the levee looking upstream. Fall 2017

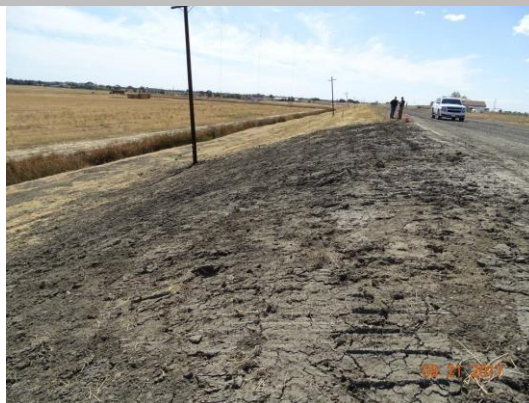
Photo 4 of 4 : FA_2017_RD0900_231_41_20170925_00053.jpg

LM Start	5.26	Rating **	A	Issue No.	41 (cont)	
LM End	5.26	Issue Type +	Ma	Location *	WS	
Category	Earthen Levee			GPS Latitude/Longitude		
				Start		End
Item	Slope Stability			38.511915 °		38.511915 °
				-121.582167 °		-121.582167 °
DWR ID	DWR_RD0900_02_s_2017_41					
Comment Code						
S1 : Repair slope instability.						
Inspector Comment						
LMA fixed the damaged slope instability on the landside of the levee.

View of the repaired slope instability site on the landside slope of the levee looking downstream. Fall 2017
