**Flood Control Project Maintenance  
Levee Inspections**

**Maintenance Issue Types Only, Levee Inspection Report By Mile - Fall 2018**

**Reclamation District No. 0900 West Sacramento**

Waterway	Bank	Unit Miles	Inspection Start/End	Inspector
Unit No. 01 Sacramento River	Right	7.70	10/18/2018 10/18/2018	Luz Dial

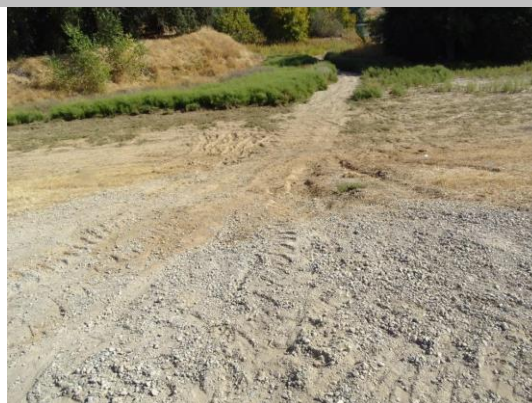
Photo 1 of 1 : FA\_2018\_RD0900\_230\_36\_20181022\_00021.jpg

LM Start	2.05	Rating **	A/W	Issue No.	36
LM End	2.05	Issue Type +	Ma	Location *	WS
Category	Earthen Levee			GPS Latitude/Longitude	
				Start	End
Item	Slope Stability			38.557865 °	38.557865 °
				-121.518175 °	-121.518175 °
DWR ID	DWR_RD0900_01_s_2018_36				
Comment Code					
S3 : Repair the levee slope damaged by vehicle traffic and prevent access where possible.					
Inspector Comment					
LMA repaired slope damage, but vehicles continue to access river.

View of slope damage from vehicular traffic. Fall 2018

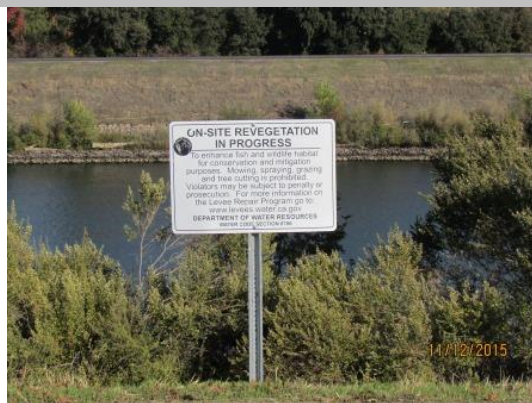
Photo 1 of 1 : FA\_2018\_RD0900\_230\_17\_20180910\_00005.jpg

LM Start	2.26	Rating **	A/W	Issue No.	17
LM End	3.72	Issue Type +	Ma	Location *	WS
Category	Earthen Levee			GPS Latitude/Longitude	
				Start	End
Item	Vegetation			38.555304 °	38.536946 °
				-121.516127 °	-121.519774 °
DWR ID	DWR_RD0900_01_s_2012_17				
Comment Code					
V8 : Environmental Requirements.					
Inspector Comment

View of the DWR environmental mitigation site.

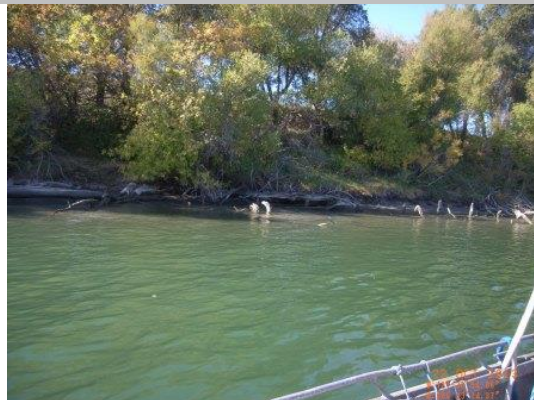
Photo 1 of 1 : FA\_2018\_RD0900\_230\_30\_20181023\_00024.jpg

LM Start	2.35	Rating **	M	Issue No.	30
LM End	2.47	Issue Type +	Ma	Location *	WS
Category	Supplemental			GPS Latitude/Longitude	
				Start	End
Item	2017 USACE Erosion Survey, DRAFT			38.554277 °	38.552504 °
				-121.515263 °	-121.514752 °
DWR ID	DWR_RD0900_01_f_2018_30				
Comment Code					
Inspector Comment					
2017 Site ID: SAC 56.7 R					
Status: Eroding					
2017 Field Notes: Fresh toe erosion. New rock placed.					
Site History: 2007 - Have good berm width with minor toe erosion.					
Close to the levee toe protection, but levee slope is steep. 2011 - New large erosion pocket. 2012 - Minor new erosion at the toe.

USACE 2013 Photo #1

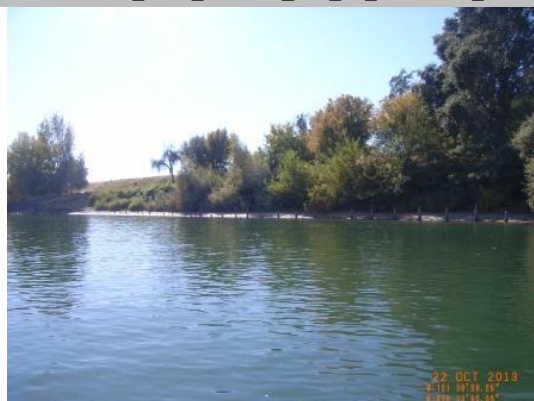
Photo 1 of 1 : FA\_2018\_RD0900\_230\_29\_20181023\_00023.jpg

LM Start	2.55	Rating **	M	Issue No.	29
LM End	2.64	Issue Type +	Ma	Location *	WS
Category	Supplemental			GPS Latitude/Longitude	
				Start	End
Item	2017 USACE Erosion Survey, DRAFT			38.551319 °	38.550090 °
				-121.514423 °	-121.513983 °
DWR ID	DWR_RD0900_01_f_2018_29				
Comment Code					
Inspector Comment					
2017 Site ID: SAC 56.5 R					
Status: Eroding					
2017 Field Notes: Fresh toe erosion.					
Site History: 1997 - Low berm is contributing to erosion. Old timber pile dikes above water parallel to bank. The upstream mitigation low berm causes a flow separation at the site. 1999 - Some new localized erosion with less than one foot of bank retreat. 2000 - Some new erosion at the upstream end. Fat toe deposits at toe. 2003 - Some new erosion upstream, but have a wide berm. 2011 - Minor new erosion at toe.

USACE 2013 Photo #1

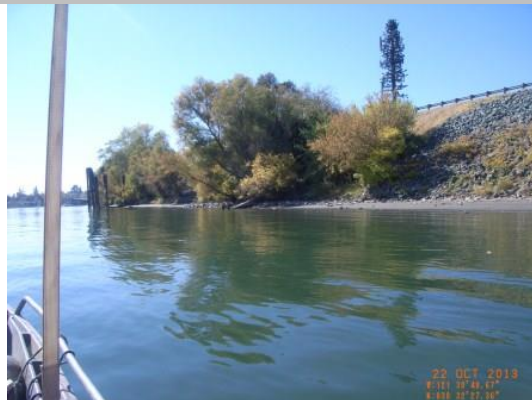
Photo 1 of 1 : FA\_2018\_RD0900\_230\_28\_20181023\_00022.jpg

LM Start	3.27	Rating **	A/W	Issue No.	28
LM End	3.48	Issue Type +	Ma	Location *	WS
Category	Supplemental			GPS Latitude/Longitude	
				Start	End
Item	2017 USACE Erosion Survey, DRAFT			38.541246 °	38.538689 °
				-121.513561 °	-121.515916 °
DWR ID	DWR_RD0900_01_f_2018_28

Comment Code					
Inspector Comment					
2017 Site ID: SAC 55.7 R					
Status: Critical					
2017 Field Notes: Fresh toe erosion. Site upgraded to critical. A setback levee is under construction behind this site.					
Site History: 2008 - Erosion into levee toe. Over steepened levee slope, worst at the upstream end. 2009 - Near vertical banks from rotational slumping, hidden by vegetation. 2010 - Boat sinking more, may be causing eddy scour around it. Difficult to see the vertical slumps due to dense vegetation. 2011 - Minor new erosion at the toe. The paddleboat that was sitting at this site for years has been removed. 2012 - Site extended upstream due to additional erosion. 2016 - New rock on slope at upstream end.

USACE 2013 Photo #1

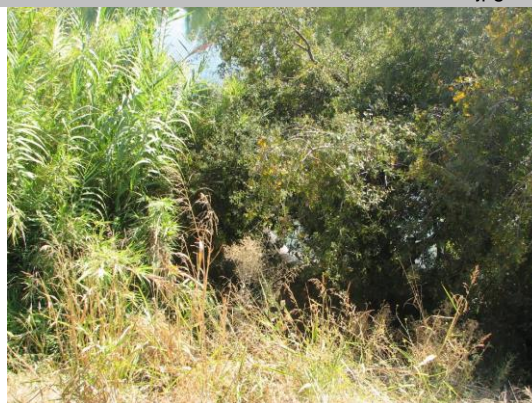
Photo 3 of 3 : UCIP\_FA\_2018\_37668\_68389.jpg

Comment Code						
Inspector Comment						
FS_ID:37668 DS_ID:17769 EP_NO: N/A Repair Type: Non-Urgent Crossing Status: Found UCIP Comments: 02/26/2018 Pipe is located within the construction limits of the Levee Improvement Project for RD0900, As-builts PENDING Project Completion. -- UNDER CONSTRUCTION Levee Improvement Project, construction schedule Summer 2016 to November 2018. Levee improvements address through seepage, underseepage and slope stability and include strengthen-in-place improvements and construction of a setback levee. Reference: [Issued FOR CONSTRUCTION] West Sacramento Area Flood Control Agency Southport Levee Improvement Project Early Implementation Program. Southport Sacramento River Levee: (Stat 3+90 to Station 287+57). Volume 3 (W.O. # 41164) December 2016 Conformed Submittal. HDR Engineering Inc. Folsom, CA – (DWR UCIP – O. Magana) 10/06/2009 Dense vegetation limits the inspector's visibility to identify signs of pipe failure (leaks) along the slope. Recommend removing vegetation along pipe alignment to conduct proper inspection of structure and appurtenances. (DWR UCIP - O. Magana) FIELD_STRUCT_DESC: 24-inch pipe through the levee, 22.0 feet below the crown. Pump house at the landside (LS) toe. Screw gate in LS of the levee. Additional Reference(s): USACE Sacramento O&M Manual Unit No. 116, August 1955, revised 2011, (USGS River Mile [RM] 55.65), As-built drawing# 6-13-1100 page 3, January 1933] FS Date: 10/6/2009

Pipe visible on waterward side visible through dense vegetation.

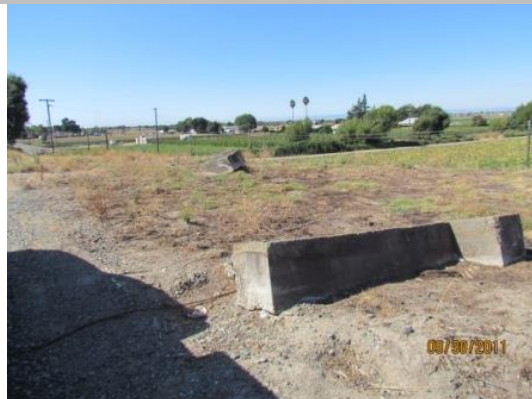
Photo 1 of 1 : FA\_2018\_RD0900\_230\_343\_20180910\_00014.jpg

LM Start	7.10	Rating **	M	Issue No.	343
LM End	7.10	Issue Type +	Ma	Location *	LS
Category	Earthen Levee			GPS Latitude/Longitude	
				Start	End
Item	Encroachments			38.512642 °	38.512642 °
				-121.554881 °	-121.554881 °
DWR ID	DWR_RD0900_01_s_2012_343				
Comment Code					
DE : Debris					
Inspector Comment					
Concrete debris from old railroad track.

Concrete debris from old rail road track was found on the landside of the levee looking upstream.

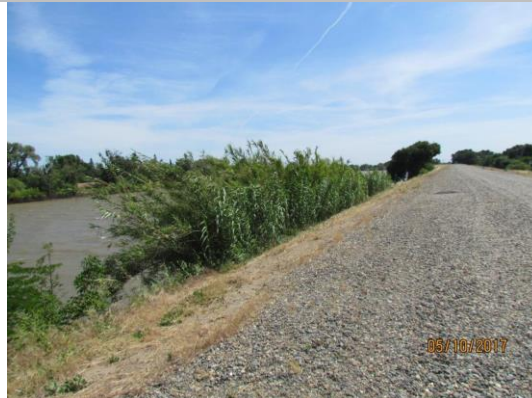
Photo 1 of 1 : FA\_2018\_RD0900\_230\_59\_20180910\_00011.jpg

LM Start	7.47	Rating **	M	Issue No.	59
LM End	7.47	Issue Type +	Ma	Location *	WS
Category	Earthen Levee			GPS Latitude/Longitude	
				Start	End
Item	Vegetation			38.507648 °	38.507648 °
				-121.557571 °	-121.557571 °
DWR ID	DWR_RD0900_01_f_2012_59				
Comment Code					
V2 : Remove the wild growth other than native grasses from the levee slopes.					
Inspector Comment					
Arrundo growth on the waterside slope of the levee.

View of the arrundo on the waterside of the levee during spring 2017 inspection.

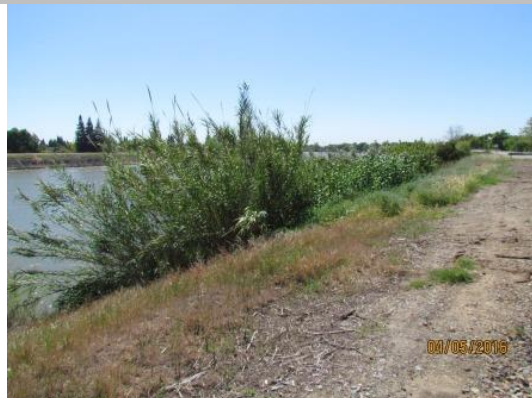
Photo 1 of 2 : FA\_2018\_RD0900\_230\_15\_20180910\_00003.jpg

LM Start	7.78	Rating **	M	Issue No.	15
LM End	7.78	Issue Type +	Ma	Location *	WS
Category	Earthen Levee			GPS Latitude/Longitude	
				Start	End
Item	Vegetation			38.503490°	38.503490°
				-121.559770°	-121.559770°
DWR ID	DWR_RD0900_01_f_2013_15				
Comment Code					
V2 : Remove the wild growth other than native grasses from the levee slopes.					
Inspector Comment					
Arrundo on the waterside

Updated picture of the arundo on the waterside of the levee during spring 2016 inspection.

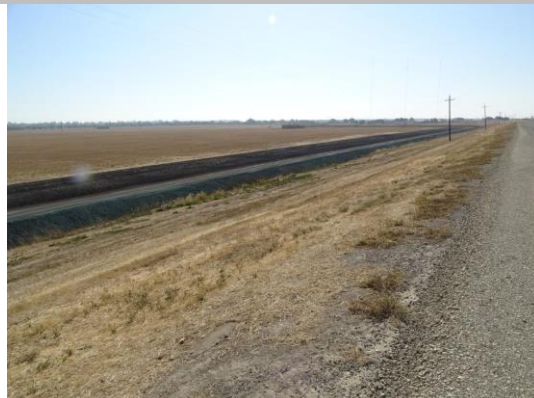
Photo 1 of 8 : FA\_2018\_RD0900\_231\_40\_20181022\_00052.jpg

Comment Code					
Inspector Comment					
Levee Evaluation Comments					
Description:					
Site ID No:198					
Site Designation:RD 900-01					
Repair Type: Erosion					
Rating:Serious					
Field Date:6/6/2017					
Notes: LS, thorny vegetation is present at levee toe/canal. Light grass present along LS slope. Primary use of canal is for drainage, ranges in width 15-25; on average 20ft. RD rep. mentioned permitting has begun to replace drainage canal with 32in pipe for storm drainage to community. 8,600 LF of the LS levee has sloughing of the LS toe access road into drainage canal. There is no imminent threat of losing levee in next storm event. DWR inspector: LMA repaired two landside erosion sites (levee mile 5.26 and 4.63) during fall 2017 inspection.

View of repaired slope instability site. Fall 2018

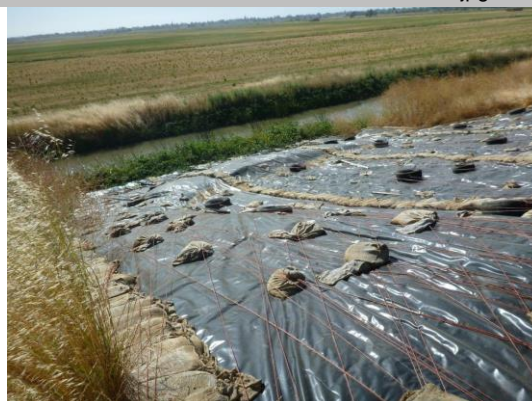
Photo 3 of 8 : LEVAL\_FA\_2018\_198\_190.jpg

Comment Code						
Inspector Comment						
Levee Evaluation Comments						
Description:						
Site ID No:198						
Site Designation:RD 900-01						
Repair Type: Erosion						
Rating:Serious						
Field Date:6/6/2017						
Notes: LS, thorny vegetation is present at levee toe/canal. Light grass present along LS slope. Primary use of canal is for drainage, ranges in width 15-25; on average 20ft. RD rep. mentioned permitting has begun to replace drainage canal with 32in pipe for storm drainage to community. 8,600 LF of the LS levee has sloughing of the LS toe access road into drainage canal. There is no imminent threat of losing levee in next storm event. DWR inspector: LMA repaired two landside erosion sites (levee mile 5.26 and 4.63) during fall 2017 inspection.

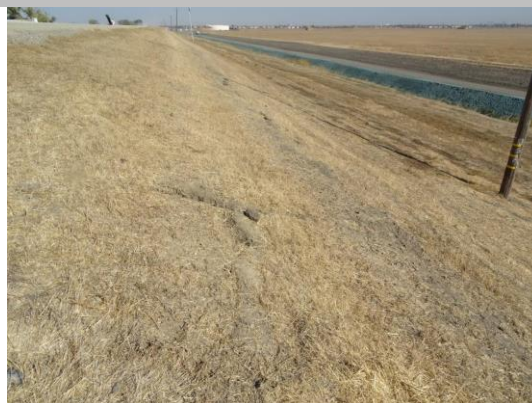
Photo 1 of 1 : FA\_2018\_RD0900\_231\_27\_20181022\_00053.jpg

LM Start	5.45	Rating **	M	Issue No.	27
LM End	5.45	Issue Type +	Ma	Location *	LS
Category	Earthen Levee			GPS Latitude/Longitude	
				Start	End
Item	Slope Stability			38.509217 °	38.509217 °
				-121.582140 °	-121.582140 °
DWR ID	DWR_RD0900_02_f_2018_27				
Comment Code					
S1 : Repair slope instability.					
Inspector Comment					
Repair desiccation cracks on levee slope.

View of desiccation cracks on levee. Fall 2018
