**Flood Control Project Maintenance
Levee Inspections**

Maintenance Issue Types Only, Levee Inspection Report By Mile - Fall 2019

Reclamation District No. 0900 West Sacramento

Waterway	Bank	Unit Miles	Inspection Start/End	Inspector
Unit No. 01 Sacramento River	Right	7.70	10/01/2019 10/01/2019	Luz Dial

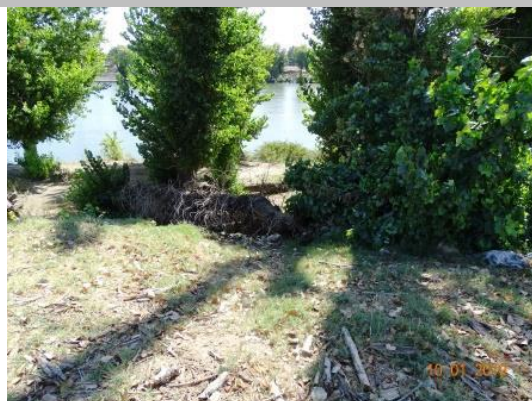
Photo 2 of 2 : FA_2019_RD0900_230_24_20191007_00016.jpg

LM Start	0.50	Rating **	M	Issue No.	24 (cont)	
LM End	0.50	Issue Type +	Ma	Location *	WS	
Category	Earthen Levee			GPS Latitude/Longitude		
				Start		End
Item	Encroachments			38.574718 °	38.574718 °	
				-121.514023 °	-121.514023 °	
DWR ID	DWR_RD0900_01_f_2019_24					
Comment Code						
TR : Tree or limb						
Inspector Comment						
Remove a large tree on the waterside slope.

View of large tree debris on waterside slope. Fall 2019

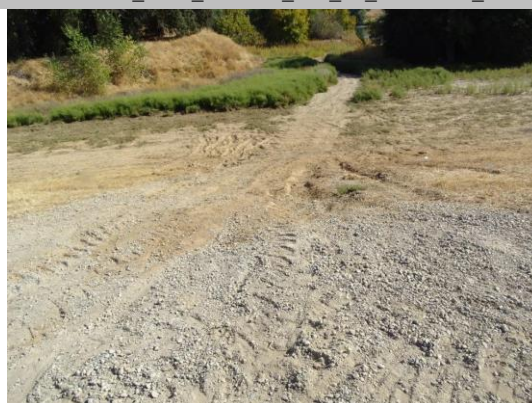
Photo 1 of 1 : FA_2019_RD0900_230_36_20190904_00005.jpg

LM Start	2.05	Rating **	A/W	Issue No.	36
LM End	2.05	Issue Type +	Ma	Location *	WS
Category	Earthen Levee			GPS Latitude/Longitude	
				Start	End
Item	Slope Stability			38.557865 °	38.557865 °
				-121.518175 °	-121.518175 °
DWR ID	DWR_RD0900_01_s_2018_36				
Comment Code					
S3 : Repair the levee slope damaged by vehicle traffic and prevent access where possible.					
Inspector Comment					
The LMA repaired slope damage, but vehicles continue to access river.

View of slope damage from vehicular traffic. Fall 2018

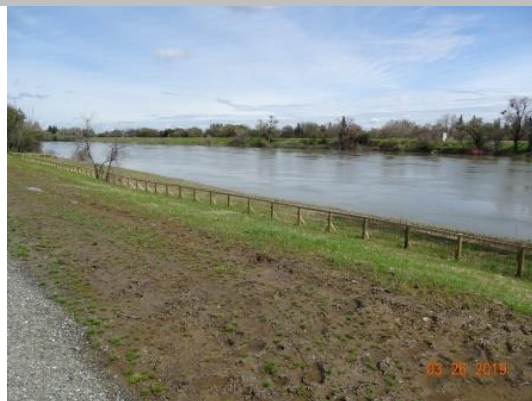
Photo 1 of 1 : FA_2019_RD0900_230_28_20190904_00004.jpg

LM Start	2.55	Rating **	A/W	Issue No.	28
LM End	2.64	Issue Type +	Ma	Location *	WS
Category	Supplemental			GPS Latitude/Longitude	
				Start	End
Item	2017 USACE Erosion Survey			38.551319 °	38.550090 °
				-121.514423 °	-121.513983 °
DWR ID	DWR_RD0900_01_s_2019_28				
Comment Code					
Inspector Comment					
2017 Site ID: SAC 56.5 R					
Status: Eroding					
2017 Field Notes: Fresh toe erosion.					
Site History: 1997 - Low berm is contributing to erosion. Old timber pile dikes above water parallel to bank. The upstream mitigation low berm causes a flow separation at the site. 1999 - Some new localized erosion with less than one foot of bank retreat. 2000 - Some new erosion at the upstream end. Fat toe deposits at toe. 2003 - Some new erosion upstream, but have a wide berm. 2011 - Minor new erosion at toe.

View looking upstream at repaired erosion site. Spring 2019

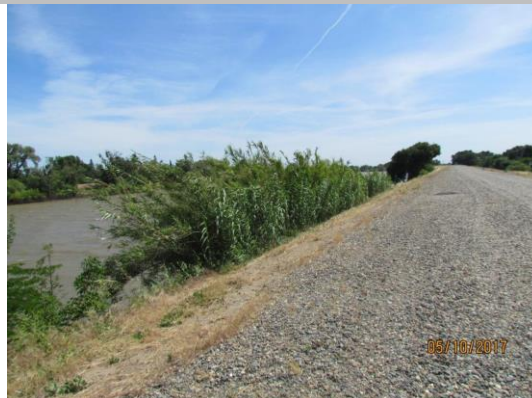
Photo 1 of 1 : FA_2019_RD0900_230_59_20190904_00008.jpg

LM Start	7.47	Rating **	A/W	Issue No.	59
LM End	7.47	Issue Type +	Ma	Location *	WS
Category	Earthen Levee			GPS Latitude/Longitude	
				Start	End
Item	Vegetation			38.507648 °	38.507648 °
				-121.557571 °	-121.557571 °
DWR ID	DWR_RD0900_01_f_2012_59				
Comment Code					
V2 : Remove the wild growth other than native grasses from the levee slopes.					
Inspector Comment					
LMA sprayed Arundo on the waterside slope of the levee, but dead vegetation needs to be removed.

View of the arundo on the waterside of the levee during spring 2017 inspection.

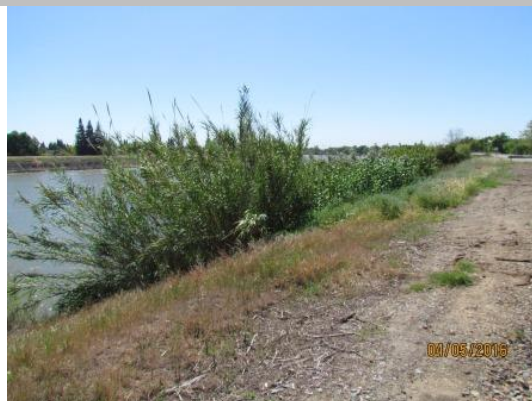
Photo 1 of 2 : FA_2019_RD0900_230_15_20190904_00001.jpg

LM Start	7.78	Rating **	M	Issue No.	15
LM End	7.78	Issue Type +	Ma	Location *	WS
Category	Earthen Levee			GPS Latitude/Longitude	
				Start	End
Item	Vegetation			38.503490 °	38.503490 °
				-121.559770 °	-121.559770 °
DWR ID	DWR_RD0900_01_f_2013_15				
Comment Code					
V2 : Remove the wild growth other than native grasses from the levee slopes.					
Inspector Comment					
LMA sprayed Arundo on the waterside, but dead vegetation needs to be removed.

Picture of the arundo on the waterside of the levee during spring 2016 inspection.

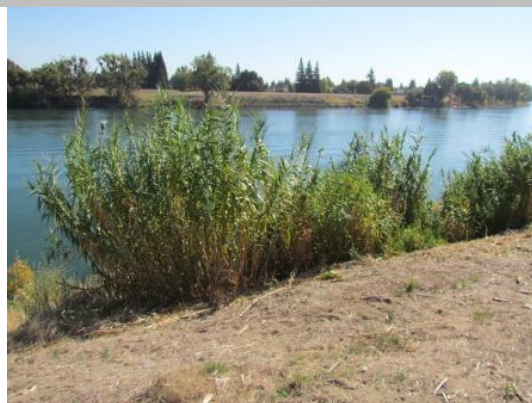
Photo 2 of 2 : FA_2019_RD0900_230_15_20190904_00002.jpg

View of arundo on the waterside of the levee looking downstream.

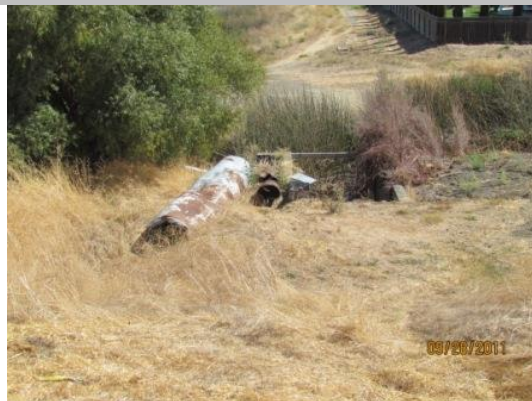
Photo 1 of 1 : FA_2019_RD0900_231_15_20190904_00002.jpg

LM Start	3.26	Rating **	M	Issue No.	15
LM End	3.26	Issue Type +	Ma	Location *	LS
Category	Earthen Levee			GPS Latitude/Longitude	
				Start	End
Item	Encroachments			38.540943 °	38.540943 °
				-121.582280 °	-121.582280 °
DWR ID	DWR_RD0900_02_s _ 2012_15				
Comment Code					
PI : Pipe					
Inspector Comment					
An abandoned pipe still remains on the levee slope.

Abandoned pipes and debris were found on the landside of the levee looking upstream. Fall 2011

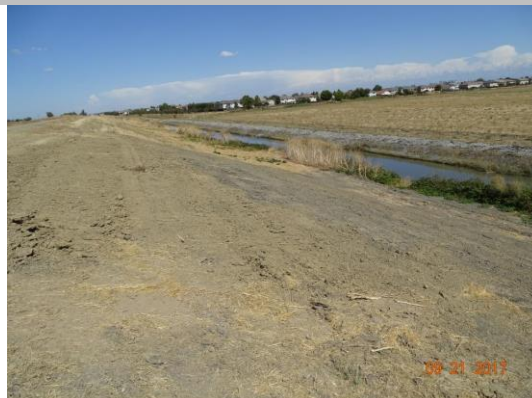
Photo 2 of 8 : FA_2019_RD0900_231_40_20190904_00010.jpg

View of a repaired slope instability site on the landside of the levee looking upstream on levee mile 4.63 (38.52111, -121.582148). Fall 2017

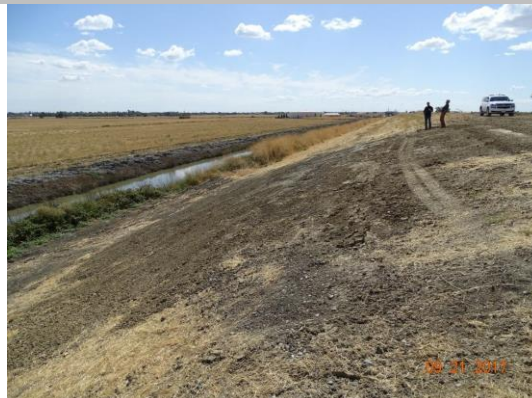
Photo 3 of 8 : FA_2019_RD0900_231_40_20190904_00011.jpg

View of a repaired slope instability site on the landside of the levee looking downstream on levee mile 4.63 (38.52111, -121.582148). Fall 2017

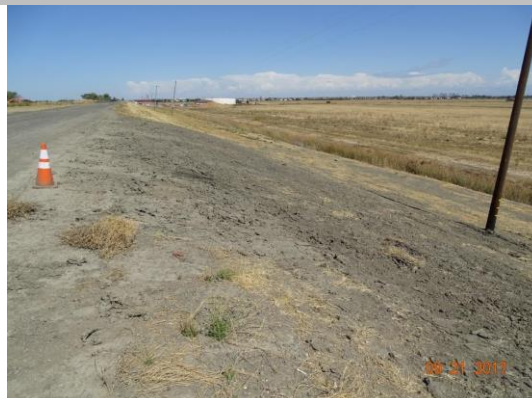
Photo 4 of 8 : FA_2019_RD0900_231_40_20190904_00008.jpg

View of the repaired slope instability site on the landside slope of the levee looking upstream on levee mile 5.26 (38.511915, -121.582167). Fall 2017

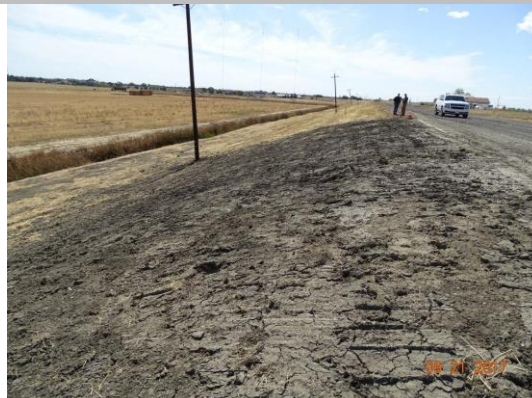
Photo 5 of 8 : FA_2019_RD0900_231_40_20190904_00009.jpg

View of the repaired slope instability site on the landside slope of the levee looking downstream on levee mile 5.26 (38.511915, -121.582167).
Fall 2017

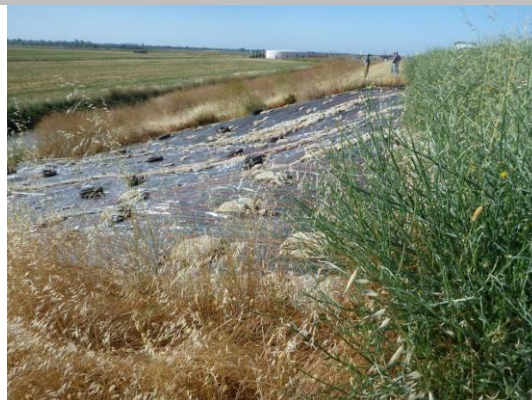
Photo 6 of 8 : LEVAL_FA_2019_198_189.jpg

Comment Code						
Inspector Comment						
Levee Evaluation Comments						
Description:						
Site ID No:198						
Site Designation:RD 900-01						
Repair Type: Erosion						
Rating:Serious						
Field Date:6/6/2017						
Notes: LS, thorny vegetation is present at levee toe/canal. Light grass present along LS slope. Primary use of canal is for drainage, ranges in width 15-25; on average 20ft. RD rep. mentioned permitting has begun to replace drainage canal with 32in pipe for storm drainage to community. 8,600 LF of the LS levee has sloughing of the LS toe access road into drainage canal. There is no imminent threat of losing levee in next storm event. DWR inspector: LMA repaired two landside erosion sites (levee mile 5.26 and 4.63) during fall 2017 inspection.

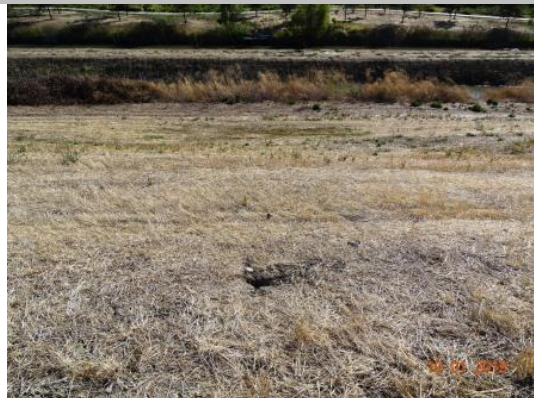
Photo 1 of 1 : FA_2019_RD0900_231_43_20191007_00055.jpg

LM Start	4.29	Rating **	A/W	Issue No.	43
LM End	4.29	Issue Type +	Ma	Location *	LS
Category	Earthen Levee			GPS Latitude/Longitude	
				Start	End
Item	Cracking			38.526007°	38.526007°
				-121.582130°	-121.582130°
DWR ID	DWR_RD0900_02_f_2019_43				
Comment Code					
CR1 : Monitor and have inspected by geotechnical engineer.					
Inspector Comment					
Monitor small desiccation cracks.

View of desiccation crack 3" deep and 5' long. Fall 2019

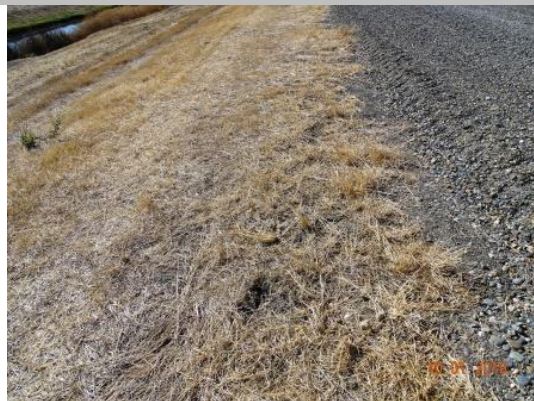
Photo 1 of 1 : FA_2019_RD0900_231_44_20191007_00056.jpg

LM Start	4.46	Rating **	A/W	Issue No.	44
LM End	4.46	Issue Type +	Ma	Location *	LS
Category	Earthen Levee			GPS Latitude/Longitude	
				Start	End
Item	Cracking			38.523537 °	38.523537 °
				-121.582130 °	-121.582130 °
DWR ID	DWR_RD0900_02_f_2019_44				
Comment Code					
CR1 : Monitor and have inspected by geotechnical engineer.					
Inspector Comment					
Monitor small desiccation cracks.

View of small desiccation cracks along landside shoulder. Fall 2019
