**Flood Control Project Maintenance
Levee Inspections**

Maintenance Issue Types Only, Levee Inspection Report By Mile - Fall 2020

Reclamation District No. 0900 West Sacramento

Waterway	Bank	Unit Miles	Inspection Start/End	Inspector
Unit No. 01 Sacramento River	Right	7.70	09/03/2020 09/03/2020	Luz Dial

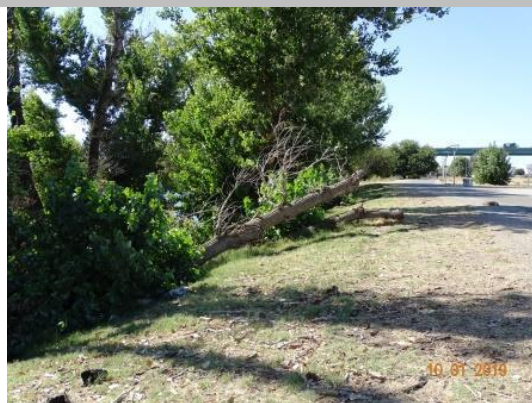
Photo 1 of 1 : FA_2020_RD0900_230_24_20200902_00002.jpg

LM Start	0.50	Rating **	M	Issue No.	24
LM End	0.50	Issue Type +	Ma	Location *	WS
Category	Earthen Levee			GPS Latitude/Longitude	
				Start	End
Item	Encroachments			38.574718 °	38.574718 °
				-121.514023 °	-121.514023 °
DWR ID	DWR_RD0900_01_f_2019_24				
Comment Code					
TR : Tree or limb					
Inspector Comment					
Remove a large tree on the waterside slope.

View of large tree debris on waterside slope. Fall 2019

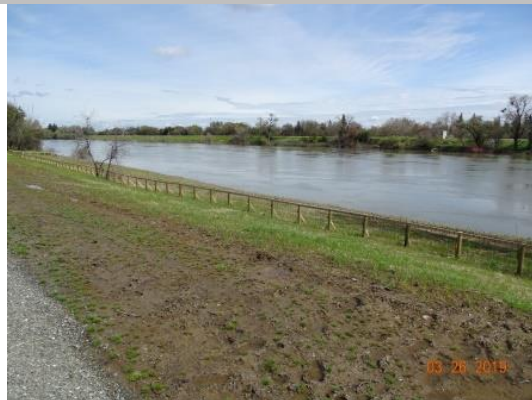
Photo 1 of 1 : FA_2020_RD0900_230_28_20200902_00003.jpg

LM Start	2.55	Rating **	A/W	Issue No.	28
LM End	2.64	Issue Type +	Ma	Location *	WS
Category	Supplemental			GPS Latitude/Longitude	
				Start	End
Item	2017 USACE Erosion Survey			38.551319 °	38.550090 °
				-121.514423 °	-121.513983 °
DWR ID	DWR_RD0900_01_s_2019_28				
Comment Code					
Inspector Comment					
2017 Site ID: SAC 56.5 R Status: Eroding 2017 Field Notes: Fresh toe erosion. Site History: 1997 - Low berm is contributing to erosion. Old timber pile dikes above water parallel to bank. The upstream mitigation low berm causes a flow separation at the site. 1999 - Some new localized erosion with less than one foot of bank retreat. 2000 - Some new erosion at the upstream end. Fat toe deposits at toe. 2003 - Some new erosion upstream, but have a wide berm. 2011 - Minor new erosion at toe.

View looking upstream at repaired erosion site. Spring 2019

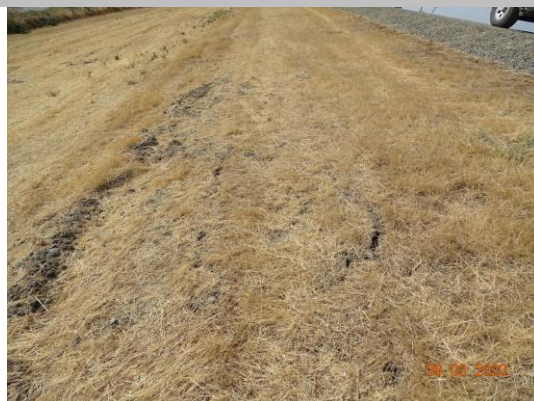
Photo 1 of 1 : FA_2020_RD0900_231_13_20200903_00032.jpg

LM Start	4.72	Rating **	A/W	Issue No.	13
LM End	4.72	Issue Type +	Ma	Location *	LS
Category	Earthen Levee			GPS Latitude/Longitude	
				Start	End
Item	Cracking			38.519808 °	38.519808 °
				-121.582150 °	-121.582150 °
DWR ID	DWR_RD0900_02_f_2020_13				
Comment Code					
CR1 : Monitor and have inspected by geotechnical engineer.					
Inspector Comment					
Monitor longitudinal and transverse cracks.

View of longitudinal and transverse cracks on the landside slope. Fall 2020

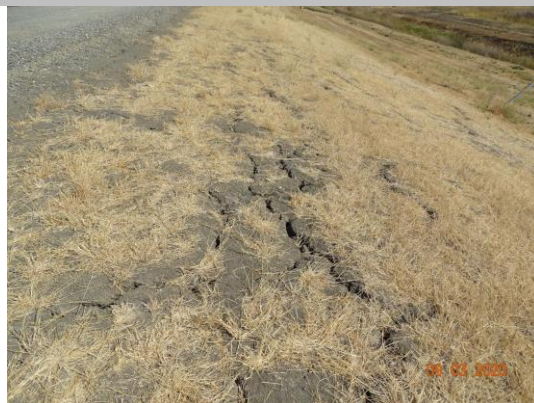
Photo 1 of 1 : FA_2020_RD0900_231_17_20200914_00033.jpg

LM Start	5.11	Rating **	M	Issue No.	17
LM End	5.11	Issue Type +	Ma	Location *	LS
Category	Earthen Levee			GPS Latitude/Longitude	
				Start	End
Item	Cracking			38.514082 °	38.514082 °
				-121.582157 °	-121.582157 °
DWR ID	DWR_RD0900_02_f_2020_17				
Comment Code					
CR2 : Schedule repair of subsidence prior to the next inspection.					
Inspector Comment					
Repair longitudinal and transverse cracks.

View of desiccation cracks on the landside shoulder. Fall 2020
