**Flood Control Project Maintenance  
Levee Inspections**

**Maintenance Issue Types Only, Levee Inspection Report By Mile - Fall 2021**

**Reclamation District No. 0900 West Sacramento**

Waterway	Bank	Unit Miles	Inspection Start/End	Inspector
Unit No. 01 Sacramento River	Right	7.70	10/08/2021 10/08/2021	Marvin Marshall

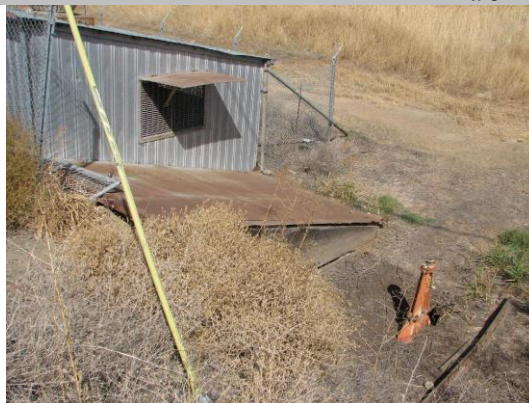
Photo 2 of 3 : UCIP\_FA\_2021\_37668\_68390.jpg

Pump house located on landward side.

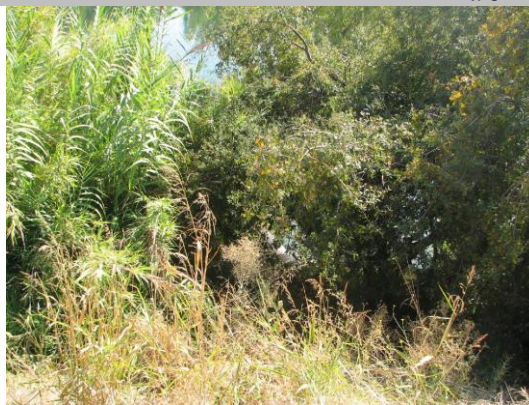
Photo 3 of 3 : UCIP\_FA\_2021\_37668\_68389.jpg

Pipe visible on waterward side visible through dense vegetation.

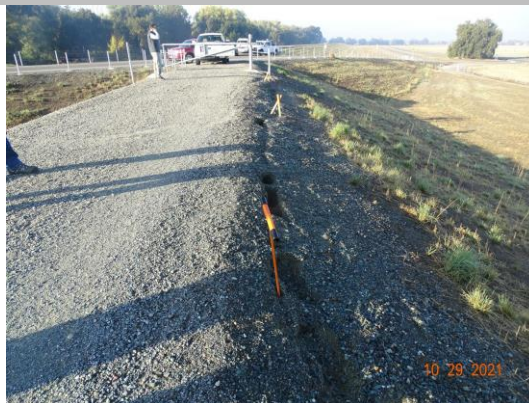
Photo 1 of 1 : FA\_2021\_RD0900\_230\_24\_20211103\_00016.jpg

LM Start	3.74	Rating **	A/W	Issue No.	24
LM End	3.74	Issue Type +	Ma	Location *	CR
Category	Earthen Levee			GPS Latitude/Longitude	
				Start	End
Item	Cracking			38.536734 °	38.536734 °
				-121.520106 °	-121.520106 °
DWR ID	DWR_RD0900_01_f_2021_24				
Comment Code					
CR2 : Schedule repair of subsidence prior to the next inspection.					
Inspector Comment					
Cracking observed on the LS crown. Probing showed cracks are +4' deep approximately 100' long. No slumping or bulging of material was observed. This is on the setback levee, upstream of the Sacramento Yacht Club access road. LMA is scheduling repairs immediately.

Crown cracking on the LS shoulder. Fall 2021

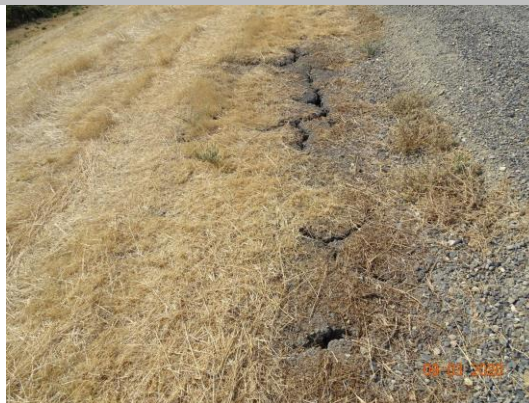
Photo 1 of 1 : FA\_2021\_RD0900\_231\_12\_20210823\_00002.jpg

LM Start	4.15	Rating **	A/W	Issue No.	12
LM End	4.15	Issue Type +	Ma	Location *	LS
Category	Earthen Levee			GPS Latitude/Longitude	
				Start	End
Item	Cracking			38.527967 °	38.527967 °
				-121.582135 °	-121.582135 °
DWR ID	DWR_RD0900_02_f_2020_12				
Comment Code					
CR1 : Monitor and have inspected by geotechnical engineer.					
Inspector Comment					
There is a longitudinal crack along the LS shoulder.

View of longitudinal, desiccation crack along the landside shoulder. Fall 2020

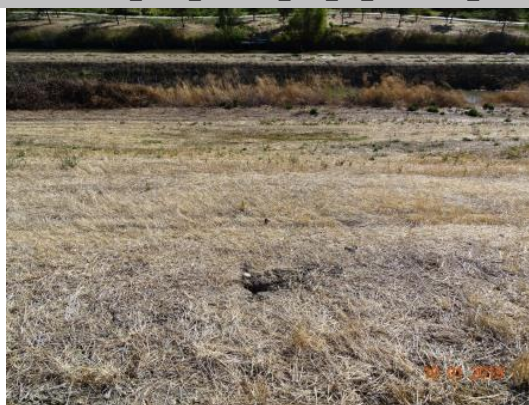
Photo 1 of 1 : FA\_2021\_RD0900\_231\_43\_20210823\_00007.jpg

LM Start	4.29	Rating **	A/W	Issue No.	43
LM End	4.29	Issue Type +	Ma	Location *	LS
Category	Earthen Levee			GPS Latitude/Longitude	
				Start	End
Item	Cracking			38.526007 °	38.526007 °
				-121.582130 °	-121.582130 °
DWR ID	DWR_RD0900_02_f_2019_43				
Comment Code					
CR1 : Monitor and have inspected by geotechnical engineer.					
Inspector Comment					
Monitor small desiccation cracks.

View of desiccation crack 3" deep and 5' long. Fall 2019

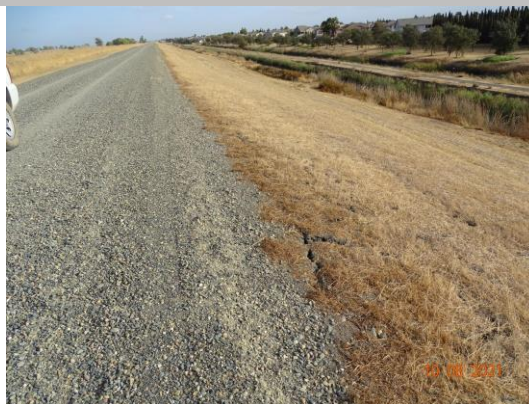
Photo 1 of 1 : FA\_2021\_RD0900\_231\_44\_20211012\_00032.jpg

LM Start	4.46	Rating **	A/W	Issue No.	44
LM End	4.46	Issue Type +	Ma	Location *	LS
Category	Earthen Levee			GPS Latitude/Longitude	
				Start	End
Item	Cracking			38.523537 °	38.523537 °
				-121.582130 °	-121.582130 °
DWR ID	DWR_RD0900_02_f_2019_44				
Comment Code					
CR1 : Monitor and have inspected by geotechnical engineer.					
Inspector Comment					
Monitor small transverse cracks.

Desiccation cracking on the LS crown and slope. Fall 2021

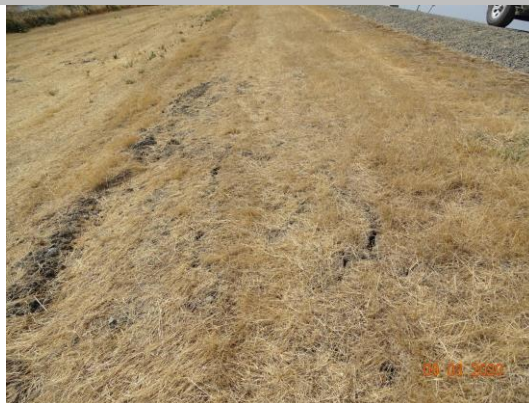
Photo 1 of 1 : FA\_2021\_RD0900\_231\_13\_20210823\_00003.jpg

LM Start	4.72	Rating **	A/W	Issue No.	13
LM End	4.72	Issue Type +	Ma	Location *	LS
Category	Earthen Levee			GPS Latitude/Longitude	
				Start	End
Item	Cracking			38.519808 °	38.519808 °
				-121.582150 °	-121.582150 °
DWR ID	DWR_RD0900_02_f_2020_13				
Comment Code					
CR1 : Monitor and have inspected by geotechnical engineer.					
Inspector Comment					
Monitor longitudinal and transverse cracks.

View of longitudinal and transverse cracks on the landside slope. Fall 2020

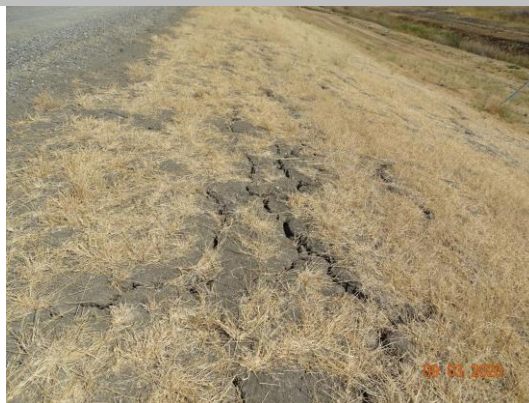
Photo 1 of 1 : FA\_2021\_RD0900\_231\_17\_20210823\_00005.jpg

LM Start	5.11	Rating **	A/W	Issue No.	17
LM End	5.11	Issue Type +	Ma	Location *	LS
Category	Earthen Levee			GPS Latitude/Longitude	
				Start	End
Item	Cracking			38.514082 °	38.514082 °
				-121.582157 °	-121.582157 °
DWR ID	DWR_RD0900_02_f_2020_17				
Comment Code					
CR1 : Monitor and have inspected by geotechnical engineer.					
Inspector Comment					
Monitor longitudinal and transverse cracks.

View of desiccation cracks on the landside shoulder. Fall 2020
