**Flood Control Project Maintenance  
Levee Inspections**

**Maintenance Issue Types Only, Levee Inspection Report By Mile - Fall 2022**

**Reclamation District No. 0900 West Sacramento**

Waterway	Bank	Unit Miles	Inspection Start/End	Inspector
Unit No. 01 Sacramento River	Right	7.70	09/30/2022 09/30/2022	Marvin Marshall

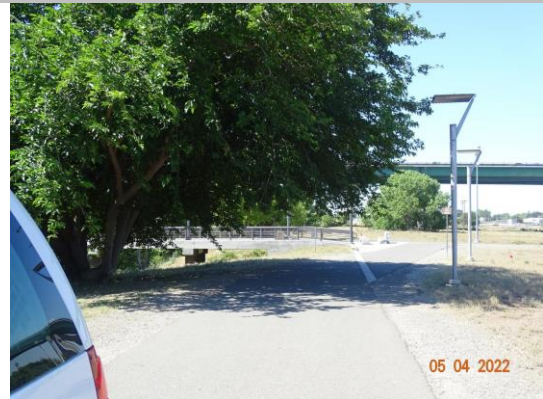
Photo 1 of 1 : FA\_2022\_RD0900\_230\_28\_20220822\_00006.jpg

LM Start	0.59	Rating **	M	Issue No.	28
LM End	0.59	Issue Type +	Ma	Location *	CR
Category	Earthen Levee			GPS Latitude/Longitude	
				Start	End
Item	Trim / Thin Trees			38.573777 °	38.573777 °
				-121.515036 °	-121.515036 °
DWR ID	DWR_RD0900_01_s_2022_28				
Comment Code					
T4 : Trim trees over roadway to at least 12 feet above ground level.					
Inspector Comment					
Trim trees to 12' above grade.

View of low branches on the crown. Spring 2022

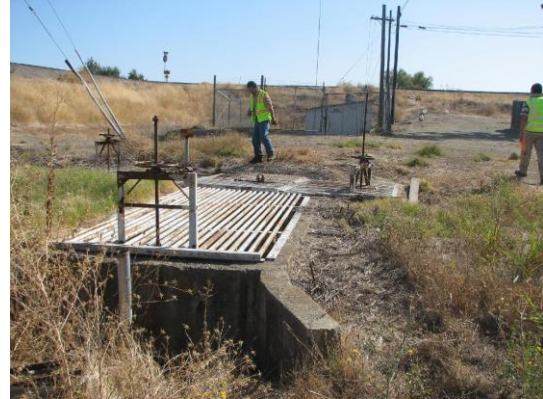
Photo 1 of 3 : UCIP\_FA\_2022\_37668\_68391.jpg

LM Start	3.32	Rating **	M	Issue No.	53
LM End	3.32	Issue Type +	Ma	Location *	
Category	Supplemental			GPS Latitude/Longitude	
				Start	End
Item	DWR UCIP LMA Responsibility			38.540803 °	38.540803 °
				-121.514255 °	-121.514255 °
DWR ID	17769

Comment Code					
Inspector Comment					
DS_ID:17769 FS_ID:37668 EP_NO: N/A Repair Type: Non-Urgent EVAL Issue: Crossing Status: Found UCIP Comments: 02/26/2018 Pipe is located within the construction limits of the Levee Improvement Project for RD0900, As-built PENDING Project Completion. -- UNDER CONSTRUCTION Levee Improvement Project, construction schedule Summer 2016 to November 2018. Levee improvements address through seepage, underseepage and slope stability and include strengthen-in-place improvements and construction of a setback levee. Reference: [Issued FOR CONSTRUCTION] West Sacramento Area Flood Control Agency Southport Levee Improvement Project Early Implementation Program. Southport Sacramento River Levee: (Stat 3+90 to Station 287+57). Volume 3 (W.O. # 41164) December 2016 Conformed Submittal. HDR Engineering Inc. Folsom, CA – (DWR UCIP – O. Magana) 10/06/2009 Dense vegetation limits the inspector's visibility to identify signs of pipe failure (leaks) along the slope. Recommend removing vegetation along pipe alignment to conduct proper inspection of structure and appurtenances. (DWR UCIP - O. Magana) FIELD_STRUCT_DESC: 24-inch pipe through the levee, 22.0 feet below the crown. Pump house at the landside (LS) toe. Screw gate in LS of the levee.[Additional Reference(s): USACE Sacramento O&M Manual Unit No. 116, August 1955, revised 2011, (USGS River Mile [RM] 55.65), As-built drawing# 6-13-1100 page 3, January 1933] FS Date: 10/6/2009

View of concrete structure located on landward side.

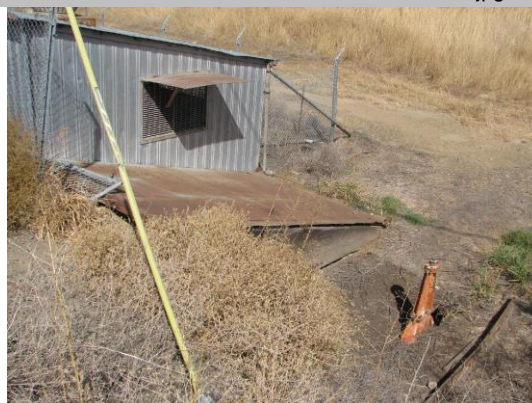
Photo 2 of 3 : UCIP\_FA\_2022\_37668\_68390.jpg

Pump house located on landward side.

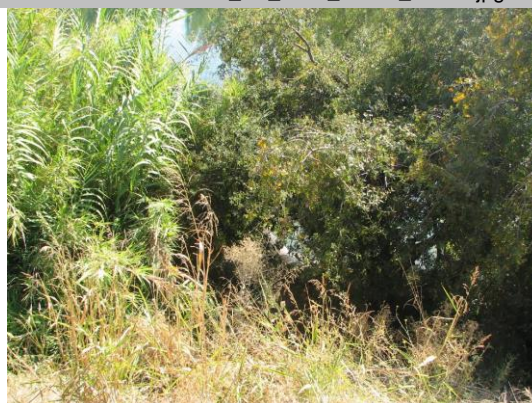
Photo 3 of 3 : UCIP\_FA\_2022\_37668\_68389.jpg

Pipe visible on waterward side visible through dense vegetation.

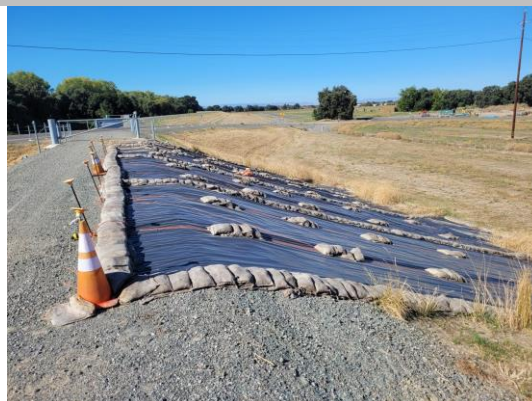
Photo 1 of 2 : FA\_2022\_RD0900\_230\_24\_20220930\_00018.jpg

LM Start	<b>3.74</b>	Rating **	A/W	Issue No.	<b>24</b>
LM End	<b>3.74</b>	Issue Type +	Ma	Location *	CR
Category	Earthen Levee			GPS Latitude/Longitude	
				Start	End
Item	Cracking			38.536734 °	38.536734 °
				-121.520106 °	-121.520106 °
DWR ID	DWR_RD0900_01_f_2021_24

Cracking observed on the LS crown. Probing showed cracks are +4' deep approximately 100' long. No slumping or bulging of material was observed. This is on the setback levee, upstream of the Sacramento Yacht Club access road. Site has been raincoated. LMA is in process of exploratory excavation and repair.

Raincoat placed on LS slope. Fall 2022

CR2 : Schedule repair of subsidence prior to the next inspection.

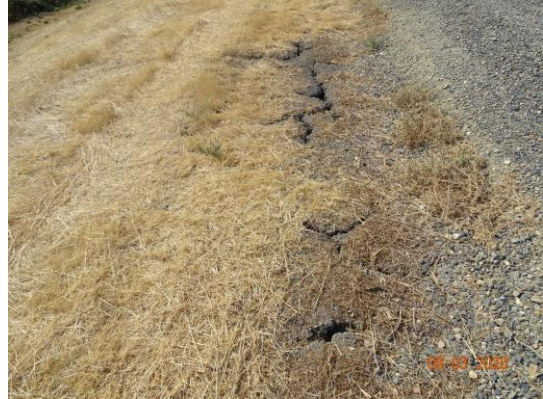
Photo 1 of 1 : FA\_2022\_RD0900\_231\_12\_20220822\_00002.jpg

LM Start	4.15	Rating **	A/W	Issue No.	12
LM End	4.15	Issue Type +	Ma	Location *	LS
Category	Earthen Levee			GPS Latitude/Longitude	
				Start	End
Item	Cracking			38.527967 °	38.527967 °
				-121.582135 °	-121.582135 °
DWR ID	DWR_RD0900_02_f_2020_12				
Comment Code					
CR1 : Monitor and have inspected by geotechnical engineer.					
Inspector Comment					
There is a longitudinal crack along the LS shoulder.

View of longitudinal, desiccation crack along the landside shoulder. Fall 2020

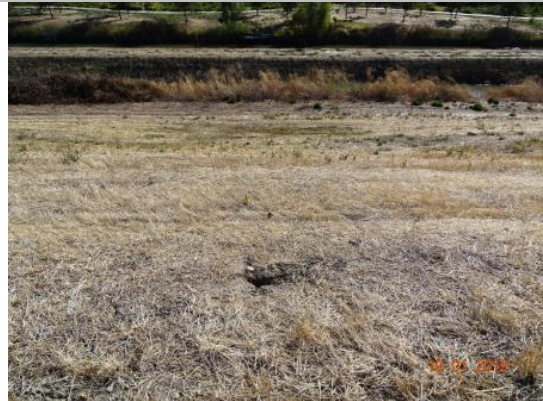
Photo 1 of 1 : FA\_2022\_RD0900\_231\_43\_20220822\_00007.jpg

LM Start	4.29	Rating **	A/W	Issue No.	43
LM End	4.29	Issue Type +	Ma	Location *	LS
Category	Earthen Levee			GPS Latitude/Longitude	
				Start	End
Item	Cracking			38.526007 °	38.526007 °
				-121.582130 °	-121.582130 °
DWR ID	DWR_RD0900_02_f_2019_43				
Comment Code					
CR1 : Monitor and have inspected by geotechnical engineer.					
Inspector Comment					
Monitor small desiccation cracks.

View of desiccation crack 3" deep and 5' long. Fall 2019

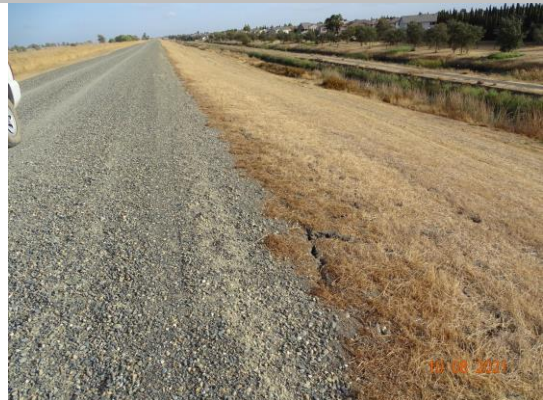
Photo 1 of 1 : FA\_2022\_RD0900\_231\_44\_20220822\_00008.jpg

LM Start	4.46	Rating **	A/W	Issue No.	44
LM End	4.46	Issue Type +	Ma	Location *	LS
Category	Earthen Levee			GPS Latitude/Longitude	
				Start	End
Item	Cracking			38.523537 °	38.523537 °
				-121.582130 °	-121.582130 °
DWR ID	DWR_RD0900_02_f_2019_44				
Comment Code					
CR1 : Monitor and have inspected by geotechnical engineer.					
Inspector Comment					
Monitor small transverse cracks.

Desiccation cracking on the LS crown and slope. Fall 2021

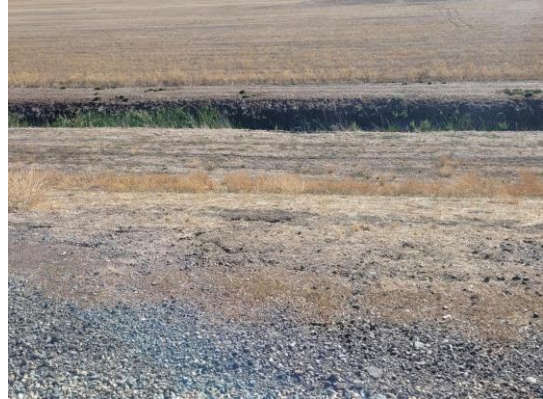
Photo 1 of 1 : FA\_2022\_RD0900\_231\_27\_20220930\_00046.jpg

LM Start	5.45	Rating **	A/W	Issue No.	27
LM End	5.45	Issue Type +	Ma	Location *	LS
Category	Earthen Levee			GPS Latitude/Longitude	
				Start	End
Item	Cracking			38.509217 °	38.509217 °
				-121.582140 °	-121.582140 °
DWR ID	DWR_RD0900_02_f_2018_27				
Comment Code					
CR1 : Monitor and have inspected by geotechnical engineer.					
Inspector Comment					
Monitor small desiccation cracks on the levee slope.

Desiccation cracking on the LS slope. Fall 2022
