**Flood Control Project Maintenance
Levee Inspections**

Maintenance Issue Types Only, Levee Inspection Report By Mile - Fall 2023

Reclamation District No. 0900 West Sacramento

Waterway	Bank	Unit Miles	Inspection Start/End	Inspector
Unit No. 01 Sacramento River	Right	7.70	10/17/2023 10/17/2023	Marvin Marshall

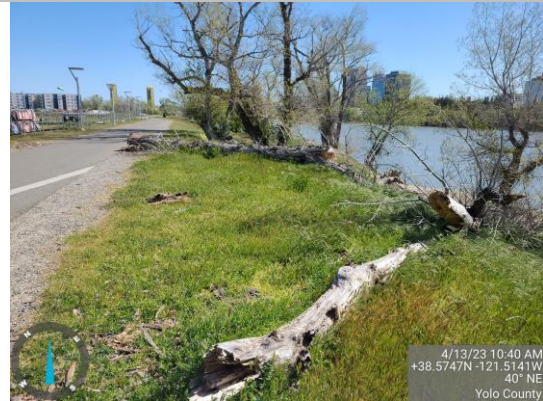
Photo 1 of 1 : FA_2023_RD0900_230_21_20230905_00001.jpg

LM Start	0.50	Rating **	M	Issue No.	21
LM End	0.50	Issue Type +	Ma	Location *	WS
Category	Earthen Levee			GPS Latitude/Longitude	
				Start	End
Item	Trim / Thin Trees			38.574733°	38.574733°
				-121.514061°	-121.514061°
DWR ID	DWR_RD0900_01_s_2023_21				
Comment Code					
T2 : Tree or limb.					
Inspector Comment					
Remove fallen limbs/trees from the crown/WS shoulder.

Logs on the WS shoulder. Spring 2023

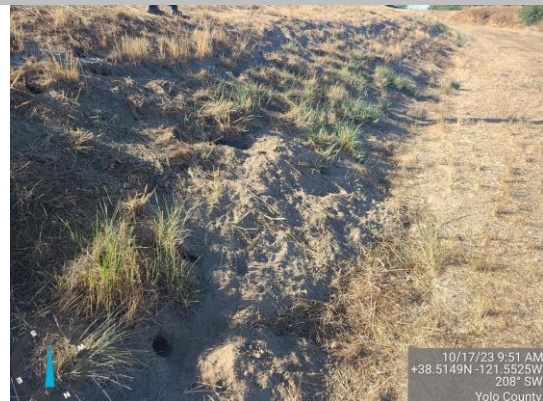
Photo 1 of 1 : FA_2023_RD0900_230_15_20231017_00035.jpg

LM Start	6.89	Rating **	M	Issue No.	15
LM End	6.89	Issue Type +	Ma	Location *	LS
Category	Earthen Levee			GPS Latitude/Longitude	
				Start	End
Item	Animal Control			38.514900°	38.514900°
				-121.552500°	-121.552500°
DWR ID	DWR_RD0900_01_f_2023_15				
Comment Code					
A1 : Exterminate rodents and backfill and compact or grout burrows.					
Inspector Comment					
Exterminate rodents and fill burrows.

Burrows on the LS berm. Fall 2023

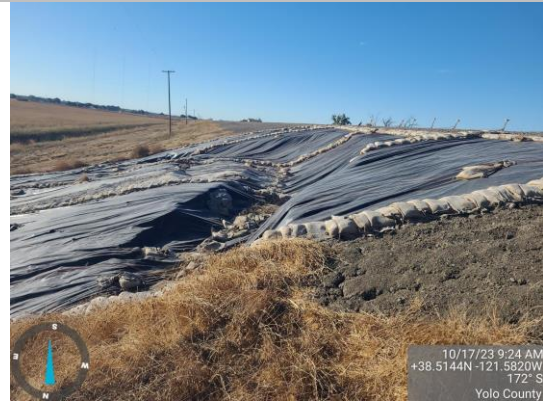
Photo 1 of 1 : FA_2023_RD0900_231_3_20231017_00022.jpg

LM Start	5.09	Rating **	U	Issue No.	3
LM End	5.09	Issue Type +	Ma	Location *	LS
Category	Earthen Levee			GPS Latitude/Longitude	
				Start	End
Item	Slope Stability			38.514355°	38.514355°
				-121.582165°	-121.582165°
DWR ID	DWR_RD0900_02_s_2023_3				
Comment Code					
S1 : Repair slope instability.					
Inspector Comment					
Fall 2023: USACE has visited the site for PL 84-99 repair. PGE has relocated pole.					
Spring 2023:Levee slip at power pole. Scarp ~50' long, 5' vertical face, 10' separation. LMA has placed raincoat.

Slope slip on the LS. Fall 2023

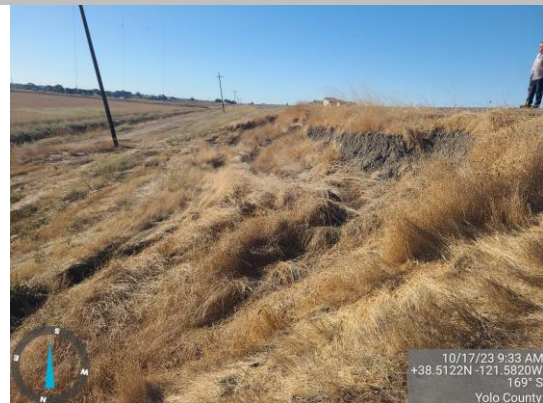
Photo 1 of 1 : FA_2023_RD0900_231_18_20231017_00023.jpg

LM Start	5.24	Rating **	U	Issue No.	18
LM End	5.24	Issue Type +	Ma	Location *	LS
Category	Earthen Levee			GPS Latitude/Longitude	
				Start	End
Item	Slope Stability			38.512197°	38.512197°
				-121.582143°	-121.582143°
DWR ID	DWR_RD0900_02_f_2020_18				
Comment Code					
S1 : Repair slope instability.					
Inspector Comment					
Fall 2023: USACE has visited the site for PL 84-99 repair.					
Spring 2023: Slope slip, ~50 long, 4' vertical face, 5' seperation

Slope slip on the LS. Fall 2023
