**Flood Control Project Maintenance  
Levee Inspections****Maintenance Issue Types Only, Levee Inspection Report By Mile - Fall 2024****Reclamation District No. 0900 West Sacramento**

Waterway	Bank	Unit Miles	Inspection Start/End	Inspector
Unit No. 01 Sacramento River	Right	7.70	10/03/2024 10/03/2024	Marvin Marshall

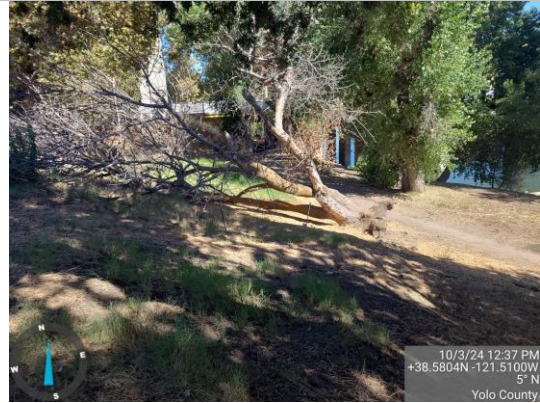
Photo 1 of 1 : FA\_2024\_RD0900\_230\_2\_20241007\_00010.jpg

LM Start	0.04	Rating **	M	Issue No.	2
LM End	0.04	Issue Type +	Ma	Location *	WS
Category	Earthen Levee			GPS Latitude/Longitude	
				Start	End
Item	Trim / Thin Trees			38.580400°	38.580400°
				-121.510000°	-121.510000°
DWR ID	DWR_RD0900_01_s _ 2024_2				
Comment Code					
T3 : Fallen tree with root ball.					
Inspector Comment

Tree with rootball on the WS slope. Fall 2024

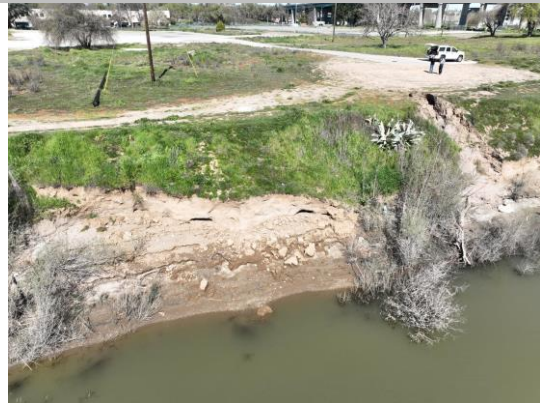
Photo 1 of 1 : FA\_2024\_RD0900\_230\_39\_20240911\_00006.jpg

LM Start	0.84	Rating **	M	Issue No.	39
LM End	0.84	Issue Type +	Ma	Location *	WS
Category	Earthen Levee			GPS Latitude/Longitude	
				Start	End
Item	Erosion / Bank Caving			38.571150°	38.571150°
				-121.518137°	-121.518137°
DWR ID	DWR_RD0900_01_s _ 2020_39				
Comment Code					
E2 : Schedule repair of erosion site prior to the next inspection.					
Inspector Comment					
Bank erosion observed on high bank condition

Bank Erosion. Spring 2024

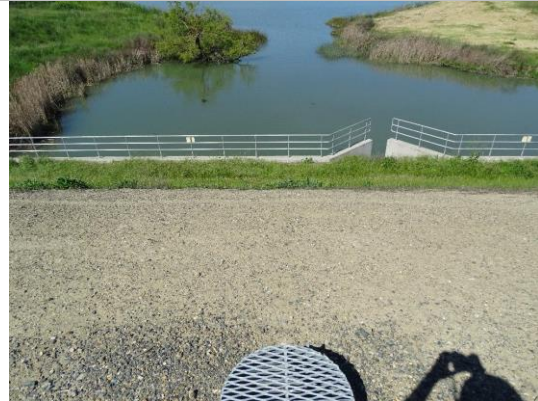
Photo 1 of 3 : UCIP\_FA\_2024\_56688\_83963.jpg

Water-Side: view of WS slope and valve box with welded close lid and concrete headwall with flap gate at toe

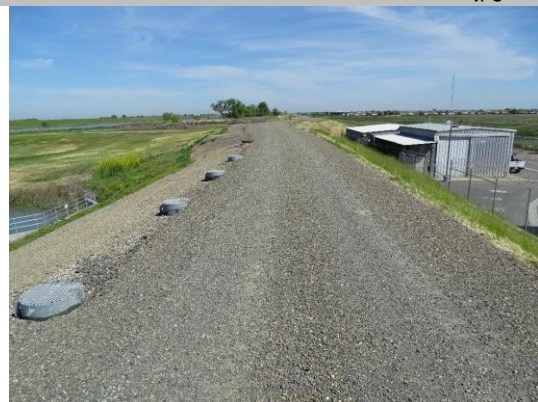
Photo 2 of 3 : UCIP\_FA\_2024\_56688\_83964.jpg

Top of Levee: view of levee crown

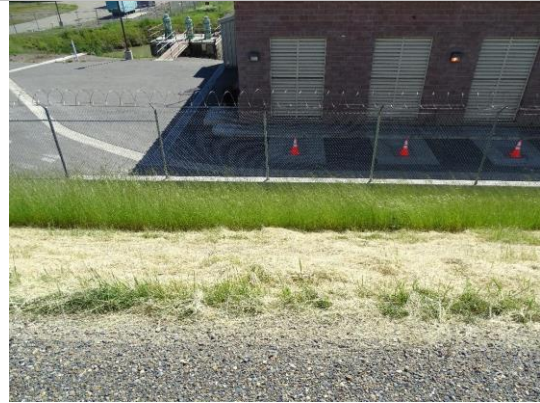
Photo 3 of 3 : UCIP\_FA\_2024\_56688\_83965.jpg

Land-Side: view of LS slope and pumphouse at toe

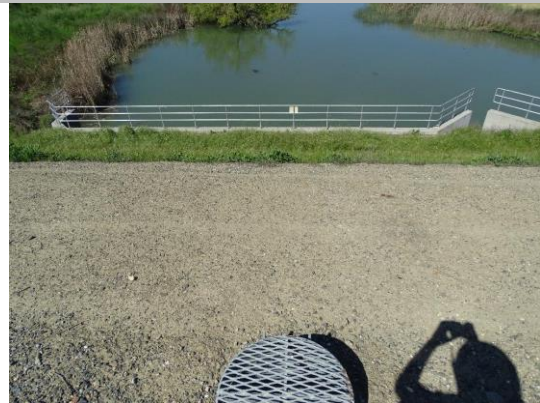
Photo 1 of 3 : UCIP\_FA\_2024\_56689\_83966.jpg

Water-Side: view of WS slope and valve box with welded close lid and concrete headwall with flap gate at toe

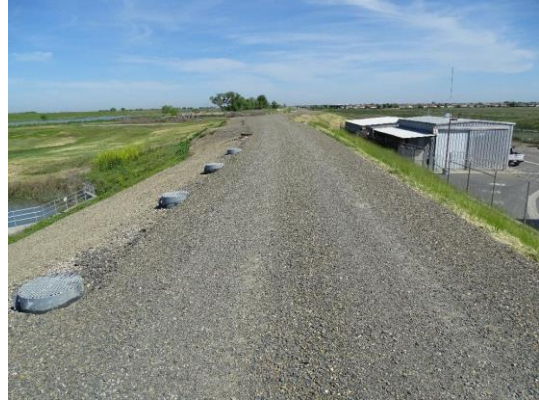
Photo 2 of 3 : UCIP\_FA\_2024\_56689\_83967.jpg

Top of Levee: view of levee crown

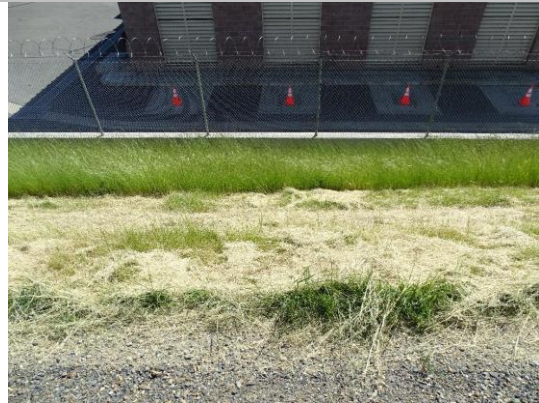
Photo 3 of 3 : UCIP\_FA\_2024\_56689\_83968.jpg

Land-Side: view of LS slope and pumphouse at toe

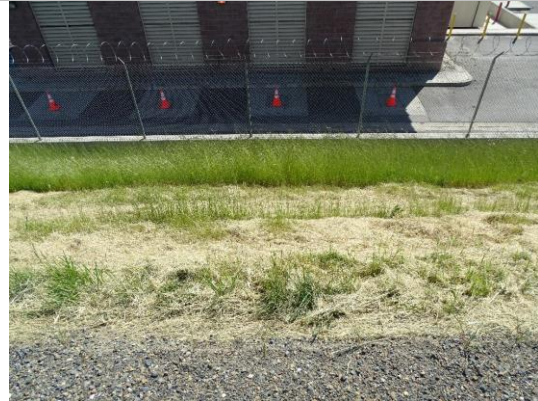
Photo 3 of 3 : UCIP\_FA\_2024\_56691\_83973.jpg

Land-Side: view of LS slope and pumphouse at toe

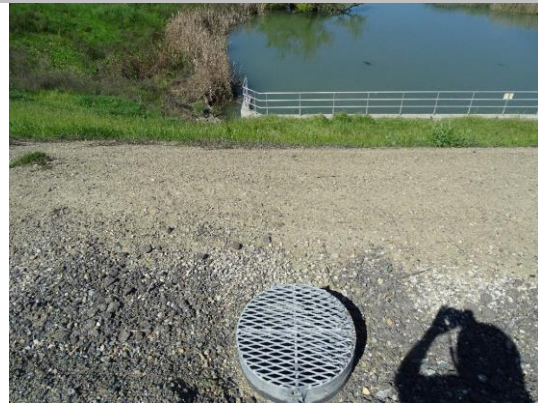
Photo 1 of 3 : UCIP\_FA\_2024\_56692\_83974.jpg

Water-Side: view of WS slope and valve box with welded close lid and concrete headwall with flap gate at toe

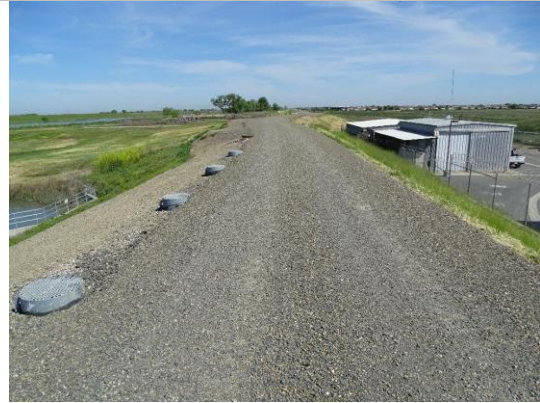
Photo 2 of 3 : UCIP\_FA\_2024\_56692\_83975.jpg

Top of Levee: view of levee crown

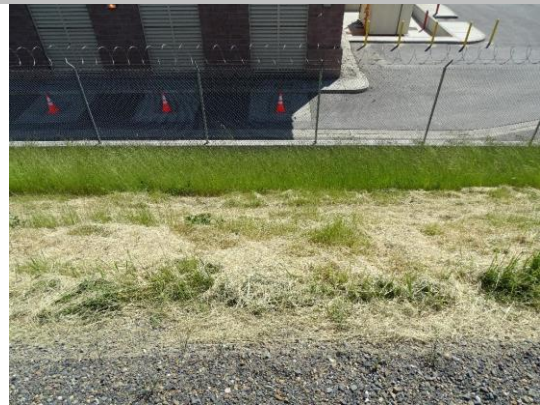
Photo 3 of 3 : UCIP\_FA\_2024\_56692\_83976.jpg

Land-Side: view of LS slope and pumphouse toe

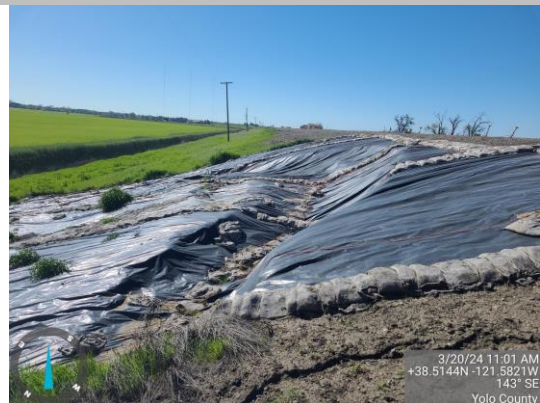
Photo 1 of 1 : FA\_2024\_RD0900\_231\_3\_20240911\_00001.jpg

LM Start	5.09	Rating **	U	Issue No.	3
LM End	5.09	Issue Type +	Ma	Location *	LS
Category	Earthen Levee			GPS Latitude/Longitude	
				Start	End
Item	Slope Stability			38.514355°	38.514355°
				-121.582165°	-121.582165°
DWR ID	DWR_RD0900_02_s_2023_3				
Comment Code					
S1 : Repair slope instability.					
Inspector Comment					
Fall 2024: USACE has visited the site for PL 84-99 repair. PGE has relocated pole.					
Spring 2023:Levee slip at power pole. Scarp ~50' long, 5' vertical face, 10' separation. LMA has placed raincoat.

Slope slip on the LS. Spring 2024

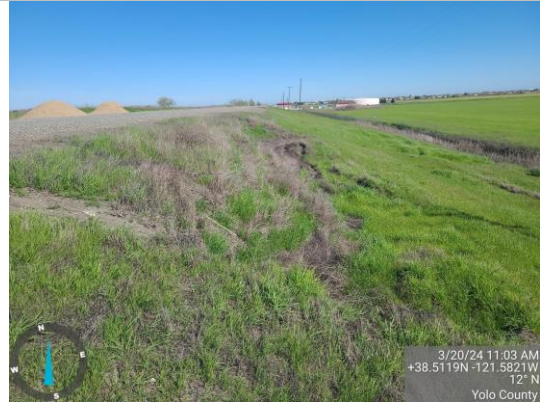
Photo 1 of 1 : FA\_2024\_RD0900\_231\_18\_20240911\_00003.jpg

LM Start	5.24	Rating **	U	Issue No.	18
LM End	5.24	Issue Type +	Ma	Location *	LS
Category	Earthen Levee			GPS Latitude/Longitude	
				Start	End
Item	Slope Stability			38.512197°	38.512197°
				-121.582143°	-121.582143°
DWR ID	DWR_RD0900_02_f _ 2020_18				
Comment Code					
S1 : Repair slope instability.					
Inspector Comment					
Fall 2024: USACE has visited the site for PL 84-99 repair.					
Spring 2023: Slope slip, ~50 long, 4' vertical face, 5' seperation

Slope slip on the LS. Spring 2024

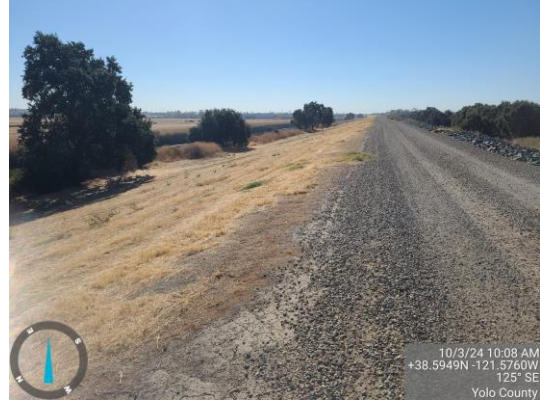
Photo 1 of 1 : FA\_2024\_RD0900\_174\_1\_20241007\_00002.jpg

LM Start	0.18	Rating **	A	Issue No.	1
LM End	0.18	Issue Type +	Ma	Location *	LS
Category	Earthen Levee			GPS Latitude/Longitude	
				Start	End
Item	Vegetation			38.594900°	38.594900°
				-121.576000°	-121.576000°
DWR ID	DWR_RD0900_03_f_2024_1				
Comment Code					
V1 : Control annual grass and weeds on the levee slopes and easements.					
Inspector Comment					
Vegetation has been maintained to standard.

Vegetation on the LS slope. Fall 2024

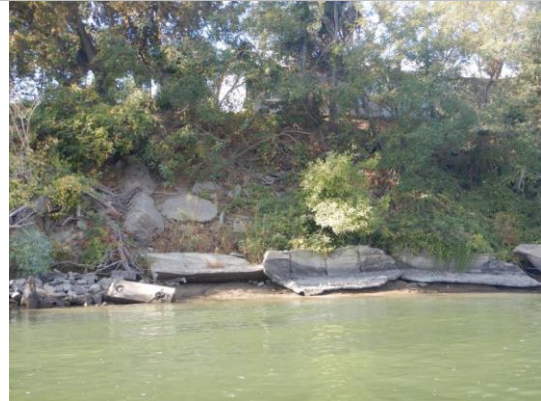
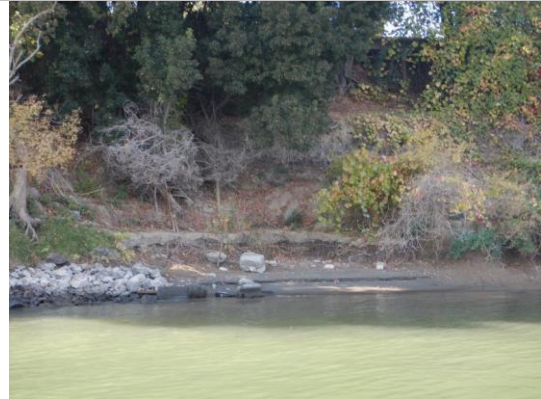
Status: Eroding

2018 Field Notes: Increased undercutting erosion at upstream end.  
Site History: 1997 - This may have been a cobble rehabilitation site to the 1957 cobble that was place all the way to the I-80 Bridge. 2000 - Local damage induced by human use. 2003 - Site is still very close to the levee and into the levee toe. 2011 - One new tree has fallen. 2015 - Sites 62.9 and 63 were combined into one site. 2017 - Fresh erosion pocket near downstream end.

USACE 2018 Erosion Photo #1

USACE 2018 Erosion Photo #2

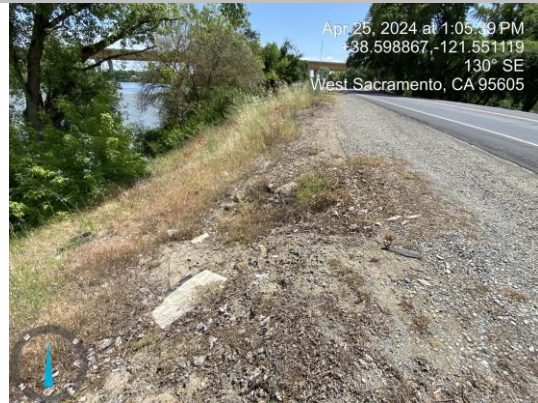
Photo 1 of 1 : FA\_2024\_RD0900\_173\_24\_20240913\_00004.jpg

LM Start	4.48	Rating **	M	Issue No.	24
LM End	4.48	Issue Type +	Ma	Location *	WS
Category	Earthen Levee			GPS Latitude/Longitude	
				Start	End
Item	Erosion / Bank Caving			38.598854°	38.598854°
				-121.551141°	-121.551141°
DWR ID	DWR_RD0537_01_f_2017_24				
Comment Code					
E2 : Schedule repair of erosion site prior to the next inspection.					
Inspector Comment					
Runoff erosion on overbuilt section of levee on the waterside.

View of erosion on the waterside hinge point (Spring 2024).

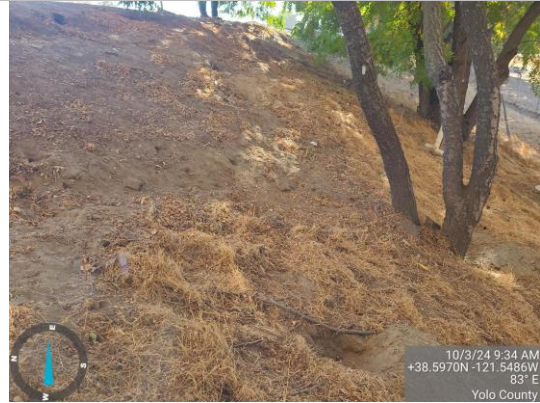
Photo 1 of 1 : FA\_2024\_RD0900\_173\_55\_20241007\_00008.jpg

LM Start	4.69	Rating **	U	Issue No.	55
LM End	4.70	Issue Type +	Ma	Location *	LS
Category	Earthen Levee			GPS Latitude/Longitude	
				Start	End
Item	Animal Control			38.597062°	38.596962°
				-121.548577°	-121.548360°
DWR ID	DWR_RD0537_01_s_2022_55				
Comment Code					
A3 : No rodents visible, but rodent burrows visible; need to backfill and compact or grout burrows.					
Inspector Comment					
Large rodent holes on the landside slope. LMA has implemented rodent control program.

Rodent holes on the LS slope. Fall 2024
