**Flood Control Project Maintenance  
Levee Inspections  
LMA District Cover Sheet  
Spring 2010 Levee Inspection Results**

**Reclamation District No. 0900 West Sacramento**

**Spring 2010 Levee Inspection Results**

**Levee Inspection Report By Mile - Spring 2010**

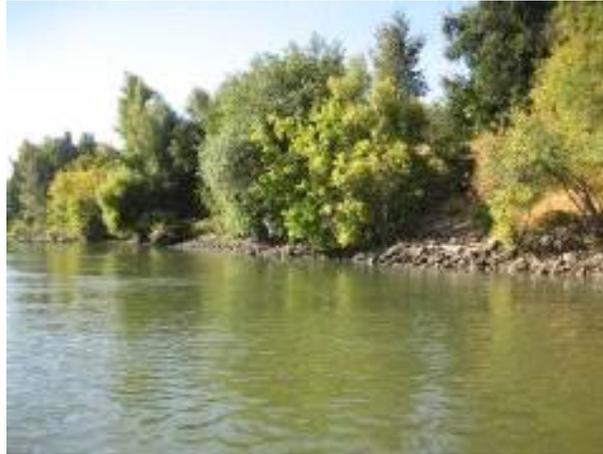
Levee Mile Report Line	1
Start Levee Mile	1.92
End Levee Mile	2.03
Location	Water Side
Category	Supplemental
Item	USACE Erosion Survey
<p>2009: no berm, 1.5:1 slope, tree hazards, holes, and slumping, sands and silts, 5.16 ft/s plus eddy currents [2009 SiteID:SAC_57-2_R]</p>	
<p>USACE2009_SAC_57-2_R_2009_09_17-D3P11_small.JPG</p>

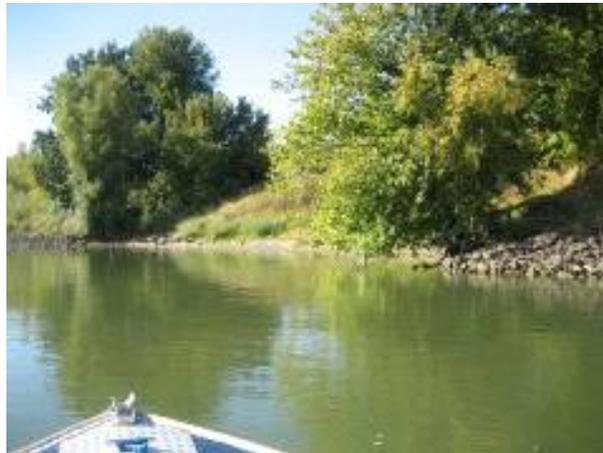
Levee Mile Report Line	5
Start Levee Mile	2.08
End Levee Mile	2.12
Location	Water Side
Category	Supplemental
Item	USACE Erosion Survey
<p>2009: no berm, 2:1 slope, tree hazards and seepage, sands and silts, 5.02 ft/s plus eddy currents [2009 SiteID:SAC_57-0_R]</p>	
<p>USACE2009_SAC_57-0_R_2009_09_17-D3P12_small.JPG</p>

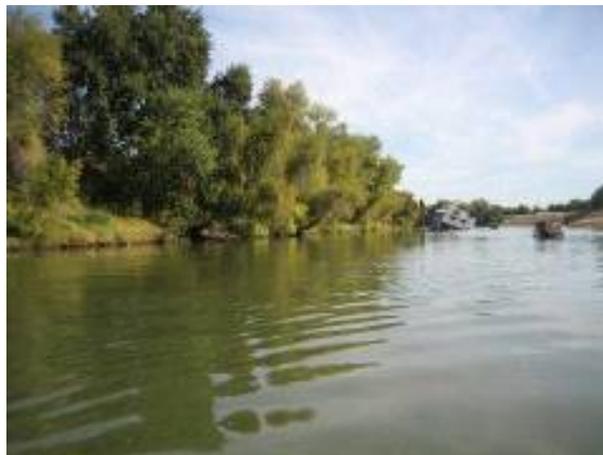
Levee Mile Report Line	16
Start Levee Mile	3.34
End Levee Mile	3.46
Location	Water Side
Category	Supplemental
Item	USACE Erosion Survey
<p>2009: no berm, 1:1 slope, tree hazards, holes, slumping, and seepage, sands and silts, 4.46 ft/s [2009 SiteID:SAC_55-7_R]</p>	
<p>USACE2009_SAC_55-7_R_2009_09_17-D3P21_small.JPG</p>

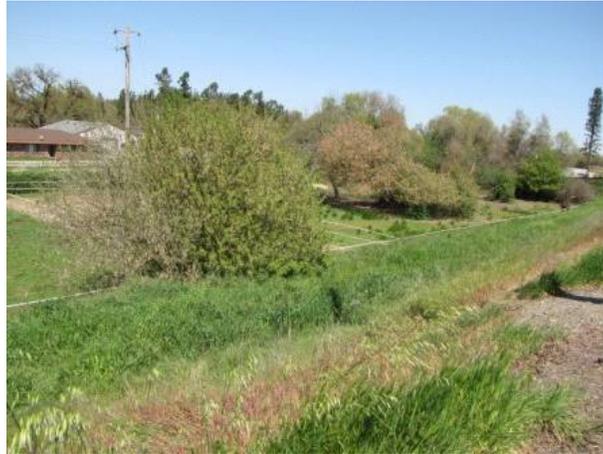
Levee Mile Report Line	19
Start Levee Mile	3.47
End Levee Mile	3.47
Location	Land Side
Category	Earthen Levee
Item	Trim / Thin Trees
View of a tree on the landward slope blocking visibility looking upstream.	
dpesaven_s_20100323_553.jpg

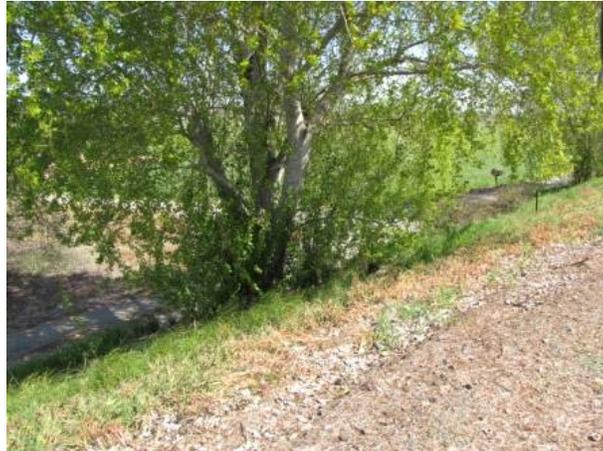
Levee Mile Report Line	53
Start Levee Mile	6.04
End Levee Mile	6.06
Location	Land Side
Category	Earthen Levee
Item	Trim / Thin Trees
View of a tree blocking visibility on the landward slope looking upstream.	
dpesaven_s_20100323_552.jpg

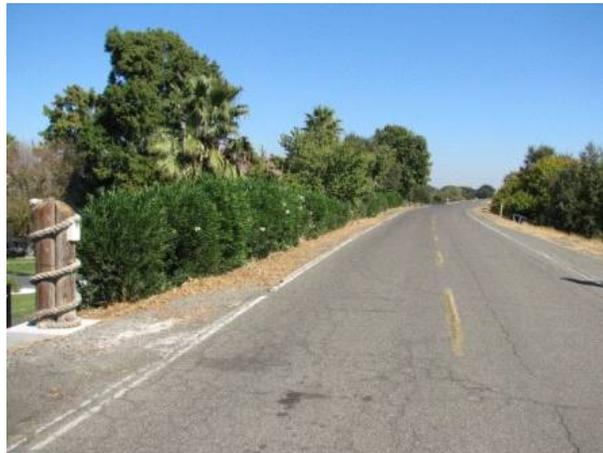
Levee Mile Report Line	58
Start Levee Mile	6.56
End Levee Mile	6.63
Location	Land Side
Category	Earthen Levee
Item	Encroachments
Landscape encroachment at LM 6.56 to LM 6.63	
dpesaven_s_20100316_508.jpg

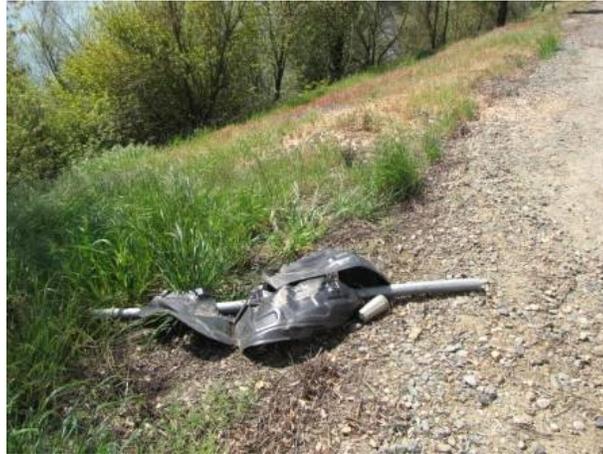
Levee Mile Report Line	62
Start Levee Mile	6.84
End Levee Mile	6.84
Location	Water Side
Category	Earthen Levee
Item	Encroachments
View of debris on the waterward slope looking downstream.	
dpesaven_s_20100323_551.jpg

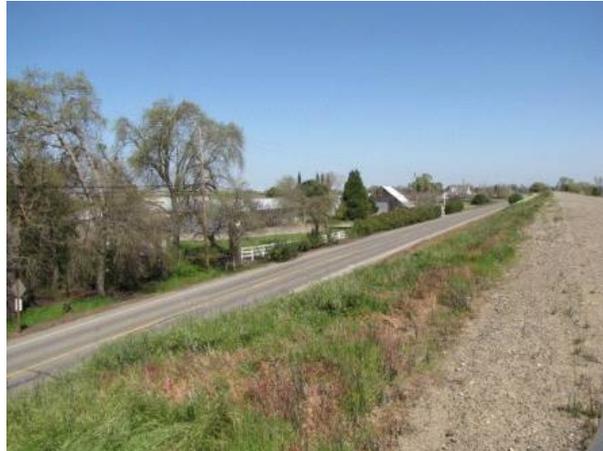
Levee Mile Report Line	63
Start Levee Mile	6.86
End Levee Mile	7.73
Location	Land Side
Category	Earthen Levee
Item	Vegetation
View of an example of annual grass on landward slope of levee that should be mowed prior to the fall looking upstream.	
dpesaven_s_20100323_546.jpg

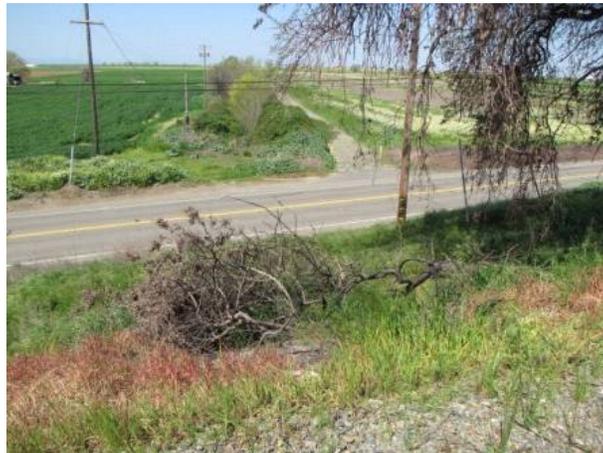
Levee Mile Report Line	67
Start Levee Mile	7.17
End Levee Mile	7.17
Location	Land Side
Category	Earthen Levee
Item	Encroachments
View of a fallen tree branch on the landward slope blocking visibility looking upstream.	
dpesaven_s_20100323_550.jpg

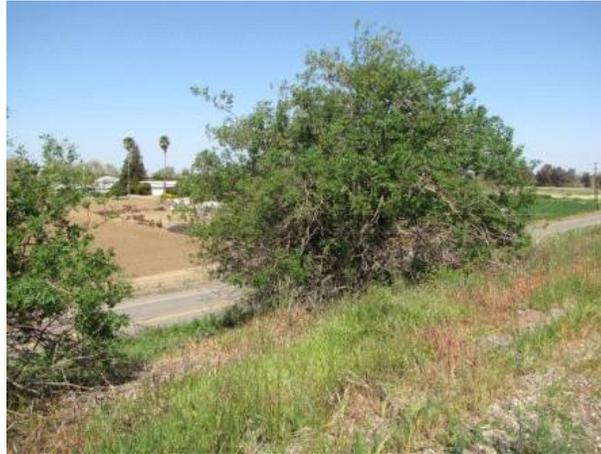
Levee Mile Report Line	73
Start Levee Mile	7.27
End Levee Mile	7.27
Location	Land Side
Category	Earthen Levee
Item	Vegetation
View of elderberries blocking visibility on the landward slope looking upstream.	
dpesaven_s_20100323_549.jpg

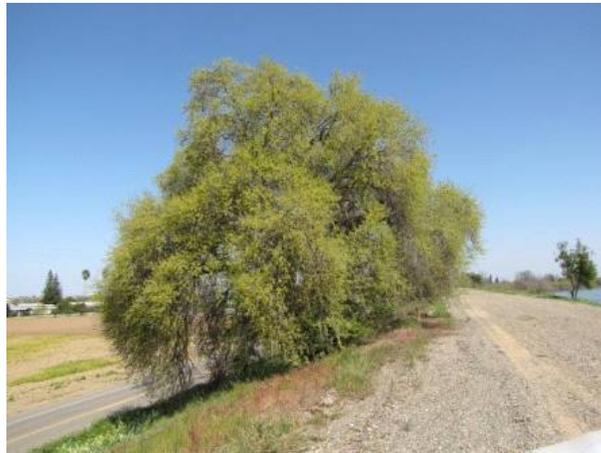
Levee Mile Report Line	78
Start Levee Mile	7.33
End Levee Mile	7.33
Location	Land Side
Category	Earthen Levee
Item	Trim / Thin Trees
View of a tree blocking visibility on the landward slope looking upstream.	
dpesaven_s_20100323_548.jpg

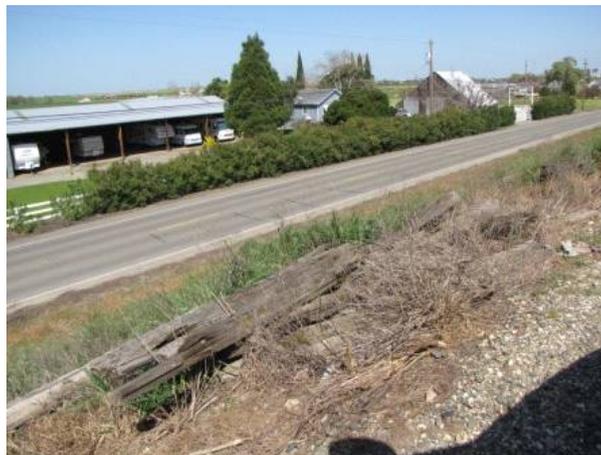
Levee Mile Report Line	84
Start Levee Mile	7.68
End Levee Mile	7.68
Location	Land Side
Category	Earthen Levee
Item	Encroachments
View of old railroad ties on the landward slope of the levee looking upstream.	
dpesaven_s_20100323_547.jpg

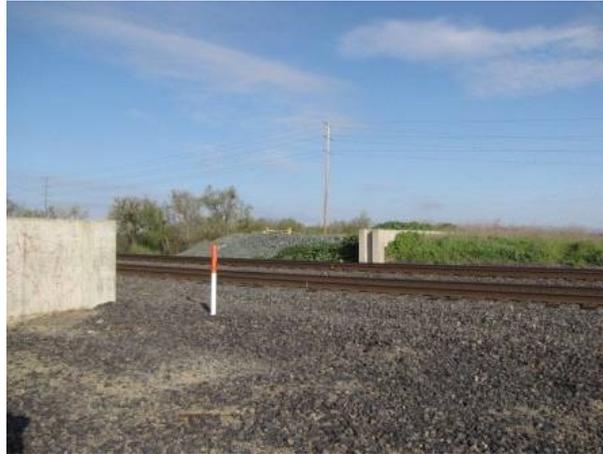
Levee Mile Report Line	1
Start Levee Mile	0.00
End Levee Mile	0.00
Location	Crown
Category	Earthen Levee
Item	Closure Structures
View of the closure structure crossing the railroad tracks looking upstream.	
dpesaven_s_20100323_554.jpg

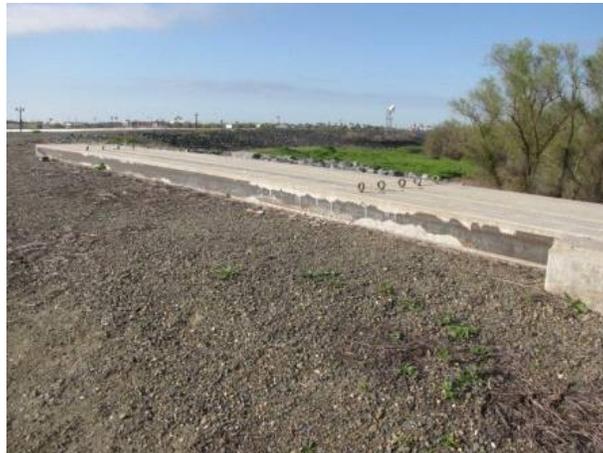
Levee Mile Report Line	1
Start Levee Mile	0.00
End Levee Mile	0.00
Location	Crown
Category	Earthen Levee
Item	Closure Structures
View of the stoplogs adjacent to the structure looking downstream.	
dpesaven_s_20100323_555.jpg

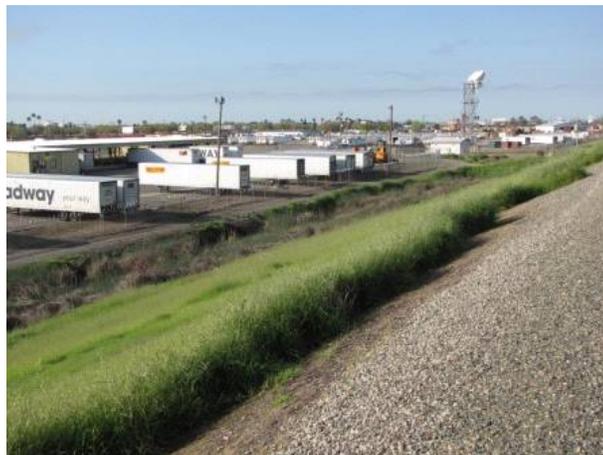
Levee Mile Report Line	2
Start Levee Mile	0.05
End Levee Mile	0.95
Location	Land Side
Category	Earthen Levee
Item	Vegetation
View of the landward slope with grass growing and blocking visibility looking downstream.	
dpesaven_s_20100323_556.jpg

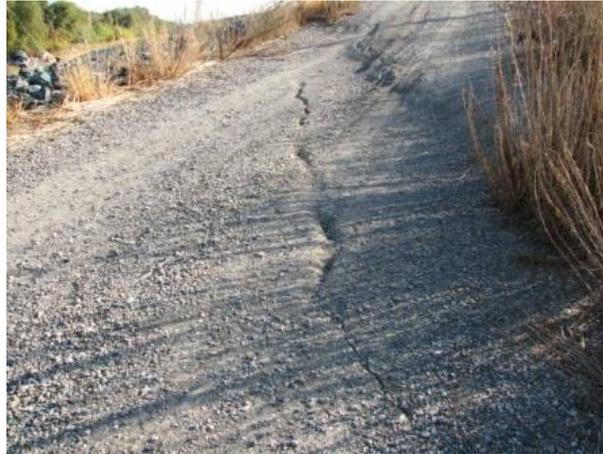
Levee Mile Report Line	3
Start Levee Mile	0.95
End Levee Mile	0.95
Location	Water Side
Category	Earthen Levee
Item	Cracking
Crack located on ramp on waterside of levee at LM 0.95.	
dpesaven_s_20100316_512.jpg

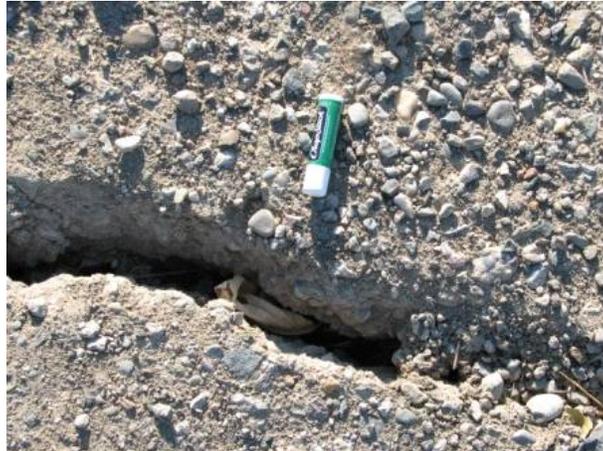
Levee Mile Report Line	3
Start Levee Mile	0.95
End Levee Mile	0.95
Location	Water Side
Category	Earthen Levee
Item	Cracking
Closer view of crack at LM 0.95.	
dpesaven_s_20100316_513.jpg

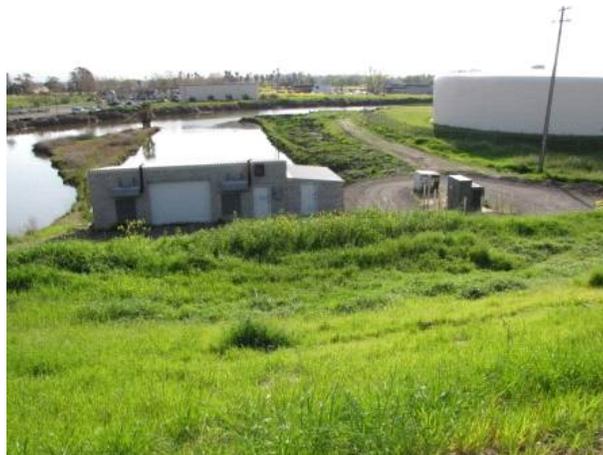
Levee Mile Report Line	4
Start Levee Mile	1.08
End Levee Mile	1.08
Location	Land Side
Category	Earthen Levee
Item	Vegetation
View of grass blocking visibility on the landward slope looking away from the levee.	
dpesaven_s_20100323_557.jpg

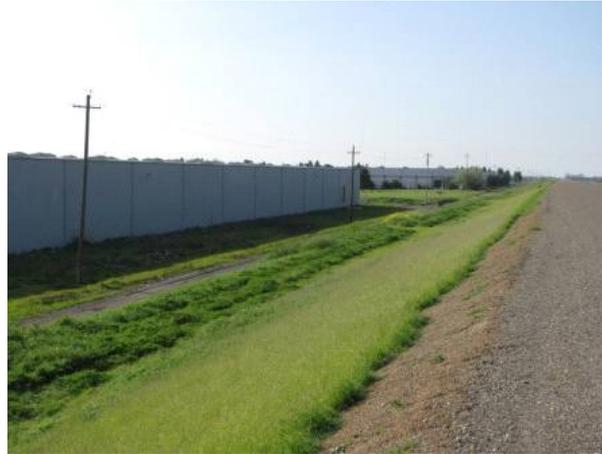
Levee Mile Report Line	5
Start Levee Mile	1.16
End Levee Mile	2.56
Location	Land Side
Category	Earthen Levee
Item	Vegetation
View of grass blocking visibility on the landward berm and slope looking downstream.	
dpesaven_s_20100323_558.jpg

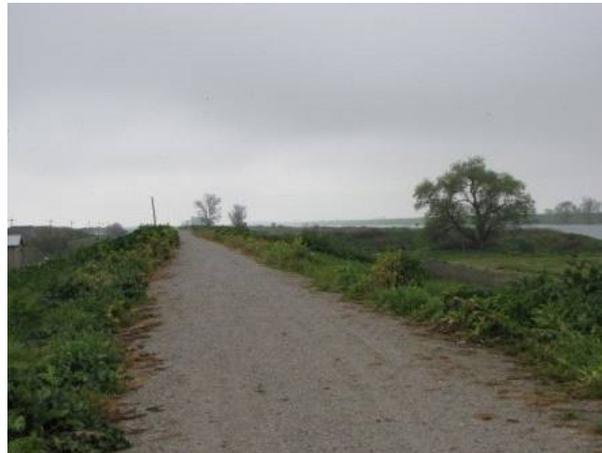
Levee Mile Report Line	6
Start Levee Mile	3.08
End Levee Mile	3.63
Location	Water Side
Category	Earthen Levee
Item	Vegetation
View of grass and vegetation blocking visibility on the waterward slope looking downstream.	
dpesaven_s_20100323_560.jpg

6	3.08	3.63	Earthen Levee	Vegetation	WS	M	Control annual grass and weeds on the levee slopes and easements.	38.543696 ° -121.582203 °	38.535680 ° -121.582172 °	6 Y
7	3.08	5.71	Earthen Levee	Vegetation	LS	M	Control annual grass and weeds on the levee slopes and easements.	38.543696 ° -121.582203 °	38.505593 ° -121.582126 °	5 Y
8	4.37	4.37	Earthen Levee	Slope Stability	CR	M	Repair slope instability.	38.524939 ° -121.582117 °	38.524939 ° -121.582117 °	7 Y
9	4.42	4.51	Earthen Levee	Crown Surface / Depressions / Rutting	CR	M	Regrade the crown roadway for proper drainage.	38.524241 ° -121.582128 °	38.522926 ° -121.582121 °	8 Y
10	4.60	4.73	Earthen Levee	Crown Surface / Depressions / Rutting	CR	M	Regrade the crown roadway for proper drainage.	38.521670 ° -121.582127 °	38.519753 ° -121.582131 °	9 Y
11	4.80	4.86	Earthen Levee	Crown Surface / Depressions / Rutting	CR	M	Regrade the crown roadway for proper drainage.	38.518770 ° -121.582127 °	38.517837 ° -121.582128 °	11 Y

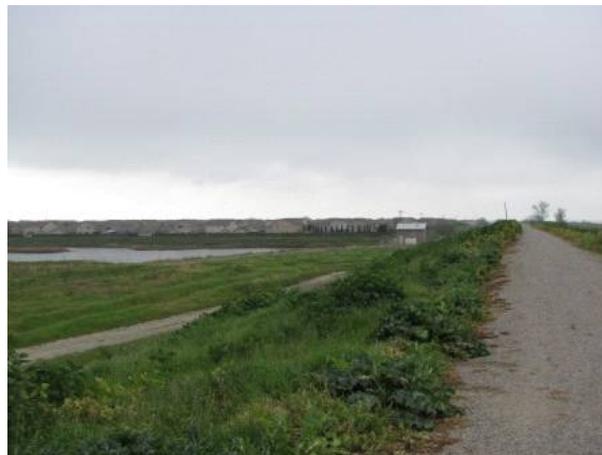
Levee Mile Report Line	7
Start Levee Mile	3.08
End Levee Mile	5.71
Location	Land Side
Category	Earthen Levee
Item	Vegetation
View of grass and vegetation blocking visibility on the landward slope looking downstream.	
dpesaven_s_20100323_559.jpg

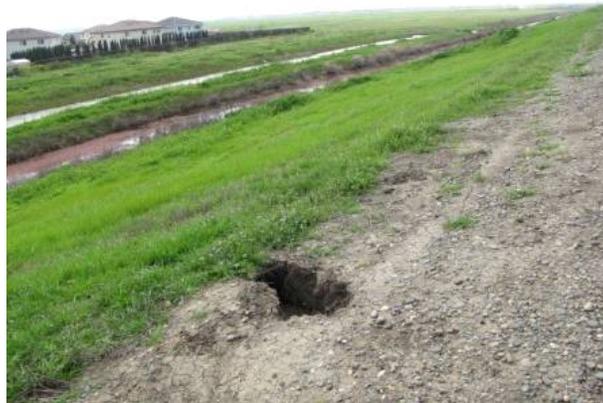
Levee Mile Report Line	8
Start Levee Mile	4.37
End Levee Mile	4.37
Location	Crown
Category	Earthen Levee
Item	Slope Stability
View of an approximate 14" depression at the landward shoulder looking downstream.	
dpesaven_s_20100323_561.jpg

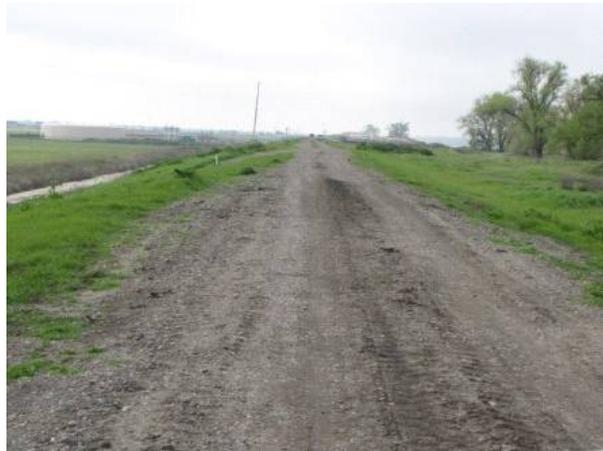
Levee Mile Report Line	9
Start Levee Mile	4.42
End Levee Mile	4.51
Location	Crown
Category	Earthen Levee
Item	Crown Surface / Depressions / Rutting
View of depressions and rutting on the crown roadway looking downstream.	
dpesaven_s_20100323_562.jpg

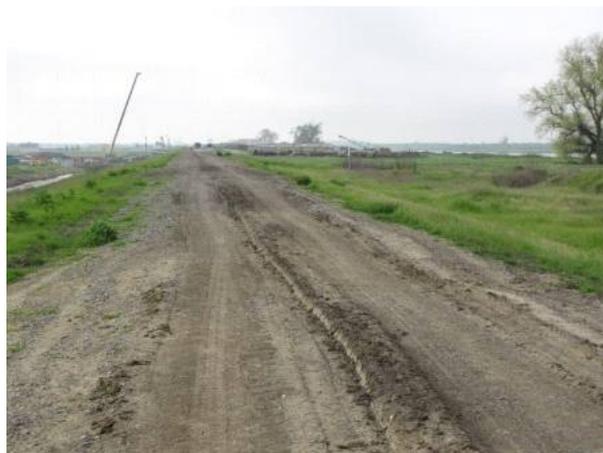
Levee Mile Report Line	10
Start Levee Mile	4.60
End Levee Mile	4.73
Location	Crown
Category	Earthen Levee
Item	Crown Surface / Depressions / Rutting
View of depressions and rutting in the crown roadway looking downstream.	
dpesaven_s_20100323_563.jpg

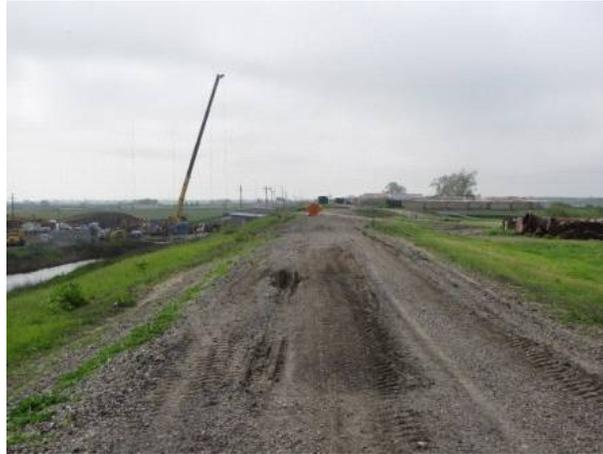
Levee Mile Report Line	11
Start Levee Mile	4.80
End Levee Mile	4.86
Location	Crown
Category	Earthen Levee
Item	Crown Surface / Depressions / Rutting
View of depressions and rutting in the crown roadway looking downstream.	
dpesaven_s_20100323_564.jpg

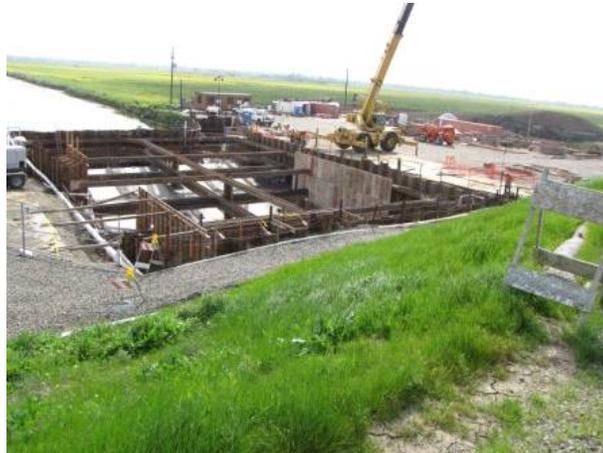
12	4.96	4.96	Earthen Levee	Encroachments	LS	PO	Buildings Inspector Comments: Ongoing pump station replacement project underway, permit #18116.	38.516401 ° -121.582205 °	38.516401 ° -121.582205 °	12 Y

Levee Mile Report Line	12
Start Levee Mile	4.96
End Levee Mile	4.96
Location	Land Side
Category	Earthen Levee
Item	Encroachments
View of the open pit and construction activity on a new pump station on the landward side of the levee.	
dpesaven_s_20100323_565.jpg
