**Flood Control Project Maintenance
Levee Inspections**

Fall 2011 Levee Maintenance Deficiency Summary Report

Reclamation District No. 0999 Netherlands

Levee Inspection Report By Mile - Fall 2011

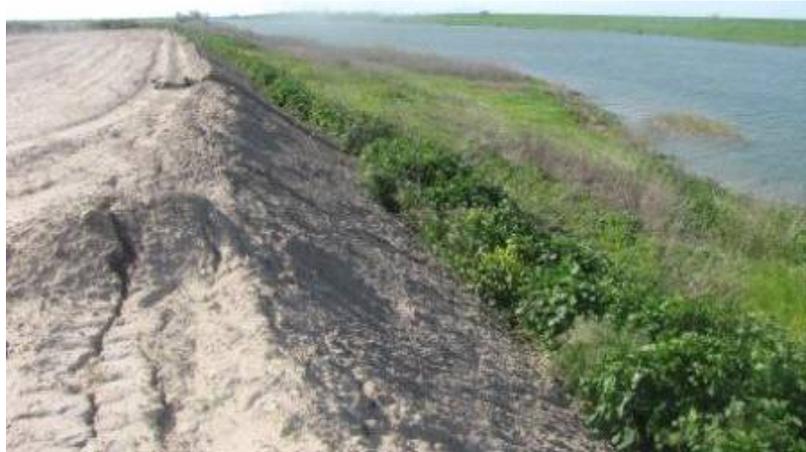
Levee Mile Report Line	1
Start Levee Mile	0.13
End Levee Mile	0.41
Location	Water Side
Category	Earthen Levee
Item	Encroachments
Looking east at fill on waterside	
richard_f_20110922_464.jpg

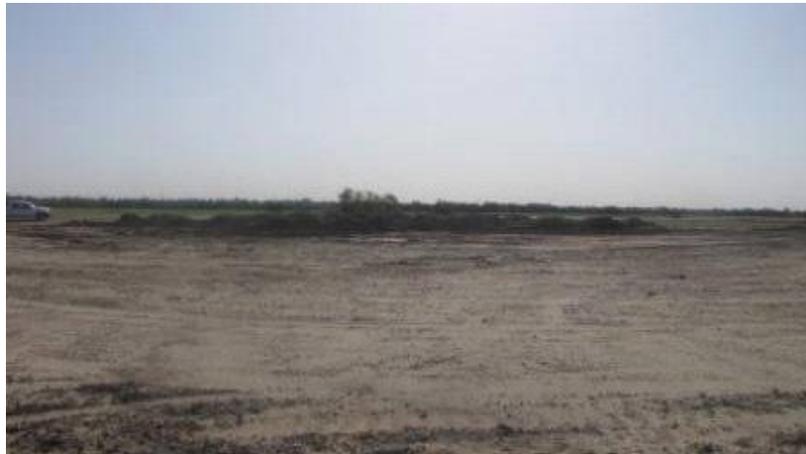
Levee Mile Report Line	1
Start Levee Mile	0.13
End Levee Mile	0.41
Location	Water Side
Category	Earthen Levee
Item	Encroachments
Looking south at fill on waterside shoulder and slope.	
richard_f_20110922_465.jpg

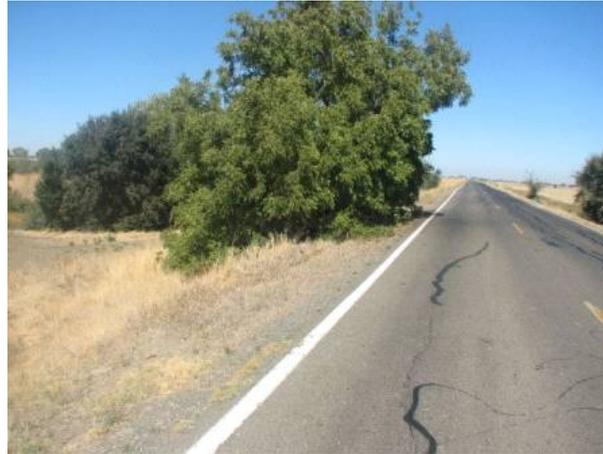
Levee Mile Report Line	3
Start Levee Mile	1.75
End Levee Mile	1.77
Location	Water Side
Category	Earthen Levee
Item	Trim / Thin Trees
Looking west at overgrown trees on waterside slope and toe.	
richard_f_20110922_467.jpg

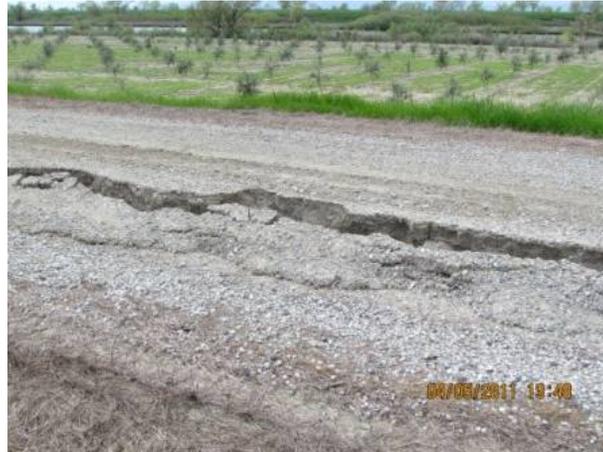
Levee Mile Report Line	9
Start Levee Mile	3.63
End Levee Mile	3.66
Location	Land Side
Category	Earthen Levee
Item	Slope Stability
Looking west at 12 inch deep cracks along landside slope and crown.	
richard_f_20110922_470.jpg

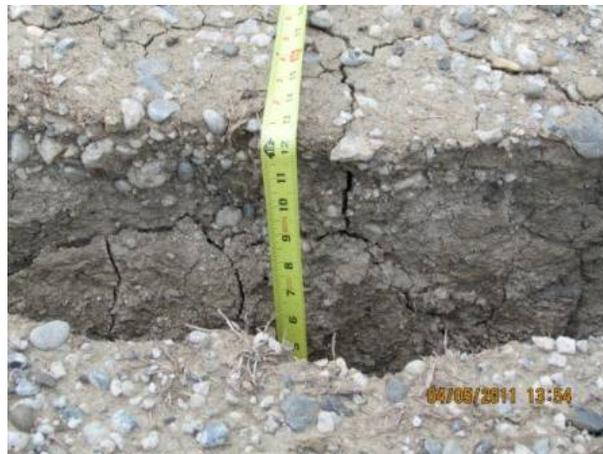
Levee Mile Report Line	9
Start Levee Mile	3.63
End Levee Mile	3.66
Location	Land Side
Category	Earthen Levee
Item	Slope Stability
Looking at cracks from 1 inch to 3 inches wide on levee crown.	
richard_f_20110922_471.jpg

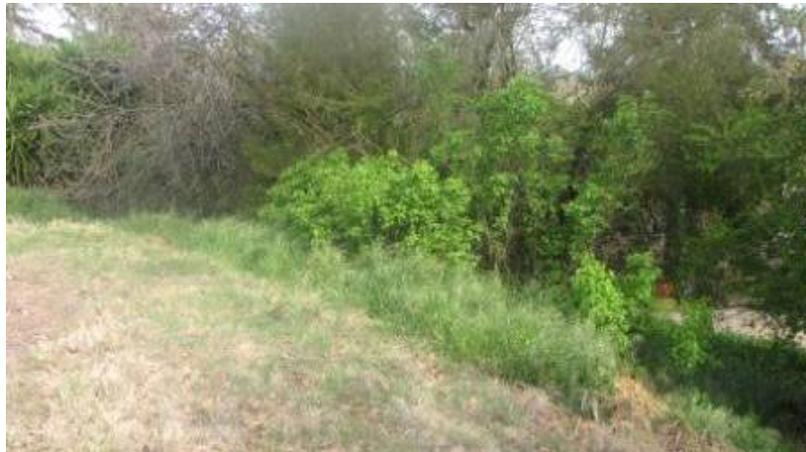
Levee Mile Report Line	14
Start Levee Mile	1.72
End Levee Mile	1.75
Location	Land Side
Category	Earthen Levee
Item	Vegetation
Looking southwest at elderberry bush on landside shoulder and slope.	
richard_f_20110922_488.jpg

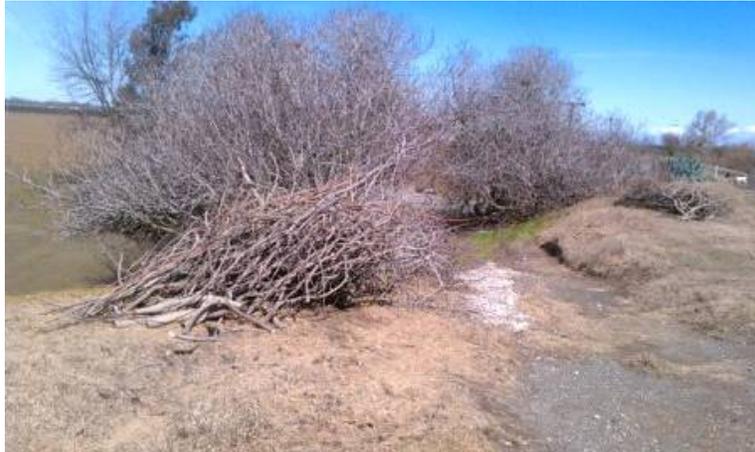
Levee Mile Report Line	2
Start Levee Mile	0.03
End Levee Mile	0.04
Location	Land Side
Category	Earthen Levee
Item	Trim / Thin Trees
Looking north at dense trees on landside slope and toe.	
richard_f_20110922_497.jpg

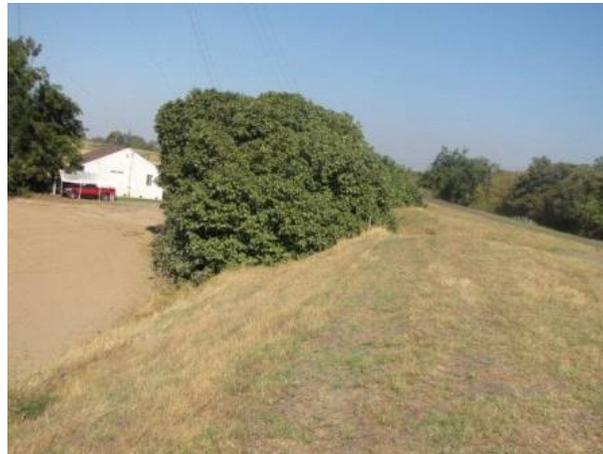
Levee Mile Report Line	2
Start Levee Mile	0.03
End Levee Mile	0.04
Location	Land Side
Category	Earthen Levee
Item	Trim / Thin Trees
Looking northwest at dense trees on landside slope and toe.	
richard_f_20110922_498.jpg

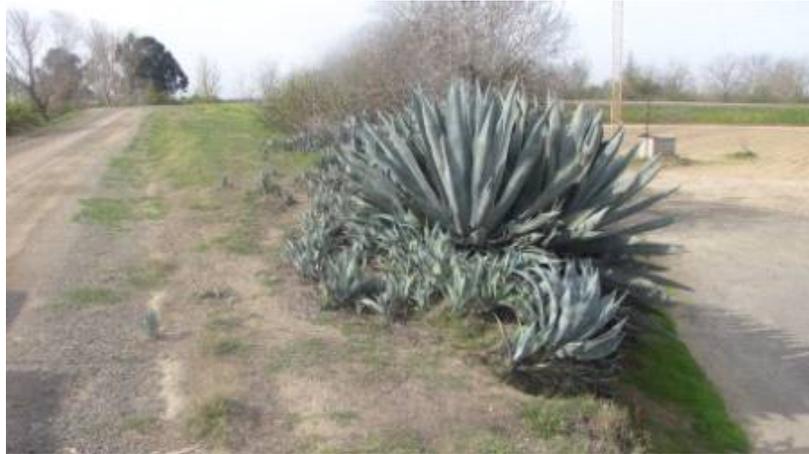
Levee Mile Report Line	3
Start Levee Mile	0.04
End Levee Mile	0.05
Location	Land Side
Category	Earthen Levee
Item	Encroachments
Looking east at partially dead cactus plant on landside slope during 2011 fall inspection.	
richard_f_20111014_625.jpg

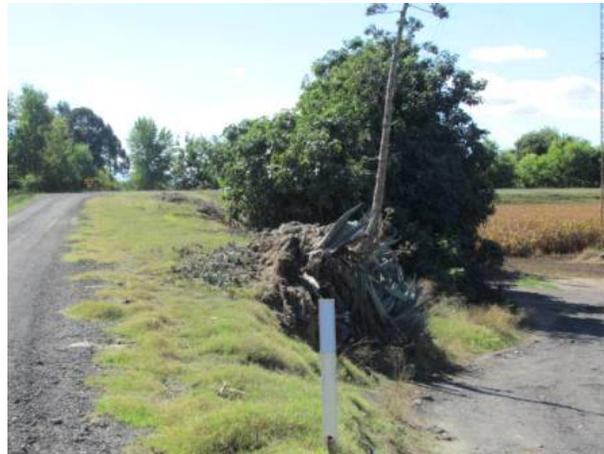
Levee Mile Report Line	4
Start Levee Mile	0.06
End Levee Mile	0.06
Location	Land Side
Category	Earthen Levee
Item	Vegetation
Looking west at dense vegetation on landside slope near ramp.	
richard_f_20111014_626.jpg

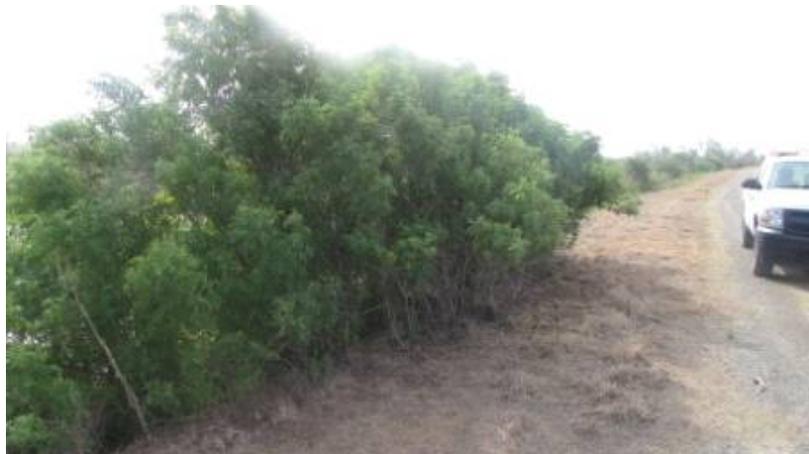
Levee Mile Report Line	7
Start Levee Mile	0.44
End Levee Mile	0.44
Location	Water Side
Category	Earthen Levee
Item	Vegetation
Looking north at elderberry bush on waterside slope.	
richard_f_20110922_501.jpg

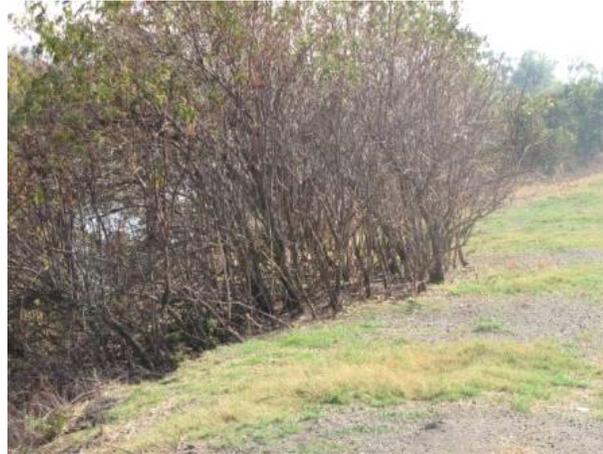
Levee Mile Report Line	8
Start Levee Mile	0.64
End Levee Mile	0.64
Location	Land Side
Category	Earthen Levee
Item	Vegetation
Elderberries blocking view of landside toe.	
richard_f_20110922_503.jpg

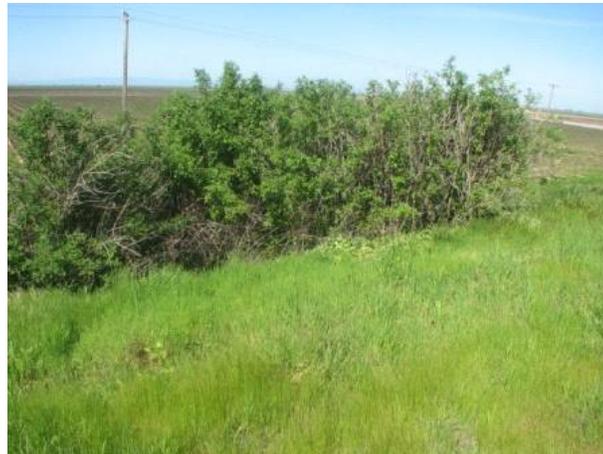
Levee Mile Report Line	13
Start Levee Mile	0.73
End Levee Mile	0.73
Location	Land Side
Category	Earthen Levee
Item	Encroachments
Looking northwest at pruning pile on landside toe.	
richard_f_20110922_495.jpg

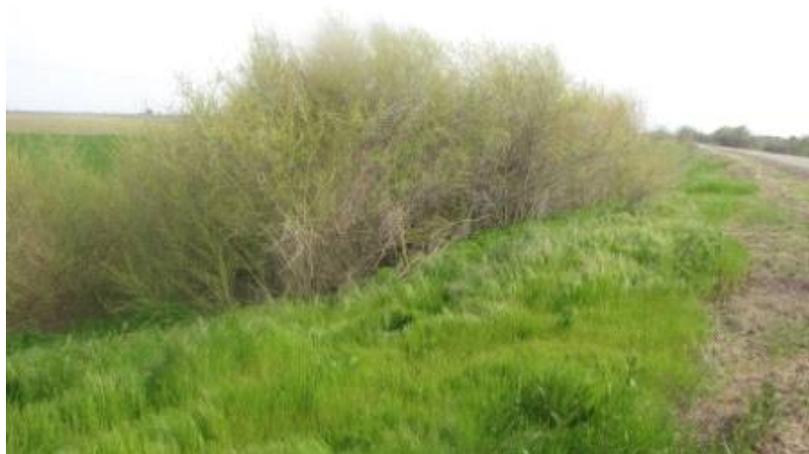
Levee Mile Report Line	26
Start Levee Mile	2.54
End Levee Mile	2.54
Location	Land Side
Category	Earthen Levee
Item	Encroachments
Looking northwest at equipment at landside toe.	
richard_f_20111014_628.jpg

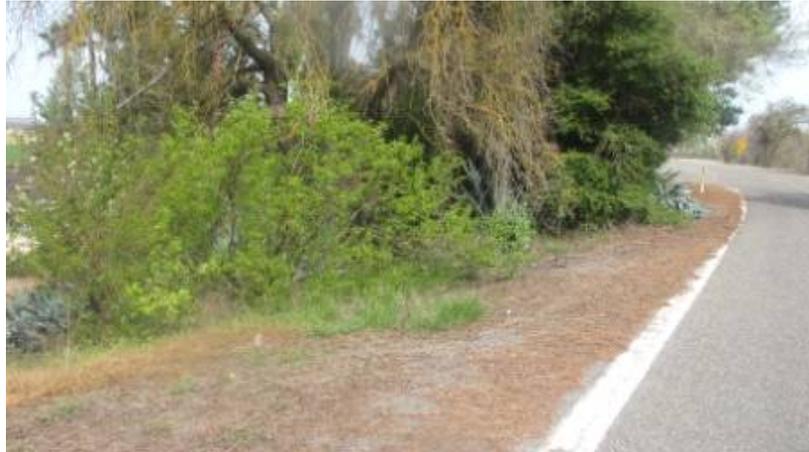
Levee Mile Report Line	28
Start Levee Mile	2.70
End Levee Mile	2.72
Location	Land Side
Category	Earthen Levee
Item	Encroachments
Looking south at landscaping and dense veg. on landside slope and toe.	
richard_f_20110922_507.jpg
