**Flood Control Project Maintenance
Levee Inspections**
LMA District Cover Sheet
Spring 2008 Levee Inspection Results

Reclamation District No. 0999

Levee Inspection Report By Mile - Spring 2008

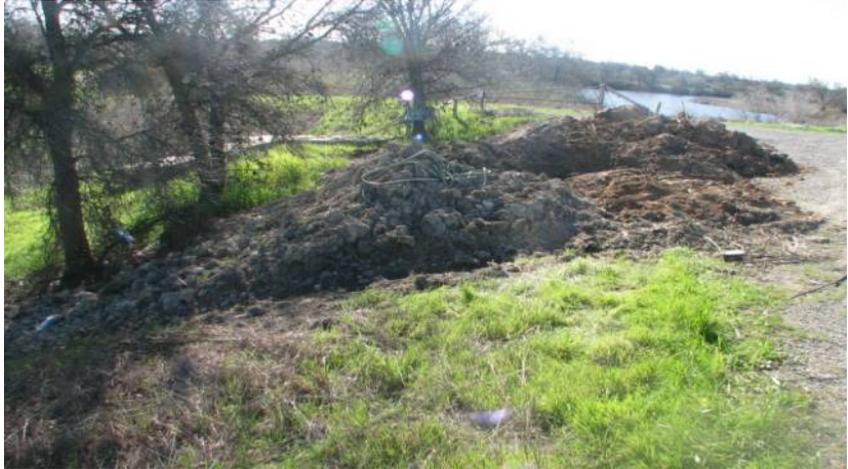
Levee Mile Report Line	4
Start Levee Mile	1.78
End Levee Mile	1.78
Location	
Category	Earthen Levee
Item	Encroachments
Material pile on waterside shoulder at LM 1.78

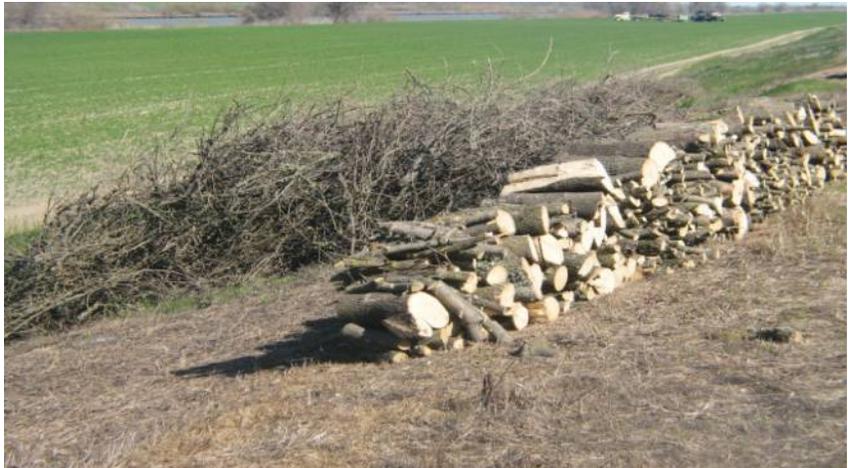
Levee Mile Report Line	11
Start Levee Mile	4.57
End Levee Mile	4.61
Location	
Category	Earthen Levee
Item	Encroachments
Pruning & Firewood pile along waterside shoulder and slope at LM 1.56

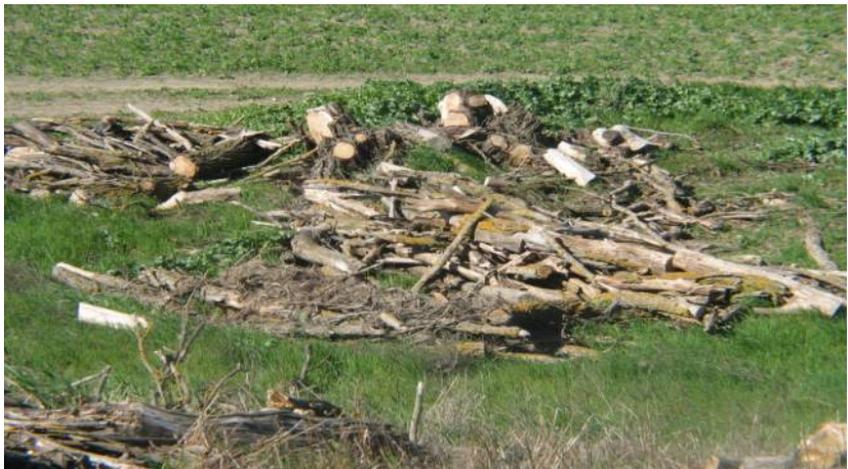
Levee Mile Report Line	12
Start Levee Mile	4.69
End Levee Mile	4.69
Location	
Category	Earthen Levee
Item	Encroachments
Prunings at waterward toe

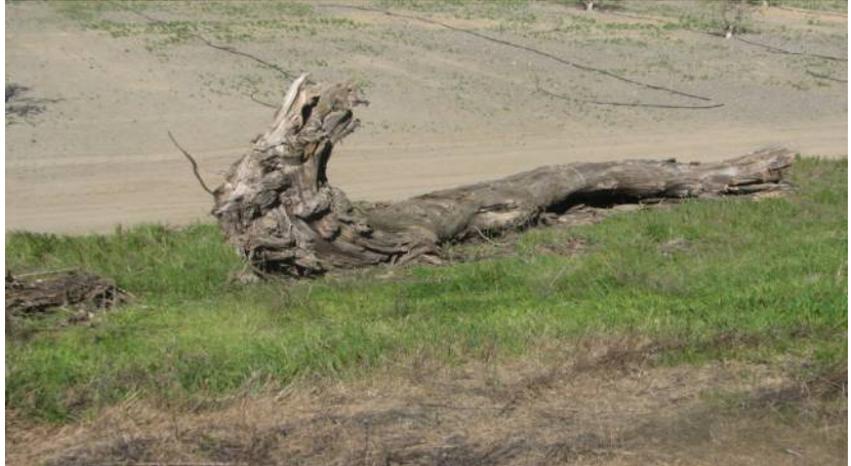
Levee Mile Report Line	14
Start Levee Mile	5.31
End Levee Mile	5.31
Location	
Category	Earthen Levee
Item	Encroachments
Tree limb at waterward toe LM 5.31

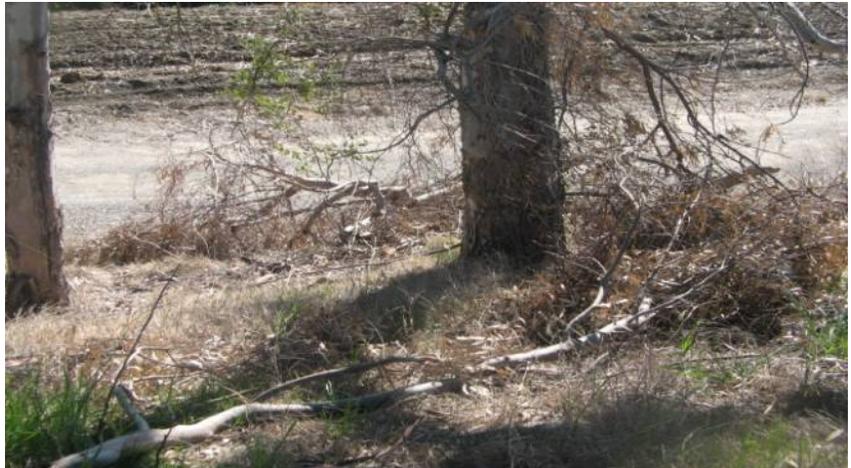
Levee Mile Report Line	15
Start Levee Mile	6.43
End Levee Mile	6.43
Location	
Category	Earthen Levee
Item	Encroachments
Down tree limbs on landward toe LM 6.43

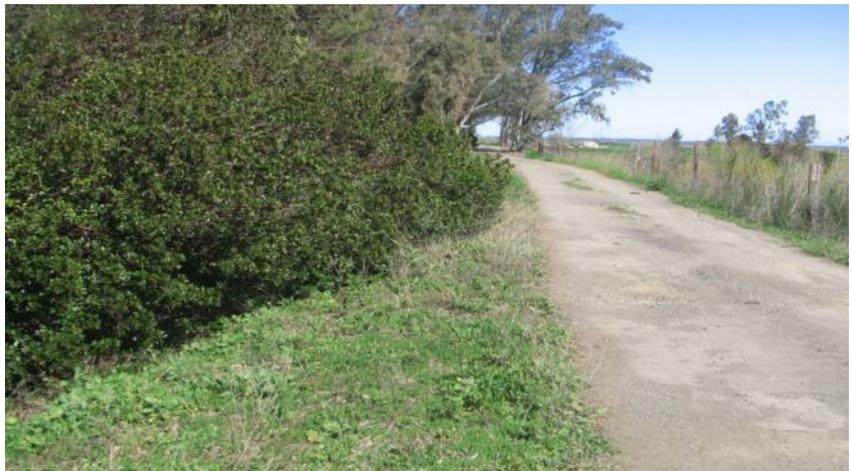
Levee Mile Report Line	20
Start Levee Mile	9.88
End Levee Mile	9.88
Location	
Category	Earthen Levee
Item	Trim / Thin Trees
Overgrown tree on waterward slope at LM 9.88

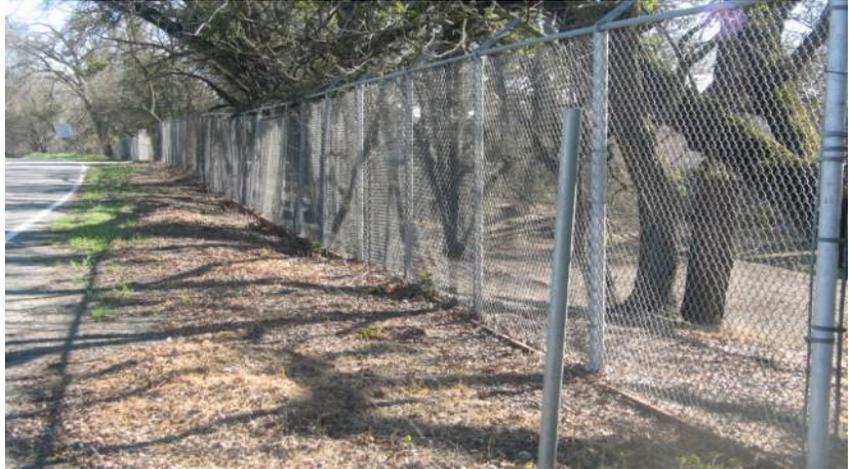
Levee Mile Report Line	4
Start Levee Mile	0.05
End Levee Mile	0.11
Location	
Category	Earthen Levee
Item	Encroachments
Cyclone fence along landside shoulder at LM 0.05 -0.11

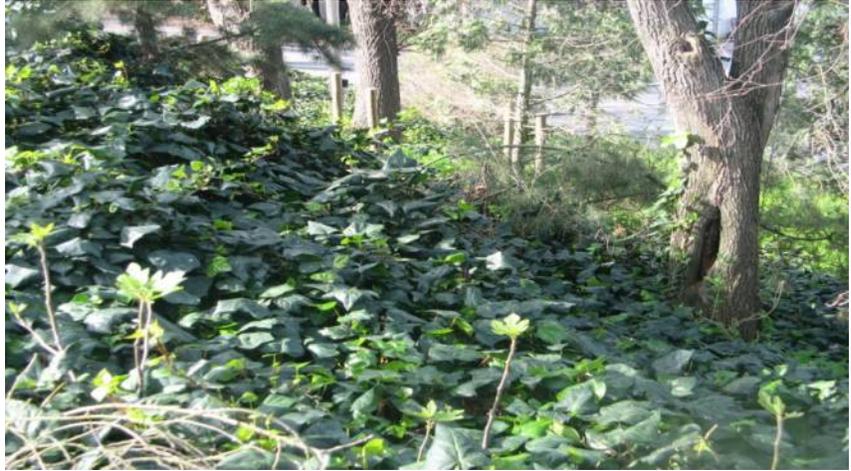
Levee Mile Report Line	11
Start Levee Mile	0.84
End Levee Mile	0.94
Location	
Category	Earthen Levee
Item	Encroachments
View of landscaping (Ivy) blocking view of landside slope from LM 0.84 to 0.94

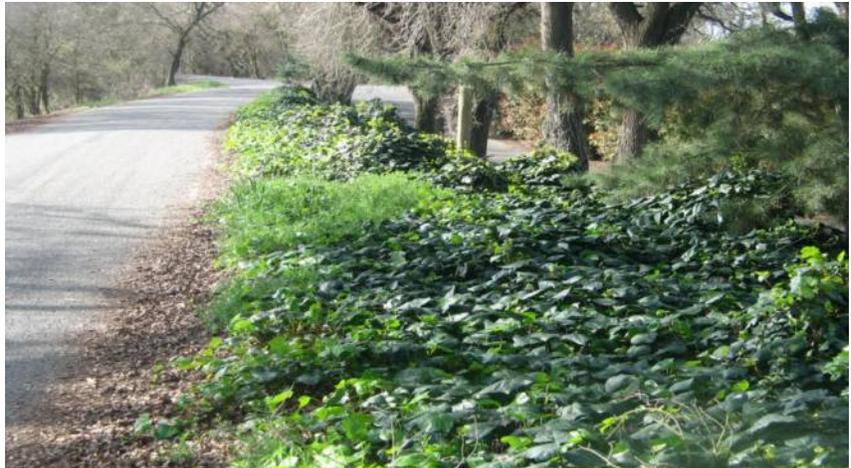
Levee Mile Report Line	11
Start Levee Mile	0.84
End Levee Mile	0.94
Location	
Category	Earthen Levee
Item	Encroachments
View of landscaping (Ivy) looking upstream from LM 0.84 to 0.94

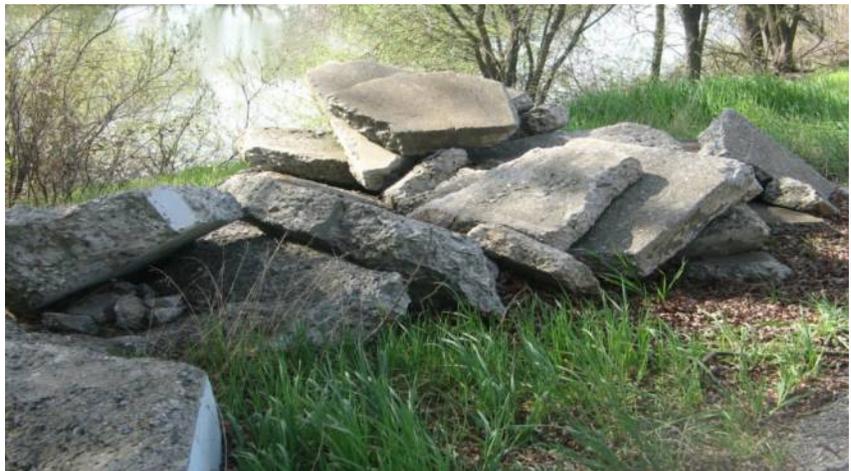
Levee Mile Report Line	22
Start Levee Mile	1.97
End Levee Mile	1.97
Location	
Category	Earthen Levee
Item	Encroachments
Concrete rubble on waterside sholder at LM 1.97

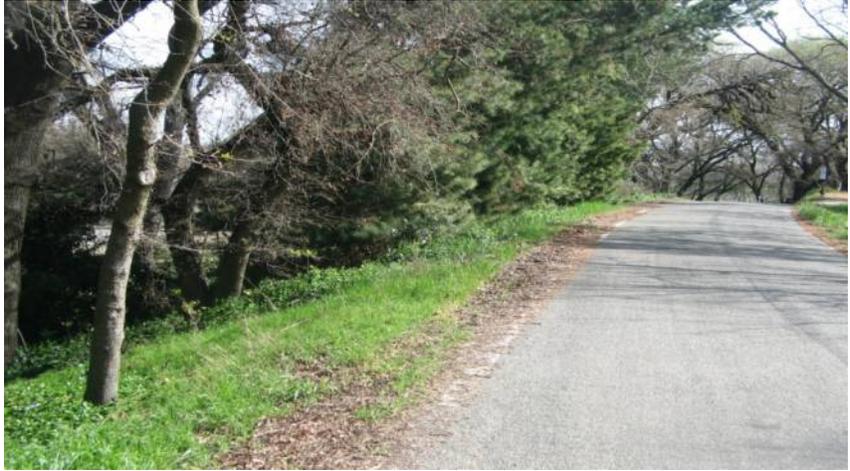
Levee Mile Report Line	31
Start Levee Mile	3.19
End Levee Mile	3.24
Location	
Category	Earthen Levee
Item	Encroachments
Looking downstream of landscaping blocking view of landside slope from LM 3.19 to 3.24

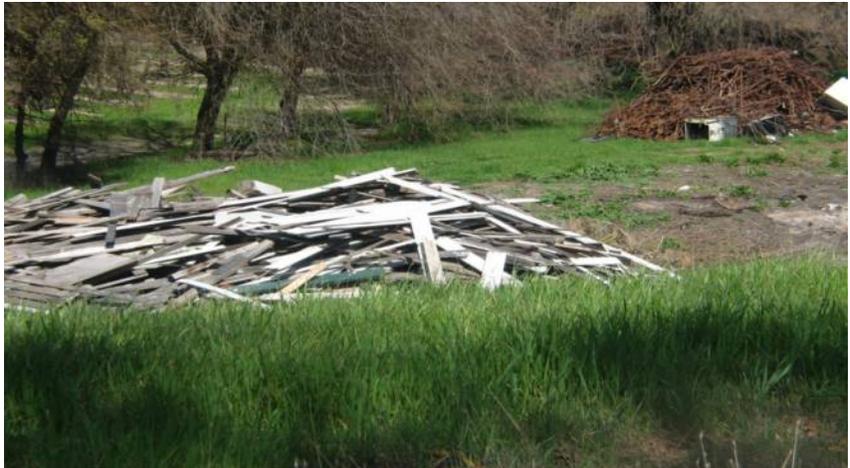
Levee Mile Report Line	39
Start Levee Mile	3.96
End Levee Mile	3.96
Location	
Category	Earthen Levee
Item	Encroachments
Garbage piles on landside toe at LM 3.96

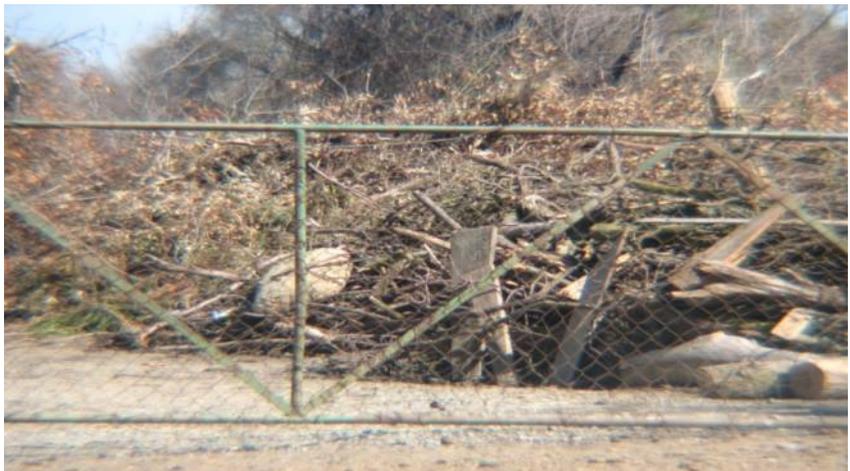
Levee Mile Report Line	43
Start Levee Mile	4.31
End Levee Mile	4.32
Location	
Category	Earthen Levee
Item	Encroachments
Pruning piles on waterward shoulder from LM 4.31 to 4.32

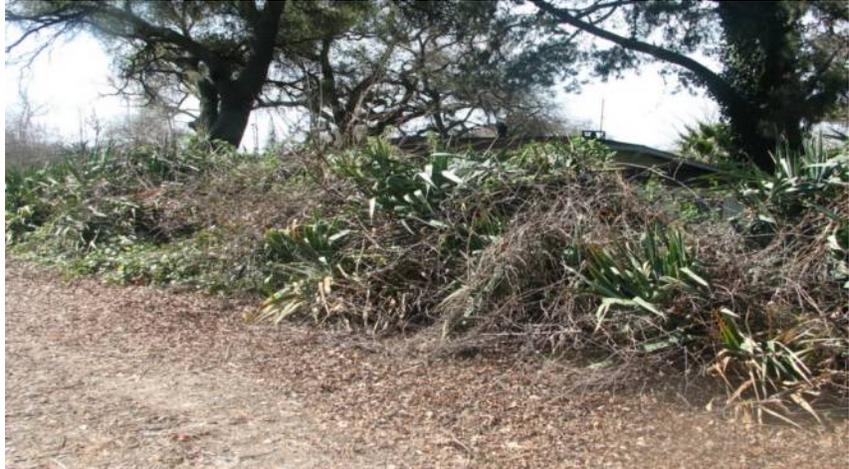
Levee Mile Report Line	44
Start Levee Mile	4.38
End Levee Mile	4.41
Location	
Category	Earthen Levee
Item	Encroachments
Overgrown landscaping on landside slope blocking view of slope from LM 4.38 to 4.41

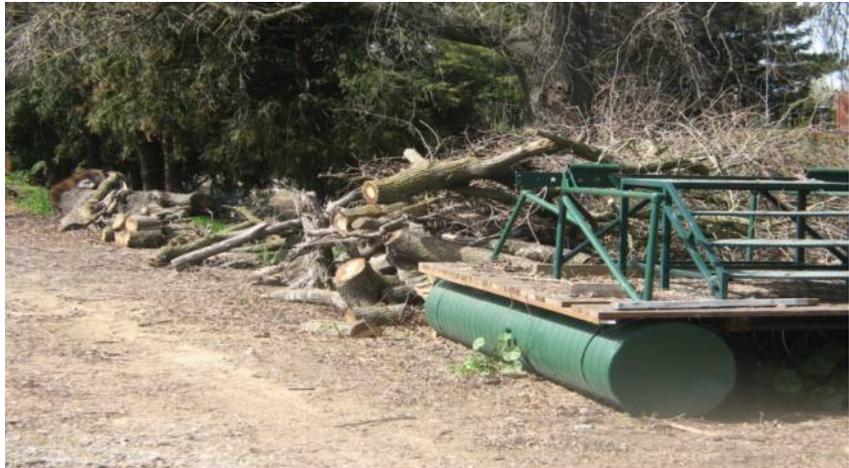
Levee Mile Report Line	51
Start Levee Mile	4.72
End Levee Mile	4.72
Location	
Category	Earthen Levee
Item	Encroachments
Prunings and firewood on landside shoulder at LM 4.72

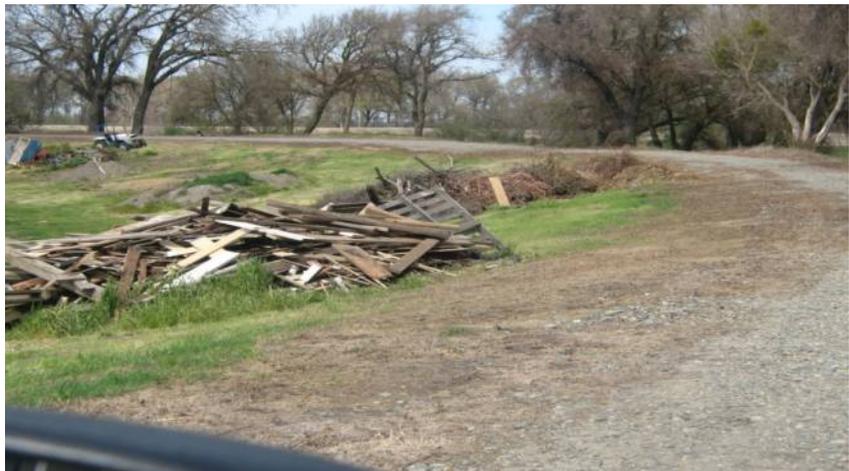
Levee Mile Report Line	56
Start Levee Mile	5.18
End Levee Mile	5.21
Location	
Category	Earthen Levee
Item	Encroachments
Garbage and Prunings on landside slope from LM 5.18 to 5.21

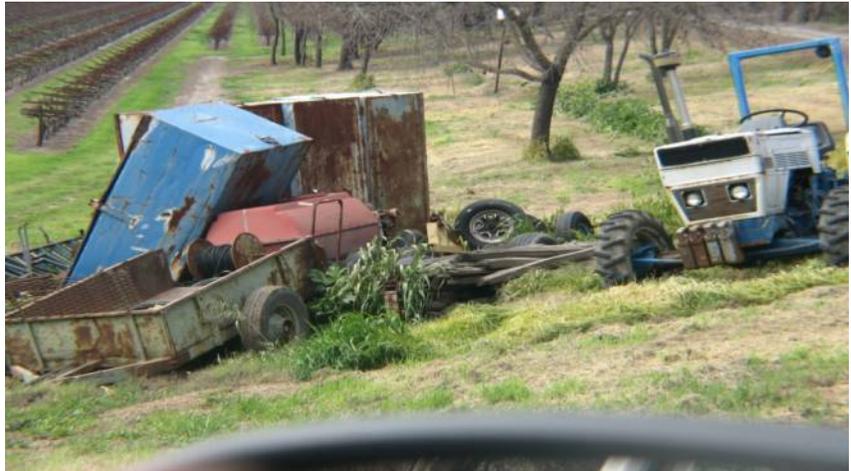
Levee Mile Report Line	57
Start Levee Mile	5.26
End Levee Mile	5.26
Location	
Category	Earthen Levee
Item	Encroachments
Farm equipment on landside slope at LM 5.26

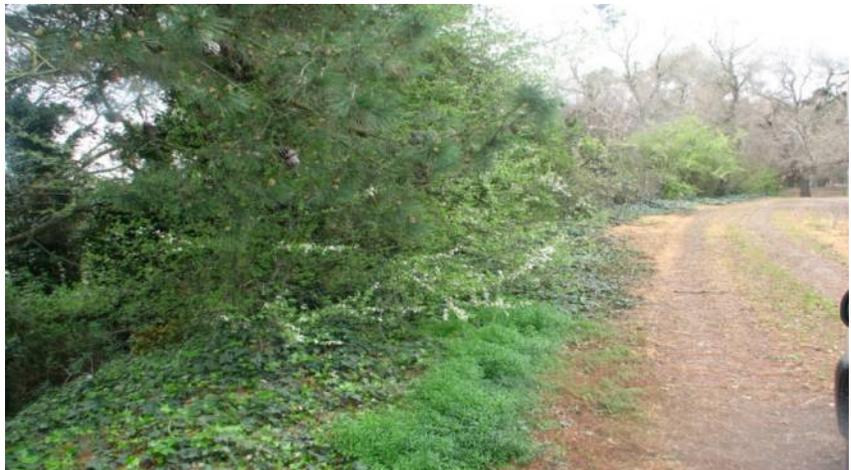
Levee Mile Report Line	66
Start Levee Mile	7.65
End Levee Mile	7.72
Location	
Category	Earthen Levee
Item	Encroachments
Landscaping on landside slope blocking view of slope from LM 7.65 to 7.72

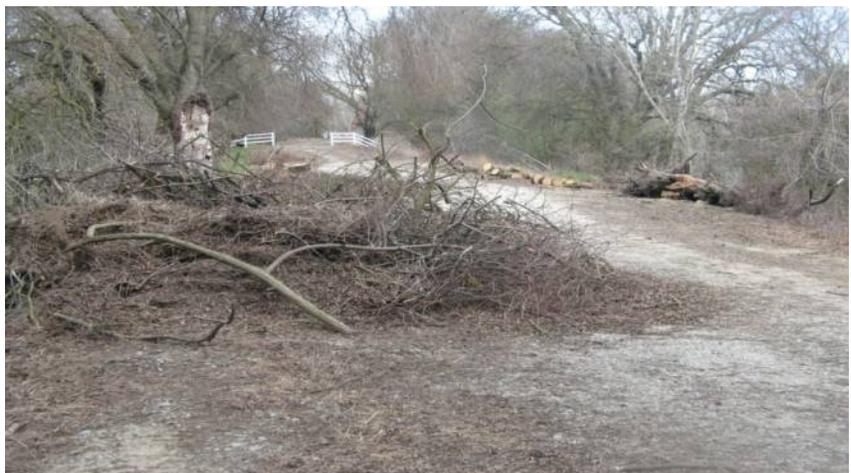
Levee Mile Report Line	70
Start Levee Mile	8.51
End Levee Mile	8.51
Location	
Category	Earthen Levee
Item	Encroachments
Prunings and firewood on waterside and landside shoulder at LM 8.51
