**Flood Control Project Maintenance
Levee Inspections
LMA District Cover Sheet
Spring 2010 Levee Inspection Results**

Reclamation District No. 0999 Netherlands

Spring 2010 Levee Inspection Results

Waterway		Bank	Unit Miles
Unit No. 01 Yolo Bypass		Left	15.43

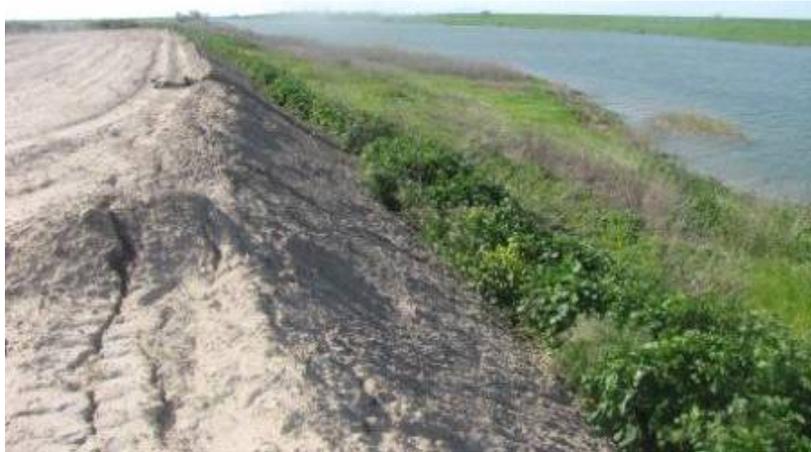
Levee Mile Report Line	1
Start Levee Mile	0.13
End Levee Mile	0.41
Location	Water Side
Category	Earthen Levee
Item	Encroachments
Looking east at fill on waterside	
richard_s_20100408_167.jpg

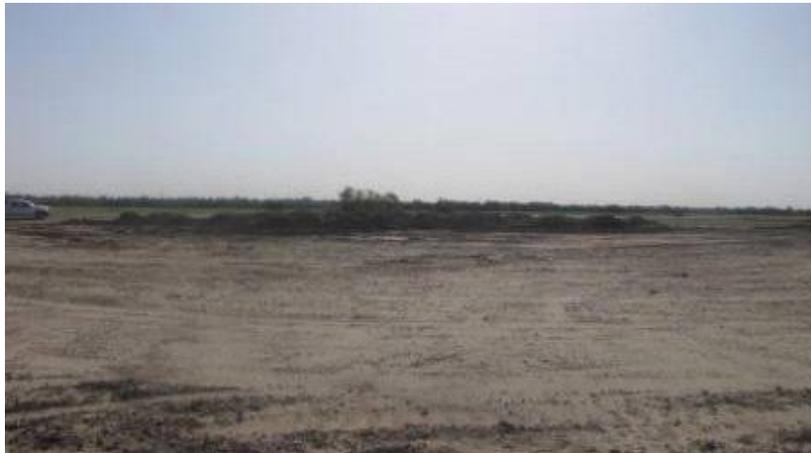
Levee Mile Report Line	1
Start Levee Mile	0.13
End Levee Mile	0.41
Location	Water Side
Category	Earthen Levee
Item	Encroachments
Looking south at fill on waterside shoulder and slope.	
richard_s_20100408_168.jpg

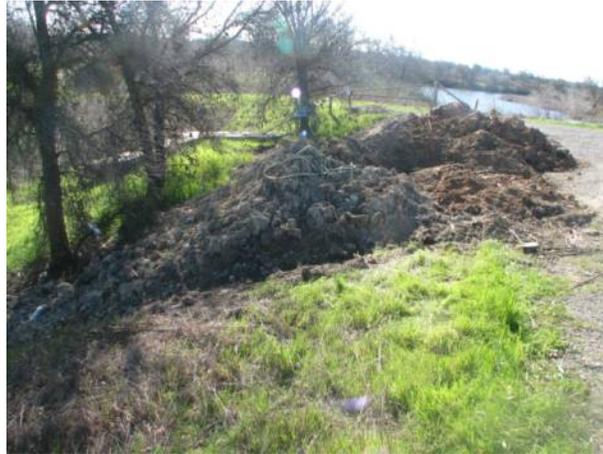
Levee Mile Report Line	6
Start Levee Mile	1.78
End Levee Mile	1.78
Location	Land Side
Category	Earthen Levee
Item	Encroachments
Looking north at garbage pile on landside shoulder.	
richard_s_20100316_099.jpg

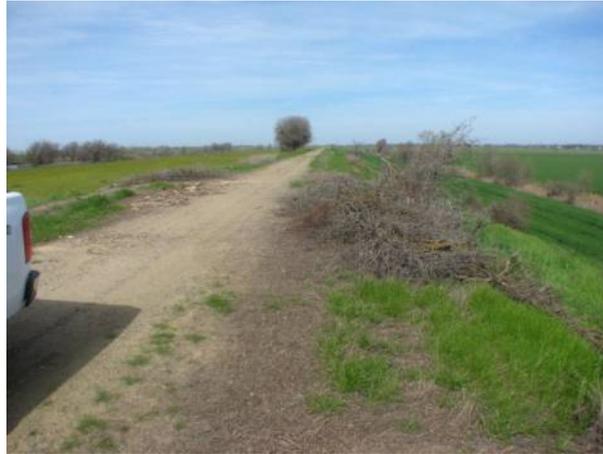
Levee Mile Report Line	13
Start Levee Mile	4.17
End Levee Mile	4.18
Location	Land Side
Category	Earthen Levee
Item	Encroachments
Prunings on waterside shoulder, slope & toe.	
richard_s_20100316_101.jpg

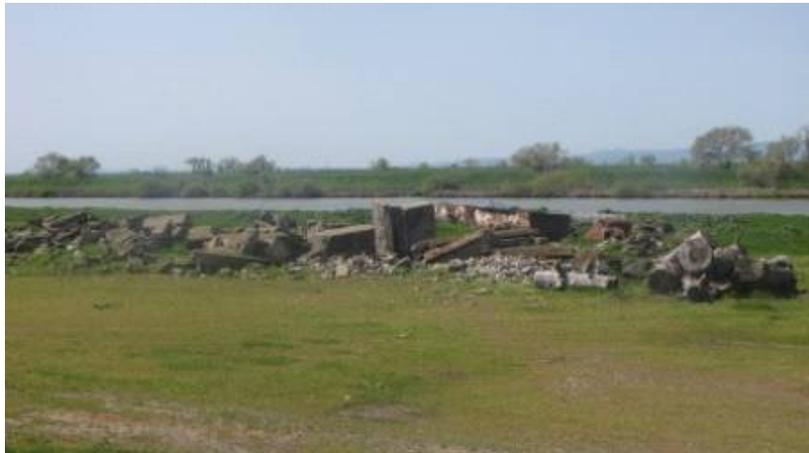
Levee Mile Report Line	33
Start Levee Mile	10.58
End Levee Mile	10.58
Location	Water Side
Category	Earthen Levee
Item	Encroachments
Looking southwest at garbage on waterside toe and berm.	
richard_s_20100408_173.jpg

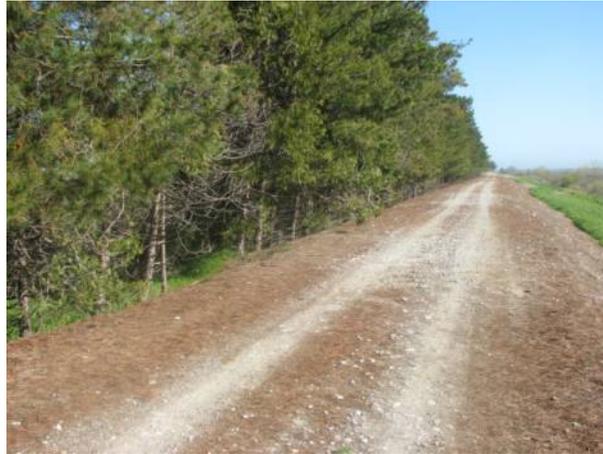
Levee Mile Report Line	35
Start Levee Mile	10.87
End Levee Mile	11.23
Location	Land Side
Category	Earthen Levee
Item	Encroachments
Tree limbs along landside slope & toe.	
richard_s_20100316_106.jpg

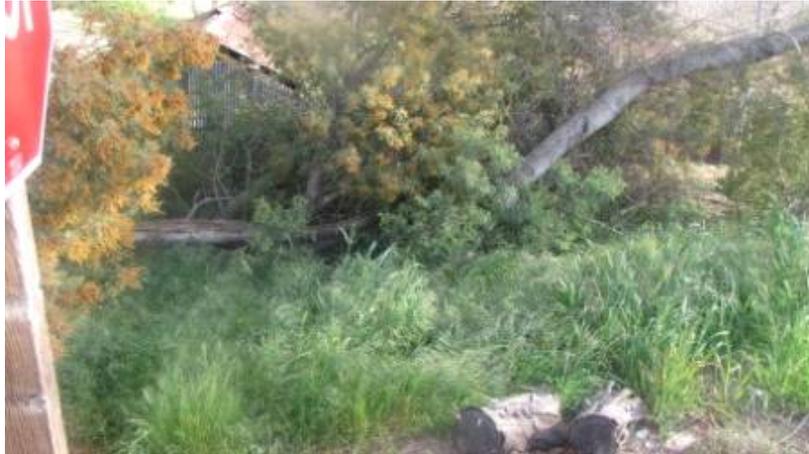
Levee Mile Report Line	8
Start Levee Mile	0.83
End Levee Mile	0.83
Location	Land Side
Category	Earthen Levee
Item	Trim / Thin Trees
Looking west at dense trees on landside slope and toe.	
richard_s_20100408_175.jpg

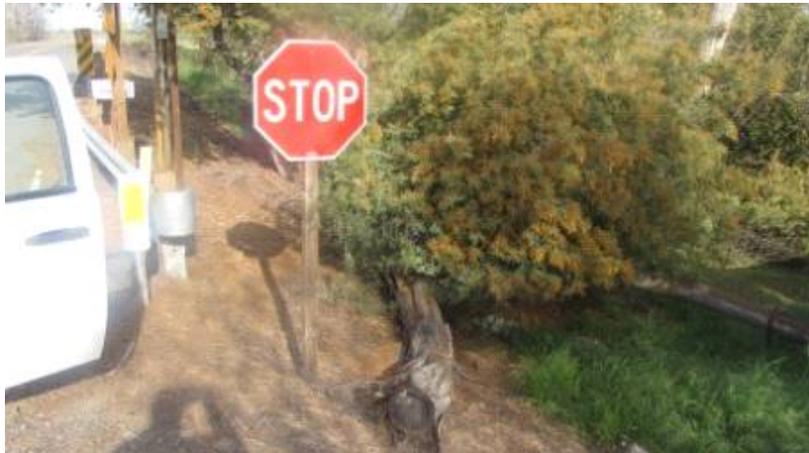
Levee Mile Report Line	10
Start Levee Mile	0.93
End Levee Mile	0.96
Location	Land Side
Category	Earthen Levee
Item	Trim / Thin Trees
Looking north at dense veg. on landside slope and toe.	
richard_s_20100408_178.jpg

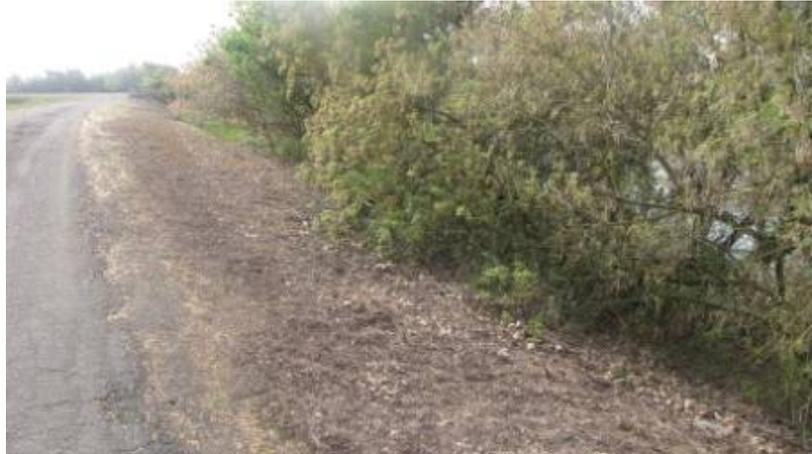
Levee Mile Report Line	17
Start Levee Mile	1.72
End Levee Mile	1.75
Location	Land Side
Category	Earthen Levee
Item	Vegetation
Looking southwest at elderberry bush on landside shoulder and slope.	
richard_s_20100408_180.jpg

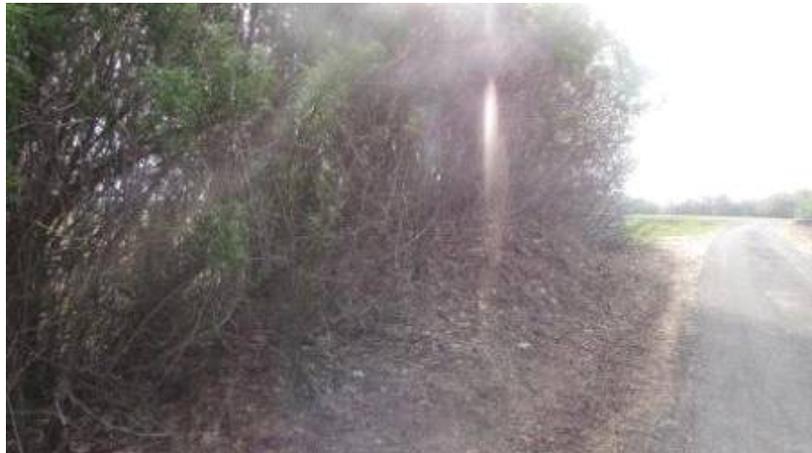
Levee Mile Report Line	18
Start Levee Mile	1.73
End Levee Mile	1.73
Location	Land Side
Category	Earthen Levee
Item	Trim / Thin Trees
Front view of overgrown fig tree on landside shoulder.	
richard_s_20100316_109.jpg

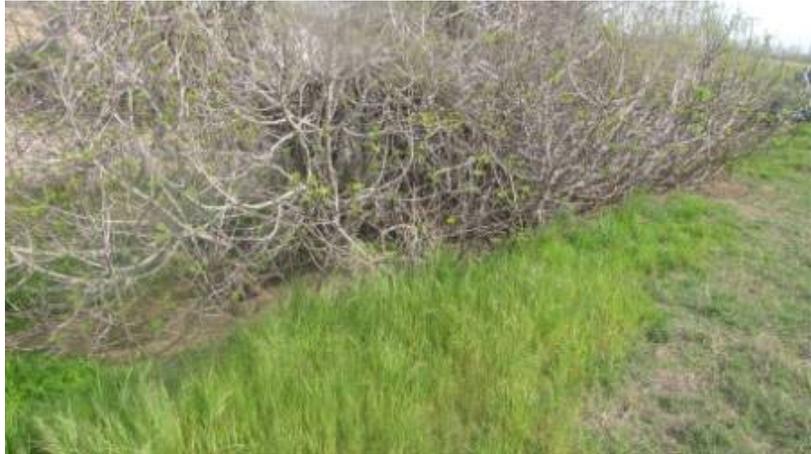
Levee Mile Report Line	3
Start Levee Mile	0.03
End Levee Mile	0.04
Location	Land Side
Category	Earthen Levee
Item	Trim / Thin Trees
Looking north at dense veg. on landside slope and toe.	
richard_s_20100408_183.jpg

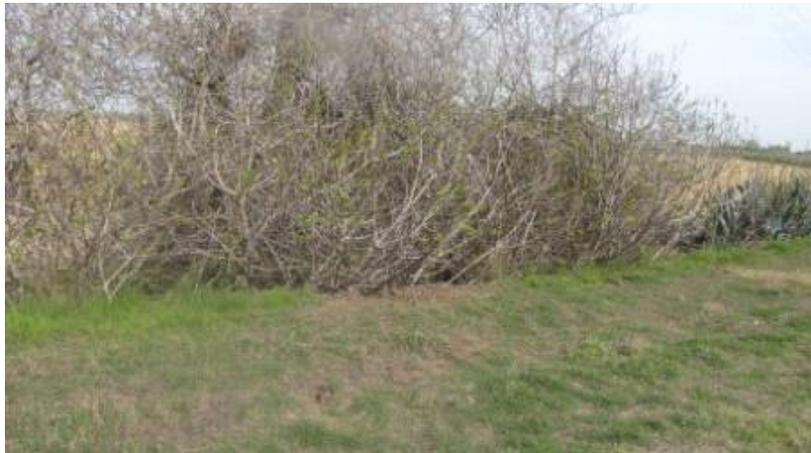
Levee Mile Report Line	4
Start Levee Mile	0.04
End Levee Mile	0.05
Location	Land Side
Category	Earthen Levee
Item	Encroachments
Looking east at cactus and landscaping on landside slope.	
richard_s_20100408_184.jpg

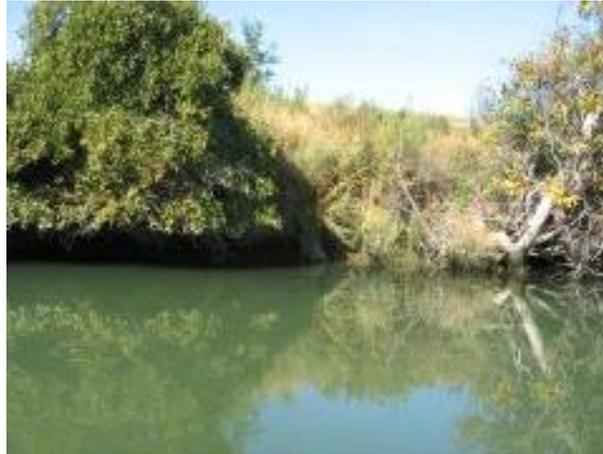
Levee Mile Report Line	6
Start Levee Mile	0.44
End Levee Mile	0.44
Location	Water Side
Category	Earthen Levee
Item	Vegetation
Looking southwest at elderberry bush on waterside slope.	
richard_s_20100408_185.jpg

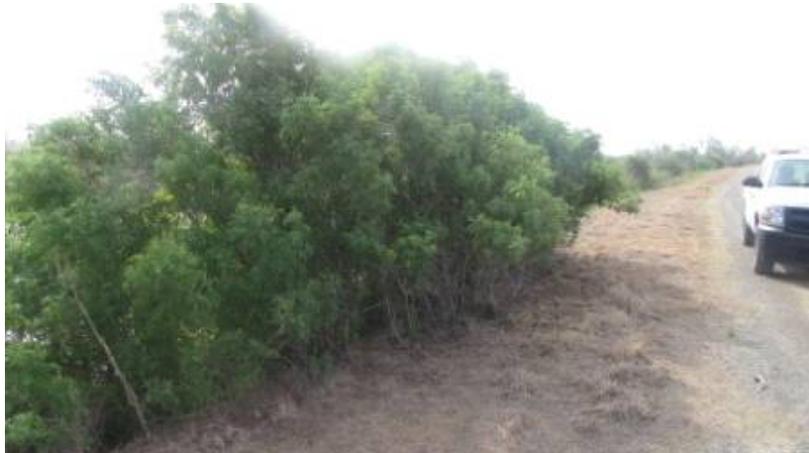
Levee Mile Report Line	6
Start Levee Mile	0.44
End Levee Mile	0.44
Location	Water Side
Category	Earthen Levee
Item	Vegetation
Looking north at elderberry bush on waterside slope.	
richard_s_20100408_186.jpg

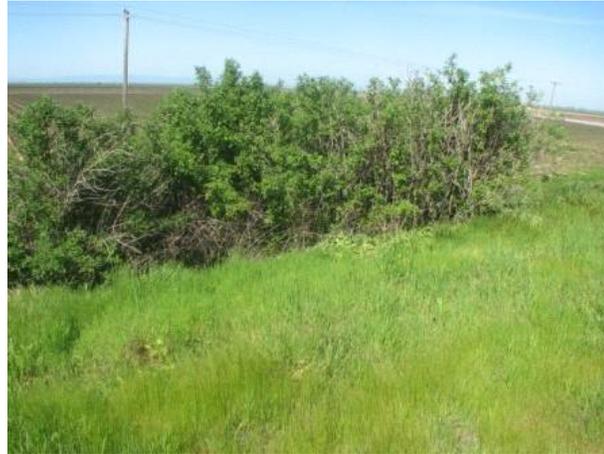
Levee Mile Report Line	14
Start Levee Mile	0.96
End Levee Mile	1.10
Location	Water Side
Category	Supplemental
Item	USACE Erosion Survey
2009: no berm, 1:1 slope, tree hazards, clays and silts, 4.64 ft/s [2009 SiteID:STR_25-2_R]	
USACE2009_STR_25-2_R_2009_09_18-D4P13_small.JPG

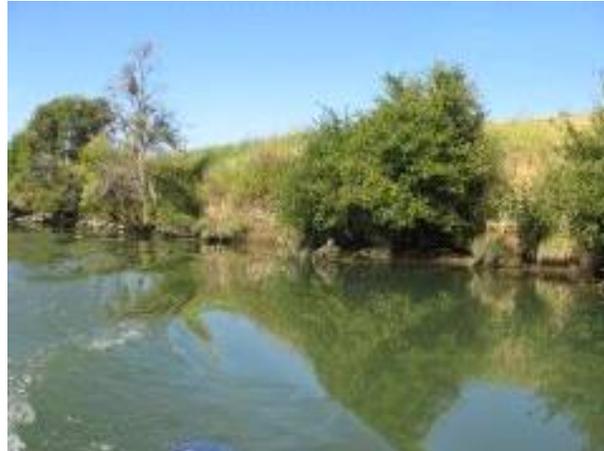
Levee Mile Report Line	21
Start Levee Mile	2.02
End Levee Mile	2.02
Location	Land Side
Category	Earthen Levee
Item	Trim / Thin Trees
Looking north at willow on landsie slope and toe.	
richard_s_20100408_187.jpg

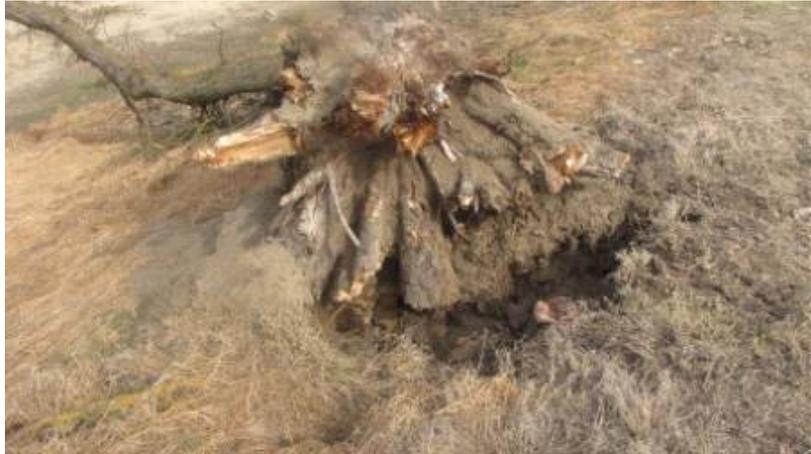
Levee Mile Report Line	24
Start Levee Mile	2.28
End Levee Mile	2.28
Location	Land Side
Category	Earthen Levee
Item	Encroachments
Looking west at dead tree on landside slope.	
richard_s_20100408_189.jpg

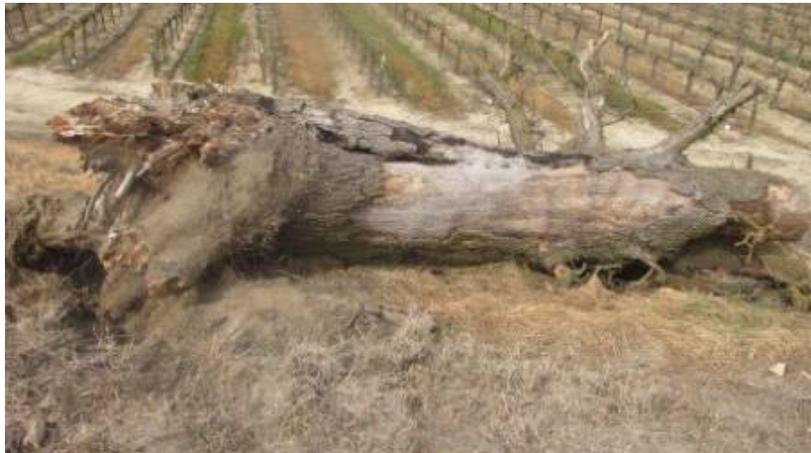
Levee Mile Report Line	26
Start Levee Mile	2.70
End Levee Mile	2.72
Location	Land Side
Category	Earthen Levee
Item	Encroachments
Looking northwest at landscaping and dense veg. on landside slope and toe.	
richard_s_20100408_190.jpg

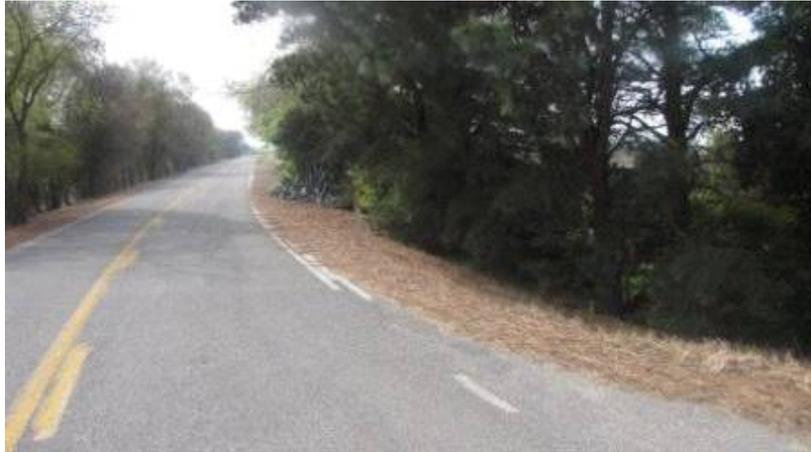
Levee Mile Report Line	31
Start Levee Mile	3.72
End Levee Mile	3.73
Location	Land Side
Category	Earthen Levee
Item	Encroachments
Looking northwest at landscaping on landside slope and toe.	
richard_s_20100408_192.jpg

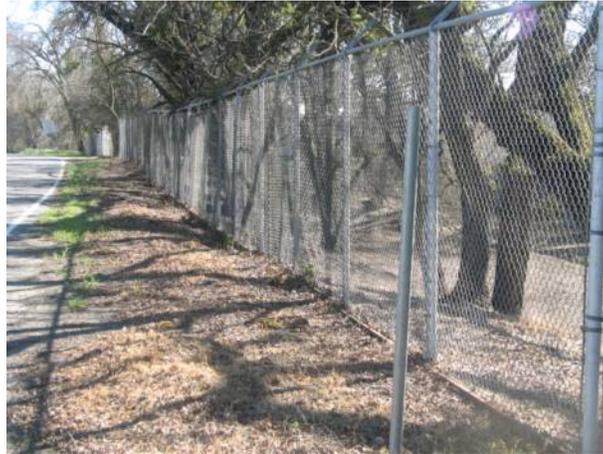
Levee Mile Report Line	8
Start Levee Mile	0.37
End Levee Mile	0.50
Location	Land Side
Category	Earthen Levee
Item	Trim / Thin Trees
Looking west at dense trees on waterside slope.	
richard_s_20100408_203.jpg

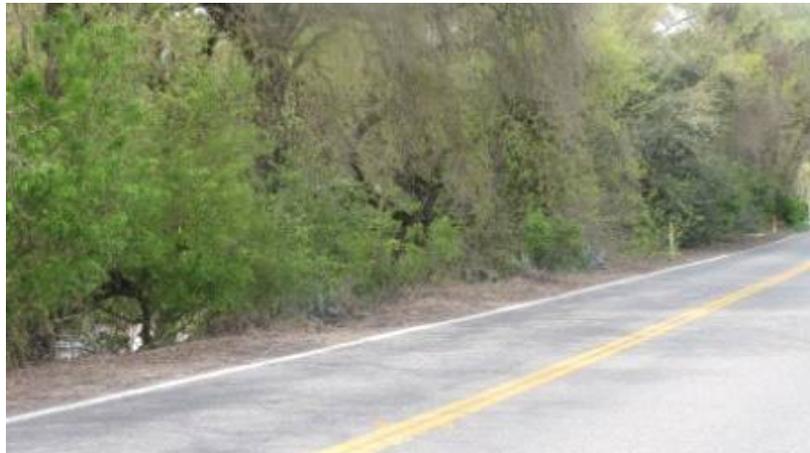
Levee Mile Report Line	8
Start Levee Mile	0.37
End Levee Mile	0.50
Location	Land Side
Category	Earthen Levee
Item	Trim / Thin Trees
Looking northwest at dense trees on landside slope and toe.	
richard_s_20100408_204.jpg

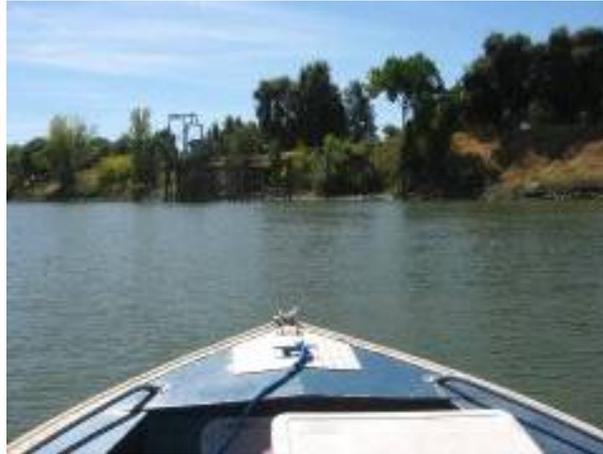
Levee Mile Report Line	17
Start Levee Mile	0.80
End Levee Mile	0.84
Location	Water Side
Category	Supplemental
Item	USACE Erosion Survey
2009: no berm, 1.5:1 slope, tree hazards and slumping, sands and silts, 5.36 ft/s [2009 SiteID:SAC_42-7_R]	
USACE2009_SAC_42-7_R_2009_09_17-D3bP25_small.JPG

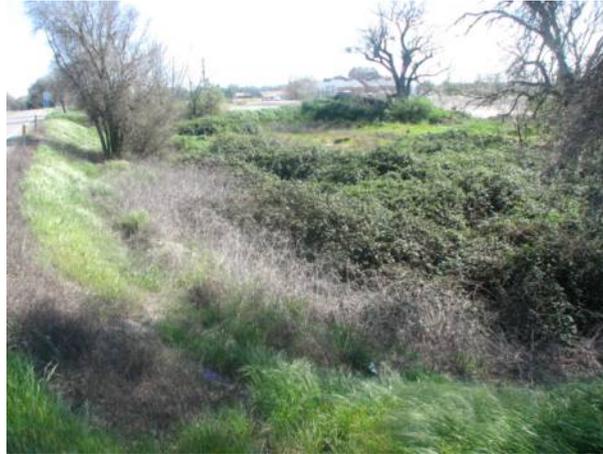
Levee Mile Report Line	3
Start Levee Mile	0.19
End Levee Mile	0.22
Location	Water Side
Category	Earthen Levee
Item	Trim / Thin Trees
Front view of dense wild roses at landside toe.	
richard_s_20100316_117.jpg

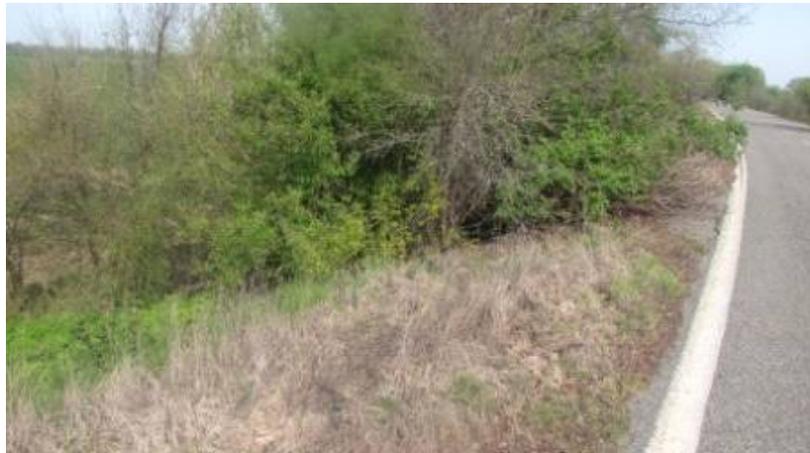
Levee Mile Report Line	12
Start Levee Mile	0.43
End Levee Mile	0.47
Location	Land Side
Category	Earthen Levee
Item	Trim / Thin Trees
Looking north at dense veg. on landside slope and toe. richard_s_20100408_194.jpg

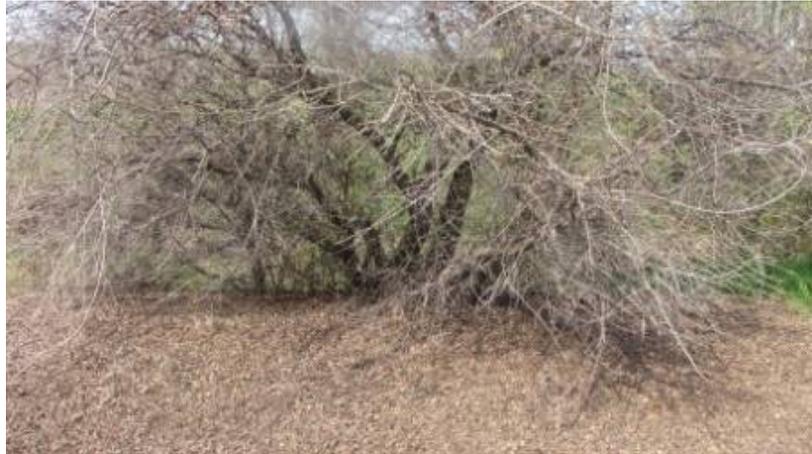
Levee Mile Report Line	17
Start Levee Mile	0.72
End Levee Mile	0.74
Location	Land Side
Category	Earthen Levee
Item	Trim / Thin Trees
Front view of dense trees at landside shoulder.	
richard_s_20100316_118.jpg

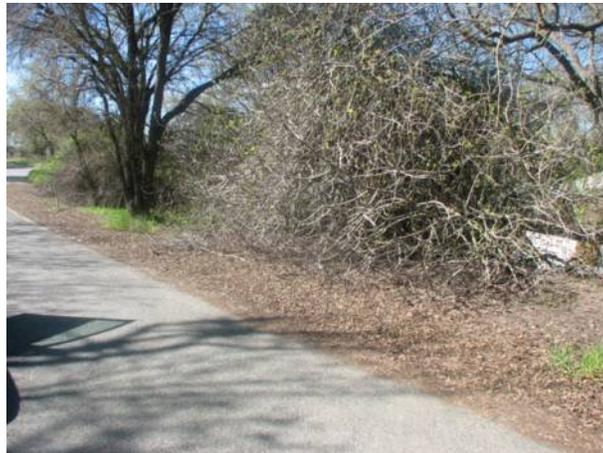
Levee Mile Report Line	19
Start Levee Mile	0.84
End Levee Mile	0.94
Location	Land Side
Category	Earthen Levee
Item	Encroachments
View of landscaping (Ivy) blocking view of landside slope from LM 0.84 to 0.94	
richard_s_20100316_119.jpg

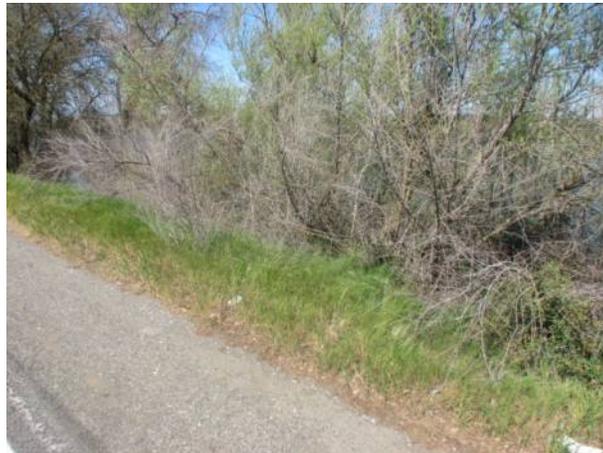
Levee Mile Report Line	28
Start Levee Mile	1.51
End Levee Mile	1.88
Location	Land Side
Category	Earthen Levee
Item	Trim / Thin Trees
Side view of dense trees along waterside slope.	
richard_s_20100316_122.jpg

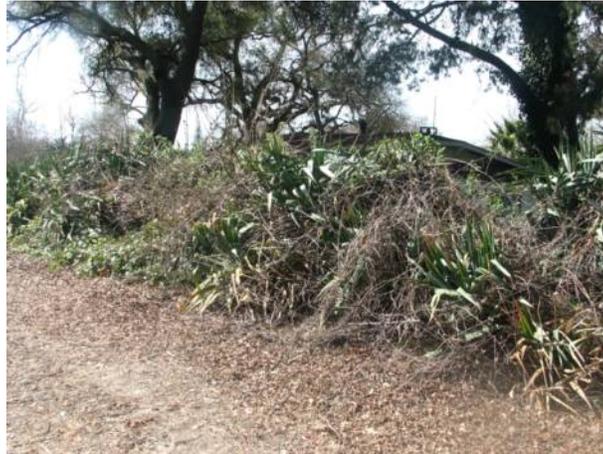
Levee Mile Report Line	62
Start Levee Mile	4.55
End Levee Mile	4.55
Location	Water Side
Category	Earthen Levee
Item	Encroachments
Looking southeast at dense trees on waterside slope	
richard_s_20100408_197.jpg
