**Flood Control Project Maintenance  
Levee Inspections**  
**LMA District Cover Sheet**  
**Spring 2014 Levee Inspection Results**

**Reclamation District No. 0999 Netherlands**

**Spring 2014 Levee Inspection Results**

| Waterway | Bank | Unit Miles |
|---|---|---|
| Unit No. 01 Yolo Bypass | Left | 15.43 |

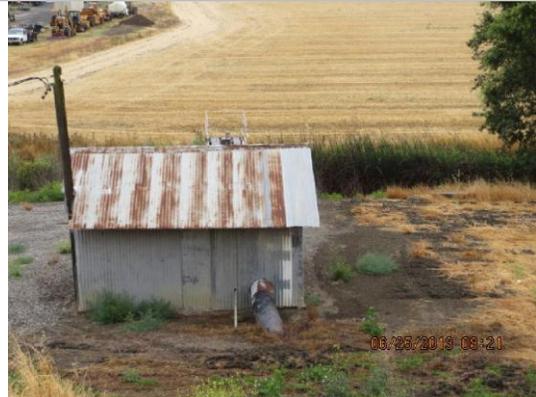
Photo 1 of 1 : UCIP\_1280.jpg

| Inspector Comments: FS_ID:15343<br>EP_NO: 16087<br>Repair Type:<br>Crossing Status:<br>UCIP Comments: Pipe appears to have a leak on the WS toe. Minor erosion is apparent under leak at WS toe. Siphon breaker should be protected in metal riser.<br>FIELD_STRUCT_DESC: 18-inch pipe through the levee 6.5 feet below the crown. Pumps on both ends with a metal walkway on the water side and a electrical panel in a shed on the LS toe. LS pump and walkway on a 8'X8' concrete box off LS toe. Siphon breaker on LS slope. 1.5-inch galvanized electrical conduit at same location on WS. Replaced an existing pipe at same location (Permit No. 16087, 1993).<br>FS Date: 6/25/2013 | | | | | |

Meter and electrical controls in corrugated metal shed on LS toe.

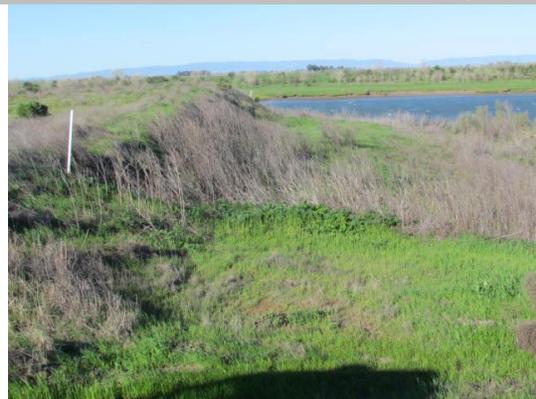
Photo 1 of 4 : richard\_s\_20140314\_431.jpg

Looking west at fill on waterside berm as of 3/2014

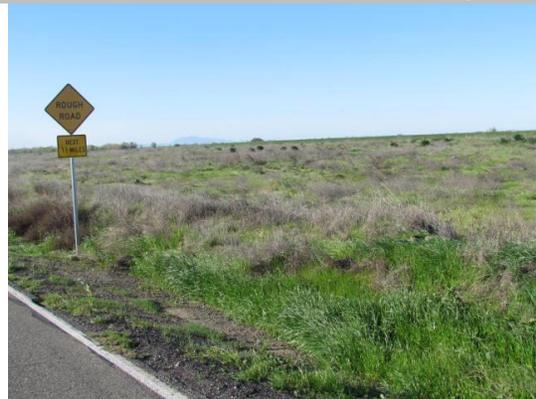
Photo 4 of 4 : richard\_s\_20140314\_432.jpg

Looking southwest at fill on waterside berm as of 3/2014

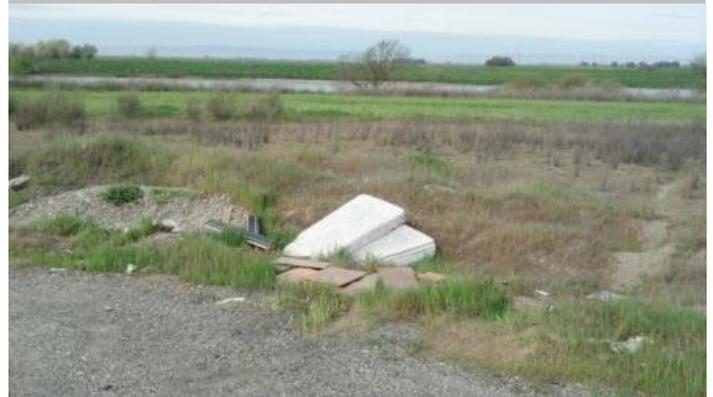
Photo 2 of 2 : richard\_s\_20140310\_163.jpg

Looking west at garbage on waterside berm.

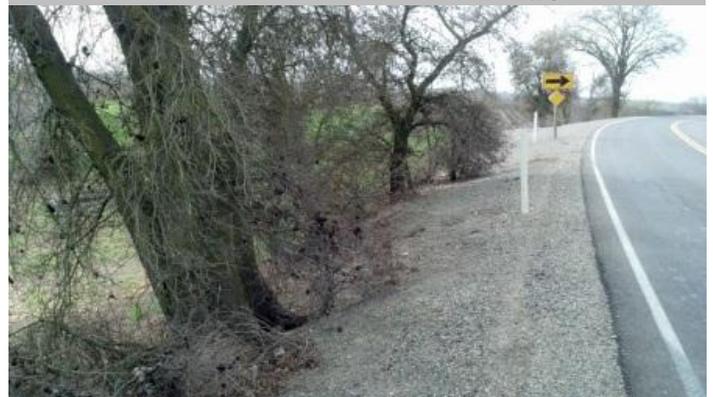
Photo 1 of 1 : richard\_s\_20140310\_177.jpg

Looking southeast at untrimmed trees on landside slope.

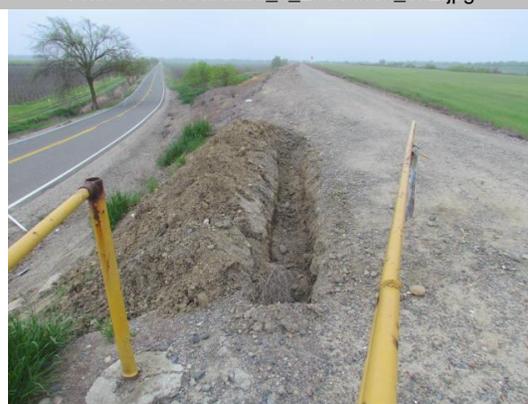
Photo 1 of 3 : richard\_s\_20140310\_182.jpg

Looking south at excavation with backhoe on landside shoulder.

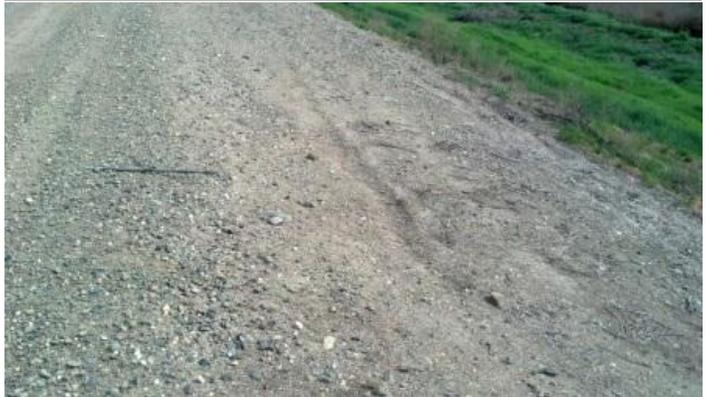
Photo 1 of 2 : richard\_s\_20140310\_196.jpg

Looking northeast at depression on landside shoulder.

| Repair slope instability. | | | | | |

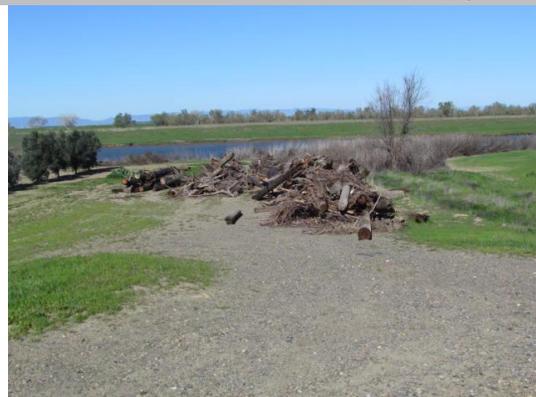
Photo 1 of 2 : richard\_s\_20140314\_436.jpg

Looking west at prunings on waterward berm.

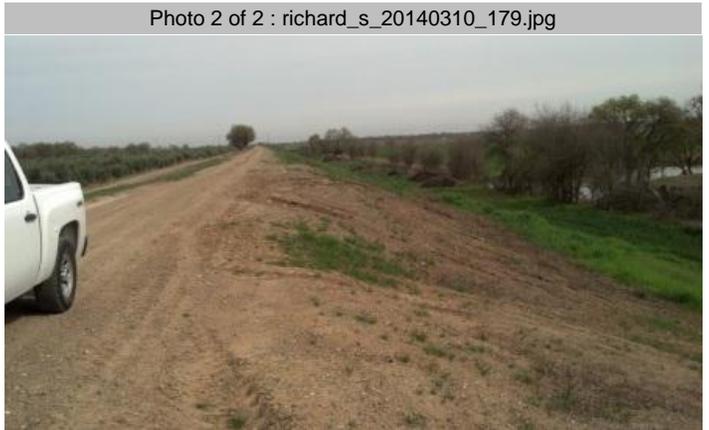
Looking north at slope damage caused by vehicle traffic.

| Repair the levee slope damaged by vehicle traffic and prevent access where possible. | | | | | |

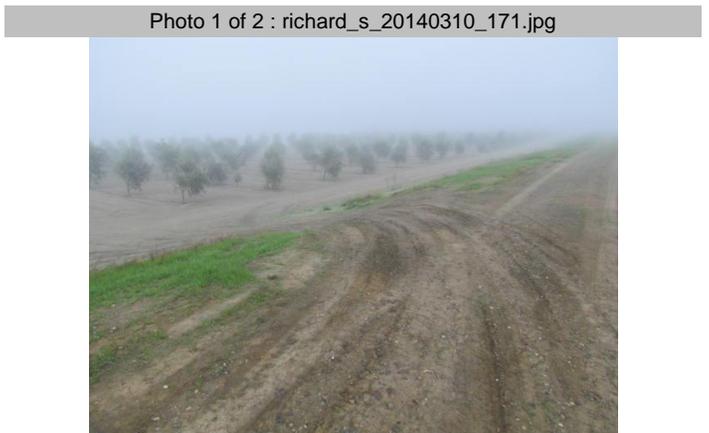
| Repair the levee slope damaged by vehicle traffic and prevent access where possible.<br>Inspector Comments: Local farmer causing slope damage by driving equipment and trucks on slope. | | | | | |

Looking northwest at slope damage caused by vehicle traffic.

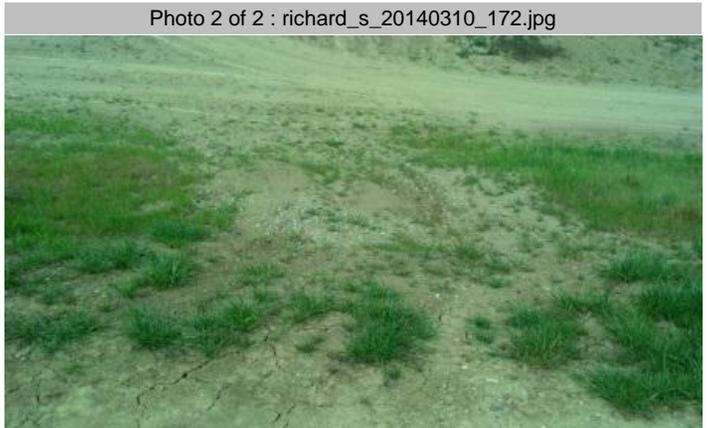
| Repair the levee slope damaged by vehicle traffic and prevent access where possible.<br>Inspector Comments: Local farmer causing slope damage by driving equipment and trucks on slope. | | | | | |

Looking west at slope damage on waterside slope.

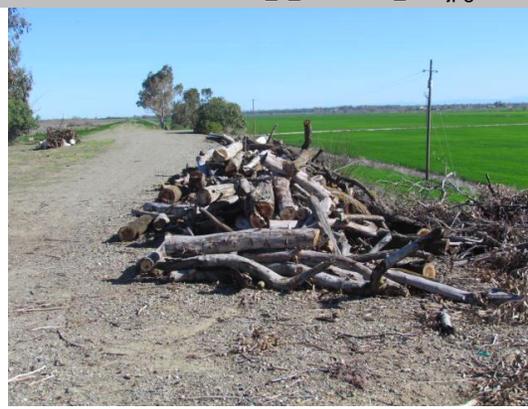
Photo 1 of 3 : richard\_s\_20140314\_441.jpg

Looking northeast at pruning pile on landside crown and shoulder.

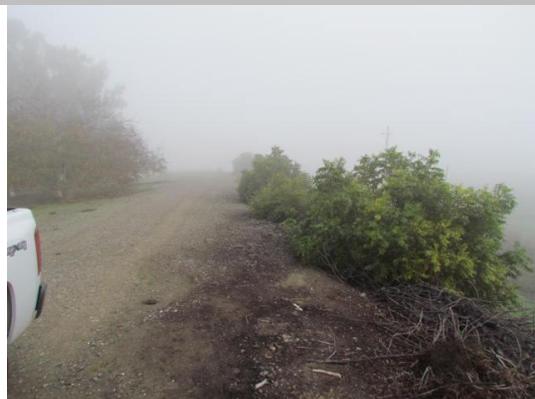
Photo 1 of 1 : richard\_s\_20140310\_174.jpg

Looking northeast at untrimmed trees on landside shoulder and slope.

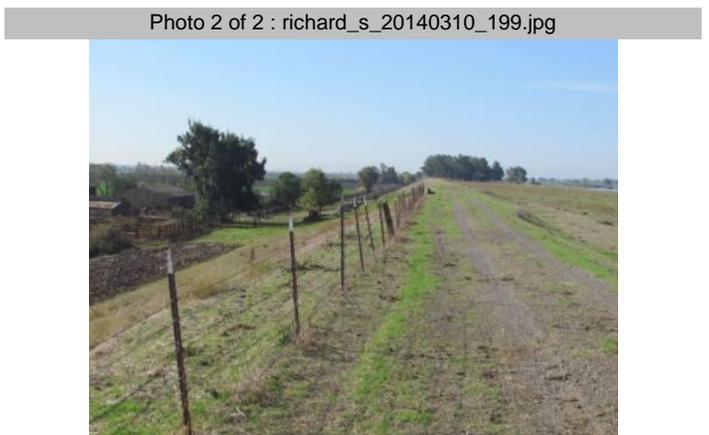
Looking south at fence along landside shoulder.

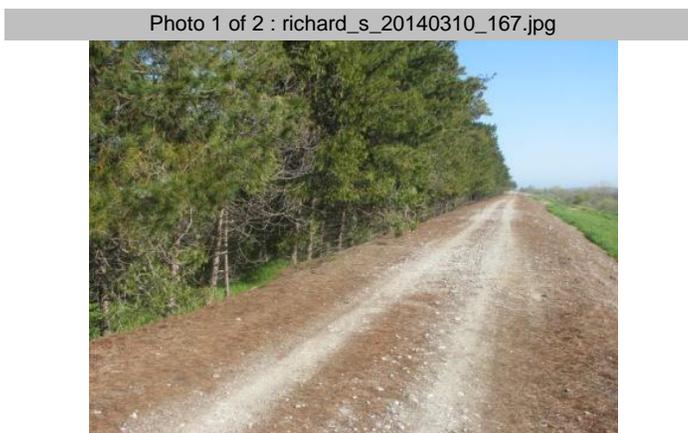
Pine trees along waterside shoulder & slope. (Site of a old christmas tree farm). (Spring 2011)

| Trim trees to at least five feet above ground level. | | | | | |

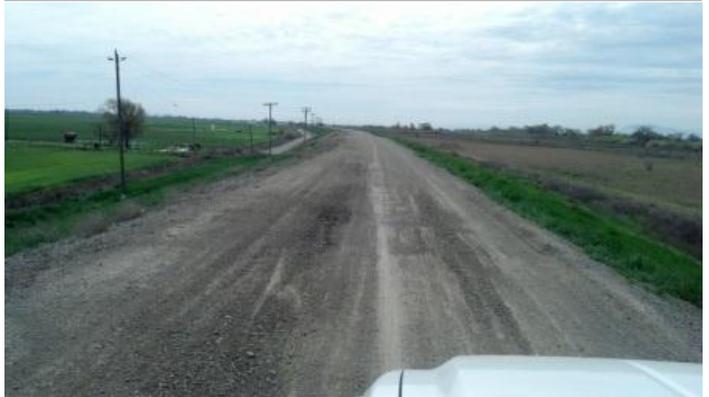
Photo 2 of 3 : richard\_s\_20140310\_166.jpg

Looking south at rutting on levee crown. Spring 2013

| Repair depressions or ruts in the crown or slope. | | | | | |

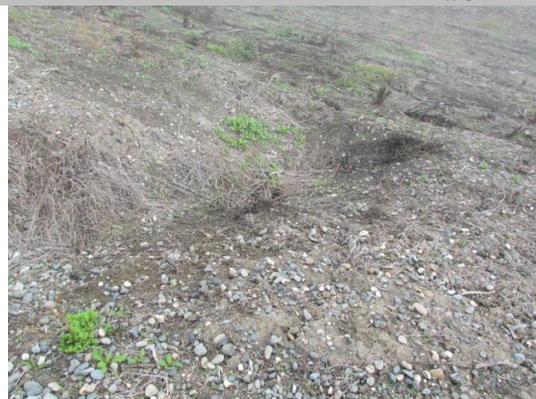
Photo 2 of 2 : richard\_s\_20140310\_194.jpg

Looking southeast at caving on landside slope.

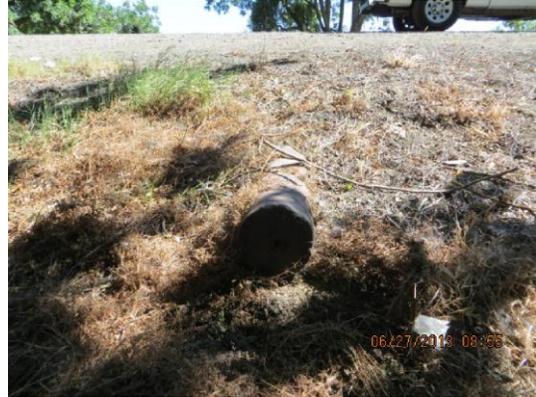
Photo 1 of 1 : UCIP\_1293.jpg

Pipe with welded steel plate over end visible on WS

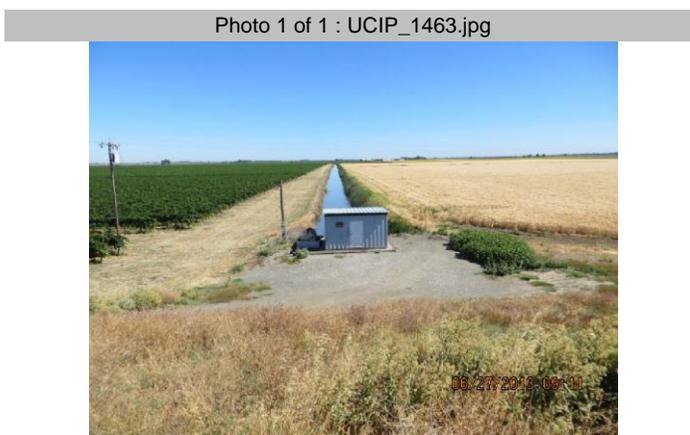
| Inspector Comments: FS_ID:16333<br>EP_NO: N/A<br>Repair Type:<br>Crossing Status:<br>UCIP Comments: Need to determine permit for this crossing.<br>FIELD_STRUCT_DESC: 24-inch steel stormdrain through the levee 3-feet below the crown with a pump in a pumphouse on the LS toe.<br>Siphon breaker in a 24-inch steel riser on WS.<br>FS Date: 6/27/2013 | | | | | |

Pumphouse off LS toe.

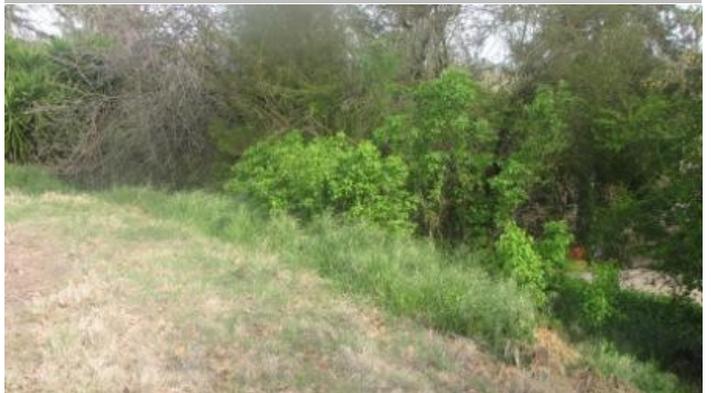
Photo 1 of 2 : richard\_s\_20140310\_220.jpg

Looking southwest at dense veg. on landside toe.

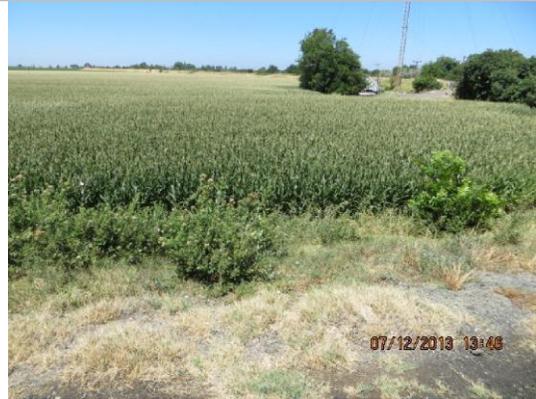
Photo 1 of 1 : UCIP\_1377.jpg

Pipe visible just off shoulder on LS slope in the rose bushes.

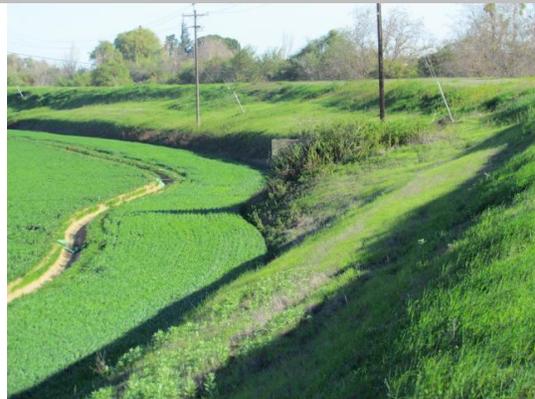
Photo 1 of 1 : richard\_s\_20140314\_453.jpg

Looking north at crops encroaching onto landside toe.

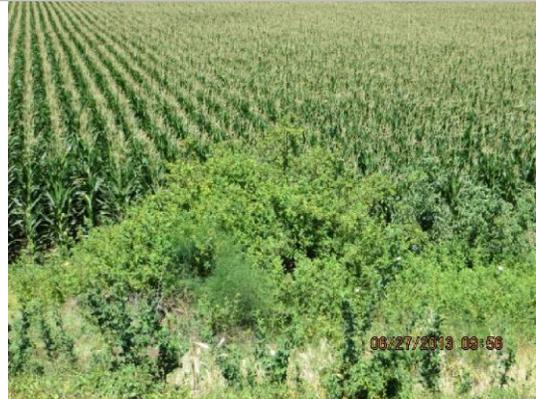
Photo 1 of 1 : UCIP\_1299.jpg

Pumphouse on LS slope covered in rose bush.

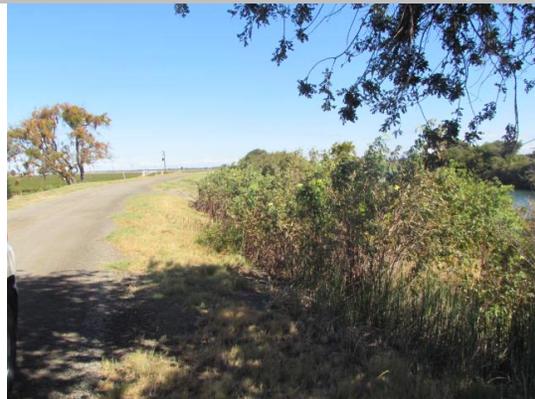
Photo 1 of 1 : richard\_s\_20140310\_254.jpg

Looking northeast at dense elderberry on waterward slope.

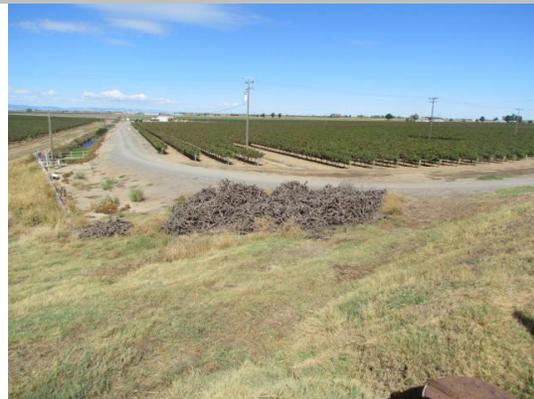
Photo 1 of 2 : richard\_s\_20140310\_244.jpg

Looking west at prunings on landward berm.

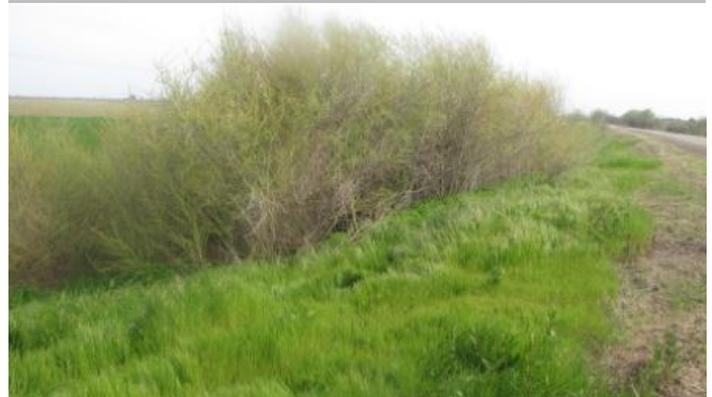
Photo 1 of 1 : richard\_s\_20140310\_257.jpg

Looking north at willow on landside slope and toe.

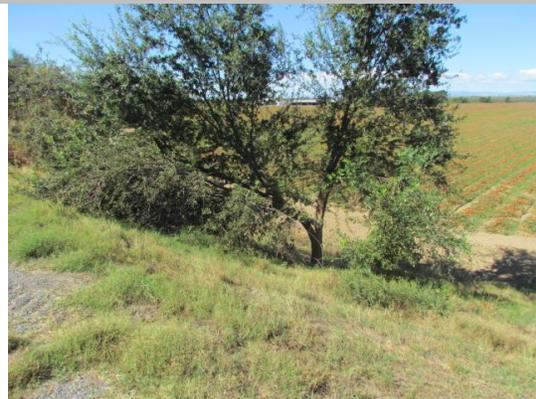
Photo 1 of 1 : richard\_s\_20140310\_277.jpg

Looking southwest at broken tree limb on landward slope.

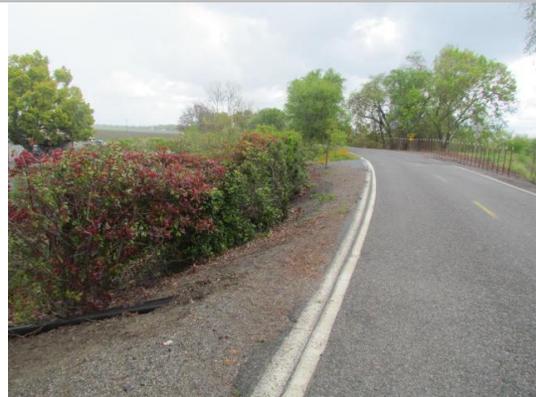
Photo 2 of 2 : richard\_s\_20140310\_259.jpg

Looking southwest at trimmed landscaping on landside slope, but still blocking levee slope.

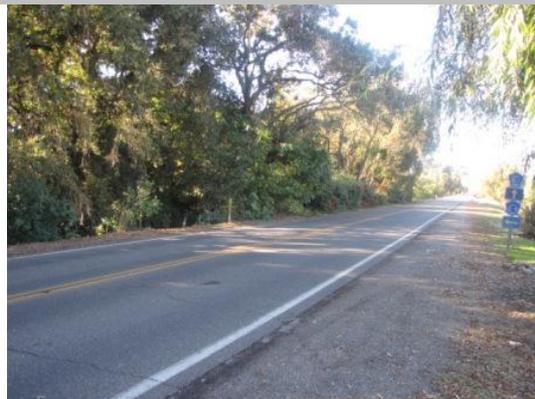
Photo 1 of 2 : richard\_s\_20140310\_293.jpg

Looking northwest at dense veg. on landside shoulder and slope.

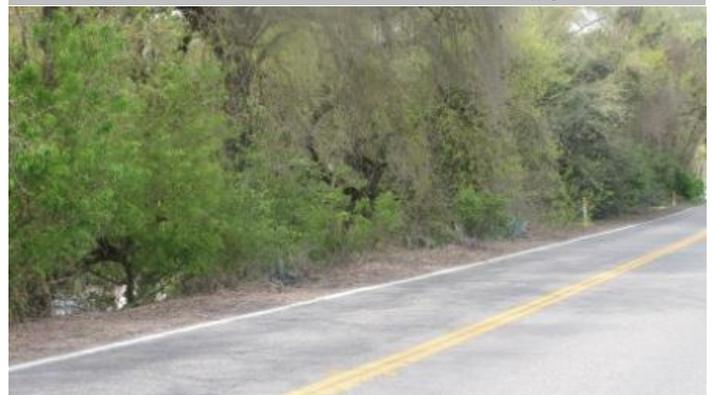
Photo 1 of 2 : richard\_s\_20140310\_290.jpg

Looking west at dense trees on waterside slope.

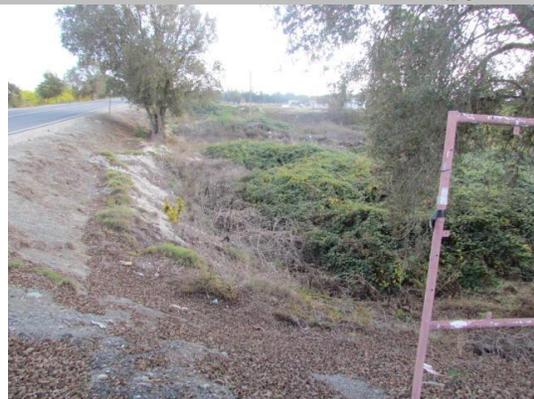
Photo 1 of 2 : richard\_s\_20140310\_296.jpg

Looking south at dense berryvines on landside toe. 2012

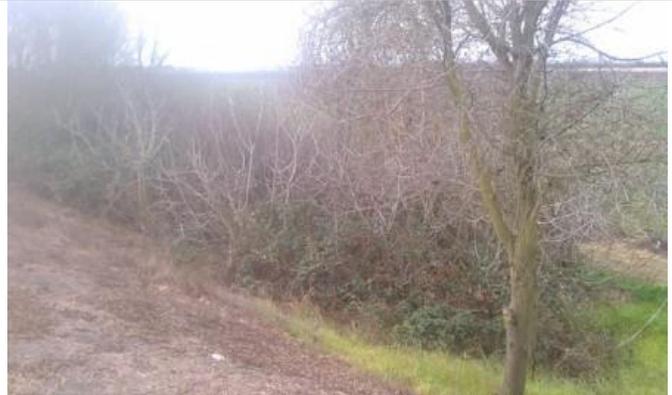
Photo 2 of 4 : richard\_s\_20140310\_326.jpg

Looking southwest at dense berry vines on landside toe.

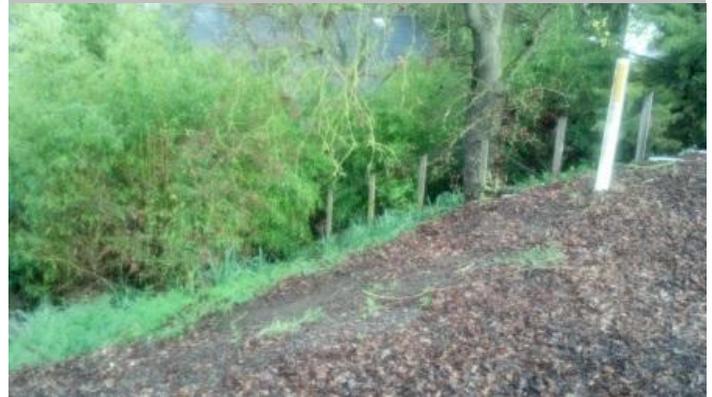
Photo 1 of 1 : richard\_s\_20140310\_382.jpg

Looking at dense trees on landside slope and toe.

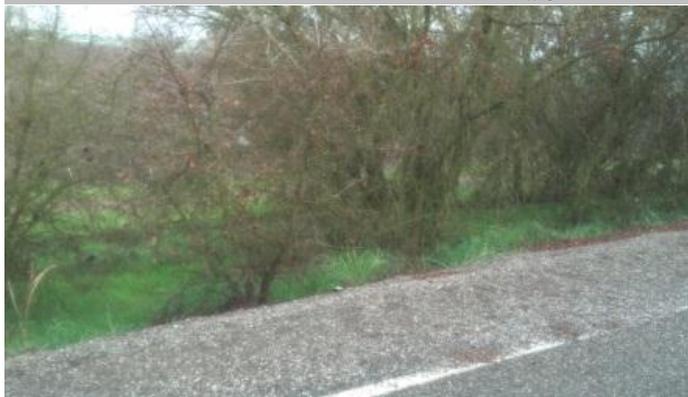
Photo 1 of 1 : richard\_s\_20140310\_316.jpg

Looking west at dense trees on landside slope and toe.

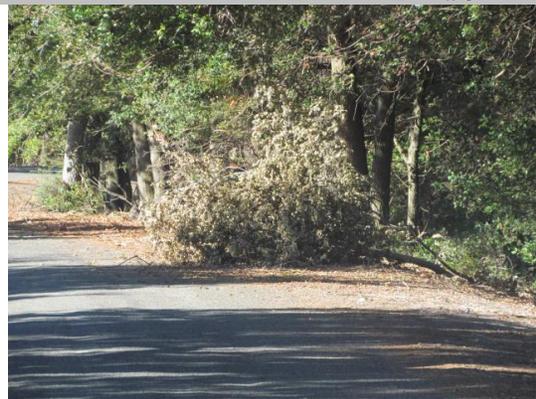
Photo 1 of 1 : richard\_s\_20140310\_395.jpg

Looking south at downed tree on landward shoulder and slope.

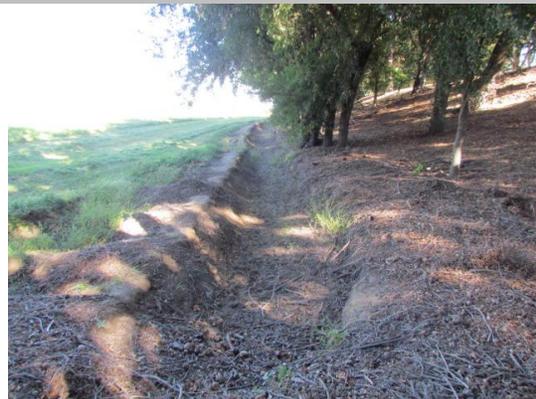
Photo 1 of 1 : richard\_s\_20140310\_396.jpg

Looking north at abandoned irrigation ditch at landward toe.

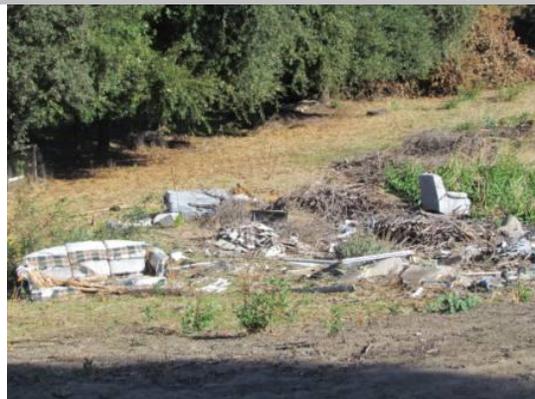
Photo 1 of 3 : richard\_s\_20140310\_319.jpg

Looking northwest at garbage on landside toe and berm. (Spring 2011)

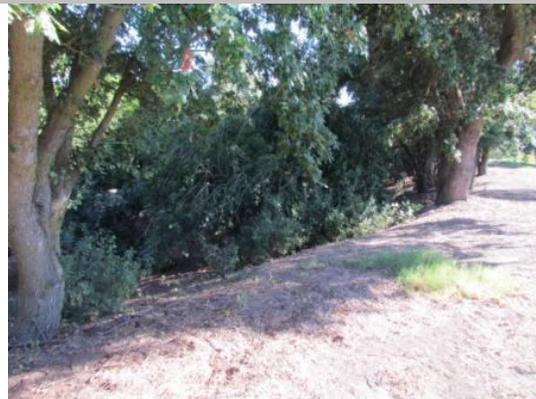
Photo 1 of 3 : richard\_s\_20140310\_334.jpg

Looking northwest at dense trees on landside slope.(Spring 2011)

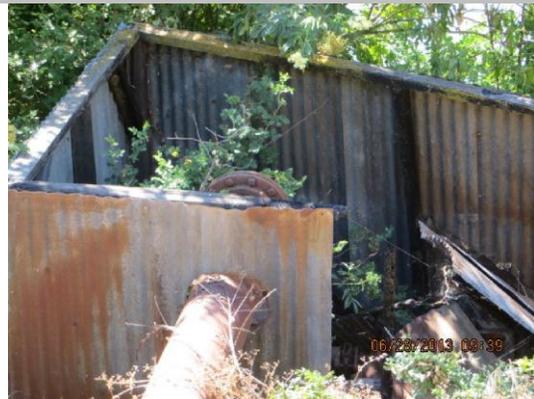
Photo 1 of 1 : UCIP\_1329.jpg

Abandoned pumphouse on WS slope.

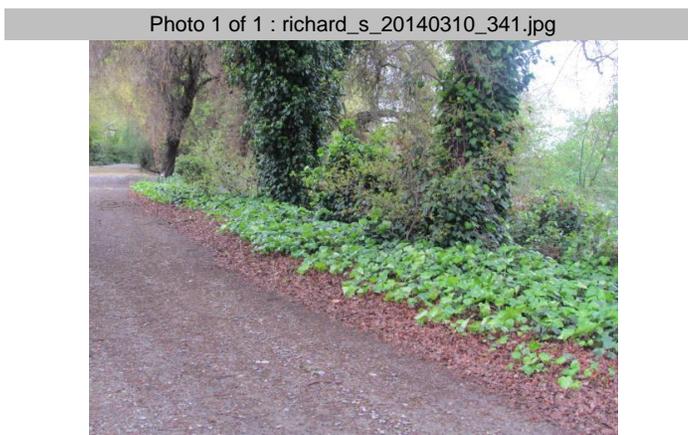
Looking northeast at dense groundcover and vegetation on waterside slope.

| Remove the wild growth other than native grasses from the levee slopes. | | | | | |

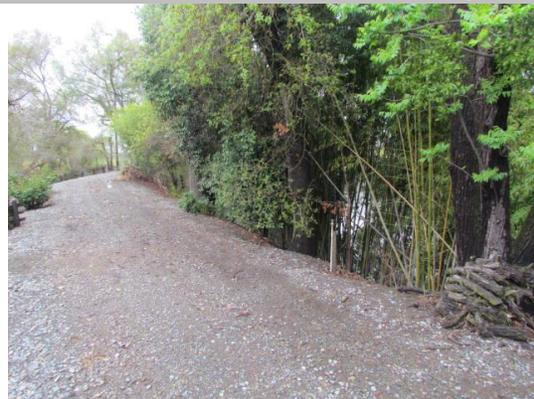
Photo 1 of 1 : richard\_s\_20140310\_352.jpg

Looking northeast at dense vegetation on waterside slope.

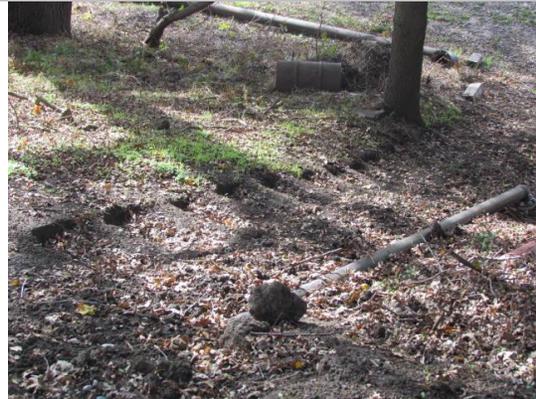
Photo 1 of 1 : richard\_s\_20140310\_359.jpg

Looking east at excavated stairs on landside slope

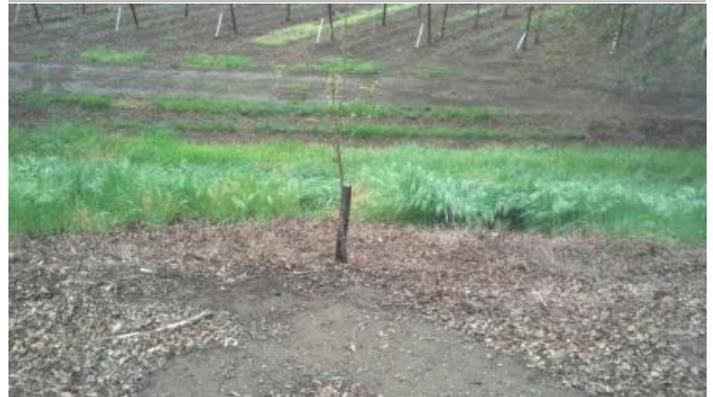
Photo 2 of 2 : richard\_s\_20140310\_377.jpg

Looking west at newly planted tree on landside slope.

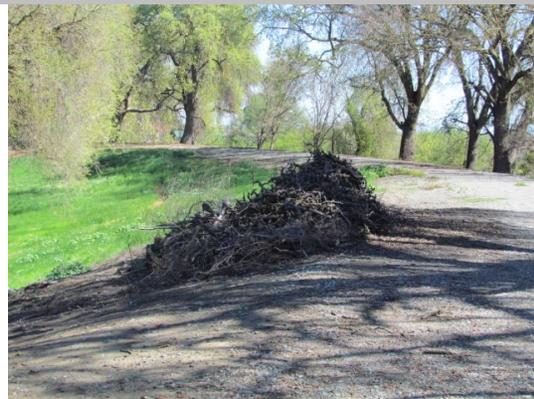
Photo 1 of 1 : richard\_s\_20140314\_461.jpg

Looking east prunings on landward slope.

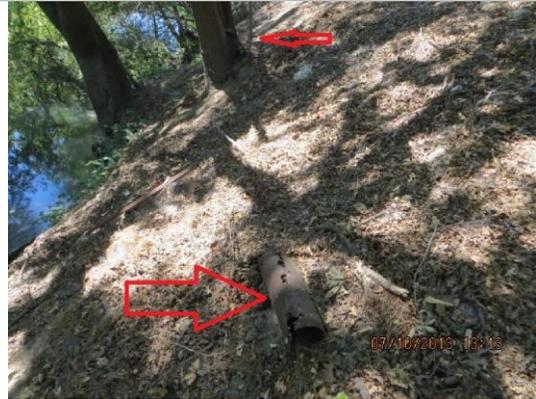
Photo 1 of 1 : UCIP\_1374.jpg

8-inch pipe debris with 1.5-inch electrical conduit visible in background on WS slope.

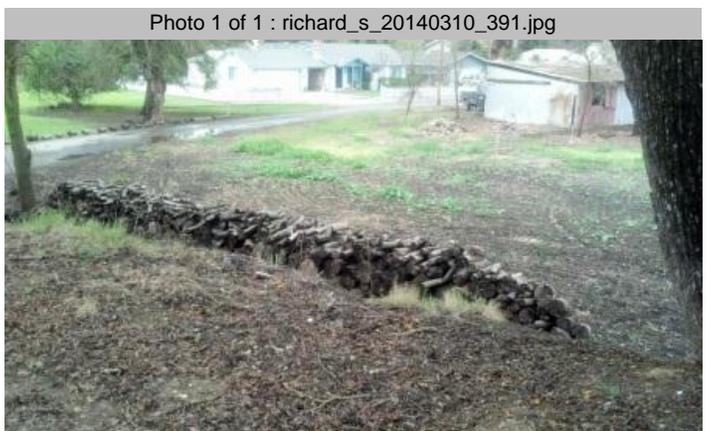
Looking north at firewood piled at landside toe.
