**Flood Control Project Maintenance
Levee Inspections**
LMA District Cover Sheet
Spring 2015 Levee Inspection Results

Reclamation District No. 0999 Netherlands

Spring 2015 Levee Inspection Results

Waterway	Bank	Unit Miles
Unit No. 01 Yolo Bypass	Left	15.41

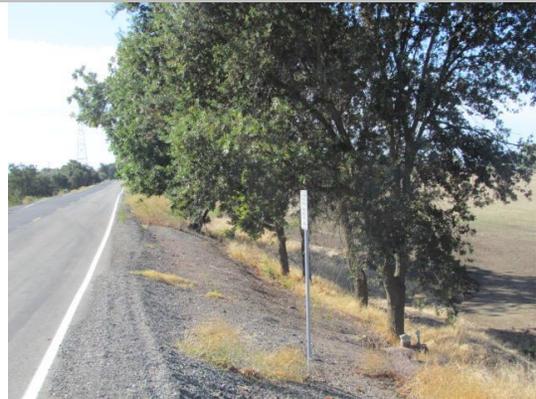
Photo 2 of 2 : SP_2015_RD0999_232_4_20150309_00007.jpg

Looking southwest at trimmed trees on waterward slope.

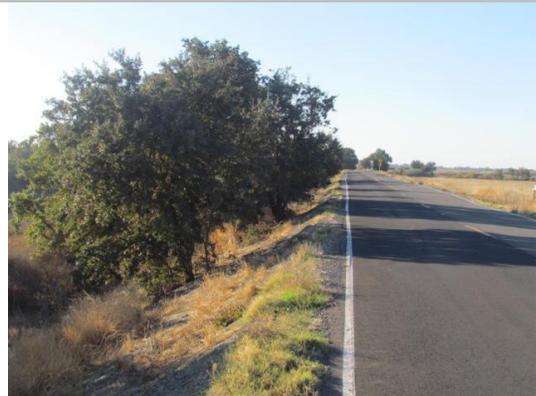
Photo 3 of 5 : SP_2015_RD0999_232_30_20150309_00030.jpg

Looking south at typical view of untrimmed trees on landward slope.

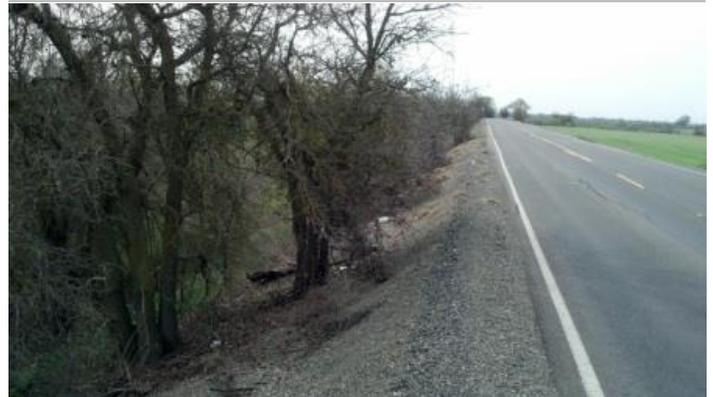
Photo 5 of 5 : SP_2015_RD0999_232_30_20150309_00032.jpg

Looking southeast at dense trees on landside slope and toe. (2013)

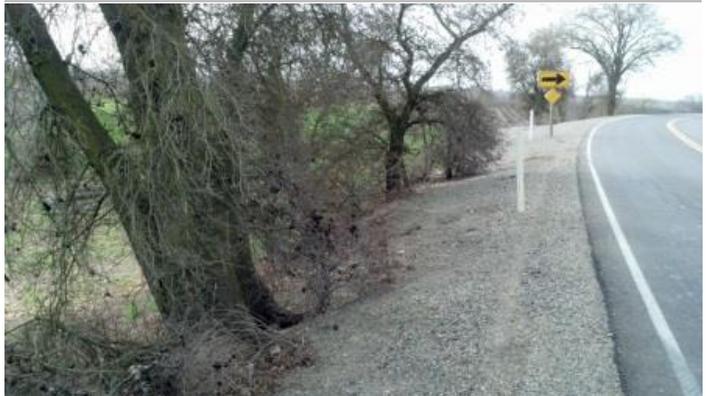
Photo 3 of 3 : SP_2015_RD0999_232_31_20150309_00034.jpg

Looking southeast at untrimmed trees on landside slope.

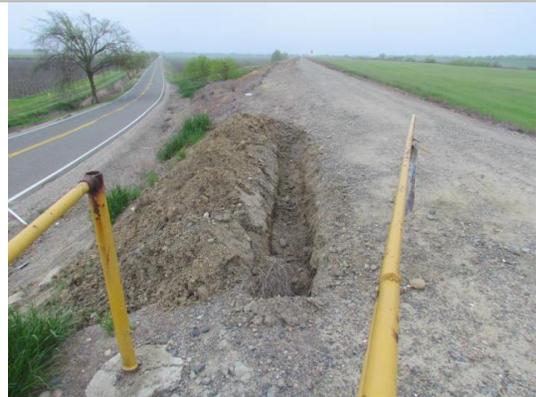
Photo 1 of 3 : SP_2015_RD0999_232_40_20150309_00039.jpg

Looking south at excavation with backhoe on landside shoulder.

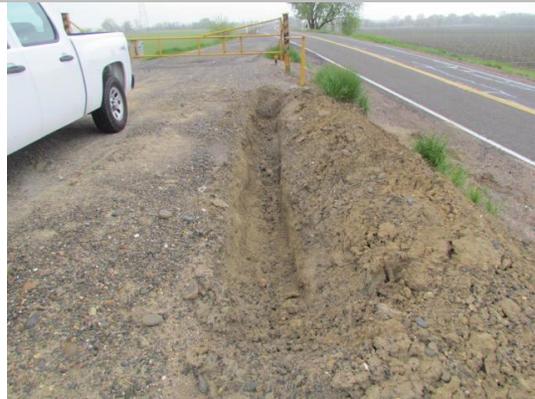
Photo 3 of 3 : SP_2015_RD0999_232_40_20150309_00041.jpg

Looking north at excavation on landside shoulder.

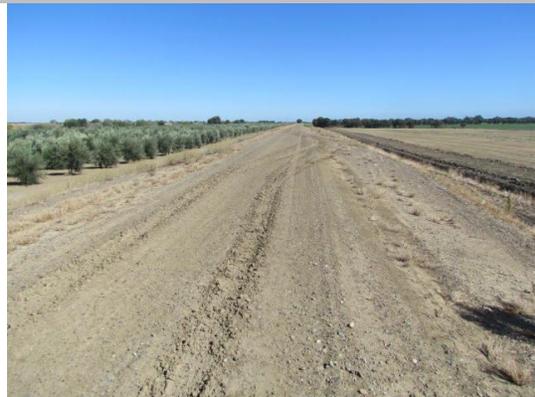
Photo 1 of 3 : SP_2015_RD0999_232_46_20150309_00046.jpg

LM Start	2.76	Rating **	A/W	Issue No.	46
LM End	4.98	Issue Type +	Ma	Location *	CR
Category	Earthen Levee		GPS Latitude/Longitude		
			Start	End	
Item	Crown Surface / Depressions / Rutting		38.465627 °	38.435378 °	
			-121.584634 °	-121.598664 °	
DWR ID	DWR_RD0999_01_f_2013_46				
Action/Comments					
Repair depressions or ruts in the crown or slope.					
Inspector Comments: Control growth on levee crown and repair ruts on levee crown.

Looking north at rutting on levee crown.

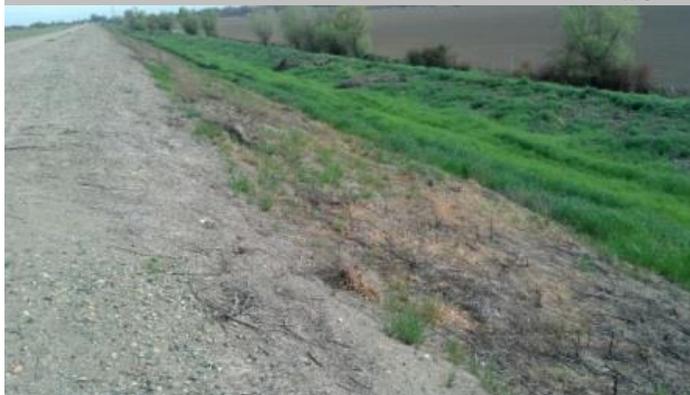
Photo 1 of 2 : SP_2015_RD0999_232_51_20150309_00056.jpg

LM Start	3.24	Rating **	M	Issue No.	51
LM End	3.26	Issue Type +	Ma	Location *	LS
Category	Earthen Levee			GPS Latitude/Longitude	
				Start	End
Item	Slope Stability				
DWR ID	DWR_RD0999_01_s_2013_51				
Action/Comments					
Repair slope instability. Inspector Comments: Depression on waterside shoulder and slope 60' x 20'. Earthen material appears to be sliding toward levee toe.

Looking north at depression on landside shoulder and slope.

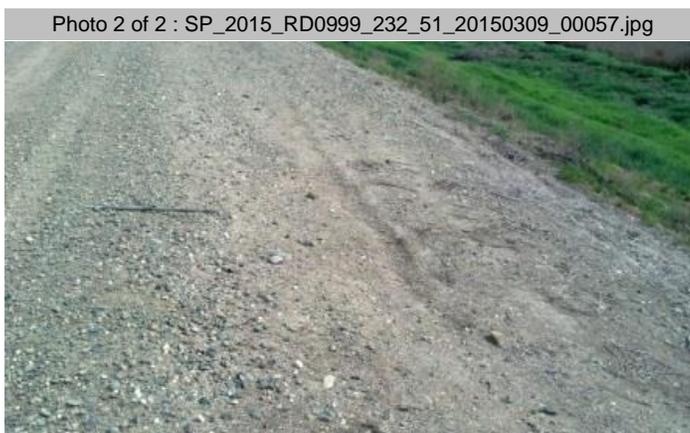
LM Start	3.24	Rating **	M	Issue No.	51 (cont)
LM End	3.26	Issue Type +	Ma	Location *	LS
Category	Earthen Levee			GPS Latitude/Longitude	
				Start	End
Item	Slope Stability			°	°
DWR ID	DWR_RD0999_01_s_2013_51				
Action/Comments					
Repair slope instability. Inspector Comments: Depression on waterside shoulder and slope 60' x 20'. Earthen material appears to be sliding toward levee toe.

Looking northeast at depression on landside shoulder.

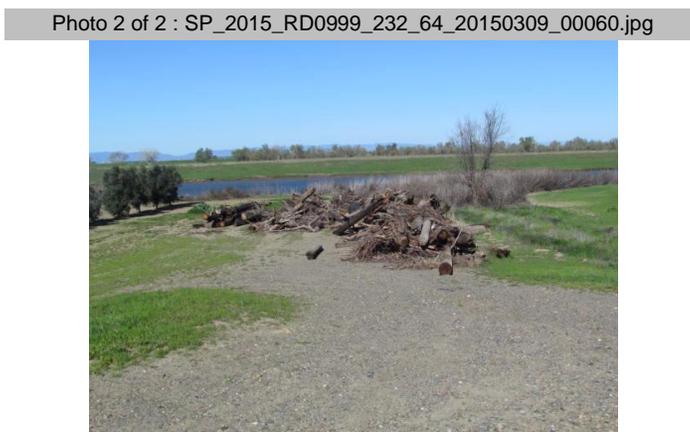
LM Start	3.30	Rating **	M	Issue No.	64 (cont)
LM End	3.30	Issue Type +	En	Location *	WS

Looking west at prunings on waterward berm.

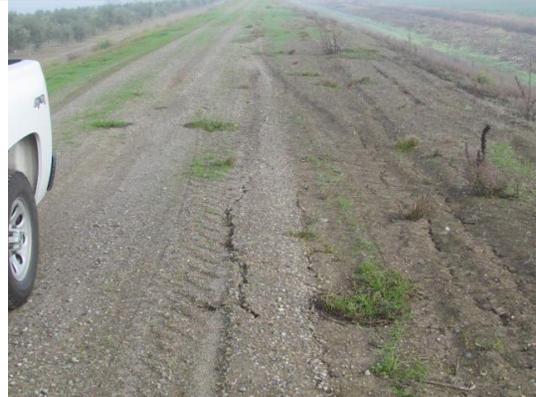
Photo 1 of 2 : SP_2015_RD0999_232_6_20150309_00011.jpg

LM Start	3.62	Rating **	M	Issue No.	6
LM End	3.64	Issue Type +	Ob	Location *	LS
Category	Earthen Levee		GPS Latitude/Longitude		
			Start	End	
Item	Slope Stability		38.454032 °	38.453680 °	
			-121.590025 °	-121.590173 °	
DWR ID	DWR_RD0999_01_s_2012_6				
Action/Comments					
Repair slope instability. Inspector Comments: District Manager (Bob Webber) indicated that the area has a history of cracking and sloughing. District plans to repair site this summer. District repaired site without notifying the Dept. No compaction results provided. Unclear how site was repaired. Need more information about repair from district. During the fall inspection

Looking north at sloughing on landside shoulder and slope.

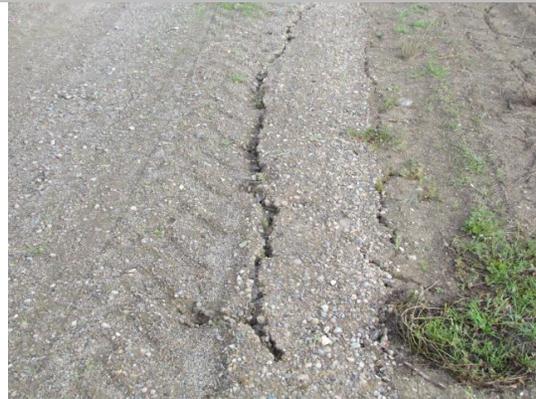
Photo 2 of 2 : SP_2015_RD0999_232_6_20150309_00012.jpg

Looking north at cracking and sloughing on landside shoulder and slope.

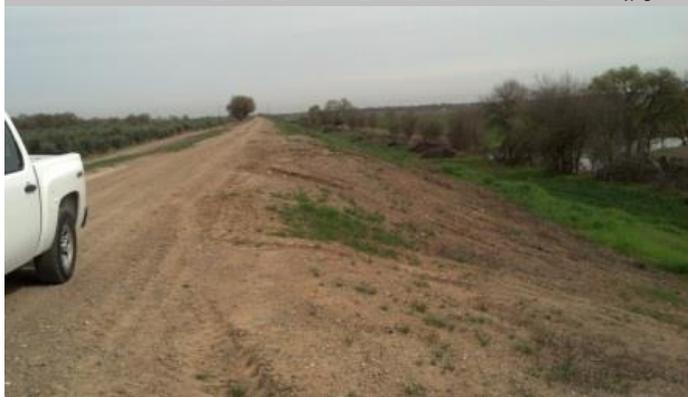
Photo 3 of 4 : SP_2015_RD0999_232_35_20150309_00035.jpg

LM Start	4.31	Rating **	M	Issue No.	35 (cont)
LM End	4.31	Issue Type +	Ma	Location *	LS
Category	Earthen Levee			GPS Latitude/Longitude	
				Start	End
Item	Slope Stability			38.444561 °	38.444561 °
				-121.594438 °	-121.594438 °
DWR ID	DWR_RD0999_01_f_2012_35				
Action/Comments					
Repair the levee slope damaged by vehicle traffic and prevent access where possible. Inspector Comments: Depression is caused by vehicle traffic.

Looking north at slope damage caused by vehicle traffic.

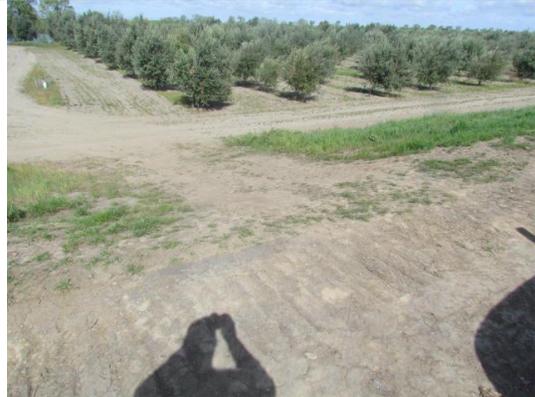
Photo 1 of 3 : SP_2015_RD0999_232_27_20150327_00078.jpg

LM Start	4.31	Rating **	M	Issue No.	27
LM End	4.31	Issue Type +	Ma	Location *	WS
Category	Earthen Levee			GPS Latitude/Longitude	
				Start	End
Item	Slope Stability			38.444560 °	38.444560 °
				-121.594440 °	-121.594440 °
DWR ID	DWR_RD0999_01_f_2012_27				
Action/Comments					
Repair the levee slope damaged by vehicle traffic and prevent access where possible. Inspector Comments: Local farmer causing slope damage by driving equipment and trucks on slope.

Looking west at slope damage cause by vehicle traffic on waterward slope. (Spring 2015)

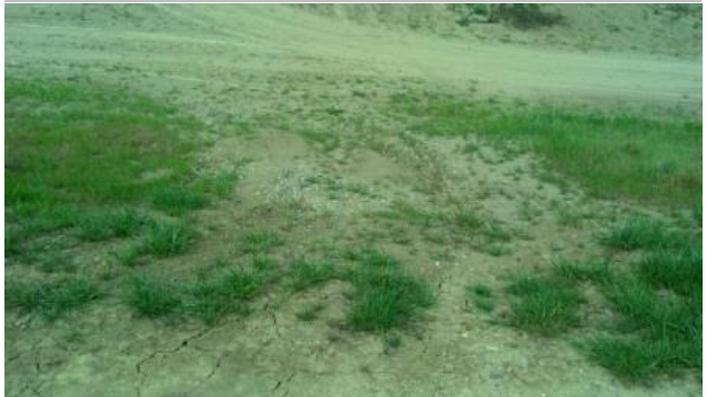
Photo 3 of 3 : SP_2015_RD0999_232_27_20150309_00026.jpg

Looking west at slope damage on waterside slope. (Spring 2014)

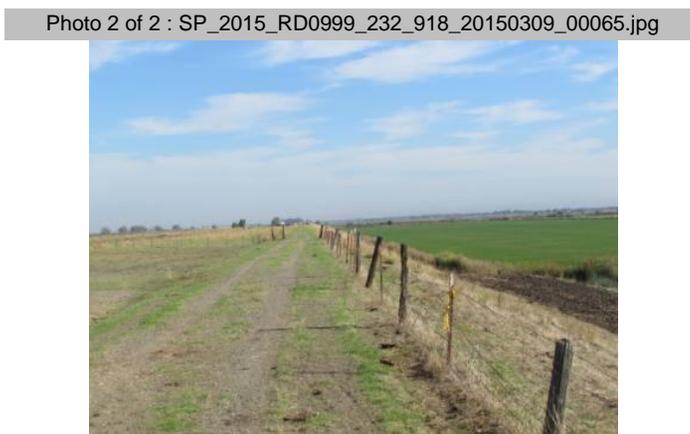
LM Start	9.19	Rating **	M	Issue No.	918 (cont)
LM End	9.25	Issue Type +	En	Location *	LS

Looking north at fence along landside shoulder.

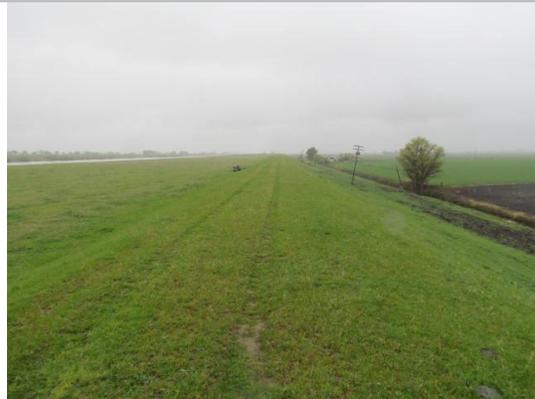
Photo 2 of 2 : SP_2015_RD0999_232_919_20150309_00066.jpg

Looking south at crown roadway. Spring 2014

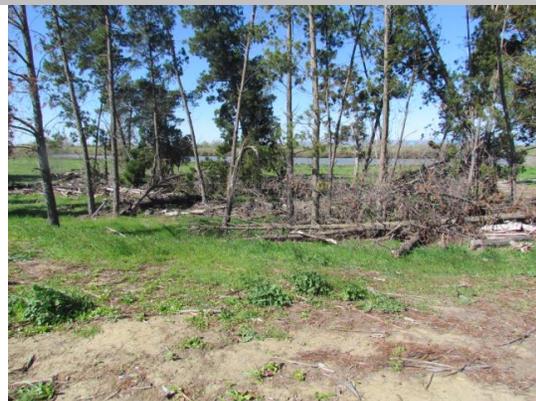
Photo 1 of 1 : SP_2015_RD0999_232_67_20150309_00063.jpg

Looking west at pruning piles on waterward berm.

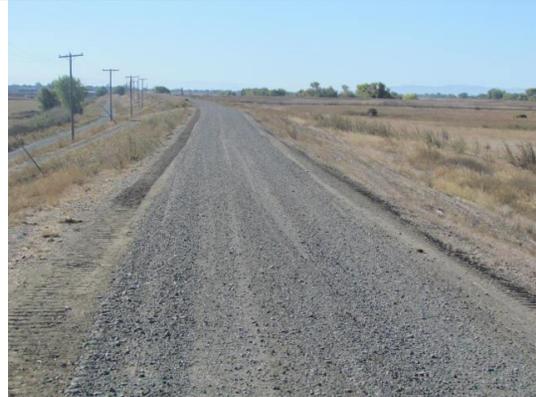
Photo 1 of 4 : SP_2015_RD0999_232_21_20150309_00018.jpg

Looking south at graded levee crown.(Fall 2014)

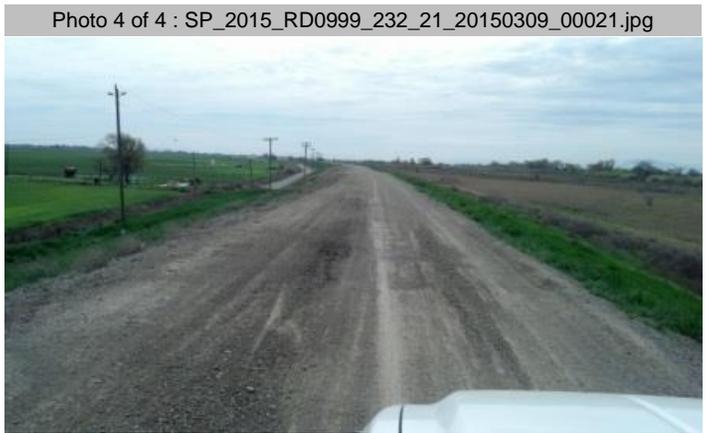
LM Start	12.53	Rating **	A/W	Issue No.	21 (cont)
LM End	12.60	Issue Type +	Ma	Location *	CR
Category	Earthen Levee			GPS Latitude/Longitude	
				Start	End
Item	Crown Surface / Depressions / Rutting			38.332288 °	38.331247 °
				-121.644640 °	-121.644765 °
DWR ID	DWR_RD0999_01_s_2012_21				
Action/Comments					
Repair depressions or ruts in the crown or slope.

Looking south at rutting on levee crown. Spring 2013

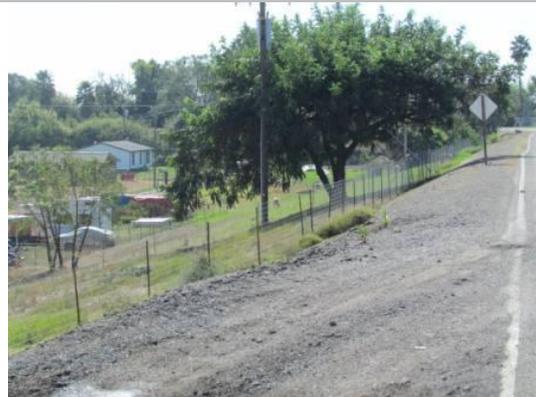
Photo 3 of 3 : SP_2015_RD0999_232_39_20150309_00038.jpg

Looking south at fence along landside slope.

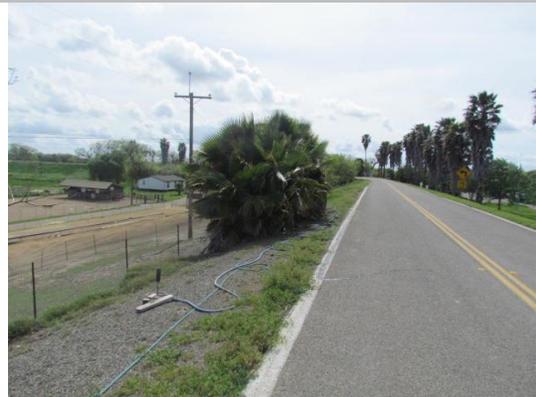
Photo 1 of 3 : SP_2015_RD0999_232_50_20150327_00087.jpg

Looking northeast at a mature palm trees on landward shoulder and slope. (Spring 2015)

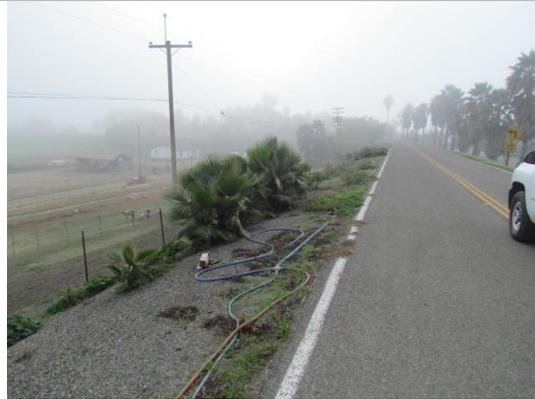
Photo 3 of 3 : SP_2015_RD0999_232_50_20150309_00055.jpg

Looking east at newly planted palm trees on landside shoulder and slope.

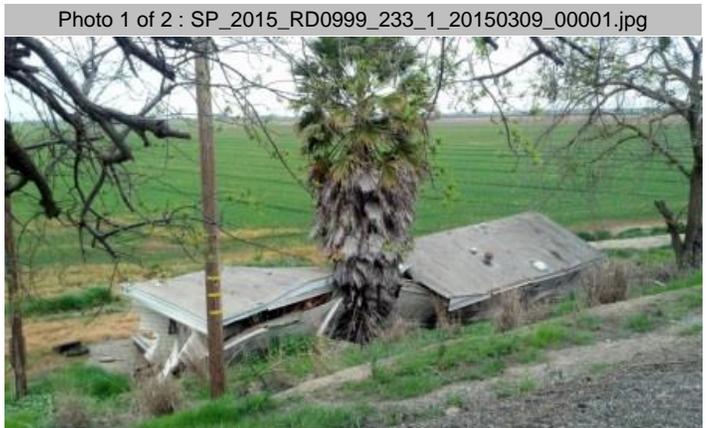
LM Start	0.21	Rating **	U	Issue No.	1
LM End	0.21	Issue Type +	En	Location *	LS
Category	Earthen Levee		GPS Latitude/Longitude		
			Start	End	
Item	Encroachments		38.290859 °	38.290859 °	
			-121.641220 °	-121.641220 °	
DWR ID	DWR_RD0999_02_f_2012_1				
Action/Comments					
Building Inspector Comments: Dilapidated building at landside toe.

Looking northwest at dilapidated building on landside toe. Spring 2013

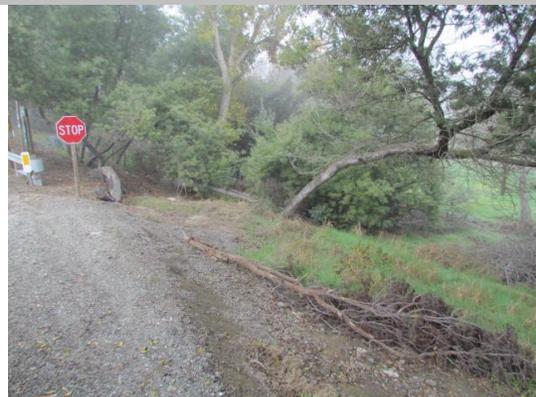
Photo 1 of 1 : SP_2015_RD0999_233_19_20150309_00020.jpg

Looking southeast at dense trees on landside slope and toe.

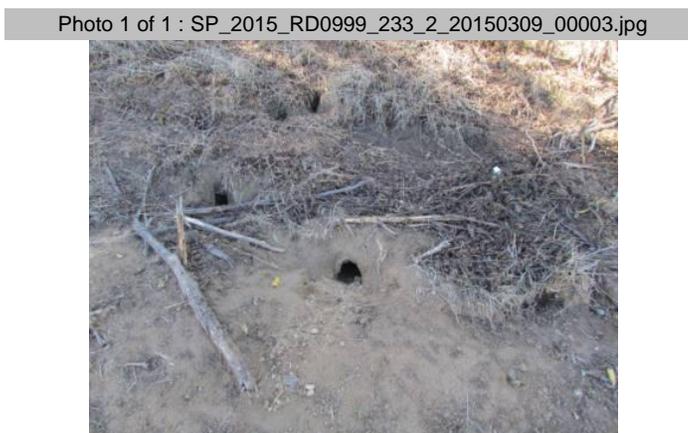
LM Start	0.93	Rating **	A/W	Issue No.	2
LM End	1.03	Issue Type +	Ma	Location *	LS
Category	Earthen Levee			GPS Latitude/Longitude	
				Start	End
Item	Animal Control			38.291823 °	38.291250 °
				-121.628973 °	-121.627285 °
DWR ID	DWR_RD0999_02_s_2012_2				
Action/Comments					
Exterminate rodents and backfill and compact or grout burrows.

Looking at several rodent holes on landside slope.

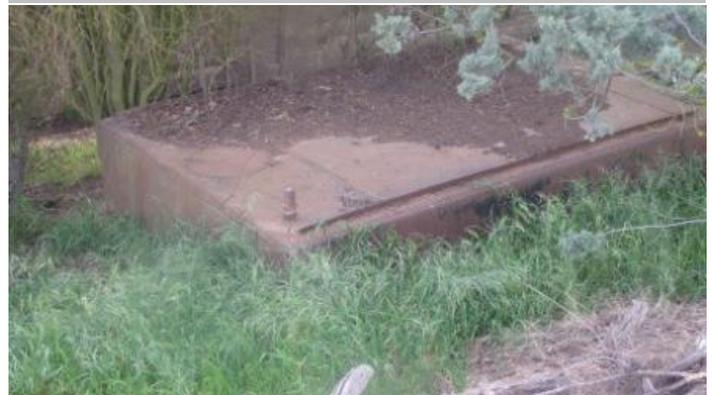
Photo 1 of 1 : SP_2015_RD0999_233_10_20150309_00010.jpg

Looking north at a tank on the landside slope and toe.

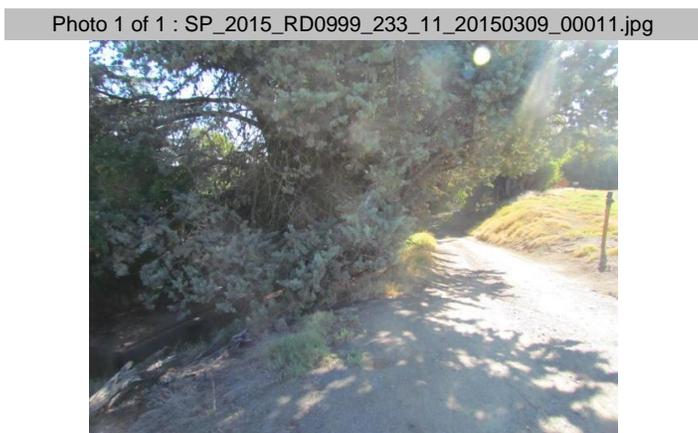
LM Start	1.70	Rating **	U	Issue No.	11
LM End	1.70	Issue Type +	Ma	Location *	LS
Category	Earthen Levee		GPS Latitude/Longitude		
			Start	End	
Item	Trim / Thin Trees		38.290171 °	38.290171 °	
			-121.615260 °	-121.615260 °	
DWR ID	DWR_RD0999_02_s_2012_11				
Action/Comments					
Trim trees to at least five feet above ground level.

Looking southwest at dense trees on landward slope.

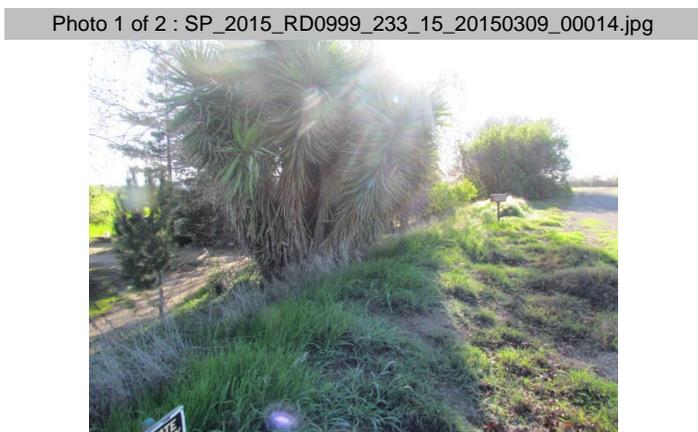
LM Start	1.72	Rating **	U	Issue No.	15
LM End	1.73	Issue Type +	En	Location *	LS
Category	Earthen Levee		GPS Latitude/Longitude		
			Start	End	
Item	Vegetation		38.290026 °	38.289865 °	
			-121.614942 °	-121.614742 °	
DWR ID	DWR_RD0999_02_s_2012_15				
Action/Comments					
Landscaping

Looking north at landscaping on landside slope.

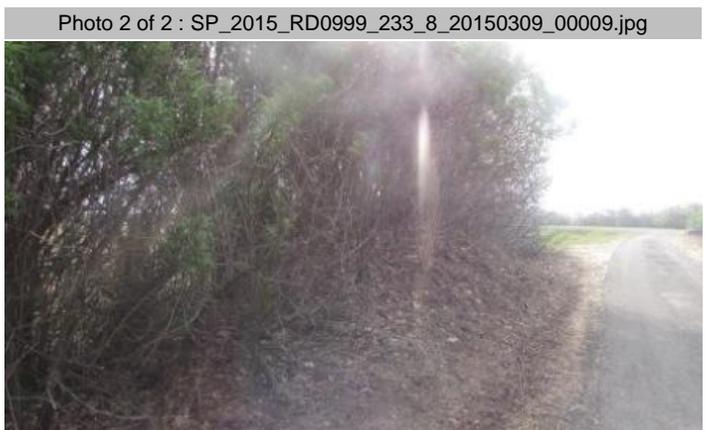
LM Start	1.73	Rating **	M	Issue No.	8 (cont)
LM End	1.76	Issue Type +	Ma	Location *	LS

Looking southwest at elderberry bush on landside shoulder and slope. (Fall 2014)

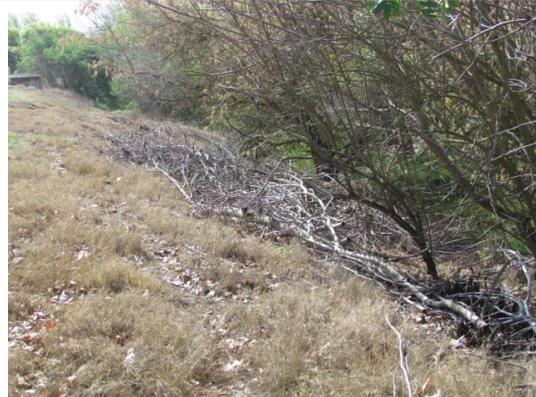
Photo 1 of 1 : SP_2015_RD0999_233_21_20150309_00021.jpg

Looking northeast at prunings on waterside slope.

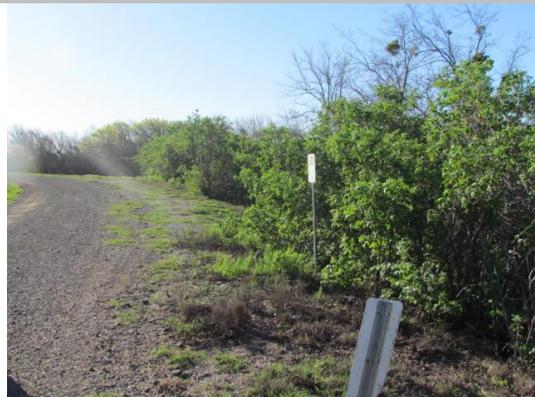
Photo 2 of 2 : SP_2015_RD0999_233_38_20150309_00030.jpg

Looking east at dense vegetation on waterside slope.

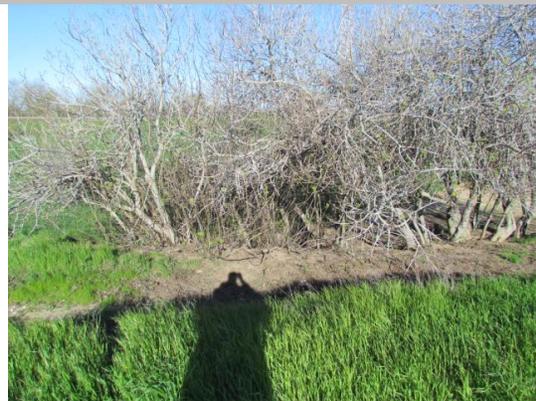
Photo 4 of 4 : SP_2015_RD0999_234_4_20150309_00009.jpg

Looking west at dense fig trees at landside toe.

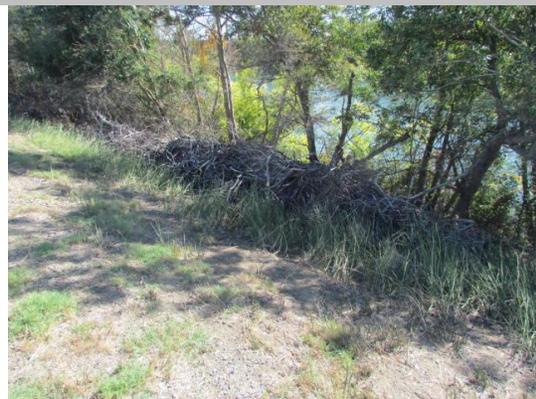
Photo 1 of 1 : SP_2015_RD0999_234_36_20150309_00028.jpg

Looking east at prunings on waterward slope.

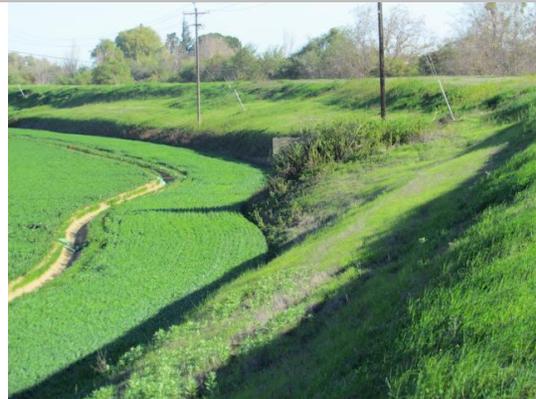
Photo 2 of 2 : SP_2015_RD0999_234_45_20150309_00032.jpg

Looking north at crops encroaching onto landside toe.

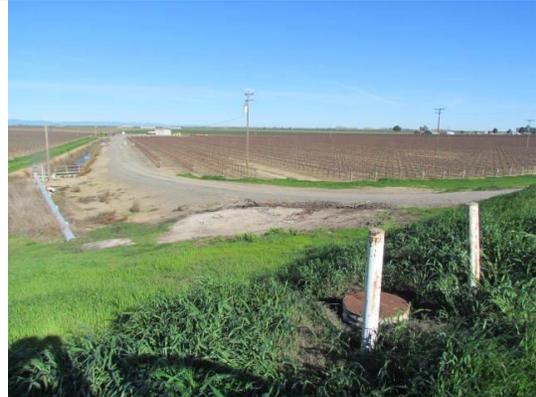
Photo 1 of 2 : SP_2015_RD0999_234_2_20150309_00004.jpg

Looking west at burned prunings on landward berm.

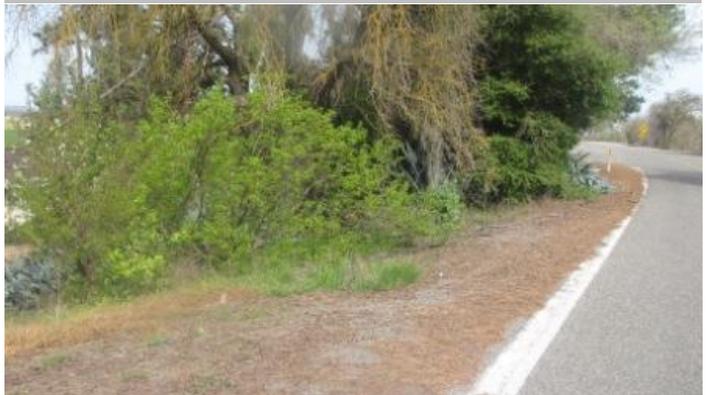
Photo 2 of 2 : SP_2015_RD0999_234_16_20150309_00017.jpg

Looking northwest at landscaping and dense veg. on landside slope and toe.

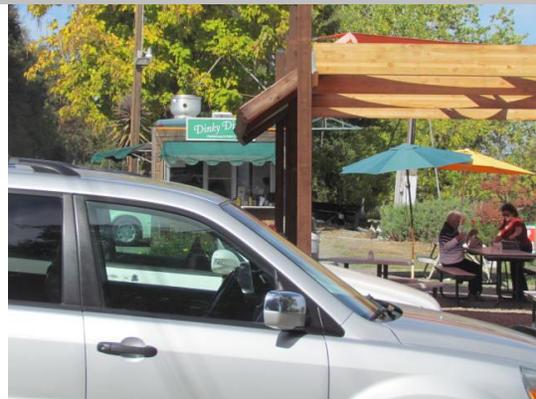
Photo 1 of 2 : SP_2015_RD0999_235_36_20150309_00018.jpg

Looking north at patio structure on waterward shoulder.

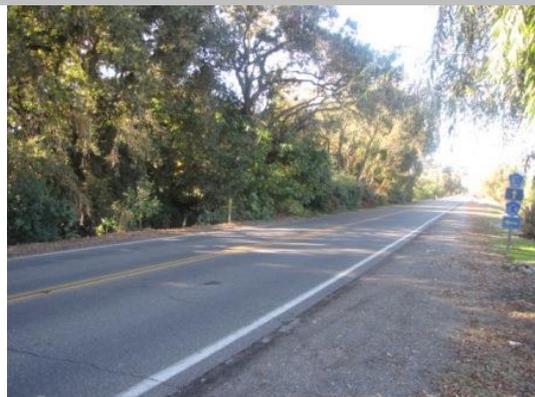
Photo 2 of 2 : SP_2015_RD0999_235_12_20150309_00011.jpg

Looking northwest at dense veg. on landside shoulder and slope.

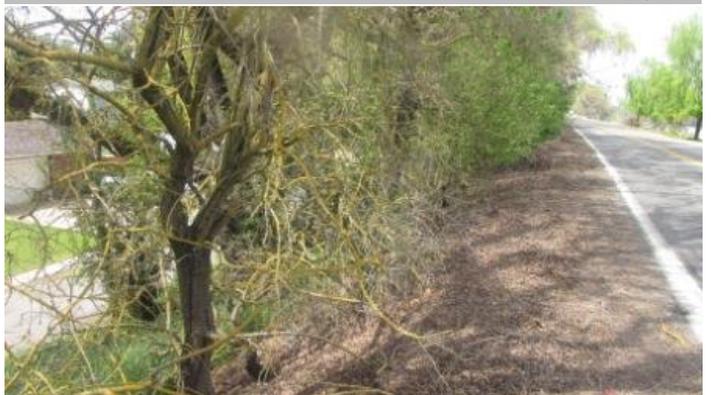
Photo 1 of 2 : SP_2015_RD0999_235_10_20150309_00007.jpg

Looking northwest at dense trees on landside slope and toe.

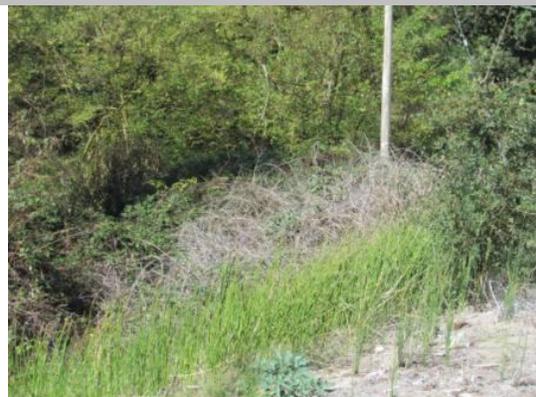
Photo 2 of 2 : SP_2015_RD0999_235_5_20150309_00003.jpg

Looking northwest at dense wild roses and berry vines on landside toe near ramp.

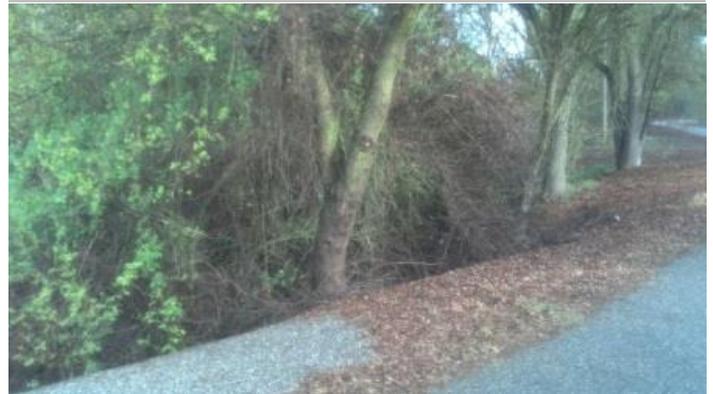
Photo 3 of 6 : SP_2015_RD0999_236_9_20150309_00005.jpg

Looking northwest at dense trees at landside slope and toe. (Spring 2013)

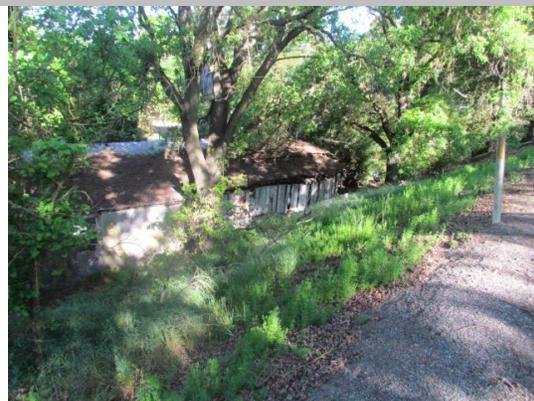
Photo 1 of 2 : SP_2015_RD0999_236_23_20150327_00144.jpg

Looking northwest at abandoned storage shed at landward toe. (Spring 2015)

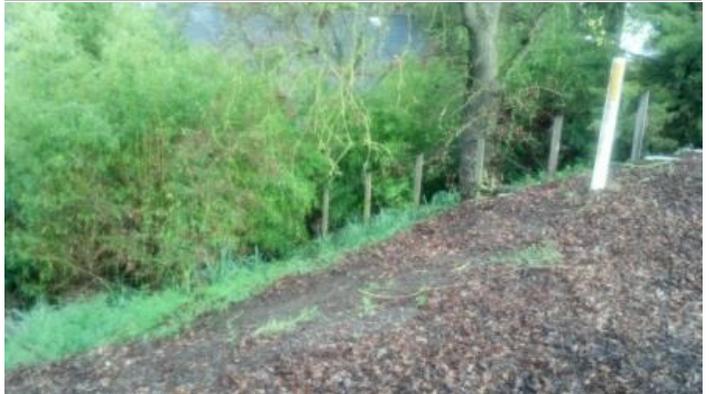
Photo 2 of 2 : SP_2015_RD0999_236_128_20150309_00076.jpg

Looking at dense trees on landside slope and toe.

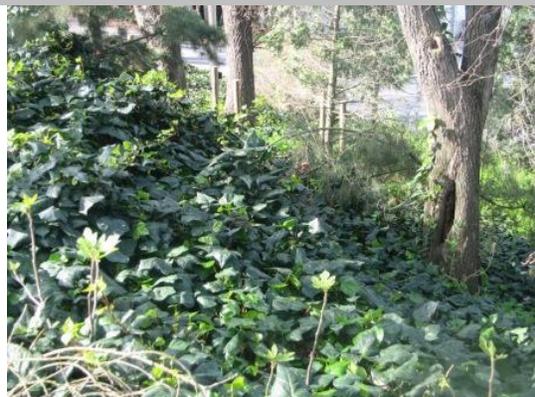
Photo 2 of 2 : SP_2015_RD0999_236_11_20150309_00009.jpg

View of landscaping (Ivy) blocking view of landside slope from.

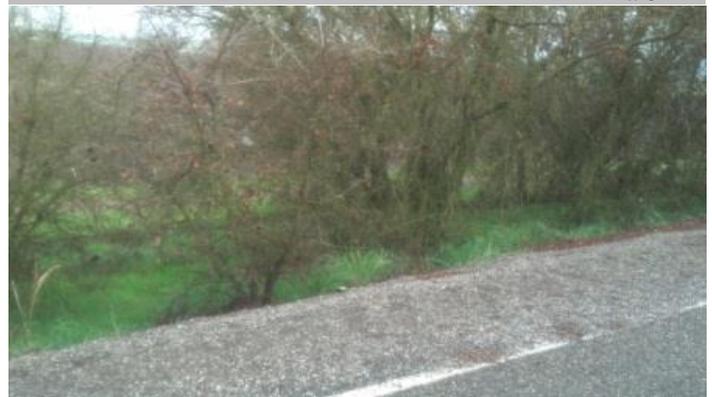
Photo 1 of 1 : SP_2015_RD0999_236_14_20150309_00010.jpg

Looking west at dense trees on landside slope and toe.

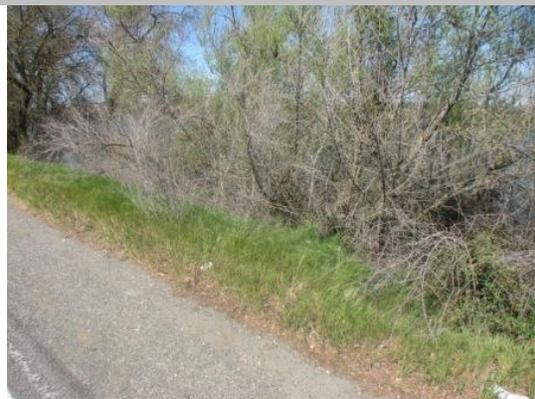
Photo 2 of 2 : SP_2015_RD0999_236_18_20150309_00016.jpg

Front view of dense trees along waterside slope.

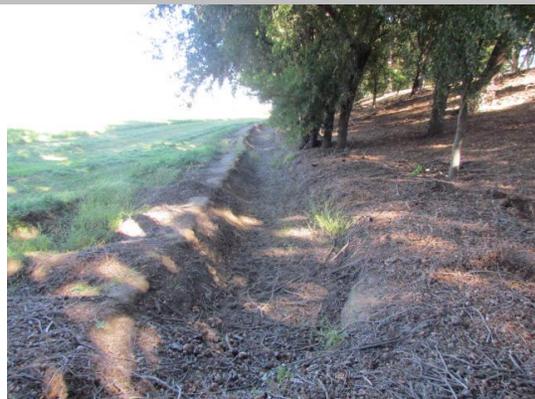
Photo 1 of 1 : SP_2015_RD0999_236_152_20150309_00092.jpg

Looking north at abandoned irrigation ditch at landward toe.

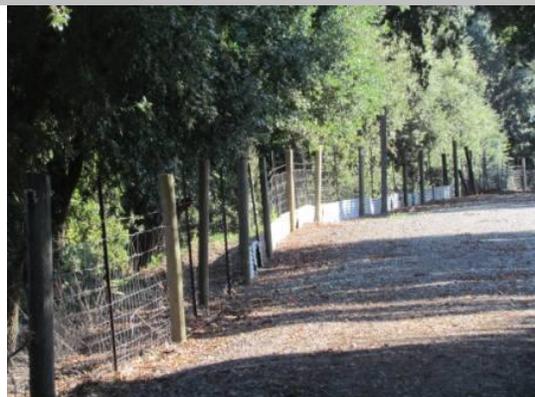
Photo 1 of 2 : SP_2015_RD0999_236_85_20150309_00059.jpg

Looking north at fence along landside shoulder.

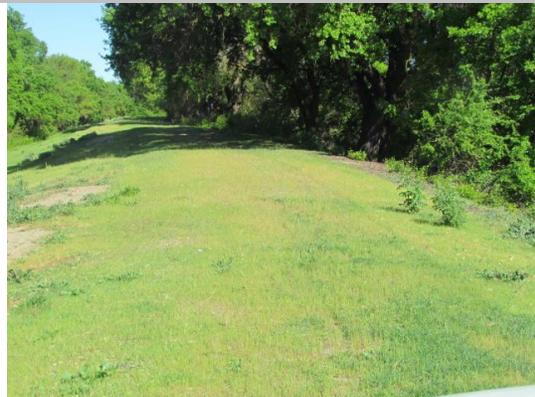
Photo 1 of 1 : SP_2015_RD0999_236_181_20150327_00152.jpg

Looking north at vegetation on levee crown. (Spring 2015)

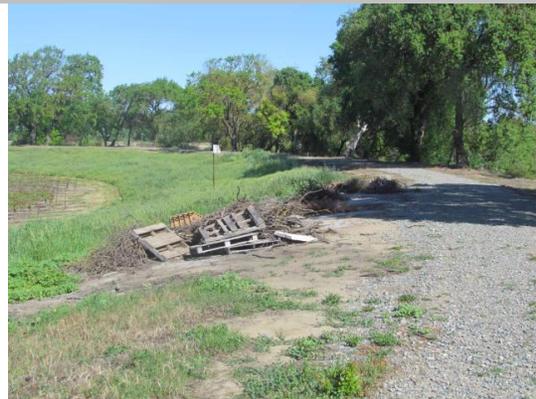
Photo 1 of 1 : SP_2015_RD0999_236_65_20150327_00156.jpg

Looking north at prunings on landward slope. (Spring 2015)

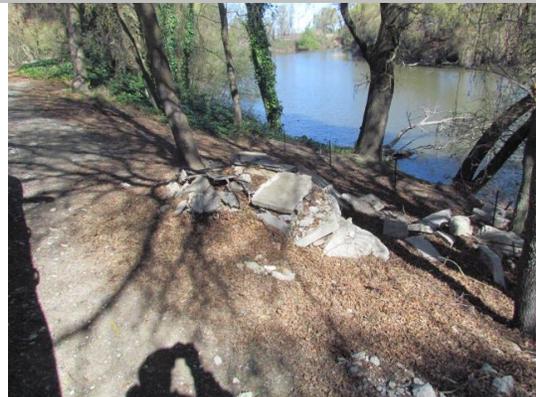
Photo 1 of 1 : SP_2015_RD0999_236_138_20150309_00085.jpg

Looking northeast at concrete rubble on waterward slope.

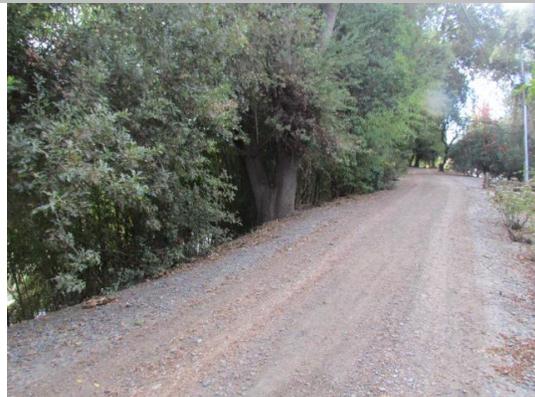
Photo 1 of 1 : SP_2015_RD0999_236_67_20150309_00051.jpg

Looking north at dense vegetation on landward shoulder and slope.

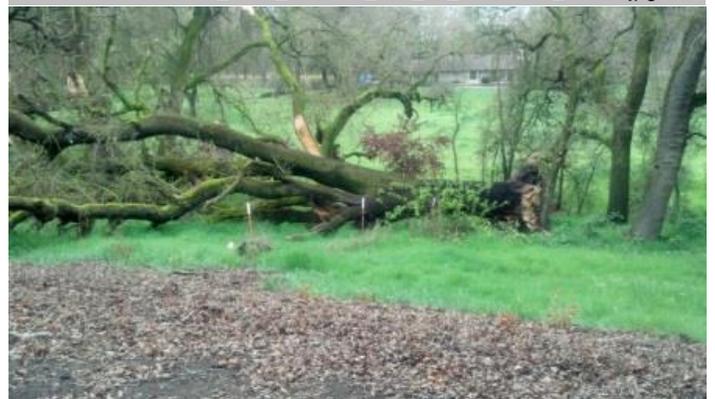
Photo 4 of 5 : SP_2015_RD0999_236_39_20150309_00033.jpg

Looking west at large tree on landside slope and toe.

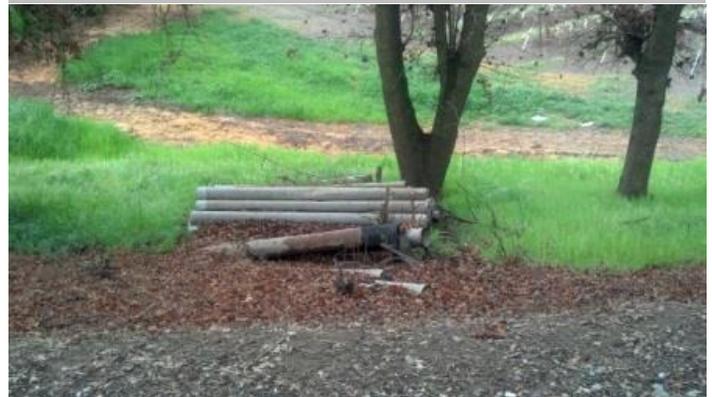
Photo 1 of 1 : SP_2015_RD0999_236_140_20150309_00086.jpg

Looking west at irrigation pipes on landside toe.

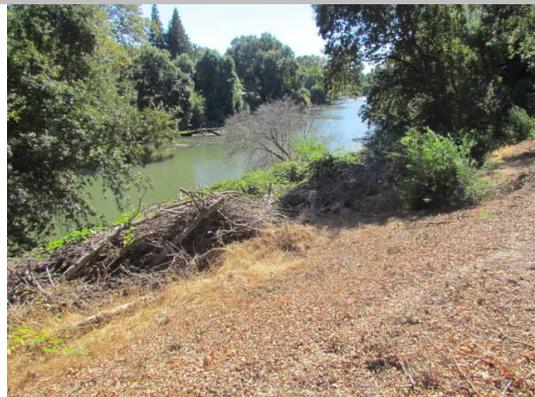
Photo 1 of 1 : SP_2015_RD0999_236_74_20150309_00055.jpg

Looking southeast at prunings on waterward slope.

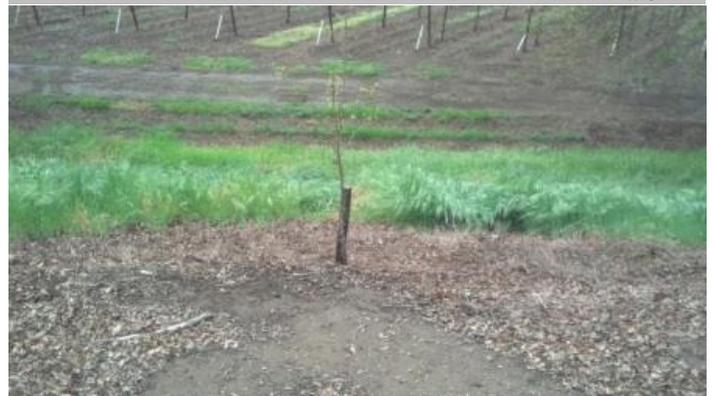
Photo 1 of 2 : SP_2015_RD0999_236_97_20150309_00069.jpg

Looking west at newly planted tree on landside slope.

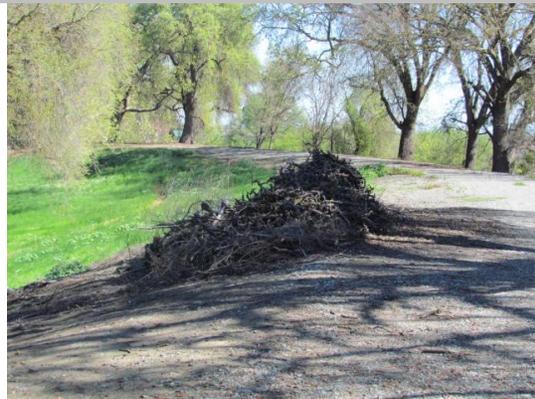
Photo 1 of 1 : SP_2015_RD0999_236_92_20150309_00063.jpg

Looking east prunings on landward slope.

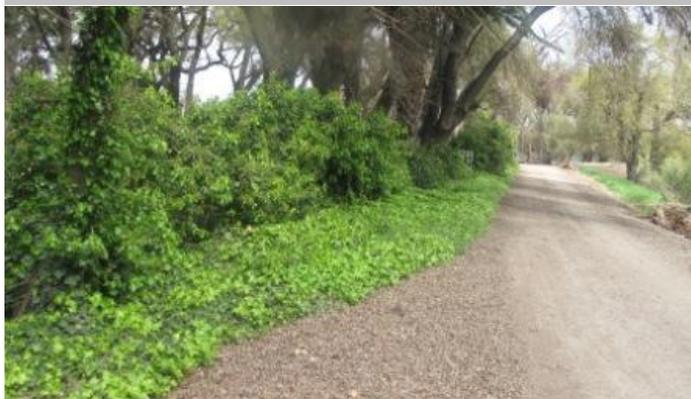
Photo 1 of 1 : SP_2015_RD0999_236_93_20150309_00064.jpg

Looking north at overgrown landscape on landside slope and toe.

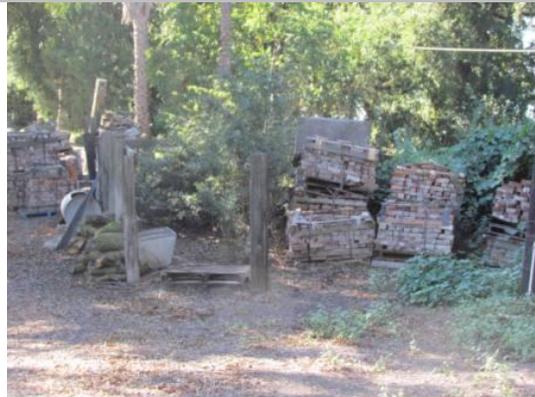
Photo 3 of 4 : SP_2015_RD0999_236_96_20150309_00067.jpg

Looking south at firewood and other material on landside shoulder and crown.

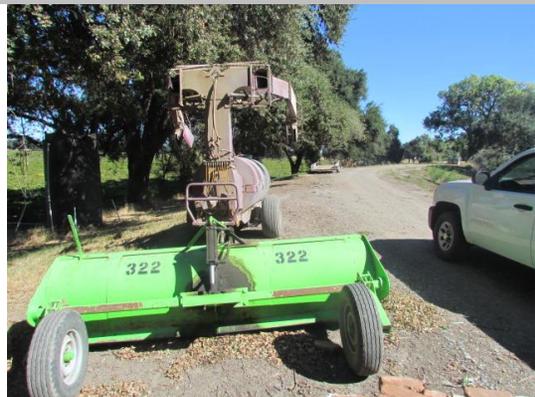
Photo 2 of 3 : SP_2015_RD0999_236_156_20150309_00099.jpg

Looking north at farm equipment on landward shoulder.

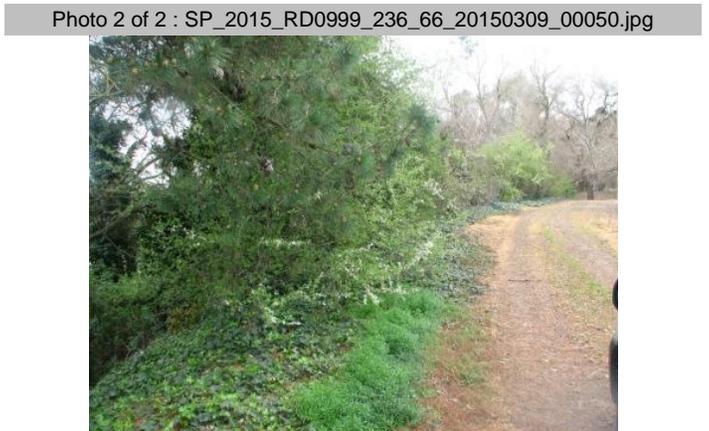
LM Start	7.54	Rating **	U	Issue No.	66 (cont)
LM End	7.58	Issue Type +	En	Location *	LS

Landscaping on landside slope blocking view of slope.

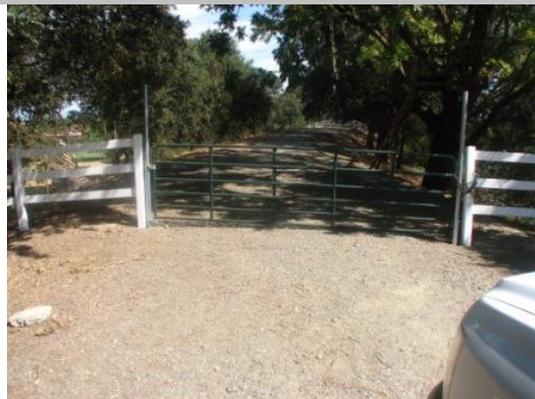
Photo 1 of 2 : SP_2015_RD0999_236_103_20150309_00072.jpg

View of fence & gate across levee crown, landside & waterside slope.

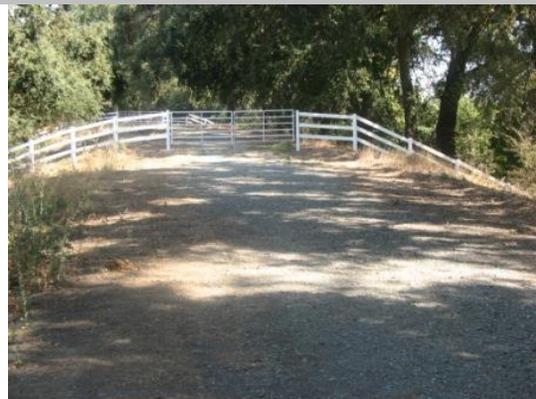
Photo 1 of 1 : SP_2015_RD0999_236_104_20150309_00074.jpg

New unauthorized fence and gate that extends from landside toe across levee crown to waterside toe.

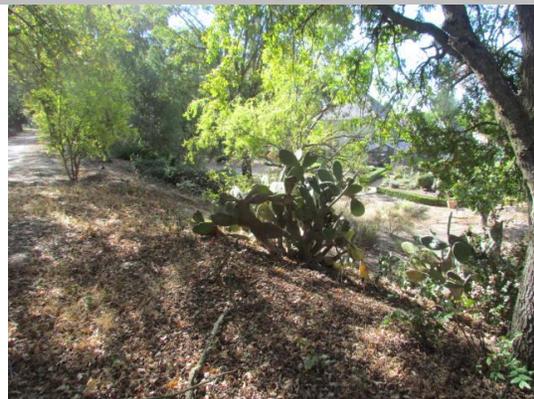
Photo 1 of 1 : SP_2015_RD0999_236_127_20150309_00075.jpg

Looking west at cactus and other vegetation on landward slope.

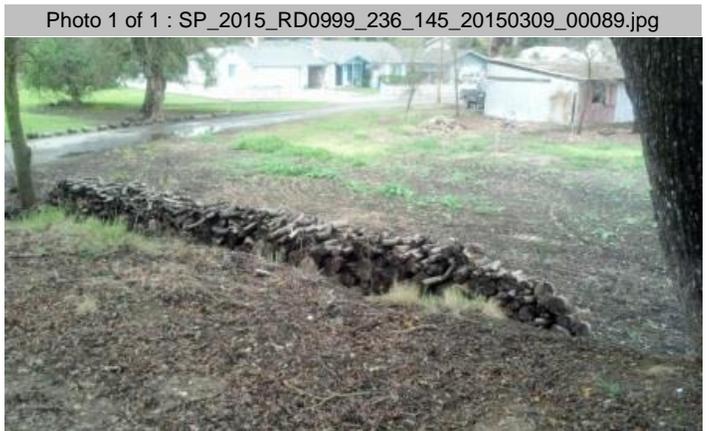
LM Start	9.44	Rating **	M	Issue No.	145
LM End	9.44	Issue Type +	En	Location *	LS
Category	Earthen Levee			GPS Latitude/Longitude	
				Start	End
Item	Encroachments			38.413755 °	38.413755 °
				-121.523723 °	-121.523723 °
DWR ID	DWR_RD0999_05_s_2013_145				
Action/Comments					
Firewood Inspector Comments: Firewood stockpile at landward toe.

Looking north at firewood piled at landside toe.
