**Flood Control Project Maintenance  
Levee Inspections**

**Maintenance Issue Types Only, Levee Inspection Report By Mile - Fall 2014**

**Reclamation District No. 0999 Netherlands**

Waterway	Bank	Unit Miles	Inspection Start/End	Inspector
Unit No. 01 Yolo Bypass	Left	15.41	10/28/2014 10/28/2014	Richard Willoughby

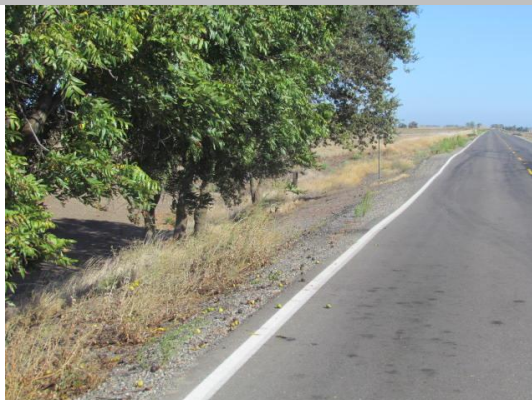
Photo 1 of 2 : FA\_2014\_RD0999\_232\_4\_20141020\_00006.jpg

Looking northwest at trimmed trees on waterward slope.

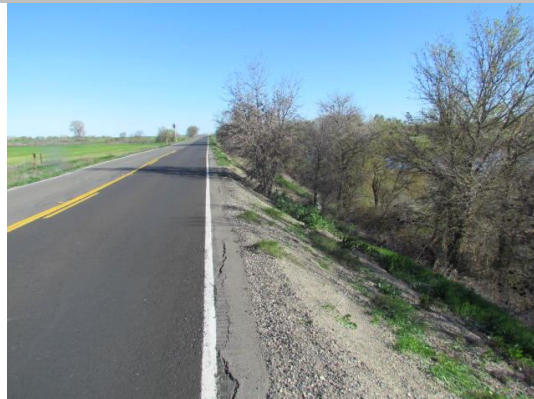
Photo 2 of 3 : FA\_2014\_RD0999\_232\_30\_20141020\_00032.jpg

Looking north at several untrimmed trees on landside slope.

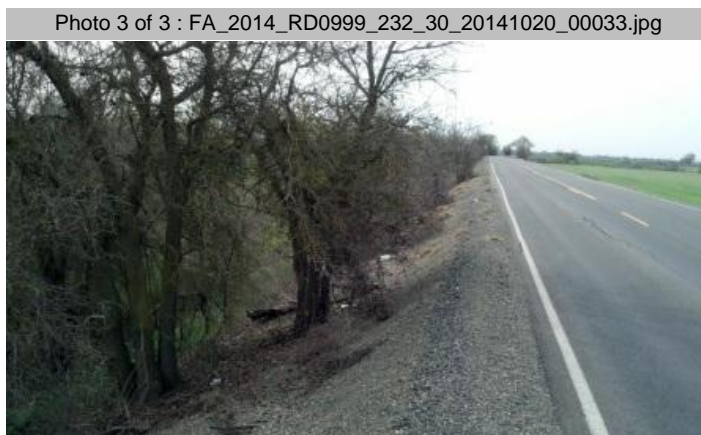
Looking southeast at dense trees on landside slope and toe. (2013)

LM Start	<b>1.81</b>	Rating **	M	Issue No.	<b>30 (cont)</b>	
LM End	<b>2.07</b>	Issue Type +	Ma	Location *	LS	
Category	Earthen Levee			GPS Latitude/Longitude		
				Start	End	
Item	Trim / Thin Trees			38.479165 °	38.475463 °	
				-121.580640 °	-121.580722 °	
DWR ID	DWR_RD0999_01_s_2012_30					
Action/Comments						
Trim trees to at least five feet above ground level.

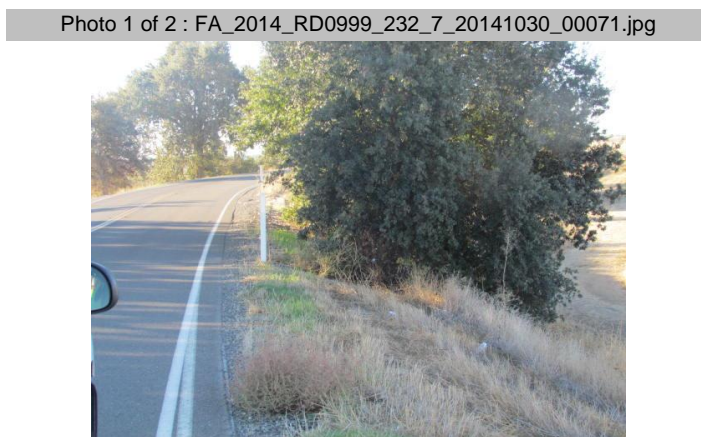
Looking south at untrimmed trees on waterward slope. (Fall 2014)

LM Start	2.15	Rating **	M	Issue No.	7
LM End	2.15	Issue Type +	Ma	Location *	WS
Category	Earthen Levee			GPS Latitude/Longitude	
				Start	End
Item	Trim / Thin Trees			38.474258 °	38.474258 °
				-121.580528 °	-121.580528 °
DWR ID	DWR_RD0999_01_s_2012_7				
Action/Comments					
Trim trees to at least five feet above ground level.

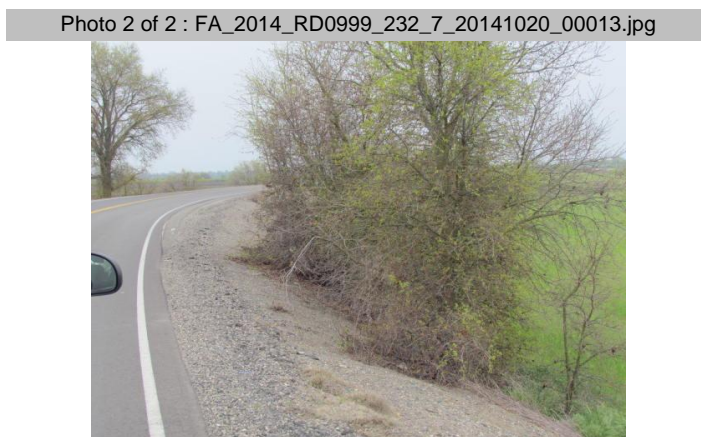
LM Start	2.15	Rating **	M	Issue No.	7 (cont)
LM End	2.15	Issue Type +	Ma	Location *	WS

Looking southwest at untrimmed trees on waterside slope.

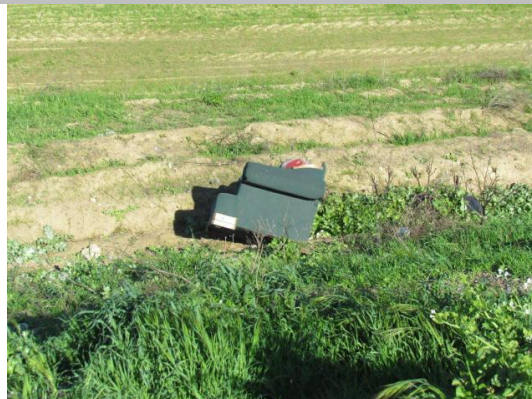
Photo 1 of 1 : FA\_2014\_RD0999\_232\_47\_20141020\_00049.jpg

Looking west at garbage (sofa) on waterward toe.

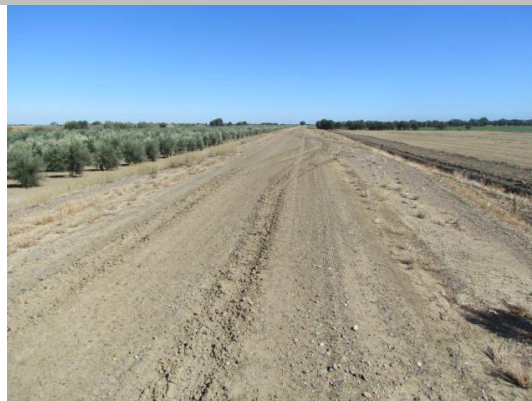
Photo 1 of 3 : FA\_2014\_RD0999\_232\_46\_20141020\_00046.jpg

Looking north at rutting on levee crown.

LM Start	2.78	Rating **	A/W	Issue No.	46
LM End	5.00	Issue Type +	Ma	Location *	CR
Category	Earthen Levee			GPS Latitude/Longitude	
				Start	End
Item	Crown Surface / Depressions / Rutting			38.465627 °	38.435378 °
				-121.584634 °	-121.598664 °
DWR ID	DWR_RD0999_01_f_2013_46				
Action/Comments					
Repair depressions or ruts in the crown or slope. Inspector Comments: Control growth on levee crown and repair ruts on levee crown.

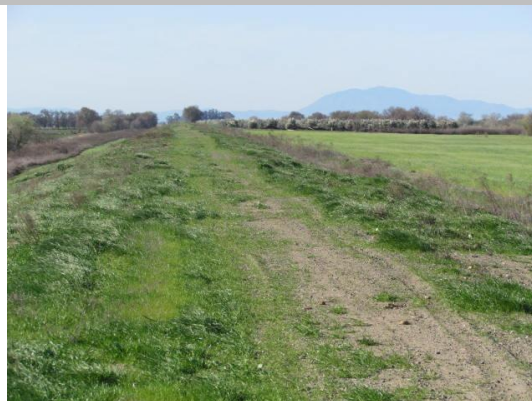
Photo 2 of 3 : FA\_2014\_RD0999\_232\_46\_20141020\_00047.jpg

Looking south at growth and ruts on levee crown.

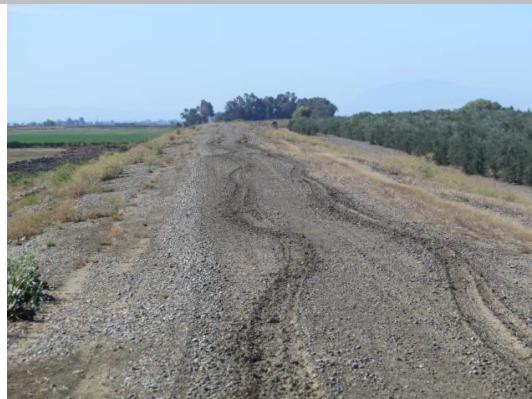
Photo 3 of 3 : FA\_2014\_RD0999\_232\_46\_20141020\_00048.jpg

Looking south at rutting on levee crown.

LM Start	2.78	Rating **	A/W	Issue No.	46 (cont)
LM End	5.00	Issue Type +	Ma	Location *	CR
Category	Earthen Levee			GPS Latitude/Longitude	
				Start	End
Item	Crown Surface / Depressions / Rutting			38.465627 °	38.435378 °
				-121.584634 °	-121.598664 °
DWR ID	DWR_RD0999_01_f_2013_46				
Action/Comments					
Repair depressions or ruts in the crown or slope.					
Inspector Comments: Control growth on levee crown and repair ruts on levee crown.

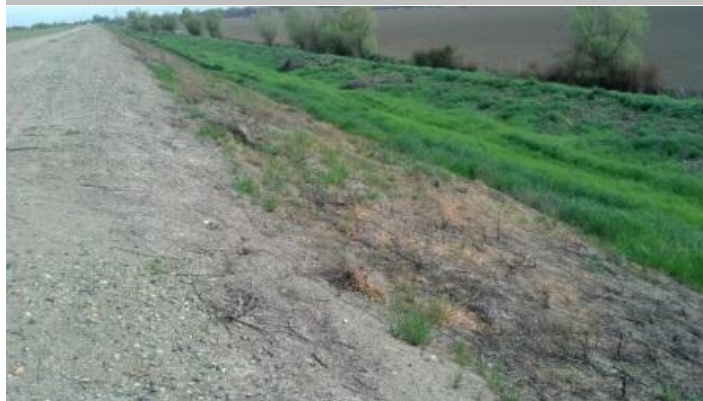
Photo 1 of 2 : FA\_2014\_RD0999\_232\_51\_20141020\_00055.jpg

LM Start	3.24	Rating **	M	Issue No.	51
LM End	3.26	Issue Type +	Ma	Location *	LS
Category	Earthen Levee			GPS Latitude/Longitude	
				Start	End
Item	Slope Stability				°
					°
DWR ID	DWR_RD0999_01_s_2013_51				
Action/Comments					
Repair slope instability. Inspector Comments: Depression on waterside shoulder and slope 60' x 20'. Earthen material appears to be sliding toward levee toe.

Looking north at depression on landside should and slope.

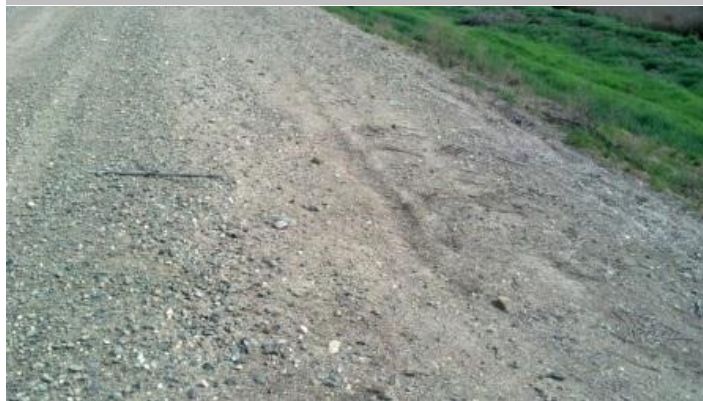
Photo 2 of 2 : FA\_2014\_RD0999\_232\_51\_20141020\_00056.jpg

Looking northeast at depression on landside shoulder.

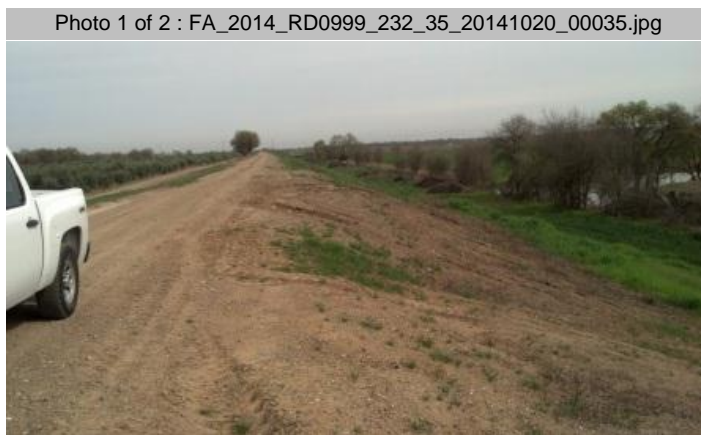
Looking north at slope damage caused by vehicle traffic.

LM Start	4.33	Rating **	M	Issue No.	35
LM End	4.33	Issue Type +	Ma	Location *	LS
Category	Earthen Levee			GPS Latitude/Longitude	
				Start	End
Item	Slope Stability			38.444561 °	38.444561 °
				-121.594438 °	-121.594438 °
DWR ID	DWR_RD0999_01_f_2012_35				
Action/Comments					
Repair the levee slope damaged by vehicle traffic and prevent access where possible.

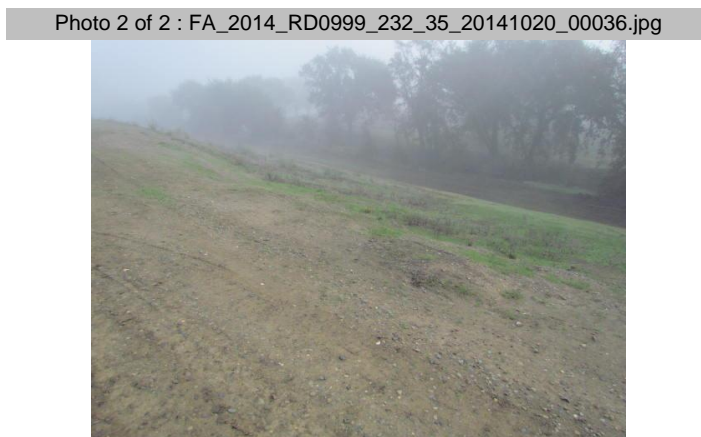
LM Start	<b>4.33</b>	Rating **	M	Issue No.	<b>35 (cont)</b>
LM End	<b>4.33</b>	Issue Type +	Ma	Location *	LS

Looking east at slope damage on landside slope.

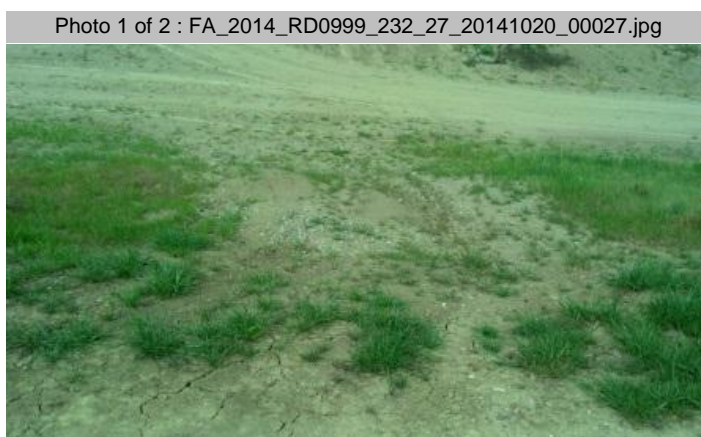
LM Start	4.33	Rating **	M	Issue No.	27
LM End	4.33	Issue Type +	Ma	Location *	WS
Category	Earthen Levee			GPS Latitude/Longitude	
				Start	End
Item	Slope Stability			38.444560 °	38.444560 °
				-121.594440 °	-121.594440 °
DWR ID	DWR_RD0999_01_f_2012_27				
Action/Comments					
Repair the levee slope damaged by vehicle traffic and prevent access where possible.					
Inspector Comments: Local farmer causing slope damage by driving equipment and trucks on slope.

Looking west at slope damage on waterside slope.

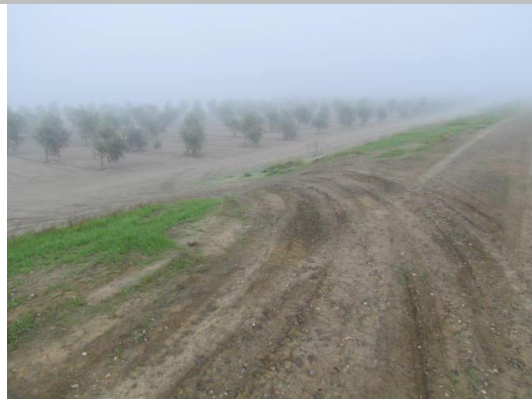
Photo 2 of 2 : FA\_2014\_RD0999\_232\_27\_20141020\_00028.jpg

LM Start	4.33	Rating **	M	Issue No.	27 (cont)
LM End	4.33	Issue Type +	Ma	Location *	WS
Category	Earthen Levee			GPS Latitude/Longitude	
				Start	End
Item	Slope Stability			38.444560 °	38.444560 °
				-121.594440 °	-121.594440 °
DWR ID	DWR_RD0999_01_f_2012_27				
Action/Comments					
Repair the levee slope damaged by vehicle traffic and prevent access where possible.					
Inspector Comments: Local farmer causing slope damage by driving equipment and trucks on slope.

Looking northwest at slope damage caused by vehicle traffic.

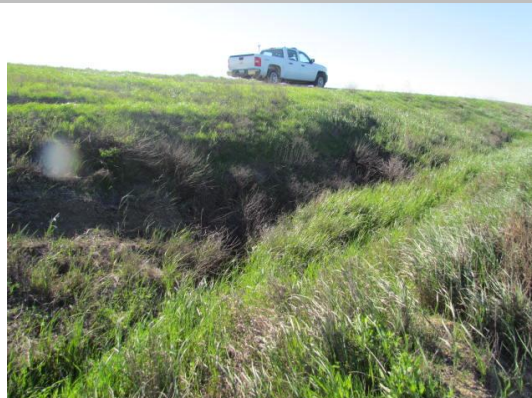
Photo 1 of 2 : FA\_2014\_RD0999\_232\_65\_20141020\_00059.jpg

LM Start	4.85	Rating **	M	Issue No.	65
LM End	4.85	Issue Type +	Ma	Location *	WS
Category	Earthen Levee			GPS Latitude/Longitude	
				Start	End
Item	Slope Stability			38.437388 °	38.437388 °
				-121.597741 °	-121.597741 °
DWR ID	DWR_RD0999_01_s_2014_65				
Action/Comments					
Repair slope instability. Inspector Comments: Slope depression on waterward near toe of levee. Depression is approx. 18' x 14' x 4' in area.

Looking southeast at depression on waterward toe.

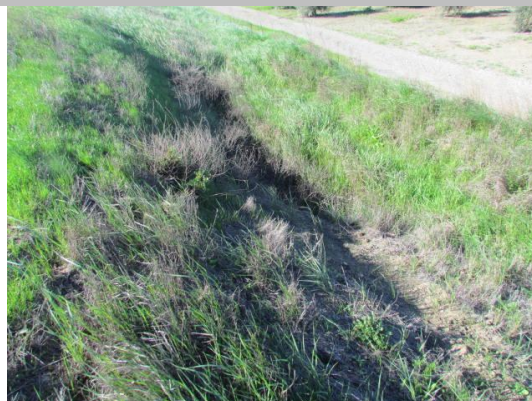
Photo 2 of 2 : FA\_2014\_RD0999\_232\_65\_20141020\_00060.jpg

LM Start	4.85	Rating **	M	Issue No.	65 (cont)	
LM End	4.85	Issue Type +	Ma	Location *	WS	
Category	Earthen Levee			GPS Latitude/Longitude		
				Start	End	
Item	Slope Stability			38.437388 °	38.437388 °	
				-121.597741 °	-121.597741 °	
DWR ID	DWR_RD0999_01_s_2014_65					
Action/Comments						
Repair slope instability. Inspector Comments: Slope depression on waterward near toe of levee. Depression is approx. 18' x 14' x 4' in area.

Looking southwest at depression on waterward toe.

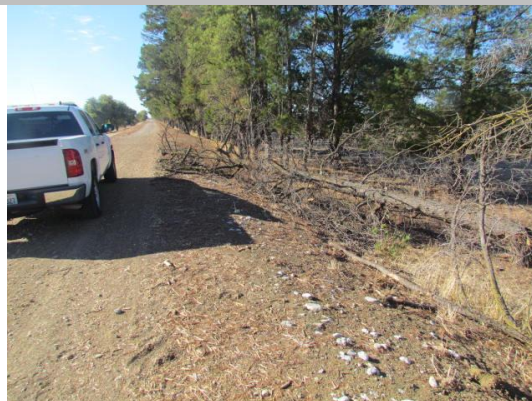
Photo 1 of 1 : FA\_2014\_RD0999\_232\_61\_20141030\_00075.jpg

Looking southwest at downed tree on waterward slope.

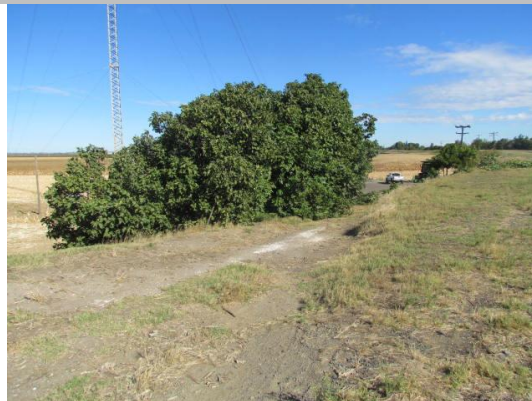
Photo 2 of 4 : FA\_2014\_RD0999\_234\_4\_20141020\_00008.jpg

Looking northwest at dense fig tree on landward slope and toe. 2013

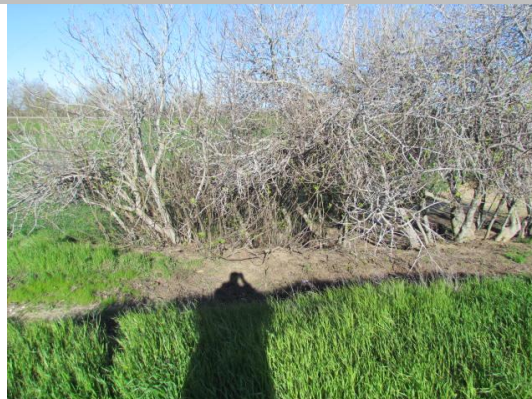
Photo 4 of 4 : FA\_2014\_RD0999\_234\_4\_20141020\_00007.jpg

Looking west at dense fig trees at landside toe.

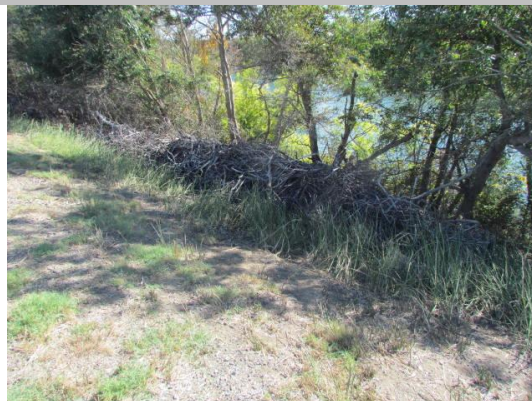
Photo 1 of 1 : FA\_2014\_RD0999\_234\_36\_20141020\_00029.jpg

LM Start	0.04	Rating **	A/W	Issue No.	36
LM End	0.04	Issue Type +	Ma	Location *	WS
Category	Earthen Levee			GPS Latitude/Longitude	
				Start	End
Item	Encroachments				°
					°
DWR ID	DWR_RD0999_03_f_2013_36				
Action/Comments					
Prunings Inspector Comments: Prunings on waterward slope outside the twenty feet zone should be burned or removed from levee slope.

Looking east at prunings on waterward slope.

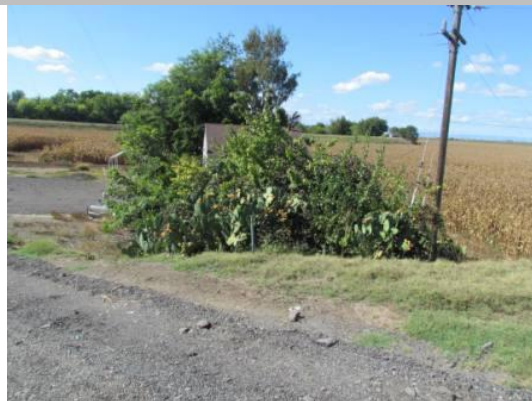
Photo 1 of 3 : FA\_2014\_RD0999\_234\_1\_20141020\_00001.jpg

Looking west at dense vegetation on landside slope near ramp. (Spring 2011)

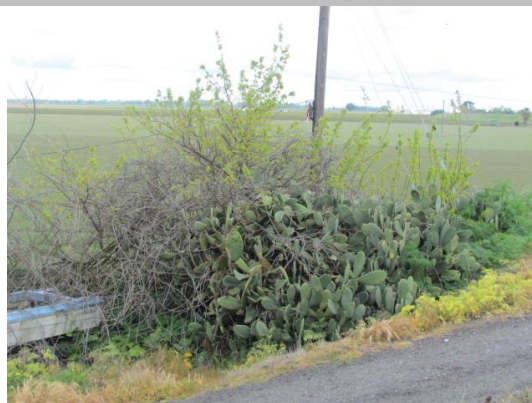
Photo 3 of 3 : FA\_2014\_RD0999\_234\_1\_20141020\_00003.jpg

Looking southwest at dense vegetation and cactus on landside slope. (Spring 2012)

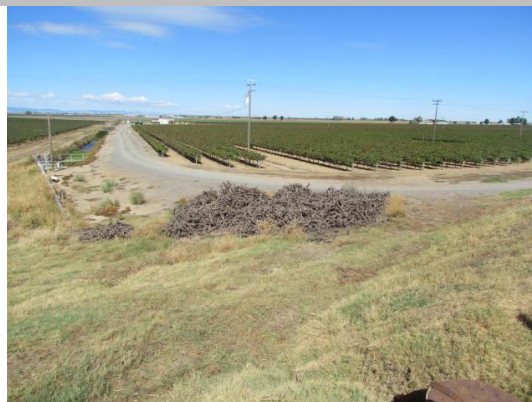
Photo 2 of 2 : FA\_2014\_RD0999\_234\_2\_20141020\_00005.jpg

Looking west at prunings on landward berm.

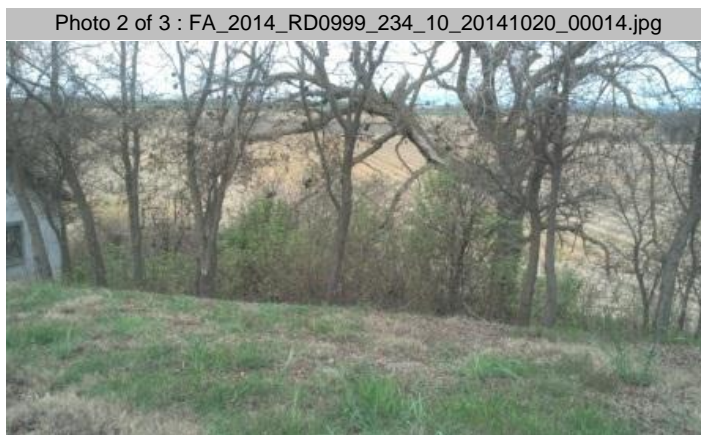
LM Start	2.89	Rating **	A/W	Issue No.	10 (cont)
LM End	2.89	Issue Type +	Ma	Location *	LS
Category	Earthen Levee			GPS Latitude/Longitude	
				Start	End
Item	Vegetation			38.322757 °	38.322757 °
				-121.590817 °	-121.590817 °
DWR ID	DWR_RD0999_03_f_2012_10				
Action/Comments					
Remove the wild growth other than native grasses from the levee slopes.					
Inspector Comments: Wild growth at landside slope and toe.

Looking west at dense trees on landside toe.

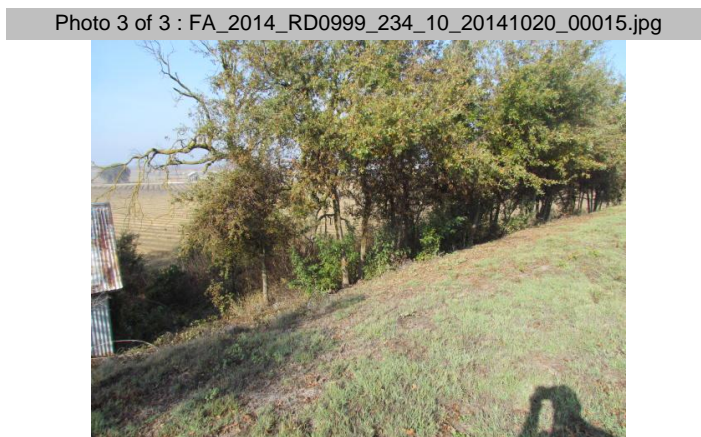
LM Start	<b>2.89</b>	Rating **	A/W	Issue No.	<b>10 (cont)</b>
LM End	<b>2.89</b>	Issue Type +	Ma	Location *	LS

Looking northwest at dense vegetation at landside slope and toe.

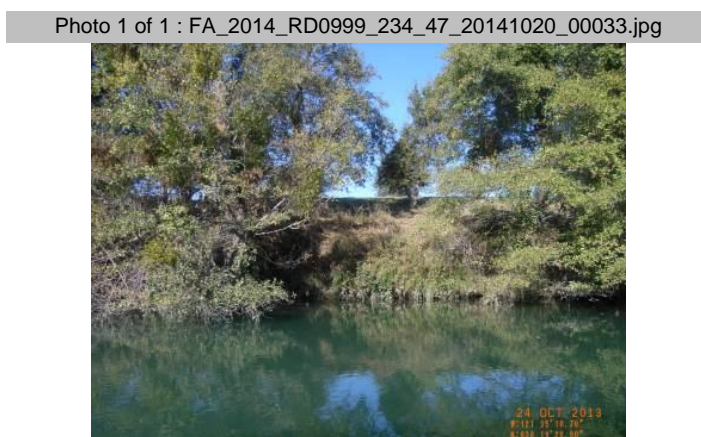
USACE 2013 Photo #1

LM Start	2.98	Rating **	M	Issue No.	47
LM End	2.98	Issue Type +	Ma	Location *	WS
Category	Supplemental			GPS Latitude/Longitude	
				Start	End
Item	USACE Erosion Survey			38.323667 °	38.325592 °
				-121.588226 °	-121.585925 °
DWR ID	DWR_RD0999_03_f_2014_47				
Action/Comments					
Inspector Comments: 2011 - Multiple erosion pockets. Some likely from tree popouts. 2013: Tall vertical sections. [2013 Site ID: STR_27-3_R]

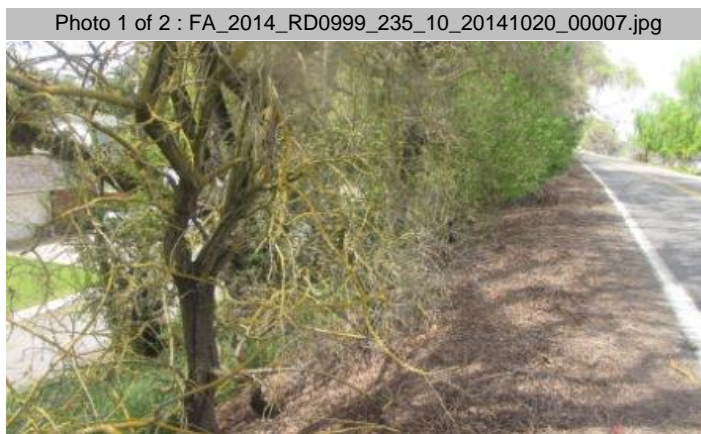
Looking northwest at dense trees on landside slope and toe.

LM Start	0.37	Rating **	M	Issue No.	10
LM End	0.50	Issue Type +	Ma	Location *	LS
Category	Earthen Levee			GPS Latitude/Longitude	
				Start	End
Item	Trim / Thin Trees			38.418838 °	38.420447 °
				-121.526225 °	-121.527380 °
DWR ID	DWR_RD0999_04_s_2012_10				
Action/Comments					
Trim trees to at least five feet above ground level.

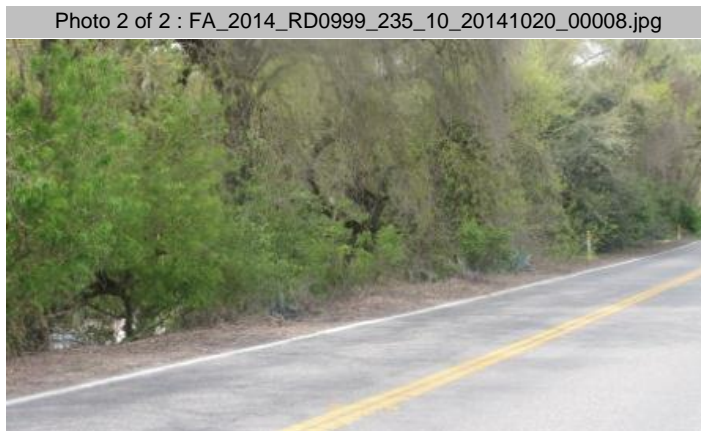
LM Start	<b>0.37</b>	Rating **	M	Issue No.	<b>10 (cont)</b>
LM End	<b>0.50</b>	Issue Type +	Ma	Location *	LS

Looking west at dense trees on waterside slope.

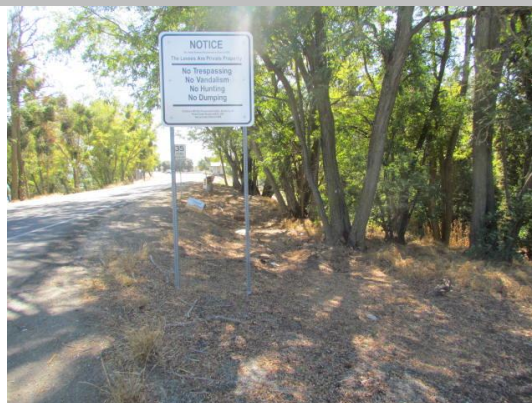
Photo 1 of 1 : FA\_2014\_RD0999\_235\_22\_20141020\_00017.jpg

Looking south at dense trees on landward slope.

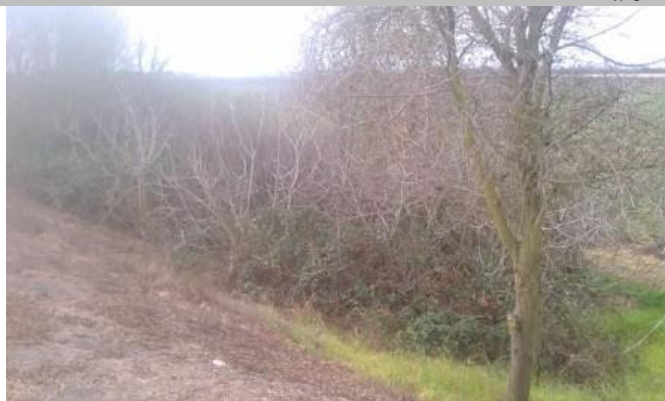
Photo 4 of 4 : FA\_2014\_RD0999\_236\_25\_20141020\_00024.jpg

Looking southwest at dense berry vines on landside toe.

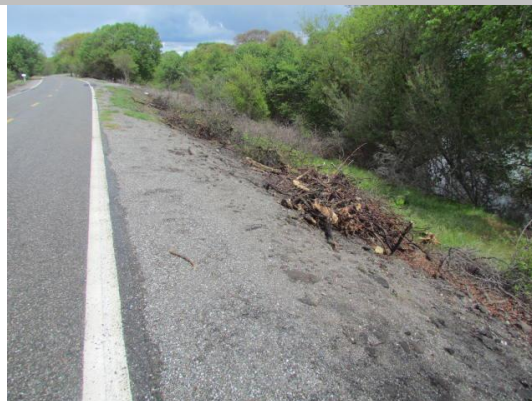
Photo 1 of 1 : FA\_2014\_RD0999\_236\_26\_20141020\_00025.jpg

Looking northeast at prunings on waterside slope.

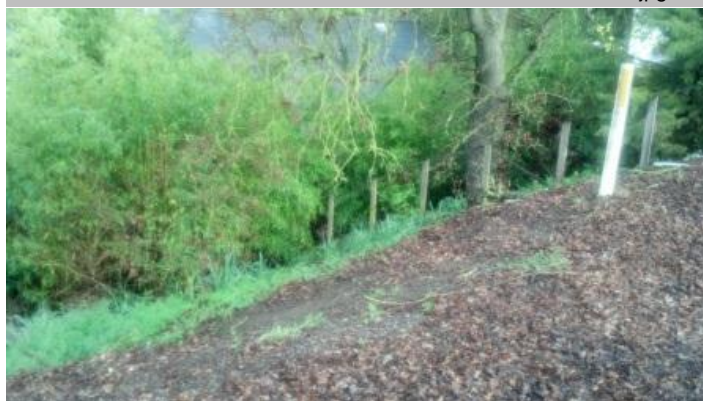
Photo 1 of 1 : FA\_2014\_RD0999\_236\_128\_20141020\_00069.jpg

Looking at dense trees on landside slope and toe.

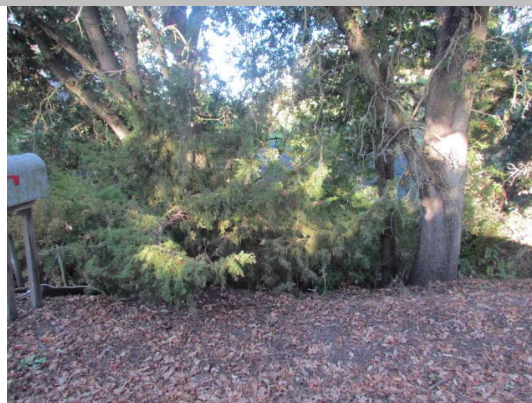
Photo 1 of 1 : FA\_2014\_RD0999\_236\_190\_20141030\_00126.jpg

Looking west at dense vegetation on landward slope and toe.

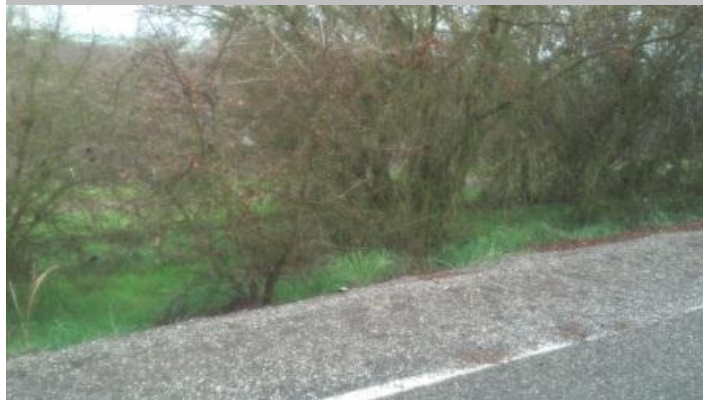
Photo 1 of 1 : FA\_2014\_RD0999\_236\_14\_20141020\_00011.jpg

Looking west at dense trees on landside slope and toe.

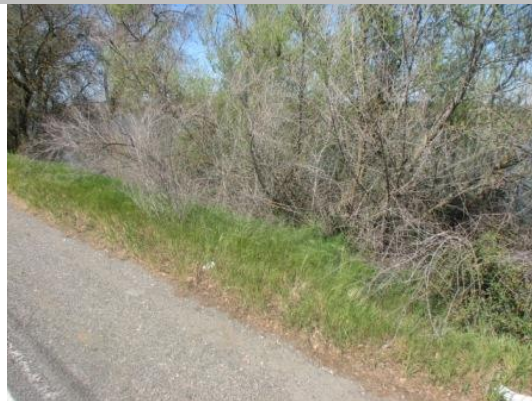
Photo 2 of 2 : FA\_2014\_RD0999\_236\_18\_20141020\_00018.jpg

Front view of dense trees along waterside slope.

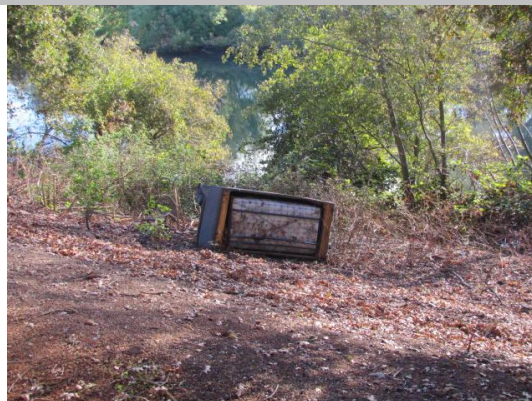
Photo 1 of 1 : FA\_2014\_RD0999\_236\_200\_20141030\_00127.jpg

Looking east at garbage (sofa) on waterward slope.

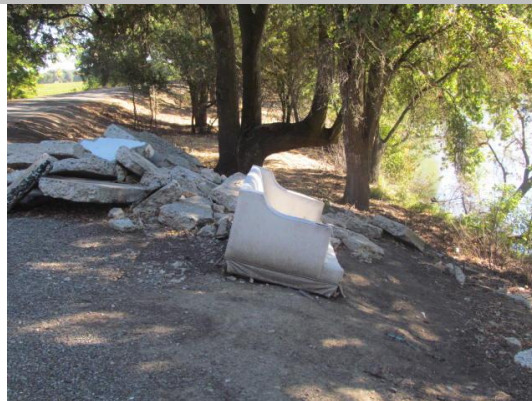
Photo 1 of 1 : FA\_2014\_RD0999\_236\_150\_20141020\_00084.jpg

Looking northeast at garbage (sofa) on waterward slope.

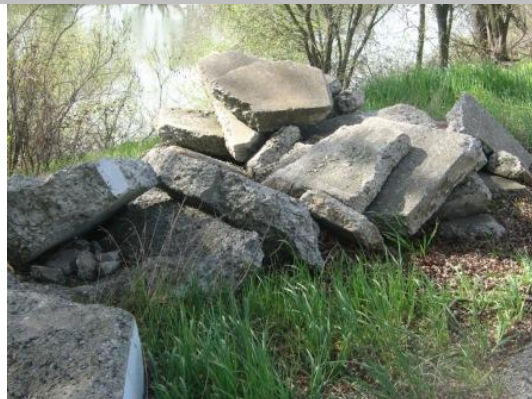
Photo 1 of 1 : FA\_2014\_RD0999\_236\_22\_20141020\_00019.jpg

Concrete rubble on waterside sholder at LM 1.97

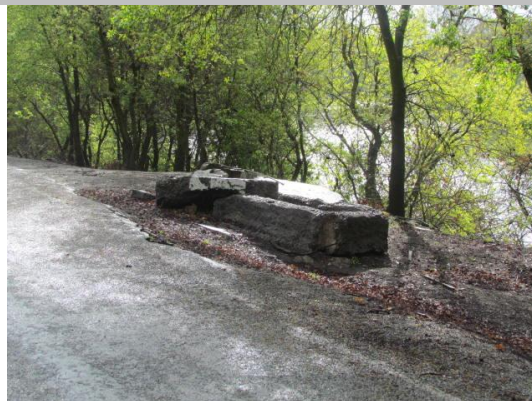
Photo 1 of 1 : FA\_2014\_RD0999\_236\_80\_20141020\_00052.jpg

Looking east at large concrete blocks at the top of ramp on waterside shoulder.

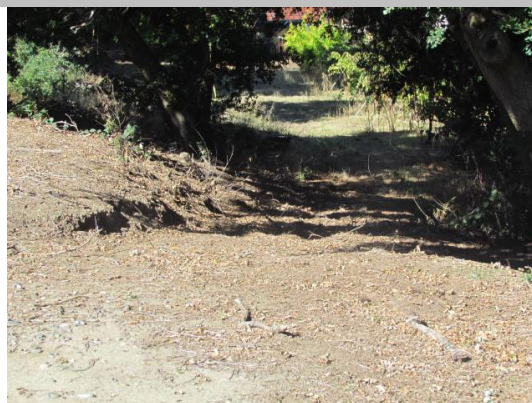
Photo 1 of 1 : FA\_2014\_RD0999\_236\_154\_20141020\_00090.jpg

Looking west at levee damage due to vehicle traffic.

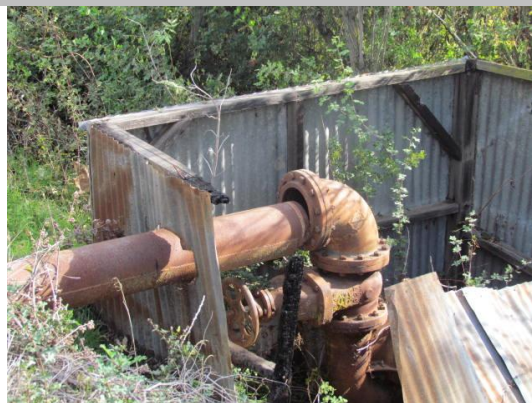
Photo 1 of 1 : FA\_2014\_RD0999\_236\_46\_20141020\_00040.jpg

Looking east at pipe disconnected from pump.

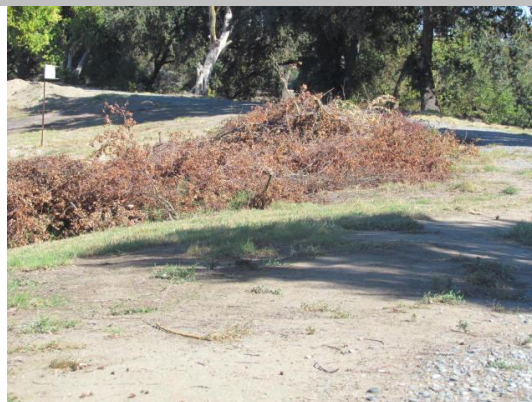
Photo 2 of 2 : FA\_2014\_RD0999\_236\_65\_20141020\_00044.jpg

Looking northeast at prunings on landward slope.

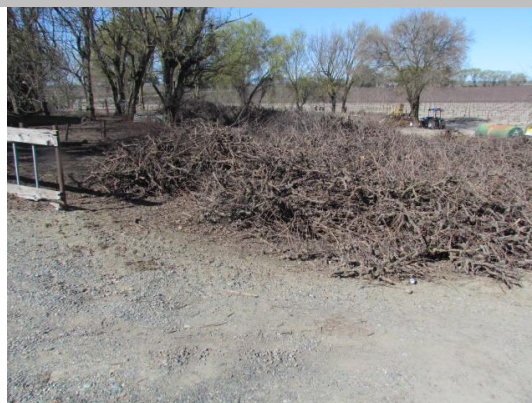
Photo 1 of 1 : FA\_2014\_RD0999\_236\_192\_20141020\_00096.jpg

Looking west at prunings on landward slope and toe.

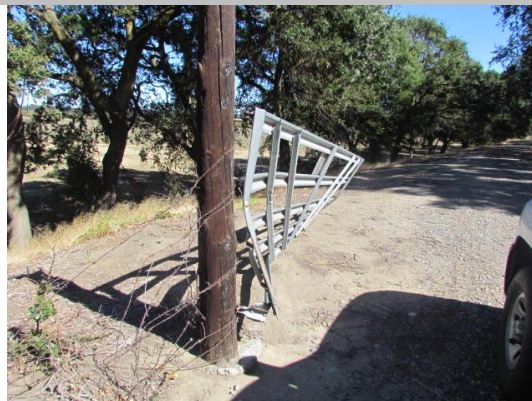
Photo 1 of 1 : FA\_2014\_RD0999\_236\_90\_20141020\_00056.jpg

Looking northwest at damaged gate on levee crown.

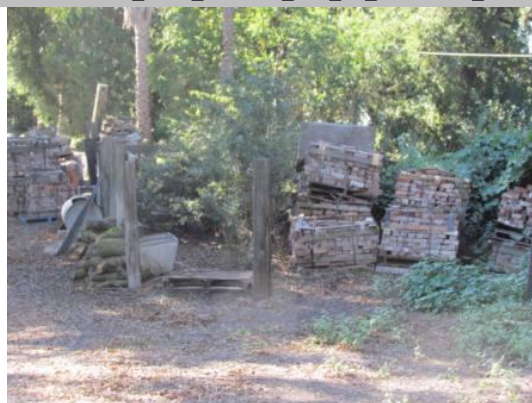
Photo 3 of 4 : FA\_2014\_RD0999\_236\_96\_20141020\_00061.jpg

Looking south at firewood and other material on landside shoulder and crown.

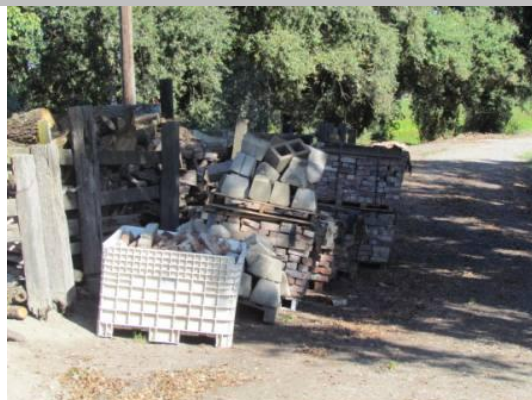
Photo 4 of 4 : FA\_2014\_RD0999\_236\_96\_20141020\_00062.jpg

Looking north at firewood and other material on landside shoulder and crown.
