**Flood Control Project Maintenance
Levee Inspections**

Maintenance Issue Types Only, Levee Inspection Report By Mile - Fall 2015

Reclamation District No. 0999 Netherlands

Waterway	Bank	Unit Miles	Inspection Start/End	Inspector
Unit No. 01 Yolo Bypass	Left	15.41	11/02/2015 11/04/2015	Richard Willoughby

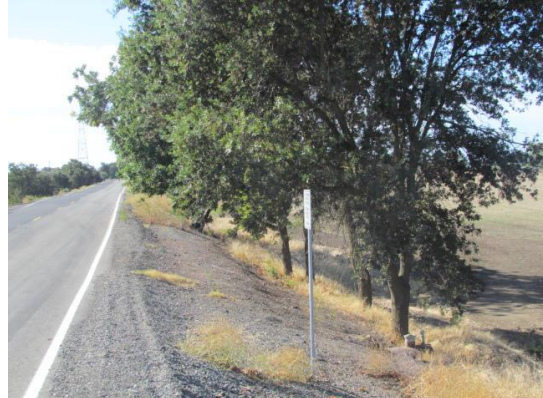
Photo 2 of 2 : FA_2015_RD0999_232_4_20150914_00009.jpg

Looking southwest at trimmed trees on waterward slope.

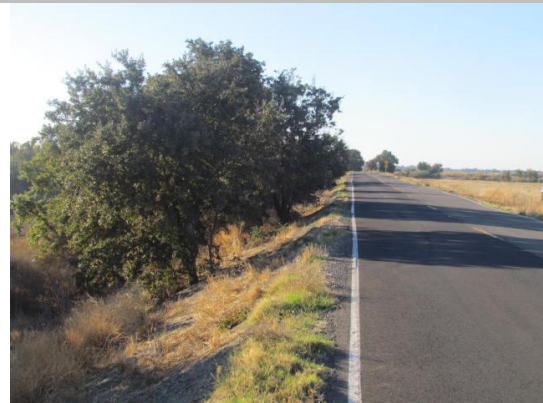
Photo 3 of 5 : FA_2015_RD0999_232_30_20150914_00036.jpg

Looking south at typical view of untrimmed trees on landward slope.

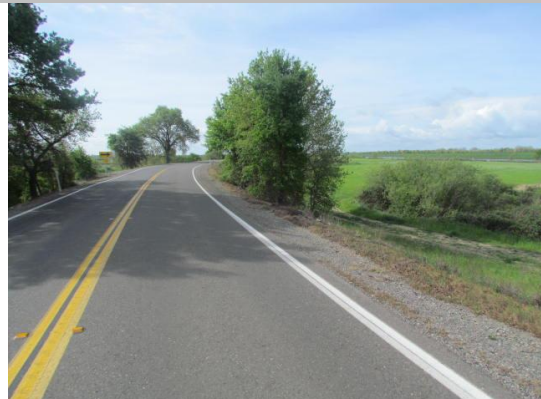
Photo 1 of 3 : FA_2015_RD0999_232_7_20150914_00015.jpg

Looking south at untrimmed trees on waterward slope. (Spring 2015)

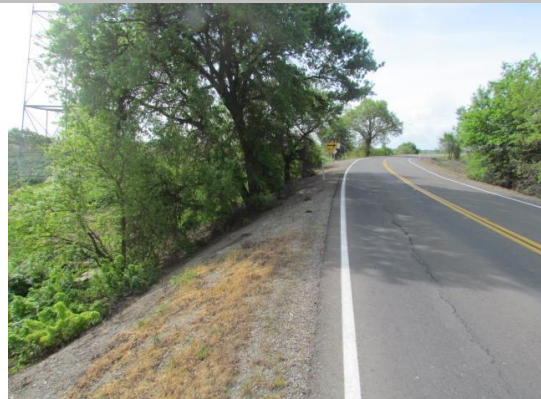
Photo 1 of 3 : FA_2015_RD0999_232_31_20150914_00039.jpg

Looking southeast at untrimmed trees on landward slope. (Spring 2015)

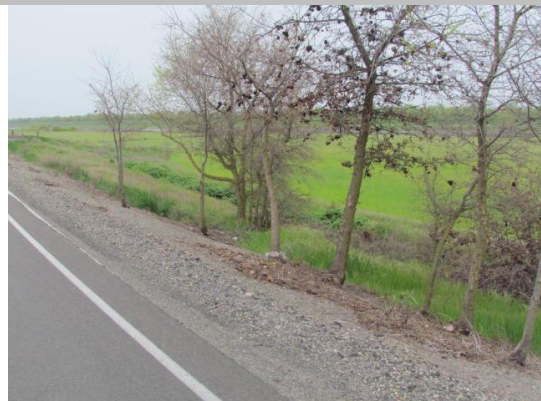
Photo 1 of 1 : FA_2015_RD0999_232_8_20150914_00018.jpg

Looking southwest at trimmed trees on waterside slope. (Spring 2012)

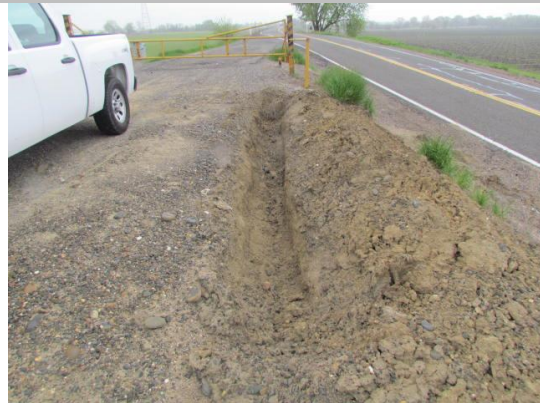
Photo 3 of 3 : FA_2015_RD0999_232_40_20150914_00051.jpg

Looking north at excavation on landside shoulder.

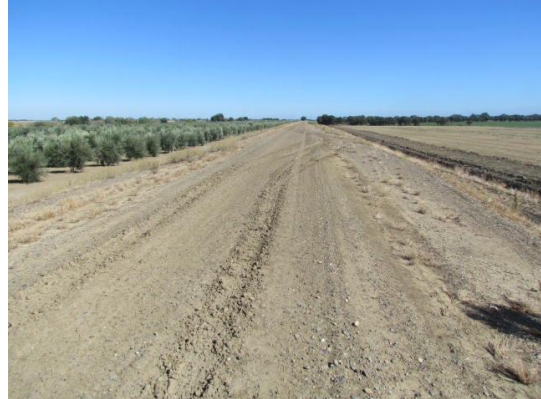
Photo 1 of 3 : FA_2015_RD0999_232_46_20150914_00056.jpg

LM Start	2.76	Rating **	A/W	Issue No.	46
LM End	4.98	Issue Type +	Ma	Location *	CR
Category	Earthen Levee			GPS Latitude/Longitude	
				Start	End
Item	Crown Surface / Depressions / Rutting			38.465627 °	38.435378 °
				-121.584634 °	-121.598664 °
DWR ID	DWR_RD0999_01_f_2013_46				
Action/Comments					
Repair depressions or ruts in the crown or slope. Inspector Comments: Control growth on levee crown and repair ruts on levee crown.

Looking north at rutting on levee crown.

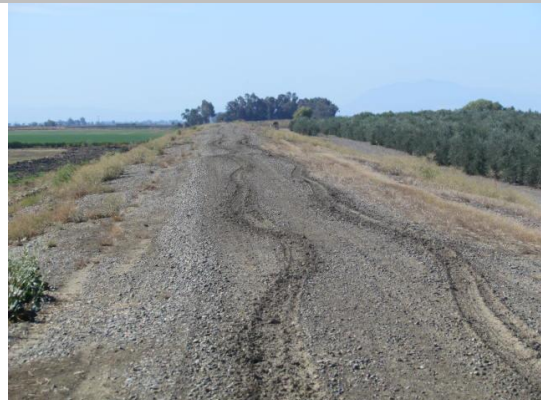
Photo 3 of 3 : FA_2015_RD0999_232_46_20150914_00058.jpg

Looking south at rutting on levee crown.

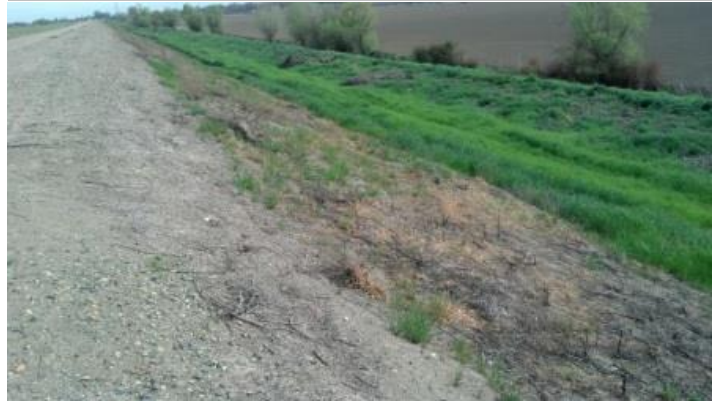
Photo 1 of 2 : FA_2015_RD0999_232_51_20150914_00067.jpg

LM Start	3.24	Rating **	M	Issue No.	51
LM End	3.26	Issue Type +	Ma	Location *	LS
Category	Earthen Levee			GPS Latitude/Longitude	
				Start	End
Item	Slope Stability				°
					°
DWR ID	DWR_RD0999_01_s_2013_51				
Action/Comments					
Repair slope instability. Inspector Comments: Depression on waterside shoulder and slope 60' x 20'. Earthen material appears to be sliding toward levee toe.

Looking north at depression on landside shoulder and slope.

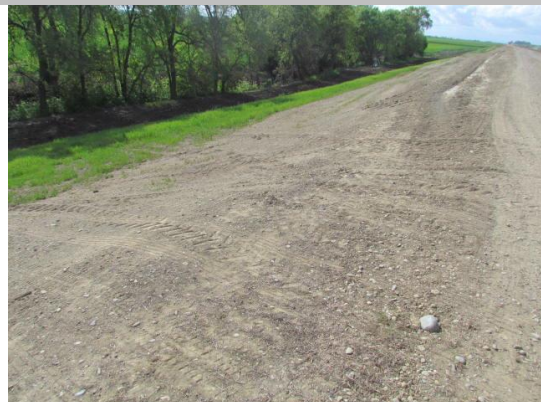
Photo 1 of 4 : FA_2015_RD0999_232_35_20150914_00042.jpg

LM Start	4.31	Rating **	M	Issue No.	35
LM End	4.31	Issue Type +	Ma	Location *	LS
Category	Earthen Levee			GPS Latitude/Longitude	
				Start	End
Item	Slope Stability			38.444561 °	38.444561 °
				-121.594438 °	-121.594438 °
DWR ID	DWR_RD0999_01_f _ 2012_35				
Action/Comments					
Repair the levee slope damaged by vehicle traffic and prevent access where possible.					
Inspector Comments: Depression is caused by vehicle traffic.

Looking southeast at slope damage cause by vehicle traffic on landward slope. (Spring 2015)

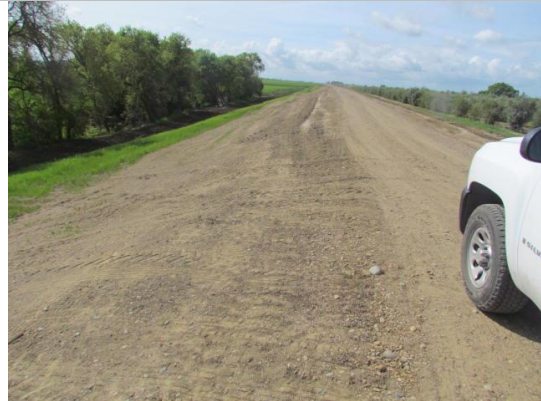
Photo 2 of 4 : FA_2015_RD0999_232_35_20150914_00043.jpg

LM Start	4.31	Rating **	M	Issue No.	35 (cont)
LM End	4.31	Issue Type +	Ma	Location *	LS
Category	Earthen Levee			GPS Latitude/Longitude	
				Start	End
Item	Slope Stability			38.444561 °	38.444561 °
				-121.594438 °	-121.594438 °
DWR ID	DWR_RD0999_01_f_2012_35				
Action/Comments					
Repair the levee slope damaged by vehicle traffic and prevent access where possible.					
Inspector Comments: Depression is caused by vehicle traffic.

Looking south at slope damage cause by vehicle traffic on landward slope. (Spring 2015)

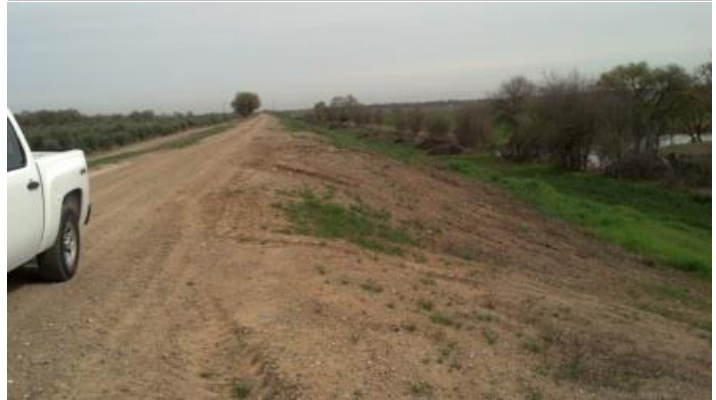
Photo 3 of 4 : FA_2015_RD0999_232_35_20150914_00044.jpg

Looking north at slope damage caused by vehicle traffic.

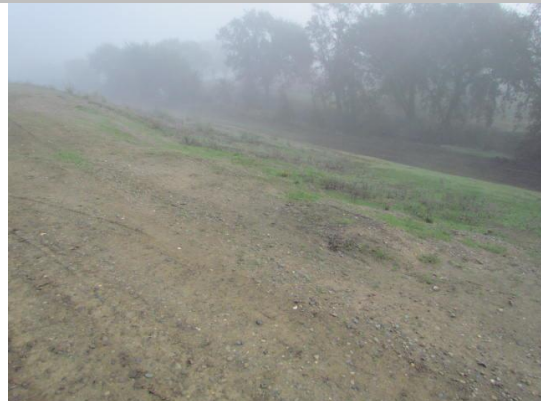
Photo 4 of 4 : FA_2015_RD0999_232_35_20150914_00045.jpg

Looking east at slope damage on landside slope.

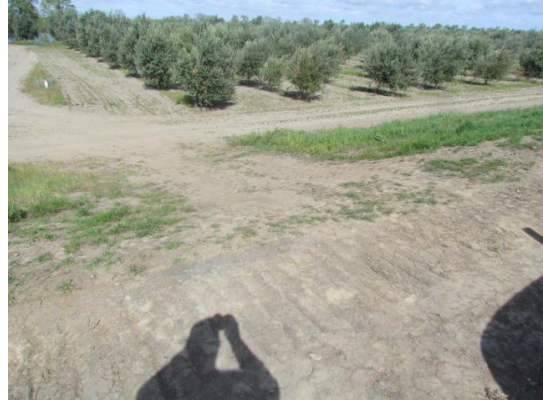
Photo 1 of 3 : FA_2015_RD0999_232_27_20150914_00030.jpg

LM Start	4.31	Rating **	M	Issue No.	27
LM End	4.31	Issue Type +	Ma	Location *	WS
Category	Earthen Levee			GPS Latitude/Longitude	
				Start	End
Item	Slope Stability			38.444560 °	38.444560 °
				-121.594440 °	-121.594440 °
DWR ID	DWR_RD0999_01_f_2012_27				
Action/Comments					
Repair the levee slope damaged by vehicle traffic and prevent access where possible.					
Inspector Comments: Local farmer causing slope damage by driving equipment and trucks on slope.

Looking west at slope damage cause by vehicle traffic on waterward slope. (Spring 2015)

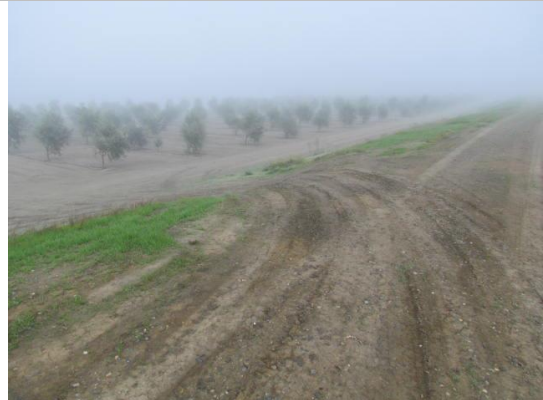
Photo 2 of 3 : FA_2015_RD0999_232_27_20150914_00031.jpg

Looking northwest at slope damage caused by vehicle traffic. (Fall 2014)

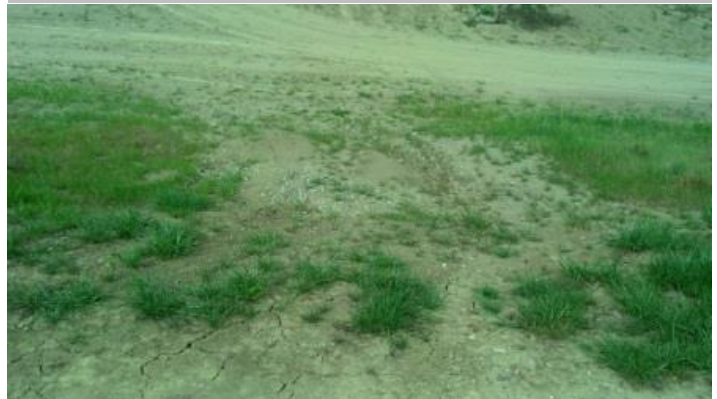
Photo 3 of 3 : FA_2015_RD0999_232_27_20150914_00032.jpg

Looking west at slope damage on waterside slope. (Spring 2014)

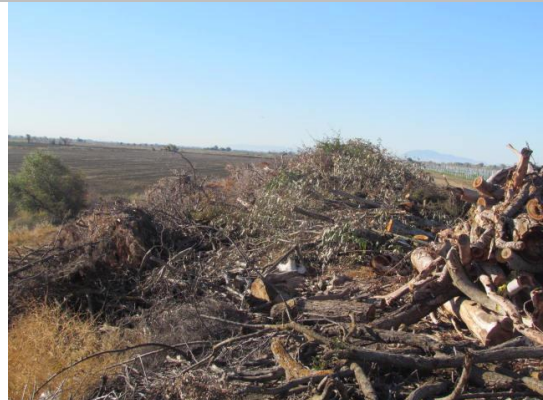
Photo 2 of 2 : FA_2015_RD0999_232_18_20150914_00020.jpg

Looking northwest at large pruning piles on landward shoulder and slope. (Fall 2014)

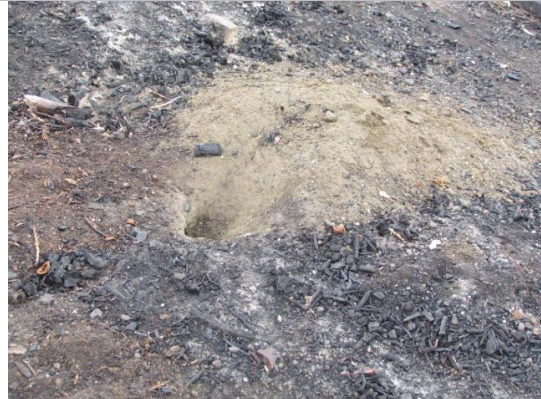
Photo 2 of 2 : FA_2015_RD0999_232_42_20150914_00053.jpg

Looking at typical rodent hole on landside slope.

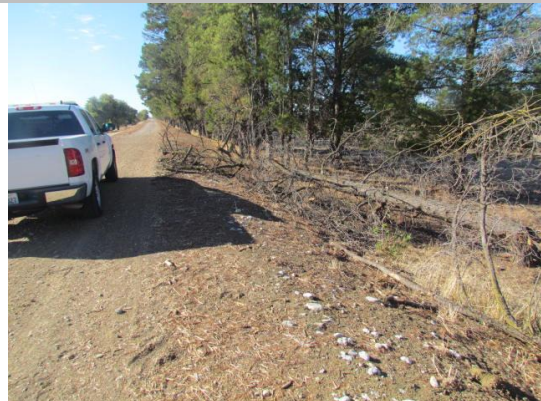
Photo 1 of 1 : FA_2015_RD0999_232_61_20150914_00070.jpg

Looking southwest at downed tree on waterward slope.

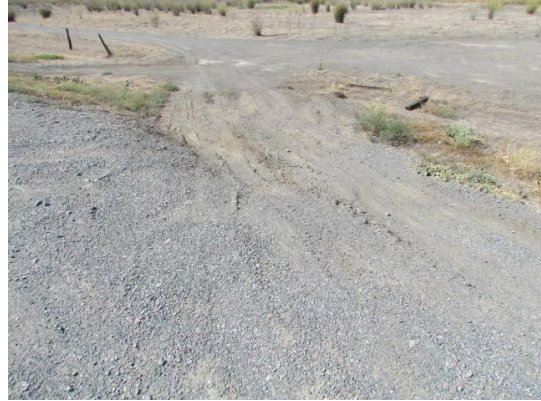
Photo 1 of 2 : FA_2015_RD0999_232_48_20150914_00059.jpg

LM Start	11.84	Rating **	M	Issue No.	48
LM End	11.84	Issue Type +	Ma	Location *	WS
Category	Earthen Levee			GPS Latitude/Longitude	
				Start	End
Item	Slope Stability			38.342068 °	38.342068 °
				-121.641944 °	-121.641944 °
DWR ID	DWR_RD0999_01_f_2012_48				
Action/Comments					
Repair the levee slope damaged by vehicle traffic and prevent access where possible.					
Inspector Comments: Slope damage caused by vehicle traffic.

Looking southwest at slope damage caused by vehicle traffic. 2013

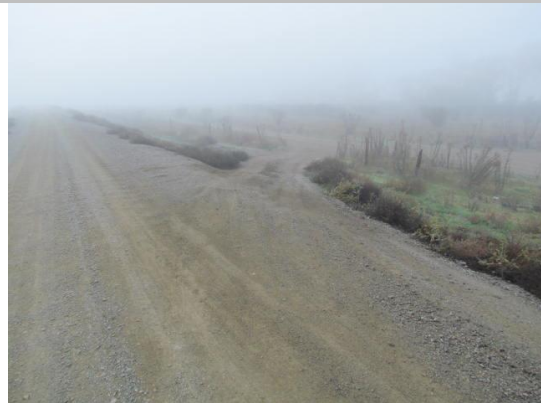
Photo 2 of 2 : FA_2015_RD0999_232_48_20150914_00060.jpg

Looking southwest at slope damage caused by vehicle traffic on waterside slope.

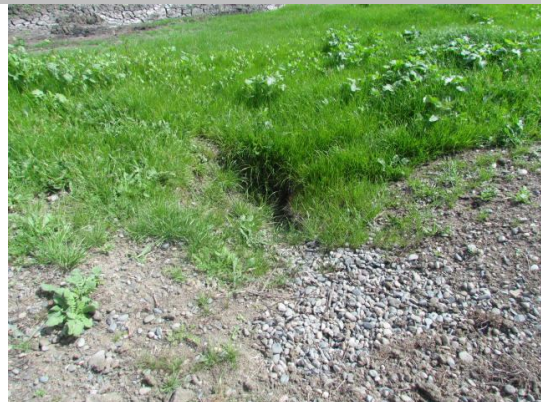
Photo 2 of 4 : FA_2015_RD0999_232_49_20150914_00061.jpg

Looking east at caving on landward shoulder and slope. (Spring 2015)

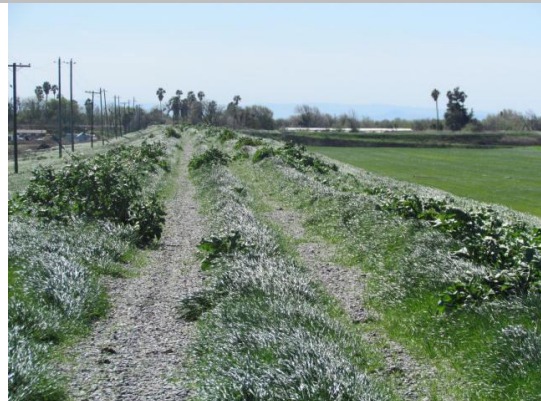
Photo 1 of 1 : FA_2015_RD0999_232_44_20150914_00054.jpg

Looking south at growth on levee crown.

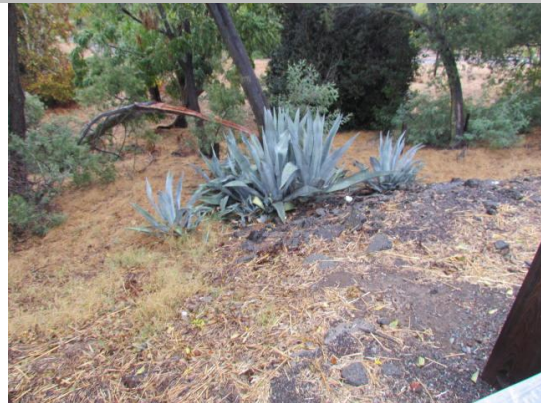
Photo 1 of 2 : FA_2015_RD0999_233_14_20151106_00043.jpg

Looking north at century plant at landward toe fall 2015.

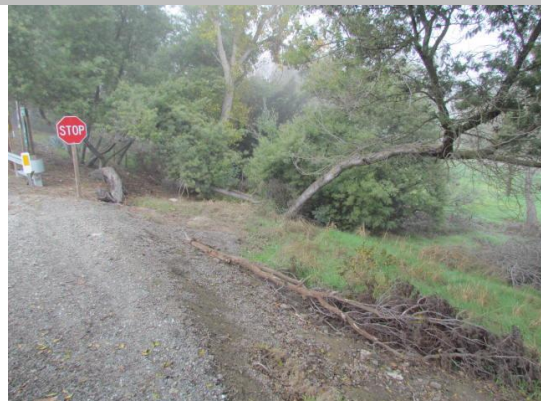
Photo 2 of 2 : FA_2015_RD0999_233_19_20150914_00022.jpg

Looking west at dense trees on landside slope and toe.

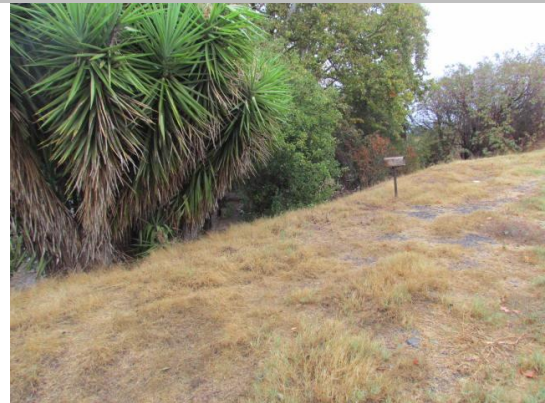
Photo 1 of 2 : FA_2015_RD0999_233_11_20151106_00048.jpg

Looking at dense trees on landward slope.

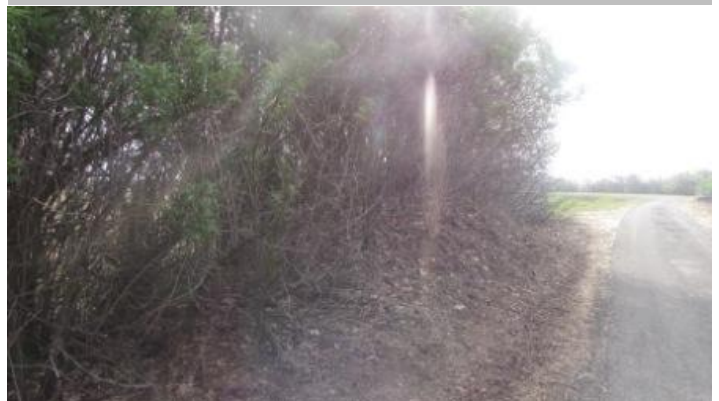
Photo 2 of 2 : FA_2015_RD0999_233_8_20150914_00011.jpg

Looking east at elderberry bush on landside shoulder and slope. (Fall 2014)

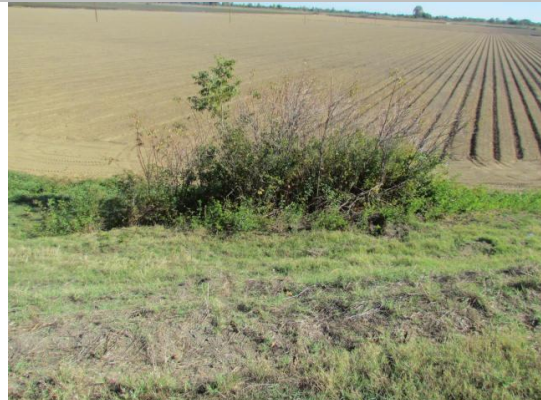
Photo 2 of 2 : FA_2015_RD0999_233_42_20150914_00036.jpg

Looking east at elderberry and wild roses blocking view of landward toe.

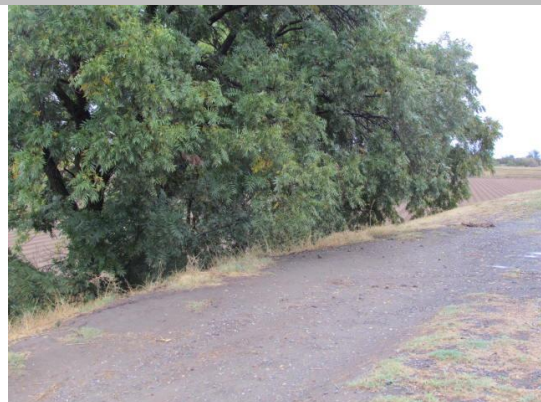
Photo 1 of 1 : FA_2015_RD0999_233_29_20151106_00049.jpg

Looking at untrimmed trees on landward slope fall 2015.

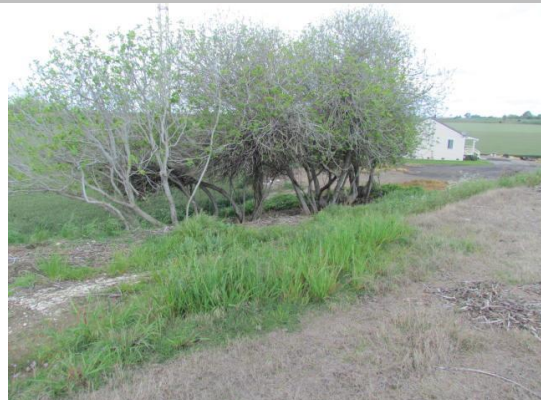
Photo 3 of 4 : FA_2015_RD0999_234_4_20150914_00005.jpg

Looking southwest at trimmed trees on landside toe. (Spring 2012)

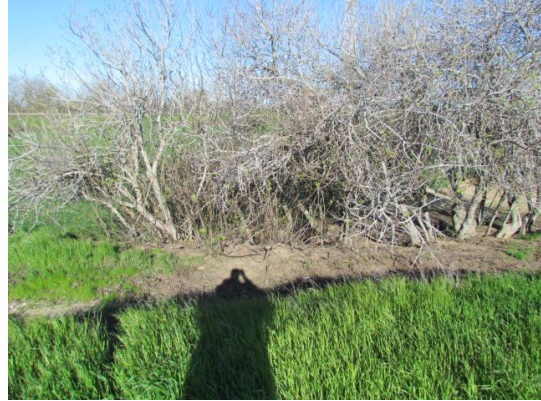
Photo 4 of 4 : FA_2015_RD0999_234_4_20150914_00006.jpg

Looking west at dense fig trees at landside toe.

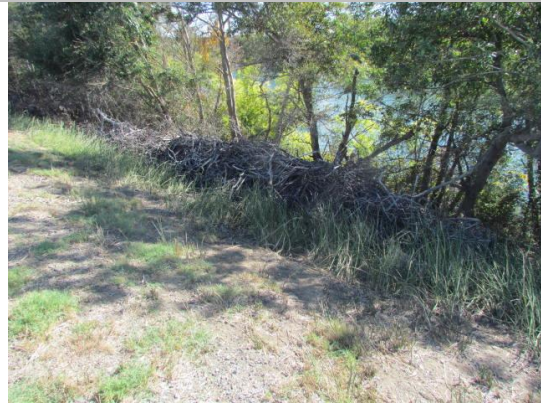
Photo 1 of 1 : FA_2015_RD0999_234_36_20150914_00028.jpg

Looking east at prunings on waterward slope.

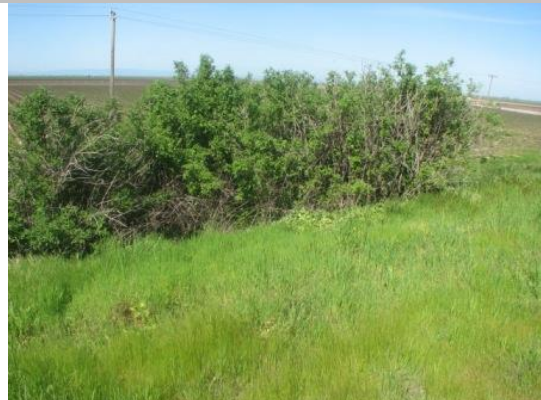
Photo 1 of 1 : FA_2015_RD0999_234_8_20150914_00008.jpg

Elderberries blocking view of landside toe.

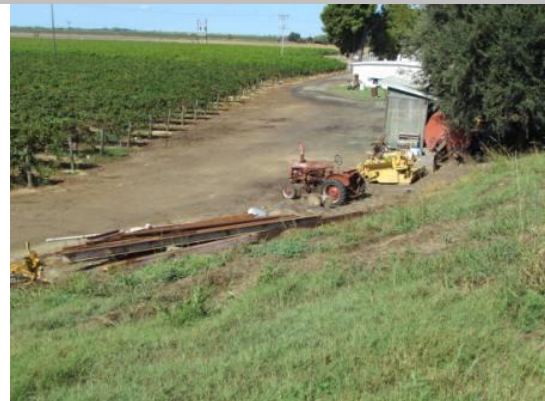
Photo 2 of 2 : FA_2015_RD0999_234_27_20150914_00020.jpg

Looking northwest at equipment at landside toe.

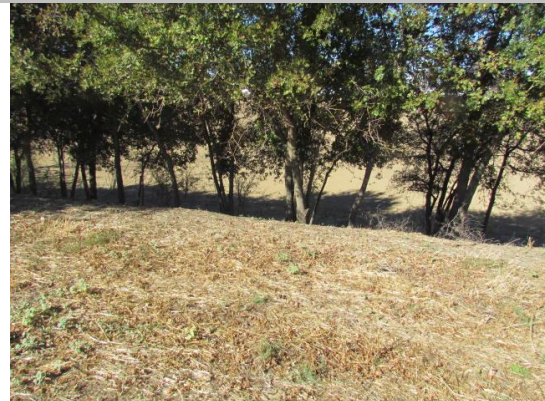
Photo 1 of 3 : FA_2015_RD0999_234_10_20150914_00010.jpg

Looking weat at trimmed trees at landward toe. (Fall 2014)

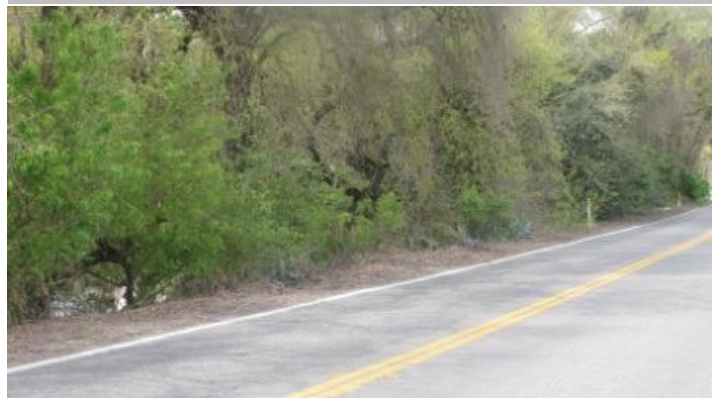
Photo 2 of 2 : FA_2015_RD0999_235_10_20150914_00008.jpg

Looking west at dense trees on waterside slope.

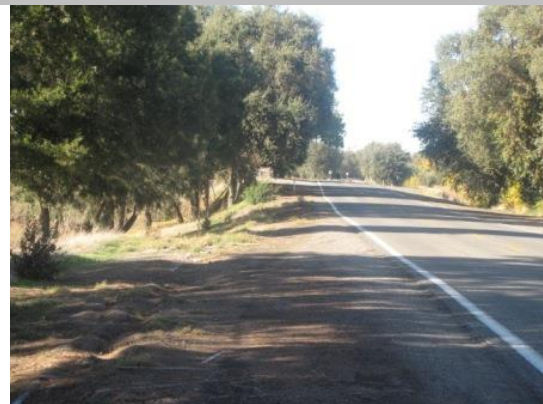
Photo 1 of 2 : FA_2015_RD0999_235_6_20150914_00004.jpg

Looking north at trimmed trees and removed fence on landside slope.

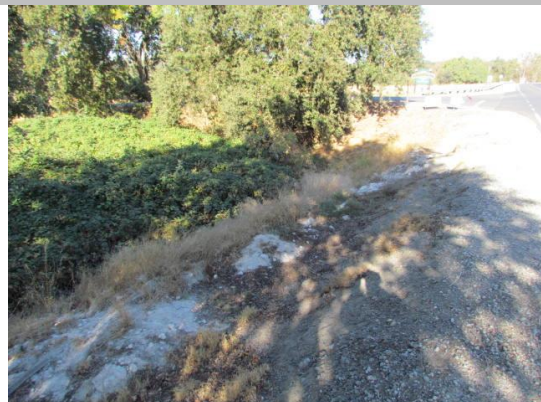
Photo 1 of 3 : FA_2015_RD0999_235_16_20151106_00031.jpg

Looking northwest at dense vines at landward toe. Fall 2015

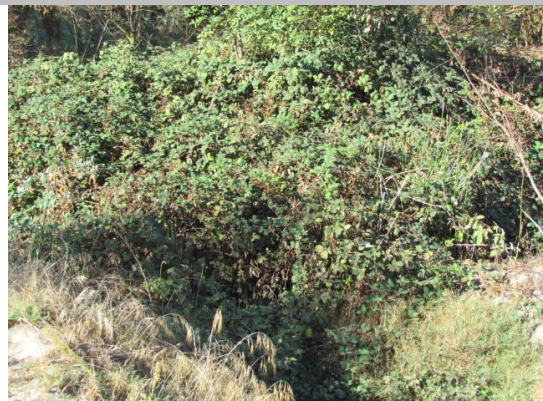
Photo 1 of 3 : FA_2015_RD0999_235_5_20151106_00032.jpg

Looking at dense vines at landward toe. Fall 2015.

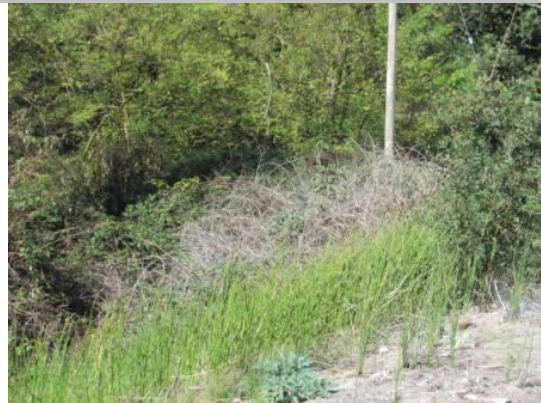
Photo 3 of 3 : FA_2015_RD0999_235_5_20150914_00003.jpg

Looking northwest at dense wild roses and berry vines on landside toe near ramp.

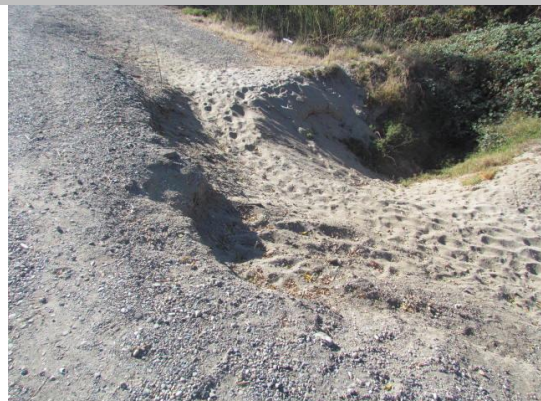
Photo 1 of 3 : FA_2015_RD0999_235_40_20151106_00033.jpg

Looking southwest at shoulder erosion and caving at landward slope and toe.

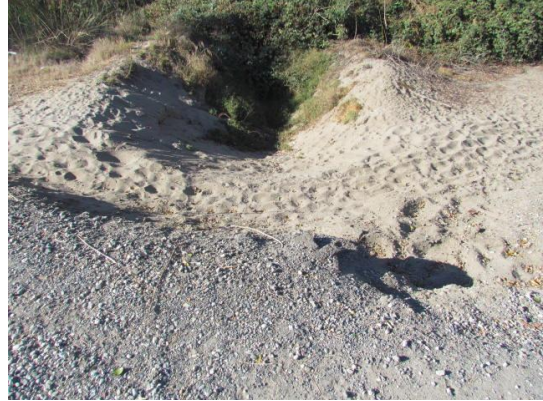
Photo 2 of 3 : FA_2015_RD0999_235_40_20151106_00034.jpg

Looking west at caving at landward slope and toe.

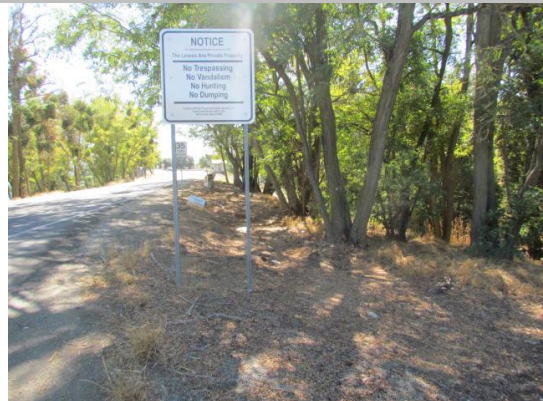
Photo 1 of 1 : FA_2015_RD0999_235_22_20150914_00018.jpg

Looking south at dense trees on landward slope.

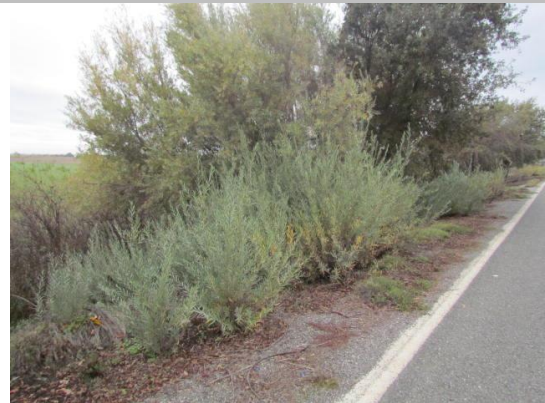
Photo 3 of 4 : FA_2015_RD0999_236_25_20150914_00026.jpg

Looking northwest at vegetation on landside shoulder. (Fall 2012)

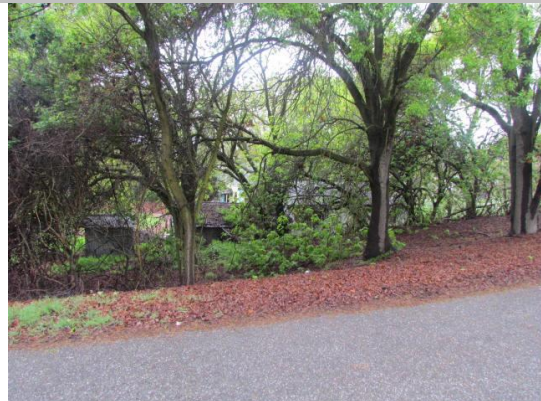
Photo 4 of 6 : FA_2015_RD0999_236_9_20150914_00008.jpg

Looking west at trimmed trees on landside slope. (Spring 2012)

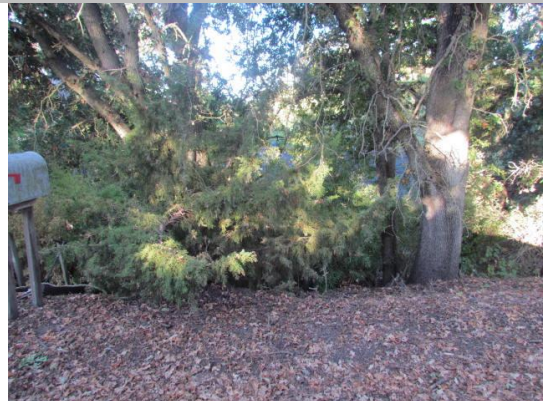
Photo 1 of 1 : FA_2015_RD0999_236_190_20150914_00116.jpg

Looking west at dense vegetation on landward slope and toe.

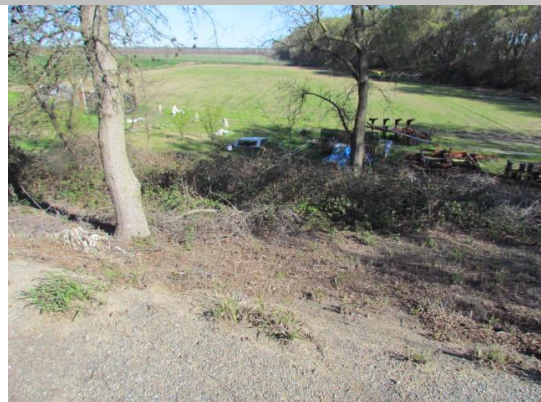
Photo 1 of 2 : FA_2015_RD0999_236_129_20150914_00090.jpg

Looking southwest at berry vines on landward slope.

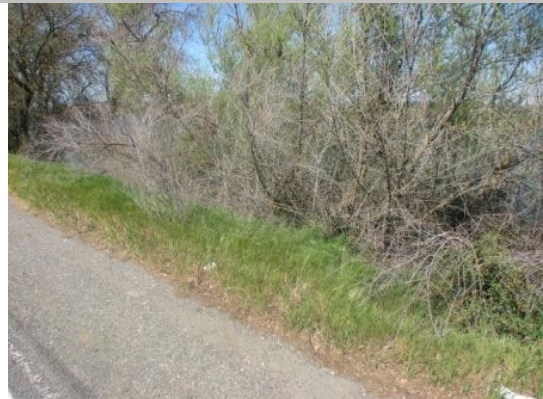
Photo 2 of 2 : FA_2015_RD0999_236_18_20150914_00020.jpg

Front view of dense trees along waterside slope.

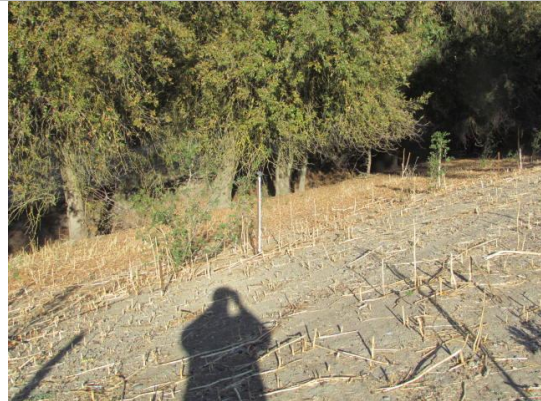
Photo 1 of 2 : FA_2015_RD0999_236_201_20150914_00122.jpg

Looking west a several small oak trees planted on landward slope.

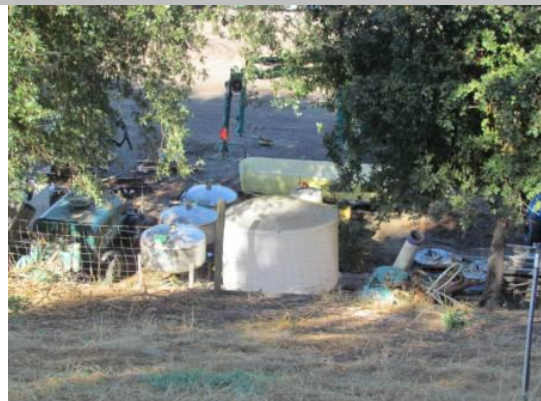
Photo 2 of 2 : FA_2015_RD0999_236_16_20150914_00016.jpg

Looking west at equipment at landside toe.

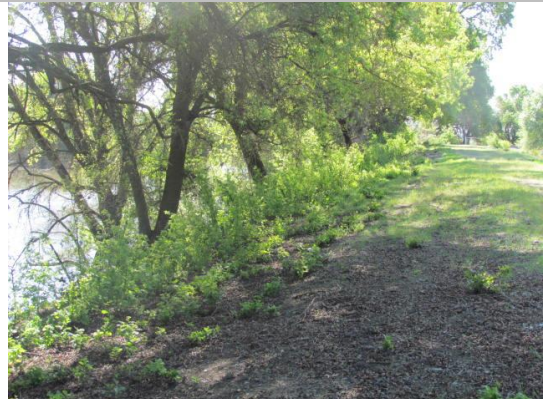
Photo 1 of 2 : FA_2015_RD0999_236_41_20150914_00042.jpg

Looking southeast at saplings on waterward slope. (Spring 2015)

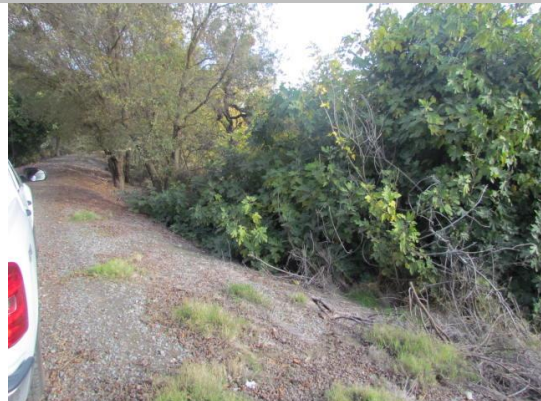
Photo 1 of 1 : FA_2015_RD0999_236_28_20150914_00029.jpg

Looking northeast at fig tree on waterside slope.

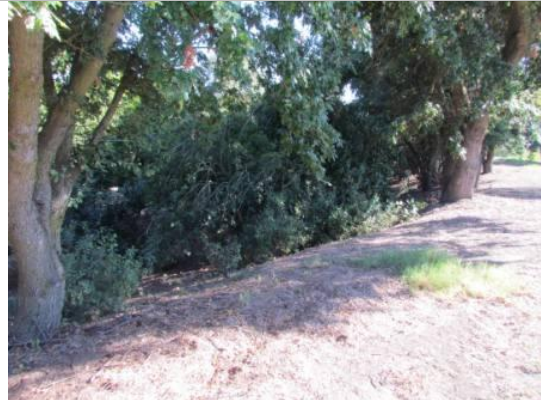
Photo 1 of 3 : FA_2015_RD0999_236_38_20150914_00034.jpg

Looking northwest at dense trees on landside slope. (Spring 2011)

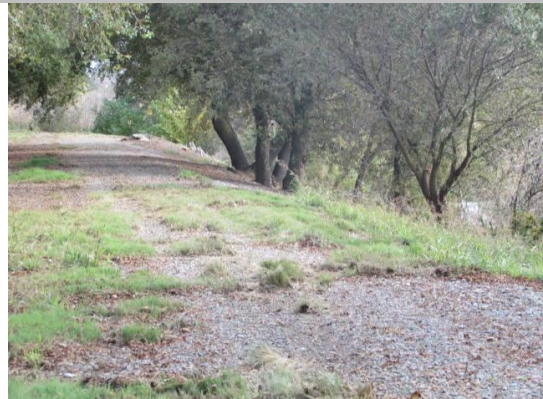
Photo 1 of 1 : FA_2015_RD0999_236_32_20150914_00031.jpg

Looking north at vegetation on levee crown.

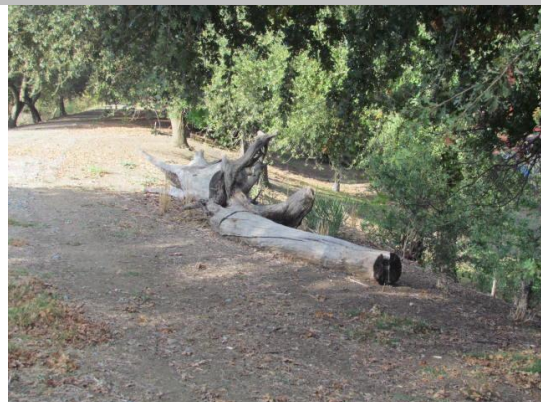
Photo 1 of 1 : FA_2015_RD0999_236_50_20150914_00052.jpg

Looking southwest at tree limbs on landward shoulder.

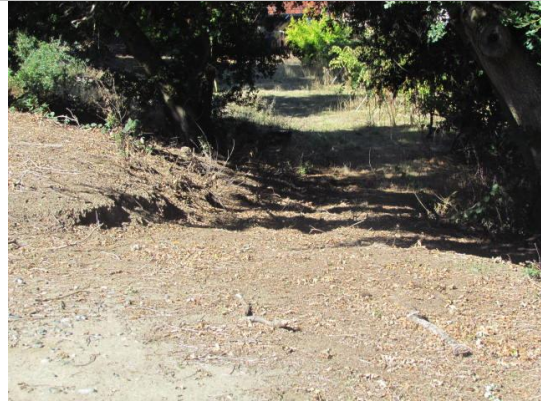
Photo 1 of 1 : FA_2015_RD0999_236_154_20150914_00105.jpg

Looking west at levee damage due to vehicle traffic.

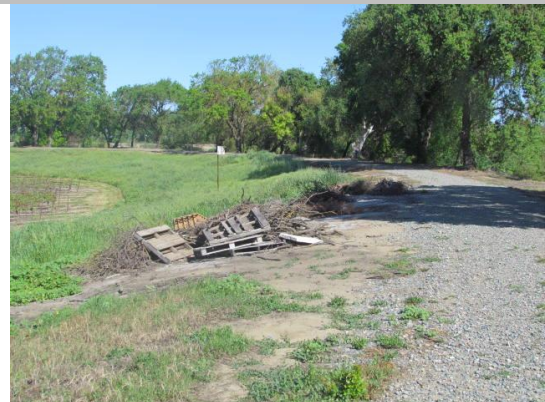
Photo 2 of 2 : FA_2015_RD0999_236_65_20150914_00059.jpg

Looking north at prunings on landward slope. (Spring 2015)

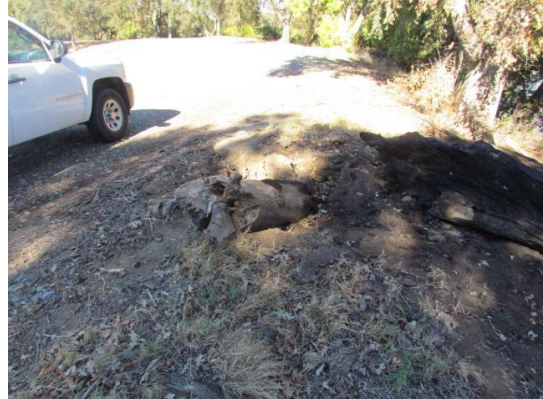
Photo 1 of 2 : FA_2015_RD0999_236_176_20151106_00163.jpg

Looking at hole on waterward shoulder caused by fallen tree.

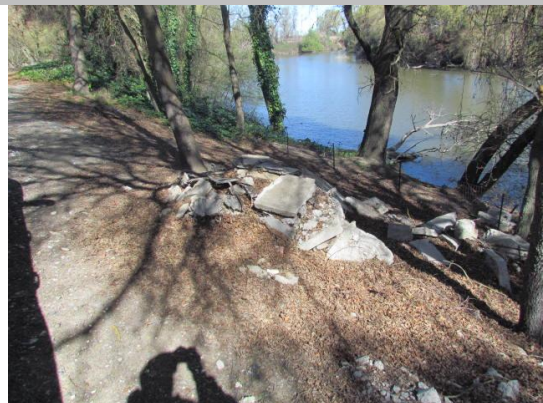
Photo 1 of 1 : FA_2015_RD0999_236_138_20150914_00096.jpg

Looking northeast at concrete rubble on waterward slope.

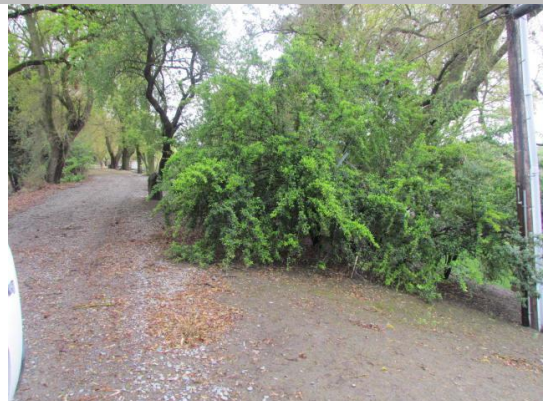
Photo 1 of 1 : FA_2015_RD0999_236_70_20150914_00064.jpg

Looking southwest at untrimmed tree on waterside shoulder and slope.

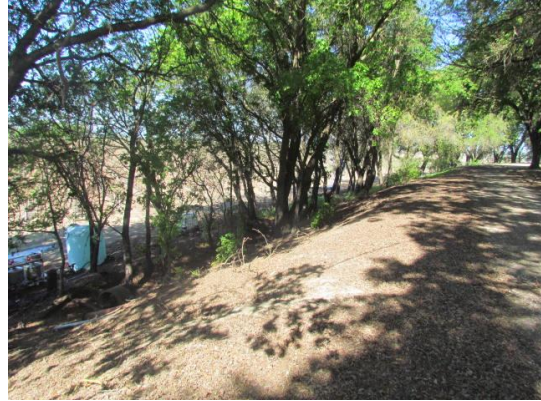
Photo 1 of 1 : FA_2015_RD0999_236_60_20150914_00058.jpg

Looking north at dense trees on landward slope. (Spring 2015)

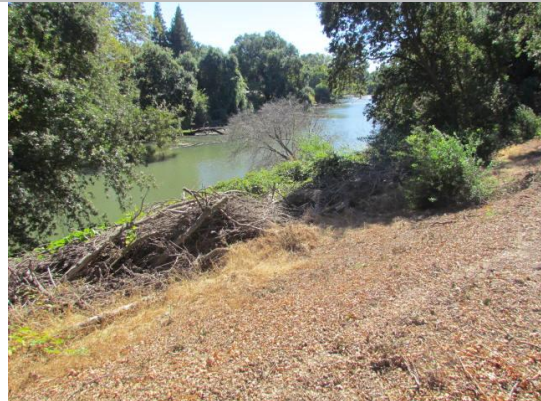
Photo 1 of 1 : FA_2015_RD0999_236_74_20150914_00067.jpg

Looking southeast at prunings on waterward slope.

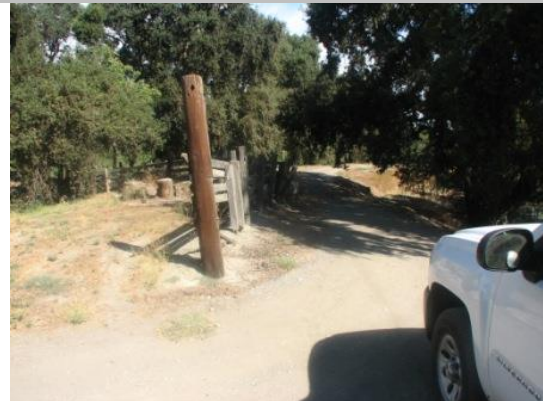
Photo 1 of 4 : FA_2015_RD0999_236_96_20150914_00077.jpg

Fence, firewood and material at landside shoulder.

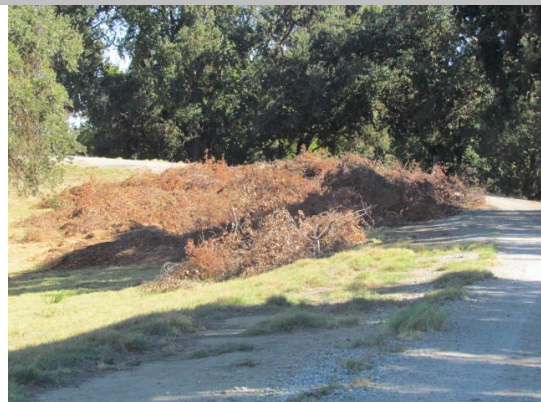
Photo 1 of 1 : FA_2015_RD0999_236_142_20150914_00098.jpg

Looking northeast at large prunings on landward slope.
