**Flood Control Project Maintenance
Levee Inspections**

Maintenance Issue Types Only, Levee Inspection Report By Mile - Fall 2016

Reclamation District No. 0999 Netherlands

Waterway	Bank	Unit Miles	Inspection Start/End	Inspector
Unit No. 01 Yolo Bypass	Left	15.41	09/19/2016 09/20/2016	Richard Willoughby

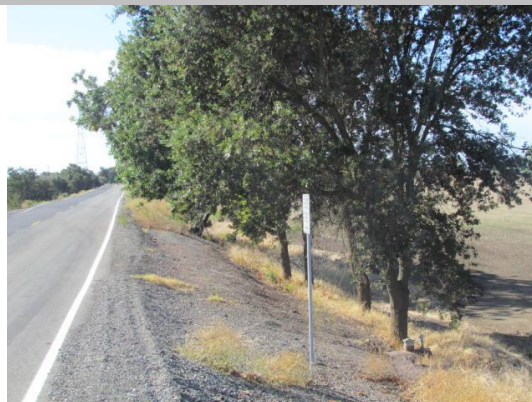
Photo 2 of 2 : FA_2016_RD0999_232_4_20160915_00012.jpg

LM Start	1.73	Rating **	M	Issue No.	4 (cont)
LM End	1.75	Issue Type +	Ma	Location *	WS

Looking southwest at trimmed trees on waterward slope.

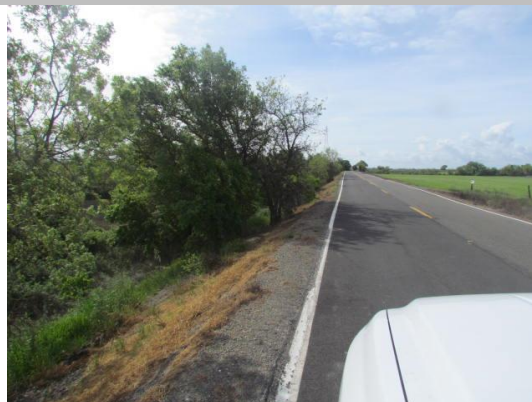
Photo 2 of 2 : FA_2016_RD0999_232_30_20160915_00034.jpg

Looking southeast at dense trees on landward slope. (Spring 2016)

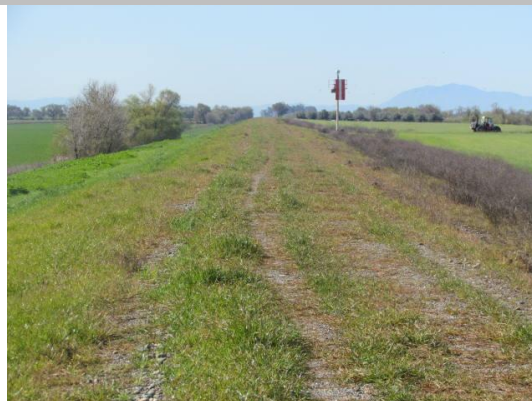
Photo 1 of 1 : FA_2016_RD0999_232_46_20160915_00059.jpg

LM Start	2.53	Rating **	A/W	Issue No.	46
LM End	4.98	Issue Type +	Ma	Location *	CR
Category	Earthen Levee			GPS Latitude/Longitude	
				Start	End
Item	Crown Surface / Depressions / Rutting			38.468801 °	38.435378 °
				-121.583189 °	-121.598664 °
DWR ID	DWR_RD0999_01_f_2013_46				
Comment Code					
C2 : Repair depressions or ruts in the crown or slope.					
Inspector Comment					
Control growth on levee crown and repair ruts on levee crown. And add appropriate gravel or road base.

Looking south at growth on levee crown.

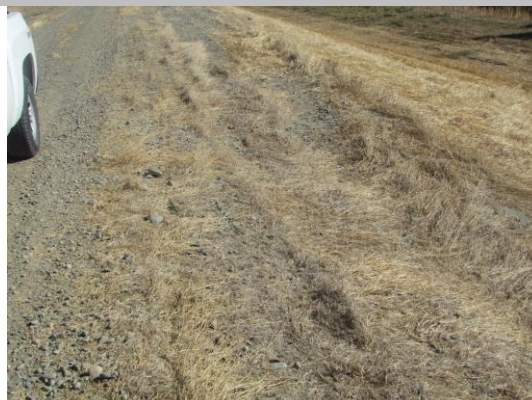
Photo 1 of 2 : FA_2016_RD0999_232_51_20160923_00113.jpg

LM Start	3.22	Rating **	M	Issue No.	51
LM End	3.22	Issue Type +	Ma	Location *	LS
Category	Earthen Levee			GPS Latitude/Longitude	
				Start	End
Item	Slope Stability			38.459399 °	38.459399 °
				-121.587523 °	-121.587523 °
DWR ID	DWR_RD0999_01_s_2013_51				
Comment Code					
S1 : Repair slope instability.					
Inspector Comment					
Depression on landward shoulder and slope 40' x 20'. Earthen material appears to be sliding toward levee toe.

Looking northeast at depression on landward slope. (Fall 2016)

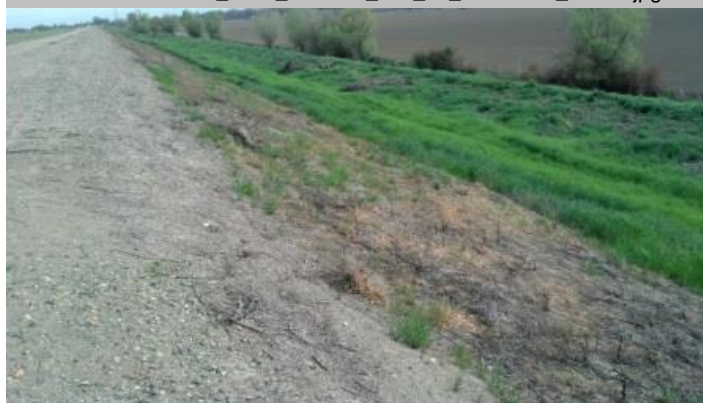
Photo 2 of 2 : FA_2016_RD0999_232_51_20160915_00070.jpg

Looking north at depression on landside shoulder and slope. (Spring 2016)

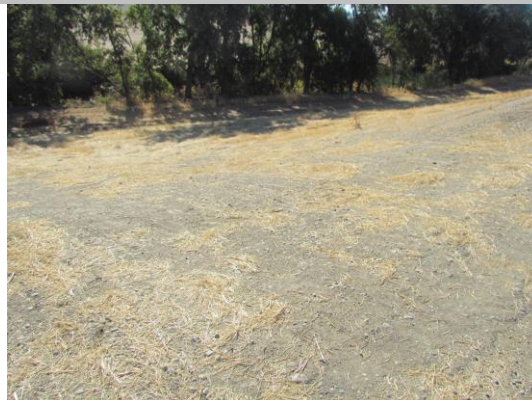
Photo 1 of 2 : FA_2016_RD0999_232_35_20160923_00114.jpg

LM Start	4.31	Rating **	M	Issue No.	35
LM End	4.31	Issue Type +	Ma	Location *	LS
Category	Earthen Levee			GPS Latitude/Longitude	
				Start	End
Item	Slope Stability			38.444561 °	38.444561 °
				-121.594438 °	-121.594438 °
DWR ID	DWR_RD0999_01_f_2012_35				
Comment Code					
S3 : Repair the levee slope damaged by vehicle traffic and prevent access where possible.					
Inspector Comment					
Depression is caused by vehicle traffic.

Looking southeast at slope damage cause by vehicle traffic on landward slope. (Fall 2016)

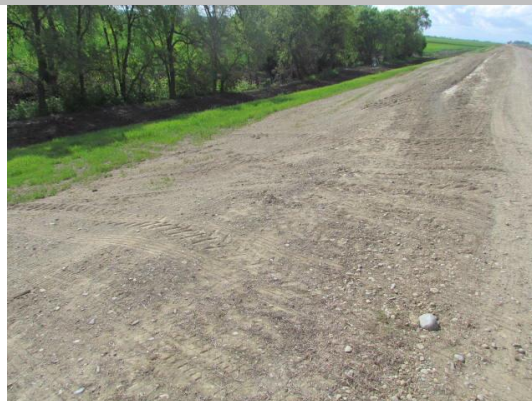
Photo 2 of 2 : FA_2016_RD0999_232_35_20160915_00041.jpg

LM Start	4.31	Rating **	M	Issue No.	35 (cont)	
LM End	4.31	Issue Type +	Ma	Location *	LS	
Category	Earthen Levee			GPS Latitude/Longitude		
				Start		End
Item	Slope Stability			38.444561 °		38.444561 °
				-121.594438 °		-121.594438 °
DWR ID	DWR_RD0999_01_f_2012_35					
Comment Code						
S3 : Repair the levee slope damaged by vehicle traffic and prevent access where possible.						
Inspector Comment						
Depression is caused by vehicle traffic.

Looking southeast at slope damage cause by vehicle traffic on landward slope. (Spring 2015)

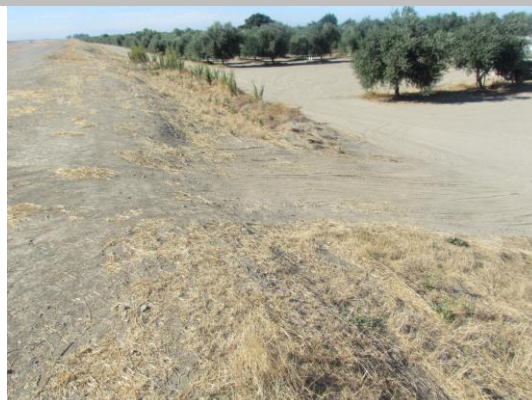
Photo 1 of 2 : FA_2016_RD0999_232_27_20160923_00115.jpg

LM Start	4.31	Rating **	M	Issue No.	27
LM End	4.31	Issue Type +	Ma	Location *	WS
Category	Earthen Levee			GPS Latitude/Longitude	
				Start	End
Item	Slope Stability			38.444560 °	38.444560 °
				-121.594440 °	-121.594440 °
DWR ID	DWR_RD0999_01_f_2012_27				
Comment Code					
S3 : Repair the levee slope damaged by vehicle traffic and prevent access where possible.					
Inspector Comment					
Local farmer causing slope damage by driving equipment and trucks on slope.

Looking at slope damage cause by vehicle traffic on waterward slope. (Fall 2016)

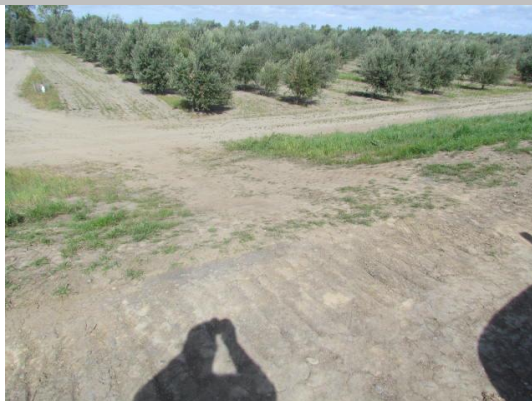
Photo 2 of 2 : FA_2016_RD0999_232_27_20160915_00028.jpg

LM Start	4.31	Rating **	M	Issue No.	27 (cont)	
LM End	4.31	Issue Type +	Ma	Location *	WS	
Category	Earthen Levee			GPS Latitude/Longitude		
				Start		End
Item	Slope Stability			38.444560 °		38.444560 °
				-121.594440 °		-121.594440 °
DWR ID	DWR_RD0999_01_f_2012_27					
Comment Code						
S3 : Repair the levee slope damaged by vehicle traffic and prevent access where possible.						
Inspector Comment						
Local farmer causing slope damage by driving equipment and trucks on slope.

Looking at slope damage cause by vehicle traffice on waterward slope.
(Spring 2015)

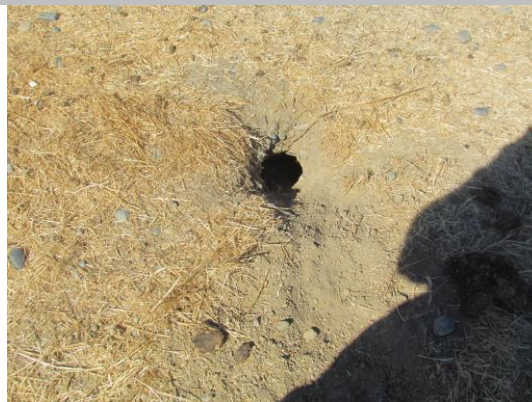
Photo 1 of 3 : FA_2016_RD0999_232_69_20160923_00120.jpg

LM Start	9.34	Rating **	M	Issue No.	69
LM End	9.34	Issue Type +	Ma	Location *	CR
Category	Earthen Levee			GPS Latitude/Longitude	
				Start	End
Item	Animal Control			38.376094 °	38.376094 °
				-121.626178 °	-121.626178 °
DWR ID	DWR_RD0999_01_s_2016_69				
Comment Code					
A1 : Exterminate rodents and backfill and compact or grout burrows.					
Inspector Comment					
Rodent holes noted on levee crown, shoulder and landward slope

Looking at typical rodent hole on landward slope. (Fall 2016)

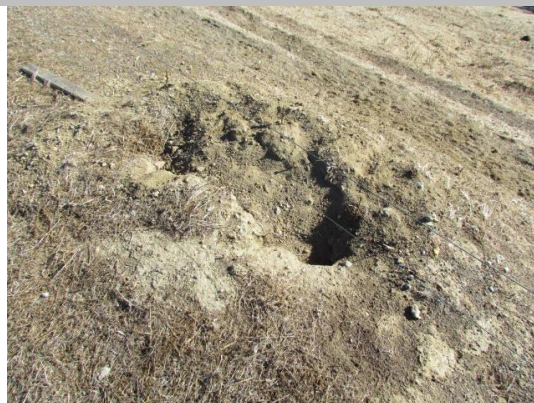
Photo 3 of 5 : FA_2016_RD0999_232_2_20160915_00008.jpg

Looking northeast at rodent holes on landward shoulder fall 2015.

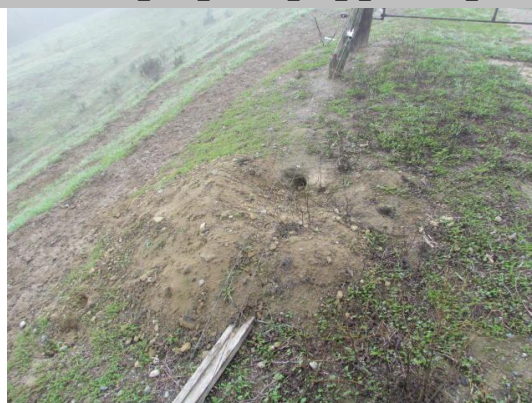
Photo 5 of 5 : FA_2016_RD0999_232_2_20160915_00010.jpg

Looking south at rodent hole on landside shoulder. (Fall 2014)

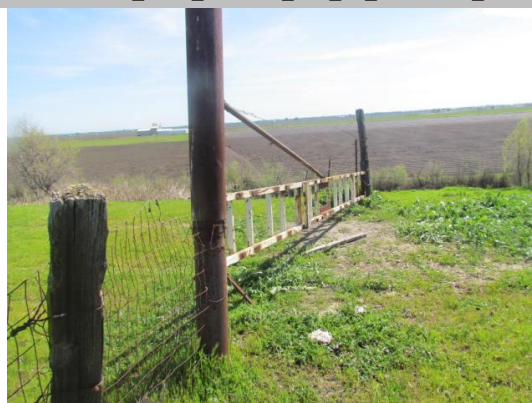
Photo 1 of 3 : FA_2016_RD0999_232_70_20160915_00088.jpg

LM Start	10.21	Rating **	A/W	Issue No.	70
LM End	10.21	Issue Type +	Ma	Location *	CR
Category	Earthen Levee			GPS Latitude/Longitude	
				Start	End
Item	Repair Gates			38.364229 °	38.364229 °
				-121.631673 °	-121.631673 °
DWR ID	DWR_RD0999_01_s_2016_70				
Comment Code					
Inspector Comment					
Gate drags difficult to open and close. Gate pole leaning.

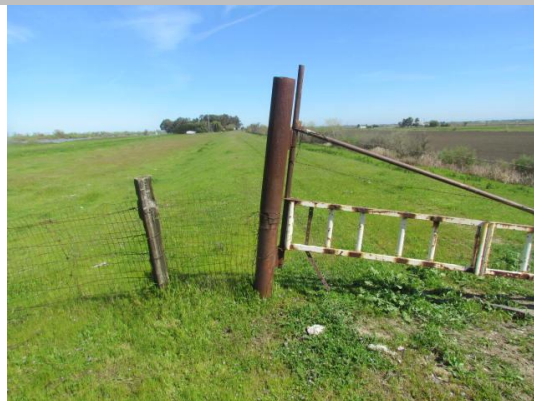
Photo 2 of 3 : FA_2016_RD0999_232_70_20160915_00089.jpg

LM Start	10.21	Rating **	A/W	Issue No.	70 (cont)	
LM End	10.21	Issue Type +	Ma	Location *	CR	
Category	Earthen Levee			GPS Latitude/Longitude		
				Start		End
Item	Repair Gates			38.364229°		38.364229°
				-121.631673°		-121.631673°
DWR ID	DWR_RD0999_01_s_2016_70					
Comment Code						
Inspector Comment						
Gate drags difficult to open and close. Gate pole leaning.

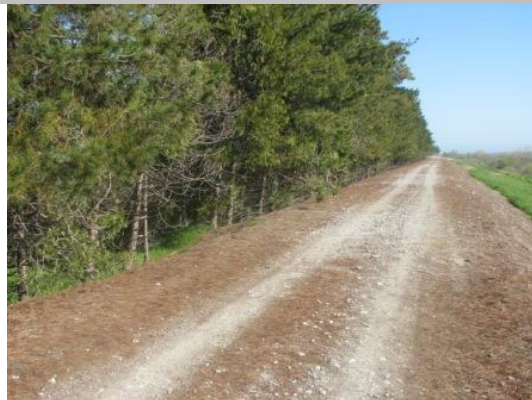
Photo 2 of 2 : FA_2016_RD0999_232_23_20160915_00025.jpg

Pine trees along waterside shoulder & slope. (Site of a old christmas tree farm). (Spring 2011)

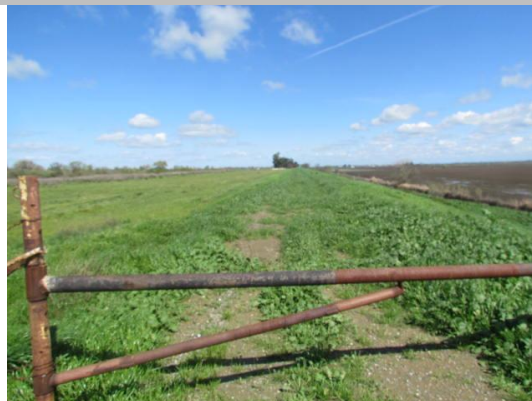
Photo 1 of 1 : FA_2016_RD0999_232_43_20160915_00056.jpg

Looking north at growth on levee crown.

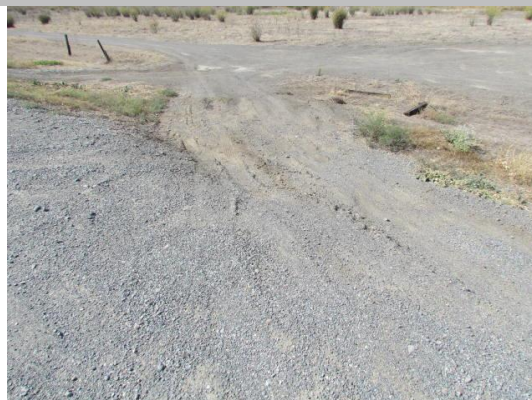
Photo 1 of 2 : FA_2016_RD0999_232_48_20160915_00061.jpg

LM Start	11.84	Rating **	M	Issue No.	48
LM End	11.84	Issue Type +	Ma	Location *	WS
Category	Earthen Levee			GPS Latitude/Longitude	
				Start	End
Item	Slope Stability			38.342068 °	38.342068 °
				-121.641944 °	-121.641944 °
DWR ID	DWR_RD0999_01_f_2012_48				
Comment Code					
S3 : Repair the levee slope damaged by vehicle traffic and prevent access where possible.					
Inspector Comment					
Slope damage caused by vehicle traffic.

Looking southwest at slope damage caused by vehicle traffic. 2013

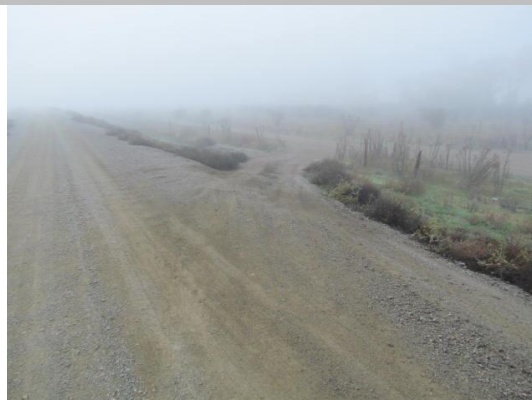
Photo 2 of 2 : FA_2016_RD0999_232_48_20160915_00062.jpg

Looking southwest at slope damage caused by vehicle traffic on waterside slope.

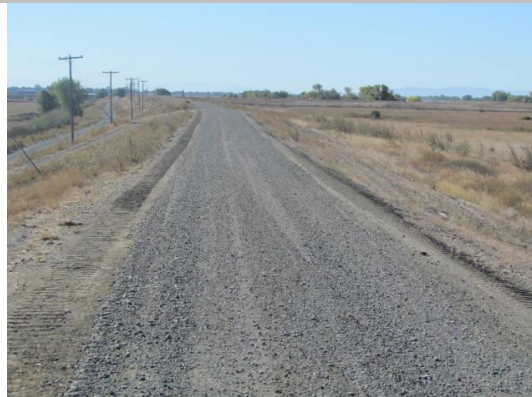
Photo 1 of 1 : FA_2016_RD0999_232_21_20160915_00021.jpg

LM Start	12.13	Rating **	A/W	Issue No.	19
LM End	12.61	Issue Type +	Ma	Location *	CR
Category	Earthen Levee			GPS Latitude/Longitude	
				Start	End
Item	Crown Surface / Depressions / Rutting			38.337980 °	38.331138 °
				-121.643403 °	-121.644781 °
DWR ID	DWR_RD0999_01_f_2014_19				
Comment Code					
C2 : Repair depressions or ruts in the crown or slope.					
Inspector Comment

Looking south at graded levee crown.(Fall 2014)

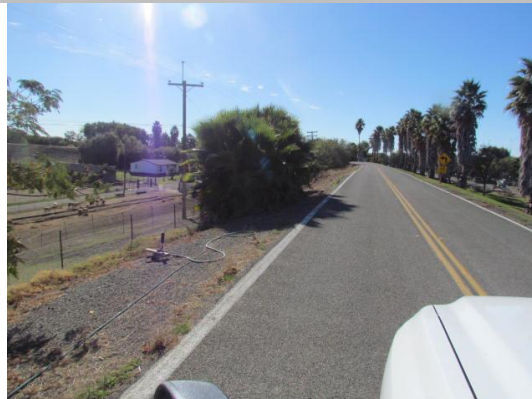
Photo 2 of 3 : FA_2016_RD0999_232_50_20160915_00068.jpg

Looking east at a maturing palm trees on landward shoulder and slope. (Fall 2014)

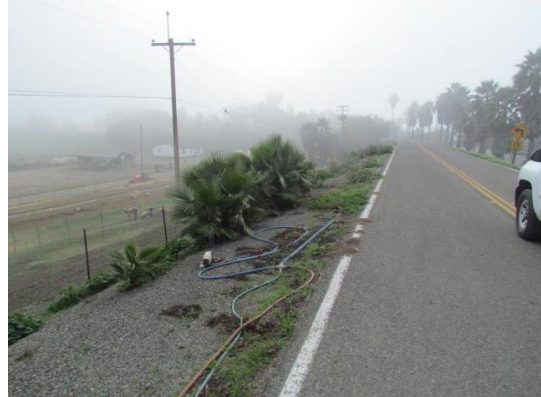
Photo 3 of 3 : FA_2016_RD0999_232_50_20160915_00069.jpg

Looking east at newly planted palm trees on landside shoulder and slope.

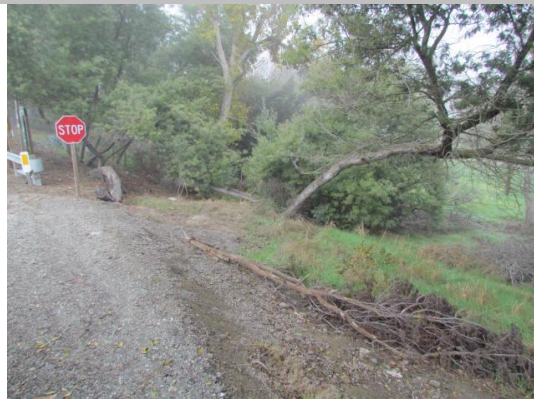
Photo 2 of 2 : FA_2016_RD0999_233_19_20160915_00022.jpg

Looking west at dense trees on landside slope and toe.

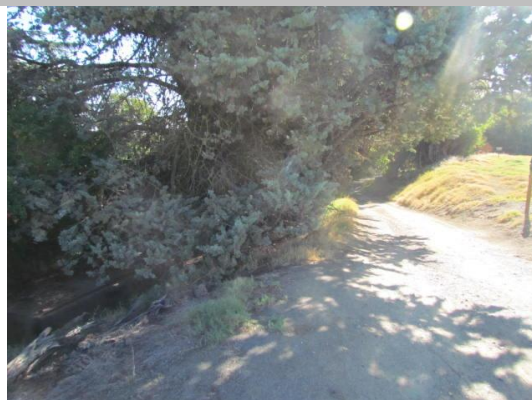
Photo 2 of 2 : FA_2016_RD0999_233_11_20160915_00013.jpg

Looking southwest at dense trees on landward slope.

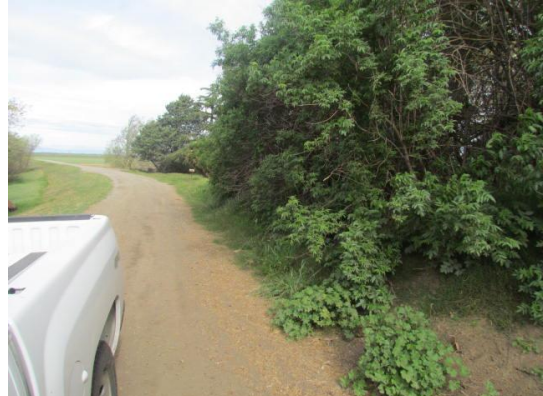
Photo 2 of 3 : FA_2016_RD0999_233_8_20160915_00009.jpg

Looking west at dense vegetation on landward shoulder and slope.
(Spring 2015)

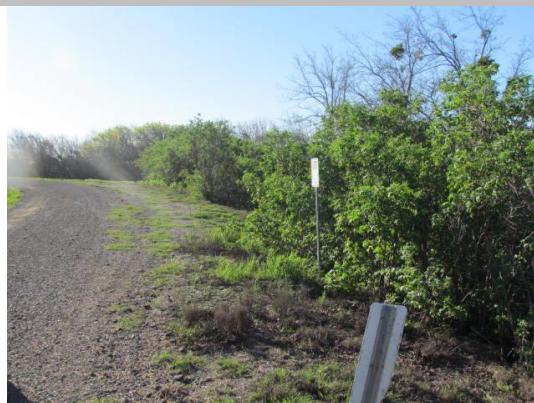
Photo 3 of 3 : FA_2016_RD0999_233_38_20160915_00032.jpg

Looking east at dense vegetation on waterside slope. (Spring 2014)

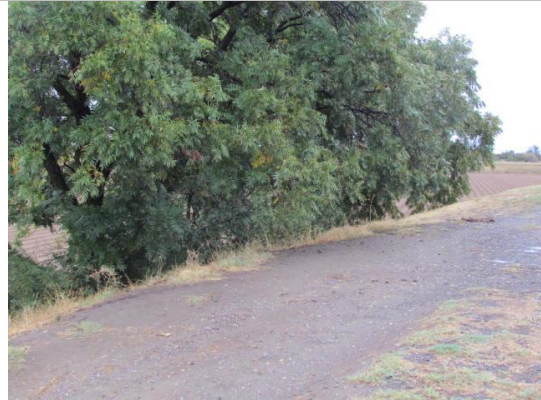
Photo 1 of 1 : FA_2016_RD0999_233_29_20160915_00028.jpg

Looking at untrimmed trees on landward slope fall 2015.

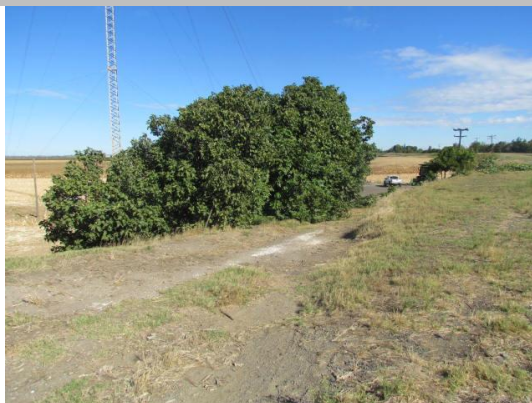
Photo 3 of 5 : FA_2016_RD0999_234_4_20160915_00006.jpg

Looking northwest at dense fig tree on landward slope and toe. 2013

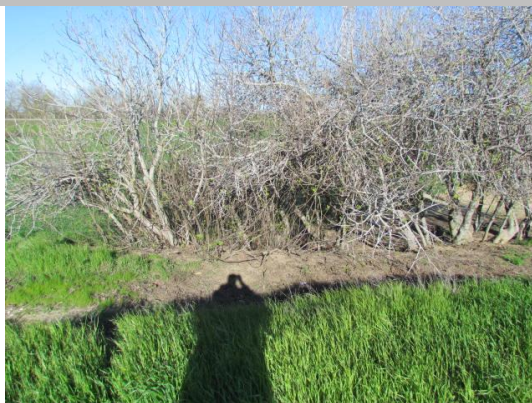
Photo 5 of 5 : FA_2016_RD0999_234_4_20160915_00008.jpg

Looking west at dense fig trees at landside toe.

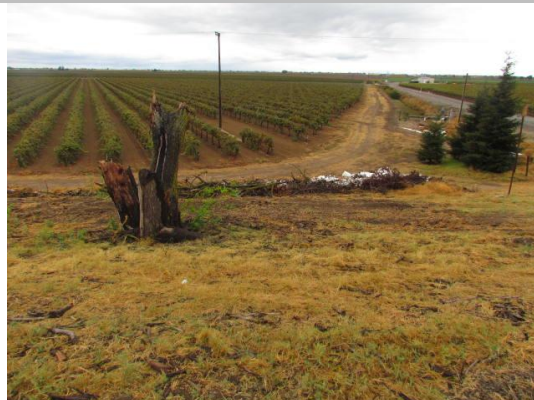
Photo 2 of 2 : FA_2016_RD0999_234_2_20160915_00003.jpg

Looking at prunings at landward toe.

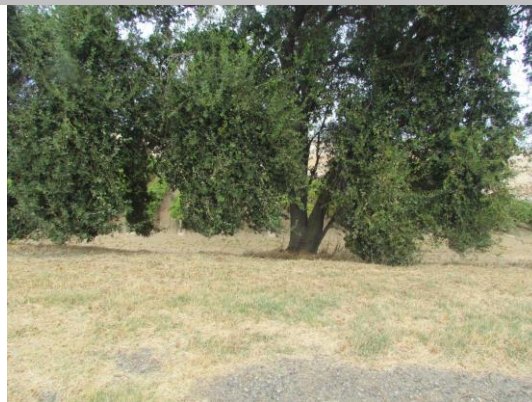
Photo 1 of 2 : FA_2016_RD0999_234_11_20160923_00056.jpg

Looking at untrimmed trees on landward slope and toe. (Fall 2016)

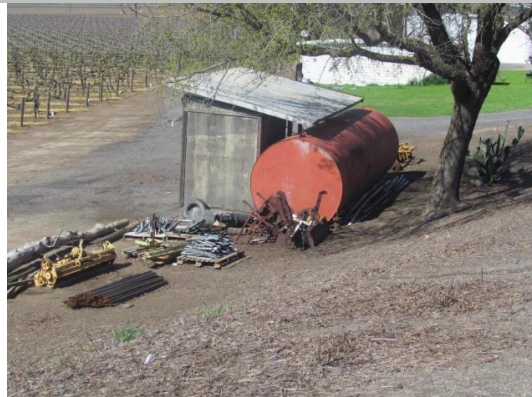
Photo 1 of 3 : FA_2016_RD0999_234_27_20160915_00028.jpg

Looking northwest at diesel tank and other farm equipment stored at landward toe. (Spring 2016)

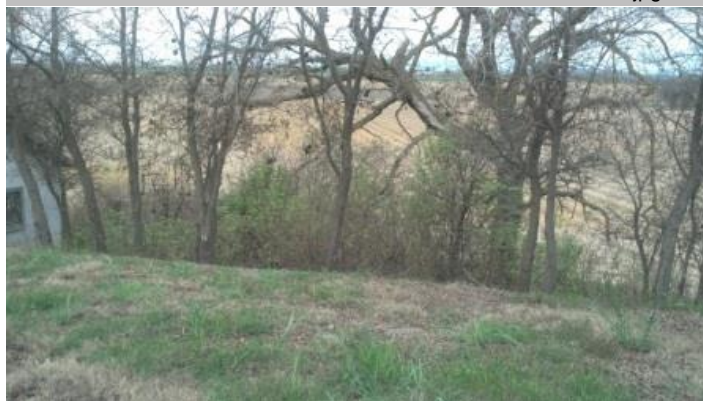
Photo 3 of 4 : FA_2016_RD0999_234_10_20160915_00017.jpg

Looking west at dense trees on landside toe.

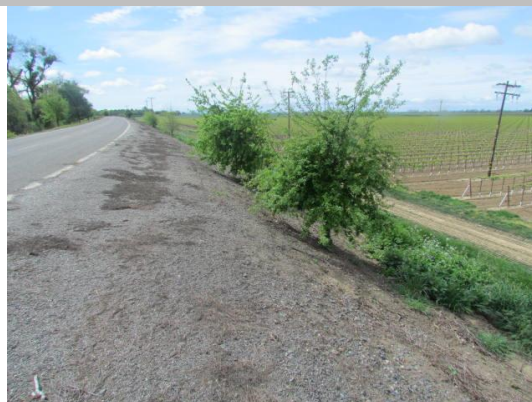
Photo 1 of 1 : FA_2016_RD0999_234_44_20160915_00039.jpg

Looking southwest at typical view of young oak trees on landward slope.
(Spring 2015)

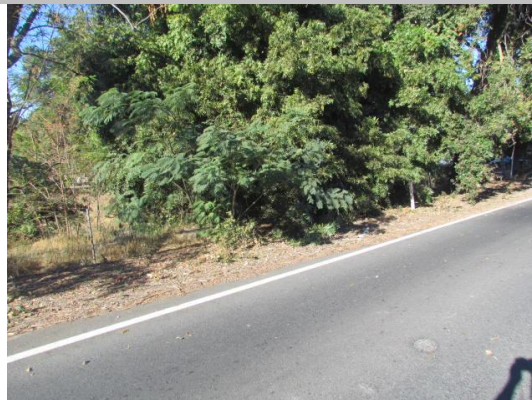
Photo 1 of 1 : FA_2016_RD0999_235_35_20160915_00022.jpg

Looking at untrimmed trees on landward slope.

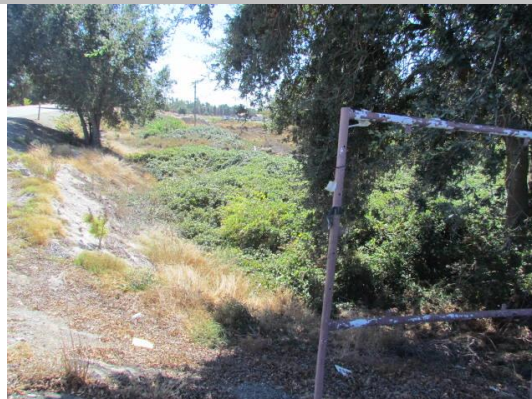
Photo 3 of 4 : FA_2016_RD0999_235_16_20160915_00017.jpg

Looking southwest at dense berry vines at landward toe. 2013

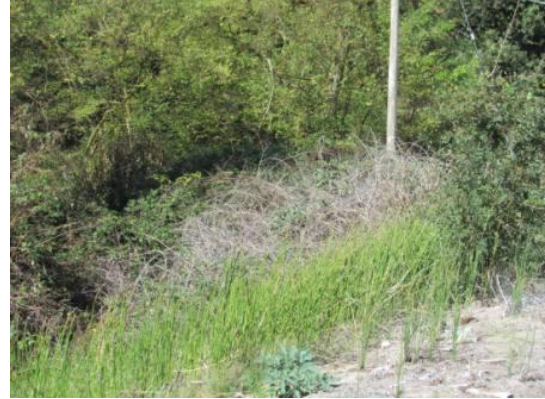
Photo 3 of 3 : FA_2016_RD0999_235_5_20160915_00004.jpg

Looking northwest at dense wild roses and berry vines on landside toe near ramp.

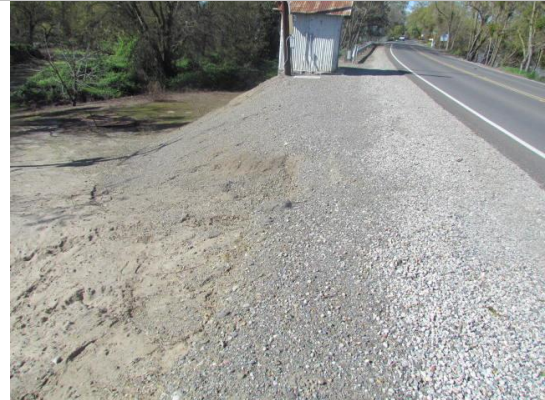
Photo 1 of 4 : FA_2016_RD0999_235_40_20160915_00028.jpg

Looking east at erosion on landward shoulder and slope. (Spring 2016)

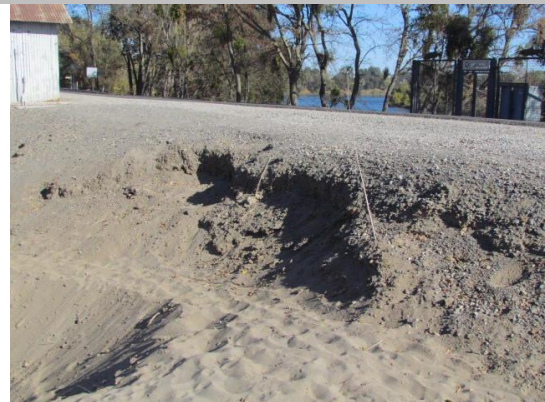
Photo 2 of 4 : FA_2016_RD0999_235_40_20160915_00031.jpg

Looking east at erosion on landward shoulder.

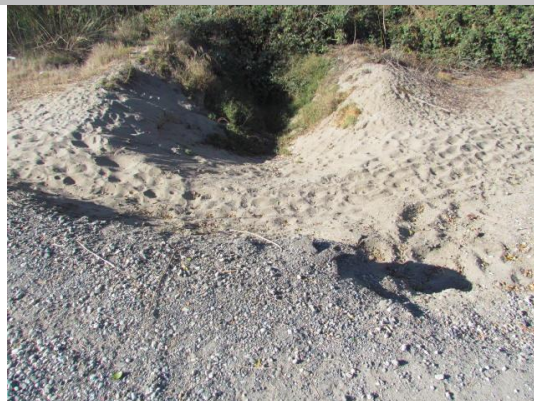
Photo 3 of 4 : FA_2016_RD0999_235_40_20160915_00032.jpg

Looking west at caving at landward slope and toe.

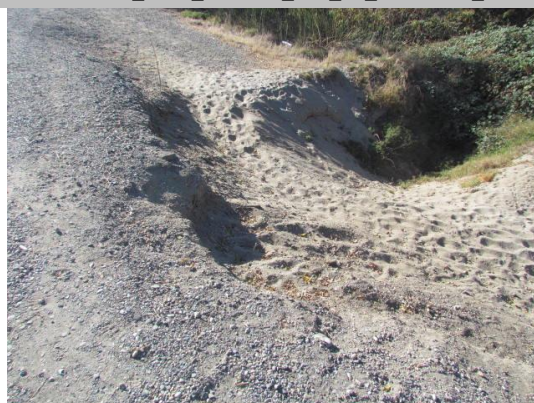
Photo 4 of 4 : FA_2016_RD0999_235_40_20160915_00033.jpg

Looking southwest at shoulder erosion and caving at landward slope and toe.

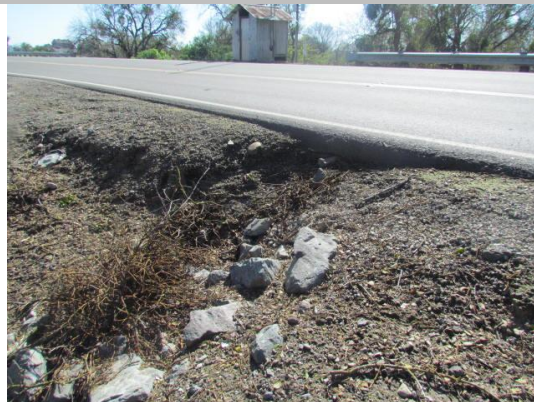
Photo 1 of 2 : FA_2016_RD0999_235_46_20160915_00034.jpg

Looking west at foot erosion on waterward shoulder and slope.

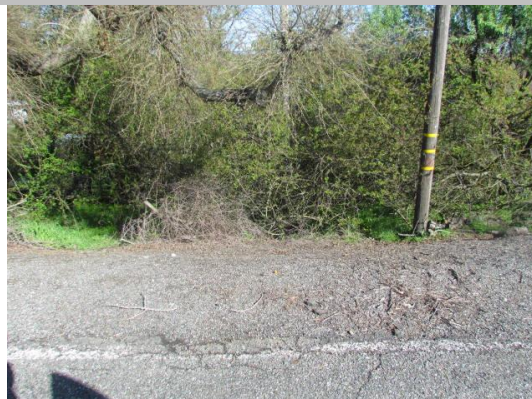
Photo 1 of 1 : FA_2016_RD0999_236_53_20160915_00055.jpg

Looking west at dense vegetation on landward slope.

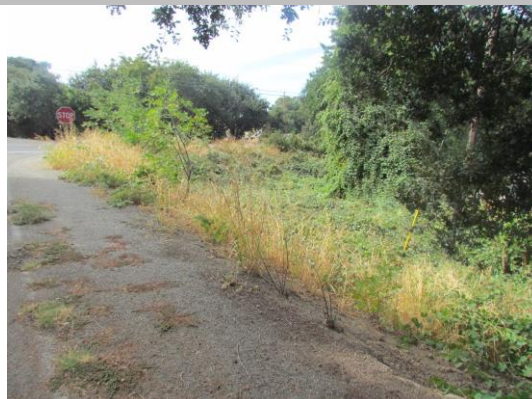
Photo 1 of 2 : FA_2016_RD0999_236_189_20160923_00224.jpg

Looking southwest at dense vegetation on landward slope and toe. (Fall 2016)

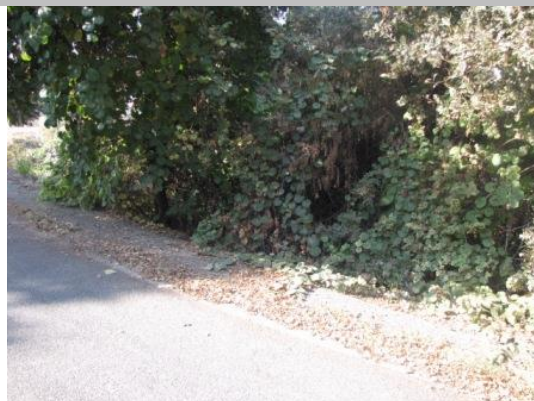
Photo 5 of 6 : FA_2016_RD0999_236_9_20160915_00011.jpg

Looking west at dense trees on landside slope and toe. (Spring 2011)

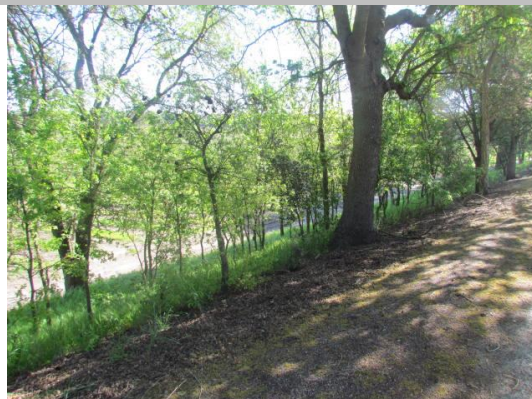
Photo 1 of 1 : FA_2016_RD0999_236_24_20160915_00025.jpg

Looking west at dense trees on landward slope. (Spring 2015)

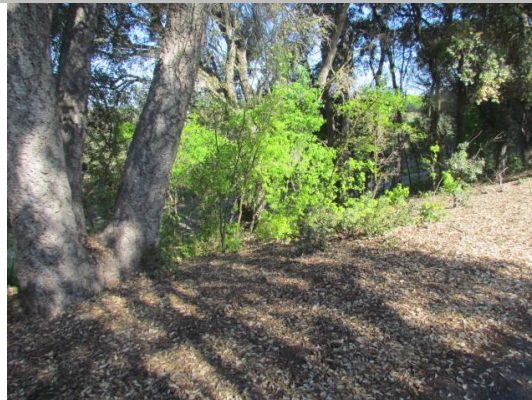
Photo 1 of 1 : FA_2016_RD0999_236_82_20160915_00076.jpg

Looking northwest at dense trees on landward slope. (Spring 2015)

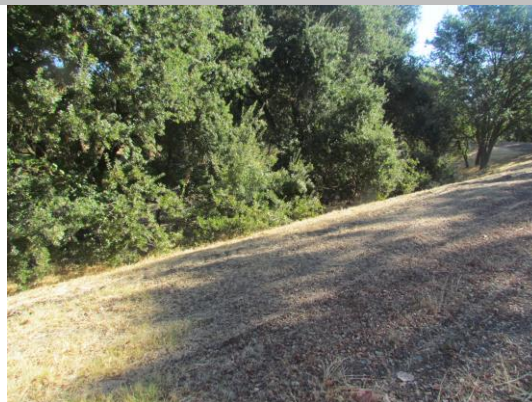
Photo 1 of 2 : FA_2016_RD0999_236_213_20160926_00229.jpg

Looking northwest at untrimmed trees on landward toe. (Fall 2016)

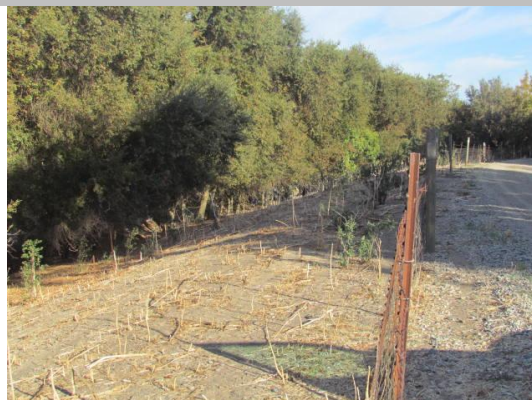
Photo 2 of 2 : FA_2016_RD0999_236_201_20160915_00142.jpg

Looking northwest at several small oak trees planted along landward slope.

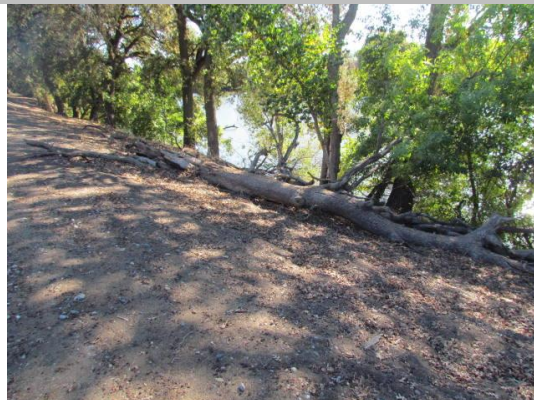
Photo 1 of 1 : FA_2016_RD0999_236_174_20160915_00125.jpg

LM Start	3.80	Rating **	M	Issue No.	174
LM End	3.80	Issue Type +	Ma	Location *	WS
Category	Earthen Levee			GPS Latitude/Longitude	
				Start	End
Item	Encroachments			38.368207 °	38.368207 °
				-121.554360 °	-121.554360 °
DWR ID	DWR_RD0999_05_f_2015_174				
Comment Code					
TR : Tree or limb					
Inspector Comment					
Downed tree branch and limbs on waterward slope.

Looking at downed tree branch on waterward slope.

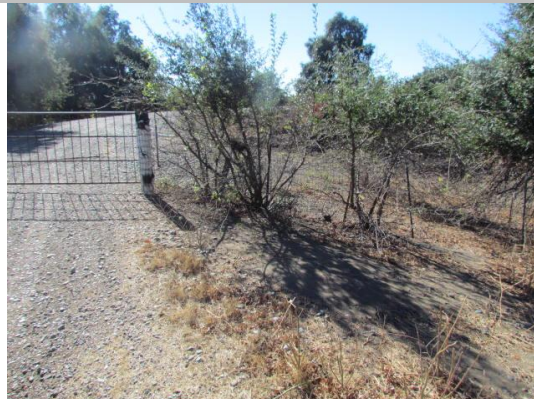
Photo 2 of 2 : FA_2016_RD0999_236_175_20160915_00126.jpg

Looking at young trees on waterward shoulder and slope. (Spring 2016)

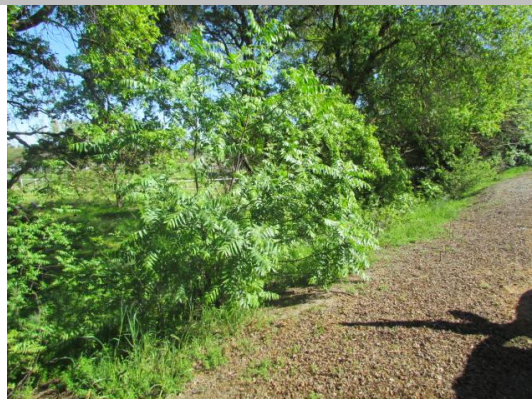
Photo 1 of 1 : FA_2016_RD0999_236_57_20160915_00058.jpg

Looking northwest at dense trees on landward slope. (Spring 2015)

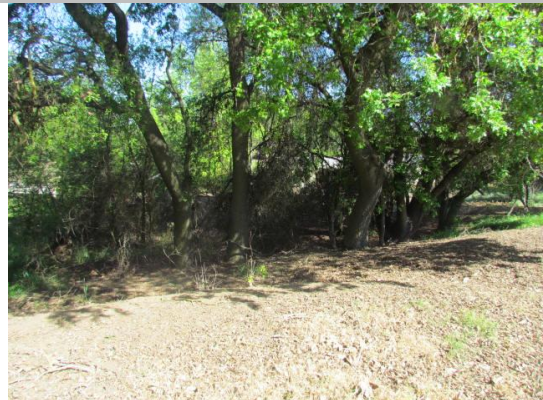
Photo 1 of 1 : FA_2016_RD0999_236_52_20160915_00054.jpg

Looking west at untrimmed trees on landward toe. (Spring 2015)

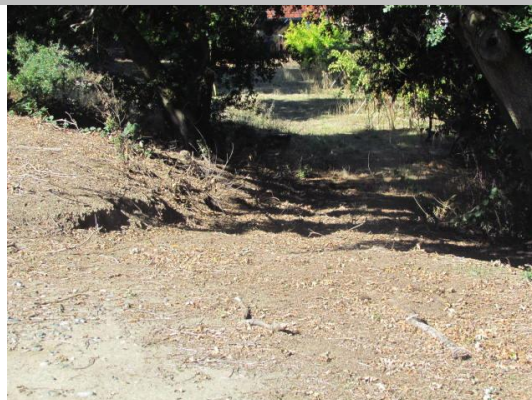
Photo 1 of 1 : FA_2016_RD0999_236_154_20160915_00112.jpg

Looking west at levee damage due to vehicle traffic.

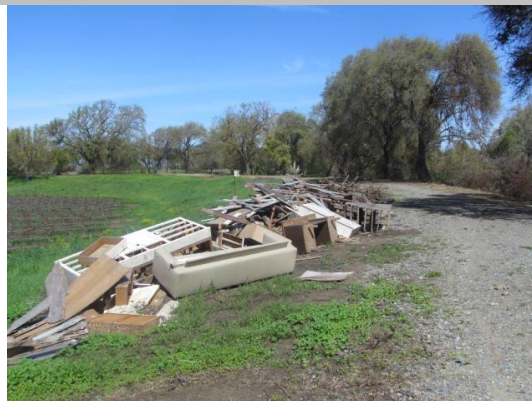
Photo 2 of 2 : FA_2016_RD0999_236_65_20160915_00060.jpg

Looking east at garbage and prunings on landward shoulder. (Spring 2016)

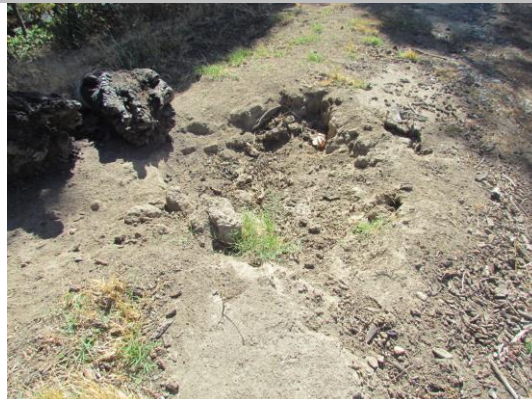
Photo 1 of 3 : FA_2016_RD0999_236_176_20160926_00236.jpg

Looking at hole from falling tree on waterward shoulder. (Fall 2016)

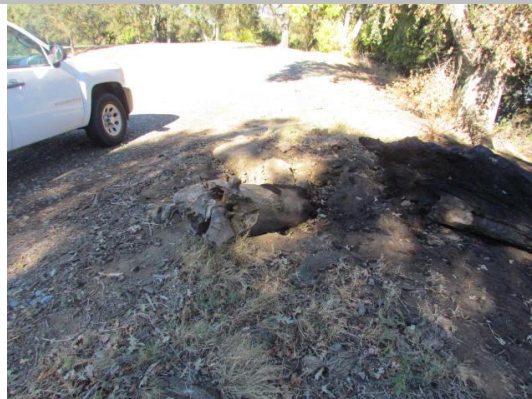
Photo 2 of 3 : FA_2016_RD0999_236_176_20160915_00127.jpg

Looking at hole on waterward shoulder caused by fallen tree.

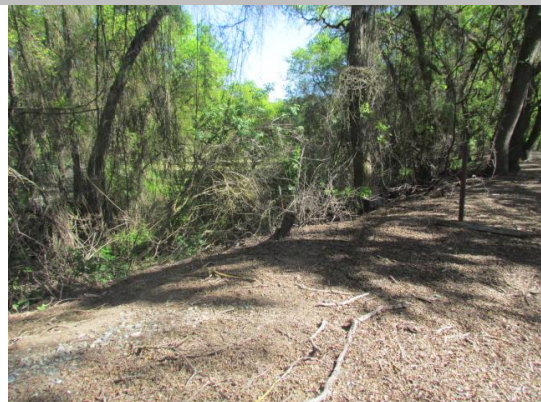
Photo 2 of 2 : FA_2016_RD0999_236_48_20160915_00051.jpg

Looking east at dense vegetation on landward slope. (Spring 2015)

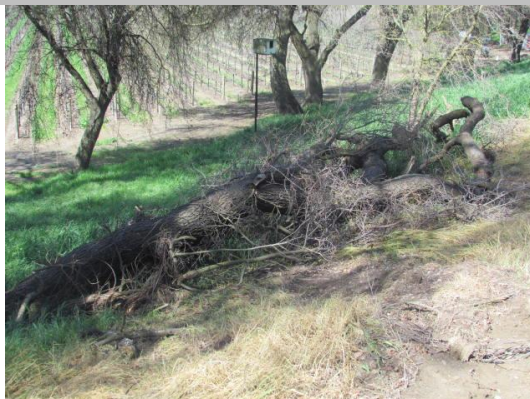
Photo 1 of 1 : FA_2016_RD0999_236_219_20160915_00154.jpg

Looking northeast at tree branch and limbs on landward slope.

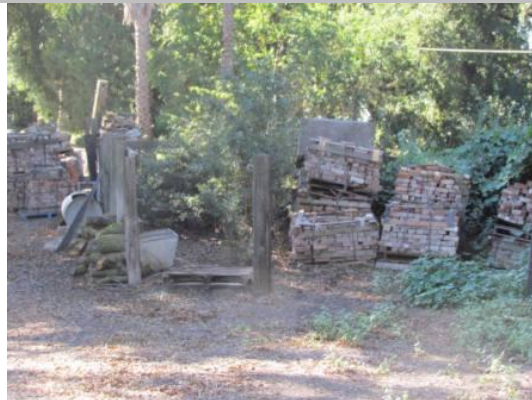
Photo 3 of 4 : FA_2016_RD0999_236_96_20160915_00085.jpg

Looking south at firewood and other material on landside shoulder and crown.

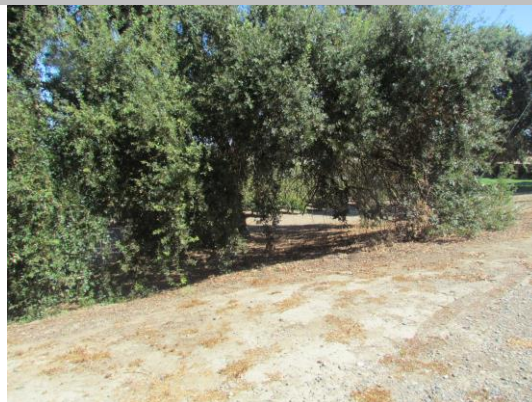
Photo 1 of 1 : FA_2016_RD0999_236_206_20160926_00240.jpg

Looking west at untrimmed trees on landward toe.
