**Flood Control Project Maintenance
Levee Inspections**

Maintenance Issue Types Only, Levee Inspection Report By Mile - Fall 2017

Reclamation District No. 0999 Netherlands

Waterway	Bank	Unit Miles	Inspection Start/End	Inspector
Unit No. 01 Yolo Bypass	Left	15.41	10/10/2017 10/10/2017	Dave Torres

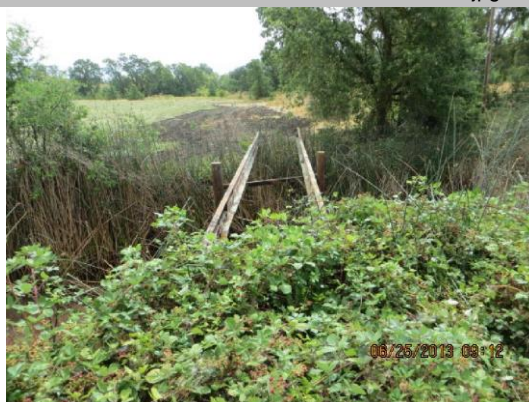
Photo 2 of 3 : UCIP_FA_2017_50092_25190.jpg

FS_ID:50092
DS_ID:22743
EP_NO: N/A
Repair Type: Urgent
Crossing Status: Found
UCIP Comments: 07/07/2016 Condition largely unchanged from previous inspection. Pipe open on the WS, waterward of the siphon breaker. Dense vegetation and steep slope limited inspection of WS outlet into Ship Channel. (T. Hatch/UCIP)
06/25/2013 Pipe abandoned and open on WS slope. Pipe should be abandoned properly. (W. Wylie/UCIP)
FIELD_STRUCT_DESC: *ABANDONED* 30-inch steel drainage pipe through the levee, 6.5 feet below the crown. Pump on a platform in the canal off the landside (LS) toe, not found. Flap gate on the waterside (WS), not found. Siphon breaker and an air vent on the WS shoulder. 1-inch galvanized iron filler pipe visible on the WS shoulder along same alignment. [Additional Reference(s): DWR Levee Log, 1992. USACE Sacramento O&M Manual 113 (Revised), October 1966, (HLM 1.73)].
FS Date: 7/7/2016

Pump platform visible off LS toe, but no appurtenances remain.

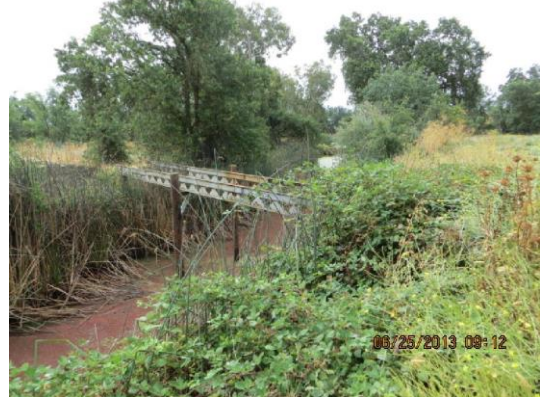
Photo 3 of 3 : UCIP_FA_2017_50092_25189.jpg

Comment Code						
Inspector Comment						
FS_ID:50092 DS_ID:22743 EP_NO: N/A Repair Type: Urgent Crossing Status: Found UCIP Comments: 07/07/2016 Condition largely unchanged from previous inspection. Pipe open on the WS, waterward of the siphon breaker. Dense vegetation and steep slope limited inspection of WS outlet into Ship Channel. (T. Hatch/UCIP) 06/25/2013 Pipe abandoned and open on WS slope. Pipe should be abandoned properly. (W. Wylie/UCIP) FIELD_STRUCT_DESC: *ABANDONED* 30-inch steel drainage pipe through the levee, 6.5 feet below the crown. Pump on a platform in the canal off the landside (LS) toe, not found. Flap gate on the waterside (WS), not found. Siphon breaker and an air vent on the WS shoulder. 1-inch galvanized iron filler pipe visible on the WS shoulder along same alignment. [Additional Reference(s): DWR Levee Log, 1992. USACE Sacramento O&M Manual 113 (Revised), October 1966, (HLM 1.73)]. FS Date: 7/7/2016

Pump platform visible off LS toe, but no appurtenances remain.

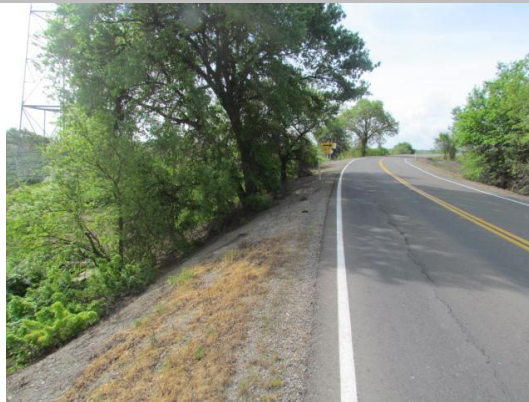
Photo 2 of 2 : FA_2017_RD0999_232_31_20171010_00031.jpg

Looking southeast at untrimmed trees on landward slope. (Spring 2016)

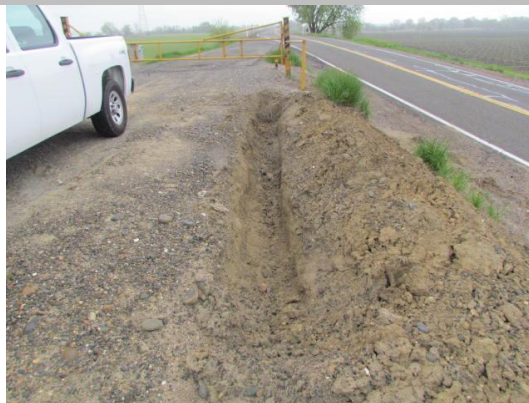
Photo 4 of 4 : FA_2017_RD0999_232_40_20171010_00041.jpg

Looking north at excavation on landside shoulder.

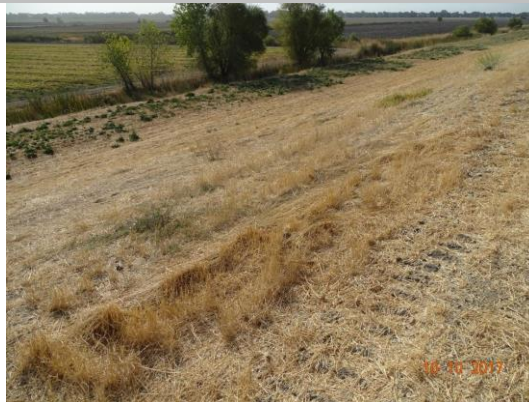
Photo 1 of 3 : FA_2017_RD0999_232_51_20171016_00126.jpg

LM Start	3.22	Rating **	M	Issue No.	51
LM End	3.22	Issue Type +	Ma	Location *	LS
Category	Earthen Levee			GPS Latitude/Longitude	
				Start	End
Item	Slope Stability			38.459399 °	38.459399 °
				-121.587523 °	-121.587523 °
DWR ID	DWR_RD0999_01_s_2013_51				
Comment Code					
S1 : Repair slope instability.					
Inspector Comment					
Depression on landward shoulder and slope 40' x 20'. Earthen material appears to be sliding toward levee toe.

View of landside slope looking south.

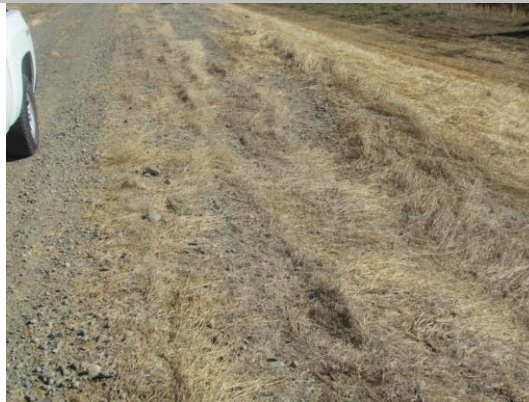
Photo 2 of 3 : FA_2017_RD0999_232_51_20171010_00061.jpg

Looking northeast at depression on landward slope. (Fall 2016)

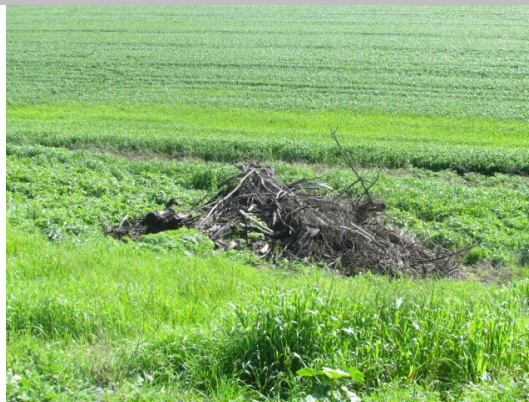
Photo 2 of 3 : FA_2017_RD0999_232_41_20171010_00043.jpg

Looking east at prunings on landward toe and berm. (Spring 2016)

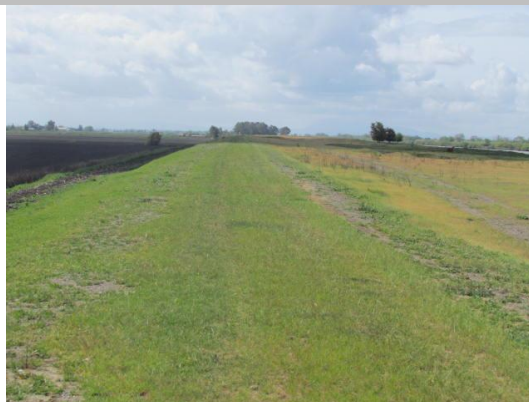
Photo 2 of 2 : FA_2017_RD0999_232_22_20171010_00020.jpg

Looking south at levee crown. (Spring 2015)

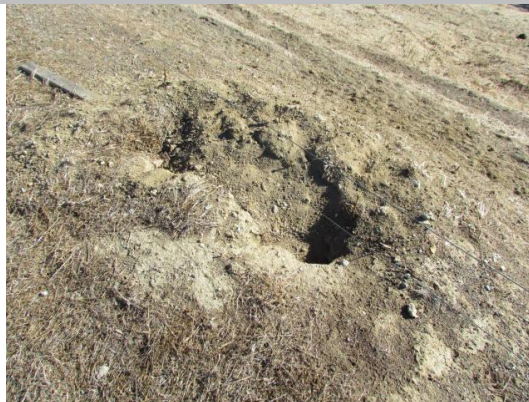
Photo 3 of 5 : FA_2017_RD0999_232_2_20171010_00008.jpg

Looking northeast at rodent holes on landward shoulder fall 2015.

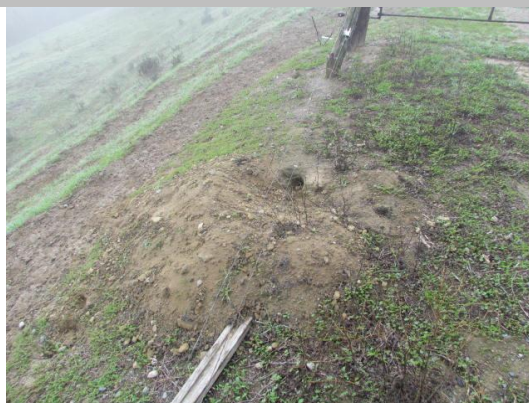
Photo 5 of 5 : FA_2017_RD0999_232_2_20171010_00010.jpg

Looking south at rodent hole on landside shoulder. (Fall 2014)

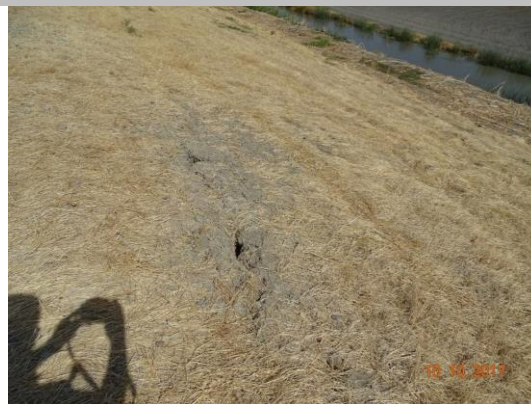
Photo 1 of 1 : FA_2017_RD0999_232_38_20171016_00131.jpg

LM Start	13.97	Rating **	A/W	Issue No.	38
LM End	13.97	Issue Type +	Ma	Location *	LS
Category	Earthen Levee			GPS Latitude/Longitude	
				Start	End
Item	Cracking			38.311394 °	38.311394 °
				-121.644946 °	-121.644946 °
DWR ID	DWR_RD0999_01_f_2017_38				
Comment Code					
CR1 : Monitor and have inspected by geotechnical engineer.					
Inspector Comment

View of landside slope looking northeast.

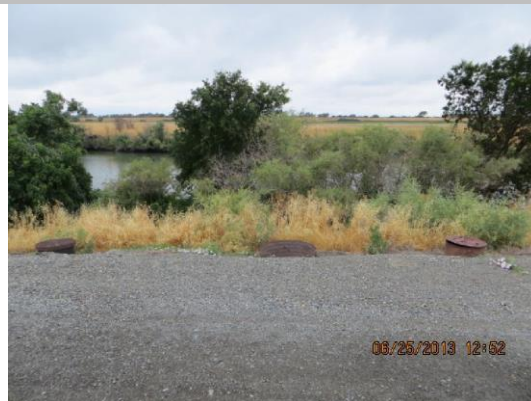
Photo 2 of 3 : UCIP_FA_2017_15365_25226.jpg

LM Start	15.24	Rating **	A/W	Issue No.	926 (cont)
LM End	15.24	Issue Type +	Ma	Location *	
Category	Supplemental			GPS Latitude/Longitude	
				Start	End
Item	DWR UCIP LMA Responsibility			38.292973 °	38.292973 °
				-121.644977 °	-121.644977 °
DWR ID					
Comment Code					
Inspector Comment					
FS_ID:15365 DS_ID:22756 EP_NO: N/A Repair Type: No Action Needed Crossing Status: Found UCIP Comments: FIELD_STRUCT_DESC: 30-inch steel drainage pipe through the levee, 7 feet below the crown. Flap gate on the waterside (WS) end. Pump in pump house on the landside (LS) toe. Siphon breaker in a corrugated metal pipe (CMP) riser on the WS shoulder. [Additional Reference(s): DWR Levee Log, 1992. USACE Sacramento O&M Manual 113 (Revised), October 1966, (HLM 15.25) (36-inch pipe listed)]. FS Date: 6/25/2013

Siphon breaker in CMP riser on WS shoulder.

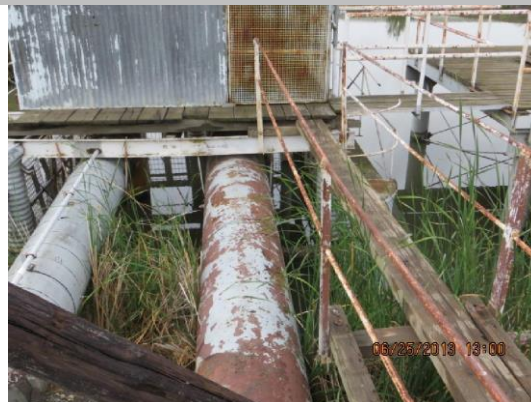
Photo 3 of 3 : UCIP_FA_2017_15365_25225.jpg

Closeup of pipe at pump house on LS toe.

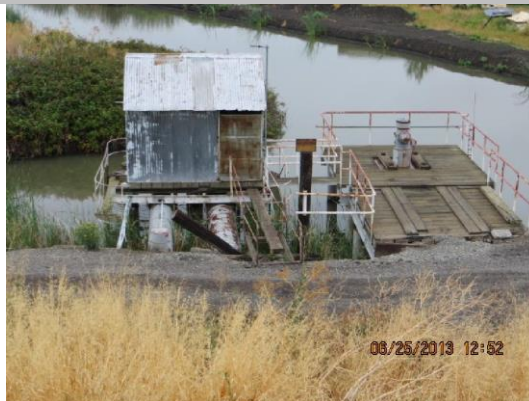
Photo 1 of 3 : UCIP_FA_2017_15363_25219.jpg

Pump platform to right of pumphouse.

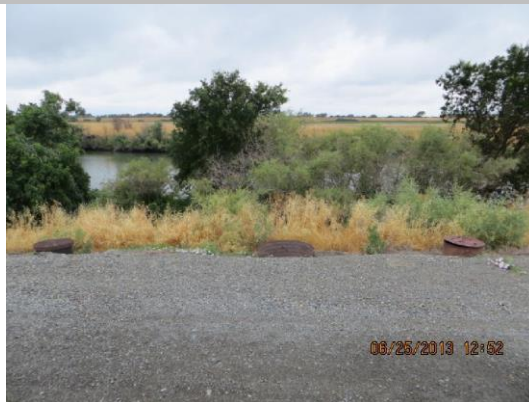
Photo 2 of 3 : UCIP_FA_2017_15363_25218.jpg

Siphon breaker in CMP riser on WS shoulder.

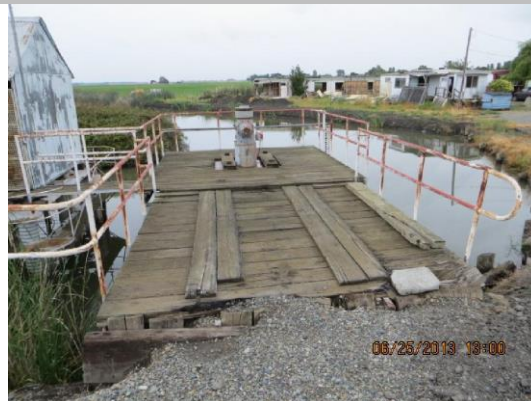
Photo 3 of 3 : UCIP_FA_2017_15363_25217.jpg

Pump and platform on LS toe.

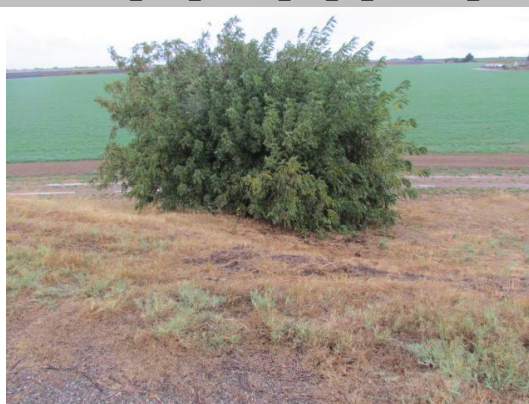
Photo 3 of 3 : FA_2017_RD0999_233_37_20170919_00022.jpg

Looking at untrimmed tree on landward slope. (Spring 2016)

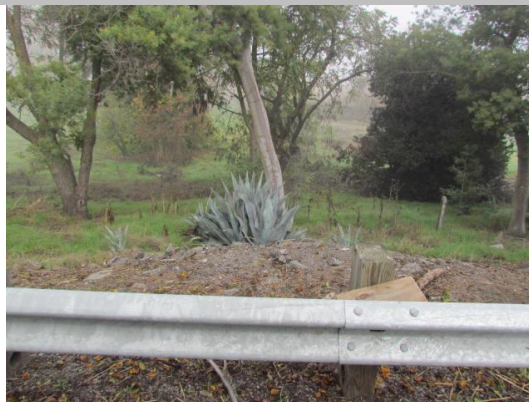
Photo 2 of 2 : FA_2017_RD0999_233_14_20170919_00012.jpg

Looking north at century plant at landside toe.

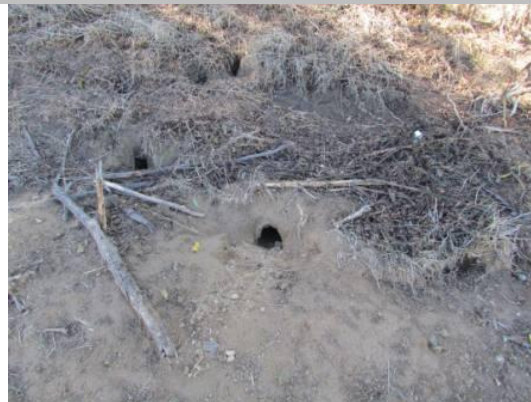
Photo 1 of 1 : FA_2017_RD0999_233_2_20170919_00001.jpg

Looking at several rodent holes on landside slope.

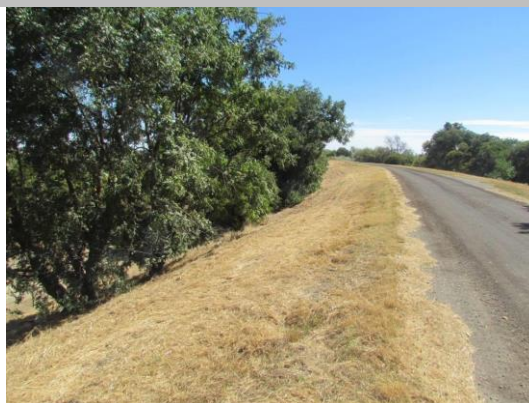
Photo 2 of 2 : FA_2017_RD0999_233_39_20170919_00023.jpg

Looking south at untrimmed trees on landward slope.

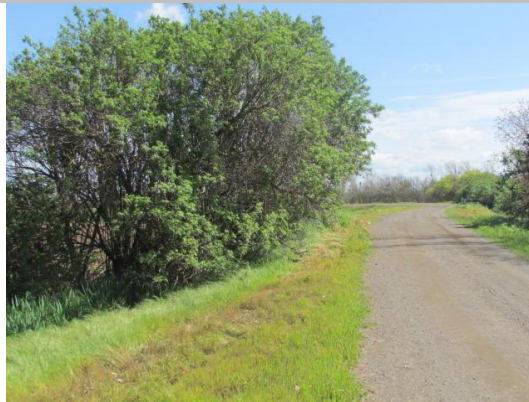
Photo 1 of 3 : FA_2017_RD0999_233_8_20170919_00004.jpg

Looking east at dense vegetation on landward shoulder and slope.
(Spring 2016)

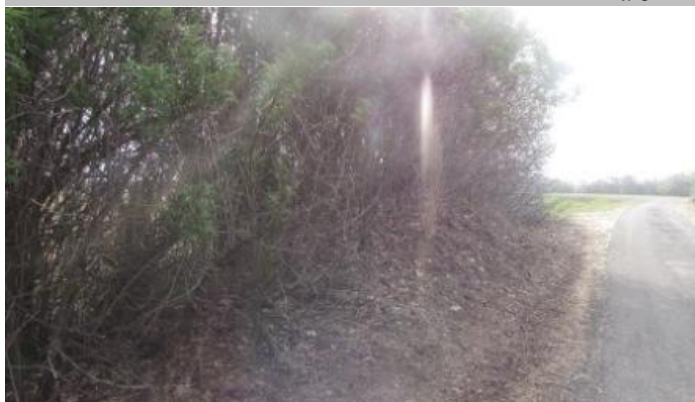
Photo 3 of 3 : FA_2017_RD0999_233_8_20170919_00006.jpg

Looking east at elderberry bush on landside shoulder and slope. (Fall 2014)

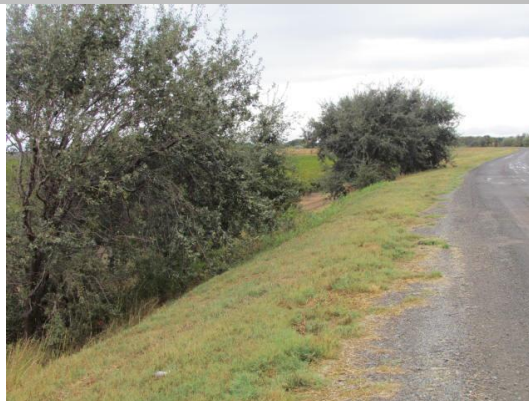
Photo 2 of 2 : FA_2017_RD0999_234_43_20170919_00028.jpg

Looking at untrimmed trees on landward slope and toe.

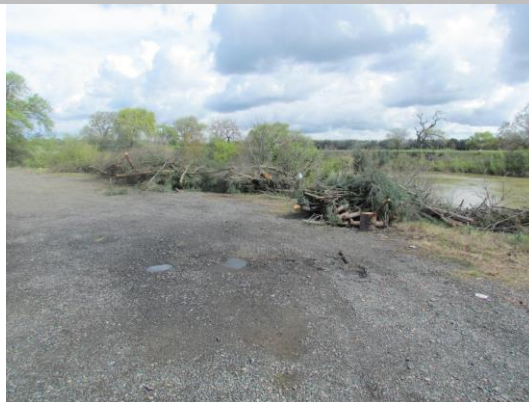
Photo 2 of 2 : FA_2017_RD0999_234_25_20170919_00020.jpg

Looking east at several large pruning piles on waterward slope.

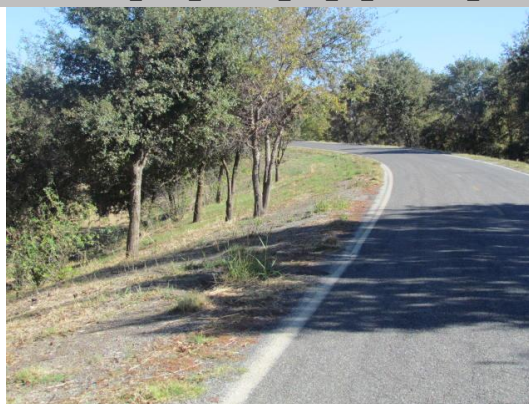
Photo 2 of 2 : FA_2017_RD0999_234_31_20170919_00027.jpg

Looking north at trimmed trees on landward slope.

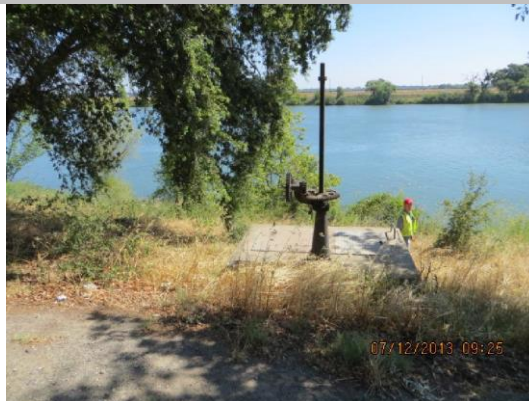
Photo 1 of 2 : UCIP_FA_2017_15708_26137.jpg

Slide gate in concrete vault on WS shoulder.

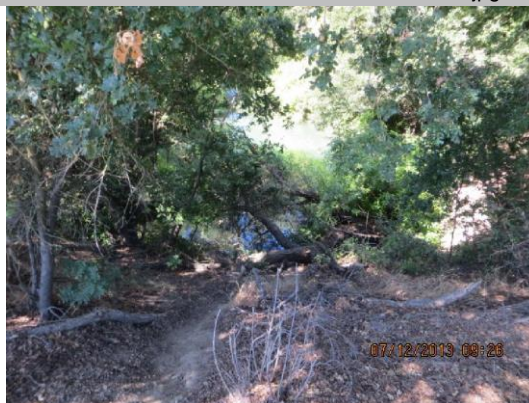
Photo 2 of 2 : UCIP_FA_2017_15708_26136.jpg

Toe of LS at approximate location of outlet/inlet.

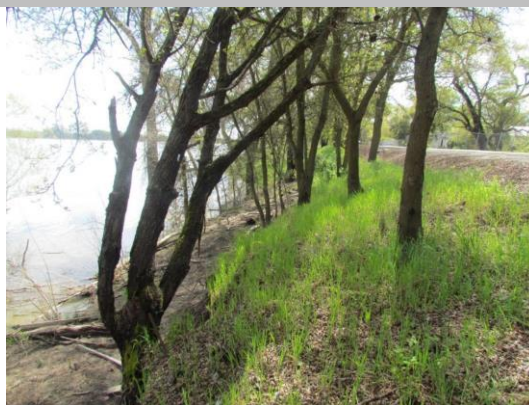
Photo 1 of 2 : FA_2017_RD0999_235_15_20170919_00013.jpg

LM Start	0.11	Rating **	A/W	Issue No.	15
LM End	0.21	Issue Type +	Ma	Location *	WS
Category	Earthen Levee			GPS Latitude/Longitude	
				Start	End
Item	Erosion / Bank Caving			38.415425 °	38.416733 °
				-121.523920 °	-121.524705 °
DWR ID	DWR_RD0999_04_s_2017_15				
Comment Code					
E2 : Schedule repair of erosion site prior to the next inspection.					
Inspector Comment					
Waterside erosion 2ft vertical cut.

Looking downstream at 2ft plus vertical erosion on waterward slope.

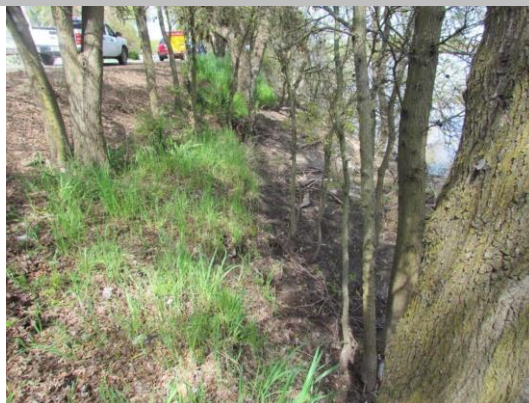
Photo 2 of 2 : FA_2017_RD0999_235_15_20170919_00014.jpg

Looking upstream at 2ft plus vertical erosion on waterward slope.

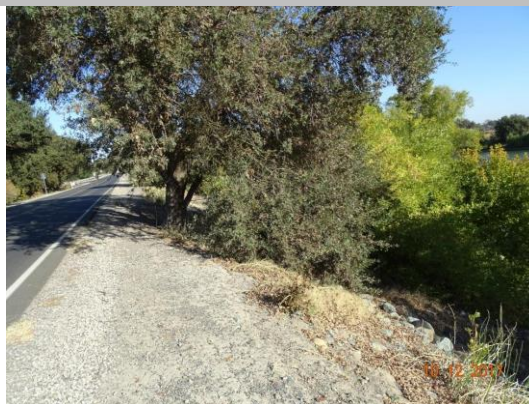
Photo 1 of 1 : FA_2017_RD0999_235_3_20171030_00092.jpg

Looking north at the waterside slope.

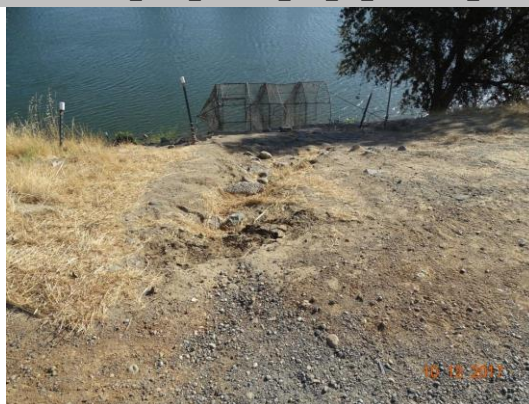
Photo 2 of 3 : FA_2017_RD0999_235_47_20171120_00099.jpg

Looking east at the waterside slope.

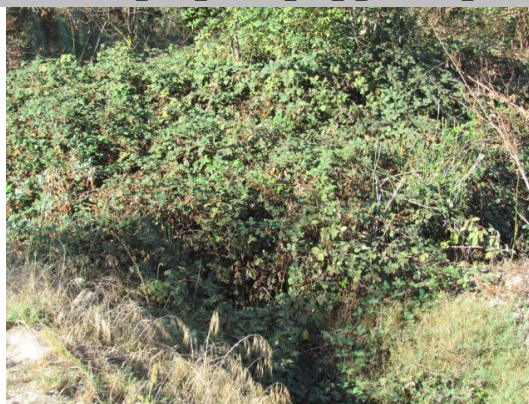
Photo 2 of 3 : FA_2017_RD0999_235_5_20170919_00002.jpg

Looking at dense vines at landward toe. Fall 2015.

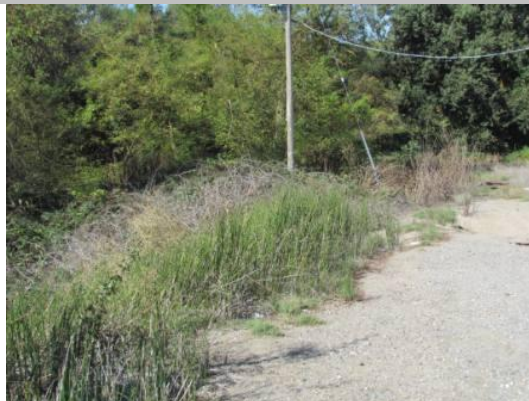
Photo 3 of 3 : FA_2017_RD0999_235_5_20170919_00003.jpg

Looking north at dense vegetation on landside slope near ramp.

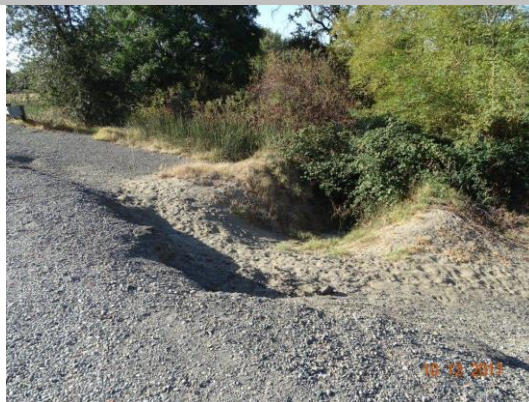
Photo 1 of 3 : FA_2017_RD0999_235_40_20171030_00088.jpg

Looking southwest at the landside slope.

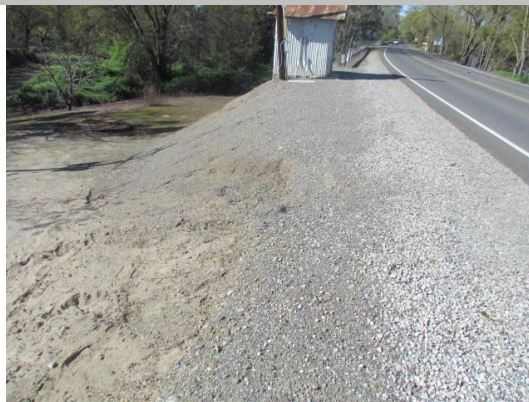
Photo 2 of 3 : FA_2017_RD0999_235_40_20170919_00029.jpg

Looking east at erosion on landward shoulder and slope. (Spring 2016)

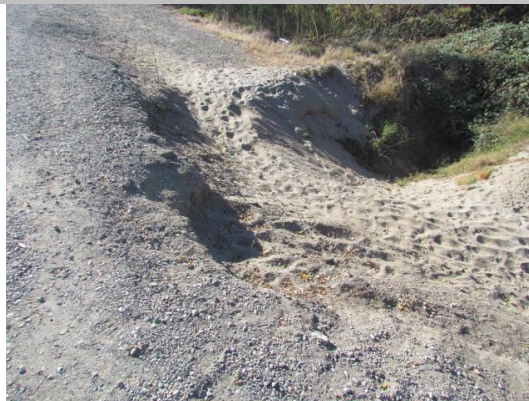
Photo 3 of 3 : FA_2017_RD0999_235_40_20170919_00032.jpg

Looking southwest at shoulder erosion and caving at landward slope and toe.

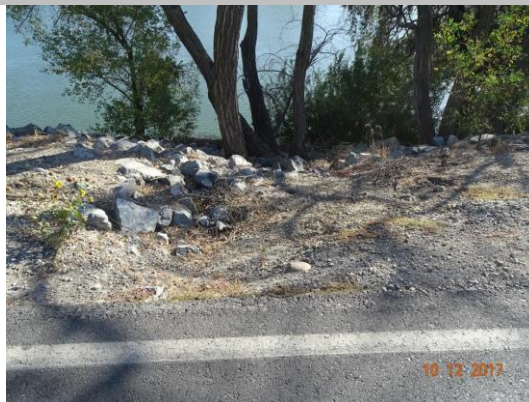
Photo 1 of 2 : FA_2017_RD0999_235_46_20171030_00087.jpg

Looking east at the erosion on the waterside slope.

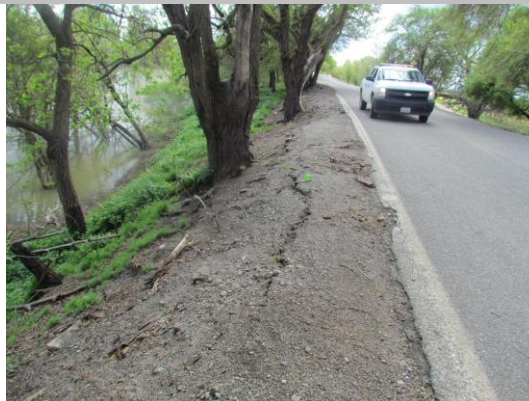
Photo 3 of 3 : FA_2017_RD0999_236_165_20170919_00105.jpg

Looking downstream at crack along waterward shoulder.

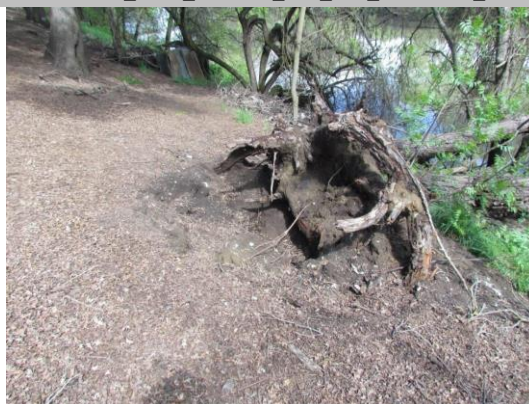
Photo 3 of 3 : FA_2017_RD0999_236_166_20170919_00108.jpg

Looking east at fallen tree on waterward slope.

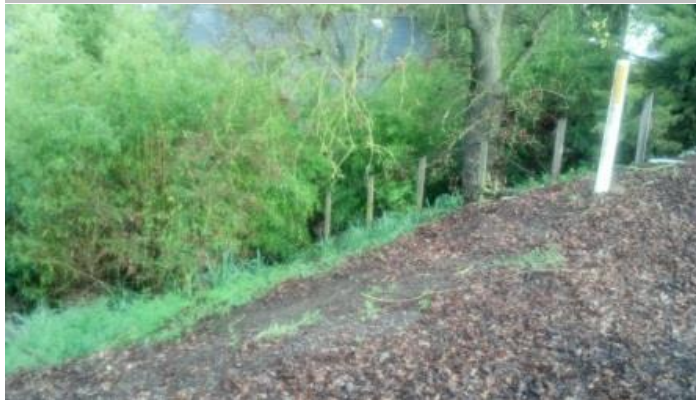
Photo 2 of 2 : FA_2017_RD0999_236_128_20170919_00080.jpg

Looking at dense trees on landside slope and toe.

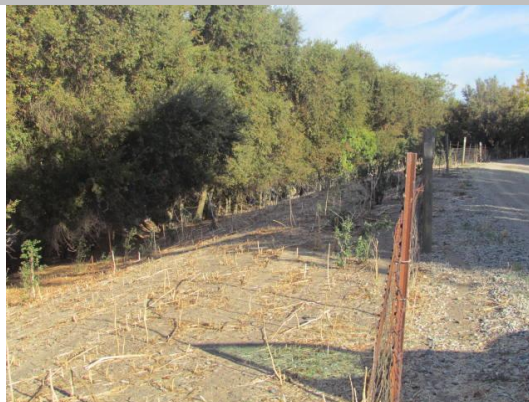
Photo 2 of 2 : FA_2017_RD0999_236_201_20170919_00140.jpg

Looking northwest at several small oak trees planted along landward slope.

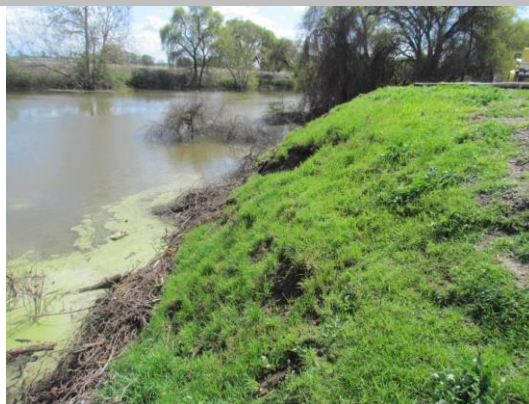
Photo 2 of 2 : FA_2017_RD0999_236_12_20170919_00010.jpg

Looking downstream at finger erosion on downstream side of slough.

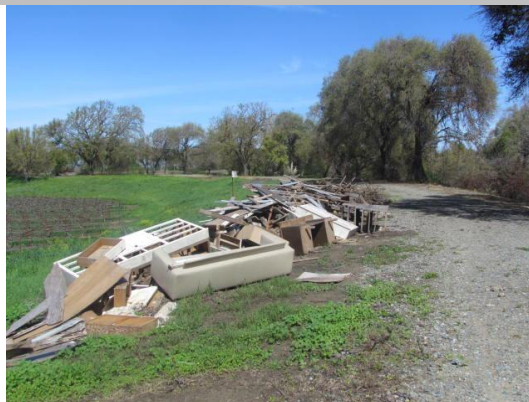
Photo 2 of 2 : FA_2017_RD0999_236_65_20170919_00045.jpg

Looking east at garbage and prunings on landward shoulder. (Spring 2016)

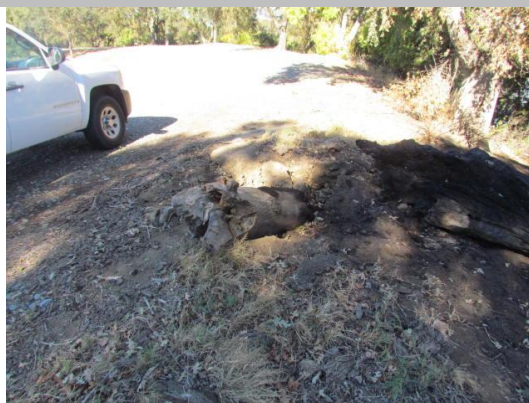
Photo 2 of 3 : FA_2017_RD0999_236_176_20170919_00123.jpg

Looking at hole on waterward shoulder caused by fallen tree.

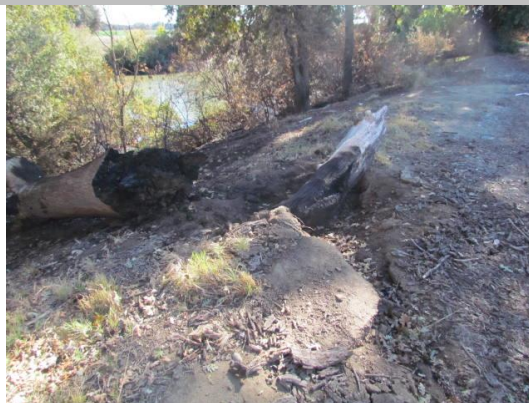
Photo 3 of 3 : FA_2017_RD0999_236_176_20170919_00124.jpg

Looking at fallen tree and hole on waterward slope and shoulder.

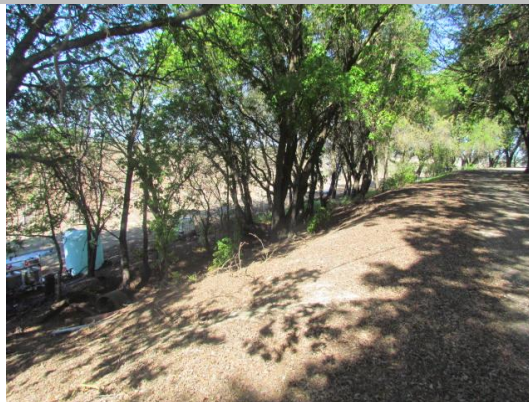
Photo 1 of 1 : FA_2017_RD0999_236_60_20170919_00043.jpg

Looking north at dense trees on landward slope. (Spring 2015)

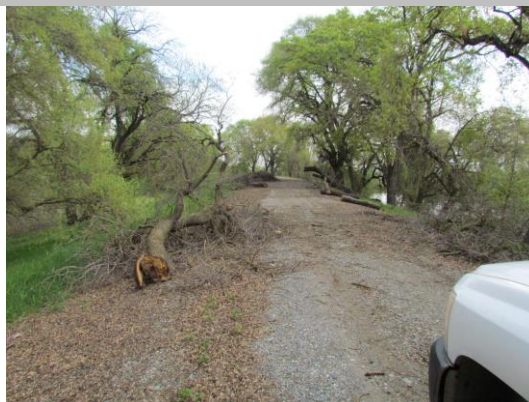
Photo 2 of 2 : FA_2017_RD0999_236_92_20170919_00065.jpg

Looking east at fallen tree and pruning on landward and waterward shoulder and slope.

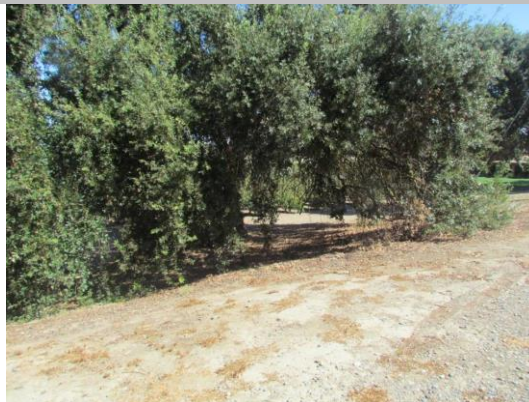
Photo 1 of 1 : FA_2017_RD0999_236_206_20170919_00144.jpg

Looking west at untrimmed trees on landward toe.

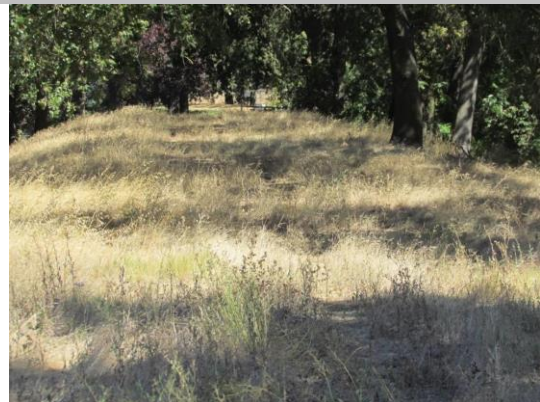
Photo 1 of 1 : FA_2017_RD0999_236_223_20170919_00155.jpg

Looking east at overgrowth on levee crown.
