**Flood Control Project Maintenance
Levee Inspections**

Maintenance Issue Types Only, Levee Inspection Report By Mile - Fall 2018

Reclamation District No. 0999 Netherlands

Waterway	Bank	Unit Miles	Inspection Start/End	Inspector
Unit No. 01 Yolo Bypass	Left	15.41	11/02/2018 11/07/2018	Luz Dial

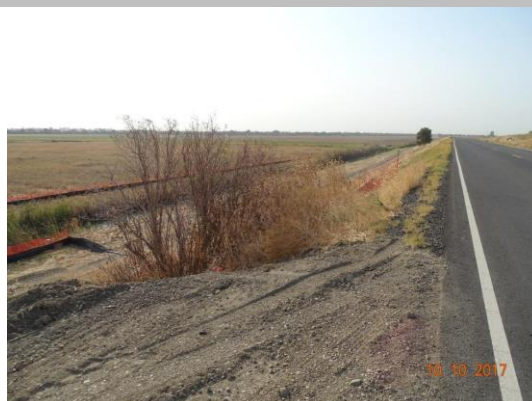
Photo 1 of 1 : FA_2018_RD0999_232_3_20180910_00006.jpg

LM Start	0.27	Rating **	M	Issue No.	3
LM End	0.27	Issue Type +	Ma	Location *	LS
Category	Earthen Levee			GPS Latitude/Longitude	
				Start	End
Item	Vegetation			38.501113 °	38.501113 °
				-121.581975 °	-121.581975 °
DWR ID	DWR_RD0999_01_s_2012_3				
Comment Code					
V4 : Elderberries are blocking visibility and flood fight capability.					
Inspector Comment

View of landside slope looking south.

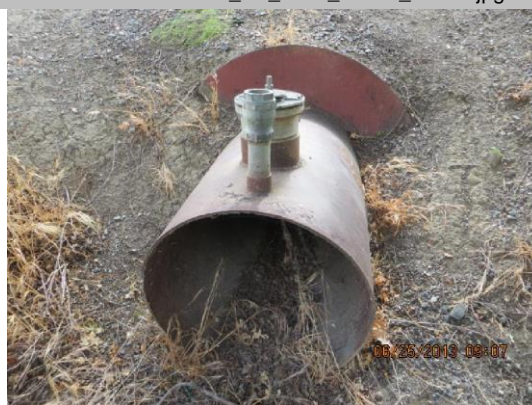
Photo 1 of 3 : UCIP_FA_2018_53368_25191.jpg

Comment Code						
Inspector Comment						
FS_ID:53368 DS_ID:22743 EP_NO: N/A Repair Type: Non-Urgent Crossing Status: Found UCIP Comments: 07/26/2018 Same as last inspection. Pipe open on WS, but no visual signs of pipe or levee integrity issues so downgrading crossing to Non-Urgent (D. Sanoski - DWR UCIP).07/07/2016 Condition largely unchanged from previous inspection. Pipe open on the WS, waterward of the siphon breaker. Dense vegetation and steep slope limited inspection of WS outlet into Ship Channel. (T. Hatch/UCIP) 06/25/2013 Pipe abandoned and open on WS slope. Pipe should be abandoned properly. (W. Wylie/UCIP) FIELD_STRUCT_DESC: *ABANDONED* 30-inch steel drainage pipe through the levee, 6.5 feet below the crown. Pump on a platform in the canal off the landside (LS) toe, not found. Flap gate on the waterside (WS), not found. Siphon breaker and an air vent on the WS shoulder. 1- inch galvanized iron filler pipe visible on the WS shoulder along same alignment. [Additional Reference(s): DWR Levee Log, 1992. USACE Sacramento O&M Manual 113 (Revised), October 1966, (HLM 1.73)]. FS Date: 7/26/2018 10:10:00 AM

Pipe open on WS slope

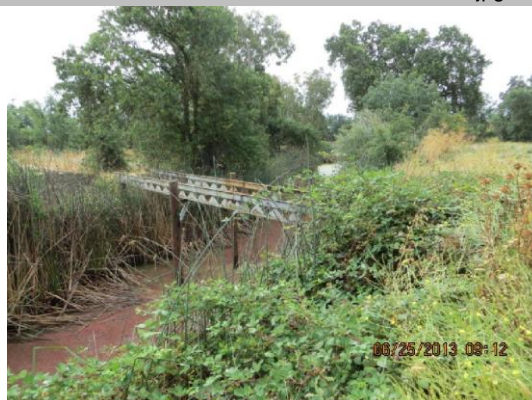
Photo 3 of 3 : UCIP_FA_2018_53368_25189.jpg

Pump platform visible off LS toe, but no appurtenances remain.

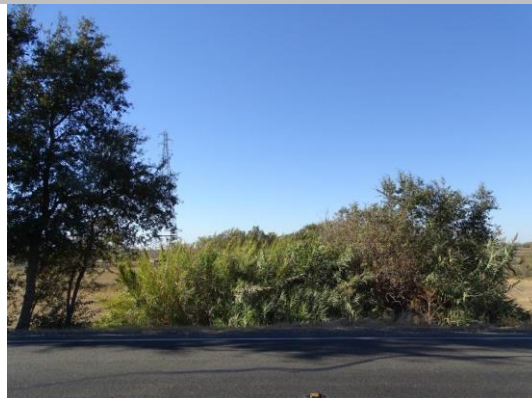
Photo 2 of 2 : FA_2018_RD0999_232_32_20181107_00087.jpg

View of Arundo further down levee slope. Fall 2018

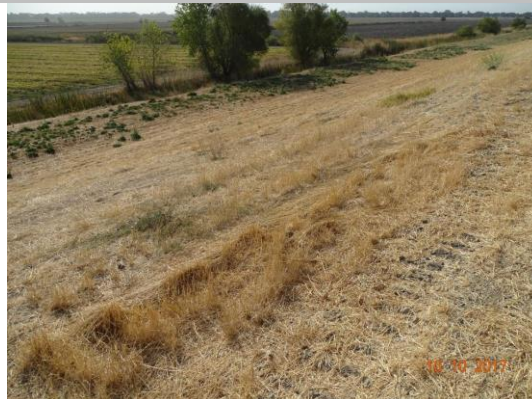
Photo 1 of 3 : FA_2018_RD0999_232_51_20180910_00036.jpg

LM Start	3.22	Rating **	M	Issue No.	51
LM End	3.22	Issue Type +	Ma	Location *	LS
Category	Earthen Levee			GPS Latitude/Longitude	
				Start	End
Item	Slope Stability			38.459399 °	38.459399 °
				-121.587523 °	-121.587523 °
DWR ID	DWR_RD0999_01_s_2013_51				
Comment Code					
S1 : Repair slope instability.					
Inspector Comment					
Depression on landward shoulder and slope 40' x 20'. Earthen material appears to be sliding toward levee toe.

View of landside slope looking south. Fall 2017

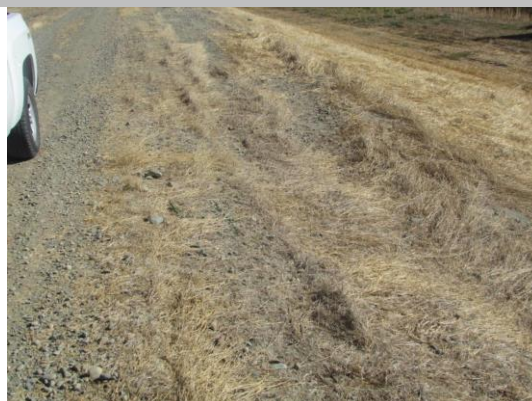
Photo 2 of 3 : FA_2018_RD0999_232_51_20180910_00037.jpg

LM Start	3.22	Rating **	M	Issue No.	51 (cont)	
LM End	3.22	Issue Type +	Ma	Location *	LS	
Category	Earthen Levee			GPS Latitude/Longitude		
				Start		End
Item	Slope Stability			38.459399°		38.459399°
				-121.587523°		-121.587523°
DWR ID	DWR_RD0999_01_s_2013_51					
Comment Code						
S1 : Repair slope instability.						
Inspector Comment						
Depression on landward shoulder and slope 40' x 20'. Earthen material appears to be sliding toward levee toe.

Looking northeast at depression on landward slope. (Fall 2016)

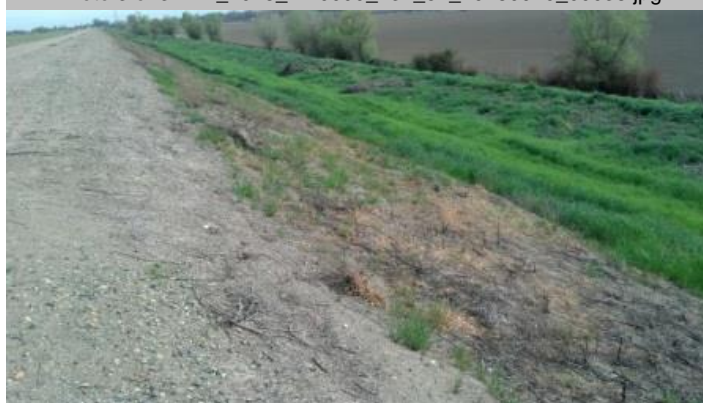
Photo 3 of 3 : FA_2018_RD0999_232_51_20180910_00038.jpg

Looking north at depression on landside shoulder and slope. (Spring 2016)

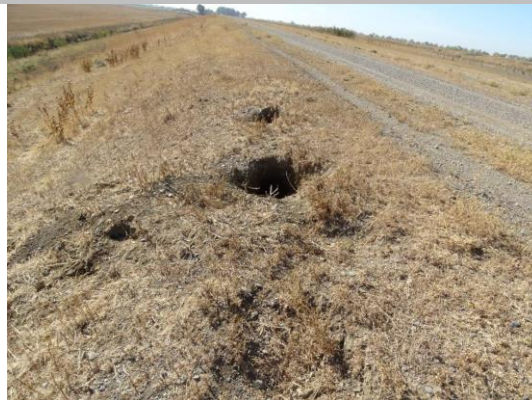
Photo 1 of 1 : FA_2018_RD0999_232_18_20181105_00075.jpg

View of large animal burrows at shoulder and slope. Fall 2018

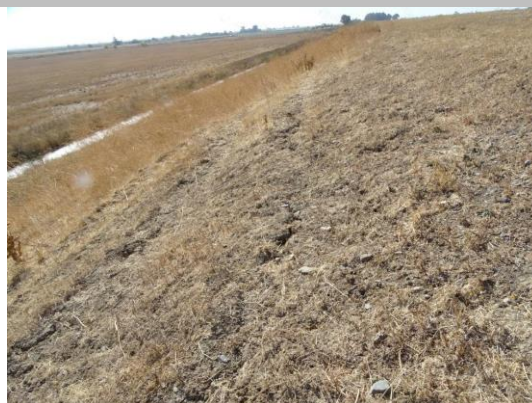
Photo 1 of 1 : FA_2018_RD0999_232_22_20181105_00076.jpg

LM Start	8.89	Rating **	A/W	Issue No.	22
LM End	8.89	Issue Type +	Ma	Location *	LS
Category	Earthen Levee			GPS Latitude/Longitude	
				Start	End
Item	Cracking			38.382145 °	38.382145 °
				-121.623363 °	-121.623363 °
DWR ID	DWR_RD0999_01_f_2018_22				
Comment Code					
CR1 : Monitor and have inspected by geotechnical engineer.					
Inspector Comment					
Desiccation cracks should be monitored.

View of cracking on slope. Fall 2018

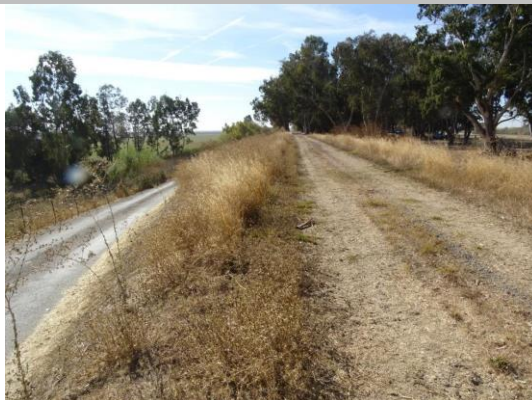
Photo 1 of 1 : FA_2018_RD0999_232_25_20181105_00079.jpg

View of landside vegetation that needs to be trimmed. Fall 2018

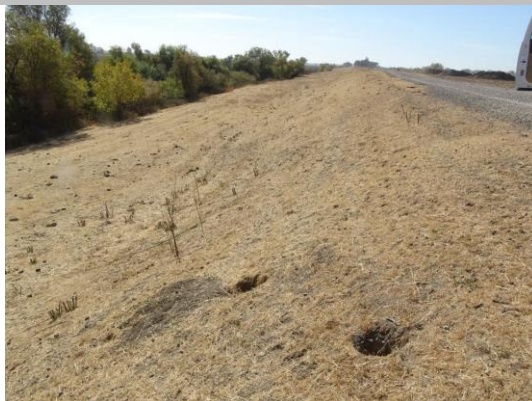
Photo 1 of 1 : FA_2018_RD0999_232_33_20181105_00081.jpg

LM Start	9.98	Rating **	M	Issue No.	33
LM End	9.98	Issue Type +	Ma	Location *	LS
Category	Earthen Levee			GPS Latitude/Longitude	
				Start	End
Item	Animal Control			38.367303 °	38.367303 °
				-121.630278 °	-121.630278 °
DWR ID	DWR_RD0999_01_f_2018_33				
Comment Code					
A3 : No rodents visible, but rodent burrows visible; need to backfill and compact or grout burrows.					
Inspector Comment					
Backfill recent rodent holes.

View of rodent holes that need to be backfilled. Fall 2018

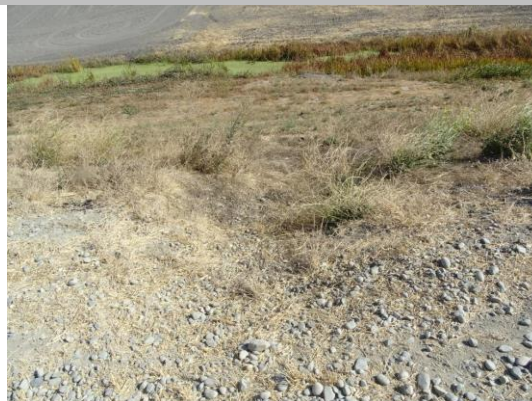
Photo 1 of 1 : FA_2018_RD0999_232_49_20181105_00083.jpg

View of caving on landward slope. Fall 2018

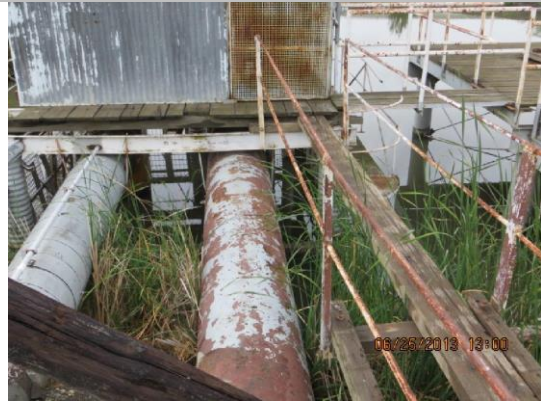
Photo 3 of 3 : UCIP_FA_2018_15365_25225.jpg

Closeup of pipe at pumphouse on LS toe.

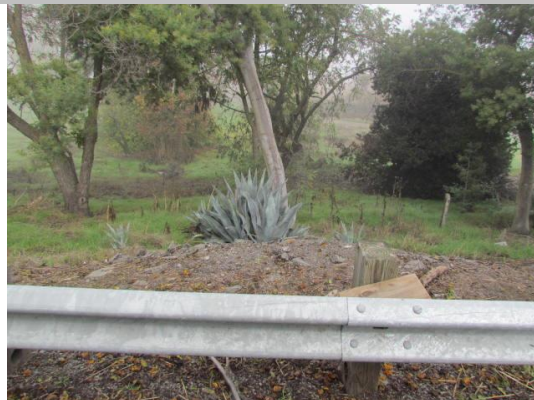
Photo 2 of 2 : FA_2018_RD0999_233_14_20180910_00012.jpg

Looking north at century plant at landside toe.

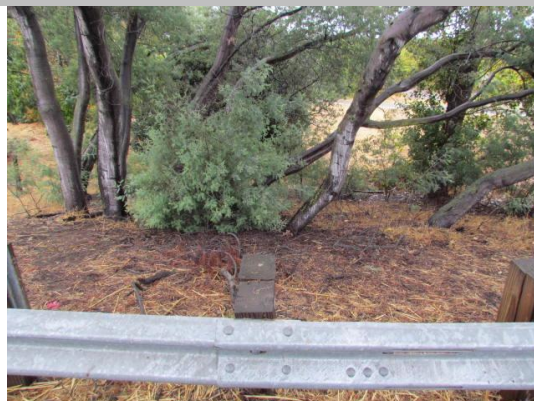
Photo 2 of 2 : FA_2018_RD0999_233_19_20180910_00017.jpg

Looking north at untrimmed and trees to be thinned at landward toe fall 2015.

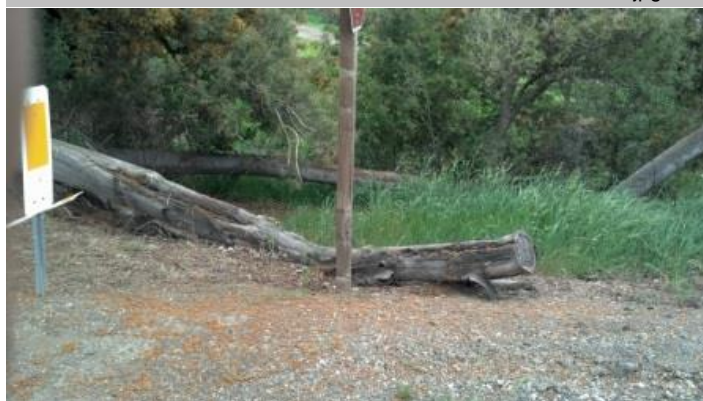
Photo 1 of 1 : FA_2018_RD0999_233_13_20180910_00010.jpg

Looking northwest at tree limb on landside slope.

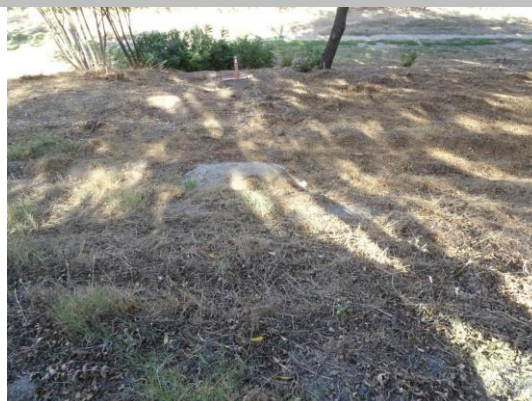
Photo 1 of 2 : FA_2018_RD0999_233_2_20181105_00051.jpg

View of backfilled rodent holes. Fall 2018

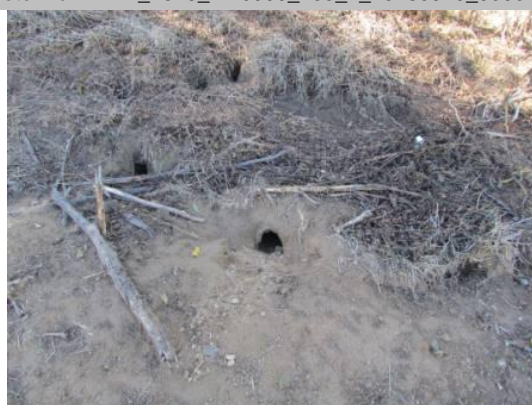
Photo 2 of 2 : FA_2018_RD0999_233_2_20180910_00001.jpg

Looking at several rodent holes on landside slope.

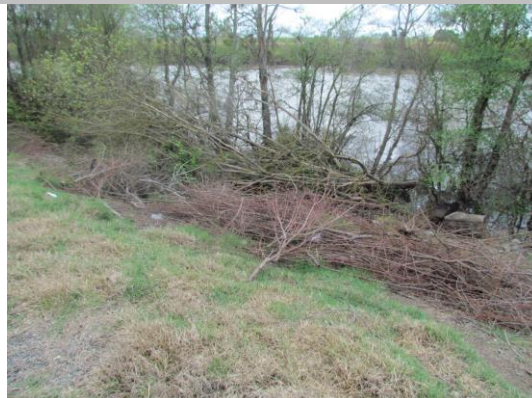
Photo 1 of 1 : FA_2018_RD0999_234_23_20180910_00017.jpg

Looking east large pruning piles on waterward slope.

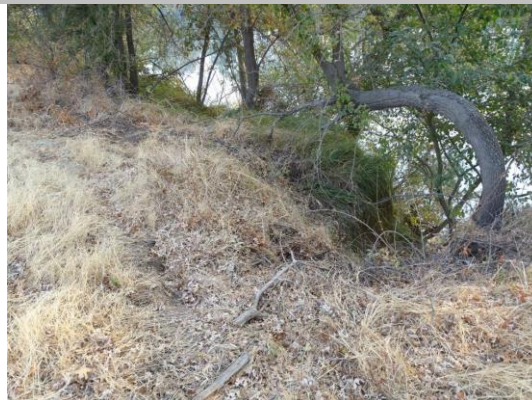
Photo 1 of 5 : FA_2018_RD0999_234_9_20181116_00044.jpg

Notes: Fall 2018 DWR Inspector: Observed erosion into the bank and fallen tree. End LM not given on report.

View of some erosion on slope. Fall 2018

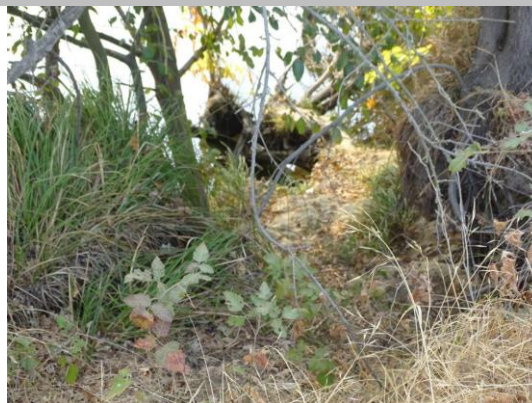
Photo 2 of 5 : FA_2018_RD0999_234_9_20181116_00045.jpg

View of fallen tree at water's edge. Fall 2018

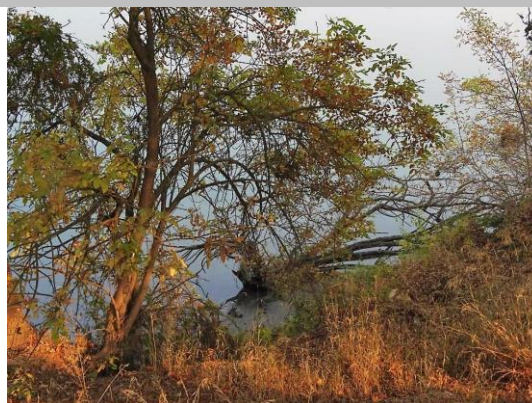
Photo 1 of 4 : FA_2018_RD0999_235_42_20181116_00082.jpg

View of fallen tree. Fall 2018

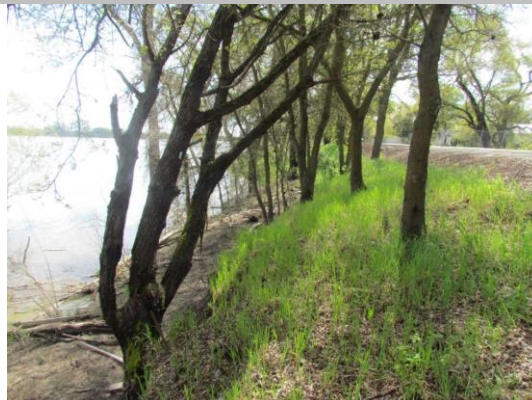
Photo 1 of 2 : FA_2018_RD0999_235_15_20180910_00010.jpg

LM Start	0.11	Rating **	A/W	Issue No.	15
LM End	0.21	Issue Type +	Ma	Location *	WS
Category	Earthen Levee			GPS Latitude/Longitude	
				Start	End
Item	Erosion / Bank Caving			38.415425 °	38.416733 °
				-121.523920 °	-121.524705 °
DWR ID	DWR_RD0999_04_s_2017_15				
Comment Code					
E2 : Schedule repair of erosion site prior to the next inspection.					
Inspector Comment					
Waterside erosion 2ft vertical cut was not visible during this inspection. Fallen trees have root ball intact.

Looking downstream at 2ft plus vertical erosion on waterward slope.

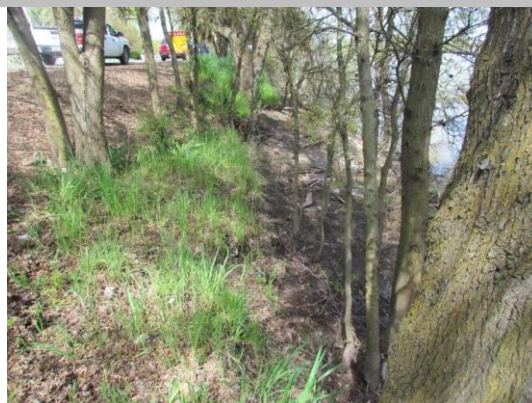
Photo 2 of 2 : FA_2018_RD0999_235_15_20180910_00011.jpg

Looking upstream at 2ft plus vertical erosion on waterward slope.

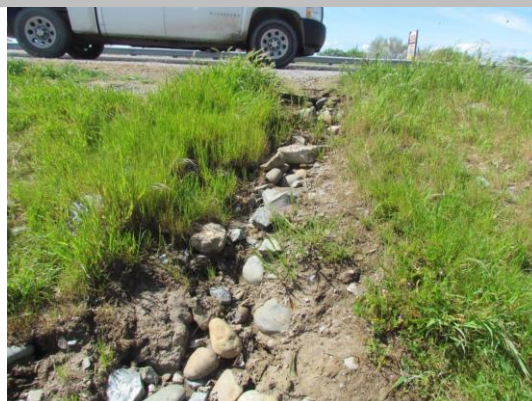
Photo 3 of 3 : FA_2018_RD0999_235_47_20180910_00037.jpg

Looking west at runoff erosion on waterward slope.

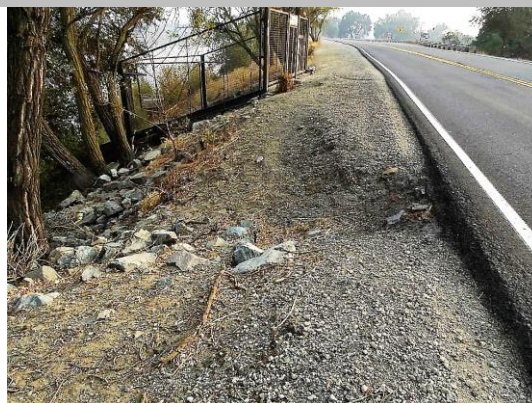
Photo 1 of 3 : FA_2018_RD0999_235_46_20181116_00083.jpg

View of erosion on shoulder and slope. Fall 2018

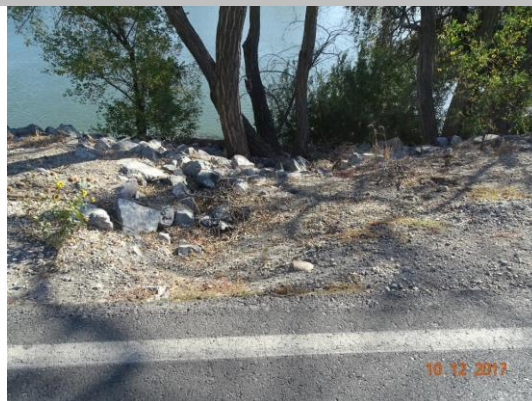
Photo 2 of 3 : FA_2018_RD0999_235_46_20180910_00033.jpg

Looking east at the erosion on the waterside slope. Fall 2017

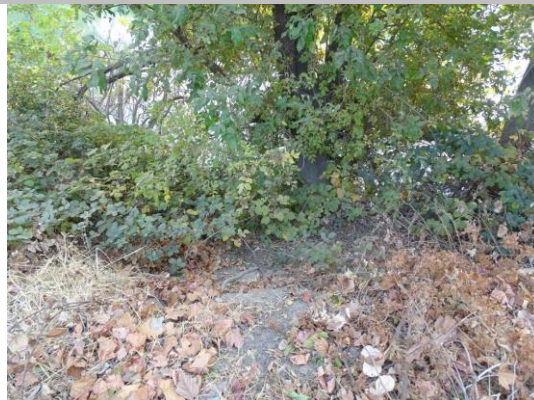
Photo 1 of 2 : FA_2018_RD0999_236_57_20181116_00192.jpg

View of erosion on levee slope. Fall 2018

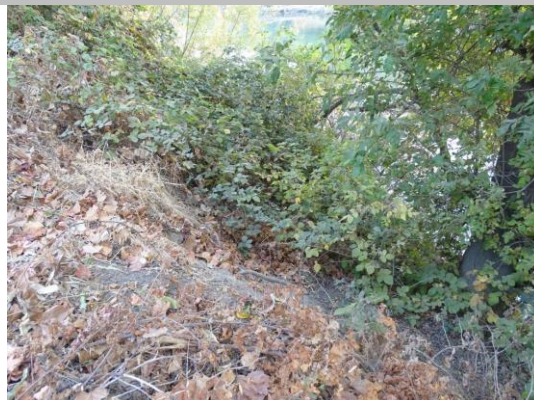
Photo 2 of 2 : FA_2018_RD0999_236_57_20181116_00193.jpg

View of erosion on levee slope. Fall 2018

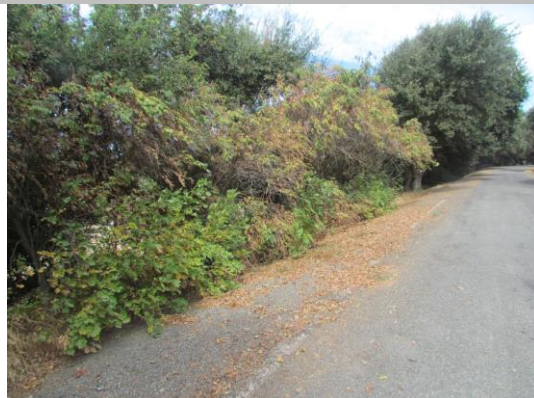
Photo 1 of 1 : FA_2018_RD0999_236_199_20180910_00105.jpg

Looking northwest at dense vegetation on landward slope.

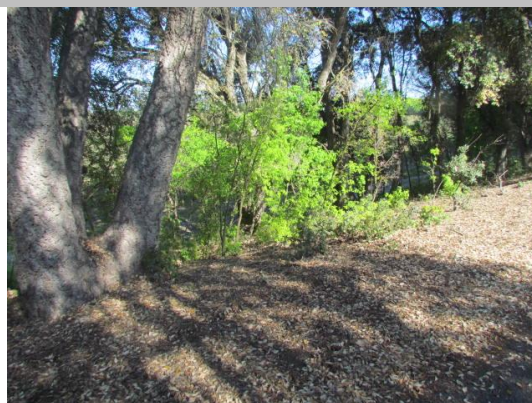
Photo 1 of 1 : FA_2018_RD0999_236_82_20180910_00042.jpg

Looking northwest at dense trees on landward slope. (Spring 2015)

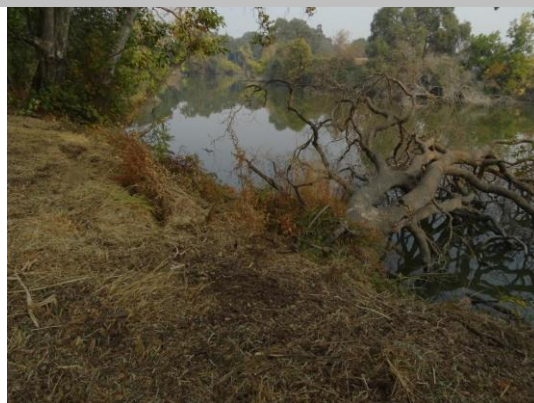
Photo 1 of 1 : FA_2018_RD0999_236_83_20181116_00196.jpg

View of a fallen tree and slope damage. Fall 2018

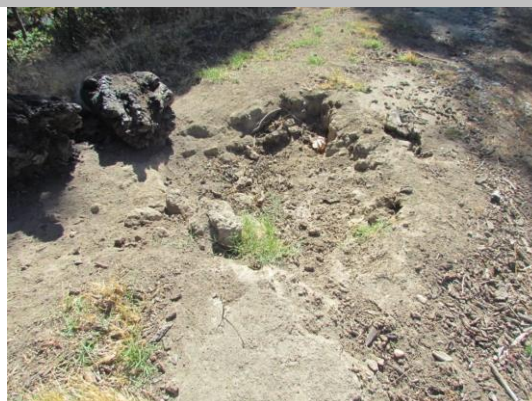
Photo 1 of 3 : FA_2018_RD0999_236_176_20180910_00094.jpg

Looking at hole from fallen tree on waterward shoulder. (Fall 2016)

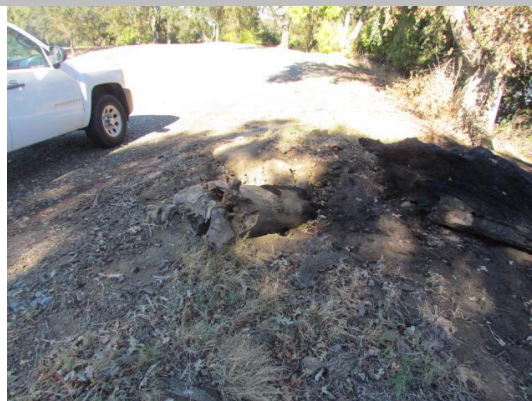
Photo 2 of 3 : FA_2018_RD0999_236_176_20180910_00095.jpg

Looking at hole on waterward shoulder caused by fallen tree.

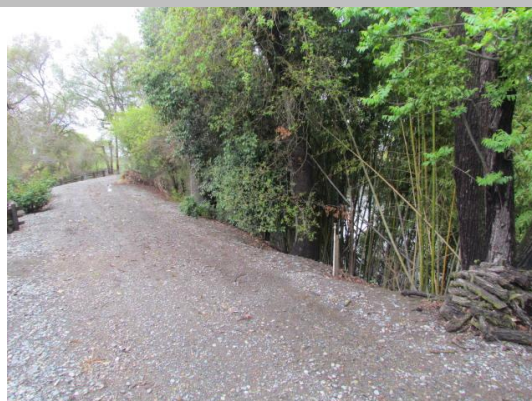
Photo 1 of 1 : FA_2018_RD0999_236_71_20180910_00039.jpg

Looking northeast at dense vegetation on waterside slope.

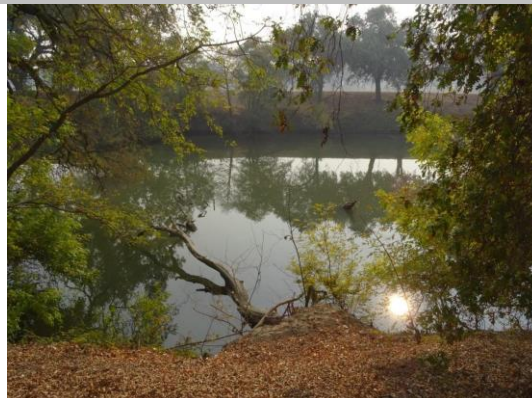
Photo 1 of 1 : FA_2018_RD0999_236_99_20181116_00205.jpg

View of fallen tree and slope damage. Fall 2018

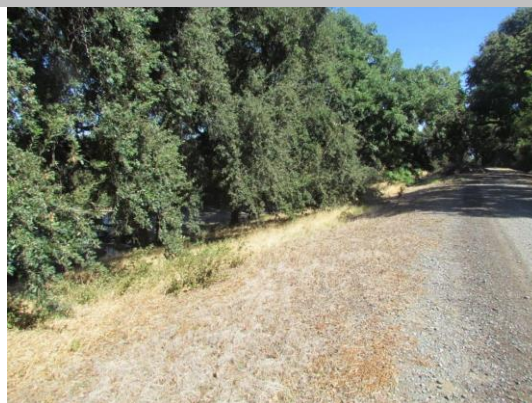
Photo 1 of 1 : FA_2018_RD0999_236_181_20180910_00097.jpg

Looking northwest at untrimmed trees on landward slope and toe.
