**Flood Control Project Maintenance  
Levee Inspections**

**Maintenance Issue Types Only, Levee Inspection Report By Mile - Fall 2019**

**Reclamation District No. 0999 Netherlands**

Waterway	Bank	Unit Miles	Inspection Start/End	Inspector
Unit No. 01 Yolo Bypass	Left	15.41	09/25/2019 09/25/2019	Luz Dial

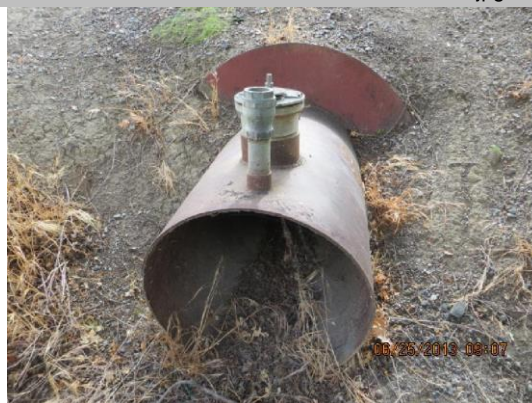
Photo 1 of 3 : UCIP\_FA\_2019\_53368\_25191.jpg

Comment Code						
Inspector Comment						
DS_ID:22743 FS_ID:53368 EP_NO: N/A Repair Type: Non-Urgent Crossing Status: Found UCIP Comments: 07/26/2018 Same as last inspection. Pipe open on WS, but no visual signs of pipe or levee integrity issues so downgrading crossing to Non-Urgent (D. Sanoski - DWR UCIP).07/07/2016 Condition largely unchanged from previous inspection. Pipe open on the WS, waterward of the siphon breaker. Dense vegetation and steep slope limited inspection of WS outlet into Ship Channel. (T. Hatch/UCIP) 06/25/2013 Pipe abandoned and open on WS slope. Pipe should be abandoned properly. (W. Wylie/UCIP) FIELD_STRUCT_DESC: *ABANDONED* 30-inch steel drainage pipe through the levee, 6.5 feet below the crown. Pump on a platform in the canal off the landside (LS) toe, not found. Flap gate on the waterside (WS), not found. Siphon breaker and an air vent on the WS shoulder. 1- inch galvanized iron filler pipe visible on the WS shoulder along same alignment. [Additional Reference(s): DWR Levee Log, 1992. USACE Sacramento O&M Manual 113 (Revised), October 1966, (HLM 1.73)]. FS Date: 7/26/2018 10:10:00 AM

Pipe open on WS slope

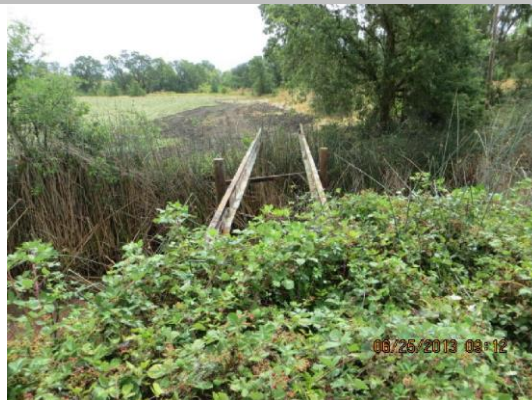
Photo 2 of 3 : UCIP\_FA\_2019\_53368\_25190.jpg

Pump platform visible off LS toe, but no appurtenances remain.

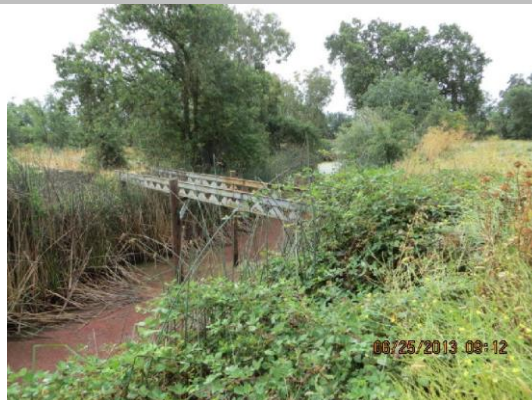
Photo 3 of 3 : UCIP\_FA\_2019\_53368\_25189.jpg

Pump platform visible off LS toe, but no appurtenances remain.

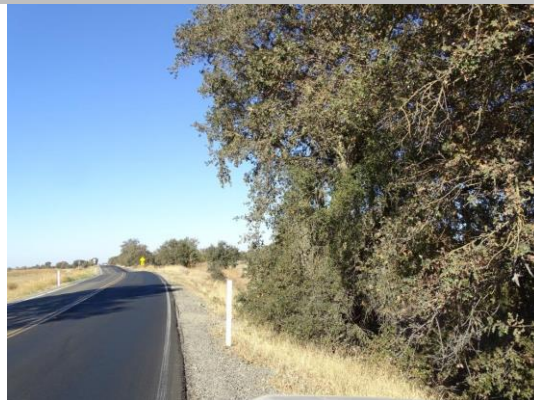
Photo 1 of 3 : FA\_2019\_RD0999\_232\_30\_20190930\_00076.jpg

View of untrimmed trees on landside slope. LMA claims that RD 765 is responsible for maintenance. Fall 2018

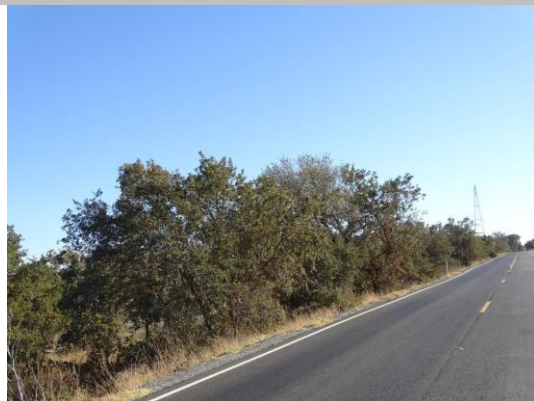
Photo 2 of 3 : FA\_2019\_RD0999\_232\_30\_20190904\_00012.jpg

View of untrimmed trees on landside slope. LMA claims that RD 765 is responsible for maintenance. Fall 2018

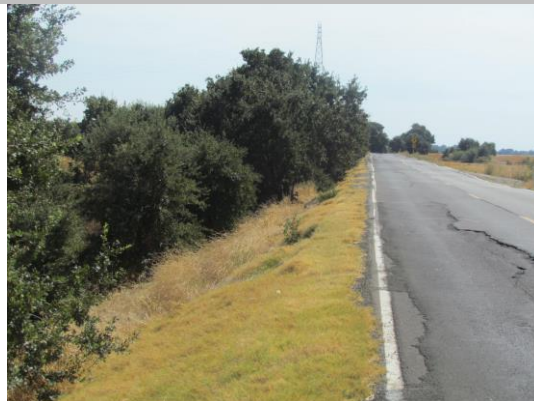
Photo 3 of 3 : FA\_2019\_RD0999\_232\_30\_20190904\_00013.jpg

Looking southeast at dense trees on landward slope. (Fall 2016)

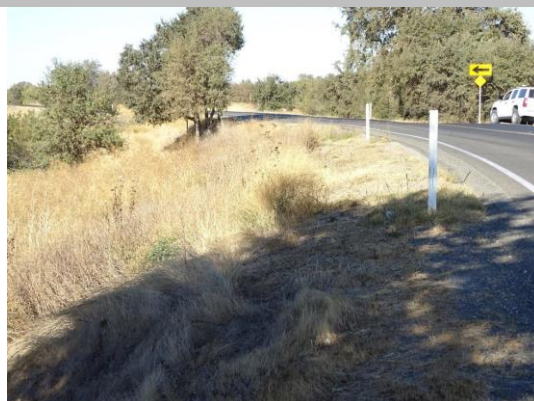
Photo 1 of 2 : FA\_2019\_RD0999\_232\_32\_20190904\_00017.jpg

View of tall weeds on levee slope. Fall 2018

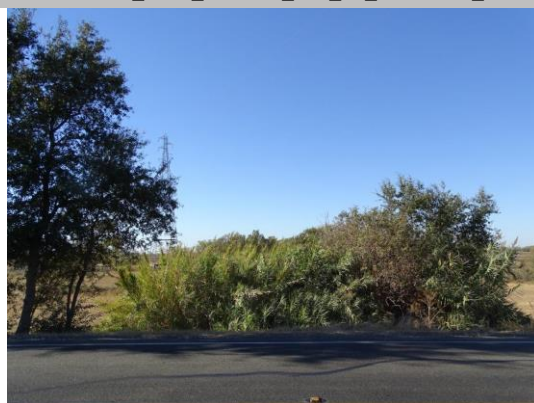
Photo 2 of 2 : FA\_2019\_RD0999\_232\_32\_20190904\_00018.jpg

View of Arundo further down levee slope. Fall 2018

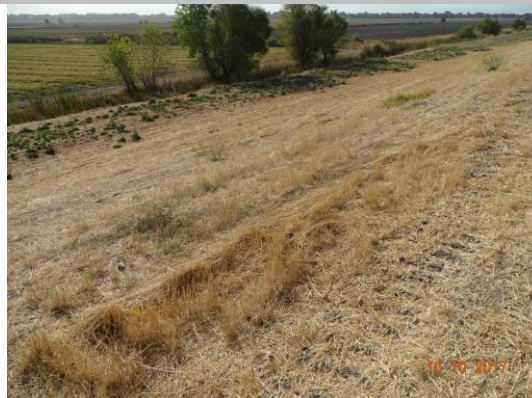
Photo 1 of 3 : FA\_2019\_RD0999\_232\_51\_20190904\_00033.jpg

LM Start	3.22	Rating **	M	Issue No.	51
LM End	3.22	Issue Type +	Ma	Location *	LS
Category	Earthen Levee			GPS Latitude/Longitude	
				Start	End
Item	Slope Stability			38.459399°	38.459399°
				-121.587523°	-121.587523°
DWR ID	DWR_RD0999_01_s_2013_51				
Comment Code					
S1 : Repair slope instability.					
Inspector Comment					
Repair depression on landward shoulder and slope approximately 40' x 20'. Earthen material appears to be sliding toward levee toe.

View of landside slope looking south. Fall 2017

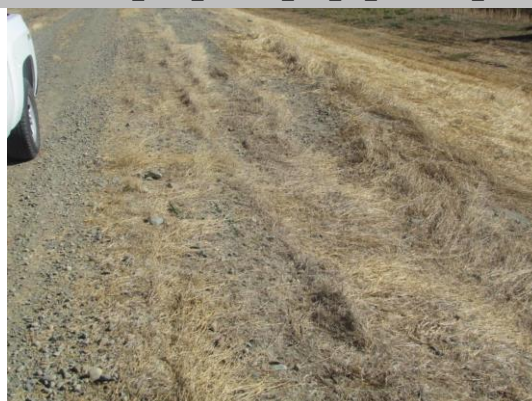
Photo 2 of 3 : FA\_2019\_RD0999\_232\_51\_20190904\_00034.jpg

Looking northeast at depression on landward slope. Fall 2016

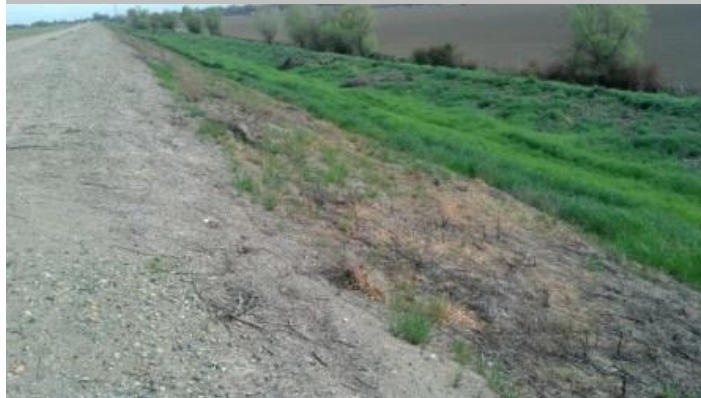
Photo 3 of 3 : FA\_2019\_RD0999\_232\_51\_20190904\_00035.jpg

Looking north at depression on landside shoulder and slope. Spring 2016

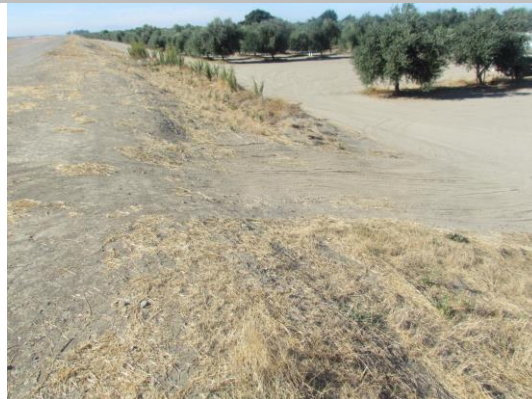
Photo 1 of 1 : FA\_2019\_RD0999\_232\_27\_20190904\_00010.jpg

Looking at slope damage cause by vehicle traffic on waterward slope.  
(Fall 2016)

LM Start	4.31	Rating **	M	Issue No.	27
LM End	4.31	Issue Type +	Ma	Location *	WS
Category	Earthen Levee			GPS Latitude/Longitude	
				Start	End
Item	Slope Stability			38.444560 °	38.444560 °
				-121.594440 °	-121.594440 °
DWR ID	DWR_RD0999_01_f_2012_27				
Comment Code					
S3 : Repair the levee slope damaged by vehicle traffic and prevent access where possible.					
Inspector Comment					
Instruct farmer to stop driving equipment and trucks on slope.

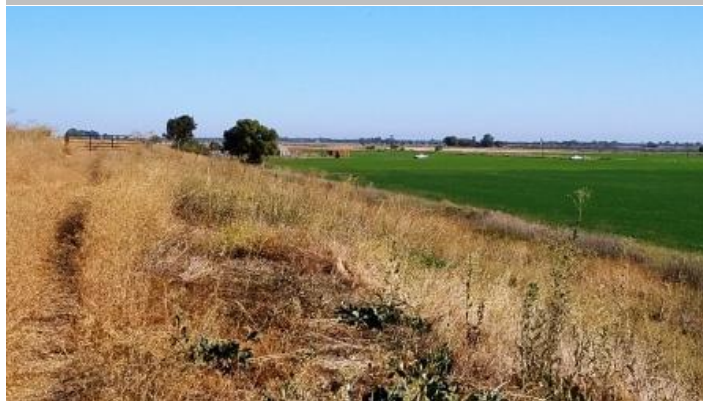
Photo 1 of 1 : FA\_2019\_RD0999\_232\_13\_20190926\_00062.jpg

View looking upstream at landside vegetation. Fall 2019

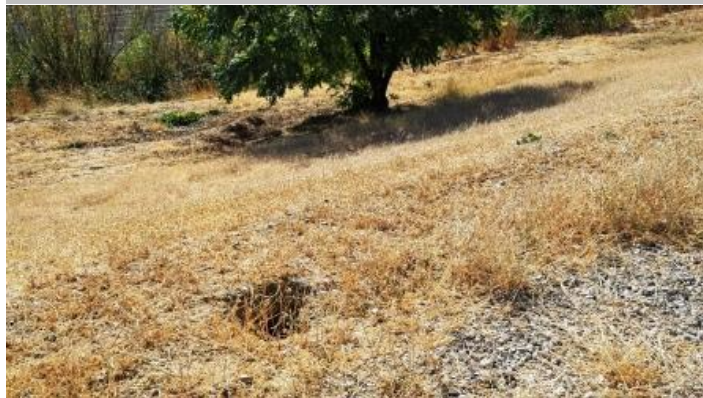
Photo 1 of 1 : FA\_2019\_RD0999\_232\_35\_20190926\_00065.jpg

View of animal hole on the landside slope. Fall 2019

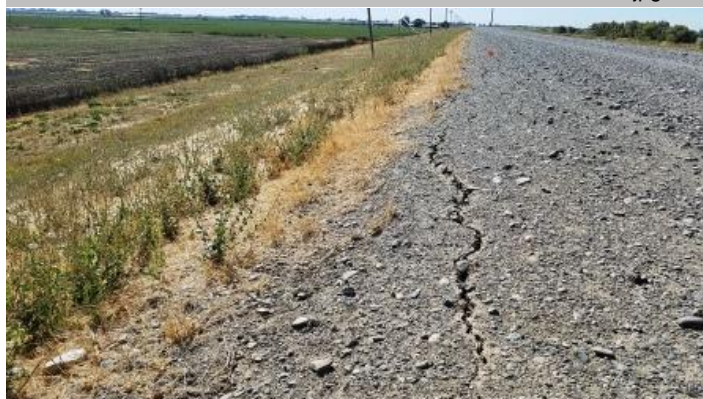
Photo 1 of 2 : FA\_2019\_RD0999\_232\_29\_20190926\_00068.jpg

LM Start	13.17	Rating **	A/W	Issue No.	29
LM End	13.19	Issue Type +	Ma	Location *	CR
Category	Earthen Levee			GPS Latitude/Longitude	
				Start	End
Item	Cracking			38.322938 °	38.322690 °
				-121.644940 °	-121.644953 °
DWR ID	DWR_RD0999_01_f_2019_29				
Comment Code					
CR1 : Monitor and have inspected by geotechnical engineer.					
Inspector Comment					
Monitor cracks as deep as 4" on the landside shoulder.

View of longitudinal cracks as deep as 4" on the landside shoulder. Fall 2019

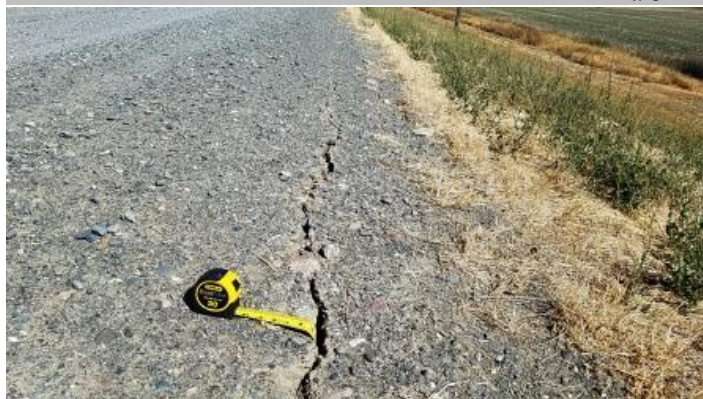
Photo 2 of 2 : FA\_2019\_RD0999\_232\_29\_20190926\_00069.jpg

View of longitudinal cracks as deep as 4" on the landside shoulder. Fall 2019

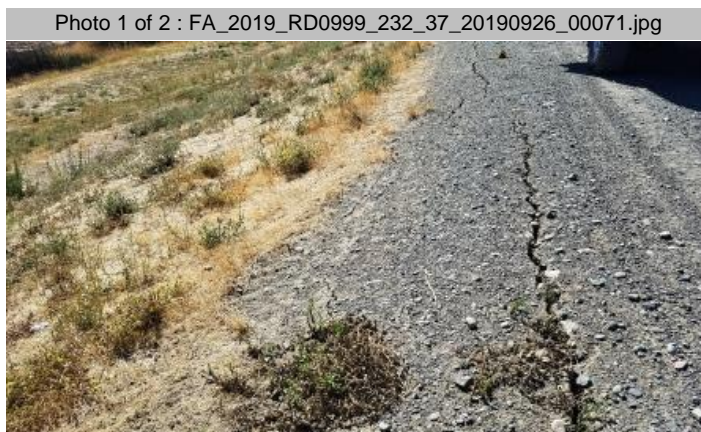
LM Start	13.26	Rating **	A/W	Issue No.	37
LM End	13.27	Issue Type +	Ma	Location *	CR
Category	Earthen Levee			GPS Latitude/Longitude	
				Start	End
Item	Cracking			38.321620°	38.321490°
				-121.644968°	-121.644968°
DWR ID	DWR_RD0999_01_f_2019_37				
Comment Code					
CR1 : Monitor and have inspected by geotechnical engineer.					
Inspector Comment					
Monitor cracks as deep as 8" on the landside shoulder.

View of longitudinal cracks as deep as 8" on the landside shoulder. Fall 2019

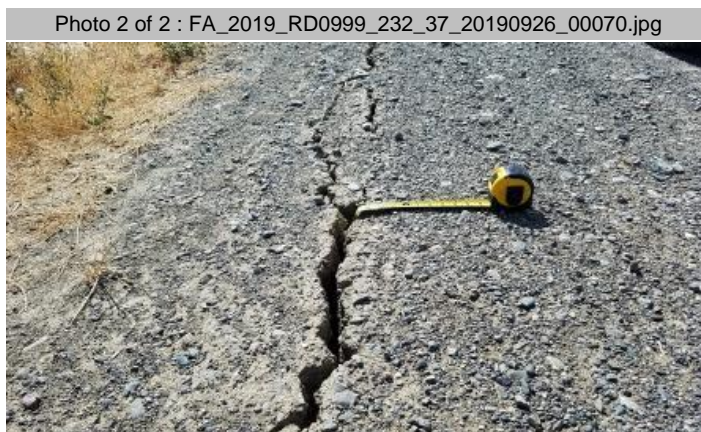
View of longitudinal cracks as deep as 8" on the landside shoulder. Fall 2019

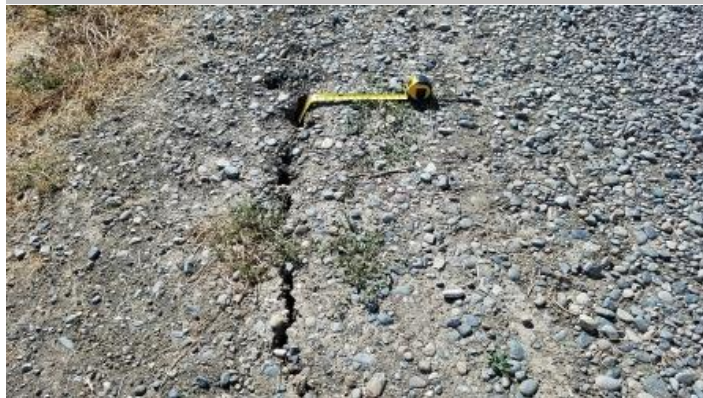
Photo 1 of 1 : FA\_2019\_RD0999\_232\_41\_20190926\_00072.jpg

LM Start	14.00	Rating **	A/W	Issue No.	41
LM End	14.00	Issue Type +	Ma	Location *	CR
Category	Earthen Levee			GPS Latitude/Longitude	
				Start	End
Item	Cracking			38.310882 °	38.310882 °
				-121.644982 °	-121.644982 °
DWR ID	DWR_RD0999_01_f_2019_41				
Comment Code					
CR1 : Monitor and have inspected by geotechnical engineer.					
Inspector Comment					
Monitor a 5'-long crack as deep as 7" on the landside shoulder.

View of longitudinal crack as deep as 7" on the landside shoulder. Fall 2019

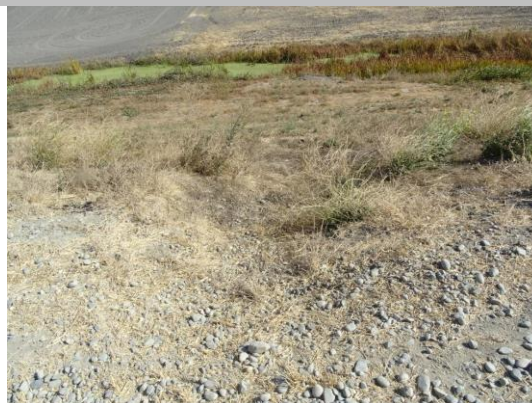
Photo 1 of 1 : FA\_2019\_RD0999\_232\_49\_20190904\_00031.jpg

View of caving on landward slope. Fall 2018

LM Start	14.04	Rating **	M	Issue No.	49
LM End	14.04	Issue Type +	Ma	Location *	LS
Category	Earthen Levee			GPS Latitude/Longitude	
				Start	End
Item	Erosion / Bank Caving			38.310347 °	38.310347 °
				-121.644955 °	-121.644955 °
DWR ID	DWR_RD0999_01_f_2012_49				
Comment Code					
E1 : Note and monitor erosion site.					
Inspector Comment					
Repair caving, 4' x 10', on the landside slope.

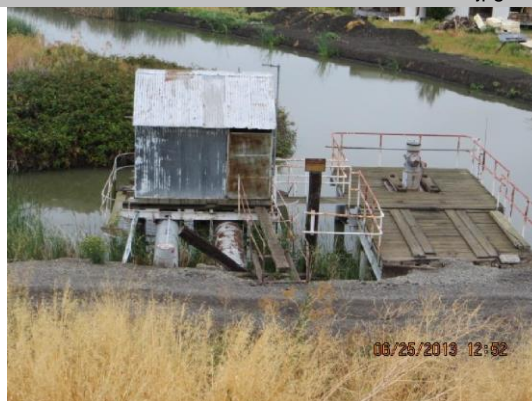
Photo 1 of 3 : UCIP\_FA\_2019\_15365\_25227.jpg

Pumphouse on LS toe.

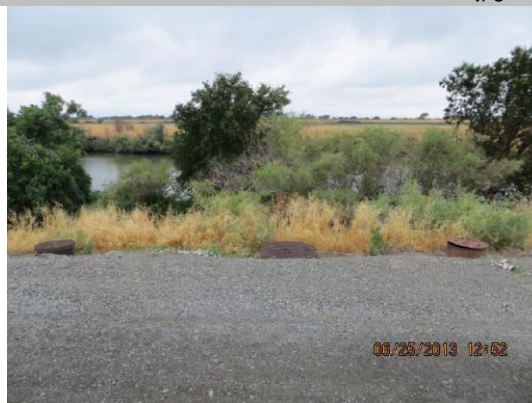
Photo 2 of 3 : UCIP\_FA\_2019\_15365\_25226.jpg

Siphon breaker in CMP riser on WS shoulder.

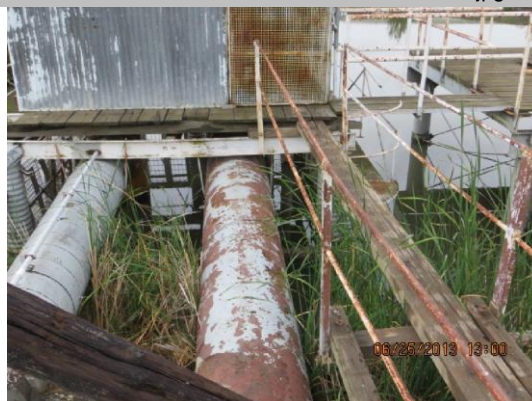
Photo 3 of 3 : UCIP\_FA\_2019\_15365\_25225.jpg

Closeup of pipe at pumphouse on LS toe.

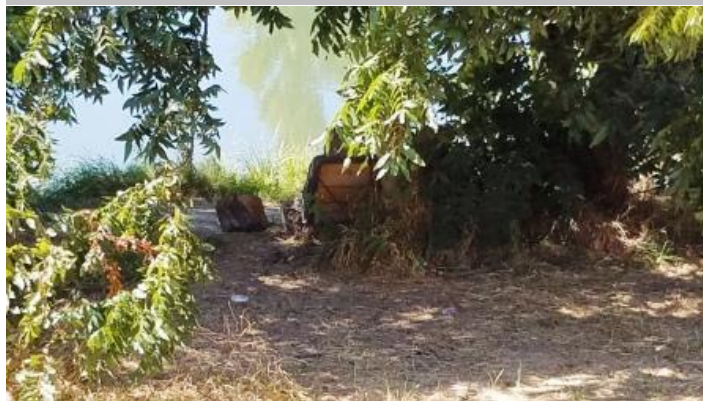
Photo 1 of 1 : FA\_2019\_RD0999\_233\_37\_20190926\_00048.jpg

View looking southward at debris on the waterside slope. Fall 2019

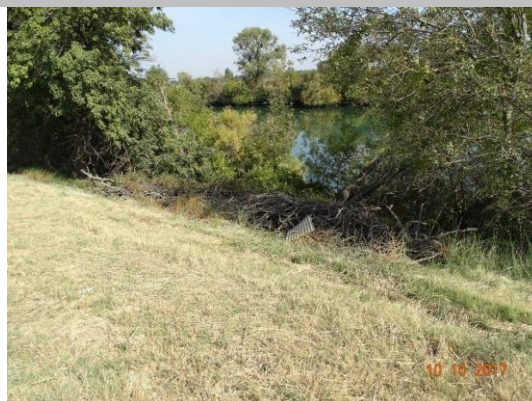
Photo 1 of 1 : FA\_2019\_RD0999\_234\_32\_20190904\_00019.jpg

View of waterside slope looking east. Fall 2017

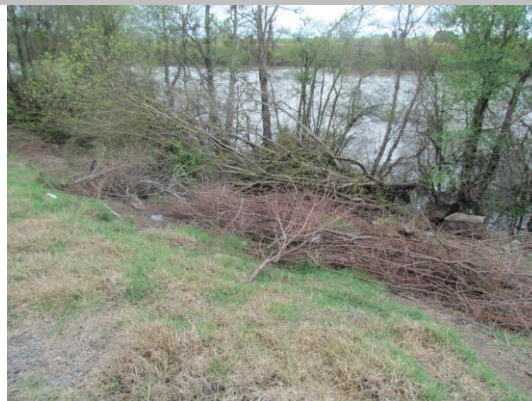
Photo 1 of 1 : FA\_2019\_RD0999\_234\_23\_20190904\_00014.jpg

Looking east at large pruning piles on waterward slope.

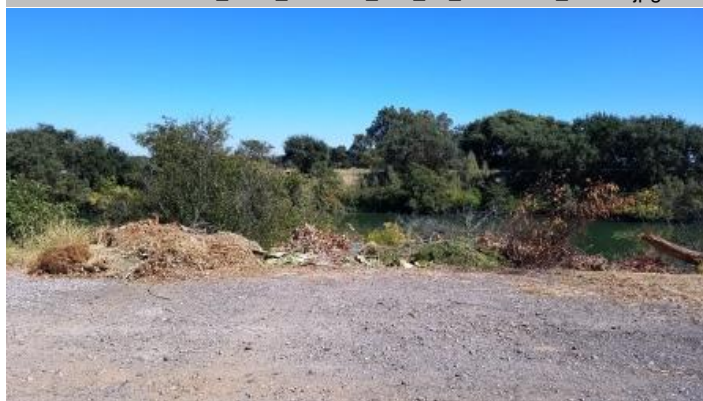
Photo 1 of 1 : FA\_2019\_RD0999\_234\_29\_20190926\_00032.jpg

View of debris on the waterside turnout. Fall 2019

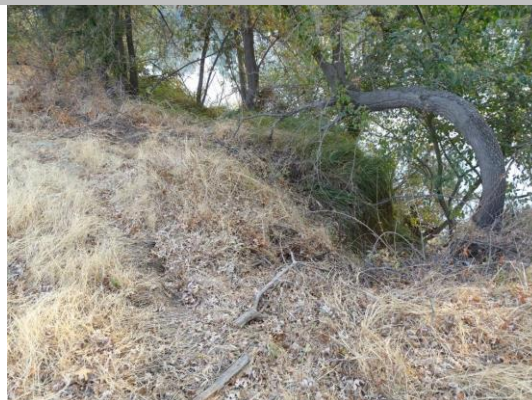
Photo 1 of 5 : FA\_2019\_RD0999\_234\_9\_20190904\_00003.jpg

View of some erosion on slope. Fall 2018

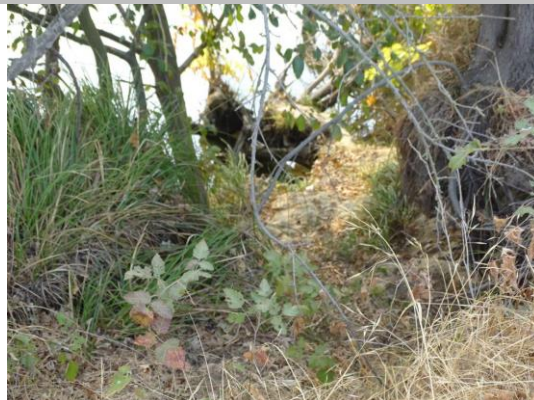
Photo 2 of 5 : FA\_2019\_RD0999\_234\_9\_20190904\_00004.jpg

View of fallen tree at water's edge. Fall 2018

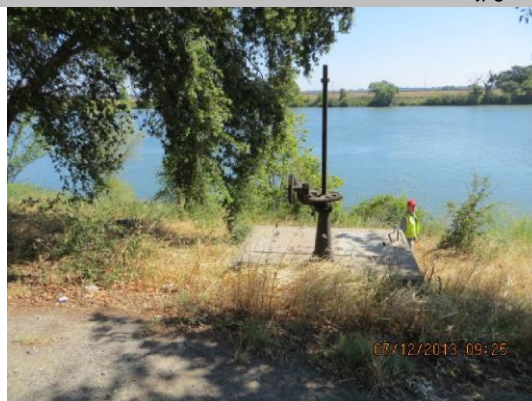
Photo 1 of 2 : UCIP\_FA\_2019\_15708\_26137.jpg

Slide gate in concrete vault on WS shoulder.

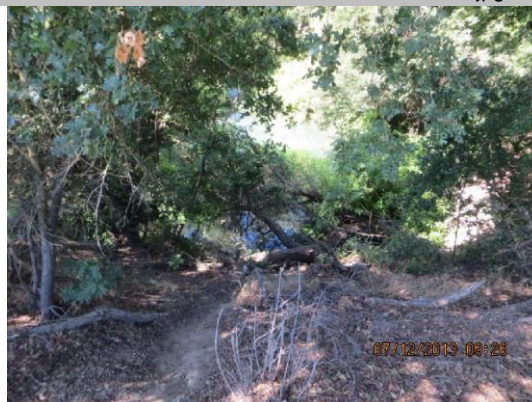
Photo 2 of 2 : UCIP\_FA\_2019\_15708\_26136.jpg

Toe of LS at approximate location of outlet/inlet.

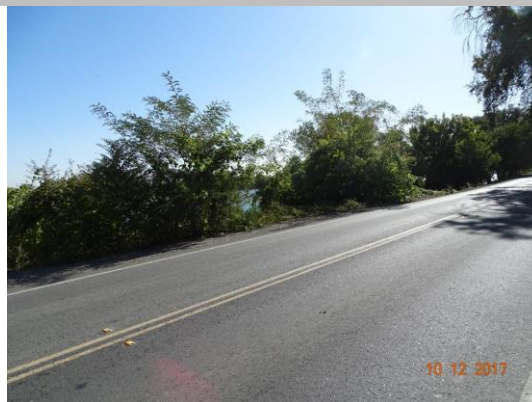
Photo 1 of 1 : FA\_2019\_RD0999\_235\_53\_20190904\_00028.jpg

Looking southeast at the waterside slope. Fall 2017

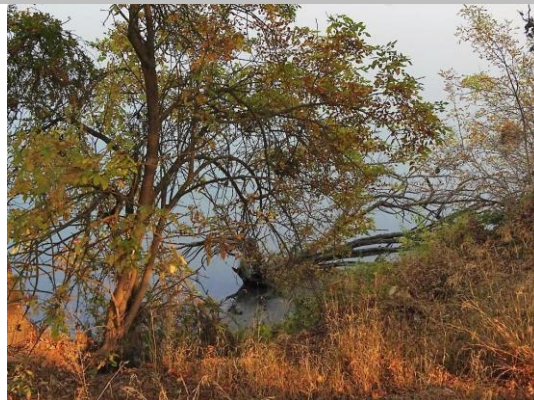
Photo 1 of 4 : FA\_2019\_RD0999\_235\_42\_20190904\_00018.jpg

View of fallen tree. Fall 2018

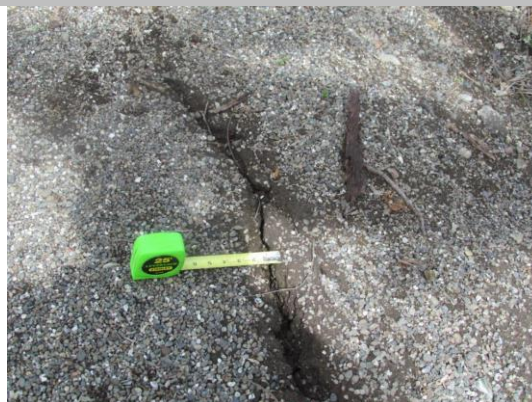
Photo 1 of 3 : FA\_2019\_RD0999\_236\_165\_20190904\_00069.jpg

Looking at two inch plus crack on waterward shoulder.

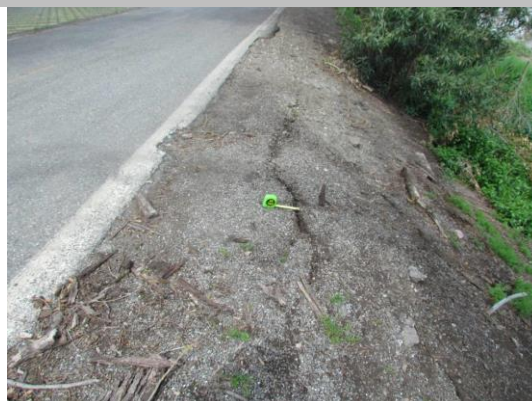
Photo 2 of 3 : FA\_2019\_RD0999\_236\_165\_20190904\_00070.jpg

Looking upstream at cracking along waterward shoulder.

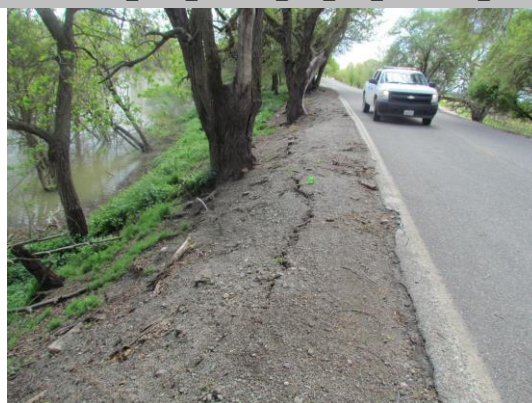
Photo 3 of 3 : FA\_2019\_RD0999\_236\_165\_20190904\_00071.jpg

Looking downstream at crack along waterward shoulder.

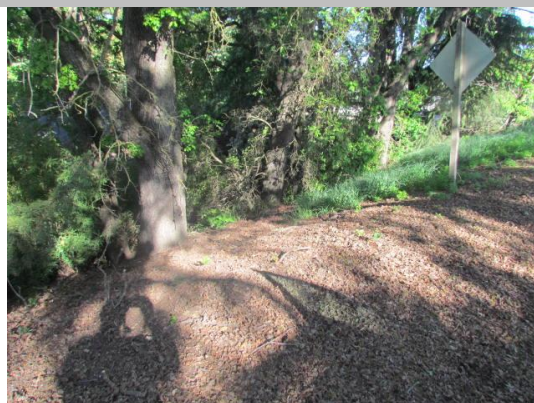
Photo 1 of 2 : FA\_2019\_RD0999\_236\_128\_20190904\_00052.jpg

Looking northwest at untrimmed trees on landward slope. (Spring 2015)

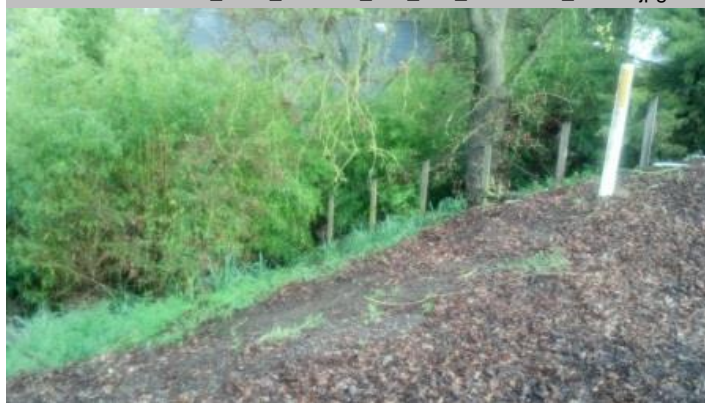
Photo 2 of 2 : FA\_2019\_RD0999\_236\_128\_20190904\_00053.jpg

Looking at dense trees on landside slope and toe.

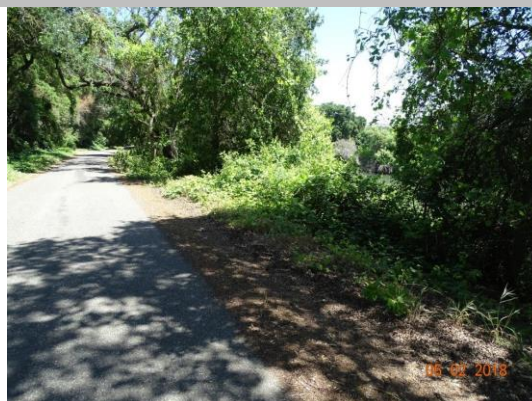
Photo 1 of 1 : FA\_2019\_RD0999\_236\_10\_20190904\_00005.jpg

Vegetation waterside looking north. Spring 2018

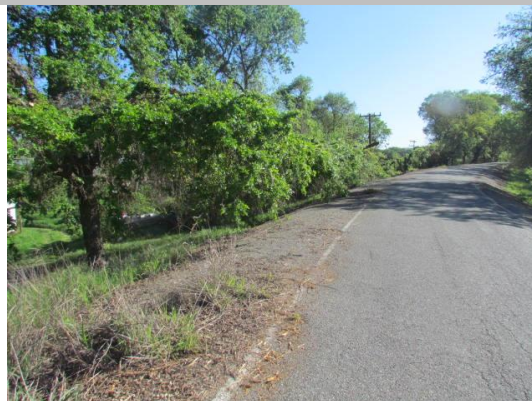
Photo 1 of 1 : FA\_2019\_RD0999\_236\_15\_20190904\_00011.jpg

Looking north at untrimmed trees on landward slope and toe.

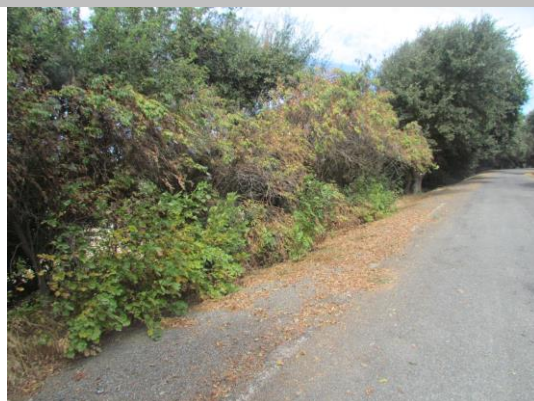
Photo 1 of 1 : FA\_2019\_RD0999\_236\_199\_20190904\_00089.jpg

Looking northwest at dense vegetation on landward slope.

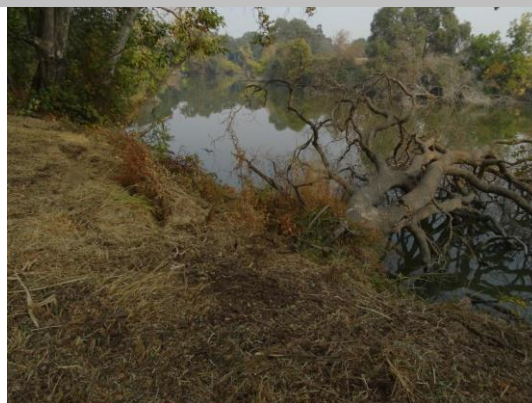
Photo 1 of 1 : FA\_2019\_RD0999\_236\_83\_20190904\_00033.jpg

View of a fallen tree and slope damage. Fall 2018

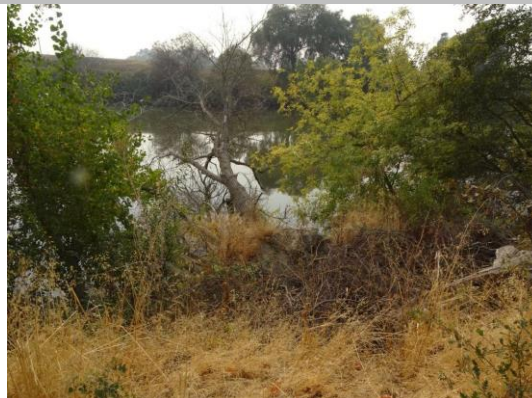
Photo 1 of 1 : FA\_2019\_RD0999\_236\_85\_20190904\_00034.jpg

View of fallen tree and slope damage. Fall 2018

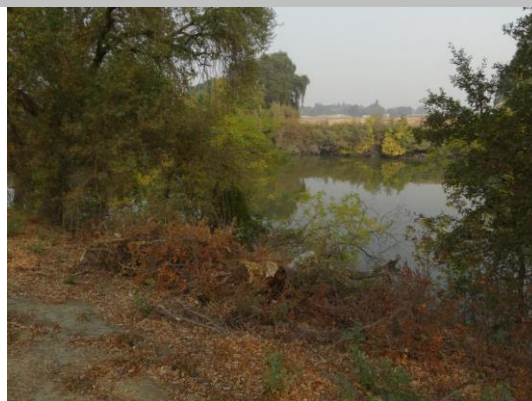
Photo 1 of 1 : FA\_2019\_RD0999\_236\_90\_20190904\_00035.jpg

View of tree debris on levee easement. Fall 2018

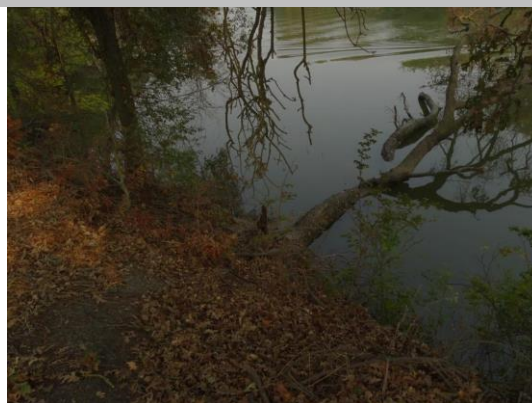
Photo 1 of 1 : FA\_2019\_RD0999\_236\_91\_20190904\_00036.jpg

View of tree with rootball exposed. Fall 2018

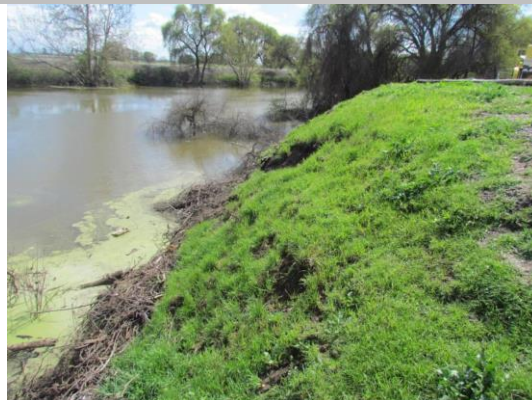
Photo 1 of 1 : FA\_2019\_RD0999\_236\_12\_20190904\_00008.jpg

Looking downstream at finger erosion on downstream side of slough.

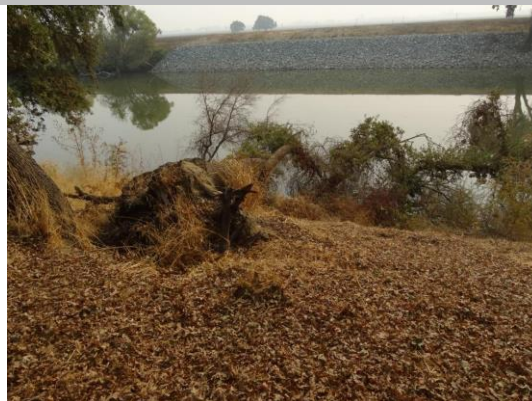
Photo 1 of 1 : FA\_2019\_RD0999\_236\_28\_20190904\_00017.jpg

View of dead tree on slope. Fall 2018

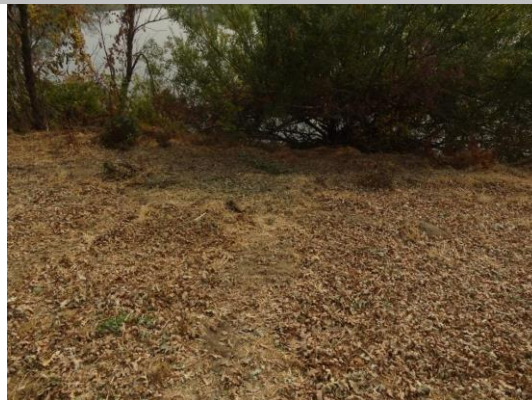
Photo 1 of 1 : FA\_2019\_RD0999\_236\_62\_20190904\_00026.jpg

View of tree stump on levee slope. Fall 2018

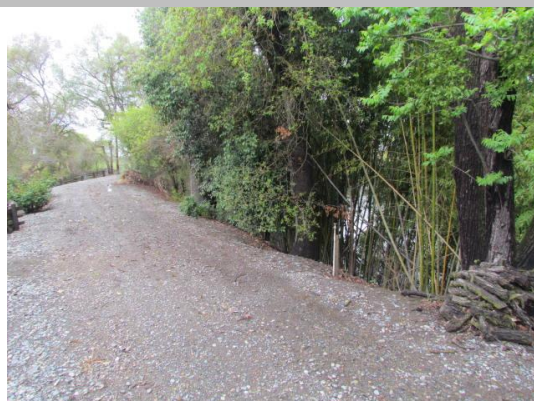
Photo 1 of 1 : FA\_2019\_RD0999\_236\_71\_20190904\_00030.jpg

Looking northeast at dense vegetation on waterside slope.

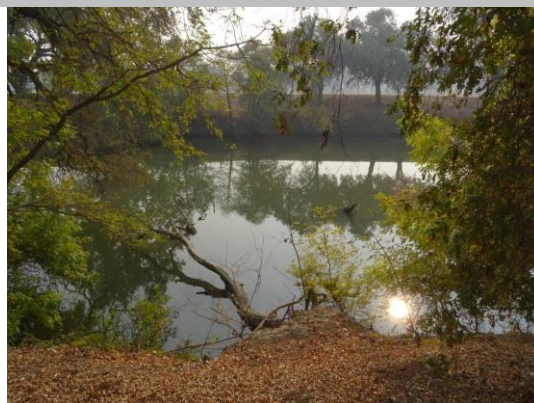
Photo 1 of 1 : FA\_2019\_RD0999\_236\_99\_20190904\_00045.jpg

View of fallen tree and slope damage. Fall 2018

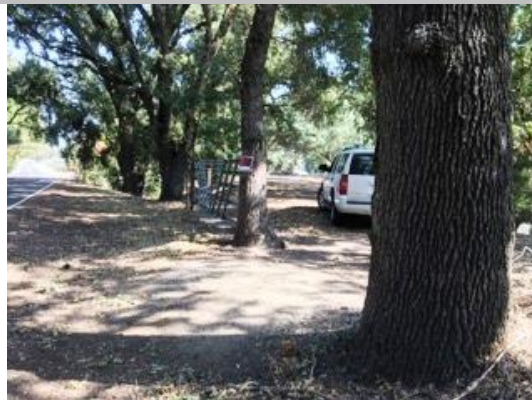
Photo 1 of 1 : FA\_2019\_RD0999\_236\_138\_20191017\_00169.jpg

View of levee access between trees next to a private gate at LM 8.13.
