**Flood Control Project Maintenance
Levee Inspections**

Maintenance Issue Types Only, Levee Inspection Report By Mile - Fall 2020

Reclamation District No. 0999 Netherlands

Waterway	Bank	Unit Miles	Inspection Start/End	Inspector
Unit No. 01 Yolo Bypass	Left	15.41	10/13/2020 10/13/2020	Luz Dial

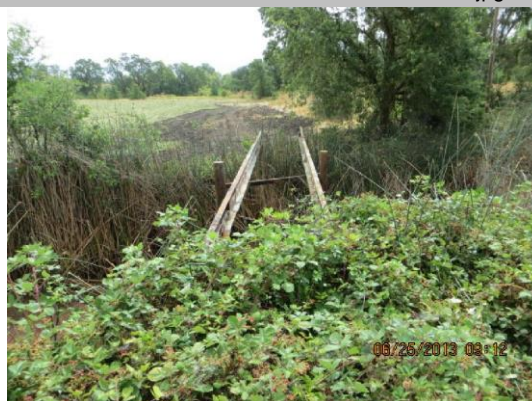
Photo 2 of 3 : UCIP_FA_2020_61245_25190.jpg

Pump platform visible off LS toe, but no appurtenances remain.

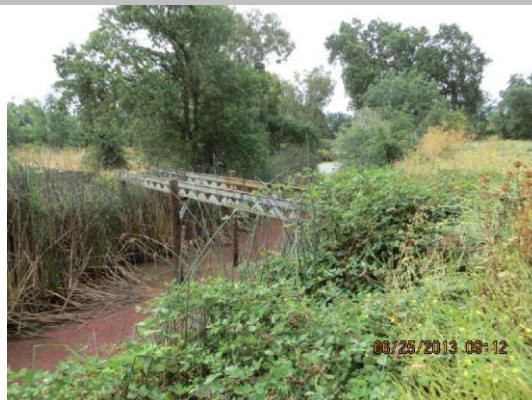
Photo 3 of 3 : UCIP_FA_2020_61245_25189.jpg

Pump platform visible off LS toe, but no appurtenances remain.

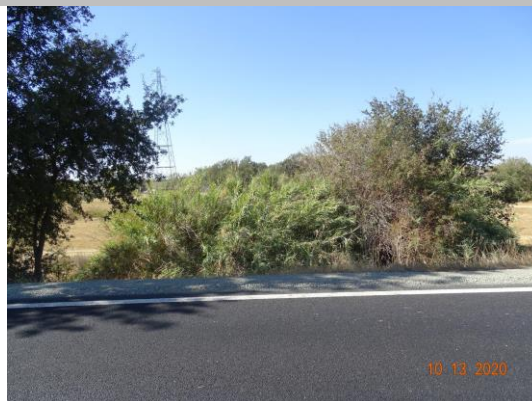
Photo 1 of 1 : FA_2020_RD0999_232_95_20201019_00087.jpg

LM Start	1.76	Rating **	M	Issue No.	95
LM End	2.49	Issue Type +	Ma	Location *	WS
Category	Earthen Levee			GPS Latitude/Longitude	
				Start	End
Item	Vegetation			38.479620 °	38.469330 °
				-121.580787 °	-121.582955 °
DWR ID	DWR_RD0999_01_s_2020_95				
Comment Code					
V2 : Remove the wild growth other than native grasses from the levee slopes.					
Inspector Comment					
Remove bull thistle and Arundo.

View of Arundo along the waterside toe near LM 2.17. Fall 2020

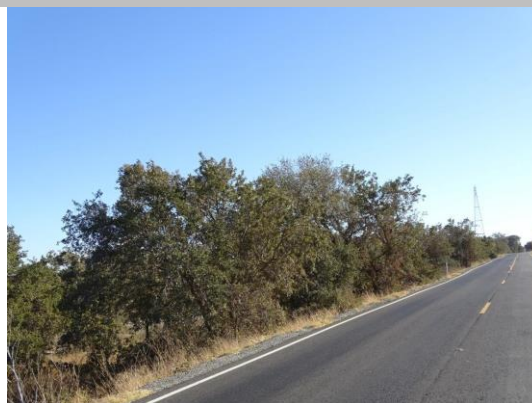
Photo 1 of 1 : FA_2020_RD0999_232_30_20200916_00009.jpg

View of untrimmed trees on landside slope. LMA claims that RD 765 is responsible for maintenance. Fall 2018

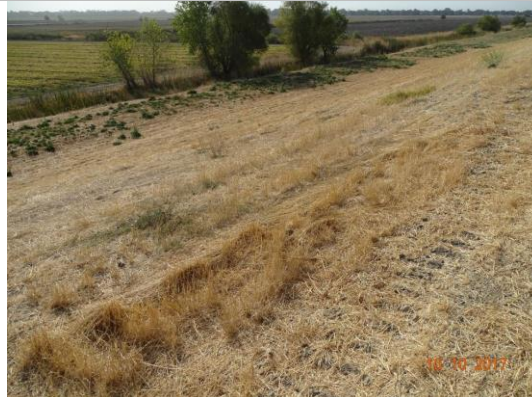
Photo 1 of 1 : FA_2020_RD0999_232_51_20200916_00020.jpg

LM Start	3.22	Rating **	M	Issue No.	51
LM End	3.22	Issue Type +	Ma	Location *	LS
Category	Earthen Levee			GPS Latitude/Longitude	
				Start	End
Item	Slope Stability			38.459399 °	38.459399 °
				-121.587523 °	-121.587523 °
DWR ID	DWR_RD0999_01_s_2013_51				
Comment Code					
S1 : Repair slope instability.					
Inspector Comment					
Repair depression on landward shoulder and slope approximately 40' x 20'. Earthen material appears to be sliding toward levee toe.

View of landside slope looking south. Fall 2017

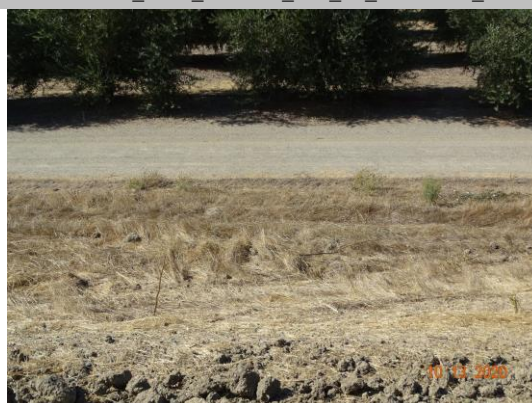
Photo 1 of 1 : FA_2020_RD0999_232_80_20201019_00074.jpg

LM Start	4.04	Rating **	M	Issue No.	80
LM End	4.04	Issue Type +	Ma	Location *	WS
Category	Earthen Levee			GPS Latitude/Longitude	
				Start	End
Item	Animal Control			38.448275 °	38.448275 °
				-121.592692 °	-121.592692 °
DWR ID	DWR_RD0999_01_f_2020_80				
Comment Code					
A1 : Exterminate rodents and backfill and compact or grout burrows.					
Inspector Comment

View of animal holes at the waterside toe. Fall 2020

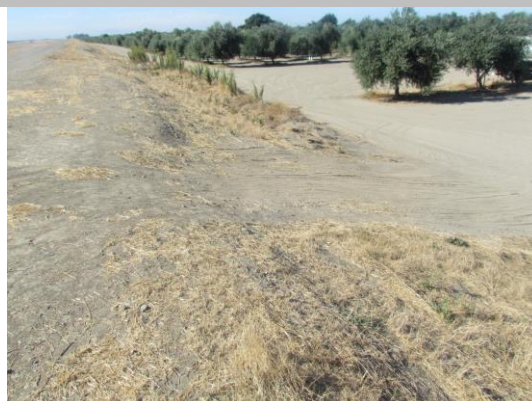
Photo 1 of 1 : FA_2020_RD0999_232_27_20200916_00007.jpg

LM Start	4.31	Rating **	M	Issue No.	27
LM End	4.31	Issue Type +	Ma	Location *	WS
Category	Earthen Levee			GPS Latitude/Longitude	
				Start	End
Item	Slope Stability			38.444560 °	38.444560 °
				-121.594440 °	-121.594440 °
DWR ID	DWR_RD0999_01_f_2012_27				
Comment Code					
S3 : Repair the levee slope damaged by vehicle traffic and prevent access where possible.					
Inspector Comment					
Instruct farmer to stop driving equipment and trucks onto the slope.

Looking at slope damage cause by vehicle traffic on waterward slope.
(Fall 2016)

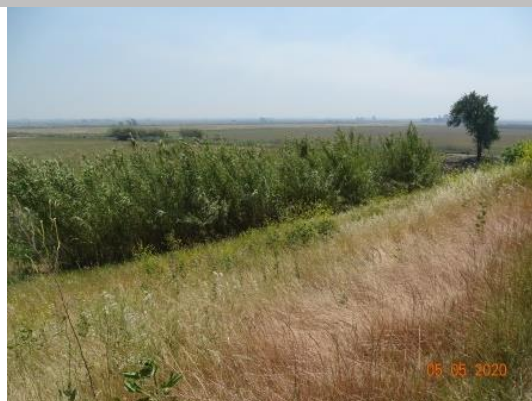
Photo 1 of 1 : FA_2020_RD0999_232_74_20200916_00028.jpg

View of Arundo growth at the landside toe. Spring 2020

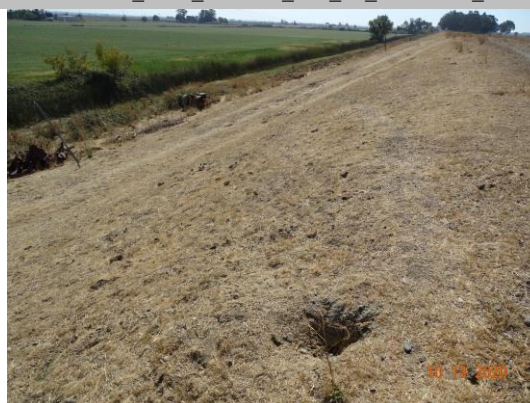
Photo 1 of 1 : FA_2020_RD0999_232_24_20201019_00077.jpg

View of large animal holes on the landside slope. Fall 2020

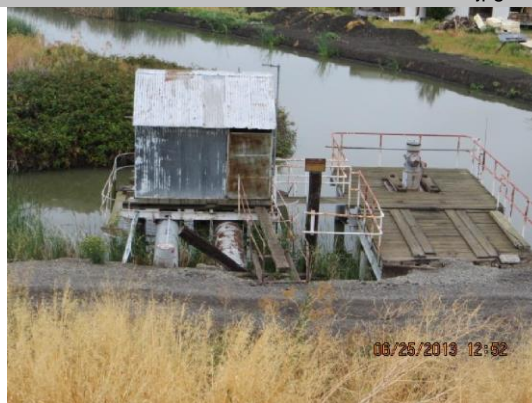
Photo 1 of 3 : UCIP_FA_2020_61278_25227.jpg

Comment Code						
Inspector Comment						
DS_ID:22756 FS_ID:61278 EP_NO: N/A Repair Type: No Action Needed EVAL Issue: Compliant Crossing Status: Found UCIP Comments: 06/16/2020 Record updated from No Action Needed to Non-Urgent. Unauthorized encroachment recorded in Levee Log prior to 2011. No permit has been identified authorizing pipe. (D.Sanoski - DWR UCIP) FIELD_STRUCT_DESC: 30-inch steel drainage pipe through the levee, 7 feet below the crown. Flap gate on the waterside (WS) end. Pump in pump house on the landside (LS) toe. Siphon breaker in a corrugated metal pipe (CMP) riser on the WS shoulder. [Additional Reference(s): DWR Levee Log, 1992. USACE Sacramento O&M Manual 113 (Revised), October 1966, (HLM 15.25) (36-inch pipe listed)]. FS Date: 6/16/2020 2:26:00 PM

Pumphouse on LS toe.

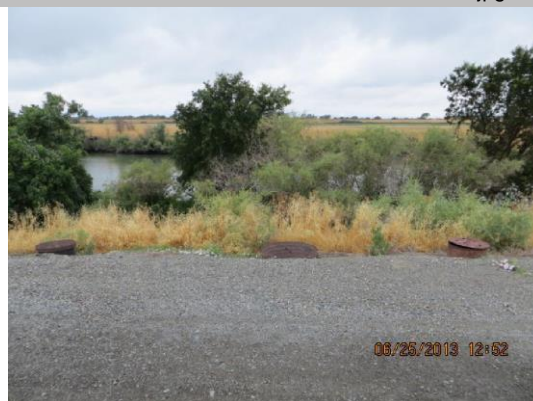
Photo 2 of 3 : UCIP_FA_2020_61278_25226.jpg

Siphon breaker in CMP riser on WS shoulder.

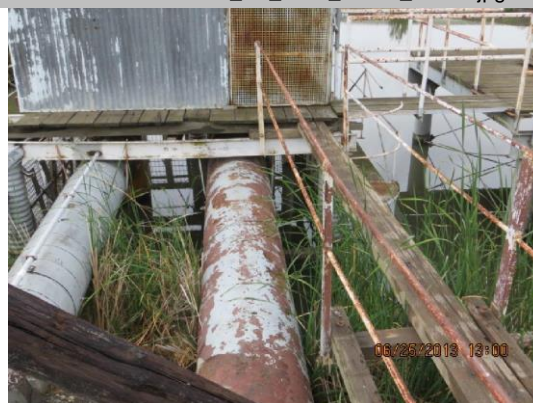
Photo 3 of 3 : UCIP_FA_2020_61278_25225.jpg

Closeup of pipe at pump house on LS toe.

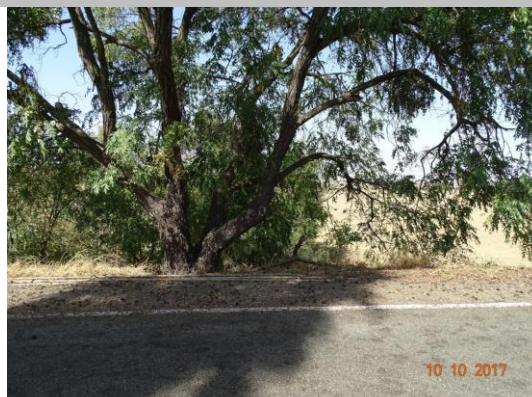
Photo 1 of 1 : FA_2020_RD0999_233_21_20200916_00006.jpg

View of trees on landside slope looking north. Fall 2017

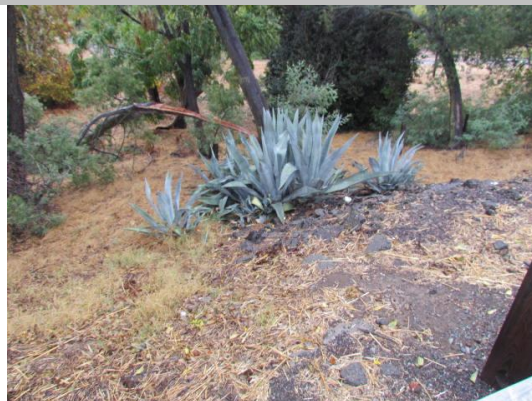
Photo 1 of 1 : FA_2020_RD0999_233_14_20200916_00004.jpg

Looking north at century plant at landward toe. Fall 2015.

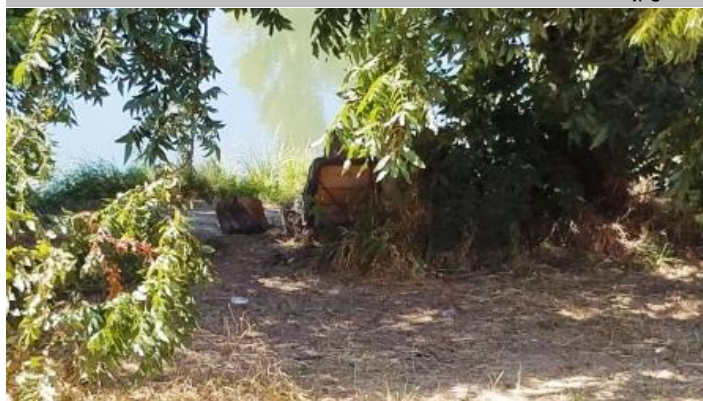
Photo 1 of 1 : FA_2020_RD0999_233_37_20200916_00012.jpg

View looking southward at debris on the waterside slope. Fall 2019

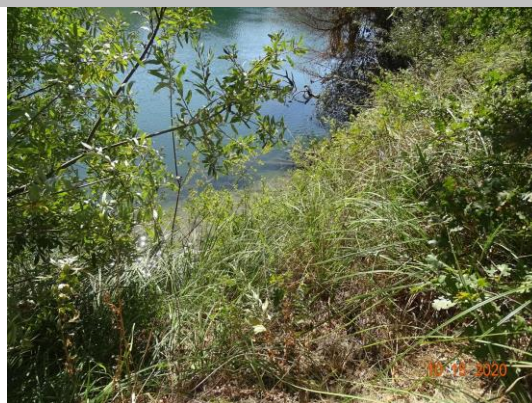
Photo 1 of 1 : FA_2020_RD0999_234_45_20201019_00041.jpg

LM Start	1.93	Rating **	M	Issue No.	45
LM End	1.97	Issue Type +	Ma	Location *	WS
Category	Supplemental			GPS Latitude/Longitude	
				Start	End
Item	2017 USACE Erosion Survey			38.311013 °	38.311342 °
				-121.597751 °	-121.596976 °
DWR ID	DWR_RD0999_03_s _ 2020_45				
Comment Code					
Inspector Comment					
2017 Site ID: STR 26.1 R					
2017 Field Notes: No observed change.					
Site History: 2015 - Tall vertical sections into the levee slope and erosion along the toe. 2016 - New tree pop-out observed. 2019 DWR					
Inspection: A fallen tree into the channel and a scarp on the waterside berm exist near LM 1.97.

View of a scarp on the waterside berm near LM 1.97. Fall 2020

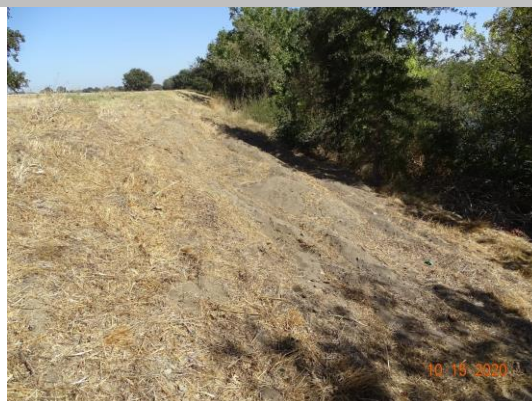
Photo 1 of 1 : FA_2020_RD0999_234_13_20201019_00042.jpg

LM Start	1.99	Rating **	M	Issue No.	13
LM End	1.99	Issue Type +	Ma	Location *	WS
Category	Earthen Levee			GPS Latitude/Longitude	
				Start	End
Item	Slope Stability			38.311618 °	38.311618 °
				-121.596887 °	-121.596887 °
DWR ID	DWR_RD0999_03_f_2020_13				
Comment Code					
S3 : Repair the levee slope damaged by vehicle traffic and prevent access where possible.					
Inspector Comment					
Repair slope depression due to vehicle traffic.

View of slope damage on the waterside slope due to vehicle traffic. Fall 2020

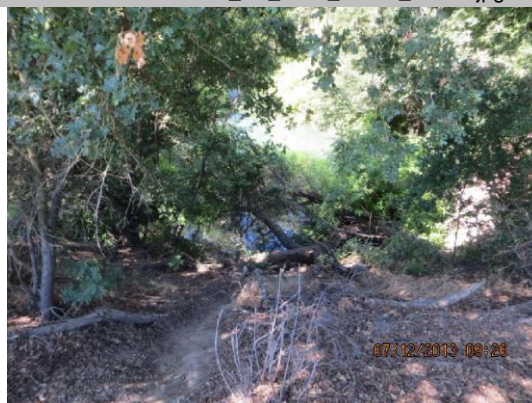
Photo 2 of 3 : UCIP_FA_2020_61407_26136.jpg

Toe of LS at approximate location of outlet/inlet.

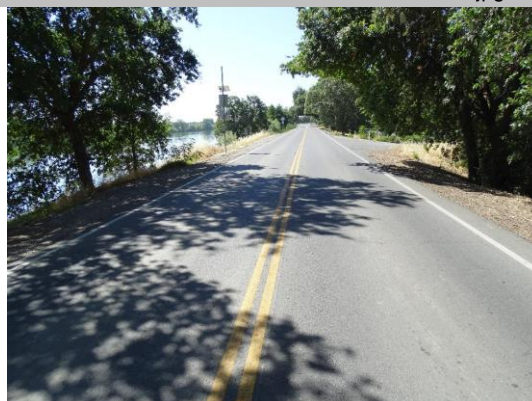
Photo 3 of 3 : UCIP_FA_2020_61407_88712.jpg

Top of Levee: view of crown.

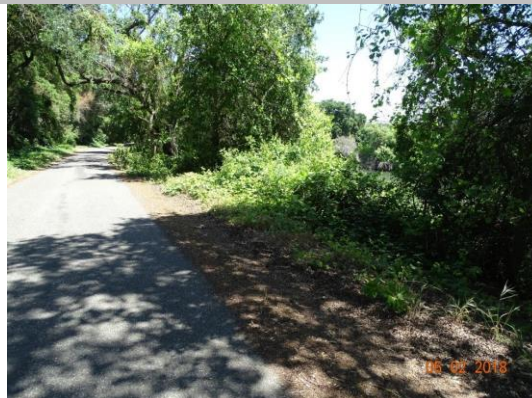
Photo 1 of 1 : FA_2020_RD0999_236_10_20200916_00005.jpg

Vegetation waterside looking north. Spring 2018

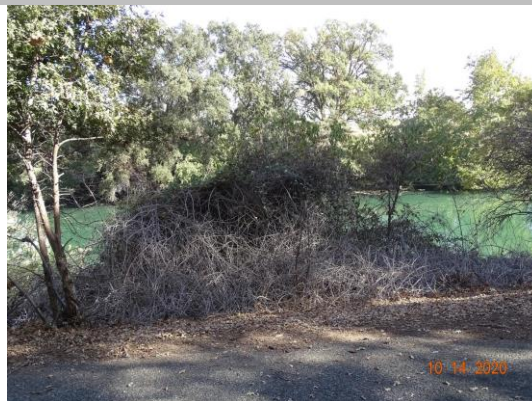
Photo 1 of 1 : FA_2020_RD0999_236_55_20201019_00215.jpg

View of wild growth on the waterside slope. Fall 2020

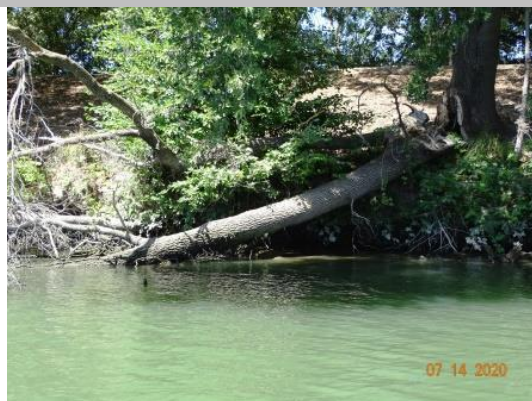
Photo 1 of 1 : FA_2020_RD0999_236_263_20200916_00098.jpg

View of a split tree on the waterside bank. Summer 2020

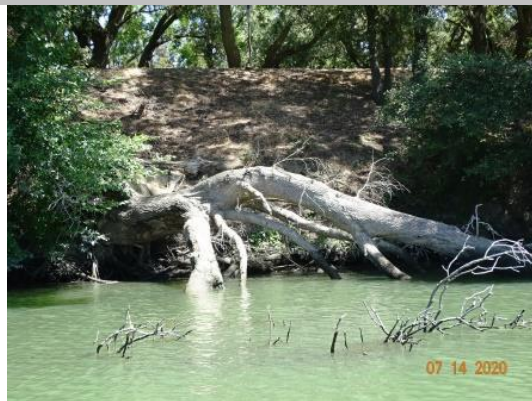
Photo 1 of 1 : FA_2020_RD0999_236_260_20200916_00095.jpg

View of slope erosion around fallen tree from the waterside. Summer 2020

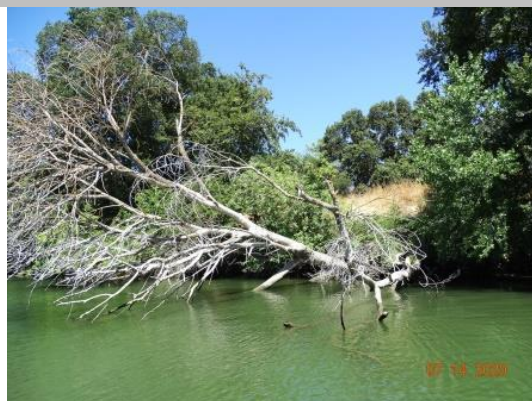
Photo 1 of 2 : FA_2020_RD0999_236_85_20200916_00031.jpg

View of fallen tree and slope damage. Summer 2020

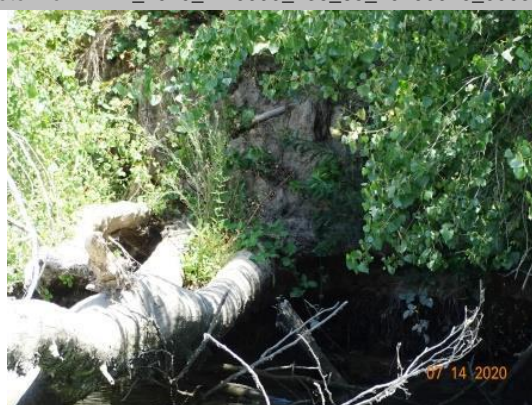
Photo 2 of 2 : FA_2020_RD0999_236_85_20200916_00032.jpg

View of fallen tree and slope damage. Summer 2020

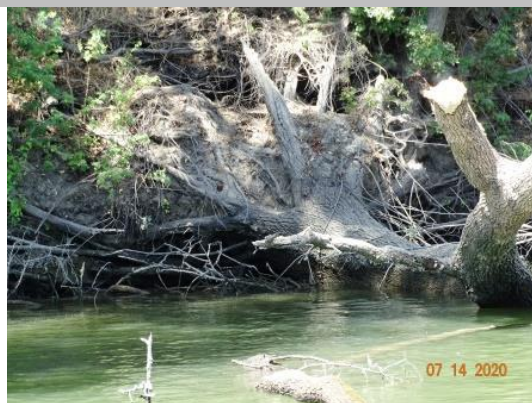
Photo 1 of 2 : FA_2020_RD0999_236_91_20200916_00034.jpg

View of fallen tree with exposed rootball. Summer 2020

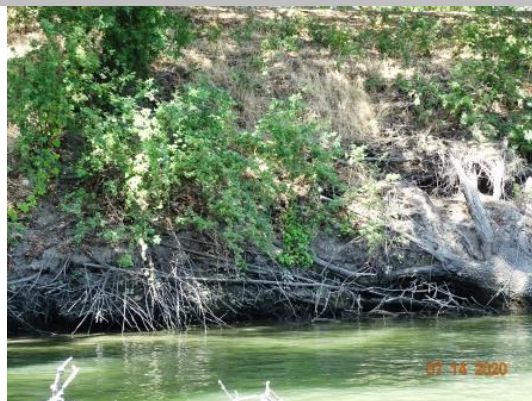
Photo 2 of 2 : FA_2020_RD0999_236_91_20200916_00035.jpg

View of scarp around fallen tree. Summer 2020

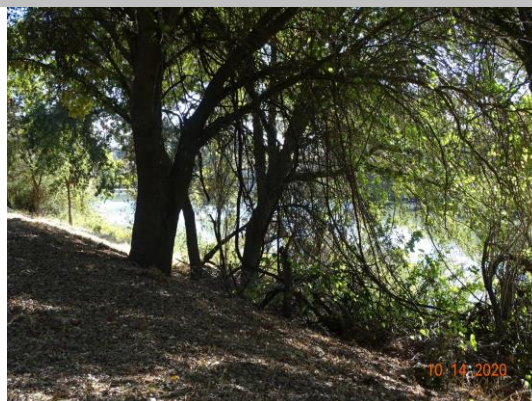
Photo 1 of 1 : FA_2020_RD0999_236_98_20201019_00219.jpg

View of low branches and vines over the waterside slope. Fall 2020

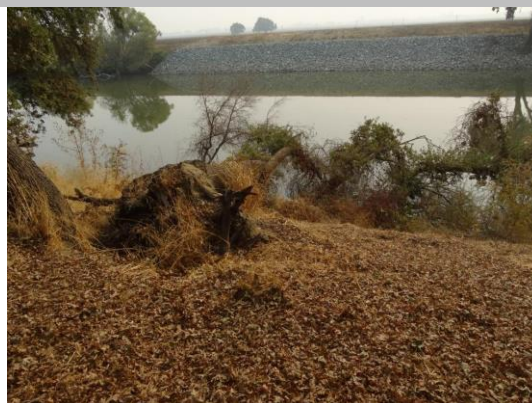
Photo 1 of 1 : FA_2020_RD0999_236_28_20200916_00013.jpg

View of dead tree on slope. Fall 2018

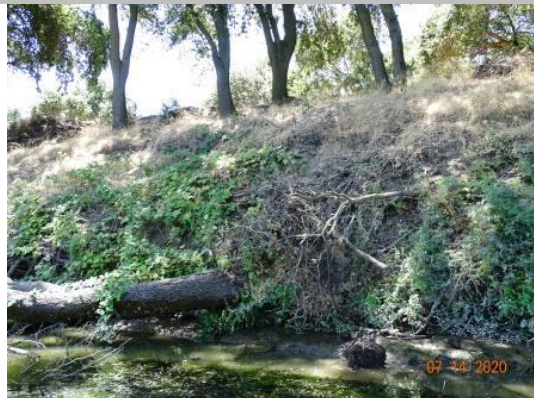
Photo 1 of 1 : FA_2020_RD0999_236_97_20200916_00040.jpg

View of fallen trees and scarp. Summer 2020

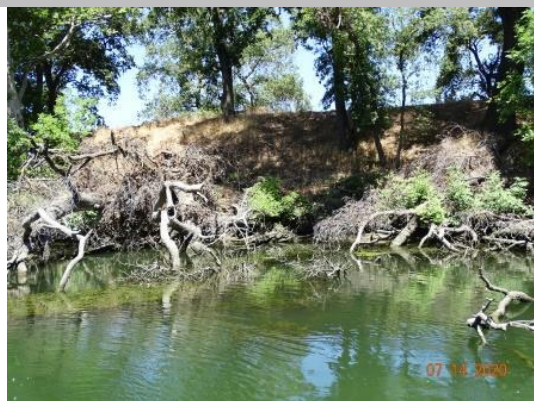
Photo 1 of 2 : FA_2020_RD0999_236_229_20200916_00088.jpg

View of two fallen trees. Summer 2020

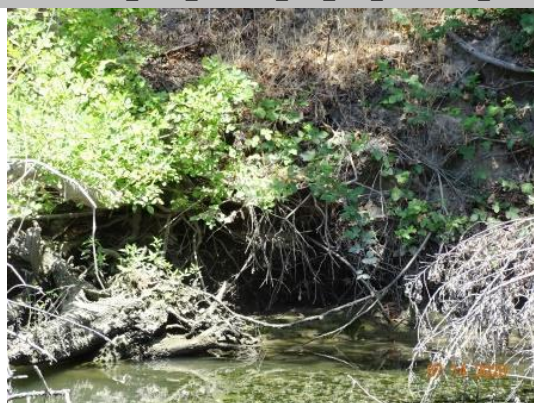
Photo 2 of 2 : FA_2020_RD0999_236_229_20200916_00089.jpg

View of large scarp near two fallen trees. Summer 2020

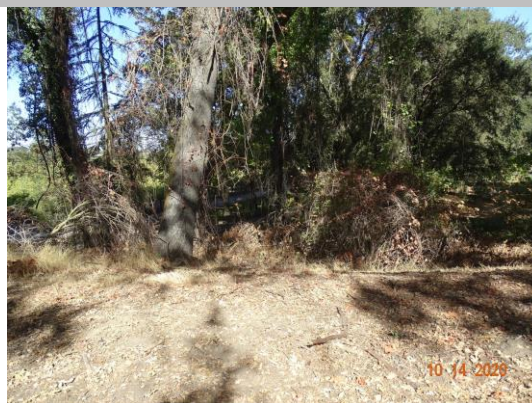
Photo 1 of 1 : FA_2020_RD0999_236_194_20201019_00223.jpg

View of vines covering the landside slope. Fall 2020

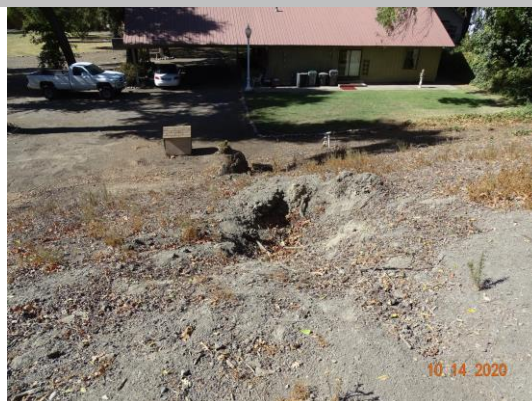
Photo 1 of 1 : FA_2020_RD0999_236_214_20201019_00226.jpg

View of a large hole on the landside slope. Fall 2020

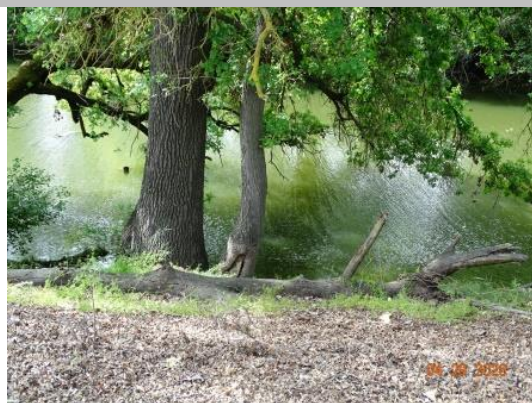
Photo 1 of 1 : FA_2020_RD0999_236_186_20200916_00073.jpg

View of a tree log on the waterside slope. Spring 2020

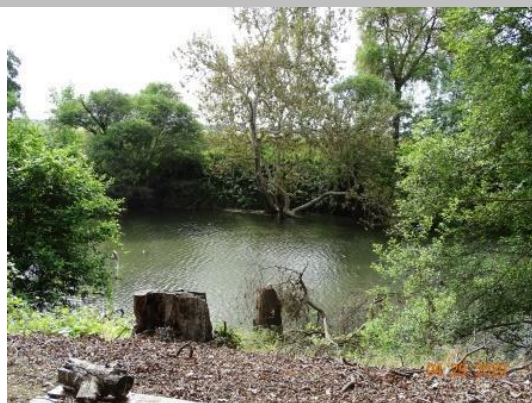
Photo 1 of 1 : FA_2020_RD0999_236_164_20200916_00065.jpg

View of a large tree stump on the waterside slope. Spring 2020

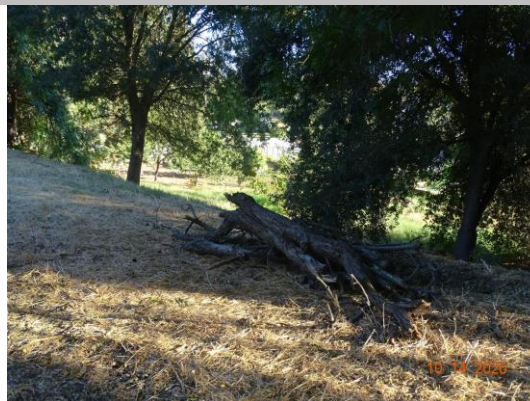
Photo 1 of 1 : FA_2020_RD0999_236_140_20201019_00238.jpg

View of tree debris on the levee crown. Fall 2020
