**Flood Control Project Maintenance  
Levee Inspections**

## Maintenance Issue Types Only, Levee Inspection Report By Mile - Fall 2021

### Reclamation District No. 0999 Netherlands

Waterway	Bank	Unit Miles	Inspection Start/End	Inspector
Unit No. 01 Yolo Bypass	Left	15.41	09/30/2021 09/30/2021	Marvin Marshall

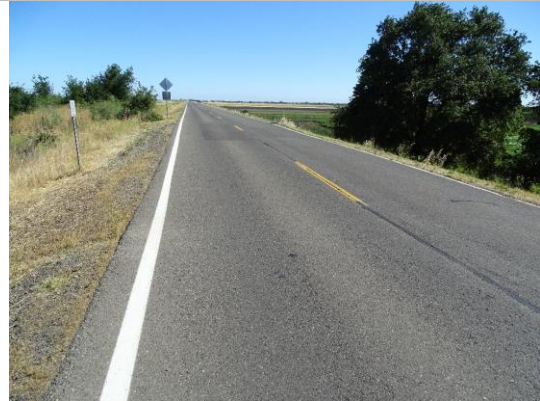
Photo 1 of 3 : UCIP\_FA\_2021\_69815\_88522.jpg

Top of Levee: view of crown.

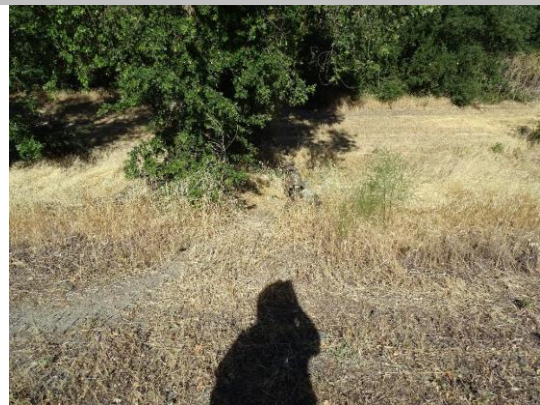
Photo 2 of 3 : UCIP\_FA\_2021\_69815\_88523.jpg

Comment Code						
Inspector Comment						
DS_ID:22743 FS_ID:69815 EP_NO: N/A Repair Type: Non-Urgent EVAL Issue: Unauthorized Encroachment, installed decades prior Crossing Status: Found UCIP Comments: 06/16/2020 Record remains Non-Urgent. No permit has been identified authorizing pipe. Crossing appears abandoned. Recommend owner to contact CVFPB to abandon or remove pipe from levee. (D.Sanoski - DWR UCIP) 07/26/2018 Same as last inspection. Pipe open on WS, but no visual signs of pipe or levee integrity issues so downgrading crossing to Non-Urgent (D. Sanoski - DWR UCIP).07/07/2016 Condition largely unchanged from previous inspection. Pipe open on the WS, waterward of the siphon breaker. Dense vegetation and steep slope limited inspection of WS outlet into Ship Channel. (T. Hatch/UCIP) 06/25/2013 Pipe abandoned and open on WS slope. Pipe should be abandoned properly. (W. Wylie/UCIP) FIELD_STRUCT_DESC: *ABANDONED* 30-inch steel drainage pipe through the levee, 6.5 feet below the crown. Pump on a platform in the canal off the landside (LS) toe. Flap gate on the waterside (WS). Siphon breaker and an air vent on the WS shoulder. 1-inch galvanized iron filler pipe visible on the WS shoulder along same alignment. [Additional Reference(s): DWR Levee Log, 1992 (HLM 1.73). USACE Sacramento O&M Manual, Unit 113, October 1966, Revised 29 December 2016, (1.73), listed as 30-inch pipe]. FS Date: 6/16/2020 2:16:00 PM

Water-Side: view of WS slope and broken crossing at toe.

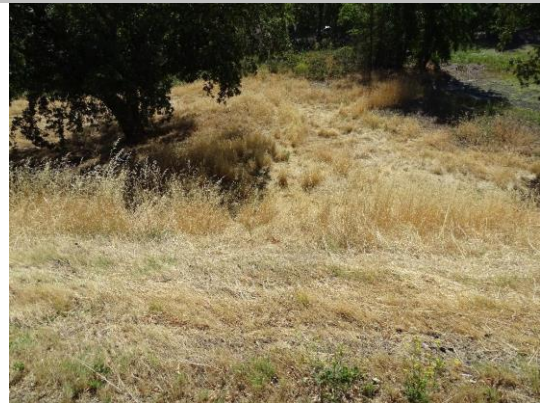
Photo 3 of 3 : UCIP\_FA\_2021\_69815\_88524.jpg

Land-Side: view of LS slope and pump platform off in distance.

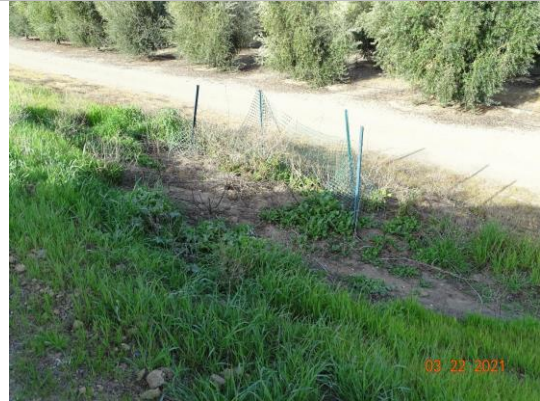
Photo 1 of 1 : FA\_2021\_RD0999\_232\_28\_20210823\_00010.jpg

View of the signs of rodent activity. Spring 2021.

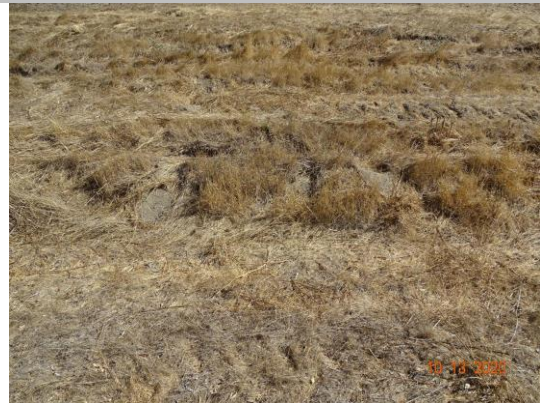
Photo 1 of 1 : FA\_2021\_RD0999\_232\_82\_20210823\_00040.jpg

LM Start	3.97	Rating **	A/W	Issue No.	82
LM End	3.97	Issue Type +	Ma	Location *	WS
Category	Earthen Levee			GPS Latitude/Longitude	
				Start	End
Item	Animal Control			38.449217 °	38.449217 °
				-121.592267 °	-121.592267 °
DWR ID	DWR_RD0999_01_f_2020_82				
Comment Code					
A3 : No rodents visible, but rodent burrows visible; need to backfill and compact or grout burrows.					
Inspector Comment

View of animal holes at the waterside toe. Fall 2020

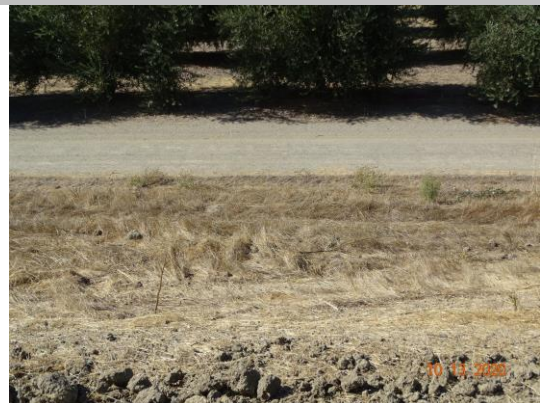
Photo 1 of 1 : FA\_2021\_RD0999\_232\_80\_20210823\_00039.jpg

LM Start	4.04	Rating **	A/W	Issue No.	80
LM End	4.04	Issue Type +	Ma	Location *	WS
Category	Earthen Levee			GPS Latitude/Longitude	
				Start	End
Item	Animal Control			38.448275 °	38.448275 °
				-121.592692 °	-121.592692 °
DWR ID	DWR_RD0999_01_f_2020_80				
Comment Code					
A3 : No rodents visible, but rodent burrows visible; need to backfill and compact or grout burrows.					
Inspector Comment

View of animal holes at the waterside toe. Fall 2020

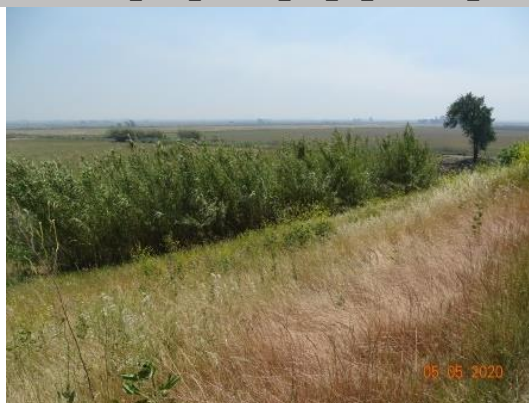
Photo 1 of 1 : FA\_2021\_RD0999\_232\_74\_20210823\_00037.jpg

View of Arundo growth at the landside toe. Spring 2020

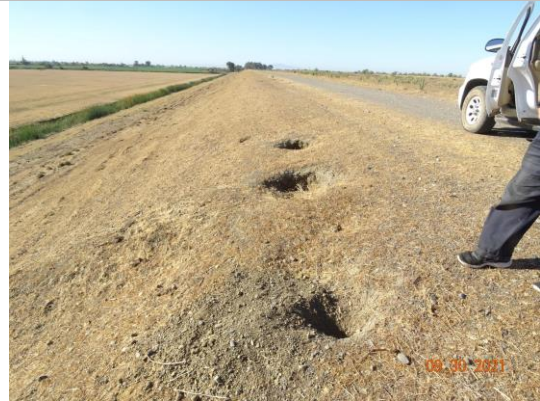
Photo 1 of 1 : FA\_2021\_RD0999\_232\_30\_20211004\_00088.jpg

Rodent burrows on LS slope. Fall 2021

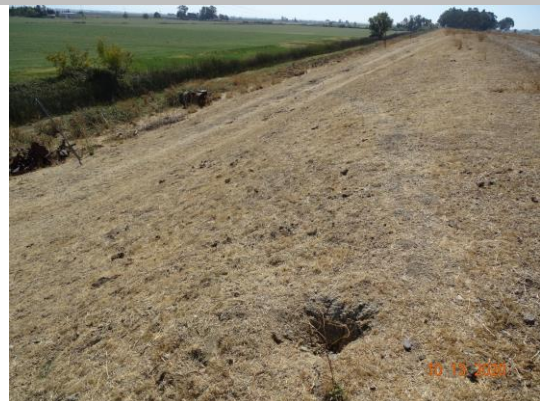
Photo 1 of 1 : FA\_2021\_RD0999\_232\_24\_20210823\_00007.jpg

View of large animal holes on the landside slope. Fall 2020

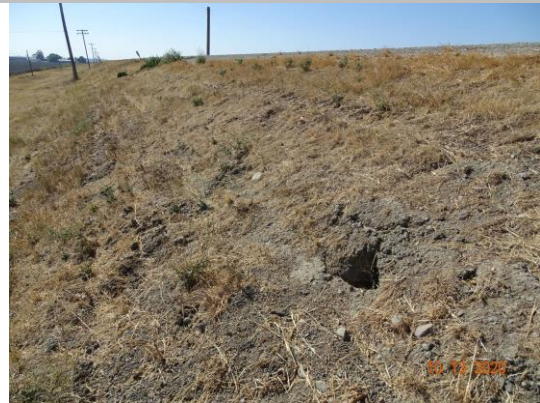
Photo 1 of 1 : FA\_2021\_RD0999\_232\_59\_20210823\_00033.jpg

View of a large animal hole on the landside slope. Fall 2020

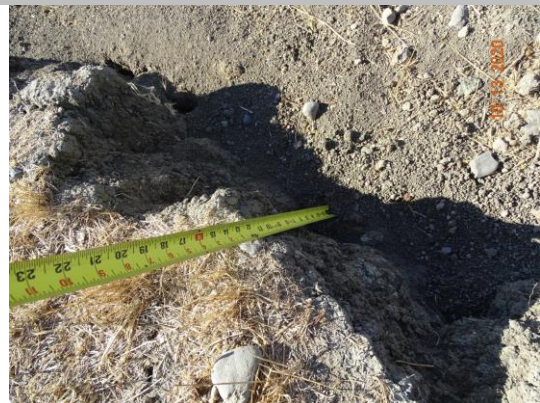
Photo 1 of 2 : FA\_2021\_RD0999\_232\_47\_20210823\_00025.jpg

LM Start	13.29	Rating **	M	Issue No.	47
LM End	13.30	Issue Type +	Ma	Location *	WS
Category	Earthen Levee			GPS Latitude/Longitude	
				Start	End
Item	Slope Stability			38.321180 °	38.321043 °
				-121.644962 °	-121.644960 °
DWR ID	DWR_RD0999_01_f_2020_47				
Comment Code					
S1 : Repair slope instability.					
Inspector Comment					
A separation of soil up to 12" deep and 40' long exists on the waterside slope.

View of soil separation on the waterside slope. Fall 2020

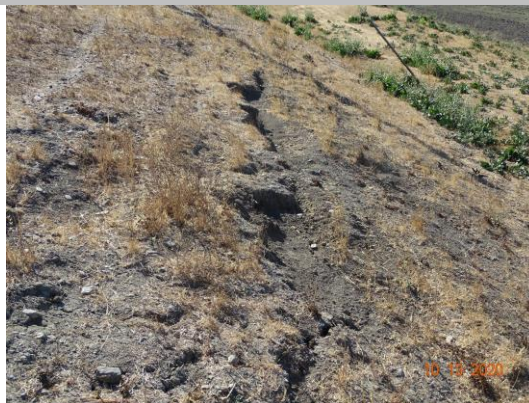
Photo 2 of 2 : FA\_2021\_RD0999\_232\_47\_20210823\_00026.jpg

View of soil separation on the waterside slope. Fall 2020

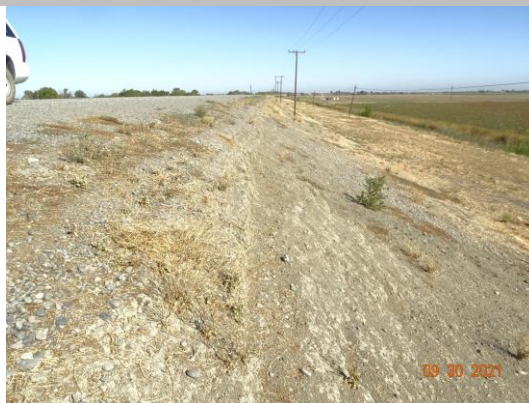
Photo 1 of 1 : FA\_2021\_RD0999\_232\_38\_20211004\_00090.jpg

LM Start	13.47	Rating **	M	Issue No.	38
LM End	13.47	Issue Type +	Ma	Location *	LS
Category	Earthen Levee			GPS Latitude/Longitude	
				Start	End
Item	Slope Stability			38.318667 °	38.318667 °
				-121.644948 °	-121.644948 °
DWR ID	DWR_RD0999_01 f _ 2021 38

LS slope sloughing. Fall 2021

S1 : Repair slope instability.

Repair slope sloughing, approximately 50' long 12" deep.

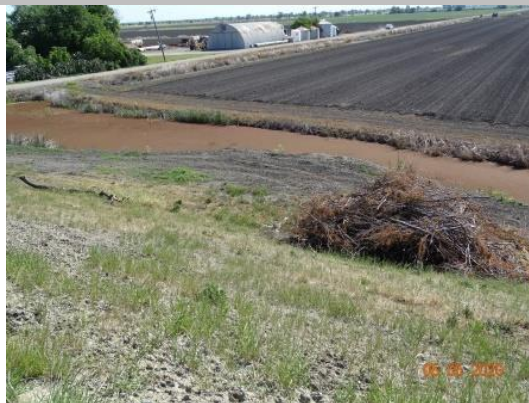
Photo 1 of 1 : FA\_2021\_RD0999\_232\_16\_20210823\_00003.jpg

View of prunings at the landside toe. Spring 2020

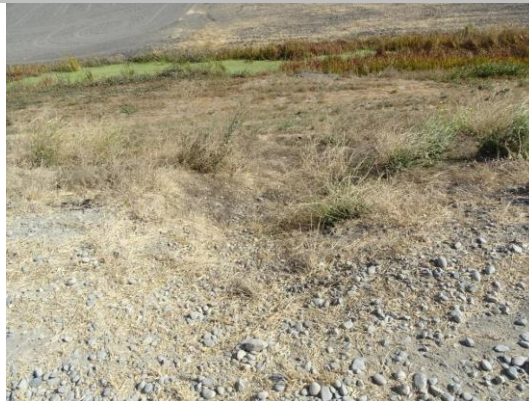
Photo 1 of 1 : FA\_2021\_RD0999\_232\_49\_20210823\_00027.jpg

LM Start	14.04	Rating **	M	Issue No.	49
LM End	14.04	Issue Type +	Ma	Location *	LS
Category	Earthen Levee			GPS Latitude/Longitude	
				Start	End
Item	Erosion / Bank Caving			38.310347 °	38.310347 °
				-121.644955 °	-121.644955 °
DWR ID	DWR_RD0999_01_f_2012_49				
Comment Code					
E1 : Note and monitor erosion site.					
Inspector Comment					
Repair caving, 4' x 10', on the landside slope.

View of caving on landward slope. Fall 2018

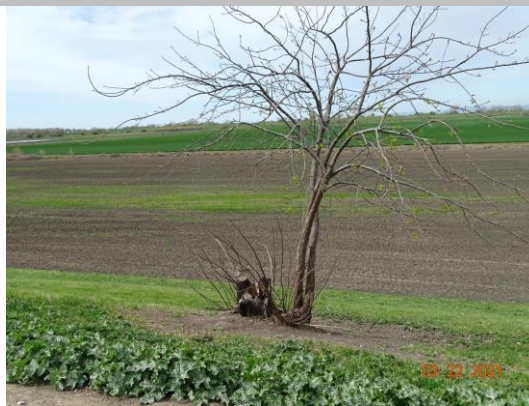
Photo 1 of 1 : FA\_2021\_RD0999\_232\_43\_20210823\_00021.jpg

View of the tree and stump at the WS levee toe. Spring 2021.

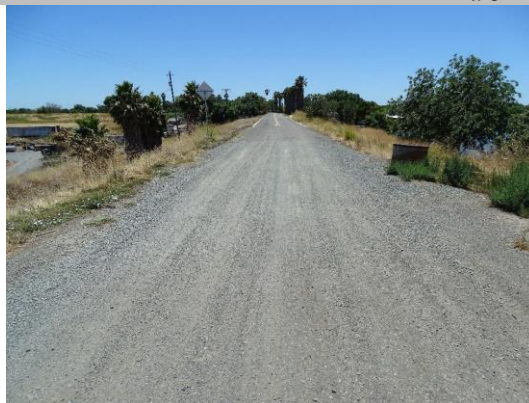
Photo 1 of 3 : UCIP\_FA\_2021\_69886\_88563.jpg

Comment Code					
Inspector Comment					
DS_ID:22756 FS_ID:69886 EP_NO: N/A Repair Type: Non-Urgent EVAL Issue: Unauthorized Encroachment, installed decades prior Crossing Status: Found UCIP Comments: 06/16/2020 Record updated from No Action Needed to Non-Urgent. No permit has been identified authorizing pipe. (D.Sanoski - DWR UCIP) FIELD_STRUCT_DESC: 30-inch steel drainage pipe through the levee, 7 feet below the crown. Flap gate on the waterside (WS) end. Pump in pump house on the landside (LS) toe. Siphon breaker in a corrugated metal pipe (CMP) riser on the WS shoulder. [Additional Reference(s): DWR Levee Log, 1992 (HLM 15.25). USACE Sacramento O&M Manual, Unit 113, October 1966, Revised 29 December 2016, (15.25), listed as 36-inch pipe]. FS Date: 6/16/2020 2:26:00 PM

Top of Levee: view of crown with riser to this pipe on WS shoulder.

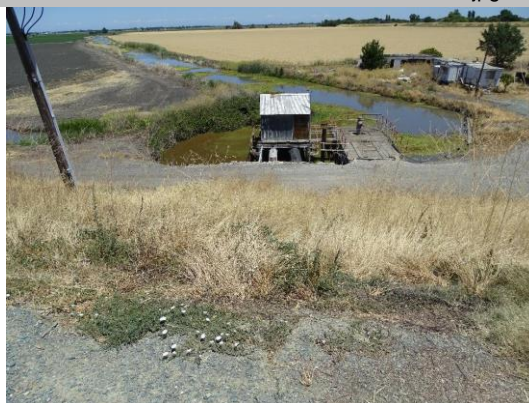
Photo 2 of 3 : UCIP\_FA\_2021\_69886\_88565.jpg

Land-Side: view of LS slope and pumphouse at toe.

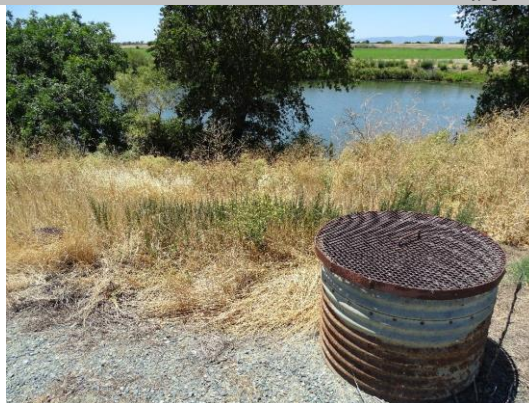
Photo 3 of 3 : UCIP\_FA\_2021\_69886\_88564.jpg

Water-Side: view of WS slope and pipe riser.

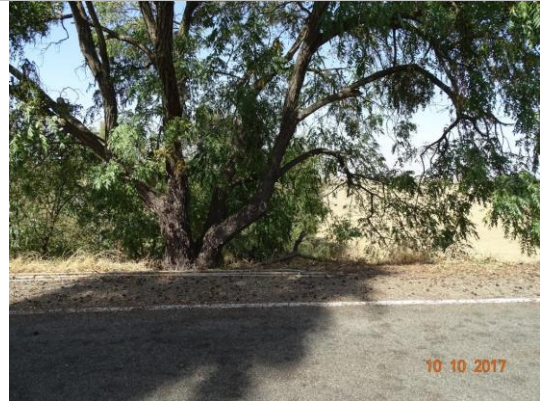
Photo 1 of 1 : FA\_2021\_RD0999\_233\_21\_20210823\_00007.jpg

View of trees on landside slope looking north. Fall 2017

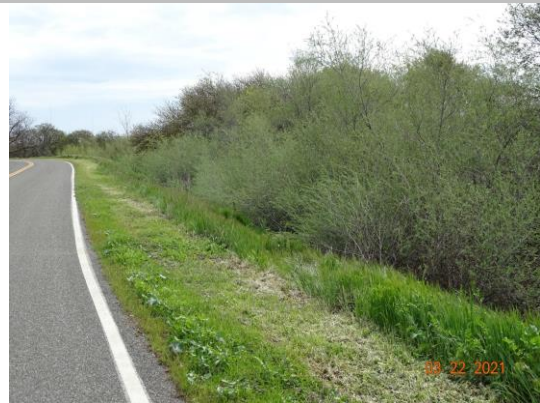
Photo 1 of 1 : FA\_2021\_RD0999\_233\_35\_20210823\_00011.jpg

View of the trees on the WS levee slope. Spring 2021.

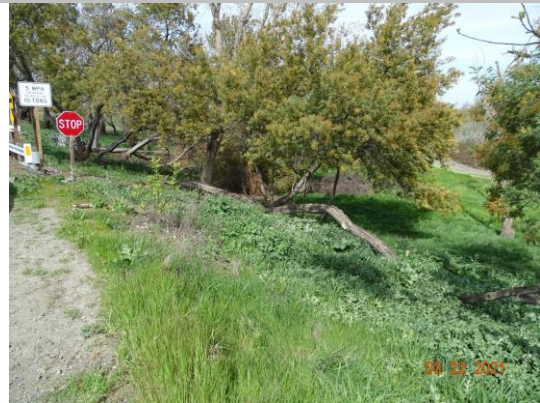
Photo 1 of 1 : FA\_2021\_RD0999\_233\_18\_20210823\_00006.jpg

View of the fallen trees on the LS levee slope. Spring 2021.

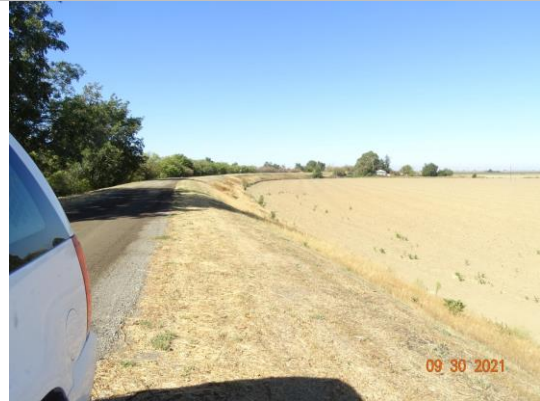
Photo 1 of 1 : FA\_2021\_RD0999\_233\_12\_20211004\_00032.jpg

LS slope annual growth on lower portion. Fall 2021

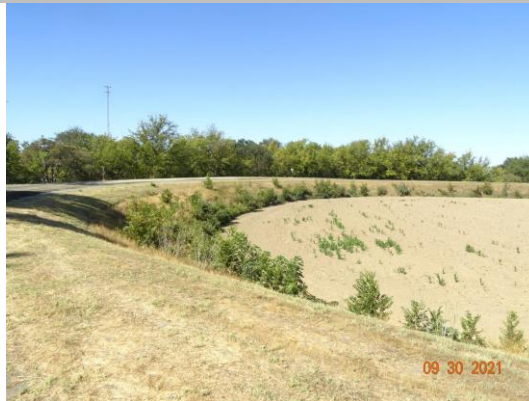
Photo 1 of 1 : FA\_2021\_RD0999\_233\_15\_20211004\_00033.jpg

Sapling growth on the LS slope/toe. Fall 2021

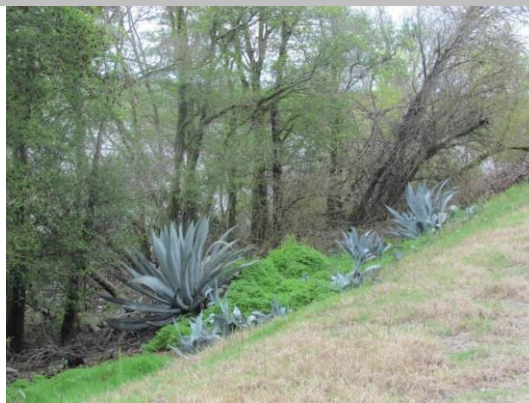
Photo 1 of 1 : FA\_2021\_RD0999\_234\_17\_20210823\_00008.jpg

Looking east at century plants on waterward slope.

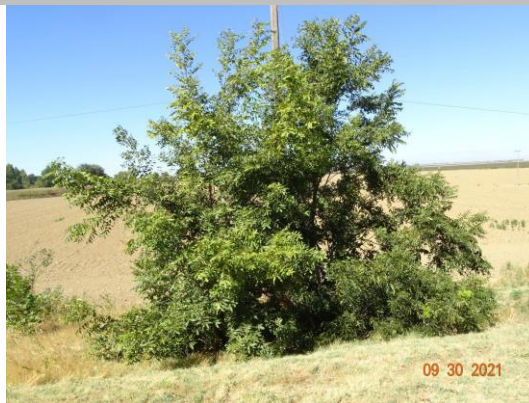
Photo 1 of 1 : FA\_2021\_RD0999\_234\_11\_20211004\_00034.jpg

Tree near pole/guy wire on the LS. Fall 2021

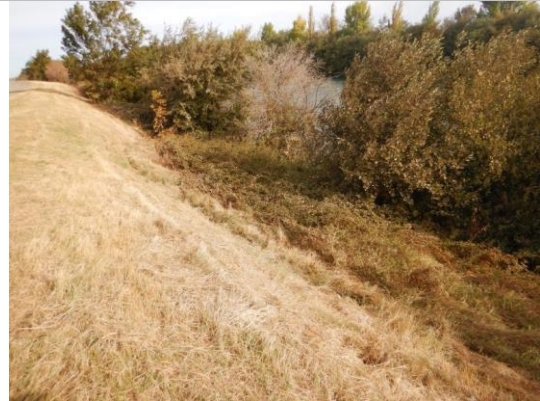
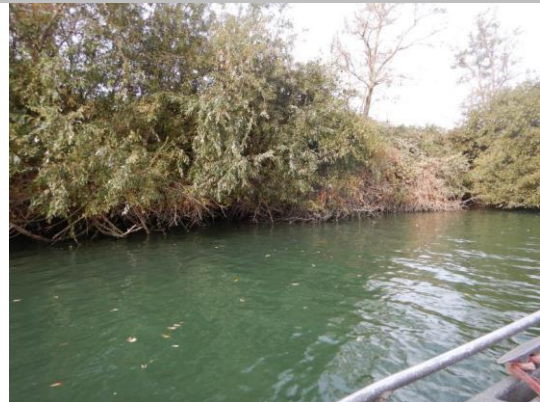
2018 Field Notes: Length reduced on downstream side to account for repaired section.

Site History: 1997 - Intermittent over-steepened sections. Large riparian vegetation along the length of the entire reach. Attempts to repair with rock on bank have failed. 1999 - New rock repair at the downstream end. 2002 - Some minor spot repairs. 2009 - Minimal new erosion. 2010 - Appears that fresh rock placed on downstream portion of site. Toe scour and overhanging trees with some overturned. 2012 - Minor new erosion at the toe. 2013 - Site upgraded to CRITICAL. Severe slumping into levee at downstream end of site. Fresh erosion into bank toe. 2015 - New slumping, tall vertical sections. 2016 - Upper slumped section continues to worsen. 2017 - Locals have placed rock in worst sections. Fresh erosion at toe. New tall vertical sections observed.

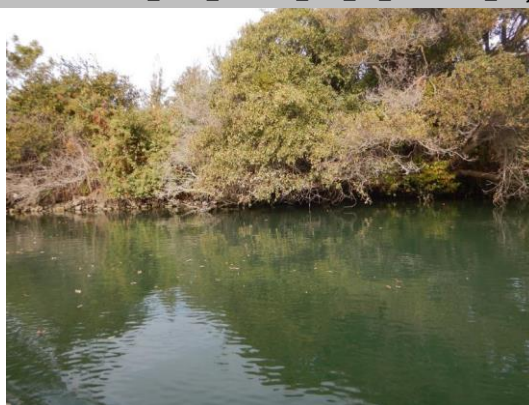
Photo 1 of 2 : FA\_2021\_RD0999\_234\_12\_20211218\_20.jpg

2018 Site ID: STR 26.1 R  
Status: Eroding  
2018 Field Notes: No observed change.  
Site History: 2015 - Tall vertical sections into the levee slope and erosion along the toe. 2016 - New tree pop-out observed.

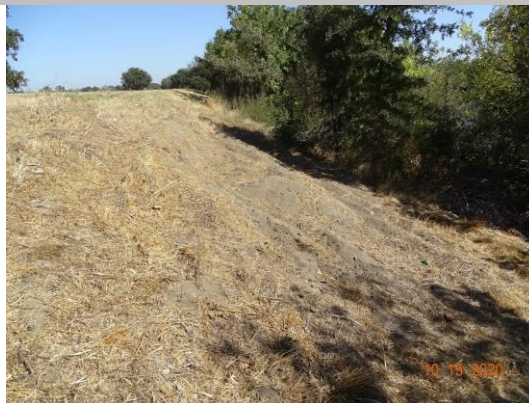
Photo 1 of 1 : FA\_2021\_RD0999\_234\_13\_20210823\_00006.jpg

LM Start	1.99	Rating **	M	Issue No.	13
LM End	1.99	Issue Type +	Ma	Location *	WS
Category	Earthen Levee			GPS Latitude/Longitude	
				Start	End
Item	Slope Stability			38.311618 °	38.311618 °
				-121.596887 °	-121.596887 °
DWR ID	DWR_RD0999_03_f_2020_13				
Comment Code					
S3 : Repair the levee slope damaged by vehicle traffic and prevent access where possible.					
Inspector Comment					
Repair slope depression due to vehicle traffic.

View of slope damage on the waterside slope due to vehicle traffic. Fall 2020

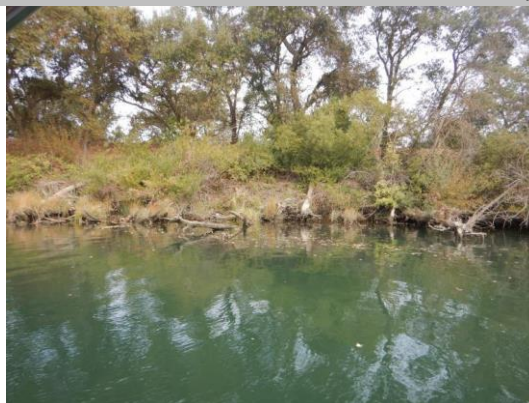
Photo 1 of 1 : FA\_2021\_RD0999\_234\_14\_20211218\_22.jpg

LM Start	2.97	Rating **	A/W	Issue No.	14	
LM End	3.22	Issue Type +	Ma	Location *	WS	
Category	Supplemental			GPS Latitude/Longitude		
				Start		End
Item	2018 USACE Erosion Survey			38.323419 °		38.325592 °
				-121.589645 °		-121.585925 °
DWR ID						
Comment Code						
Inspector Comment						
2018 Site ID: STR 27.3 R						
Status: Eroding						
2018 Field Notes: No observed change.						
Site History: 2011 - Multiple erosion pockets. Some likely from tree popouts. 2013 - Tall vertical sections. 2015 - New tree pop-out and significant new erosion. 2016 - New erosion at toe. 2017 - Site extended downstream, section of lower bank has slumped off. Fresh toe erosion and fresh tree popout.

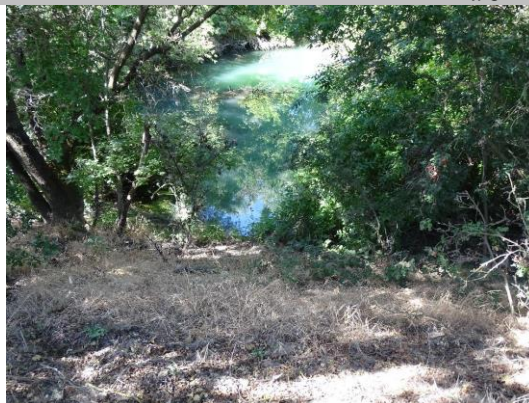
Photo 3 of 3 : UCIP\_FA\_2021\_69326\_88714.jpg

Land-Side: view of LS slope and channel at toe.

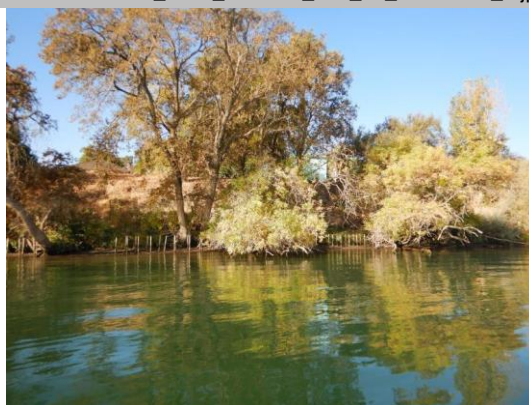
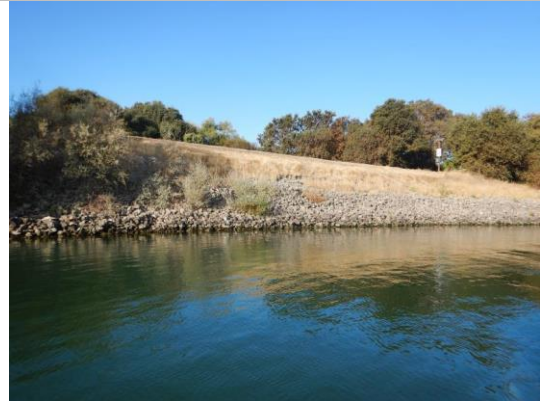
2018 Site ID: SAC 41.9 R  
 Status: Critical  
 2018 Field Notes: Site continues to look worse.  
 Site History: 1997 - Structural problem rather than erosional, failed cobble at downstream end. 2005 - New brush boxes at waterline for several hundred feet downstream, No toe or bank protection present. 2006 - Some minor new erosion. Brush boxes not working well; most of the brush has floated out. 2007 - Brush boxes have recently been repaired. 2016 - Minor new slumping. 2017 - Fresh erosion on entire bank. Upgraded to CRITICAL.

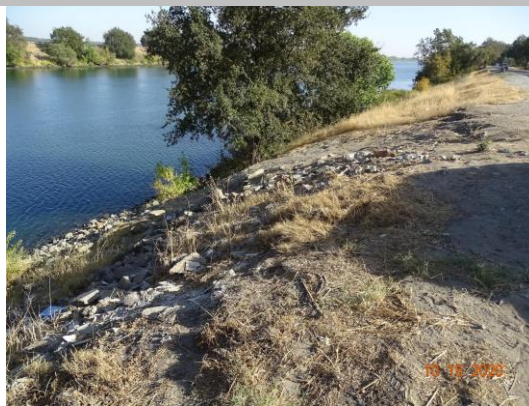
Photo 1 of 1 : FA\_2021\_RD0999\_235\_47\_20210823\_00010.jpg

View of erosion on the waterside slope with broken concrete riprap. Fall 2020

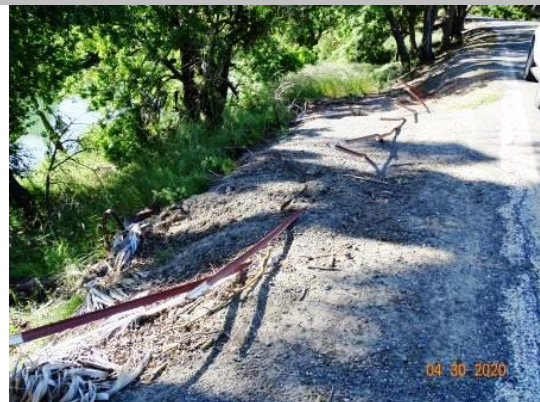
Photo 1 of 1 : FA\_2021\_RD0999\_236\_165\_20210823\_00055.jpg

View of minor cracks near a ramp. Spring 2020

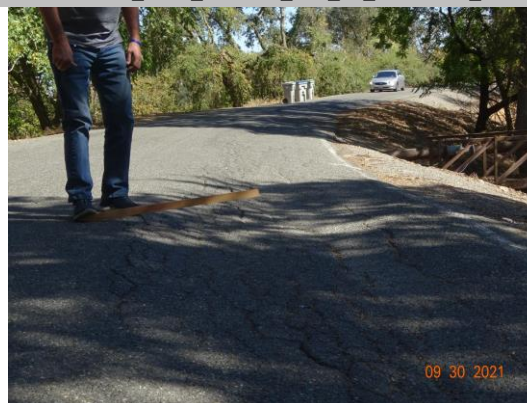
Photo 1 of 2 : FA\_2021\_RD0999\_236\_55\_20211004\_00206.jpg

Depth of sloughing on WS crown. Fall 2021

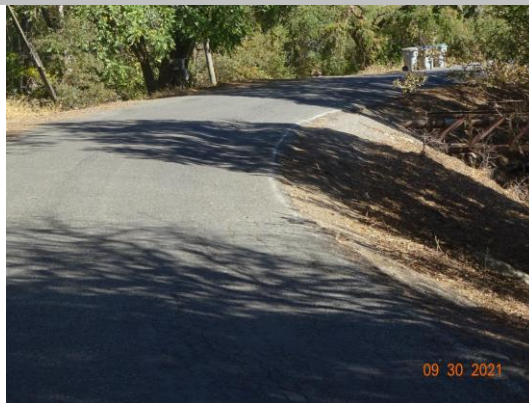
Photo 2 of 2 : FA\_2021\_RD0999\_236\_55\_20211004\_00207.jpg

Length of sloughing on WS crown. Fall 2021

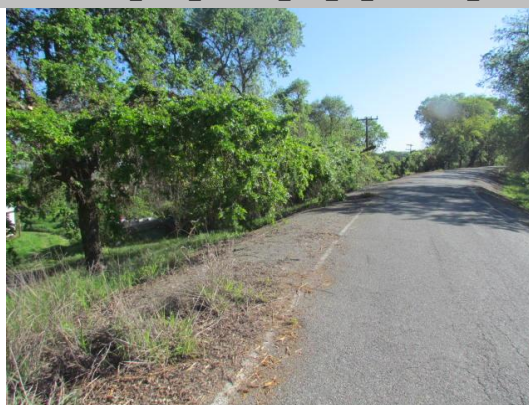
Photo 1 of 1 : FA\_2021\_RD0999\_236\_15\_20210823\_00006.jpg

Looking north at untrimmed trees on landward slope and toe.

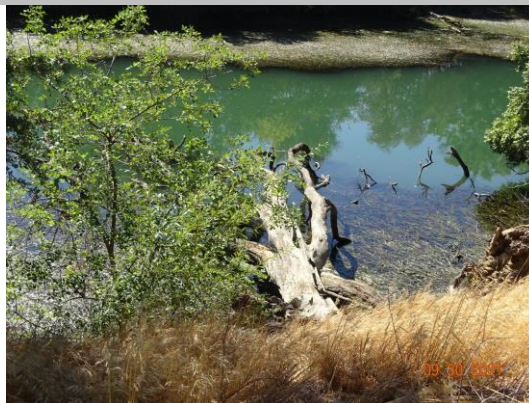
Photo 1 of 1 : FA\_2021\_RD0999\_236\_273\_20211004\_00208.jpg

Fallen tree in channel. Fall 2021

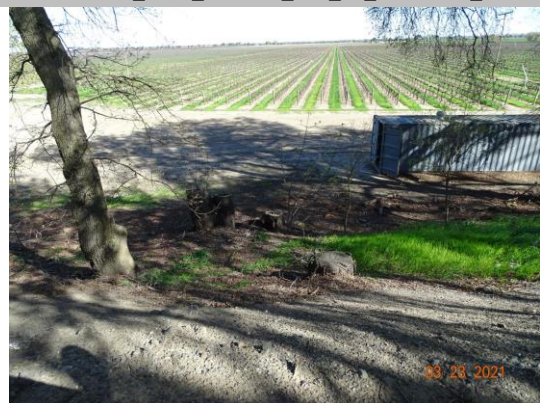
Photo 1 of 1 : FA\_2021\_RD0999\_236\_79\_20210823\_00020.jpg

View of the tree stumps on the LS levee slope. Spring 2021.

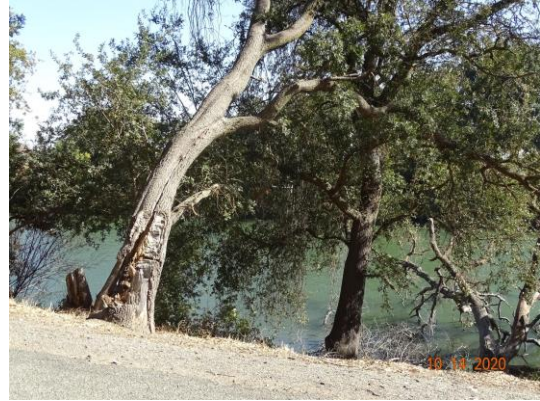
Photo 1 of 1 : FA\_2021\_RD0999\_236\_218\_20210823\_00078.jpg

View of a tree on the waterside slope that split at the trunk. Fall 2020

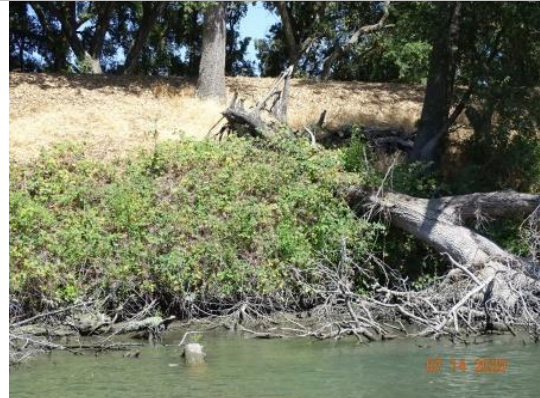
Photo 1 of 1 : FA\_2021\_RD0999\_236\_264\_20210823\_00090.jpg

View of fallen tree with exposed rootball. Summer 2020

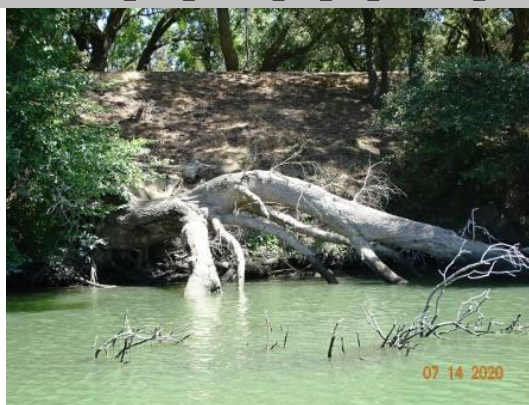
Photo 1 of 1 : FA\_2021\_RD0999\_236\_260\_20210823\_00088.jpg

View of slope erosion around fallen tree from the waterside. Summer 2020

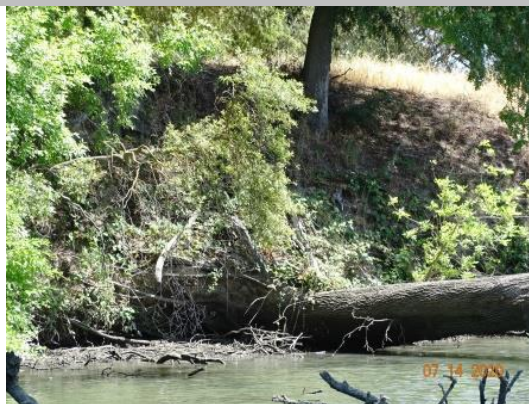
Photo 1 of 1 : FA\_2021\_RD0999\_236\_83\_20210823\_00023.jpg

View of a fallen tree with exposed rootball. Summer 2020

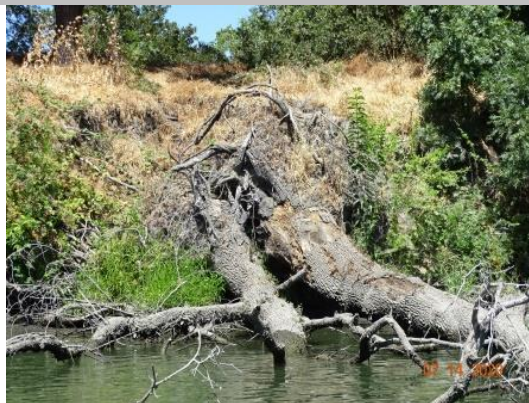
Photo 1 of 1 : FA\_2021\_RD0999\_236\_1\_20210823\_00001.jpg

View of large, fallen tree on the waterside slope. Summer 2020

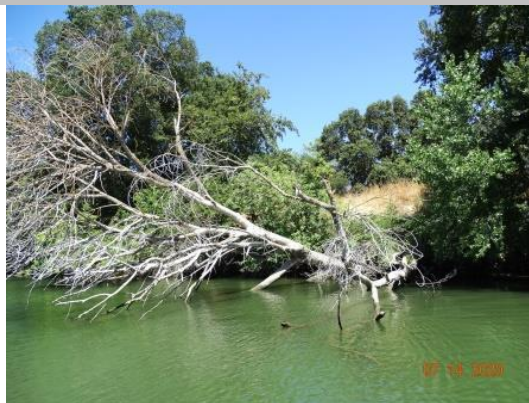
Photo 1 of 1 : FA\_2021\_RD0999\_236\_85\_20210823\_00024.jpg

View of fallen tree and slope damage. Summer 2020

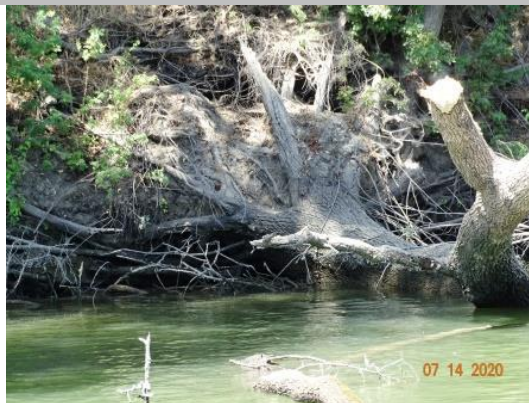
Photo 1 of 1 : FA\_2021\_RD0999\_236\_91\_20210823\_00026.jpg

View of fallen tree with exposed rootball. Summer 2020

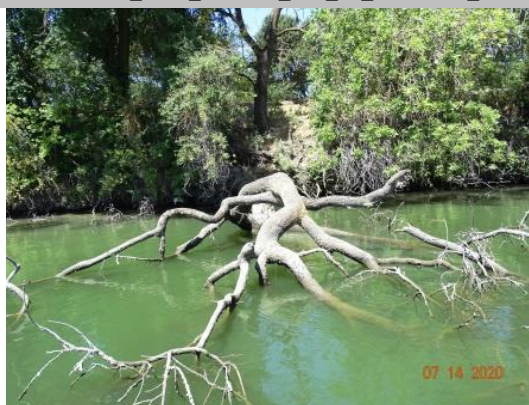
Photo 1 of 2 : FA\_2021\_RD0999\_236\_82\_20210823\_00021.jpg

View of large, fallen tree with exposed rootball. Summer 2020

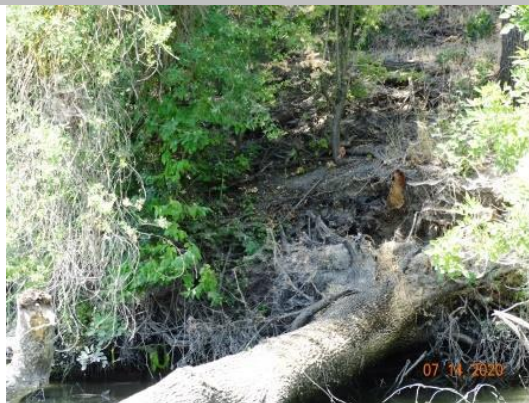
Photo 2 of 2 : FA\_2021\_RD0999\_236\_82\_20210823\_00022.jpg

View of scarp around fallen tree. Summer 2020

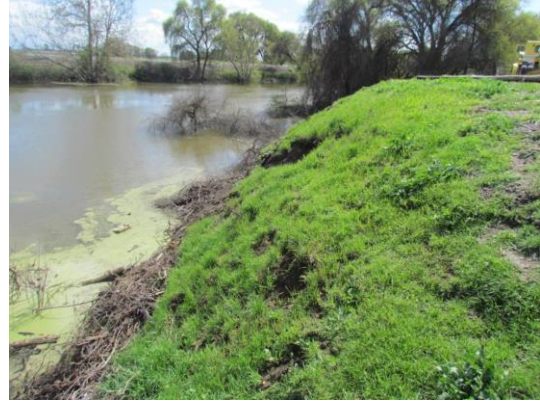
Photo 1 of 1 : FA\_2021\_RD0999\_236\_12\_20210823\_00004.jpg

Looking downstream at finger erosion on downstream side of slough.

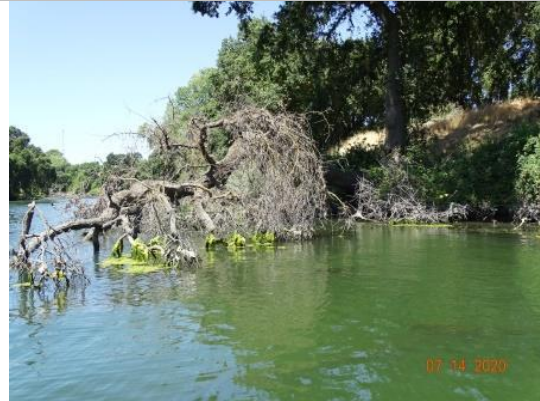
Photo 1 of 1 : FA\_2021\_RD0999\_236\_102\_20210823\_00032.jpg

View of fallen tree split at the base. Summer 2020

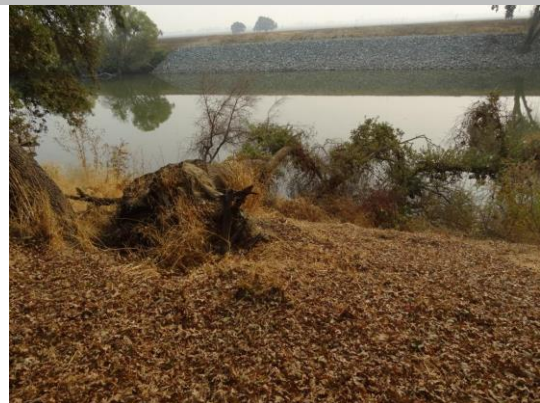
Photo 1 of 1 : FA\_2021\_RD0999\_236\_28\_20210823\_00009.jpg

View of dead tree on slope. Fall 2018

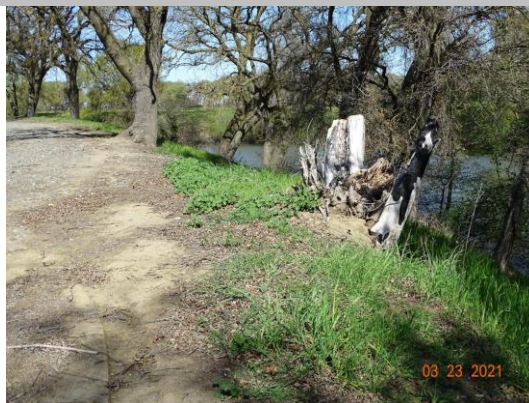
Photo 1 of 1 : FA\_2021\_RD0999\_236\_117\_20210823\_00037.jpg

View of the tree stump on the WS levee slope. Spring 2021.

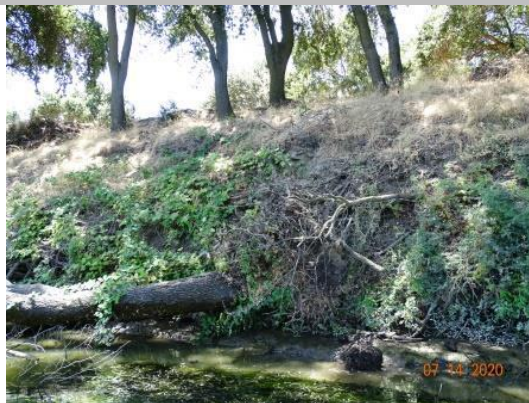
Photo 1 of 1 : FA\_2021\_RD0999\_236\_97\_20210823\_00029.jpg

View of fallen trees and scarp. Summer 2020

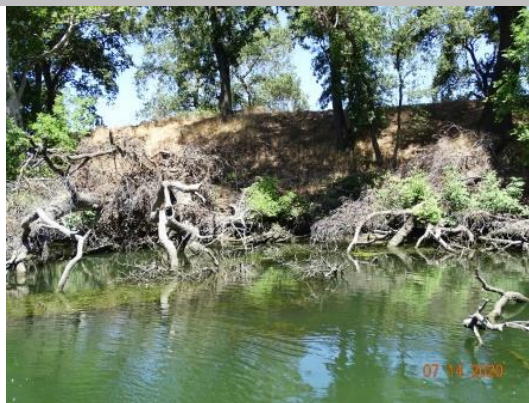
Photo 1 of 2 : FA\_2021\_RD0999\_236\_229\_20210823\_00084.jpg

View of two fallen trees. Summer 2020

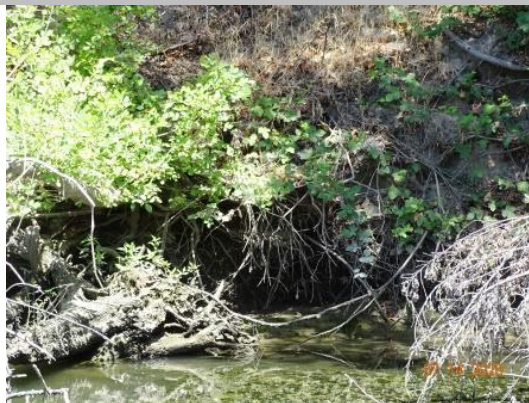
Photo 2 of 2 : FA\_2021\_RD0999\_236\_229\_20210823\_00085.jpg

View of large scarp near two fallen trees. Summer 2020

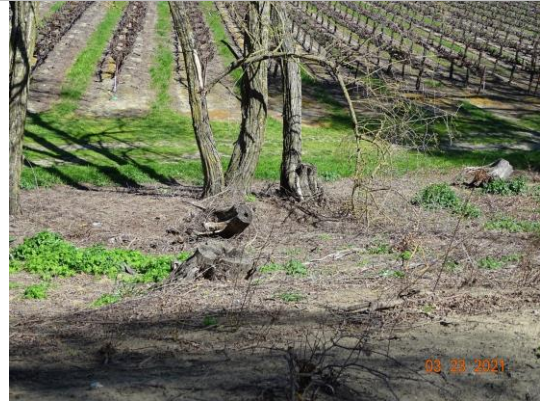
Photo 1 of 1 : FA\_2021\_RD0999\_236\_129\_20210823\_00041.jpg

View of the tree stumps on the LS levee slope and toe. Spring 2021.

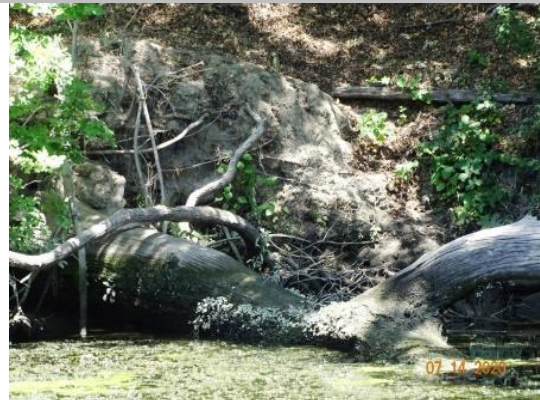
Photo 1 of 1 : FA\_2021\_RD0999\_236\_99\_20210823\_00030.jpg

View of slope damage near fallen tree. Summer 2020

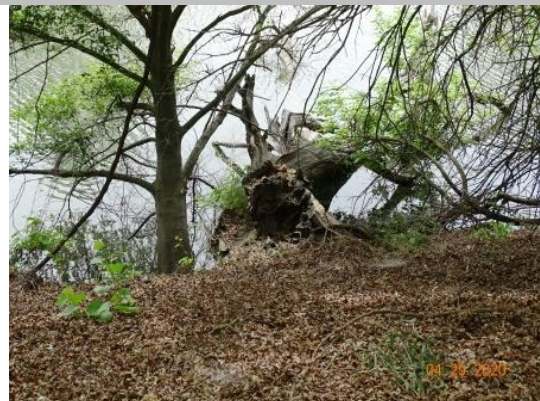
Photo 1 of 1 : FA\_2021\_RD0999\_236\_227\_20210823\_00083.jpg

View of a fallen tree on the waterside slope. Spring 2020

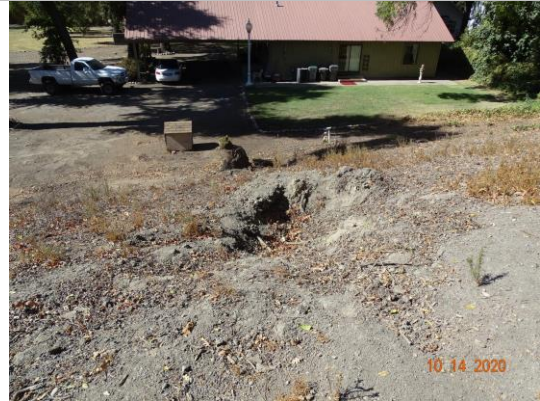
Photo 1 of 1 : FA\_2021\_RD0999\_236\_214\_20210823\_00075.jpg

View of a large hole on the landside slope. Fall 2020

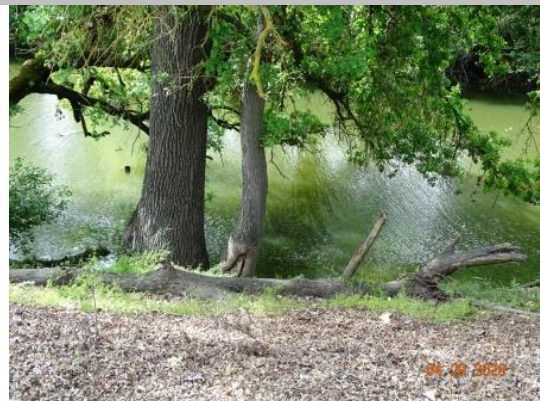
Photo 1 of 1 : FA\_2021\_RD0999\_236\_186\_20210823\_00066.jpg

View of a tree log on the waterside slope. Spring 2020

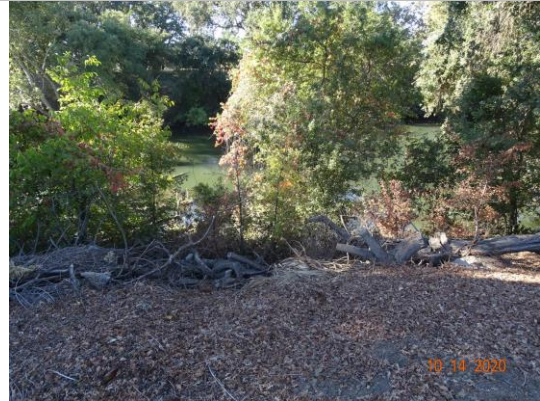
Photo 1 of 1 : FA\_2021\_RD0999\_236\_177\_20210823\_00063.jpg

View of tree logs and limbs on the waterside slope. Fall 2020

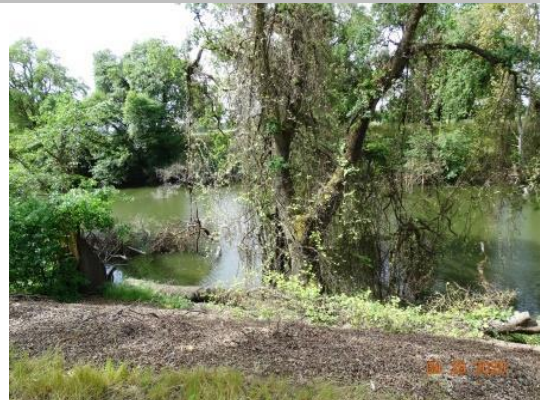
Photo 1 of 1 : FA\_2021\_RD0999\_236\_181\_20210823\_00065.jpg

View of fallen tree on the waterside slope. Spring 2020

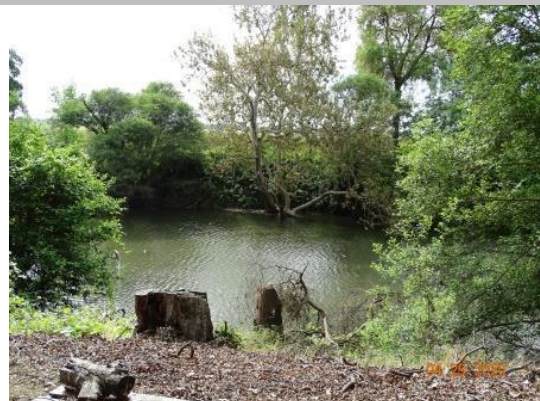
Photo 1 of 1 : FA\_2021\_RD0999\_236\_164\_20210823\_00054.jpg

View of a large tree stump on the waterside slope. Spring 2020
