**Flood Control Project Maintenance  
Levee Inspections**

**Maintenance Issue Types Only, Levee Inspection Report By Mile - Fall 2022**

**Reclamation District No. 0999 Netherlands**

Waterway	Bank	Unit Miles	Inspection Start/End	Inspector
Unit No. 01 Yolo Bypass	Left	15.41	10/10/2022 10/10/2022	Marvin Marshall

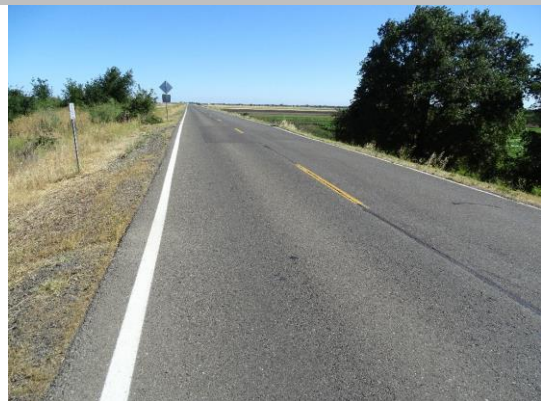
Photo 1 of 3 : UCIP\_FA\_2022\_73776\_88522.jpg

Comment Code						
Inspector Comment						
DS_ID:22743 FS_ID:73776 EP_NO: N/A Repair Type: Urgent EVAL Issue: 1, Pipe Integrity Crossing Status: Found UCIP Comments: 06/16/2020 Record remains Non-Urgent. Crossing appears abandoned. Recommend owner to contact CVFPB to abandon or remove pipe from levee. System Feature. (D.Sanoski - DWR UCIP) 07/26/2018 Same as last inspection. Pipe open on WS, but no visual signs of pipe or levee integrity issues so downgrading crossing to Non-Urgent (D. Sanoski - DWR UCIP).07/07/2016 Condition largely unchanged from previous inspection. Pipe open on the WS, waterward of the siphon breaker. Dense vegetation and steep slope limited inspection of WS outlet into Ship Channel. (T. Hatch/UCIP)06/25/2013 Pipe abandoned and open on WS slope. Pipe should be abandoned properly. (W. Wylie/UCIP) FIELD_STRUCT_DESC: 30-inch steel drainage pipe through the levee, 6.5 feet below the crown. Pump on a platform in the canal off the landside (LS) toe. Flap gate on the waterside (WS). Siphon breaker and an air vent on the WS shoulder. 1-inch galvanized iron filler pipe visible on the WS shoulder along same alignment. [Additional Reference(s): DWR Levee Log, 1992 (HLM 1.73). USACE Sacramento O&M Manual, Unit 113, October 1966, Revised 29 December 2016, (1.73), listed as 30-inch pipe]. FS Date: 6/16/2020 2:16:00 PM

Top of Levee: view of crown.

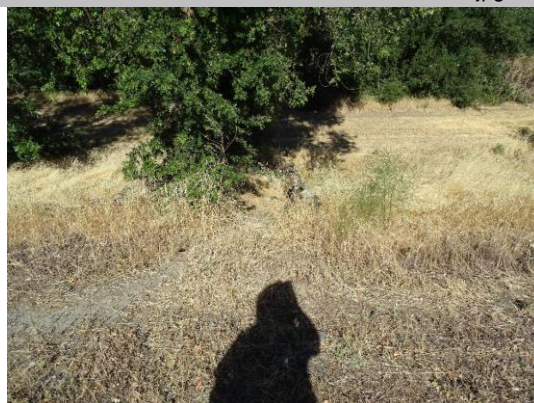
Photo 2 of 3 : UCIP\_FA\_2022\_73776\_88523.jpg

Water-Side: view of WS slope and broken crossing at toe.

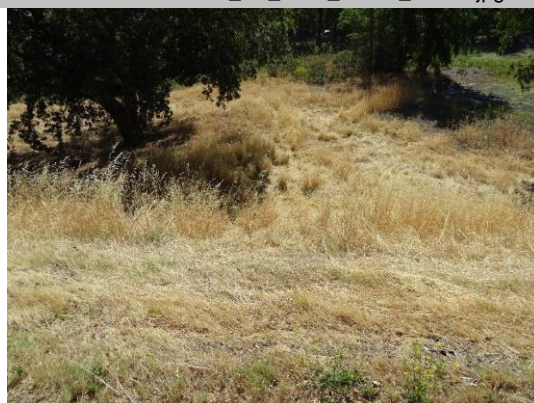
Photo 3 of 3 : UCIP\_FA\_2022\_73776\_88524.jpg

Land-Side: view of LS slope and pump platform off in distance.

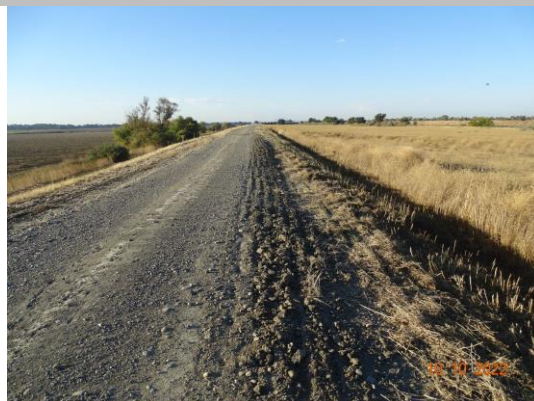
Photo 1 of 1 : FA\_2022\_RD0999\_232\_25\_20221025\_00080.jpg

LM Start	2.83	Rating **	A/W	Issue No.	25
LM End	2.92	Issue Type +	Ma	Location *	CR
Category	Earthen Levee			GPS Latitude/Longitude	
				Start	End
Item	Cracking			38.464788 °	38.463504 °
				-121.585021 °	-121.585613 °
DWR ID	DWR_RD0999_01_s_2022_25				
Comment Code					
CR1 : Monitor and have inspected by geotechnical engineer.					
Inspector Comment					
LMA has disced and filled cracking areas.

Disced and compacted desiccation areas. Fall 2022

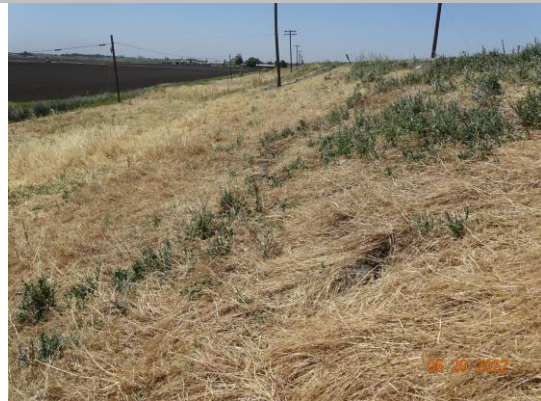
Photo 1 of 1 : FA\_2022\_RD0999\_232\_69\_20220822\_00040.jpg

LM Start	13.27	Rating **	U	Issue No.	69
LM End	13.27	Issue Type +	Ma	Location *	LS
Category	Earthen Levee			GPS Latitude/Longitude	
				Start	End
Item	Slope Stability			38.321562 °	38.321562 °
				-121.644943 °	-121.644943 °
DWR ID	DWR_RD0999_01_s_2022_69				
Comment Code					
S1 : Repair slope instability.					
Inspector Comment					
Large crack midway up landside slope with sloughing.

Desiccation cracking and sloughing on the landside slope. Spring 2022

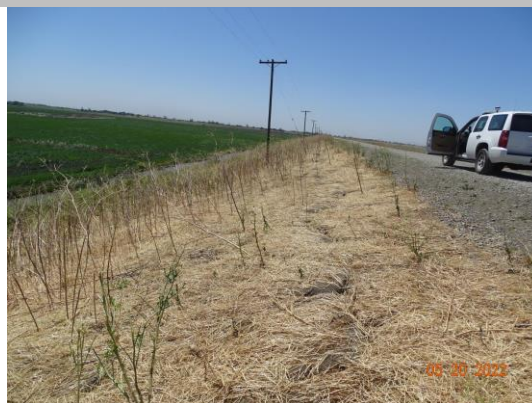
Photo 1 of 1 : FA\_2022\_RD0999\_232\_70\_20220822\_00041.jpg

LM Start	13.88	Rating **	U	Issue No.	70
LM End	14.40	Issue Type +	Ma	Location *	LS
Category	Earthen Levee			GPS Latitude/Longitude	
				Start	End
Item	Cracking			38.312696 °	38.305155 °
				-121.644935 °	-121.644931 °
DWR ID	DWR_RD0999_01_s_2022_70				
Comment Code					
CR1 : Monitor and have inspected by geotechnical engineer.					
Inspector Comment					
Large longitudinal and transverse cracks on both slopes. The landside cracking is worse.

Desiccation cracking on the shoulder. Spring 2022

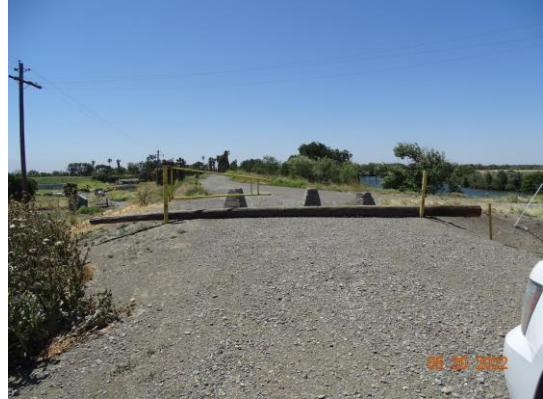
Photo 1 of 1 : FA\_2022\_RD0999\_232\_71\_20220822\_00042.jpg

Telephone pole and concrete blocks prevent access. Gate in disrepair.  
Spring 2022

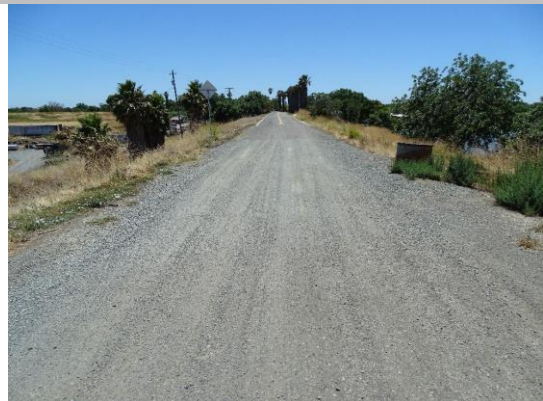
Photo 1 of 3 : UCIP\_FA\_2022\_73775\_88563.jpg

Comment Code					
Inspector Comment					
DS_ID:22756 FS_ID:73775 EP_NO: N/A Repair Type: No Action Needed EVAL Issue: Crossing Status: Found UCIP Comments: 06/16/2020 Record remains No Action Needed. No issues observed during inspection. System Feature. (D.Sanoski - DWR UCIP) FIELD_STRUCT_DESC: 30-inch steel drainage pipe through the levee, 7 feet below the crown. Flap gate on the waterside (WS) end. Pump in pump house on the landside (LS) toe. Siphon breaker in a corrugated metal pipe (CMP) riser on the WS shoulder. [Additional Reference(s): DWR Levee Log, 1992 (HLM 15.25). USACE Sacramento O&M Manual, Unit 113, October 1966, Revised 29 December 2016, (15.25), listed as 36-inch pipe]. FS Date: 6/16/2020 2:26:00 PM

Top of Levee: view of crown with riser to this pipe on WS shoulder.

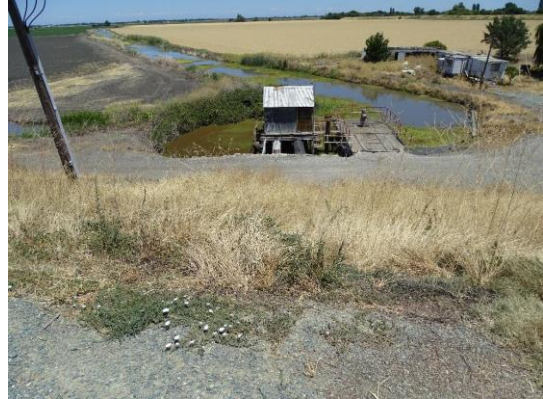
Photo 2 of 3 : UCIP\_FA\_2022\_73775\_88565.jpg

Land-Side: view of LS slope and pumphouse at toe.

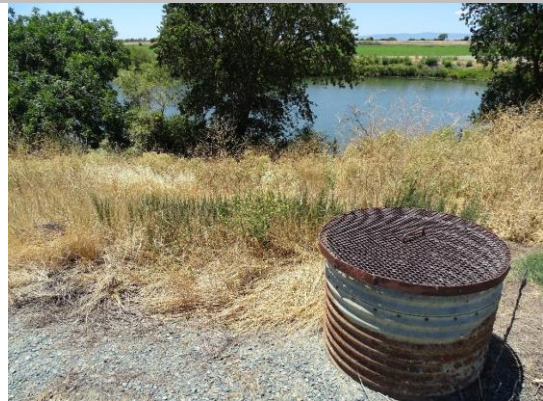
Photo 3 of 3 : UCIP\_FA\_2022\_73775\_88564.jpg

Water-Side: view of WS slope and pipe riser.

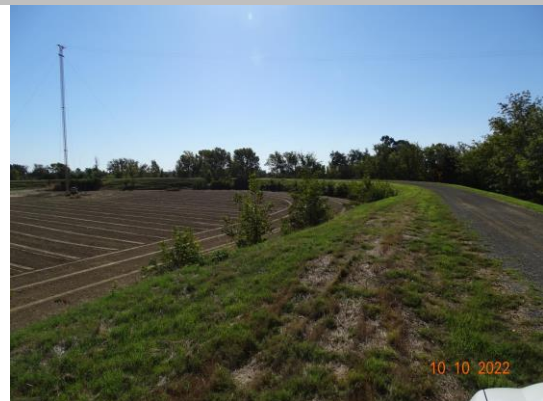
Photo 1 of 1 : FA\_2022\_RD0999\_233\_15\_20221010\_00030.jpg

Saplings and small trees are on the LS slope and toe. Fall 2022

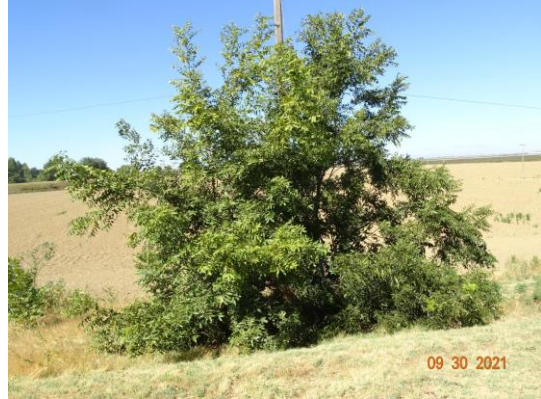
Photo 1 of 1 : FA\_2022\_RD0999\_234\_11\_20220822\_00008.jpg

Tree near pole/guy wire on the LS. Fall 2021

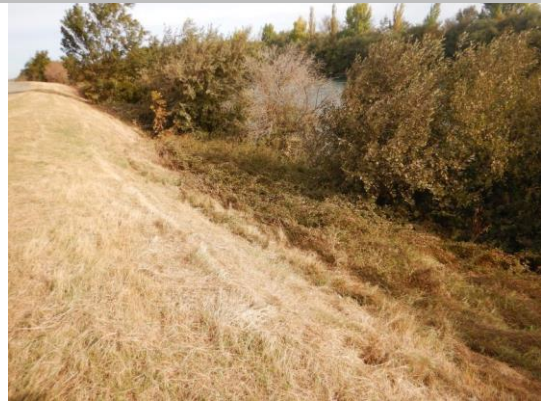
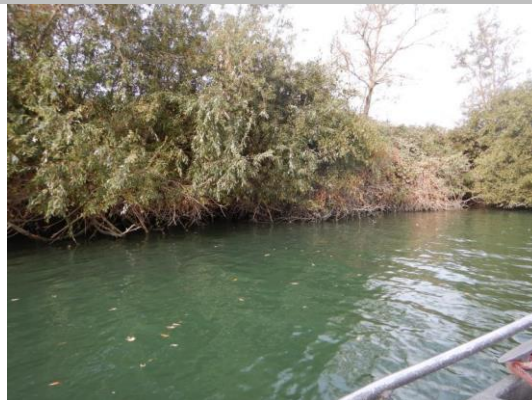
LM Start	0.24	Rating **	U	Issue No.	5
LM End	0.65	Issue Type +	Ma	Location *	WS
Category	Supplemental			GPS Latitude/Longitude	
				Start	End
Item	2018 USACE Erosion Survey			38.289634 °	38.295505 °
				-121.604343 °	-121.605648 °
DWR ID	DWR_RD0999_03_s_2022_5

Comment Code					
Inspector Comment					
2018 Site ID: STR 24.7 R					
Status: Critical					
2022 Field Notes: No observed changes.					
Site History: 1997 - Intermittent over-steepened sections. Large riparian vegetation along the length of the entire reach. Attempts to repair with rock on bank have failed. 1999 - New rock repair at the downstream end. 2002 - Some minor spot repairs. 2009 - Minimal new erosion. 2010 - Appears that fresh rock placed on downstream portion of site. Toe scour and overhanging trees with some overturned. 2012 - Minor new erosion at the toe. 2013 - Site upgraded to CRITICAL. Severe slumping into levee at downstream end of site. Fresh erosion into bank toe. 2015 - New slumping, tall vertical sections. 2016 - Upper slumped section continues to worsen. 2017 - Locals have placed rock in worst sections. Fresh erosion at toe. New tall vertical sections observed. 2018 -Length reduced on downstream side to account for repaired section.

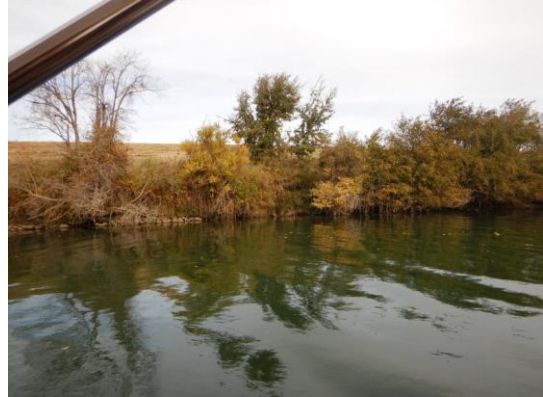
LM Start	0.97	Rating **	M	Issue No.	6
LM End	1.10	Issue Type +	Ma	Location *	WS
Category	Supplemental			GPS Latitude/Longitude	
				Start	End
Item	2018 USACE Erosion Survey			38.299402 °	38.300542 °
				-121.603056 °	-121.601118 °
DWR ID	DWR_RD0999_03_s_2022_6				
Comment Code					
Inspector Comment					
2018 Site ID: STR 25.2 R					
Status: Eroding					
2022 Field Notes: No observed changes.					
Site History: 2008 - Over steepened levee section. 2009 - Significant new erosion. 2010 - Minor new erosion. 2017 - Minor new erosion at toe. 2018 - New large slump on upper levee slope.

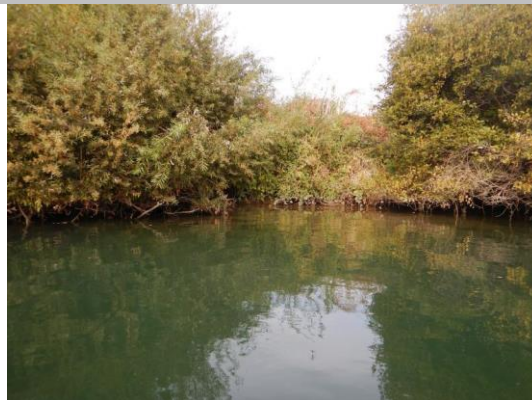
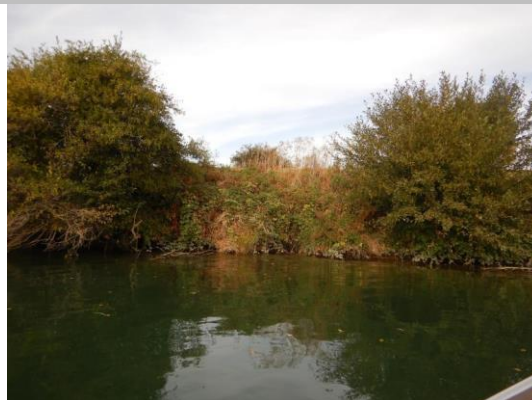
LM Start	1.43	Rating **	A/W	Issue No.	10
LM End	1.57	Issue Type +	Ma	Location *	WS
Category	Supplemental			GPS Latitude/Longitude	
				Start	End
Item	2018 USACE Erosion Survey			38.305229 °	38.306667 °
				-121.599933 °	-121.598266 °
DWR ID	DWR_RD0999_03_s_2022_10				
Comment Code					
Inspector Comment					
2018 Site ID: STR 25.7 R					
Status: Eroding					
2022 Field Notes: No observed changes.					
Site History: 2011 - Toe scour along length of site and erosion pockets.					
2012 - Site extended slightly upstream due to new erosion pocket.					
2013 - Tall vertical sections at upstream end of site. 2017 - Large erosion scarp near downstream end. 2018 - Site extended upstream.

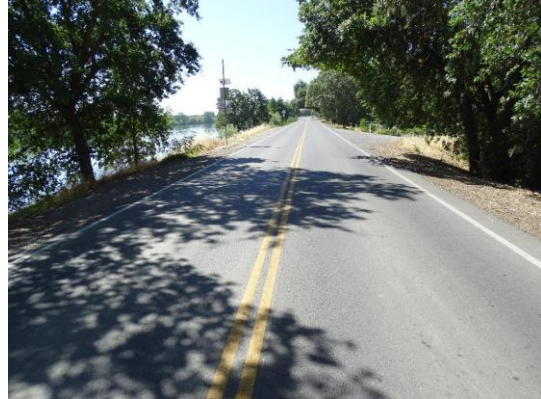
Photo 1 of 3 : UCIP\_FA\_2022\_73928\_88712.jpg

Top of Levee: view of crown.

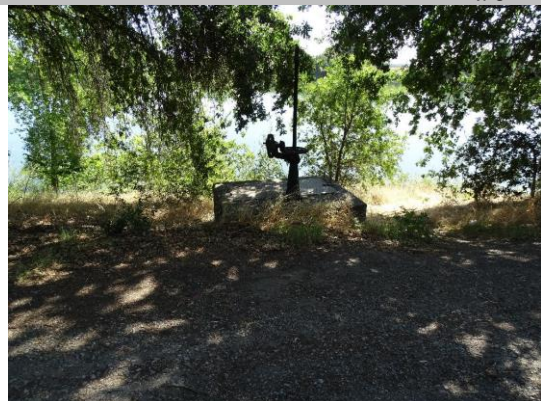
Photo 2 of 3 : UCIP\_FA\_2022\_73928\_88713.jpg

Water-Side: view of WS slope and concrete vault.

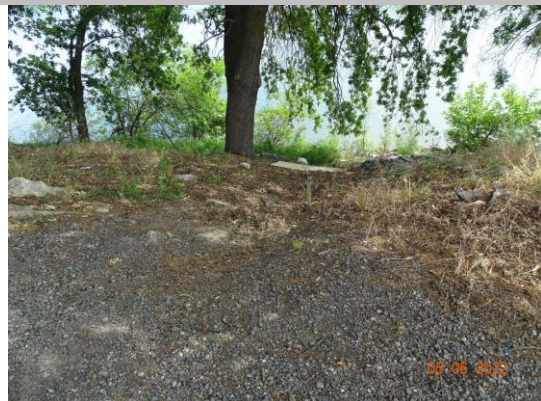
Photo 1 of 1 : FA\_2022\_RD0999\_235\_39\_20220822\_00012.jpg

LM Start	0.55	Rating **	A/W	Issue No.	39
LM End	0.55	Issue Type +	Ma	Location *	WS
Category	Earthen Levee			GPS Latitude/Longitude	
				Start	End
Item	Erosion / Foot Traffic			38.421051 °	38.421051 °
				-121.527692 °	-121.527692 °
DWR ID	DWR_RD0999_04_s_2022_39				
Comment Code					
E3 : Repair the levee slope damaged by foot traffic and prevent access where possible.					
Inspector Comment					
Monitor footpath for erosion.

Footpath on the waterside slope. Spring 2022

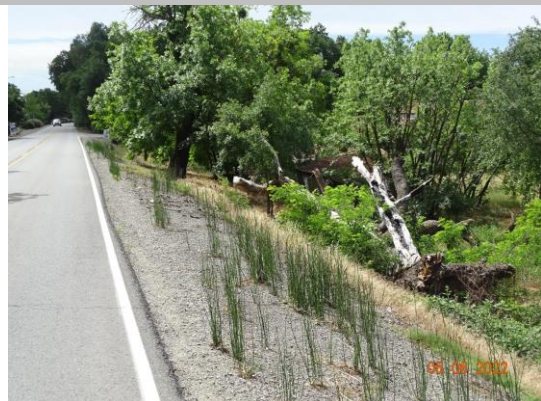
Photo 1 of 1 : FA\_2022\_RD0999\_235\_35\_20220822\_00009.jpg

Fallen tree on the landside slope. Spring 2022

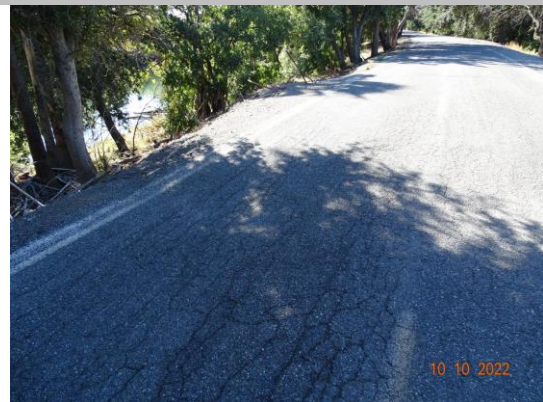
Photo 1 of 1 : FA\_2022\_RD0999\_236\_165\_20221027\_00196.jpg

View of minor cracks near a ramp. Fall 2022

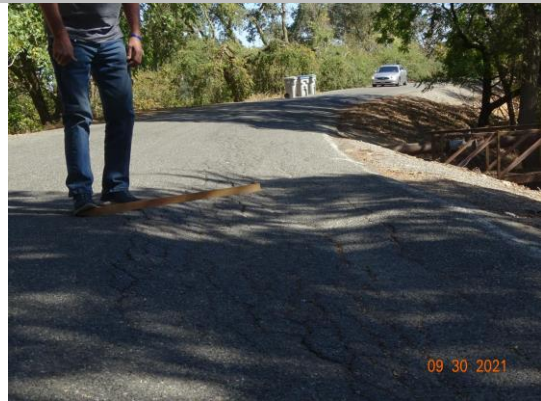
Photo 1 of 2 : FA\_2022\_RD0999\_236\_55\_20220822\_00016.jpg

Depth of sloughing on WS crown. Fall 2021

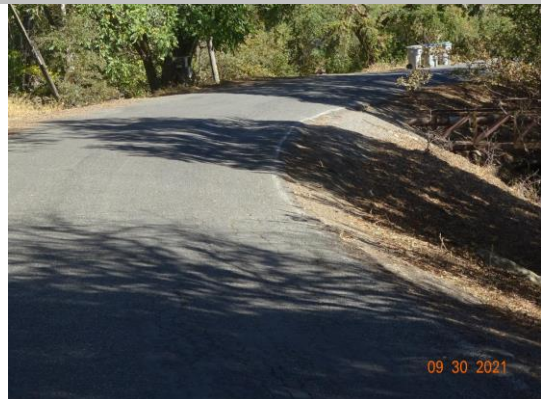
Photo 2 of 2 : FA\_2022\_RD0999\_236\_55\_20220822\_00017.jpg

Length of sloughing on WS crown. Fall 2021

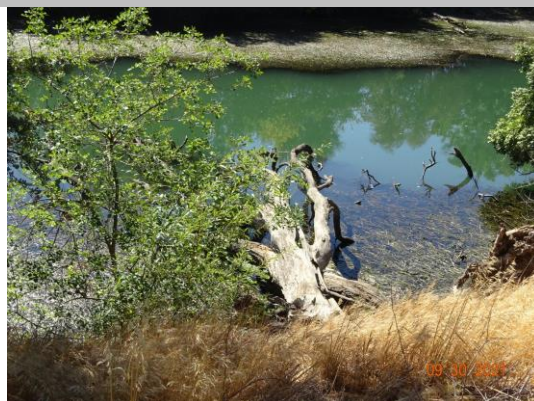
Photo 1 of 1 : FA\_2022\_RD0999\_236\_273\_20220822\_00096.jpg

Fallen tree in channel. Fall 2021

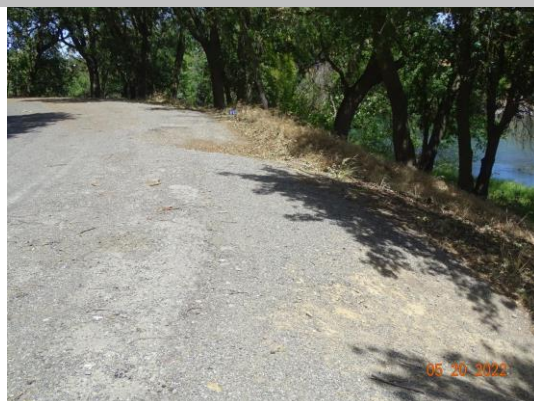
Photo 1 of 1 : FA\_2022\_RD0999\_236\_61\_20220822\_00018.jpg

Footpaths on the waterside slope. Spring 2022

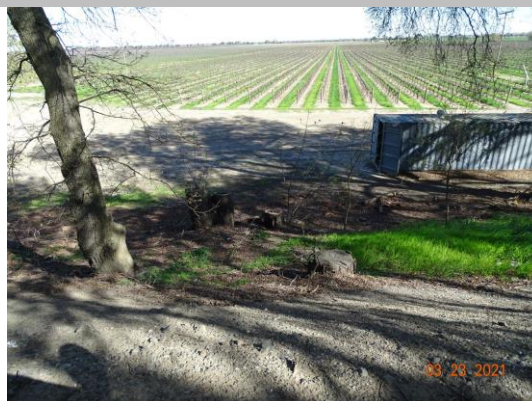
Photo 1 of 1 : FA\_2022\_RD0999\_236\_79\_20220822\_00027.jpg

View of the tree stumps on the LS levee slope. Spring 2021.

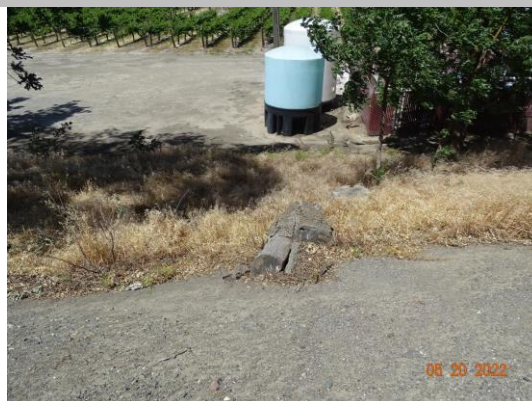
Photo 1 of 1 : FA\_2022\_RD0999\_236\_90\_20220822\_00032.jpg

Tree stump and logs on the landside slope. Spring 2022

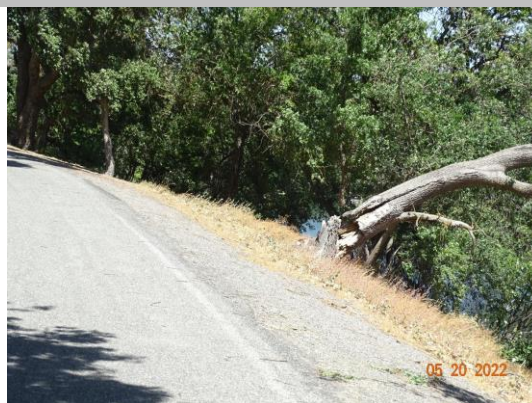
Photo 1 of 1 : FA\_2022\_RD0999\_236\_218\_20220822\_00084.jpg

Fallen tree on the waterside slope. Spring 2022

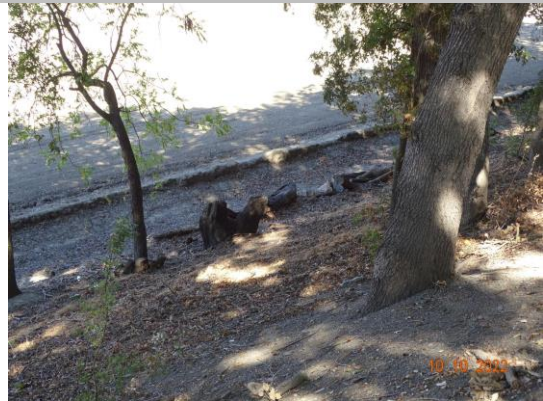
Photo 1 of 1 : FA\_2022\_RD0999\_236\_56\_20221027\_00199.jpg

Cut logs and stumps on the LS toe. Fall 2022

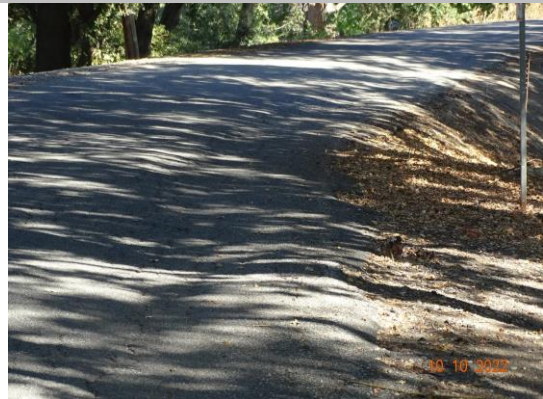
Photo 1 of 1 : FA\_2022\_RD0999\_236\_51\_20221027\_00200.jpg

Crown depression. Fall 2022

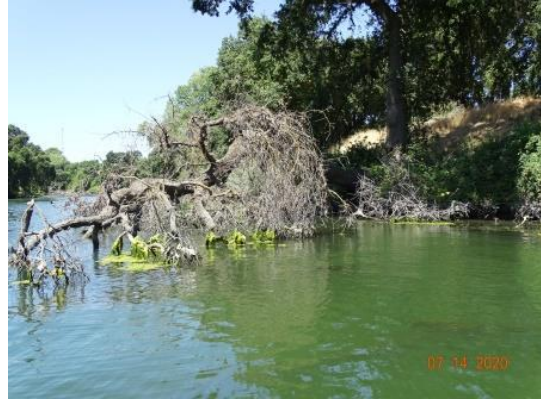
Photo 1 of 1 : FA\_2022\_RD0999\_236\_102\_20220822\_00040.jpg

View of fallen tree split at the base. Summer 2020

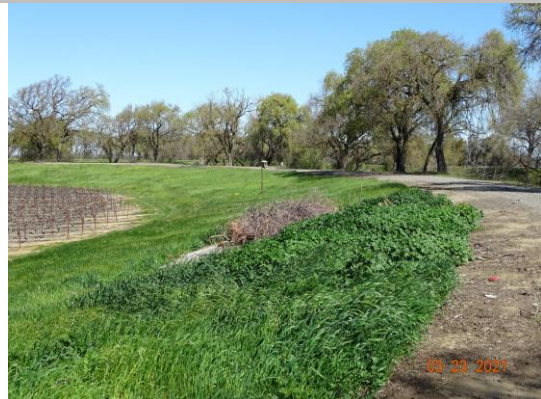
Photo 1 of 1 : FA\_2022\_RD0999\_236\_106\_20220822\_00043.jpg

View of the debris and pruning pile on the LS levee slope. Spring 2021.

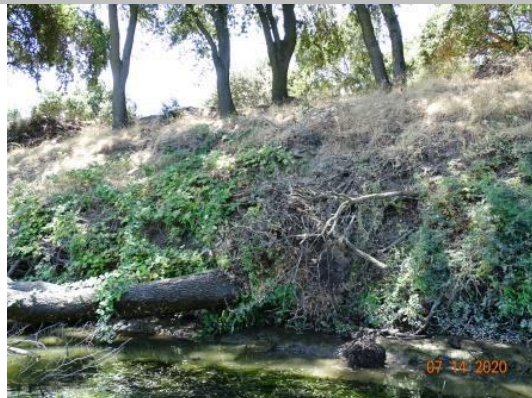
Photo 1 of 1 : FA\_2022\_RD0999\_236\_97\_20220822\_00037.jpg

View of fallen trees and scarp. Summer 2020

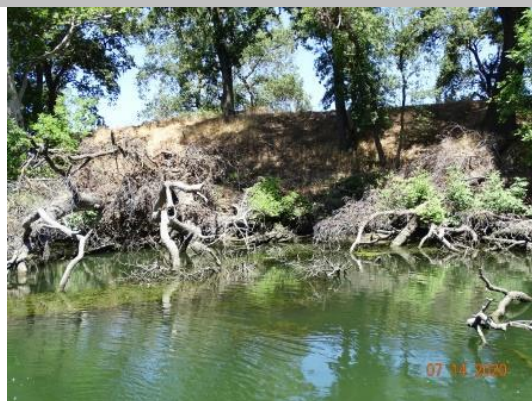
Photo 1 of 2 : FA\_2022\_RD0999\_236\_229\_20220822\_00090.jpg

View of two fallen trees. Summer 2020

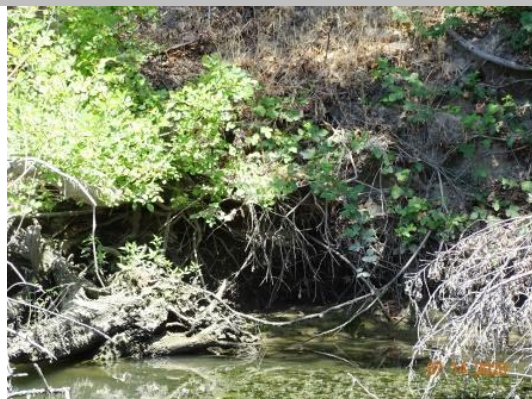
Photo 2 of 2 : FA\_2022\_RD0999\_236\_229\_20220822\_00091.jpg

View of large scarp near two fallen trees. Summer 2020

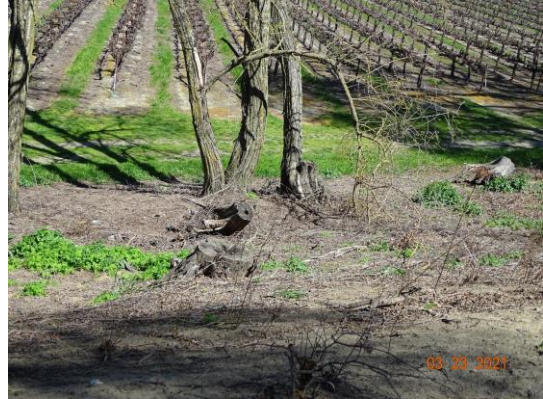
Photo 1 of 1 : FA\_2022\_RD0999\_236\_129\_20220822\_00049.jpg

View of the tree stumps on the LS levee slope and toe. Spring 2021.

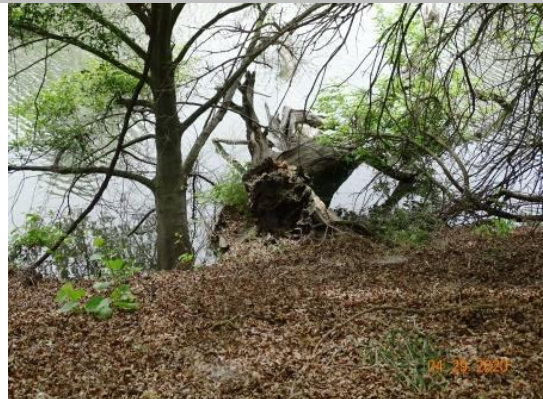
Photo 1 of 1 : FA\_2022\_RD0999\_236\_227\_20220822\_00089.jpg

View of a fallen tree on the waterside slope. Spring 2020

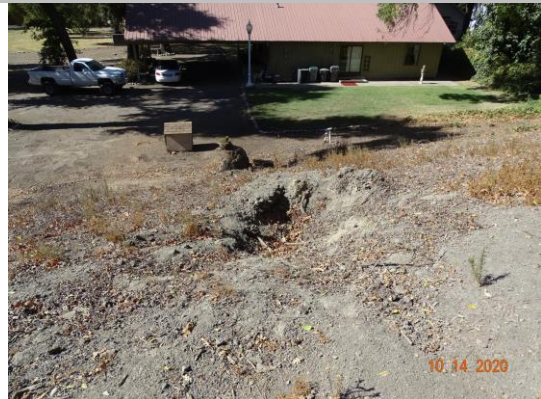
Photo 1 of 1 : FA\_2022\_RD0999\_236\_214\_20220822\_00081.jpg

View of a large hole on the landside slope. Fall 2020
