**Flood Control Project Maintenance  
Levee Inspections**

**Maintenance Issue Types Only, Levee Inspection Report By Mile - Fall 2023**

**Reclamation District No. 0999 Netherlands**

Waterway	Bank	Unit Miles	Inspection Start/End	Inspector
Unit No. 01 Yolo Bypass	Left	15.41	10/27/2023 10/27/2023	Marvin Marshall

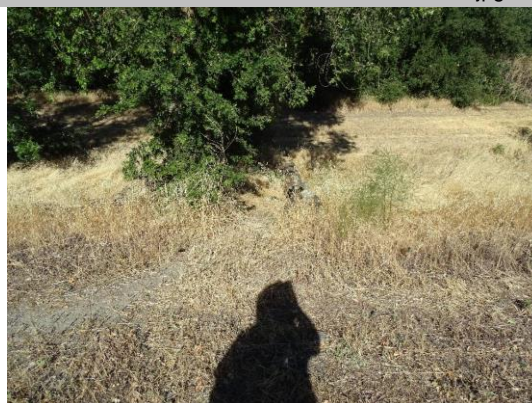
Photo 2 of 3 : UCIP\_FA\_2023\_73776\_88523.jpg

Comment Code						
Inspector Comment						
DS_ID:22743 FS_ID:73776 EP_NO: N/A Repair Type: Urgent EVAL Issue: 1, Pipe Integrity Crossing Status: Found UCIP Comments: 06/16/2020 Record remains Non-Urgent. Crossing appears abandoned. Recommend owner to contact CVFPB to abandon or remove pipe from levee. System Feature. (D.Sanoski - DWR UCIP) 07/26/2018 Same as last inspection. Pipe open on WS, but no visual signs of pipe or levee integrity issues so downgrading crossing to Non-Urgent (D. Sanoski - DWR UCIP).07/07/2016 Condition largely unchanged from previous inspection. Pipe open on the WS, waterward of the siphon breaker. Dense vegetation and steep slope limited inspection of WS outlet into Ship Channel. (T. Hatch/UCIP)06/25/2013 Pipe abandoned and open on WS slope. Pipe should be abandoned properly. (W. Wylie/UCIP) FIELD_STRUCT_DESC: 30-inch steel drainage pipe through the levee, 6.5 feet below the crown. Pump on a platform in the canal off the landside (LS) toe. Flap gate on the waterside (WS). Siphon breaker and an air vent on the WS shoulder. 1-inch galvanized iron filler pipe visible on the WS shoulder along same alignment. [Additional Reference(s): DWR Levee Log, 1992 (HLM 1.73). USACE Sacramento O&M Manual, Unit 113, October 1966, Revised 29 December 2016, (1.73), listed as 30-inch pipe]. FS Date: 6/16/2020 2:16:00 PM

Water-Side: view of WS slope and broken crossing at toe.

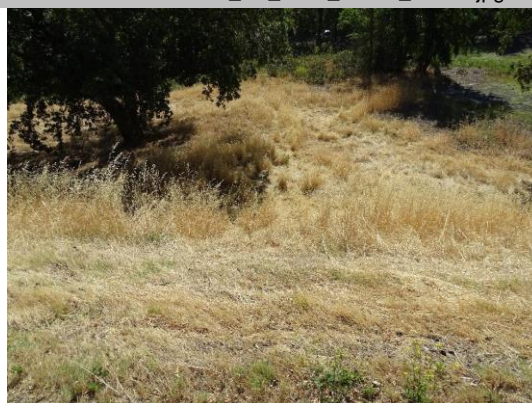
Photo 3 of 3 : UCIP\_FA\_2023\_73776\_88524.jpg

Land-Side: view of LS slope and pump platform off in distance.

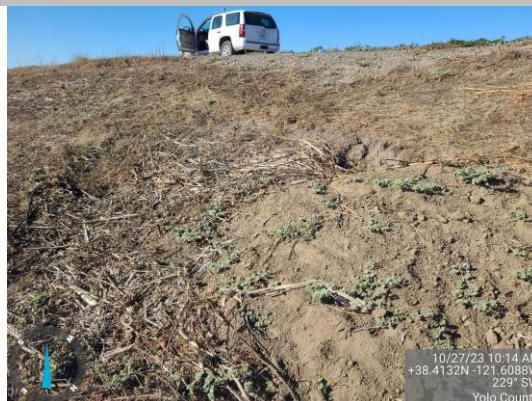
Photo 1 of 1 : FA\_2023\_RD0999\_232\_9\_20231101\_00034.jpg

LM Start	6.62	Rating **	M	Issue No.	9
LM End	6.62	Issue Type +	Ma	Location *	LS
Category	Earthen Levee			GPS Latitude/Longitude	
				Start	End
Item	Animal Control			38.413153°	38.413153°
				-121.608929°	-121.608929°
DWR ID	DWR_RD0999_01_f_2023_9				
Comment Code					
A3 : No rodents visible, but rodent burrows visible; need to backfill and compact or grout burrows.					
Inspector Comment

Burrows on the LS slope. Fall 2023

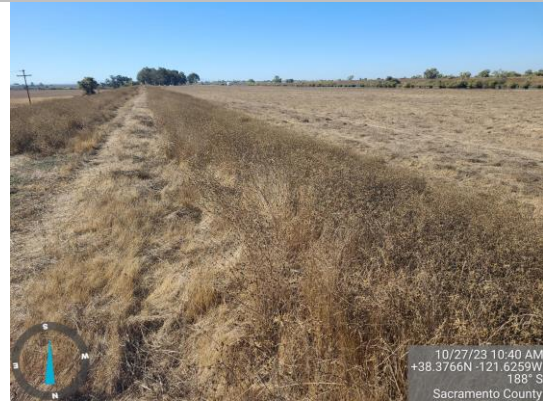
Photo 1 of 1 : FA\_2023\_RD0999\_232\_11\_20231101\_00038.jpg

Vegetation on the WS slope. Fall 2023

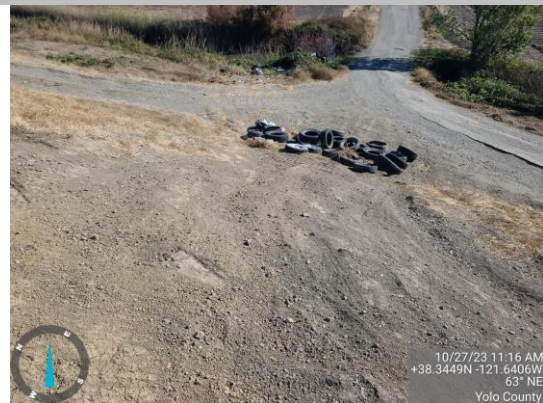
Photo 1 of 1 : FA\_2023\_RD0999\_232\_7\_20231101\_00041.jpg

LM Start	11.63	Rating **	M	Issue No.	7
LM End	11.63	Issue Type +	Ma	Location *	LS
Category	Earthen Levee			GPS Latitude/Longitude	
				Start	End
Item	Erosion / Vehicle Traffic			38.344942°	38.344942°
				-121.640647°	-121.640647°
DWR ID	DWR_RD0999_01_s_2023_7				
Comment Code					
E6 : Repair the levee slope damaged by vehicle traffic and prevent access where possible.					
Inspector Comment					
Repair slope damage from vehicle traffic. Remove tires from toe.

Rutting and tires on the LS slope. Fall 2023

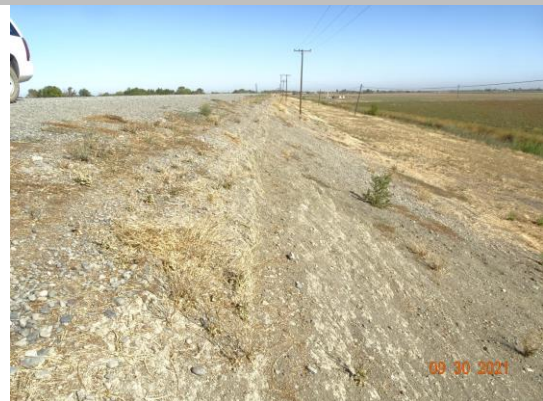
Photo 1 of 1 : FA\_2023\_RD0999\_232\_38\_20230905\_00012.jpg

LM Start	13.47	Rating **	M	Issue No.	38
LM End	13.47	Issue Type +	Ma	Location *	LS
Category	Earthen Levee			GPS Latitude/Longitude	
				Start	End
Item	Slope Stability			38.318667°	38.318667°
				-121.644948°	-121.644948°
DWR ID	DWR_RD0999_01_f_2021_38				
Comment Code					
S1 : Repair slope instability.					
Inspector Comment					
Repair slope sloughing, approximately 50' long 12" deep.

LS slope sloughing. Fall 2021

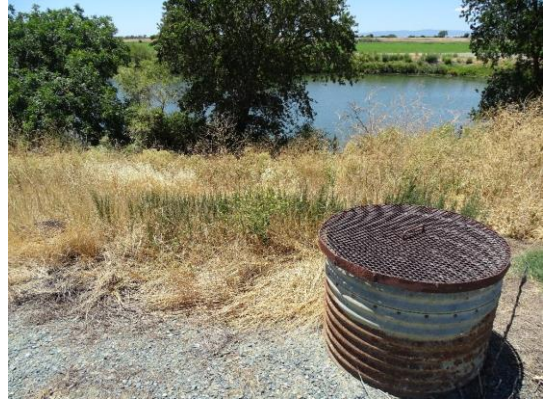
Photo 3 of 3 : UCIP\_FA\_2023\_73775\_88564.jpg

Water-Side: view of WS slope and pipe riser.

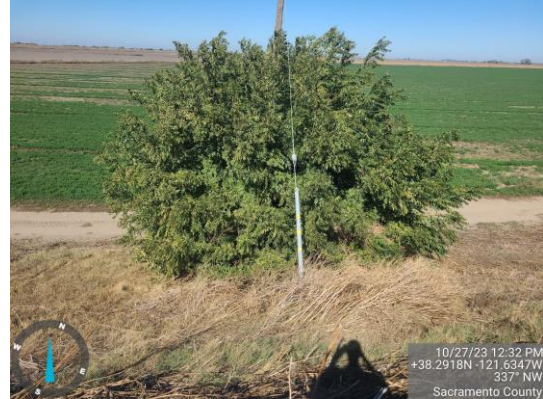
Photo 1 of 1 : FA\_2023\_RD0999\_233\_1\_20231101\_00008.jpg

Tree on the WS slope. Fall 2023

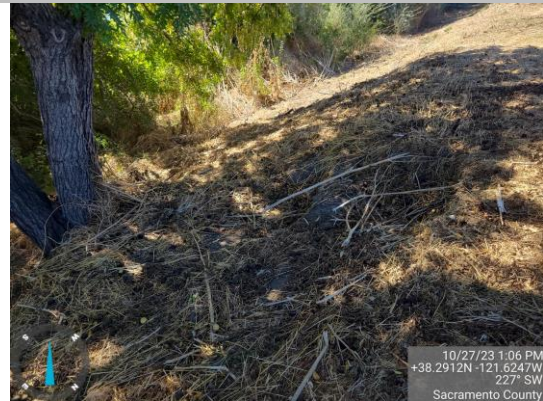
Photo 1 of 1 : FA\_2023\_RD0999\_233\_2\_20231101\_00009.jpg

LM Start	1.15	Rating **	M	Issue No.	2
LM End	1.15	Issue Type +	Ma	Location *	WS
Category	Earthen Levee			GPS Latitude/Longitude	
				Start	End
Item	Erosion / Bank Caving			38.291045°	38.291045°
				-121.625112°	-121.625112°
DWR ID	DWR_RD0999_02_f_2023_2				
Comment Code					
E2 : Schedule repair of erosion site prior to the next inspection.					
Inspector Comment					
Repair benching cut in the WS slope.

Bench in the WS slope. Fall 2023

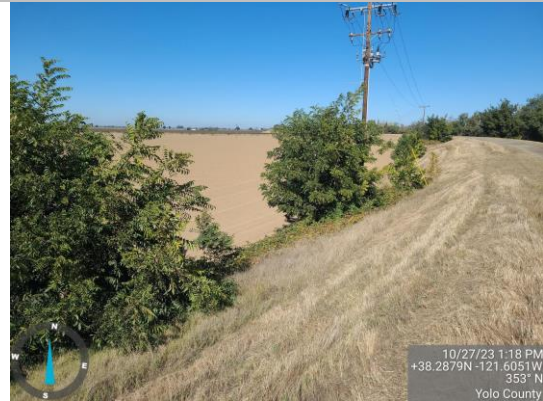
Photo 1 of 1 : FA\_2023\_RD0999\_234\_11\_20231101\_00016.jpg

Trees on the LS slope. Fall 2023

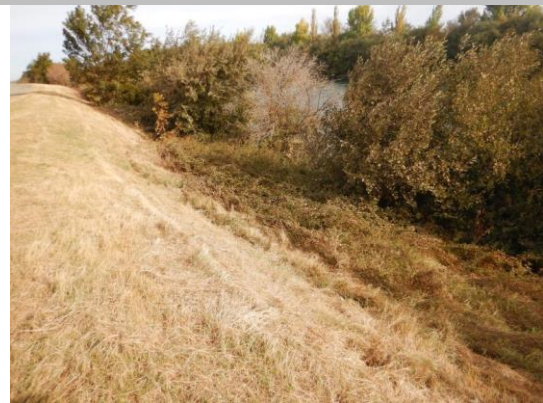
Photo 1 of 2 : FA\_2023\_RD0999\_234\_5\_20230905\_00001.jpg

LM Start	0.24	Rating **	U	Issue No.	5
LM End	0.65	Issue Type +	Ma	Location *	WS
Category	Supplemental			GPS Latitude/Longitude	
				Start	End
Item	2018 USACE Erosion Survey			38.289634°	38.295505°
				-121.604343°	-121.605648°
DWR ID	DWR_RD0999_03_s_2022_5

Comment Code					
Inspector Comment					
2018 Site ID: STR 24.7 R					
Status: Critical					
2022 Field Notes: No observed changes.					
Site History: 1997 - Intermittent over-steepened sections. Large riparian vegetation along the length of the entire reach. Attempts to repair with rock on bank have failed. 1999 - New rock repair at the downstream end. 2002 - Some minor spot repairs. 2009 - Minimal new erosion. 2010 - Appears that fresh rock placed on downstream portion of site. Toe scour and overhanging trees with some overturned. 2012 - Minor new erosion at the toe. 2013 - Site upgraded to CRITICAL. Severe slumping into levee at downstream end of site. Fresh erosion into bank toe. 2015 - New slumping, tall vertical sections. 2016 - Upper slumped section continues to worsen. 2017 - Locals have placed rock in worst sections. Fresh erosion at toe. New tall vertical sections observed. 2018 -Length reduced on downstream side to account for repaired section.

USACE 2018 Erosion Photo #1

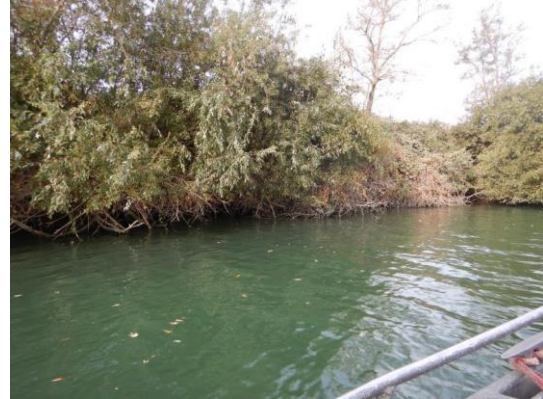
Photo 2 of 2 : FA\_2023\_RD0999\_234\_5\_20230905\_00002.jpg

USACE 2018 Erosion Photo #2

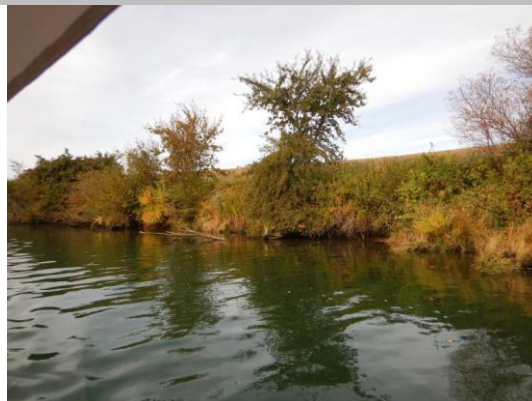
Photo 2 of 2 : FA\_2023\_RD0999\_234\_6\_20230905\_00004.jpg

LM Start	0.97	Rating **	M	Issue No.	6
LM End	1.10	Issue Type +	Ma	Location *	WS
Category	Supplemental			GPS Latitude/Longitude	
				Start	End
Item	2018 USACE Erosion Survey			38.299402°	38.300542°
				-121.603056°	-121.601118°
DWR ID	DWR_RD0999_03_s_2022_6				
Comment Code					
Inspector Comment					
2018 Site ID: STR 25.2 R					
Status: Eroding					
2022 Field Notes: No observed changes.					
Site History: 2008 - Over steepened levee section. 2009 - Significant new erosion. 2010 - Minor new erosion. 2017 - Minor new erosion at toe. 2018 - New large slump on upper levee slope.

USACE 2018 Erosion Photo #2

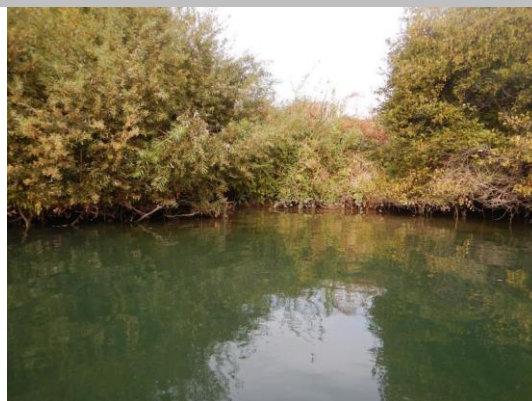
Photo 1 of 2 : FA\_2023\_RD0999\_234\_10\_20230905\_00006.jpg

LM Start	1.43	Rating **	A/W	Issue No.	10
LM End	1.57	Issue Type +	Ma	Location *	WS
Category	Supplemental			GPS Latitude/Longitude	
				Start	End
Item	2018 USACE Erosion Survey			38.305229°	38.306667°
				-121.599933°	-121.598266°
DWR ID	DWR_RD0999_03_s_2022_10				
Comment Code					
Inspector Comment					
2018 Site ID: STR 25.7 R					
Status: Eroding					
2022 Field Notes: No observed changes.					
Site History: 2011 - Toe scour along length of site and erosion pockets.					
2012 - Site extended slightly upstream due to new erosion pocket.					
2013 - Tall vertical sections at upstream end of site. 2017 - Large erosion scarp near downstream end. 2018 - Site extended upstream.

USACE 2018 Erosion Photo #1

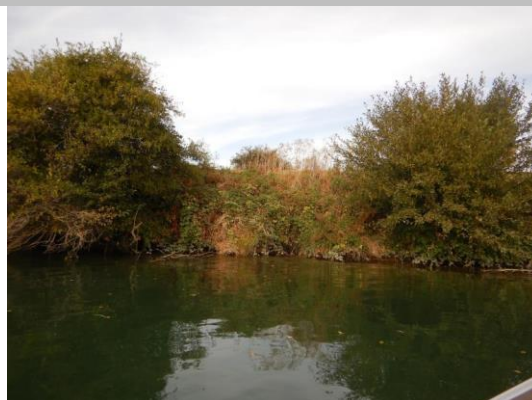
Photo 2 of 2 : FA\_2023\_RD0999\_234\_10\_20230905\_00007.jpg

USACE 2018 Erosion Photo #2

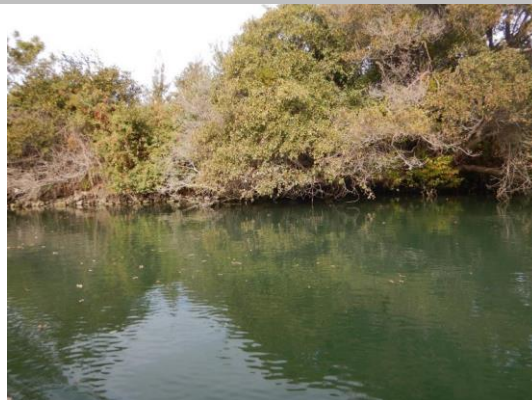
Photo 1 of 2 : FA\_2023\_RD0999\_234\_12\_20230905\_00009.jpg

LM Start	1.93	Rating **	M	Issue No.	12
LM End	1.97	Issue Type +	Ma	Location *	WS
Category	Supplemental			GPS Latitude/Longitude	
				Start	End
Item	2018 USACE Erosion Survey			38.311013°	38.311342°
				-121.597751°	-121.596976°
DWR ID	DWR_RD0999_03_s_2022_12				
Comment Code					
Inspector Comment					
2018 Site ID: STR 26.1 R					
Status: Eroding					
2022 Field Notes: No observed change.					
Site History: 2015 - Tall vertical sections into the levee slope and erosion along the toe. 2016 - New tree pop-out observed. 2018 - No observed change.

USACE 2018 Erosion Photo #1

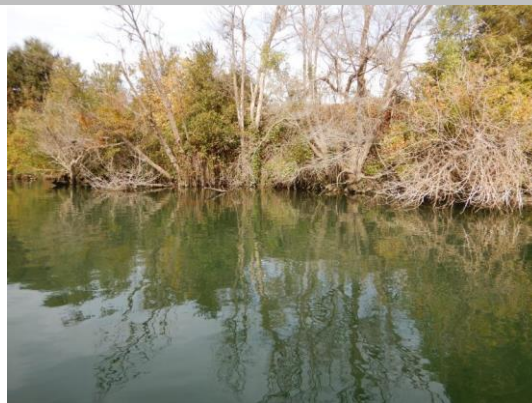
Photo 2 of 2 : FA\_2023\_RD0999\_234\_12\_20230905\_00010.jpg

USACE 2018 Erosion Photo #2

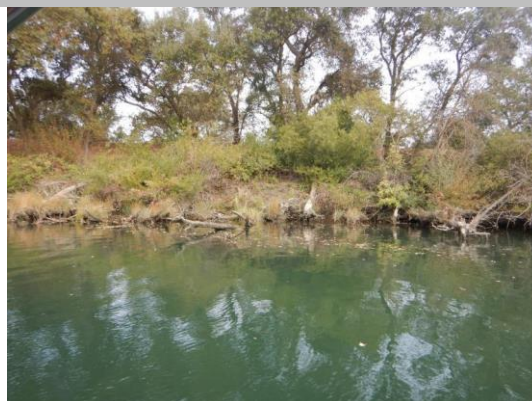
Photo 1 of 1 : FA\_2023\_RD0999\_234\_14\_20230905\_00011.jpg

LM Start	2.97	Rating **	A/W	Issue No.	14
LM End	3.22	Issue Type +	Ma	Location *	WS
Category	Supplemental			GPS Latitude/Longitude	
				Start	End
Item	2018 USACE Erosion Survey			38.323419°	38.325592°
				-121.589645°	-121.585925°
DWR ID	DWR_RD0999_03_s_2022_14				
Comment Code					
Inspector Comment					
2018 Site ID: STR 27.3 R					
Status: Eroding					
2022 Field Notes: No observed change.					
Site History: 2011 - Multiple erosion pockets. Some likely from tree popouts. 2013 - Tall vertical sections. 2015 - New tree pop-out and significant new erosion. 2016 - New erosion at toe. 2017 - Site extended downstream, section of lower bank has slumped off. Fresh toe erosion and fresh tree popout. 2018 - No observed change.

USACE 2018 Erosion Photo #1

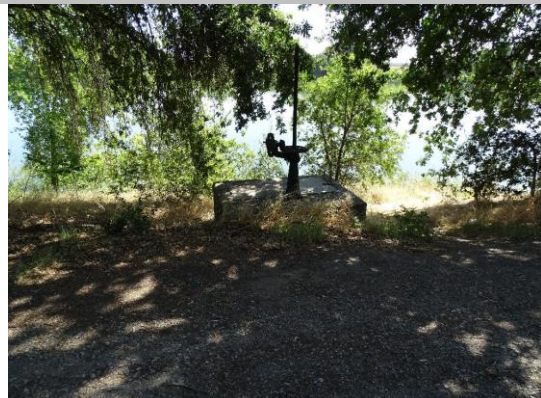
Photo 2 of 3 : UCIP\_FA\_2023\_73928\_88713.jpg

Water-Side: view of WS slope and concrete vault.

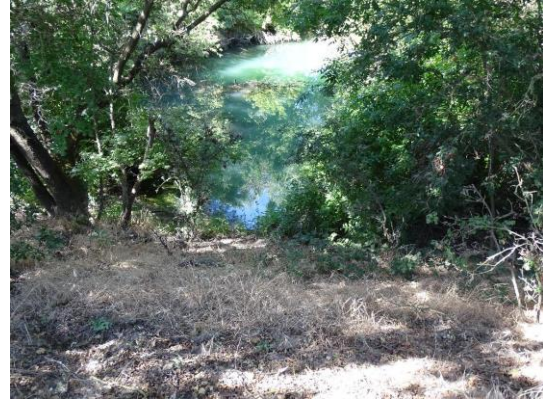
Photo 3 of 3 : UCIP\_FA\_2023\_73928\_88714.jpg

Land-Side: view of LS slope and channel at toe.

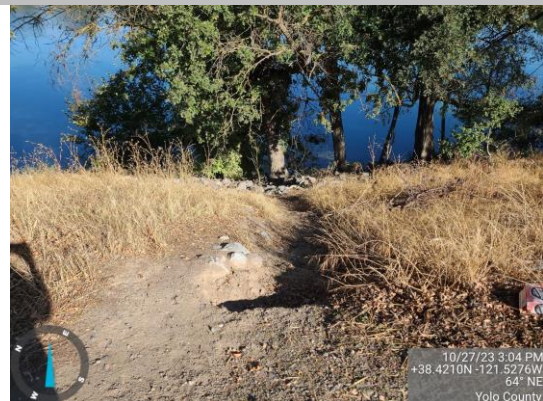
Photo 1 of 1 : FA\_2023\_RD0999\_235\_39\_20231101\_00038.jpg

LM Start	0.55	Rating **	M	Issue No.	39
LM End	0.55	Issue Type +	Ma	Location *	WS
Category	Earthen Levee			GPS Latitude/Longitude	
				Start	End
Item	Erosion / Foot Traffic			38.421051°	38.421051°
				-121.527692°	-121.527692°
DWR ID	DWR_RD0999_04_s_2022_39				
Comment Code					
E3 : Repair the levee slope damaged by foot traffic and prevent access where possible.					
Inspector Comment					
Repair two footpaths on the WS slope.

Footpath on the WS slope. Fall 2023

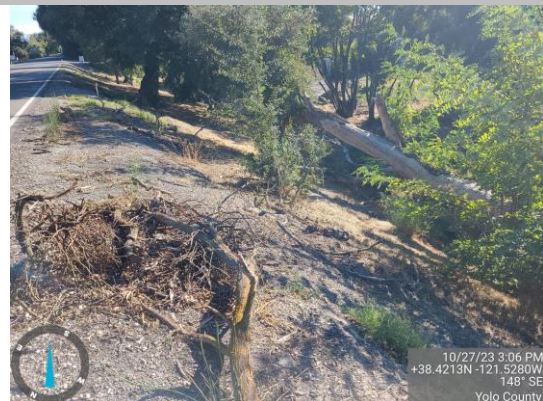
Photo 1 of 1 : FA\_2023\_RD0999\_235\_35\_20231101\_00039.jpg

Fallen tree on the LS slope. Fall 2023

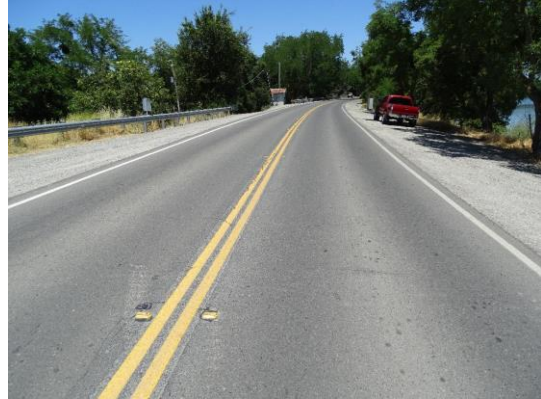
Photo 1 of 3 : UCIP\_FA\_2023\_61435\_88829.jpg

Comment Code					
Inspector Comment					
DS_ID:22803 FS_ID:61435 EP_NO: N/A Repair Type: No Action Needed EVAL Issue: Crossing Status: Indicator Found UCIP Comments: 07/01/2020 Record remains No Action Needed. No issues observed during inspection. (D.Sanoski - DWR UCIP) FIELD_STRUCT_DESC: *ABANDONED* 16-inch steel drainage pipe through the levee, 20 feet below the crown. (16-inch pipe abandoned and grouted in place authorized under Permit No. 6685, 1969 - American Crystal Sugar Company). Location identified by electromagnetic survey. [Additional Reference(s): USACE Sacramento O&M Manual, Unit 113, October 1966, Revised 29 December 2016, (1.13), listed as 16-inch pipe.] FS Date: 7/1/2020 10:17:00 AM

Top of Levee: view of crown.

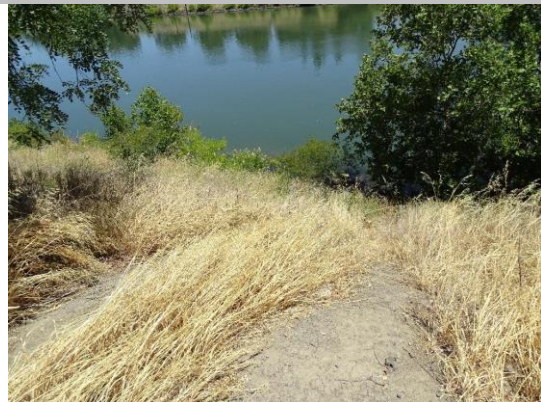
Photo 2 of 3 : UCIP\_FA\_2023\_61435\_88830.jpg

Water-Side: view of WS slope.

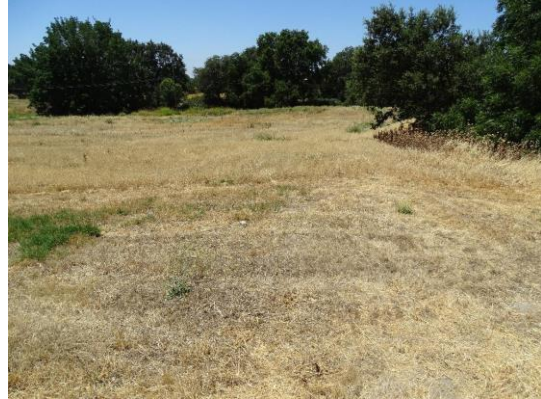
Photo 3 of 3 : UCIP\_FA\_2023\_61435\_88831.jpg

Land-Side: view of LS slope.

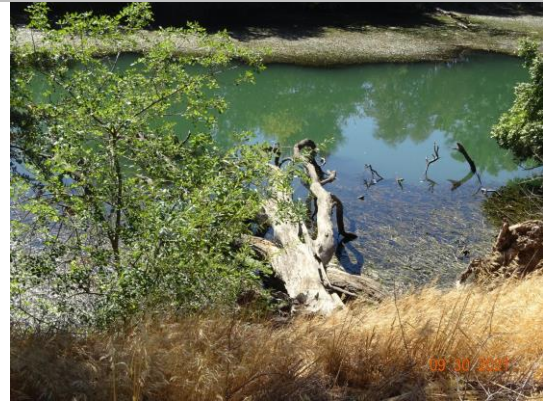
Photo 1 of 1 : FA\_2023\_RD0999\_236\_273\_20230905\_00102.jpg

Fallen tree in channel. Fall 2021

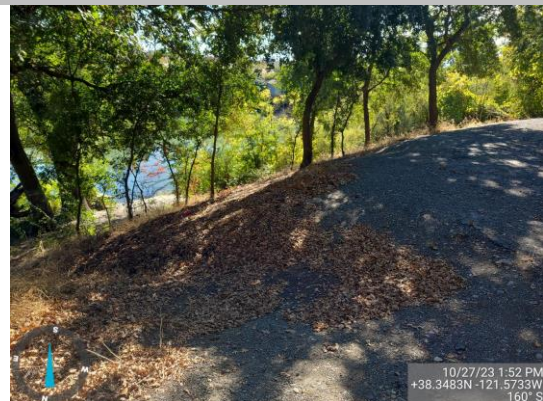
Photo 1 of 1 : FA\_2023\_RD0999\_236\_61\_20231101\_00119.jpg

Footpath on the WS slope. Fall 2023

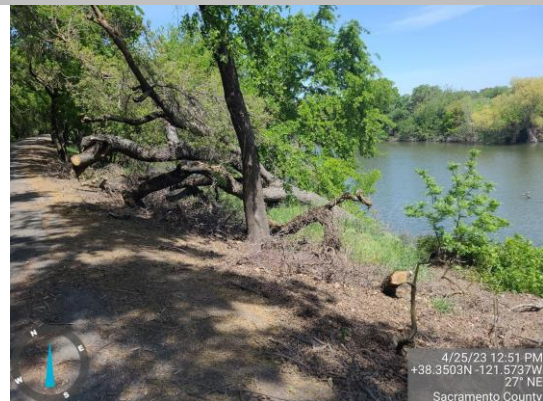
Photo 1 of 1 : FA\_2023\_RD0999\_236\_8\_20230905\_00003.jpg

Tree with root ball on the WS slope. Spring 2023

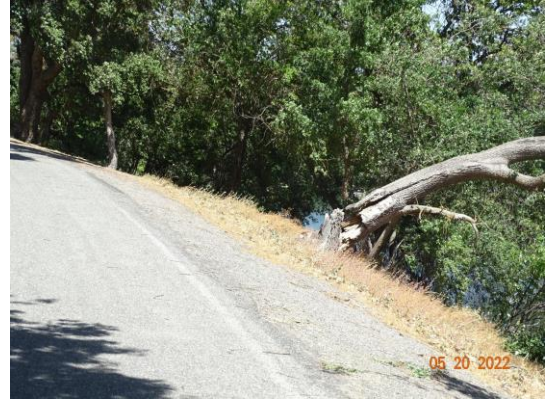
Photo 1 of 1 : FA\_2023\_RD0999\_236\_218\_20230905\_00091.jpg

Fallen tree on the waterside slope. Spring 2022

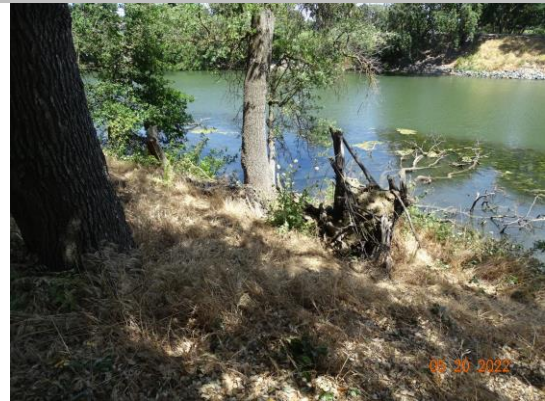
Photo 1 of 1 : FA\_2023\_RD0999\_236\_264\_20230905\_00101.jpg

Void from root ball on the waterside slope. Spring 2022

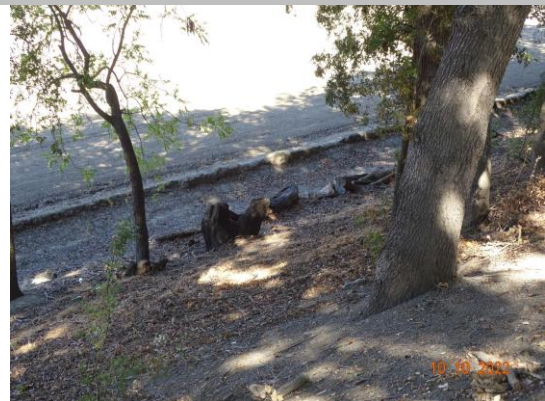
Photo 1 of 1 : FA\_2023\_RD0999\_236\_56\_20230905\_00021.jpg

Cut logs and stumps on the LS toe. Fall 2022

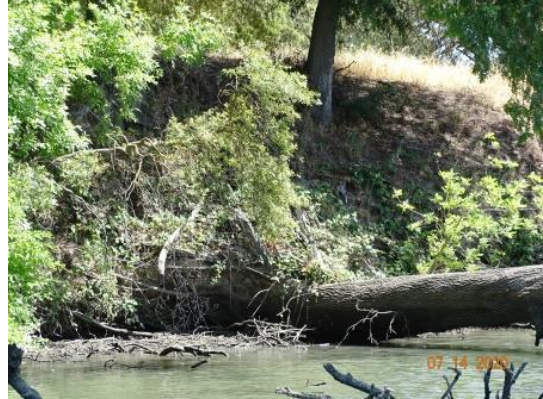
Photo 1 of 1 : FA\_2023\_RD0999\_236\_83\_20230905\_00038.jpg

View of a fallen tree with exposed root ball. Summer 2020

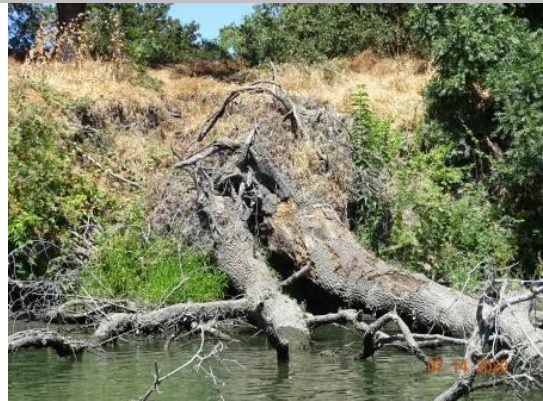
Photo 1 of 1 : FA\_2023\_RD0999\_236\_1\_20230905\_00001.jpg

View of large, fallen tree on the waterside slope. Summer 2020

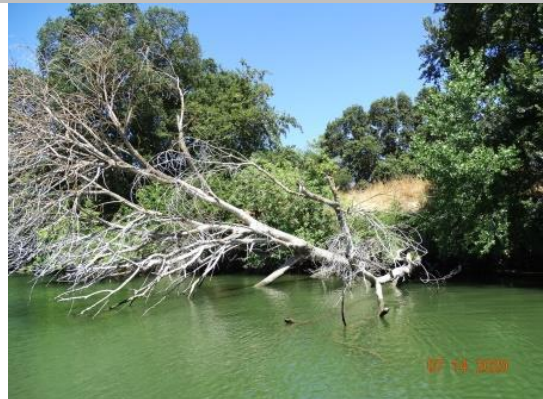
Photo 1 of 1 : FA\_2023\_RD0999\_236\_85\_20230905\_00039.jpg

View of fallen tree and slope damage. Summer 2020

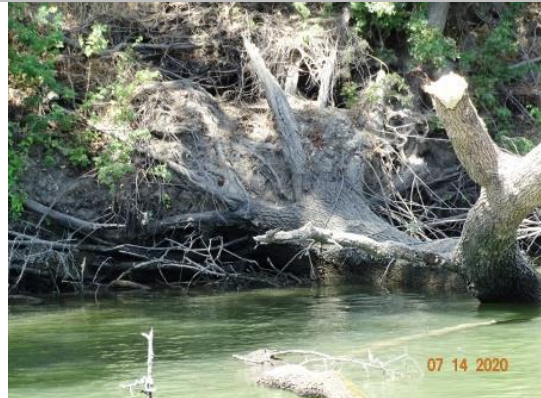
Photo 1 of 1 : FA\_2023\_RD0999\_236\_91\_20230905\_00041.jpg

View of fallen tree with exposed root ball. Summer 2020

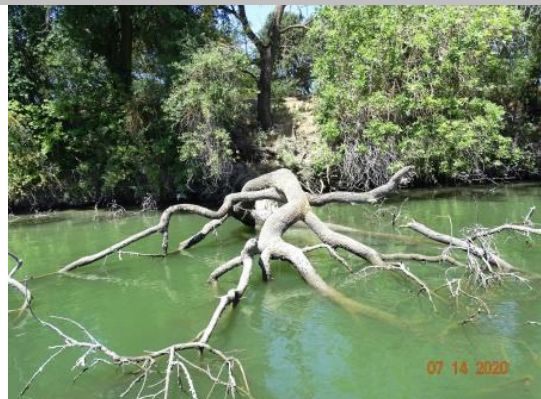
Photo 1 of 2 : FA\_2023\_RD0999\_236\_82\_20230905\_00036.jpg

View of large, fallen tree with exposed root ball. Summer 2020

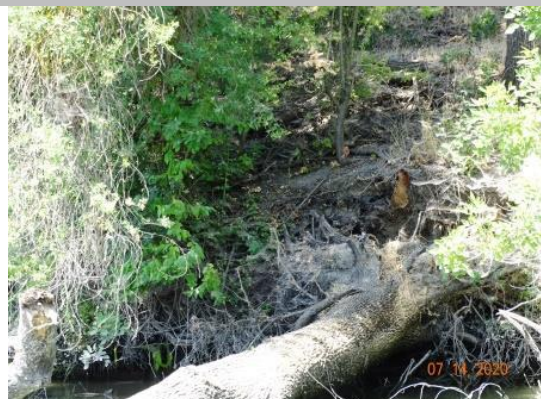
Photo 2 of 2 : FA\_2023\_RD0999\_236\_82\_20230905\_00037.jpg

View of scarp around fallen tree. Summer 2020

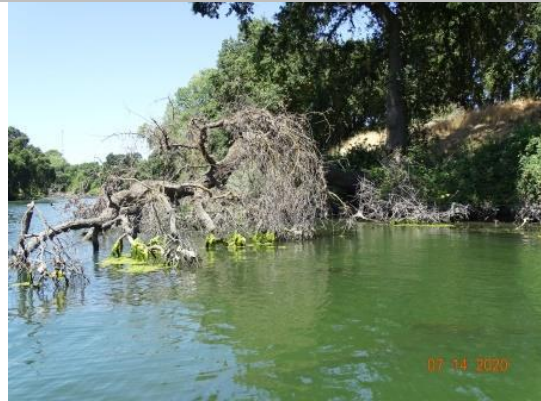
Photo 1 of 1 : FA\_2023\_RD0999\_236\_102\_20230905\_00048.jpg

View of fallen tree split at the base. Summer 2020

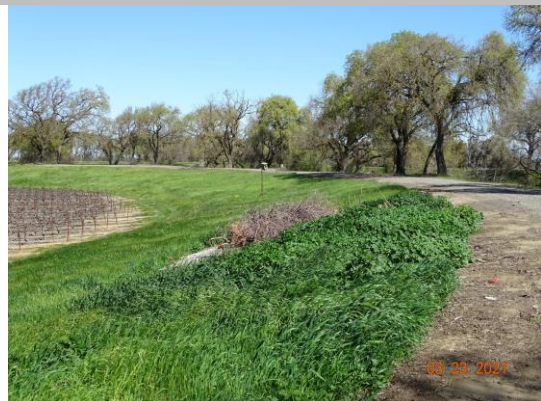
Photo 1 of 1 : FA\_2023\_RD0999\_236\_106\_20230905\_00051.jpg

View of the debris and pruning pile on the LS levee slope. Spring 2021.

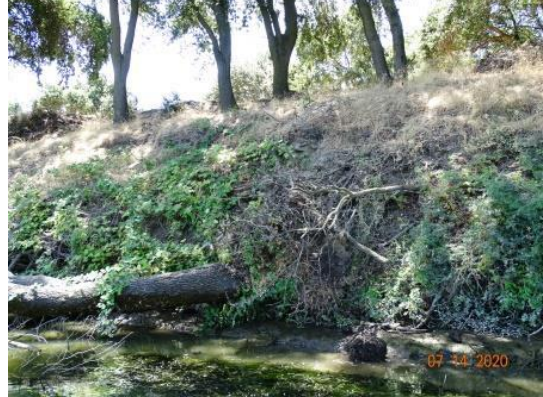
Photo 1 of 1 : FA\_2023\_RD0999\_236\_97\_20230905\_00045.jpg

View of fallen trees and scarp. Summer 2020

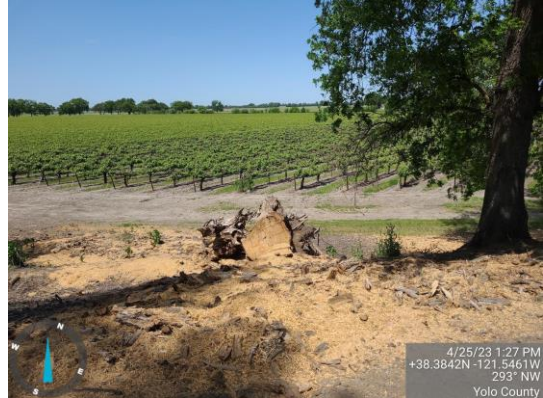
Photo 1 of 1 : FA\_2023\_RD0999\_236\_62\_20230905\_00026.jpg

Stumps on the LS slope. Spring 2023

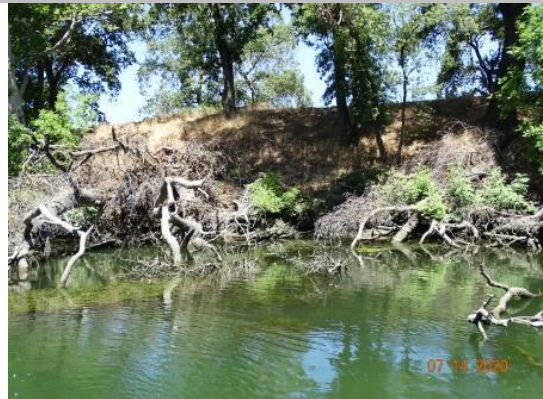
Photo 1 of 2 : FA\_2023\_RD0999\_236\_229\_20230905\_00097.jpg

View of two fallen trees. Summer 2020

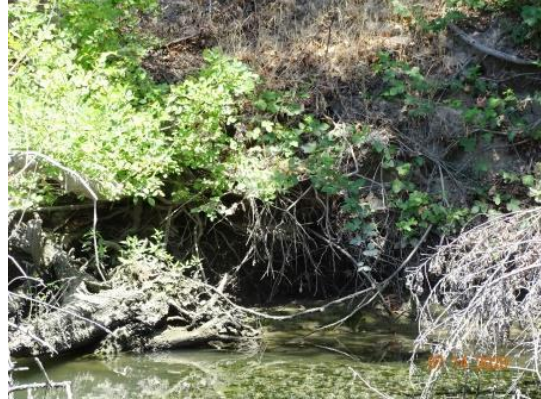
Photo 2 of 2 : FA\_2023\_RD0999\_236\_229\_20230905\_00098.jpg

View of large scarp near two fallen trees. Summer 2020

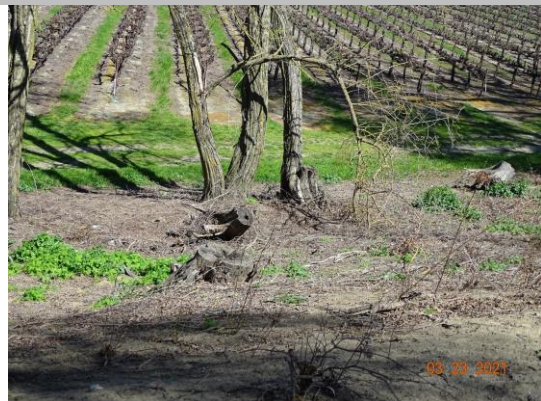
Photo 1 of 1 : FA\_2023\_RD0999\_236\_129\_20230905\_00058.jpg

View of the tree stumps on the LS levee slope and toe. Spring 2021.

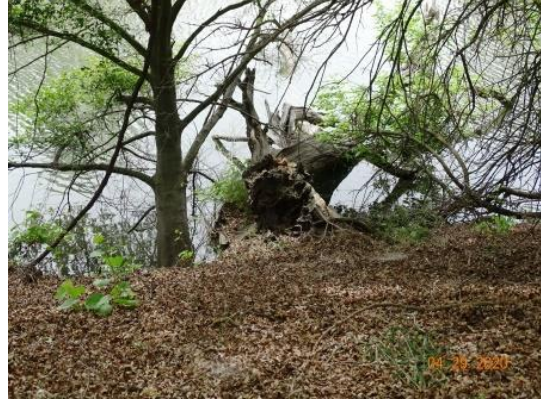
Photo 1 of 1 : FA\_2023\_RD0999\_236\_227\_20230905\_00096.jpg

View of a fallen tree on the waterside slope. Spring 2020

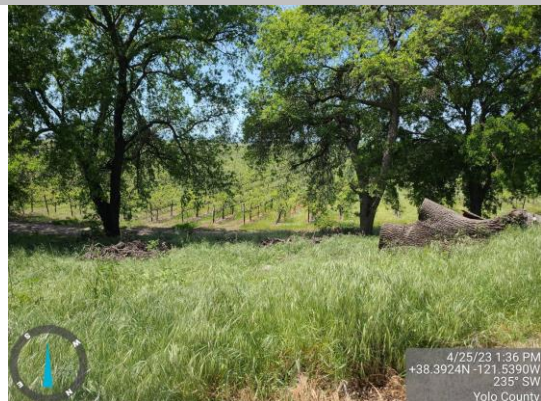
Photo 1 of 1 : FA\_2023\_RD0999\_236\_14\_20230905\_00007.jpg

Logs and prunings on the LS slope. Spring 2023

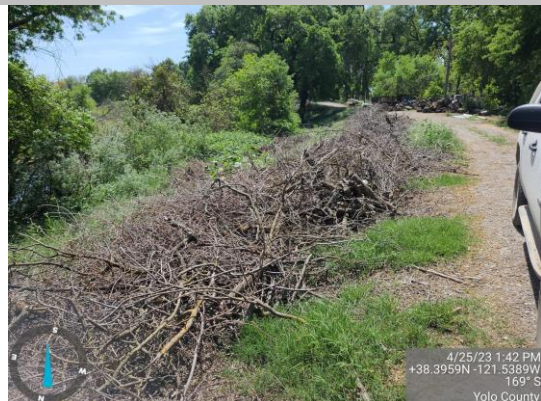
Photo 1 of 1 : FA\_2023\_RD0999\_236\_208\_20230905\_00086.jpg

Prunings on the WS shoulder. Spring 2023

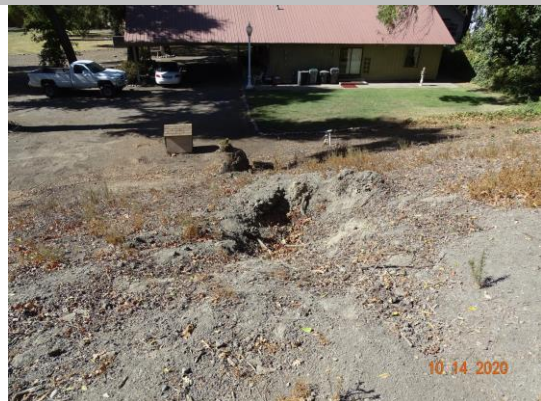
Photo 1 of 1 : FA\_2023\_RD0999\_236\_214\_20230905\_00087.jpg

View of a large hole on the landside slope. Fall 2020

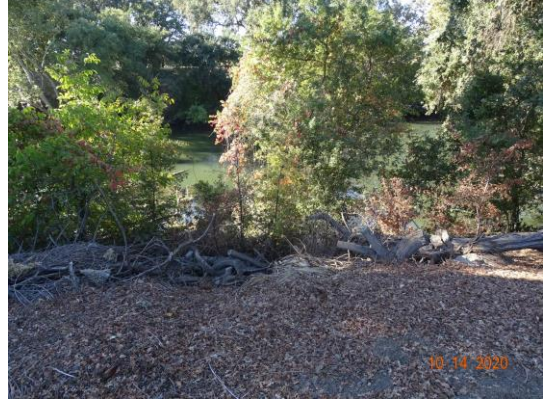
Photo 1 of 1 : FA\_2023\_RD0999\_236\_177\_20230905\_00078.jpg

View of tree logs and limbs on the waterside slope. Fall 2020

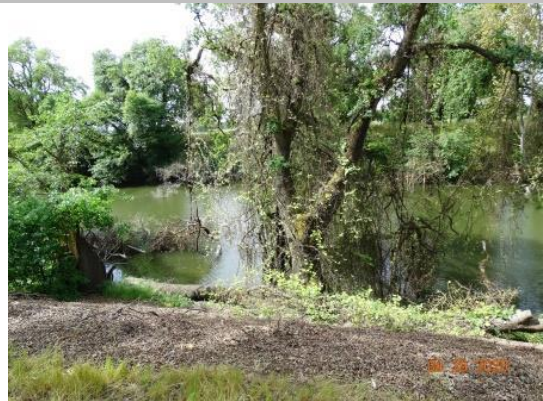
Photo 1 of 1 : FA\_2023\_RD0999\_236\_181\_20230905\_00080.jpg

View of fallen tree on the waterside slope. Spring 2020

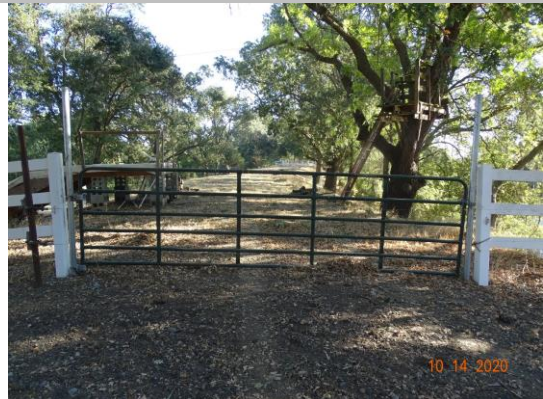
Photo 1 of 1 : FA\_2023\_RD0999\_236\_175\_20230905\_00077.jpg

View of energized wire fencing across the levee crown behind the metal gate. Fall 2020

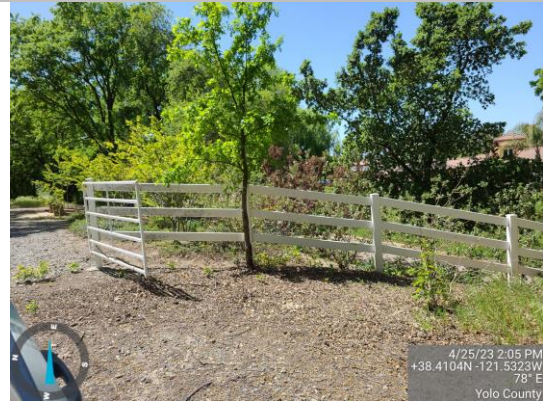
Photo 1 of 1 : FA\_2023\_RD0999\_236\_103\_20230905\_00049.jpg

Fence and gate on the slopes and crown. Spring 2023

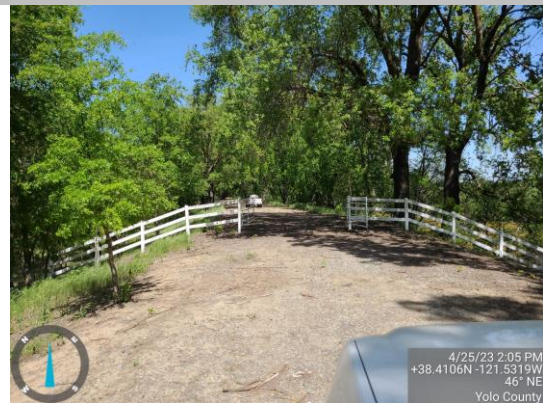
Photo 1 of 1 : FA\_2023\_RD0999\_236\_104\_20230905\_00050.jpg

Gate and fence on the levee. Spring 2023

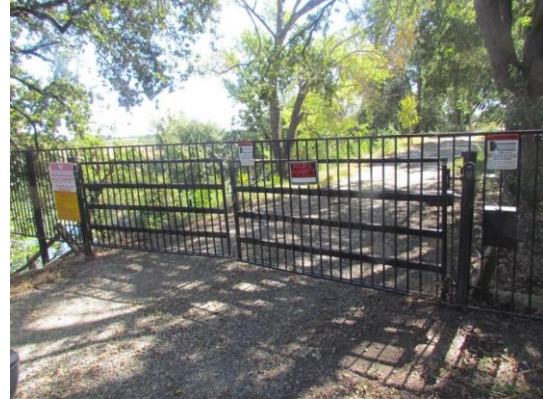
Photo 1 of 1 : FA\_2023\_RD0999\_236\_224\_20230905\_00094.jpg

Looking west at code pad on right side of gate.
