**Flood Control Project Maintenance
Levee Inspections**

Maintenance Issue Types Only, Levee Inspection Report By Mile - Fall 2024

Reclamation District No. 0999 Netherlands

Waterway	Bank	Unit Miles	Inspection Start/End	Inspector
Unit No. 01 Yolo Bypass	Left	15.41	10/22/2024 10/22/2024	Marvin Marshall

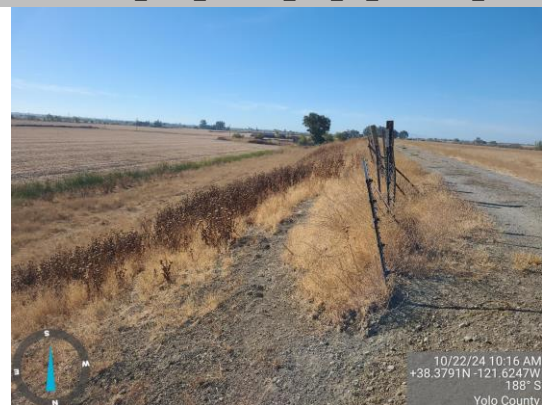
Photo 1 of 1 : FA_2024_RD0999_232_11_20241025_00043.jpg

Annual vegetation on the LS slope. Fall 2024

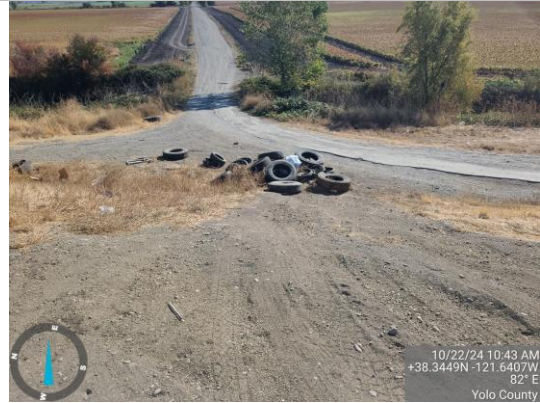
Photo 1 of 1 : FA_2024_RD0999_232_7_20241025_00045.jpg

LM Start	11.63	Rating **	M	Issue No.	7
LM End	11.63	Issue Type +	Ma	Location *	LS
Category	Earthen Levee			GPS Latitude/Longitude	
				Start	End
Item	Erosion / Vehicle Traffic			38.344942°	38.344942°
				-121.640647°	-121.640647°
DWR ID	DWR_RD0999_01_s_2023_7				
Comment Code					
E6 : Repair the levee slope damaged by vehicle traffic and prevent access where possible.					
Inspector Comment					
Repair slope damage from vehicle traffic. Remove tires from toe.

Rutting and tires on the LS slope. Fall 2024

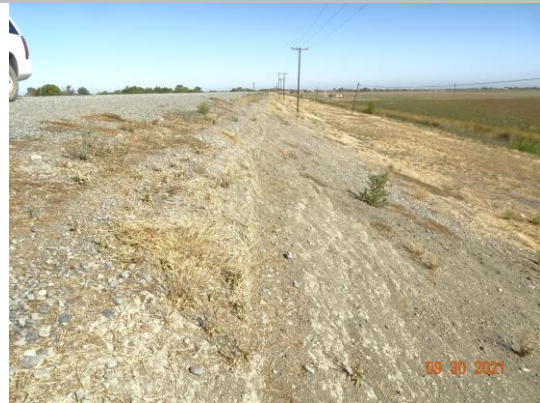
Photo 1 of 1 : FA_2024_RD0999_232_38_20240911_00017.jpg

LM Start	13.47	Rating **	M	Issue No.	38
LM End	13.47	Issue Type +	Ma	Location *	LS
Category	Earthen Levee			GPS Latitude/Longitude	
				Start	End
Item	Slope Stability			38.318667°	38.318667°
				-121.644948°	-121.644948°
DWR ID	DWR_RD0999_01_f_2021_38				
Comment Code					
S1 : Repair slope instability.					
Inspector Comment					
Repair slope sloughing, approximately 50' long 12" deep.

LS slope sloughing. Fall 2021

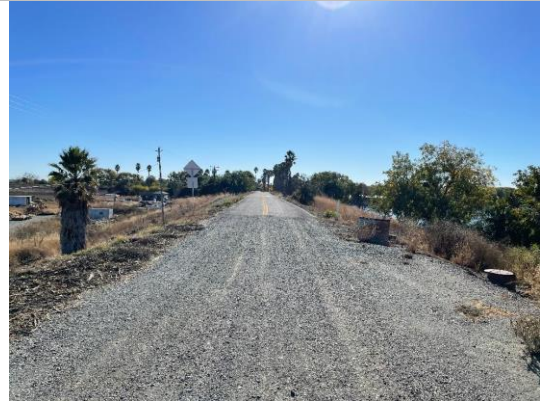
Photo 1 of 3 : UCIP_FA_2024_81690_118446.jpg

Comment Code					
Inspector Comment					
DS_ID:22756 FS_ID:81690 EP_NO: N/A Repair Type: No Action Needed EVAL Issue: Crossing Status: Found UCIP Comments: 11/20/2023 Record remains No Action Needed. (J. Taylor - DWR UCIP) 11/16/2020 Record remains No Action Needed. No issues observed during inspection. System Feature. (D.Sanoski - DWR UCIP) FIELD_STRUCT_DESC: 2 of 3: 30-inch steel drainage pipe through the levee, 7 feet below the crown. Flap gate on the waterside (WS) end. Pump in pump house on the landside (LS) toe. Siphon breaker in a corrugated metal pipe (CMP) riser on the WS shoulder. [Additional Reference(s): DWR Levee Log, 1992 (HLM 15.25). USACE Sacramento O&M Manual, Unit 113, October 1966, Revised 29 December 2016, (15.25), listed as 36-inch pipe]. FS Date: 11/20/2023 1:43:08 PM

Overview of levee crown looking D/S.

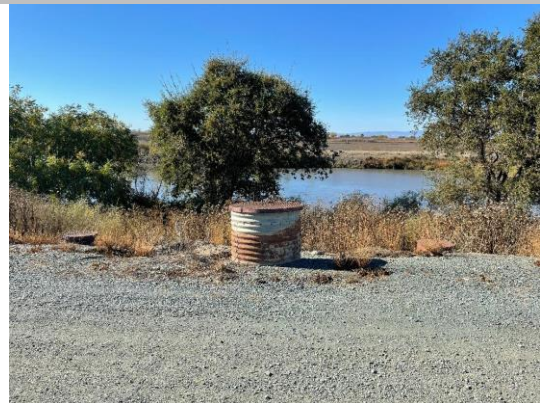
Photo 2 of 3 : UCIP_FA_2024_81690_118447.jpg

WS view: overview of WS.

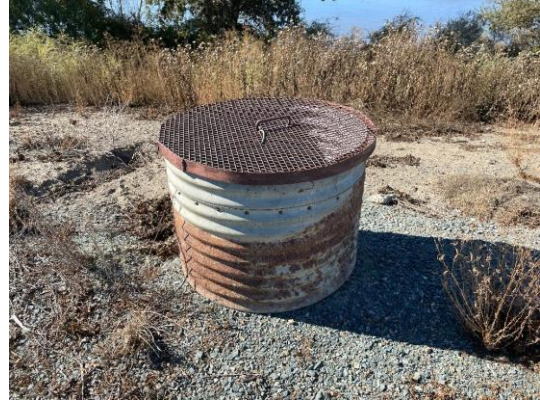
Photo 3 of 3 : UCIP_FA_2024_81690_118443.jpg

WS view: CMP riser with siphon breaker inside.

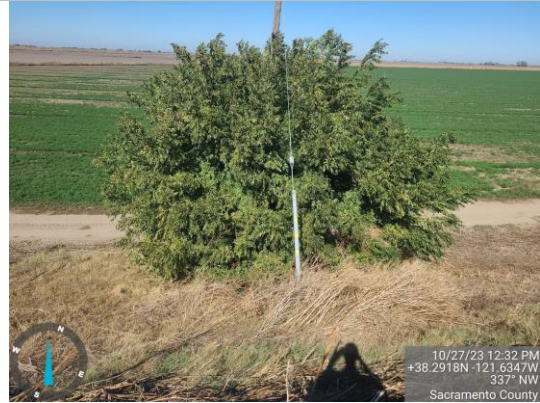
Photo 1 of 1 : FA_2024_RD0999_233_1_20240911_00001.jpg

Tree on the LS slope. Fall 2023

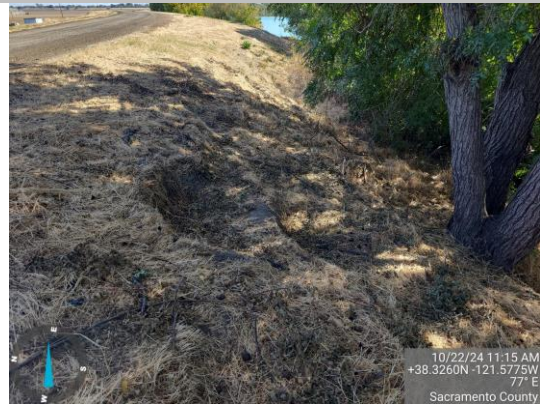
Photo 1 of 1 : FA_2024_RD0999_233_2_20241025_00009.jpg

LM Start	1.15	Rating **	M	Issue No.	2
LM End	1.15	Issue Type +	Ma	Location *	WS
Category	Earthen Levee			GPS Latitude/Longitude	
				Start	End
Item	Erosion / Bank Caving			38.291045°	38.291045°
				-121.625112°	-121.625112°
DWR ID	DWR_RD0999_02_f_2023_2				
Comment Code					
E2 : Schedule repair of erosion site prior to the next inspection.					
Inspector Comment					
Repair benching cut in the WS slope.

Bench in the WS slope. Fall 2024

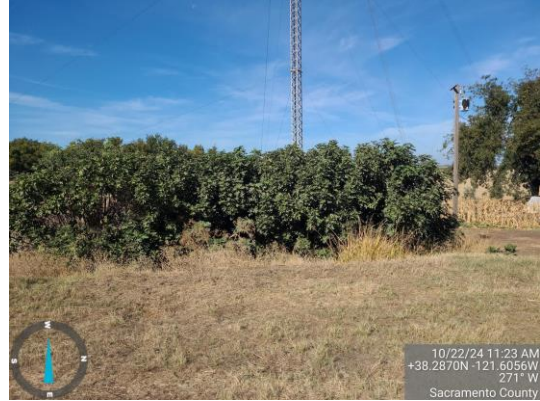
Photo 1 of 1 : FA_2024_RD0999_234_1_20241025_00016.jpg

Trees on the LS slope. Fall 2024

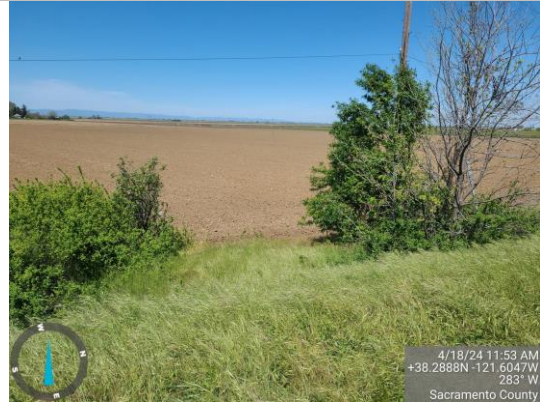
Photo 1 of 1 : FA_2024_RD0999_234_11_20240911_00008.jpg

LM Start	0.18	Rating **	M	Issue No.	11
LM End	0.18	Issue Type +	Ma	Location *	LS
Category	Earthen Levee			GPS Latitude/Longitude	
				Start	End
Item	Trim / Thin Trees			38.288893°	38.288893°
				-121.604663°	-121.604663°
DWR ID	DWR_RD0999_03_f_2021_11				
Comment Code					
T1 : Trim and thin trees to at least five feet above ground level to allow visibility of the ground and room to flood fight.					
Inspector Comment					
Remove trees or trim to 5' above the slope.

Trees on the LS slope. Spring 2024

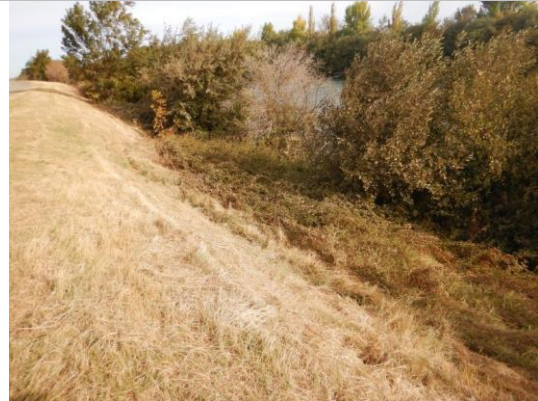
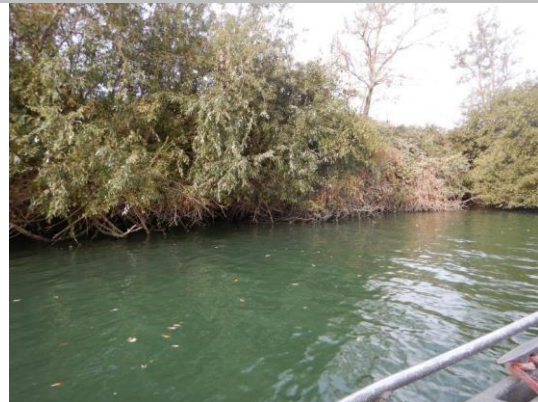
Comment Code					
Inspector Comment					
2018 Site ID: STR 24.7 R					
Status: Critical					
2022 Field Notes: No observed changes.					
Site History: 1997 - Intermittent over-steepened sections. Large riparian vegetation along the length of the entire reach. Attempts to repair with rock on bank have failed. 1999 - New rock repair at the downstream end. 2002 - Some minor spot repairs. 2009 - Minimal new erosion. 2010 - Appears that fresh rock placed on downstream portion of site. Toe scour and overhanging trees with some overturned. 2012 - Minor new erosion at the toe. 2013 - Site upgraded to CRITICAL. Severe slumping into levee at downstream end of site. Fresh erosion into bank toe. 2015 - New slumping, tall vertical sections. 2016 - Upper slumped section continues to worsen. 2017 - Locals have placed rock in worst sections. Fresh erosion at toe. New tall vertical sections observed. 2018 -Length reduced on downstream side to account for repaired section.

USACE 2018 Erosion Photo #1

USACE 2018 Erosion Photo #2

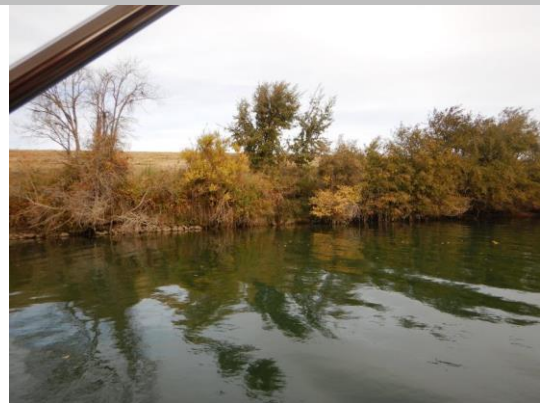
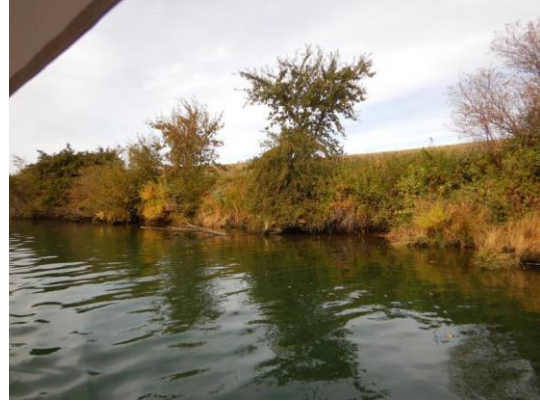
LM Start	0.97	Rating **	M	Issue No.	6
LM End	1.10	Issue Type +	Ma	Location *	WS
Category	Supplemental			GPS Latitude/Longitude	
				Start	End
Item	2018 USACE Erosion Survey			38.299402°	38.300542°
				-121.603056°	-121.601118°
DWR ID	DWR_RD0999_03_s_2022_6				
Comment Code					
Inspector Comment					
2018 Site ID: STR 25.2 R					
Status: Eroding					
2022 Field Notes: No observed changes.					
Site History: 2008 - Over steepened levee section. 2009 - Significant new erosion. 2010 - Minor new erosion. 2017 - Minor new erosion at toe. 2018 - New large slump on upper levee slope.

USACE 2018 Erosion Photo #1

USACE 2018 Erosion Photo #2

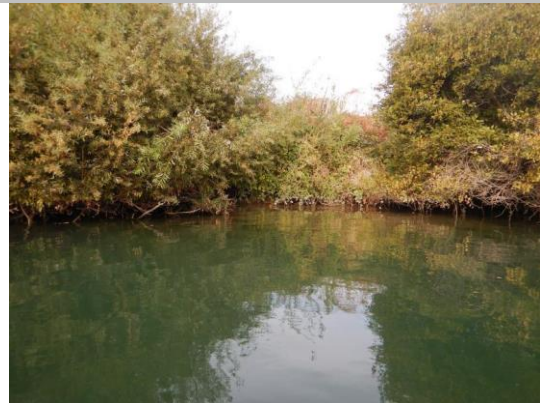
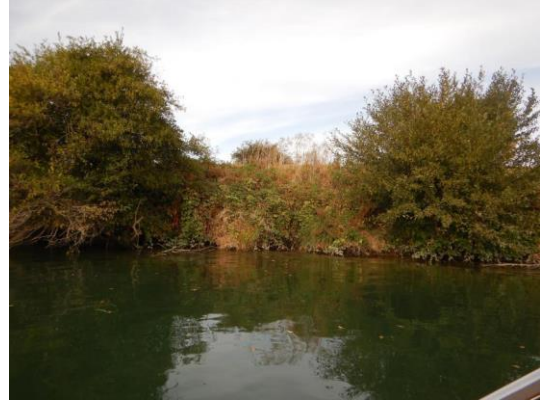
2018 Site ID: STR 25.7 R
Status: Eroding
2022 Field Notes: No observed changes.
Site History: 2011 - Toe scour along length of site and erosion pockets.
2012 - Site extended slightly upstream due to new erosion pocket.
2013 - Tall vertical sections at upstream end of site. 2017 - Large erosion scarp near downstream end. 2018 - Site extended upstream.

USACE 2018 Erosion Photo #1

USACE 2018 Erosion Photo #2

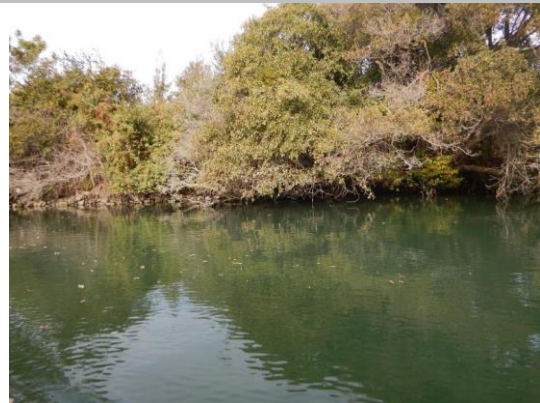
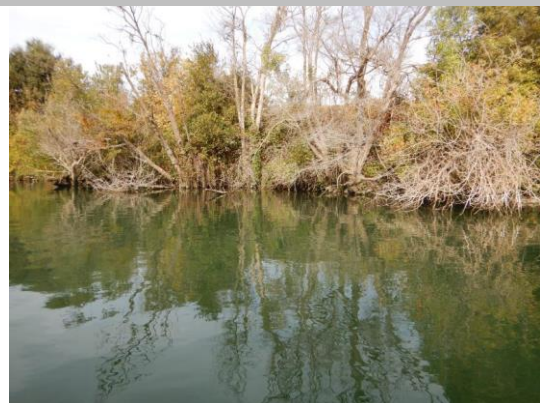
2018 Site ID: STR 26.1 R
Status: Eroding
2022 Field Notes: No observed change.
Site History: 2015 - Tall vertical sections into the levee slope and erosion along the toe. 2016 - New tree pop-out observed. 2018 - No observed change.

USACE 2018 Erosion Photo #1

USACE 2018 Erosion Photo #2

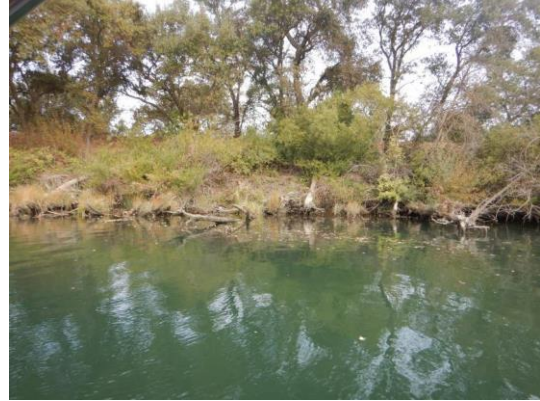
Photo 1 of 1 : FA_2024_RD0999_234_14_20240911_00011.jpg

LM Start	2.97	Rating **	A/W	Issue No.	14
LM End	3.22	Issue Type +	Ma	Location *	WS
Category	Supplemental			GPS Latitude/Longitude	
				Start	End
Item	2018 USACE Erosion Survey			38.323419°	38.325592°
				-121.589645°	-121.585925°
DWR ID	DWR_RD0999_03_s_2022_14				
Comment Code					
Inspector Comment					
2018 Site ID: STR 27.3 R					
Status: Eroding					
2022 Field Notes: No observed change.					
Site History: 2011 - Multiple erosion pockets. Some likely from tree popouts. 2013 - Tall vertical sections. 2015 - New tree pop-out and significant new erosion. 2016 - New erosion at toe. 2017 - Site extended downstream, section of lower bank has slumped off. Fresh toe erosion and fresh tree popout. 2018 - No observed change.

USACE 2018 Erosion Photo #1

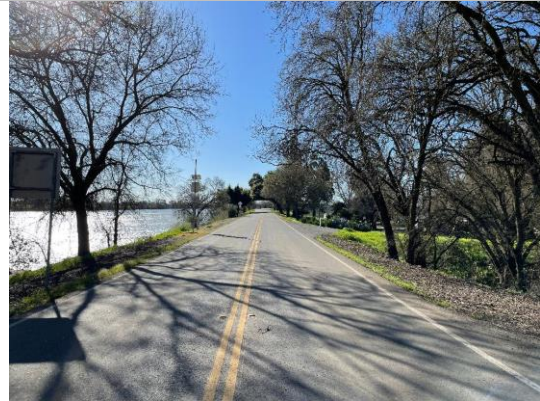
Photo 1 of 3 : UCIP_FA_2024_82532_119642.jpg

Comment Code						
Inspector Comment						
DS_ID:22788 FS_ID:82532 EP_NO: N/A Repair Type: No Action Needed EVAL Issue: Crossing Status: Found UCIP Comments: 03/14/2024 Record remains No Action Needed. (J. Taylor - DWR UCIP) 07/01/2020 Record remains No Action Needed. No issues observed during inspection. This crossing was identified as a System Feature. (D.Sanoski - DWR UCIP) 10/27/2017 This structure is inspected annually under the Structure and Channel Summer Inspection (part of the Levee Inspection Program) conducted by the DWR Flood Project Integrity and Inspection Branch (FPIIB). (DWR UCIP - O. Magana) FIELD_STRUCT_DESC: [Elk Slough Inlet Structure] 60-inch by 60-inch reinforced concrete drainage culvert through the levee, 30 feet below the crown. Slide gate in a 6-foot by 8-foot concrete vault on the waterside (WS) shoulder. [Additional Reference(s): DWR Levee Log, 1992 (HLM 0.00). USACE Sacramento O&M Manual, Unit 113, October 1966, Revised 29 December 2016, (0.00), listed as 5-foot by 5-foot culvert.] FS Date: 3/14/2024 12:02:28 PM

Overview of levee crown looking D/S.

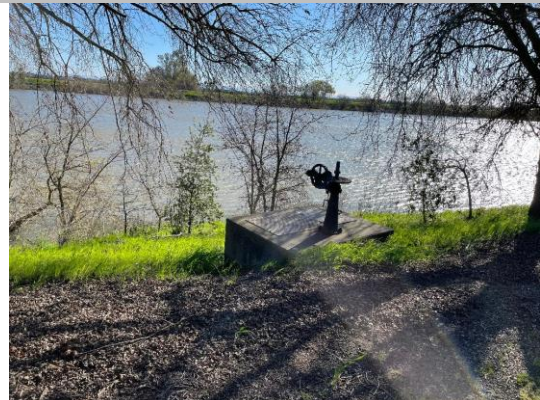
Photo 2 of 3 : UCIP_FA_2024_82532_119643.jpg

WS view: Overview of WS with concrete vault on shoulder.

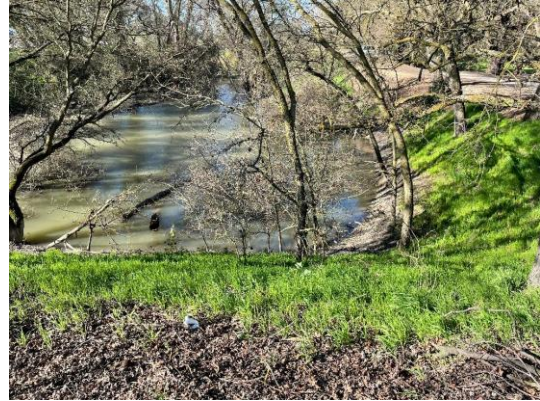
Photo 3 of 3 : UCIP_FA_2024_82532_119644.jpg

LS view: overview of LS slope and drainage channel.

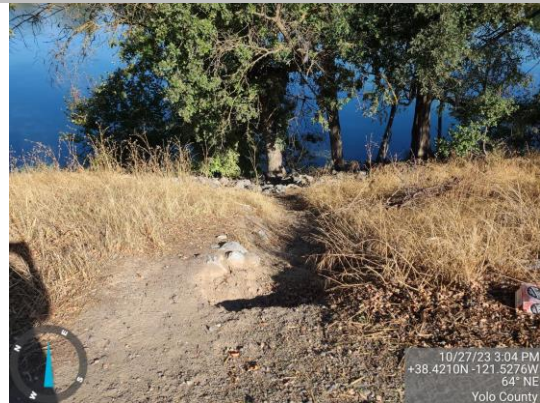
Photo 1 of 1 : FA_2024_RD0999_235_39_20240911_00009.jpg

LM Start	0.55	Rating **	M	Issue No.	39
LM End	0.55	Issue Type +	Ma	Location *	WS
Category	Earthen Levee			GPS Latitude/Longitude	
				Start	End
Item	Erosion / Foot Traffic			38.421051°	38.421051°
				-121.527692°	-121.527692°
DWR ID	DWR_RD0999_04_s_2022_39				
Comment Code					
E3 : Repair the levee slope damaged by foot traffic and prevent access where possible.					
Inspector Comment					
Repair two footpaths on the WS slope.

Footpath on the WS slope. Fall 2023

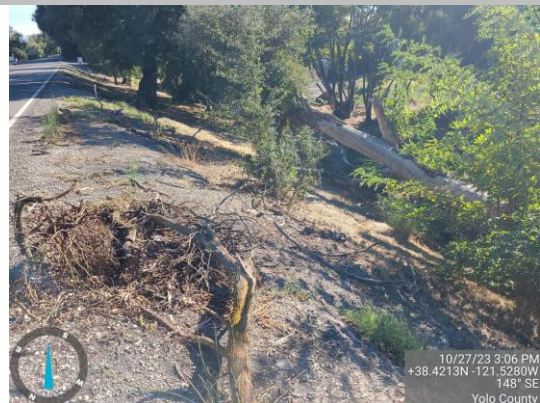
Photo 1 of 1 : FA_2024_RD0999_235_35_20240911_00006.jpg

Fallen tree on the LS slope. Fall 2023

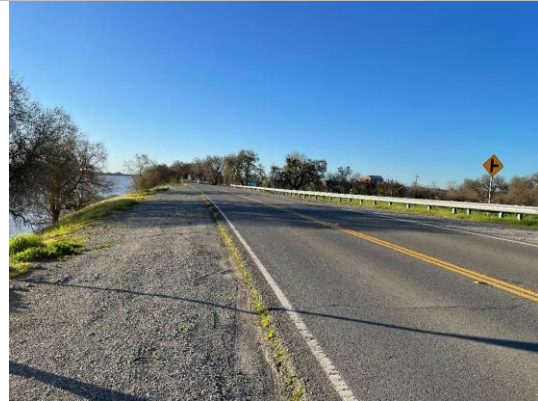
Photo 1 of 3 : UCIP_FA_2024_82565_119733.jpg

Comment Code						
Inspector Comment						
DS_ID:22803 FS_ID:82565 EP_NO: N/A Repair Type: No Action Needed EVAL Issue: Crossing Status: Indicator Found UCIP Comments: 03/14/2024 Record remains No Action Needed. (J. Taylor - DWR UCIP) 07/01/2020 Record remains No Action Needed. No issues observed during inspection. (D.Sanoski - DWR UCIP) FIELD_STRUCT_DESC: *ABANDONED* 16-inch steel drainage pipe through the levee, 20 feet below the crown. (16-inch pipe abandoned and grouted in place authorized under Permit No. 6685, 1969 - American Crystal Sugar Company). Location identified by electromagnetic survey. [Additional Reference(s): USACE Sacramento O&M Manual, Unit 113, October 1966, Revised 29 December 2016, (1.13), listed as 16-inch pipe.] FS Date: 3/14/2024 3:17:13 PM

Overview of levee crown looking D/S.

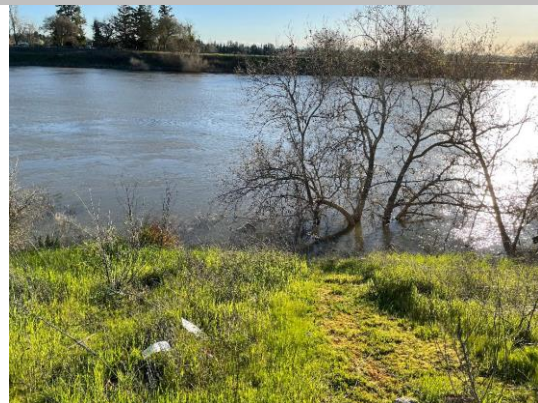
Photo 2 of 3 : UCIP_FA_2024_82565_119734.jpg

WS view: overview of WS.

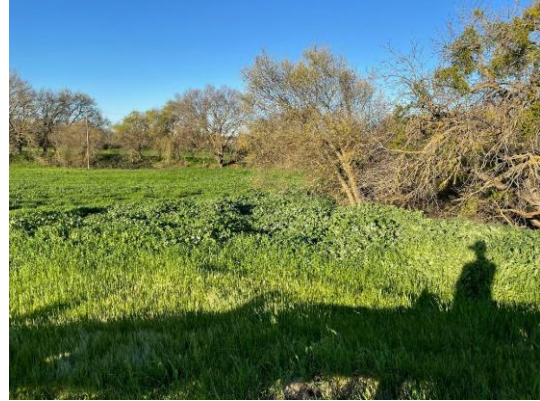
Photo 3 of 3 : UCIP_FA_2024_82565_119735.jpg

LS view: overview of LS.

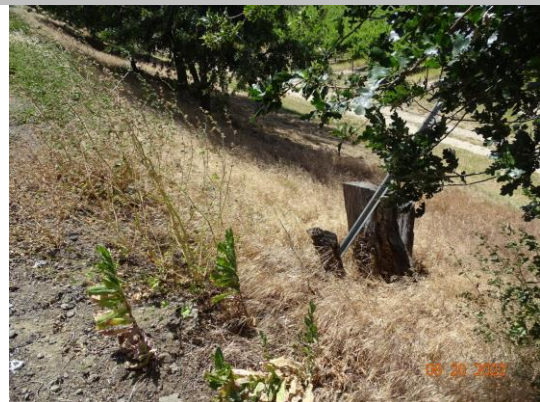
Photo 1 of 1 : FA_2024_RD0999_236_75_20240911_00030.jpg

Stumps on the landside slope. Spring 2022

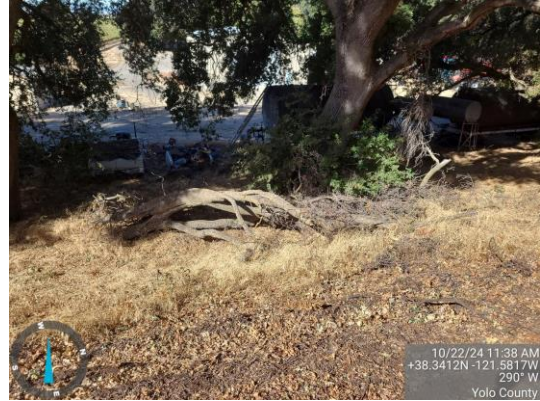
Photo 1 of 1 : FA_2024_RD0999_236_31_20241025_00155.jpg

Tree on the LS slope. Fall 2024

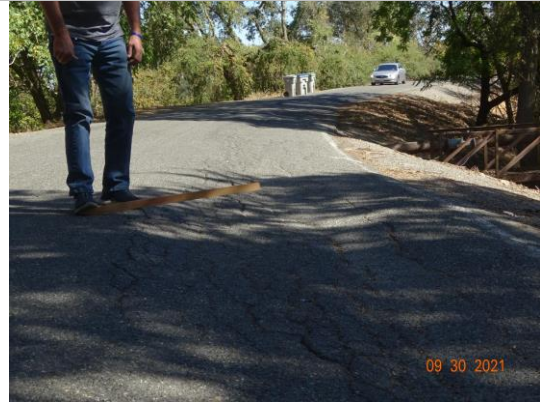
Photo 1 of 2 : FA_2024_RD0999_236_55_20240911_00018.jpg

LM Start	1.10	Rating **	U	Issue No.	55
LM End	1.14	Issue Type +	Ma	Location *	CR
Category	Earthen Levee			GPS Latitude/Longitude	
				Start	End
Item	Crown Surface / Depressions / Rutting			38.347889°	38.348159°
				-121.579191°	-121.578665°
DWR ID	DWR_RD0999_05_f_2021_55				
Comment Code					
C2 : Repair depressions or ruts in the crown or slope.					
Inspector Comment					
Crown sloughing at roadway edge. Approximately 500' long and 6" deep.

Depth of sloughing on WS crown. Fall 2021

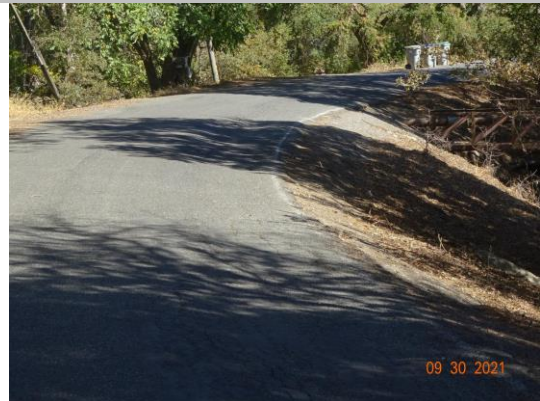
Photo 2 of 2 : FA_2024_RD0999_236_55_20240911_00019.jpg

Length of sloughing on WS crown. Fall 2021

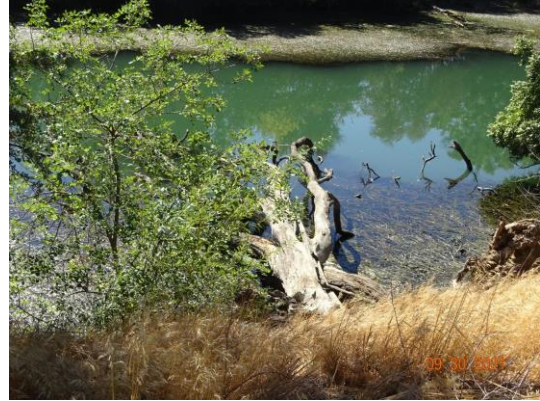
Photo 1 of 1 : FA_2024_RD0999_236_273_20240911_00099.jpg

Fallen tree in channel. Fall 2021

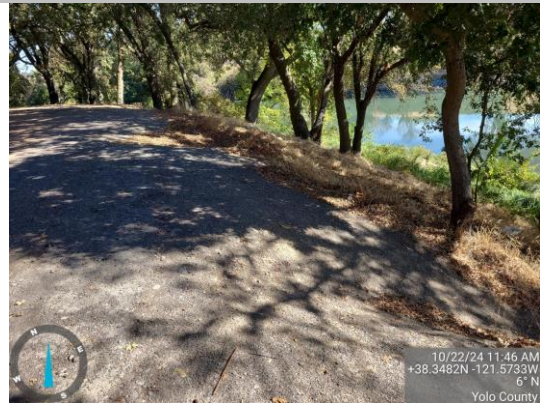
Photo 1 of 1 : FA_2024_RD0999_236_61_20241025_00156.jpg

LM Start	1.43	Rating **	M	Issue No.	61
LM End	1.43	Issue Type +	Ma	Location *	WS
Category	Earthen Levee			GPS Latitude/Longitude	
				Start	End
Item	Erosion / Foot Traffic			38.348283°	38.348283°
				-121.573347°	-121.573347°
DWR ID	DWR_RD0999_05_s_2020_61				
Comment Code					
E3 : Repair the levee slope damaged by foot traffic and prevent access where possible.					
Inspector Comment					
Repair the three footpaths in the area.

Footpaths on the WS slope. Fall 2024

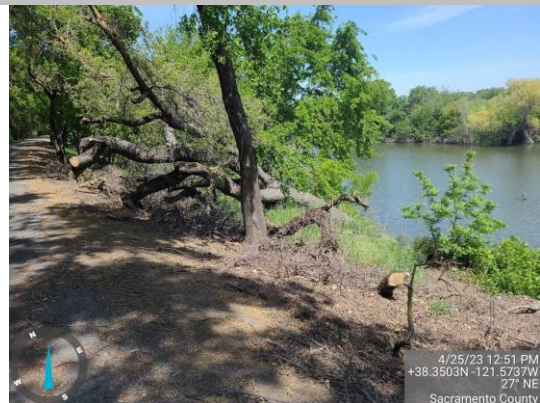
Photo 1 of 1 : FA_2024_RD0999_236_8_20240911_00003.jpg

Tree with root ball on the WS slope. Spring 2023

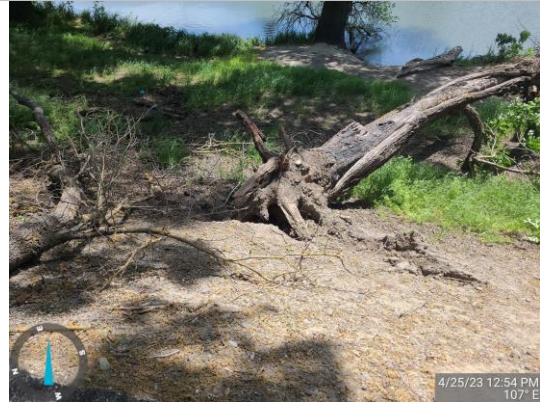
Photo 1 of 1 : FA_2024_RD0999_236_9_20240911_00004.jpg

LM Start	1.98	Rating **	U	Issue No.	9
LM End	1.98	Issue Type +	Ma	Location *	WS
Category	Earthen Levee			GPS Latitude/Longitude	
				Start	End
Item	Trim / Thin Trees			38.355434°	38.355434°
				-121.571767°	-121.571767°
DWR ID	DWR_RD0999_05_s_2023_9				
Comment Code					
T3 : Fallen tree with root ball.					
Inspector Comment					
Remove tree from slope and repair void from root ball.

Tree with root ball on the WS slope. Spring 2023

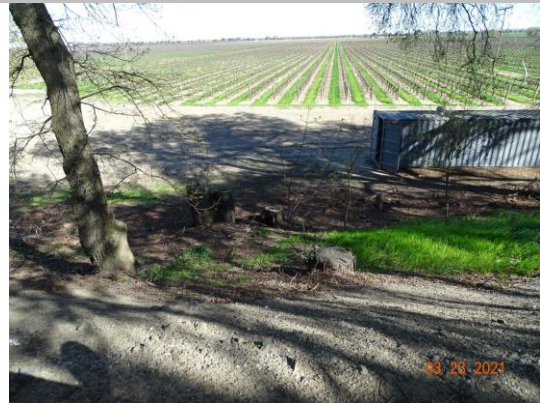
Photo 1 of 1 : FA_2024_RD0999_236_79_20240911_00032.jpg

View of the tree stumps on the LS levee slope. Spring 2021.

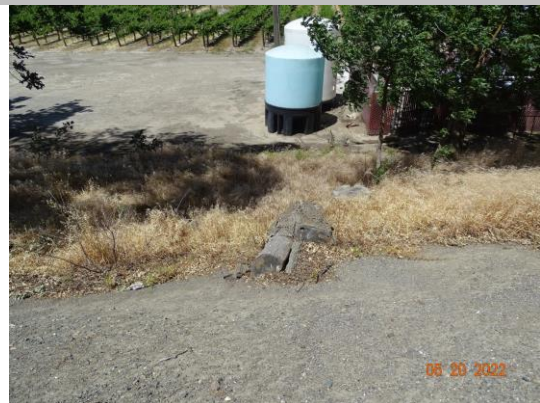
Photo 1 of 1 : FA_2024_RD0999_236_90_20240911_00038.jpg

Tree stump and logs on the landside slope. Spring 2022

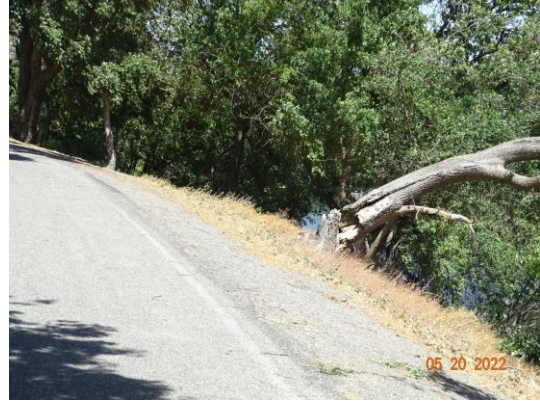
Photo 1 of 1 : FA_2024_RD0999_236_218_20240911_00088.jpg

LM Start	2.51	Rating **	M	Issue No.	218
LM End	2.51	Issue Type +	Ma	Location *	WS
Category	Earthen Levee			GPS Latitude/Longitude	
				Start	End
Item	Trim / Thin Trees			38.356378°	38.356378°
				-121.563185°	-121.563185°
DWR ID	DWR_RD0999_05_f_2020_218				
Comment Code					
T2 : Tree or limb.					
Inspector Comment					
Tree has split and stump will decay.

Fallen tree on the waterside slope. Spring 2022

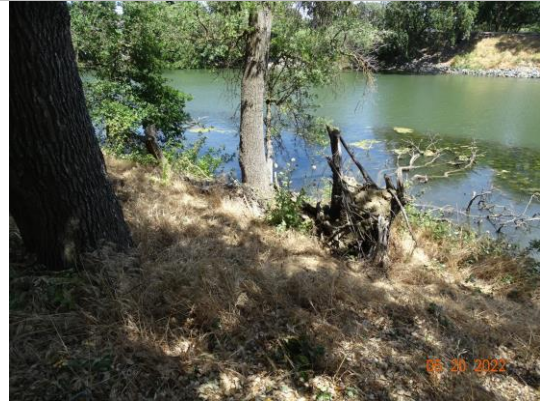
Photo 1 of 1 : FA_2024_RD0999_236_264_20240911_00098.jpg

LM Start	2.56	Rating **	M	Issue No.	264
LM End	2.56	Issue Type +	Ma	Location *	WS
Category	Earthen Levee			GPS Latitude/Longitude	
				Start	End
Item	Trim / Thin Trees			38.356910°	38.356910°
				-121.562635°	-121.562635°
DWR ID	DWR_RD0999_05_s_2020_264				
Comment Code					
T3 : Fallen tree with root ball.					
Inspector Comment					
Repair erosion due to a fallen tree with exposed root ball.

Void from root ball on the waterside slope. Spring 2022

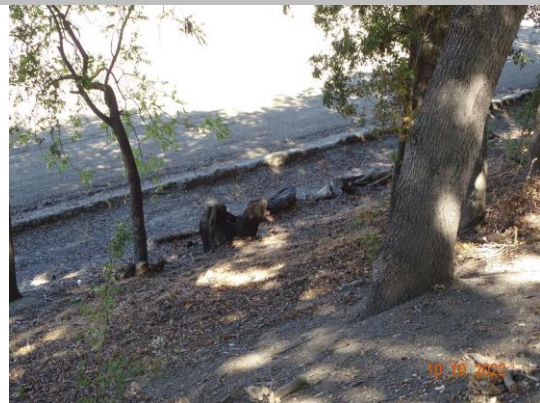
Photo 1 of 1 : FA_2024_RD0999_236_56_20240911_00020.jpg

Stumps on the LS toe. Fall 2022

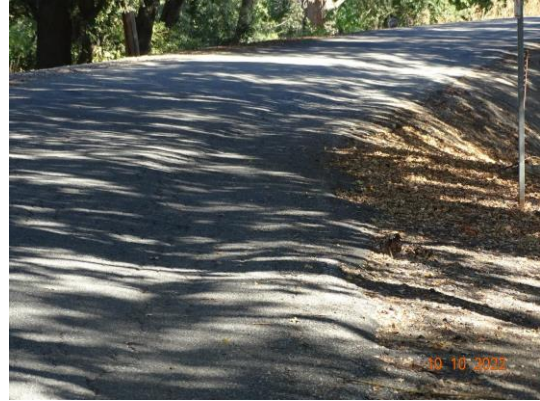
Photo 1 of 1 : FA_2024_RD0999_236_51_20240911_00015.jpg

LM Start	3.05	Rating **	M	Issue No.	51
LM End	3.09	Issue Type +	Ma	Location *	CR
Category	Earthen Levee			GPS Latitude/Longitude	
				Start	End
Item	Crown Surface / Depressions / Rutting			38.363789°	38.364151°
				-121.562826°	-121.562424°
DWR ID	DWR_RD0999_05_f_2022_51				
Comment Code					
C2 : Repair depressions or ruts in the crown or slope.					
Inspector Comment					
Repair crown road depression.

Crown depression. Fall 2022

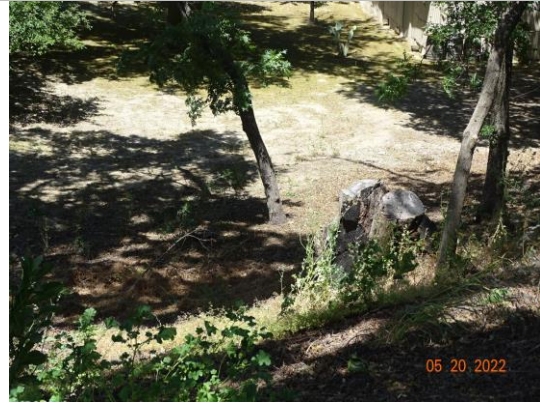
Photo 1 of 1 : FA_2024_RD0999_236_95_20240911_00041.jpg

Tree stump at the landside toe. Spring 2022

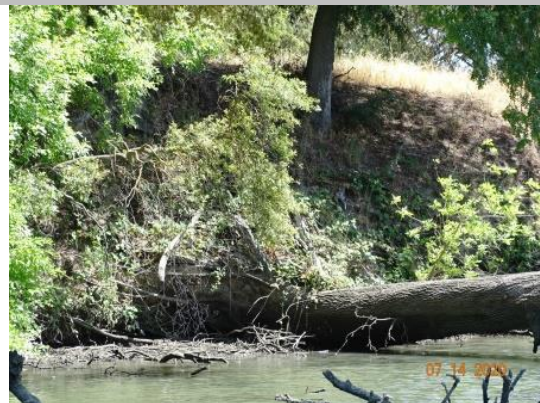
Photo 1 of 1 : FA_2024_RD0999_236_83_20240911_00036.jpg

LM Start	3.55	Rating **	M	Issue No.	83
LM End	3.55	Issue Type +	Ma	Location *	WS
Category	Earthen Levee			GPS Latitude/Longitude	
				Start	End
Item	Trim / Thin Trees			38.365742°	38.365742°
				-121.556778°	-121.556778°
DWR ID	DWR_RD0999_05_f_2018_83				
Comment Code					
T3 : Fallen tree with root ball.					
Inspector Comment					
Repair slope damage caused by a large fallen tree.

View of a fallen tree with exposed root ball. Summer 2020

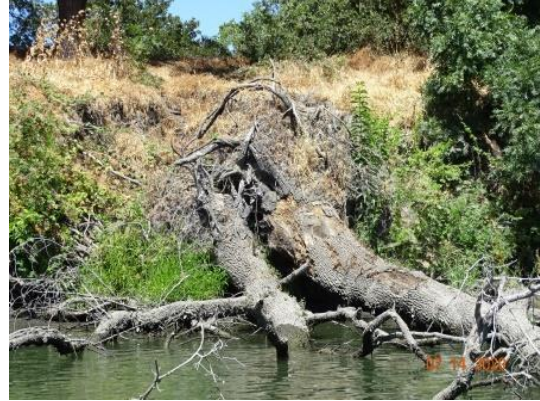
Photo 1 of 1 : FA_2024_RD0999_236_1_20240911_00001.jpg

View of large, fallen tree on the waterside slope. Summer 2020

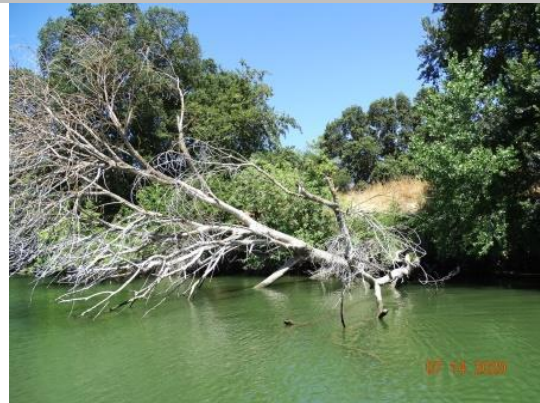
Photo 1 of 1 : FA_2024_RD0999_236_85_20240911_00037.jpg

View of fallen tree and slope damage. Summer 2020

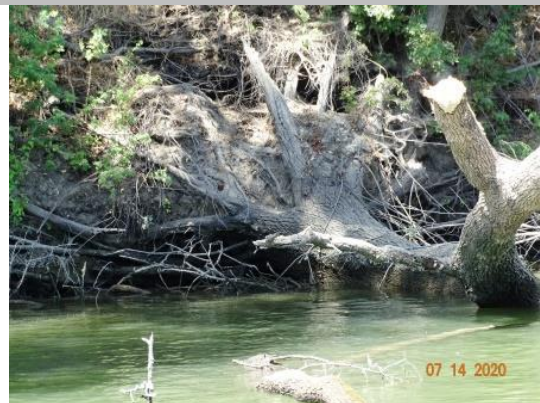
Photo 1 of 1 : FA_2024_RD0999_236_91_20240911_00039.jpg

View of fallen tree with exposed root ball. Summer 2020

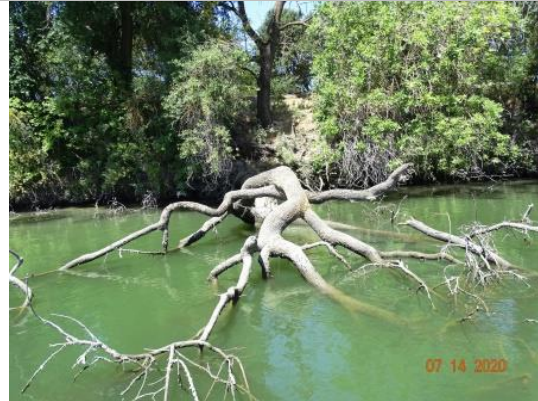
Photo 1 of 2 : FA_2024_RD0999_236_82_20240911_00034.jpg

View of large, fallen tree with exposed root ball. Summer 2020

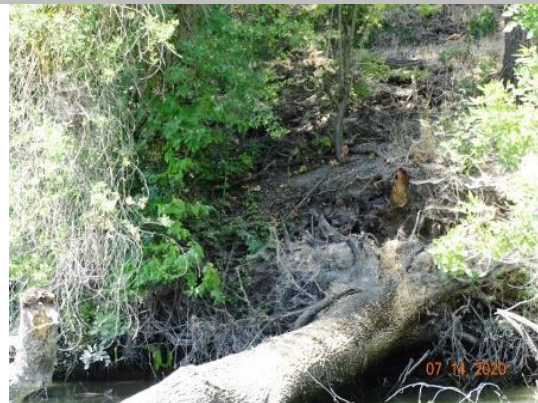
Photo 2 of 2 : FA_2024_RD0999_236_82_20240911_00035.jpg

View of scarp around fallen tree. Summer 2020

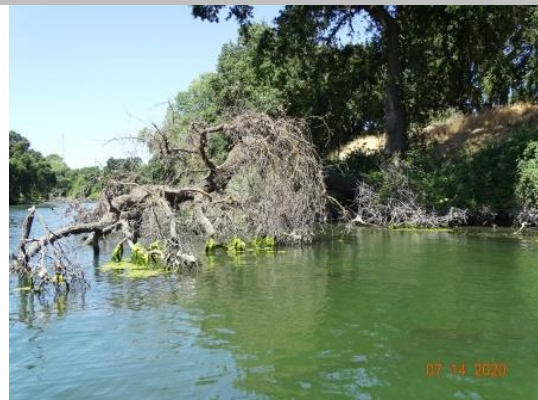
Photo 1 of 1 : FA_2024_RD0999_236_102_20240911_00046.jpg

View of fallen tree split at the base. Summer 2020

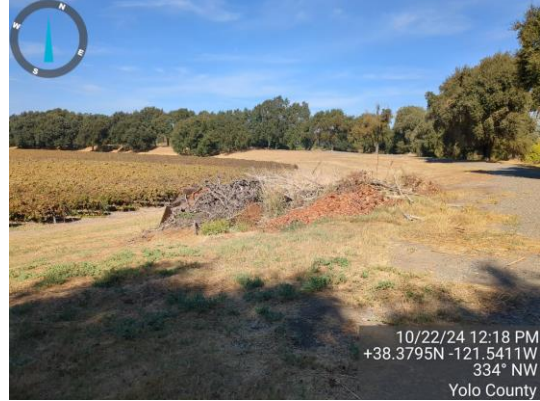
Photo 1 of 1 : FA_2024_RD0999_236_106_20241025_00159.jpg

Pruning pile on the LS slope. Fall 2024

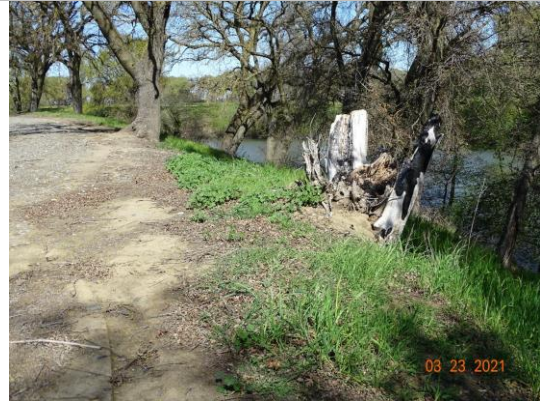
Photo 1 of 1 : FA_2024_RD0999_236_117_20240911_00052.jpg

View of the tree stump on the WS levee slope. Spring 2021.

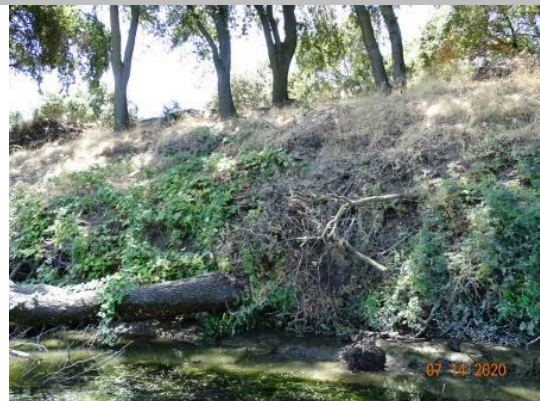
Photo 1 of 1 : FA_2024_RD0999_236_97_20240911_00043.jpg

View of fallen trees and scarp. Summer 2020

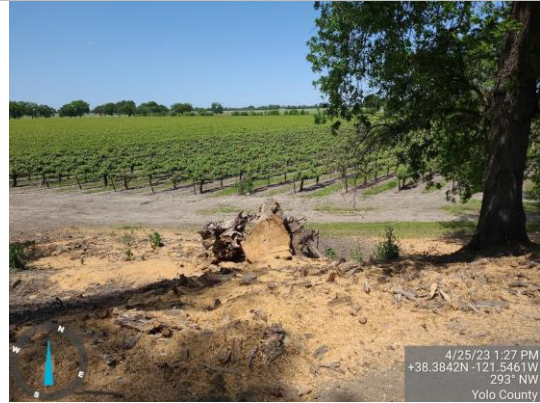
Photo 1 of 1 : FA_2024_RD0999_236_62_20240911_00024.jpg

Stumps on the LS slope. Spring 2023

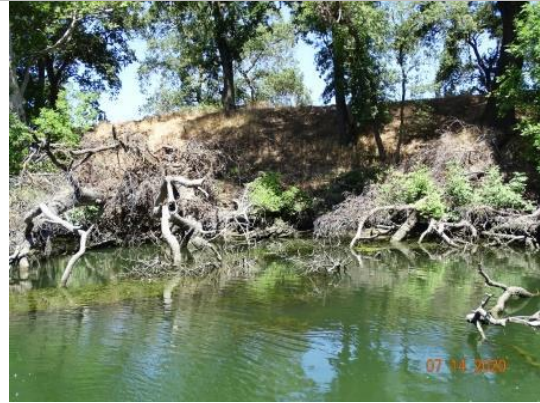
Photo 1 of 2 : FA_2024_RD0999_236_229_20240911_00094.jpg

View of two fallen trees. Summer 2020

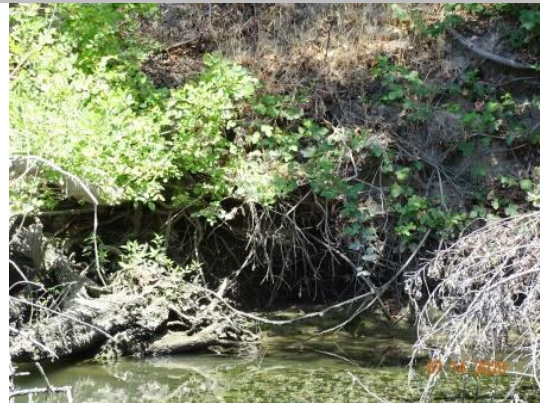
Photo 2 of 2 : FA_2024_RD0999_236_229_20240911_00095.jpg

View of large scarp near two fallen trees. Summer 2020

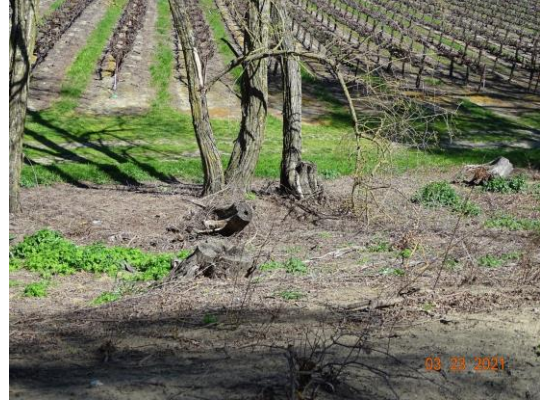
Photo 1 of 1 : FA_2024_RD0999_236_129_20240911_00056.jpg

View of the tree stumps on the LS levee slope and toe. Spring 2021.

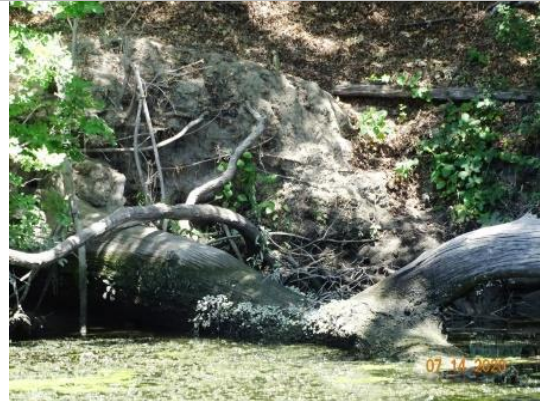
Photo 1 of 1 : FA_2024_RD0999_236_99_20240911_00044.jpg

View of slope damage near fallen tree. Summer 2020

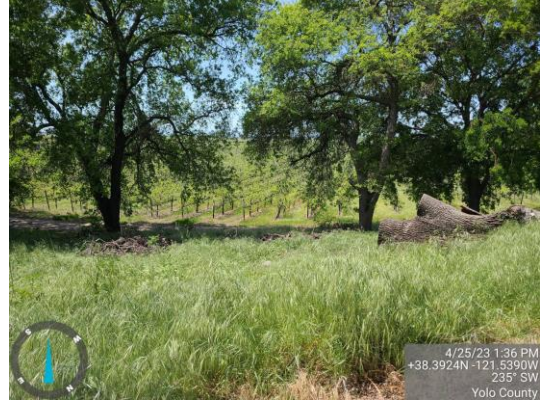
Photo 1 of 1 : FA_2024_RD0999_236_14_20240911_00008.jpg

Logs and prunings on the LS slope. Spring 2023

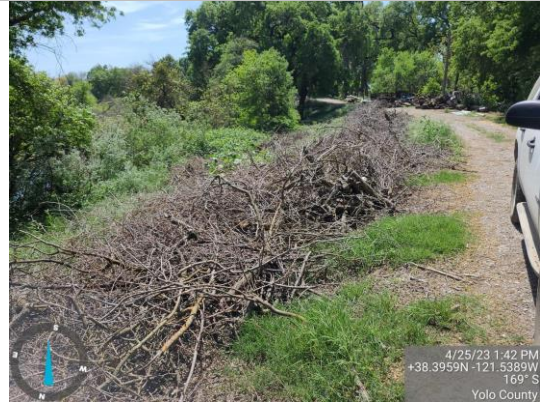
Photo 1 of 1 : FA_2024_RD0999_236_208_20240911_00083.jpg

Prunings on the WS shoulder. Spring 2023

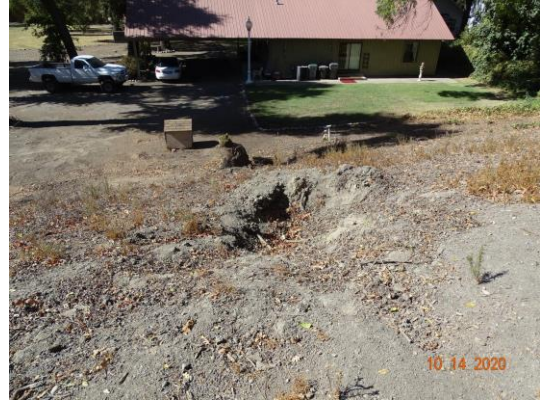
Photo 1 of 1 : FA_2024_RD0999_236_214_20240911_00084.jpg

View of a large hole on the landside slope. Fall 2020

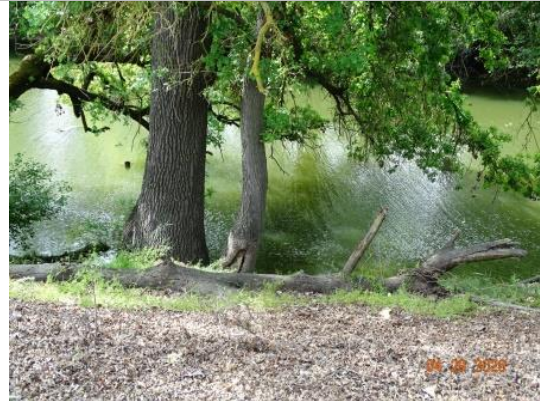
Photo 1 of 1 : FA_2024_RD0999_236_186_20240911_00078.jpg

View of a tree log on the waterside slope. Spring 2020

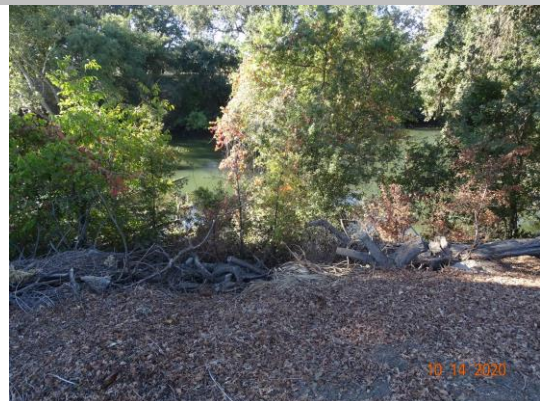
Photo 1 of 1 : FA_2024_RD0999_236_177_20240911_00075.jpg

View of tree logs and limbs on the waterside slope. Fall 2020

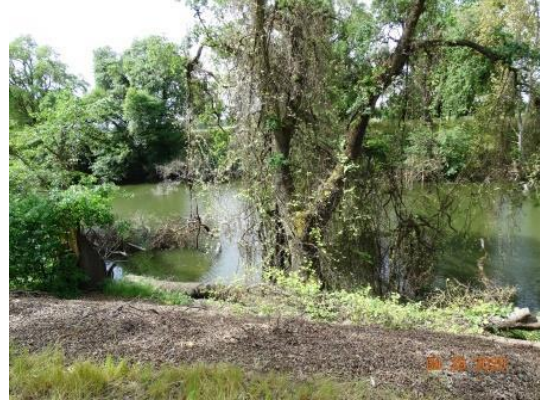
Photo 1 of 1 : FA_2024_RD0999_236_181_20240911_00077.jpg

View of fallen tree on the waterside slope. Spring 2020

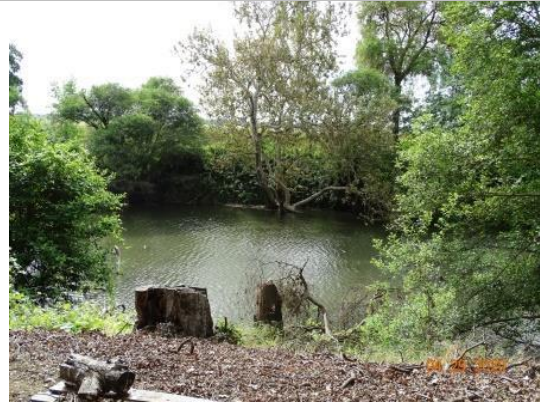
Photo 1 of 1 : FA_2024_RD0999_236_164_20240911_00070.jpg

View of a large tree stump on the waterside slope. Spring 2020

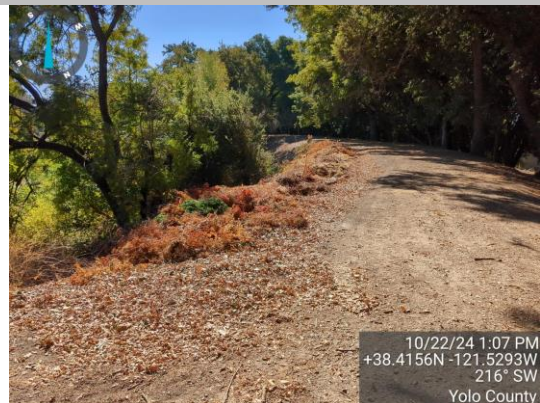
Photo 1 of 1 : FA_2024_RD0999_236_33_20241025_00169.jpg

Prunings on the WS shoulder. Fall 2024
