**Flood Control Project Maintenance  
Levee Inspections**

## Maintenance Issue Types Only, Levee Inspection Report By Mile - Spring 2015

### Reclamation District No. 0999 Netherlands

Waterway	Bank	Unit Miles	Inspection Start/End	Inspector
Unit No. 01 Yolo Bypass	Left	15.41	03/23/2015 03/23/2015	Richard Willoughby

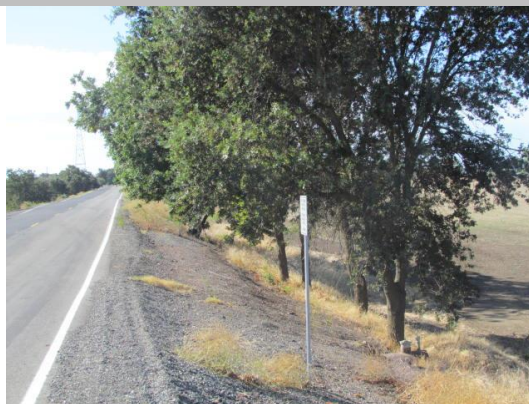
Photo 2 of 2 : SP\_2015\_RD0999\_232\_4\_20150309\_00007.jpg

Looking southwest at trimmed trees on waterward slope.

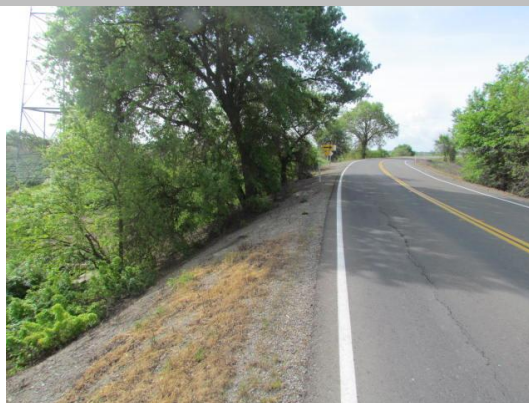
Photo 1 of 3 : SP\_2015\_RD0999\_232\_31\_20150327\_00075.jpg

Looking southeast at untrimmed trees on landward slope. (Spring 2015)

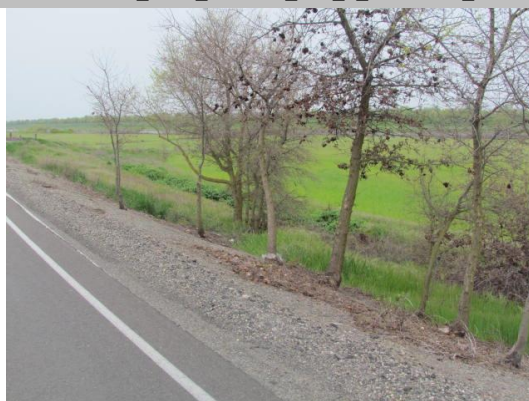
Photo 1 of 1 : SP\_2015\_RD0999\_232\_8\_20150309\_00015.jpg

Looking southwest at trimmed trees on waterside slope. (Spring 2012)

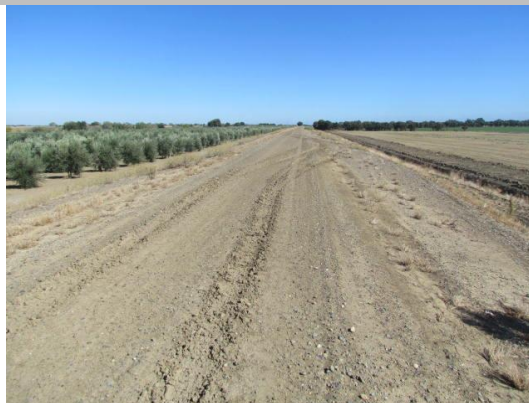
Photo 1 of 3 : SP\_2015\_RD0999\_232\_46\_20150309\_00046.jpg

LM Start	2.76	Rating **	A/W	Issue No.	46
LM End	4.98	Issue Type +	Ma	Location *	CR
Category	Earthen Levee			GPS Latitude/Longitude	
				Start	End
Item	Crown Surface / Depressions / Rutting			38.465627 °	38.435378 °
				-121.584634 °	-121.598664 °
DWR ID	DWR_RD0999_01_f_2013_46				
Action/Comments					
Repair depressions or ruts in the crown or slope. Inspector Comments: Control growth on levee crown and repair ruts on levee crown.

Looking north at rutting on levee crown.

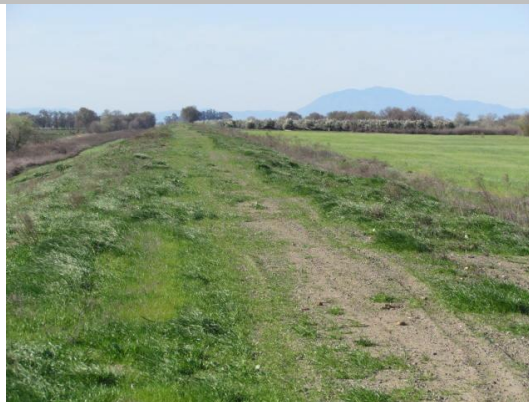
Photo 2 of 3 : SP\_2015\_RD0999\_232\_46\_20150309\_00047.jpg

Looking south at growth and ruts on levee crown.

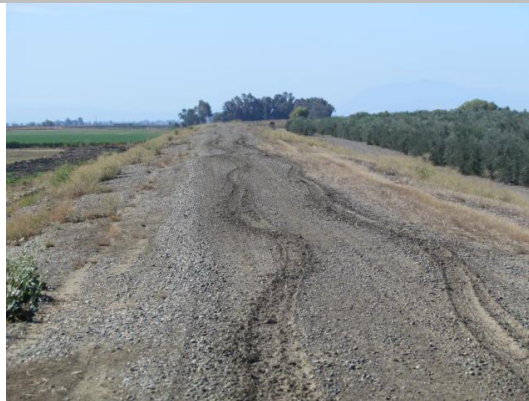
Photo 3 of 3 : SP\_2015\_RD0999\_232\_46\_20150309\_00048.jpg

LM Start	2.76	Rating **	A/W	Issue No.	46 (cont)
LM End	4.98	Issue Type +	Ma	Location *	CR
Category	Earthen Levee			GPS Latitude/Longitude	
				Start	End
Item	Crown Surface / Depressions / Rutting			38.465627 °	38.435378 °
				-121.584634 °	-121.598664 °
DWR ID	DWR_RD0999_01_f_2013_46				
Action/Comments					
Repair depressions or ruts in the crown or slope. Inspector Comments: Control growth on levee crown and repair ruts on levee crown.

Looking south at rutting on levee crown.

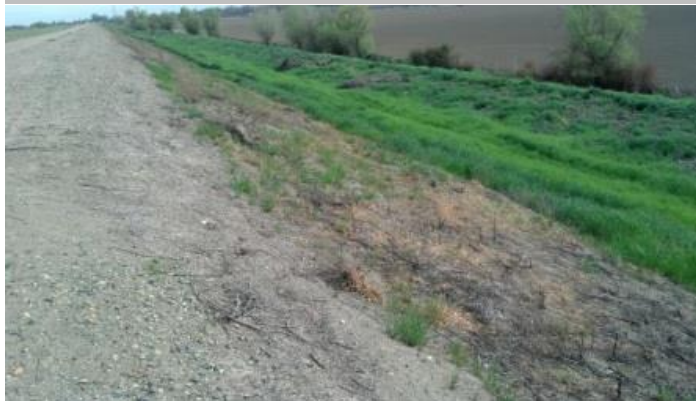
Photo 1 of 2 : SP\_2015\_RD0999\_232\_51\_20150309\_00056.jpg

LM Start	3.24	Rating **	M	Issue No.	51
LM End	3.26	Issue Type +	Ma	Location *	LS
Category	Earthen Levee			GPS Latitude/Longitude	
				Start	End
Item	Slope Stability				°
					°
DWR ID	DWR_RD0999_01_s_2013_51				
Action/Comments					
Repair slope instability. Inspector Comments: Depression on waterside shoulder and slope 60' x 20'. Earthen material appears to be sliding toward levee toe.

Looking north at depression on landside shoulder and slope.

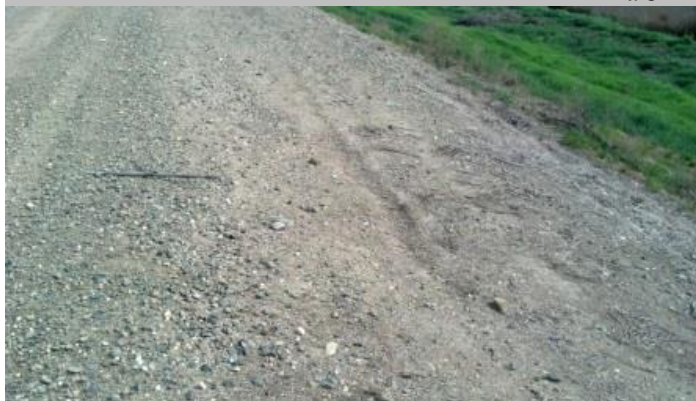
Photo 2 of 2 : SP\_2015\_RD0999\_232\_51\_20150309\_00057.jpg

Looking northeast at depression on landside shoulder.

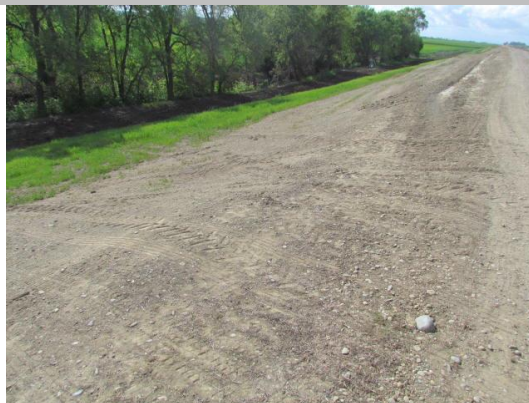
Photo 1 of 4 : SP\_2015\_RD0999\_232\_35\_20150327\_00076.jpg

LM Start	4.31	Rating **	M	Issue No.	35
LM End	4.31	Issue Type +	Ma	Location *	LS
Category	Earthen Levee			GPS Latitude/Longitude	
				Start	End
Item	Slope Stability			38.444561 °	38.444561 °
				-121.594438 °	-121.594438 °
DWR ID	DWR_RD0999_01_f_2012_35				
Action/Comments					
Repair the levee slope damaged by vehicle traffic and prevent access where possible.					
Inspector Comments: Depression is caused by vehicle traffic.

Looking southeast at slope damage cause by vehicle traffic on landward slope. (Spring 2015)

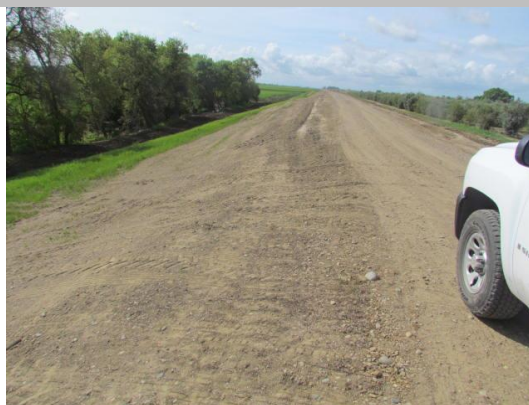
Photo 2 of 4 : SP\_2015\_RD0999\_232\_35\_20150327\_00077.jpg

Looking south at slope damage cause by vehicle traffic on landward slope. (Spring 2015)

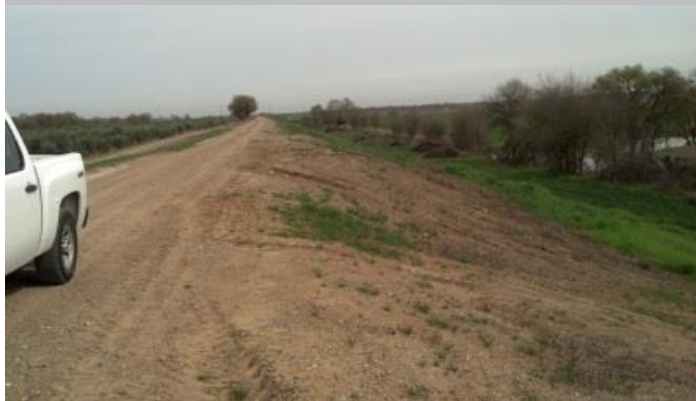
Photo 3 of 4 : SP\_2015\_RD0999\_232\_35\_20150309\_00035.jpg

Looking north at slope damage caused by vehicle traffic.

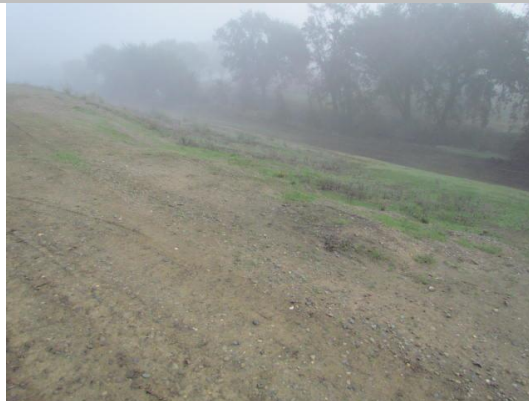
Photo 4 of 4 : SP\_2015\_RD0999\_232\_35\_20150309\_00036.jpg

LM Start	4.31	Rating **	M	Issue No.	35 (cont)	
LM End	4.31	Issue Type +	Ma	Location *	LS	
Category	Earthen Levee			GPS Latitude/Longitude		
				Start		End
Item	Slope Stability			38.444561 °	38.444561 °	
				-121.594438 °	-121.594438 °	
DWR ID	DWR_RD0999_01_f_2012_35					
Action/Comments						
Repair the levee slope damaged by vehicle traffic and prevent access where possible.						
Inspector Comments: Depression is caused by vehicle traffic.

Looking east at slope damage on landside slope.

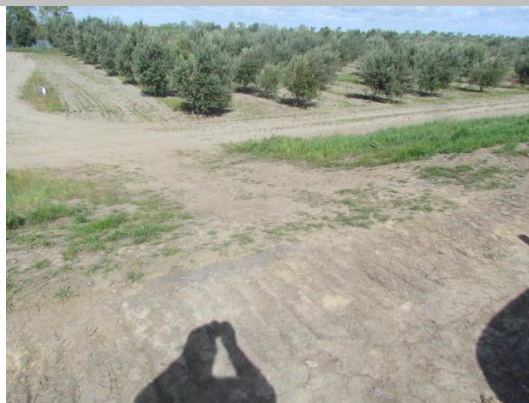
Photo 1 of 3 : SP\_2015\_RD0999\_232\_27\_20150327\_00078.jpg

LM Start	4.31	Rating **	M	Issue No.	27
LM End	4.31	Issue Type +	Ma	Location *	WS
Category	Earthen Levee			GPS Latitude/Longitude	
				Start	End
Item	Slope Stability			38.444560 °	38.444560 °
				-121.594440 °	-121.594440 °
DWR ID	DWR_RD0999_01_f_2012_27				
Action/Comments					
Repair the levee slope damaged by vehicle traffic and prevent access where possible.					
Inspector Comments: Local farmer causing slope damage by driving equipment and trucks on slope.

Looking west at slope damage cause by vehicle traffic on waterward slope. (Spring 2015)

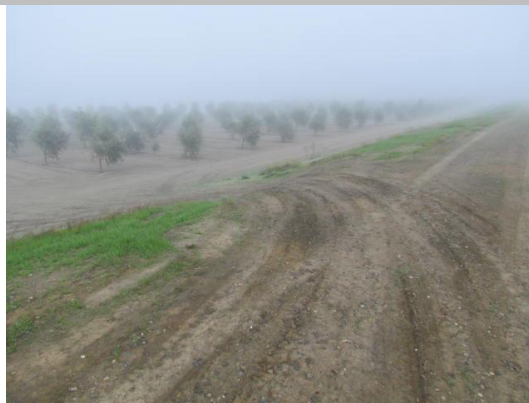
Photo 2 of 3 : SP\_2015\_RD0999\_232\_27\_20150309\_00027.jpg

Looking northwest at slope damage caused by vehicle traffic. (Fall 2014)

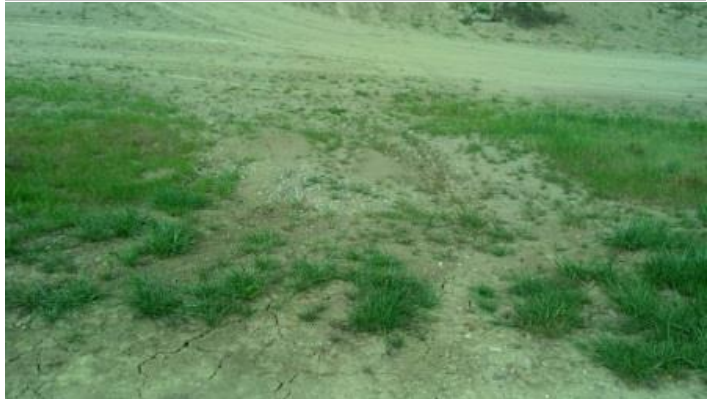
Photo 3 of 3 : SP\_2015\_RD0999\_232\_27\_20150309\_00026.jpg

LM Start	4.31	Rating **	M	Issue No.	27 (cont)
LM End	4.31	Issue Type +	Ma	Location *	WS
Category	Earthen Levee			GPS Latitude/Longitude	
				Start	End
Item	Slope Stability			38.444560 °	38.444560 °
				-121.594440 °	-121.594440 °
DWR ID	DWR_RD0999_01_f_2012_27				
Action/Comments					
Repair the levee slope damaged by vehicle traffic and prevent access where possible.					
Inspector Comments: Local farmer causing slope damage by driving equipment and trucks on slope.

Looking west at slope damage on waterside slope. (Spring 2014)

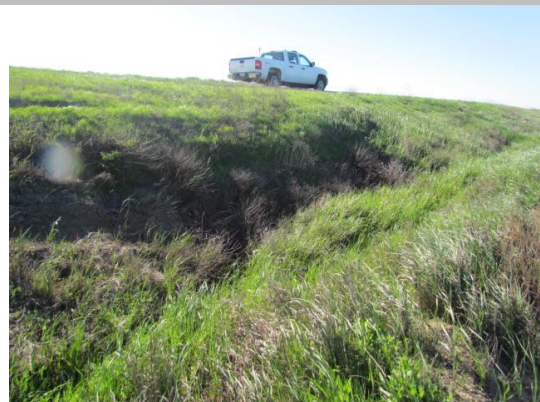
Photo 1 of 2 : SP\_2015\_RD0999\_232\_65\_20150309\_00061.jpg

LM Start	4.84	Rating **	M	Issue No.	65
LM End	4.84	Issue Type +	Ma	Location *	WS
Category	Earthen Levee			GPS Latitude/Longitude	
				Start	End
Item	Slope Stability			38.437388 °	38.437388 °
				-121.597741 °	-121.597741 °
DWR ID	DWR_RD0999_01_s_2014_65				
Action/Comments					
Repair slope instability. Inspector Comments: Slope depression on waterward near toe of levee. Depression is approx. 18' x 14' x 4' in area.

Looking southeast at depression on waterward toe.

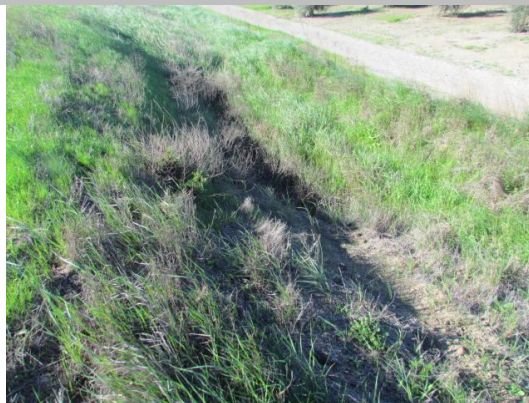
Photo 2 of 2 : SP\_2015\_RD0999\_232\_65\_20150309\_00062.jpg

LM Start	4.84	Rating **	M	Issue No.	65 (cont)	
LM End	4.84	Issue Type +	Ma	Location *	WS	
Category	Earthen Levee			GPS Latitude/Longitude		
				Start		End
Item	Slope Stability			38.437388 °		38.437388 °
				-121.597741 °		-121.597741 °
DWR ID	DWR_RD0999_01_s _ 2014_65					
Action/Comments						
Repair slope instability. Inspector Comments: Slope depression on waterward near toe of levee. Depression is approx. 18' x 14' x 4' in area.

Looking southwest at depression on waterward toe.

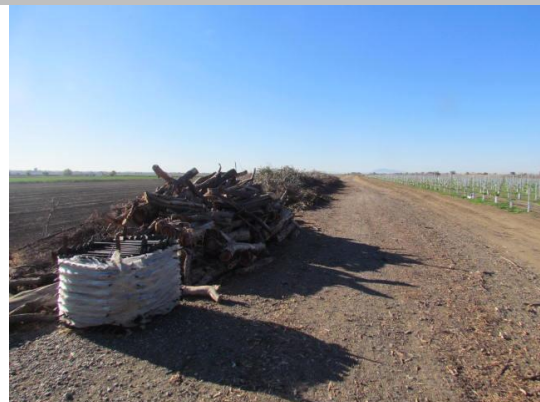
Photo 1 of 2 : SP\_2015\_RD0999\_232\_18\_20150309\_00016.jpg

Looking south at pruning piles on landward shoulder. (Fall 2014)

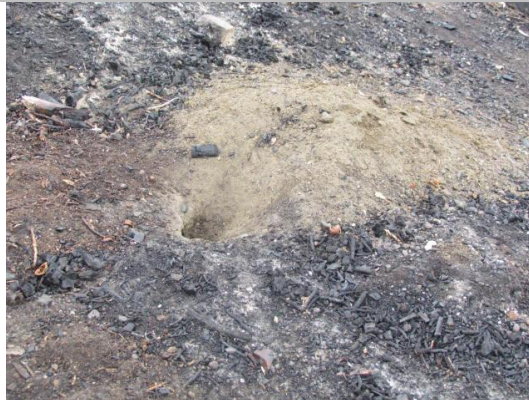
Photo 2 of 2 : SP\_2015\_RD0999\_232\_42\_20150309\_00043.jpg

Looking at typical rodent hole on landside slope.

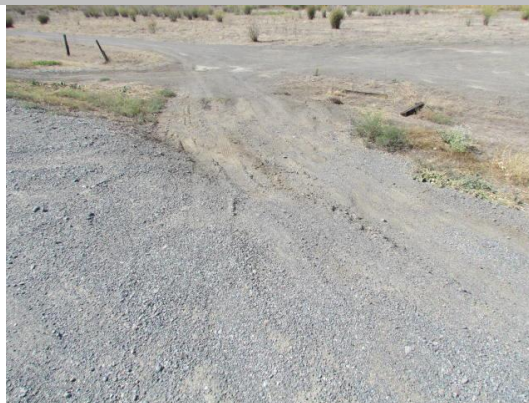
Photo 1 of 2 : SP\_2015\_RD0999\_232\_48\_20150309\_00050.jpg

LM Start	11.84	Rating **	M	Issue No.	48
LM End	11.84	Issue Type +	Ma	Location *	WS
Category	Earthen Levee			GPS Latitude/Longitude	
				Start	End
Item	Slope Stability			38.342068 °	38.342068 °
				-121.641944 °	-121.641944 °
DWR ID	DWR_RD0999_01_f_2012_48				
Action/Comments					
Repair the levee slope damaged by vehicle traffic and prevent access where possible.					
Inspector Comments: Slope damage caused by vehicle traffic.

Looking southwest at slope damage caused by vehicle traffic. 2013

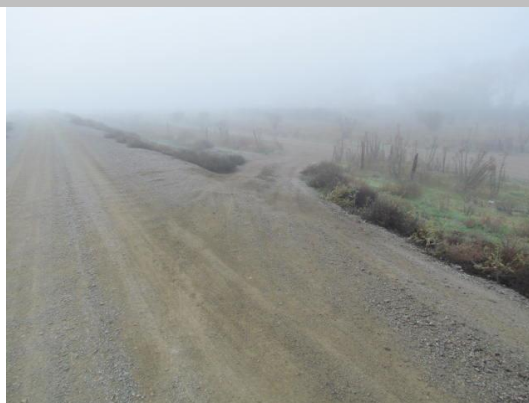
Photo 2 of 2 : SP\_2015\_RD0999\_232\_48\_20150309\_00051.jpg

Looking southwest at slope damage caused by vehicle traffic on waterside slope.

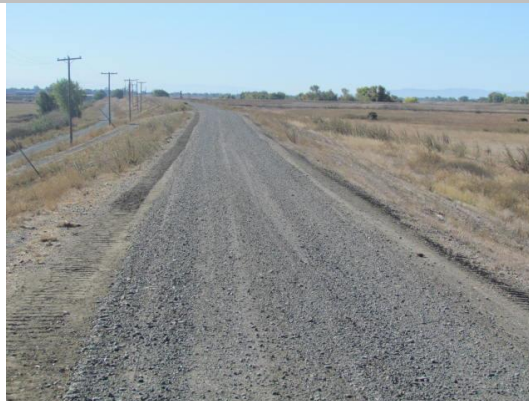
Photo 1 of 4 : SP\_2015\_RD0999\_232\_21\_20150309\_00018.jpg

LM Start	12.53	Rating **	A/W	Issue No.	21
LM End	12.60	Issue Type +	Ma	Location *	CR
Category	Earthen Levee			GPS Latitude/Longitude	
				Start	End
Item	Crown Surface / Depressions / Rutting			38.332288 °	38.331247 °
				-121.644640 °	-121.644765 °
DWR ID	DWR_RD0999_01_s_2012_21				
Action/Comments					
Repair depressions or ruts in the crown or slope.

Looking south at graded levee crown.(Fall 2014)

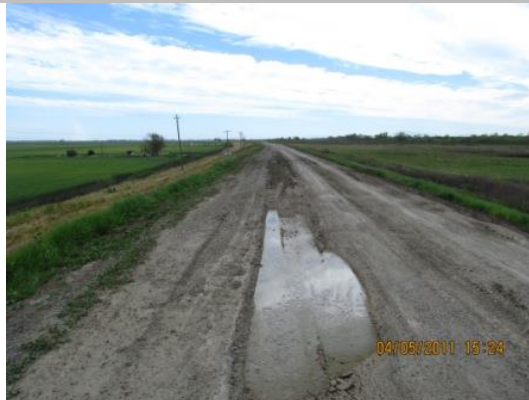
Photo 3 of 4 : SP\_2015\_RD0999\_232\_21\_20150309\_00020.jpg

Looking south at rutting on levee crown.

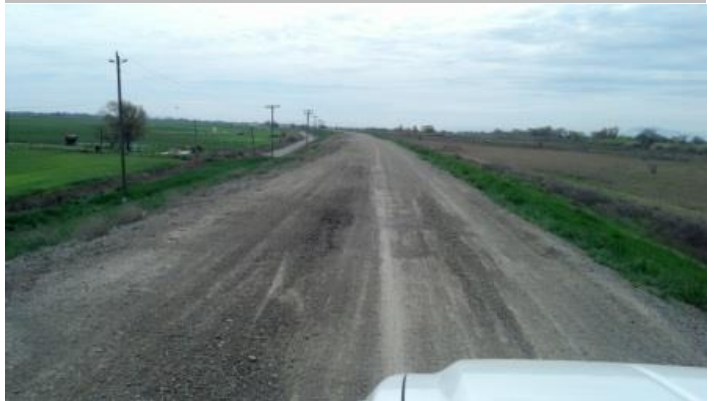
Photo 4 of 4 : SP\_2015\_RD0999\_232\_21\_20150309\_00021.jpg

LM Start	12.53	Rating **	A/W	Issue No.	21 (cont)
LM End	12.60	Issue Type +	Ma	Location *	CR
Category	Earthen Levee			GPS Latitude/Longitude	
				Start	End
Item	Crown Surface / Depressions / Rutting			38.332288 °	38.331247 °
				-121.644640 °	-121.644765 °
DWR ID	DWR_RD0999_01_s_2012_21				
Action/Comments					
Repair depressions or ruts in the crown or slope.

Looking south at rutting on levee crown. Spring 2013

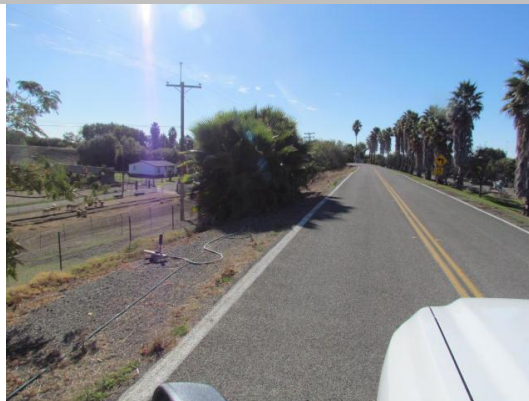
Photo 2 of 3 : SP\_2015\_RD0999\_232\_50\_20150309\_00054.jpg

Looking east at a maturing palm trees on landward shoulder and slope. (Fall 2014)

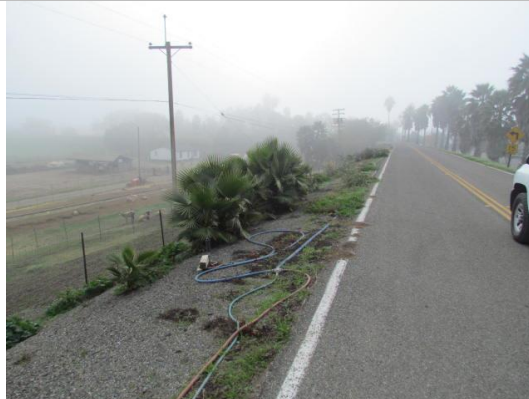
Photo 3 of 3 : SP\_2015\_RD0999\_232\_50\_20150309\_00055.jpg

Looking east at newly planted palm trees on landside shoulder and slope.

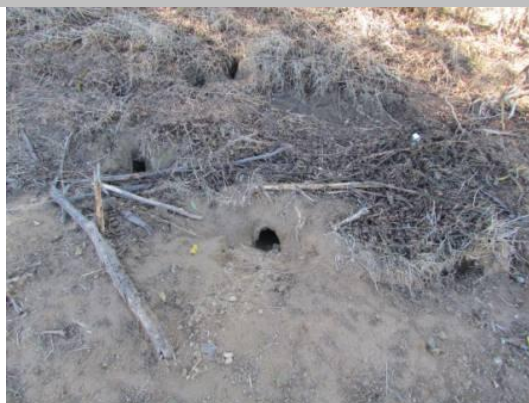
Photo 1 of 1 : SP\_2015\_RD0999\_233\_2\_20150309\_00003.jpg

Looking at several rodent holes on landside slope.

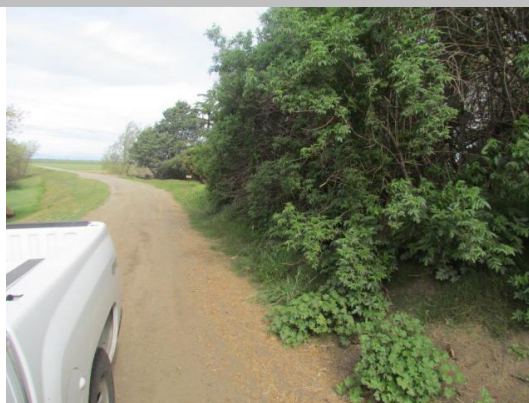
Photo 1 of 2 : SP\_2015\_RD0999\_233\_8\_20150327\_00040.jpg

Looking south at dense vegetation on landward shoulder and slope.  
(Spring 2015)

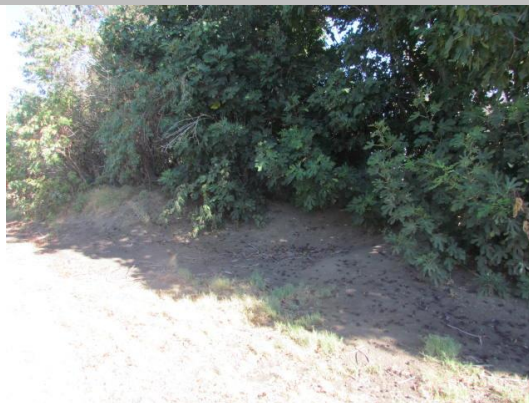
Photo 2 of 3 : SP\_2015\_RD0999\_233\_23\_20150309\_00024.jpg

Looking southwest at dense trees on landward slope and toe.

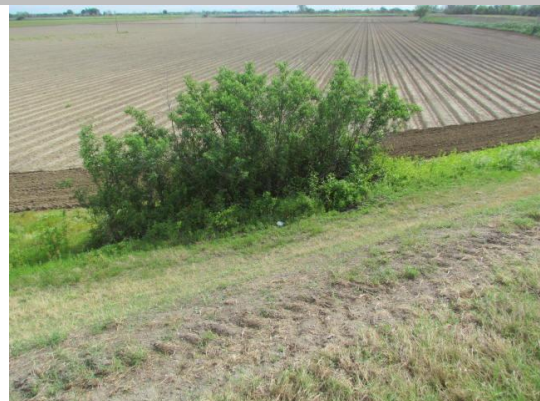
Photo 1 of 2 : SP\_2015\_RD0999\_233\_42\_20150327\_00042.jpg

Looking west at wild rose blocking landward toe. (Spring 2015)

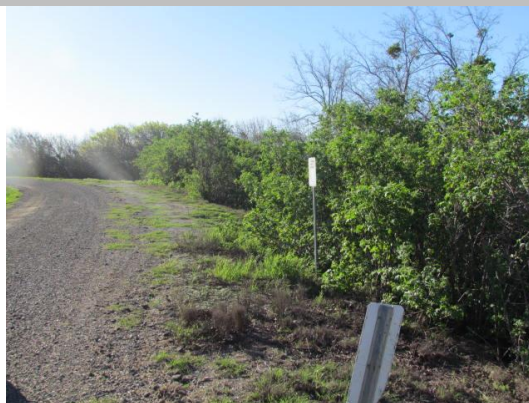
Photo 2 of 2 : SP\_2015\_RD0999\_233\_38\_20150309\_00030.jpg

Looking east at dense vegetation on waterside slope.

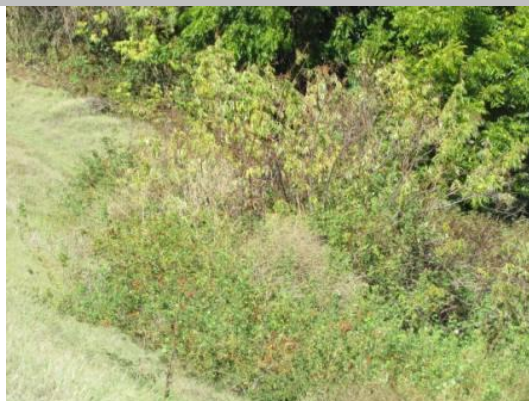
Photo 3 of 3 : SP\_2015\_RD0999\_233\_6\_20150309\_00008.jpg

Looking north at wild roses on landside toe. (Spring 2011)

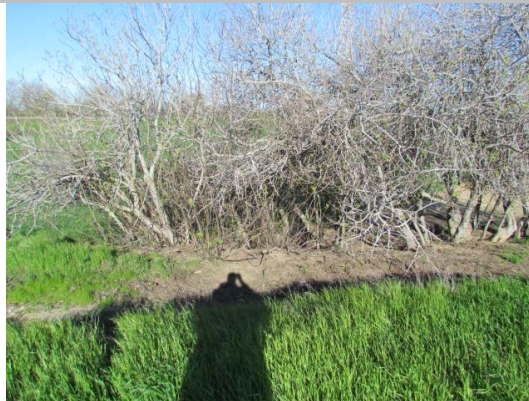
Photo 4 of 4 : SP\_2015\_RD0999\_234\_4\_20150309\_00009.jpg

Looking west at dense fig trees at landside toe.

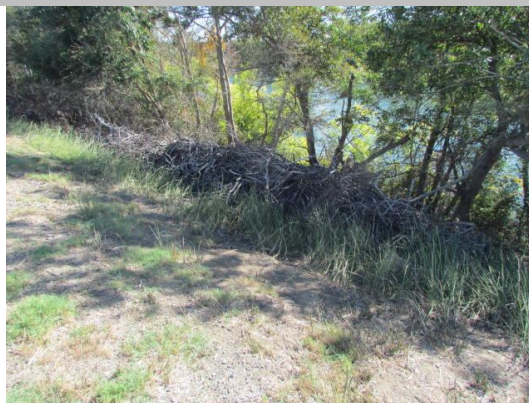
Photo 1 of 1 : SP\_2015\_RD0999\_234\_36\_20150309\_00028.jpg

Looking east at prunings on waterward slope.

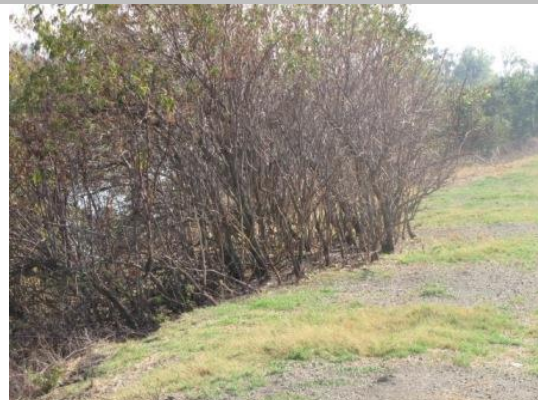
Photo 1 of 1 : SP\_2015\_RD0999\_234\_7\_20150309\_00010.jpg

Looking south at thinned Elderberry on waterside slope.

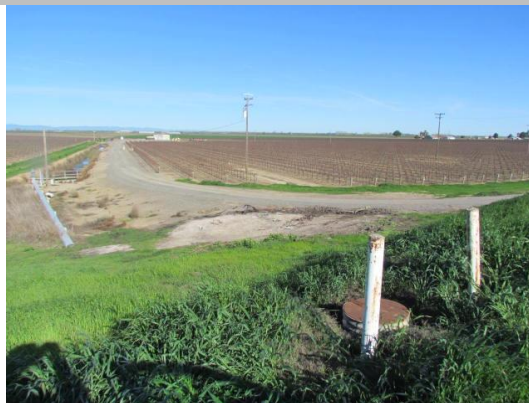
Photo 1 of 2 : SP\_2015\_RD0999\_234\_2\_20150309\_00004.jpg

Looking west at burned prunings on landward berm.

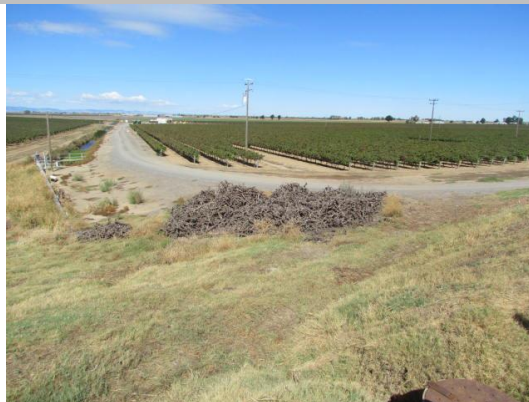
Photo 2 of 2 : SP\_2015\_RD0999\_234\_2\_20150309\_00005.jpg

Looking west at prunings on landward berm.

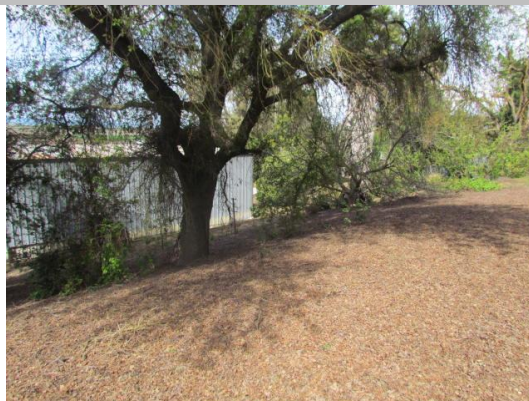
Photo 1 of 1 : SP\_2015\_RD0999\_234\_32\_20150327\_00041.jpg

Looking northwest at untrimmed trees on landward slope. (Spring 2015)

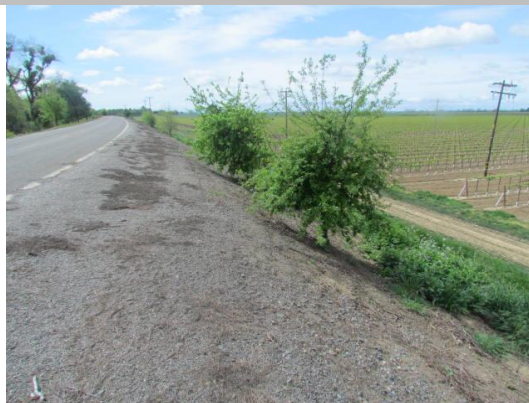
Photo 1 of 1 : SP\_2015\_RD0999\_234\_44\_20150327\_00042.jpg

Looking southwest at typical view of young oak trees on landward slope.  
(Spring 2015)

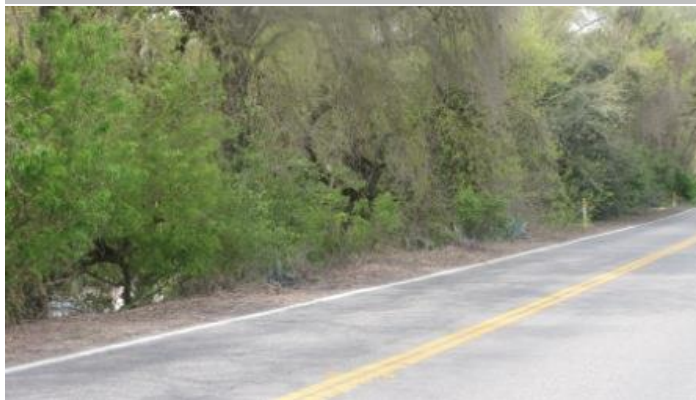
Photo 2 of 2 : SP\_2015\_RD0999\_235\_10\_20150309\_00008.jpg

Looking west at dense trees on waterside slope.

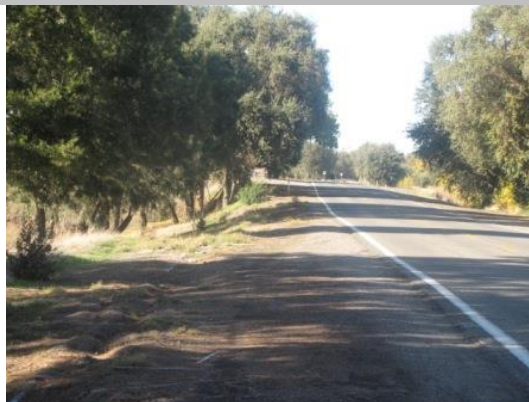
Photo 1 of 2 : SP\_2015\_RD0999\_235\_6\_20150309\_00004.jpg

Looking north at trimmed trees and removed fence on landside slope.

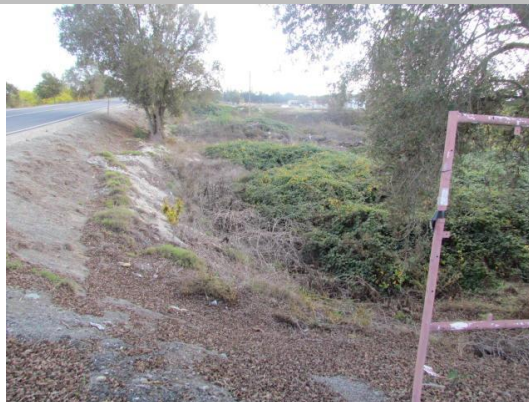
Photo 2 of 2 : SP\_2015\_RD0999\_235\_16\_20150309\_00014.jpg

Looking south at dense berryvines on landside toe. 2012

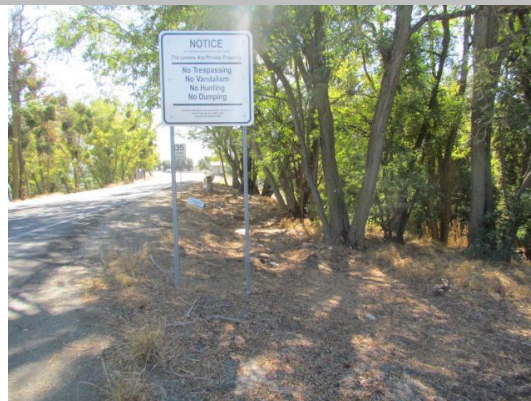
Photo 1 of 1 : SP\_2015\_RD0999\_235\_22\_20150309\_00017.jpg

Looking south at dense trees on landward slope.

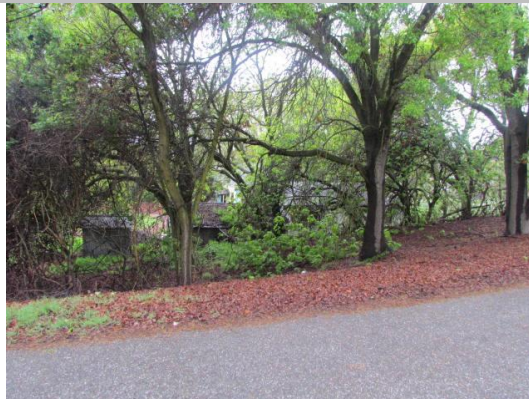
Photo 4 of 6 : SP\_2015\_RD0999\_236\_9\_20150309\_00006.jpg

Looking west at trimmed trees on landside slope. (Spring 2012)

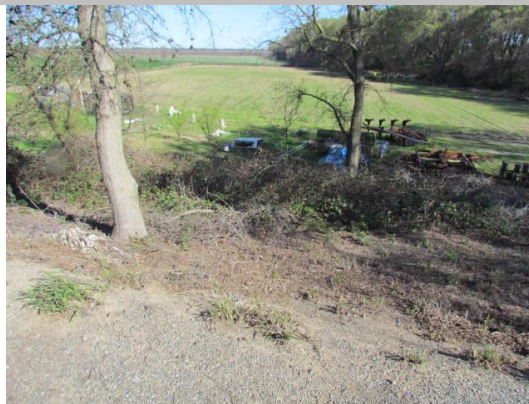
Photo 1 of 2 : SP\_2015\_RD0999\_236\_129\_20150309\_00077.jpg

Looking southwest at berry vines on landward slope.

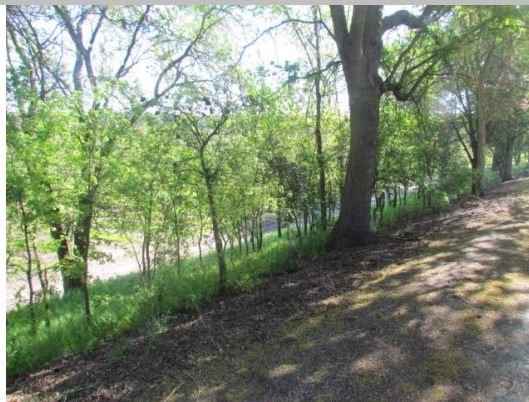
Photo 1 of 1 : SP\_2015\_RD0999\_236\_24\_20150327\_00148.jpg

Looking west at dense trees on landward slope. (Spring 2015)

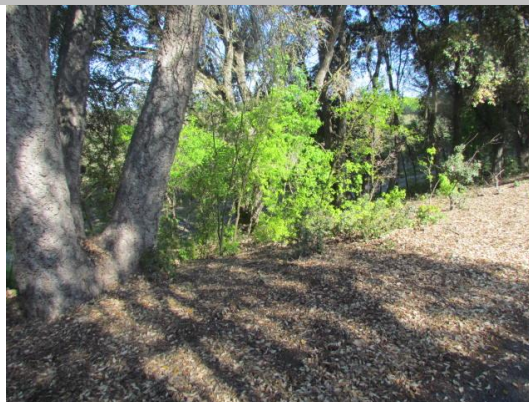
Photo 1 of 1 : SP\_2015\_RD0999\_236\_82\_20150327\_00149.jpg

Looking northwest at dense trees on landward slope. (Spring 2015)

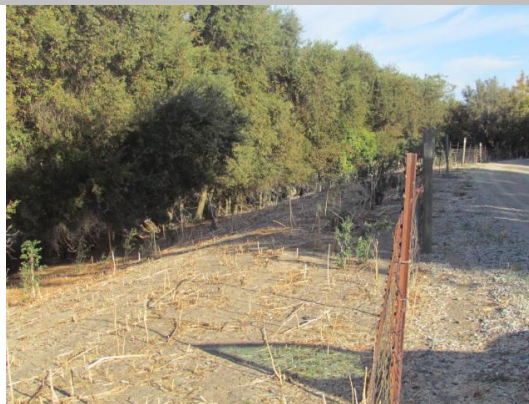
Photo 1 of 2 : SP\_2015\_RD0999\_236\_201\_20150309\_00111.jpg

Looking northwest at several small oak trees planted along landward slope.

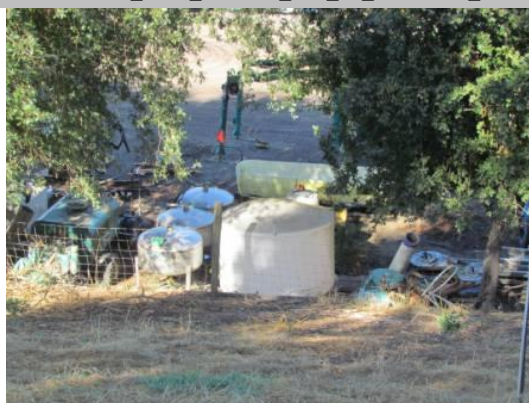
Photo 2 of 2 : SP\_2015\_RD0999\_236\_16\_20150309\_00012.jpg

Looking west at equipment at landside toe.

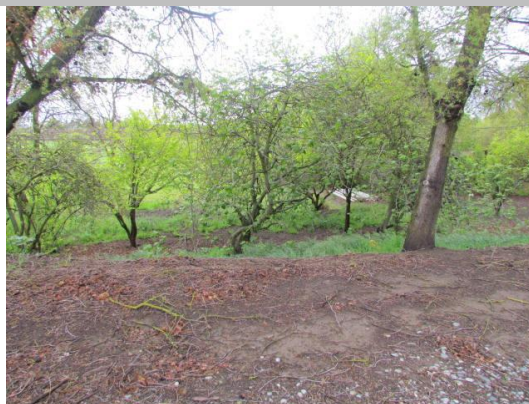
Photo 2 of 3 : SP\_2015\_RD0999\_236\_38\_20150309\_00030.jpg

Looking west at trimmed trees on landside slope. (Spring 2012)

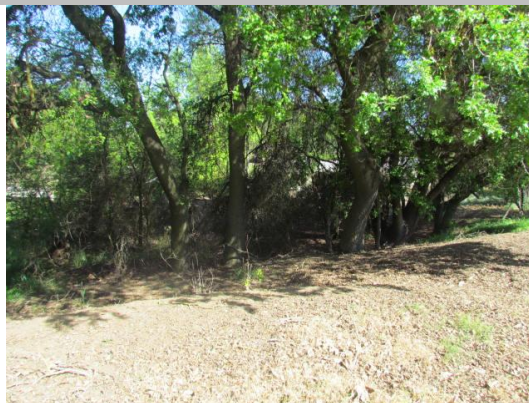
Photo 1 of 1 : SP\_2015\_RD0999\_236\_52\_20150327\_00155.jpg

Looking west at untrimmed trees on landward toe. (Spring 2015)

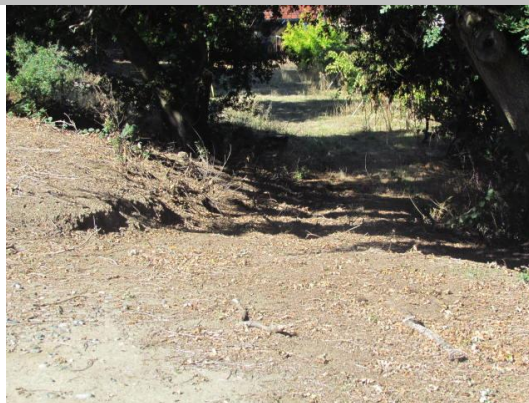
Photo 1 of 1 : SP\_2015\_RD0999\_236\_154\_20150309\_00096.jpg

Looking west at levee damage due to vehicle traffic.

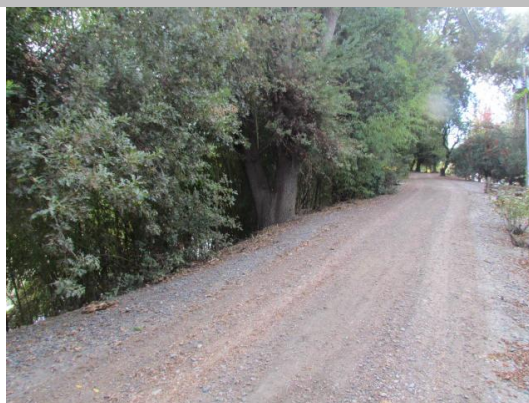
Photo 1 of 1 : SP\_2015\_RD0999\_236\_67\_20150309\_00051.jpg

Looking north at dense vegetation on landward shoulder and slope.

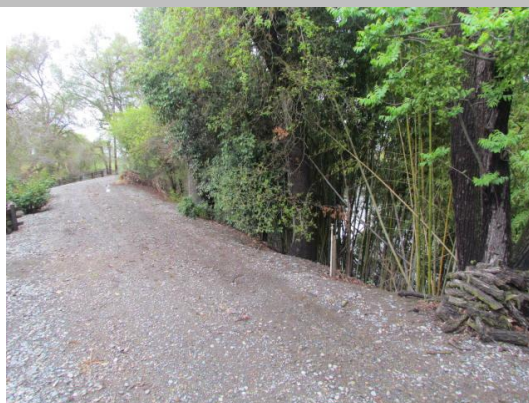
Photo 1 of 1 : SP\_2015\_RD0999\_236\_71\_20150309\_00053.jpg

Looking northeast at dense vegetation on waterside slope.

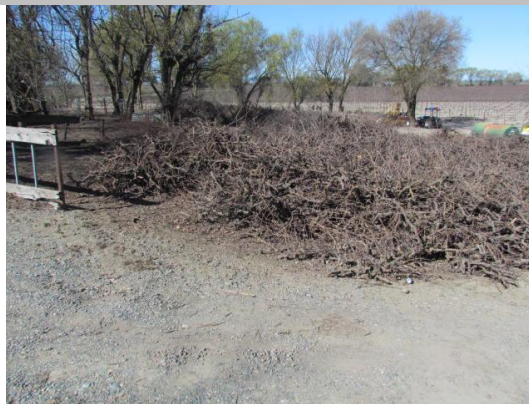
Photo 1 of 1 : SP\_2015\_RD0999\_236\_192\_20150309\_00105.jpg

Looking west at prunings on landward slope and toe.

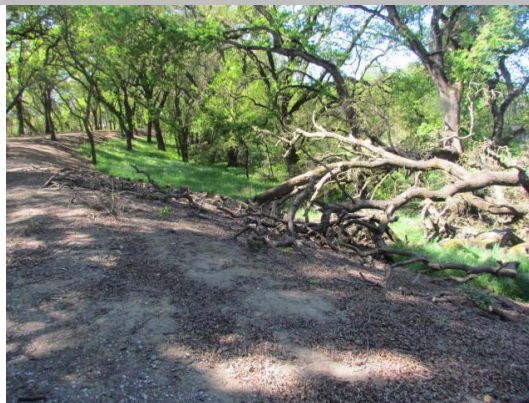
Photo 1 of 5 : SP\_2015\_RD0999\_236\_39\_20150327\_00160.jpg

Looking south at fallen tree on landward slope. (Spring 2015)

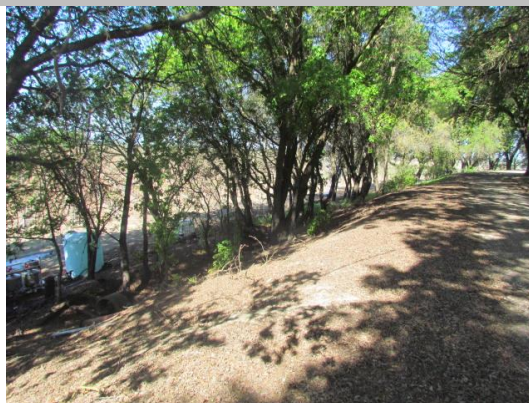
Photo 1 of 1 : SP\_2015\_RD0999\_236\_60\_20150327\_00162.jpg

Looking north at dense trees on landward slope. (Spring 2015)

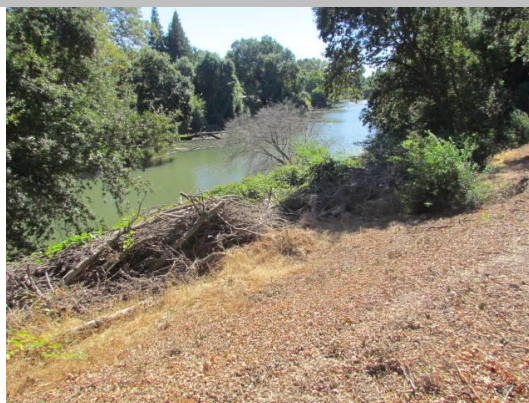
Photo 1 of 1 : SP\_2015\_RD0999\_236\_74\_20150309\_00055.jpg

Looking southeast at prunings on waterward slope.

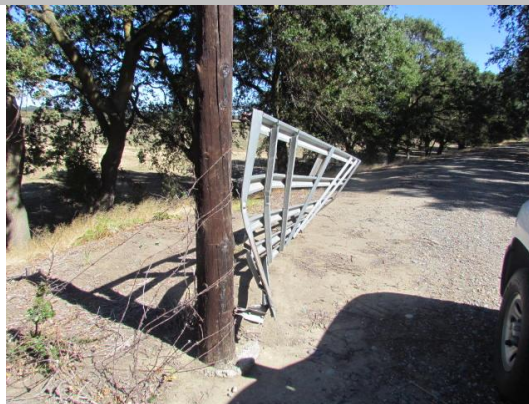
Photo 1 of 1 : SP\_2015\_RD0999\_236\_90\_20150309\_00062.jpg

Looking northwest at damaged gate on levee crown.

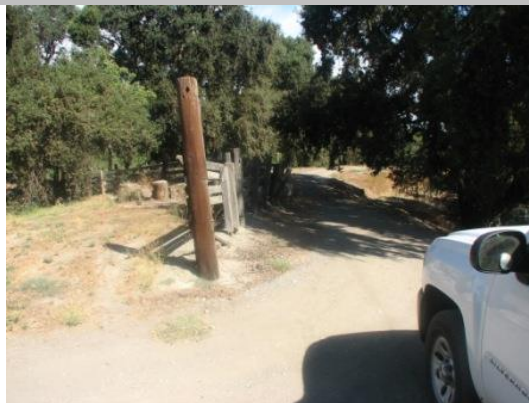
Photo 1 of 4 : SP\_2015\_RD0999\_236\_96\_20150309\_00065.jpg

Fence, firewood and material at landside shoulder.

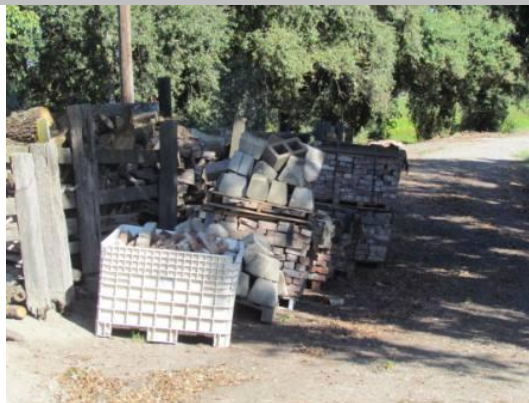
Photo 4 of 4 : SP\_2015\_RD0999\_236\_96\_20150309\_00068.jpg

Looking north at firewood and other material on landside shoulder and crown.

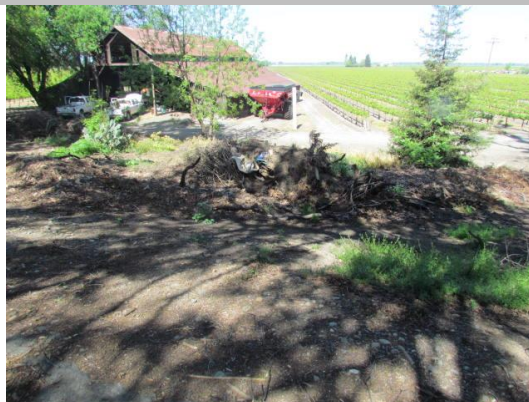
Photo 1 of 1 : SP\_2015\_RD0999\_236\_185\_20150327\_00163.jpg

Looking west at pruning piles on landward slope. (Spring 2015)
