**Flood Control Project Maintenance
Levee Inspections**

Maintenance Issue Types Only, Levee Inspection Report By Mile - Spring 2016

Reclamation District No. 0999 Netherlands

Waterway	Bank	Unit Miles	Inspection Start/End	Inspector
Unit No. 01 Yolo Bypass	Left	15.41	03/14/2016 03/16/2016	Richard Willoughby

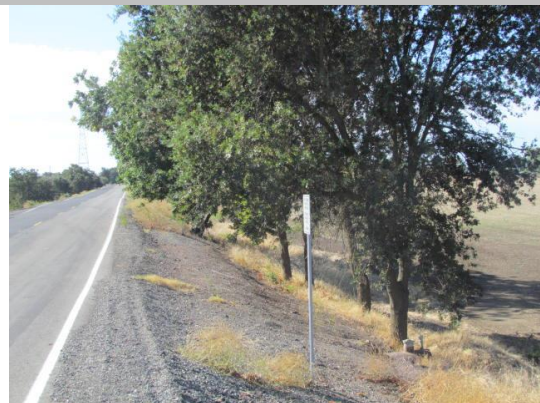
Photo 2 of 2 : SP_2016_RD0999_232_4_20160308_00009.jpg

Looking southwest at trimmed trees on waterward slope.

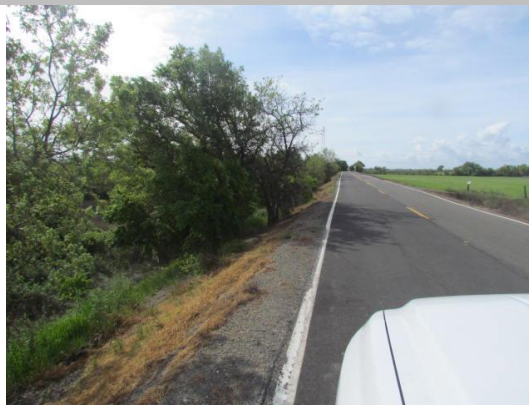
Photo 2 of 5 : SP_2016_RD0999_232_30_20160308_00030.jpg

Looking southeast at dense trees on landwater slope. (Spring 2015)

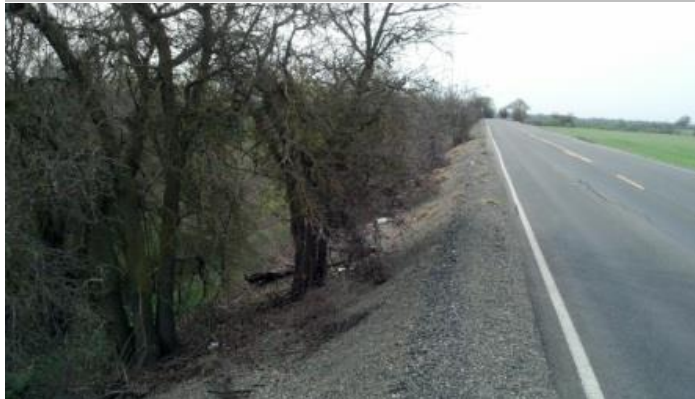
Photo 5 of 5 : SP_2016_RD0999_232_30_20160308_00033.jpg

Looking southeast at dense trees on landside slope and toe. (2013)

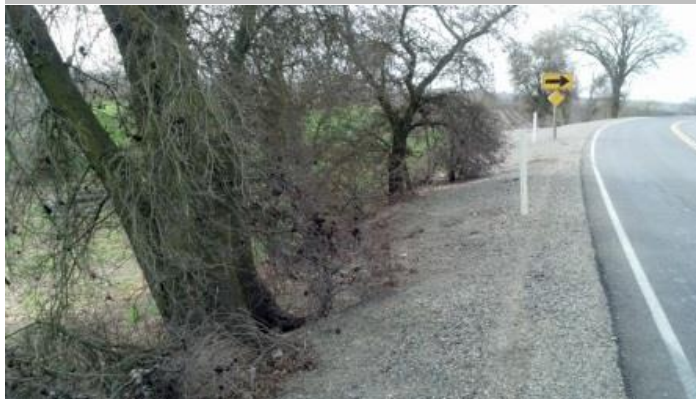
Photo 3 of 3 : SP_2016_RD0999_232_31_20160308_00036.jpg

Looking southeast at untrimmed trees on landside slope.

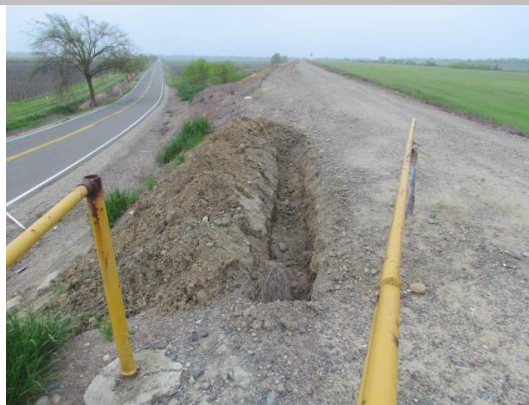
Photo 2 of 4 : SP_2016_RD0999_232_40_20160308_00045.jpg

Looking south at excavation on landside shoulder.

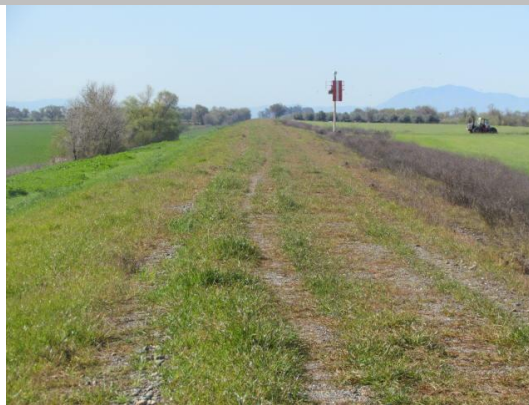
Photo 1 of 1 : SP_2016_RD0999_232_46_20160317_00100.jpg

LM Start	2.53	Rating **	M	Issue No.	46
LM End	4.98	Issue Type +	Ma	Location *	CR
Category	Earthen Levee			GPS Latitude/Longitude	
				Start	End
Item	Crown Surface / Depressions / Rutting			38.468801 °	38.435378 °
				-121.583189 °	-121.598664 °
DWR ID	DWR_RD0999_01_f_2013_46				
Comment Code					
C2 : Repair depressions or ruts in the crown or slope.					
Inspector Comment					
Control growth on levee crown and repair ruts on levee crown. And add appropriate gravel or road base.

Looking south at growth on levee crown.

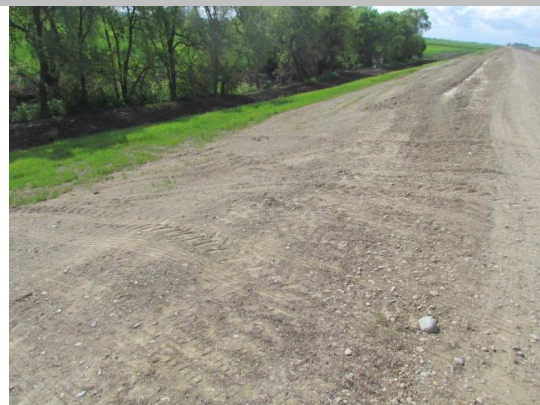
Photo 1 of 4 : SP_2016_RD0999_232_35_20160308_00037.jpg

LM Start	4.31	Rating **	M	Issue No.	35
LM End	4.31	Issue Type +	Ma	Location *	LS
Category	Earthen Levee			GPS Latitude/Longitude	
				Start	End
Item	Slope Stability			38.444561 °	38.444561 °
				-121.594438 °	-121.594438 °
DWR ID	DWR_RD0999_01_f_2012_35				
Comment Code					
S3 : Repair the levee slope damaged by vehicle traffic and prevent access where possible.					
Inspector Comment					
Depression is caused by vehicle traffic.

Looking southeast at slope damage cause by vehicle traffic on landward slope. (Spring 2015)

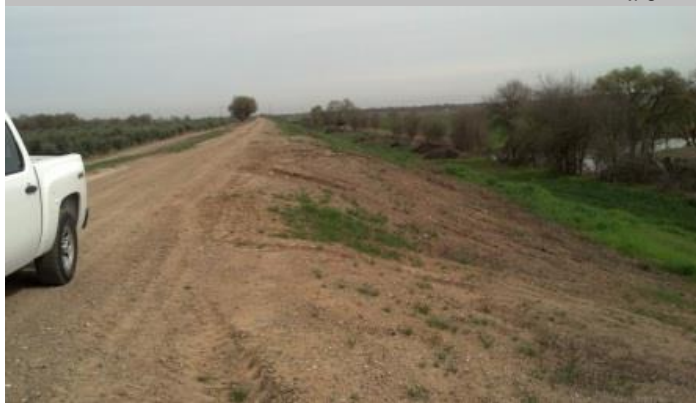
Photo 3 of 4 : SP_2016_RD0999_232_35_20160308_00039.jpg

Looking north at slope damage caused by vehicle traffic.

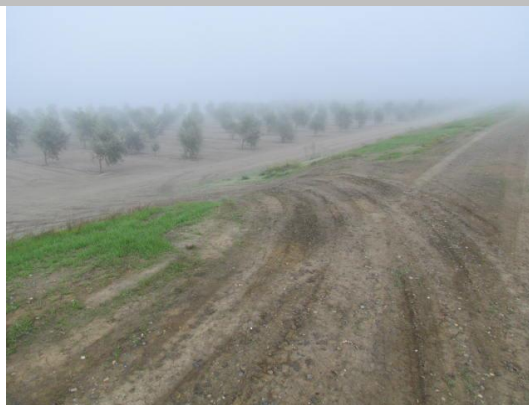
Photo 2 of 3 : SP_2016_RD0999_232_27_20160308_00025.jpg

LM Start	4.31	Rating **	M	Issue No.	27
LM End	4.31	Issue Type +	Ma	Location *	WS
Category	Earthen Levee			GPS Latitude/Longitude	
				Start	End
Item	Slope Stability			38.444560 °	38.444560 °
				-121.594440 °	-121.594440 °
DWR ID	DWR_RD0999_01_f_2012_27				
Comment Code					
S3 : Repair the levee slope damaged by vehicle traffic and prevent access where possible.					
Inspector Comment					
Local farmer causing slope damage by driving equipment and trucks on slope.

Looking northwest at slope damage caused by vehicle traffic. (Fall 2014)

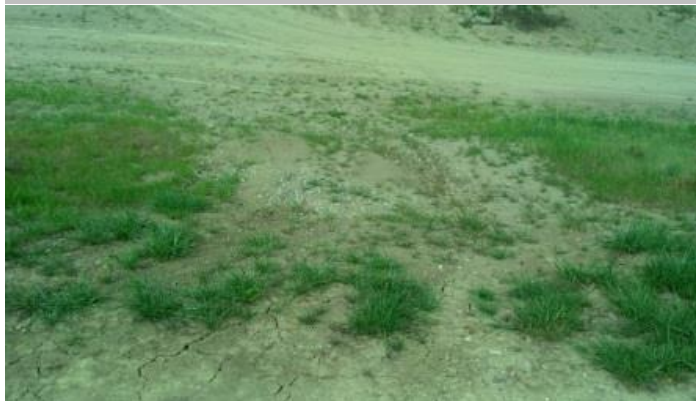
Photo 3 of 3 : SP_2016_RD0999_232_27_20160308_00026.jpg

Looking west at slope damage on waterside slope. (Spring 2014)

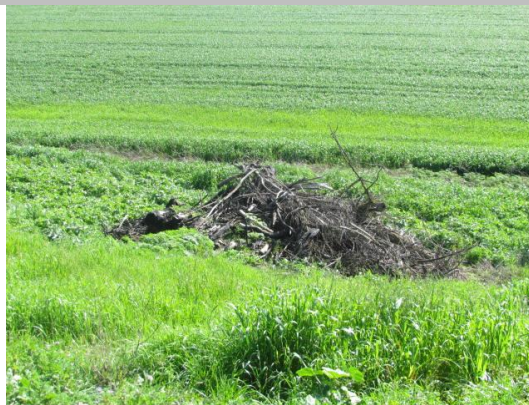
Photo 1 of 1 : SP_2016_RD0999_232_41_20160317_00102.jpg

Looking east at prunings on landward toe and berm.

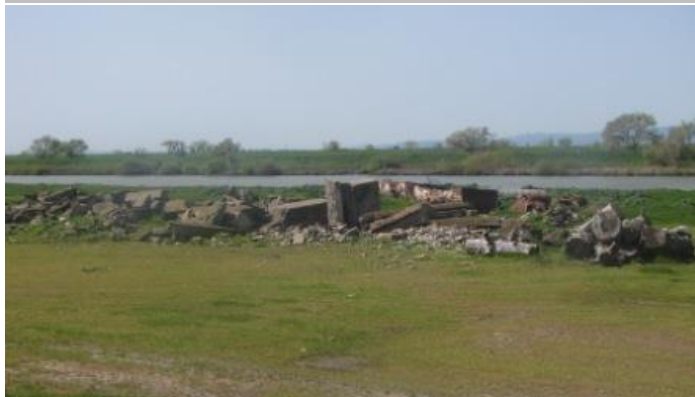
Photo 1 of 1 : SP_2016_RD0999_232_25_20160308_00022.jpg

Looking west at concrete rubble on waterside berm.

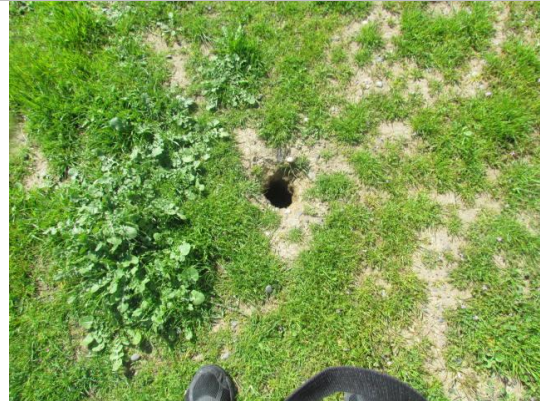
Photo 1 of 1 : SP_2016_RD0999_232_69_20160317_00104.jpg

LM Start	9.34	Rating **	M	Issue No.	69
LM End	9.34	Issue Type +	Ma	Location *	CR
Category	Earthen Levee			GPS Latitude/Longitude	
				Start	End
Item	Animal Control			38.376094 °	38.376094 °
				-121.626178 °	-121.626178 °
DWR ID	DWR_RD0999_01_s_2016_69				
Comment Code					
A1 : Exterminate rodents and backfill and compact or grout burrows.					
Inspector Comment					
Rodent holes noted on levee crown.

Looking at typical rodent hole on levee crown and slope.

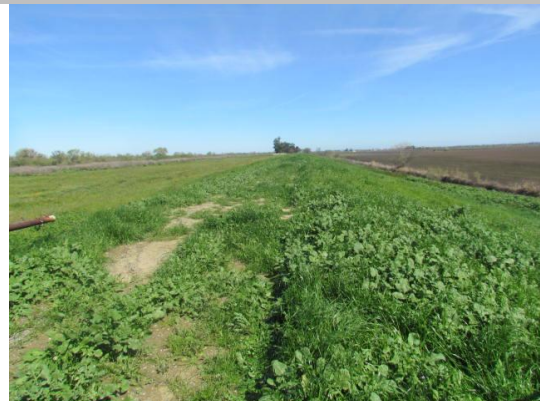
Photo 1 of 3 : SP_2016_RD0999_232_920_20160317_00105.jpg

Looking south at growth on levee crown (Spring 2016)

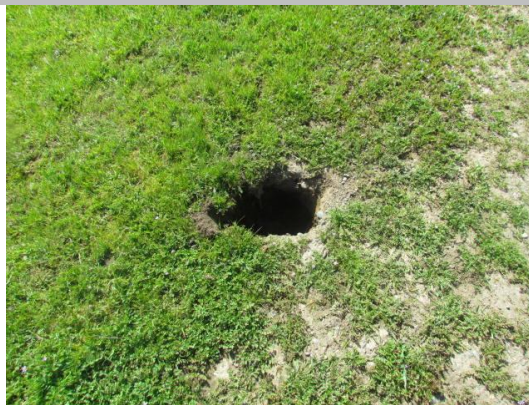
Photo 1 of 5 : SP_2016_RD0999_232_2_20160317_00106.jpg

Looking southeast at large rodent hole on landward shoulder. (Spring 2016)

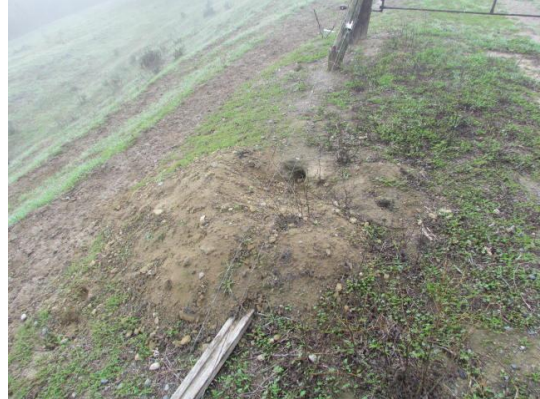
Photo 5 of 5 : SP_2016_RD0999_232_2_20160308_00007.jpg

Looking south at rodent hole on landside shoulder. (Fall 2014)

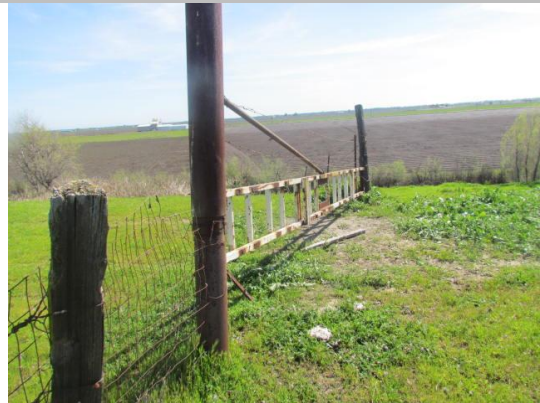
Photo 1 of 3 : SP_2016_RD0999_232_70_20160317_00108.jpg

LM Start	10.21	Rating **	U	Issue No.	70
LM End	10.21	Issue Type +	Ma	Location *	CR
Category	Earthen Levee			GPS Latitude/Longitude	
				Start	End
Item	Repair Gates			38.364229 °	38.364229 °
				-121.631673 °	-121.631673 °
DWR ID	DWR_RD0999_01_s_2016_70				
Comment Code					
Inspector Comment					
Gate drags difficult to open and close. Gate pole leaning.

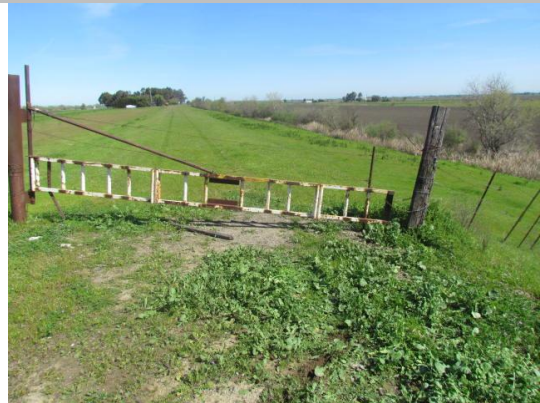
Photo 2 of 3 : SP_2016_RD0999_232_70_20160317_00107.jpg

Looking south at fence pole.

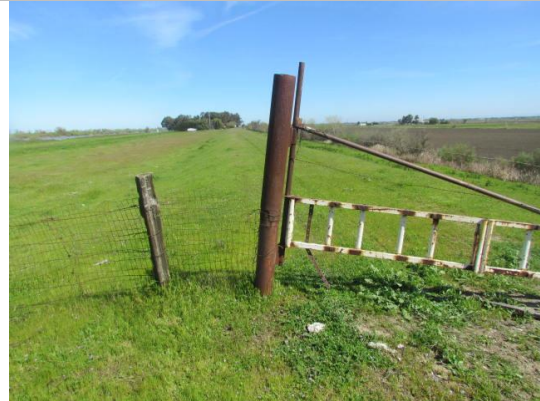
Photo 3 of 3 : SP_2016_RD0999_232_70_20160317_00109.jpg

LM Start	10.21	Rating **	U	Issue No.	70 (cont)	
LM End	10.21	Issue Type +	Ma	Location *	CR	
Category	Earthen Levee			GPS Latitude/Longitude		
				Start		End
Item	Repair Gates			38.364229 °		38.364229 °
				-121.631673 °		-121.631673 °
DWR ID	DWR_RD0999_01_s_2016_70					
Comment Code						
Inspector Comment						
Gate drags difficult to open and close. Gate pole leaning.

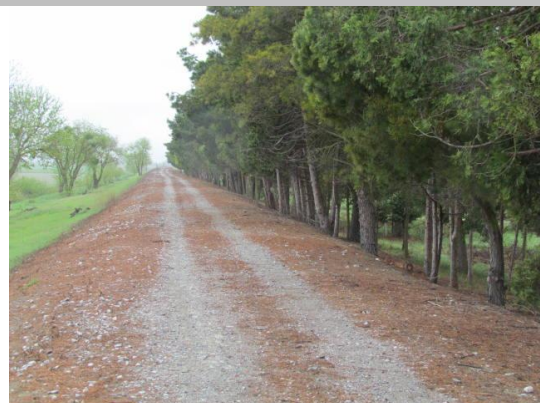
Photo 1 of 2 : SP_2016_RD0999_232_23_20160308_00020.jpg

Looking south at trimmed pine trees on waterside shoulder and slope.
(Spring 2012)

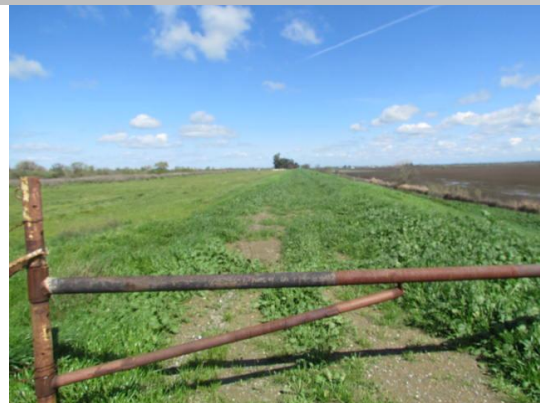
Photo 1 of 1 : SP_2016_RD0999_232_43_20160317_00110.jpg

Looking north at growth on levee crown.

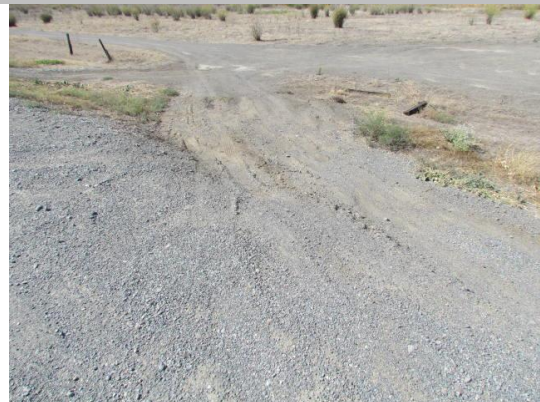
Photo 1 of 2 : SP_2016_RD0999_232_48_20160308_00056.jpg

LM Start	11.84	Rating **	M	Issue No.	48
LM End	11.84	Issue Type +	Ma	Location *	WS
Category	Earthen Levee			GPS Latitude/Longitude	
				Start	End
Item	Slope Stability			38.342068 °	38.342068 °
				-121.641944 °	-121.641944 °
DWR ID	DWR_RD0999_01_f_2012_48				
Comment Code					
S3 : Repair the levee slope damaged by vehicle traffic and prevent access where possible.					
Inspector Comment					
Slope damage caused by vehicle traffic.

Looking southwest at slope damage caused by vehicle traffic. 2013

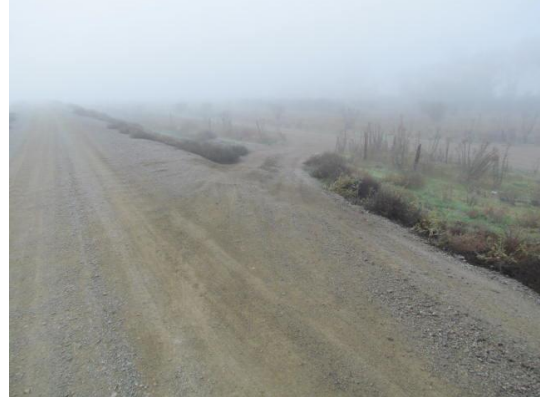
Photo 2 of 2 : SP_2016_RD0999_232_48_20160308_00057.jpg

LM Start	11.84	Rating **	M	Issue No.	48 (cont)	
LM End	11.84	Issue Type +	Ma	Location *	WS	
Category	Earthen Levee			GPS Latitude/Longitude		
				Start	End	
Item	Slope Stability			38.342068 °	38.342068 °	
				-121.641944 °	-121.641944 °	
DWR ID	DWR_RD0999_01_f_2012_48					
Comment Code						
S3 : Repair the levee slope damaged by vehicle traffic and prevent access where possible.						
Inspector Comment						
Slope damage caused by vehicle traffic.

Looking southwest at slope damage caused by vehicle traffic on waterside slope.

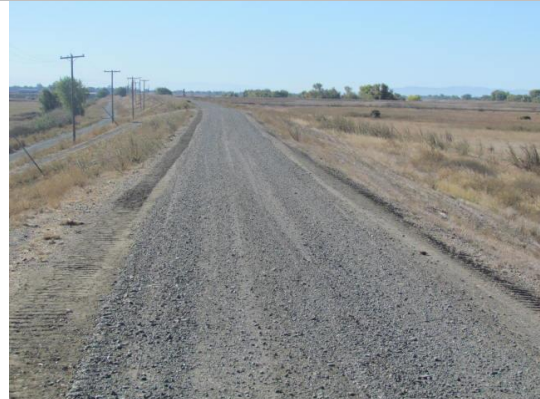
Photo 1 of 1 : SP_2016_RD0999_232_21_20160308_00018.jpg

Looking south at graded levee crown.(Fall 2014)

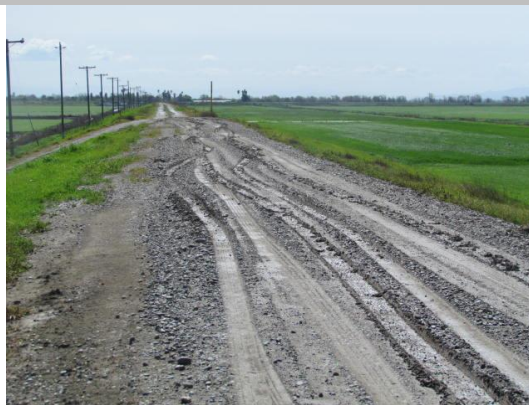
Photo 1 of 2 : SP_2016_RD0999_232_68_20160317_00113.jpg

Looking south at growth on levee crown.

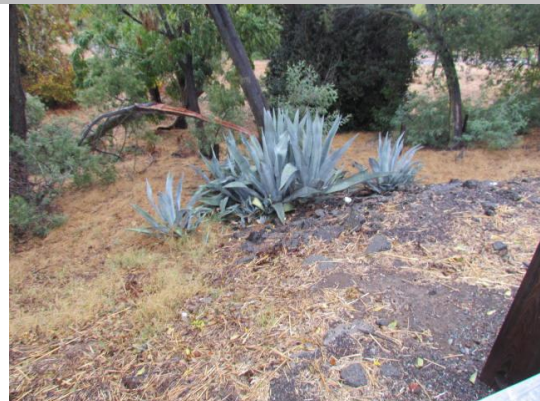
Photo 1 of 2 : SP_2016_RD0999_233_14_20160308_00013.jpg

Looking north at century plant at landward toe fall 2015.

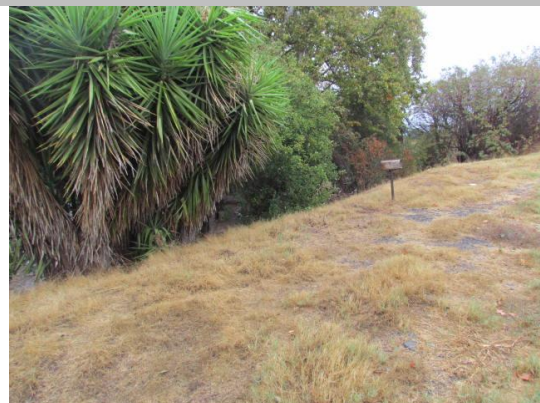
Photo 1 of 2 : SP_2016_RD0999_233_11_20160308_00010.jpg

Looking at dense trees on landward slope.

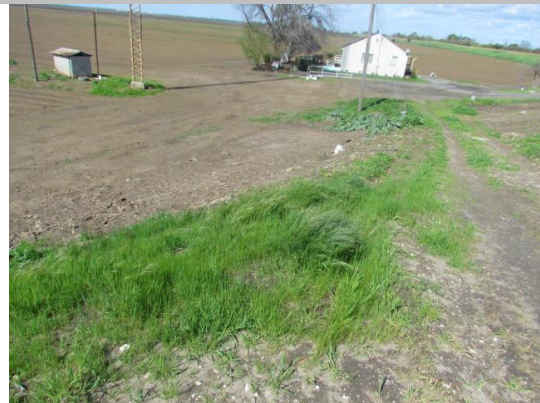
Photo 1 of 5 : SP_2016_RD0999_234_4_20160317_00047.jpg

Looking southwest at cleared fig tree from landward slope and toe.
(Spring 2016) GREAT JOB!

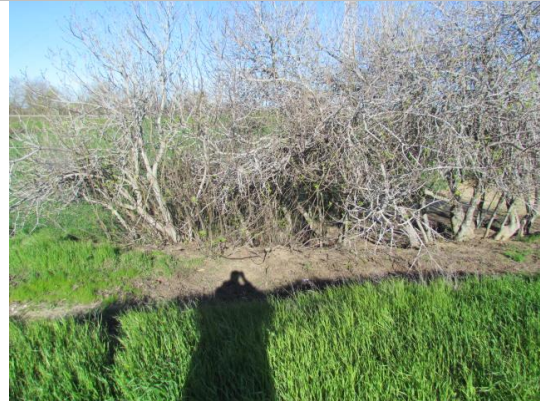
Photo 5 of 5 : SP_2016_RD0999_234_4_20160308_00006.jpg

Looking west at dense fig trees at landside toe.

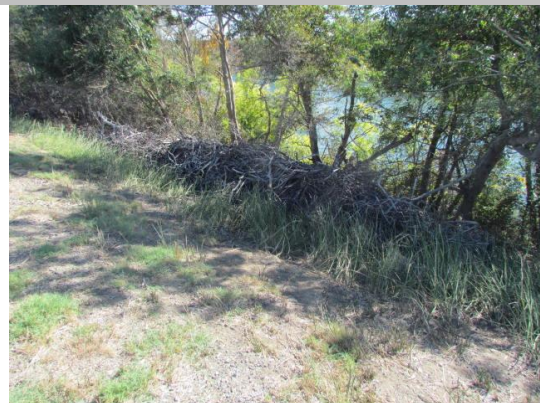
Photo 1 of 1 : SP_2016_RD0999_234_36_20160308_00029.jpg

Looking east at prunings on waterward slope.

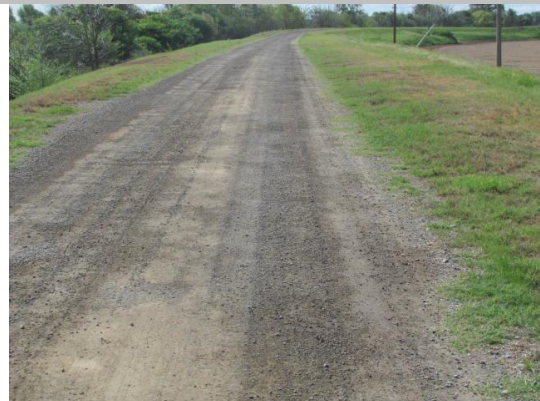
Photo 1 of 1 : SP_2016_RD0999_234_9_20160308_00010.jpg

Looking south at levee crown. (Spring 2015)

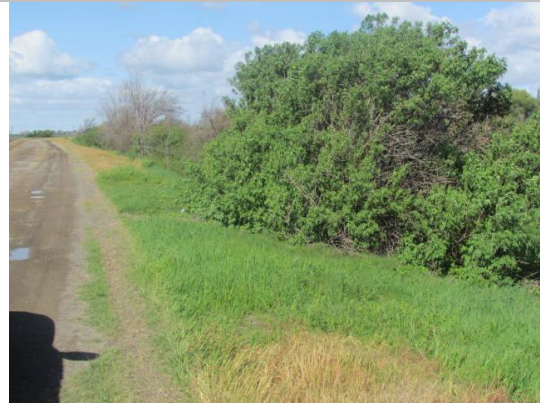
Photo 1 of 2 : SP_2016_RD0999_234_7_20160317_00048.jpg

Looking southeast at dense elderberry on waterward slope. (Spring 2016)

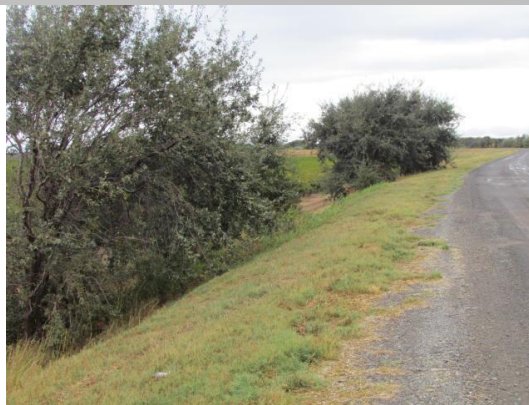
Photo 1 of 1 : SP_2016_RD0999_234_43_20160308_00031.jpg

Looking at untrimmed trees on landward slope and toe.

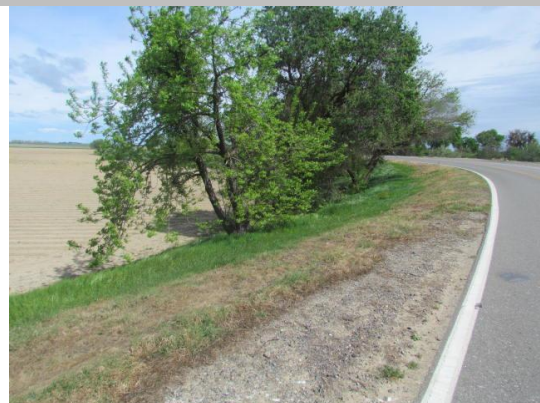
Photo 1 of 1 : SP_2016_RD0999_234_13_20160308_00015.jpg

Looking north at untrimmed trees on landward toe. (Spring 2015)

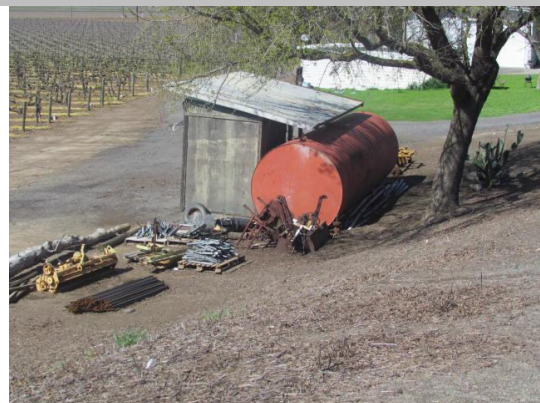
Photo 1 of 3 : SP_2016_RD0999_234_27_20160317_00051.jpg

Looking northwest at diesel tank and other farm equipment stored at landside toe. (Spring 2016)

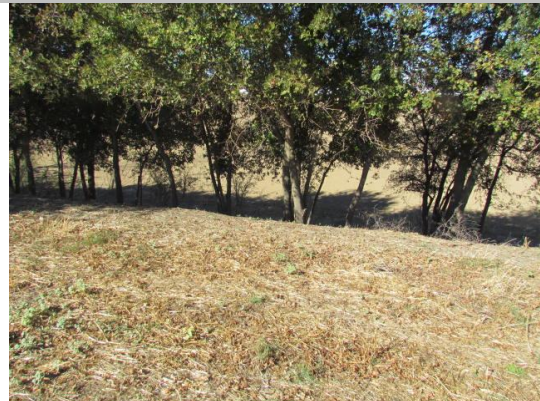
Photo 2 of 4 : SP_2016_RD0999_234_10_20160308_00011.jpg

Looking west at trimmed trees at landward toe. (Fall 2014)

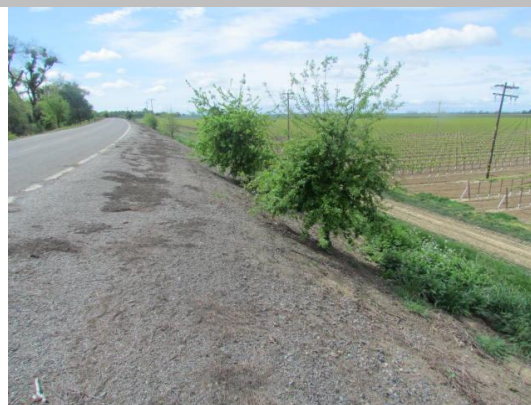
Photo 1 of 1 : SP_2016_RD0999_234_44_20160308_00032.jpg

Looking southwest at typical view of young oak trees on landward slope. (Spring 2015)

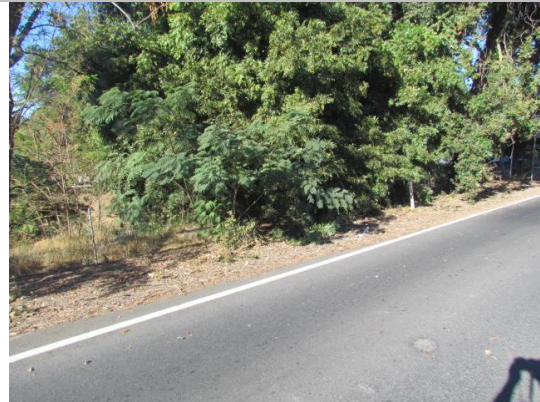
Photo 1 of 1 : SP_2016_RD0999_235_35_20160308_00021.jpg

Looking at untrimmed trees on landward slope.

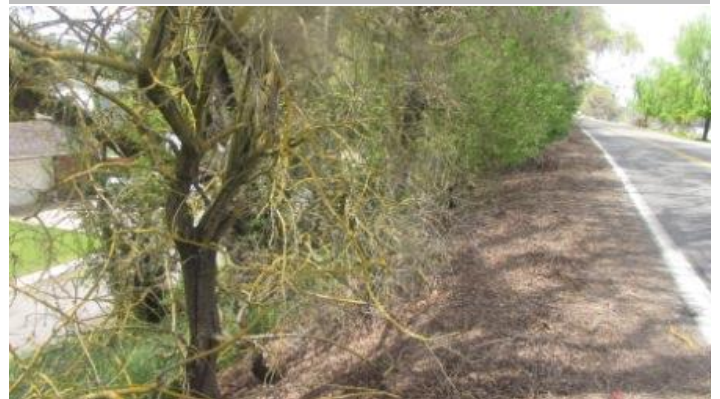
Photo 1 of 2 : SP_2016_RD0999_235_10_20160308_00008.jpg

Looking northwest at dense trees on landside slope and toe.

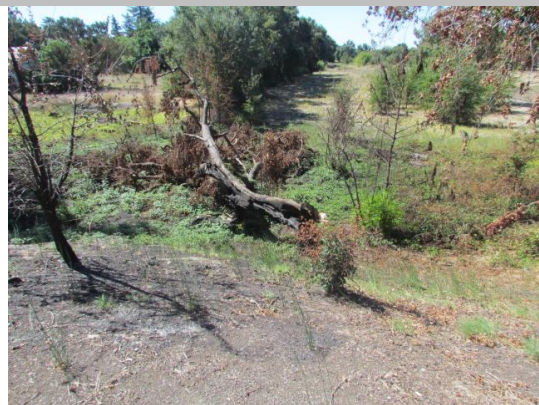
Photo 1 of 1 : SP_2016_RD0999_235_21_20160308_00019.jpg

Looking west at dead tree on landward toe and berm.

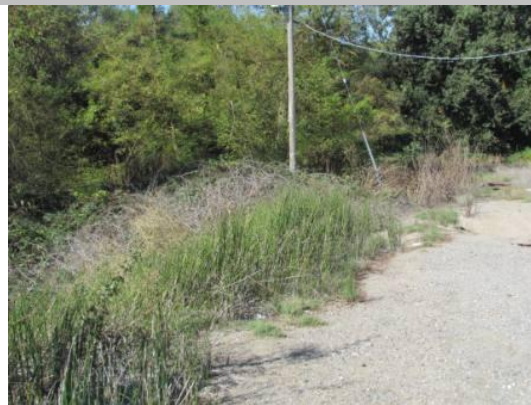
Photo 2 of 3 : SP_2016_RD0999_235_5_20160308_00003.jpg

Looking north at dense vegetation on landside slope near ramp.

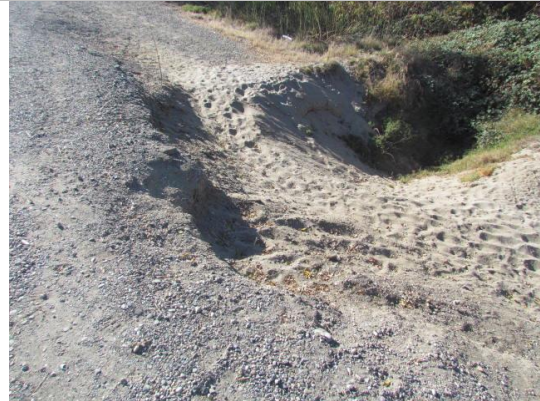
Photo 6 of 6 : SP_2016_RD0999_235_40_20160308_00027.jpg

Looking southwest at shoulder erosion and caving at landward slope and toe.

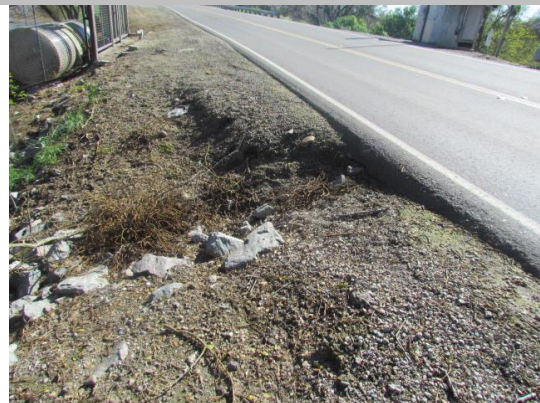
Photo 1 of 2 : SP_2016_RD0999_235_46_20160317_00074.jpg

Looking west at foot erosion on waterward shoulder and slope.

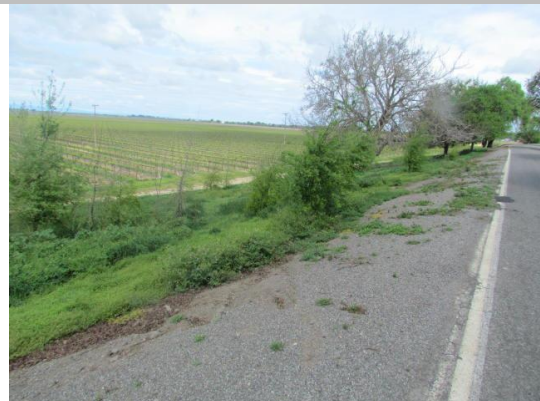
Photo 1 of 1 : SP_2016_RD0999_236_178_20160308_00124.jpg

Looking at typical view of young oak trees on landward slope. (Spring 2015)

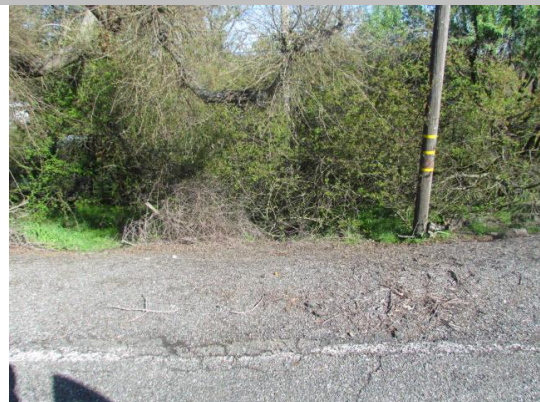
Photo 1 of 1 : SP_2016_RD0999_236_53_20160317_00211.jpg

Looking west at dense vegetation on landward slope.

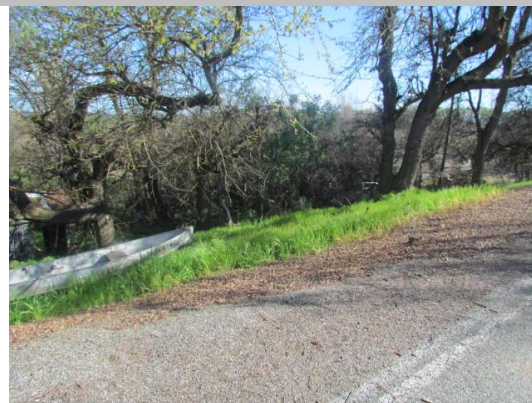
Photo 1 of 1 : SP_2016_RD0999_236_147_20160317_00212.jpg

Looking northwest at dense vegetation at landward toe.

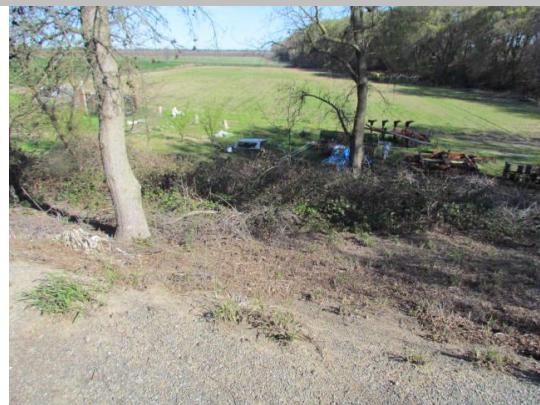
Photo 1 of 2 : SP_2016_RD0999_236_129_20160308_00092.jpg

Looking southwest at berry vines on landward slope.

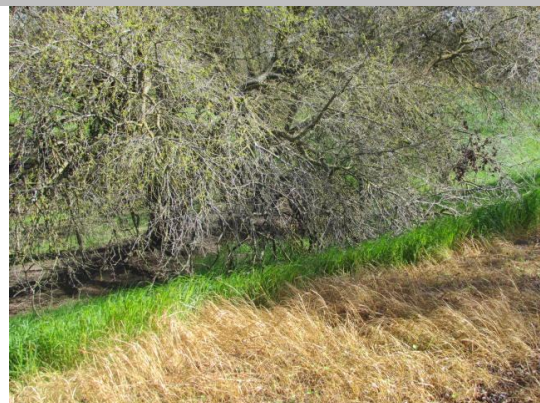
Photo 1 of 1 : SP_2016_RD0999_236_213_20160317_00216.jpg

Looking northeast at untrimmed trees at landward toe.

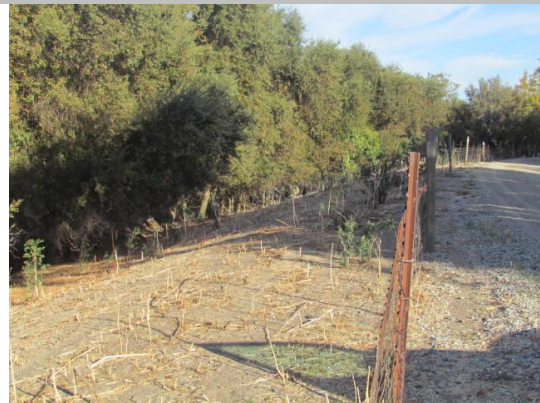
Photo 1 of 2 : SP_2016_RD0999_236_201_20160308_00136.jpg

Looking northwest at several small oak trees planted along landward slope.

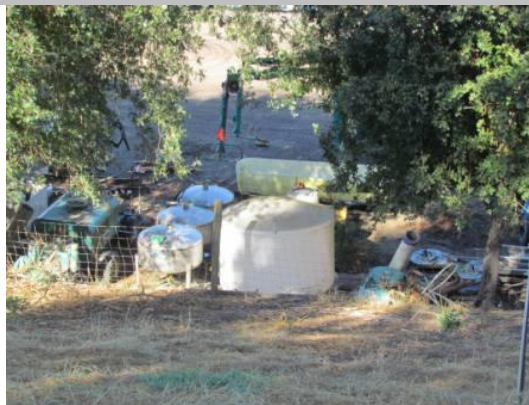
Photo 2 of 2 : SP_2016_RD0999_236_16_20160308_00016.jpg

Looking west at equipment at landside toe.

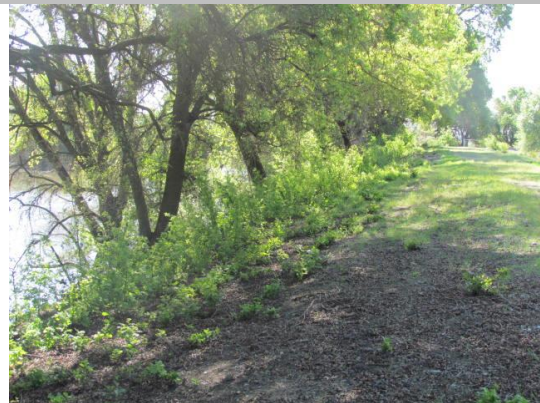
Photo 1 of 2 : SP_2016_RD0999_236_41_20160308_00040.jpg

Looking southeast at saplings on waterward slope. (Spring 2015)

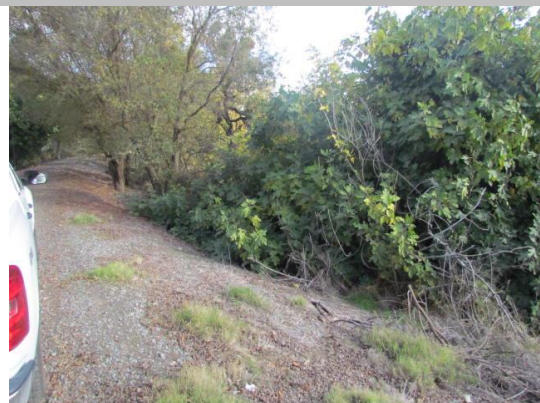
Photo 1 of 1 : SP_2016_RD0999_236_28_20160308_00030.jpg

Looking northeast at fig tree on waterside slope.

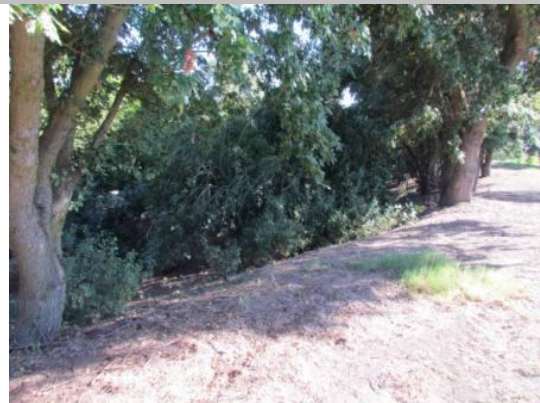
Photo 1 of 3 : SP_2016_RD0999_236_38_20160308_00035.jpg

Looking northwest at dense trees on landside slope. (Spring 2011)

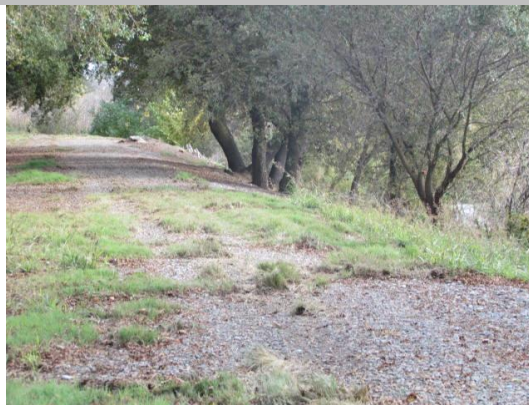
Photo 1 of 1 : SP_2016_RD0999_236_32_20160308_00032.jpg

Looking north at vegetation on levee crown.

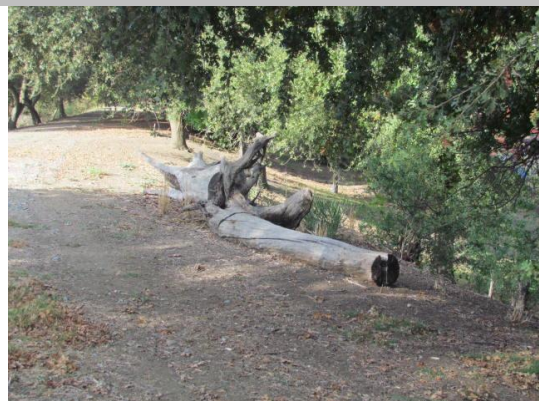
Photo 1 of 1 : SP_2016_RD0999_236_50_20160308_00051.jpg

Looking southwest at tree limbs on landward shoulder.

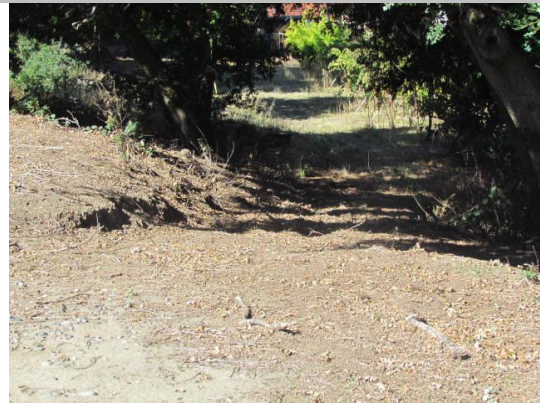
Photo 1 of 1 : SP_2016_RD0999_236_154_20160308_00107.jpg

Looking west at levee damage due to vehicle traffic.

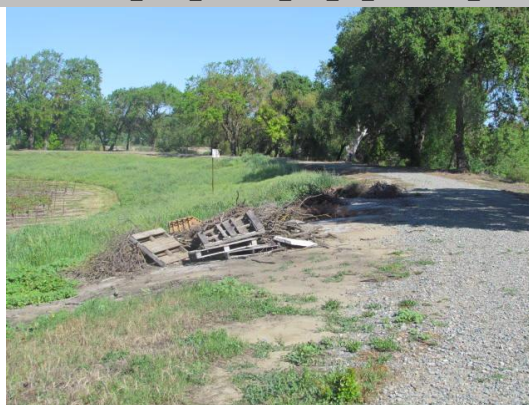
Photo 2 of 3 : SP_2016_RD0999_236_65_20160308_00059.jpg

Looking north at prunings on landward slope. (Spring 2015)

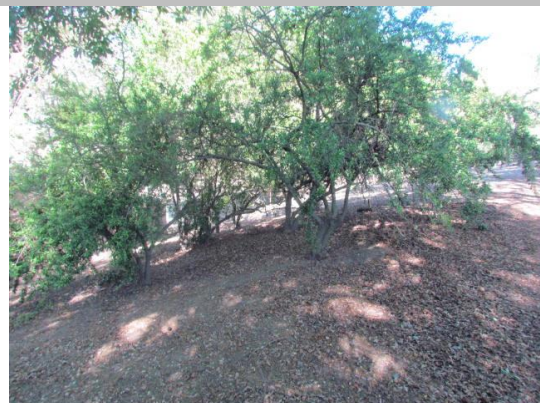
Photo 1 of 1 : SP_2016_RD0999_236_68_20160308_00063.jpg

Looking northeast at untrimmed trees on landward slope. (Spring 2015)

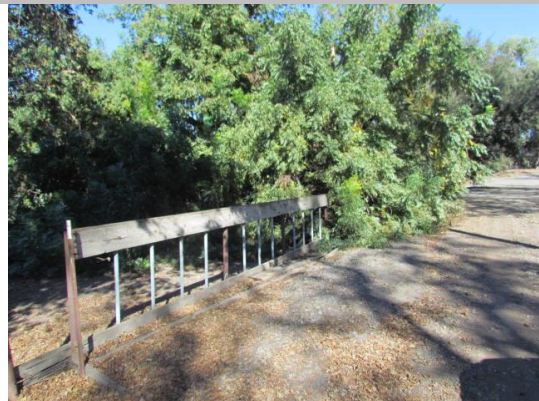
Photo 1 of 1 : SP_2016_RD0999_236_203_20160308_00139.jpg

Looking at untrimmed trees on landward slope and toe.

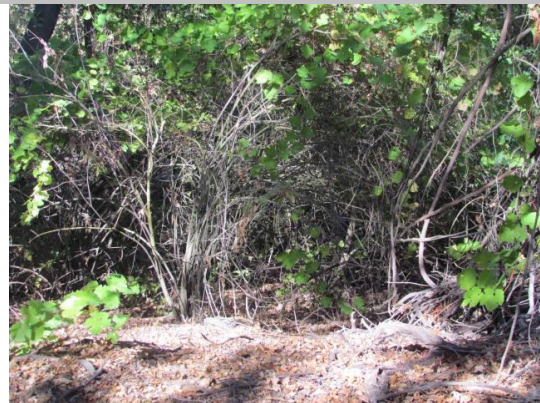
Photo 1 of 2 : SP_2016_RD0999_236_48_20160308_00049.jpg

Looking west at dense vegetation on landward slope and toe. Fall 2015

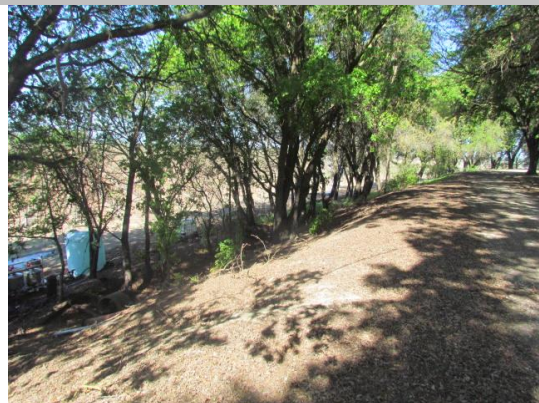
Photo 1 of 1 : SP_2016_RD0999_236_60_20160308_00057.jpg

Looking north at dense trees on landward slope. (Spring 2015)

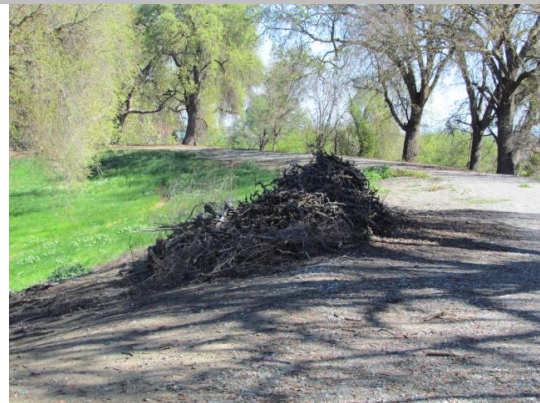
Photo 1 of 1 : SP_2016_RD0999_236_92_20160308_00077.jpg

Looking east prunings on landward slope.
