**Flood Control Project Maintenance  
Levee Inspections**

## Maintenance Issue Types Only, Levee Inspection Report By Mile - Spring 2017

### Reclamation District No. 0999 Netherlands

Waterway	Bank	Unit Miles	Inspection Start/End	Inspector
Unit No. 01 Yolo Bypass	Left	15.41	03/22/2017 05/16/2017	Dave Torres

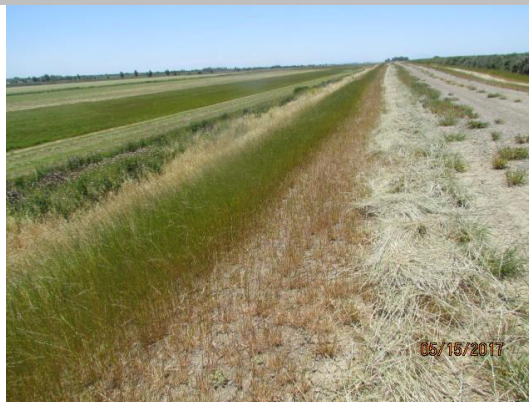
Photo 2 of 2 : SP\_2017\_RD0999\_232\_32\_20170516\_00103.jpg

LM Start	0.00	Rating **	M	Issue No.	32
LM End	13.86	Issue Type +	Ma	Location *	LS
Category	Earthen Levee			GPS Latitude/Longitude	
				Start	End
Item	Vegetation			38.505070 °	38.312917 °
				-121.582033 °	-121.644955 °
DWR ID	DWR_RD0999_01_s_2017_32				
Comment Code					
V1 : Control annual grass and weeds on the levee slopes and easements.					
Inspector Comment

Landside vegetation looking south(Spring 2017)

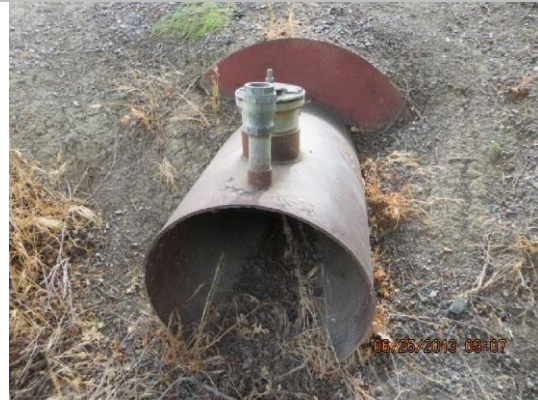
Photo 1 of 3 : UCIP\_SP\_2017\_50092\_25191.jpg

Comment Code					
Inspector Comment					
FS_ID:50092 DS_ID:22743 EP_NO: N/A Repair Type: Urgent Crossing Status: Found UCIP Comments: 07/07/2016 Condition largely unchanged from previous inspection. Pipe open on the WS, waterward of the siphon breaker. Dense vegetation and steep slope limited inspection of WS outlet into Ship Channel. (T. Hatch/UCIP) 06/25/2013 Pipe abandoned and open on WS slope. Pipe should be abandoned properly. (W. Wylie/UCIP) FIELD_STRUCT_DESC: *ABANDONED* 30-inch steel pipe through the levee, 6.5 feet below the crown. Pump on a platform in the canal off of the landside (LS) toe, not found. Flap gate on the waterside (WS), not found. Siphon breaker and an air vent on the WS shoulder. 1-inch galvanized iron filler pipe visible on the WS shoulder along same alignment. [Additional Reference(s): DWR Levee Log, 1992. USACE Sacramento O&M Manual 113 (Revised), October 1966 (LM 1.73)]. FS Date: 7/7/2016

Pipe open on WS slope

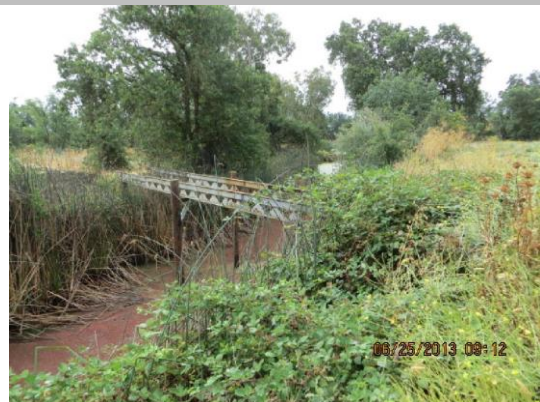
Photo 3 of 3 : UCIP\_SP\_2017\_50092\_25189.jpg

FS\_ID:50092  
DS\_ID:22743  
EP\_NO: N/A  
Repair Type: Urgent  
Crossing Status: Found  
UCIP Comments: 07/07/2016 Condition largely unchanged from previous inspection. Pipe open on the WS, waterward of the siphon breaker. Dense vegetation and steep slope limited inspection of WS outlet into Ship Channel. (T. Hatch/UCIP)  
06/25/2013 Pipe abandoned and open on WS slope. Pipe should be abandoned properly. (W. Wylie/UCIP)  
FIELD\_STRUCT\_DESC: \*ABANDONED\* 30-inch steel pipe through the levee, 6.5 feet below the crown. Pump on a platform in the canal off of the landside (LS) toe, not found. Flap gate on the waterside (WS), not found. Siphon breaker and an air vent on the WS shoulder. 1-inch galvanized iron filler pipe visible on the WS shoulder along same alignment. [Additional Reference(s): DWR Levee Log, 1992. USACE Sacramento O&M Manual 113 (Revised), October 1966 (LM 1.73)].  
FS Date: 7/7/2016

Pump platform visible off LS toe, but no appurtenances remain.

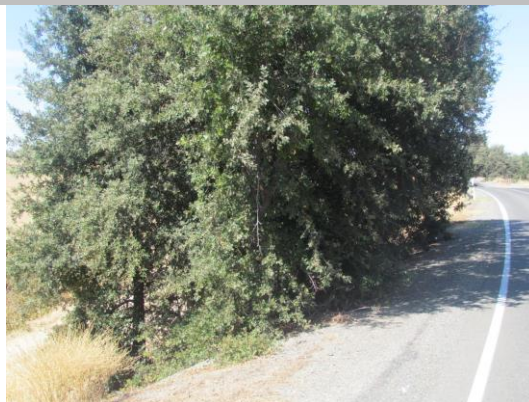
Photo 1 of 2 : SP\_2017\_RD0999\_232\_7\_20170314\_00015.jpg

Looking north at untrimmed trees on waterward slope. ( Fall 2016)

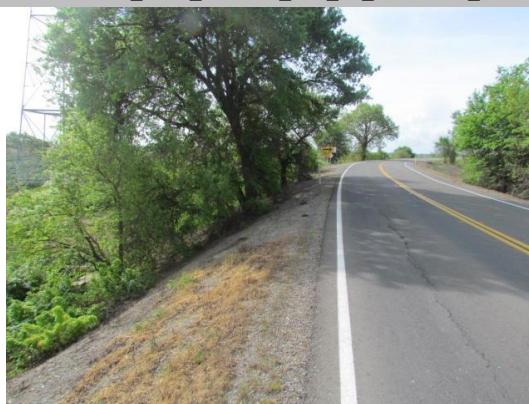
Photo 2 of 2 : SP\_2017\_RD0999\_232\_31\_20170314\_00031.jpg

Looking southeast at untrimmed trees on landward slope. (Spring 2016)

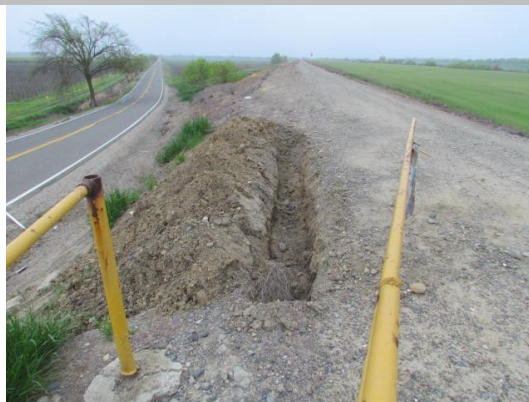
Photo 2 of 4 : SP\_2017\_RD0999\_232\_40\_20170314\_00038.jpg

Looking south at excavation on landside shoulder.

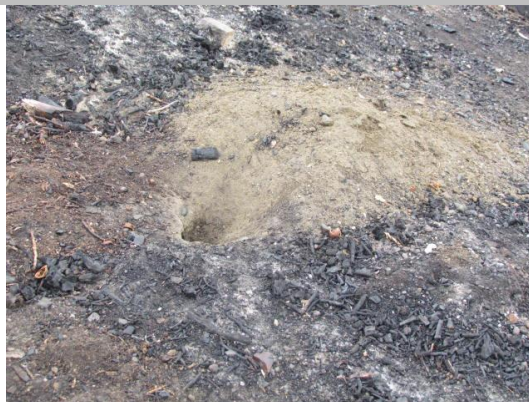
Photo 2 of 2 : SP\_2017\_RD0999\_232\_42\_20170314\_00044.jpg

Looking at typical rodent hole on landside slope.

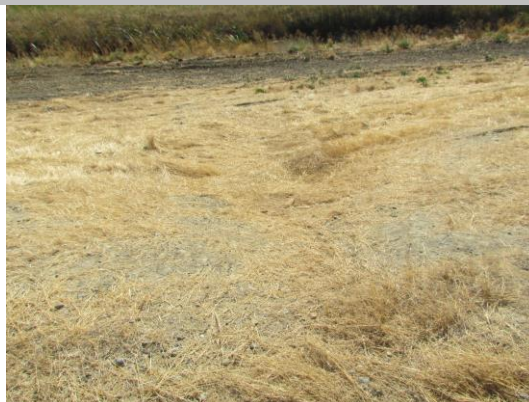
Photo 2 of 2 : SP\_2017\_RD0999\_232\_58\_20170314\_00063.jpg

Looking northeast at depression on landward slope.

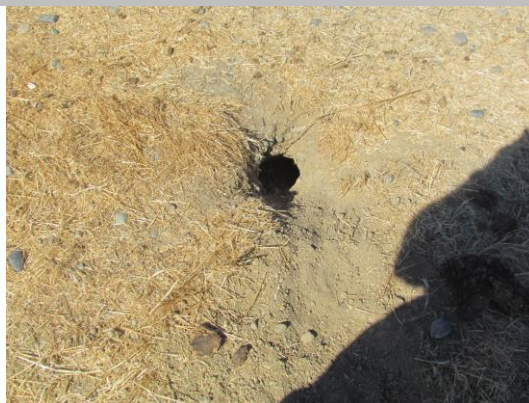
Photo 1 of 3 : SP\_2017\_RD0999\_232\_69\_20170314\_00074.jpg

LM Start	9.34	Rating **	M	Issue No.	69
LM End	9.34	Issue Type +	Ma	Location *	CR
Category	Earthen Levee			GPS Latitude/Longitude	
				Start	End
Item	Animal Control			38.376094 °	38.376094 °
				-121.626178 °	-121.626178 °
DWR ID	DWR_RD0999_01_s_2016_69				
Comment Code					
A1 : Exterminate rodents and backfill and compact or grout burrows.					
Inspector Comment					
Rodent holes noted on levee crown, shoulder and landward slope

Looking at typical rodent hole on landward slope. (Fall 2016)

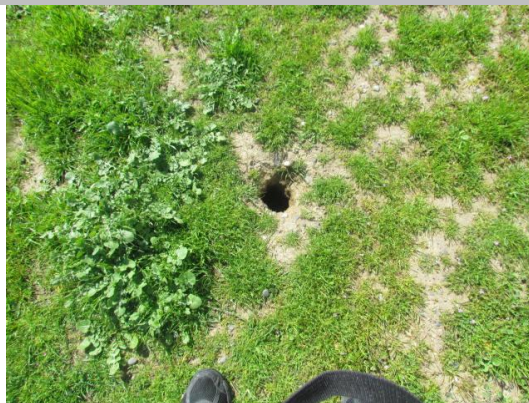
Photo 3 of 3 : SP\_2017\_RD0999\_232\_69\_20170314\_00076.jpg

Looking at typical rodent hole on levee crown and slope. (Spring 2016)

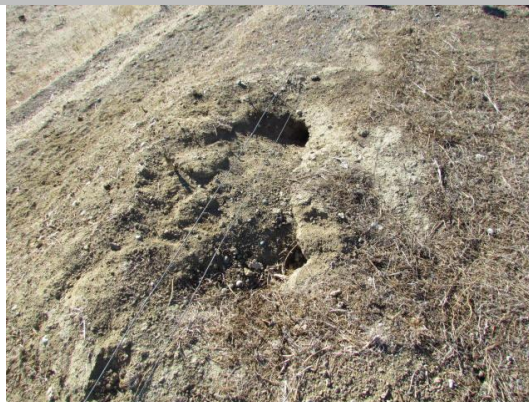
Photo 2 of 5 : SP\_2017\_RD0999\_232\_2\_20170314\_00007.jpg

Looking southeast at rodent holes on landward shoulder fall 2015.

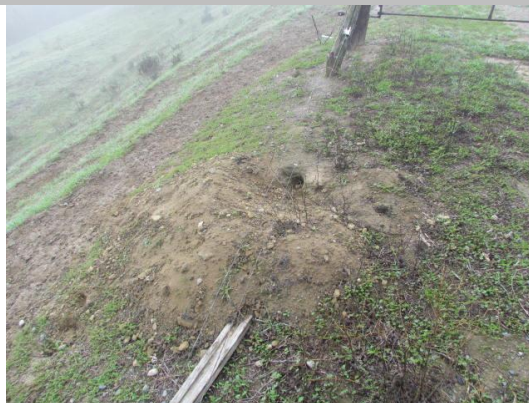
Photo 5 of 5 : SP\_2017\_RD0999\_232\_2\_20170314\_00010.jpg

Looking south at rodent hole on landside shoulder. (Fall 2014)

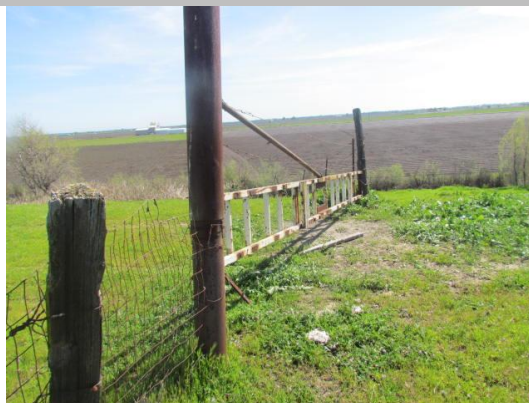
Photo 1 of 4 : SP\_2017\_RD0999\_232\_70\_20170314\_00077.jpg

LM Start	10.21	Rating **	M	Issue No.	70
LM End	10.21	Issue Type +	Ma	Location *	CR
Category	Earthen Levee			GPS Latitude/Longitude	
				Start	End
Item	Repair Gates			38.364229 °	38.364229 °
				-121.631673 °	-121.631673 °
DWR ID	DWR_RD0999_01_s_2016_70				
Comment Code					
Inspector Comment					
Gate drags difficult to open and close. Gate pole leaning.

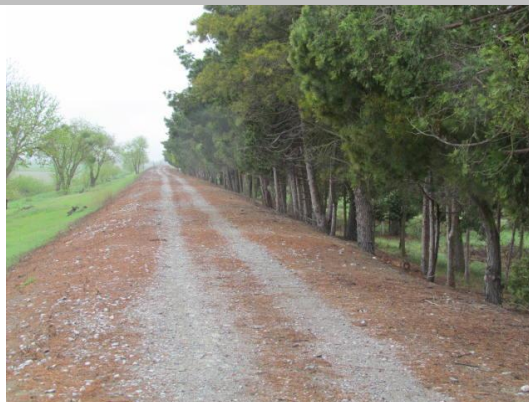
Photo 1 of 2 : SP\_2017\_RD0999\_232\_23\_20170314\_00021.jpg

Looking south at trimmed pine trees on waterside shoulder and slope. (Spring 2012)

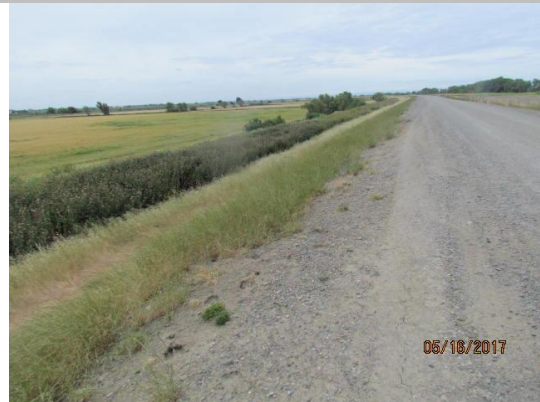
Photo 1 of 1 : SP\_2017\_RD0999\_232\_36\_20170516\_00113.jpg

Dense vegetation at landside levee toe.

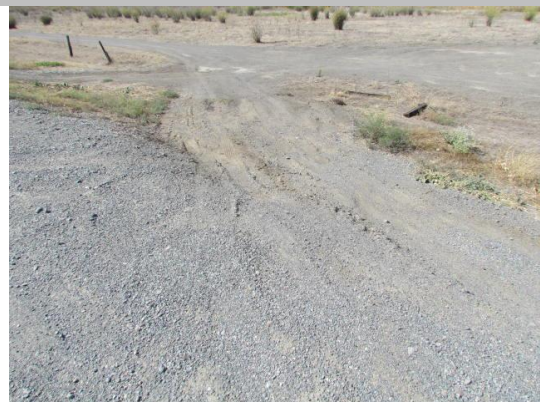
Photo 1 of 2 : SP\_2017\_RD0999\_232\_48\_20170314\_00049.jpg

LM Start	11.84	Rating **	M	Issue No.	48
LM End	11.84	Issue Type +	Ma	Location *	WS
Category	Earthen Levee			GPS Latitude/Longitude	
				Start	End
Item	Slope Stability			38.342068 °	38.342068 °
				-121.641944 °	-121.641944 °
DWR ID	DWR_RD0999_01_f_2012_48				
Comment Code					
S3 : Repair the levee slope damaged by vehicle traffic and prevent access where possible.					
Inspector Comment					
Slope damage caused by vehicle traffic.

Looking southwest at slope damage caused by vehicle traffic. 2013

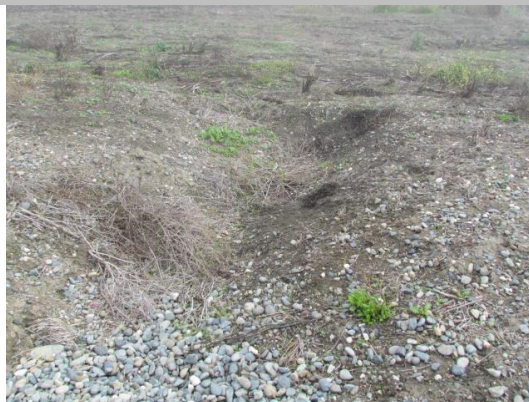
Photo 3 of 4 : SP\_2017\_RD0999\_232\_49\_20170314\_00053.jpg

Looking east caving on landside slope.

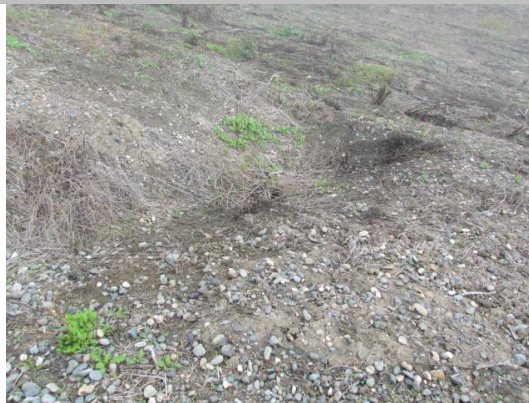
Photo 4 of 4 : SP\_2017\_RD0999\_232\_49\_20170314\_00054.jpg

Looking southeast at caving on landside slope.

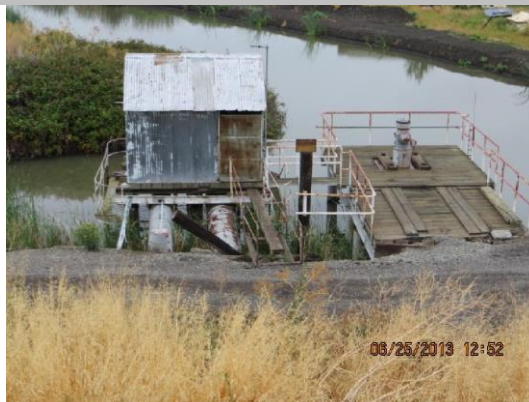
Photo 1 of 3 : UCIP\_SP\_2017\_15366\_25231.jpg

Pump in pumphouse on LS toe.

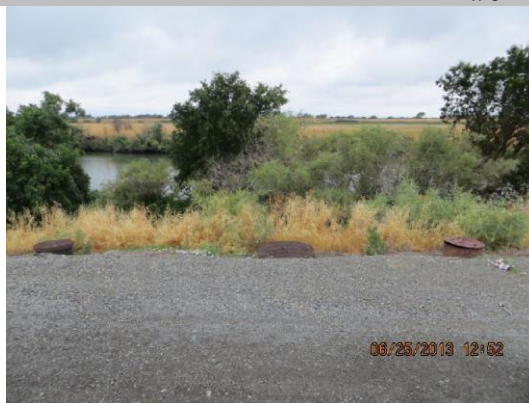
Photo 2 of 3 : UCIP\_SP\_2017\_15365\_25226.jpg

Siphon breaker in CMP riser on WS shoulder.

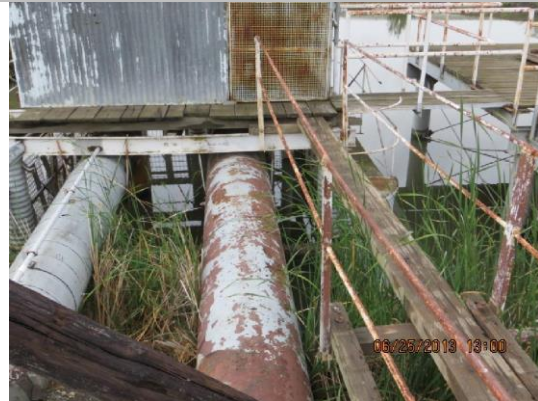
Photo 3 of 3 : UCIP\_SP\_2017\_15365\_25225.jpg

Closeup of pipe at pumphouse on LS toe.

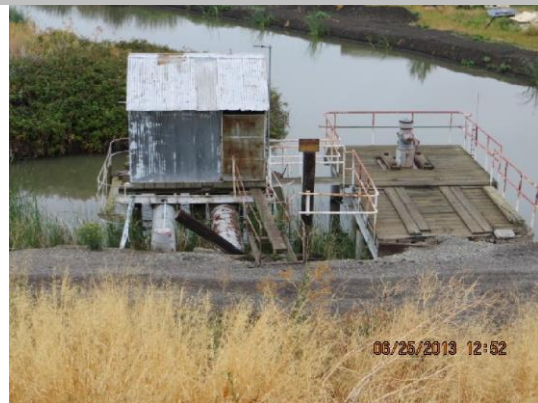
Photo 1 of 3 : UCIP\_SP\_2017\_15363\_25219.jpg

Pump platform to right of pumphouse.

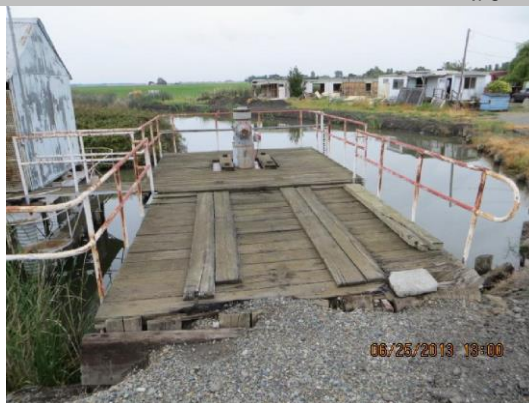
Photo 3 of 3 : UCIP\_SP\_2017\_15363\_25217.jpg

Pump and platform on LS toe.

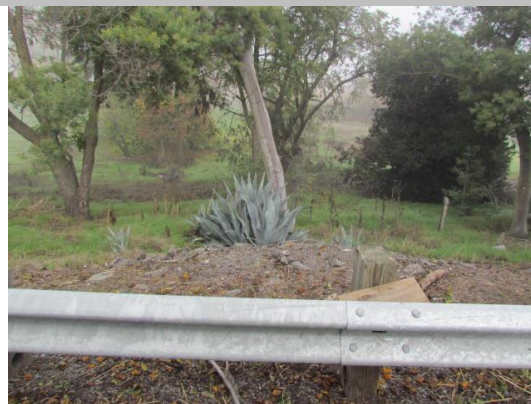
Photo 2 of 2 : SP\_2017\_RD0999\_233\_14\_20170314\_00016.jpg

Looking north at century plant at landside toe.

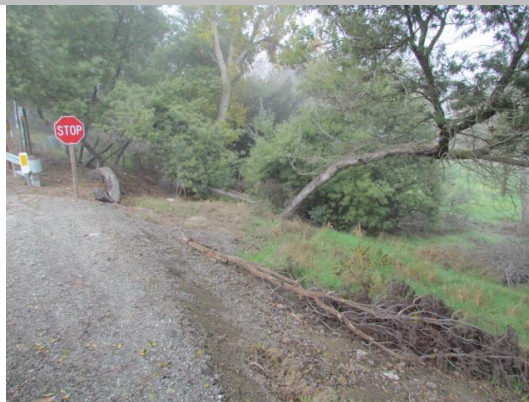
Photo 2 of 2 : SP\_2017\_RD0999\_233\_19\_20170314\_00022.jpg

Looking west at dense trees on landside slope and toe.

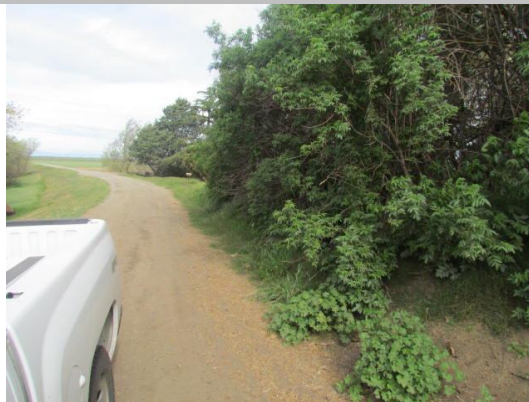
Photo 2 of 3 : SP\_2017\_RD0999\_233\_8\_20170314\_00009.jpg

Looking west at dense vegetation on landward shoulder and slope.  
(Spring 2015)

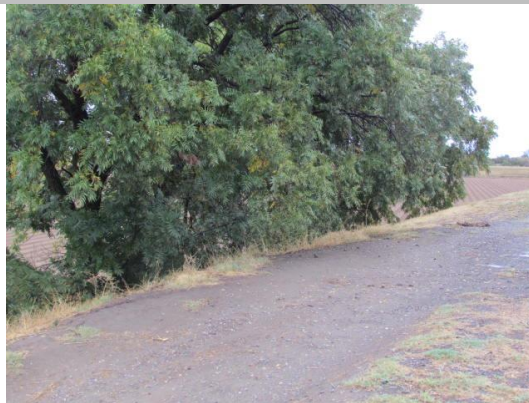
Photo 1 of 1 : SP\_2017\_RD0999\_233\_29\_20170314\_00028.jpg

Looking at untrimmed trees on landward slope fall 2015.

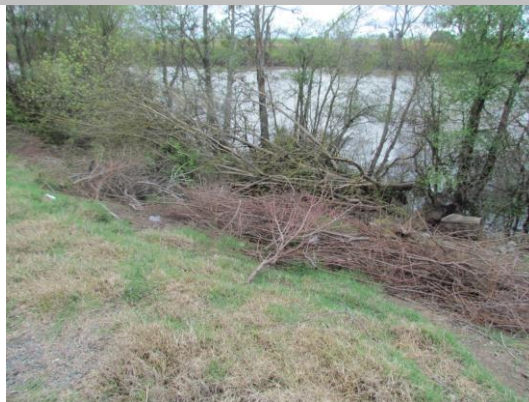
Photo 1 of 1 : SP\_2017\_RD0999\_234\_23\_20170324\_00043.jpg

Looking east large pruning piles on waterward slope.

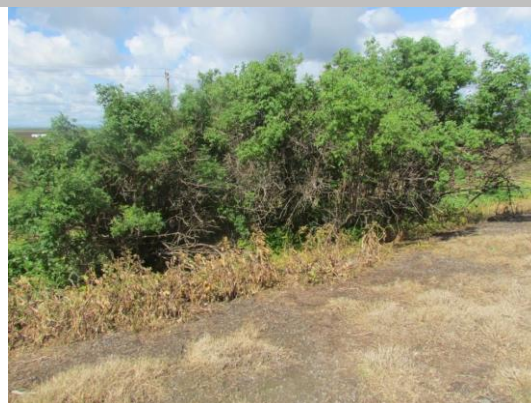
Photo 1 of 3 : SP\_2017\_RD0999\_234\_8\_20170324\_00044.jpg

Looking east at dense veg on landward slope. (Spring 2017)

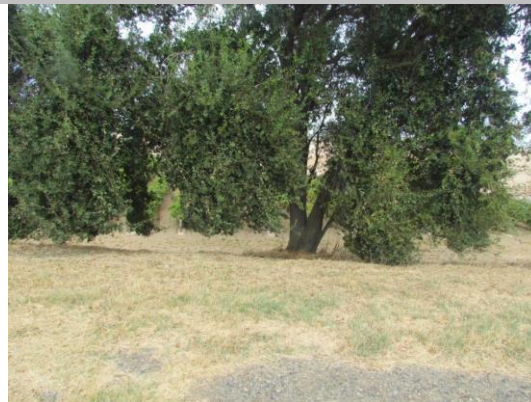
Photo 1 of 2 : SP\_2017\_RD0999\_234\_11\_20170314\_00011.jpg

Looking at untrimmed trees on landward slope and toe. (Fall 2016)

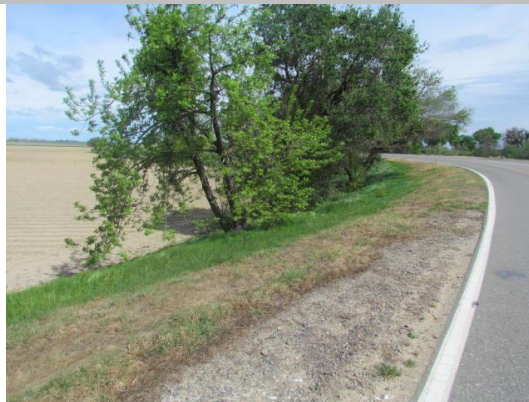
Photo 1 of 1 : SP\_2017\_RD0999\_234\_13\_20170314\_00014.jpg

Looking north at untrimmed trees on landward toe. (Spring 2015)

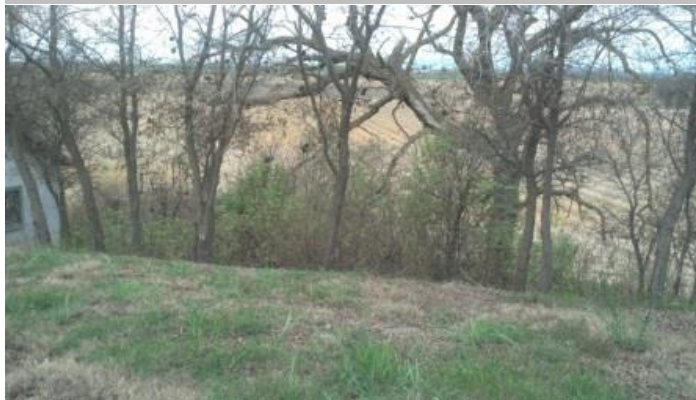
Photo 3 of 4 : SP\_2017\_RD0999\_234\_10\_20170314\_00009.jpg

Looking west at dense trees on landside toe.

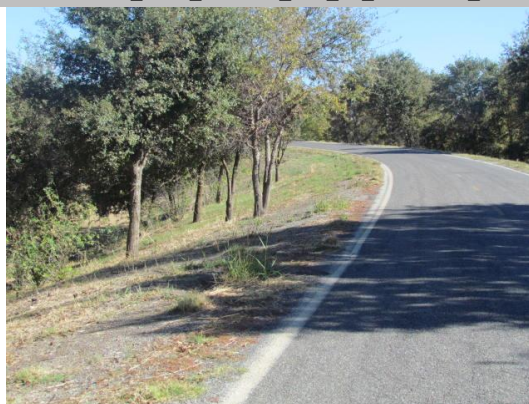
Photo 2 of 2 : SP\_2017\_RD0999\_234\_31\_20170314\_00027.jpg

Looking north at trimmed trees on landward slope.

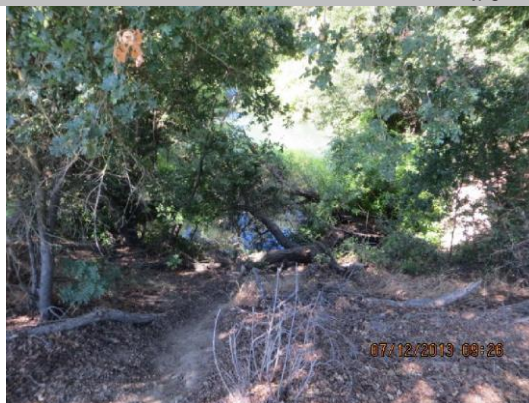
Photo 2 of 2 : UCIP\_SP\_2017\_15708\_26136.jpg

Toe of LS at approximate location of outlet/inlet.

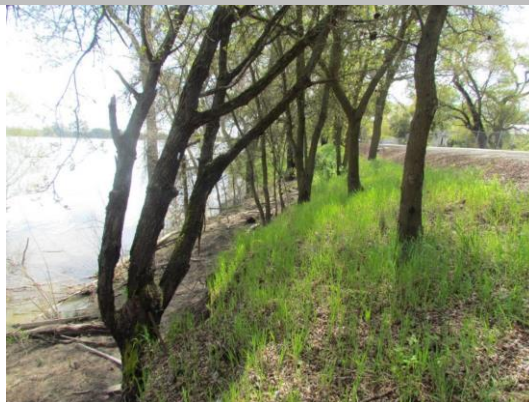
Photo 1 of 2 : SP\_2017\_RD0999\_235\_15\_20170324\_00074.jpg

Looking downstream at 2ft plus vertical erosion on waterward slope.

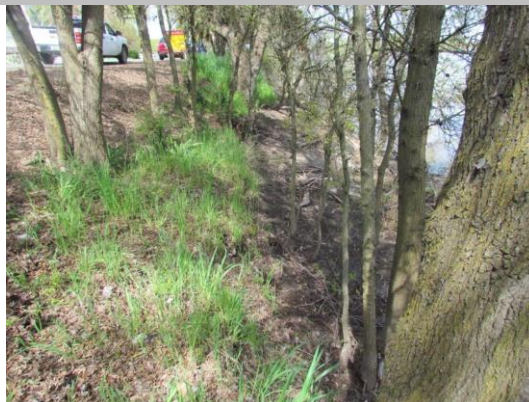
Photo 2 of 2 : SP\_2017\_RD0999\_235\_15\_20170324\_00075.jpg

Looking upstream at 2ft plus vertical erosion on waterward slope.

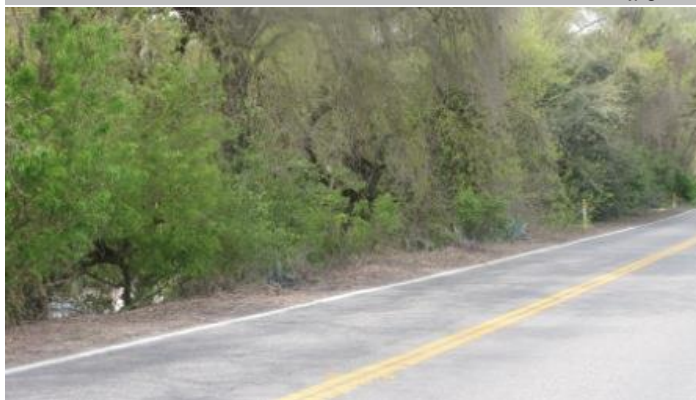
Photo 2 of 2 : SP\_2017\_RD0999\_235\_10\_20170314\_00007.jpg

Looking west at dense trees on waterside slope.

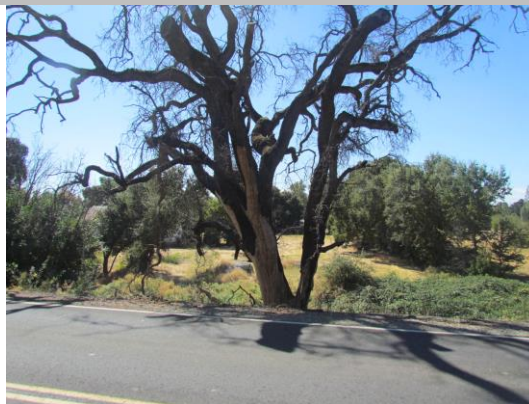
Photo 2 of 2 : SP\_2017\_RD0999\_235\_21\_20170314\_00019.jpg

Looking west at dead tree at landward toe.

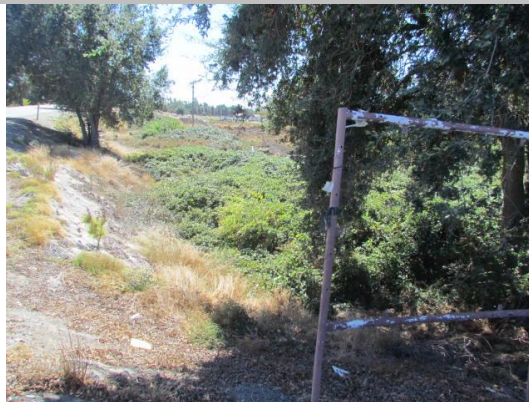
Photo 3 of 4 : SP\_2017\_RD0999\_235\_16\_20170314\_00015.jpg

Looking southwest at dense berry vines at landward toe. 2013

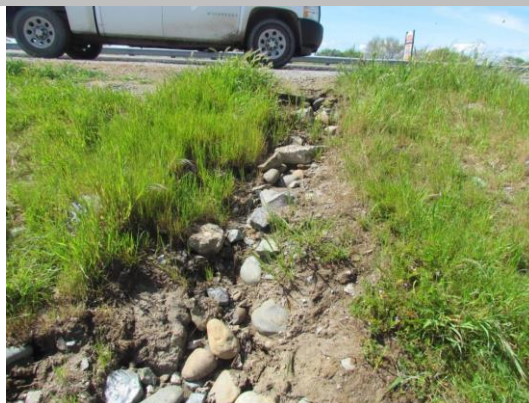
Photo 1 of 1 : SP\_2017\_RD0999\_235\_48\_20170324\_00078.jpg

Looking west at runoff erosion on waterward slope.

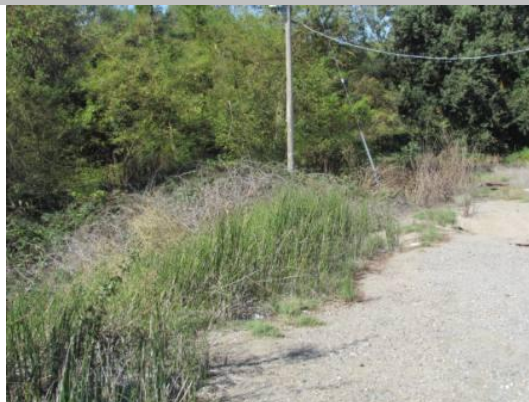
Photo 2 of 3 : SP\_2017\_RD0999\_235\_5\_20170314\_00003.jpg

Looking north at dense vegetation on landside slope near ramp.

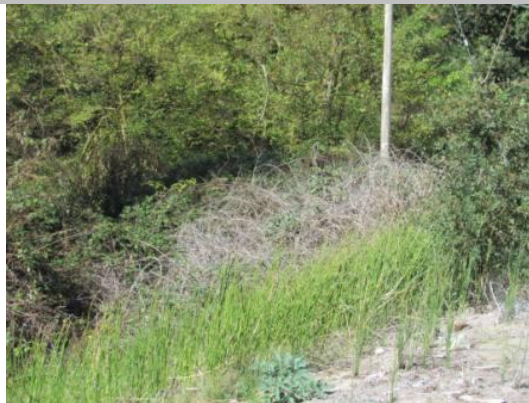
Photo 3 of 3 : SP\_2017\_RD0999\_235\_5\_20170314\_00004.jpg

Looking northwest at dense wild roses and berry vines on landside toe near ramp.

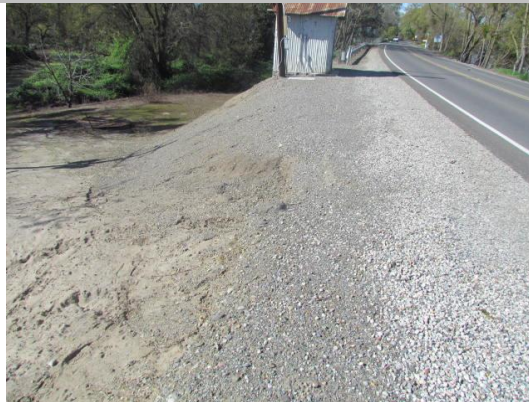
Photo 1 of 4 : SP\_2017\_RD0999\_235\_40\_20170314\_00027.jpg

Looking east at erosion on landward shoulder and slope. (Spring 2016)

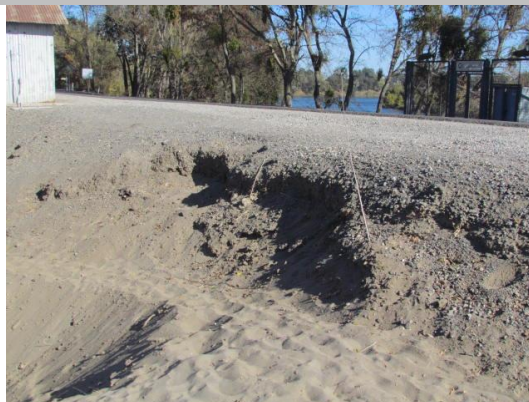
Photo 2 of 4 : SP\_2017\_RD0999\_235\_40\_20170314\_00028.jpg

Looking east at erosion on landward shoulder.

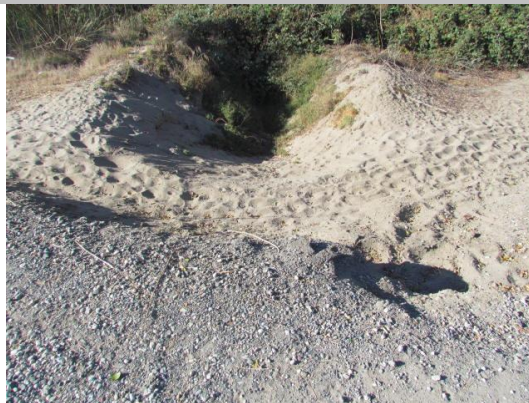
Photo 3 of 4 : SP\_2017\_RD0999\_235\_40\_20170314\_00029.jpg

Looking west at caving at landward slope and toe.

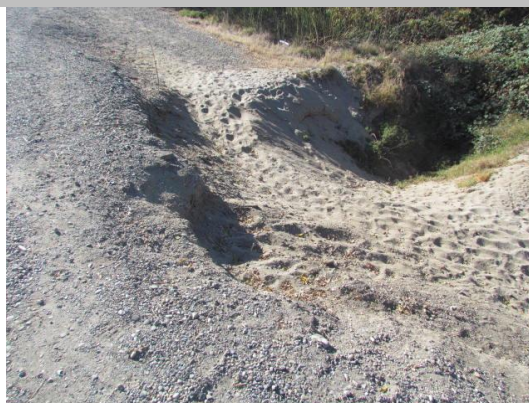
Photo 4 of 4 : SP\_2017\_RD0999\_235\_40\_20170314\_00030.jpg

Looking southwest at shoulder erosion and caving at landward slope and toe.

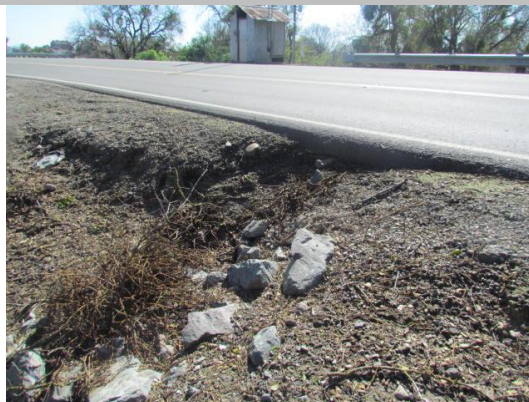
Photo 1 of 2 : SP\_2017\_RD0999\_235\_46\_20170314\_00031.jpg

Looking west at foot erosion on waterward shoulder and slope.

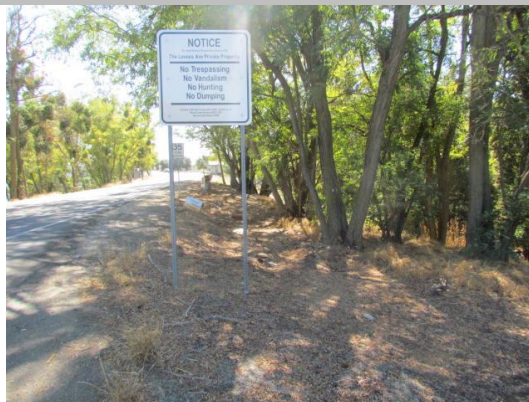
Photo 1 of 1 : SP\_2017\_RD0999\_235\_22\_20170314\_00020.jpg

Looking south at dense trees on landward slope.

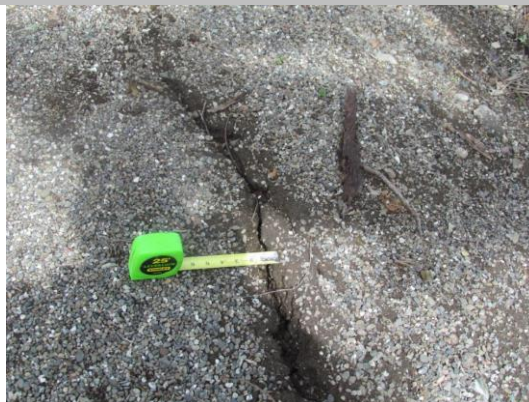
Photo 1 of 3 : SP\_2017\_RD0999\_236\_165\_20170324\_00232.jpg

Looking at two inch plus crack on waterward shoulder.

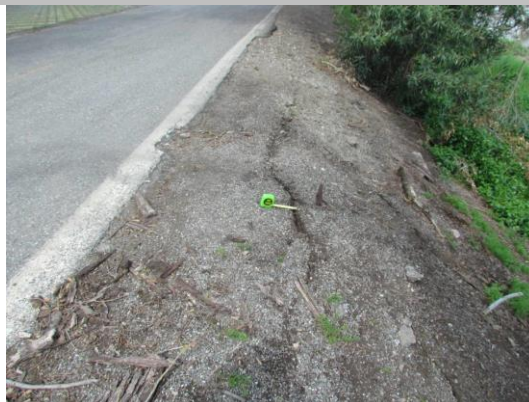
Photo 2 of 3 : SP\_2017\_RD0999\_236\_165\_20170324\_00233.jpg

Looking upstream at cracking along waterward shoulder.

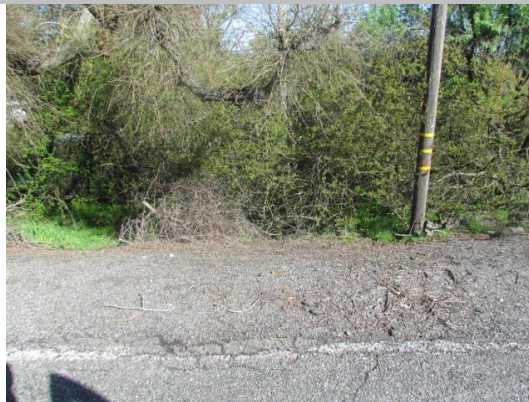
Photo 1 of 1 : SP\_2017\_RD0999\_236\_53\_20170314\_00047.jpg

Looking west at dense vegetation on landward slope.

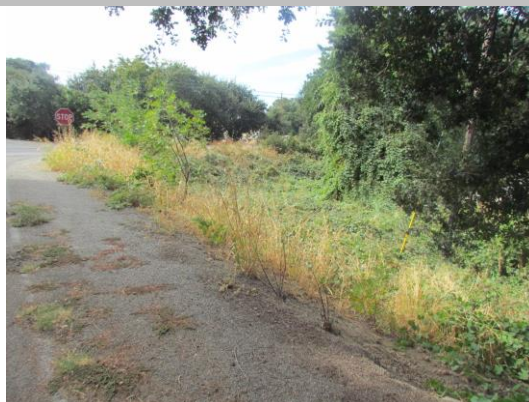
Photo 1 of 2 : SP\_2017\_RD0999\_236\_189\_20170314\_00129.jpg

Looking southwest at dense vegetation on landward slope and toe. (Fall 2016)

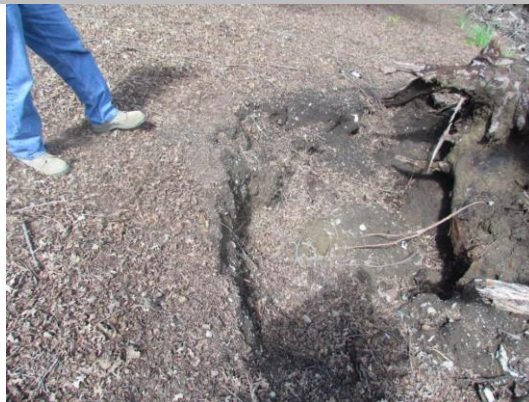
Photo 1 of 3 : SP\_2017\_RD0999\_236\_166\_20170324\_00236.jpg

Looking at hole left by fallen tree on waterward slope.

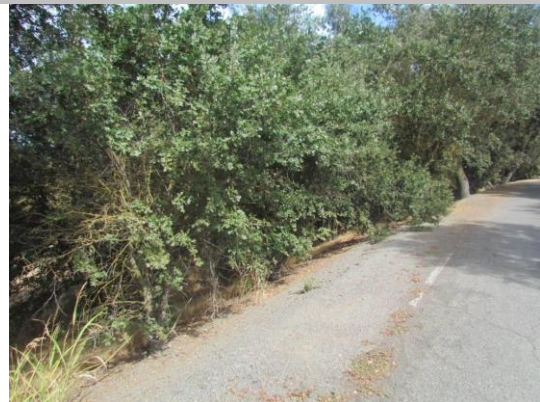
Photo 1 of 1 : SP\_2017\_RD0999\_236\_14\_20170314\_00015.jpg

Looking west at untrimmed trees on landward slope and toe.

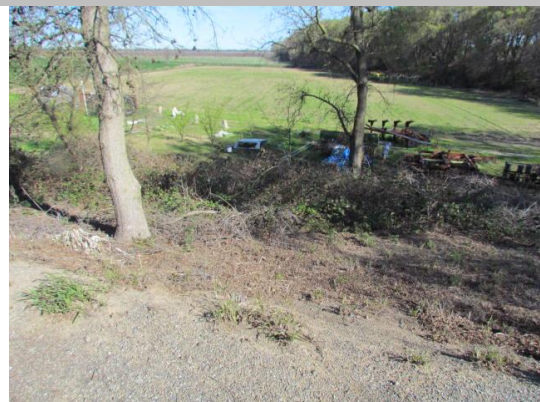
Photo 1 of 2 : SP\_2017\_RD0999\_236\_129\_20170314\_00087.jpg

Looking southwest at berry vines on landward slope.

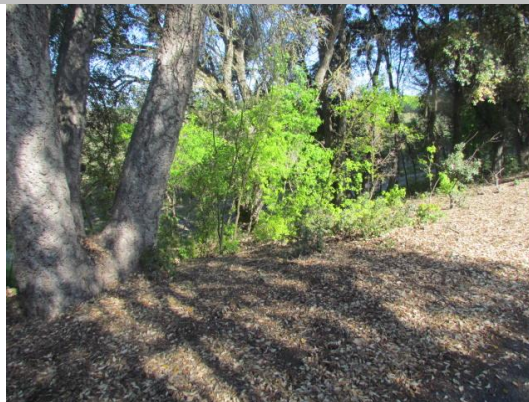
Photo 1 of 1 : SP\_2017\_RD0999\_236\_82\_20170314\_00066.jpg

Looking northwest at dense trees on landward slope. (Spring 2015)

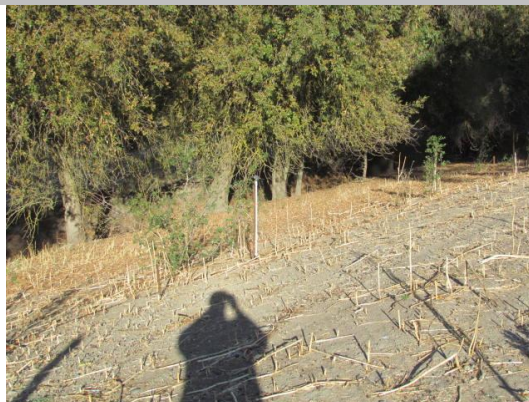
Photo 2 of 2 : SP\_2017\_RD0999\_236\_201\_20170314\_00141.jpg

Looking west at several small oak trees planted on landward slope.

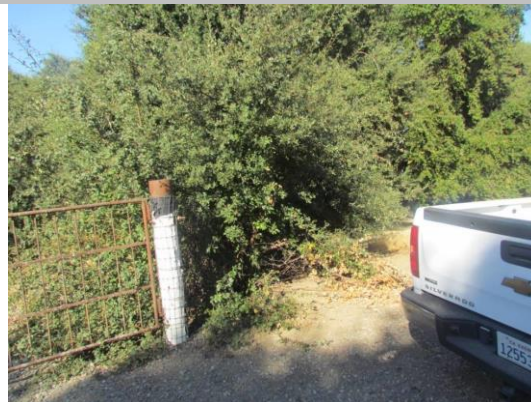
Photo 1 of 2 : SP\_2017\_RD0999\_236\_175\_20170314\_00118.jpg

Looking west at untrimmed trees along fenceline on landward slope.  
(Fall 2016)

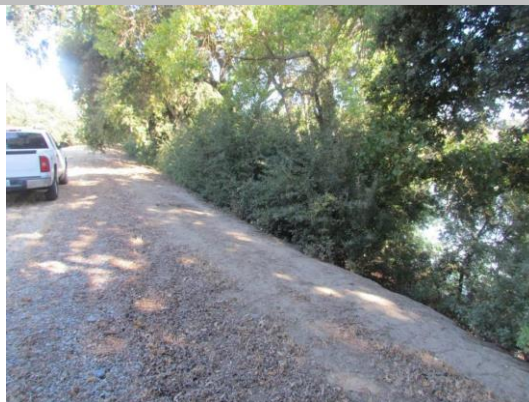
Photo 1 of 1 : SP\_2017\_RD0999\_236\_41\_20170314\_00034.jpg

Looking northeast at untrimmed trees on waterward slope.

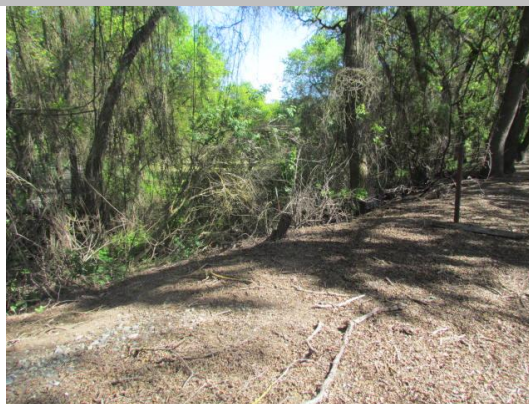
Photo 2 of 2 : SP\_2017\_RD0999\_236\_48\_20170314\_00043.jpg

Looking east at dense vegetation on landward slope. (Spring 2015)

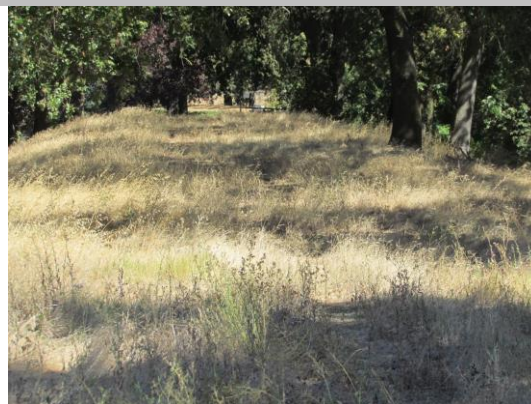
Photo 1 of 1 : SP\_2017\_RD0999\_236\_223\_20170314\_00161.jpg

Looking east at overgrowth on levee crown.
