**Flood Control Project Maintenance  
Levee Inspections**

## Maintenance Issue Types Only, Levee Inspection Report By Mile - Spring 2018

### Reclamation District No. 0999 Netherlands

Waterway	Bank	Unit Miles	Inspection Start/End	Inspector
Unit No. 01 Yolo Bypass	Left	15.41	05/08/2018 05/08/2018	Dave Torres

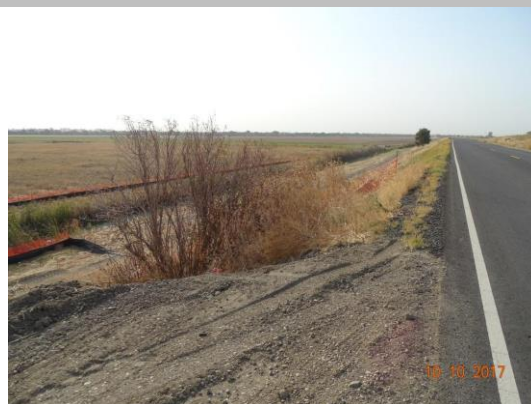
Photo 1 of 1 : SP\_2018\_RD0999\_232\_3\_20180301\_00011.jpg

LM Start	0.27	Rating **	M	Issue No.	3
LM End	0.27	Issue Type +	Ma	Location *	LS
Category	Earthen Levee			GPS Latitude/Longitude	
				Start	End
Item	Vegetation			38.501113 °	38.501113 °
				-121.581975 °	-121.581975 °
DWR ID	DWR_RD0999_01_s_2012_3				
Comment Code					
V4 : Elderberries are blocking visibility and flood fight capability.					
Inspector Comment

View of landside slope looking south.

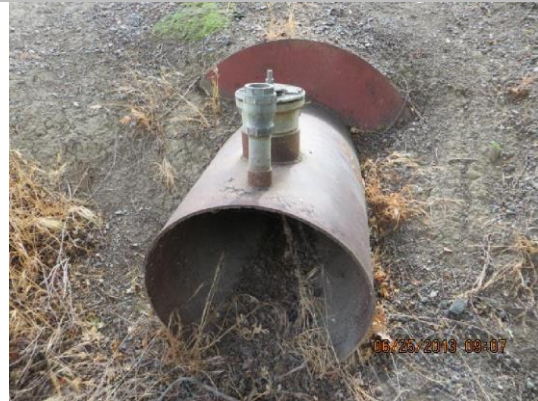
Photo 1 of 3 : UCIP\_SP\_2018\_50092\_25191.jpg

FS\_ID:50092  
DS\_ID:22743  
EP\_NO: N/A  
Repair Type: Urgent  
Crossing Status: Found  
UCIP Comments: 07/07/2016 Condition largely unchanged from previous inspection. Pipe open on the WS, waterward of the siphon breaker. Dense vegetation and steep slope limited inspection of WS outlet into Ship Channel. (T. Hatch/UCIP)  
06/25/2013 Pipe abandoned and open on WS slope. Pipe should be abandoned properly. (W. Wylie/UCIP)  
FIELD\_STRUCT\_DESC: \*ABANDONED\* 30-inch steel drainage pipe through the levee, 6.5 feet below the crown. Pump on a platform in the canal off the landside (LS) toe, not found. Flap gate on the waterside (WS), not found. Siphon breaker and an air vent on the WS shoulder. 1-inch galvanized iron filler pipe visible on the WS shoulder along same alignment. [Additional Reference(s): DWR Levee Log, 1992. USACE Sacramento O&M Manual 113 (Revised), October 1966, (HLM 1.73)].  
FS Date: 7/7/2016

Pipe open on WS slope

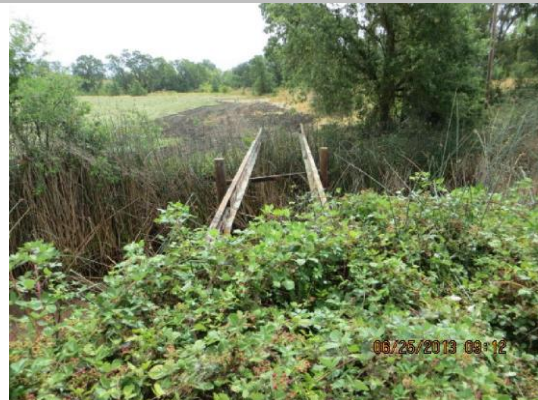
Photo 2 of 3 : UCIP\_SP\_2018\_50092\_25190.jpg

Pump platform visible off LS toe, but no appurtances remain.

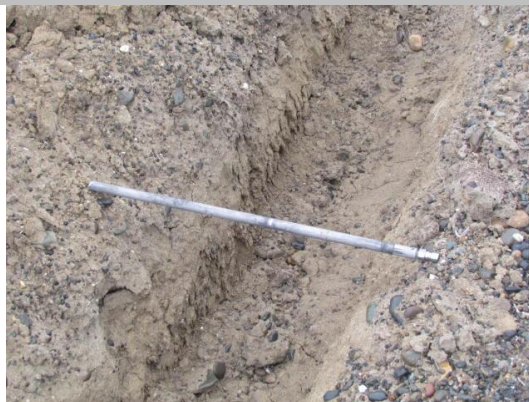
Photo 3 of 4 : SP\_2018\_RD0999\_232\_40\_20180301\_00035.jpg

Looking south at close-up view of excavation on landside shoulder.

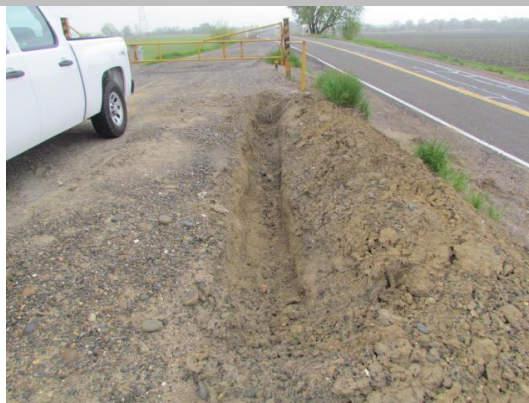
Photo 4 of 4 : SP\_2018\_RD0999\_232\_40\_20180301\_00036.jpg

Looking north at excavation on landside shoulder.

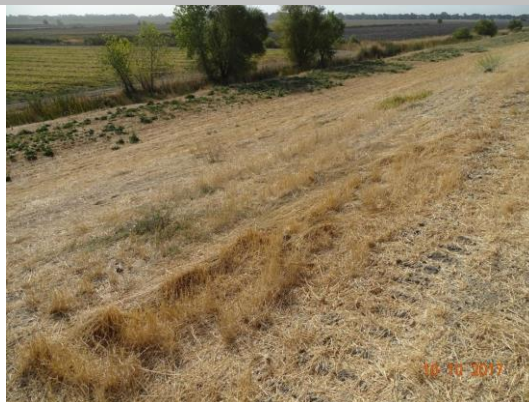
Photo 1 of 3 : SP\_2018\_RD0999\_232\_51\_20180301\_00052.jpg

LM Start	3.22	Rating **	M	Issue No.	51
LM End	3.22	Issue Type +	Ma	Location *	LS
Category	Earthen Levee			GPS Latitude/Longitude	
				Start	End
Item	Slope Stability			38.459399 °	38.459399 °
				-121.587523 °	-121.587523 °
DWR ID	DWR_RD0999_01_s_2013_51				
Comment Code					
S1 : Repair slope instability.					
Inspector Comment					
Depression on landward shoulder and slope 40' x 20'. Earthen material appears to be sliding toward levee toe.

View of landside slope looking south.

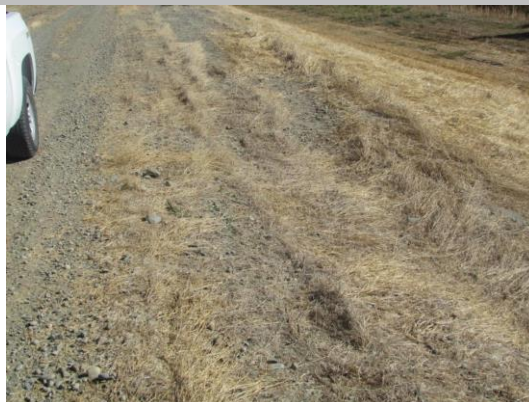
Photo 2 of 3 : SP\_2018\_RD0999\_232\_51\_20180301\_00053.jpg

Looking northeast at depression on landward slope. (Fall 2016)

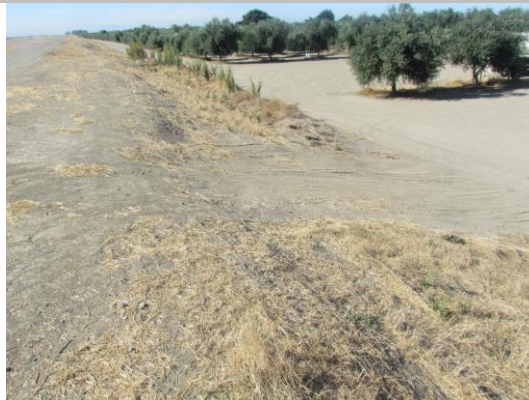
Photo 1 of 2 : SP\_2018\_RD0999\_232\_27\_20180301\_00020.jpg

LM Start	4.31	Rating **	M	Issue No.	27
LM End	4.31	Issue Type +	Ma	Location *	WS
Category	Earthen Levee			GPS Latitude/Longitude	
				Start	End
Item	Slope Stability			38.444560 °	38.444560 °
				-121.594440 °	-121.594440 °
DWR ID	DWR_RD0999_01_f_2012_27				
Comment Code					
S3 : Repair the levee slope damaged by vehicle traffic and prevent access where possible.					
Inspector Comment					
Local farmer causing slope damage by driving equipment and trucks on slope.

Looking at slope damage cause by vehicle traffic on waterward slope.  
(Fall 2016)

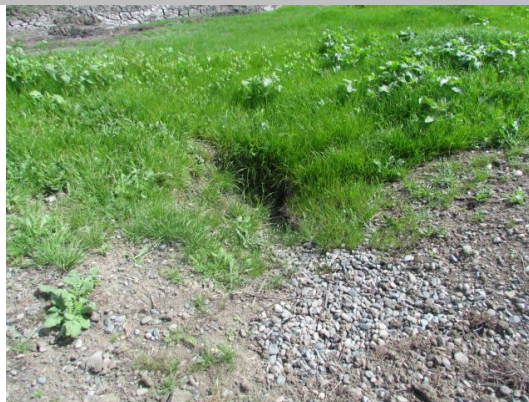
Photo 2 of 4 : SP\_2018\_RD0999\_232\_49\_20180301\_00045.jpg

Looking east at caving on landward shoulder and slope. (Spring 2015)

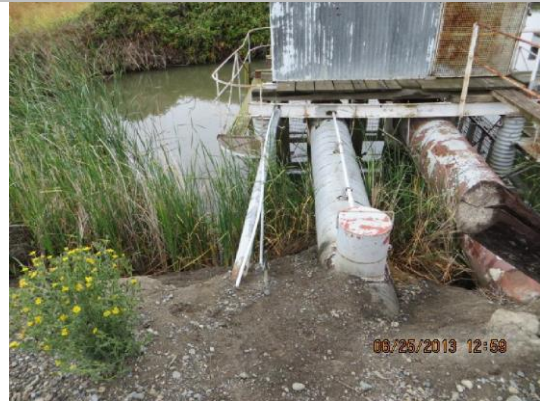
Photo 3 of 3 : UCIP\_SP\_2018\_15366\_25229.jpg

Closeup of 24-inch pipe on LS toe.

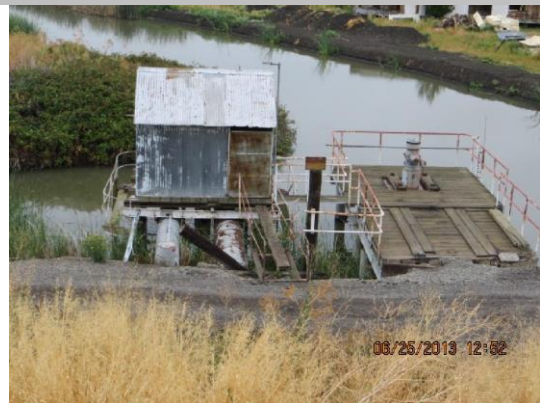
Photo 1 of 3 : UCIP\_SP\_2018\_15365\_25227.jpg

LM Start	15.24	Rating **	A/W	Issue No.	926
LM End	15.24	Issue Type +	Ma	Location *	
Category	Supplemental			GPS Latitude/Longitude	
				Start	End
Item	DWR UCIP LMA Responsibility			38.292973 °	38.292973 °
				-121.644977 °	-121.644977 °
DWR ID					
Comment Code					
Inspector Comment					
FS_ID:15365					
DS_ID:22756					
EP_NO: N/A					
Repair Type: No Action Needed					
Crossing Status: Found					
UCIP Comments:					
FIELD_STRUCT_DESC: 30-inch steel drainage pipe through the levee, 7 feet below the crown. Flap gate on the waterside (WS) end. Pump in pump house on the landside (LS) toe. Siphon breaker in a corrugated metal pipe (CMP) riser on the WS shoulder. [Additional Reference(s): DWR Levee Log, 1992. USACE Sacramento O&M Manual 113 (Revised), October 1966, (HLM 15.25) (36-inch pipe listed)].					
FS Date: 6/25/2013

Pumphouse on LS toe.

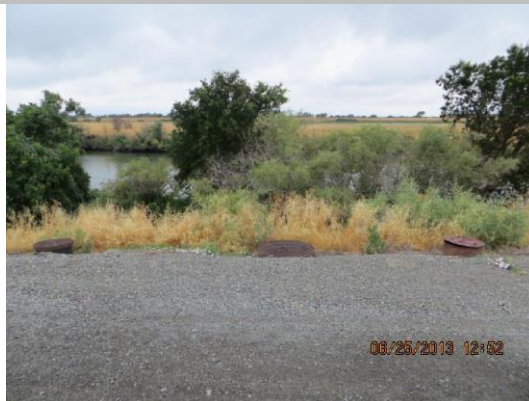
Photo 2 of 3 : UCIP\_SP\_2018\_15365\_25226.jpg

Siphon breaker in CMP riser on WS shoulder.

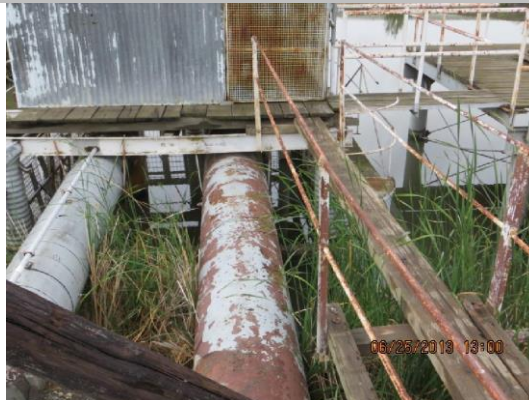
Photo 3 of 3 : UCIP\_SP\_2018\_15365\_25225.jpg

Closeup of pipe at pump house on LS toe.

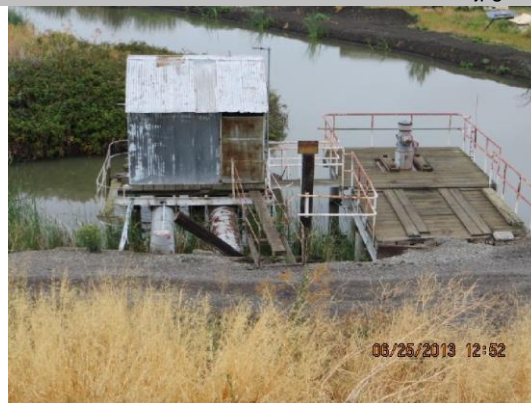
Photo 1 of 3 : UCIP\_SP\_2018\_15363\_25219.jpg

LM Start	15.24	Rating **	A/W	Issue No.	927
LM End	15.24	Issue Type +	Ma	Location *	
Category	Supplemental			GPS Latitude/Longitude	
				Start	End
Item	DWR UCIP LMA Responsibility			38.292943 °	38.292943 °
				-121.644980 °	-121.644980 °
DWR ID					
Comment Code					
Inspector Comment					
FS_ID:15363 DS_ID:22755 EP_NO: 15303 Repair Type: No Action Needed Crossing Status: Found UCIP Comments: FIELD_STRUCT_DESC: 30-inch steel discharge pipe through the levee, 7 feet below the crown. Pump on platform on the landside (LS) toe. Siphon breaker in corrugated metal pipe (CMP) riser on the waterside (WS) shoulder. (Permit No. 15303, 1989 - Reclamation District No. 999). [Additional Reference(s): DWR Levee Log, 1992]. FS Date: 6/25/2013

Pump platform to right of pumphouse.

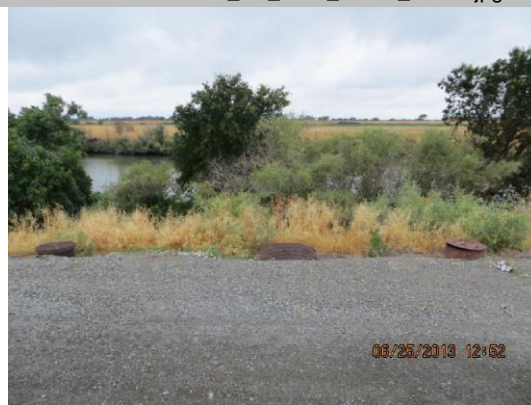
Photo 2 of 3 : UCIP\_SP\_2018\_15363\_25218.jpg

Siphon breaker in CMP riser on WS shoulder.

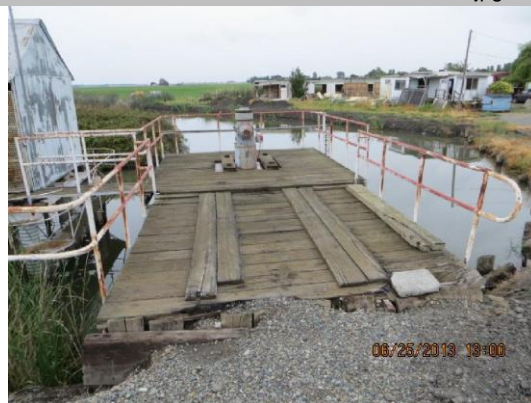
Photo 3 of 3 : UCIP\_SP\_2018\_15363\_25217.jpg

Pump and platform on LS toe.

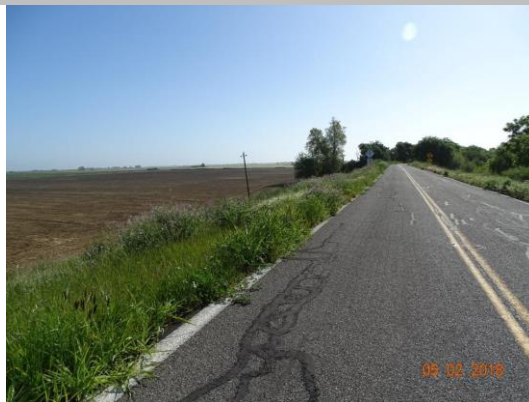
Photo 1 of 1 : SP\_2018\_RD0999\_233\_32\_20180507\_00053.jpg

Vegetation landside looking east.

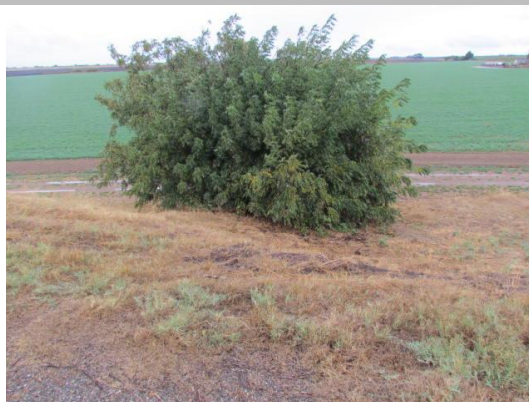
Photo 3 of 3 : SP\_2018\_RD0999\_233\_37\_20180301\_00027.jpg

Looking at untrimmed tree on landward slope. (Spring 2016)

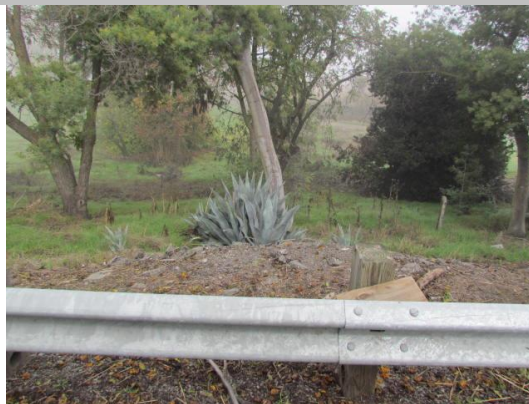
Photo 2 of 2 : SP\_2018\_RD0999\_233\_14\_20180301\_00012.jpg

Looking north at century plant at landside toe.

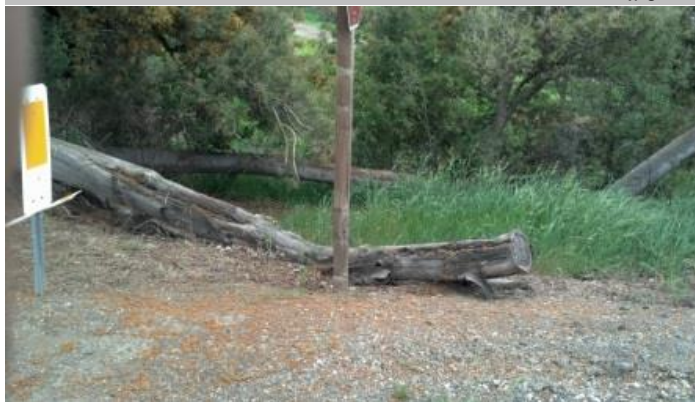
Photo 1 of 1 : SP\_2018\_RD0999\_233\_13\_20180301\_00010.jpg

Looking northwest at tree limb on landside slope.

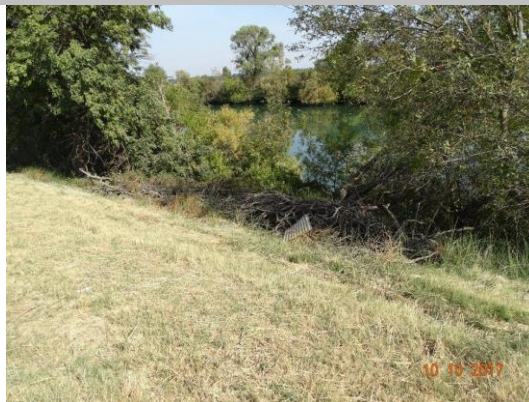
Photo 1 of 1 : SP\_2018\_RD0999\_234\_32\_20180301\_00033.jpg

View of waterside slope looking east.

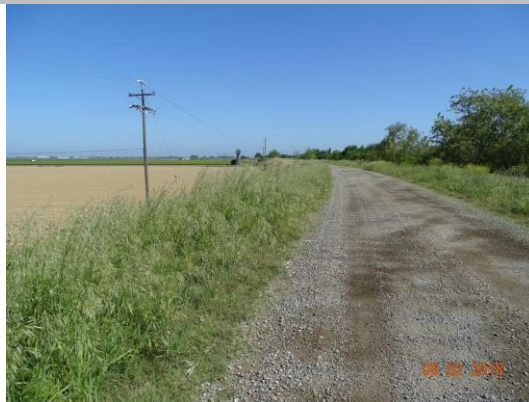
Photo 1 of 1 : SP\_2018\_RD0999\_234\_35\_20180507\_00050.jpg

Vegetation landside looking north.

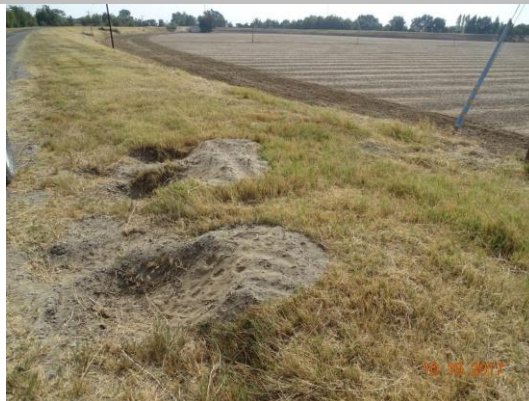
Photo 1 of 1 : SP\_2018\_RD0999\_234\_33\_20180301\_00034.jpg

View of landside slope looking southwest.

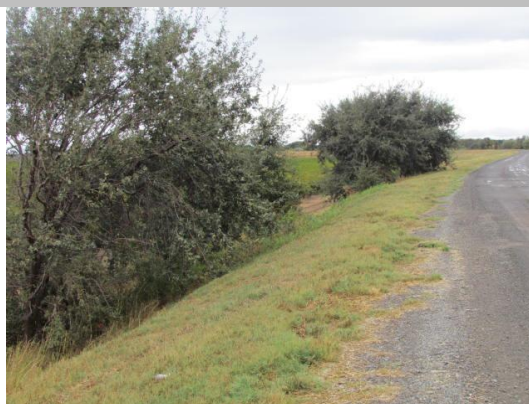
Photo 2 of 2 : SP\_2018\_RD0999\_234\_43\_20180301\_00036.jpg

Looking at untrimmed trees on landward slope and toe.

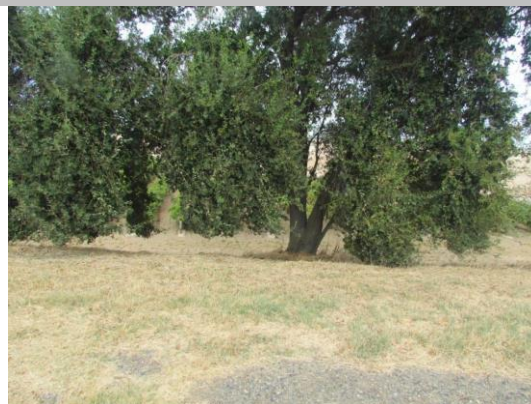
Photo 1 of 2 : SP\_2018\_RD0999\_234\_11\_20180301\_00010.jpg

Looking at untrimmed trees on landward slope and toe. (Fall 2016)

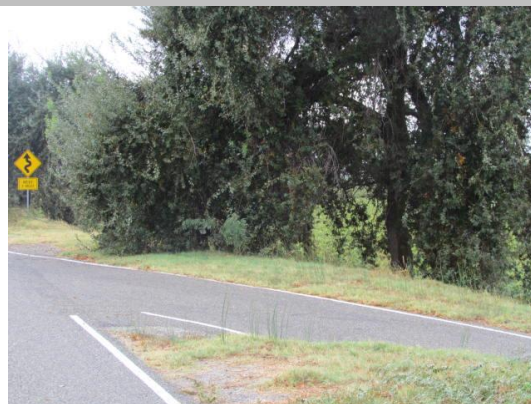
Photo 2 of 2 : SP\_2018\_RD0999\_234\_11\_20180301\_00011.jpg

Looking at untrimmed trees on landward slope and toe. (Spring 2016)

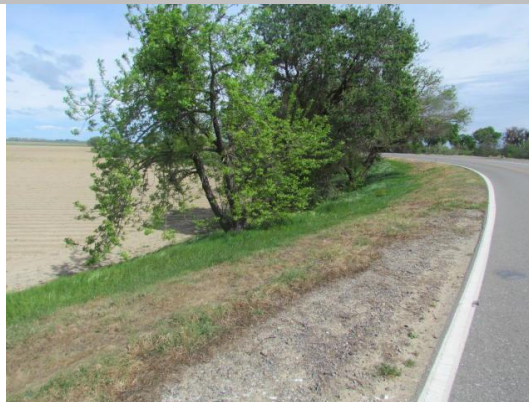
Photo 1 of 1 : SP\_2018\_RD0999\_234\_13\_20180301\_00013.jpg

Looking north at untrimmed trees on landward toe. (Spring 2015)

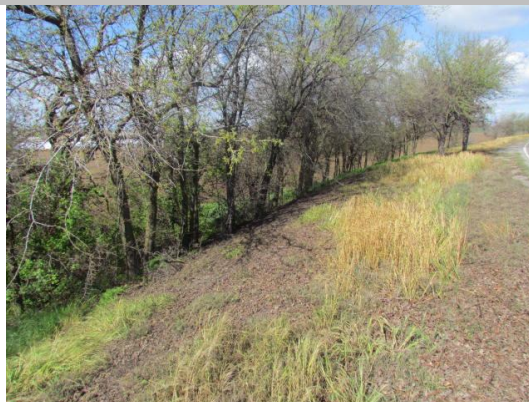
Photo 2 of 2 : SP\_2018\_RD0999\_234\_10\_20180301\_00006.jpg

Looking northwest at dense vegetation on landward slope and toe.  
(Spring 2016)

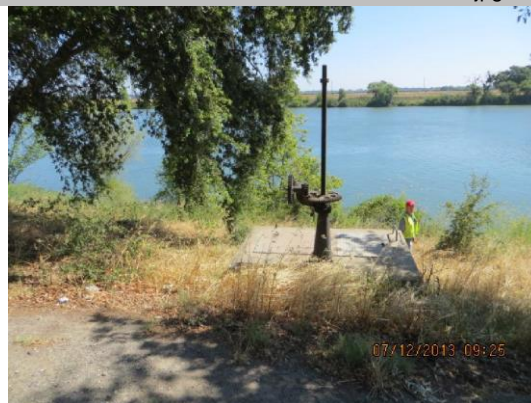
Photo 1 of 2 : UCIP\_SP\_2018\_15708\_26137.jpg

Slide gate in concrete vault on WS shoulder.

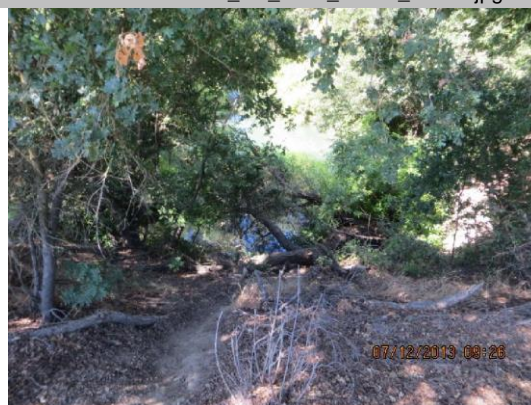
Photo 2 of 2 : UCIP\_SP\_2018\_15708\_26136.jpg

Toe of LS at approximate location of outlet/inlet.

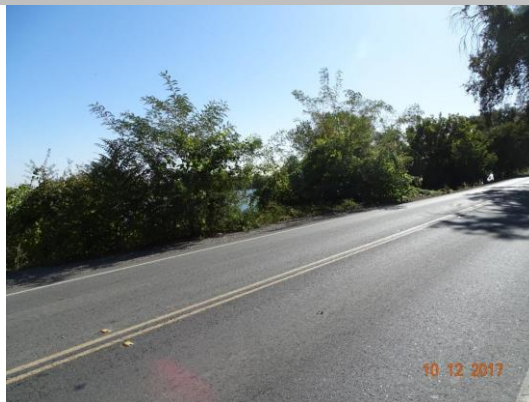
Photo 1 of 1 : SP\_2018\_RD0999\_235\_53\_20180301\_00042.jpg

Looking southeast at the waterside slope.

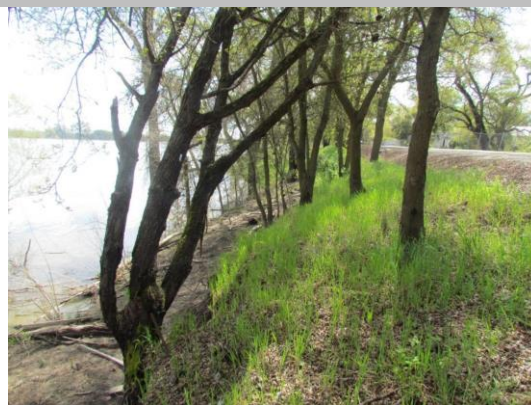
Photo 1 of 2 : SP\_2018\_RD0999\_235\_15\_20180301\_00012.jpg

LM Start	0.11	Rating **	A/W	Issue No.	15
LM End	0.21	Issue Type +	Ma	Location *	WS
Category	Earthen Levee			GPS Latitude/Longitude	
				Start	End
Item	Erosion / Bank Caving			38.415425 °	38.416733 °
				-121.523920 °	-121.524705 °
DWR ID	DWR_RD0999_04_s_2017_15				
Comment Code					
E2 : Schedule repair of erosion site prior to the next inspection.					
Inspector Comment					
Waterside erosion 2ft vertical cut.

Looking downstream at 2ft plus vertical erosion on waterward slope.

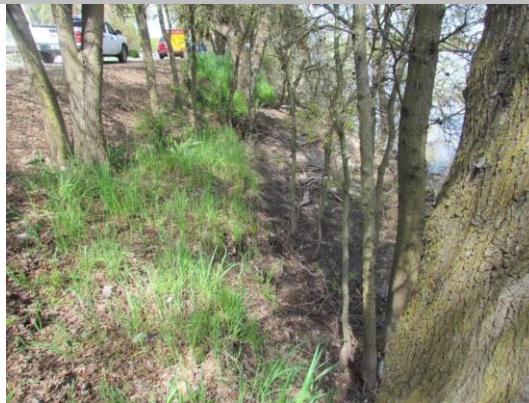
Photo 2 of 2 : SP\_2018\_RD0999\_235\_15\_20180301\_00013.jpg

Looking upstream at 2ft plus vertical erosion on waterward slope.

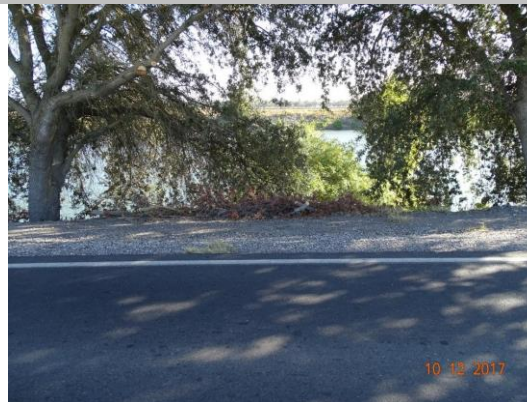
Photo 1 of 1 : SP\_2018\_RD0999\_235\_43\_20180301\_00033.jpg

Looking east at the waterside slope.

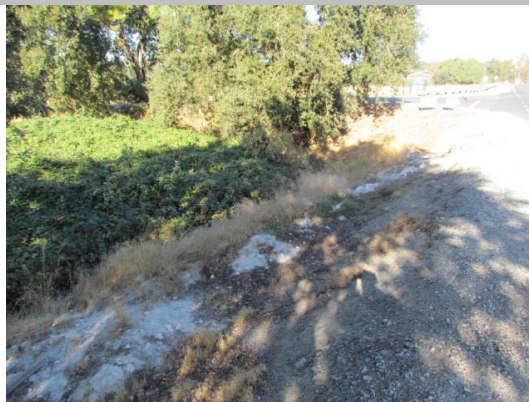
Photo 2 of 4 : SP\_2018\_RD0999\_235\_16\_20180301\_00015.jpg

Looking northwest at dense vines at landward toe. Fall 2015

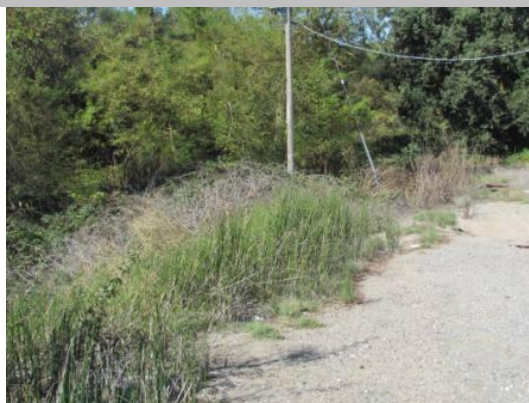
Photo 3 of 3 : SP\_2018\_RD0999\_235\_5\_20180301\_00005.jpg

Looking north at dense vegetation on landside slope near ramp.

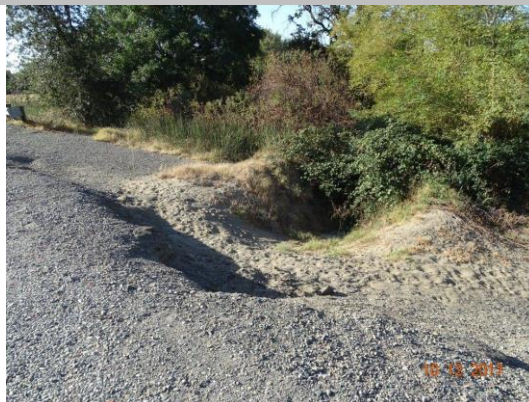
Photo 1 of 3 : SP\_2018\_RD0999\_235\_40\_20180301\_00027.jpg

Looking southwest at the landside slope.

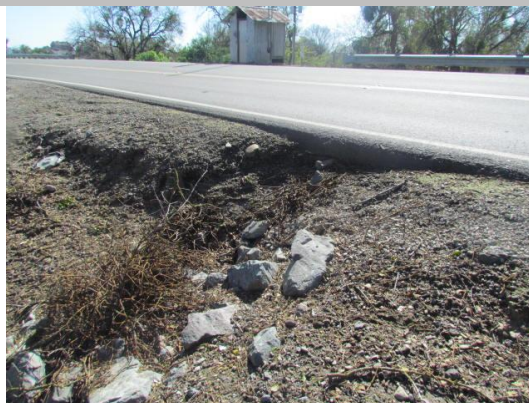
Photo 2 of 2 : SP\_2018\_RD0999\_235\_46\_20180301\_00037.jpg

Looking west at foot erosion on waterward shoulder and slope.

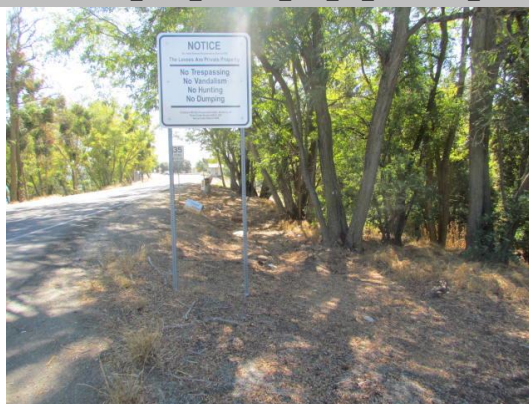
Photo 2 of 2 : SP\_2018\_RD0999\_235\_22\_20180301\_00021.jpg

Looking south at dense trees on landward slope.

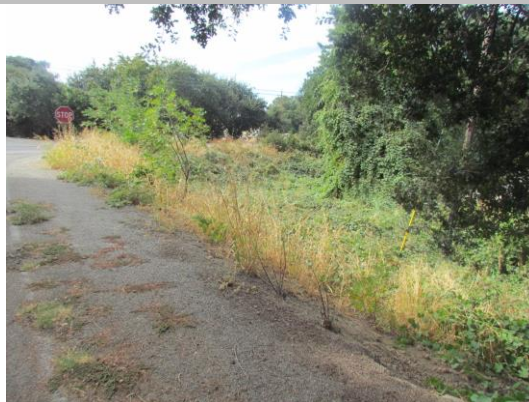
Photo 1 of 2 : SP\_2018\_RD0999\_236\_189\_20180301\_00103.jpg

Looking southwest at dense vegetation on landward slope and toe. (Fall 2016)

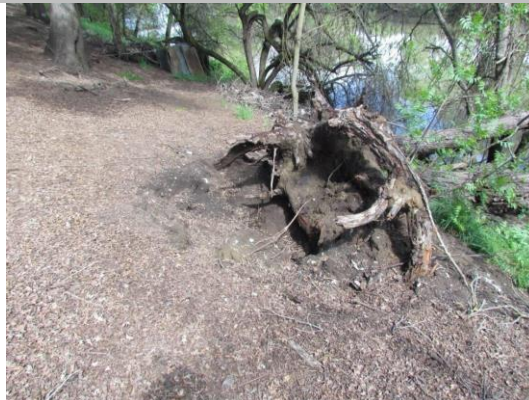
Photo 2 of 3 : SP\_2018\_RD0999\_236\_166\_20180301\_00084.jpg

Looking east at fallen tree on waterward slope.

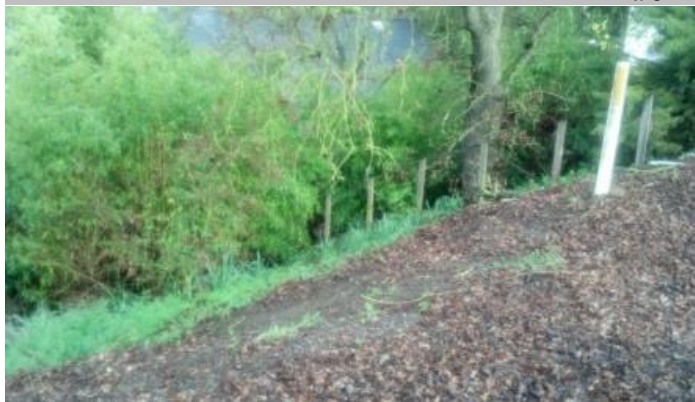
Photo 2 of 2 : SP\_2018\_RD0999\_236\_128\_20180301\_00062.jpg

Looking at dense trees on landside slope and toe.

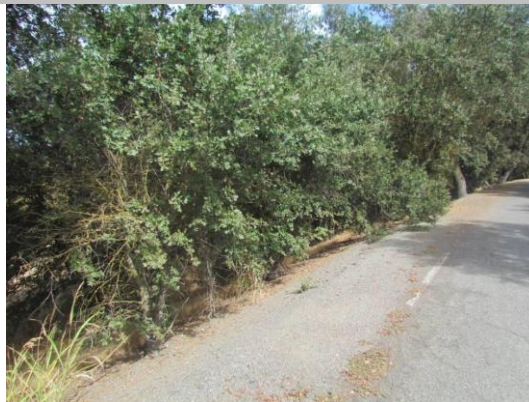
Photo 1 of 1 : SP\_2018\_RD0999\_236\_14\_20180301\_00011.jpg

Looking west at untrimmed trees on landward slope and toe.

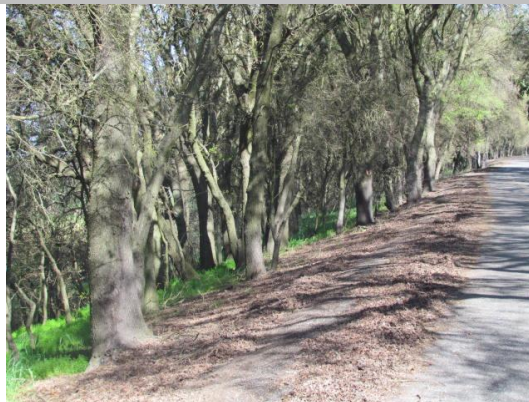
Photo 1 of 1 : SP\_2018\_RD0999\_236\_18\_20180301\_00018.jpg

Looking east at dense trees on landward slope.

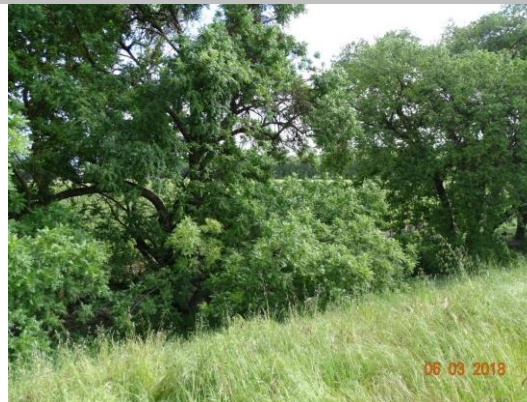
Photo 1 of 1 : SP\_2018\_RD0999\_236\_68\_20180503\_00197.jpg

Trim thin trees landside looking north.

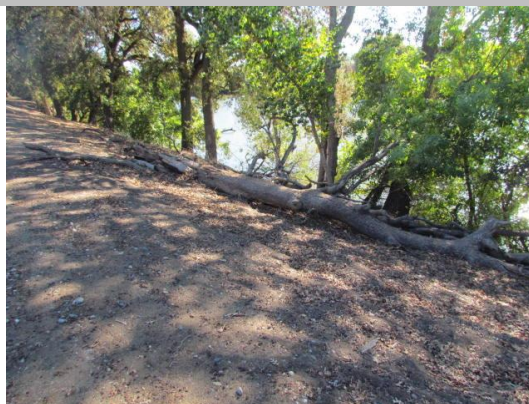
Photo 1 of 1 : SP\_2018\_RD0999\_236\_174\_20180301\_00096.jpg

Looking at downed tree branch on waterward slope.

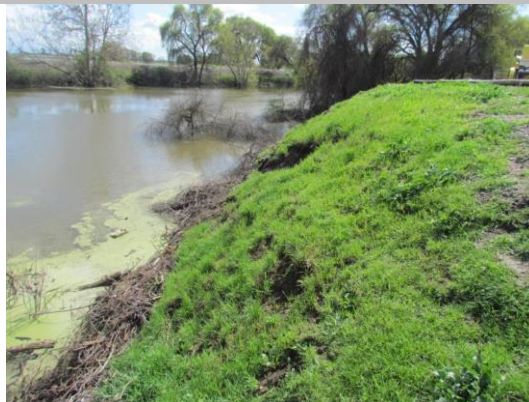
Photo 1 of 2 : SP\_2018\_RD0999\_236\_12\_20180301\_00009.jpg

Looking downstream at finger erosion on downstream side of slough.

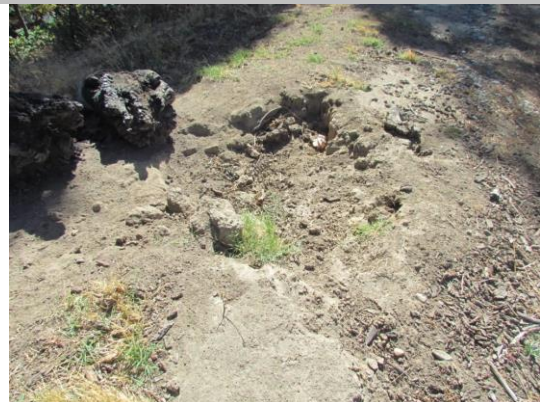
Photo 1 of 3 : SP\_2018\_RD0999\_236\_176\_20180301\_00097.jpg

Looking at hole from falling tree on waterward shoulder. (Fall 2016)

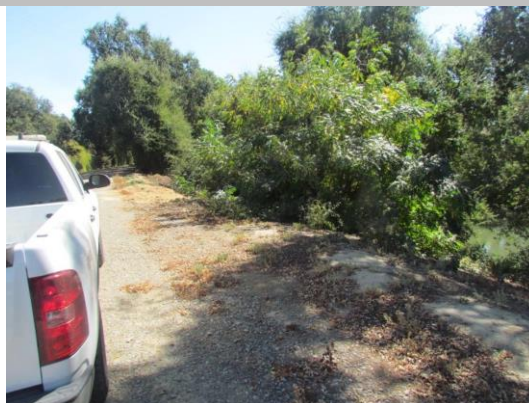
Photo 1 of 1 : SP\_2018\_RD0999\_236\_118\_20180301\_00058.jpg

Looking northeast at untrimmed trees on watward slope.
