**Flood Control Project Maintenance
Levee Inspections**

Maintenance Issue Types Only, Levee Inspection Report By Mile - Spring 2019

Reclamation District No. 0999 Netherlands

Waterway	Bank	Unit Miles	Inspection Start/End	Inspector
Unit No. 01 Yolo Bypass	Left	15.41	03/21/2019 03/21/2019	Luz Dial

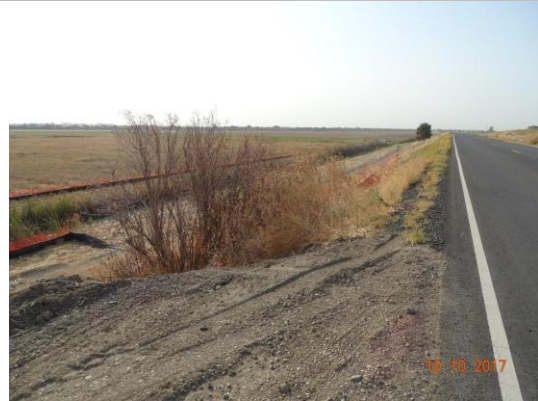
Photo 1 of 1 : SP_2019_RD0999_232_3_20190307_00004.jpg

LM Start	0.27	Rating **	M	Issue No.	3
LM End	0.27	Issue Type +	Ma	Location *	LS
Category	Earthen Levee			GPS Latitude/Longitude	
				Start	End
Item	Vegetation			38.501113 °	38.501113 °
				-121.581975 °	-121.581975 °
DWR ID	DWR_RD0999_01_s_2012_3				
Comment Code					
V4 : Elderberries are blocking visibility and flood fight capability.					
Inspector Comment

View of landside slope looking south. Fall 2017

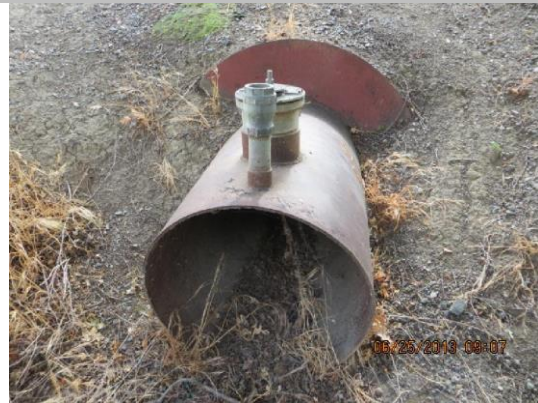
Photo 1 of 3 : UCIP_SP_2019_53368_25191.jpg

Comment Code					
Inspector Comment					
FS_ID:53368 DS_ID:22743 EP_NO: N/A Repair Type: Non-Urgent Crossing Status: Found UCIP Comments: 07/26/2018 Same as last inspection. Pipe open on WS, but no visual signs of pipe or levee integrity issues so downgrading crossing to Non-Urgent (D. Sanoski - DWR UCIP).07/07/2016 Condition largely unchanged from previous inspection. Pipe open on the WS, waterward of the siphon breaker. Dense vegetation and steep slope limited inspection of WS outlet into Ship Channel. (T. Hatch/UCIP) 06/25/2013 Pipe abandoned and open on WS slope. Pipe should be abandoned properly. (W. Wylie/UCIP) FIELD_STRUCT_DESC: *ABANDONED* 30-inch steel drainage pipe through the levee, 6.5 feet below the crown. Pump on a platform in the canal off the landside (LS) toe, not found. Flap gate on the waterside (WS), not found. Siphon breaker and an air vent on the WS shoulder. 1-inch galvanized iron filler pipe visible on the WS shoulder along same alignment. [Additional Reference(s): DWR Levee Log, 1992. USACE Sacramento O&M Manual 113 (Revised), October 1966, (HLM 1.73)]. FS Date: 7/26/2018 10:10:00 AM

Pipe open on WS slope

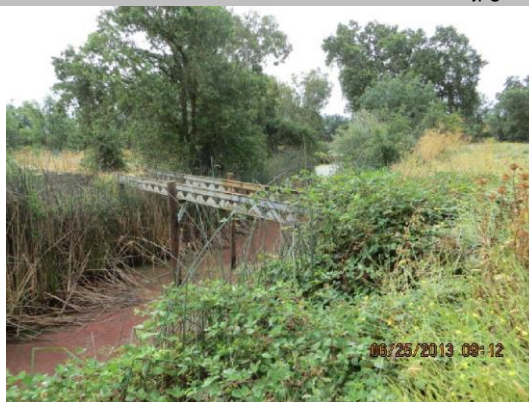
Photo 3 of 3 : UCIP_SP_2019_53368_25189.jpg

Comment Code						
Inspector Comment						
FS_ID:53368 DS_ID:22743 EP_NO: N/A Repair Type: Non-Urgent Crossing Status: Found UCIP Comments: 07/26/2018 Same as last inspection. Pipe open on WS, but no visual signs of pipe or levee integrity issues so downgrading crossing to Non-Urgent (D. Sanoski - DWR UCIP).07/07/2016 Condition largely unchanged from previous inspection. Pipe open on the WS, waterward of the siphon breaker. Dense vegetation and steep slope limited inspection of WS outlet into Ship Channel. (T. Hatch/UCIP) 06/25/2013 Pipe abandoned and open on WS slope. Pipe should be abandoned properly. (W. Wylie/UCIP) FIELD_STRUCT_DESC: *ABANDONED* 30-inch steel drainage pipe through the levee, 6.5 feet below the crown. Pump on a platform in the canal off the landside (LS) toe, not found. Flap gate on the waterside (WS), not found. Siphon breaker and an air vent on the WS shoulder. 1- inch galvanized iron filler pipe visible on the WS shoulder along same alignment. [Additional Reference(s): DWR Levee Log, 1992. USACE Sacramento O&M Manual 113 (Revised), October 1966, (HLM 1.73)]. FS Date: 7/26/2018 10:10:00 AM

Pump platform visible off LS toe, but no appurtenances remain.

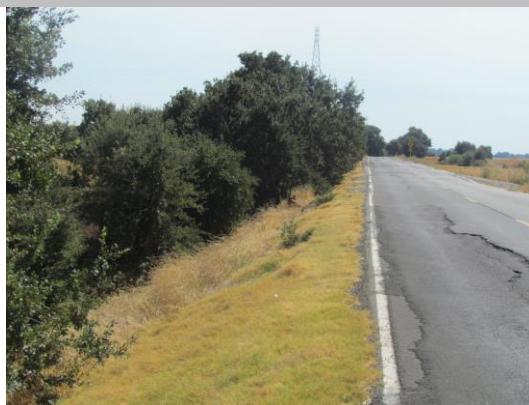
Photo 2 of 2 : SP_2019_RD0999_232_30_20190307_00016.jpg

Looking southeast at dense trees on landward slope. (Fall 2016)

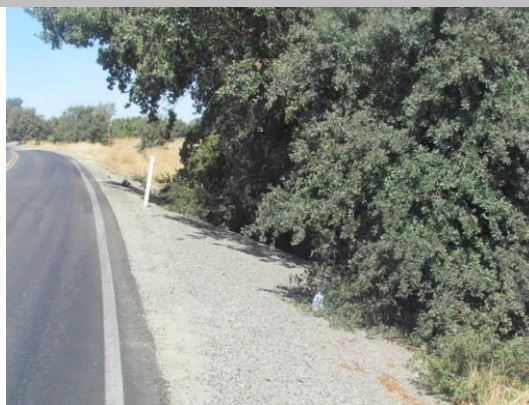
Photo 2 of 3 : SP_2019_RD0999_232_31_20190307_00018.jpg

Looking north at untrimmed trees on landward slope. (Fall 2016)

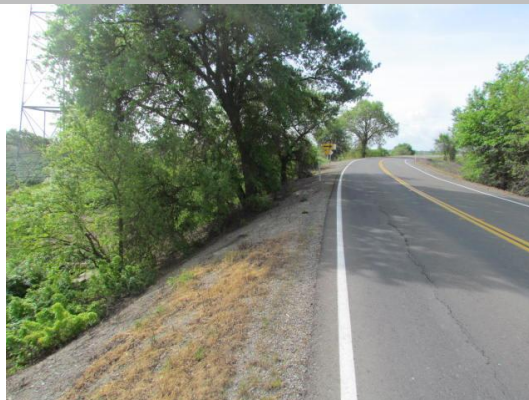
Photo 3 of 3 : SP_2019_RD0999_232_31_20190307_00019.jpg

LM Start	2.13	Rating **	M	Issue No.	31 (cont)
LM End	2.13	Issue Type +	Ma	Location *	LS

Looking southeast at untrimmed trees on landward slope. (Spring 2016)

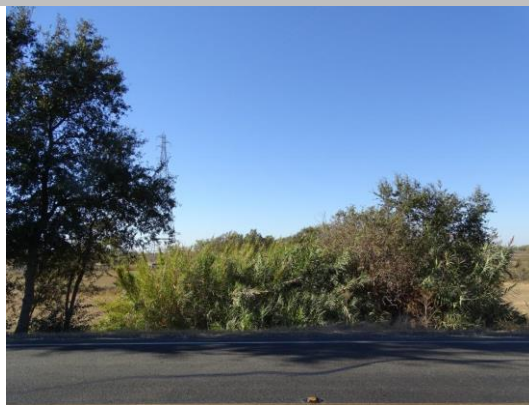
Photo 2 of 2 : SP_2019_RD0999_232_32_20190307_00021.jpg

View of Arundo further down levee slope. Fall 2018

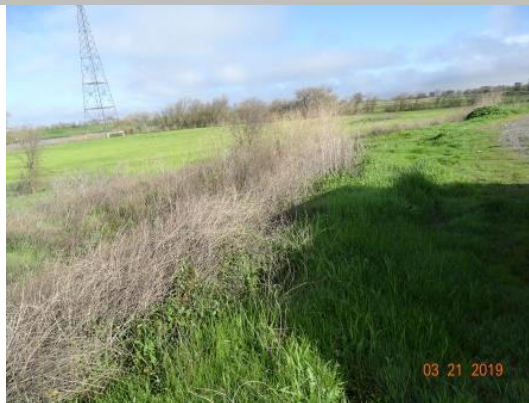
Photo 1 of 1 : SP_2019_RD0999_232_15_20190325_00064.jpg

LM Start	2.24	Rating **	M	Issue No.	15
LM End	2.30	Issue Type +	Ma	Location *	WS
Category	Earthen Levee			GPS Latitude/Longitude	
				Start	End
Item	Vegetation			38.472842 °	38.471937 °
				-121.581348 °	-121.581760 °
DWR ID	DWR_RD0999_01_s_2019_15				
Comment Code					
V1 : Control annual grass and weeds on the levee slopes and easements.					
Inspector Comment

View of tall weeds on waterside slope. Spring 2019

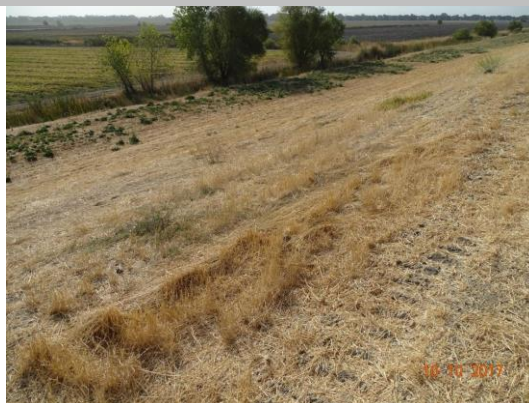
Photo 1 of 3 : SP_2019_RD0999_232_51_20190307_00031.jpg

LM Start	3.22	Rating **	M	Issue No.	51
LM End	3.22	Issue Type +	Ma	Location *	LS
Category	Earthen Levee			GPS Latitude/Longitude	
				Start	End
Item	Slope Stability			38.459399 °	38.459399 °
				-121.587523 °	-121.587523 °
DWR ID	DWR_RD0999_01_s_2013_51				
Comment Code					
S1 : Repair slope instability.					
Inspector Comment					
Depression on landward shoulder and slope 40' x 20'. Earthen material appears to be sliding toward levee toe.

View of landside slope looking south. Fall 2017

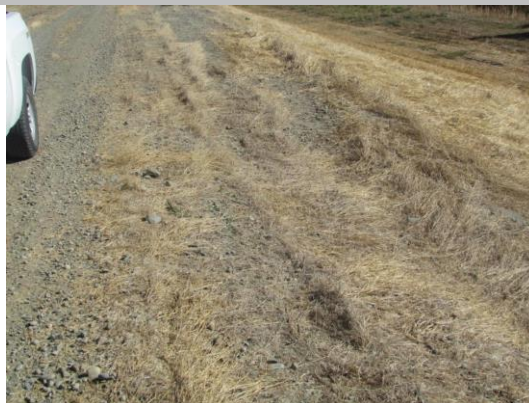
Photo 2 of 3 : SP_2019_RD0999_232_51_20190307_00032.jpg

LM Start	3.22	Rating **	M	Issue No.	51 (cont)
LM End	3.22	Issue Type +	Ma	Location *	LS

Looking northeast at depression on landward slope. Fall 2016

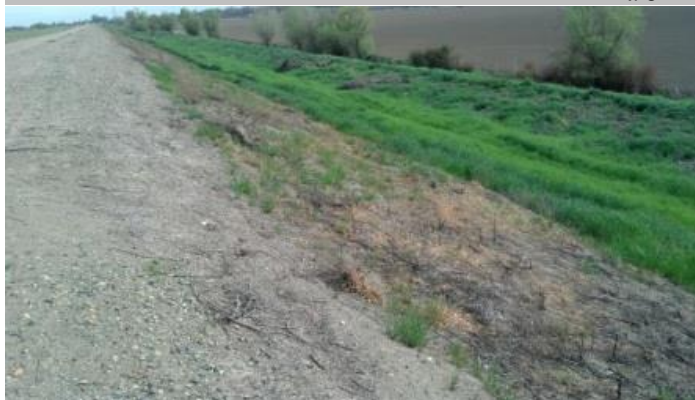
Photo 3 of 3 : SP_2019_RD0999_232_51_20190307_00033.jpg

LM Start	3.22	Rating **	M	Issue No.	51 (cont)	
LM End	3.22	Issue Type +	Ma	Location *	LS	
Category	Earthen Levee			GPS Latitude/Longitude		
				Start		End
Item	Slope Stability			38.459399 °		38.459399 °
				-121.587523 °		-121.587523 °
DWR ID	DWR_RD0999_01_s_2013_51					
Comment Code						
S1 : Repair slope instability.						
Inspector Comment						
Depression on landward shoulder and slope 40' x 20'. Earthen material appears to be sliding toward levee toe.

Looking north at depression on landside shoulder and slope. Spring 2016

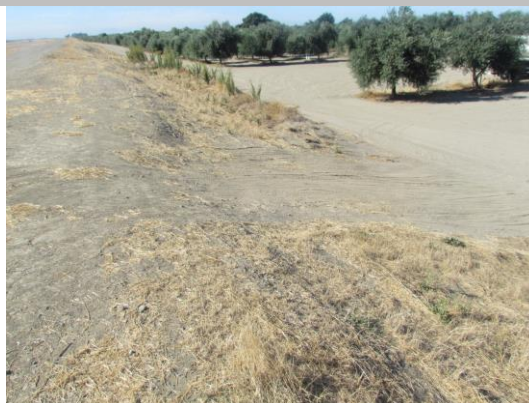
Photo 1 of 2 : SP_2019_RD0999_232_27_20190307_00012.jpg

LM Start	4.31	Rating **	M	Issue No.	27
LM End	4.31	Issue Type +	Ma	Location *	WS
Category	Earthen Levee			GPS Latitude/Longitude	
				Start	End
Item	Slope Stability			38.444560 °	38.444560 °
				-121.594440 °	-121.594440 °
DWR ID	DWR_RD0999_01_f_2012_27				
Comment Code					
S3 : Repair the levee slope damaged by vehicle traffic and prevent access where possible.					
Inspector Comment					
Instruct farmer to stop driving equipment and trucks on slope.

Looking at slope damage cause by vehicle traffic on waterward slope.
(Fall 2016)

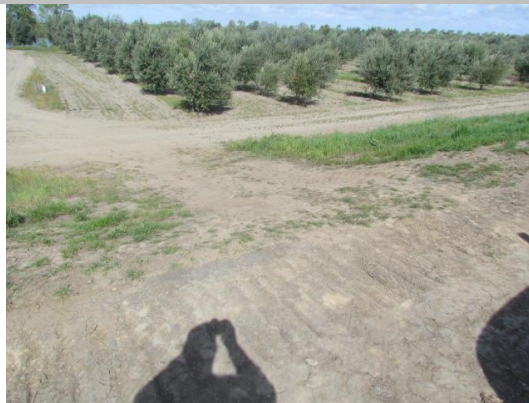
Photo 2 of 2 : SP_2019_RD0999_232_27_20190307_00013.jpg

Looking at slope damage cause by vehicle traffic on waterward slope.
(Spring 2015)

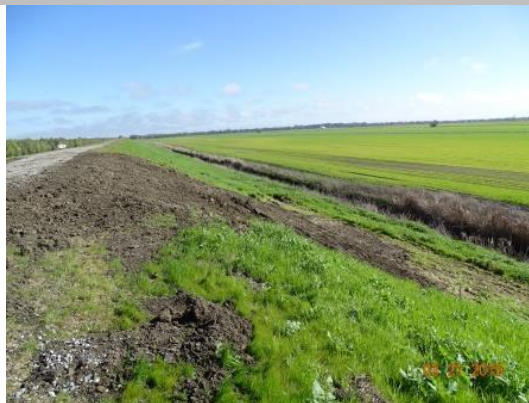
Photo 1 of 1 : SP_2019_RD0999_232_43_20190325_00066.jpg

LM Start	5.21	Rating **	M	Issue No.	43
LM End	5.21	Issue Type +	Ma	Location *	LS
Category	Earthen Levee			GPS Latitude/Longitude	
				Start	End
Item	Slope Stability			38.432322 °	38.432322 °
				-121.600123 °	-121.600123 °
DWR ID	DWR_RD0999_01_s_2019_43				
Comment Code					
S1 : Repair slope instability.					
Inspector Comment					
Complete repair of a ~60' length of slip.

View of slip on landside slope. Spring 2019

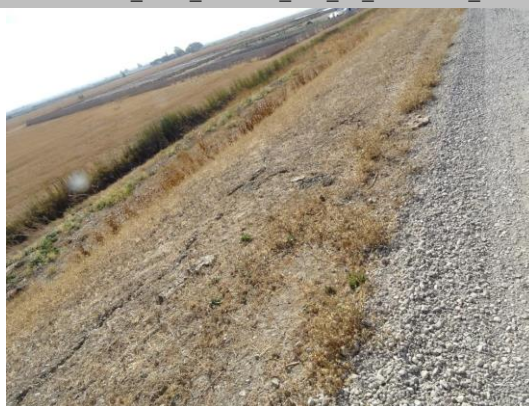
Photo 1 of 1 : SP_2019_RD0999_232_16_20190307_00005.jpg

LM Start	8.17	Rating **	A/W	Issue No.	16
LM End	8.17	Issue Type +	Ma	Location *	LS
Category	Earthen Levee			GPS Latitude/Longitude	
				Start	End
Item	Cracking			38.391963 °	38.391963 °
				-121.618782 °	-121.618782 °
DWR ID	DWR_RD0999_01_f_2018_16				
Comment Code					
CR1 : Monitor and have inspected by geotechnical engineer.					
Inspector Comment					
Monitor desiccation cracks on slope.

View of desiccation cracks on levee slope. Fall 2018

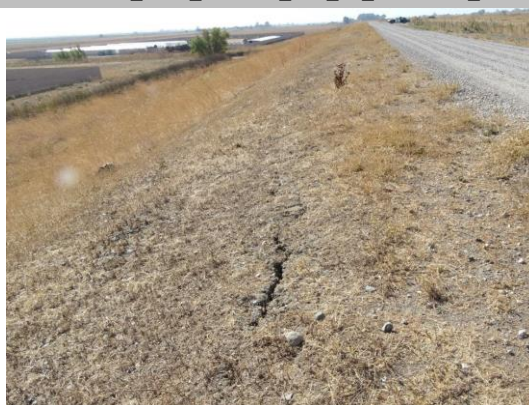
Photo 1 of 1 : SP_2019_RD0999_232_17_20190307_00006.jpg

LM Start	8.49	Rating **	A/W	Issue No.	17
LM End	8.49	Issue Type +	Ma	Location *	LS
Category	Earthen Levee			GPS Latitude/Longitude	
				Start	End
Item	Cracking			38.387645 °	38.387645 °
				-121.620810 °	-121.620810 °
DWR ID	DWR_RD0999_01_f_2018_17				
Comment Code					
CR1 : Monitor and have inspected by geotechnical engineer.					
Inspector Comment					
Monitor desiccation cracks on landside shoulder.

View of desiccation cracks on levee shoulder. Fall 2018

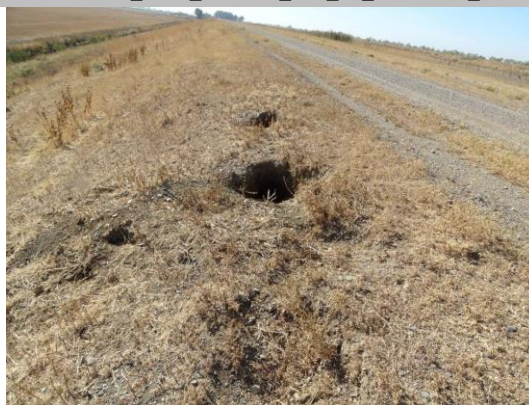
Photo 1 of 1 : SP_2019_RD0999_232_18_20190307_00007.jpg

View of large animal burrows at shoulder and slope. Fall 2018

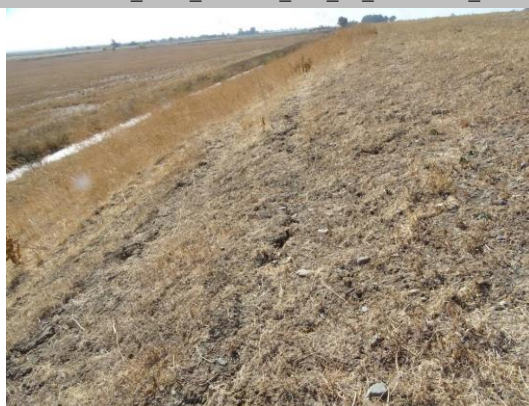
Photo 1 of 1 : SP_2019_RD0999_232_22_20190307_00008.jpg

LM Start	8.89	Rating **	A/W	Issue No.	22
LM End	8.89	Issue Type +	Ma	Location *	LS
Category	Earthen Levee			GPS Latitude/Longitude	
				Start	End
Item	Cracking			38.382145 °	38.382145 °
				-121.623363 °	-121.623363 °
DWR ID	DWR_RD0999_01_f_2018_22				
Comment Code					
CR1 : Monitor and have inspected by geotechnical engineer.					
Inspector Comment					
Desiccation cracks should be monitored.

View of cracking on slope. Fall 2018

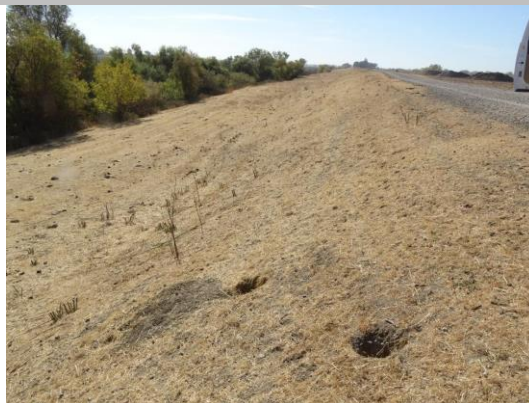
Photo 1 of 1 : SP_2019_RD0999_232_33_20190307_00022.jpg

View of rodent holes that need to be backfilled. Fall 2018

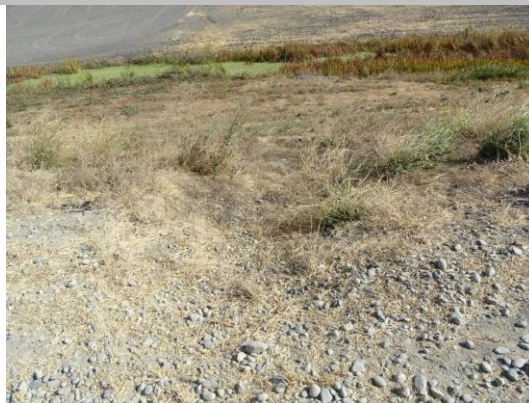
Photo 1 of 1 : SP_2019_RD0999_232_49_20190307_00029.jpg

LM Start	14.04	Rating **	M	Issue No.	49
LM End	14.04	Issue Type +	Ma	Location *	LS
Category	Earthen Levee			GPS Latitude/Longitude	
				Start	End
Item	Erosion / Bank Caving			38.310347 °	38.310347 °
				-121.644955 °	-121.644955 °
DWR ID	DWR_RD0999_01_f_2012_49				
Comment Code					
E1 : Note and monitor erosion site.					
Inspector Comment					
Repair caving, 4' x 10', on landside slope.

View of caving on landward slope. Fall 2018

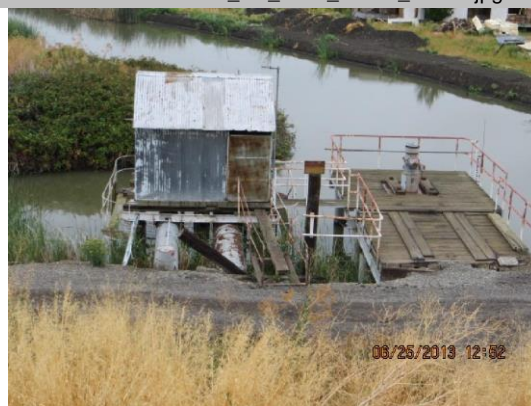
Photo 1 of 3 : UCIP_SP_2019_15365_25227.jpg

LM Start	15.24	Rating **	A/W	Issue No.	925
LM End	15.24	Issue Type +	Ma	Location *	
Category	Supplemental			GPS Latitude/Longitude	
				Start	End
Item	DWR UCIP LMA Responsibility			38.292973 °	38.292973 °
				-121.644977 °	-121.644977 °
DWR ID	22756				
Comment Code					
Inspector Comment					
FS_ID:15365 DS_ID:22756 EP_NO: N/A Repair Type: No Action Needed Crossing Status: Found UCIP Comments: FIELD_STRUCT_DESC: 30-inch steel drainage pipe through the levee, 7 feet below the crown. Flap gate on the waterside (WS) end. Pump in pump house on the landside (LS) toe. Siphon breaker in a corrugated metal pipe (CMP) riser on the WS shoulder. [Additional Reference(s): DWR Levee Log, 1992. USACE Sacramento O&M Manual 113 (Revised), October 1966, (HLM 15.25) (36-inch pipe listed)]. FS Date: 6/25/2013

Pumphouse on LS toe.

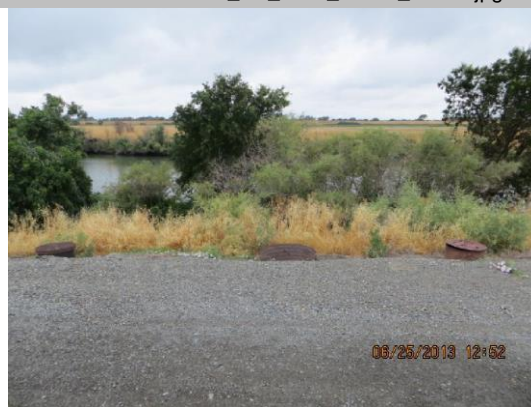
Photo 2 of 3 : UCIP_SP_2019_15365_25226.jpg

Siphon breaker in CMP riser on WS shoulder.

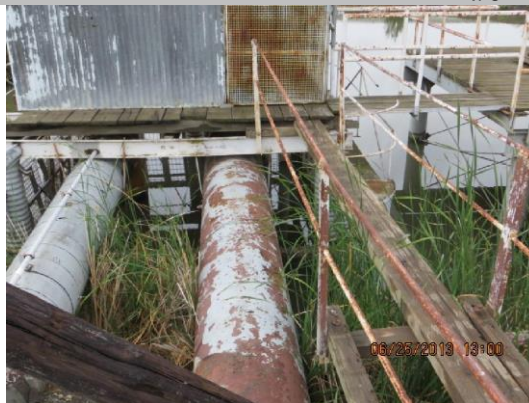
Photo 3 of 3 : UCIP_SP_2019_15365_25225.jpg

LM Start	15.24	Rating **	A/W	Issue No.	925 (cont)	
LM End	15.24	Issue Type +	Ma	Location *		
Category	Supplemental			GPS Latitude/Longitude		
				Start	End	
Item	DWR UCIP LMA Responsibility			38.292973 °	38.292973 °	
				-121.644977 °	-121.644977 °	
DWR ID	22756					
Comment Code						
Inspector Comment						
FS_ID:15365 DS_ID:22756 EP_NO: N/A Repair Type: No Action Needed Crossing Status: Found UCIP Comments: FIELD_STRUCT_DESC: 30-inch steel drainage pipe through the levee, 7 feet below the crown. Flap gate on the waterside (WS) end. Pump in pump house on the landside (LS) toe. Siphon breaker in a corrugated metal pipe (CMP) riser on the WS shoulder. [Additional Reference(s): DWR Levee Log, 1992. USACE Sacramento O&M Manual 113 (Revised), October 1966, (HLM 15.25) (36-inch pipe listed)]. FS Date: 6/25/2013

Closeup of pipe at pumphouse on LS toe.

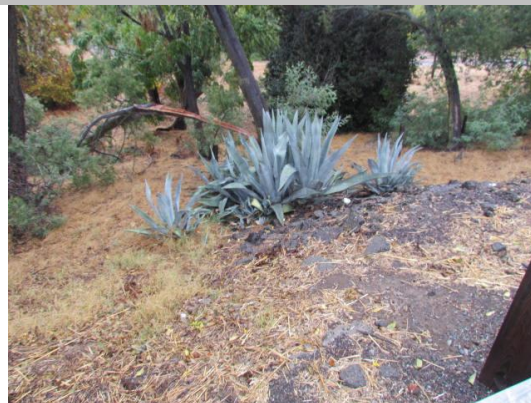
Photo 1 of 2 : SP_2019_RD0999_233_14_20190307_00012.jpg

Looking north at century plant at landward toe. Fall 2015.

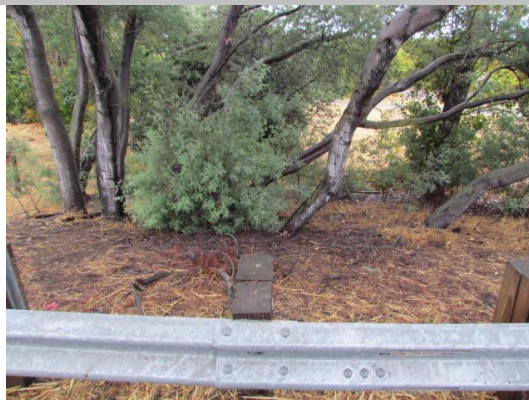
Photo 2 of 2 : SP_2019_RD0999_233_19_20190307_00018.jpg

Looking north at untrimmed and trees to be thinned at landward toe fall 2015.

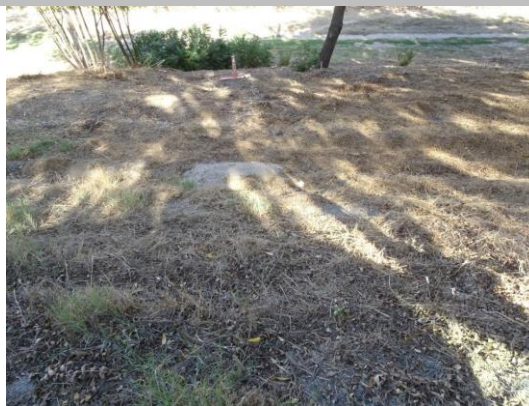
Photo 1 of 2 : SP_2019_RD0999_233_2_20190307_00001.jpg

View of backfilled rodent holes. Fall 2018

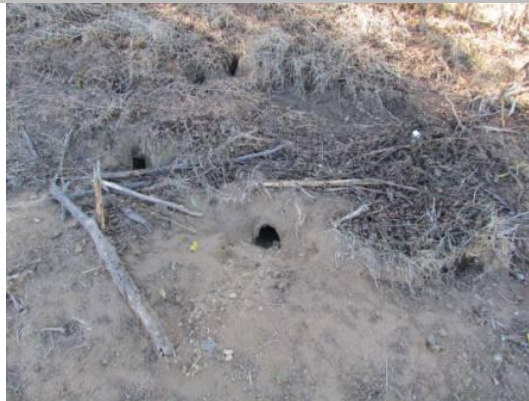
Photo 2 of 2 : SP_2019_RD0999_233_2_20190307_00002.jpg

Looking at several rodent holes on landside slope.

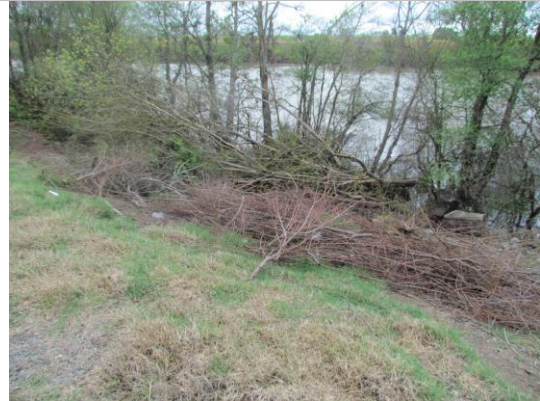
Photo 1 of 1 : SP_2019_RD0999_234_23_20190307_00015.jpg

Looking east at large pruning piles on waterward slope.

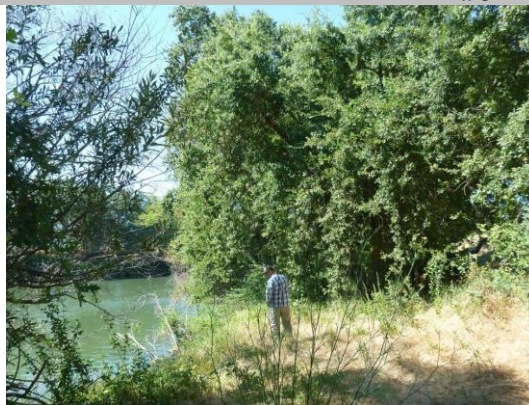
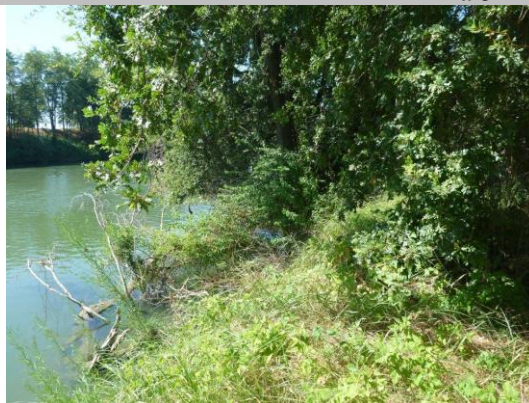
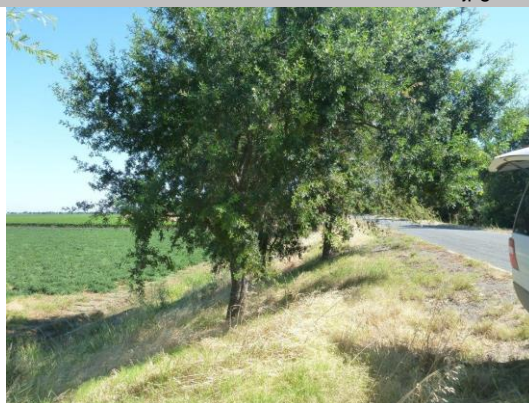
LM Start	3.18	Rating **	A/W	Issue No.	15
LM End	3.21	Issue Type +	Ma	Location *	WS
Category	Supplemental			GPS Latitude/Longitude	
				Start	End
Item	2017 Storm Damage			38.325053 °	38.325489 °
				-121.586347 °	-121.586100 °
DWR ID	DWR_RD0999_03_f_2017_15				
Comment Code					
Inspector Comment					
Levee Evaluation Comments					
Description:The damage consists of erosion of the lower waterside levee slope and bank approximately 172 feet in length along the west (right) bank of Sutter Slough. See attached pages for photos. Site location T06N R04E Section 3 and 4.					
Site ID No:356					
Site Designation:LMA-183					
Repair Type: Erosion					
Rating:Area of Concern					
Field Date:7/27/2017					
Notes: 2018 DWR Inspector: Erosion not visible from levee slope.

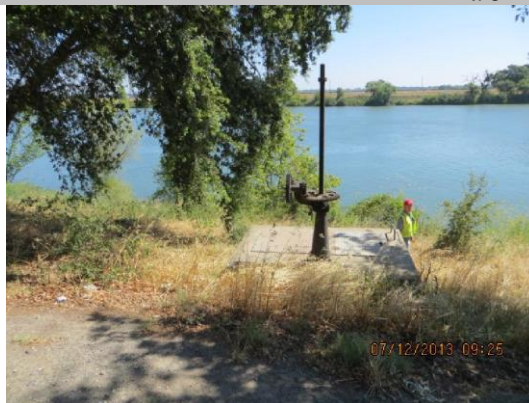
Photo 1 of 2 : UCIP_SP_2019_15708_26137.jpg

Slide gate in concrete vault on WS shoulder.

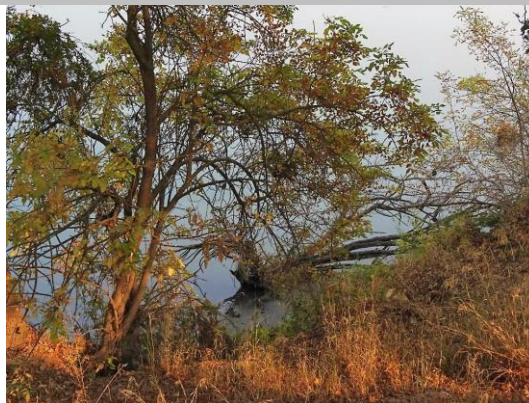
Photo 1 of 4 : SP_2019_RD0999_235_42_20190307_00016.jpg

View of fallen tree. Fall 2018

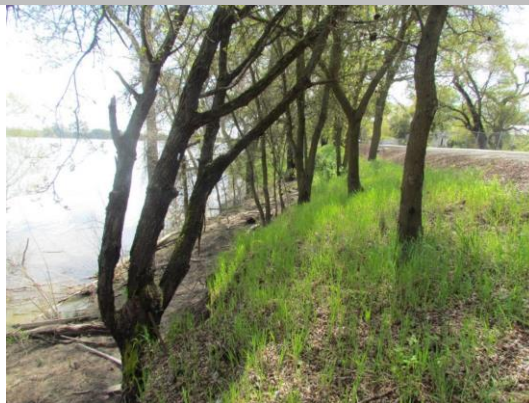
Photo 1 of 2 : SP_2019_RD0999_235_15_20190307_00007.jpg

Looking downstream at 2ft plus vertical erosion on waterward slope.

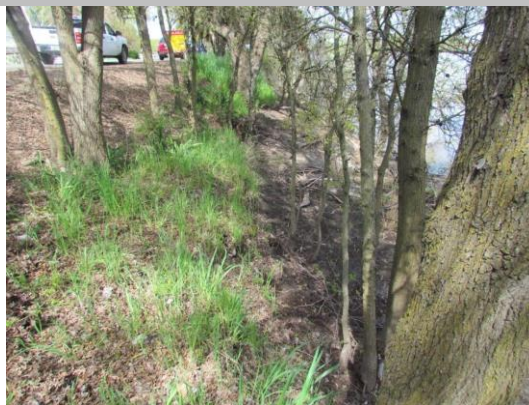
Photo 2 of 2 : SP_2019_RD0999_235_15_20190307_00008.jpg

Looking upstream at 2ft plus vertical erosion on waterward slope.

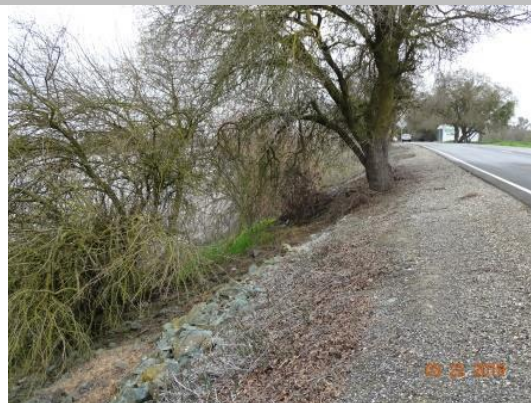
Photo 1 of 1 : SP_2019_RD0999_235_25_20190405_00069.jpg

View looking downstream of low-hanging tree branches on levee slope.
Spring 2019

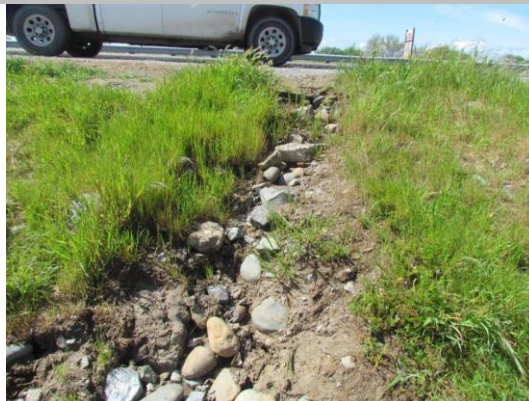
Photo 3 of 3 : SP_2019_RD0999_235_47_20190307_00025.jpg

Looking west at runoff erosion on waterward slope.

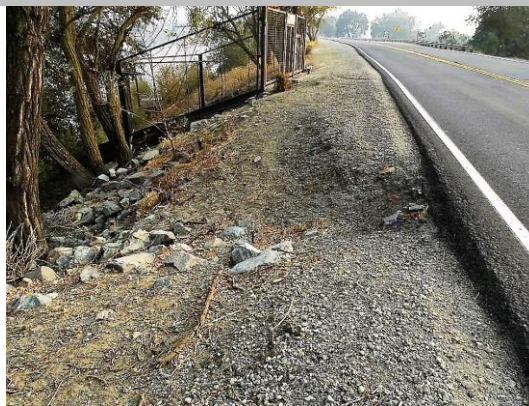
Photo 1 of 3 : SP_2019_RD0999_235_46_20190307_00020.jpg

View of erosion on shoulder and slope. Fall 2018

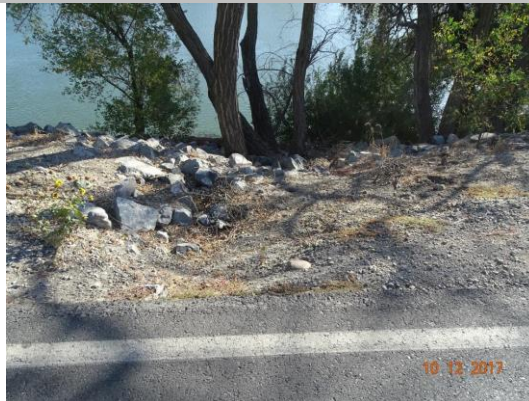
Photo 2 of 3 : SP_2019_RD0999_235_46_20190307_00021.jpg

Looking east at the erosion on the waterside slope. Fall 2017

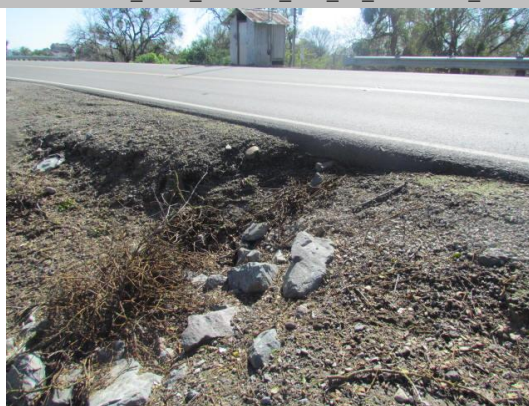
Photo 3 of 3 : SP_2019_RD0999_235_46_20190307_00022.jpg

Looking west at foot erosion on waterward shoulder and slope.

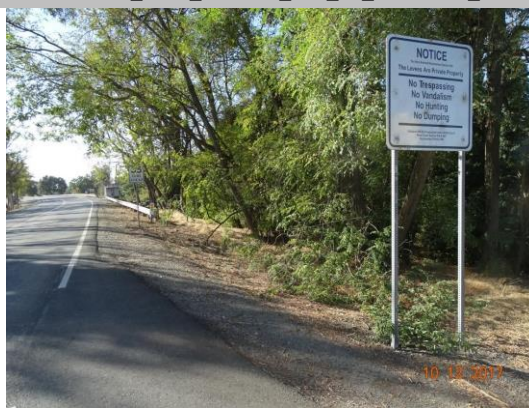
Photo 1 of 2 : SP_2019_RD0999_235_22_20190307_00009.jpg

Looking south at dense trees on landside slope.

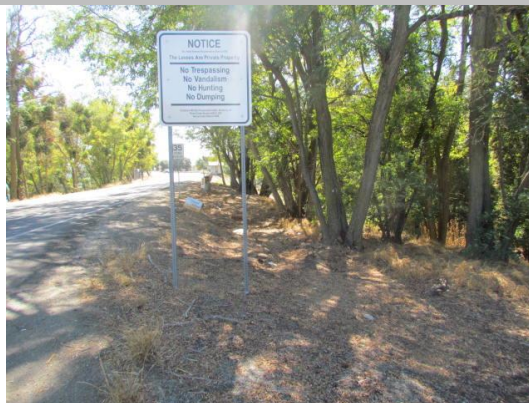
Photo 2 of 2 : SP_2019_RD0999_235_22_20190307_00010.jpg

Looking south at dense trees on landward slope.

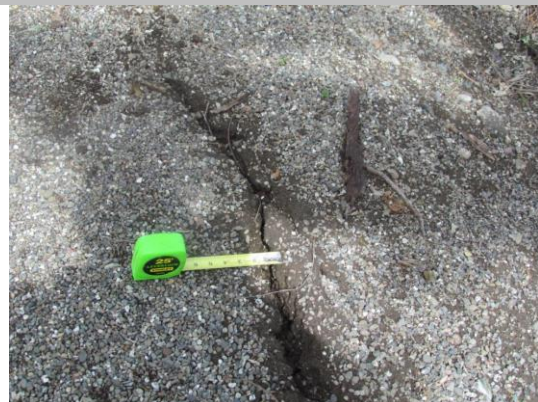
Photo 1 of 3 : SP_2019_RD0999_236_165_20190307_00070.jpg

Looking at two inch plus crack on waterward shoulder.

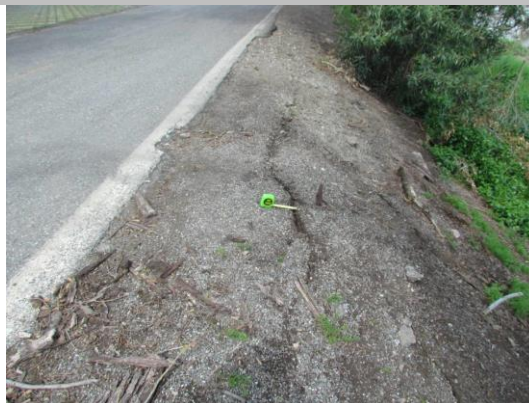
Photo 2 of 3 : SP_2019_RD0999_236_165_20190307_00071.jpg

Looking upstream at cracking along waterward shoulder.

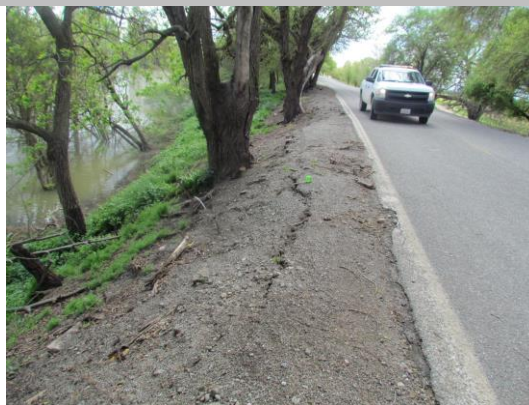
Photo 3 of 3 : SP_2019_RD0999_236_165_20190307_00072.jpg

Looking downstream at crack along waterward shoulder.

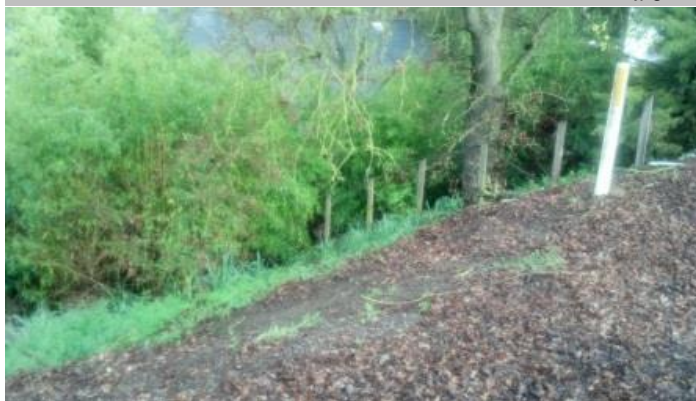
Photo 2 of 2 : SP_2019_RD0999_236_128_20190307_00054.jpg

Looking at dense trees on landside slope and toe.

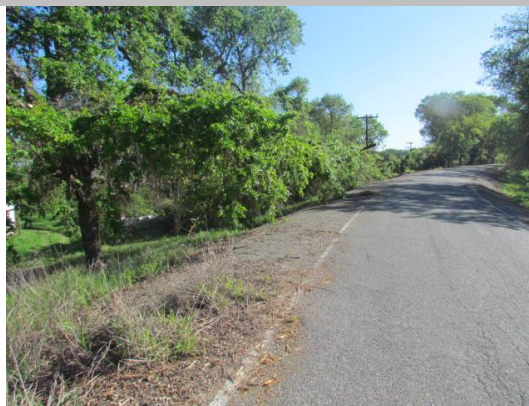
Photo 1 of 1 : SP_2019_RD0999_236_15_20190307_00011.jpg

Looking north at untrimmed trees on landward slope and toe.

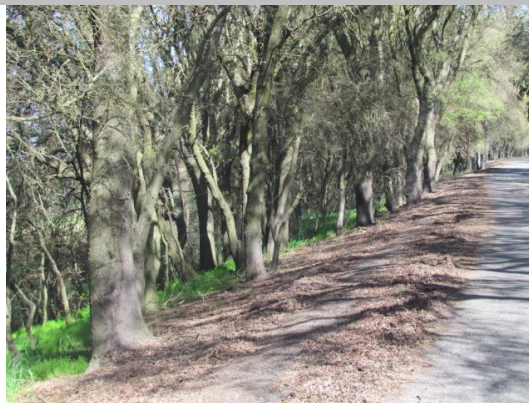
Photo 1 of 1 : SP_2019_RD0999_236_18_20190307_00014.jpg

Looking east at dense trees on landward slope.

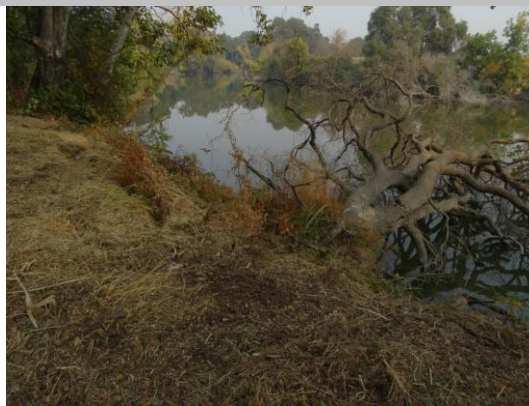
Photo 1 of 1 : SP_2019_RD0999_236_83_20190307_00034.jpg

View of a fallen tree and slope damage. Fall 2018

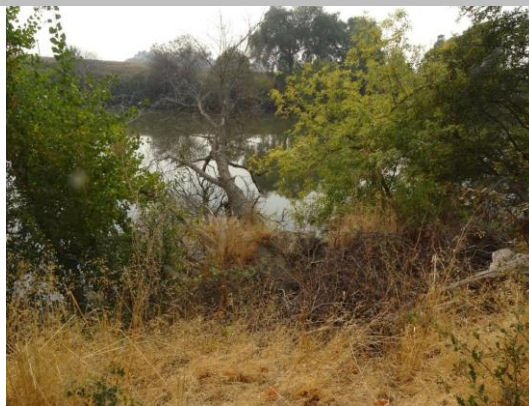
Photo 1 of 1 : SP_2019_RD0999_236_85_20190307_00035.jpg

View of fallen tree and slope damage. Fall 2018

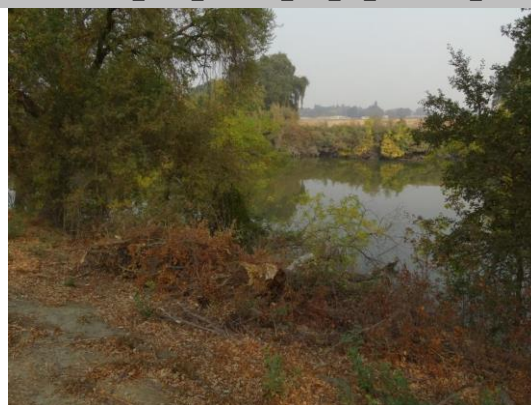
Photo 1 of 1 : SP_2019_RD0999_236_90_20190307_00036.jpg

View of tree debris on levee easement. Fall 2018

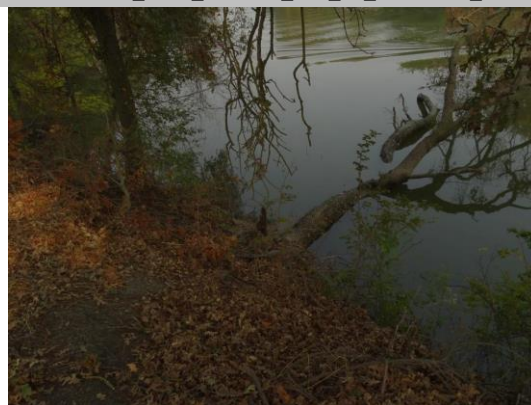
Photo 1 of 1 : SP_2019_RD0999_236_91_20190307_00037.jpg

View of tree with rootball exposed. Fall 2018

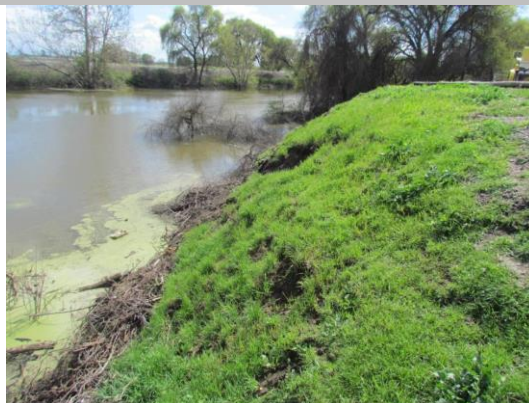
Photo 1 of 1 : SP_2019_RD0999_236_12_20190307_00008.jpg

Looking downstream at finger erosion on downstream side of slough.

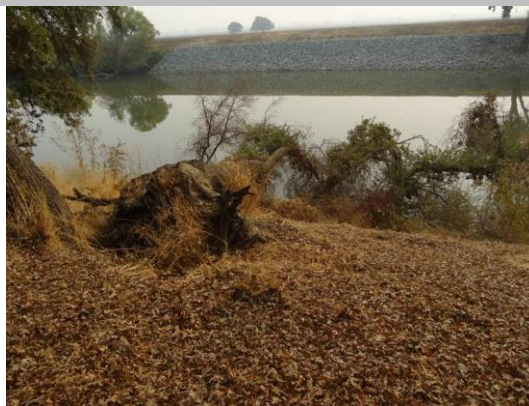
Photo 1 of 1 : SP_2019_RD0999_236_28_20190307_00017.jpg

View of dead tree on slope. Fall 2018

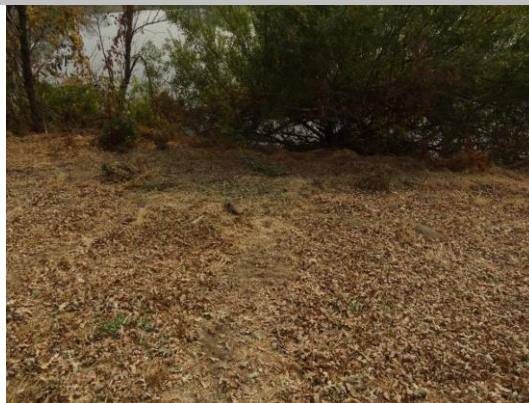
Photo 1 of 1 : SP_2019_RD0999_236_62_20190307_00025.jpg

View of tree stump on levee slope. Fall 2018

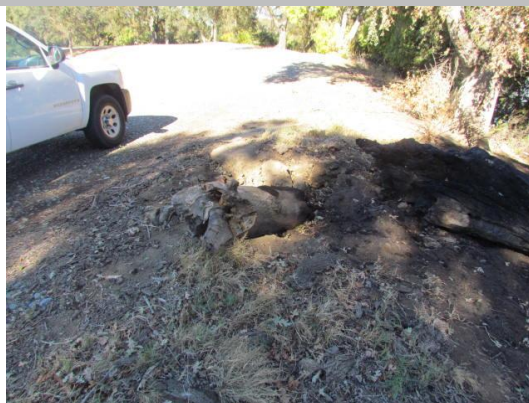
Photo 2 of 3 : SP_2019_RD0999_236_176_20190307_00084.jpg

Looking at hole on waterward shoulder caused by fallen tree.

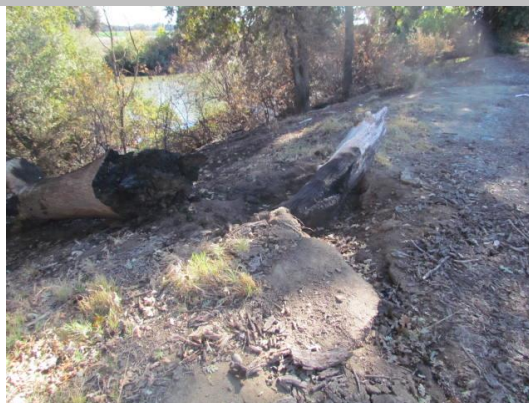
Photo 3 of 3 : SP_2019_RD0999_236_176_20190307_00085.jpg

Looking at fallen tree and hole on waterward slope and shoulder.

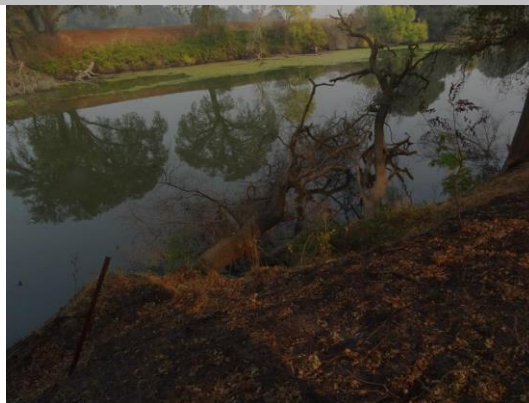
Photo 1 of 2 : SP_2019_RD0999_236_97_20190307_00044.jpg

View of fallen tree and levee scarp. Fall 2018

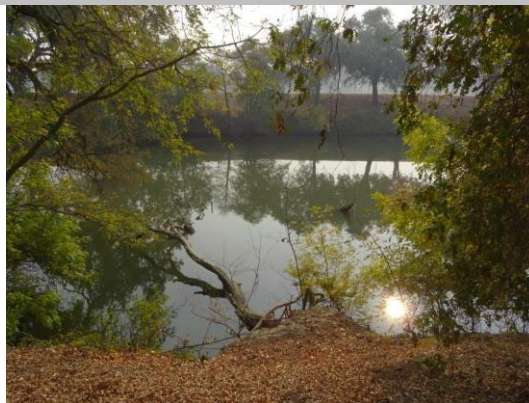
Photo 1 of 1 : SP_2019_RD0999_236_99_20190307_00046.jpg

View of fallen tree and slope damage. Fall 2018
