**Flood Control Project Maintenance  
Levee Inspections**

## Maintenance Issue Types Only, Levee Inspection Report By Mile - Spring 2020

### Reclamation District No. 0999 Netherlands

Waterway	Bank	Unit Miles	Inspection Start/End	Inspector
Unit No. 01 Yolo Bypass	Left	15.41	04/30/2020 05/05/2020	Luz Dial

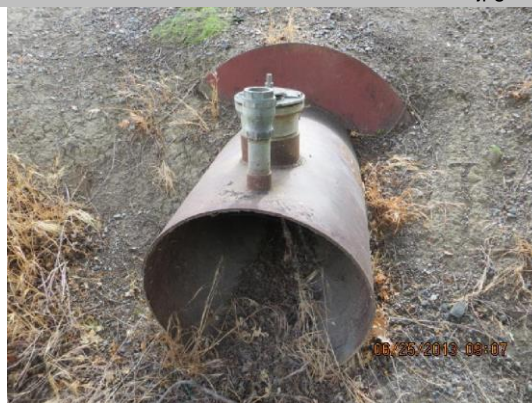
Photo 1 of 3 : UCIP\_SP\_2020\_53368\_25191.jpg

Comment Code						
Inspector Comment						
DS_ID:22743 FS_ID:53368 EP_NO: N/A Repair Type: Non-Urgent Crossing Status: Found UCIP Comments: 07/26/2018 Same as last inspection. Pipe open on WS, but no visual signs of pipe or levee integrity issues so downgrading crossing to Non-Urgent (D. Sanoski - DWR UCIP).07/07/2016 Condition largely unchanged from previous inspection. Pipe open on the WS, waterward of the siphon breaker. Dense vegetation and steep slope limited inspection of WS outlet into Ship Channel. (T. Hatch/UCIP) 06/25/2013 Pipe abandoned and open on WS slope. Pipe should be abandoned properly. (W. Wylie/UCIP) FIELD_STRUCT_DESC: *ABANDONED* 30-inch steel drainage pipe through the levee, 6.5 feet below the crown. Pump on a platform in the canal off the landside (LS) toe, not found. Flap gate on the waterside (WS), not found. Siphon breaker and an air vent on the WS shoulder. 1- inch galvanized iron filler pipe visible on the WS shoulder along same alignment. [Additional Reference(s): DWR Levee Log, 1992. USACE Sacramento O&M Manual 113 (Revised), October 1966, (HLM 1.73)]. FS Date: 7/26/2018 10:10:00 AM

Pipe open on WS slope

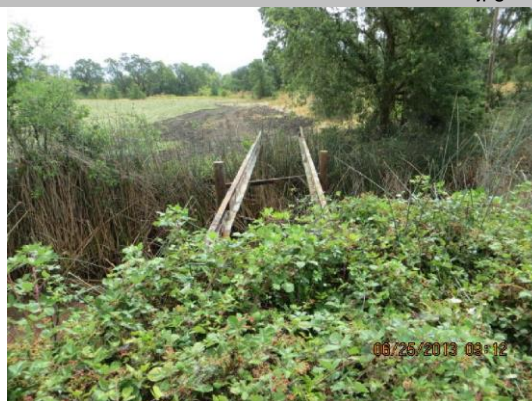
Photo 2 of 3 : UCIP\_SP\_2020\_53368\_25190.jpg

Pump platform visible off LS toe, but no appurtenances remain.

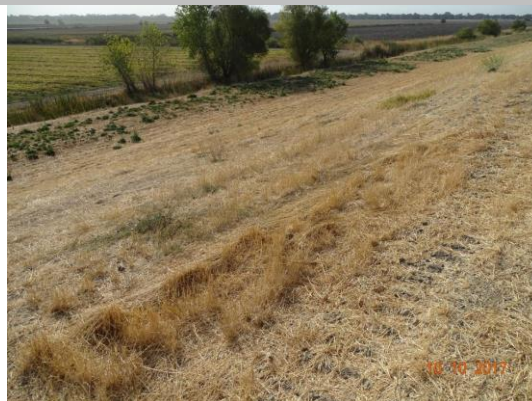
Photo 1 of 1 : SP\_2020\_RD0999\_232\_51\_20200302\_00030.jpg

LM Start	<b>3.22</b>	Rating **	M	Issue No.	<b>51</b>
LM End	<b>3.22</b>	Issue Type +	Ma	Location *	LS
Category	Earthen Levee		GPS Latitude/Longitude		
			Start	End	
Item	Slope Stability		38.459399 °	38.459399 °	
			-121.587523 °	-121.587523 °	
DWR ID	DWR_RD0999_01_s_2013_51				
Comment Code					
S1 : Repair slope instability.					
Inspector Comment					
Repair depression on landward shoulder and slope approximately 40' x 20'. Earthen material appears to be sliding toward levee toe.

View of landside slope looking south. Fall 2017

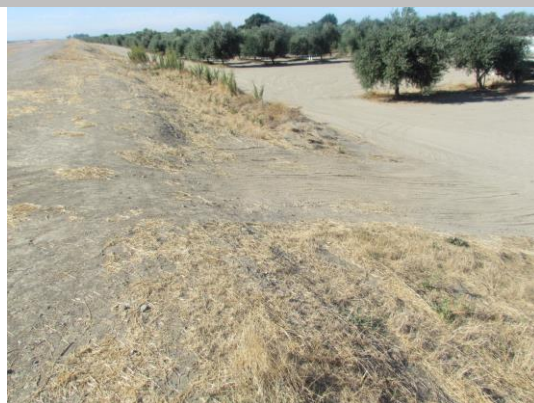
Photo 1 of 1 : SP\_2020\_RD0999\_232\_27\_20200302\_00007.jpg

LM Start	4.31	Rating **	M	Issue No.	27
LM End	4.31	Issue Type +	Ma	Location *	WS
Category	Earthen Levee			GPS Latitude/Longitude	
				Start	End
Item	Slope Stability			38.444560 °	38.444560 °
				-121.594440 °	-121.594440 °
DWR ID	DWR_RD0999_01_f_2012_27				
Comment Code					
S3 : Repair the levee slope damaged by vehicle traffic and prevent access where possible.					
Inspector Comment					
Instruct farmer to stop driving equipment and trucks onto the slope.

Looking at slope damage cause by vehicle traffic on waterward slope.  
(Fall 2016)

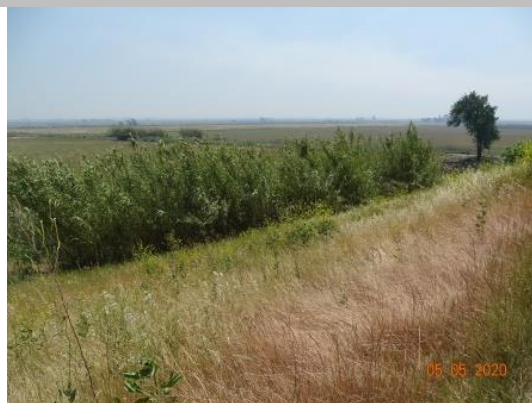
Photo 1 of 1 : SP\_2020\_RD0999\_232\_74\_20200507\_00066.jpg

View of Arundo growth at the landside toe. Spring 2020

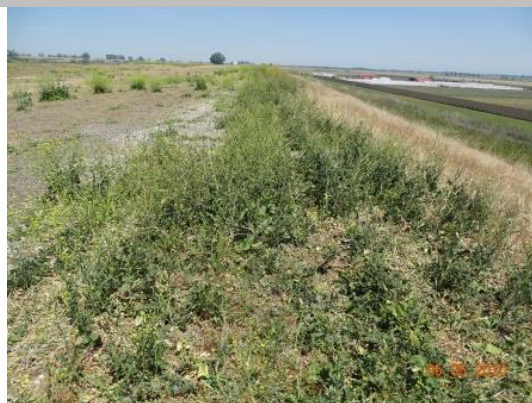
Photo 1 of 1 : SP\_2020\_RD0999\_232\_70\_20200507\_00065.jpg

View of crown vegetation. Spring 2020

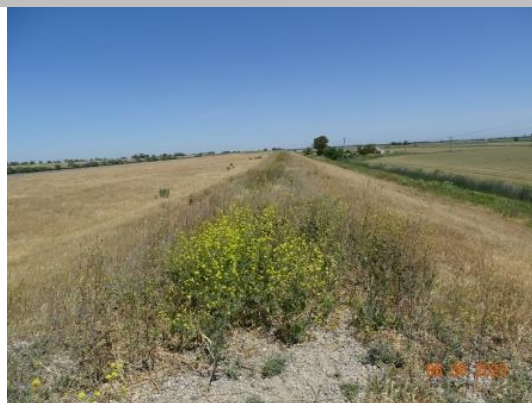
Photo 1 of 1 : SP\_2020\_RD0999\_232\_68\_20200507\_00064.jpg

View of crown vegetation. Spring 2020

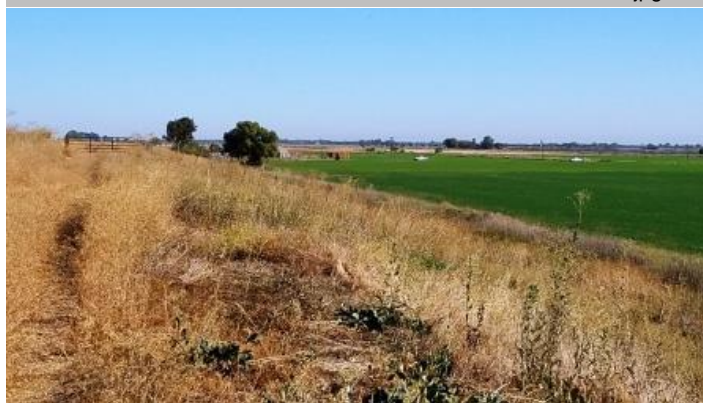
Photo 1 of 1 : SP\_2020\_RD0999\_232\_13\_20200302\_00004.jpg

LM Start	9.67	Rating **	M	Issue No.	13
LM End	9.74	Issue Type +	Ma	Location *	LS
Category	Earthen Levee			GPS Latitude/Longitude	
				Start	End
Item	Vegetation			38.371553 °	38.370563 °
				-121.628265 °	-121.628743 °
DWR ID	DWR_RD0999_01_f_2019_13				
Comment Code					
V1 : Control annual grass and weeds on the levee slopes and easements.					
Inspector Comment

View looking upstream at landside vegetation. Fall 2019

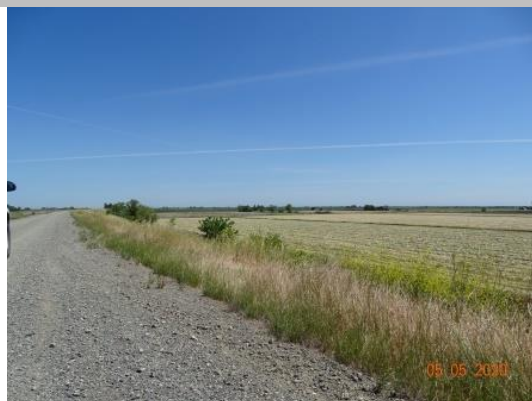
Photo 1 of 1 : SP\_2020\_RD0999\_232\_25\_20200507\_00059.jpg

View of tall landside vegetation. Spring 2020

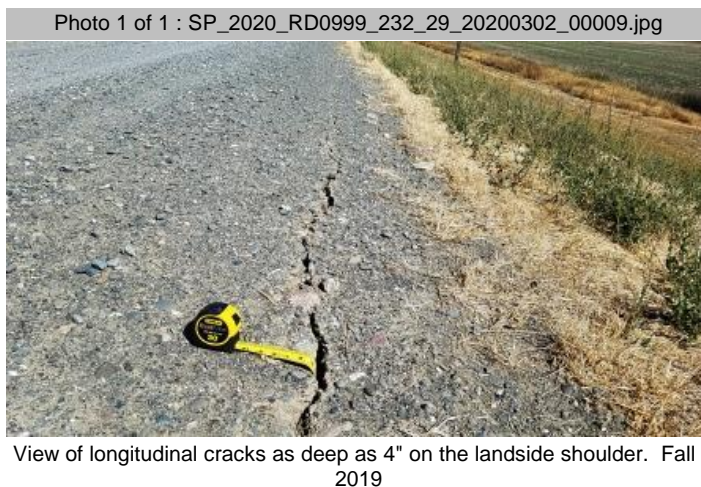
LM Start	13.17	Rating **	A/W	Issue No.	29
LM End	13.19	Issue Type +	Ma	Location *	CR
Category	Earthen Levee			GPS Latitude/Longitude	
				Start	End
Item	Cracking			38.322938 °	38.322690 °
				-121.644940 °	-121.644953 °
DWR ID	DWR_RD0999_01_f_2019_29				
Comment Code					
CR1 : Monitor and have inspected by geotechnical engineer.					
Inspector Comment					
Monitor cracks as deep as 4" on the landside shoulder.

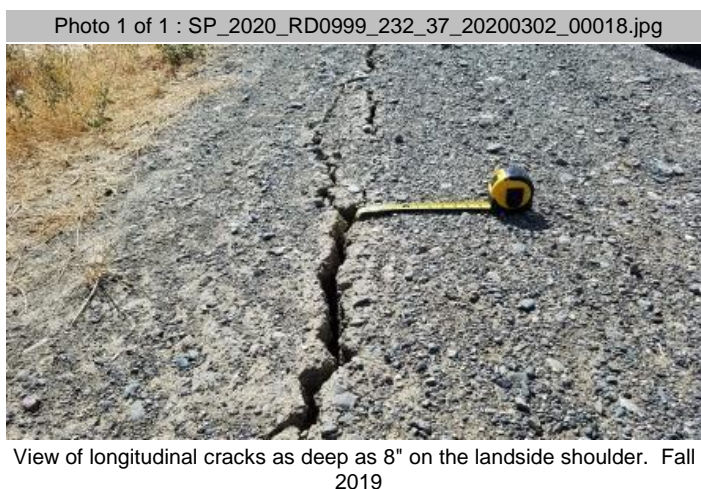
LM Start	13.26	Rating **	A/W	Issue No.	37
LM End	13.27	Issue Type +	Ma	Location *	CR
Category	Earthen Levee			GPS Latitude/Longitude	
				Start	End
Item	Cracking			38.321620 °	38.321490 °
				-121.644968 °	-121.644968 °
DWR ID	DWR_RD0999_01_f_2019_37				
Comment Code					
CR1 : Monitor and have inspected by geotechnical engineer.					
Inspector Comment					
Monitor cracks as deep as 8" on the landside shoulder.

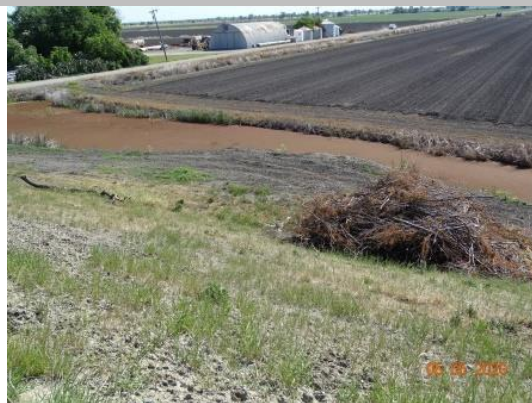
Photo 1 of 1 : SP\_2020\_RD0999\_232\_16\_20200507\_00055.jpg

View of prunings at the landside toe. Spring 2020

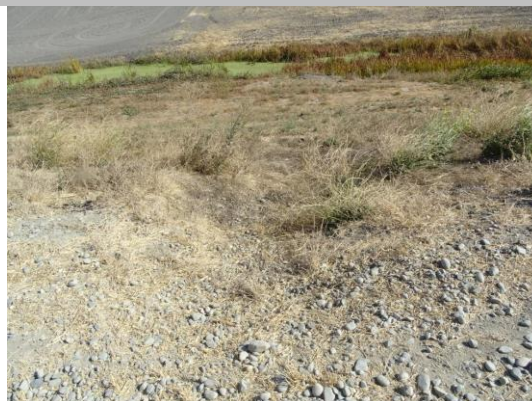
Photo 1 of 1 : SP\_2020\_RD0999\_232\_49\_20200302\_00028.jpg

LM Start	14.04	Rating **	M	Issue No.	49
LM End	14.04	Issue Type +	Ma	Location *	LS
Category	Earthen Levee			GPS Latitude/Longitude	
				Start	End
Item	Erosion / Bank Caving			38.310347 °	38.310347 °
				-121.644955 °	-121.644955 °
DWR ID	DWR_RD0999_01_f_2012_49				
Comment Code					
E1 : Note and monitor erosion site.					
Inspector Comment					
Repair caving, 4' x 10', on the landside slope.

View of caving on landward slope. Fall 2018

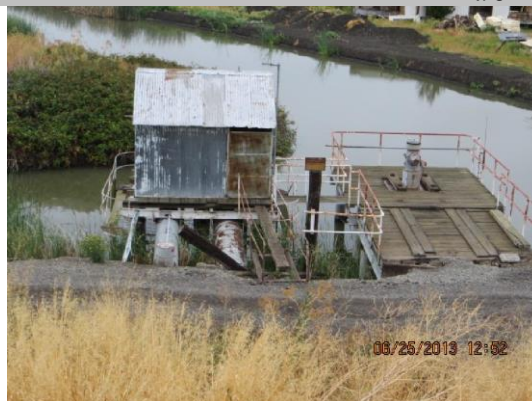
Photo 1 of 3 : UCIP\_SP\_2020\_15365\_25227.jpg

LM Start	15.24	Rating **	A/W	Issue No.	925
LM End	15.24	Issue Type +	Ma	Location *	
Category	Supplemental			GPS Latitude/Longitude	
				Start	End
Item	DWR UCIP LMA Responsibility			38.292973 °	38.292973 °
				-121.644977 °	-121.644977 °
DWR ID	22756				
Comment Code					
Inspector Comment					
DS_ID:22756 FS_ID:15365 EP_NO: N/A Repair Type: No Action Needed Crossing Status: Found UCIP Comments: FIELD_STRUCT_DESC: 30-inch steel drainage pipe through the levee, 7 feet below the crown. Flap gate on the waterside (WS) end. Pump in pump house on the landside (LS) toe. Siphon breaker in a corrugated metal pipe (CMP) riser on the WS shoulder. [Additional Reference(s): DWR Levee Log, 1992. USACE Sacramento O&M Manual 113 (Revised), October 1966, (HLM 15.25) (36-inch pipe listed)]. FS Date: 6/25/2013

Pumphouse on LS toe.

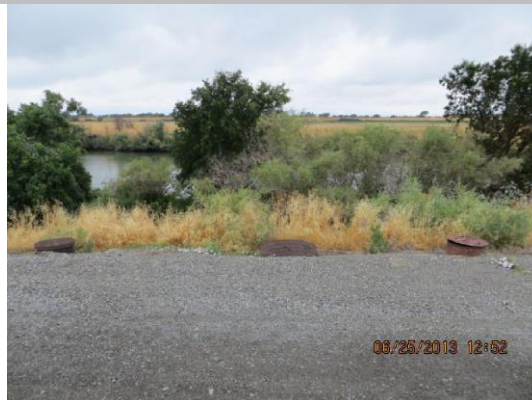
Photo 2 of 3 : UCIP\_SP\_2020\_15365\_25226.jpg

Siphon breaker in CMP riser on WS shoulder.

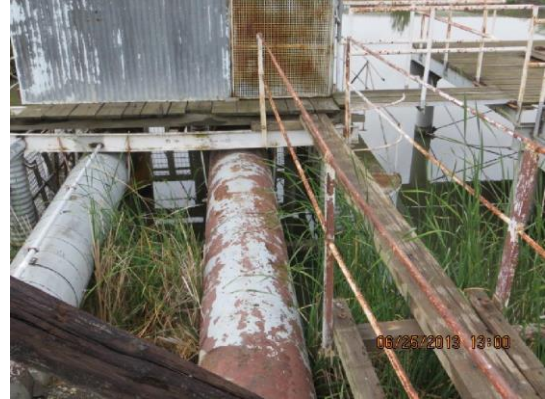
Photo 3 of 3 : UCIP\_SP\_2020\_15365\_25225.jpg

Closeup of pipe at pumphouse on LS toe.

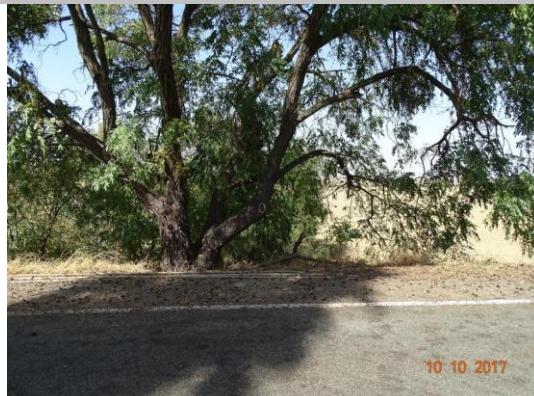
Photo 1 of 1 : SP\_2020\_RD0999\_233\_21\_20200302\_00011.jpg

View of trees on landside slope looking north. Fall 2017

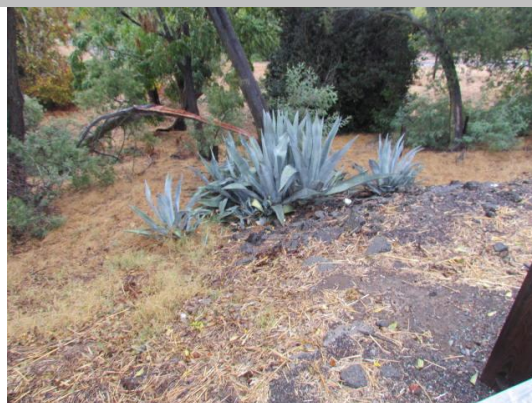
Photo 1 of 1 : SP\_2020\_RD0999\_233\_14\_20200302\_00006.jpg

Looking north at century plant at landward toe. Fall 2015.

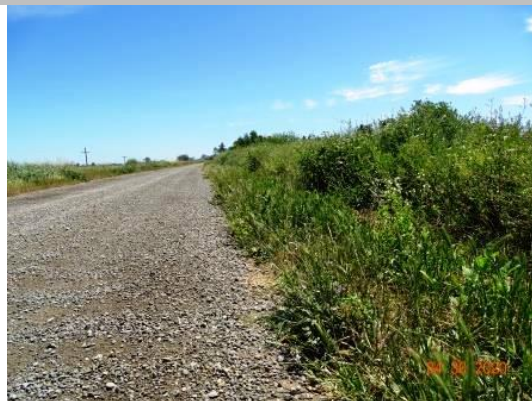
Photo 1 of 1 : SP\_2020\_RD0999\_233\_22\_20200508\_00039.jpg

View of waterside vegetation. Spring 2020

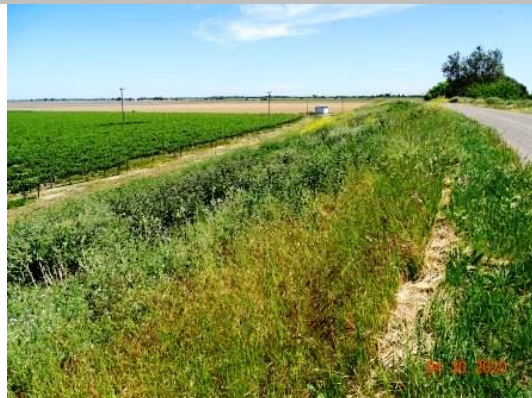
Photo 1 of 1 : SP\_2020\_RD0999\_233\_25\_20200508\_00040.jpg

View of landside vegetation. Spring 2020

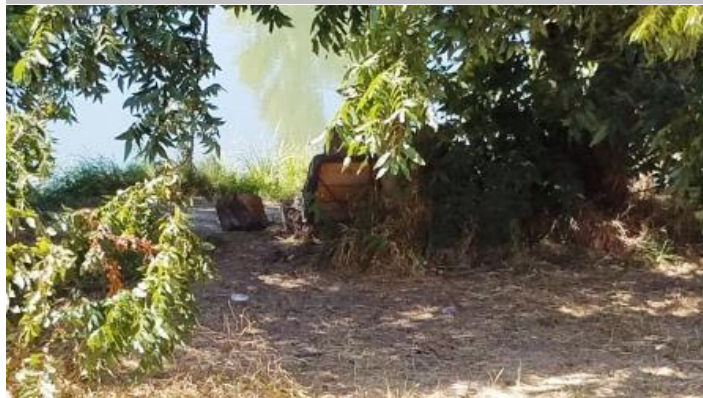
Photo 1 of 1 : SP\_2020\_RD0999\_233\_37\_20200302\_00015.jpg

View looking southward at debris on the waterside slope. Fall 2019

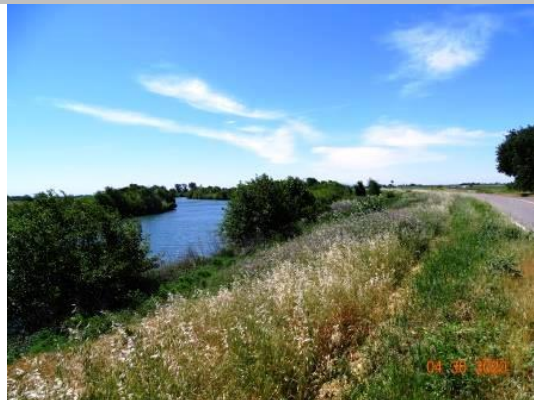
Photo 1 of 1 : SP\_2020\_RD0999\_234\_10\_20200508\_00035.jpg

View of erosion site that appears to be at least 20' from the waterside shoulder. Spring 2020

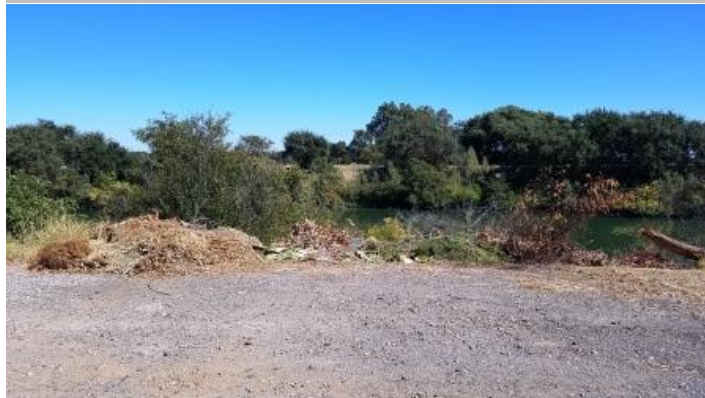
Photo 1 of 1 : SP\_2020\_RD0999\_234\_29\_20200302\_00020.jpg

View of debris on the waterside turnout. Fall 2019

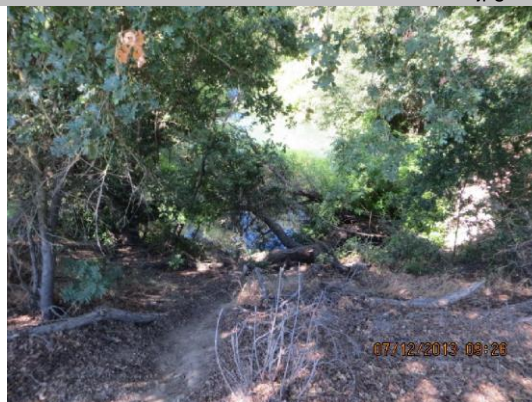
Photo 2 of 2 : UCIP\_SP\_2020\_15708\_26136.jpg

Toe of LS at approximate location of outlet/inlet.

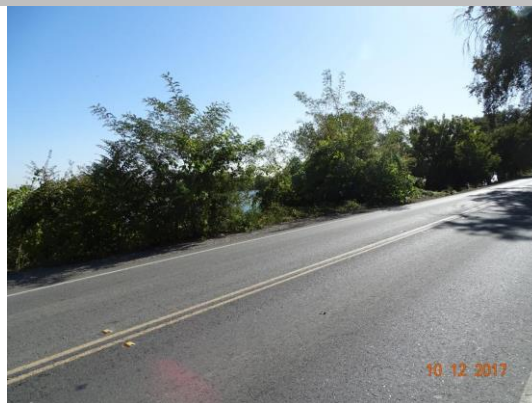
Photo 1 of 1 : SP\_2020\_RD0999\_235\_53\_20200302\_00023.jpg

Looking southeast at the waterside slope. Fall 2017

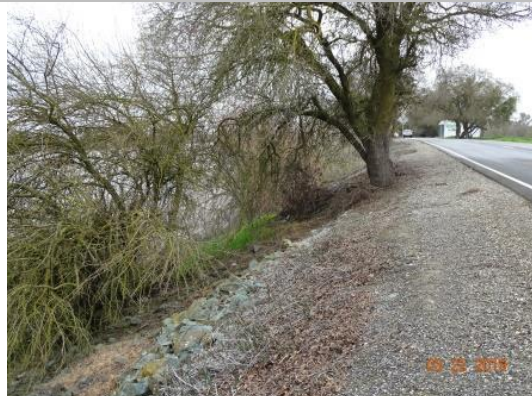
Photo 1 of 1 : SP\_2020\_RD0999\_235\_25\_20200302\_00010.jpg

View looking downstream at low-hanging tree branches on levee slope.  
Spring 2019

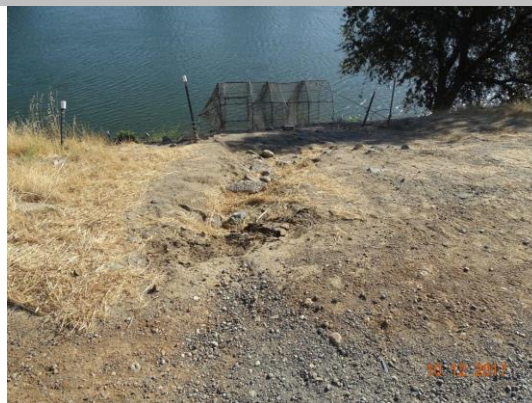
Photo 1 of 1 : SP\_2020\_RD0999\_235\_47\_20200302\_00021.jpg

Looking east at the waterside slope.

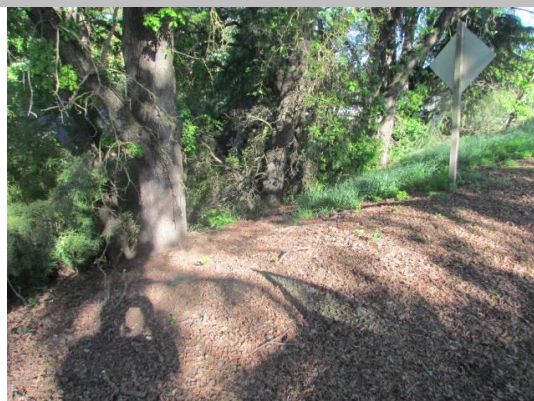
Photo 1 of 1 : SP\_2020\_RD0999\_236\_128\_20200302\_00050.jpg

Looking northwest at untrimmed trees on landward slope. (Spring 2015)

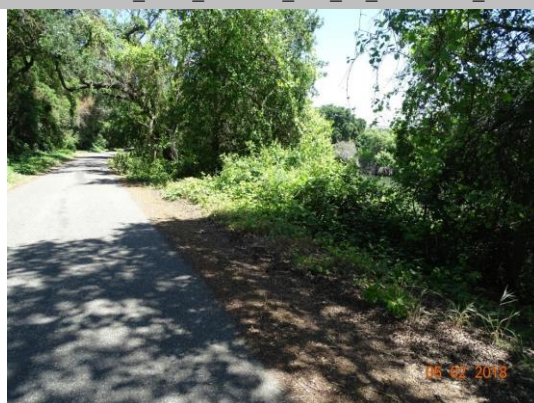
Photo 1 of 1 : SP\_2020\_RD0999\_236\_10\_20200302\_00005.jpg

Vegetation waterside looking north. Spring 2018

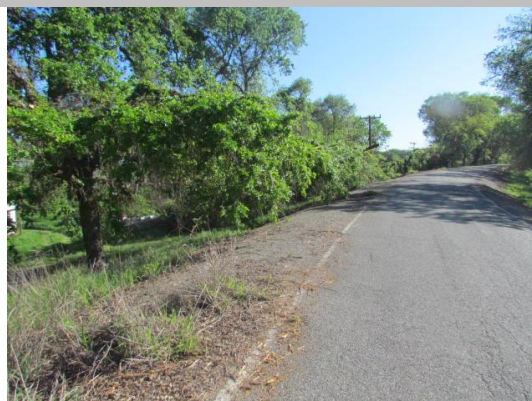
Photo 1 of 1 : SP\_2020\_RD0999\_236\_15\_20200302\_00011.jpg

Looking north at untrimmed trees on landward slope and toe.

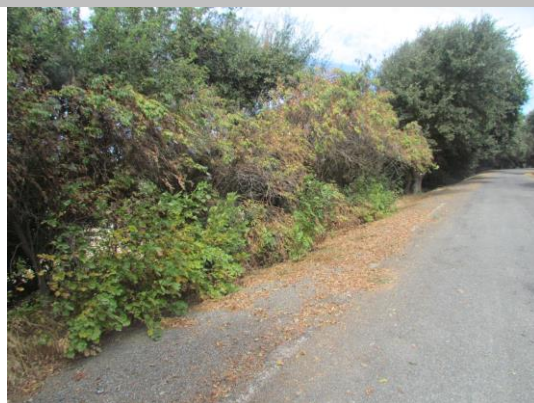
Photo 1 of 1 : SP\_2020\_RD0999\_236\_199\_20200302\_00080.jpg

Looking northwest at dense vegetation on landward slope.

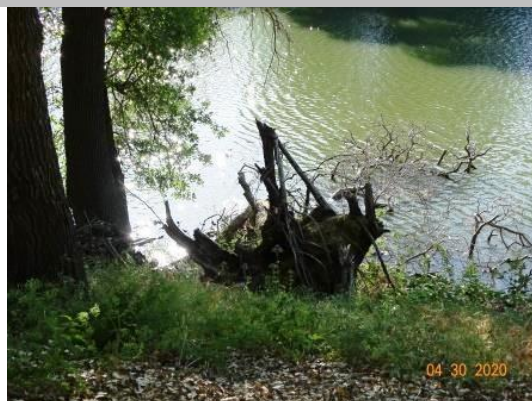
Photo 1 of 1 : SP\_2020\_RD0999\_236\_264\_20200508\_00174.jpg

View of erosion caused by a fallen tree with exposed rootball. Spring 2020

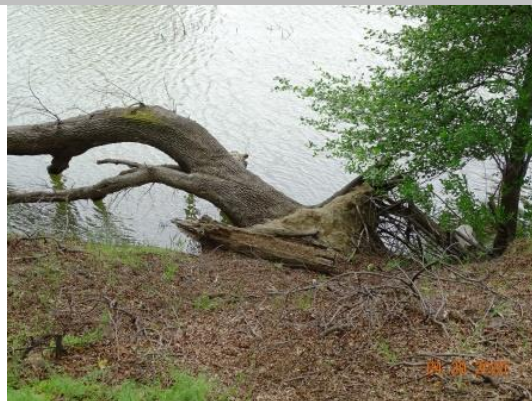
Photo 1 of 1 : SP\_2020\_RD0999\_236\_260\_20200508\_00173.jpg

View of erosion caused by a fallen tree with exposed rootball. Spring 2020

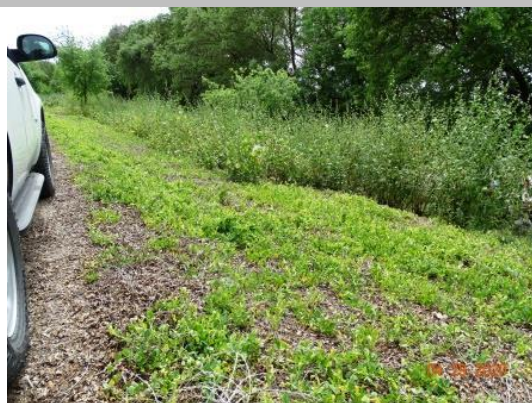
Photo 1 of 1 : SP\_2020\_RD0999\_236\_254\_20200508\_00172.jpg

View of landside vegetation. Spring 2020

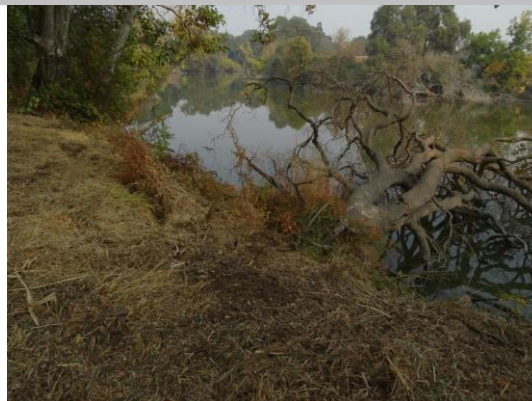
Photo 1 of 1 : SP\_2020\_RD0999\_236\_83\_20200302\_00031.jpg

View of a fallen tree and slope damage. Fall 2018

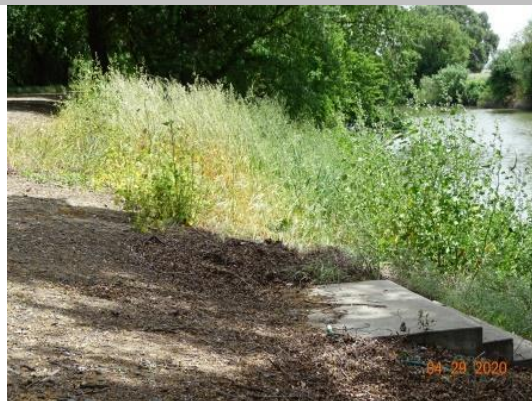
Photo 1 of 1 : SP\_2020\_RD0999\_236\_247\_20200508\_00170.jpg

View of waterside vegetation. Spring 2020

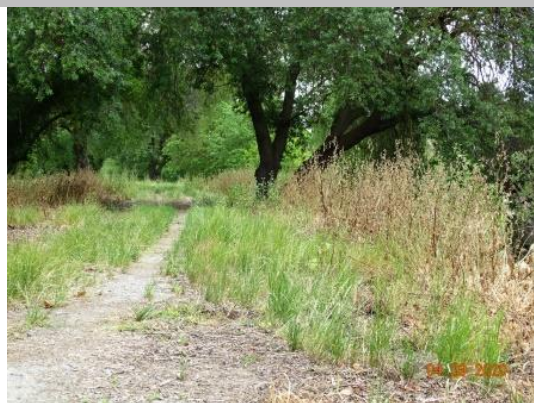
Photo 1 of 1 : SP\_2020\_RD0999\_236\_243\_20200508\_00169.jpg

View of waterside vegetation. Spring 2020

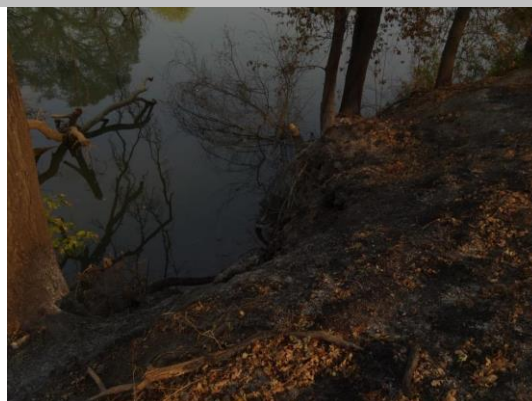
Photo 1 of 1 : SP\_2020\_RD0999\_236\_97\_20200302\_00042.jpg

View of fallen tree and levee scarp. Fall 2018

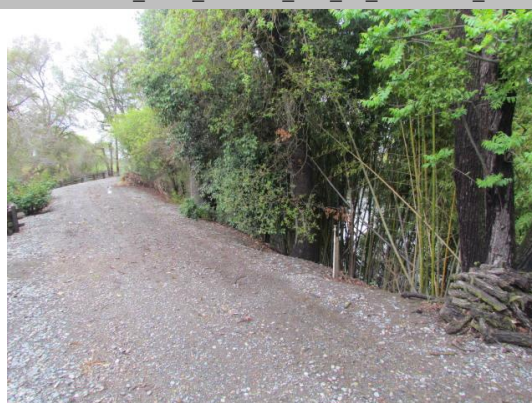
Photo 1 of 1 : SP\_2020\_RD0999\_236\_71\_20200302\_00029.jpg

Looking northeast at dense vegetation on waterside slope.

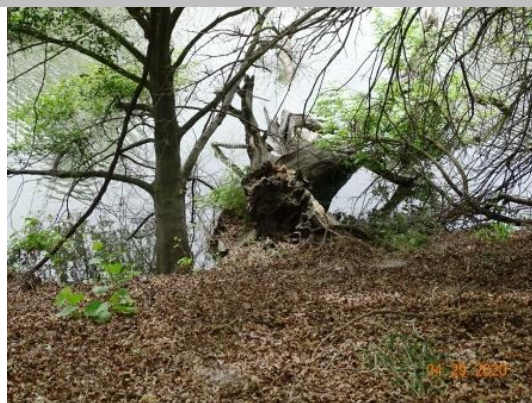
Photo 1 of 1 : SP\_2020\_RD0999\_236\_227\_20200507\_00166.jpg

View of a fallen tree on the waterside slope. Spring 2020

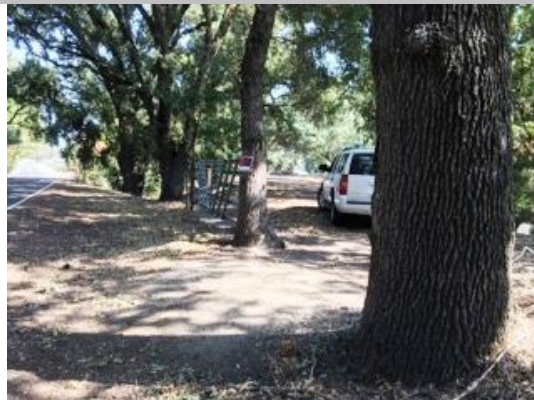
Photo 1 of 1 : SP\_2020\_RD0999\_236\_138\_20200302\_00055.jpg

View of levee access between trees next to a private gate at LM 8.13.

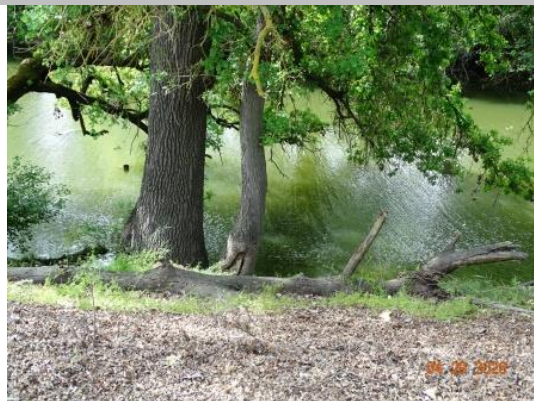
Photo 1 of 1 : SP\_2020\_RD0999\_236\_186\_20200507\_00163.jpg

View of a tree log on the waterside slope. Spring 2020

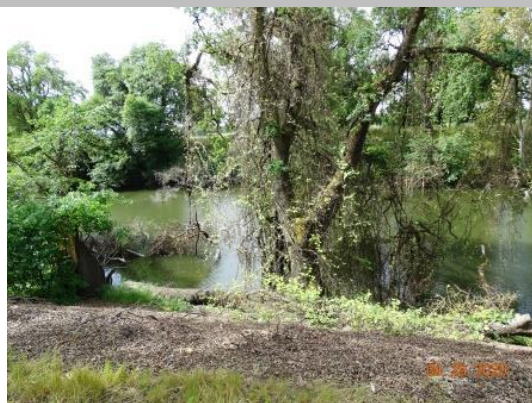
Photo 1 of 1 : SP\_2020\_RD0999\_236\_181\_20200507\_00162.jpg

View of fallen tree on the waterside slope. Spring 2020

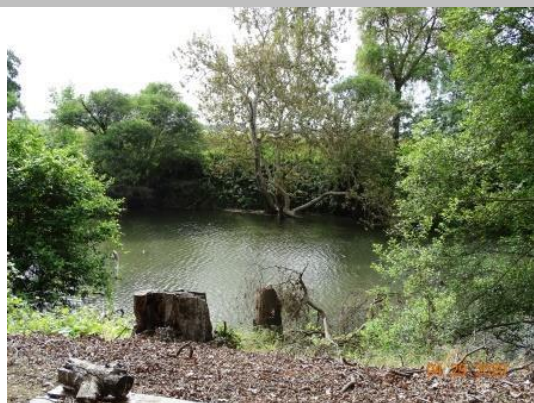
Photo 1 of 1 : SP\_2020\_RD0999\_236\_164\_20200507\_00161.jpg

View of a large tree stump on the waterside slope. Spring 2020
