**Flood Control Project Maintenance  
Levee Inspections**

## Maintenance Issue Types Only, Levee Inspection Report By Mile - Spring 2021

### Reclamation District No. 0999 Netherlands

Waterway	Bank	Unit Miles	Inspection Start/End	Inspector
Unit No. 01 Yolo Bypass	Left	15.41	03/22/2021 03/22/2021	Saskia Donovan

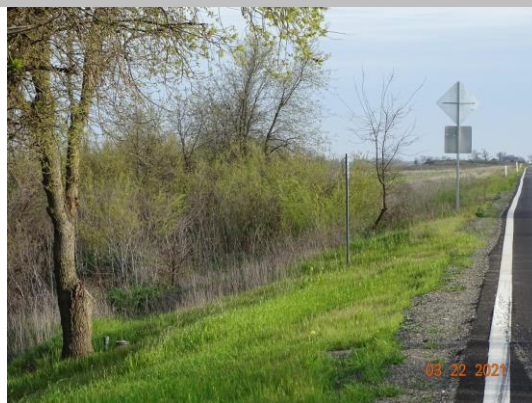
Photo 1 of 1 : SP\_2021\_RD0999\_232\_95\_20210405\_00083.jpg

View of the Arundo on the WS levee slope. Spring 2021.

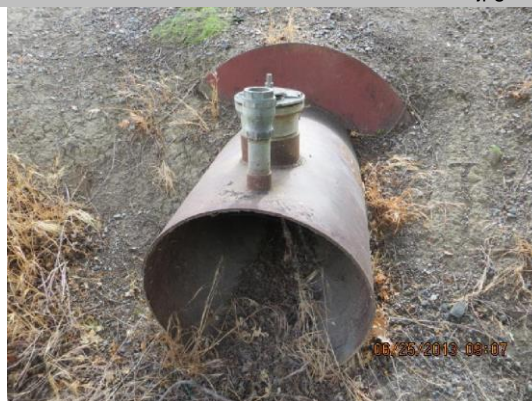
Photo 1 of 3 : UCIP\_SP\_2021\_61245\_25191.jpg

FS\_ID:61245  
DS\_ID:22743  
EP\_NO: N/A  
Repair Type: Non-Urgent  
Crossing Status: Found  
UCIP Comments: 06/16/2020 Record remains Non-Urgent. Unauthorized encroachment recorded in Levee Log prior to 2011. No permit has been identified authorizing pipe. Crossing appears abandoned. (D.Sanoski - DWR UCIP) 07/26/2018 Same as last inspection. Pipe open on WS, but no visual signs of pipe or levee integrity issues so downgrading crossing to Non-Urgent (D. Sanoski - DWR UCIP). 07/07/2016 Condition largely unchanged from previous inspection. Pipe open on the WS, waterward of the siphon breaker. Dense vegetation and steep slope limited inspection of WS outlet into Ship Channel. (T. Hatch/UCIP)  
06/25/2013 Pipe abandoned and open on WS slope. Pipe should be abandoned properly. (W. Wylie/UCIP)  
FIELD\_STRUCT\_DESC: \*ABANDONED\* 30-inch steel drainage pipe through the levee, 6.5 feet below the crown. Pump on a platform in the canal off the landside (LS) toe, not found. Flap gate on the waterside (WS), not found. Siphon breaker and an air vent on the WS shoulder. 1-inch galvanized iron filler pipe visible on the WS shoulder along same alignment. [Additional Reference(s): DWR Levee Log, 1992. USACE Sacramento O&M Manual 113 (Revised), October 1966, (HLM 1.73)].

Pipe open on WS slope

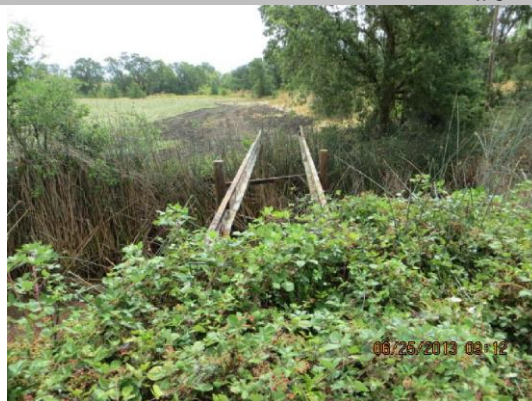
Photo 2 of 3 : UCIP\_SP\_2021\_61245\_25190.jpg

Pump platform visible off LS toe, but no appurtenances remain.

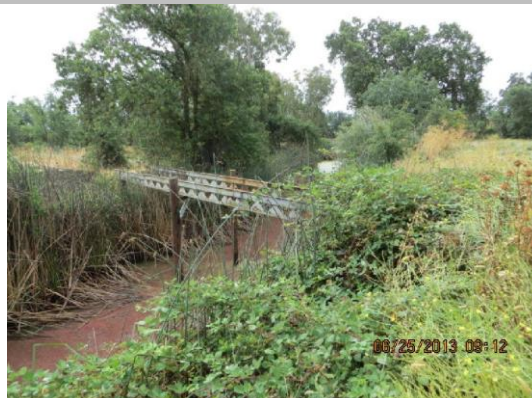
Photo 3 of 3 : UCIP\_SP\_2021\_61245\_25189.jpg

Pump platform visible off LS toe, but no appurtenances remain.

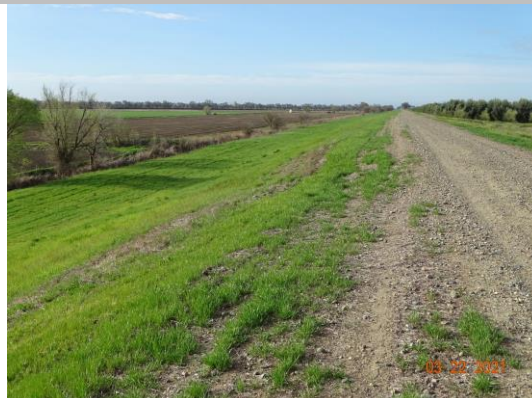
Photo 1 of 1 : SP\_2021\_RD0999\_232\_51\_20210405\_00084.jpg

LM Start	3.22	Rating **	M	Issue No.	51
LM End	3.22	Issue Type +	Ma	Location *	LS
Category	Earthen Levee			GPS Latitude/Longitude	
				Start	End
Item	Slope Stability			38.459399 °	38.459399 °
				-121.587523 °	-121.587523 °
DWR ID	DWR_RD0999_01_s_2013_51				
Comment Code					
S1 : Repair slope instability.					
Inspector Comment					
Repair depression on landward shoulder and slope approximately 40' x 20'. Earthen material appears to be sliding toward levee toe.

View of the depression on the LS levee slope. Spring 2021.

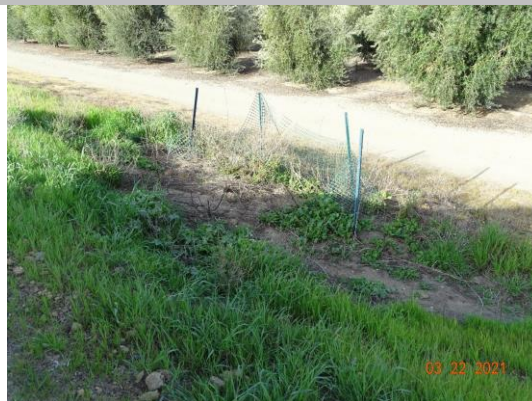
Photo 1 of 1 : SP\_2021\_RD0999\_232\_28\_20210405\_00085.jpg

View of the signs of rodent activity. Spring 2021.

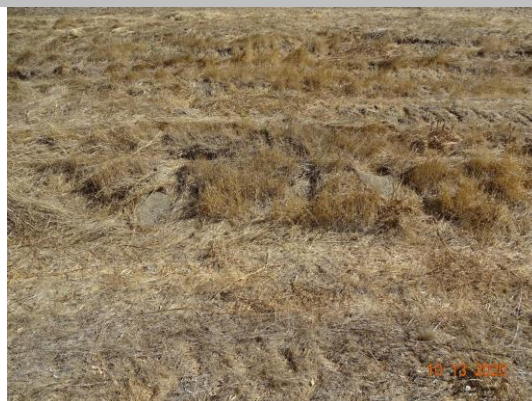
Photo 1 of 1 : SP\_2021\_RD0999\_232\_82\_20210308\_00038.jpg

View of animal holes at the waterside toe. Fall 2020

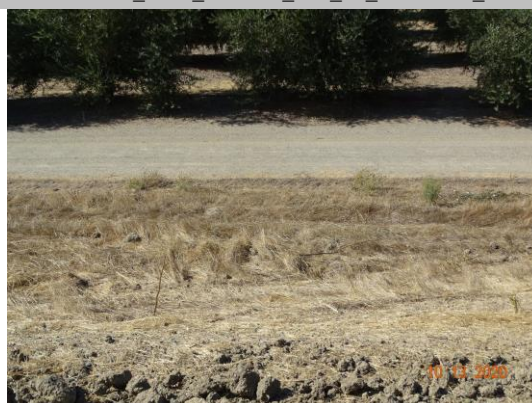
Photo 1 of 1 : SP\_2021\_RD0999\_232\_80\_20210308\_00037.jpg

LM Start	4.04	Rating **	M	Issue No.	80
LM End	4.04	Issue Type +	Ma	Location *	WS
Category	Earthen Levee			GPS Latitude/Longitude	
				Start	End
Item	Animal Control			38.448275 °	38.448275 °
				-121.592692 °	-121.592692 °
DWR ID	DWR_RD0999_01_f_2020_80				
Comment Code					
A3 : No rodents visible, but rodent burrows visible; need to backfill and compact or grout burrows.					
Inspector Comment

View of animal holes at the waterside toe. Fall 2020

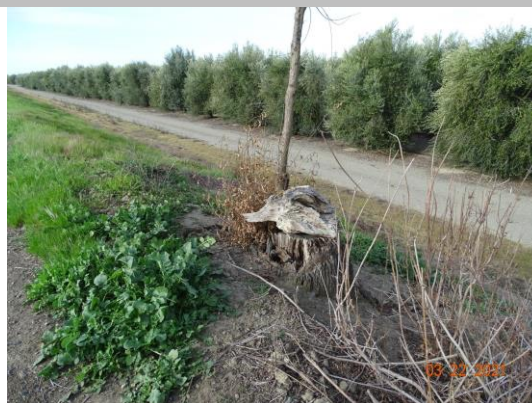
Photo 1 of 1 : SP\_2021\_RD0999\_232\_14\_20210405\_00086.jpg

View of the tree stump on the WS levee slope. Spring 2021.

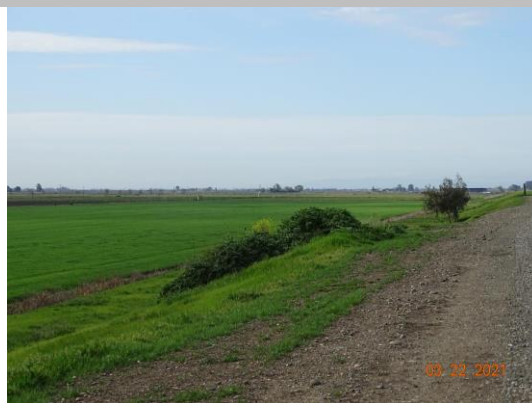
Photo 1 of 1 : SP\_2021\_RD0999\_232\_35\_20210405\_00089.jpg

LM Start	6.63	Rating **	M	Issue No.	35
LM End	6.63	Issue Type +	Ma	Location *	LS
Category	Earthen Levee			GPS Latitude/Longitude	
				Start	End
Item	Vegetation			38.413010 °	38.413010 °
				-121.609040 °	-121.609040 °
DWR ID	DWR_RD0999_01_s_2021_35				
Comment Code					
V2 : Remove the wild growth other than native grasses from the levee slopes.					
Inspector Comment					
Bull thistle is growing on the LS levee slope. Spring 2021.

View of the bull thistle on the LS levee slope. Spring 2021.

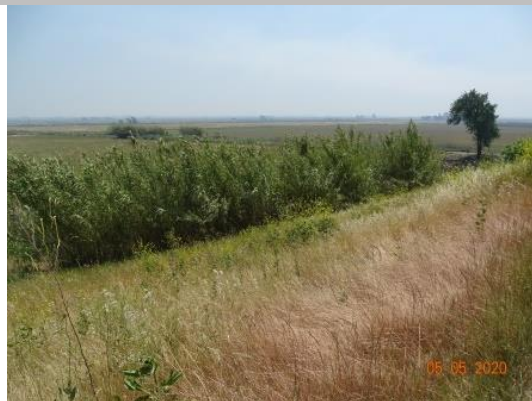
Photo 1 of 1 : SP\_2021\_RD0999\_232\_74\_20210308\_00034.jpg

LM Start	8.01	Rating **	M	Issue No.	74
LM End	8.01	Issue Type +	Ma	Location *	LS
Category	Earthen Levee			GPS Latitude/Longitude	
				Start	End
Item	Vegetation			38.394150 °	38.394150 °
				-121.617805 °	-121.617805 °
DWR ID	DWR_RD0999_01_s_2020_74				
Comment Code					
V2 : Remove the wild growth other than native grasses from the levee slopes.					
Inspector Comment					
Remove Arundo growth at the landside toe.

View of Arundo growth at the landside toe. Spring 2020

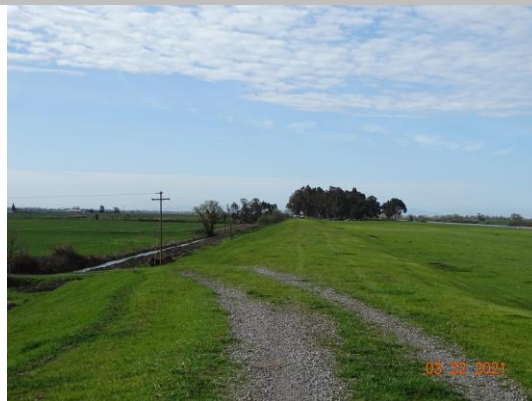
Photo 1 of 1 : SP\_2021\_RD0999\_232\_36\_20210405\_00093.jpg

View of the grassy crown. Spring 2021.

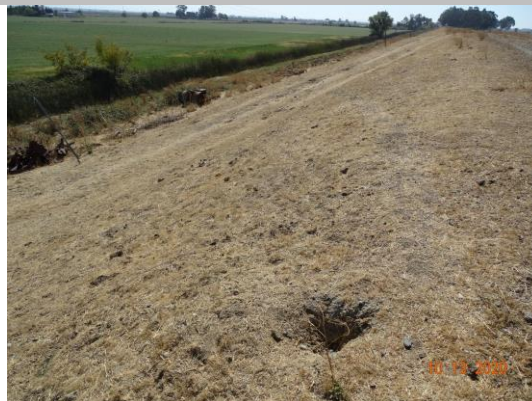
Photo 1 of 1 : SP\_2021\_RD0999\_232\_24\_20210308\_00005.jpg

View of large animal holes on the landside slope. Fall 2020

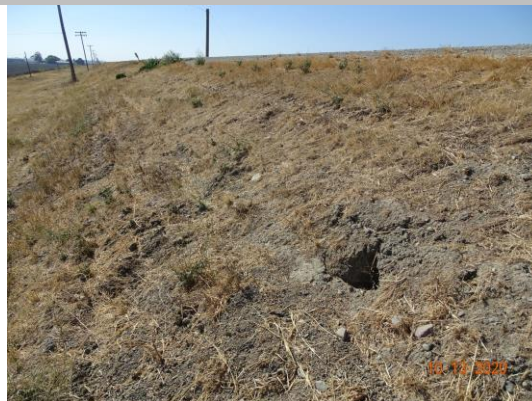
Photo 1 of 1 : SP\_2021\_RD0999\_232\_59\_20210308\_00028.jpg

View of a large animal hole on the landside slope. Fall 2020

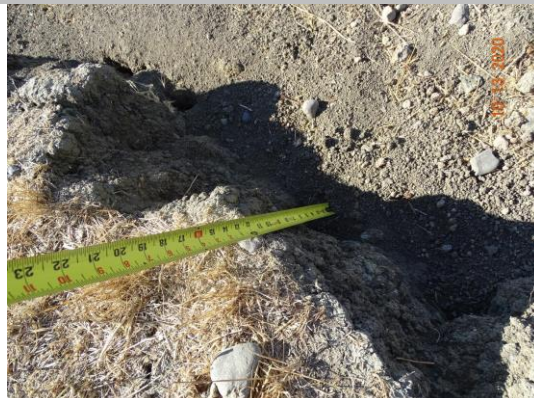
Photo 1 of 2 : SP\_2021\_RD0999\_232\_47\_20210308\_00020.jpg

LM Start	13.29	Rating **	M	Issue No.	47
LM End	13.30	Issue Type +	Ma	Location *	WS
Category	Earthen Levee			GPS Latitude/Longitude	
				Start	End
Item	Slope Stability			38.321180 °	38.321043 °
				-121.644962 °	-121.644960 °
DWR ID	DWR_RD0999_01_f_2020_47				
Comment Code					
S1 : Repair slope instability.					
Inspector Comment					
A separation of soil up to 12" deep and 40' long exists on the waterside slope.

View of soil separation on the waterside slope. Fall 2020

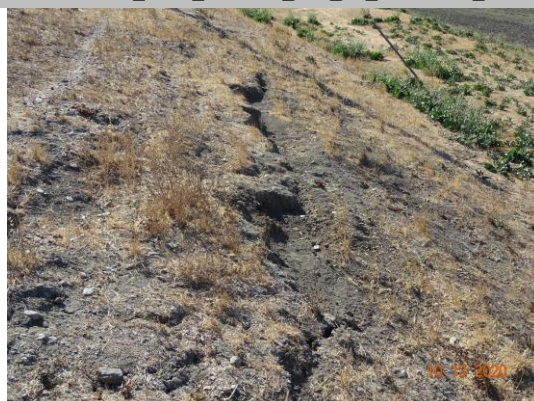
Photo 2 of 2 : SP\_2021\_RD0999\_232\_47\_20210308\_00021.jpg

View of soil separation on the waterside slope. Fall 2020

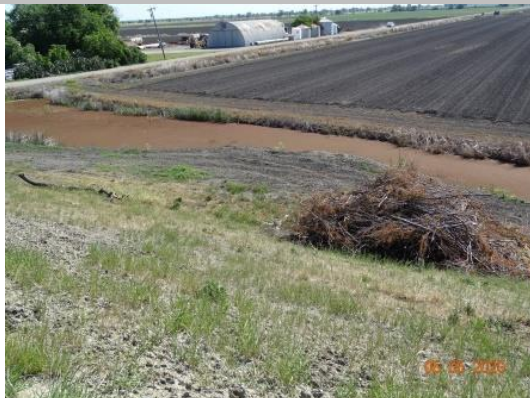
Photo 1 of 1 : SP\_2021\_RD0999\_232\_16\_20210308\_00002.jpg

View of prunings at the landside toe. Spring 2020

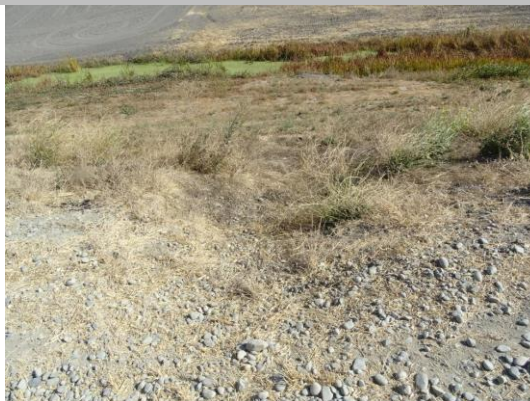
Photo 1 of 1 : SP\_2021\_RD0999\_232\_49\_20210308\_00002.jpg

LM Start	14.04	Rating **	M	Issue No.	49
LM End	14.04	Issue Type +	Ma	Location *	LS
Category	Earthen Levee			GPS Latitude/Longitude	
				Start	End
Item	Erosion / Bank Caving			38.310347 °	38.310347 °
				-121.644955 °	-121.644955 °
DWR ID	DWR_RD0999_01_f_2012_49				
Comment Code					
E1 : Note and monitor erosion site.					
Inspector Comment					
Repair caving, 4' x 10', on the landside slope.

View of caving on landward slope. Fall 2018

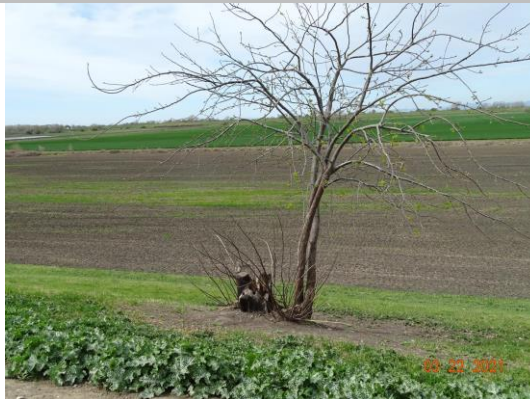
Photo 1 of 1 : SP\_2021\_RD0999\_232\_43\_20210405\_00095.jpg

LM Start	15.06	Rating **	N	Issue No.	43
LM End	15.06	Issue Type +	Ma	Location *	WS
Category	Earthen Levee			GPS Latitude/Longitude	
				Start	End
Item	Trim / Thin Trees			38.295526 °	38.295526 °
				-121.644993 °	-121.644993 °
DWR ID	DWR_RD0999_01_s_2021_43				
Comment Code					
T5 : Tree stumps.					
Inspector Comment					
The stump and small tree should be removed. Spring 2021.

View of the tree and stump at the WS levee toe. Spring 2021.

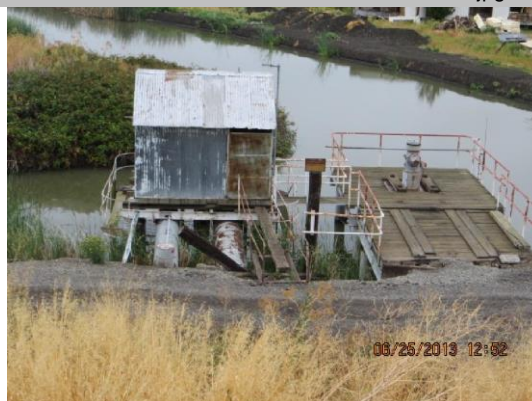
Photo 1 of 3 : UCIP\_SP\_2021\_61278\_25227.jpg

Comment Code						
Inspector Comment						
FS_ID:61278 DS_ID:22756 EP_NO: N/A Repair Type: No Action Needed Crossing Status: Found UCIP Comments: 06/16/2020 Record updated from No Action Needed to Non-Urgent. Unauthorized encroachment recorded in Levee Log prior to 2011. No permit has been identified authorizing pipe. (D.Sanoski - DWR UCIP) FIELD_STRUCT_DESC: 30-inch steel drainage pipe through the levee, 7 feet below the crown. Flap gate on the waterside (WS) end. Pump in pump house on the landside (LS) toe. Siphon breaker in a corrugated metal pipe (CMP) riser on the WS shoulder. [Additional Reference(s): DWR Levee Log, 1992. USACE Sacramento O&M Manual 113 (Revised), October 1966, (HLM 15.25) (36-inch pipe listed)]. FS Date: 6/16/2020 2:26:00 PM

Pumphouse on LS toe.

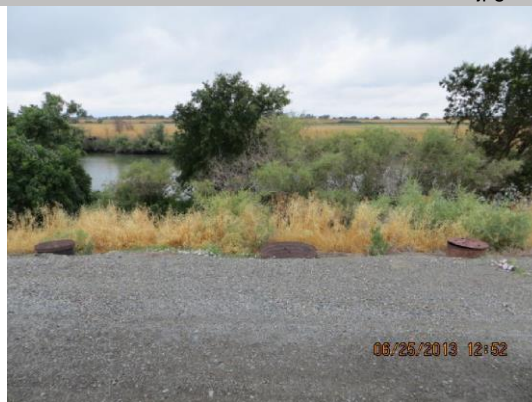
Photo 2 of 3 : UCIP\_SP\_2021\_61278\_25226.jpg

Siphon breaker in CMP riser on WS shoulder.

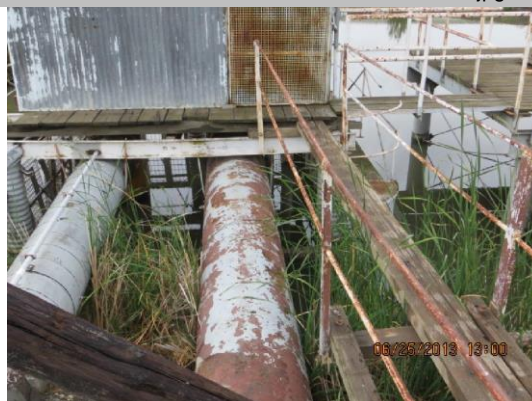
Photo 3 of 3 : UCIP\_SP\_2021\_61278\_25225.jpg

Closeup of pipe at pumphouse on LS toe.

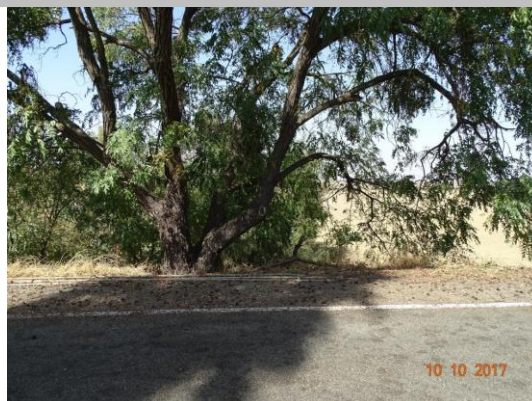
Photo 1 of 1 : SP\_2021\_RD0999\_233\_21\_20210308\_00007.jpg

View of trees on landside slope looking north. Fall 2017

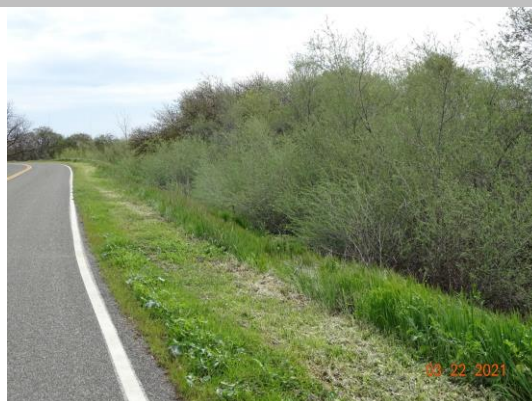
Photo 1 of 1 : SP\_2021\_RD0999\_233\_35\_20210405\_00034.jpg

View of the trees on the WS levee slope. Spring 2021.

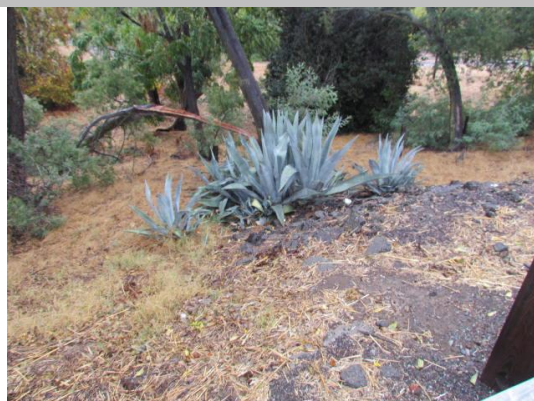
Photo 1 of 1 : SP\_2021\_RD0999\_233\_14\_20210308\_00005.jpg

Looking north at century plant at landward toe. Fall 2015.

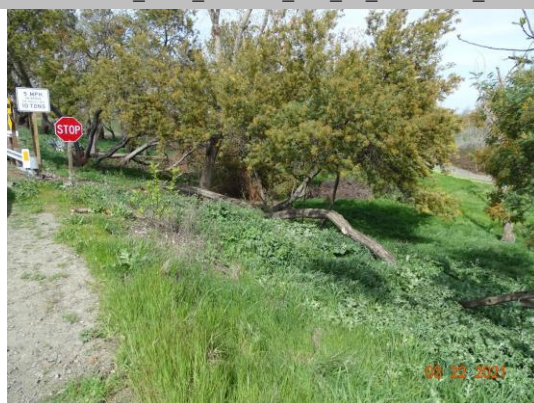
Photo 1 of 1 : SP\_2021\_RD0999\_233\_18\_20210405\_00033.jpg

View of the fallen trees on the LS levee slope. Spring 2021.

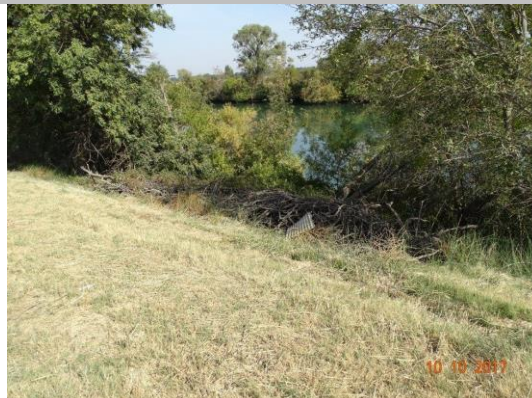
Photo 1 of 1 : SP\_2021\_RD0999\_234\_32\_20210308\_00013.jpg

View of waterside slope looking east. Fall 2017

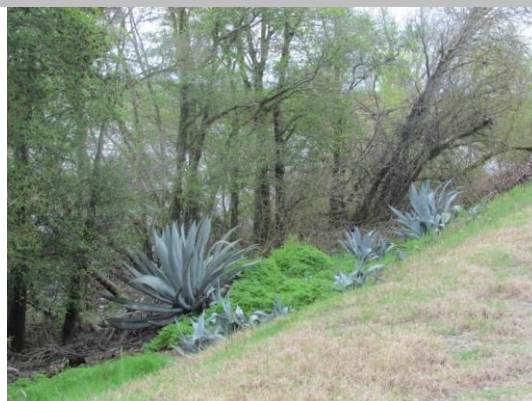
Photo 1 of 1 : SP\_2021\_RD0999\_234\_17\_20210308\_00008.jpg

Looking east at century plants on waterward slope.

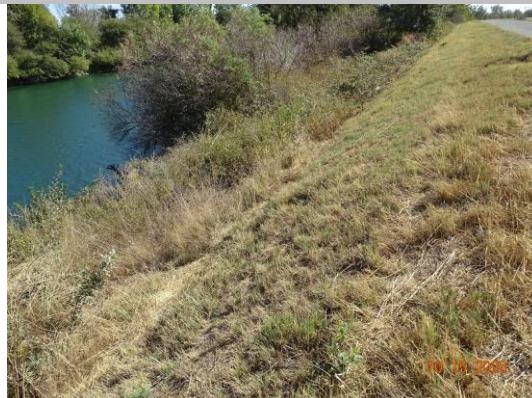
Photo 1 of 1 : SP\_2021\_RD0999\_234\_5\_20210308\_00001.jpg

Comment Code					
Inspector Comment					
2017 Site ID: STR 24.7 R					
Status: Critical					
2017 Field Notes: Locals have placed rock in worst sections. Fresh erosion at toe. New tall vertical sections observed.					
Site History: 1997 - Intermittent over-steepened sections. Large riparian vegetation along the length of the entire reach. Attempts to repair with rock on bank have failed. 1999 - New rock repair at the downstream end. 2002 - Some minor spot repairs. 2009 - Minimal new erosion. 2010 - Appears that fresh rock placed on downstream portion of site. Toe scour and overhanging trees with some overturned. 2012 - Minor new erosion at the toe. 2013 - Site upgraded to CRITICAL. Severe slumping into levee at downstream end of site. Fresh erosion into bank toe. 2015 - New slumping, tall vertical sections. 2016 - Upper slumped section continues to worsen. Fall 2019 DWR Inspection: Dense vegetation covers the lower half of the slope and erosion. Roughly 5-10' of the upper slope is accessible.

View of waterside slope at LM 0.59 looking downstream. Fall 2020

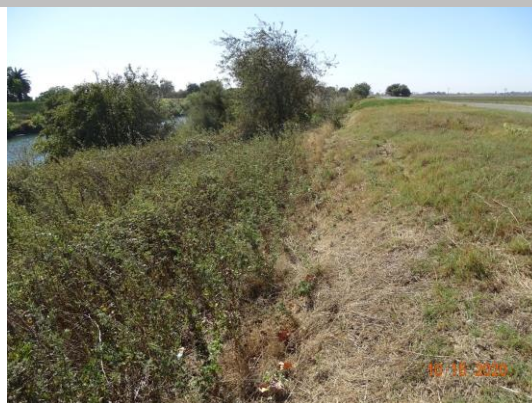
Photo 1 of 1 : SP\_2021\_RD0999\_234\_6\_20210308\_00002.jpg

View of the waterside slope near LM 1.10. The short slope is consistent to at least LM1.00. Fall 2020

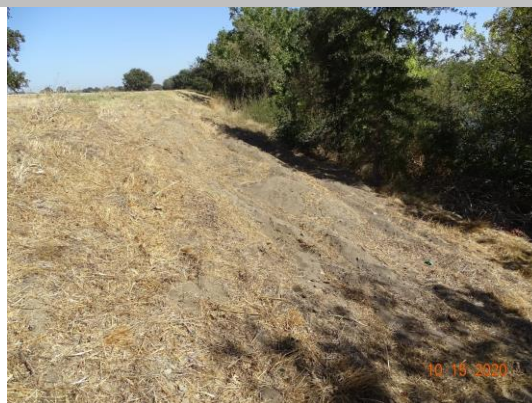
Photo 1 of 1 : SP\_2021\_RD0999\_234\_13\_20210308\_00006.jpg

LM Start	1.99	Rating **	M	Issue No.	13
LM End	1.99	Issue Type +	Ma	Location *	WS
Category	Earthen Levee			GPS Latitude/Longitude	
				Start	End
Item	Slope Stability			38.311618 °	38.311618 °
				-121.596887 °	-121.596887 °
DWR ID	DWR_RD0999_03_f_2020_13				
Comment Code					
S3 : Repair the levee slope damaged by vehicle traffic and prevent access where possible.					
Inspector Comment					
Repair slope depression due to vehicle traffic.

View of slope damage on the waterside slope due to vehicle traffic. Fall 2020

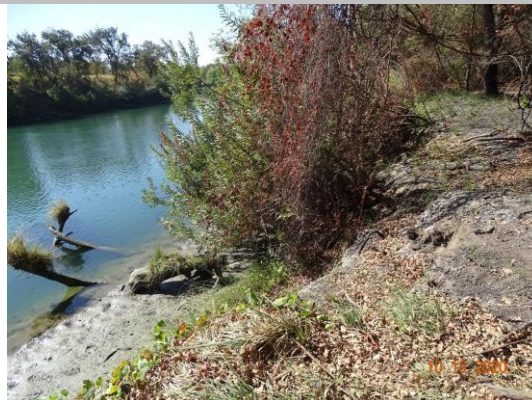
Photo 1 of 1 : SP\_2021\_RD0999\_234\_12\_20210308\_00005.jpg

View of a large scarp on the waterside berm. Fall 2020

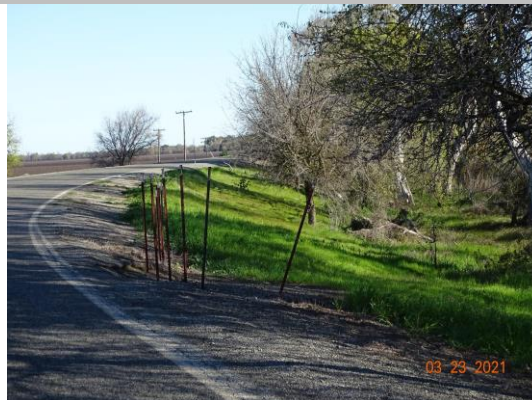
Photo 1 of 1 : SP\_2021\_RD0999\_234\_21\_20210405\_00036.jpg

LM Start	3.43	Rating **	M	Issue No.	21
LM End	3.43	Issue Type +	Ma	Location *	WS
Category	Earthen Levee			GPS Latitude/Longitude	
				Start	End
Item	Slope Stability			38.328518 °	38.328518 °
				-121.586683 °	-121.586683 °
DWR ID	DWR_RD0999_03_s_2021_21				
Comment Code					
S1 : Repair slope instability.					
Inspector Comment					
There is some visible sloughing at the WS below the edge of the pavement. The site is marked with several iron fence posts. Spring 2021.

View of the sloughing and fence posts below the WS levee shoulder.  
Spring 2021.

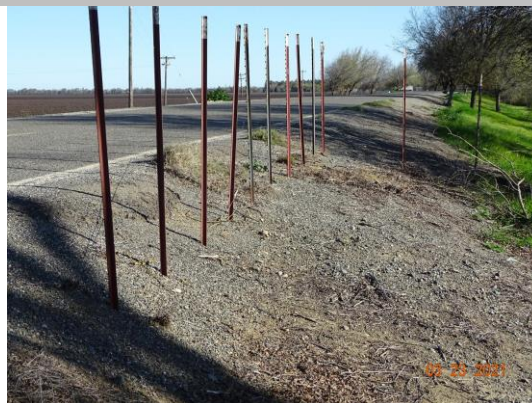
Photo 1 of 1 : SP\_2021\_RD0999\_234\_23\_20210405\_00037.jpg

LM Start	3.50	Rating **	M	Issue No.	23
LM End	3.50	Issue Type +	Ma	Location *	WS
Category	Earthen Levee			GPS Latitude/Longitude	
				Start	End
Item	Slope Stability			38.329476 °	38.329476 °
				-121.586506 °	-121.586506 °
DWR ID	DWR_RD0999_03_s_2021_23				
Comment Code					
S1 : Repair slope instability.					
Inspector Comment					
There is some visible sloughing at the WS below the edge of the pavement. The site is marked with several iron fence posts. Spring 2021.

View of the sloughing and fence posts below the WS levee shoulder.  
Spring 2021.

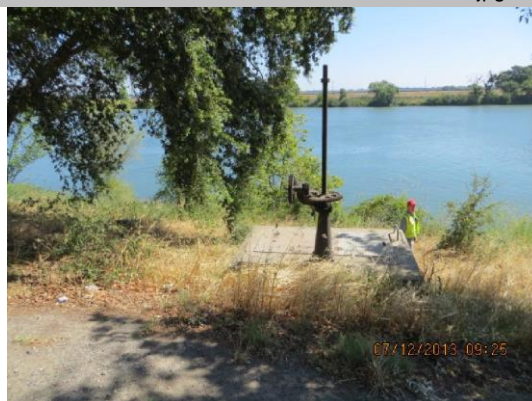
Photo 1 of 3 : UCIP\_SP\_2021\_61407\_26137.jpg

Comment Code						
Inspector Comment						
FS_ID:61407 DS_ID:22788 EP_NO: N/A Repair Type: Non-Urgent Crossing Status: Found UCIP Comments: 07/01/2020 Record updated from No Action Needed to Non-Urgent. Unauthorized encroachment recorded in Levee Log prior to 2011. No permit has been identified authorizing pipe. (D.Sanoski - DWR UCIP) 10/27/2017 This structure is inspected annually under the Structure and Channel Summer Inspection (part of the Levee Inspection Program) conducted by the DWR Flood Project Integrity and Inspection Branch (FPIIB). (DWR UCIP - O. Magana) FIELD_STRUCT_DESC: [Elk Slough Inlet Structure] 60-inch by 60-inch reinforced concrete drainage culvert through the levee, 30 feet below the crown. Slide gate in a 6-foot by 8-foot concrete vault on the waterside (WS) shoulder. [Additional Reference(s): DWR Levee Log, 1992. USACE Sacramento O&M Manual 113 (Revised), October 1966, (HLM 0.00)]. FS Date: 7/1/2020 10:09:00 AM

Slide gate in concrete vault on WS shoulder.

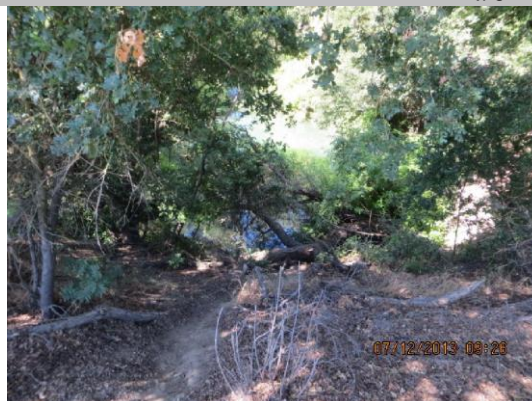
Photo 2 of 3 : UCIP\_SP\_2021\_61407\_26136.jpg

Toe of LS at approximate location of outlet/inlet.

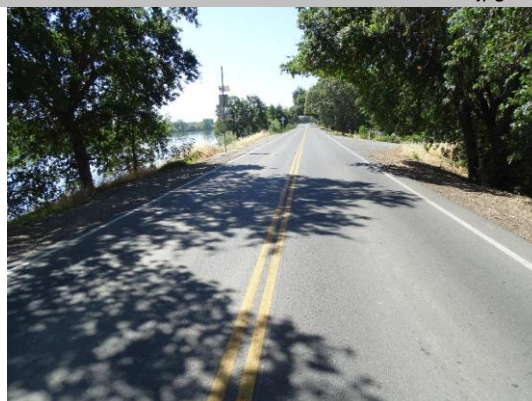
Photo 3 of 3 : UCIP\_SP\_2021\_61407\_88712.jpg

Top of Levee: view of crown.

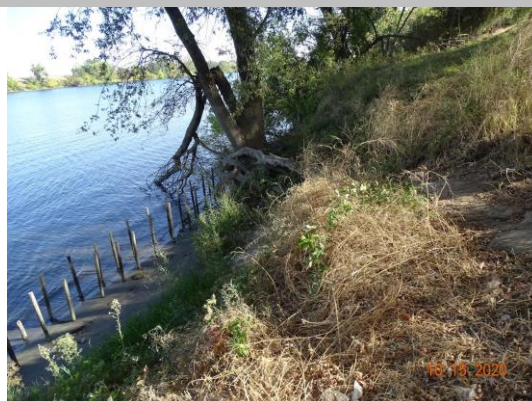
Photo 1 of 1 : SP\_2021\_RD0999\_235\_23\_20210308\_00004.jpg

Planned For  
Repair  
2017 Site ID: SAC 41.9 R  
Site ID No:357  
Site Designation:LMA-184  
2017 Field Notes: Fresh erosion on entire bank. Upgraded to critical.  
Site History: 1997 - Structural problem rather than erosional, failed cobble at downstream end. 2005 - New brush boxes at waterline for several hundred feet downstream, No toe or bank protection present.  
2006 - Some minor new erosion. Brush boxes not working well; most of the brush has floated out. 2007 - Brush boxes have recently been repaired. 2016 - Minor new slumping. Fall 2020 DWR Inspection: Erosion exposes a tree's roots at LM 0.11 near a footpath.

View of a split tree and bank erosion near LM 0.11. Fall 2020

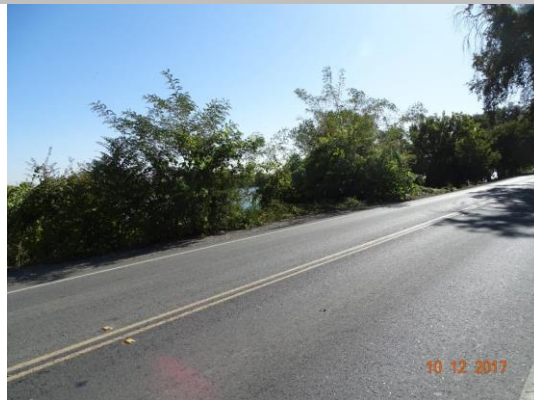
Photo 1 of 1 : SP\_2021\_RD0999\_235\_53\_20210308\_00009.jpg

Looking southeast at the waterside slope. Fall 2017

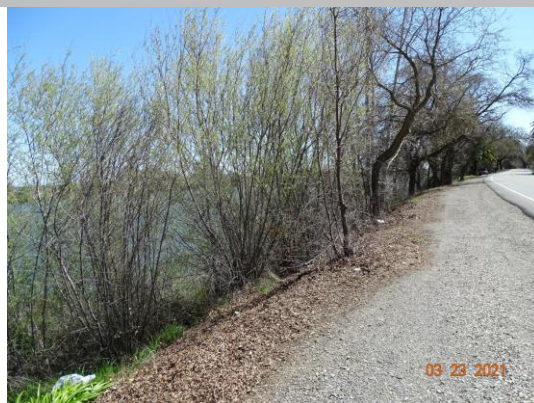
Photo 1 of 1 : SP\_2021\_RD0999\_235\_24\_20210412\_00079.jpg

View of the trees on the WS levee slope. Spring 2021.

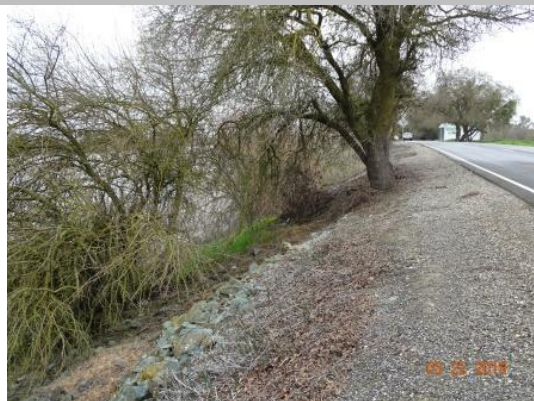
Photo 1 of 1 : SP\_2021\_RD0999\_235\_25\_20210308\_00005.jpg

View looking downstream at low-hanging tree branches on levee slope. Spring 2019

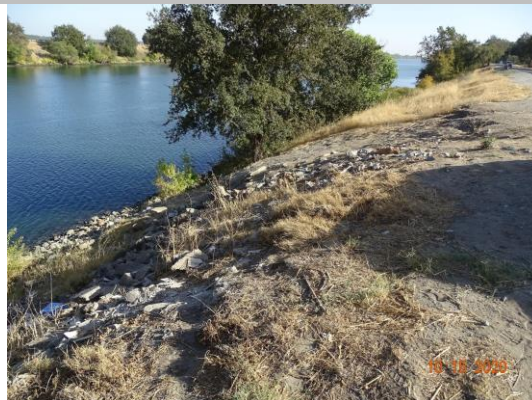
Photo 1 of 1 : SP\_2021\_RD0999\_235\_47\_20210308\_00008.jpg

View of erosion on the waterside slope with broken concrete riprap. Fall 2020

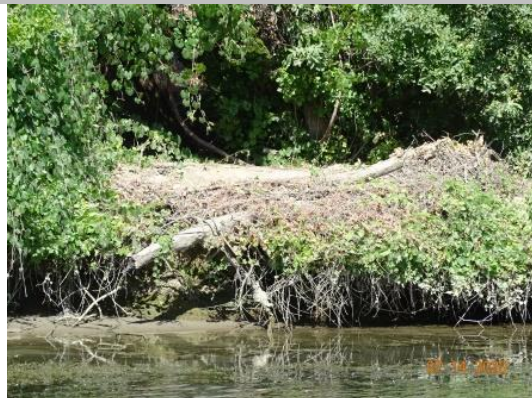
Photo 1 of 1 : SP\_2021\_RD0999\_236\_49\_20210308\_00015.jpg

View of scarp with vegetation growth. Summer 2020

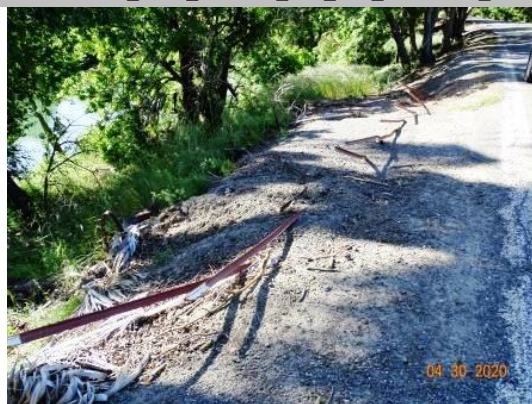
Photo 1 of 1 : SP\_2021\_RD0999\_236\_165\_20210308\_00058.jpg

View of minor cracks near a ramp. Spring 2020

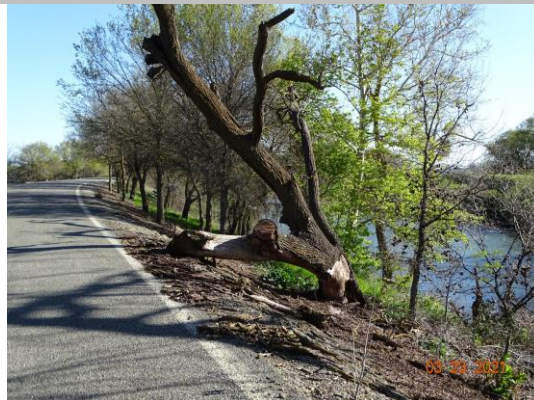
Photo 1 of 1 : SP\_2021\_RD0999\_236\_60\_20210409\_00210.jpg

View of the fallen tree on the WS levee slope. Spring 2021.

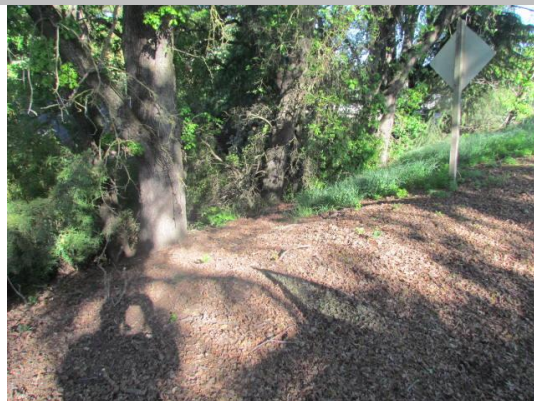
Photo 1 of 1 : SP\_2021\_RD0999\_236\_128\_20210308\_00044.jpg

Looking northwest at untrimmed trees on landward slope. (Spring 2015)

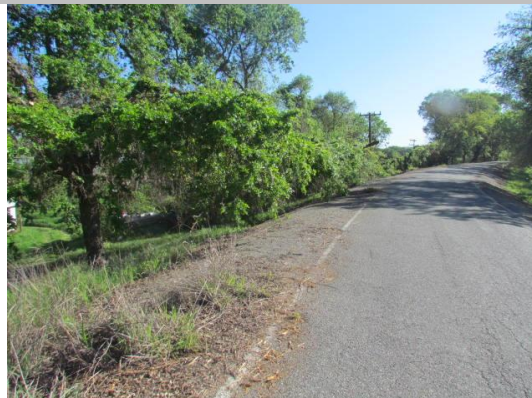
Photo 1 of 1 : SP\_2021\_RD0999\_236\_15\_20210308\_00008.jpg

Looking north at untrimmed trees on landward slope and toe.

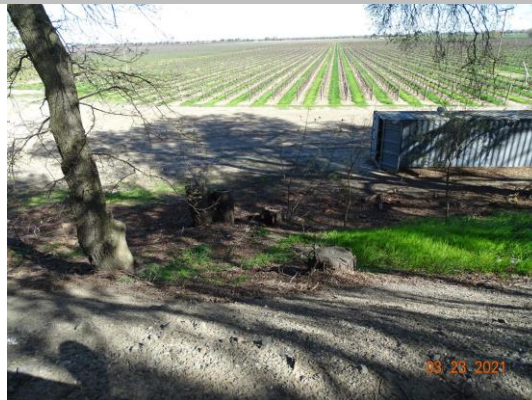
Photo 1 of 1 : SP\_2021\_RD0999\_236\_79\_20210409\_00211.jpg

View of the tree stumps on the LS levee slope. Spring 2021.

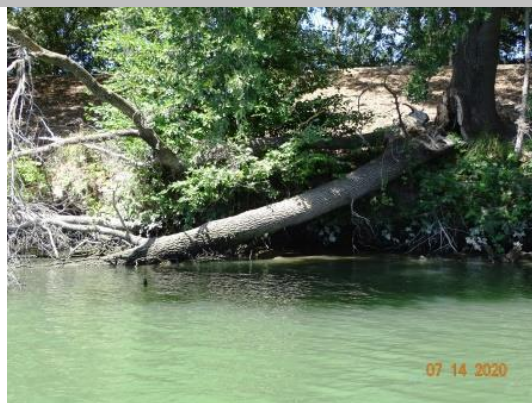
Photo 1 of 1 : SP\_2021\_RD0999\_236\_263\_20210308\_00094.jpg

View of a split tree on the waterside bank. Summer 2020

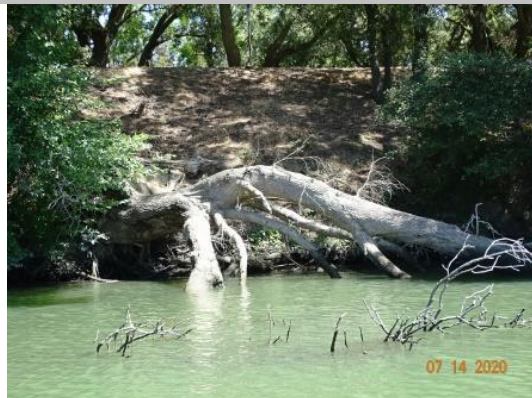
Photo 1 of 1 : SP\_2021\_RD0999\_236\_260\_20210308\_00093.jpg

View of slope erosion around fallen tree from the waterside. Summer 2020

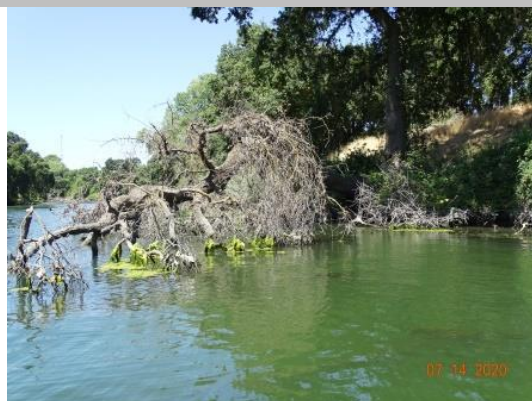
Photo 1 of 1 : SP\_2021\_RD0999\_236\_102\_20210308\_00039.jpg

View of fallen tree split at the base. Summer 2020

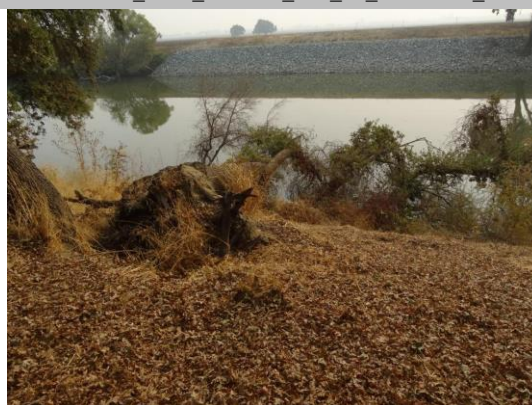
Photo 1 of 1 : SP\_2021\_RD0999\_236\_28\_20210308\_00011.jpg

View of dead tree on slope. Fall 2018

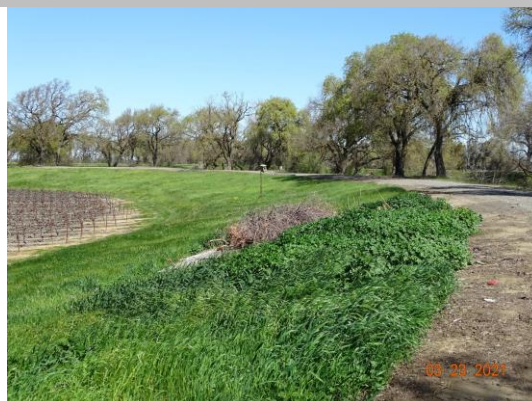
Photo 1 of 1 : SP\_2021\_RD0999\_236\_106\_20210409\_00215.jpg

View of the debris and pruning pile on the LS levee slope. Spring 2021.

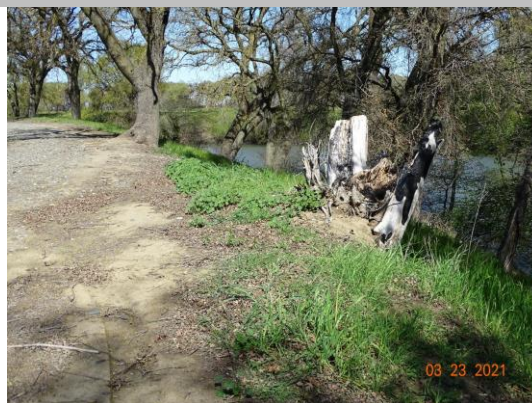
Photo 1 of 1 : SP\_2021\_RD0999\_236\_117\_20210409\_00216.jpg

View of the tree stump on the WS levee slope. Spring 2021.

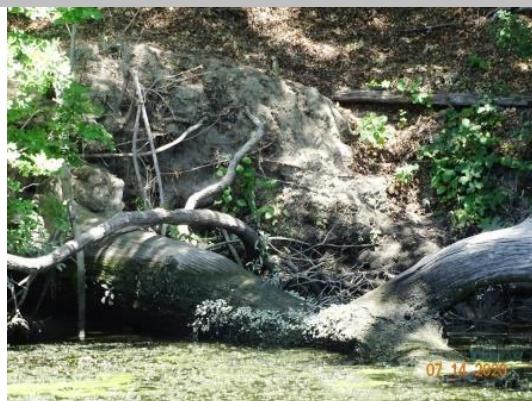
Photo 1 of 1 : SP\_2021\_RD0999\_236\_99\_20210308\_00037.jpg

View of slope damage near fallen tree. Summer 2020

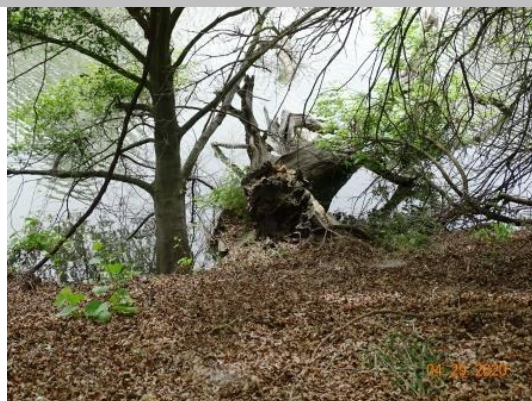
Photo 1 of 1 : SP\_2021\_RD0999\_236\_227\_20210308\_00088.jpg

View of a fallen tree on the waterside slope. Spring 2020

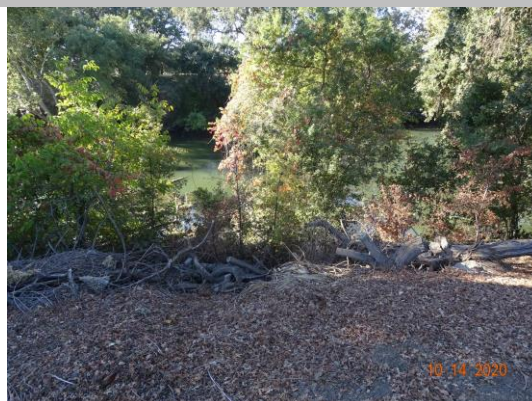
Photo 1 of 1 : SP\_2021\_RD0999\_236\_177\_20210308\_00066.jpg

View of tree logs and limbs on the waterside slope. Fall 2020

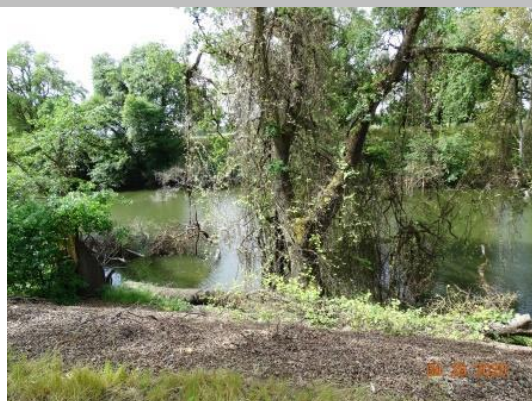
Photo 1 of 1 : SP\_2021\_RD0999\_236\_181\_20210308\_00068.jpg

View of fallen tree on the waterside slope. Spring 2020

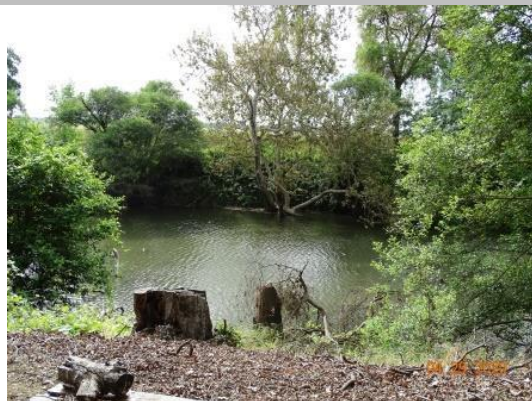
Photo 1 of 1 : SP\_2021\_RD0999\_236\_164\_20210308\_00057.jpg

View of a large tree stump on the waterside slope. Spring 2020
