**Flood Control Project Maintenance
Levee Inspections**

Maintenance Issue Types Only, Levee Inspection Report By Mile - Spring 2022

Reclamation District No. 0999 Netherlands

| Waterway | Bank | Unit Miles | Inspection Start/End | Inspector |
|---|---|---|---|---|
| Unit No. 01 Yolo Bypass | Left | 15.41 | 05/18/2022 05/20/2022 | Marvin Marshall |

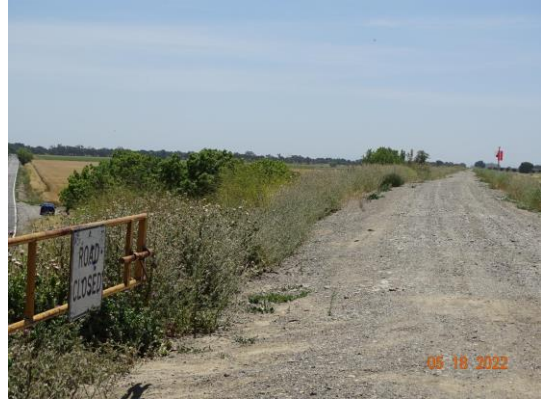
Photo 1 of 1 : SP_2022_RD0999_232_22_20220524_00084.jpg

Annual vegetation on the landsides slope. Spring 2022

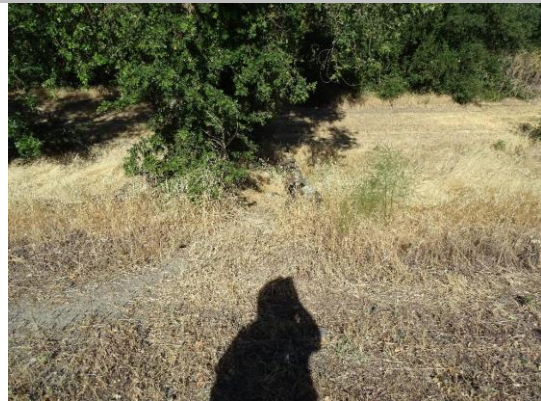
Photo 2 of 3 : UCIP_SP_2022_69815_88523.jpg

| FS_ID:69815 DS_ID:22743 EP_NO: N/A Repair Type: Urgent Crossing Status: Found UCIP Comments: 06/16/2020 Record remains Non-Urgent. No permit has been identified authorizing pipe. Crossing appears abandoned. Recommend owner to contact CVFPB to abandon or remove pipe from levee. (D.Sanoski - DWR UCIP) 07/26/2018 Same as last inspection. Pipe open on WS, but no visual signs of pipe or levee integrity issues so downgrading crossing to Non-Urgent (D. Sanoski - DWR UCIP).07/07/2016 Condition largely unchanged from previous inspection. Pipe open on the WS, waterward of the siphon breaker. Dense vegetation and steep slope limited inspection of WS outlet into Ship Channel. (T. Hatch/UCIP) 06/25/2013 Pipe abandoned and open on WS slope. Pipe should be abandoned properly. (W. Wylie/UCIP) FIELD_STRUCT_DESC: 30-inch steel drainage pipe through the levee, 6.5 feet below the crown. Pump on a platform in the canal off the landside (LS) toe. Flap gate on the waterside (WS). Siphon breaker and an air vent on the WS shoulder. 1-inch galvanized iron filler pipe visible on the WS shoulder along same alignment. [Additional Reference(s): DWR Levee Log, 1992 (HLM 1.73). USACE Sacramento O&M Manual, Unit 113, October 1966, Revised 29 December 2016, (1.73), listed as 30-inch pipe]. FS Date: 6/16/2020 2:16:00 PM | | | | | | |

Water-Side: view of WS slope and broken crossing at toe.

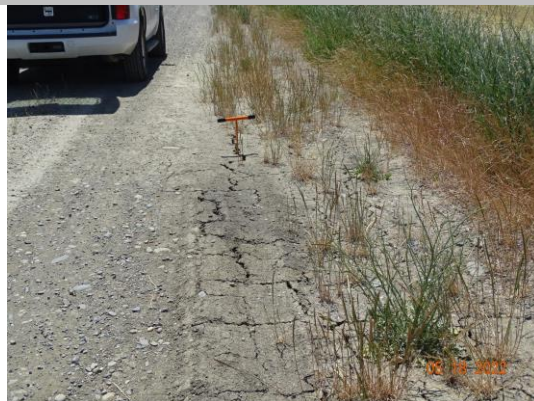
Photo 1 of 1 : SP_2022_RD0999_232_25_20220524_00086.jpg

Desiccation cracking on the shoulder. Spring 2022

| Have desiccation cracking inspected by geotechnical engineer. 3'+ depth on both sides of crown. | | | | | |

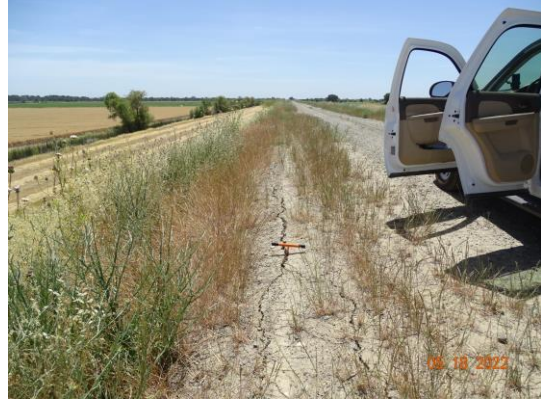
Photo 1 of 1 : SP_2022_RD0999_232_32_20220524_00087.jpg

Desiccation cracking on the shoulder. Spring 2022

| Have desiccation cracking inspected by geotechnical engineer. 3'+ depth on landside of crown. | | | | | |

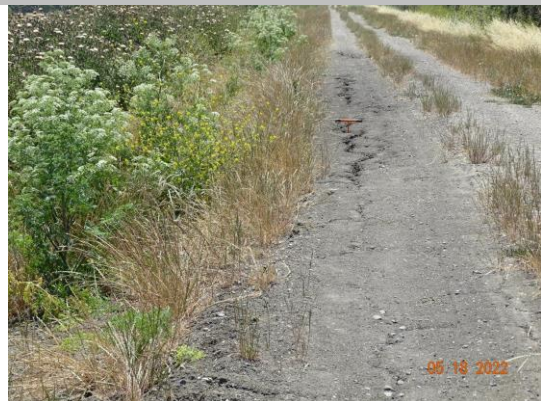
Photo 1 of 1 : SP_2022_RD0999_232_35_20220524_00088.jpg

Desiccation cracking on the shoulder. Spring 2022

| Have desiccation cracking inspected by geotechnical engineer. 3'+ depth on crown. | | | | | |

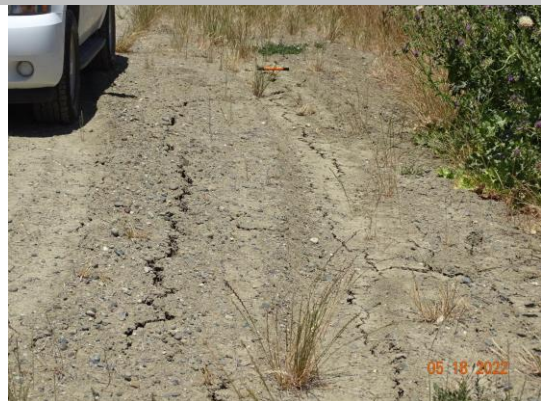
Photo 1 of 1 : SP_2022_RD0999_232_36_20220524_00089.jpg

Desiccation cracking on the shoulder. Spring 2022

| Have desiccation cracking inspected by geotechnical engineer. 3'+ depth on crown. | | | | | |

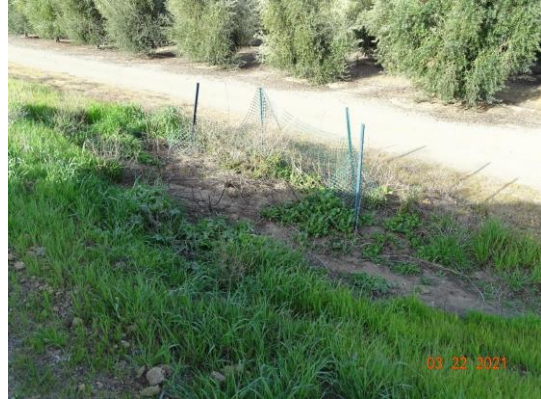
Photo 1 of 1 : SP_2022_RD0999_232_28_20220307_00008.jpg

View of the signs of rodent activity. Spring 2021.

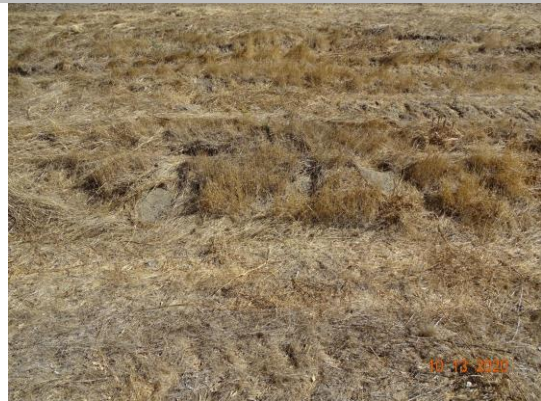
Photo 1 of 1 : SP_2022_RD0999_232_82_20220307_00037.jpg

View of animal holes at the waterside toe. Fall 2020

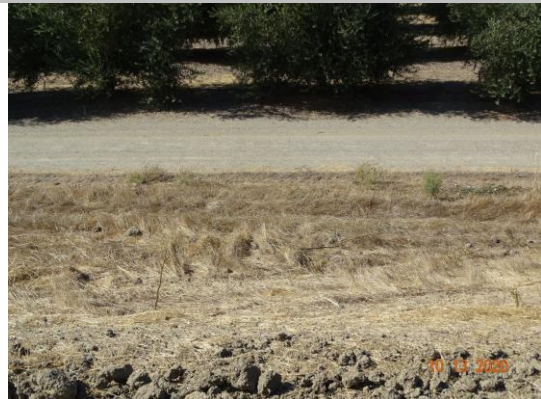
Photo 1 of 1 : SP_2022_RD0999_232_80_20220307_00036.jpg

View of animal holes at the waterside toe. Fall 2020

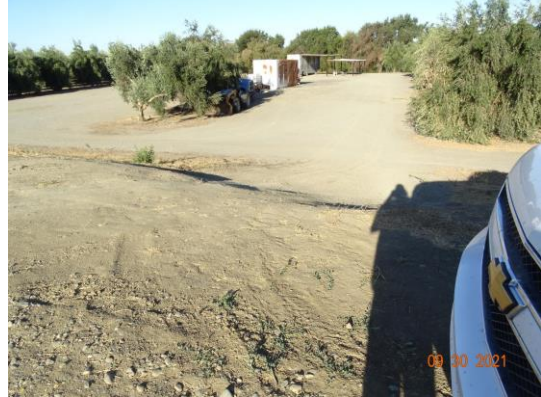
Photo 1 of 1 : SP_2022_RD0999_232_27_20220307_00007.jpg

WS slope damage from vehicle and equipment traffic. Fall 2021

| E6 : Repair the levee slope damaged by vehicle traffic and prevent access where possible. | | | | | |

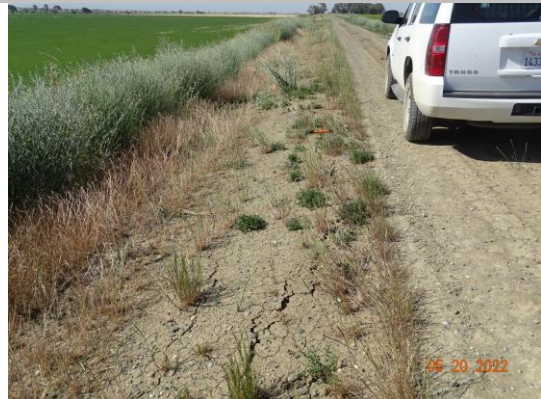
Photo 1 of 1 : SP_2022_RD0999_232_41_20220524_00090.jpg

Desiccation cracking on the shoulder. Spring 2022

| Have desiccation cracking inspected by geotechnical engineer. 3'+ depth on crown. | | | | | |

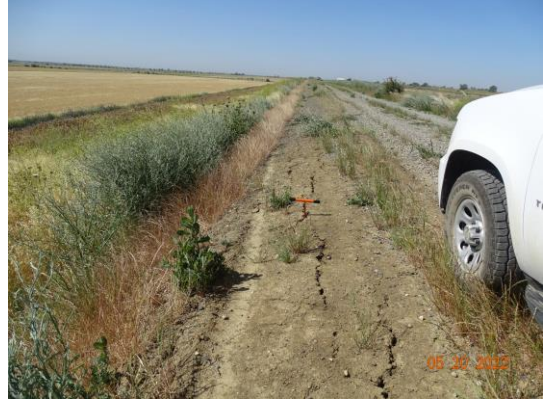
Photo 1 of 1 : SP_2022_RD0999_232_48_20220524_00091.jpg

Desiccation cracking on the shoulder. Spring 2022

| Have desiccation cracking inspected by geotechnical engineer. 3'+ depth on crown. | | | | | |

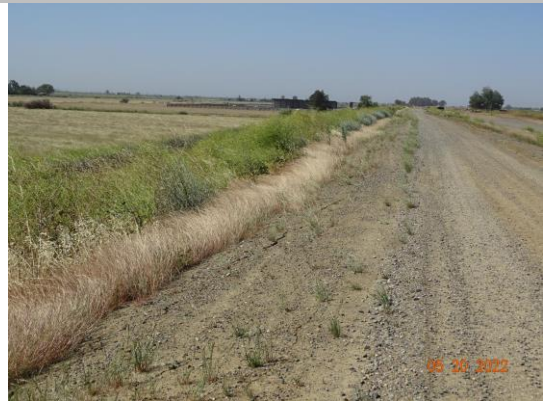
Photo 1 of 1 : SP_2022_RD0999_232_60_20220524_00092.jpg

Desiccation cracking on the shoulder. Spring 2022

| Have desiccation cracking inspected by geotechnical engineer. 3'+ depth on crown. | | | | | |

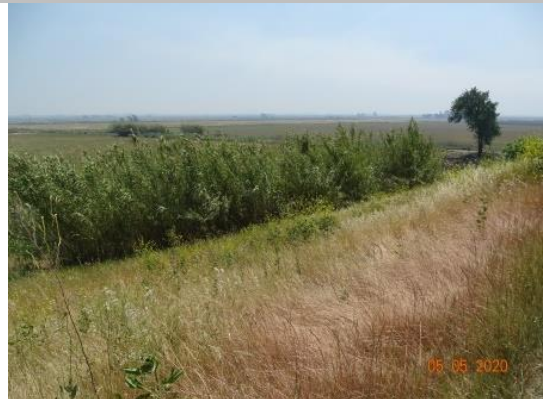
Photo 1 of 1 : SP_2022_RD0999_232_74_20220307_00034.jpg

View of Arundo growth at the landside toe. Spring 2020

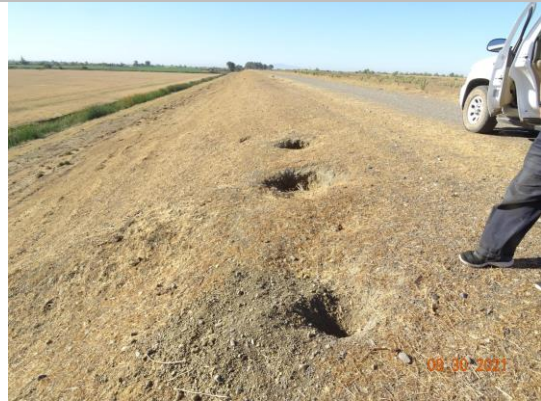
Photo 1 of 1 : SP_2022_RD0999_232_30_20220307_00010.jpg

Rodent burrows on LS slope. Fall 2021

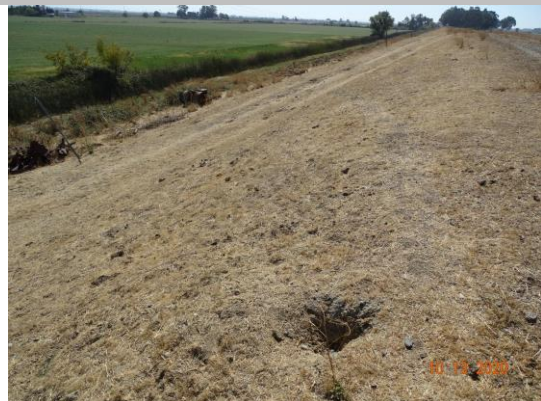
Photo 1 of 1 : SP_2022_RD0999_232_24_20220307_00005.jpg

View of large animal holes on the landside slope. Fall 2020

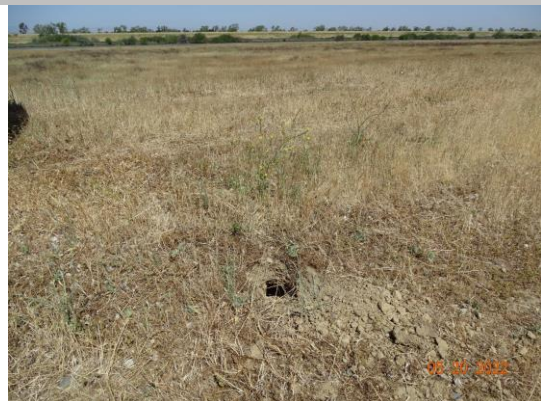
Photo 1 of 1 : SP_2022_RD0999_232_61_20220524_00094.jpg

Burrows near the crown on the landside. Spring 2022

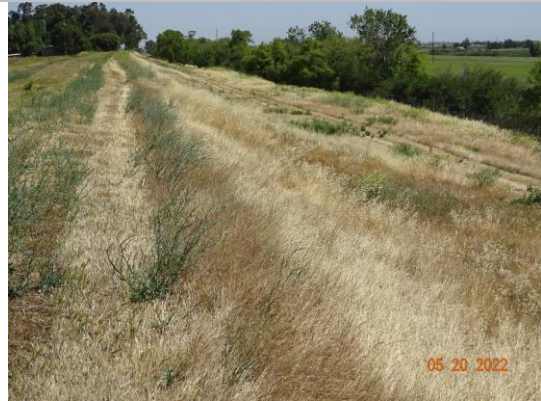
Photo 1 of 1 : SP_2022_RD0999_232_62_20220524_00097.jpg

Annual vegetation on the landside slope and toe. Spring 2022

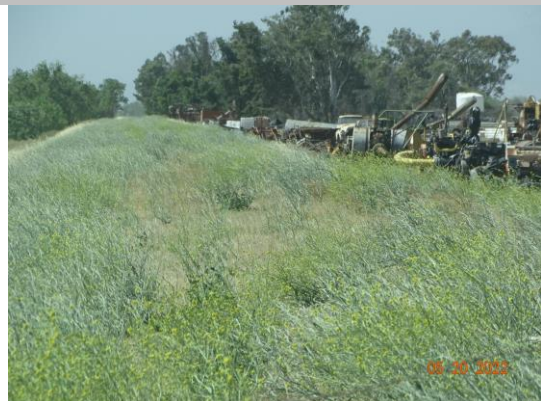
Photo 1 of 1 : SP_2022_RD0999_232_64_20220524_00098.jpg

Annual vegetation on the waterside slope. Spring 2022

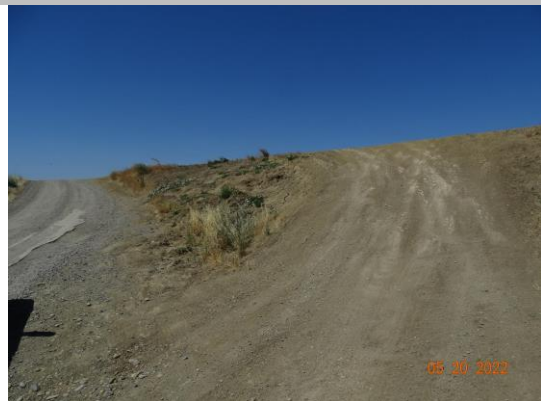
Photo 1 of 1 : SP_2022_RD0999_232_65_20220524_00099.jpg

Erosion from vehicle traffic between two ramps. Spring 2022

| E6 : Repair the levee slope damaged by vehicle traffic and prevent access where possible. | | | | | |
| Repair erosion from vehicle traffic between the ramps. | | | | | |

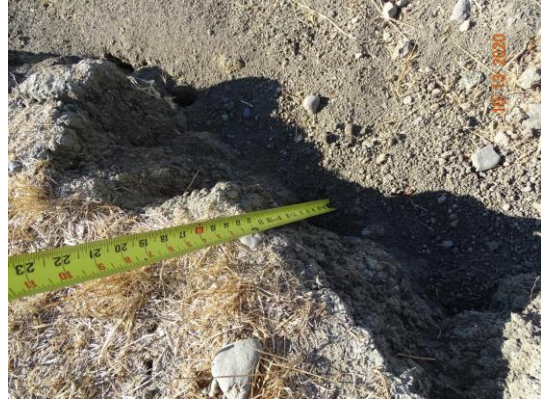
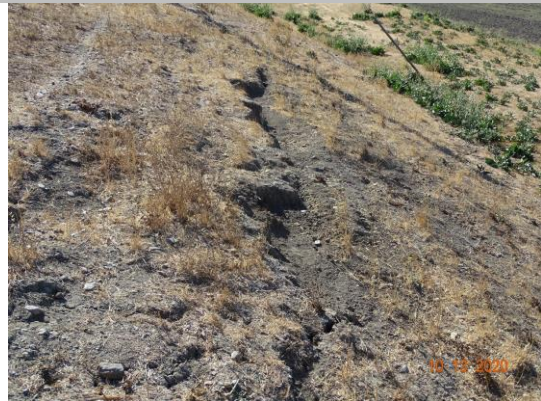
View of soil separation on the waterside slope. Fall 2020

| S1 : Repair slope instability. | | | | | |

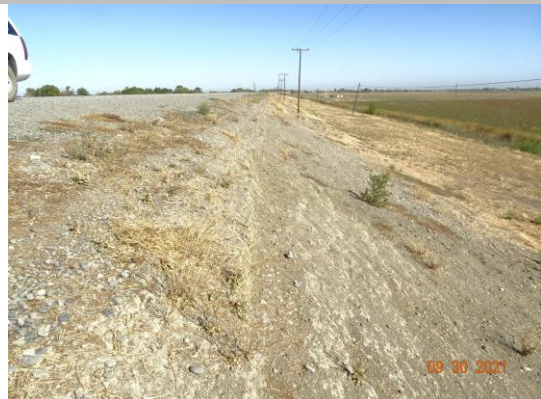
Photo 1 of 1 : SP_2022_RD0999_232_38_20220307_00015.jpg

LS slope sloughing. Fall 2021

| S1 : Repair slope instability. | | | | | |
| Repair slope sloughing, approximately 50' long 12" deep. | | | | | |

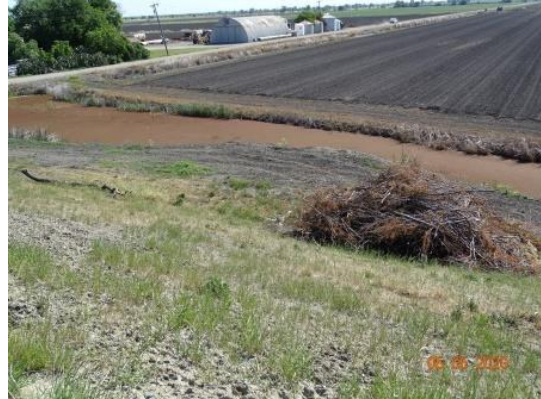
Photo 1 of 1 : SP_2022_RD0999_232_16_20220307_00002.jpg

View of prunings at the landside toe. Spring 2020

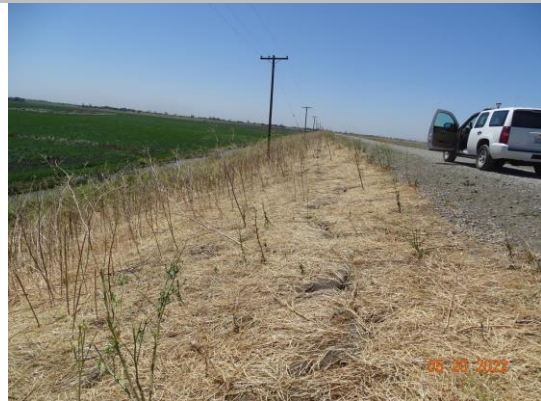
Photo 1 of 1 : SP_2022_RD0999_232_70_20220524_00102.jpg

| Large longitudinal and transverse cracks on both slopes. The landside cracking is worse. | | | | | |

Desiccation cracking on the shoulder. Spring 2022

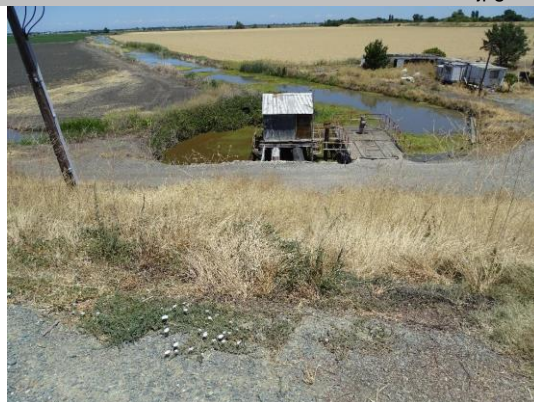
Photo 2 of 3 : UCIP_SP_2022_69886_88565.jpg

Land-Side: view of LS slope and pumphouse at toe.

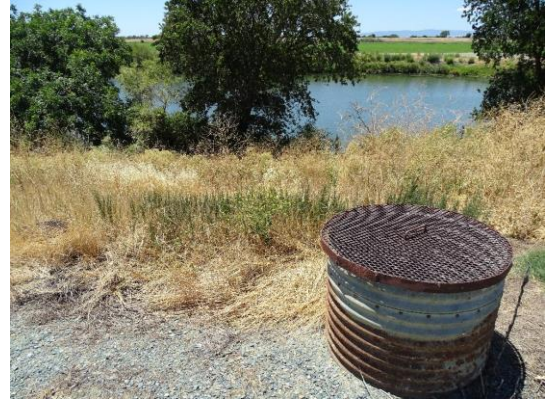
Photo 3 of 3 : UCIP_SP_2022_69886_88564.jpg

Water-Side: view of WS slope and pipe riser.

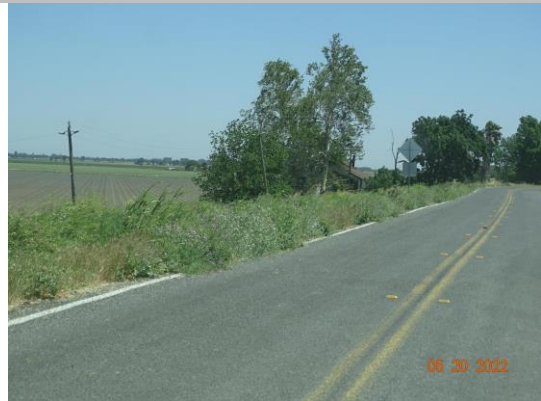
Photo 1 of 1 : SP_2022_RD0999_233_14_20220524_00033.jpg

Annual vegetation growth on the landside slope. Spring 2022

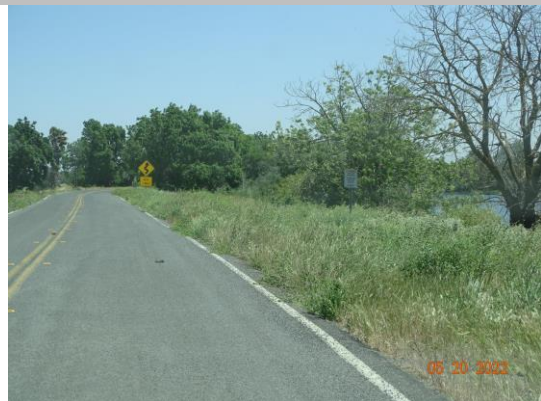
Photo 1 of 1 : SP_2022_RD0999_233_19_20220524_00034.jpg

Annual vegetation on the waterside slope. Spring 2022

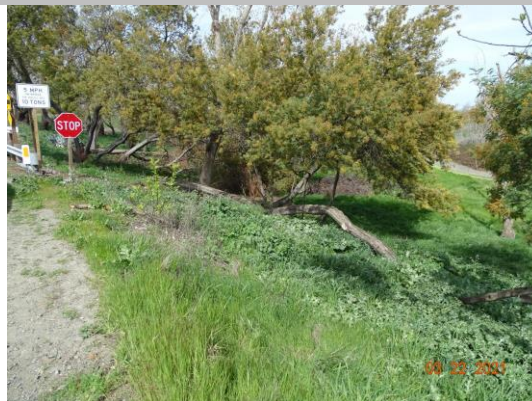
Photo 1 of 1 : SP_2022_RD0999_233_18_20220307_00008.jpg

View of the fallen trees on the LS levee slope. Spring 2021.

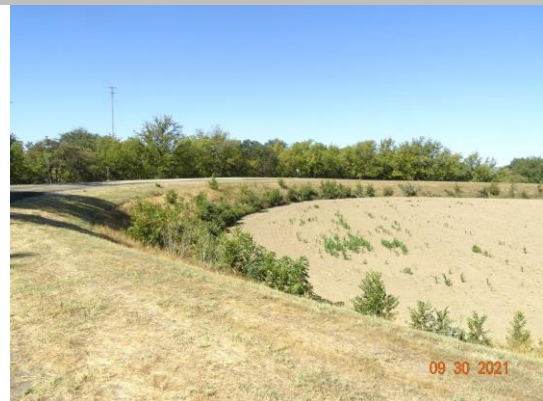
Photo 1 of 1 : SP_2022_RD0999_233_15_20220307_00006.jpg

Sapling growth on the LS slope/toe. Fall 2021

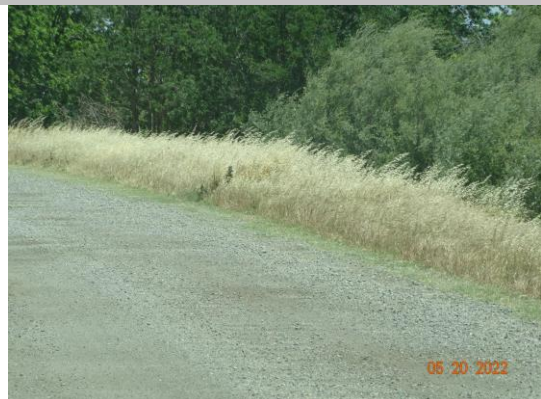
Photo 1 of 1 : SP_2022_RD0999_234_19_20220524_00037.jpg

Annual vegetation growth on the waterside slope. Spring 2022

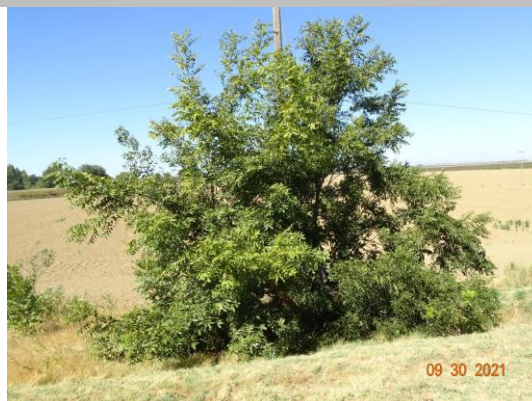
Photo 1 of 1 : SP_2022_RD0999_234_11_20220307_00008.jpg

Tree near pole/guy wire on the LS. Fall 2021

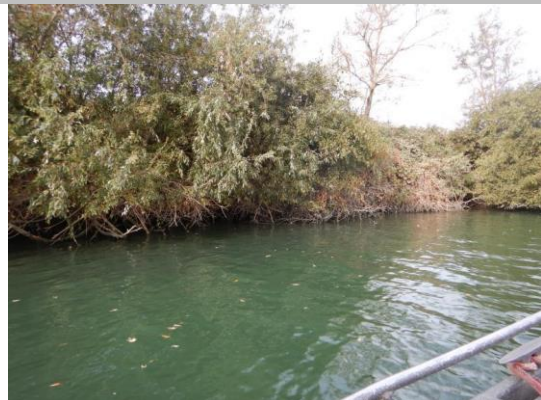
USACE 2018 Erosion Photo #2

| Site History: 1997 - Intermittent over-steepened sections. Large riparian vegetation along the length of the entire reach. Attempts to repair with rock on bank have failed. 1999 - New rock repair at the downstream end. 2002 - Some minor spot repairs. 2009 - Minimal new erosion. 2010 - Appears that fresh rock placed on downstream portion of site. Toe scour and overhanging trees with some overturned. 2012 - Minor new erosion at the toe. 2013 - Site upgraded to CRITICAL. Severe slumping into levee at downstream end of site. Fresh erosion into bank toe. 2015 - New slumping, tall vertical sections. 2016 - Upper slumped section continues to worsen. 2017 - Locals have placed rock in worst sections. Fresh erosion at toe. New tall vertical sections observed. | | | | | |

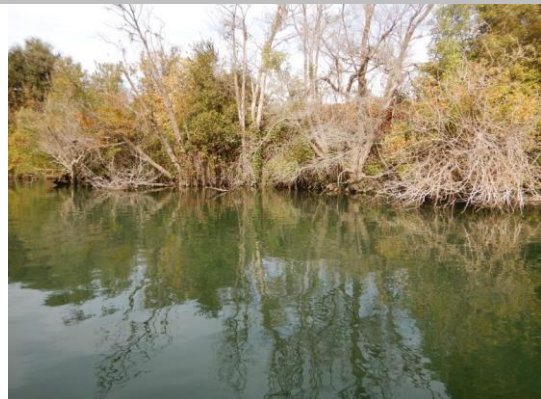
USACE 2018 Erosion Photo #2

2018 Site ID: STR 26.1 R
Status: Eroding
2018 Field Notes: No observed change.
Site History: 2015 - Tall vertical sections into the levee slope and erosion along the toe. 2016 - New tree pop-out observed.

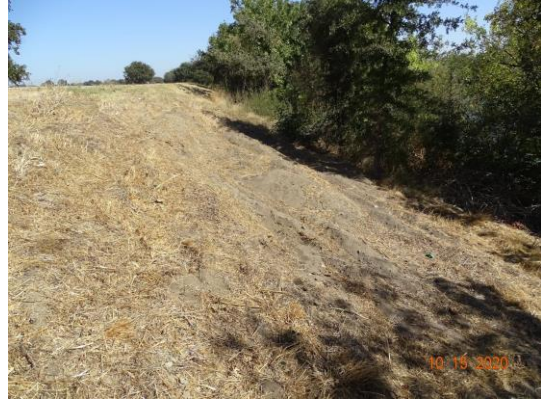
Photo 1 of 1 : SP_2022_RD0999_234_13_20220307_00011.jpg

View of slope damage on the waterside slope due to vehicle traffic. Fall 2020

| E6 : Repair the levee slope damaged by vehicle traffic and prevent access where possible. | | | | | |
| Repair slope depression due to vehicle traffic. | | | | | |

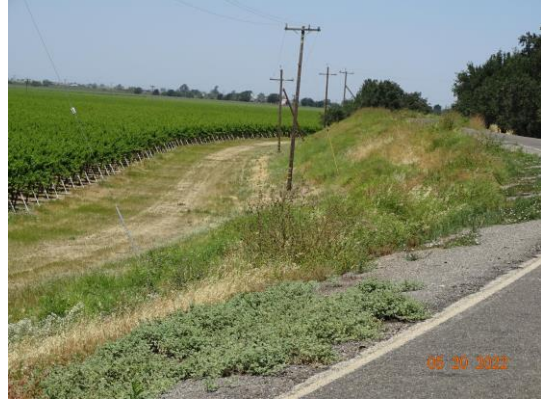
Photo 1 of 1 : SP_2022_RD0999_234_21_20220524_00041.jpg

Annual vegetation on the landside slope. Spring 2022

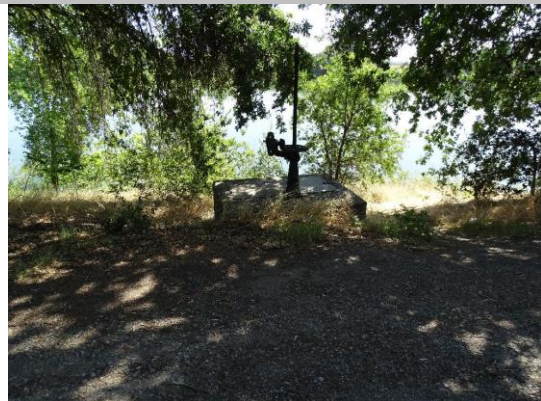
Photo 2 of 3 : UCIP_SP_2022_69326_88713.jpg

| FS_ID:69326 DS_ID:22788 EP_NO: N/A Repair Type: Non-Urgent Crossing Status: Found UCIP Comments: 07/01/2020 Record updated from No Action Needed to Non-Urgent. No permit has been identified authorizing pipe. (D.Sanoski - DWR UCIP) 10/27/2017 This structure is inspected annually under the Structure and Channel Summer Inspection (part of the Levee Inspection Program) conducted by the DWR Flood Project Integrity and Inspection Branch (FPIIB). (DWR UCIP - O. Magana) FIELD_STRUCT_DESC: [Elk Slough Inlet Structure] 60-inch by 60-inch reinforced concrete drainage culvert through the levee, 30 feet below the crown. Slide gate in a 6-foot by 8-foot concrete vault on the waterside (WS) shoulder. [Additional Reference(s): DWR Levee Log, 1992 (HLM 0.00). USACE Sacramento O&M Manual, Unit 113, October 1966, Revised 29 December 2016, (0.00), listed as 5-foot by 5-foot culvert.] FS Date: 7/1/2020 10:09:00 AM | | | | | | |

Water-Side: view of WS slope and concrete vault.

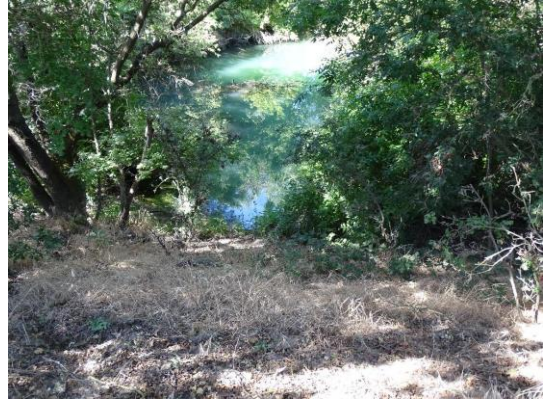
Photo 3 of 3 : UCIP_SP_2022_69326_88714.jpg

Land-Side: view of LS slope and channel at toe.

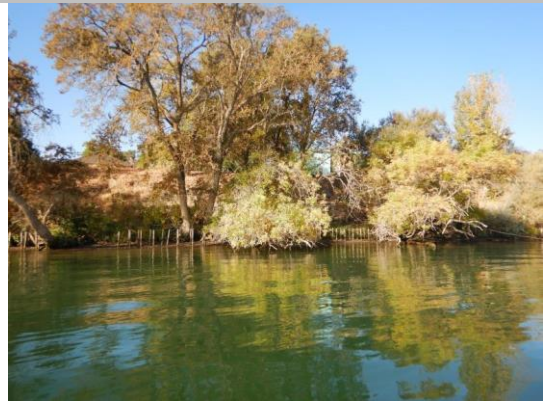
USACE 2018 Erosion Photo #1

2018 Site ID: SAC 41.9 R
 Status: Critical
 2018 Field Notes: Site continues to look worse.
 Site History: 1997 - Structural problem rather than erosional, failed cobble at downstream end. 2005 - New brush boxes at waterline for several hundred feet downstream, No toe or bank protection present. 2006 - Some minor new erosion. Brush boxes not working well; most of the brush has floated out. 2007 - Brush boxes have recently been repaired. 2016 - Minor new slumping. 2017 - Fresh erosion on entire bank. Upgraded to CRITICAL.

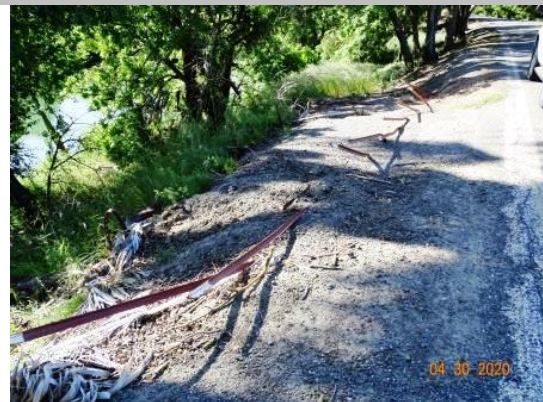
Photo 1 of 1 : SP_2022_RD0999_236_165_20220307_00054.jpg

View of minor cracks near a ramp. Spring 2020

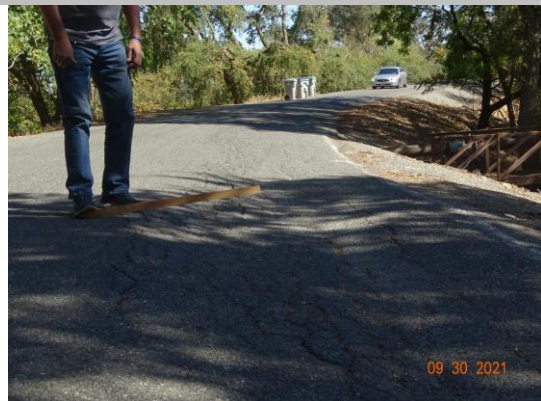
Photo 1 of 2 : SP_2022_RD0999_236_55_20220307_00015.jpg

Depth of sloughing on WS crown. Fall 2021

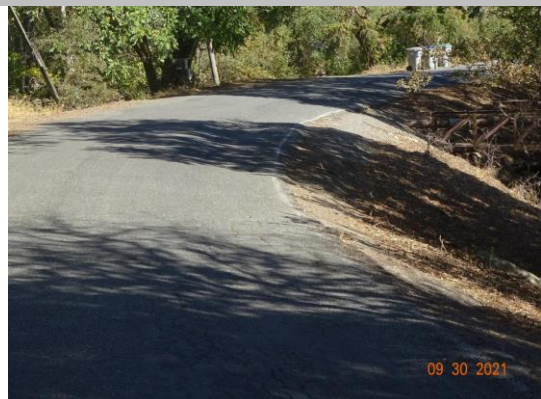
Photo 2 of 2 : SP_2022_RD0999_236_55_20220307_00016.jpg

Length of sloughing on WS crown. Fall 2021

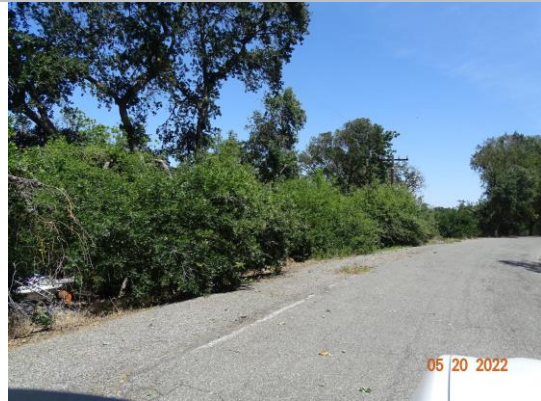
Photo 1 of 1 : SP_2022_RD0999_236_15_20220524_00206.jpg

Trees on the landside slope. Spring 2022

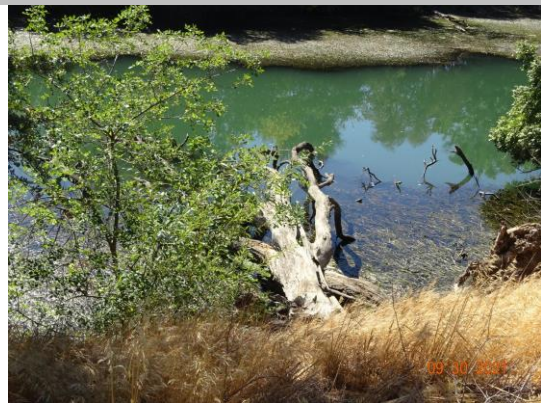
Photo 1 of 1 : SP_2022_RD0999_236_273_20220307_00088.jpg

Fallen tree in channel. Fall 2021

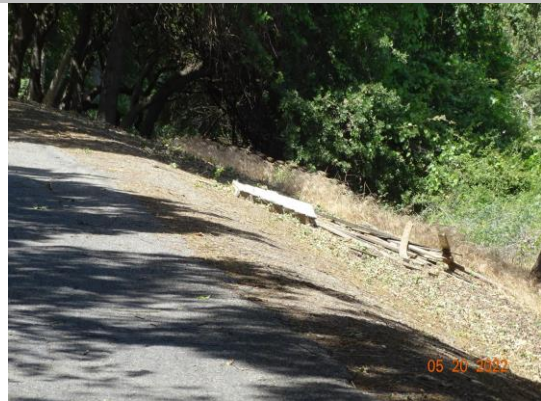
Photo 1 of 1 : SP_2022_RD0999_236_53_20220524_00215.jpg

Debris on the waterside shoulder. Spring 2022

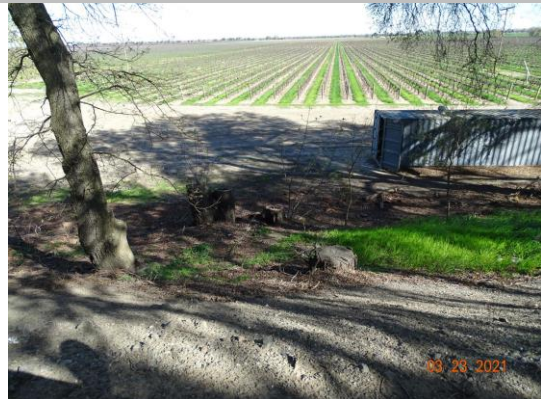
Photo 1 of 1 : SP_2022_RD0999_236_79_20220307_00020.jpg

View of the tree stumps on the LS levee slope. Spring 2021.

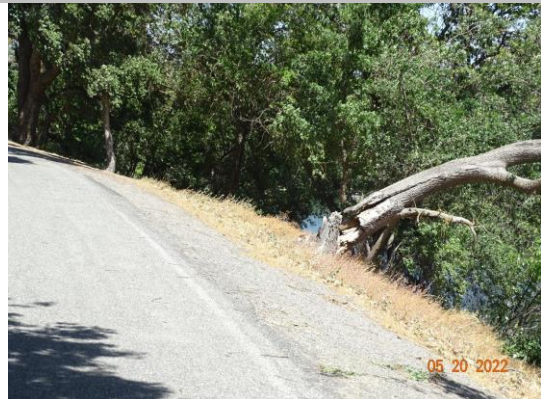
Photo 1 of 1 : SP_2022_RD0999_236_218_20220524_00220.jpg

Fallen tree on the waterside slope. Spring 2022

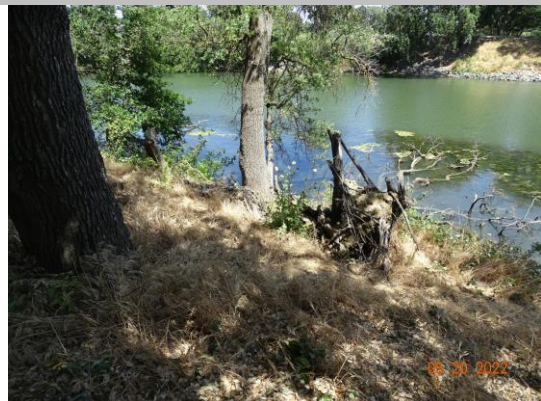
Photo 1 of 1 : SP_2022_RD0999_236_264_20220524_00221.jpg

Void from rootball on the waterside slope. Spring 2022

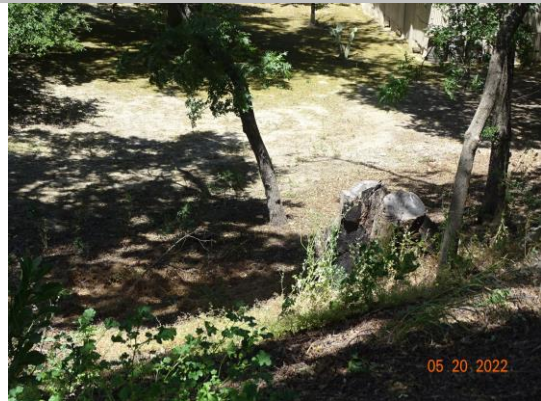
Photo 1 of 1 : SP_2022_RD0999_236_95_20220524_00223.jpg

Tree stump at the landside toe. Spring 2022

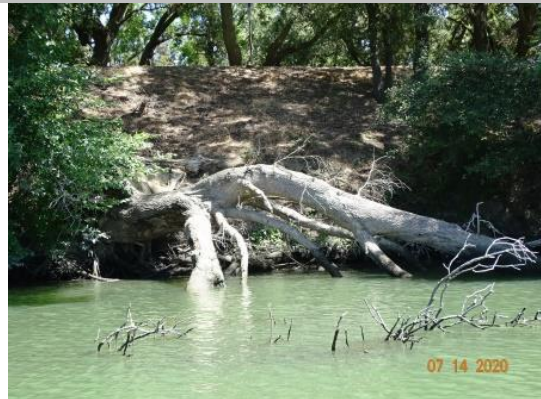
Photo 1 of 1 : SP_2022_RD0999_236_260_20220307_00086.jpg

View of slope erosion around fallen tree from the waterside. Summer 2020

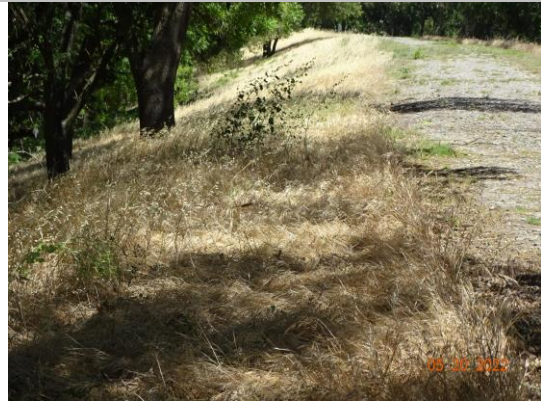
Photo 1 of 1 : SP_2022_RD0999_236_60_20220524_00225.jpg

Annual vegetation on the landside slope. Spring 2022

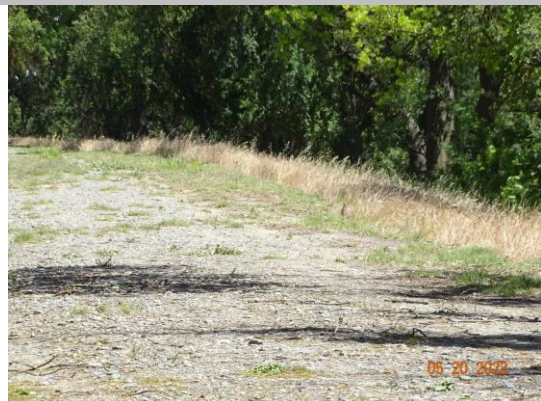
Photo 1 of 1 : SP_2022_RD0999_236_65_20220524_00226.jpg

Annual vegetation growth on the waterside slope. Spring 2022

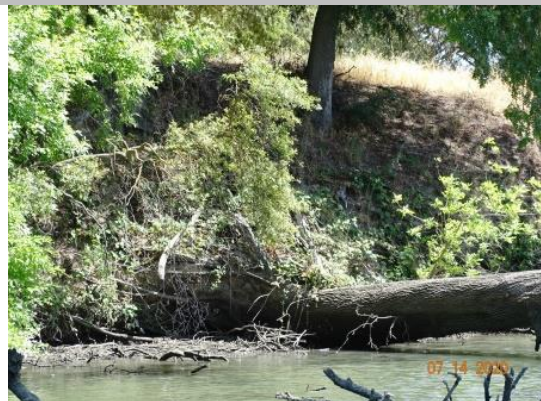
Photo 1 of 1 : SP_2022_RD0999_236_83_20220307_00023.jpg

View of a fallen tree with exposed rootball. Summer 2020

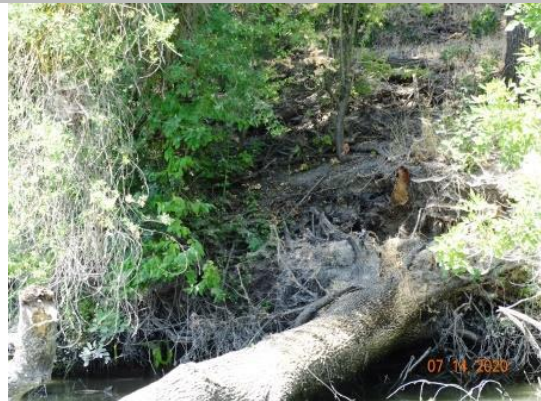
Photo 2 of 2 : SP_2022_RD0999_236_82_20220307_00022.jpg

View of scarp around fallen tree. Summer 2020

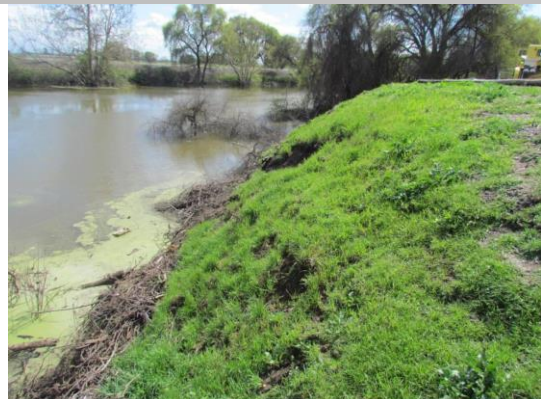
Photo 1 of 1 : SP_2022_RD0999_236_12_20220307_00004.jpg

Looking downstream at finger erosion on downstream side of slough.

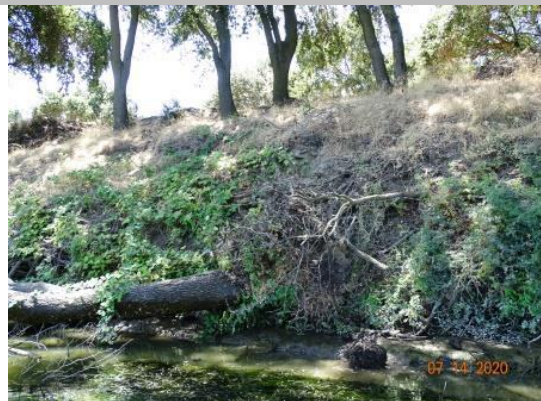
Photo 1 of 1 : SP_2022_RD0999_236_97_20220307_00028.jpg

View of fallen trees and scarp. Summer 2020

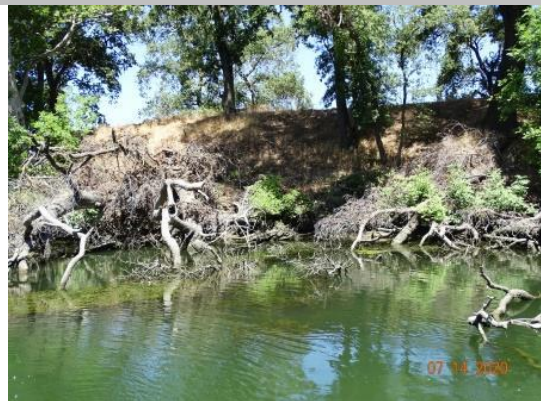
Photo 1 of 2 : SP_2022_RD0999_236_229_20220307_00082.jpg

View of two fallen trees. Summer 2020

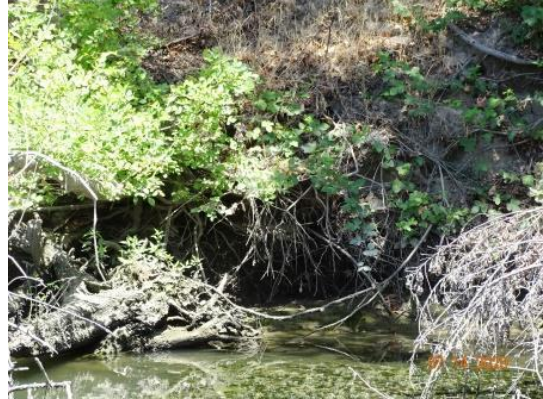
Photo 2 of 2 : SP_2022_RD0999_236_229_20220307_00083.jpg

View of large scarp near two fallen trees. Summer 2020

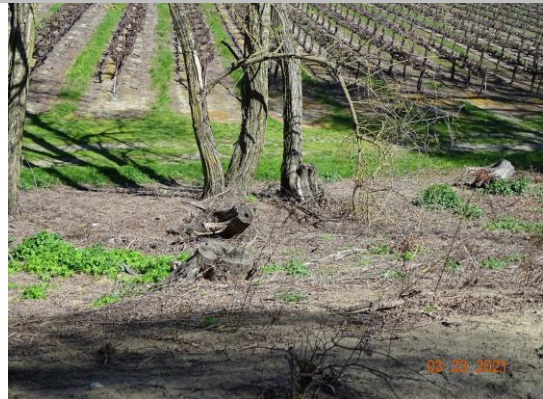
Photo 1 of 1 : SP_2022_RD0999_236_129_20220307_00040.jpg

View of the tree stumps on the LS levee slope and toe. Spring 2021.

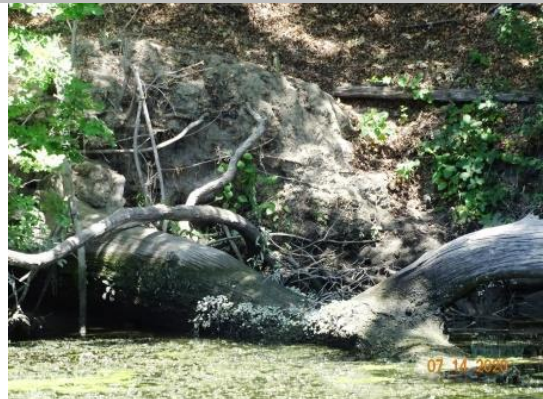
Photo 1 of 1 : SP_2022_RD0999_236_99_20220307_00029.jpg

View of slope damage near fallen tree. Summer 2020

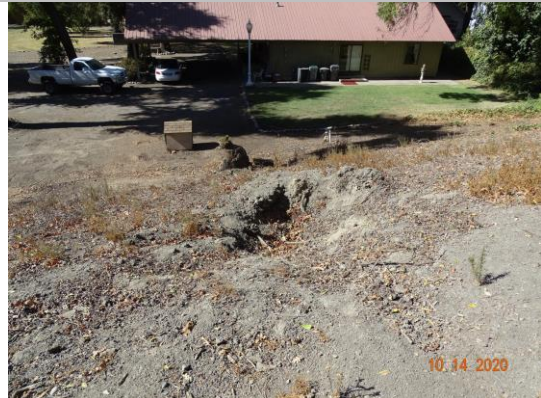
Photo 1 of 1 : SP_2022_RD0999_236_214_20220307_00073.jpg

View of a large hole on the landside slope. Fall 2020

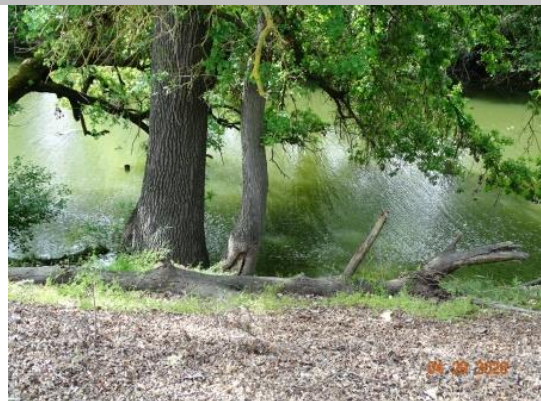
Photo 1 of 1 : SP_2022_RD0999_236_186_20220307_00065.jpg

View of a tree log on the waterside slope. Spring 2020

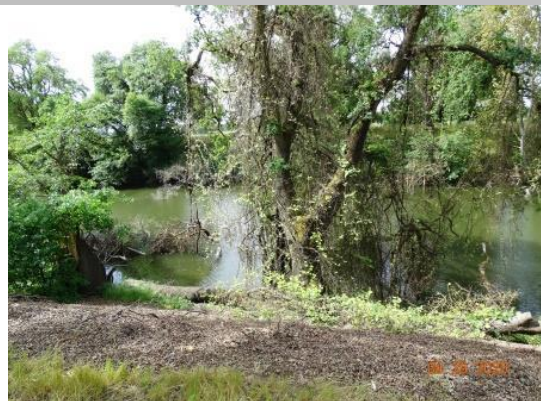
Photo 1 of 1 : SP_2022_RD0999_236_181_20220307_00064.jpg

View of fallen tree on the waterside slope. Spring 2020

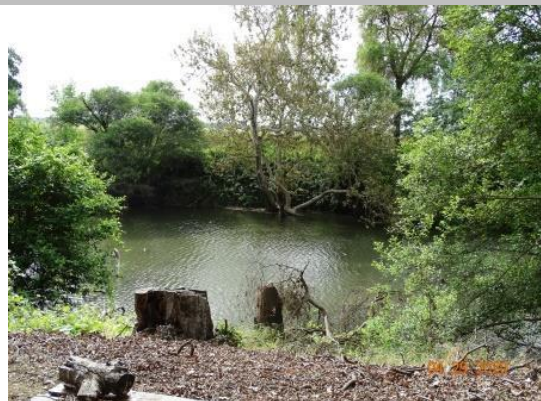
Photo 1 of 1 : SP_2022_RD0999_236_164_20220307_00053.jpg

View of a large tree stump on the waterside slope. Spring 2020
