**Flood Control Project Maintenance  
Levee Inspections**

**Maintenance Issue Types Only, Levee Inspection Report By Mile - Spring 2023**

**Reclamation District No. 0999 Netherlands**

Waterway	Bank	Unit Miles	Inspection Start/End	Inspector
Unit No. 01 Yolo Bypass	Left	15.41	04/25/2023 04/25/2023	Marvin Marshall

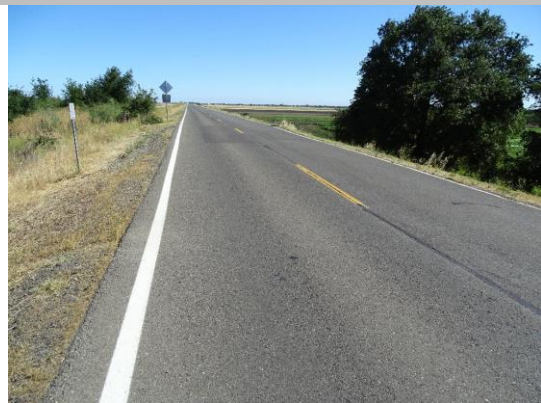
Photo 1 of 3 : UCIP\_SP\_2023\_73776\_88522.jpg

Comment Code						
Inspector Comment						
DS_ID:22743 FS_ID:73776 EP_NO: N/A Repair Type: Urgent EVAL Issue: 1, Pipe Integrity Crossing Status: Found UCIP Comments: 06/16/2020 Record remains Non-Urgent. Crossing appears abandoned. Recommend owner to contact CVFPB to abandon or remove pipe from levee. System Feature. (D.Sanoski - DWR UCIP) 07/26/2018 Same as last inspection. Pipe open on WS, but no visual signs of pipe or levee integrity issues so downgrading crossing to Non-Urgent (D. Sanoski - DWR UCIP).07/07/2016 Condition largely unchanged from previous inspection. Pipe open on the WS, waterward of the siphon breaker. Dense vegetation and steep slope limited inspection of WS outlet into Ship Channel. (T. Hatch/UCIP)06/25/2013 Pipe abandoned and open on WS slope. Pipe should be abandoned properly. (W. Wylie/UCIP) FIELD_STRUCT_DESC: 30-inch steel drainage pipe through the levee, 6.5 feet below the crown. Pump on a platform in the canal off the landside (LS) toe. Flap gate on the waterside (WS). Siphon breaker and an air vent on the WS shoulder. 1-inch galvanized iron filler pipe visible on the WS shoulder along same alignment. [Additional Reference(s): DWR Levee Log, 1992 (HLM 1.73). USACE Sacramento O&M Manual, Unit 113, October 1966, Revised 29 December 2016, (1.73), listed as 30-inch pipe]. FS Date: 6/16/2020 2:16:00 PM

Top of Levee: view of crown.

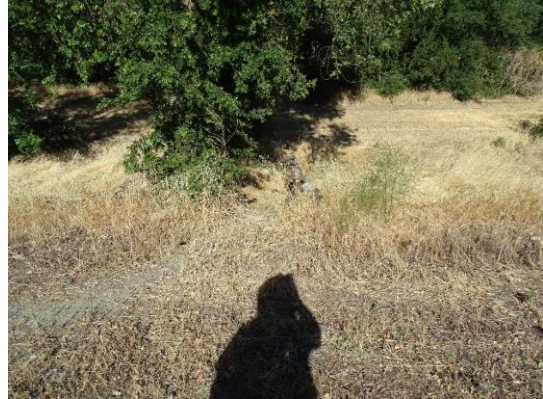
Photo 2 of 3 : UCIP\_SP\_2023\_73776\_88523.jpg

Water-Side: view of WS slope and broken crossing at toe.

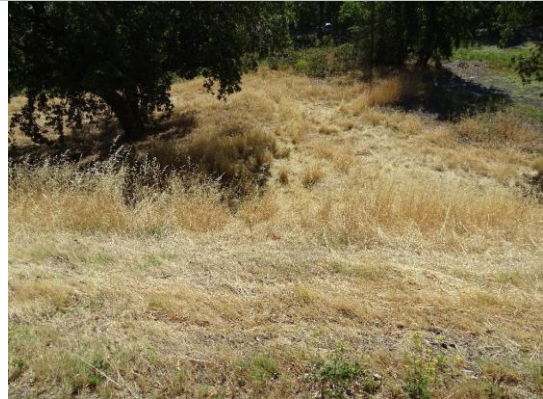
Photo 3 of 3 : UCIP\_SP\_2023\_73776\_88524.jpg

Land-Side: view of LS slope and pump platform off in distance.

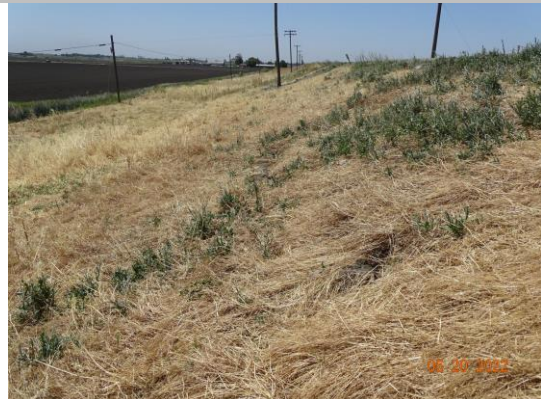
Photo 1 of 1 : SP\_2023\_RD0999\_232\_69\_20230306\_00025.jpg

LM Start	13.27	Rating **	U	Issue No.	69
LM End	13.27	Issue Type +	Ma	Location *	LS
Category	Earthen Levee			GPS Latitude/Longitude	
				Start	End
Item	Slope Stability			38.321562°	38.321562°
				-121.644943°	-121.644943°
DWR ID	DWR_RD0999_01_s_2022_69				
Comment Code					
S1 : Repair slope instability.					
Inspector Comment					
Large crack midway up landside slope with sloughing.

Desiccation cracking and sloughing on the landside slope. Spring 2022

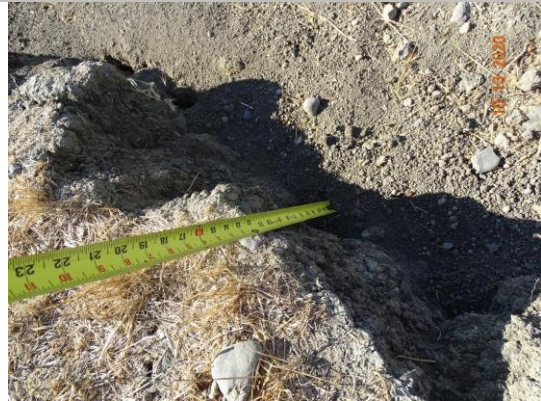
Photo 1 of 2 : SP\_2023\_RD0999\_232\_47\_20230306\_00019.jpg

LM Start	13.29	Rating **	U	Issue No.	47
LM End	13.30	Issue Type +	Ma	Location *	WS
Category	Earthen Levee			GPS Latitude/Longitude	
				Start	End
Item	Slope Stability			38.321180°	38.321043°
				-121.644962°	-121.644960°
DWR ID	DWR_RD0999_01_f_2020_47				
Comment Code					
S1 : Repair slope instability.					
Inspector Comment					
A separation of soil up to 12" deep and 40' long exists on the waterside slope.

View of soil separation on the waterside slope. Fall 2020

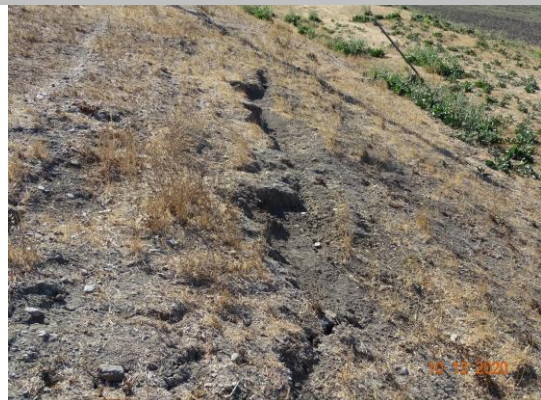
Photo 2 of 2 : SP\_2023\_RD0999\_232\_47\_20230306\_00020.jpg

View of soil separation on the waterside slope. Fall 2020

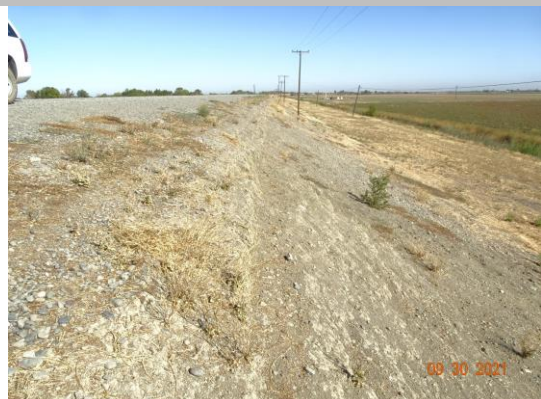
Photo 1 of 1 : SP\_2023\_RD0999\_232\_38\_20230306\_00013.jpg

LM Start	13.47	Rating **	U	Issue No.	38
LM End	13.47	Issue Type +	Ma	Location *	LS
Category	Earthen Levee			GPS Latitude/Longitude	
				Start	End
Item	Slope Stability			38.318667°	38.318667°
				-121.644948°	-121.644948°
DWR ID	DWR_RD0999_01_f_2021_38				
Comment Code					
S1 : Repair slope instability.					
Inspector Comment					
Repair slope sloughing, approximately 50' long 12" deep.

LS slope sloughing. Fall 2021

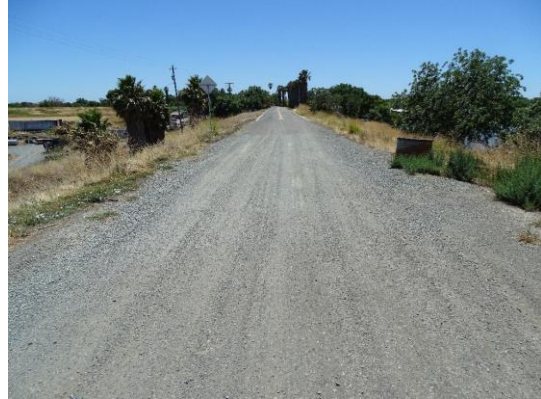
Photo 1 of 3 : UCIP\_SP\_2023\_73775\_88563.jpg

Comment Code						
Inspector Comment						
DS_ID:22756						
FS_ID:73775						
EP_NO: N/A						
Repair Type: No Action Needed						
EVAL Issue:						
Crossing Status: Found						
UCIP Comments: 06/16/2020 Record remains No Action Needed. No issues observed during inspection. System Feature. (D.Sanoski - DWR UCIP)						
FIELD_STRUCT_DESC: 30-inch steel drainage pipe through the levee, 7 feet below the crown. Flap gate on the waterside (WS) end. Pump in pump house on the landside (LS) toe. Siphon breaker in a corrugated metal pipe (CMP) riser on the WS shoulder. [Additional Reference(s): DWR Levee Log, 1992 (HLM 15.25). USACE Sacramento O&M Manual, Unit 113, October 1966, Revised 29 December 2016, (15.25), listed as 36-inch pipe].						
FS Date: 6/16/2020 2:26:00 PM

Top of Levee: view of crown with riser to this pipe on WS shoulder.

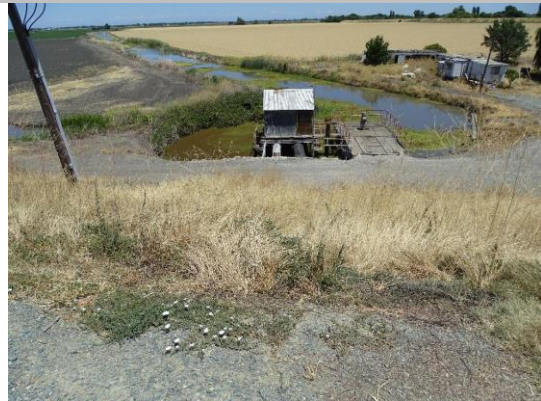
Photo 2 of 3 : UCIP\_SP\_2023\_73775\_88565.jpg

Land-Side: view of LS slope and pumphouse at toe.

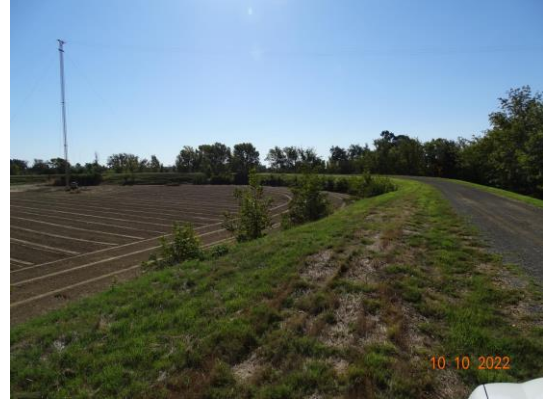
Photo 1 of 1 : SP\_2023\_RD0999\_233\_15\_20230306\_00004.jpg

Saplings and small trees are on the LS slope and toe. Fall 2022

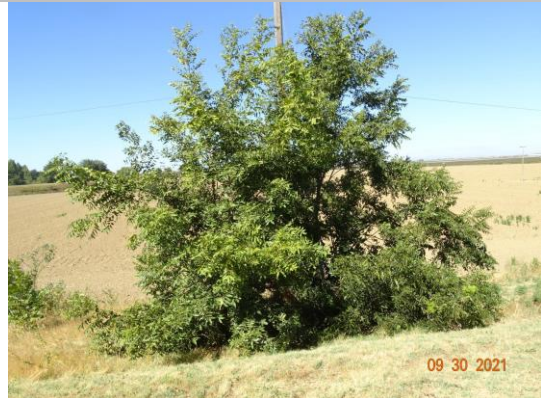
Photo 1 of 1 : SP\_2023\_RD0999\_234\_11\_20230306\_00008.jpg

Tree near pole/guy wire on the LS. Fall 2021

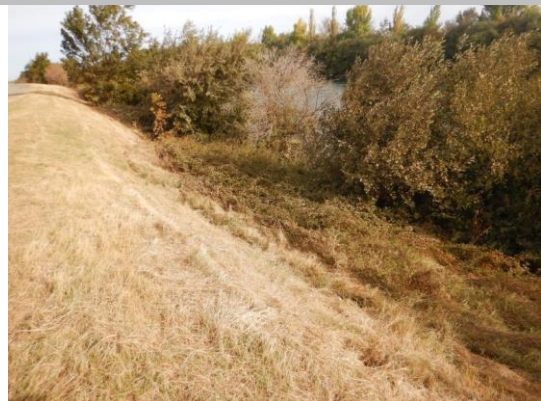
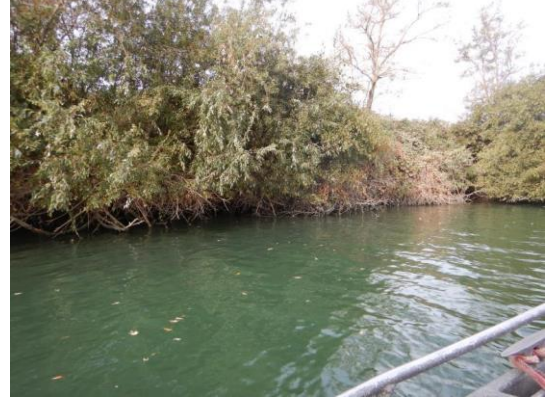
LM Start	0.24	Rating **	U	Issue No.	5
LM End	0.65	Issue Type +	Ma	Location *	WS
Category	Supplemental			GPS Latitude/Longitude	
				Start	End
Item	2018 USACE Erosion Survey			38.289634°	38.295505°
				-121.604343°	-121.605648°
DWR ID	DWR_RD0999_03_s_2022_5

Comment Code					
Inspector Comment					
2018 Site ID: STR 24.7 R					
Status: Critical					
2022 Field Notes: No observed changes.					
Site History: 1997 - Intermittent over-steepened sections. Large riparian vegetation along the length of the entire reach. Attempts to repair with rock on bank have failed. 1999 - New rock repair at the downstream end. 2002 - Some minor spot repairs. 2009 - Minimal new erosion. 2010 - Appears that fresh rock placed on downstream portion of site. Toe scour and overhanging trees with some overturned. 2012 - Minor new erosion at the toe. 2013 - Site upgraded to CRITICAL. Severe slumping into levee at downstream end of site. Fresh erosion into bank toe. 2015 - New slumping, tall vertical sections. 2016 - Upper slumped section continues to worsen. 2017 - Locals have placed rock in worst sections. Fresh erosion at toe. New tall vertical sections observed. 2018 -Length reduced on downstream side to account for repaired section.

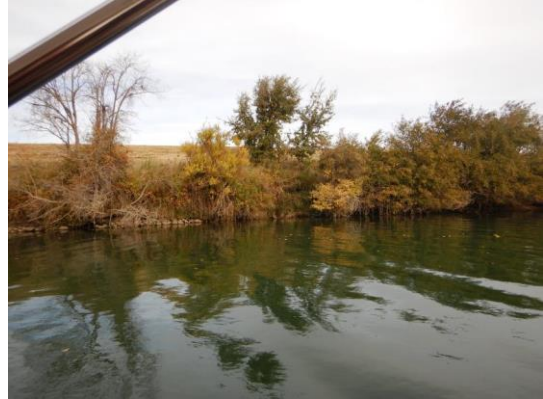
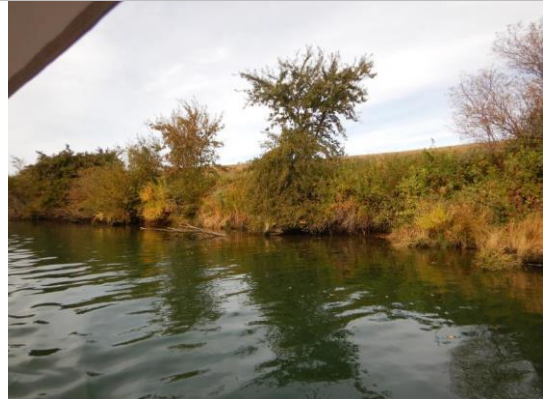
LM Start	0.97	Rating **	M	Issue No.	6
LM End	1.10	Issue Type +	Ma	Location *	WS
Category	Supplemental			GPS Latitude/Longitude	
				Start	End
Item	2018 USACE Erosion Survey			38.299402°	38.300542°
				-121.603056°	-121.601118°
DWR ID	DWR_RD0999_03_s_2022_6				
Comment Code					
Inspector Comment					
2018 Site ID: STR 25.2 R					
Status: Eroding					
2022 Field Notes: No observed changes.					
Site History: 2008 - Over steepened levee section. 2009 - Significant new erosion. 2010 - Minor new erosion. 2017 - Minor new erosion at toe. 2018 - New large slump on upper levee slope.

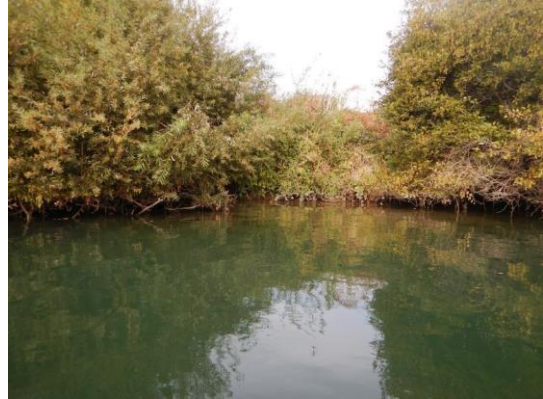
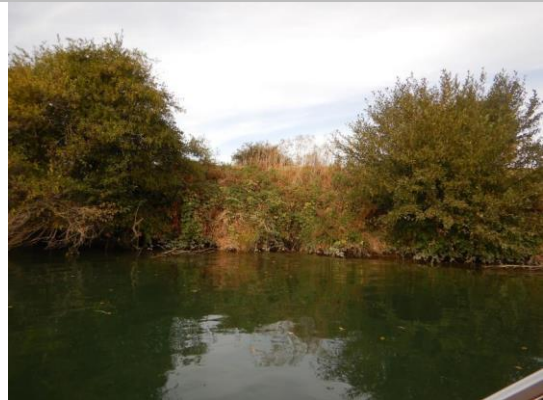
LM Start	1.43	Rating **	A/W	Issue No.	10
LM End	1.57	Issue Type +	Ma	Location *	WS
Category	Supplemental			GPS Latitude/Longitude	
				Start	End
Item	2018 USACE Erosion Survey			38.305229°	38.306667°
				-121.599933°	-121.598266°
DWR ID	DWR_RD0999_03_s_2022_10				
Comment Code					
Inspector Comment					
2018 Site ID: STR 25.7 R					
Status: Eroding					
2022 Field Notes: No observed changes.					
Site History: 2011 - Toe scour along length of site and erosion pockets.					
2012 - Site extended slightly upstream due to new erosion pocket.					
2013 - Tall vertical sections at upstream end of site. 2017 - Large erosion scarp near downstream end. 2018 - Site extended upstream.

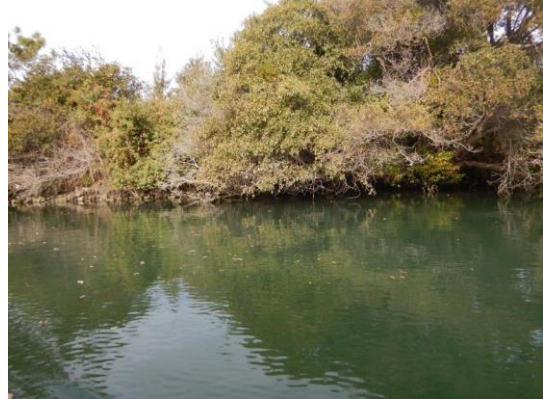
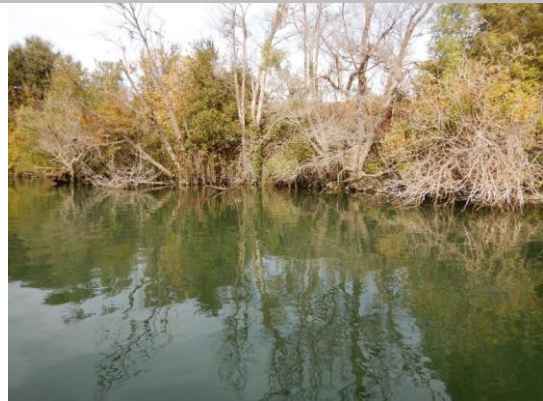
LM Start	1.93	Rating **	M	Issue No.	12
LM End	1.97	Issue Type +	Ma	Location *	WS
Category	Supplemental			GPS Latitude/Longitude	
				Start	End
Item	2018 USACE Erosion Survey			38.311013°	38.311342°
				-121.597751°	-121.596976°
DWR ID	DWR_RD0999_03_s_2022_12				
Comment Code					
Inspector Comment					
2018 Site ID: STR 26.1 R					
Status: Eroding					
2022 Field Notes: No observed change.					
Site History: 2015 - Tall vertical sections into the levee slope and erosion along the toe. 2016 - New tree pop-out observed. 2018 - No observed change.

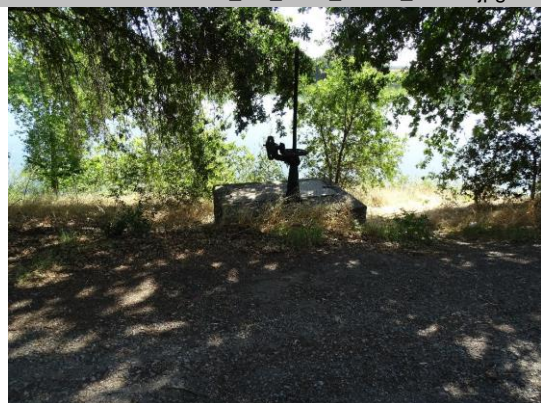
Photo 2 of 3 : UCIP\_SP\_2023\_73928\_88713.jpg

Water-Side: view of WS slope and concrete vault.

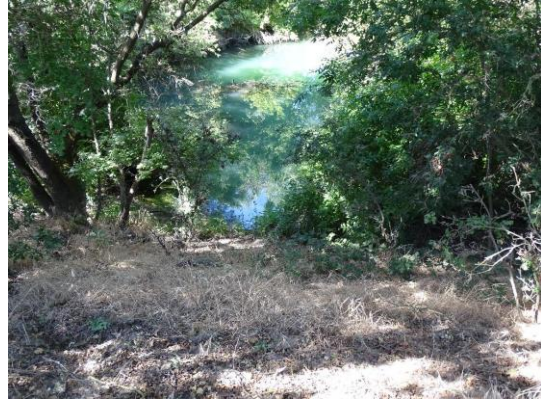
Photo 3 of 3 : UCIP\_SP\_2023\_73928\_88714.jpg

Land-Side: view of LS slope and channel at toe.

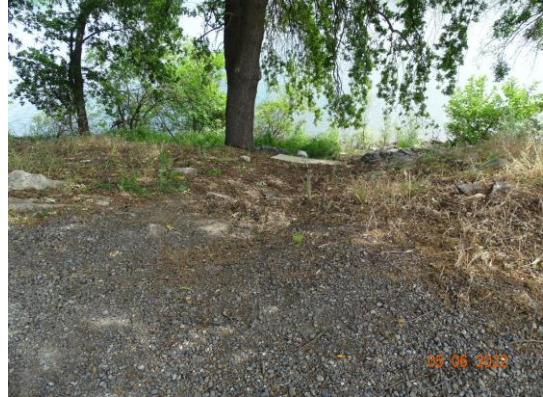
Photo 1 of 1 : SP\_2023\_RD0999\_235\_39\_20230306\_00012.jpg

Footpath on the waterside slope. Spring 2022

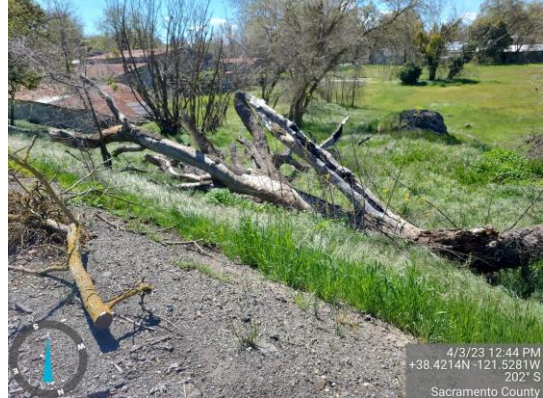
Photo 1 of 1 : SP\_2023\_RD0999\_235\_35\_20230404\_00039.jpg

Fallen tree on the LS slope. Spring 2023

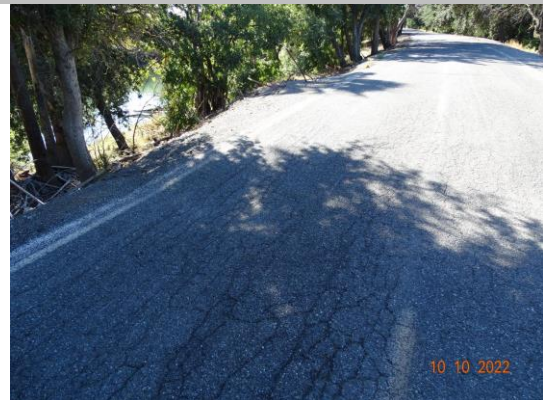
Photo 1 of 1 : SP\_2023\_RD0999\_236\_165\_20230306\_00068.jpg

View of minor cracks near a ramp. Fall 2022

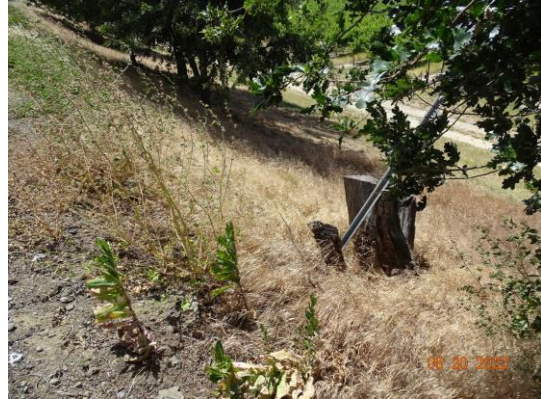
Photo 1 of 1 : SP\_2023\_RD0999\_236\_75\_20230306\_00029.jpg

Stumps on the landside slope. Spring 2022

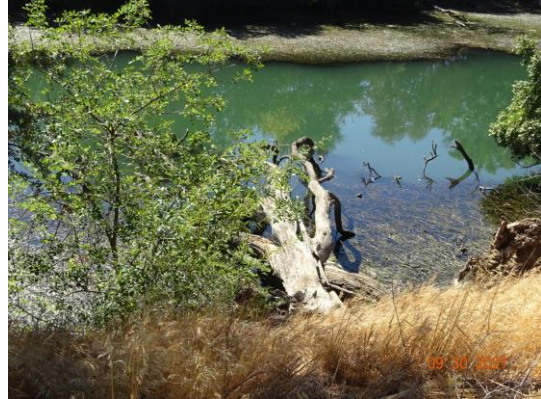
Photo 1 of 1 : SP\_2023\_RD0999\_236\_273\_20230306\_00099.jpg

Fallen tree in channel. Fall 2021

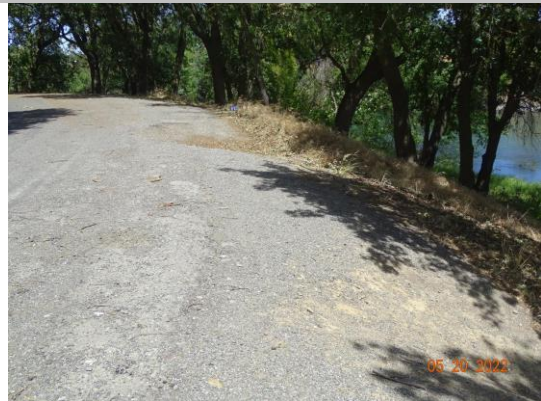
Photo 1 of 1 : SP\_2023\_RD0999\_236\_61\_20230306\_00023.jpg

Footpaths on the waterside slope. Spring 2022

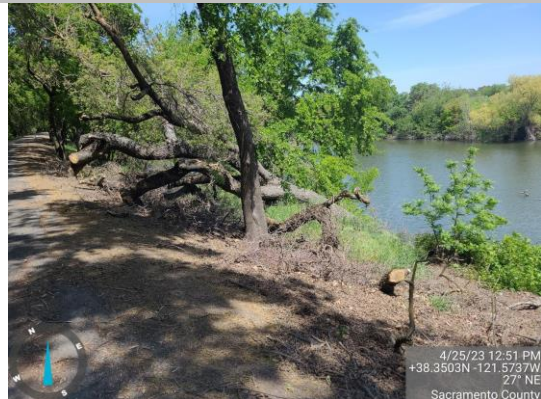
Photo 1 of 1 : SP\_2023\_RD0999\_236\_8\_20230426\_00116.jpg

Tree with rootball on the WS slope. Spring 2023

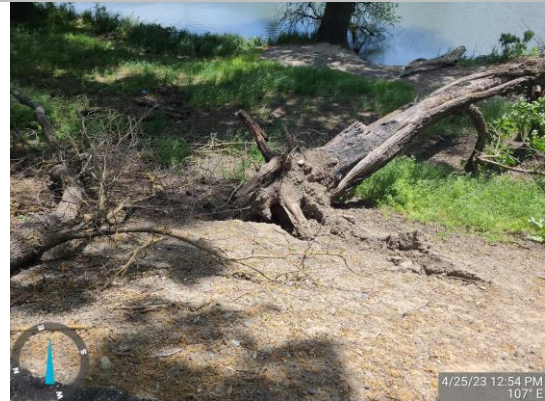
Photo 1 of 1 : SP\_2023\_RD0999\_236\_9\_20230426\_00117.jpg

Tree with rootball on the WS slope. Spring 2023

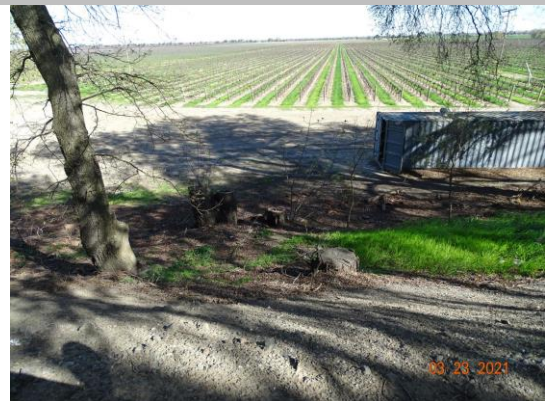
Photo 1 of 1 : SP\_2023\_RD0999\_236\_79\_20230306\_00032.jpg

View of the tree stumps on the LS levee slope. Spring 2021.

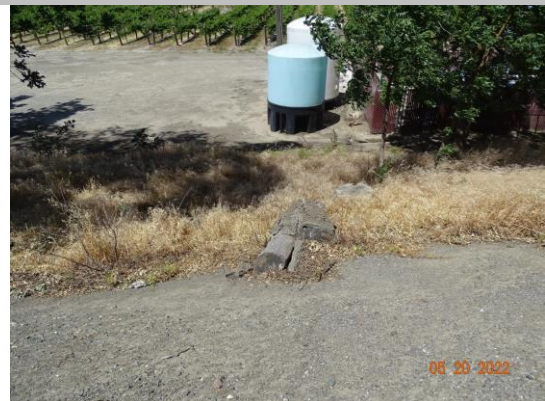
Photo 1 of 1 : SP\_2023\_RD0999\_236\_90\_20230306\_00037.jpg

Tree stump and logs on the landside slope. Spring 2022

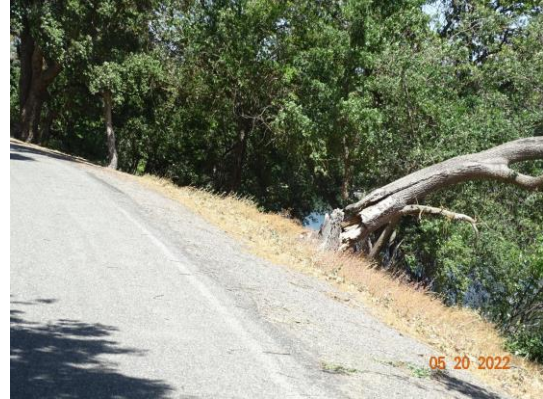
Photo 1 of 1 : SP\_2023\_RD0999\_236\_218\_20230306\_00087.jpg

Fallen tree on the waterside slope. Spring 2022

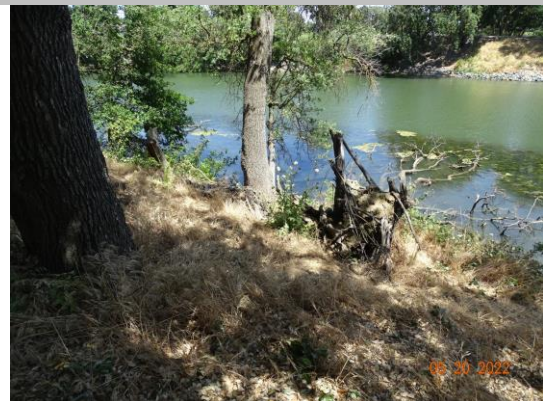
Photo 1 of 1 : SP\_2023\_RD0999\_236\_264\_20230306\_00098.jpg

Void from rootball on the waterside slope. Spring 2022

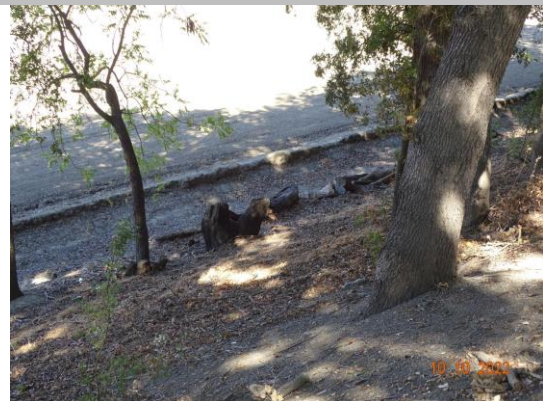
Photo 1 of 1 : SP\_2023\_RD0999\_236\_56\_20230306\_00019.jpg

Cut logs and stumps on the LS toe. Fall 2022

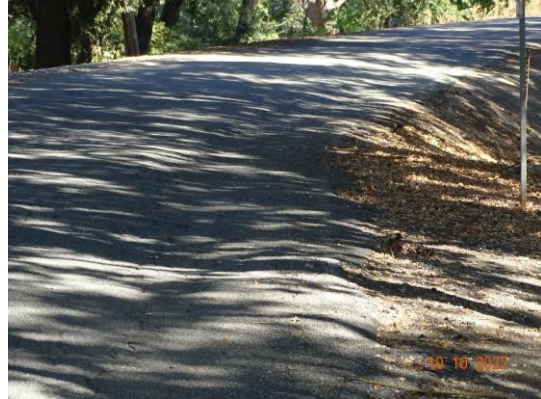
Photo 1 of 1 : SP\_2023\_RD0999\_236\_51\_20230306\_00014.jpg

Crown depression. Fall 2022

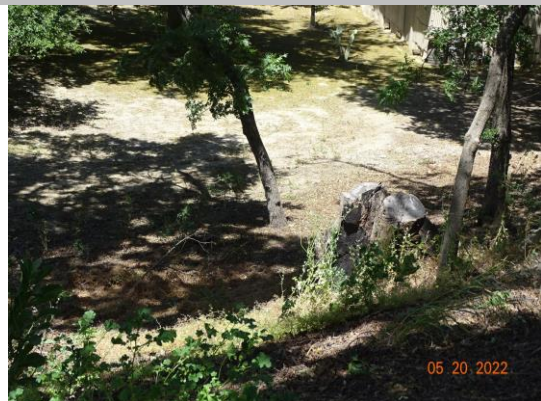
Photo 1 of 1 : SP\_2023\_RD0999\_236\_95\_20230306\_00040.jpg

Tree stump at the landside toe. Spring 2022

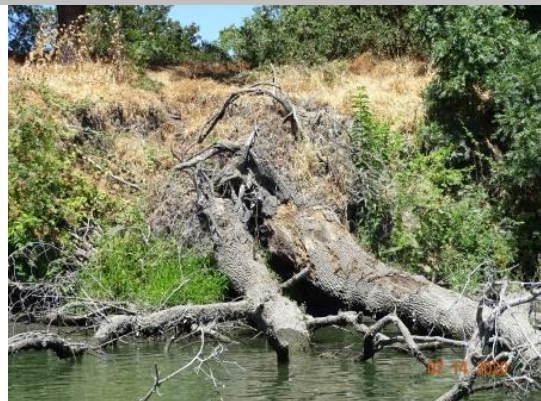
Photo 1 of 1 : SP\_2023\_RD0999\_236\_1\_20230306\_00001.jpg

View of large, fallen tree on the waterside slope. Summer 2020

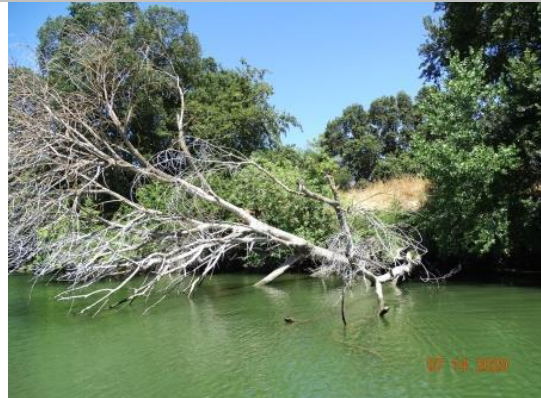
Photo 1 of 1 : SP\_2023\_RD0999\_236\_85\_20230306\_00036.jpg

View of fallen tree and slope damage. Summer 2020

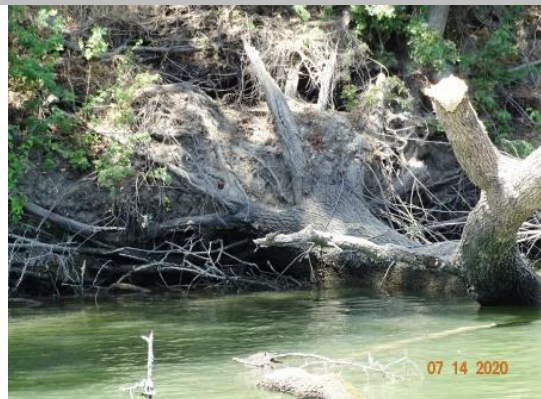
Photo 1 of 1 : SP\_2023\_RD0999\_236\_91\_20230306\_00038.jpg

View of fallen tree with exposed rootball. Summer 2020

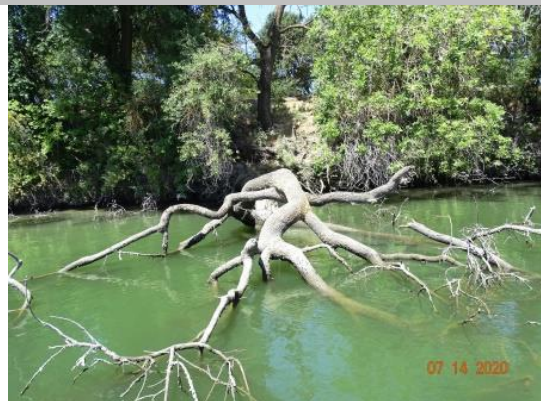
Photo 1 of 2 : SP\_2023\_RD0999\_236\_82\_20230306\_00033.jpg

View of large, fallen tree with exposed rootball. Summer 2020

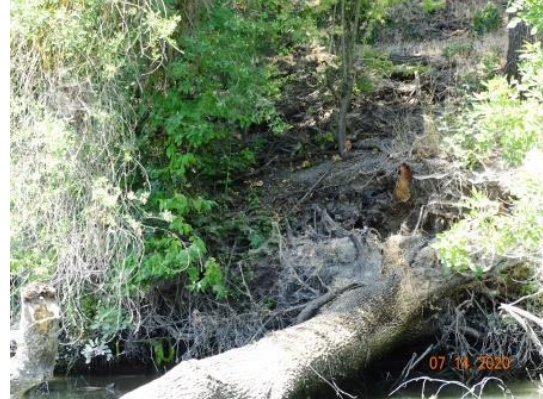
Photo 2 of 2 : SP\_2023\_RD0999\_236\_82\_20230306\_00034.jpg

View of scarp around fallen tree. Summer 2020

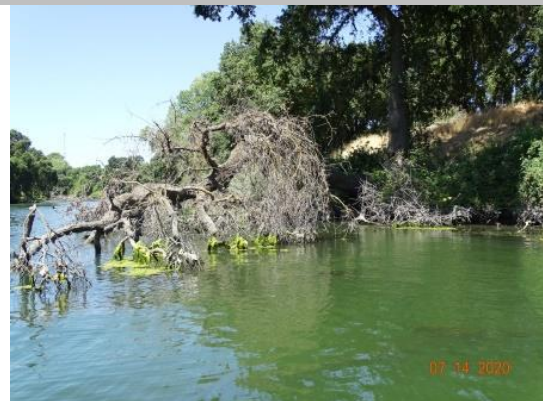
Photo 1 of 1 : SP\_2023\_RD0999\_236\_102\_20230306\_00045.jpg

View of fallen tree split at the base. Summer 2020

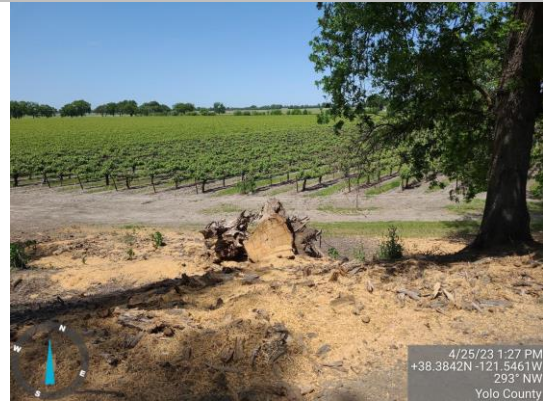
Photo 1 of 1 : SP\_2023\_RD0999\_236\_62\_20230426\_00120.jpg

Stumps on the LS slope. Spring 2023

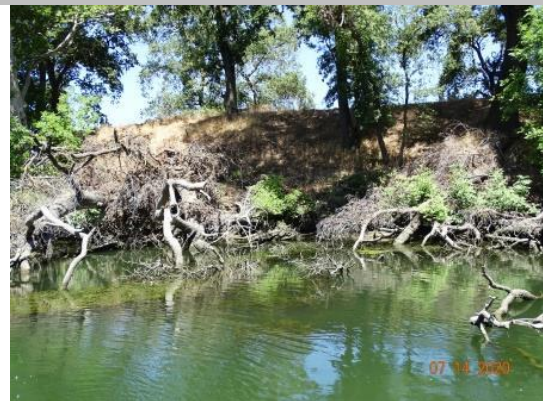
Photo 1 of 2 : SP\_2023\_RD0999\_236\_229\_20230306\_00093.jpg

View of two fallen trees. Summer 2020

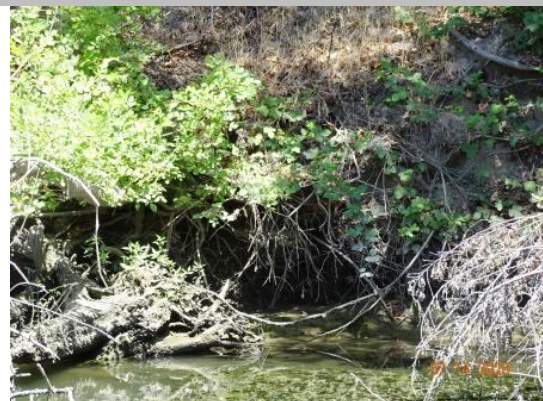
Photo 2 of 2 : SP\_2023\_RD0999\_236\_229\_20230306\_00094.jpg

View of large scarp near two fallen trees. Summer 2020

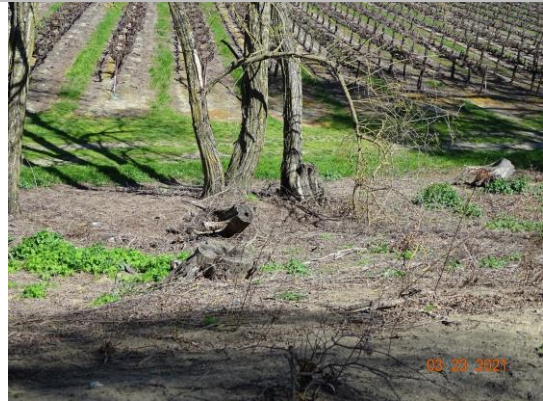
Photo 1 of 1 : SP\_2023\_RD0999\_236\_129\_20230306\_00054.jpg

View of the tree stumps on the LS levee slope and toe. Spring 2021.

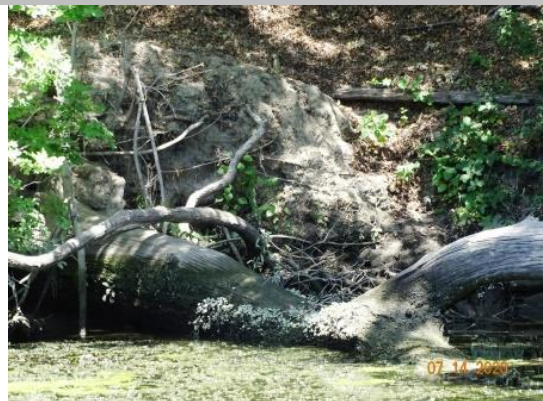
Photo 1 of 1 : SP\_2023\_RD0999\_236\_99\_20230306\_00043.jpg

View of slope damage near fallen tree. Summer 2020

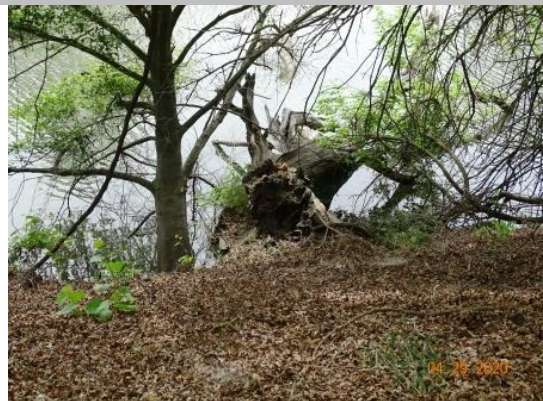
Photo 1 of 1 : SP\_2023\_RD0999\_236\_227\_20230306\_00092.jpg

View of a fallen tree on the waterside slope. Spring 2020

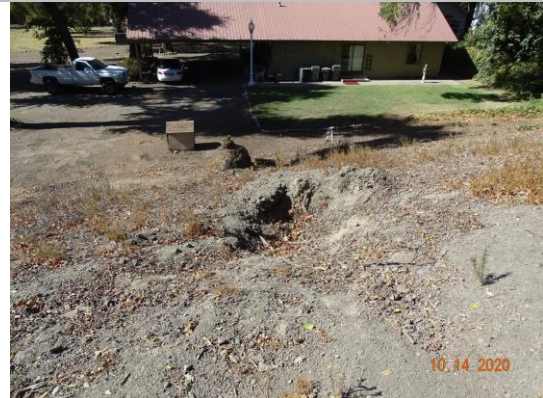
Photo 1 of 1 : SP\_2023\_RD0999\_236\_214\_20230306\_00084.jpg

View of a large hole on the landside slope. Fall 2020

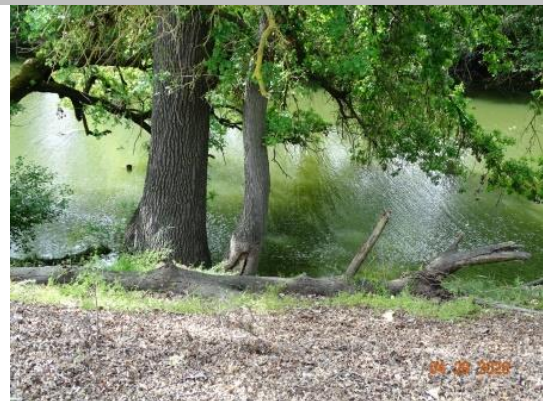
Photo 1 of 1 : SP\_2023\_RD0999\_236\_186\_20230306\_00077.jpg

View of a tree log on the waterside slope. Spring 2020

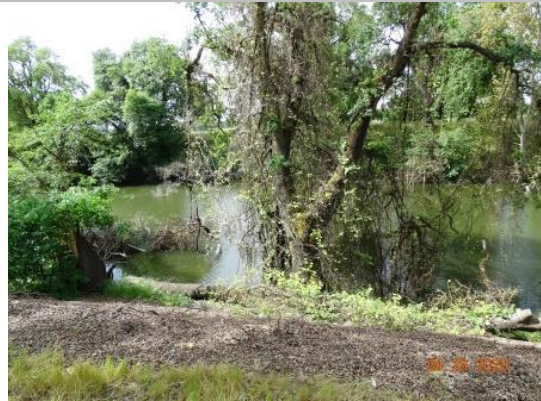
Photo 1 of 1 : SP\_2023\_RD0999\_236\_181\_20230306\_00076.jpg

View of fallen tree on the waterside slope. Spring 2020

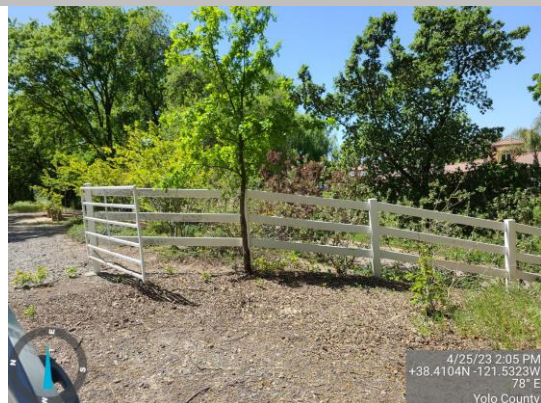
Photo 1 of 1 : SP\_2023\_RD0999\_236\_103\_20230426\_00137.jpg

Fence and gate on the slopes and crown. Spring 2023

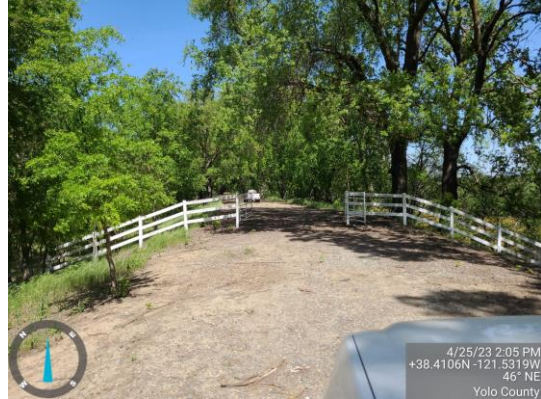
Photo 1 of 1 : SP\_2023\_RD0999\_236\_104\_20230426\_00138.jpg

Gate and fence on the levee. Spring 2023

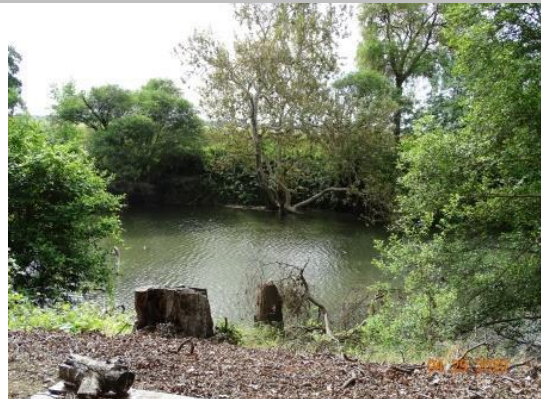
Photo 1 of 1 : SP\_2023\_RD0999\_236\_164\_20230306\_00067.jpg

View of a large tree stump on the waterside slope. Spring 2020
