**Flood Control Project Maintenance
Levee Inspections**

Maintenance Issue Types Only, Levee Inspection Report By Mile - Spring 2024

Reclamation District No. 0999 Netherlands

Waterway	Bank	Unit Miles	Inspection Start/End	Inspector
Unit No. 01 Yolo Bypass	Left	15.41	04/18/2024 04/18/2024	Marvin Marshall

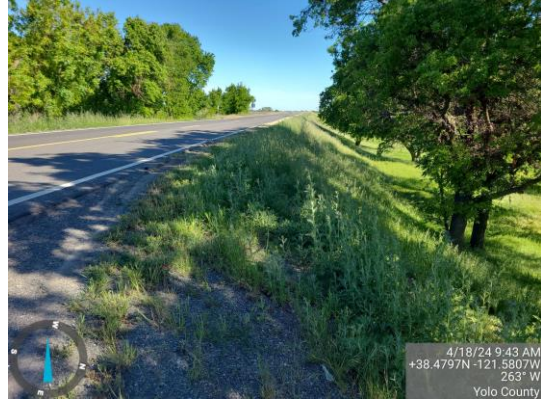
Photo 1 of 1 : SP_2024_RD0999_232_15_20240423_00039.jpg

LM Start	0.03	Rating **	M	Issue No.	15
LM End	1.75	Issue Type +	Ma	Location *	LS
Category	Earthen Levee			GPS Latitude/Longitude	
				Start	End
Item	Vegetation			38.504700°	38.479700°
				-121.582200°	-121.580700°
DWR ID	DWR_RD0999_01_s_2024_15				
Comment Code					
V1 : Control annual grass and weeds on the levee slopes and easements.					
Inspector Comment					
Maintain annual vegetation growth.

Annual vegetation on the LS slope. Spring 2024

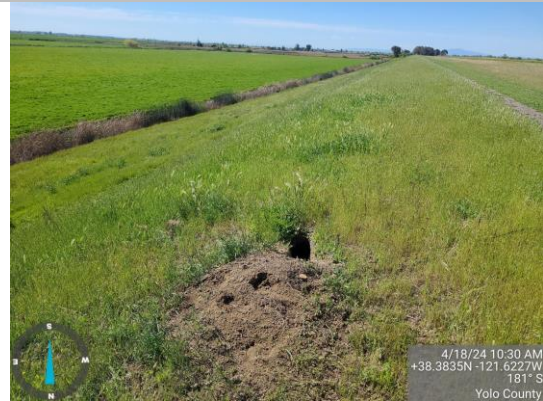
Photo 1 of 1 : SP_2024_RD0999_232_16_20240423_00041.jpg

Burrow in the LS slope. Spring 2024

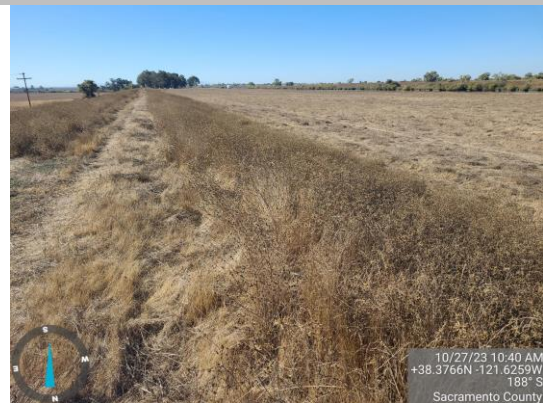
Photo 1 of 1 : SP_2024_RD0999_232_11_20240212_00007.jpg

LM Start	9.30	Rating **	M	Issue No.	11
LM End	9.50	Issue Type +	Ma	Location *	WS
Category	Earthen Levee			GPS Latitude/Longitude	
				Start	End
Item	Vegetation			38.376640°	38.373872°
				-121.625907°	-121.627179°
DWR ID	DWR_RD0999_01_f_2023_11				
Comment Code					
V1 : Control annual grass and weeds on the levee slopes and easements.					
Inspector Comment

Vegetation on the WS slope. Fall 2023

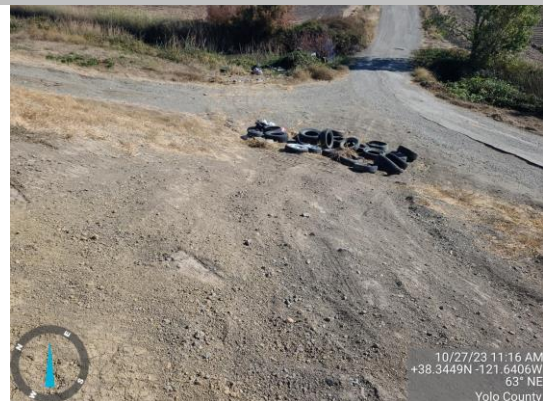
Photo 1 of 1 : SP_2024_RD0999_232_7_20240212_00003.jpg

LM Start	11.63	Rating **	M	Issue No.	7
LM End	11.63	Issue Type +	Ma	Location *	LS
Category	Earthen Levee			GPS Latitude/Longitude	
				Start	End
Item	Erosion / Vehicle Traffic			38.344942°	38.344942°
				-121.640647°	-121.640647°
DWR ID	DWR_RD0999_01_s_2023_7				
Comment Code					
E6 : Repair the levee slope damaged by vehicle traffic and prevent access where possible.					
Inspector Comment					
Repair slope damage from vehicle traffic. Remove tires from toe.

Rutting and tires on the LS slope. Fall 2023

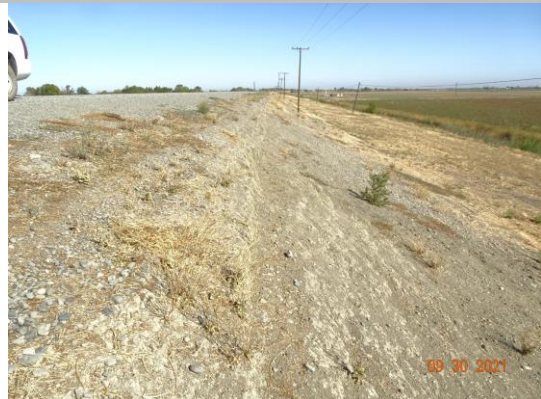
Photo 1 of 1 : SP_2024_RD0999_232_38_20240212_00019.jpg

LM Start	13.47	Rating **	M	Issue No.	38
LM End	13.47	Issue Type +	Ma	Location *	LS
Category	Earthen Levee			GPS Latitude/Longitude	
				Start	End
Item	Slope Stability			38.318667°	38.318667°
				-121.644948°	-121.644948°
DWR ID	DWR_RD0999_01_f_2021_38				
Comment Code					
S1 : Repair slope instability.					
Inspector Comment					
Repair slope sloughing, approximately 50' long 12" deep.

LS slope sloughing. Fall 2021

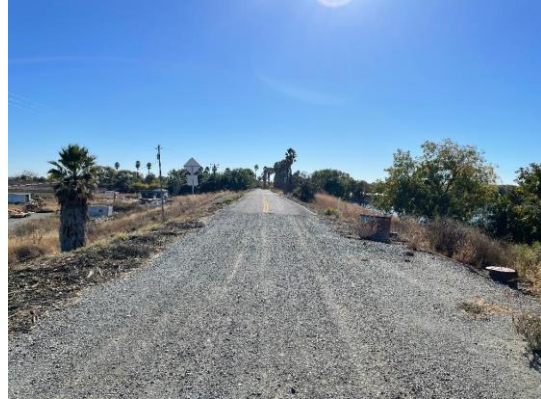
Photo 1 of 3 : UCIP_SP_2024_81690_118446.jpg

Overview of levee crown looking D/S.

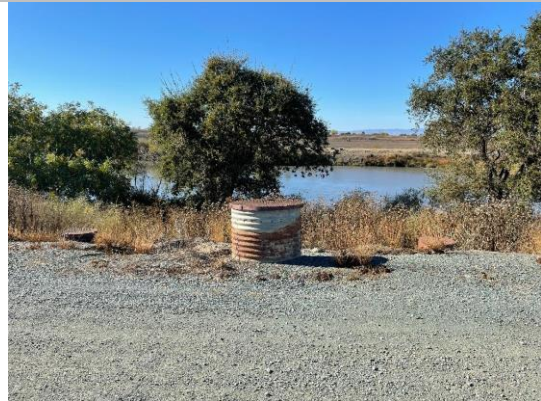
Photo 2 of 3 : UCIP_SP_2024_81690_118447.jpg

WS view: overview of WS.

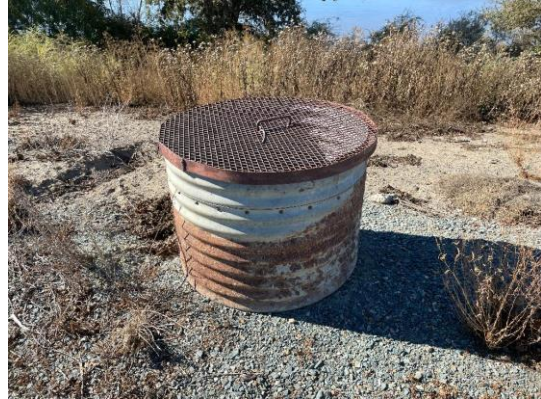
Photo 3 of 3 : UCIP_SP_2024_81690_118443.jpg

WS view: CMP riser with siphon breaker inside.

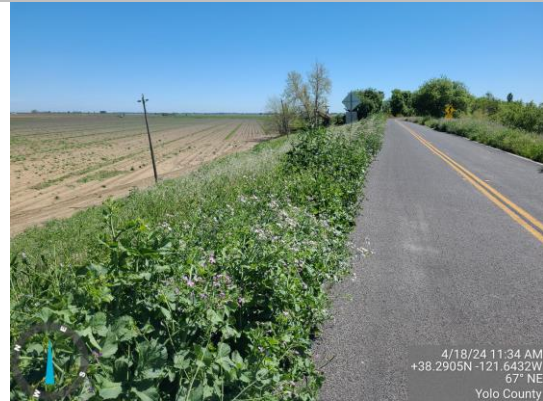
Photo 1 of 1 : SP_2024_RD0999_233_4_20240423_00009.jpg

Annual vegetation on the LS slope. Spring 2024

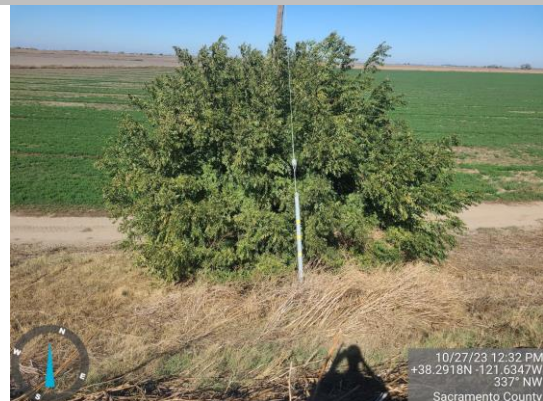
Photo 1 of 1 : SP_2024_RD0999_233_1_20240212_00001.jpg

LM Start	0.58	Rating **	M	Issue No.	1
LM End	0.58	Issue Type +	Ma	Location *	LS
Category	Earthen Levee			GPS Latitude/Longitude	
				Start	End
Item	Trim / Thin Trees			38.291674°	38.291674°
				-121.634624°	-121.634624°
DWR ID	DWR_RD0999_02_f_2023_1				
Comment Code					
T1 : Trim and thin trees to at least five feet above ground level to allow visibility of the ground and room to flood fight.					
Inspector Comment					
Remove tree or trim to 5' above grade.

Tree on the LS slope. Fall 2023

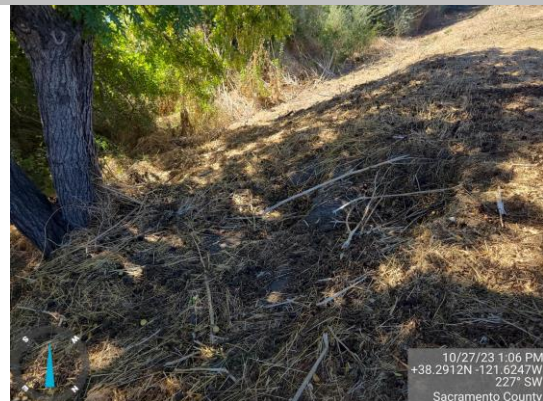
Photo 1 of 1 : SP_2024_RD0999_233_2_20240212_00002.jpg

LM Start	1.15	Rating **	M	Issue No.	2
LM End	1.15	Issue Type +	Ma	Location *	WS
Category	Earthen Levee			GPS Latitude/Longitude	
				Start	End
Item	Erosion / Bank Caving			38.291045°	38.291045°
				-121.625112°	-121.625112°
DWR ID	DWR_RD0999_02_f_2023_2				
Comment Code					
E2 : Schedule repair of erosion site prior to the next inspection.					
Inspector Comment					
Repair benching cut in the WS slope.

Bench in the WS slope. Fall 2023

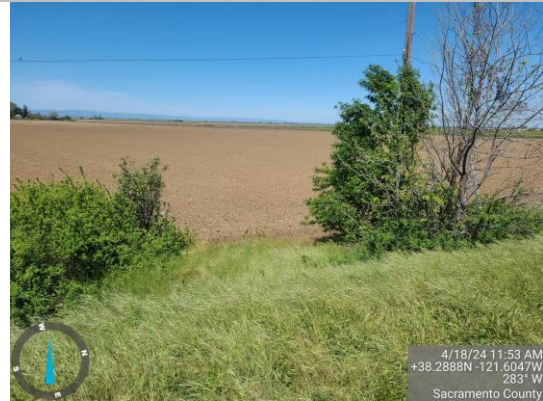
Photo 1 of 1 : SP_2024_RD0999_234_11_20240423_00016.jpg

Trees on the LS slope. Spring 2024

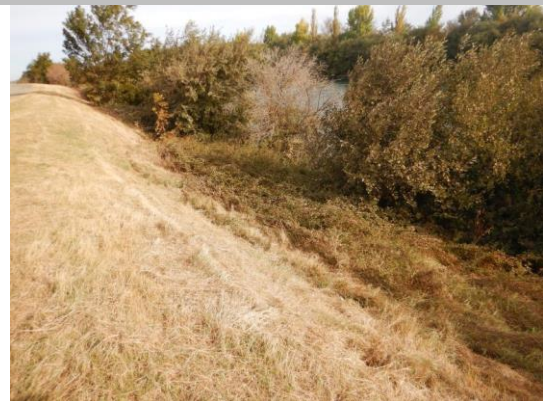
Photo 1 of 2 : SP_2024_RD0999_234_5_20240212_00001.jpg

LM Start	0.24	Rating **	U	Issue No.	5
LM End	0.65	Issue Type +	Ma	Location *	WS
Category	Supplemental			GPS Latitude/Longitude	
				Start	End
Item	2018 USACE Erosion Survey			38.289634°	38.295505°
				-121.604343°	-121.605648°
DWR ID	DWR_RD0999_03_s_2022_5

Comment Code					
Inspector Comment					
2018 Site ID: STR 24.7 R					
Status: Critical					
2022 Field Notes: No observed changes.					
Site History: 1997 - Intermittent over-steepened sections. Large riparian vegetation along the length of the entire reach. Attempts to repair with rock on bank have failed. 1999 - New rock repair at the downstream end. 2002 - Some minor spot repairs. 2009 - Minimal new erosion. 2010 - Appears that fresh rock placed on downstream portion of site. Toe scour and overhanging trees with some overturned. 2012 - Minor new erosion at the toe. 2013 - Site upgraded to CRITICAL. Severe slumping into levee at downstream end of site. Fresh erosion into bank toe. 2015 - New slumping, tall vertical sections. 2016 - Upper slumped section continues to worsen. 2017 - Locals have placed rock in worst sections. Fresh erosion at toe. New tall vertical sections observed. 2018 -Length reduced on downstream side to account for repaired section.

USACE 2018 Erosion Photo #1

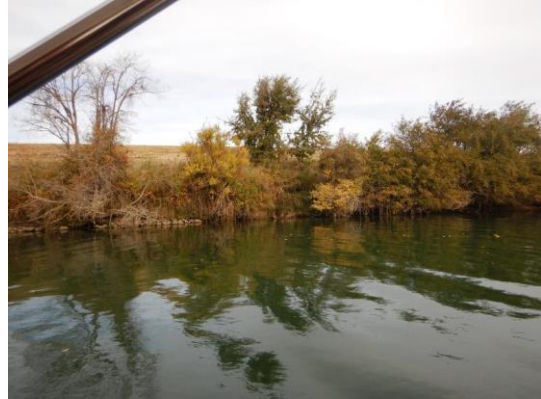
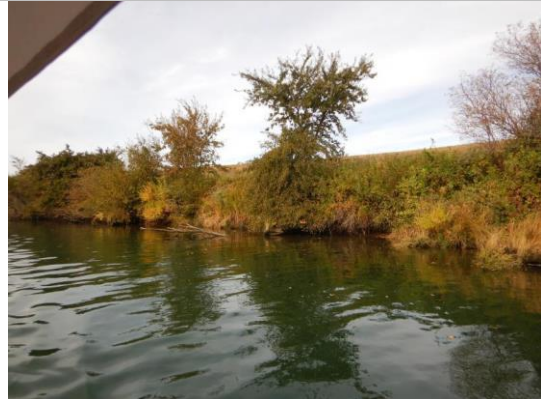
LM Start	0.97	Rating **	M	Issue No.	6
LM End	1.10	Issue Type +	Ma	Location *	WS
Category	Supplemental			GPS Latitude/Longitude	
				Start	End
Item	2018 USACE Erosion Survey			38.299402°	38.300542°
				-121.603056°	-121.601118°
DWR ID	DWR_RD0999_03_s_2022_6				
Comment Code					
Inspector Comment					
2018 Site ID: STR 25.2 R					
Status: Eroding					
2022 Field Notes: No observed changes.					
Site History: 2008 - Over steepened levee section. 2009 - Significant new erosion. 2010 - Minor new erosion. 2017 - Minor new erosion at toe. 2018 - New large slump on upper levee slope.

USACE 2018 Erosion Photo #1

USACE 2018 Erosion Photo #2

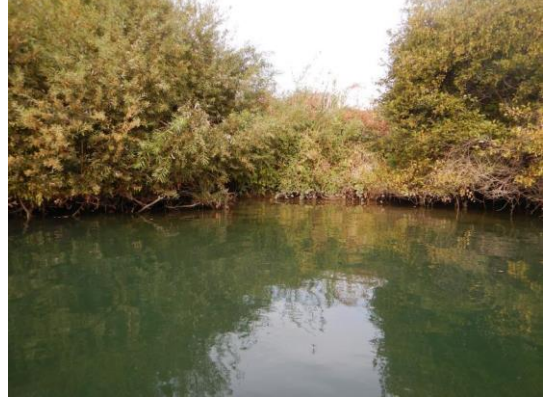
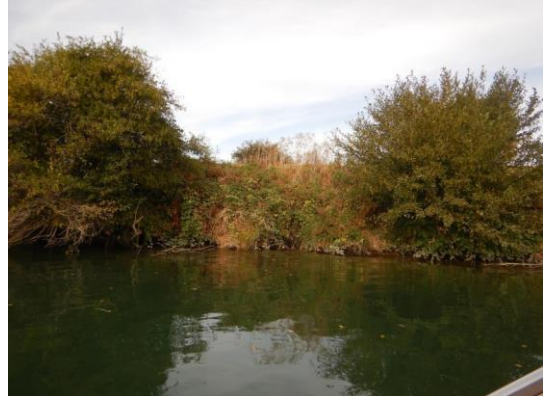
LM Start	1.43	Rating **	A/W	Issue No.	10
LM End	1.57	Issue Type +	Ma	Location *	WS
Category	Supplemental			GPS Latitude/Longitude	
				Start	End
Item	2018 USACE Erosion Survey			38.305229°	38.306667°
				-121.599933°	-121.598266°
DWR ID	DWR_RD0999_03_s_2022_10				
Comment Code					
Inspector Comment					
2018 Site ID: STR 25.7 R					
Status: Eroding					
2022 Field Notes: No observed changes.					
Site History: 2011 - Toe scour along length of site and erosion pockets.					
2012 - Site extended slightly upstream due to new erosion pocket.					
2013 - Tall vertical sections at upstream end of site. 2017 - Large erosion scarp near downstream end. 2018 - Site extended upstream.

USACE 2018 Erosion Photo #1

USACE 2018 Erosion Photo #2

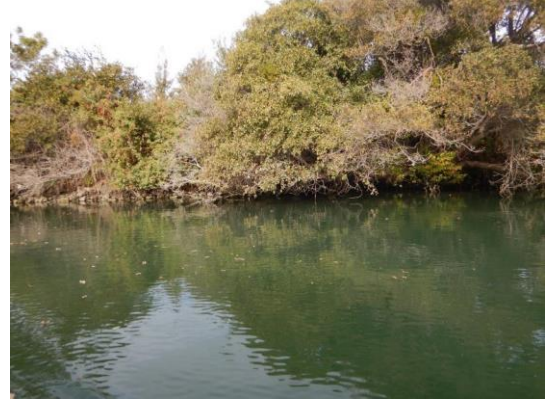
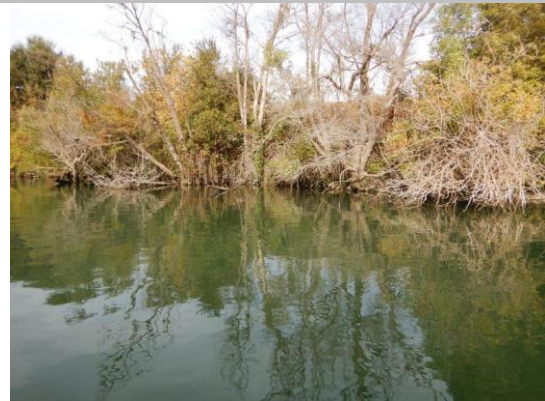
LM Start	1.93	Rating **	M	Issue No.	12
LM End	1.97	Issue Type +	Ma	Location *	WS
Category	Supplemental			GPS Latitude/Longitude	
				Start	End
Item	2018 USACE Erosion Survey			38.311013°	38.311342°
				-121.597751°	-121.596976°
DWR ID	DWR_RD0999_03_s_2022_12				
Comment Code					
Inspector Comment					
2018 Site ID: STR 26.1 R					
Status: Eroding					
2022 Field Notes: No observed change.					
Site History: 2015 - Tall vertical sections into the levee slope and erosion along the toe. 2016 - New tree pop-out observed. 2018 - No observed change.

USACE 2018 Erosion Photo #1

USACE 2018 Erosion Photo #2

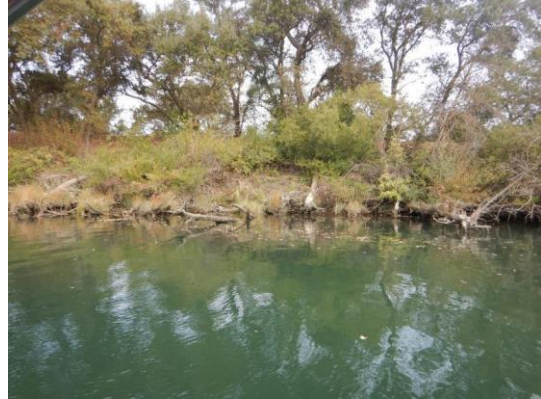
Photo 1 of 1 : SP_2024_RD0999_234_14_20240212_00011.jpg

LM Start	2.97	Rating **	A/W	Issue No.	14
LM End	3.22	Issue Type +	Ma	Location *	WS
Category	Supplemental			GPS Latitude/Longitude	
				Start	End
Item	2018 USACE Erosion Survey			38.323419°	38.325592°
				-121.589645°	-121.585925°
DWR ID	DWR_RD0999_03_s_2022_14				
Comment Code					
Inspector Comment					
2018 Site ID: STR 27.3 R					
Status: Eroding					
2022 Field Notes: No observed change.					
Site History: 2011 - Multiple erosion pockets. Some likely from tree popouts. 2013 - Tall vertical sections. 2015 - New tree pop-out and significant new erosion. 2016 - New erosion at toe. 2017 - Site extended downstream, section of lower bank has slumped off. Fresh toe erosion and fresh tree popout. 2018 - No observed change.

USACE 2018 Erosion Photo #1

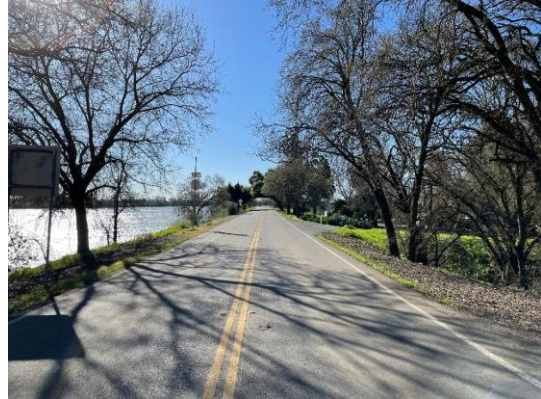
Photo 1 of 3 : UCIP_SP_2024_82532_119642.jpg

Overview of levee crown looking D/S.

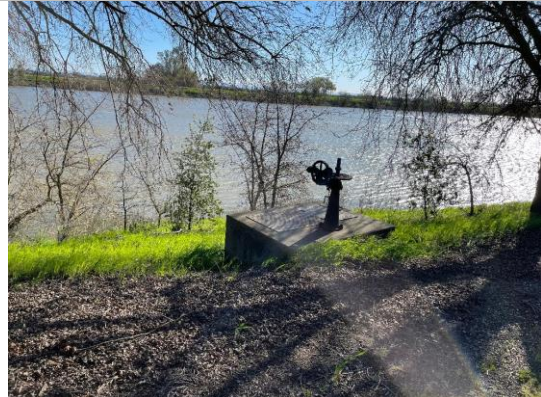
Photo 2 of 3 : UCIP_SP_2024_82532_119643.jpg

WS view: Overview of WS with concrete vault on shoulder.

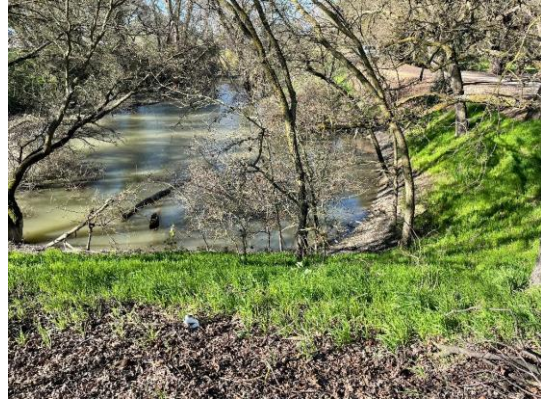
Photo 3 of 3 : UCIP_SP_2024_82532_119644.jpg

LS view: overview of LS slope and drainage channel.

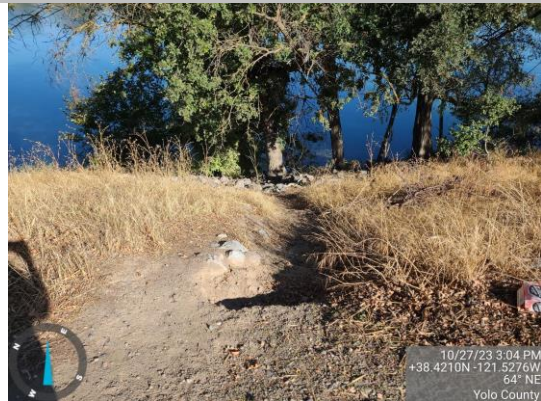
Photo 1 of 1 : SP_2024_RD0999_235_39_20240212_00009.jpg

LM Start	0.55	Rating **	M	Issue No.	39
LM End	0.55	Issue Type +	Ma	Location *	WS
Category	Earthen Levee			GPS Latitude/Longitude	
				Start	End
Item	Erosion / Foot Traffic			38.421051°	38.421051°
				-121.527692°	-121.527692°
DWR ID	DWR_RD0999_04_s_2022_39				
Comment Code					
E3 : Repair the levee slope damaged by foot traffic and prevent access where possible.					
Inspector Comment					
Repair two footpaths on the WS slope.

Footpath on the WS slope. Fall 2023

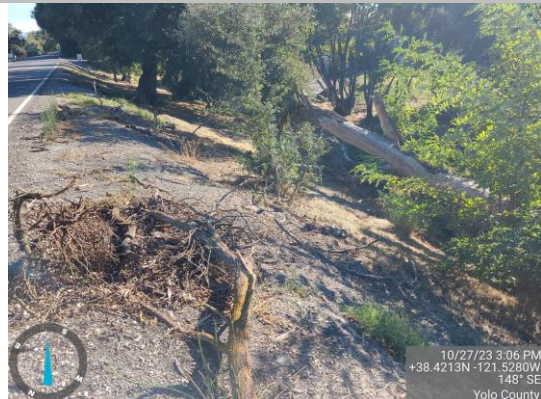
Photo 1 of 1 : SP_2024_RD0999_235_35_20240212_00006.jpg

Fallen tree on the LS slope. Fall 2023

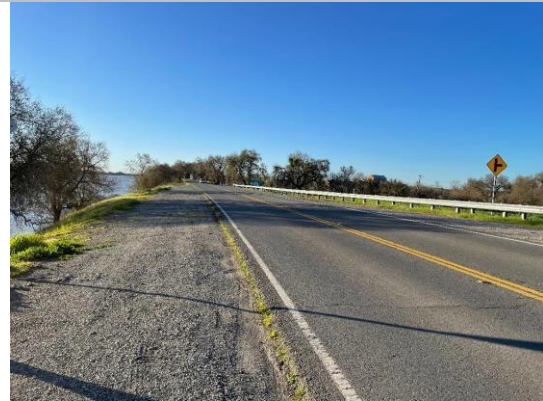
Photo 1 of 3 : UCIP_SP_2024_82565_119733.jpg

Overview of levee crown looking D/S.

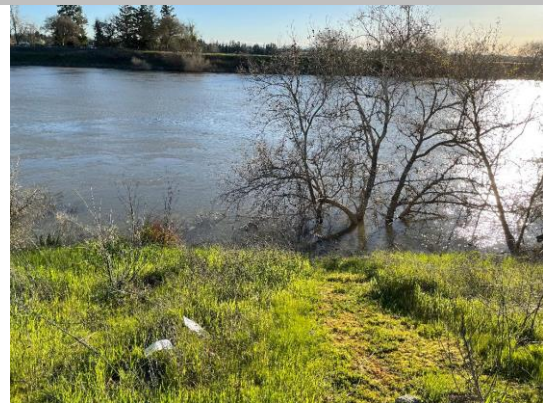
Photo 2 of 3 : UCIP_SP_2024_82565_119734.jpg

WS view: overview of WS.

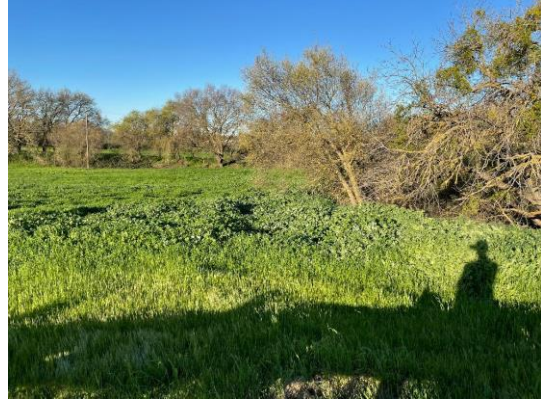
Photo 3 of 3 : UCIP_SP_2024_82565_119735.jpg

LS view: overview of LS.

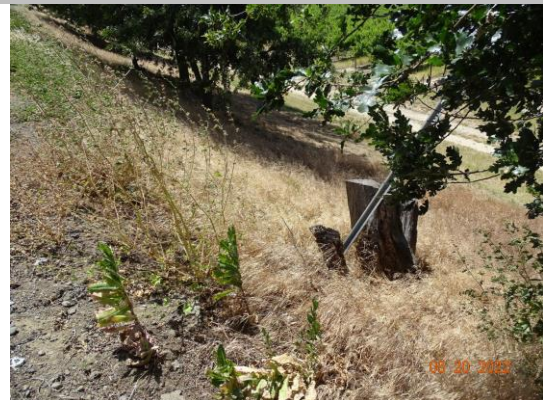
Photo 1 of 1 : SP_2024_RD0999_236_75_20240212_00030.jpg

Stumps on the landside slope. Spring 2022

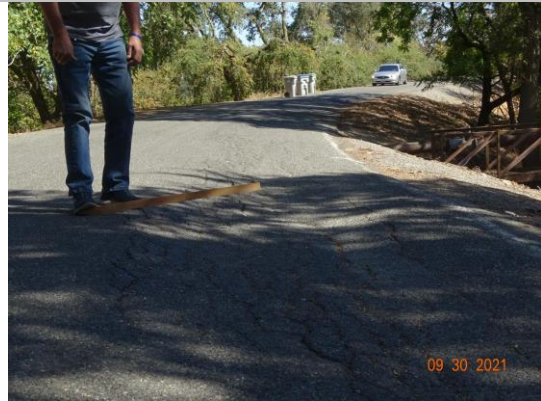
Photo 1 of 2 : SP_2024_RD0999_236_55_20240212_00018.jpg

LM Start	1.10	Rating **	U	Issue No.	55
LM End	1.14	Issue Type +	Ma	Location *	CR
Category	Earthen Levee			GPS Latitude/Longitude	
				Start	End
Item	Crown Surface / Depressions / Rutting			38.347889°	38.348159°
				-121.579191°	-121.578665°
DWR ID	DWR_RD0999_05_f_2021_55				
Comment Code					
C2 : Repair depressions or ruts in the crown or slope.					
Inspector Comment					
Crown sloughing at roadway edge. Approximately 500' >6"

Depth of sloughing on WS crown. Fall 2021

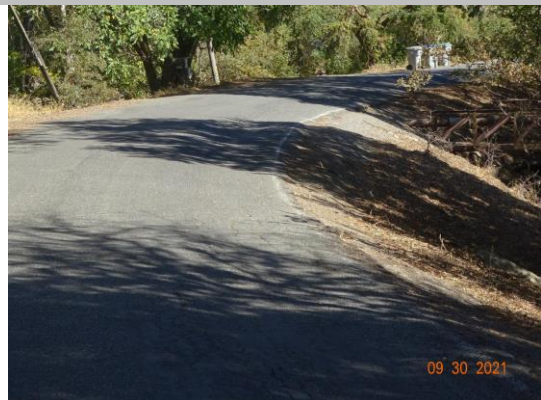
Photo 2 of 2 : SP_2024_RD0999_236_55_20240212_00019.jpg

Length of sloughing on WS crown. Fall 2021

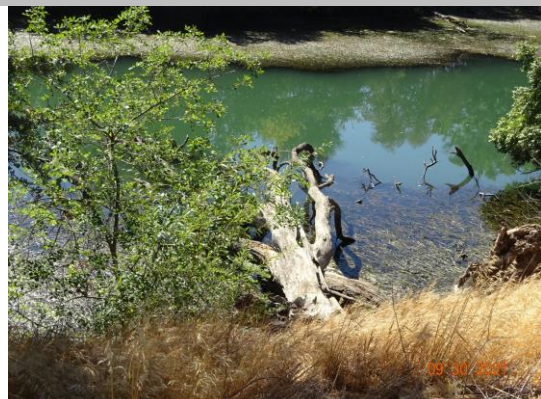
Photo 1 of 1 : SP_2024_RD0999_236_273_20240212_00099.jpg

Fallen tree in channel. Fall 2021

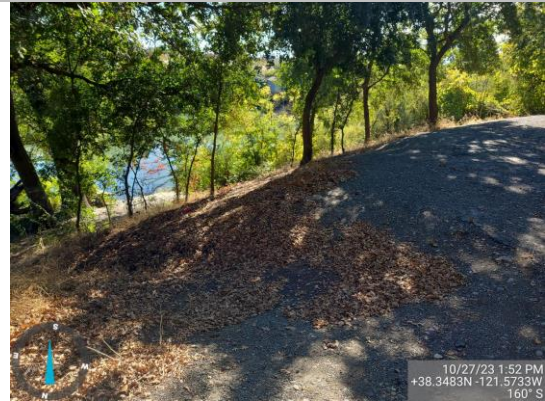
Photo 1 of 1 : SP_2024_RD0999_236_61_20240212_00023.jpg

LM Start	1.43	Rating **	M	Issue No.	61
LM End	1.43	Issue Type +	Ma	Location *	WS
Category	Earthen Levee			GPS Latitude/Longitude	
				Start	End
Item	Erosion / Foot Traffic			38.348283°	38.348283°
				-121.573347°	-121.573347°
DWR ID	DWR_RD0999_05_s_2020_61				
Comment Code					
E3 : Repair the levee slope damaged by foot traffic and prevent access where possible.					
Inspector Comment					
Repair the three footpaths in the area.

Footpath on the WS slope. Fall 2023

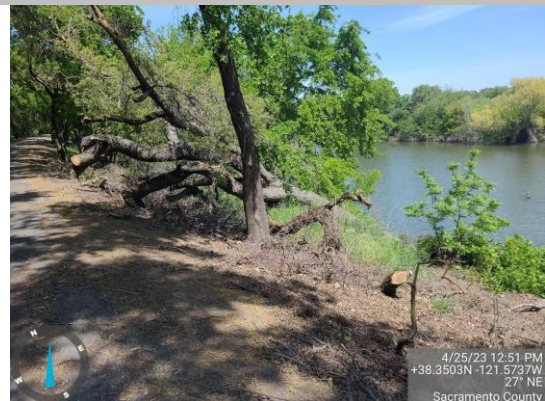
Photo 1 of 1 : SP_2024_RD0999_236_8_20240212_00003.jpg

Tree with root ball on the WS slope. Spring 2023

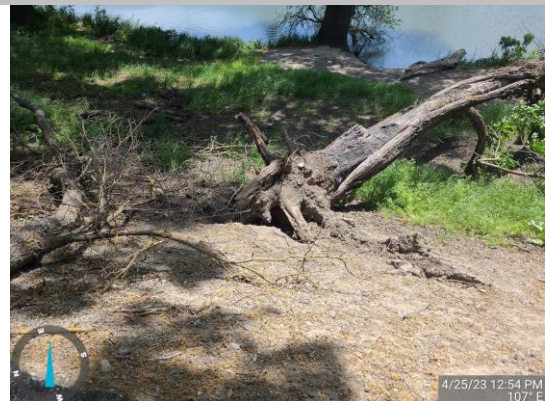
Photo 1 of 1 : SP_2024_RD0999_236_9_20240212_00004.jpg

LM Start	1.98	Rating **	U	Issue No.	9
LM End	1.98	Issue Type +	Ma	Location *	WS
Category	Earthen Levee			GPS Latitude/Longitude	
				Start	End
Item	Trim / Thin Trees			38.355434°	38.355434°
				-121.571767°	-121.571767°
DWR ID	DWR_RD0999_05_s_2023_9				
Comment Code					
T3 : Fallen tree with root ball.					
Inspector Comment					
Remove tree from slope and repair void from root ball.

Tree with root ball on the WS slope. Spring 2023

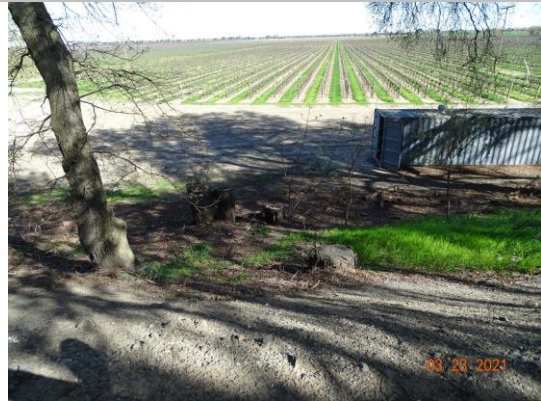
Photo 1 of 1 : SP_2024_RD0999_236_79_20240212_00032.jpg

View of the tree stumps on the LS levee slope. Spring 2021.

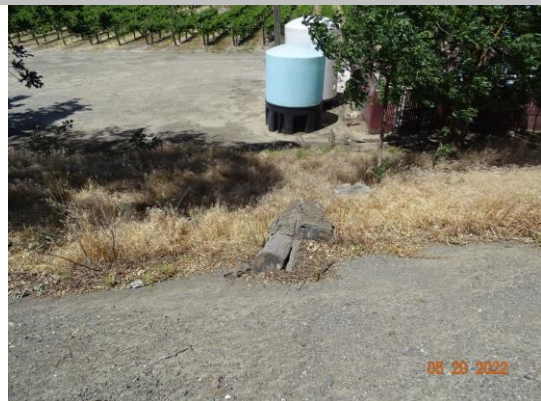
Photo 1 of 1 : SP_2024_RD0999_236_90_20240212_00038.jpg

Tree stump and logs on the landside slope. Spring 2022

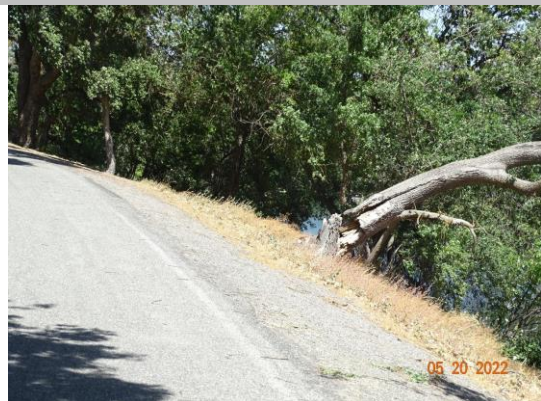
Photo 1 of 1 : SP_2024_RD0999_236_218_20240212_00088.jpg

LM Start	2.51	Rating **	M	Issue No.	218
LM End	2.51	Issue Type +	Ma	Location *	WS
Category	Earthen Levee			GPS Latitude/Longitude	
				Start	End
Item	Trim / Thin Trees			38.356378°	38.356378°
				-121.563185°	-121.563185°
DWR ID	DWR_RD0999_05_f_2020_218				
Comment Code					
T2 : Tree or limb.					
Inspector Comment					
Tree has split and stump will decay.

Fallen tree on the waterside slope. Spring 2022

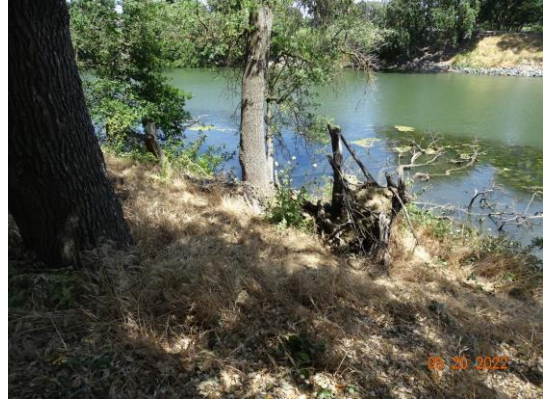
Photo 1 of 1 : SP_2024_RD0999_236_264_20240212_00098.jpg

Void from root ball on the waterside slope. Spring 2022

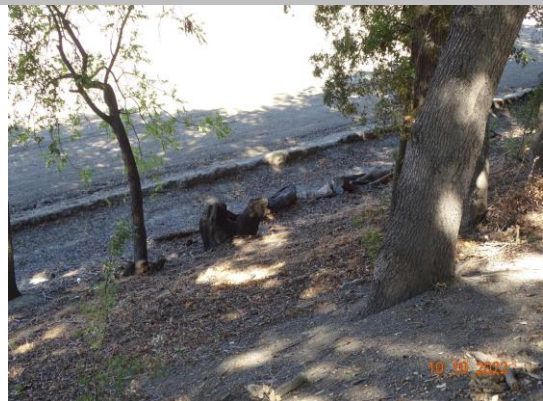
Photo 1 of 1 : SP_2024_RD0999_236_56_20240212_00020.jpg

Stumps on the LS toe. Fall 2022

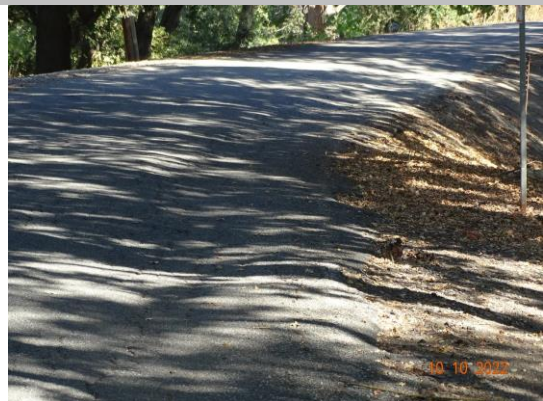
Photo 1 of 1 : SP_2024_RD0999_236_51_20240212_00015.jpg

Crown depression. Fall 2022

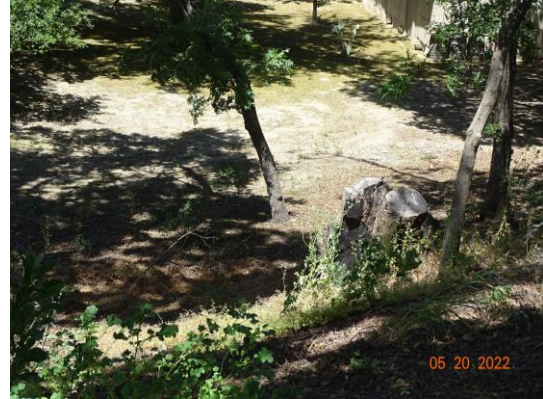
Photo 1 of 1 : SP_2024_RD0999_236_95_20240212_00041.jpg

Tree stump at the landside toe. Spring 2022

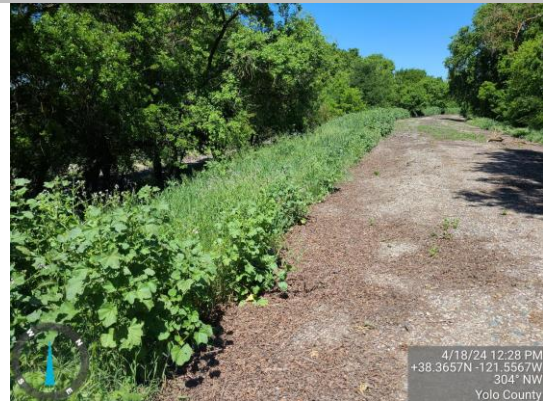
Photo 1 of 1 : SP_2024_RD0999_236_10_20240423_00116.jpg

Annual vegetation on the LS slope. Spring 2024

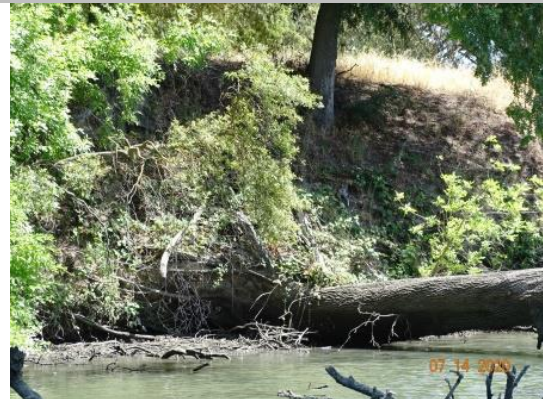
Photo 1 of 1 : SP_2024_RD0999_236_83_20240212_00036.jpg

View of a fallen tree with exposed root ball. Summer 2020

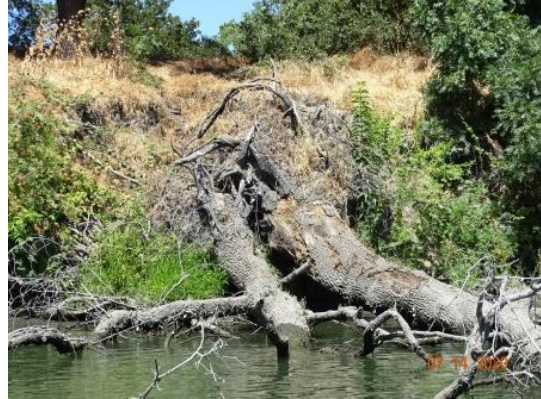
Photo 1 of 1 : SP_2024_RD0999_236_1_20240212_00001.jpg

View of large, fallen tree on the waterside slope. Summer 2020

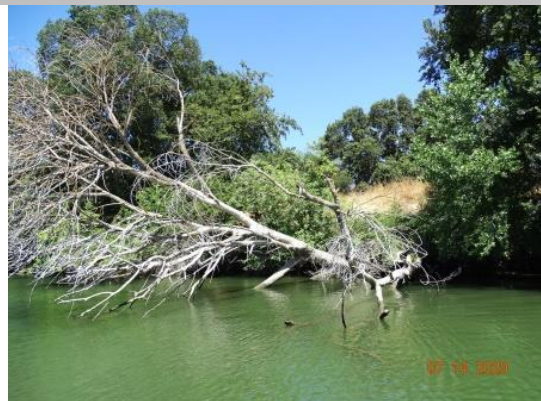
Photo 1 of 1 : SP_2024_RD0999_236_85_20240212_00037.jpg

View of fallen tree and slope damage. Summer 2020

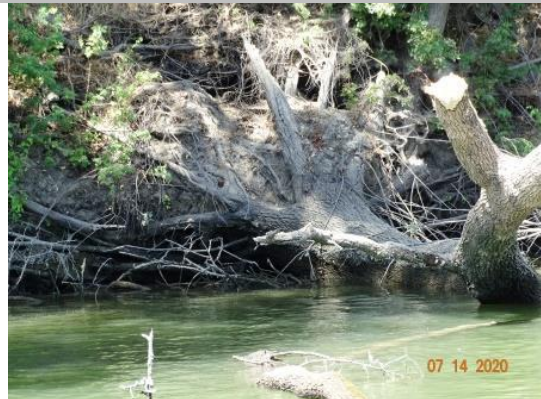
Photo 1 of 1 : SP_2024_RD0999_236_91_20240212_00039.jpg

View of fallen tree with exposed root ball. Summer 2020

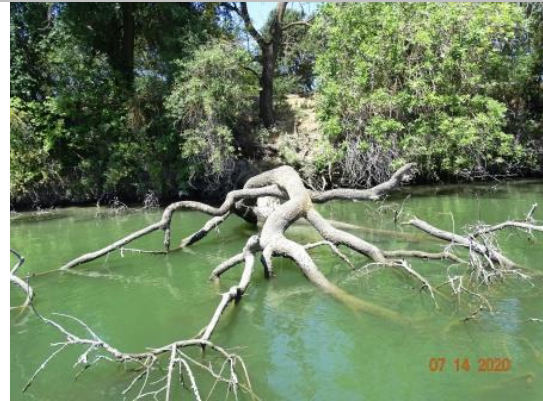
Photo 1 of 2 : SP_2024_RD0999_236_82_20240212_00034.jpg

View of large, fallen tree with exposed root ball. Summer 2020

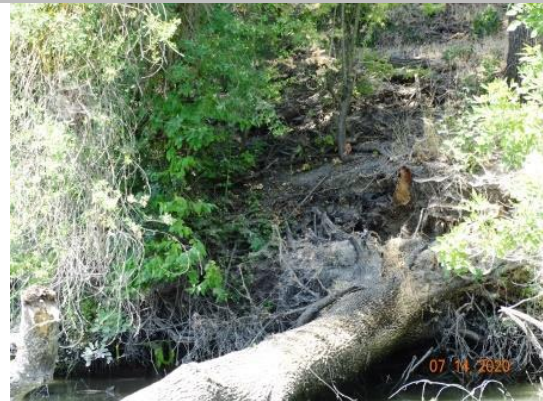
Photo 2 of 2 : SP_2024_RD0999_236_82_20240212_00035.jpg

View of scarp around fallen tree. Summer 2020

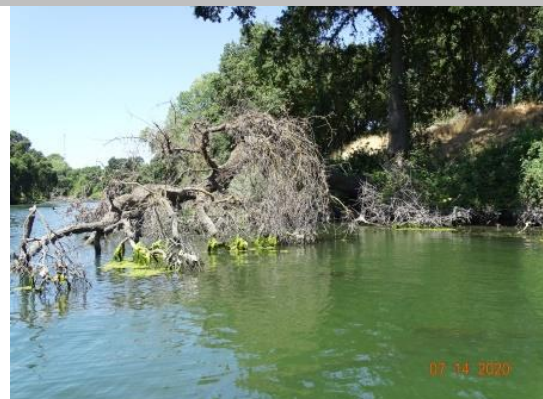
Photo 1 of 1 : SP_2024_RD0999_236_102_20240212_00046.jpg

View of fallen tree split at the base. Summer 2020

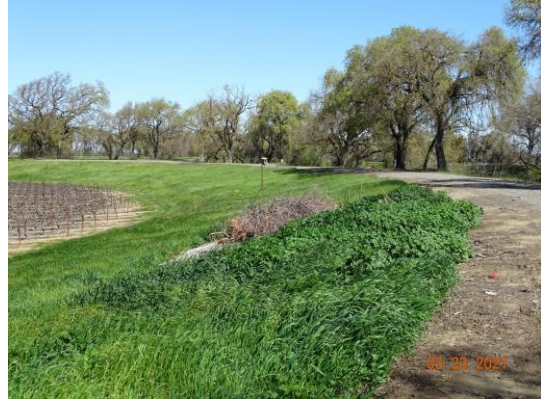
Photo 1 of 1 : SP_2024_RD0999_236_106_20240212_00049.jpg

View of the debris and pruning pile on the LS levee slope. Spring 2021.

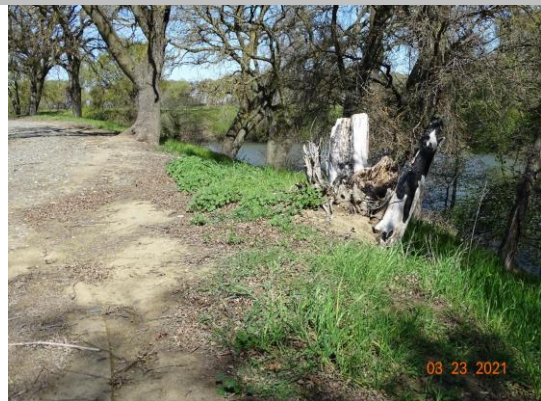
Photo 1 of 1 : SP_2024_RD0999_236_117_20240212_00052.jpg

View of the tree stump on the WS levee slope. Spring 2021.

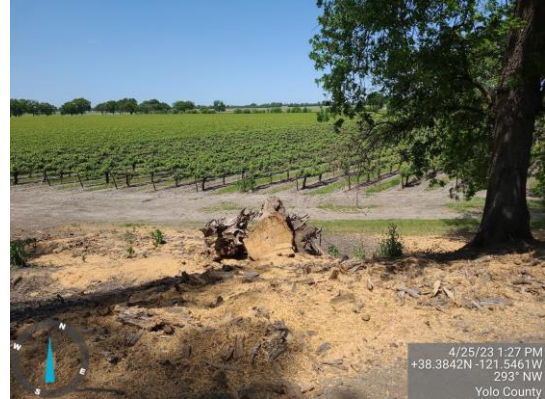
Photo 1 of 1 : SP_2024_RD0999_236_62_20240212_00024.jpg

Stumps on the LS slope. Spring 2023

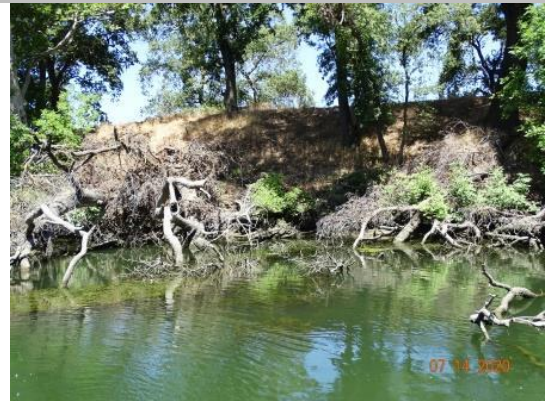
Photo 1 of 2 : SP_2024_RD0999_236_229_20240212_00094.jpg

View of two fallen trees. Summer 2020

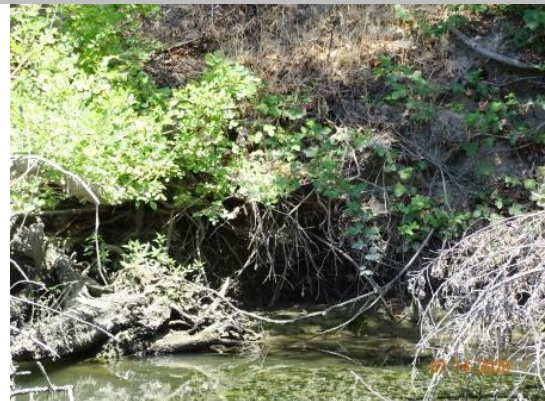
Photo 2 of 2 : SP_2024_RD0999_236_229_20240212_00095.jpg

View of large scarp near two fallen trees. Summer 2020

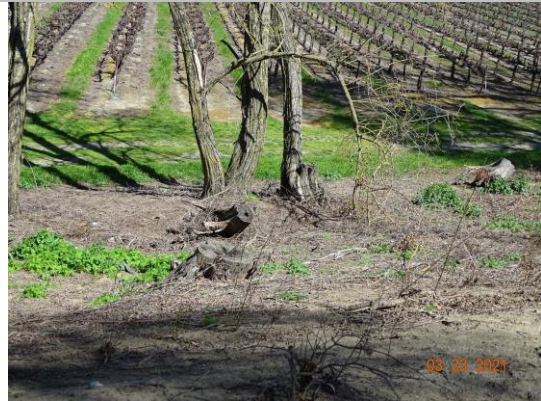
Photo 1 of 1 : SP_2024_RD0999_236_129_20240212_00056.jpg

View of the tree stumps on the LS levee slope and toe. Spring 2021.

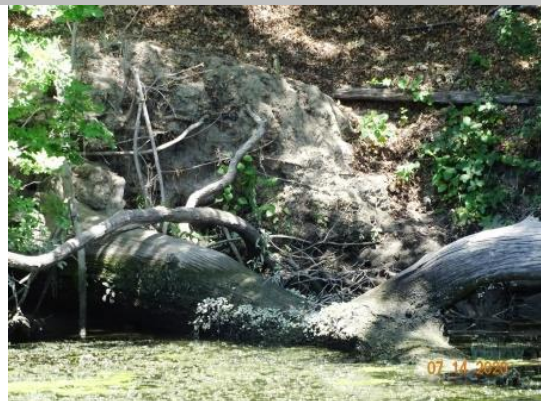
Photo 1 of 1 : SP_2024_RD0999_236_99_20240212_00044.jpg

View of slope damage near fallen tree. Summer 2020

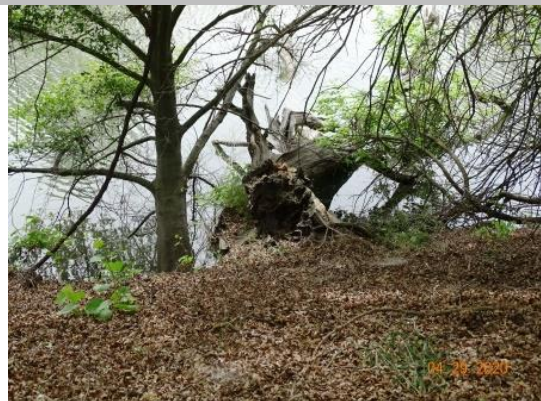
Photo 1 of 1 : SP_2024_RD0999_236_227_20240212_00093.jpg

View of a fallen tree on the waterside slope. Spring 2020

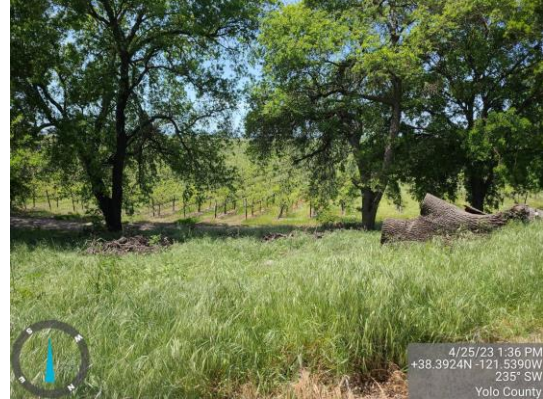
Photo 1 of 1 : SP_2024_RD0999_236_14_20240212_00008.jpg

Logs and prunings on the LS slope. Spring 2023

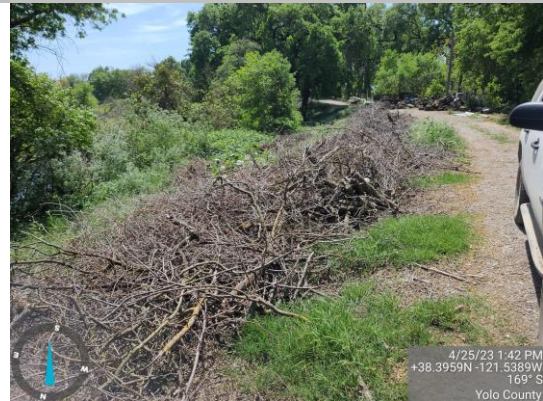
Photo 1 of 1 : SP_2024_RD0999_236_208_20240212_00083.jpg

Prunings on the WS shoulder. Spring 2023

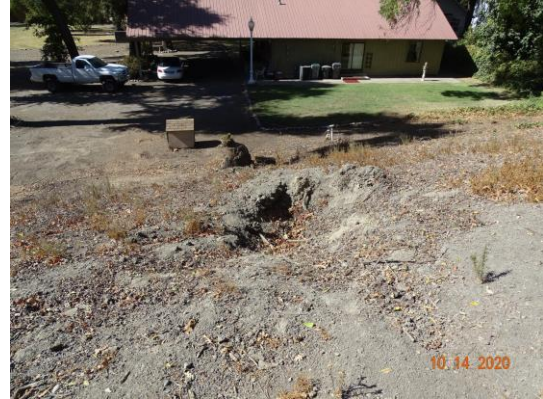
Photo 1 of 1 : SP_2024_RD0999_236_214_20240212_00084.jpg

View of a large hole on the landside slope. Fall 2020

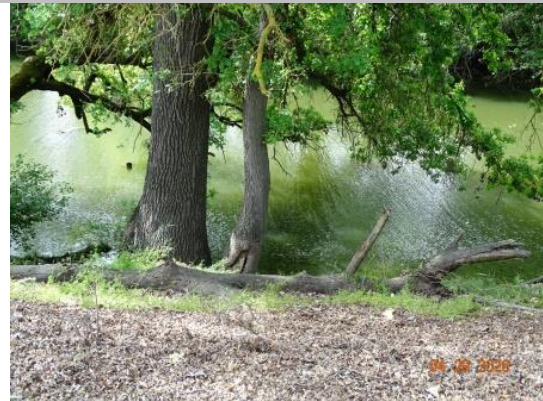
Photo 1 of 1 : SP_2024_RD0999_236_186_20240212_00078.jpg

View of a tree log on the waterside slope. Spring 2020

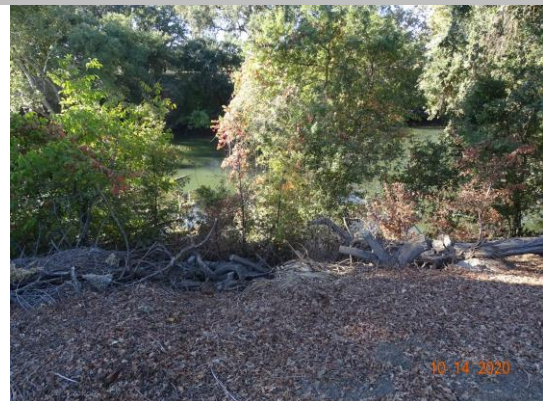
Photo 1 of 1 : SP_2024_RD0999_236_177_20240212_00075.jpg

View of tree logs and limbs on the waterside slope. Fall 2020

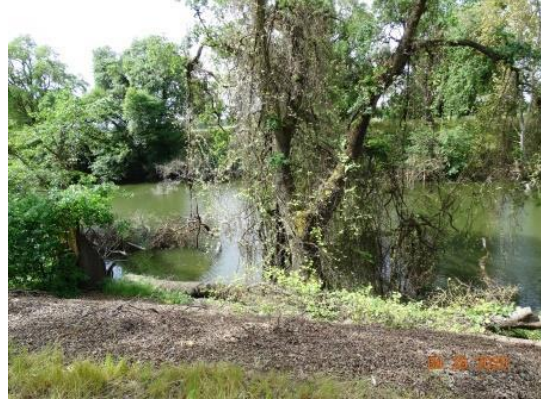
Photo 1 of 1 : SP_2024_RD0999_236_181_20240212_00077.jpg

View of fallen tree on the waterside slope. Spring 2020

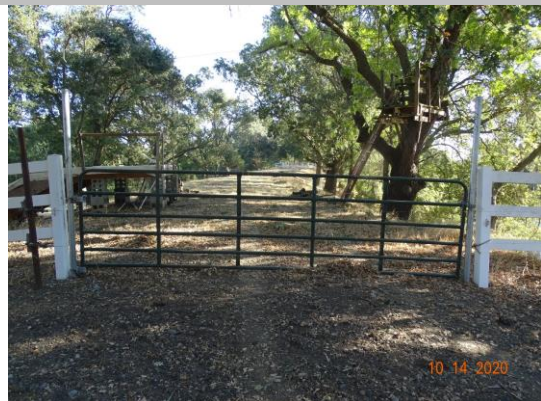
Photo 1 of 1 : SP_2024_RD0999_236_175_20240212_00074.jpg

View of energized wire fencing across the levee crown behind the metal gate. Fall 2020

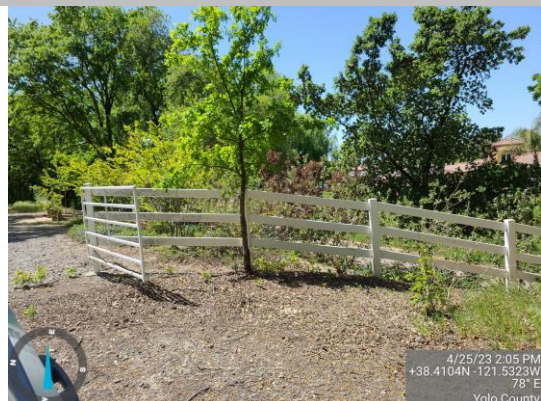
Photo 1 of 1 : SP_2024_RD0999_236_103_20240212_00047.jpg

Fence and gate on the slopes and crown. Spring 2023

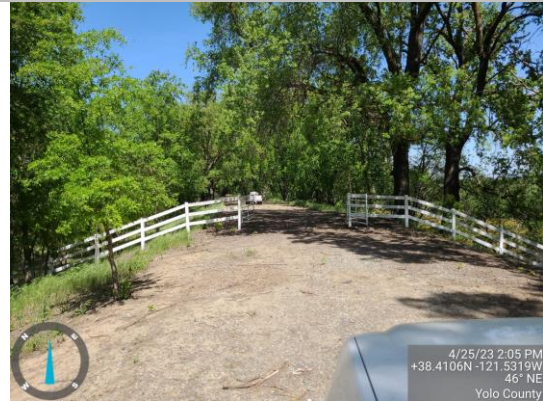
Photo 1 of 1 : SP_2024_RD0999_236_104_20240212_00048.jpg

Gate and fence on the levee. Spring 2023

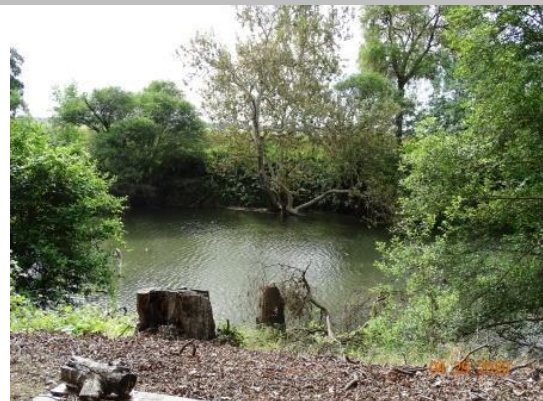
Photo 1 of 1 : SP_2024_RD0999_236_164_20240212_00070.jpg

View of a large tree stump on the waterside slope. Spring 2020

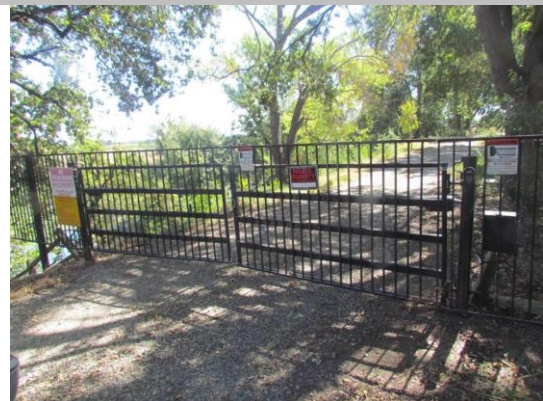
Photo 1 of 1 : SP_2024_RD0999_236_224_20240212_00091.jpg

Looking west at code pad on right side of gate.
