**Flood Control Project Maintenance**  
**2013 Structure Summary Report**  
**Overall Unit and Item Ratings**

**Reclamation District No. 0999 Netherlands**

**Elk Slough Inlet Structure**

Structure Rating	<b>A</b>
Date of Inspection	07/17/2013
DWR Inspector	Richard Willoughby
Accompanied By

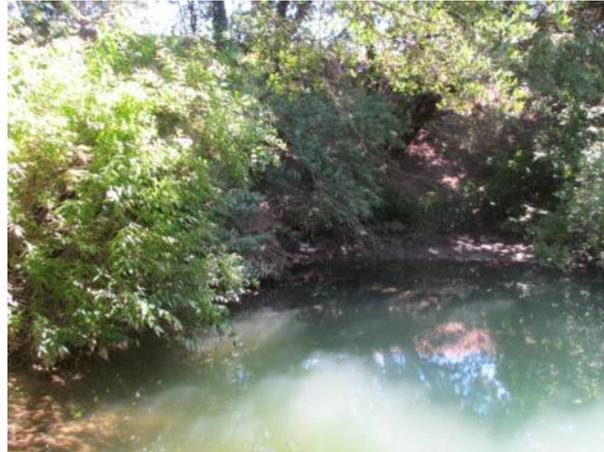
Levee Mile Report Line	1
Start Levee Mile	0.00
End Levee Mile	0.00
Location	
Category	Structures
Item	Photo Documentation
Looking southeast at inlet side of the structure the pipe is not visible due to water level.	
richard_t_20130828_001.JPG

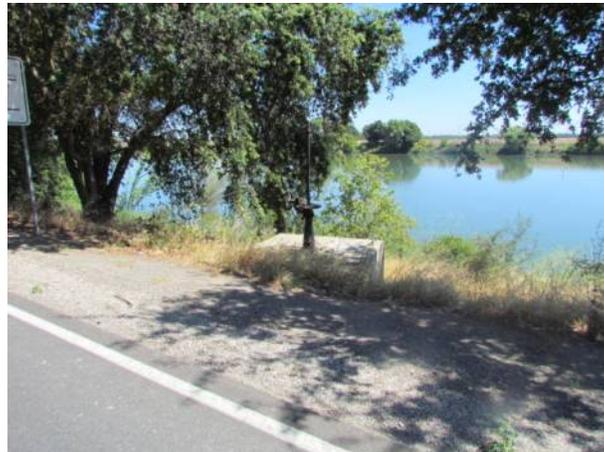
Levee Mile Report Line	1
Start Levee Mile	0.00
End Levee Mile	0.00
Location	
Category	Structures
Item	Photo Documentation
Looking northeast at control structure on waterside of levee.	
richard_t_20130828_003.JPG

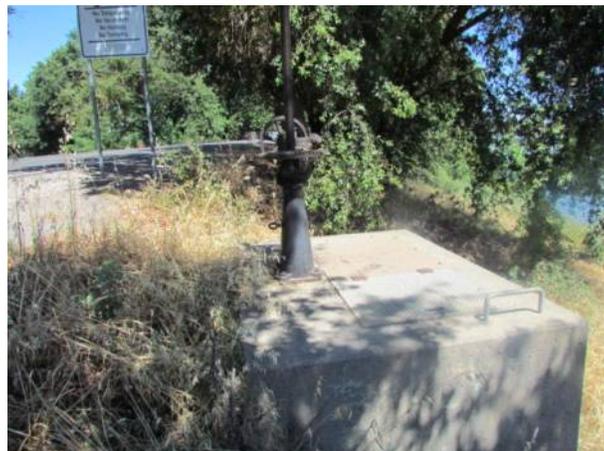
Levee Mile Report Line	1
Start Levee Mile	0.00
End Levee Mile	0.00
Location	
Category	Structures
Item	Photo Documentation
Looking north (upstream) at control structure on waterside of levee.	
richard_t_20130828_004.JPG

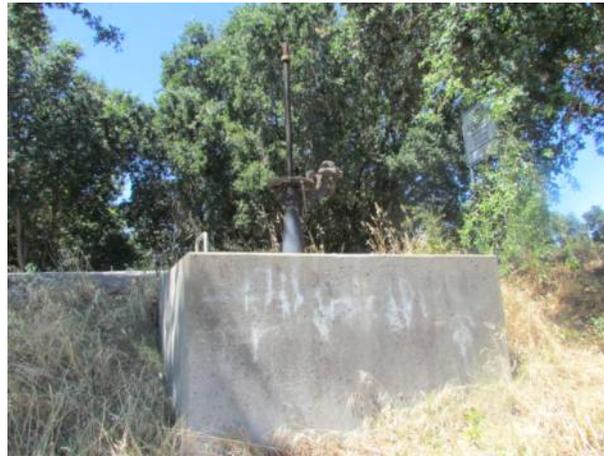
Levee Mile Report Line	1
Start Levee Mile	0.00
End Levee Mile	0.00
Location	
Category	Structures
Item	Photo Documentation
Looking west at control structure on waterside of levee.	
richard_t_20130828_005.JPG

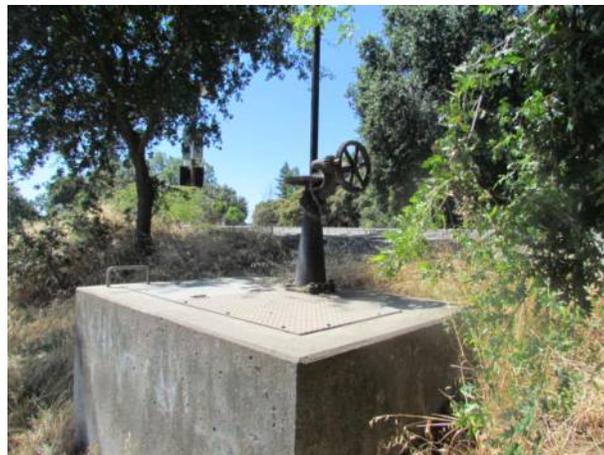
Levee Mile Report Line	1
Start Levee Mile	0.00
End Levee Mile	0.00
Location	
Category	Structures
Item	Photo Documentation
Looking southwest at control structure on waterside of levee.	
richard_t_20130828_006.JPG

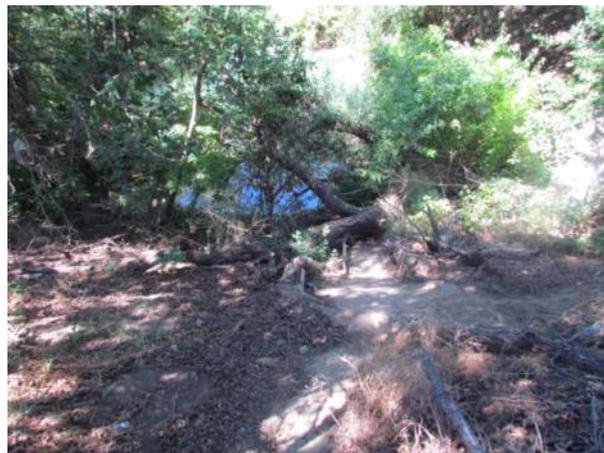
Levee Mile Report Line	2
Start Levee Mile	0.00
End Levee Mile	0.00
Location	
Category	Structures
Item	Vegetation & Obstructions
Looking west at outlet side of structure on landside of the levee pipe not visible due to vegetation and water level.	
richard_t_20130828_007.JPG
