**Flood Control Project Maintenance
Levee Inspections**

Fall 2010 Levee Maintenance Deficiency Summary Report

Reclamation District No. 1000 Natomas

Levee Inspection Report By Mile - Fall 2010

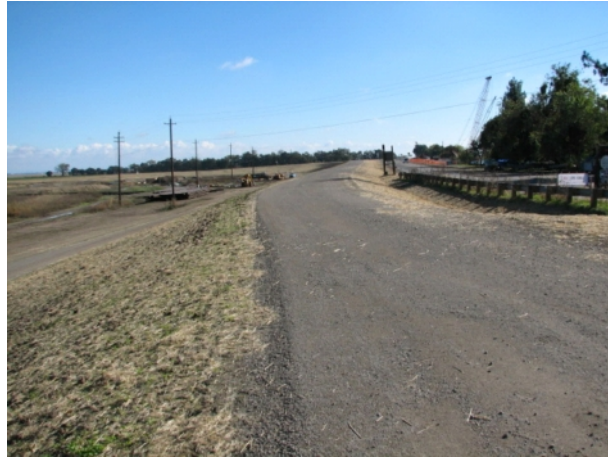
cathom_f_20101122_204.jpg

Levee Mile Report Line	1
Start Levee Mile	0.00
End Levee Mile	0.00
Location	Land Side
Category	Earthen Levee
Item	Vegetation

levee mile 0.00, land side vegetation. This is part of the levee widening.

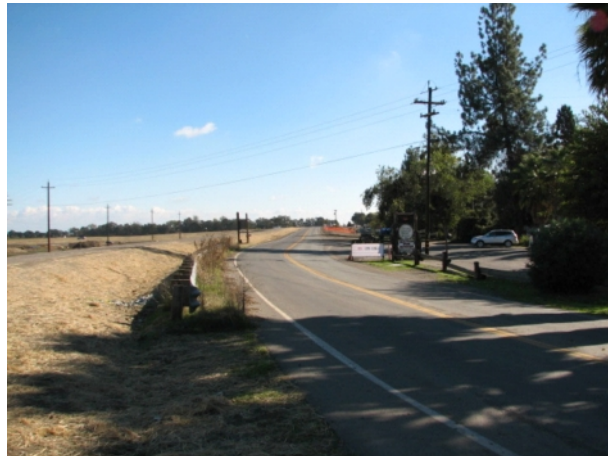
cathom_f_20101122_202.jpg

Levee Mile Report Line	2
Start Levee Mile	0.00
End Levee Mile	0.00
Location	Water Side
Category	Earthen Levee
Item	Vegetation

Levee mile 0.00, vegetation water side.

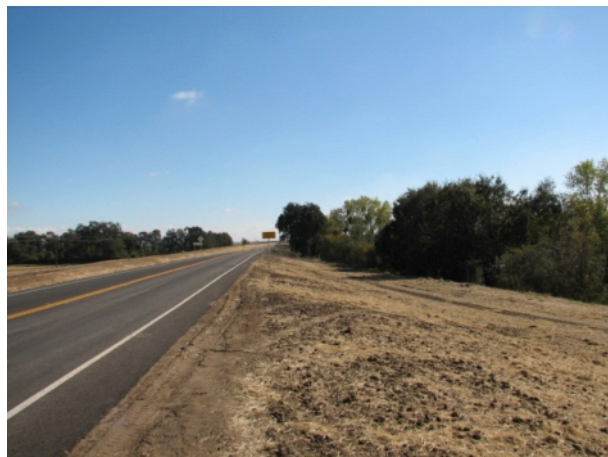
cathom_f_20101122_203.jpg

Levee Mile Report Line	2
Start Levee Mile	0.00
End Levee Mile	0.00
Location	Water Side
Category	Earthen Levee
Item	Vegetation

This is the water side of the levee at levee mile 0.30.

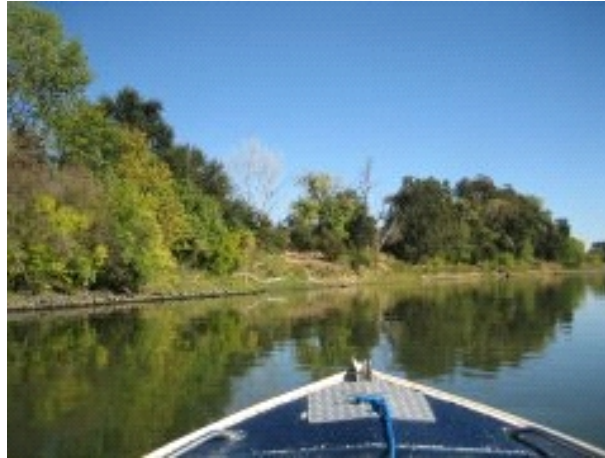
Levee Mile Report Line	5
Start Levee Mile	0.48
End Levee Mile	0.61
Location	Water Side
Category	Supplemental
Item	USACE Erosion Survey
2009: 15 ft berm, 2.5:1 slope, seepage, clays and silts, 4.89 ft/s [2009 SiteID:SAC_78-3_L]	
cathom_f_20100928_025.JPG

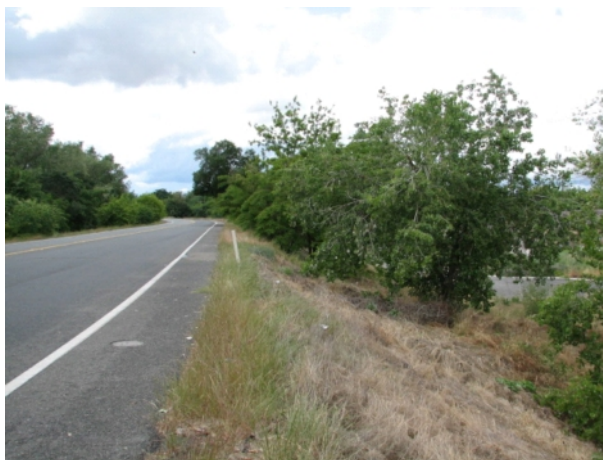
Levee Mile Report Line	1
Start Levee Mile	0.00
End Levee Mile	2.33
Location	Land Side
Category	Earthen Levee
Item	Encroachments
Land side encroachment, landscaping, levee mile 1.68.	
cathom_f_20100928_026.jpg

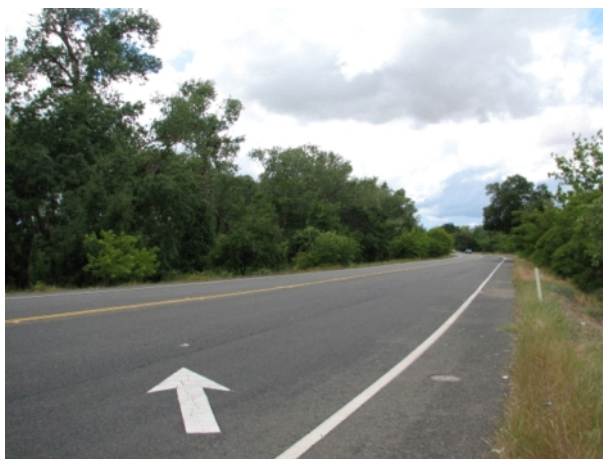
Levee Mile Report Line	2
Start Levee Mile	0.00
End Levee Mile	2.33
Location	Water Side
Category	Earthen Levee
Item	Encroachments
Water side encroachment, landscaping, levee mile 1.68.	
cathom_f_20100928_027.jpg

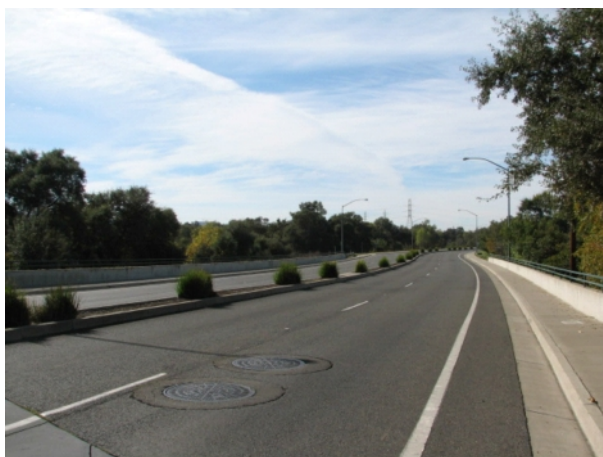
Levee Mile Report Line	3
Start Levee Mile	0.00
End Levee Mile	2.33
Location	Water Side
Category	Earthen Levee
Item	Vegetation
Levee mile 2.33, looking across Garden Hwy at the water side.	
cathom_f_20101108_183.jpg

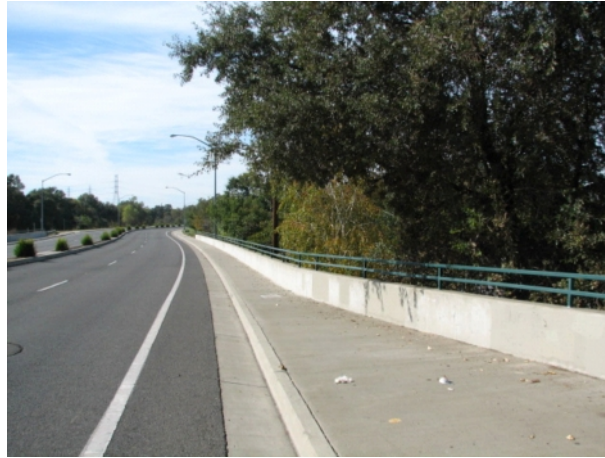
Levee Mile Report Line	4
Start Levee Mile	0.00
End Levee Mile	2.33
Location	Land Side
Category	Earthen Levee
Item	Vegetation
Levee mile 2.33 looking down stream.	
cathom_f_20101108_184.jpg

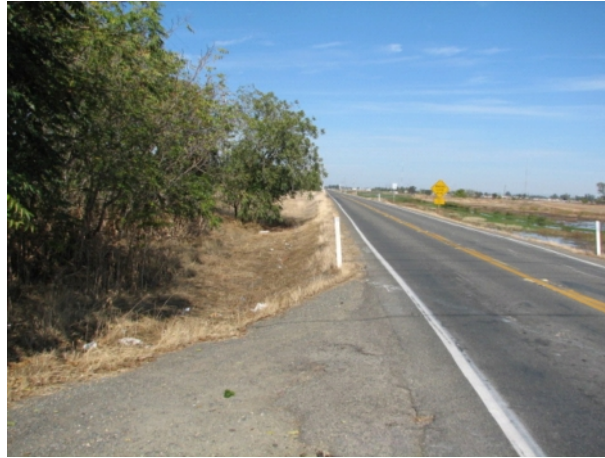
cathom_f_20101101_179.jpg

Levee Mile Report Line	6
Start Levee Mile	5.83
End Levee Mile	17.08
Location	Land Side
Category	Earthen Levee
Item	Vegetation

Levee mile 5.83. land side.

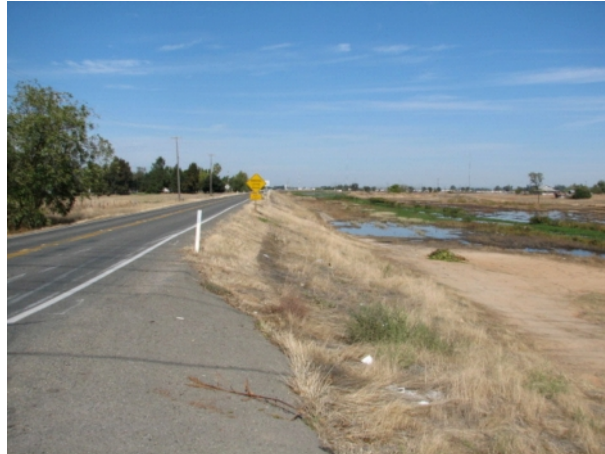
cathom_f_20101101_180.jpg

Levee Mile Report Line	7
Start Levee Mile	5.83
End Levee Mile	17.08
Location	Water Side
Category	Earthen Levee
Item	Vegetation

Levee mile 5.83. water side.

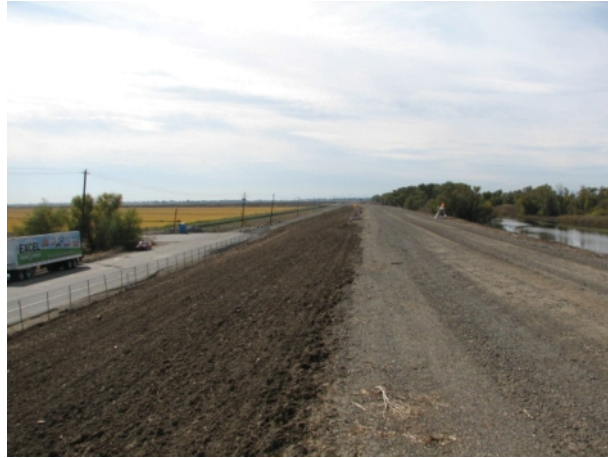
Levee Mile Report Line	1
Start Levee Mile	0.00
End Levee Mile	4.38
Location	Land Side
Category	Earthen Levee
Item	Vegetation
Levee mile 0.00, land side.	
cathom_f_20101101_182.jpg

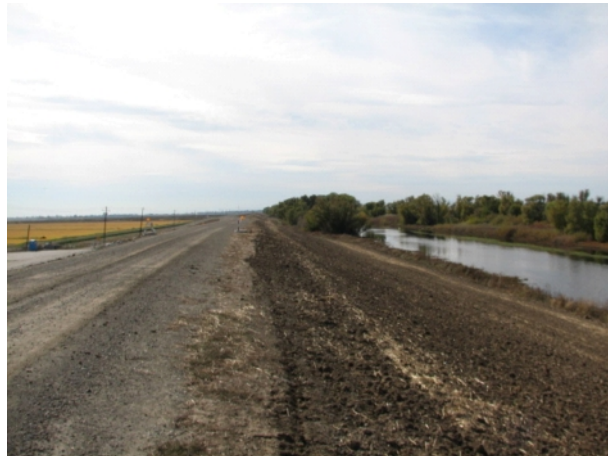
Levee Mile Report Line	2
Start Levee Mile	0.00
End Levee Mile	4.38
Location	Water Side
Category	Earthen Levee
Item	Vegetation
Levee mile 0.00, water side.	
cathom_f_20101101_181.jpg
