**Flood Control Project Maintenance  
Levee Inspections**

**Fall 2011 Levee Maintenance Deficiency Summary Report**

**Sacramento River Basin**

**Reclamation District No. 1000 Natomas**

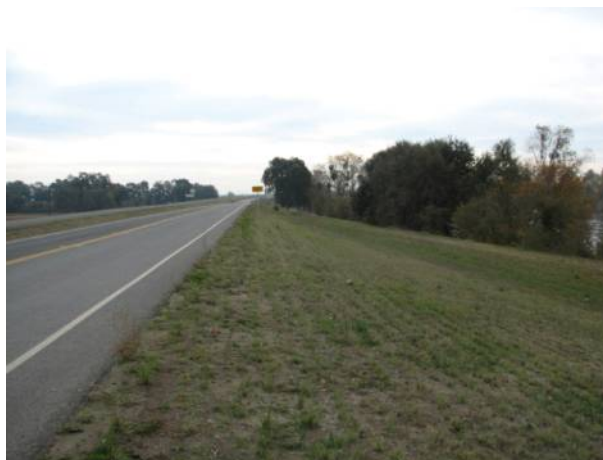
Levee Mile Report Line	1
Start Levee Mile	0.05
End Levee Mile	18.27
Location	Water Side
Category	Earthen Levee
Item	Vegetation

This photo shows the waterside vegetation at levee mile 0.30.

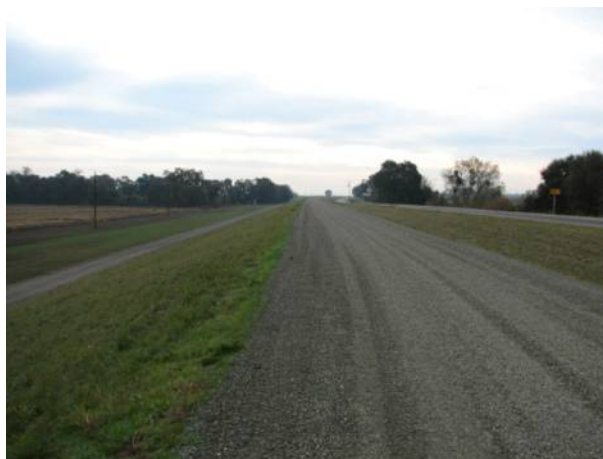
Levee Mile Report Line	2
Start Levee Mile	0.05
End Levee Mile	18.27
Location	Land Side
Category	Earthen Levee
Item	Vegetation

This photo shows the landside vegetation at levee mile 0.30.

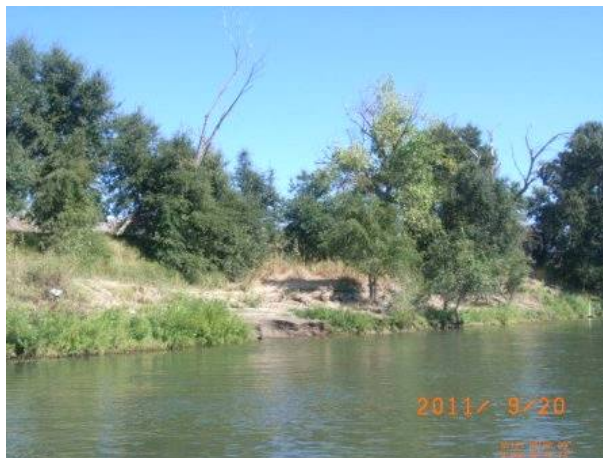
Levee Mile Report Line	5
Start Levee Mile	0.43
End Levee Mile	0.49
Location	Water Side
Category	Supplemental
Item	USACE Erosion Survey

USACE 2011 Photo #1

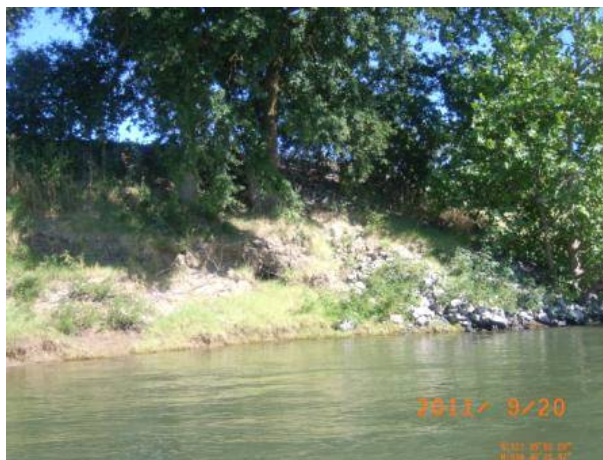
Levee Mile Report Line	5
Start Levee Mile	0.43
End Levee Mile	0.49
Location	Water Side
Category	Supplemental
Item	USACE Erosion Survey

USACE 2011 Photo #2

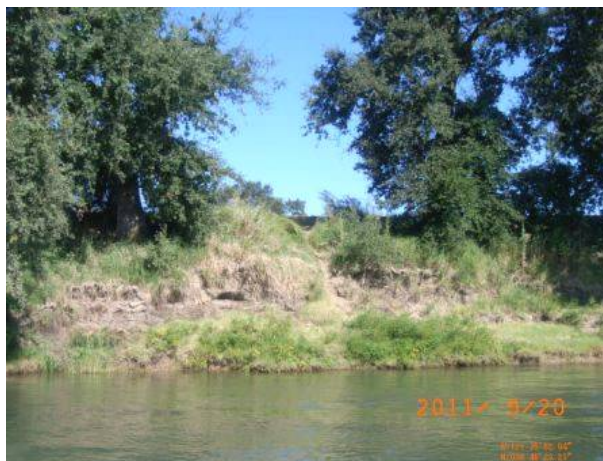
Levee Mile Report Line	5
Start Levee Mile	0.43
End Levee Mile	0.49
Location	Water Side
Category	Supplemental
Item	USACE Erosion Survey

USACE 2011 Photo #3

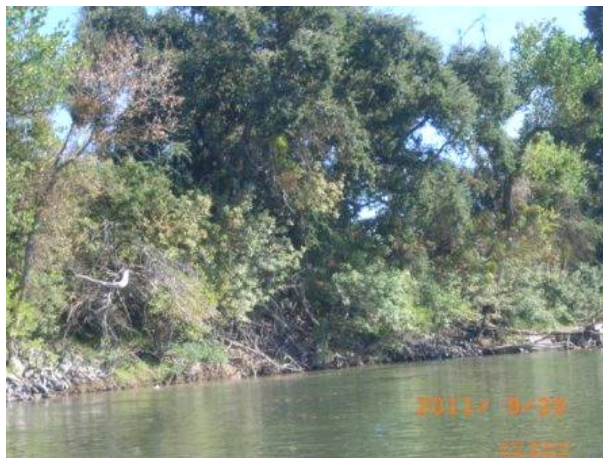
Levee Mile Report Line	6
Start Levee Mile	1.44
End Levee Mile	1.63
Location	Water Side
Category	Supplemental
Item	USACE Erosion Survey

6	1.44	1.63	Supplemental	USACE Erosion Survey	WS	M	Inspector Comments: 1997 - Levee section problem at irrigation pump; levee veers away from river on the downstream end. 2005 - Site was staked and rock was stockpiled along the top of the bank. 2006 - Minor new erosion. 2010 - New adjacent levee is under construction. 2011: New erosion. Site is under contract for repair, expected completion in 2012. [2011 Site ID: SAC_77-2_L]	38.761061 ° -121.591885 °	38.759210 ° -121.592102 °	39 Y
7	1.69	1.71	Earthen Levee	Encroachments	WS PO		Landscaping	38.758697 ° -121.591178 °	38.758447 ° -121.591253 °	136
8	1.74	1.77	Earthen Levee	Encroachments	WS PO		Landscaping	38.757962 ° -121.591342 °	38.757480 ° -121.591147 °	135
9	1.77	1.79	Earthen Levee	Encroachments	WS PO		Landscaping	38.757478 ° -121.591140 °	38.757238 ° -121.591272 °	134
10	1.88	1.91	Earthen Levee	Encroachments	WS PO		Landscaping	38.755975 ° -121.591433 °	38.755585 ° -121.591530 °	133

USACE 2011 Photo #1

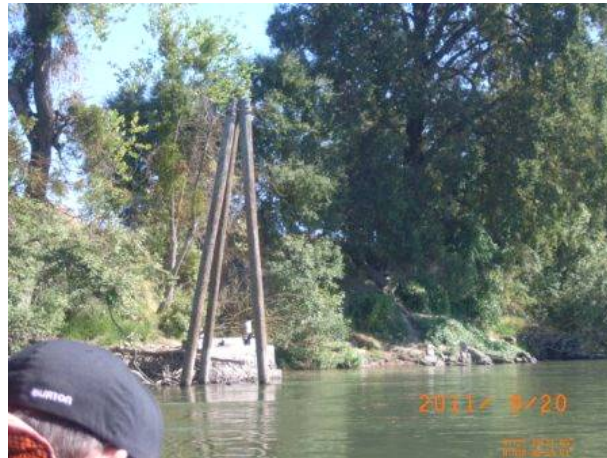
Levee Mile Report Line	6
Start Levee Mile	1.44
End Levee Mile	1.63
Location	Water Side
Category	Supplemental
Item	USACE Erosion Survey

USACE 2011 Photo #2

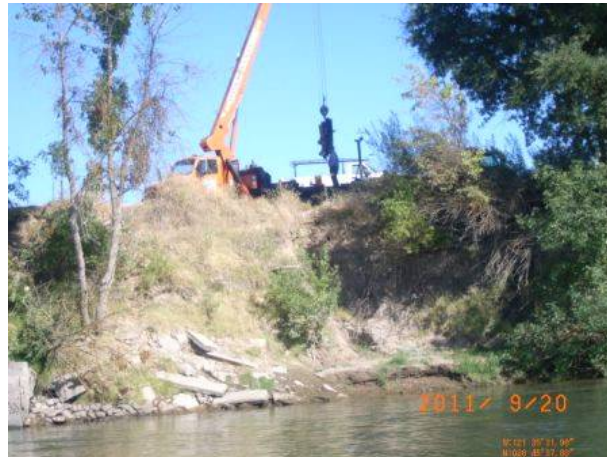
Levee Mile Report Line	6
Start Levee Mile	1.44
End Levee Mile	1.63
Location	Water Side
Category	Supplemental
Item	USACE Erosion Survey

USACE 2011 Photo #3

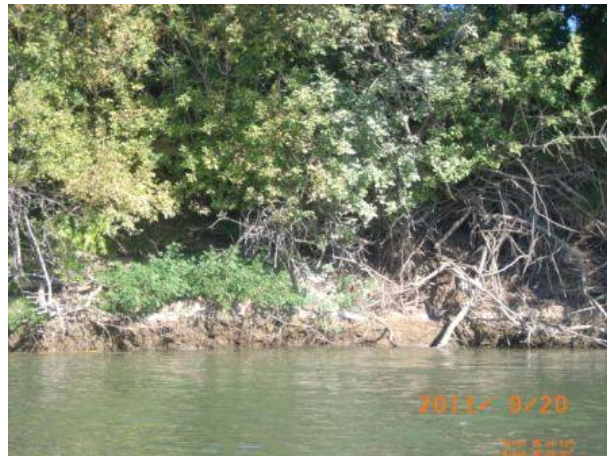
Levee Mile Report Line	6
Start Levee Mile	1.44
End Levee Mile	1.63
Location	Water Side
Category	Supplemental
Item	USACE Erosion Survey

USACE 2011 Photo #4

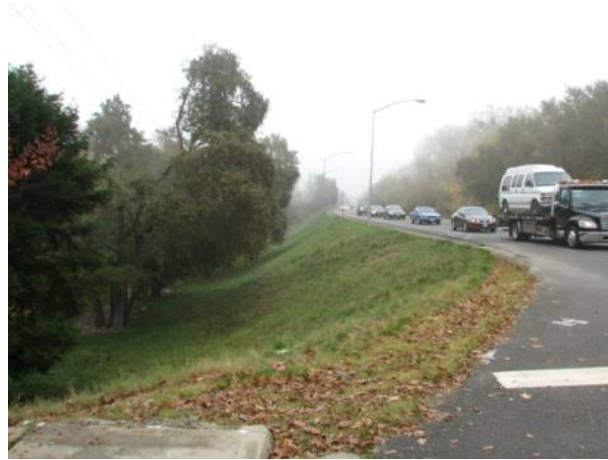
Levee Mile Report Line	1
Start Levee Mile	0.00
End Levee Mile	2.33
Location	Land Side
Category	Earthen Levee
Item	Vegetation

This photo shows the landside vegetation at levee mile 0.56.

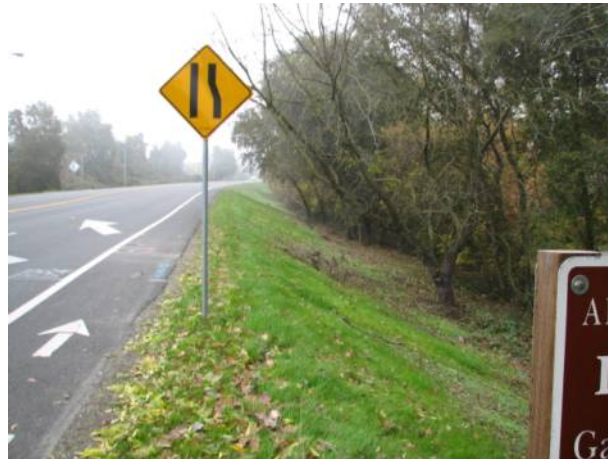
Levee Mile Report Line	2
Start Levee Mile	0.00
End Levee Mile	2.33
Location	Water Side
Category	Earthen Levee
Item	Vegetation

This photo shows the waterside vegetation at levee mile 0.56.

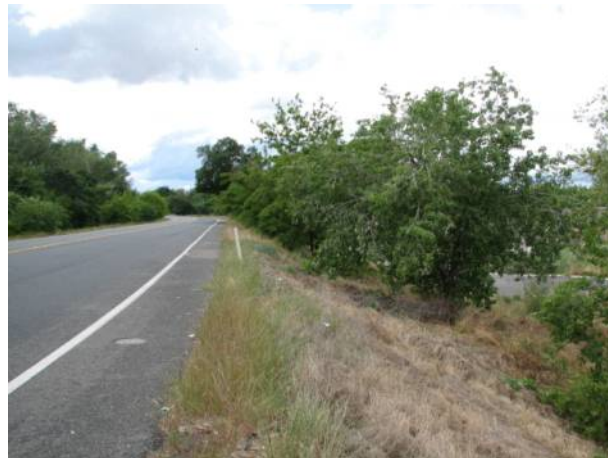
Levee Mile Report Line	3
Start Levee Mile	0.56
End Levee Mile	2.33
Location	Land Side
Category	Earthen Levee
Item	Encroachments

Land side encroachment, landscaping, levee mile 1.68.

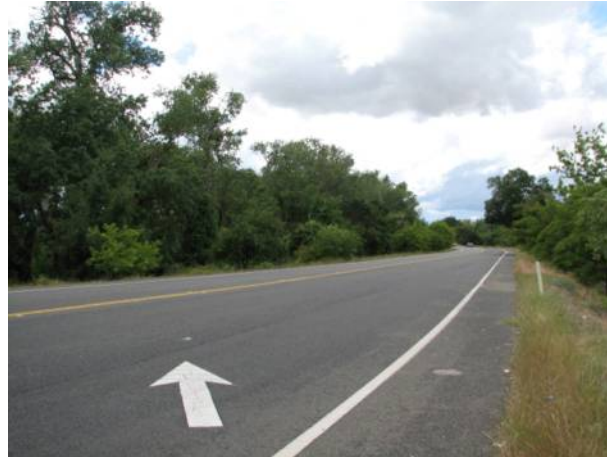
Levee Mile Report Line	4
Start Levee Mile	0.56
End Levee Mile	2.33
Location	Water Side
Category	Earthen Levee
Item	Encroachments
Water side encroachment, landscaping, levee mile 1.68.	
cathom_f_20111010_378.jpg

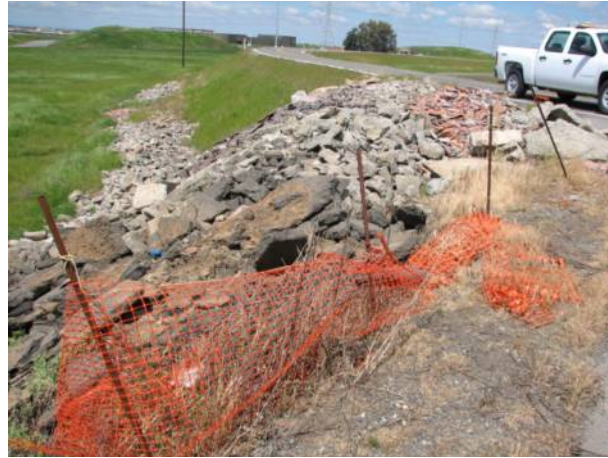
Levee mile 5.03, this is the landside shoulder and slope.

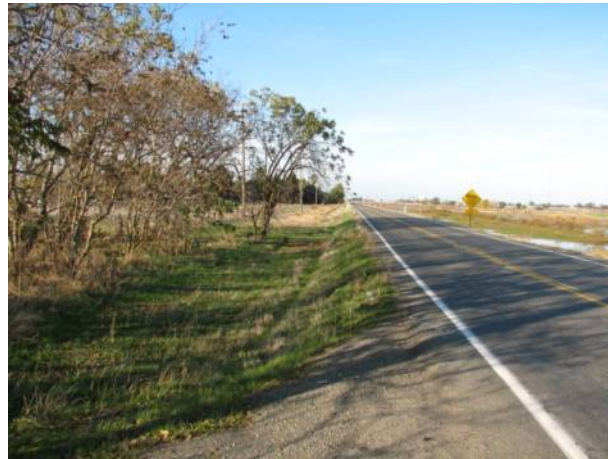
Levee Mile Report Line	9
Start Levee Mile	5.83
End Levee Mile	17.11
Location	Land Side
Category	Earthen Levee
Item	Vegetation

This photo shows the landside vegetation at levee mile 5.83.

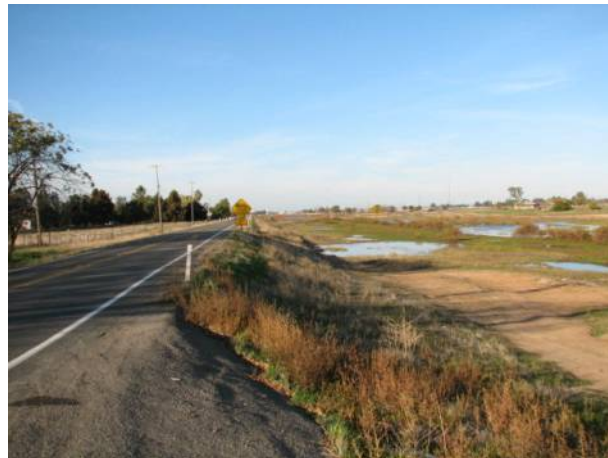
Levee Mile Report Line	10
Start Levee Mile	5.83
End Levee Mile	17.11
Location	Water Side
Category	Earthen Levee
Item	Vegetation

This photo shows the waterside vegetation at levee mile 5.83.

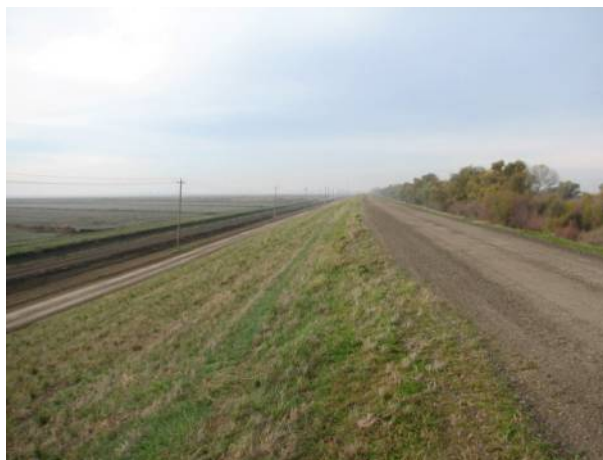
This photo shows the landside vegetation at levee mile 0.23.

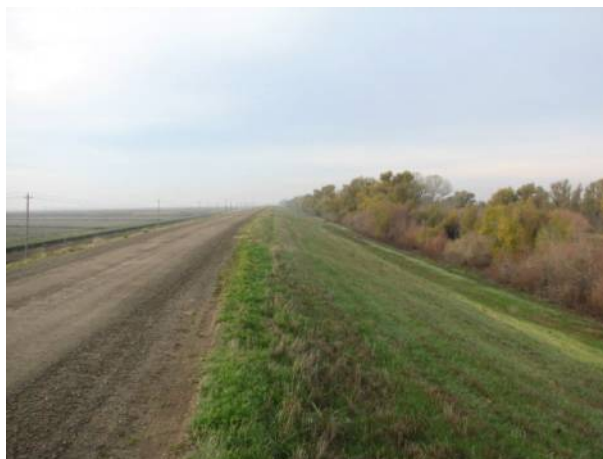
Levee Mile Report Line	2
Start Levee Mile	0.12
End Levee Mile	4.33
Location	Water Side
Category	Earthen Levee
Item	Vegetation

This photo shows the waterside vegetation at levee mile 0.23.
