**Flood Control Project Maintenance
Levee Inspections**

Fall 2012 Levee Maintenance Deficiency Summary Report

Sacramento River Basin

Reclamation District No. 1000 Natomas

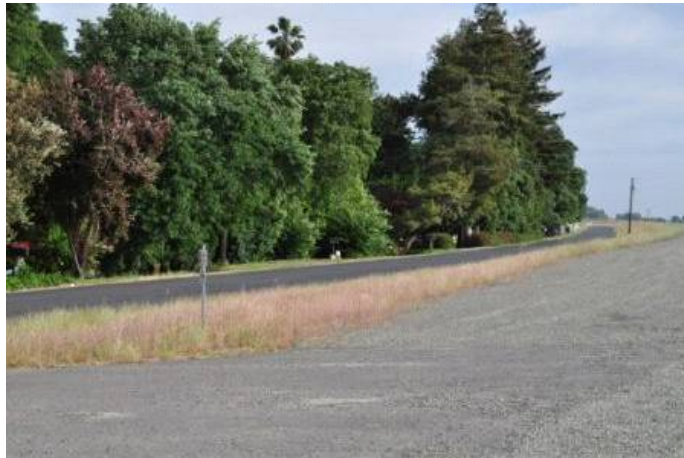
Levee Mile Report Line	5
Start Levee Mile	0.18
End Levee Mile	0.22
Location	Water Side
Category	Earthen Levee
Item	Vegetation

RD 1000 Unit 1 W/S - Landscaping - Typical throughout unit.

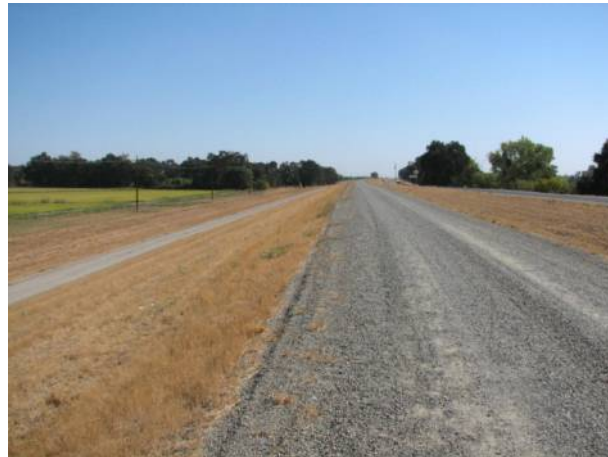
Levee Mile Report Line	6
Start Levee Mile	0.20
End Levee Mile	18.20
Location	Land Side
Category	Earthen Levee
Item	Vegetation

Levee mile 0.20, The landside levee slope.

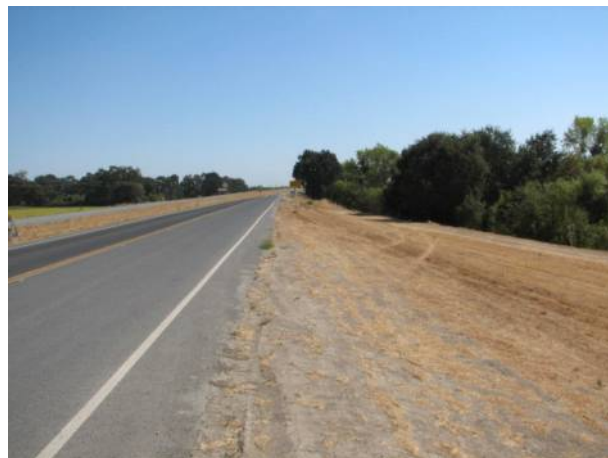
Levee Mile Report Line	7
Start Levee Mile	0.20
End Levee Mile	18.20
Location	Water Side
Category	Earthen Levee
Item	Vegetation

Levee mile 0.20, The waterside slope.

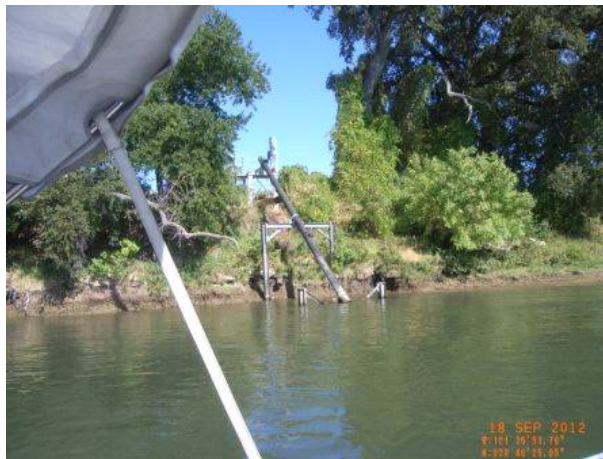
Levee Mile Report Line	8
Start Levee Mile	0.51
End Levee Mile	0.61
Location	Water Side
Category	Supplemental
Item	USACE Erosion Survey

USACE 2012 Photo #2

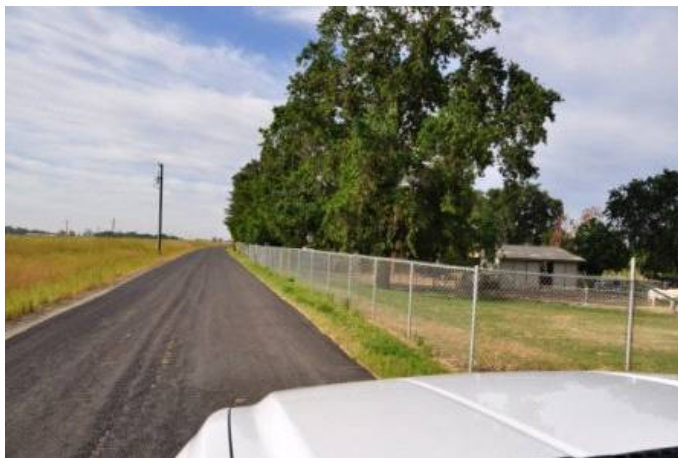
Levee Mile Report Line	9
Start Levee Mile	1.65
End Levee Mile	1.65
Location	Water Side
Category	Earthen Levee
Item	Encroachments

Unauthorized encroachment, 'Fence'

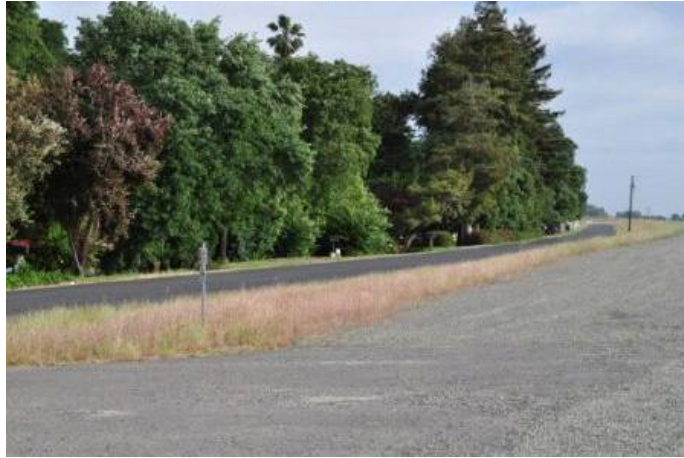
Typical Garden Hwy 'Landscaping'

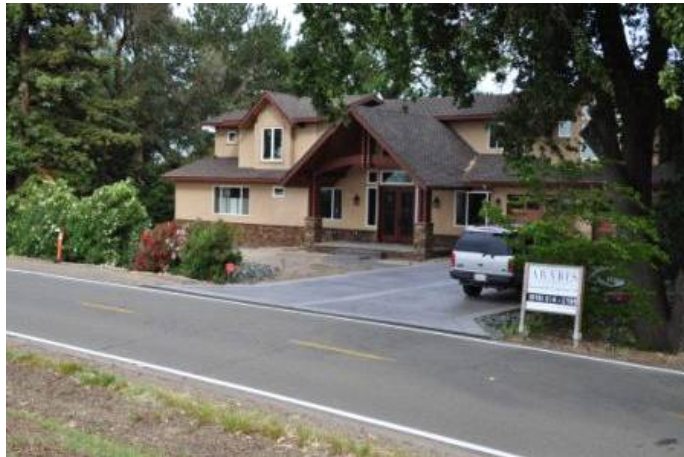
Levee Mile Report Line	29
Start Levee Mile	6.57
End Levee Mile	6.57
Location	Water Side
Category	Earthen Levee
Item	Encroachments

Newly Constructed Home

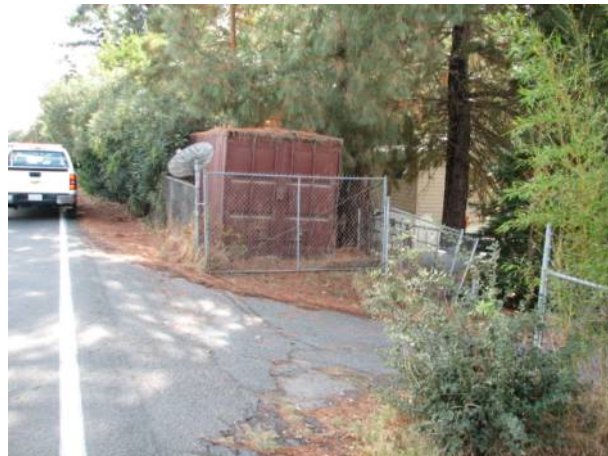
Levee Mile Report Line	99
Start Levee Mile	15.35
End Levee Mile	15.35
Location	Water Side
Category	Earthen Levee
Item	Encroachments

Levee mile 15.35, cargo container on levee shoulder, the property appears to be on fill material.

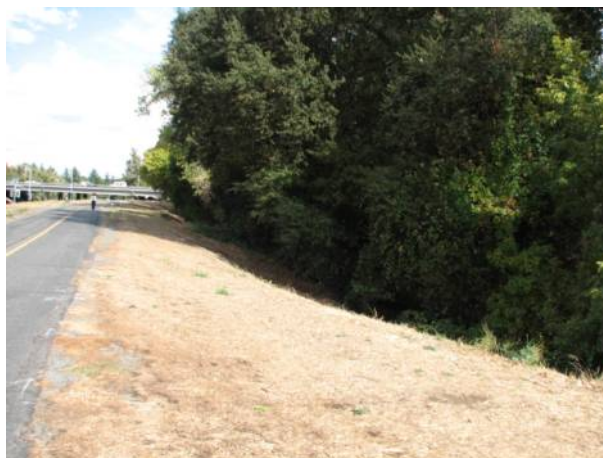
Levee mile 0.00, waterside levee slope.

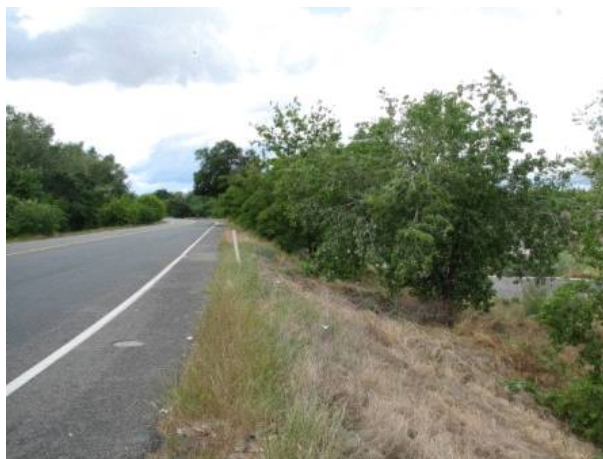
Levee Mile Report Line	2
Start Levee Mile	0.56
End Levee Mile	2.33
Location	Land Side
Category	Earthen Levee
Item	Encroachments

Landside encroachment, landscaping, levee mile 1.68.

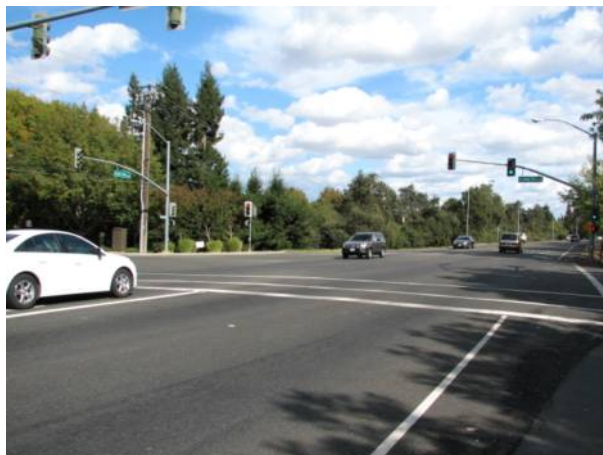
Levee Mile Report Line	2
Start Levee Mile	0.56
End Levee Mile	2.33
Location	Land Side
Category	Earthen Levee
Item	Encroachments

Levee mile 0.56. This photo is looking upstream from the waterside levee shoulder to the landside shoulder.

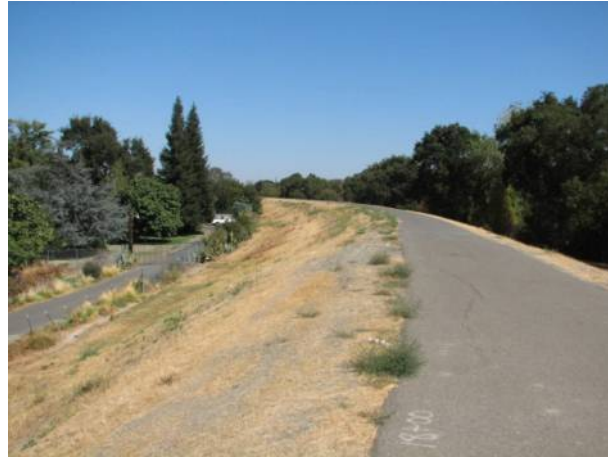
Levee mile 0.05, The landside slope of the levee.

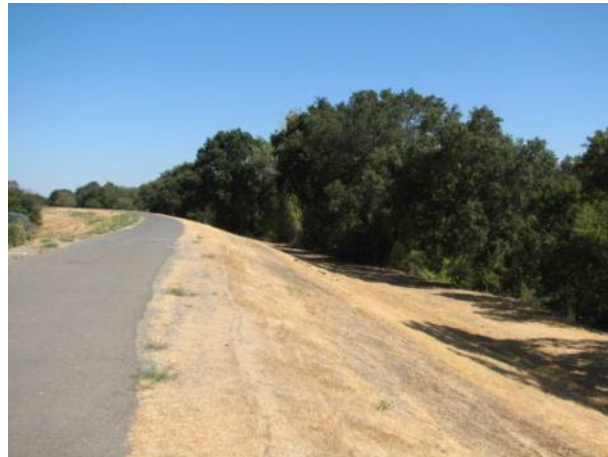
Levee Mile Report Line	2
Start Levee Mile	0.05
End Levee Mile	16.90
Location	Water Side
Category	Earthen Levee
Item	Vegetation

Levee mile 0.05. This is the waterside slope of the levee.

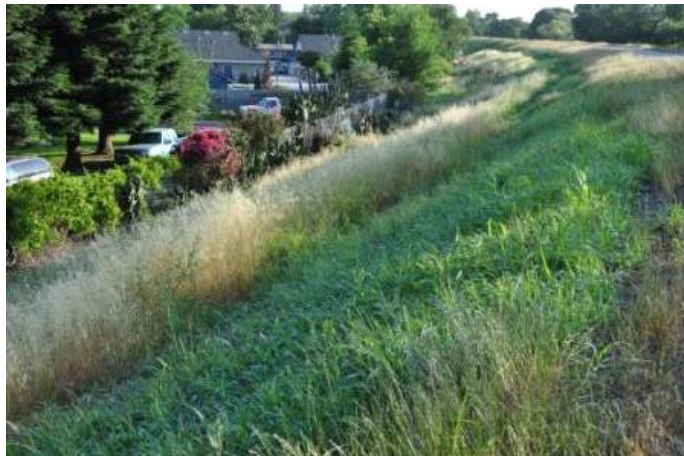
Levee Mile Report Line	3
Start Levee Mile	0.07
End Levee Mile	0.13
Location	Land Side
Category	Earthen Levee
Item	Encroachments

Fence with vegetation at L/S toe.

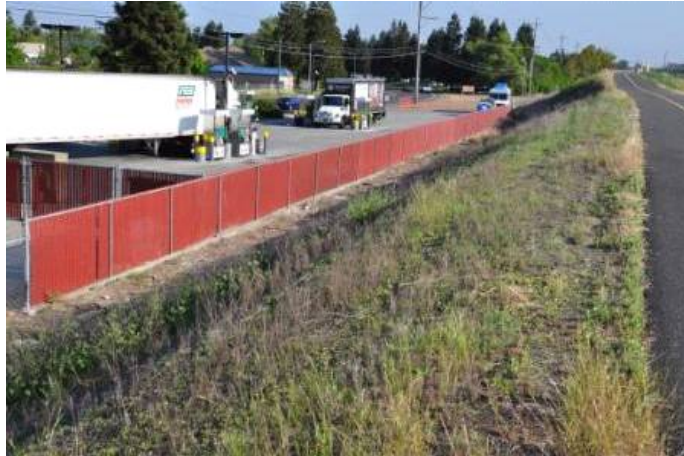
Fence within 10' of L/S toe.

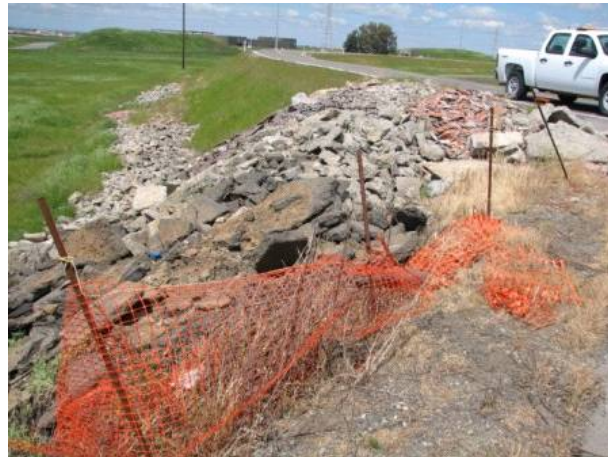
Levee Mile Report Line	12
Start Levee Mile	5.03
End Levee Mile	5.03
Location	Land Side
Category	Earthen Levee
Item	Encroachments

Levee mile 5.03, this is the landside shoulder and slope.

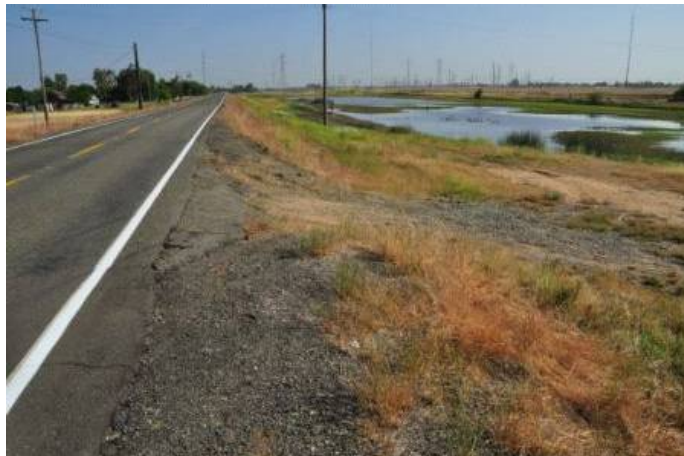
Levee Mile Report Line	13
Start Levee Mile	6.82
End Levee Mile	6.82
Location	Water Side
Category	Earthen Levee
Item	Slope Stability

W/S slope damage. Control vehicle traffic.

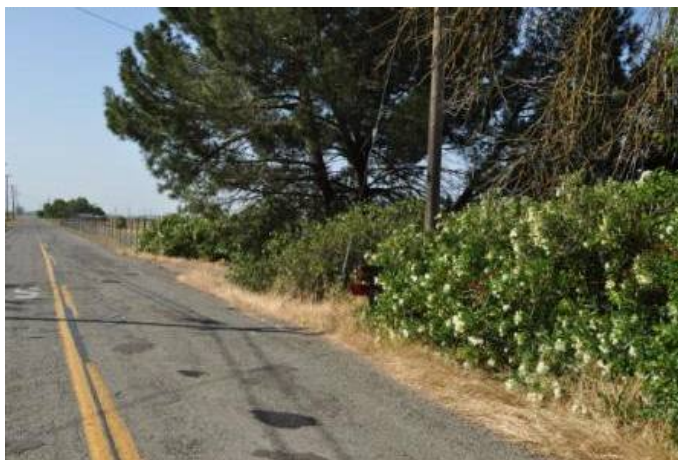
L/S landscaping.

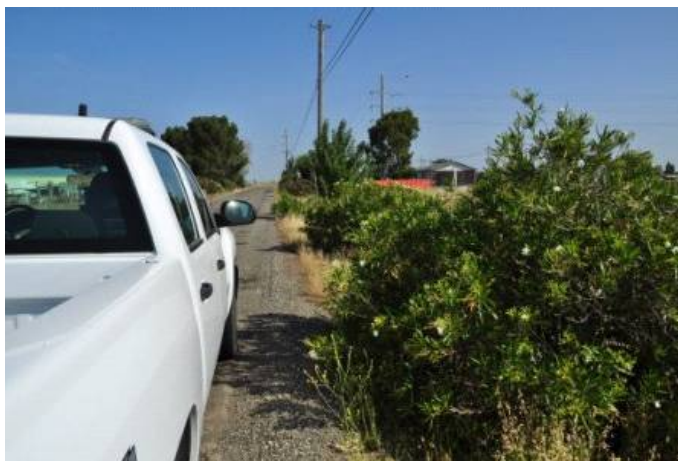
Levee Mile Report Line	15
Start Levee Mile	12.54
End Levee Mile	12.63
Location	Water Side
Category	Earthen Levee
Item	Vegetation

W/S vegetation.

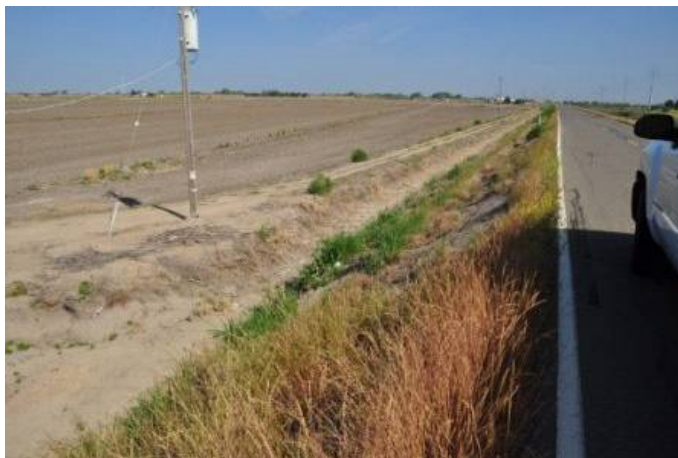
Levee Mile Report Line	16
Start Levee Mile	15.51
End Levee Mile	16.07
Location	Land Side
Category	Earthen Levee
Item	Encroachments

L/S Ag ditch @ L/S toe.

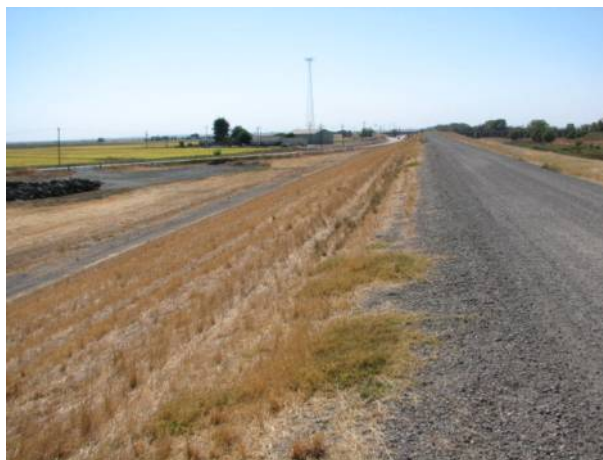
Levee mile 0.05. The landside levee slope.

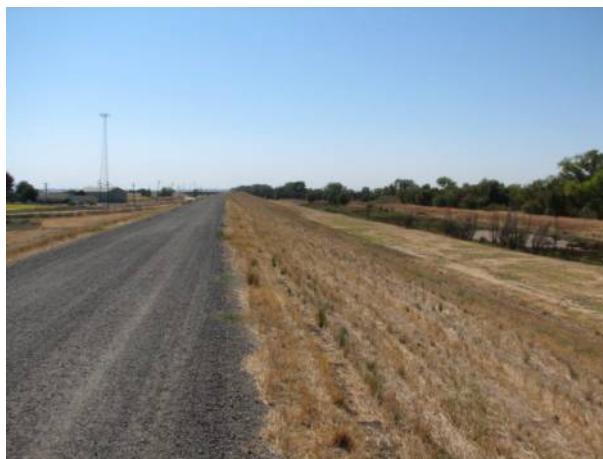
Levee Mile Report Line	2
Start Levee Mile	0.05
End Levee Mile	4.32
Location	Water Side
Category	Earthen Levee
Item	Vegetation

Levee mile 0.05. The waterside slope of the levee.
