**Flood Control Project Maintenance
Levee Inspections**

Fall 2013 Levee Maintenance Deficiency Summary Report

Sacramento River Basin

Reclamation District No. 1000 Natomas

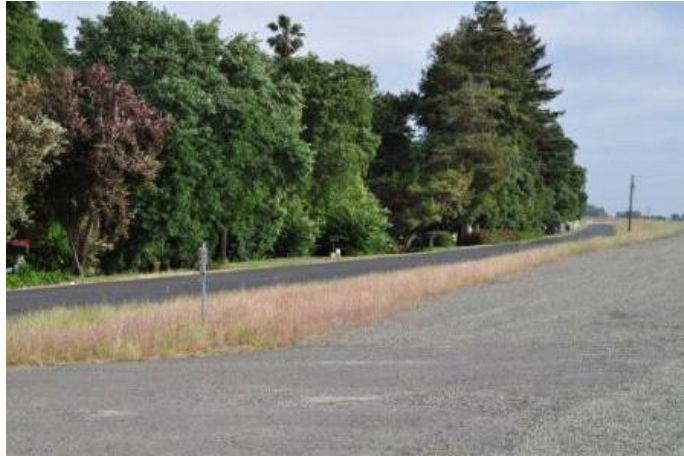
Levee Mile Report Line	2
Start Levee Mile	0.18
End Levee Mile	0.22
Location	Water Side
Category	Earthen Levee
Item	Vegetation

RD 1000 Unit 1 W/S - Landscaping - Typical throughout unit.

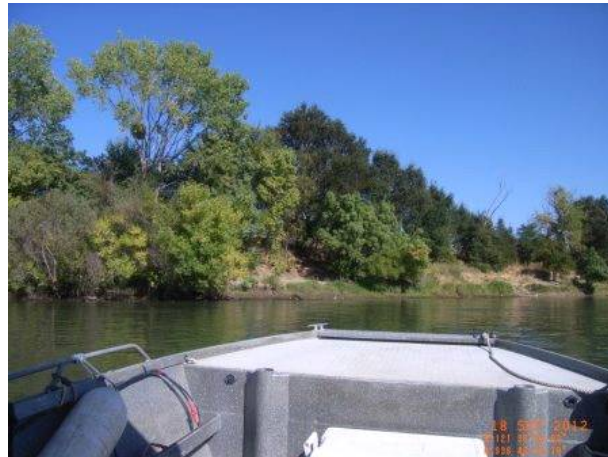
USACE 2012 Photo #1

Levee Mile Report Line	3
Start Levee Mile	0.51
End Levee Mile	0.61
Location	Water Side
Category	Supplemental
Item	USACE Erosion Survey

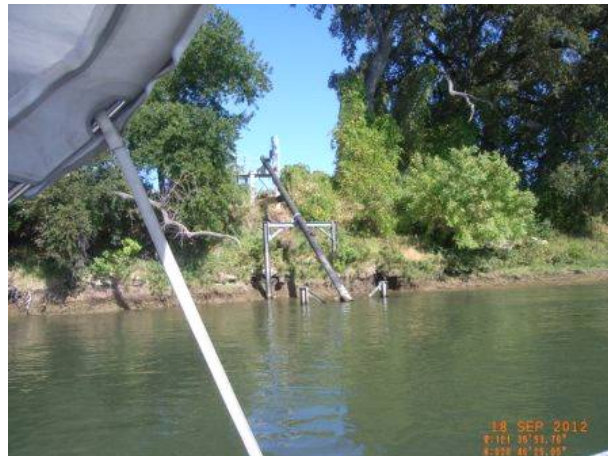
USACE 2012 Photo #2

Levee Mile Report Line	3
Start Levee Mile	0.51
End Levee Mile	0.61
Location	Water Side
Category	Supplemental
Item	USACE Erosion Survey

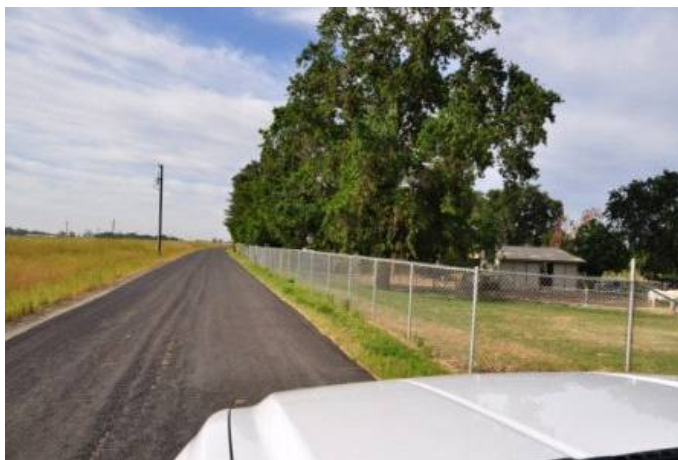
Levee Mile Report Line	4
Start Levee Mile	1.65
End Levee Mile	1.65
Location	Water Side
Category	Earthen Levee
Item	Encroachments

Unauthorized encroachment, 'Fence'

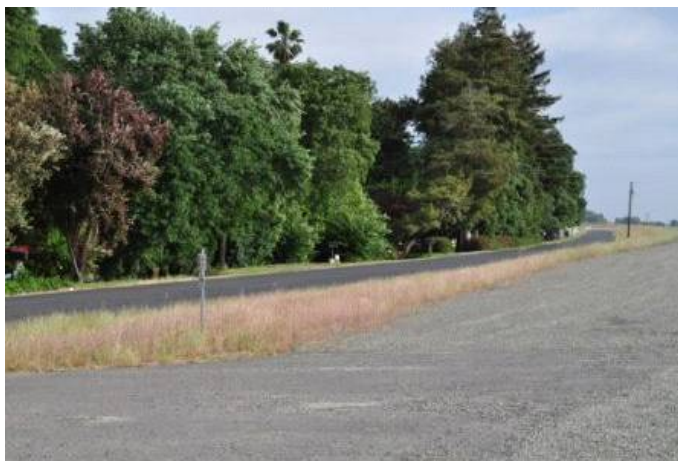
Levee Mile Report Line	7
Start Levee Mile	1.88
End Levee Mile	1.91
Location	Water Side
Category	Earthen Levee
Item	Vegetation

Typical Garden Hwy 'Landscaping'

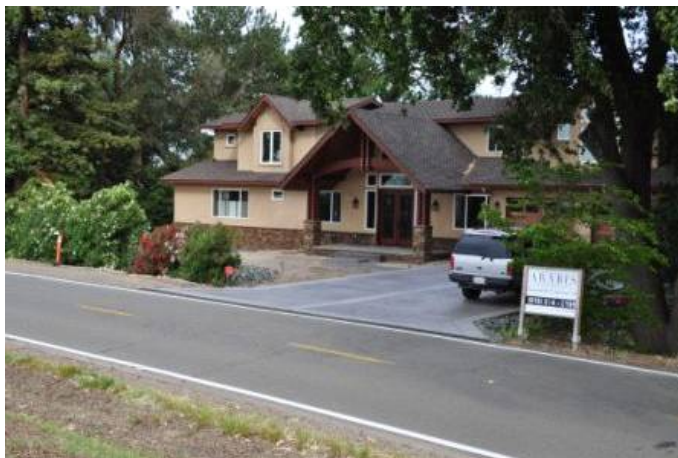
Levee Mile Report Line	23
Start Levee Mile	6.57
End Levee Mile	6.57
Location	Water Side
Category	Earthen Levee
Item	Encroachments

Newly Constructed Home

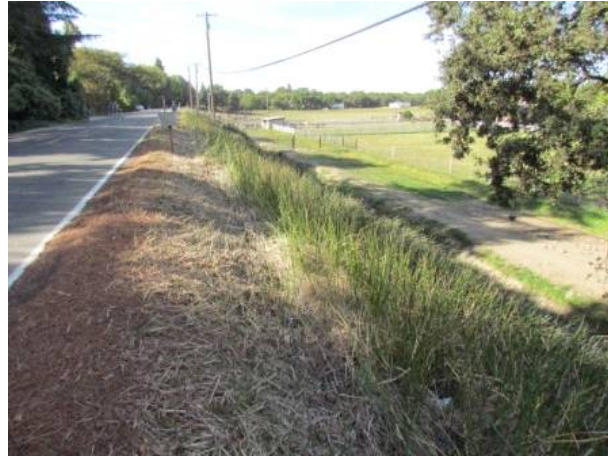
Levee Mile Report Line	75
Start Levee Mile	13.31
End Levee Mile	14.01
Location	Land Side
Category	Earthen Levee
Item	Vegetation

This photo was taken from the crown of the levee facing west looking at the joint grass on the landward slope.

DWR ID: DWR_RD1000_01_s_2012_52										
75	13.31	14.01	Earthen Levee	Vegetation	LS	M Ma	V1 : Control annual grass and weeds on the levee slopes and easements.	38.641163 ° -121.562661 °	38.631303 ° -121.560729 °	12 Y
DWR ID: DWR_RD1000_01_f_2013_12										
76	13.34	17.63	Earthen Levee	Encroachments	LS	M En	DT : Ditch	38.640469 ° -121.562502 °	38.605560 ° -121.528054 °	956
DWR ID: DWR_RD1000_01_s_2012_956										
77	13.36	13.41	Earthen Levee	Vegetation	WS	M En	V6 : Landscaping	38.640205 ° -121.562370 °	38.639540 ° -121.562238 °	51
DWR ID: DWR_RD1000_01_s_2012_51										
78	13.47	13.51	Earthen Levee	Vegetation	WS	M En	V6 : Landscaping	38.638668 ° -121.562085 °	38.638065 ° -121.562015 °	50
DWR ID: DWR_RD1000_01_s_2012_50										
79	13.51	13.55	Earthen Levee	Vegetation	WS	M En	V6 : Landscaping	38.638067 ° -121.562013 °	38.637600 ° -121.561932 °	49
DWR ID: DWR_RD1000_01_s_2012_49

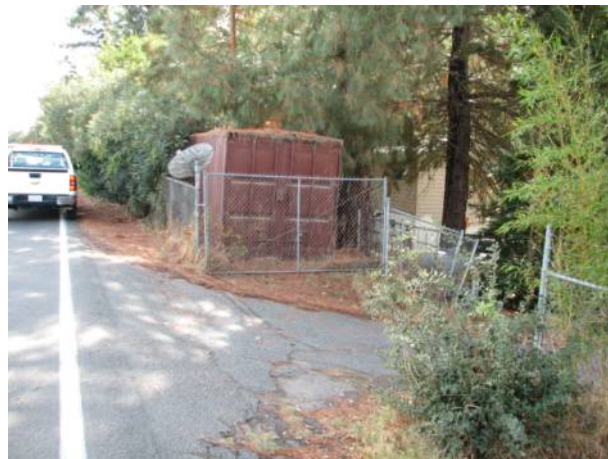
Levee Mile Report Line	94
Start Levee Mile	15.35
End Levee Mile	15.35
Location	Water Side
Category	Earthen Levee
Item	Encroachments

Levee mile 15.35, cargo container on levee shoulder, the property appears to be on fill material.

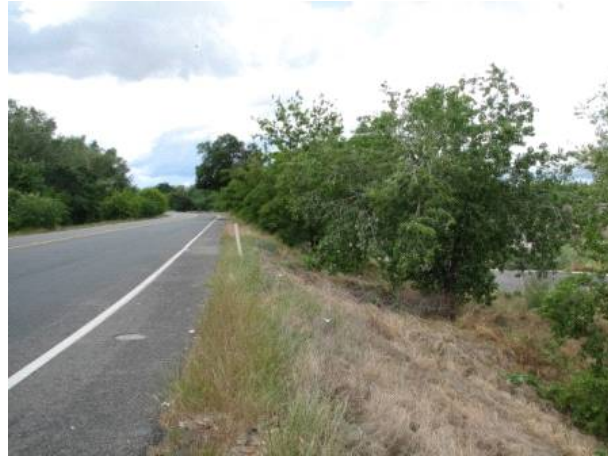
Levee Mile Report Line	1
Start Levee Mile	0.56
End Levee Mile	2.33
Location	Land Side
Category	Earthen Levee
Item	Encroachments
Landside encroachment, landscaping, levee mile 1.68.	
mhoffman_f_20130917_112.jpg

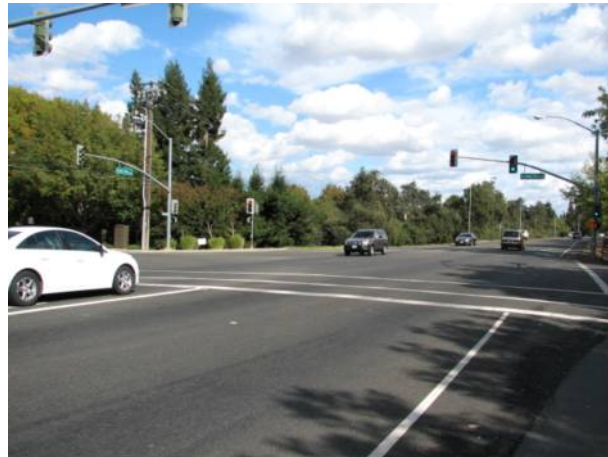
Levee Mile Report Line	1
Start Levee Mile	0.56
End Levee Mile	2.33
Location	Land Side
Category	Earthen Levee
Item	Encroachments
Levee mile 0.56. This photo is looking upstream from the waterside levee shoulder to the landside shoulder.	
mhoffman_f_20130917_113.JPG

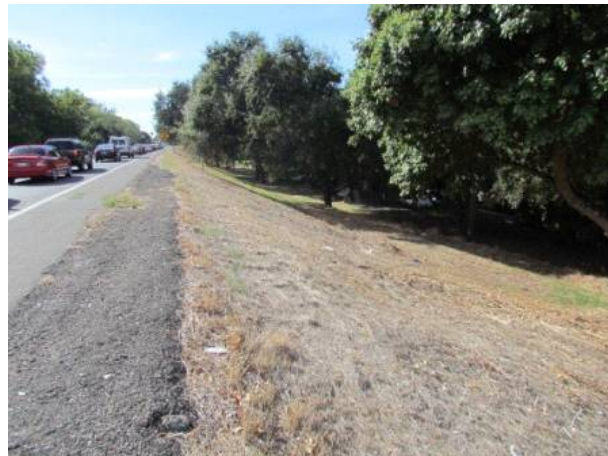
Levee Mile Report Line	2
Start Levee Mile	0.93
End Levee Mile	0.93
Location	Land Side
Category	Earthen Levee
Item	Vegetation
This photo is taken from the crown of the levee facing west looking down the landward levee slope. The levee has no unwanted vegetation and is properly maintained.	
mhoffman_f_20131009_651.JPG

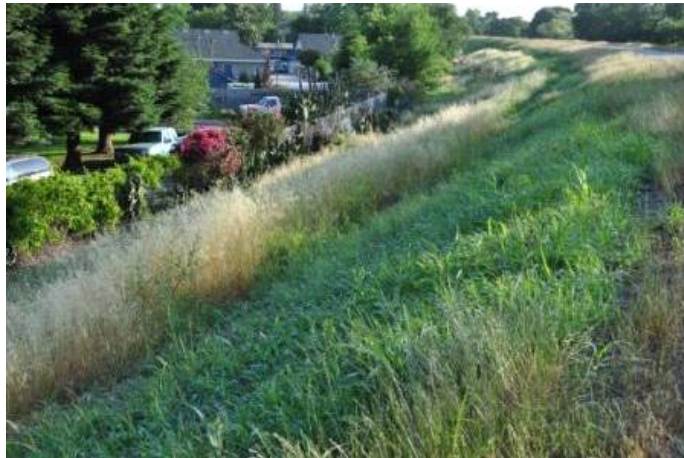
Fence with vegetation at L/S toe.

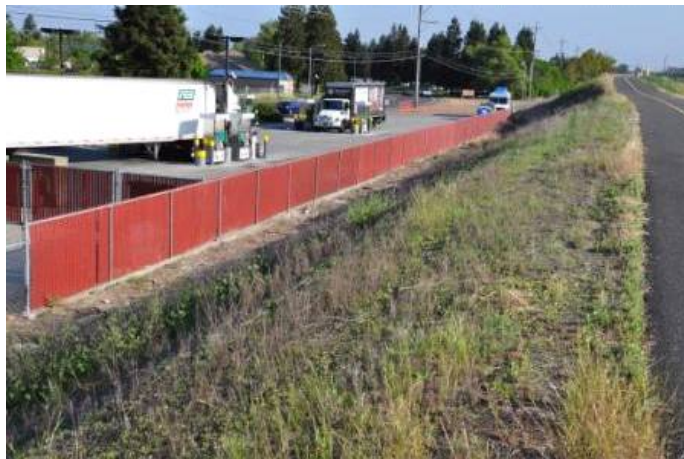
Levee Mile Report Line	6
Start Levee Mile	3.05
End Levee Mile	3.10
Location	Land Side
Category	Earthen Levee
Item	Encroachments

Fence within 10' of L/S toe.

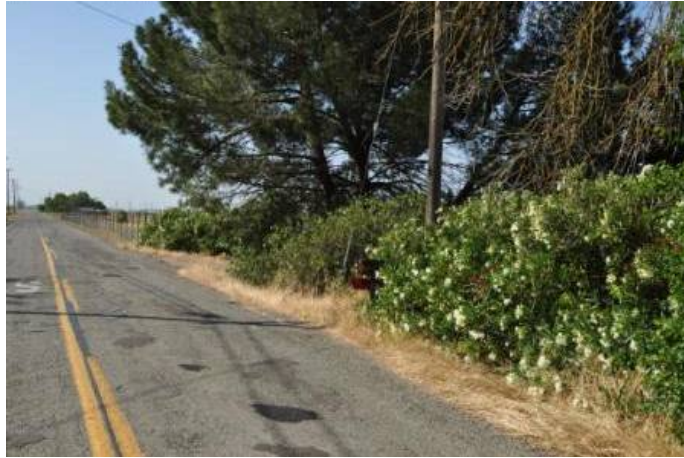
L/S landscaping.

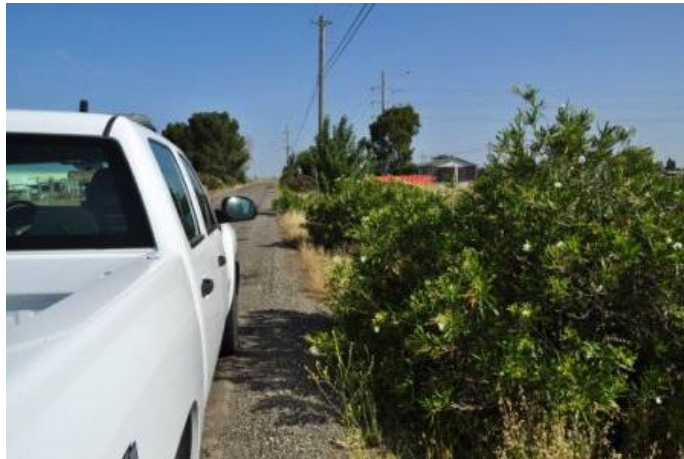
Levee Mile Report Line	11
Start Levee Mile	12.54
End Levee Mile	12.63
Location	Water Side
Category	Earthen Levee
Item	Vegetation

W/S vegetation.

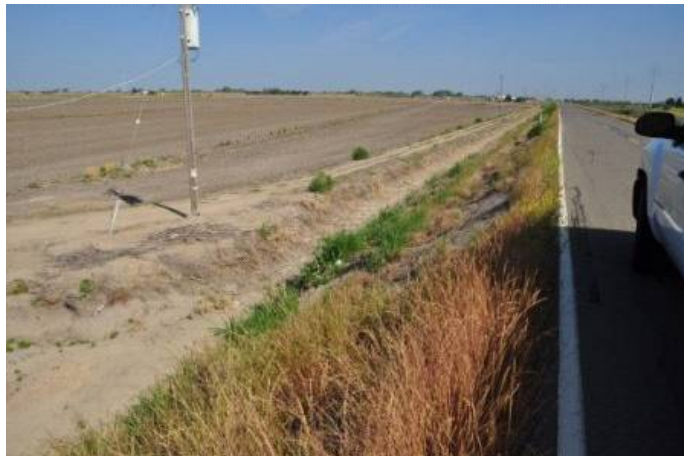
Levee Mile Report Line	12
Start Levee Mile	15.51
End Levee Mile	16.07
Location	Land Side
Category	Earthen Levee
Item	Encroachments

L/S Ag ditch @ L/S toe.

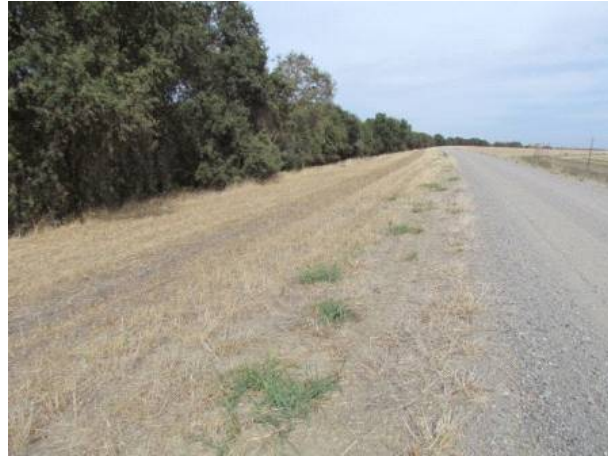
This photo was taken from the levee crown facing east looking down the waterward slope of the levee. The levee has no unwanted vegetation and receives an acceptable rating.
